May 16, 2018

Northwoods Condominium Association
600 Vail Valley Drive
Vail, Colorado 81657

Subject: Engineering Consultation
Golden Peak Improvements Project
Vail Ski Area
Vail, Colorado
Project No. GS06142.000-145

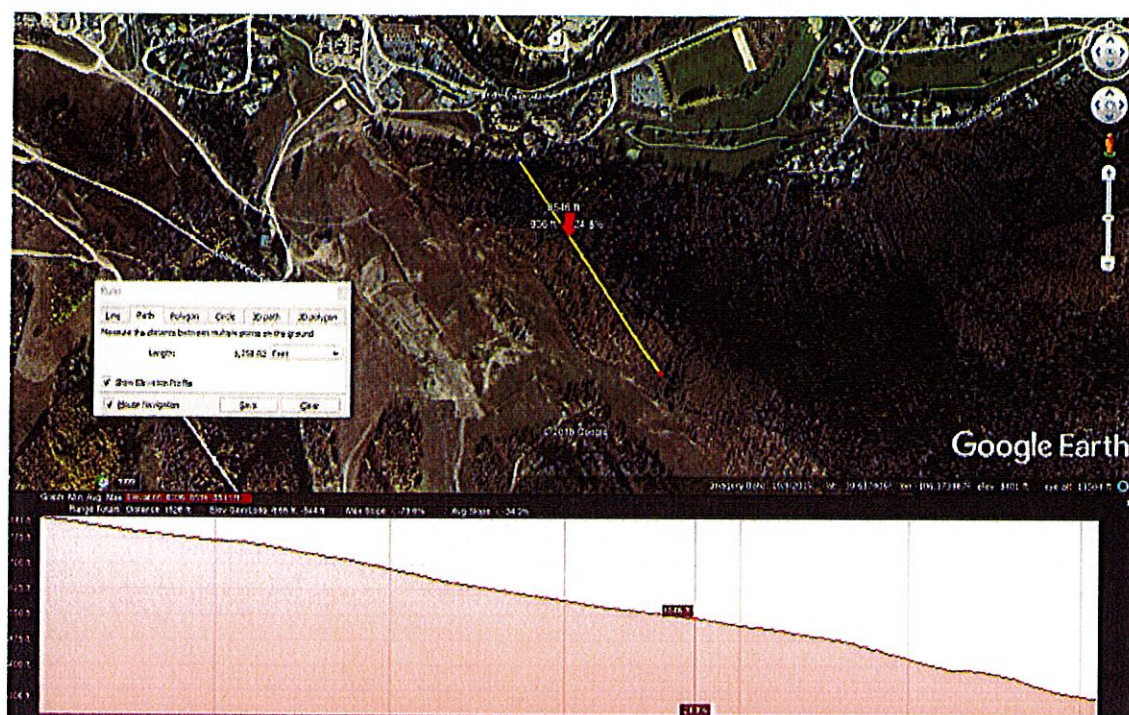
ment loads may be significant, especially if the Golden Peak features are constructed as proposed. A profile of the slope from the bottom of the mogul course to the ridge top above Northwoods is shown below.

This slope profile, generated with Google Earth, indicates that surface and subsurface water at the base of the mogul course is likely to travel to the slopes directly above the Northwoods property. Tree clearing, reshaped surface grades, and additional manmade snow required for the course is likely to increase the amount of surface runoff and subsurface water to the slope directly above Northwoods. This could increase driving forces for slope failures and sediment loads resulting in mudfloods and mudflows.

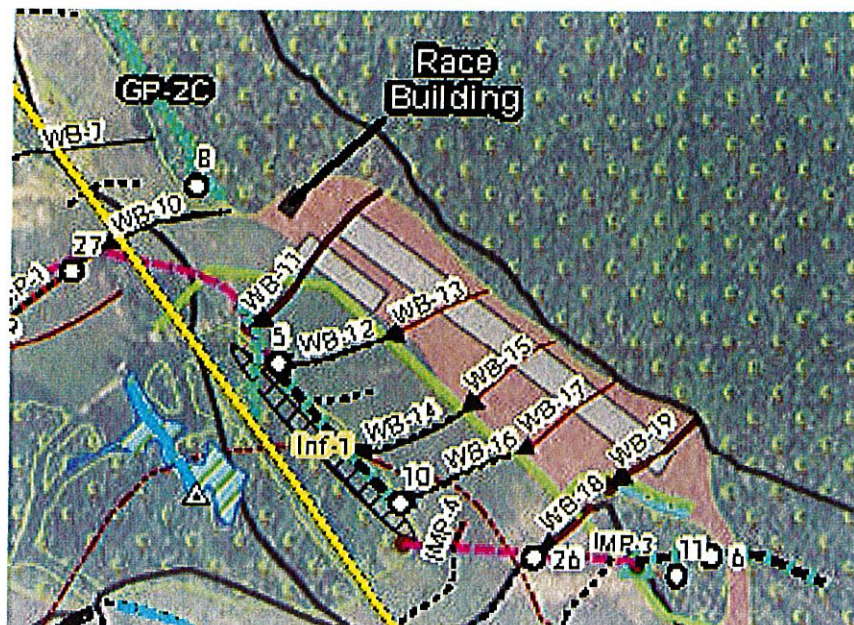
Drainage improvements related to basin GP-2G and the mogul course are indicated on the figure below taken from the LRE report. New water bars (i.e., ditches) WB-11, WB-13, WB-15, WB-17 and WB-19 are proposed to be built. Existing water bars WB-7, WB-10, WB-12, WB-14 and WB-16 would be improved and enlarged. The existing drainage channel IMP-3 would be enlarged with enhanced erosion control.

The planned drainage improvements are positive, but not designed with the intent of mitigating risk of landslides, mudfloods, and mudflows that could affect Northwoods. Considering that a substantial degree of risk from flooding and mudflow currently exists and mogul course construction could increase the risk, we recommend this risk be evaluated by the Forest Service in a supplemental DEIS. Potential Project Design Criteria or new alternatives may range from not constructing the mogul course, moving of the planned mogul course, or construction of berms, lined detention ponds and subsurface drains, none of which have been analyzed in the DEIS or associated reports.

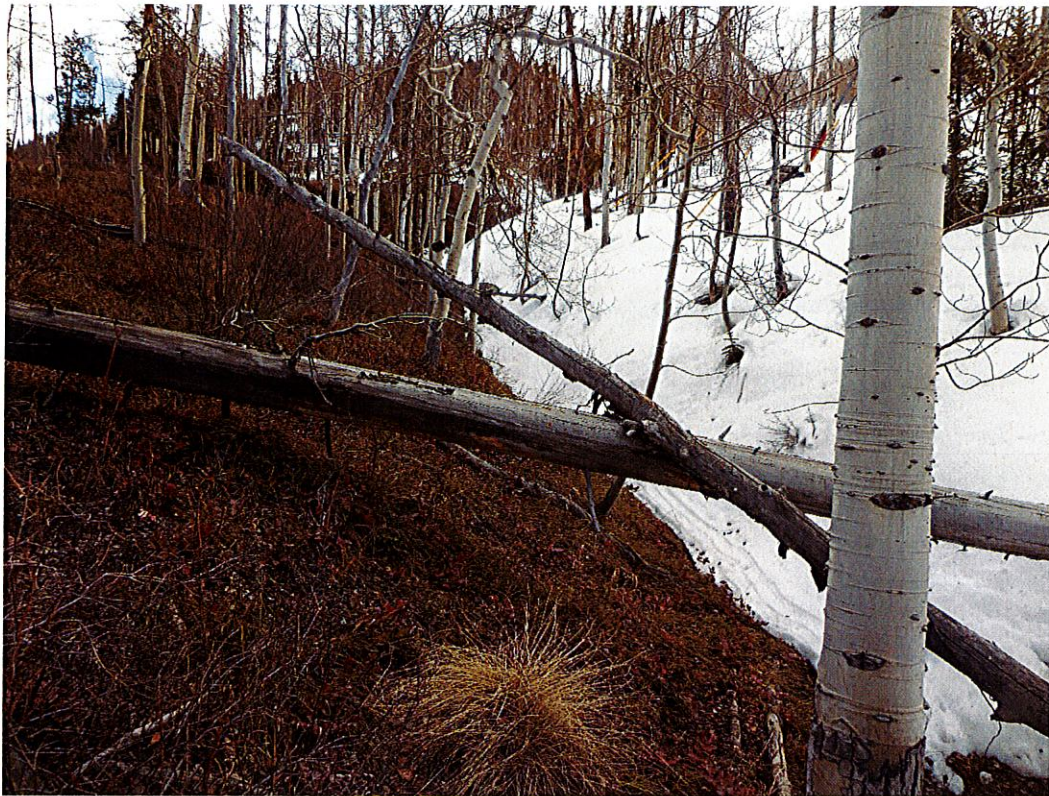
Incised Drainage Channel Above Northwoods
