## Field Review Pocahontas TS Unit 1

Eastern Divide Ranger District, GWJ

March 19, 2019

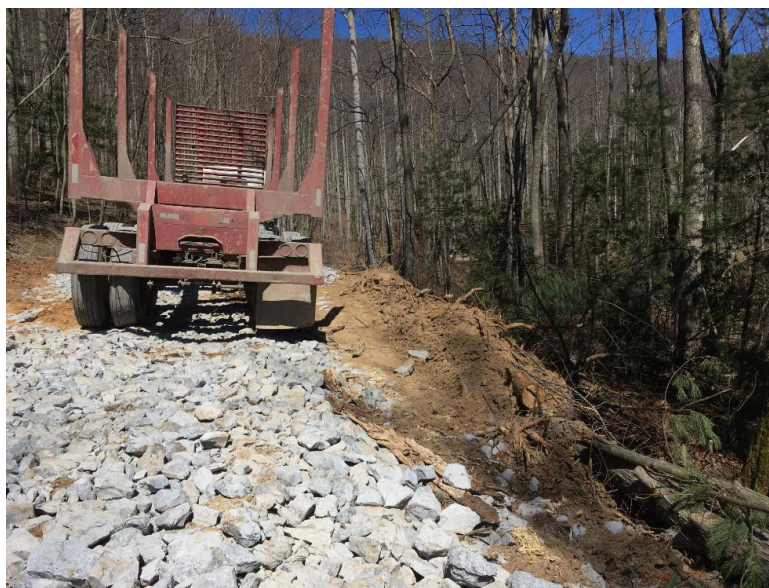
**Observation 1:** The temporary road is on the west side of Unit 1 within 60 feet of the edge of the wetland; the slope was less than 10%. It is surfaced with large erosion stone. Appropriately, the sale administrator added a section of silt fence at the edge of the road. There was no obvious sediment leaving the road surface toward the wetland. The decision to construct the road at this location was made during the logging operation on site with the contractor. It was not identified as being necessary to encroach on the riparian corridor during project planning.

**Comments/Recommendations:** In the Forest Plan, motorized vehicles outside of designated crossings, and ground disturbing activities, may be allowed in the riparian corridor on a case-by-case basis, after site specific analysis. Any activity allowed under these conditions is minimized and effective sediment trapping structures are required. The need for this should be identified up front in the planning process so that specialist input can be provided and adequate mitigation measures developed. In addition, this would allow for disclosure during effects analysis. Wetland is to the right in the picture below. We discussed in field that during unit close out it would be best not to disturb the loose dirt by pulling the brush back into the road, but rather stabilize it in place.

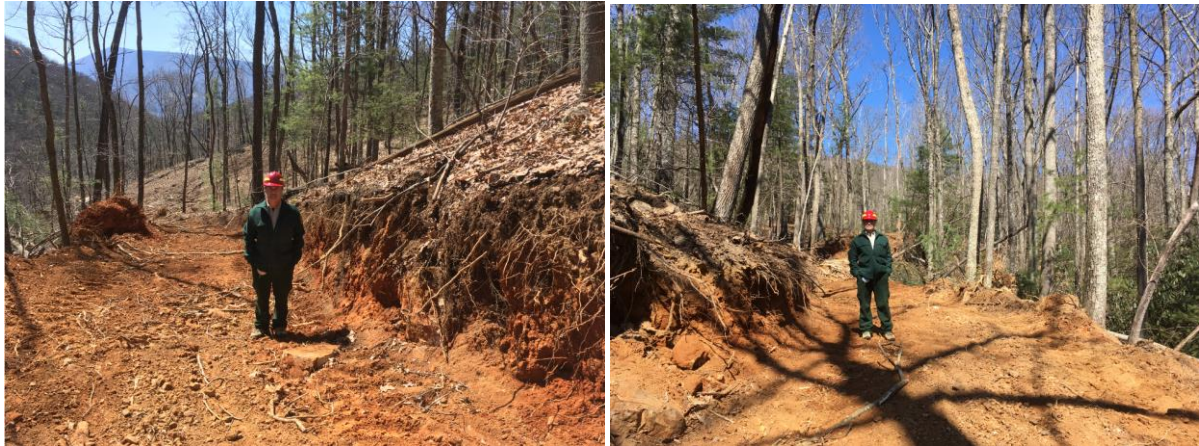
**Observation 2:** An unauthorized skid road was bladed into the west side of Unit 1, with a 5 foot high cut bank. This was not the skid road location previously agreed to and flagged by the contractor and sale administrator. The skid road is just outside the riparian corridor.

**Comments/Recommendations:** This location should be closely monitored during continued use; because of steeper slopes (particularly if there is wet weather) there is potential for rutting and erosion into the riparian corridor that could reach the perennial stream. There was discussion on how to effectively rehab this road during close out of the unit. To pull slash and soil back into the road profile would take an excavator. The pictures below depict the road looking downhill and uphill.

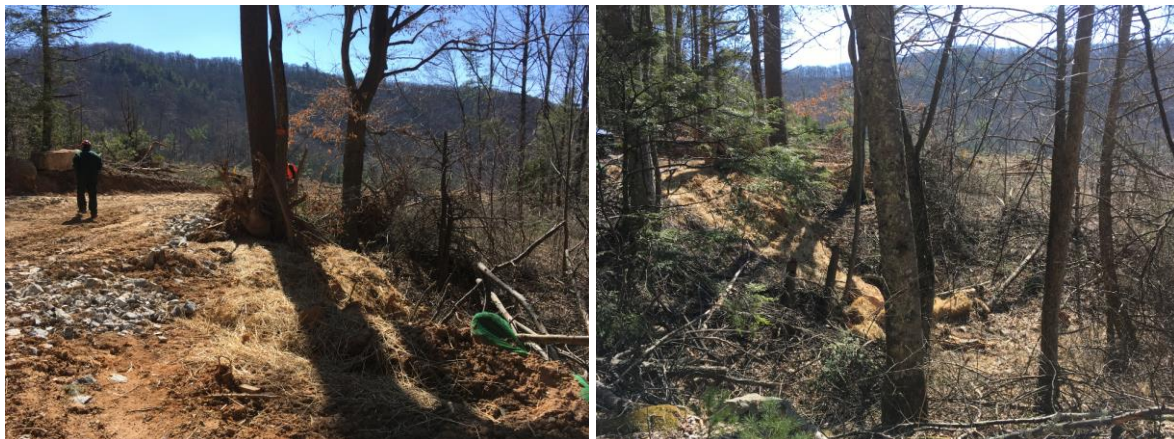
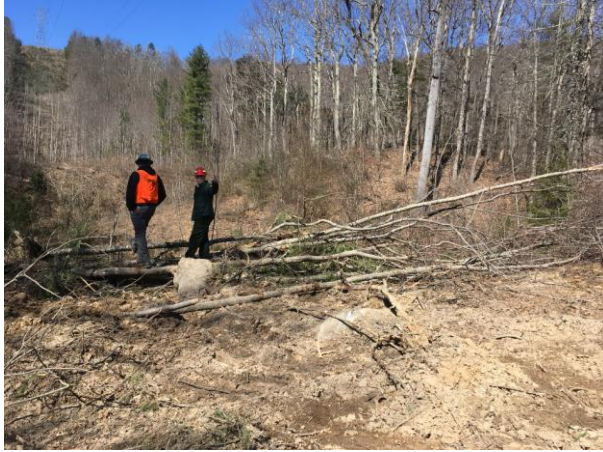
**Observation 3:** Soil was pushed into the head of a drainage, pushing aside the filter sock placed by MVP at the entrance road to the east side of Unit 1. Straw was spread on the loose soil over the bank, and straw bales were placed at the bottom of the bank. In addition, slash and soil were pushed into the riparian corridor of the same stream, under the powerline.

**Comments/Recommendations:** These actions were unnecessary and unacceptable. Additional erosion control in the form of silt fence or filter socks should be placed at the edge of the road and the head of the drain. Bare soil within the riparian corridor should be protected with either a thick mattress of slash, or seeded, fertilized and mulched. The first picture shows the soil pushed into the drain with the filter sock pushed aside. The second picture shows the hay bales at the bottom of the bank, and edge of the seep. The third picture depicts the slash and bare soil within the riparian corridor.

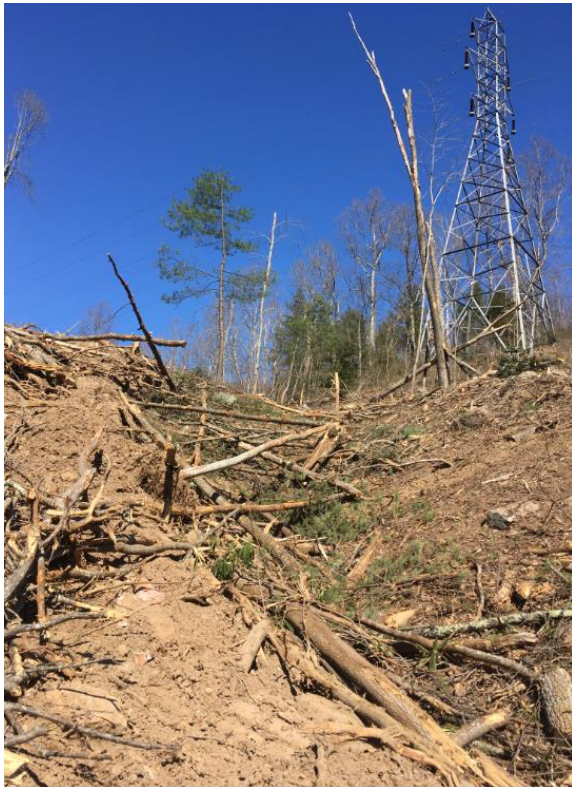
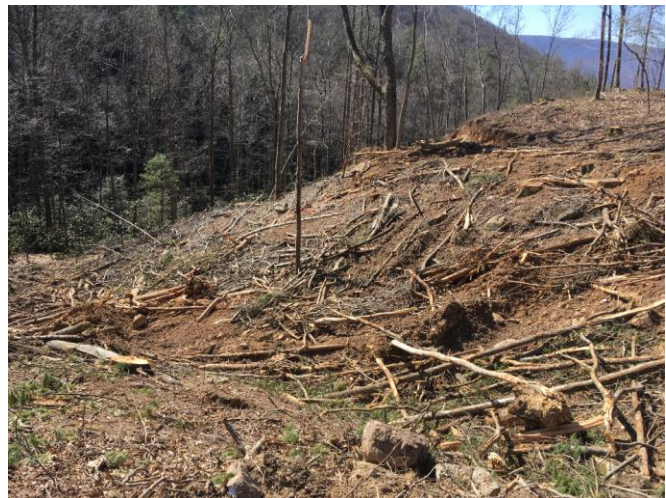
**Observation 4:** There was an unauthorized skid trail parallel to and then crossing an ephemeral drainage on steep slopes on the east side of Unit 1, with soil pushed into the drain. Waterbars were constructed, but pointing the wrong direction, funneling water towards the drain. There was an alternative to cross the area on a gentler grade outside of the drainage that was not utilized.

**Comments/Recommendations:** The bare soil should be stabilized immediately with either a thick mattress of slash, or seeded, fertilized and mulched. Erosion and sediment control measure should be taken so that loose soil does not travel further down the drainage and waterbars constructed properly. First picture is looking up the trail adjacent to the drainage. Second picture is looking down the ephemeral channel.

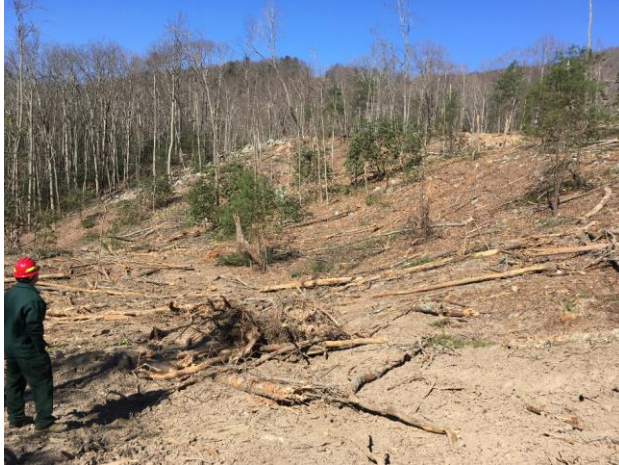
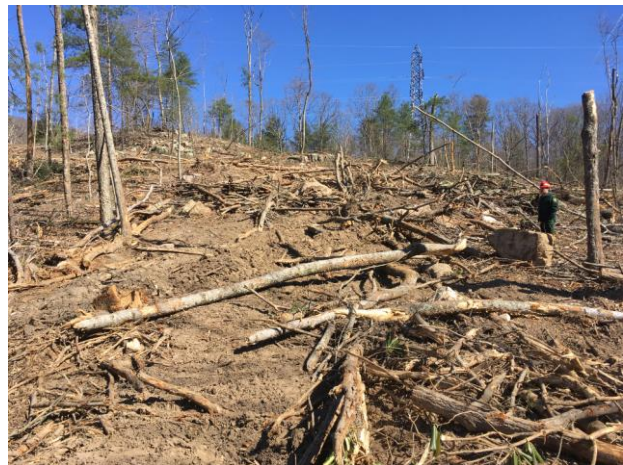
**Observation 5:** Much of the unit had bare soil that had been bladed or disturbed by heavy equipment. It is understood that the unit has not been closed out yet, but there was inadequate slash on the skid trails, in addition, there did not seem to be enough slash on site to cover all of the bare ground.

**Comments/Recommendations:** Winter wheat or annual rye and mulch should be used to cover exposed ground where slash is lacking to provide proper erosion protection. The first picture shows exposed ground and little slash to pull in. The second picture shows a skid trail with a waterbar pointing the wrong direction.
