**Independent Expert Engineering Investigation and Review Panel**

# **Report on Mount Polley Tailings Storage Facility Breach**

**January 30, 2015**

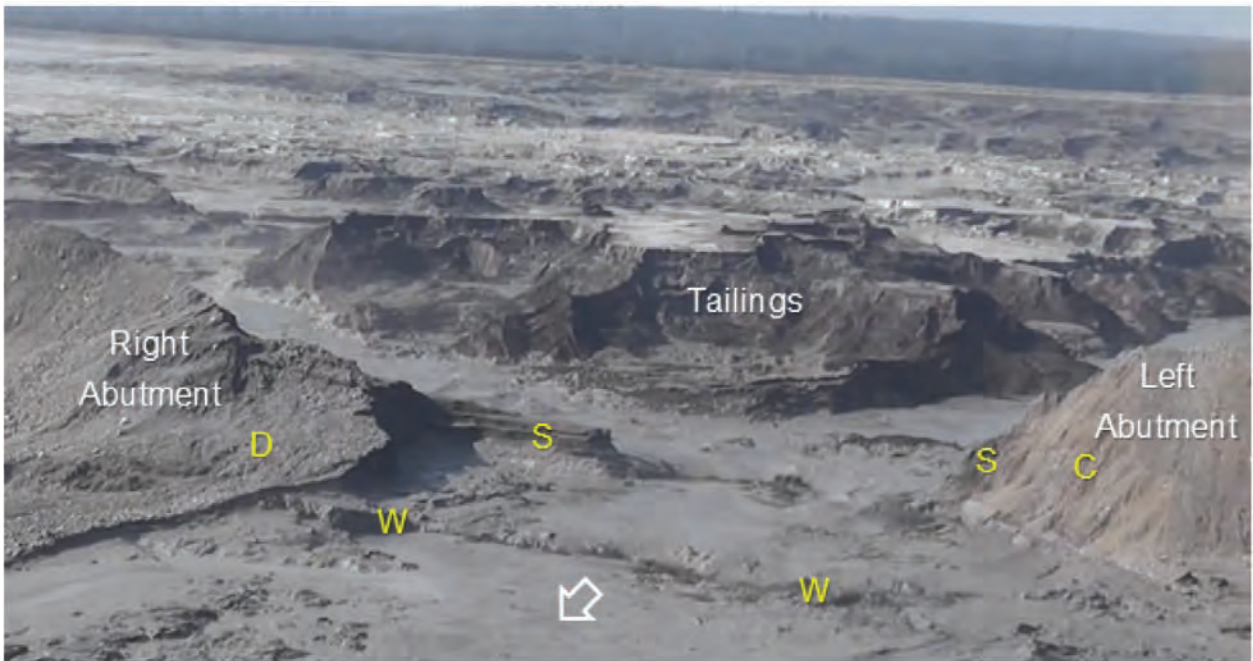
**FIGURE 5.1.1: VIEW LOOKING UPSTREAM THROUGH THE BREACH (ARROW SHOWS DIRECTION OF OUTFLOW)**

The labelled features in **Figure 5.1.1** can be interpreted with reference to the internal zoning of the dam previously provided as **Figure 4.1.1**. On the upstream side of the breach, remnant projections of the dam core (S) can be seen on the left and right abutments. The projection on the right abutment acts like a jetty in directing flow toward the left abutment.

Zone C rockfill (C) is exposed on the left abutment, where it has been eroded by these redirected breach outflows. On the right abutment, the surface of the displaced rockfill (D) was subject to erosional overflow during earlier stages of breach development. It was subsequently protected from erosional undercutting in the main channel by the projecting core remnant and eddies that developed downstream.

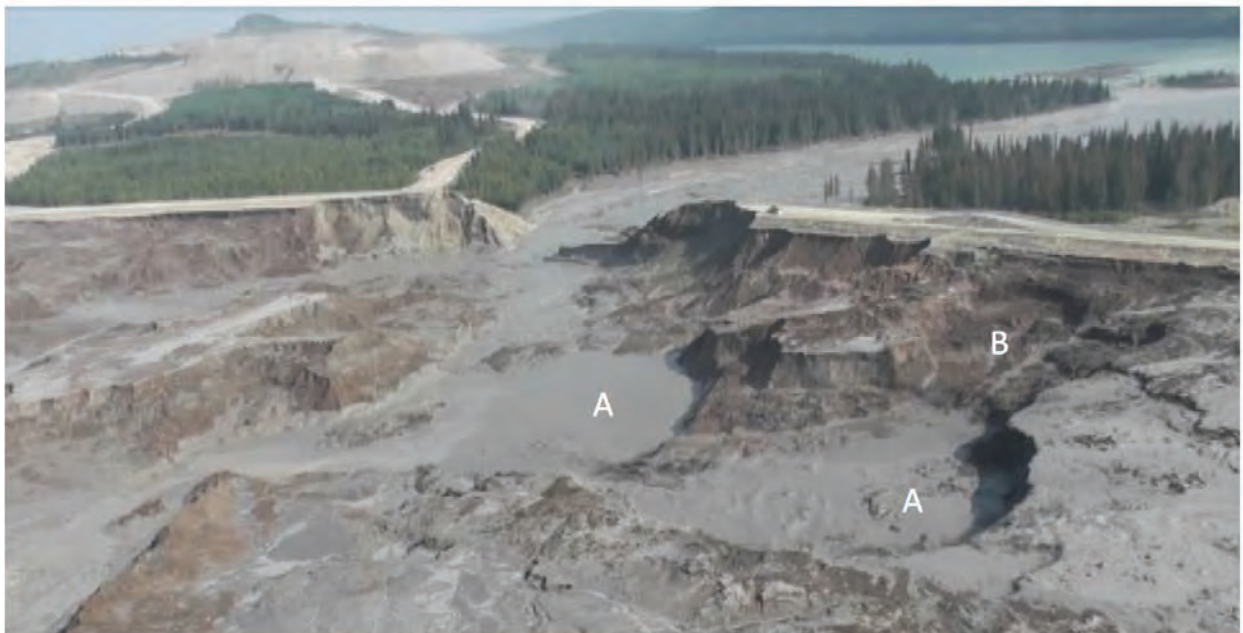
**FIGURE 5.1.2: VIEW LOOKING DOWNSTREAM SHOWING UPSTREAM SIDE OF DAM AND REMAINING TAILINGS**

At this point, two major flow channels have developed within the impoundment that converge at the upstream entry to the breach. In the distance (centre left), one of these can be seen flowing along the left side of the dam. As it did so, it eroded away the supporting tailings. This caused the upstream side of the dam to collapse, leaving the prominent near-vertical face. These structural effects are again best appreciated with reference to **Figure 4.1.1**.

Conditions adjacent to the right side of the dam illustrate how the combined action of fluvial erosion and tailings flowsliding produced similar effects. The active flowslide (B) has left a semicircular headscarp that is progressing back and undermining the Zone U tailings supporting the upstream side of the dam core. Arcuate headscarps of earlier flowslides (A) have captured and concentrated overland flows from surface water remaining in the impoundment. The resulting cascades readily transport flowslide debris, while at the same time causing backward erosion of the headscarps by scour within their terraced plunge pools.

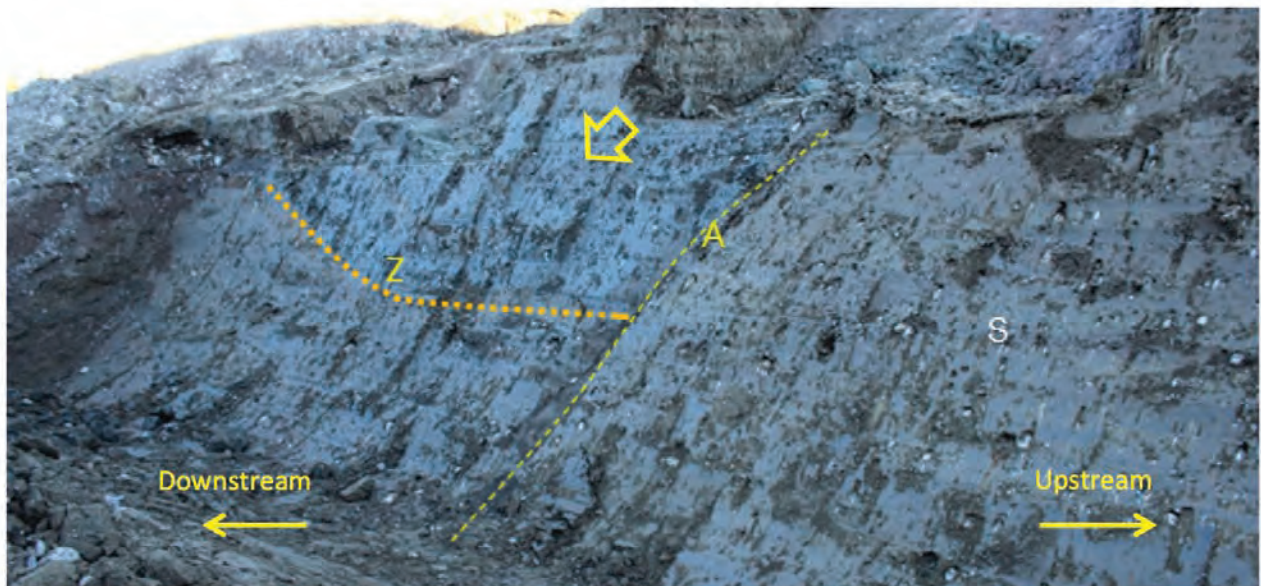
**FIGURE 5.1.3: SHEAR SURFACE THROUGH REMNANT DAM CORE (ARROW INDICATES DIRECTION OF DOWNDROP)**

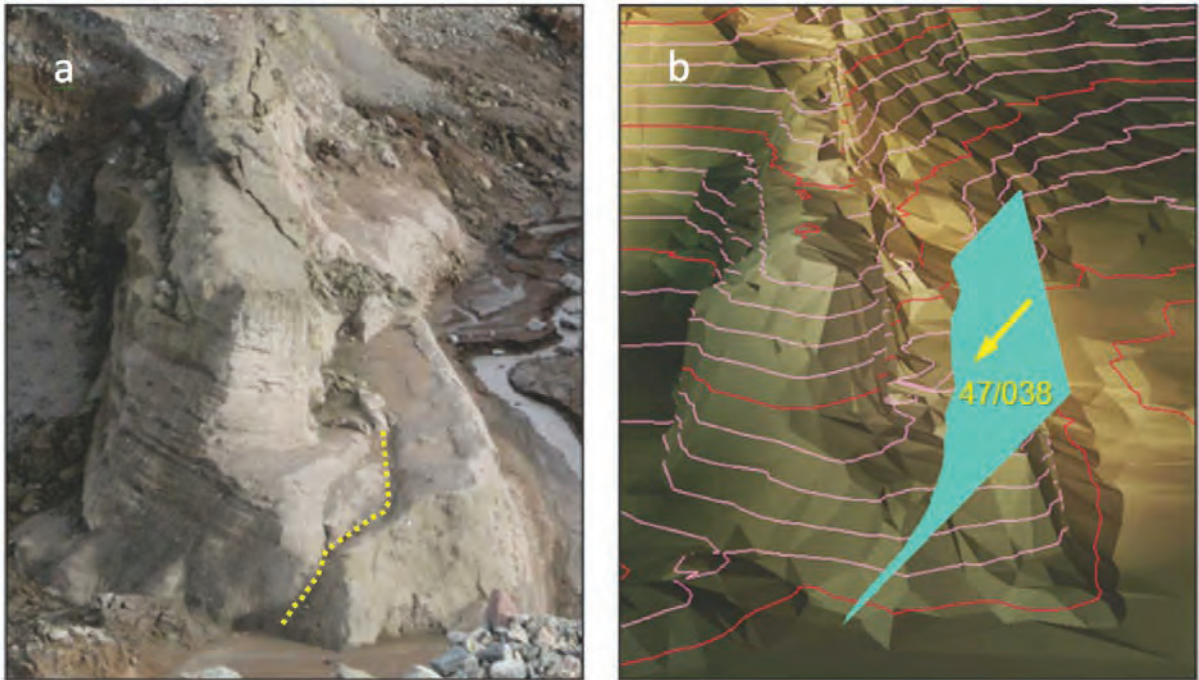
The surface trace and 3-D orientation of the shear are shown on the core remnant in Figure 5.1.4, with a dip angle and direction as indicated.

**FIGURE 5.1.4: PHOTO (a) AND SURFACE MODEL (b) SHOWING SHEAR SURFACE ORIENTATION**

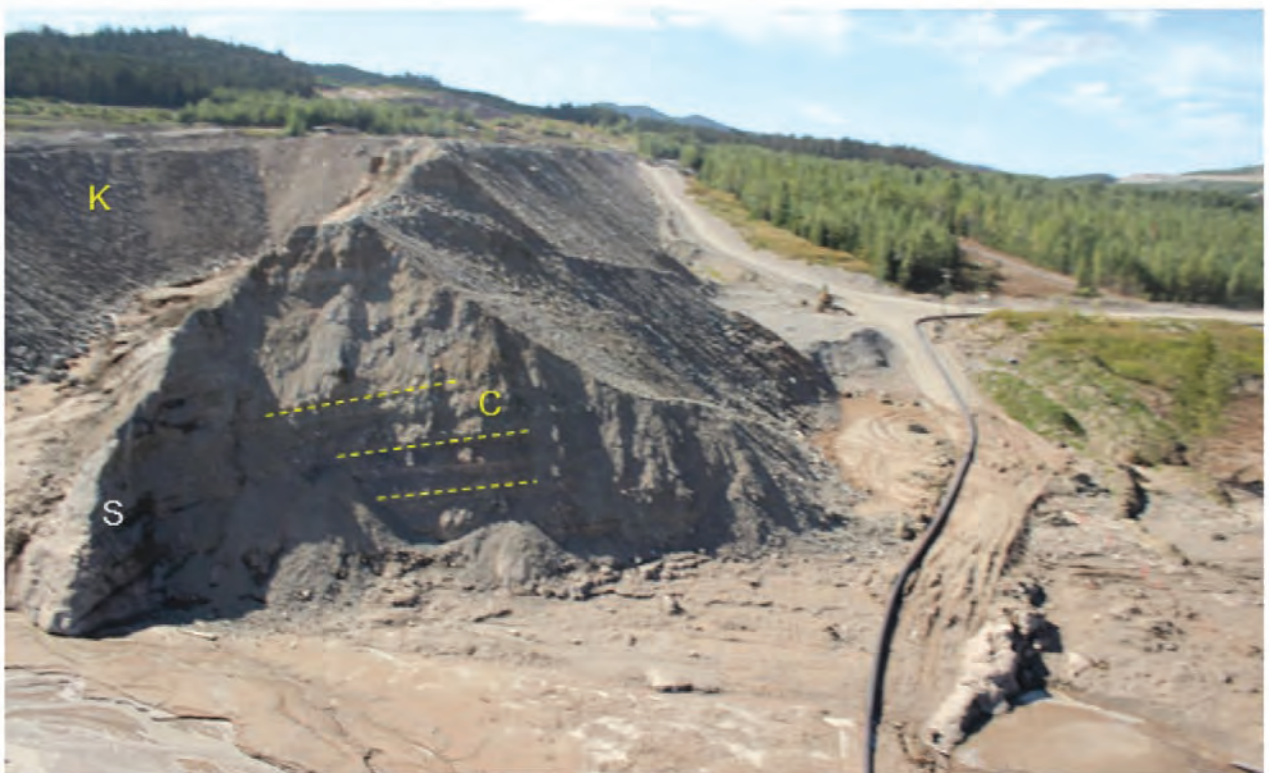
Other artifacts of foundation sliding are evident elsewhere. As indicated in **Figure 5.1.5**, lift lines in the Zone C rockfill on the left abutment (C) are tilted at an inclination of 7° to 10°, with corollary inclinations on the right abutment of 5° to 14°. Also shown in **Figure 5.1.5** are the Zone S core (S), with a containment dike (K) under construction in the background. Scarps higher on the left abutment were produced by post-sliding downdrop of large slump blocks into the breach due to erosional undercutting at foundation level.

**FIGURE 5.1.5: APPARENT BEDDING ROTATION ON LEFT ABUTMENT OF BREACH (SEPT. 4, 2014 PHOTO)**

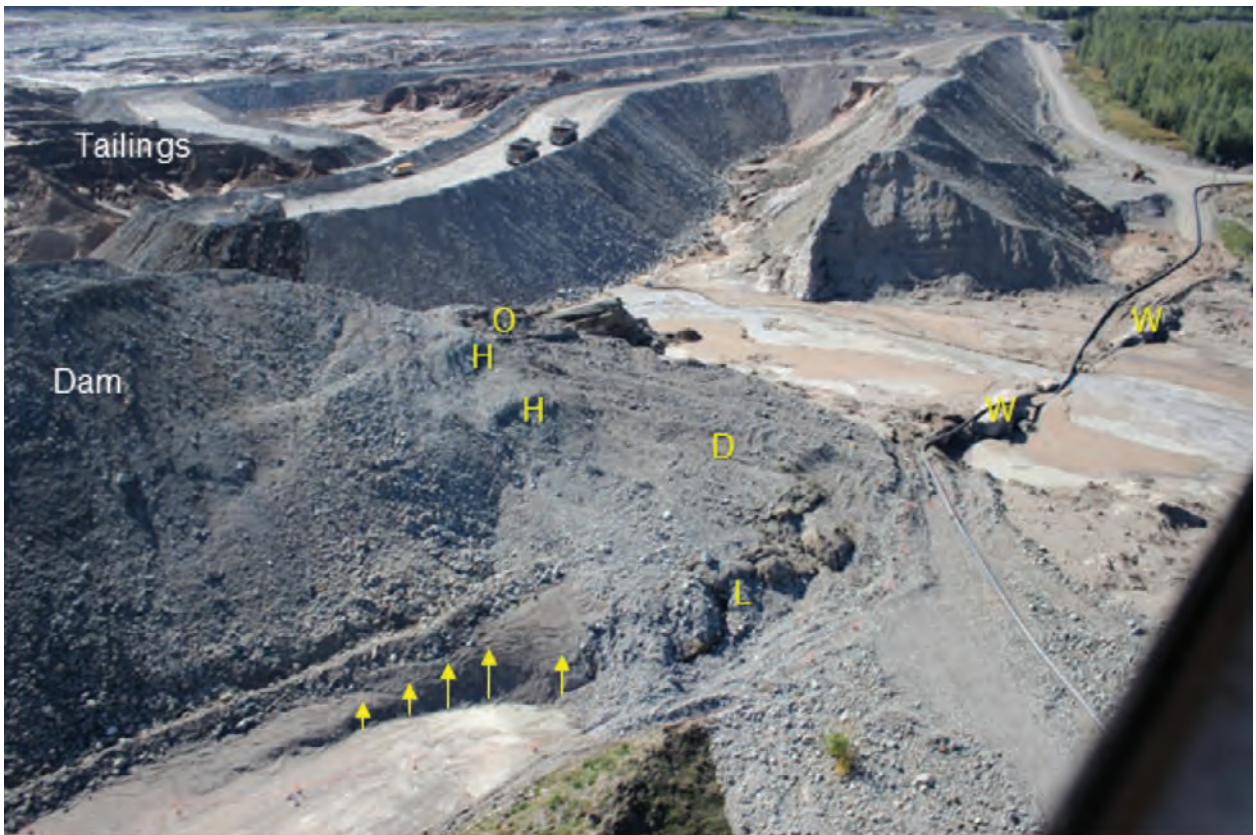
**Figure 5.1.6** shows the right abutment, with the left abutment in the background. Noteworthy features include open cracks (O) and headscarps (H) at higher elevations. At the downstream toe, upthrust of foundation till (L) ranging from 2.8 m to 3.5 m has occurred along an alignment collinear with the whaleback (W).

**FIGURE 5.1.6: SLIDING-RELATED FEATURES AT RIGHT ABUTMENT (SEPT. 4, 2014 PHOTO)**

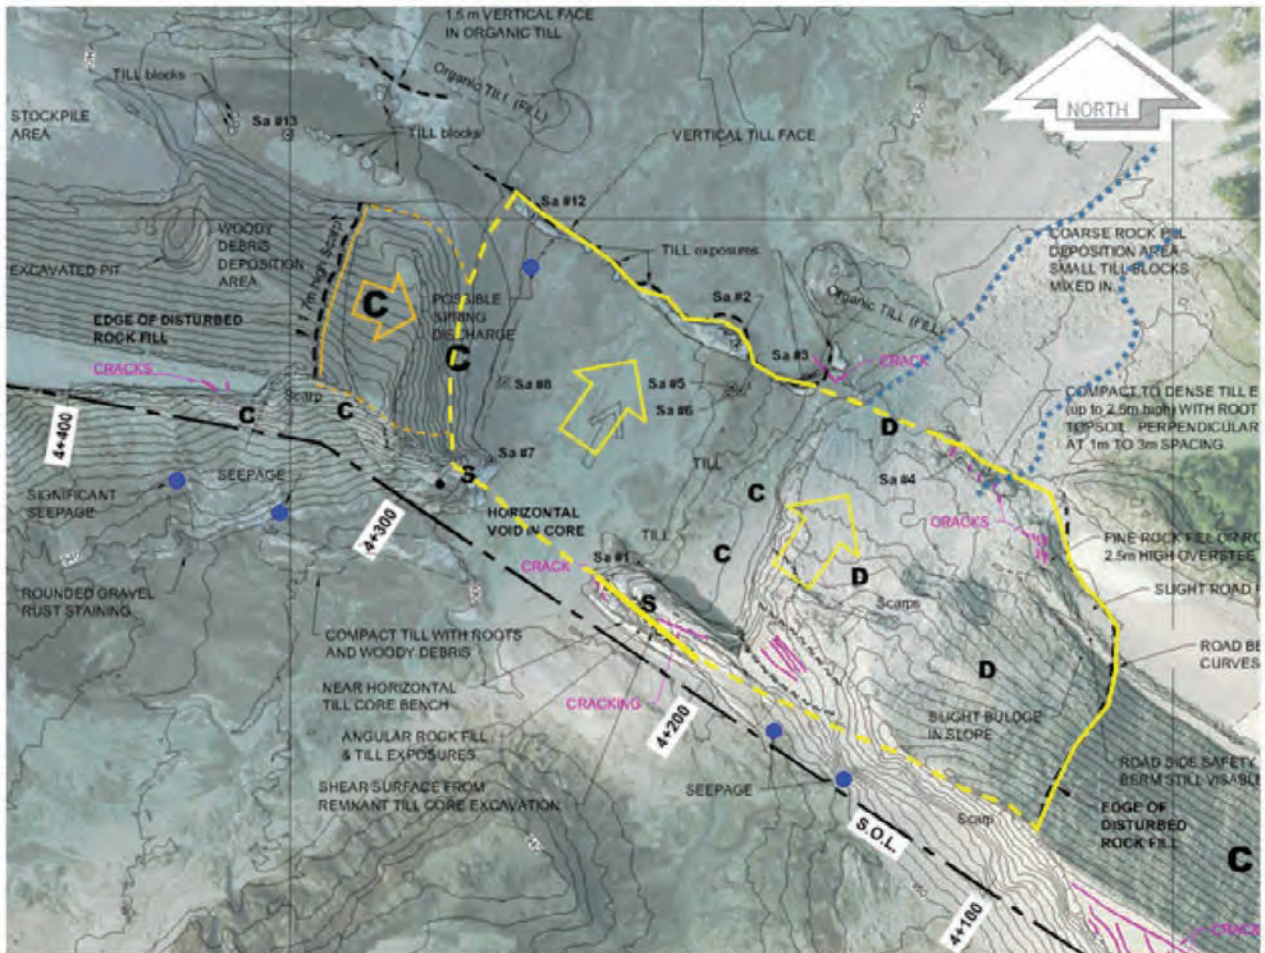
Surface investigations delineate the limits of foundation sliding given in **Figure 5.1.7**, with the solid and dashed yellow lines indicating observed and inferred boundaries, respectively. These are superimposed on the post-failure orthophoto and contours to show the extent of mass movement in relation to the breach. Arrows indicate directions of movement from surface observations.

**FIGURE 5.1.7: PLAN SHOWING DIRECTION AND EXTENT OF MASS MOVEMENTS**

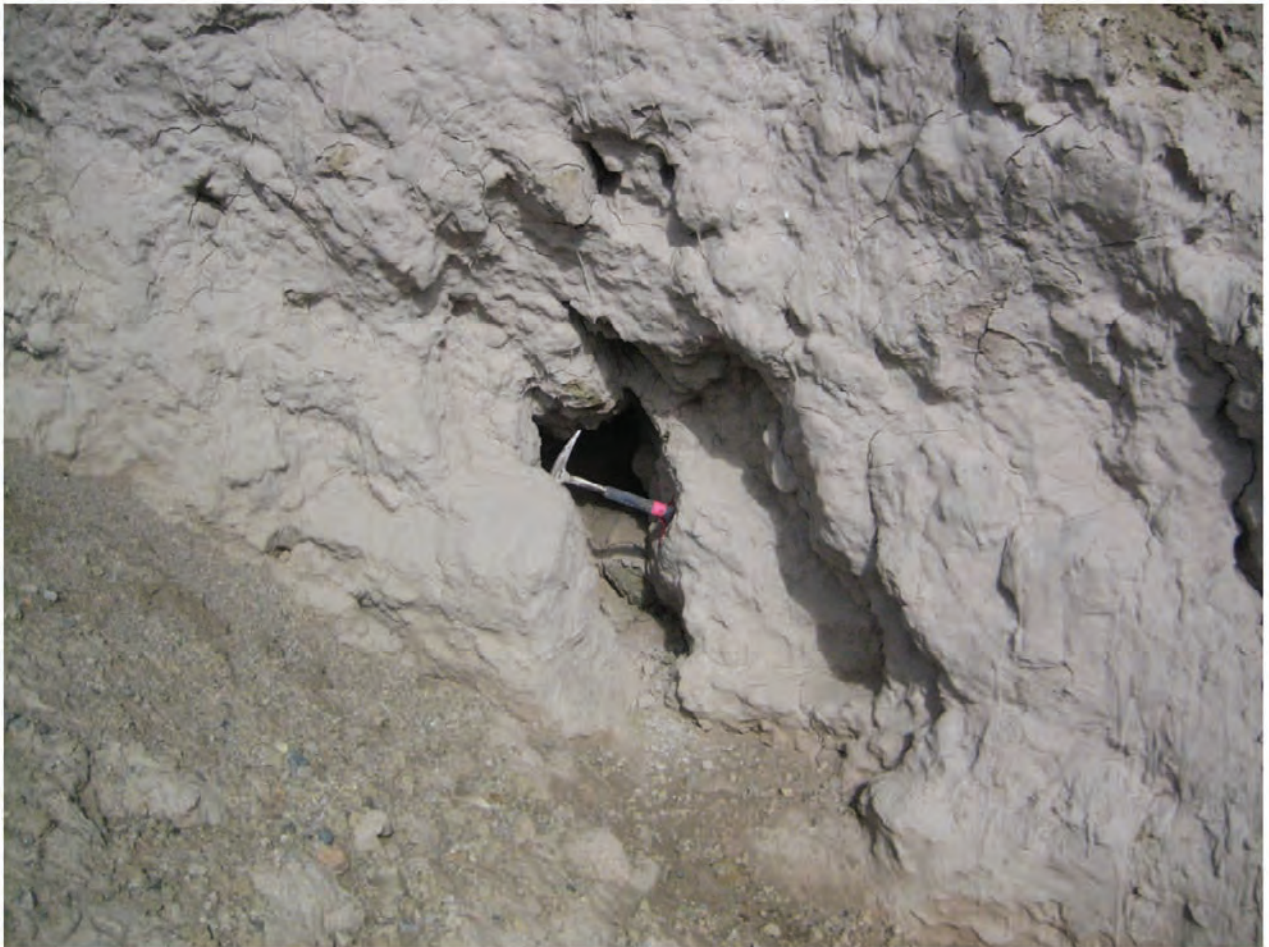
**FIGURE 5.1.8: VOID ON UPSTREAM SIDE OF LEFT ABUTMENT**

Additionally, Zone F filter material immediately downstream from the core was sampled in the right abutment excavation. Gradation data show that none of these samples met filter criteria that would have enabled them to prevent transport of fines from the till. Together, these factors suggest internal erosion as the likely cause of the left abutment void.

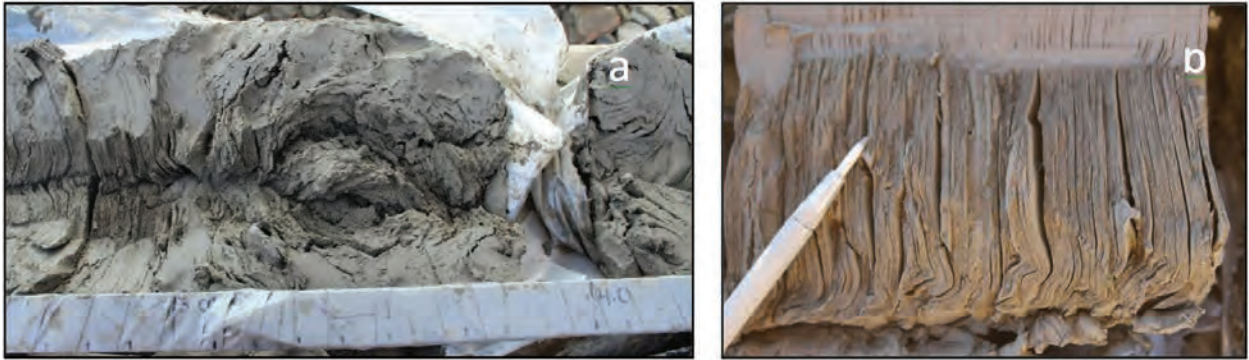
**FIGURE 5.2.8 UPPER GLU (a) INSIDE THE BREACH, (b) OUTSIDE THE BREACH**

The thinly laminated, planar varving outside the breach contrasts sharply with the contorted and folded laminations within it. This is consistent with shearing of the Upper GLU having occurred within the breach.

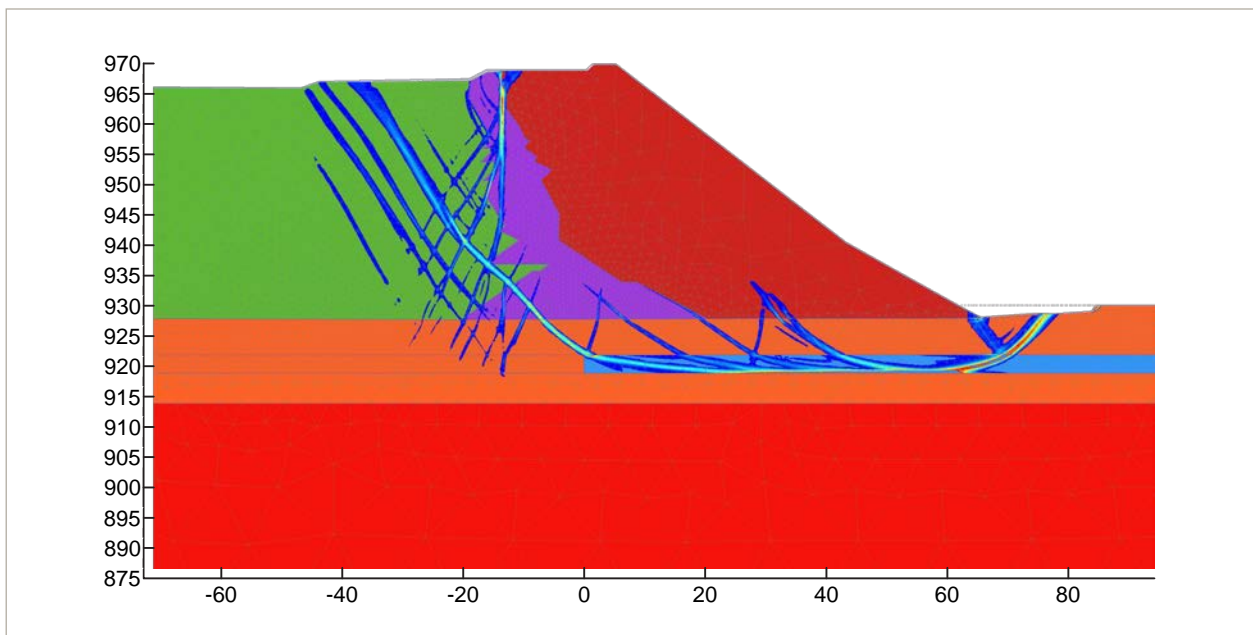
**FIGURE 6.2.3: PLAXIS MODEL AT COLLAPSE (UNDRAINED STRENGTH RATIO 0.29)**

Both the entry and exit of the failure surface in the foundation correspond closely with field observations summarized in **Figure C4.2.2** in Appendix C.

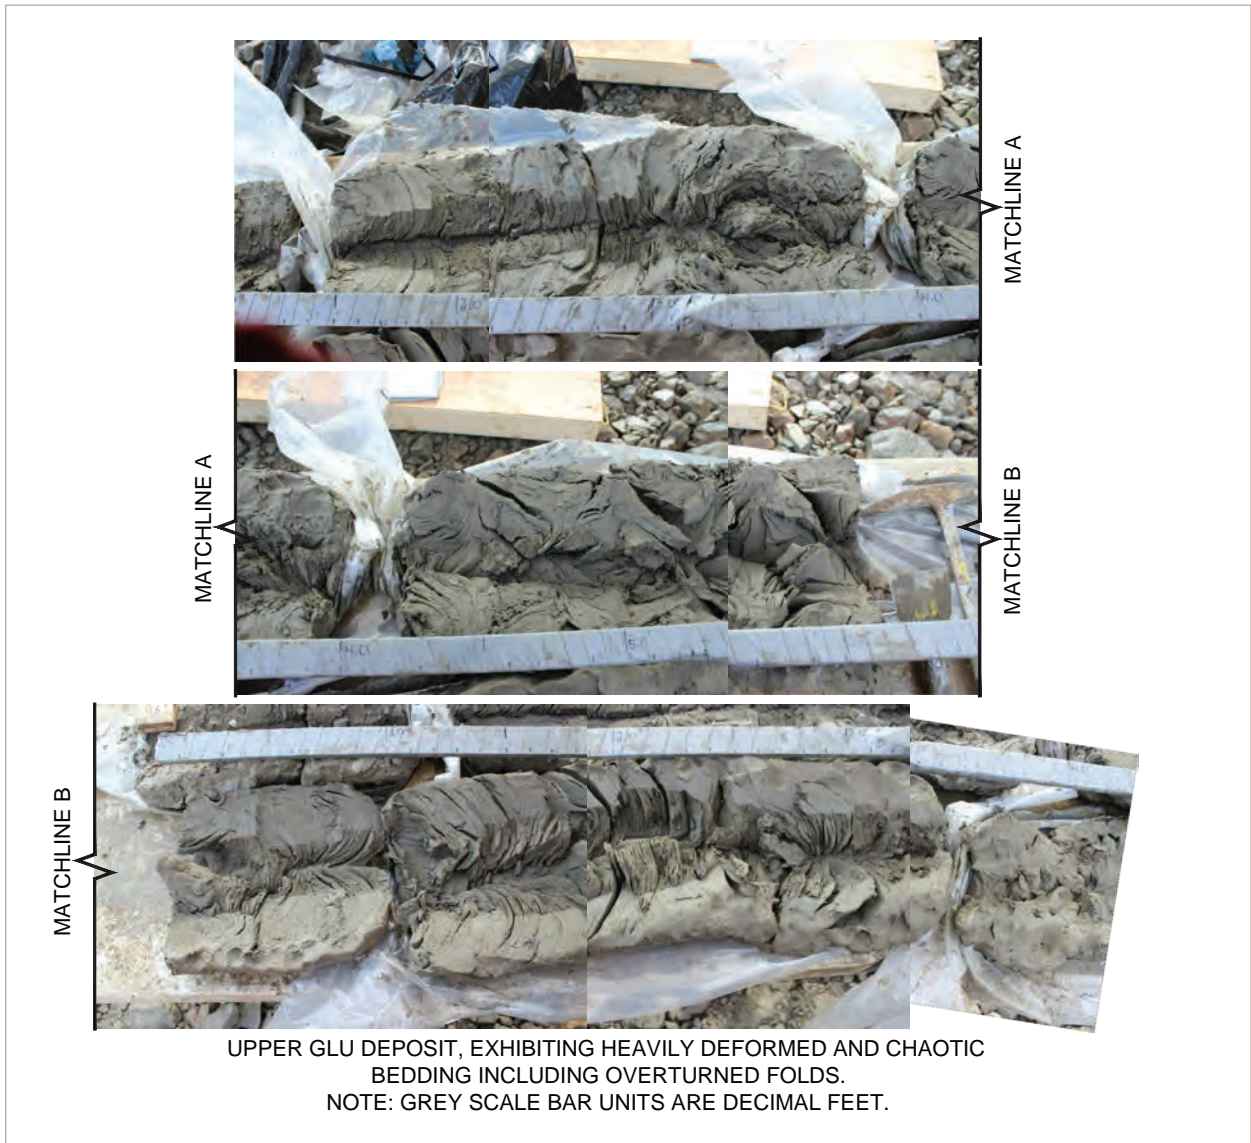
**FIGURE 6.2.6: TYPICAL SHEARING IN THE UPPER GLU**
