Environmental Audit Of the Greens Creek Mine

FINAL REPORT

SRK Project 1UK005.001

March 2009

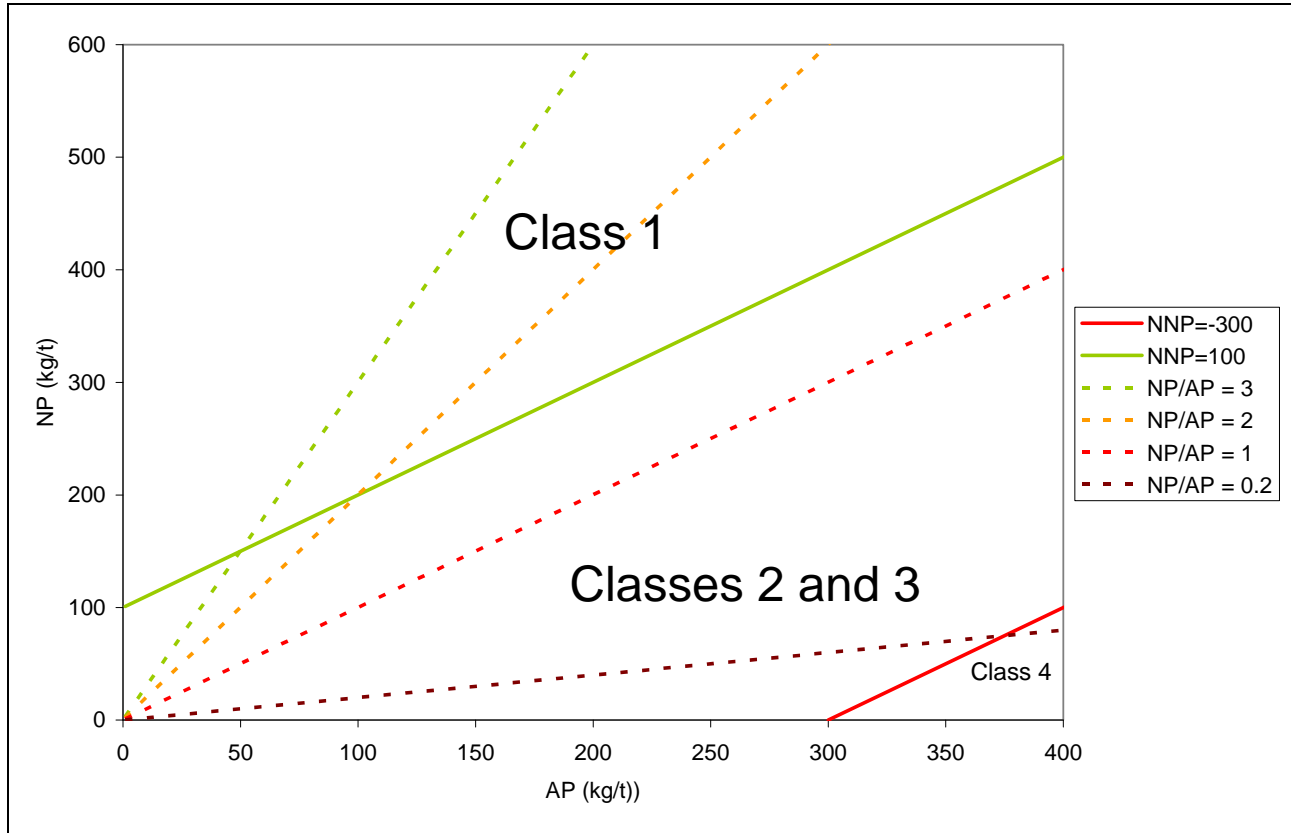
- Dispatch system – the possibility for classification errors exist. This is mitigated by the visual association of Class 1 with the argillites which are darker than the phyllites. During the audit, the piles were visibly distinctive.

In summary, the classification system has limitations; however these do not fundamentally affect the assessment of the geochemical stability of the production rock dump.

Figure 3: Production Rock Classification System – Comparison of NNP and NP/AP Criteria

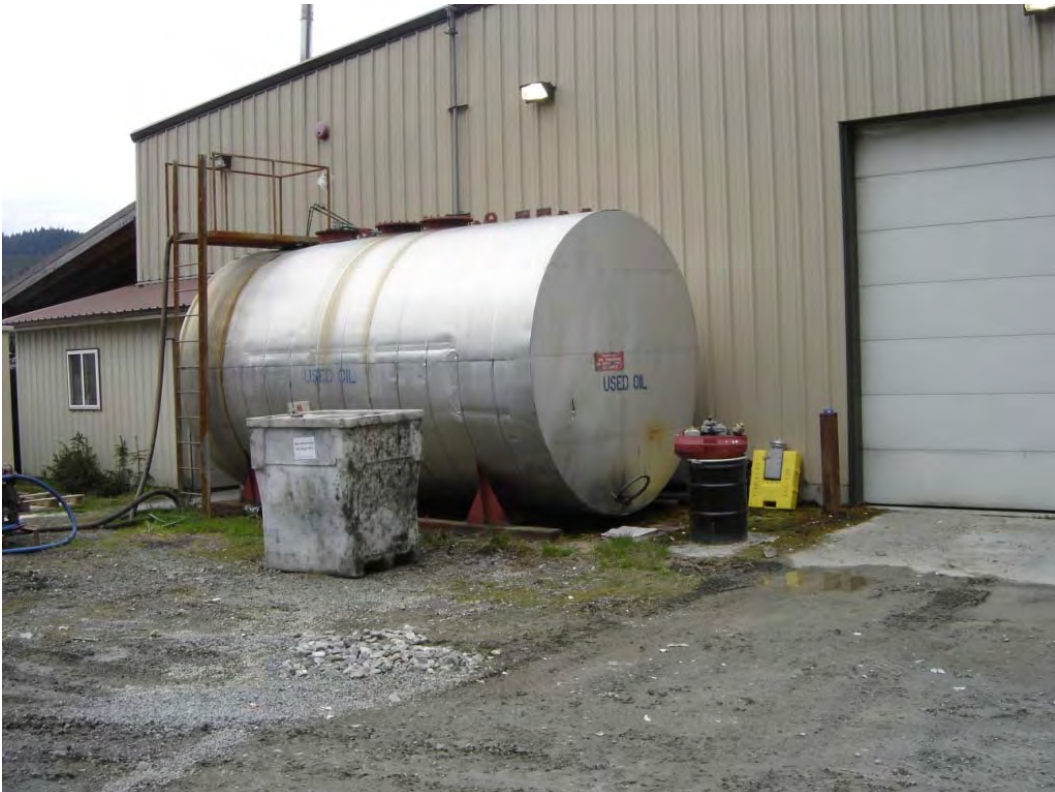
There is a 10,000-gallon tank containing used oil located at the Hawk Inlet Warehouse for which no secondary containment is provided (Photo 2). SRK recommends that HGCMC consider providing secondary containment for this tank.

Photo 2: Used Oil Tank at Hawk Inlet Warehouse
