SOUTH PLATTE BASELINE STUDY

October, 2018

This report has been prepared by Carol Ekarius, Executive Director of the Coalition for the Upper South Platte (CUSP).

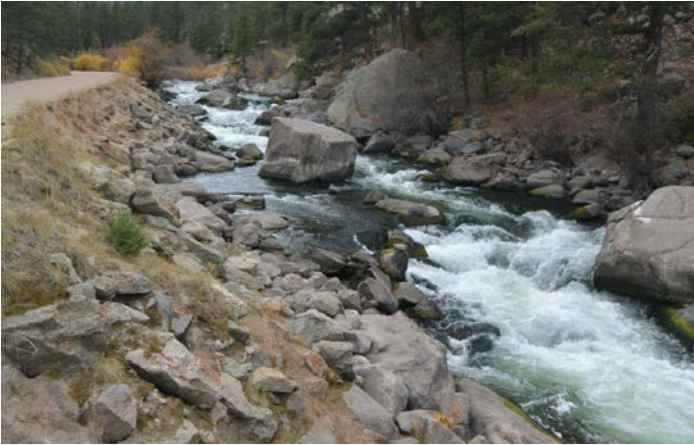
Reach 29 has several areas of highly eroding bank, driven primarily by proximity to the road, parking, and fishermen climbing up and down the banks to enter the river.

RECOMMENDATION: We recommend that in the future the partners install rock stair points to help stabilize the banks, and that the U.S. Forest Service remove parking areas adjacent to the river in this reach.

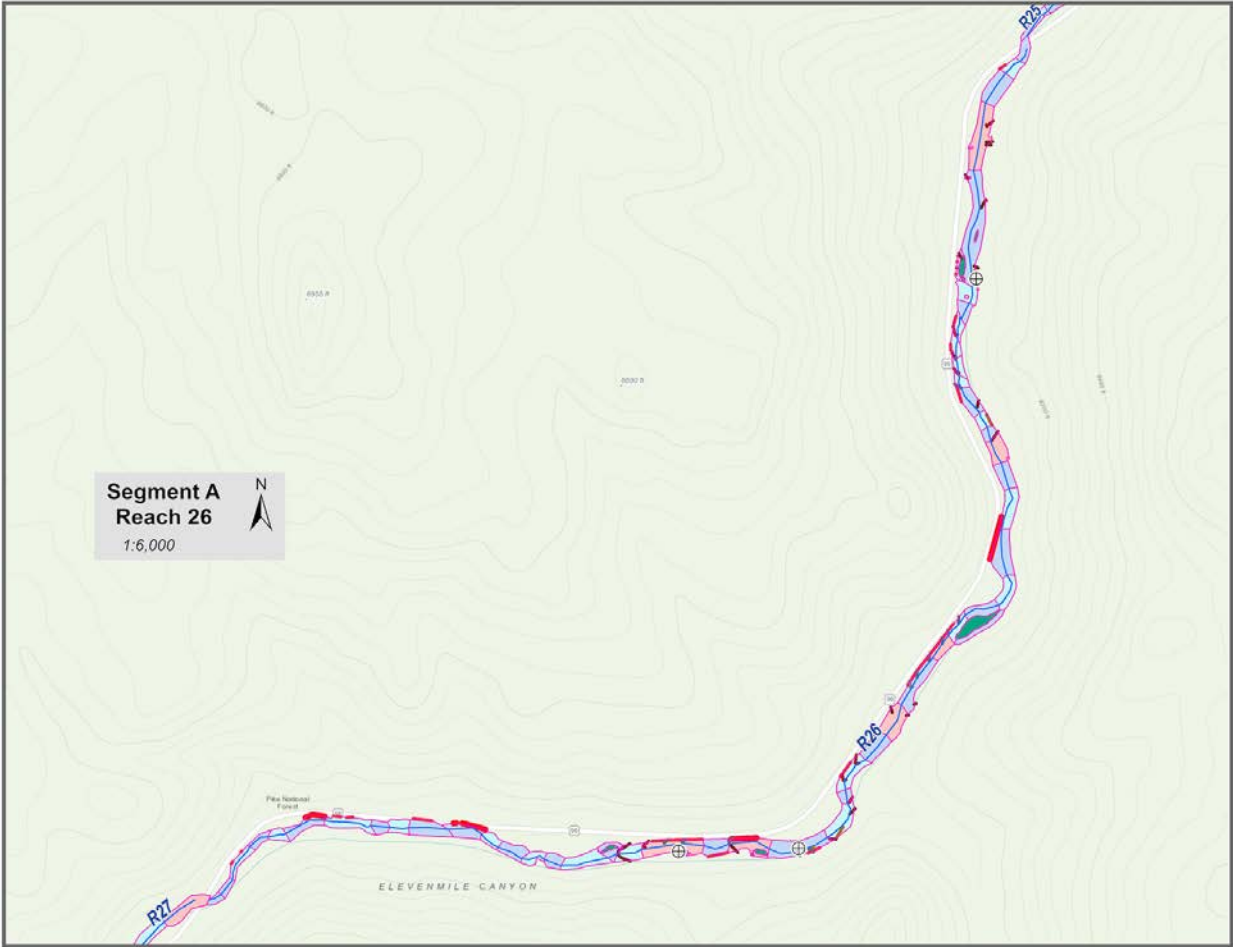
Reach 26

Excess algae is readily seen in the photo below. During water quality sampling in hot weather in the Canyon, we have had some hits for nitrates that exceed water quality standards. We still don't have a clear understanding of what is causing the nutrients or the excessive algae growth. The banks are continuing to degrade along the roadside.

RECOMMENDATION: Address bank instability and road issues. Develop a monitoring program to understand what is driving nutrients and aglae.

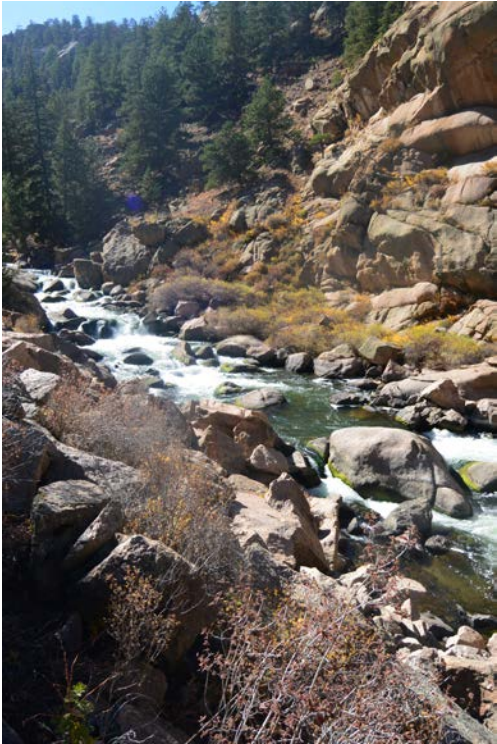
Reach 23

As with other areas of the Canyon, degraded areas are primarily associated with the road.

RECOMMENDATION: Address bank instability and road issues. Continue efforts to remove the diversion dam.

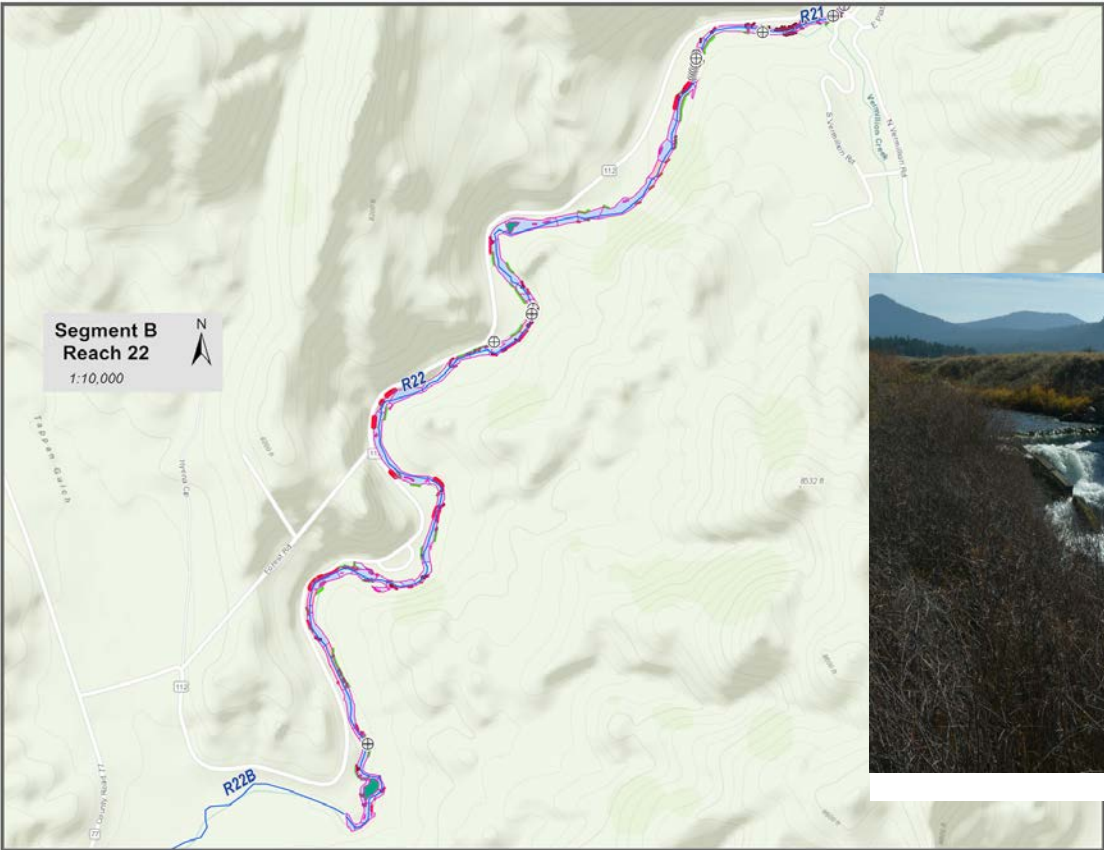
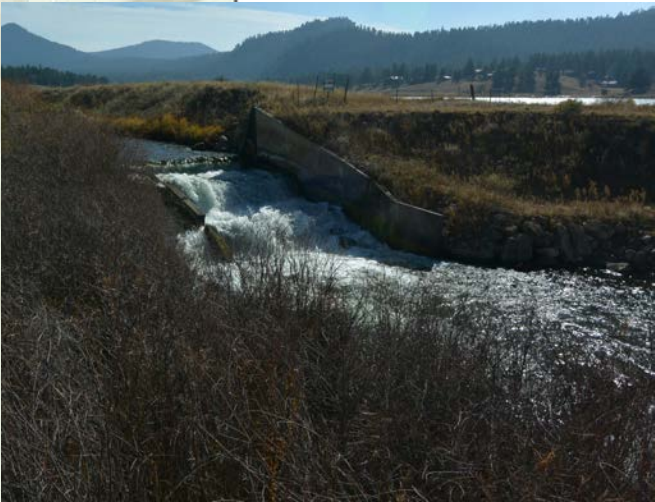
Reach 22

We know that 22B has significant portions of eroding banks from roadside observations, and that the diversion on this section has created overwidening and headcutting. Along 22A, the portion that runs through Happy Meadows, there are still small areas of eroding bank, again, a direct impact from adjacent gravel roads, and there is still some sediment making it to the river from the Hayman scar, though this is highly reduced at this time. Overall, however, 22C, the segment through Happy Meadows, is in much better overall condition then when the last data was taken in 2009, immediately following the Happy Meadows restoration project. That said, there are significant social trails that continue to add sediment as well.

RECOMMENDATION: Reduce the number of social trails along the river, and move parking and camping away from the banks.

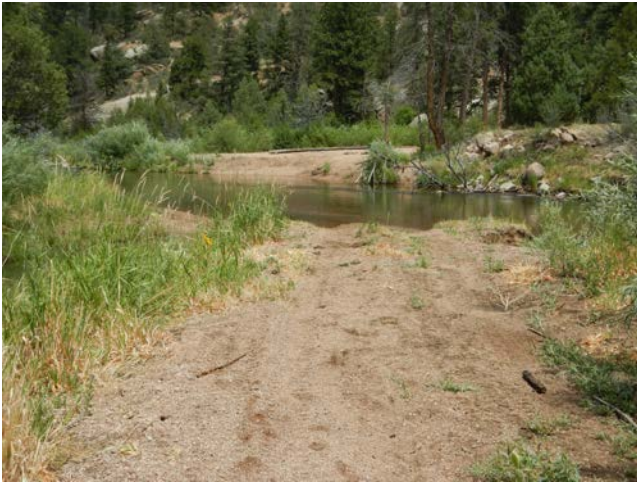
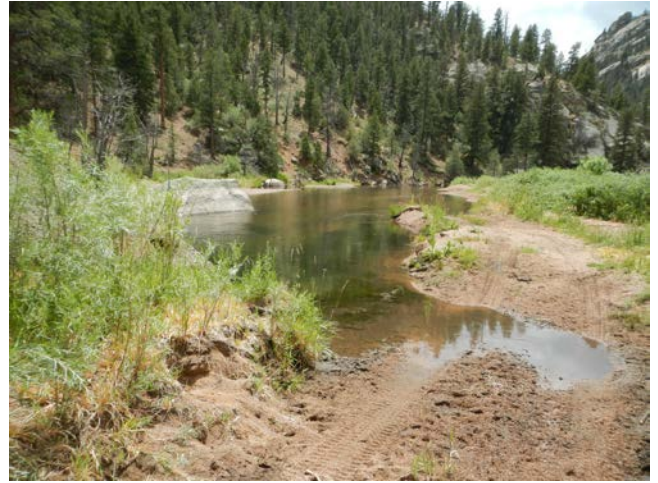
Reach 19

We have concerns with the continued OHV use on the Hackett Gulch area, which is officially closed to OHV traffic, but is being utilized in spite of the closure. Photos show sediment and mid-channel islands forming due to crossing.

RECOMMENDATION: Enforce and harden closure, or develop a plan to manage recreation.
