EXHIBIT 12

FLOYD PHOTO COMPARISON MAY 31, 2019 VERSUS JUNE 29, 2015 NORTH CAROLINA HEADWATERS OF THE CHATTOOGA RIVER

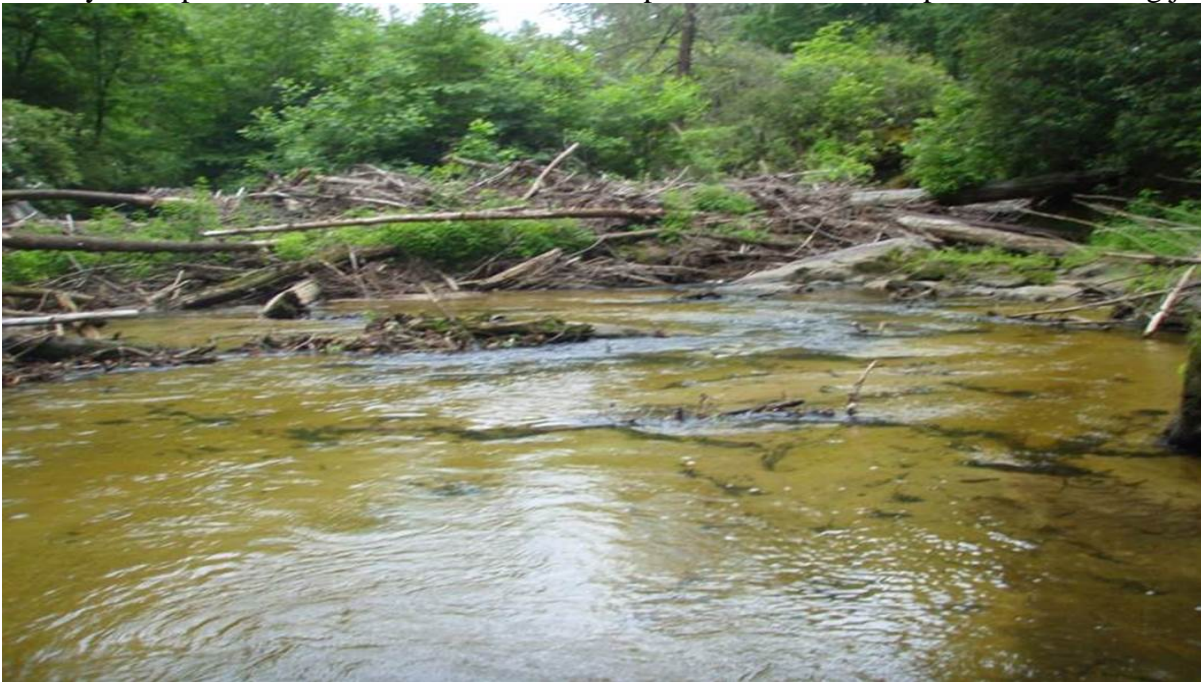
The photo below was taken by Floyd on June 29, 2015 @ 2:45:18. This downstream wide angle photo demonstrates the visibly obvious accumulation of sedimentation on the upstream side of the log jam located @ 35.033897, -83.128544—something which wasn't shown in either of the photographs published in 2007. This downstream view shows the river right side of the log jam where whitewater paddlers were shown to be portaging in the January 2007 photo above. This bedded sediment problem extends far upstream of this log jam and far downstream of this log jam.

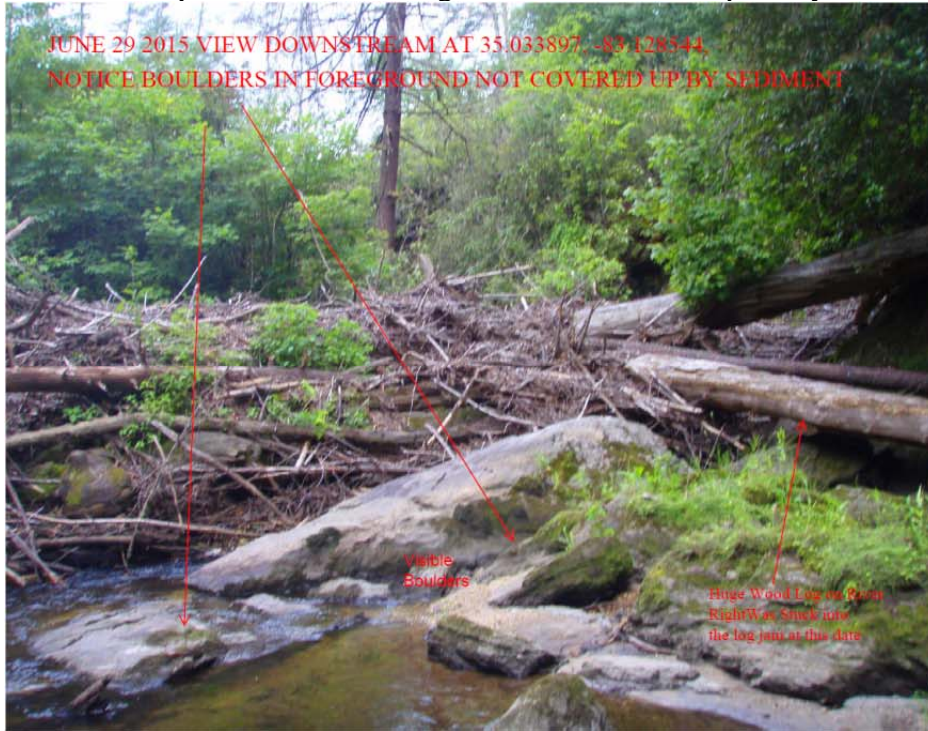
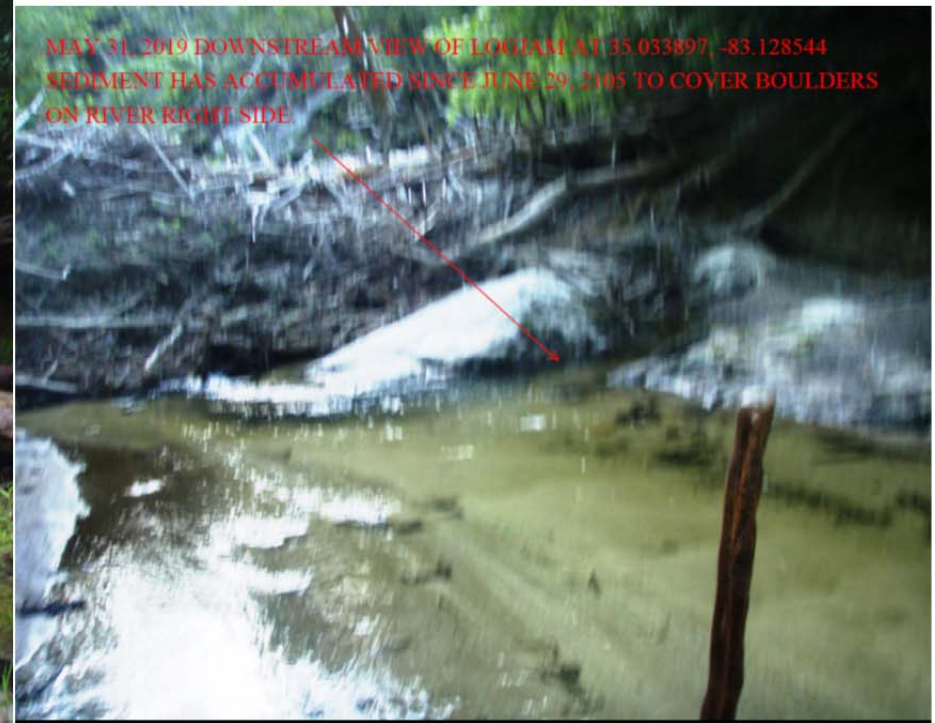
The photo above on left evidences the presence of a large log stuck into the center of the logjam on river right at June 29, 2015. The photo above on right evidences that this large piece of wood has somehow disappeared as of May 31, 2019 although the rest of the log jam remains intact. Floyd alleges there is circumstantial evidence that this inexplicably disappeared large piece of wood may have been *unlawfully* sawed into smaller pieces to allow this piece of wood to be washed downstream during high waters in order to avoid causing additional wood to pile up in front of it.

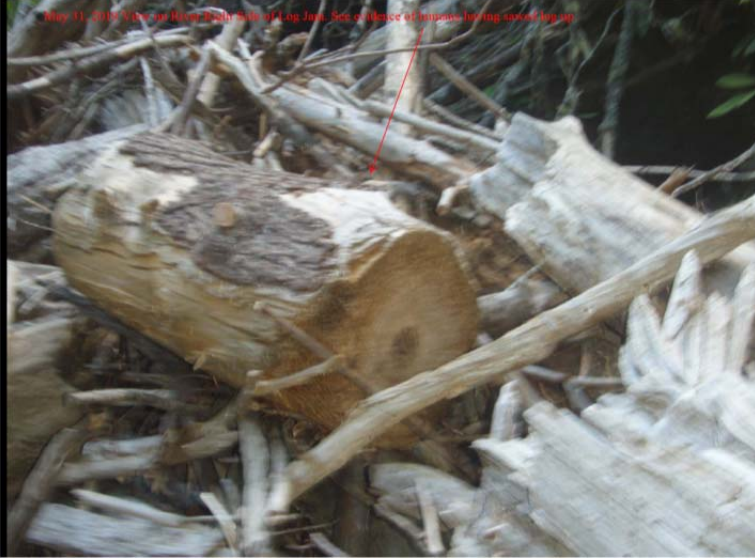
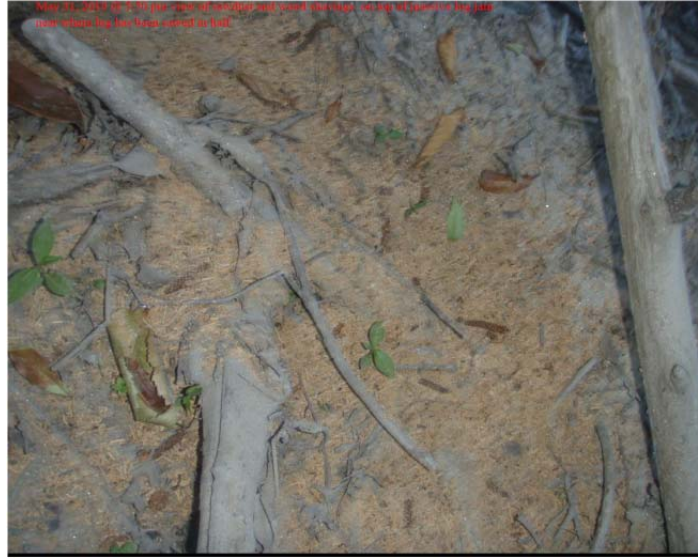
The photo below on the left evidences a piece of log resting on the river right side of the log jam on May 31, 2019. The bright yellow end of this piece of log suggests the log has been recently cut. The photo on the right evidences wood shavings like those that are created when a chain saw is used to cut a log. These yellow colored wood shavings were observed beneath where the sawed off piece of log rests. These two photos were taken on May 31, 2019 at 5:52 pm and 5:51 pm. The bright yellow end of the cut piece of log and presence of the wood debris would imply that the log had been recently cut. Sawing out pieces of large woody debris is not allowed on these headwaters.

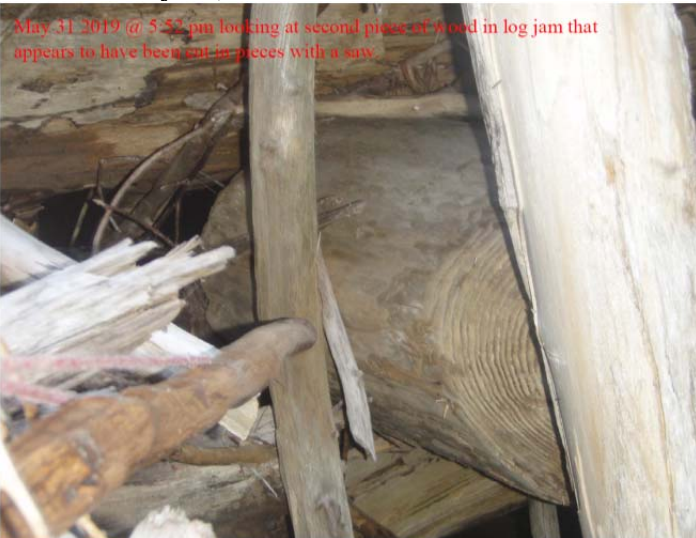
The photo below evidences a second piece of wood that has been sawn into pieces lying inside the log jam on its river right side. This photo was taken on May 31, 2019.

The cut end of this second piece of wood does not evidence a bright yellow color. This second piece of log has been discolored by the passage of time. Both photos evidence somebody is cutting wood out of this log jam. Somebody is trying to encourage this log jam to collapse sending sediment downstream. The photos shown below document the size of the sediments that are covering up and filling in the interstitial spaces between the larger stream bed substrates which would otherwise be suitable for spawning and early life cycle survival of trout. The photo on the left below evidences the small particle size sandy sediments that have blanketed the stream. The photo on the right below evidences the kind of stream bed substrates that have been filled in and covered by this sandy sediment. Both photos were taken in front of the massive logjam on May 31, 2019.

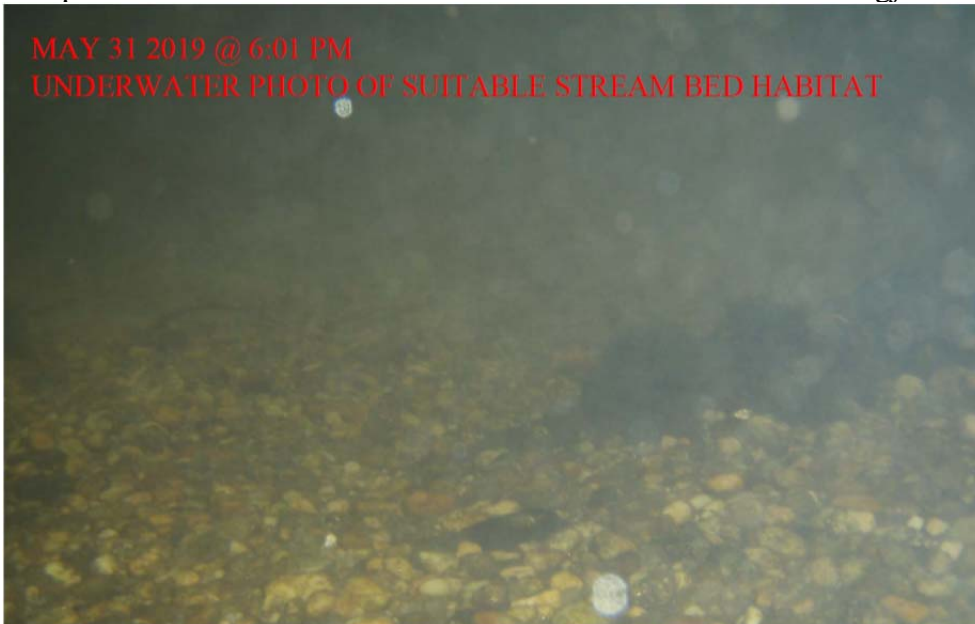
The photo below was taken underwater at 6:01 PM in front of the logjam.

But for this sediment, this stream bed substrate could be used by trout.

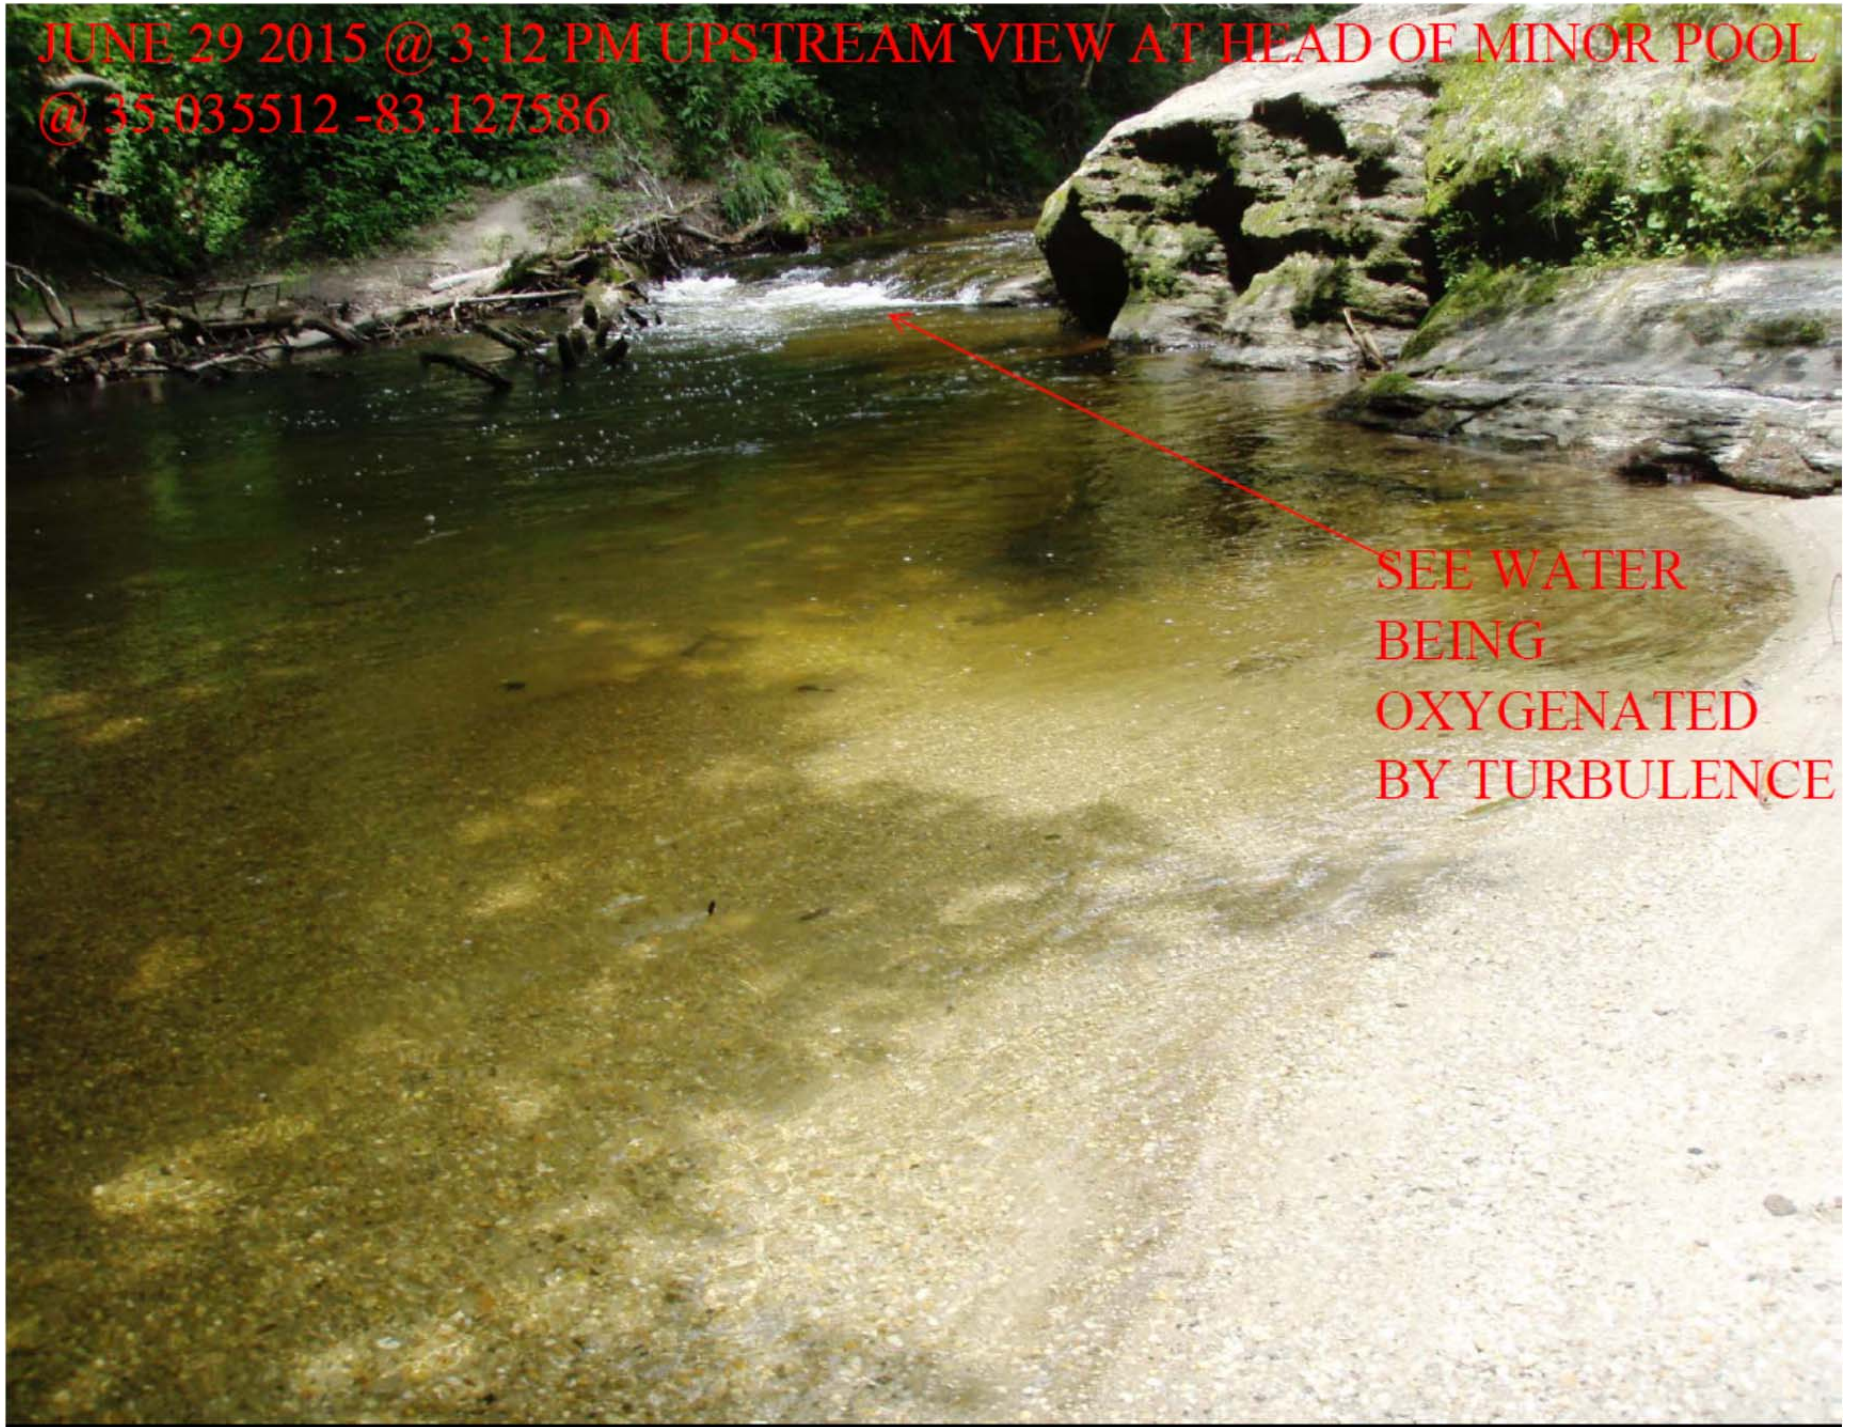
JUNE 29 2015 @ 3:12 PM UPSTREAM VIEW AT HEAD OF MINOR POOL
@ 35.035512 -83.127586

SEE WATER
BEING
OXYGENATED
BY TURBULENCE

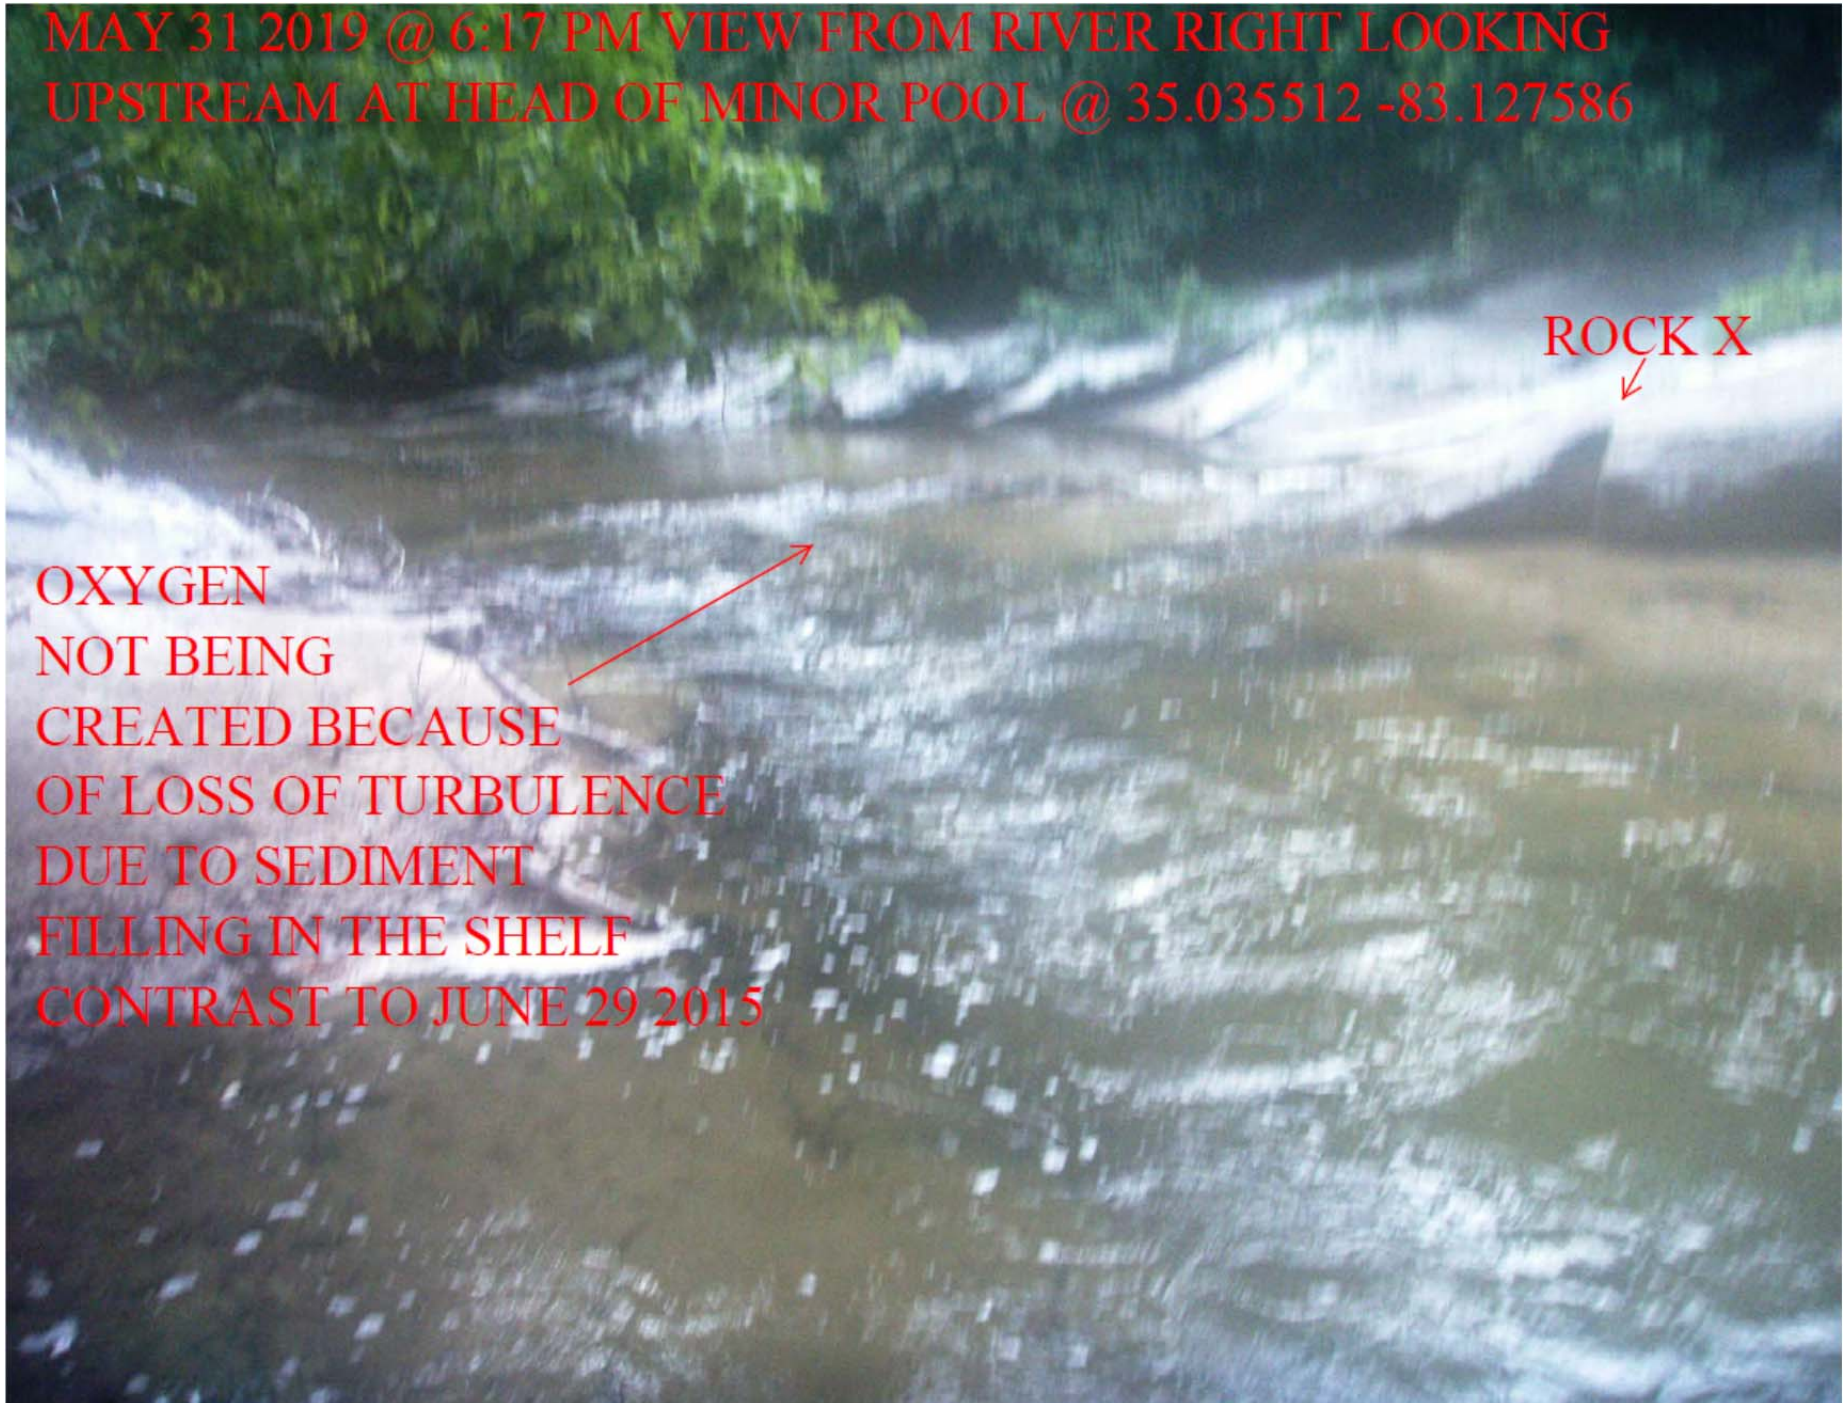
MAY 31 2019 @ 6:17 PM VIEW FROM RIVER RIGHT LOOKING
UPSTREAM AT HEAD OF MINOR POOL @ 35.035512 -83.127586

OXYGEN
NOT BEING
CREATED BECAUSE
OF LOSS OF TURBULENCE
DUE TO SEDIMENT
FILLING IN THE SHELF
CONTRAST TO JUNE 29 2015

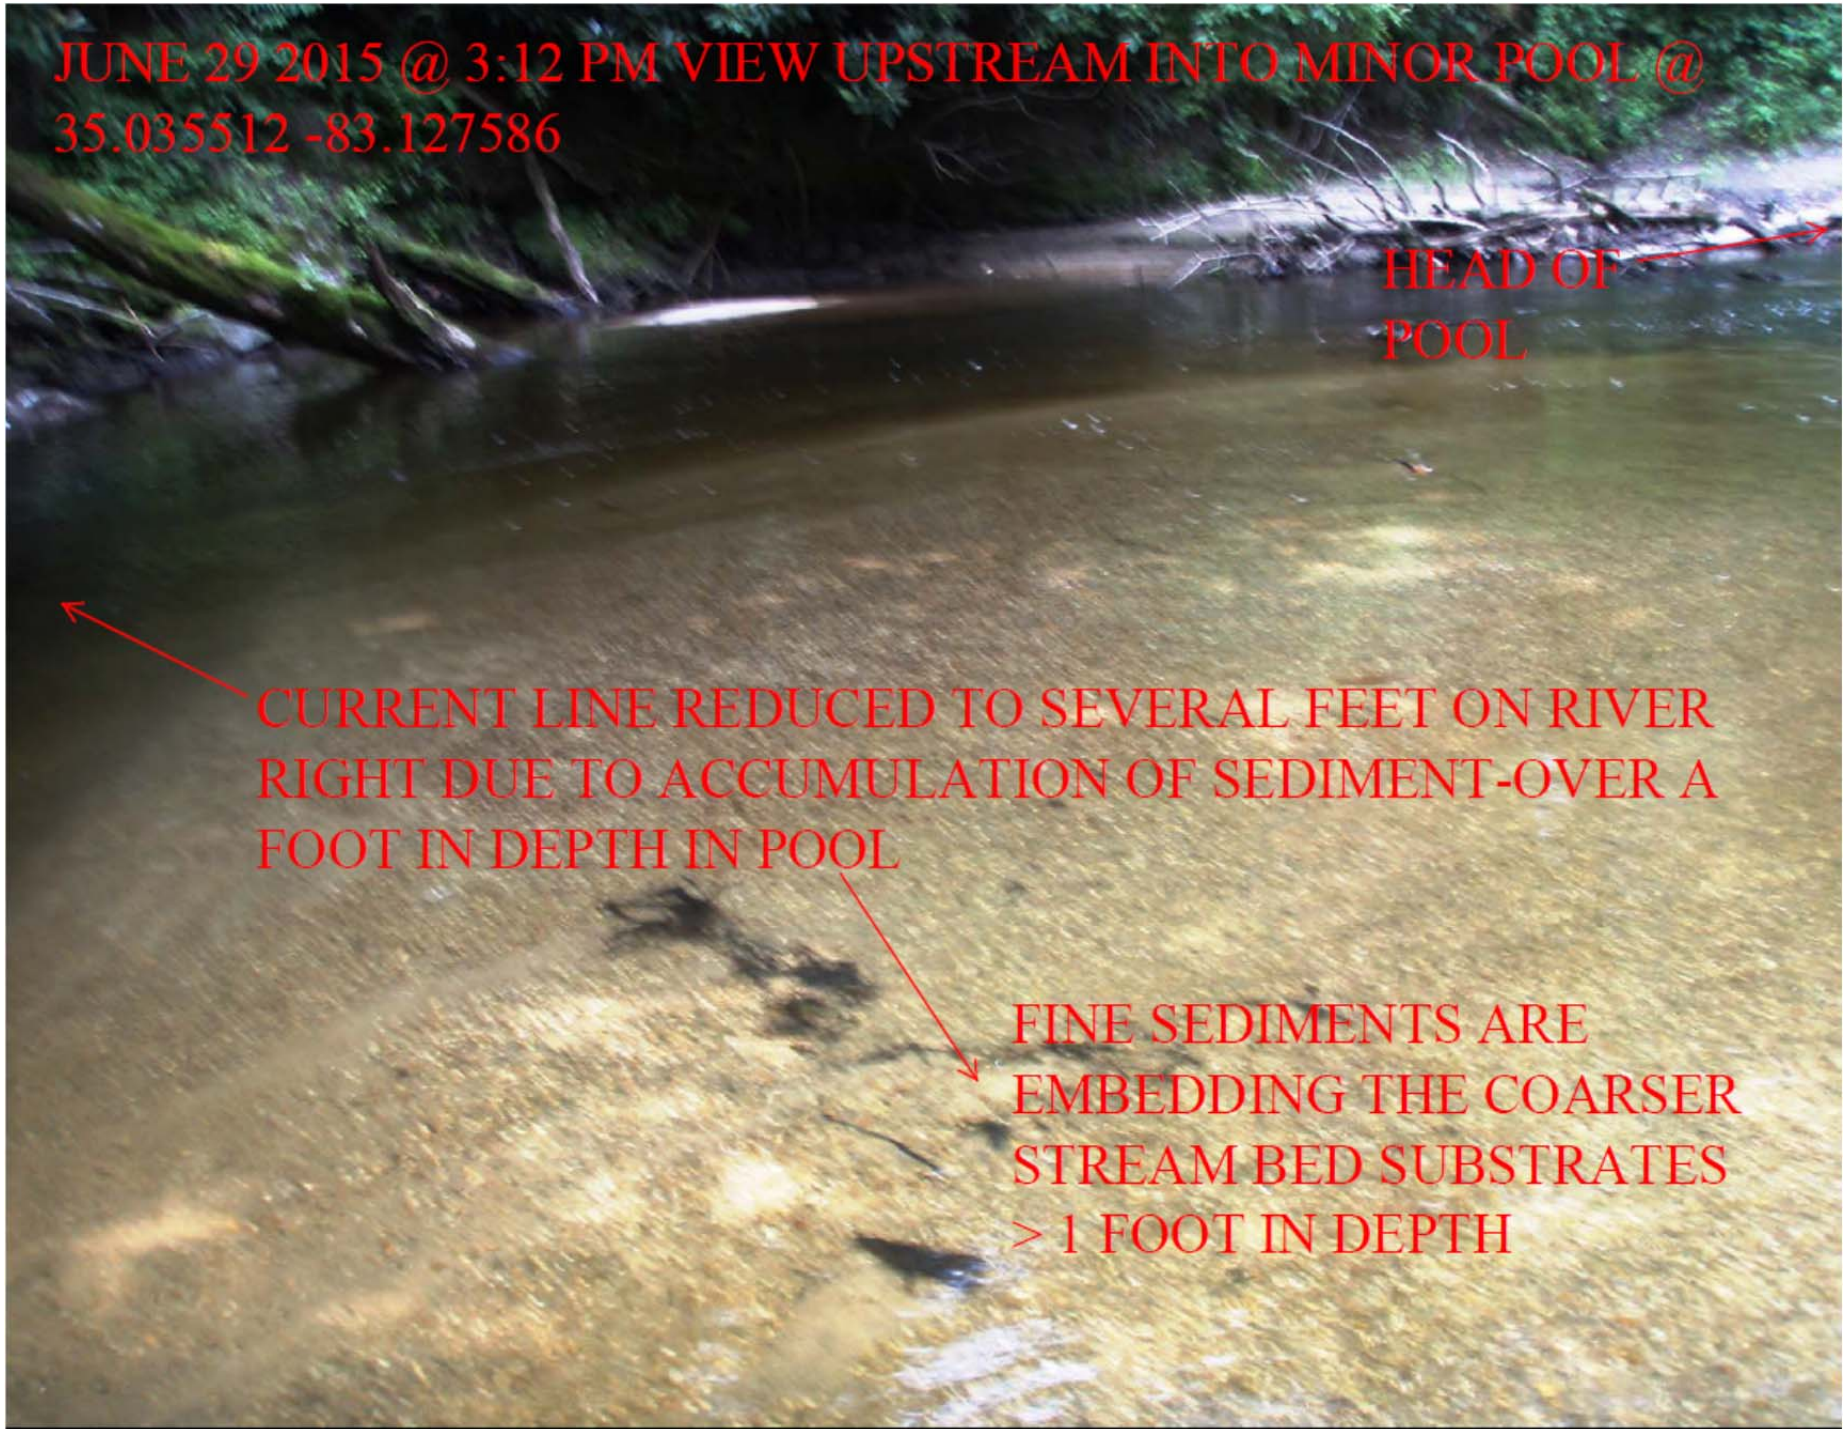
JUNE 29 2015 @ 3:12 PM VIEW UPSTREAM INTO MINOR POOL @
35.035512 -83.127586

CURRENT LINE REDUCED TO SEVERAL FEET ON RIVER
RIGHT DUE TO ACCUMULATION OF SEDIMENT-OVER A
FOOT IN DEPTH IN POOL

FINE SEDIMENTS ARE
EMBEDDING THE COARSER
STREAM BED SUBSTRATES
> 1 FOOT IN DEPTH

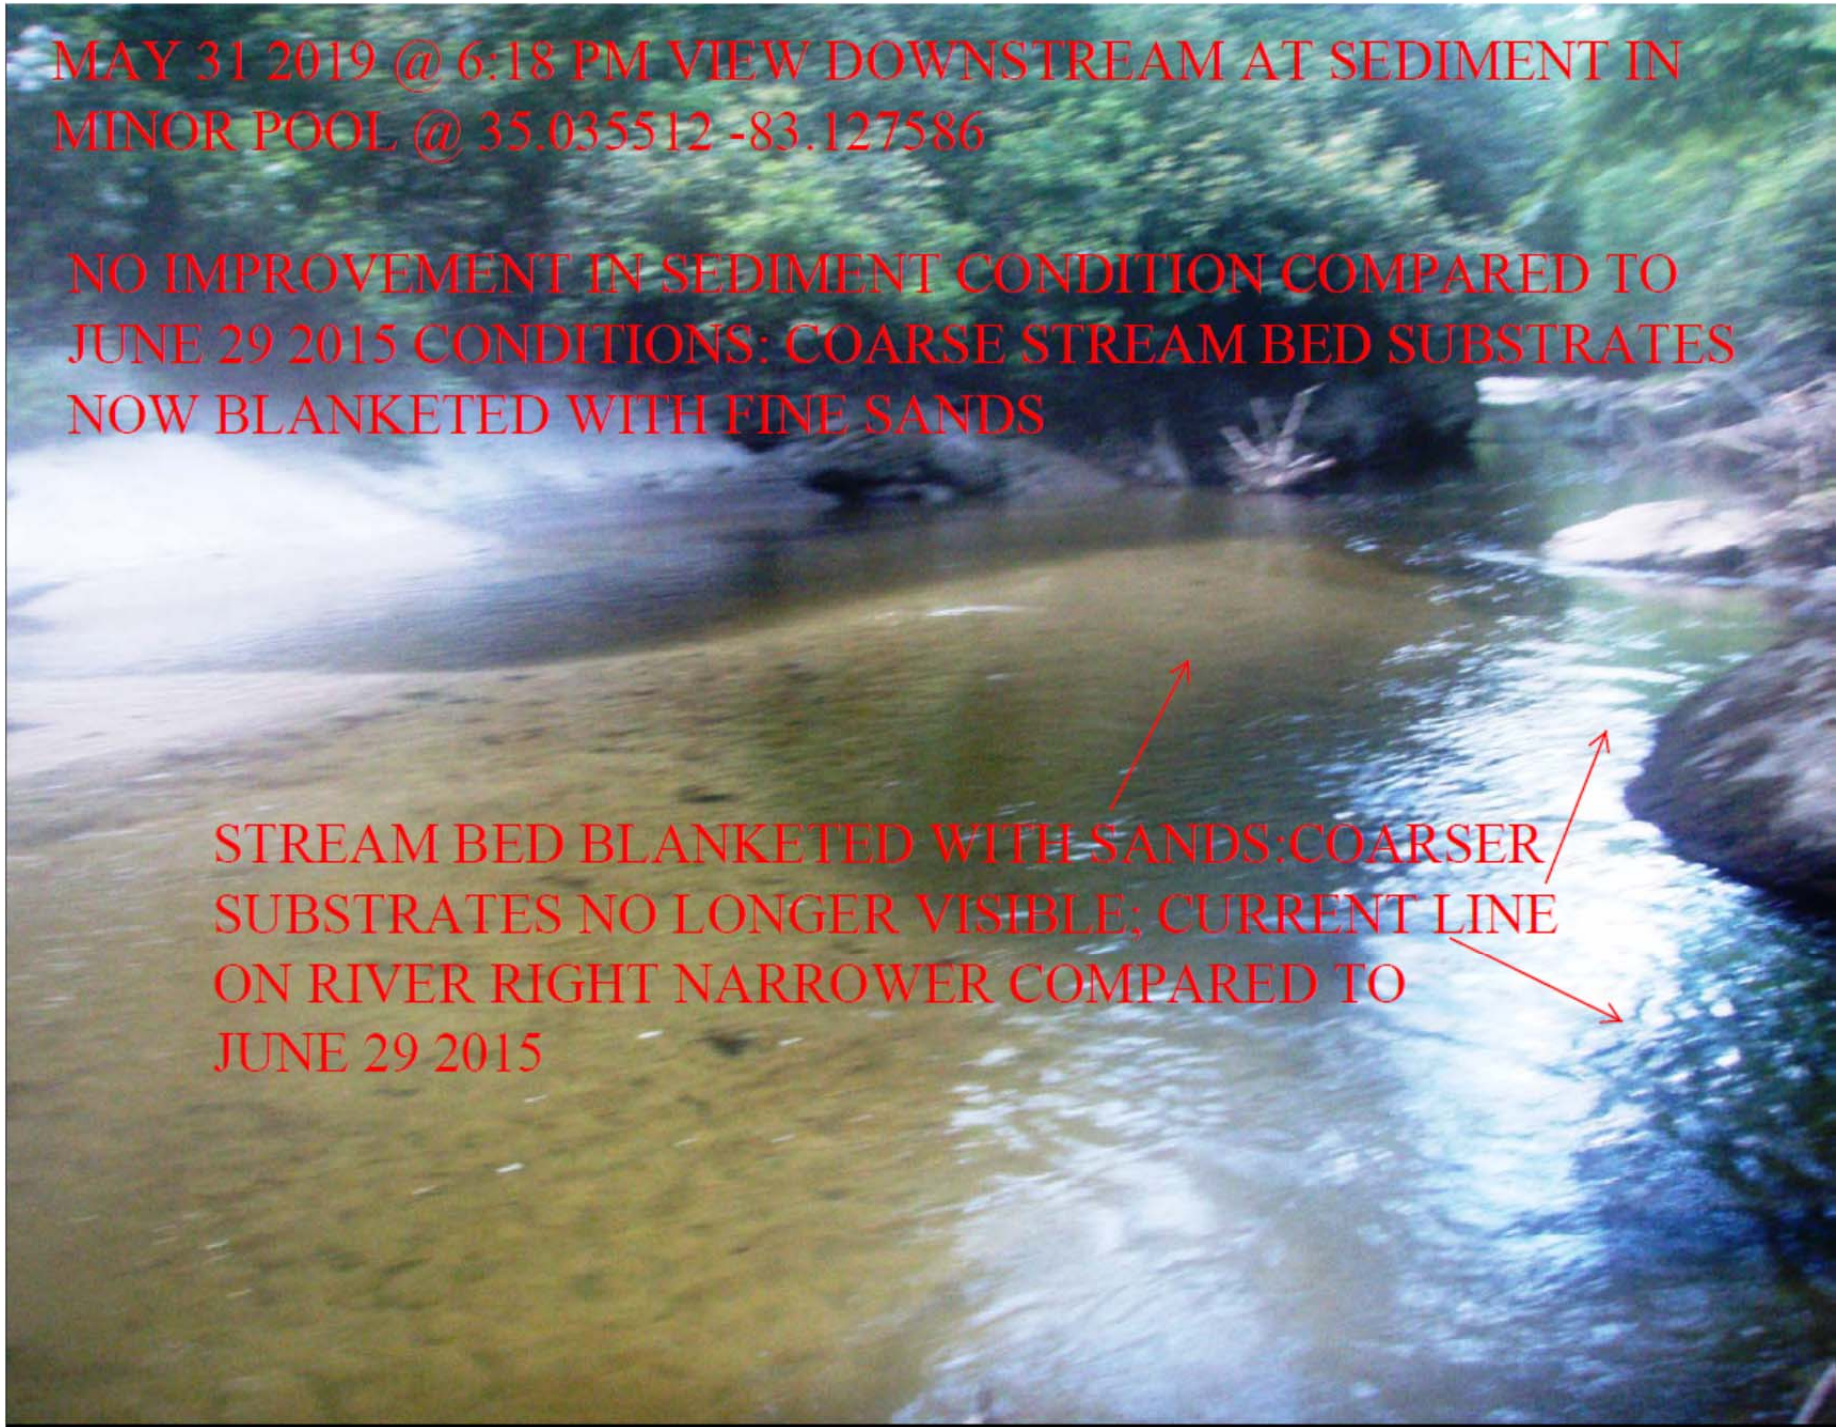
MAY 31 2019 @ 6:18 PM VIEW DOWNSTREAM AT SEDIMENT IN
MINOR POOL @ 35.035512 -83.127586

NO IMPROVEMENT IN SEDIMENT CONDITION COMPARED TO
JUNE 29 2015 CONDITIONS: COARSE STREAM BED SUBSTRATES
NOW BLANKETED WITH FINE SANDS

STREAM BED BLANKETED WITH SANDS: COARSER
SUBSTRATES NO LONGER VISIBLE; CURRENT LINE
ON RIVER RIGHT NARROWER COMPARED TO
JUNE 29 2015
