EXHIBIT 36

The compilation of photographs set forth below illustrate the excessive embedded sediment conditions being suffered on an extended reach (approximately 2 miles) of a stream that simultaneously carries Class B, Trout, Outstanding Resource Waters (“ORW”) water quality classifications plus a National Wild and Scenic River designation. This stream is 1 of 3 out of 12,000 bodies of water that have this status. The *specific reason* why this stream was classified ORW in 1989 was to provide for the highest intensity of the Clean Water Act’s antidegradation protection for the stream’s *then* “outstanding” trout habitat and its “outstanding” wild rainbow, brook, and brown trout fisheries—a *much narrower designated use of ORW water quality than the broader aquatic life use*. So far, efforts to have this problem recognized by the responsible federal and state agencies have not succeeded. These agencies have not yet agreed to use the *best available science* (peer reviewed)¹ for recognizing how the amount of embedded sediment shown below exceeds any reasonable minimum effects threshold for disrupting the reproductive and early life cycle needs of trout—in violation of the Clean Wa

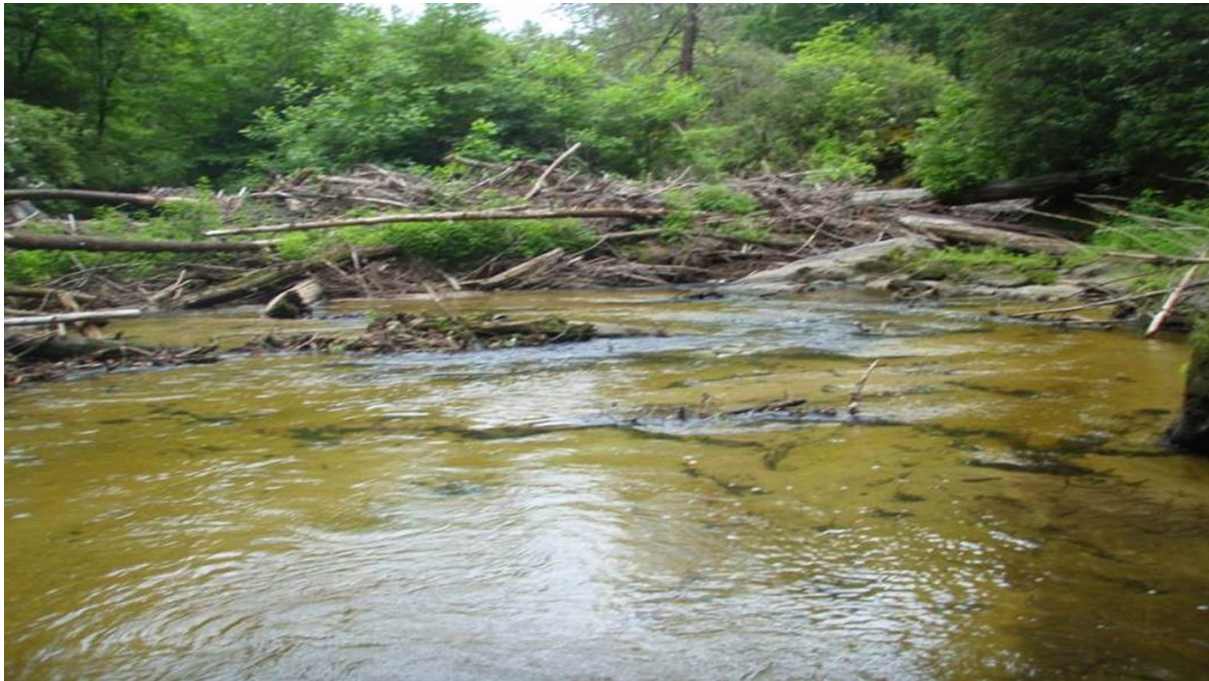
Downstream view, of excessive embedded sediment conditions in front of the huge logjam @ 35.033897, -83.128544, photographed by me on June 29, 2015 @ 2:45:18 PM. This logjam constitutes a blessing because it acts as a sediment catch basin which serves to slow the fouling of the trout habitat further downstream. However sediments are managing to pass through this logjam as evidenced by the following photographs taken June 29, 2015.

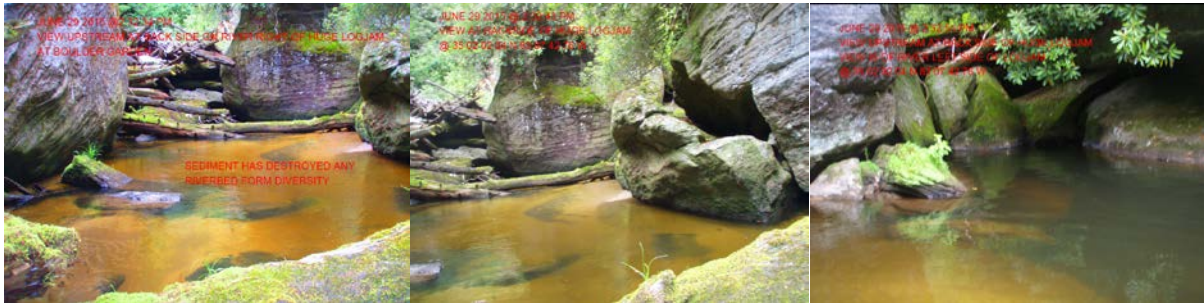
The following photos look back upstream at the back of the logjam. Clearly sediment is making its way through this logjam. This logjam is prevented from being dislodged during high water due to these boulders that serve as a foundation for the dam.

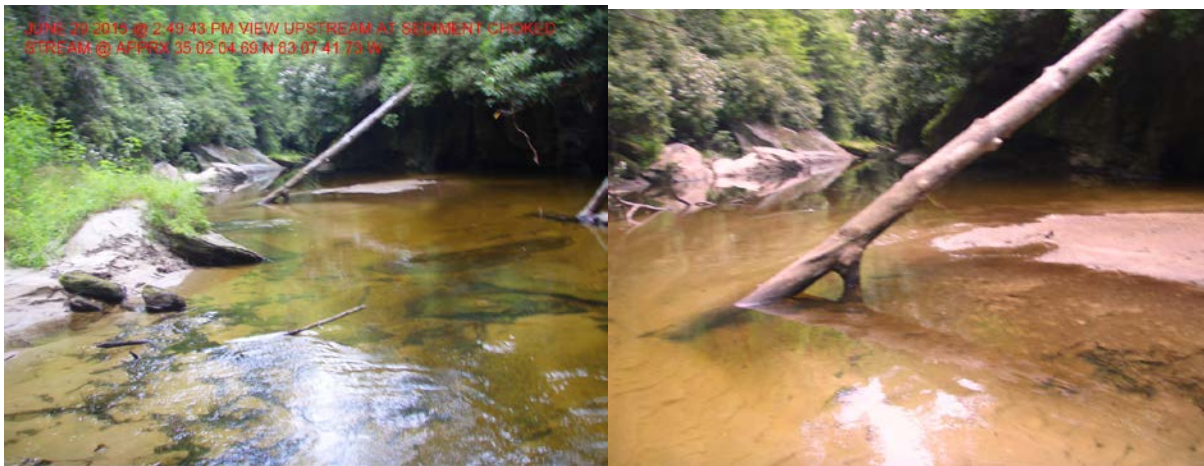
The Photos below demonstrate how sediments are impounding upstream of the logjam.

The stream bed is embedded by a foot of sandy sediment which is bank to bank.

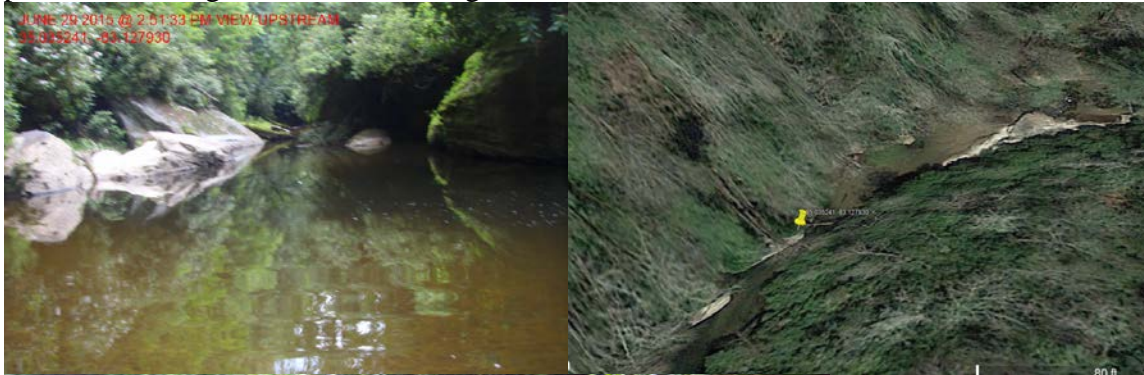
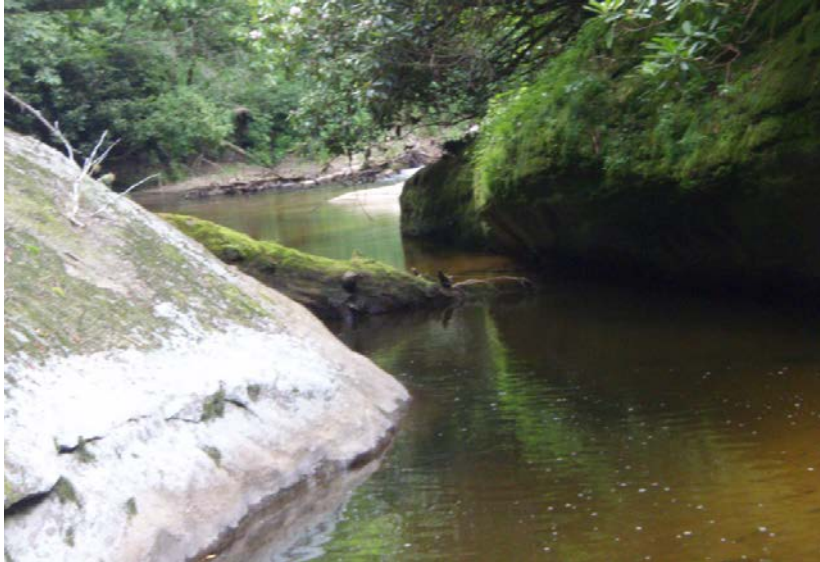
The following photos evidence the degraded trout habitat conditions as you approach a minor pool that no longer holds outstanding numbers of wild trout

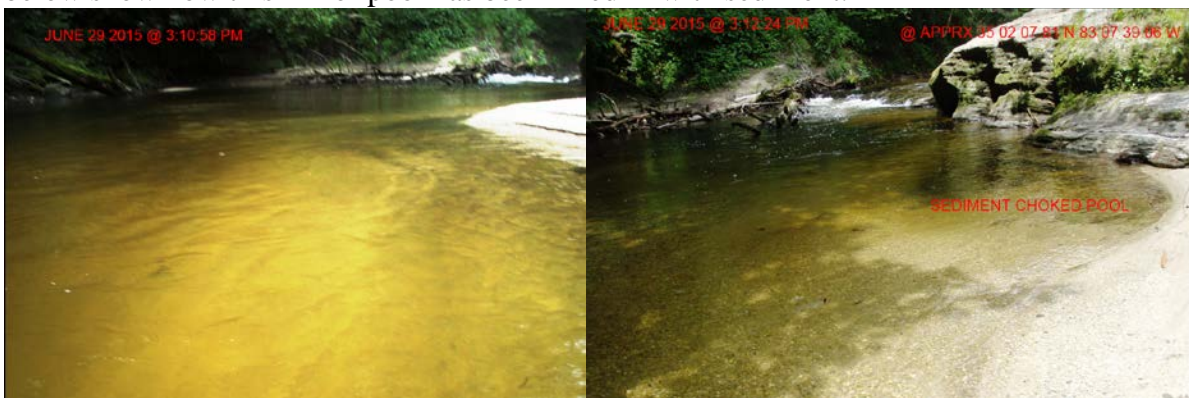
These photos look upstream at a point approximately 525 feet upstream of the logjam. This view looks up into the tail of a minor pool that has become filled in with sandy sediment. The photos below show how this minor pool has been filled in with sediment.

This minor pool is approximately 550 feet upstream of the logjam.

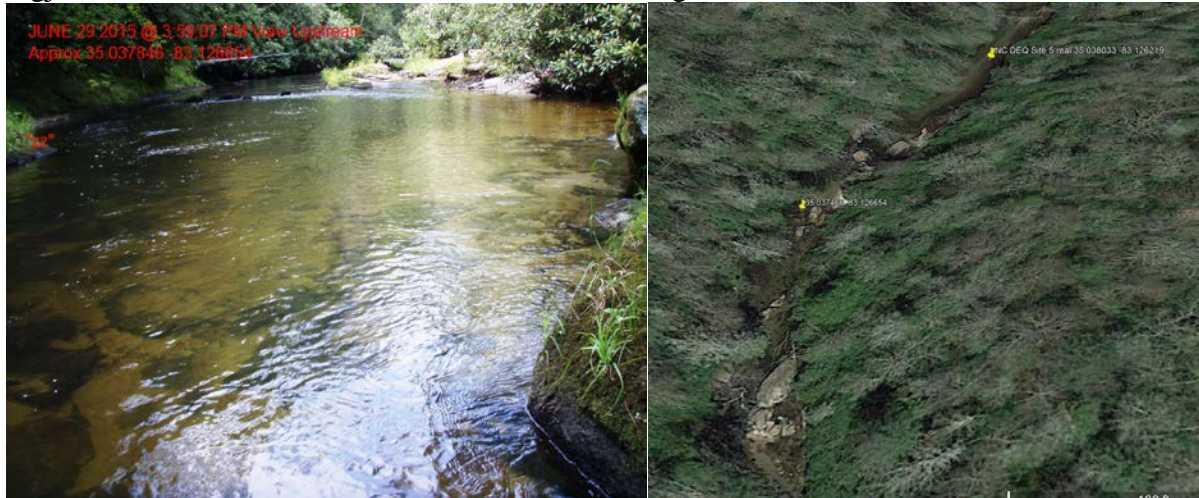
The photo below illustrates streambed conditions approximately 1,600 feet upstream of the logjam at 35.037846, -83.126654. See also the Google Earth Pro aerial view.

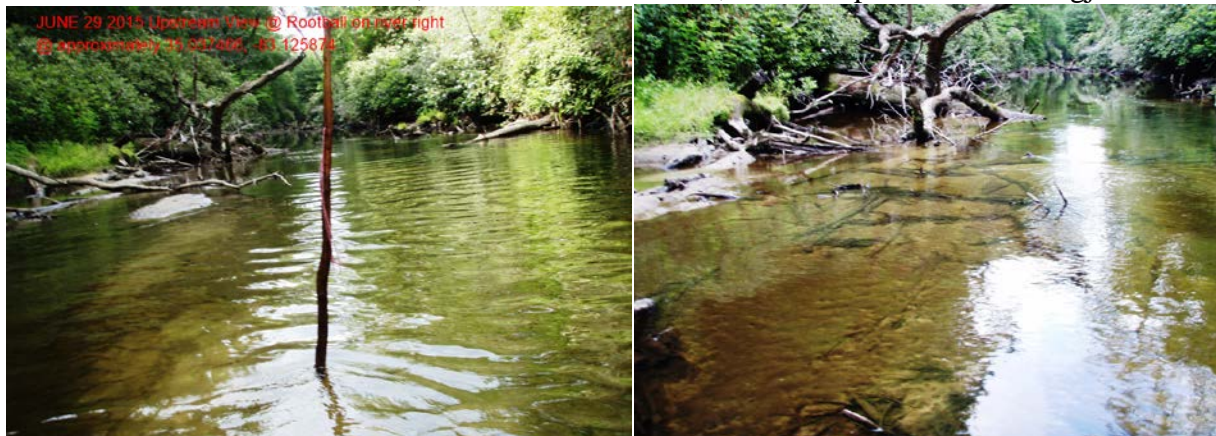
Sediment has embedded the larger streambed substrates in quantities that exceed any minimum effects threshold for disrupting the reproductive and early life cycle of trout. The photo below reflects conditions at 35.037466, -83.125874 which is 2,100 feet upstream of the logjam.

As the hiking staff evidences, the sediment was almost a foot deep at that point in time. The photos below evidence how large wood continues to fall into the river as a consequence of the hemlock die off. This personifies conditions found up and down these headwaters.

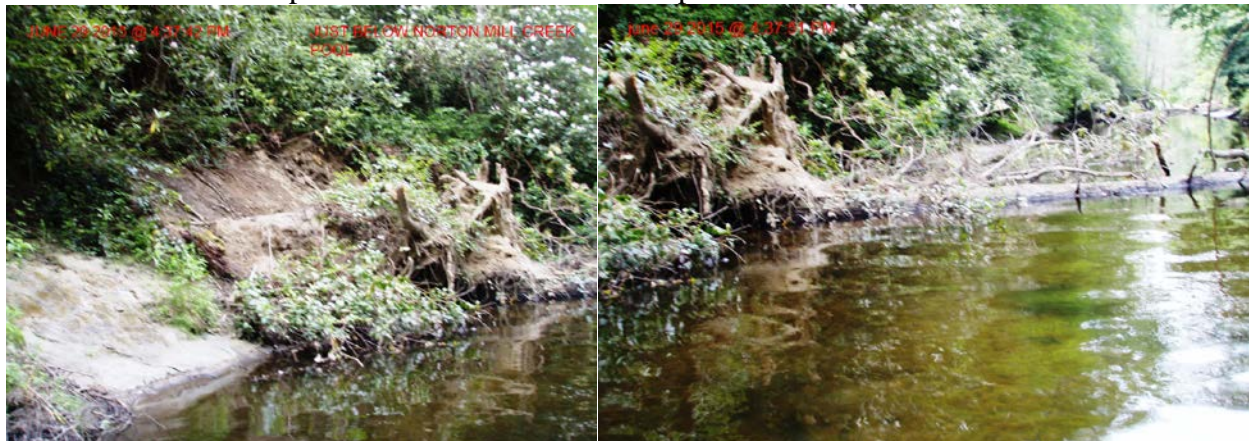
This obstruction evidences why this narrow stream is ill-suited for the sport of creek boating.

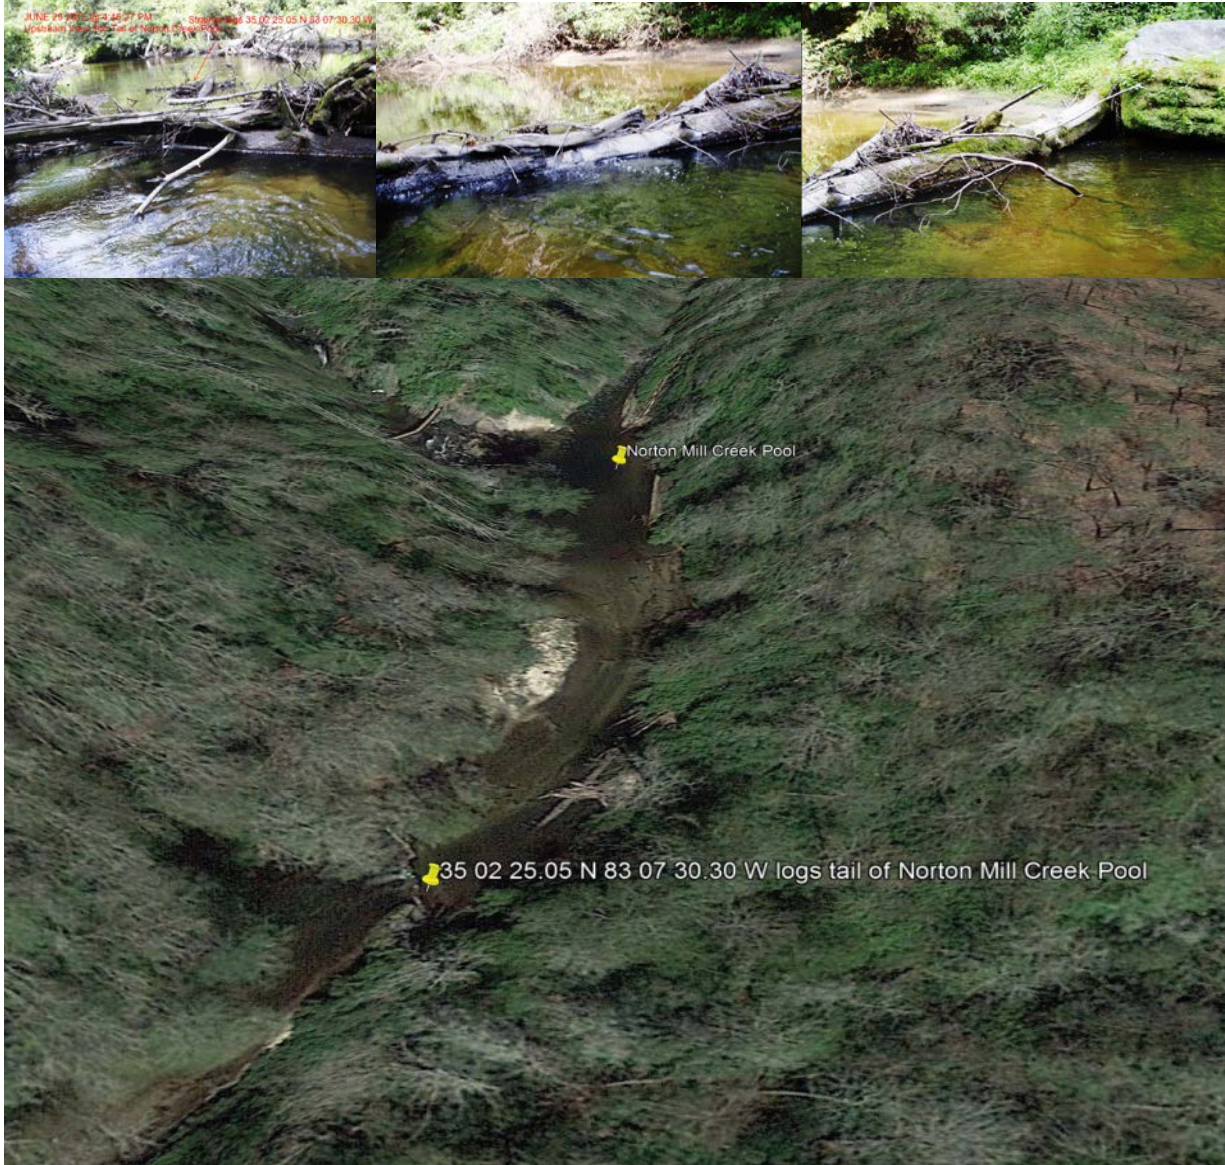
The photos below look upstream at yet another stream obstruction that is less than 300 feet upstream from the obstruction shown in the photo immediately above. This obstruction (35 02 25.05 N, 83 07 30.30 W) exists in the tail of Norton Mill Creek pool—which constitutes one of two large pools on the North Carolina part of the river—the other pool being Bull Pen pool.

As the Google Earth Pro aerial reflects above, significant amounts of sediment have embedded the stream bottom in Norton Mill Creek pool. An individual wading in the tail of Norton Mill Creek pool will find themselves sinking well above their shins in this sediment.

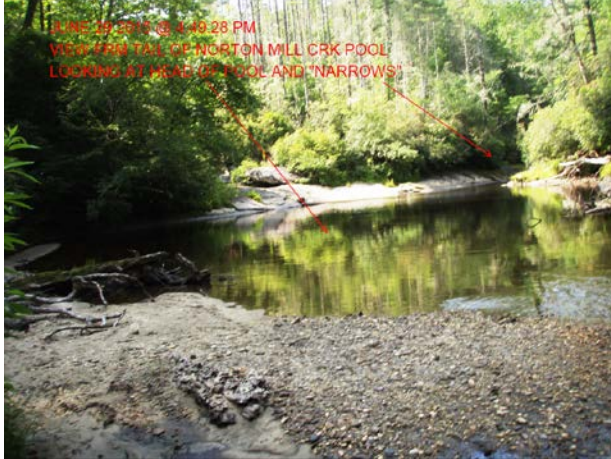
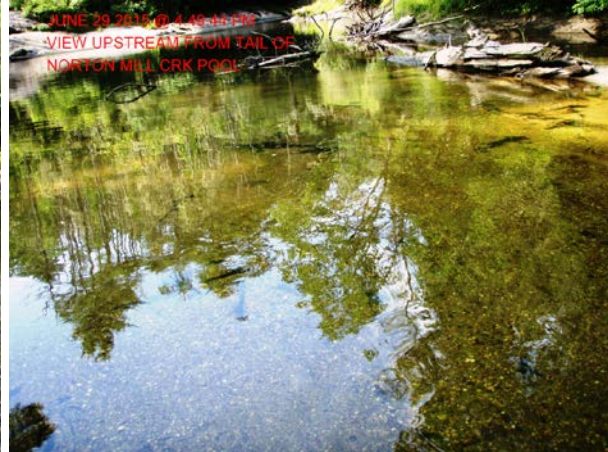
In 1998, the state of North Carolina placed Norton Mill Creek on its Section 303(d) list of impaired waters because of excessive sediment. In 2000, North Carolina took this tributary off of the Section 303(d) list because North Carolina relaxed the standards being used to make its Section 303(d) determinations—and not because this sediment had somehow been abated by human efforts. The amount of sediment that has become embedded in the tail of Norton Mill Creek pool shows no evidence of being reduced through downstream hydraulic transport. This suggests that the quantity of sediment that is present exceeds the hydraulic capacity of this river

to move this sediment downstream over any reasonably short a period of time—if ever. These conditions on Norton Mill Creek Pool suggests that the Chattooga’s headwaters have insufficient sediment transport capacity to abate this embedded sediment problem. Human assistance is required. See below the large amount of sediment that has become impounded in the tail of Norton Mill Creek Pool.

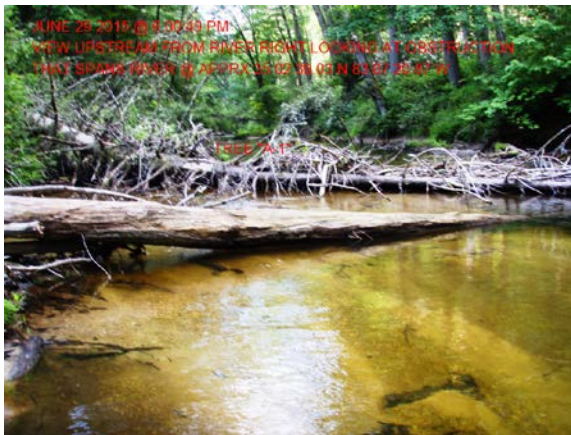
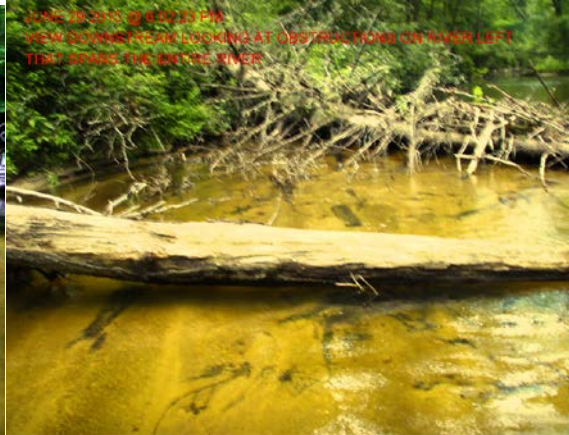
See the two photos below that evidences conditions at approximately 1,500 feet upstream of Norton Mill Creek Pool. The left photo looks upstream while the right photo looks downstream.

As the photos evidence, sediment is impounding in visibly excessive quantities at this location.

In addition, the presence of this stream-wide log constitutes a potentially life threatening obstruction to whitewater creek boaters. Paddlers must portage around this obstruction. This need to portage around this obstacle resulted in the creation of Boater Created Erosion Site X-1 on the river right bank. Boater Created Erosion Site X-1 now constitutes a chronic point source of sediment discharge into this ORW stream.

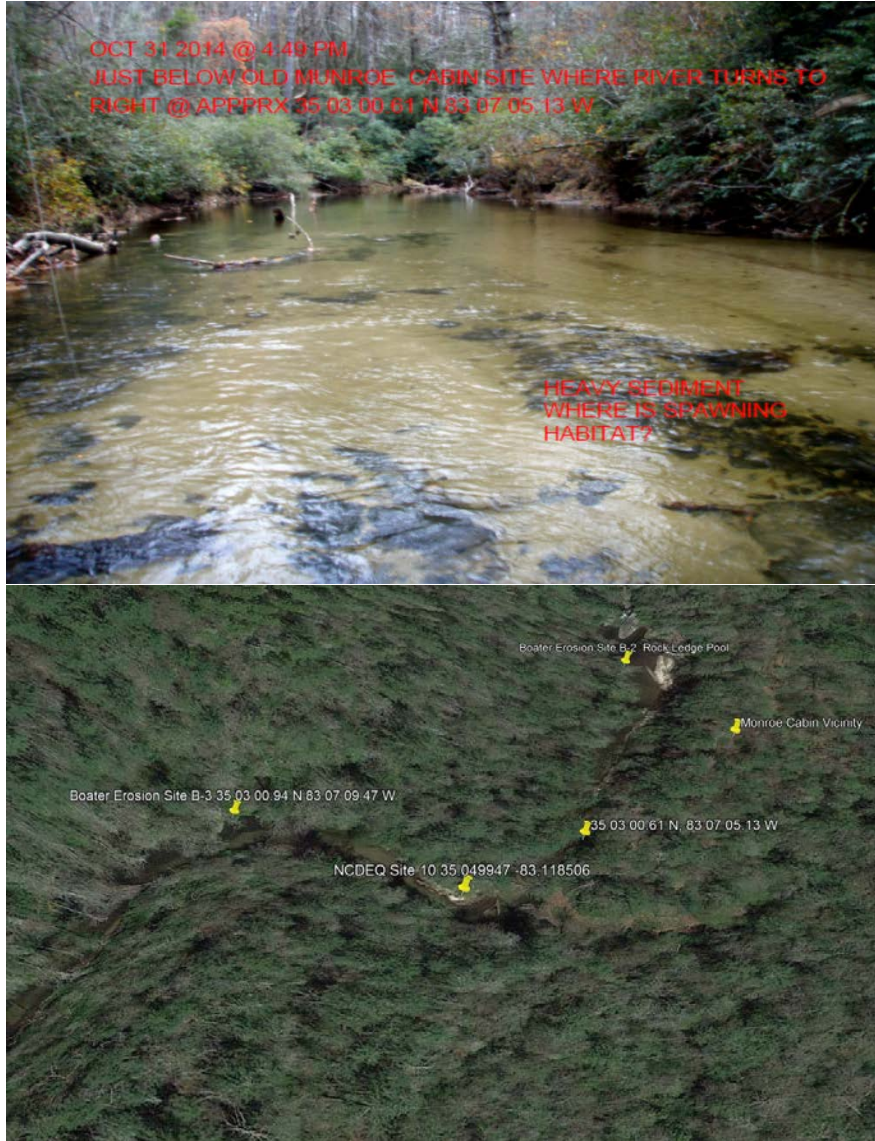
The October 31, 2014 photo below reflects degraded spawning habitat conditions at 35 03 00.61 N, 83 07 05.13 W (approximately 1.4 miles upstream from the huge logjam)..

As the Google Earth Pro aerial photo above demonstrates, this straight and relatively wide reach of riffle water, @ (35 03 00.61 N, 83 07 05.13 W, or 35.050170, -83.118091) lies within the 600 foot reach that the North Carolina Department of Environmental Quality (“NC DEQ”) defined as “Site No. 10” while electro-fishing in September 2016. In September 2016, NC DEQ captured just 2 young-of-the-year brown trout on this 600 foot reach. Similarly, Site No. 10 yielded an

extrapolated brown trout standing crop weight of just 10.1 kg/hectare—a *far from outstanding standing crop*. But for the damaging impacts of this blanket of sediment, the physical nature of Site No. 10's stream bottom substrates (availability of cobble) and lower flow characteristics should have yielded much greater young-of-the-year numbers.

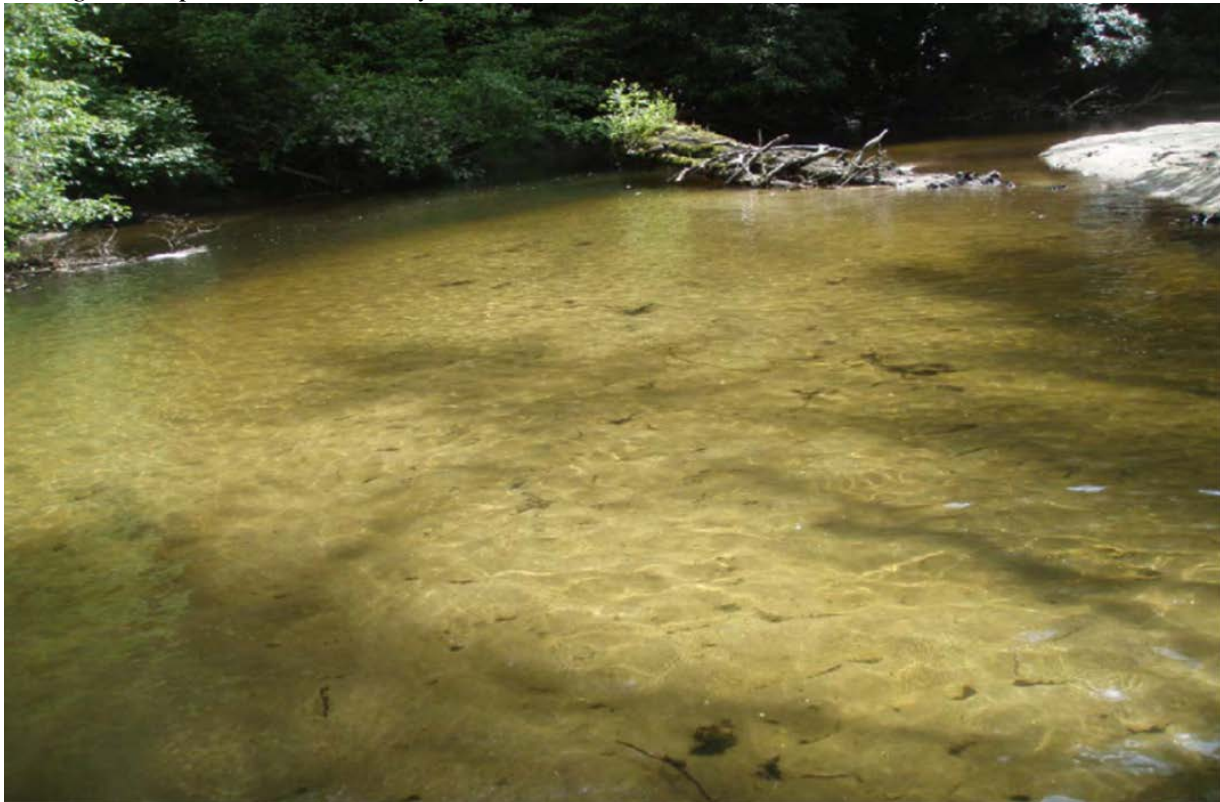
Floyd Photograph, June 29, 2015 @ 3:50:07 PM View Downstream @ 35.049947, -83.118506 . This depicts conditions on an approximate 100 foot section of the 600 foot reach that NC DEQ defined as “Site No. 10” during the September 2016 trout population study. NC DEQ assigned a *generous* habitat score of 63 out of 100 despite the fact that approximately 1/6 of the overall reach was suffering 100% embeddedness of its stream bed substrates.

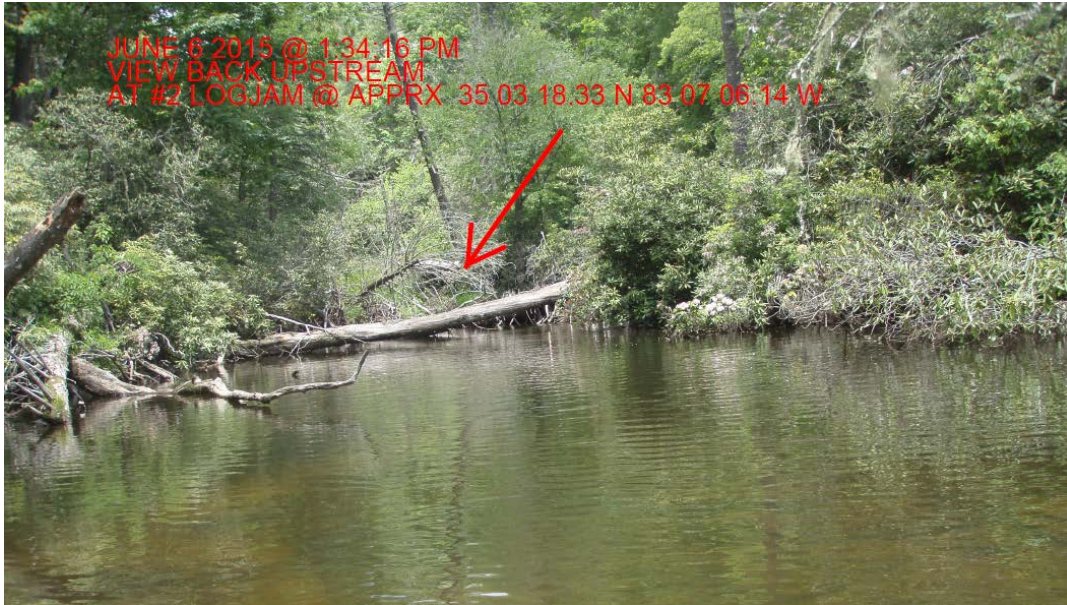
This photo below constitutes an upstream view of a minor logjam #2 located at approximately 35 03 18.38 N, 83 07 06.14 W. It is difficult to see.

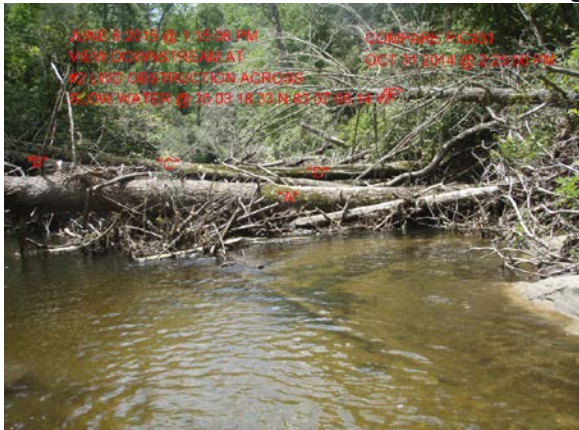
See below the downstream view of minor logjam #2 and a Google Earth Pro aerial.

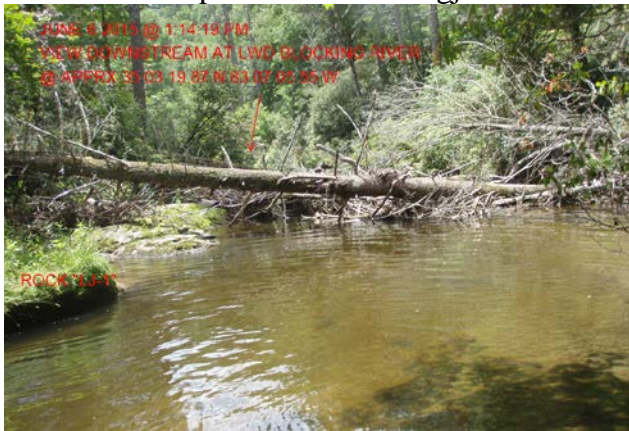
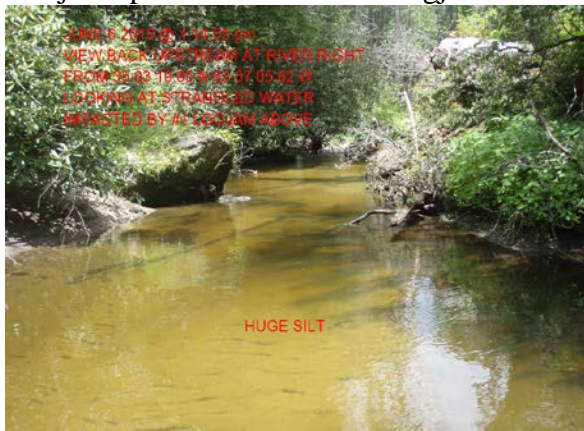
The photo on the left looks downstream at minor logjam #1. The photo on the right looks back upstream and show how excessive sediment is being impounded upstream.

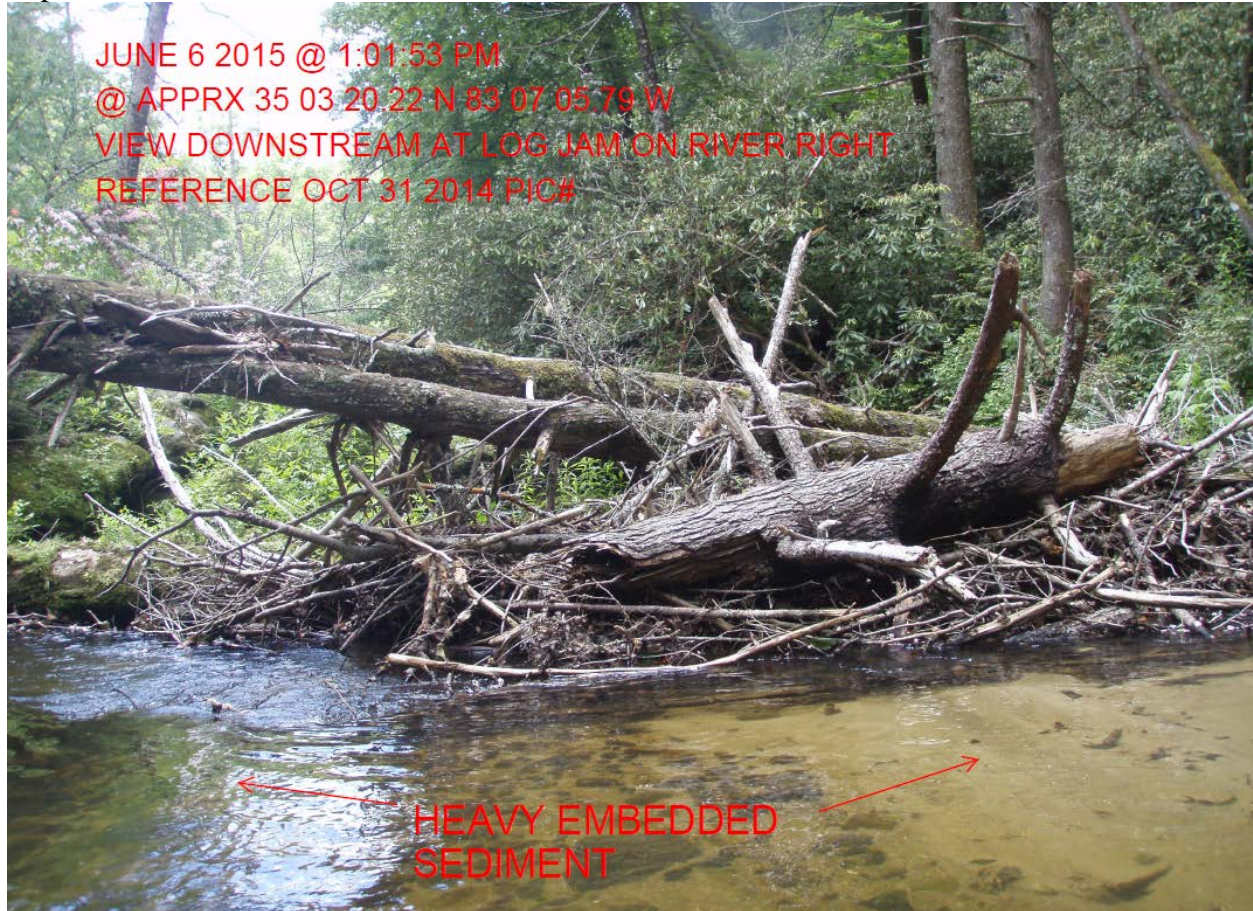
Here is another downstream view of minor logjam #1. It shows how sediment is being impounded in front of it.

All of these photos show how sediments are impounding in many locations. This sediment does not appear to be dissipating. This suggests that the river's normal sediment transport capacity is insufficient to clear away this sediment in any reasonable short period of time.

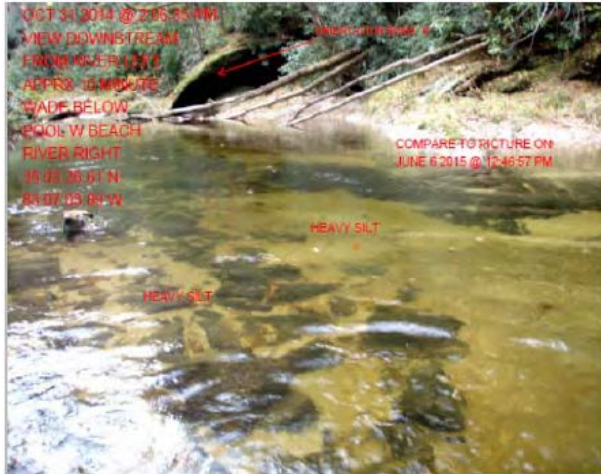
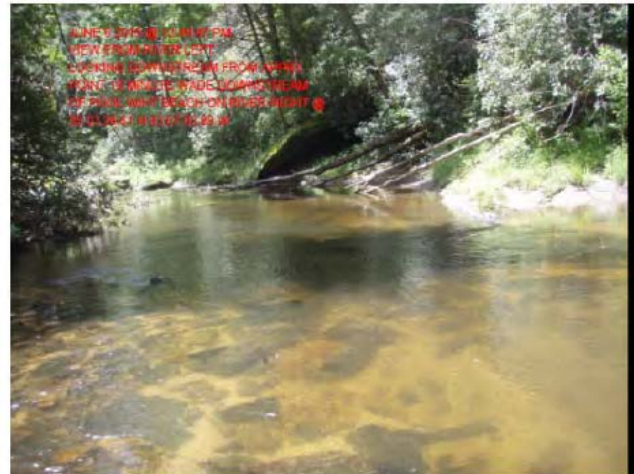
The photo on the left shows how the streambed's cobbled substrates are smothered with fine particle sized sandy sediments on October 31, 2014. The photo on the right shows the non-temporary nature of this embeddedness on June 6, 2015.

Unfortunately, these examples of what the EPA would call "Poor" stream bed habitat are representative of the degradation being suffered up and down this extended reach of stream.
