EXHIBIT 37

THE EVIDENCE OF EXCESSIVE EMBEDDED SEDIMENT AND SURFACE EXPOSED FINE SEDIMENT

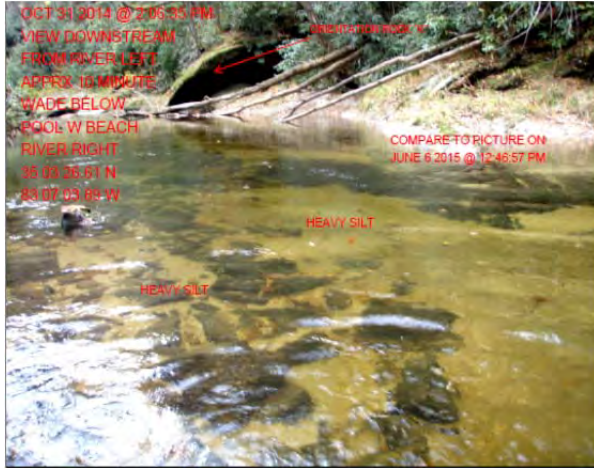
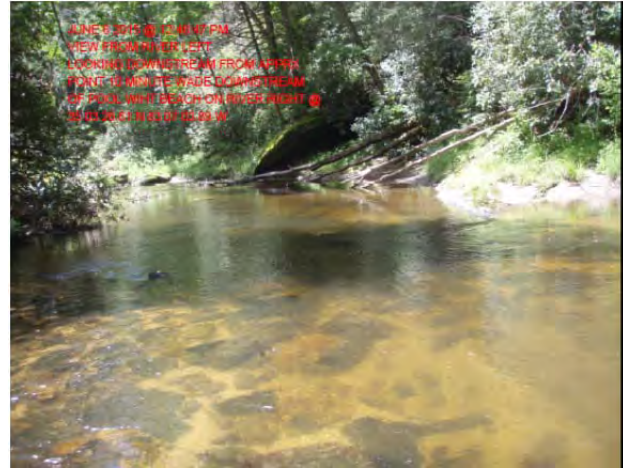
The two photographs below show the same location on October 31, 2014 and June 6, 2015 @ approximately 35 03 26.61 N 83 07 03.89 W. **35.057500 -83.117778**

The first photo shows how the stones in this section of riffle waters are smothered with small particle sediment at October 31, 2014. The photo on the right shows the continuing embedded condition on June 6, 2015. Compare those conditions to the EPA rapid assessment protocol photos below.

Applying the EPA’s Rapid Bioassessment Protocol, these riffle waters on the Chattooga ought to be assigned a “Poor” habitat condition score. Unfortunately, these two examples of “Poor” condition riffle waters are *typical* of conditions observed up and down this segment of the Chattooga.

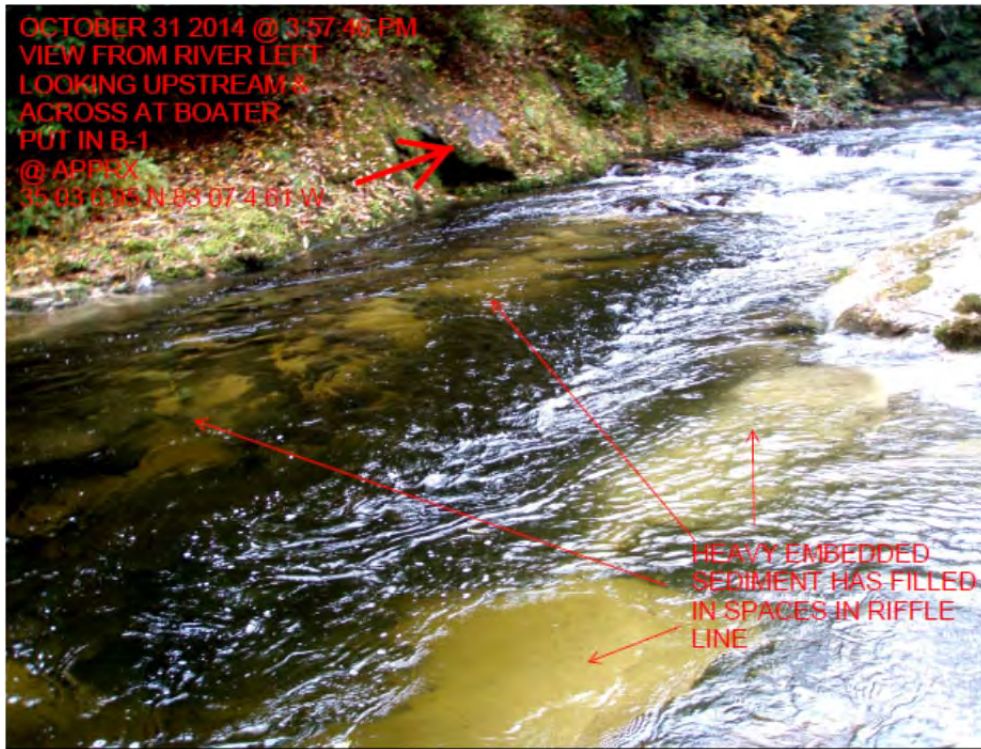
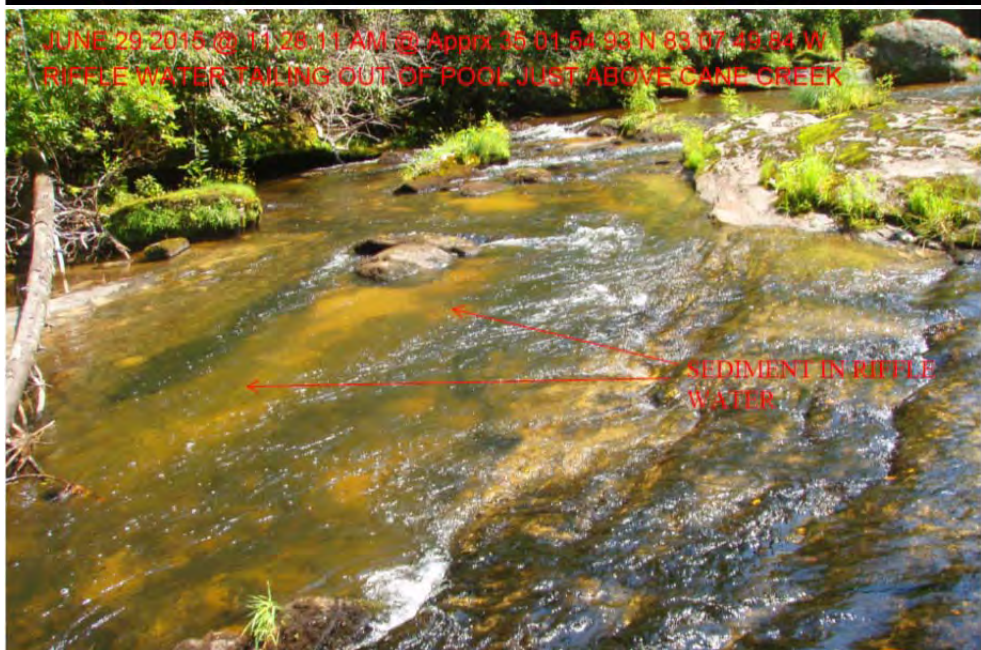
The top photo above is nearer to Green Creek and the second photo is just above Cane Creek. They are miles apart and yet both exhibit the same condition of embedded sediment in riffle waters.

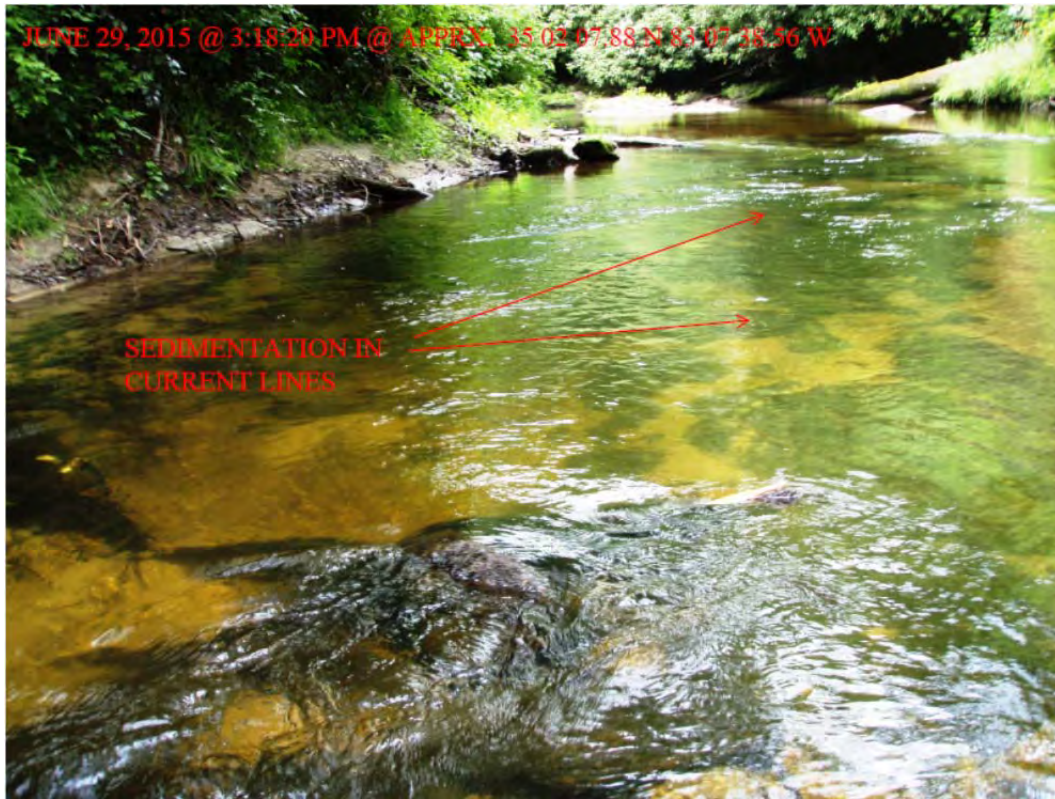
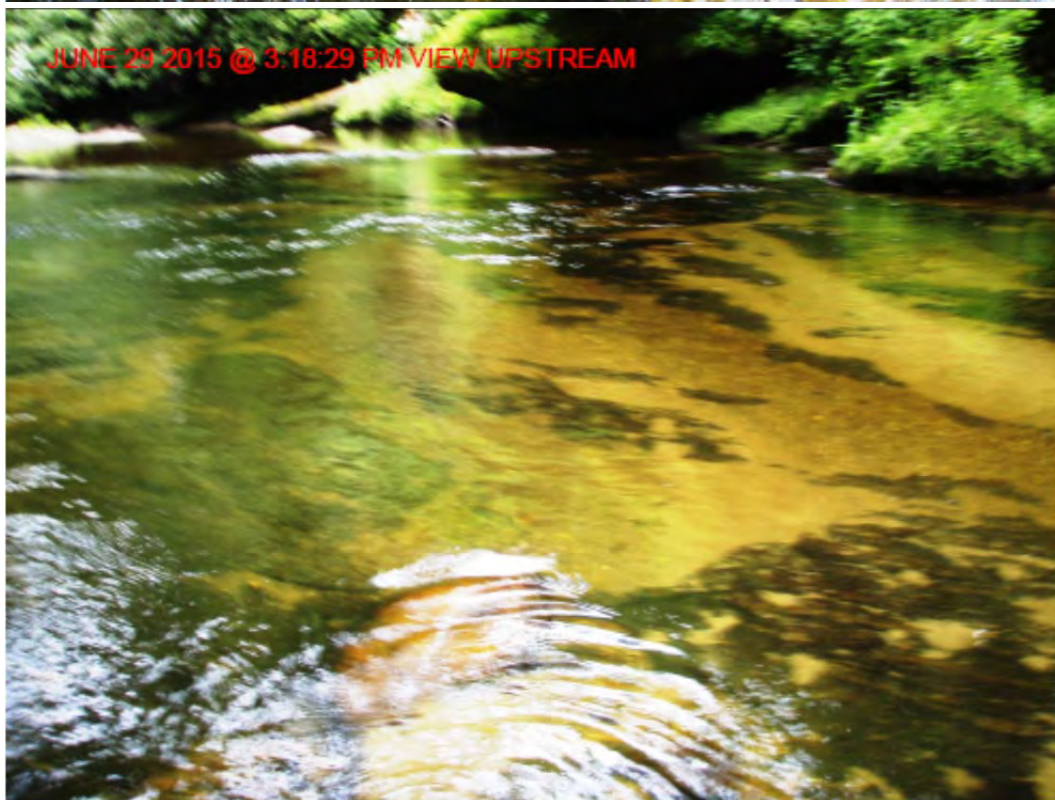
Floyd photos June 29, 2015 @ 3:18 PM. These two photos show embedded sediment spread across the entire width of the stream in riffle waters at 35 02 07.88 N 83 07 38.56 W. This riffle water is found on a shelf above a plunge pool just above the huge logjam.

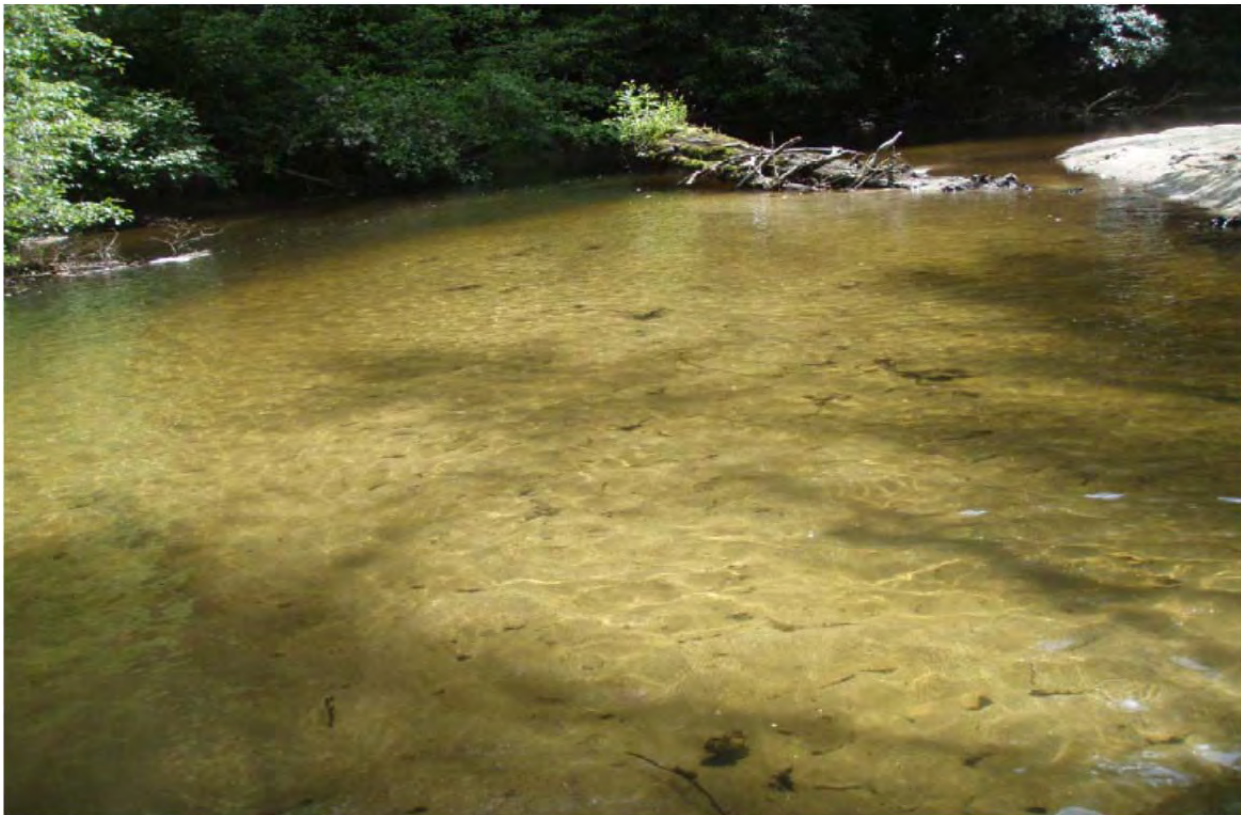
Floyd Photograph, June 29, 2015 @ 3:50:07 PM View Downstream 70 CFS @ Burrell's Ford @ Apprx. 35 02 59.81 N 83 07 06.62 W. This site is located where the river turns right approximately .7 miles downstream from the Green Creek boater put in. See the Google earth aerial above for a birds-eye view. The embedded sediment is bank to bank. The interstitial habitat is filled in with sediment.

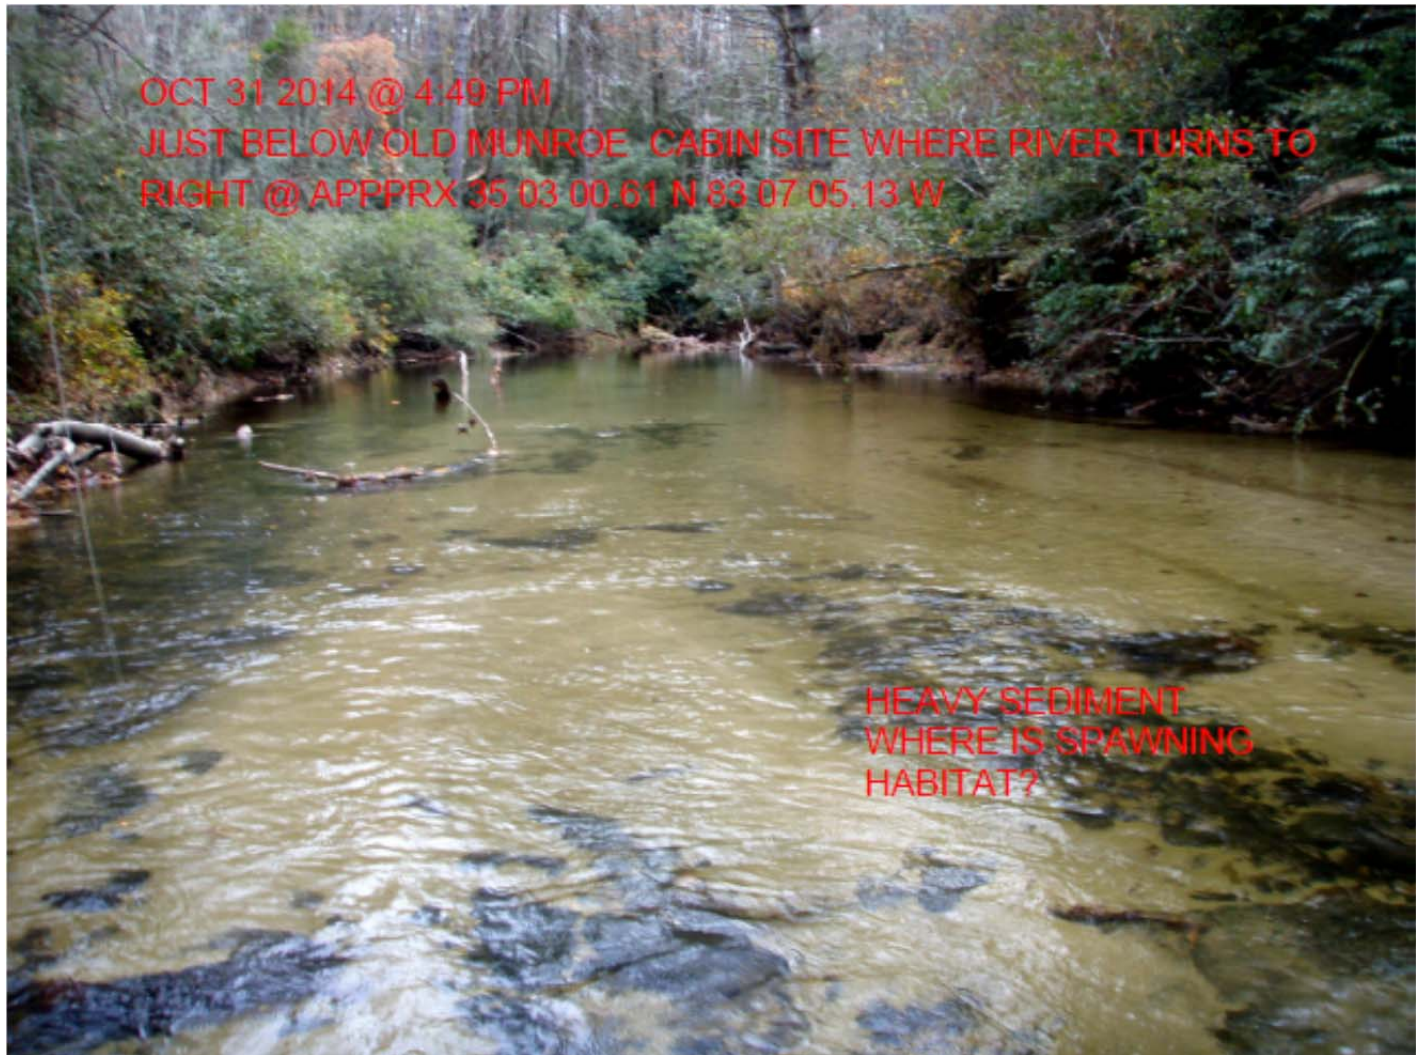
This photograph, taken on October 31, 2014, looks downstream towards where the river turns to the right in the photo shown on the previous page.

This straight and relatively wide reach of riffle water has been significantly impaired. This photograph evidences a lengthy section of the river where the rocks on the stream bed are fast disappearing under an increasingly deep blanket of fine particle sandy sediment.

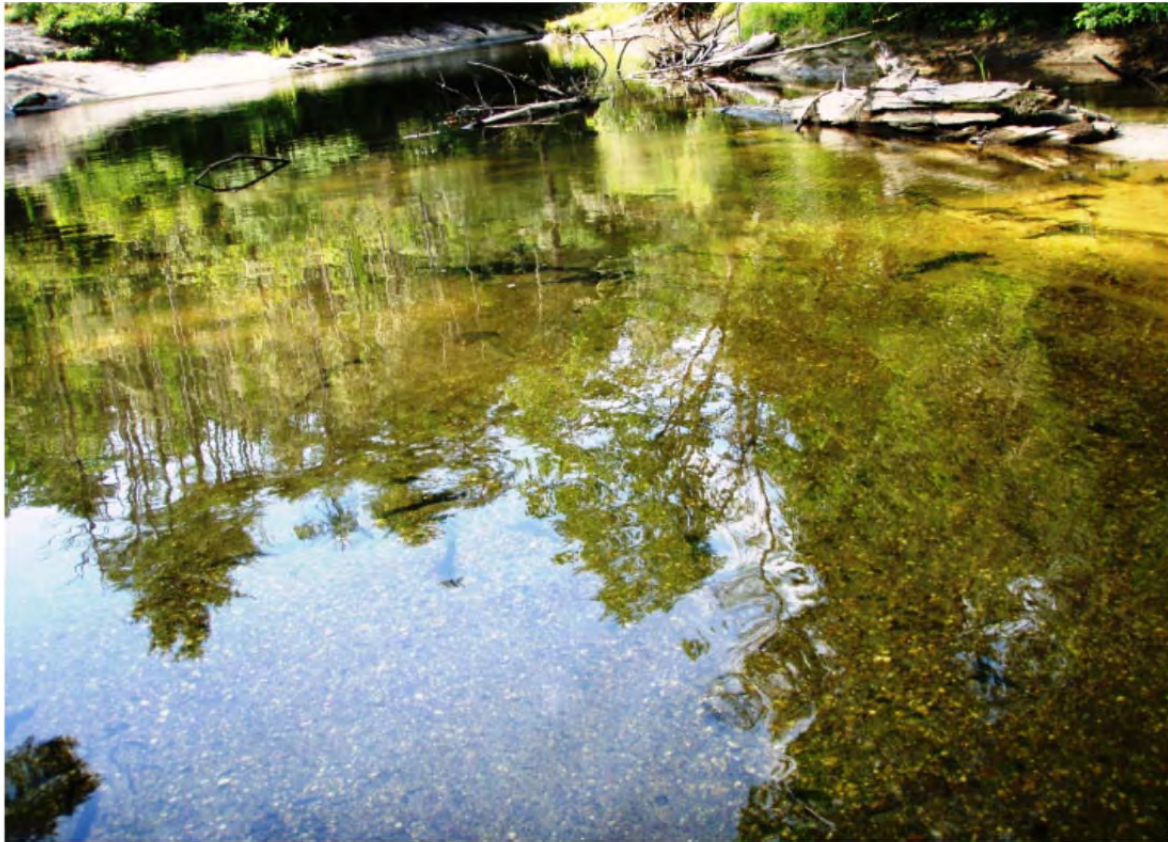
Floyd Photograph, June 29, 2015 @ 4:49:44 PM View Upstream at Tail of Norton Mill Creek Pool @ Apprx. 35 02 26.85 N 83 07 29.53 W Flow @ 70 CFS @ Burrell's Ford. The depth of this pool has been significantly reduced.

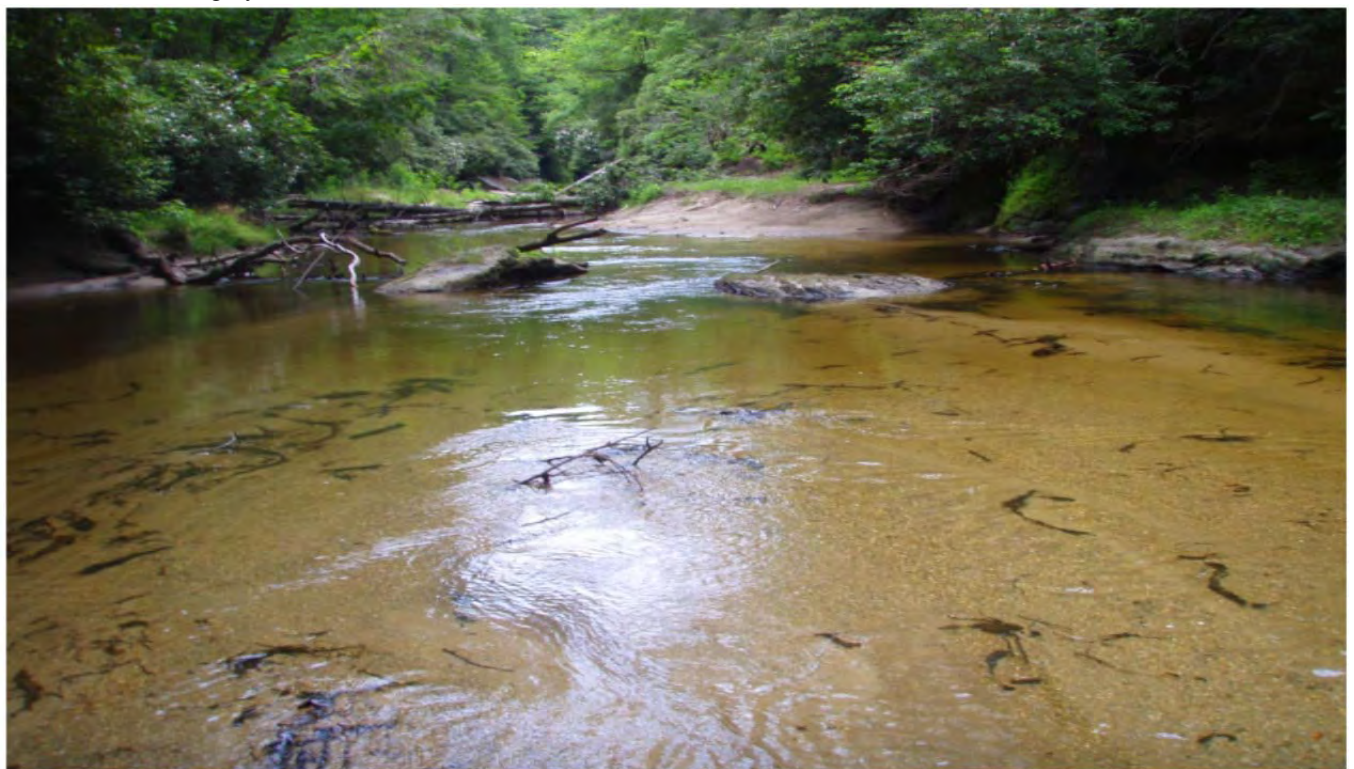
Floyd Photograph, June 29, 2015 @ 2:45:48 PM View Upstream @ 35 02 02.04 N 83 07 42.76 W (approximately .25 miles above confluence of Cane Creek) and immediately in front of the huge logjam.

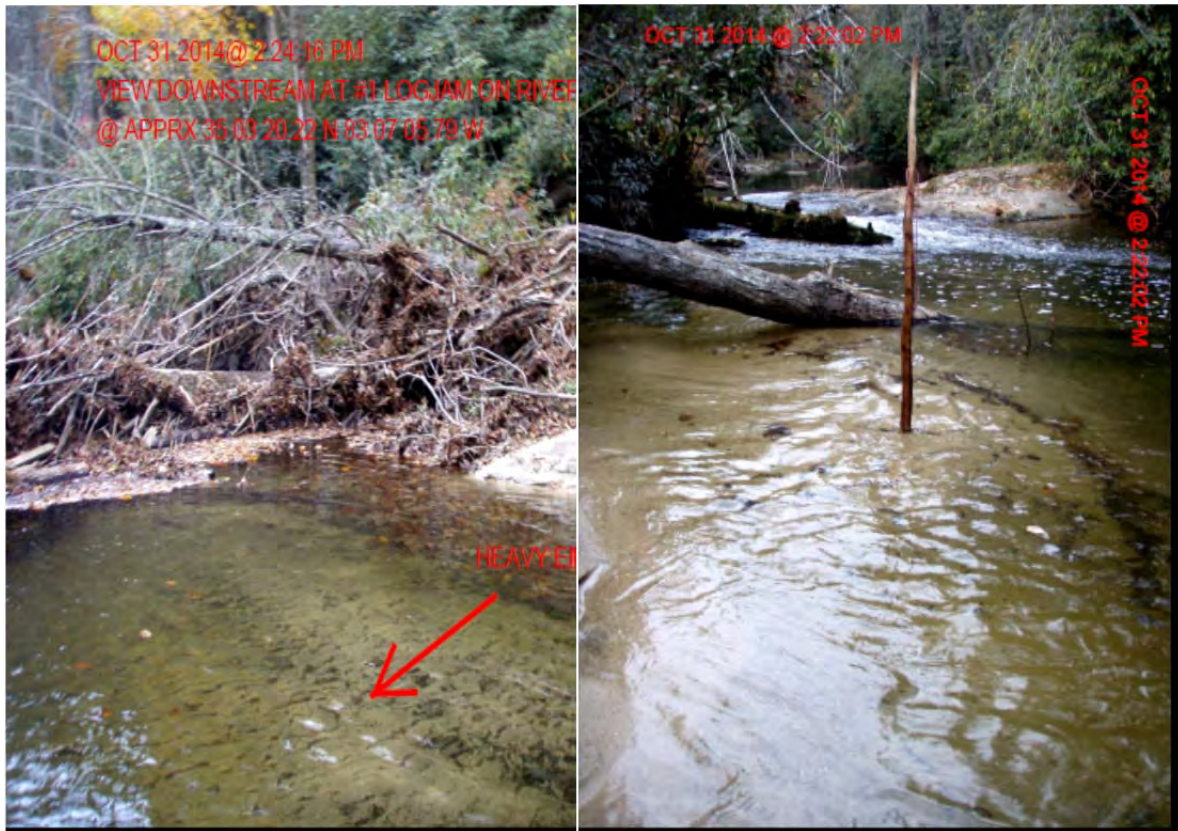
The left photo looks downstream at the first of two logjams just minutes downstream of the paddler launch site below Green Creek. The photo on the right is turned around and looking back upstream from the logjam. Note the hiking staff. It evidences how the sediment was over a foot deep.

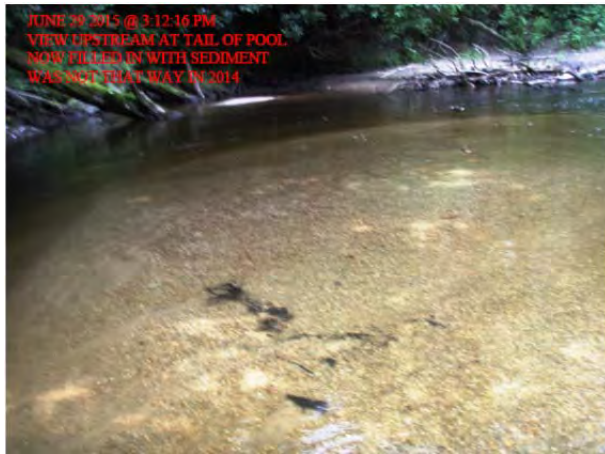
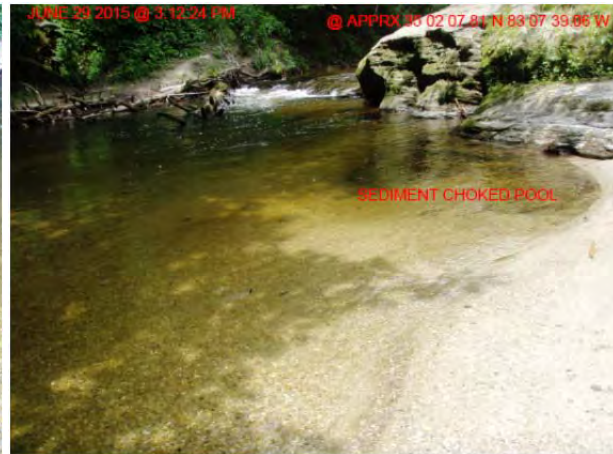
Floyd photos @ June 29, 2015. View is upstream. This used to be a *beautiful little* pool where trout were abundantly present @ approximately 35° 02' 07.81" N 83° 07' 39.66" W. This is no longer the case. See the aerial above.

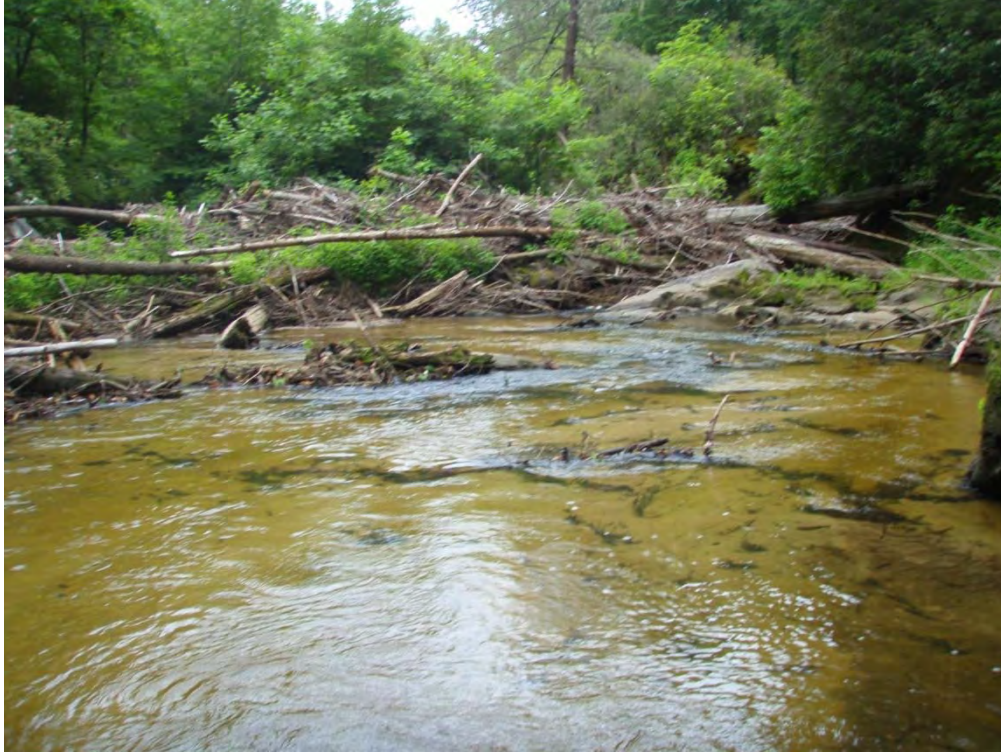
Floyd photo. June 29, 2015 @ 2:45:18 PM. View is downstream looking at the huge logjam @ 35 02 02.03 N 83 07 42.76 W. The sediment is bank to bank. This sediment condition continues upstream from here.

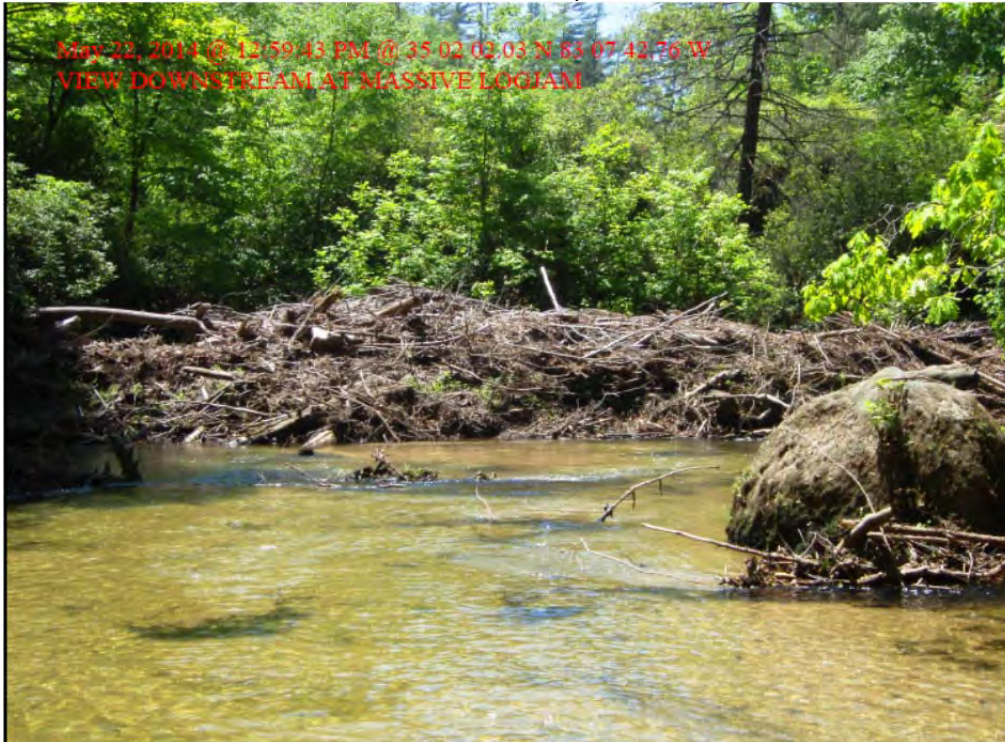
Floyd photo. May 22, 2014 @ 12:59:43 PM View is downstream. Sediment in foreground appears to be less than that present in June 29, 2015. You can still see the rocks on the river bed in the middle of the creek.
