Prescribed Fire Behavior Analyst

These are some of the many documents that I followed the Buchanan R. fire accident in which an employee was killed when the fire turned over him.

**BUCHANAN PRESCRIBED FIRE
A PORTION OF DIVISION 'C'**

Point Locations for use with Time
Sequence of Events Occuring on
the Buchanan Prescribed Fire
April 22, 1993

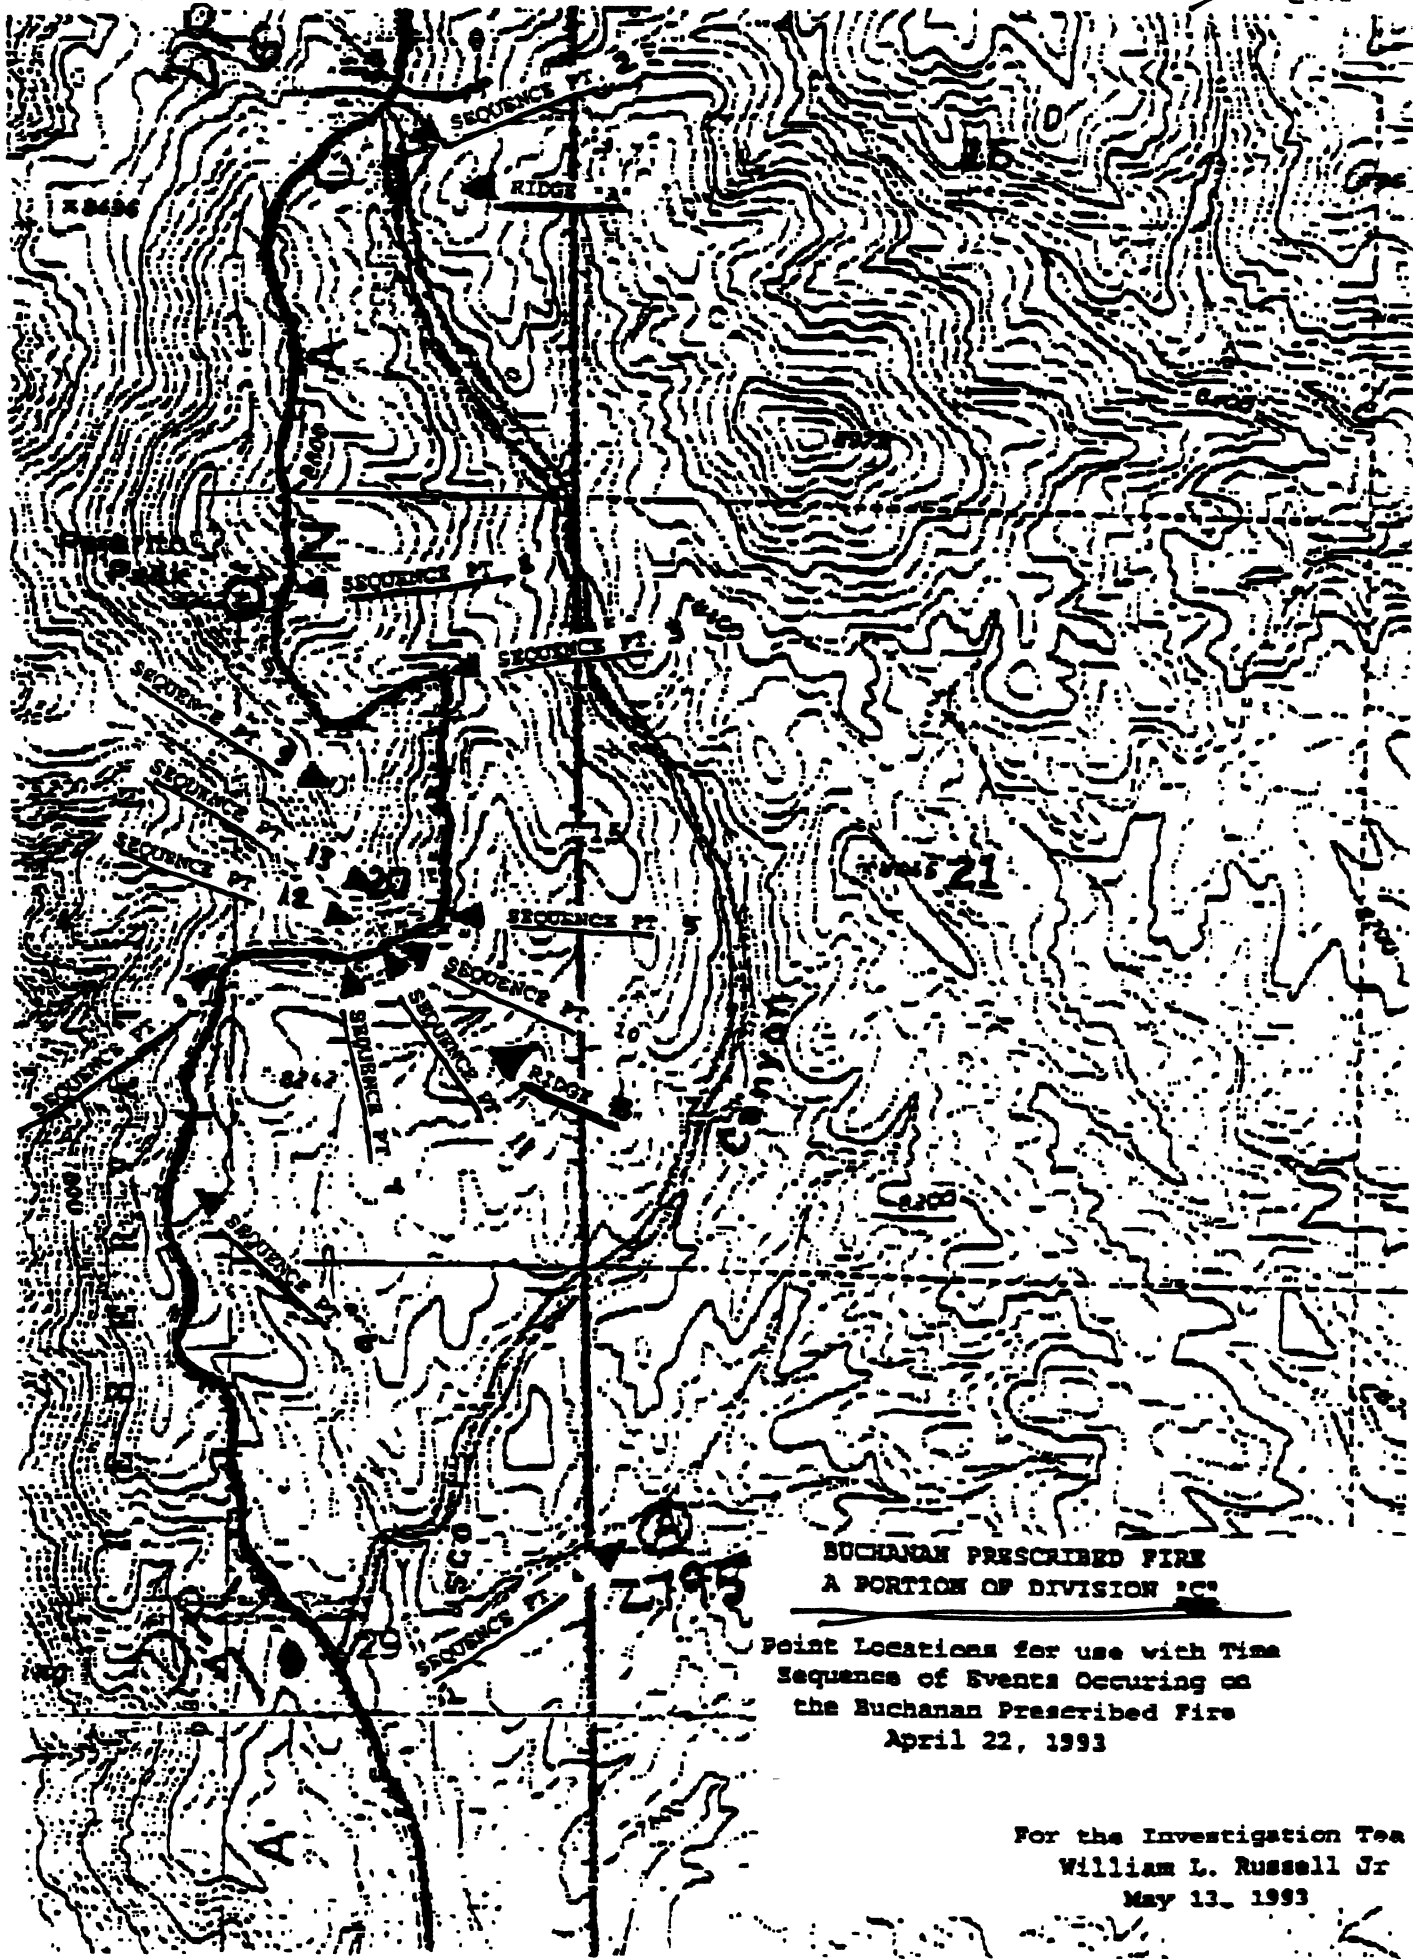
1540 Tolle The strong southwest winds caused the fire in the area below the road at Point 8 to jump into the crown, make a short run east through the crowns, then immediately jump across the road at Point 7 moving at approximately a 45-degree angle across the south-facing slope. Dave Tolle heard some garbled radio traffic, which he later thought related to Engine 5 crewmembers deploying their shelters.

- Seonia As the four individuals that wound up in shelters were getting their shelters out, Ken Seonia had trouble getting his shelter out of the plastic case and decided to go over the road embankment toward a burned area he could see through the green just below the road. A fire flame front passed over Ken as he reached, and was forced to hide behind, a large rock. He still did not have time to deploy his shelter, because he had been chasing his hard hat down the hill. The large rock was approximately 20 yards below Engine 5, sitting at Point 7.

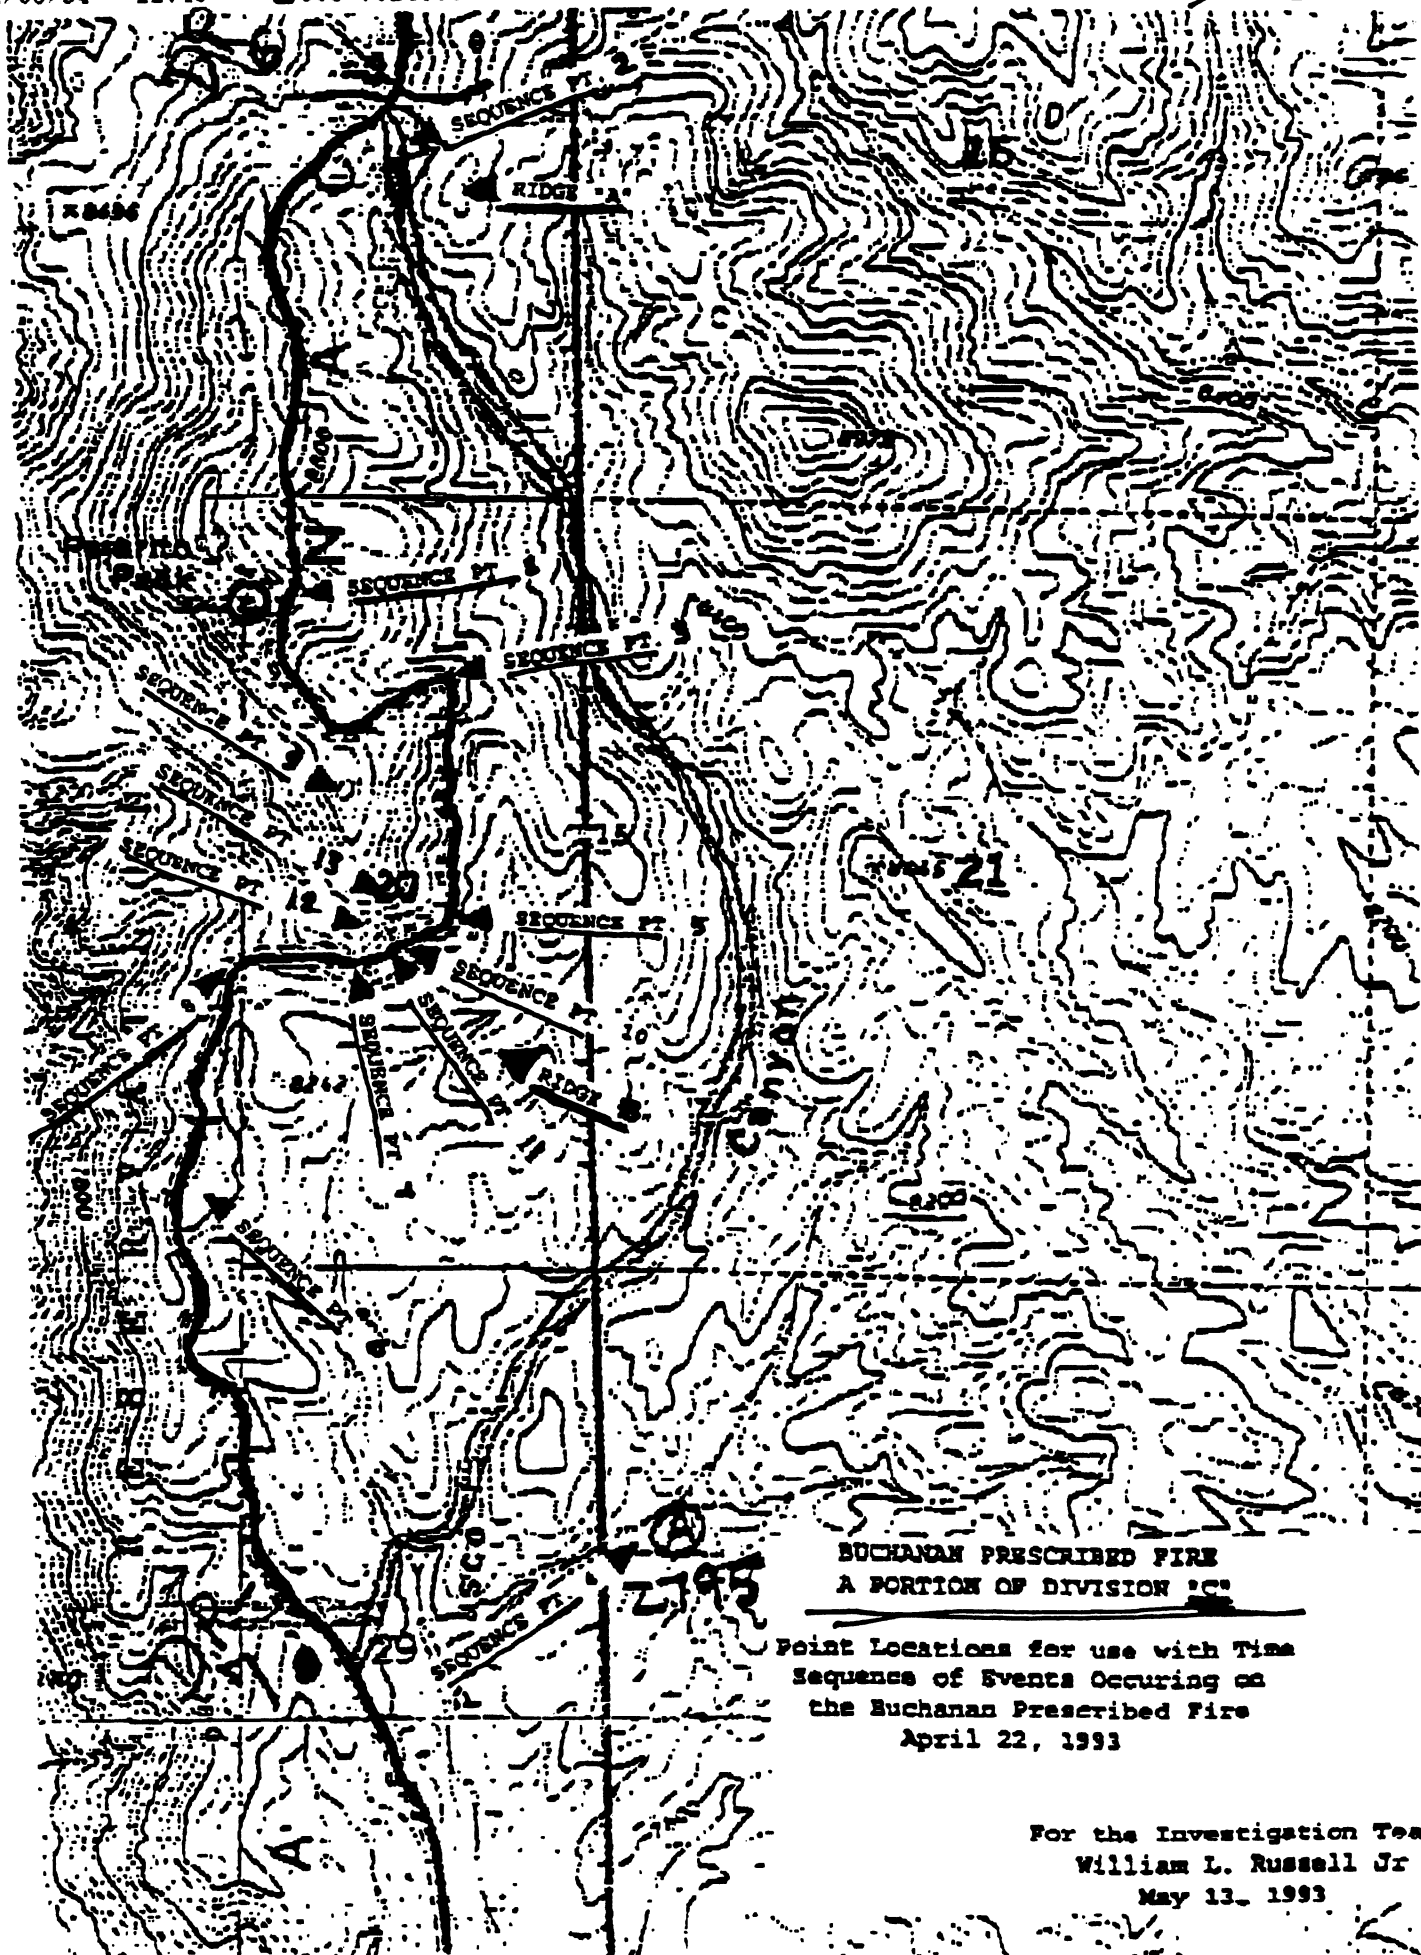
**BUCHANAN PRESCRIBED FIRE
A PORTION OF DIVISION "C"**

Point Locations for use with Time
Sequence of Events Occuring on
the Buchanan Prescribed Fire
April 22, 1993
