A REPORT BY WILD VIRGINIA

FEBRUARY 2023

MOUNTAIN VALLEY PIPELINE POLLUTION IN VIRGINIA WATERSHEDS

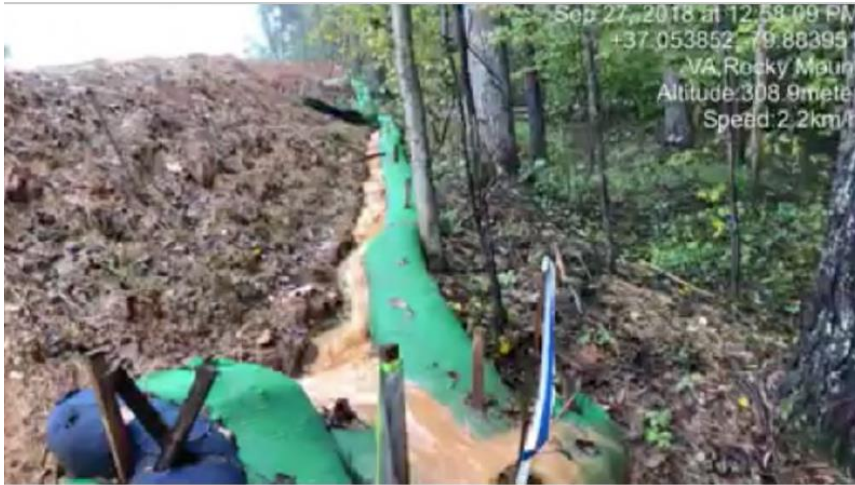
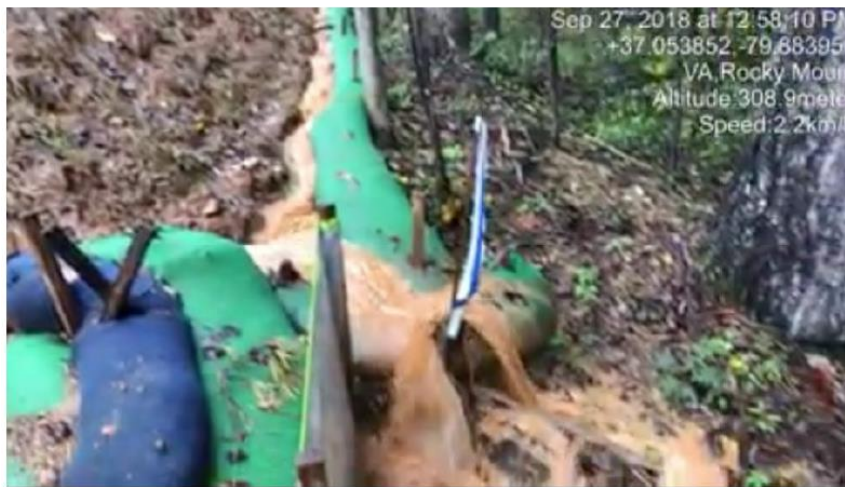
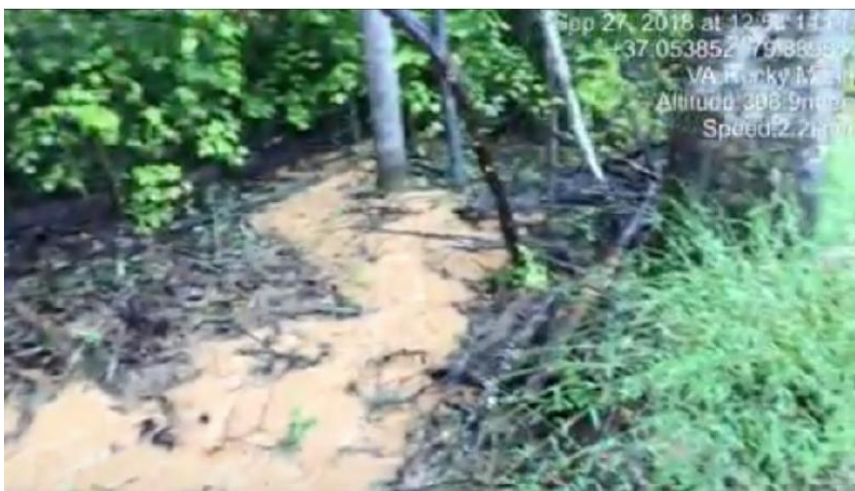
Figures 13 - 15 -
September 27, 2018
Sediment-laden water overflowing compost filter socks and leaving the MVP ROW, several hundred feet upslope of the Blackwater River.
Taken from a [video accessible at Virginia Pipeline Violations Facebook page](#)

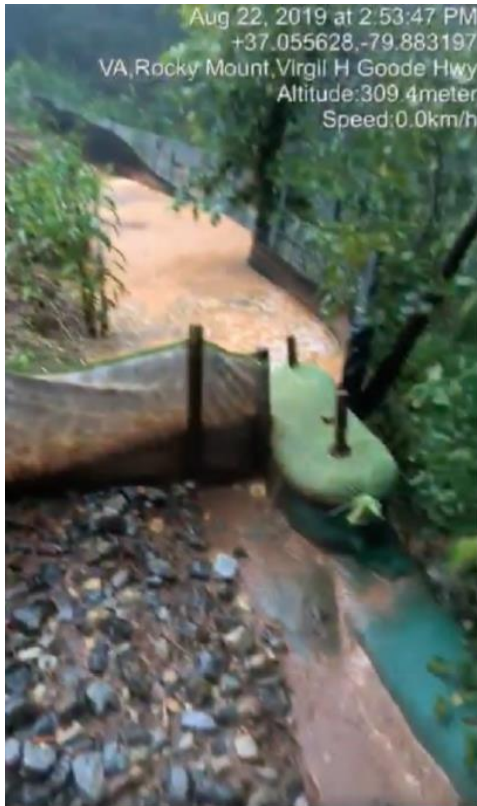
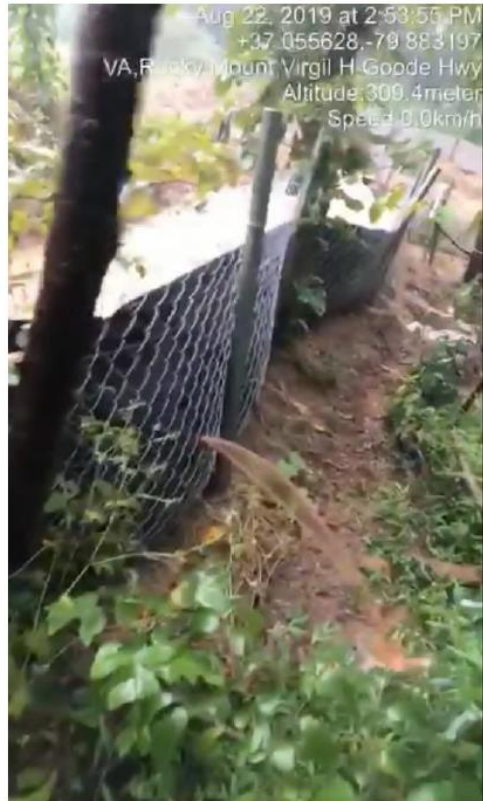
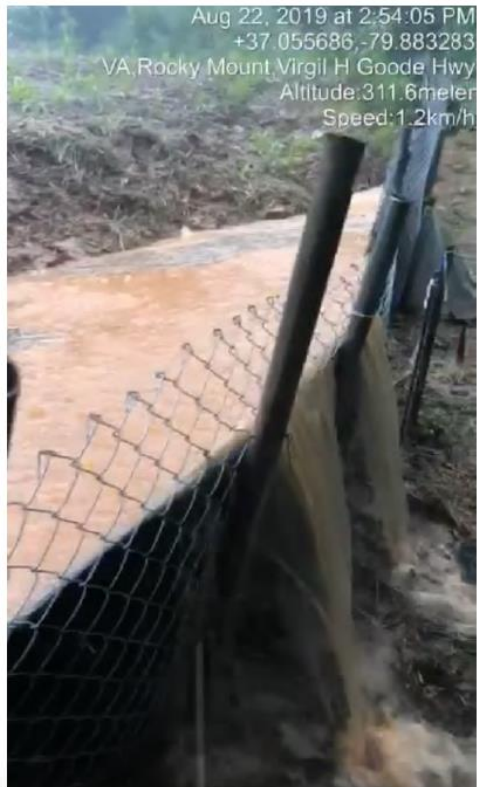
Figures 16 - 18 - August 22, 2019
Sediment-laden water flowing over, around, and through super silt fence and leaving the MVP ROW, several hundred feet upslope of the Blackwater River.
Taken from a [video accessible at Virginia Pipeline Violations Facebook page](#)

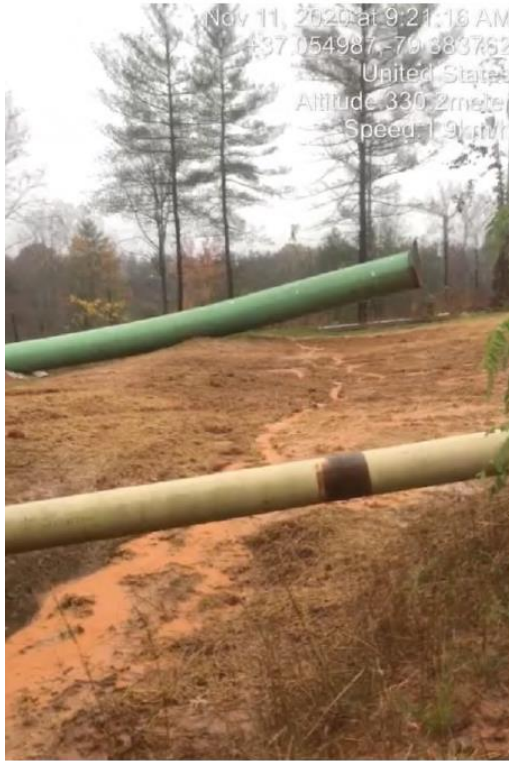
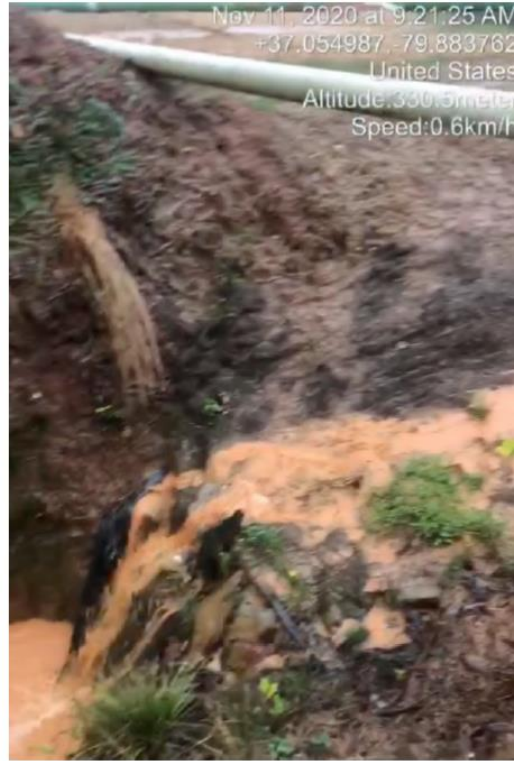
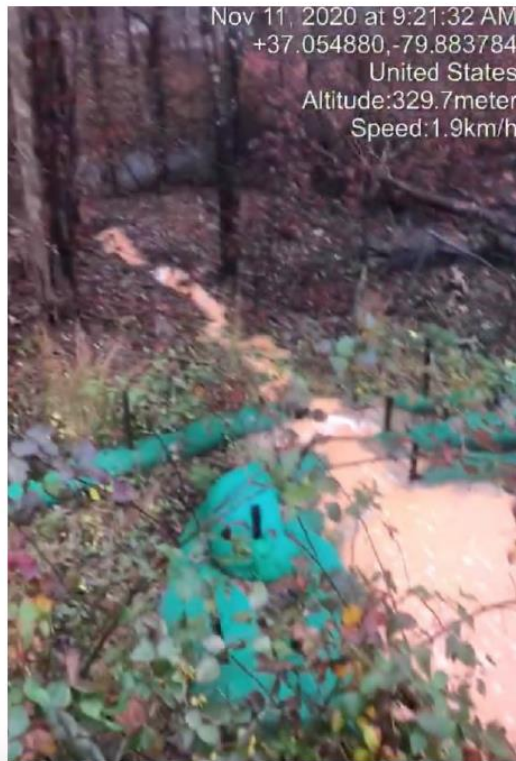
Figures 19 - 21 - November 11, 2020, Sediment-laden water overwhelming an end treatment and leaving the MVP ROW, several hundred feet upslope of the Blackwater River.
Taken from a [video accessible at Virginia Pipeline Violations Facebook page](#)

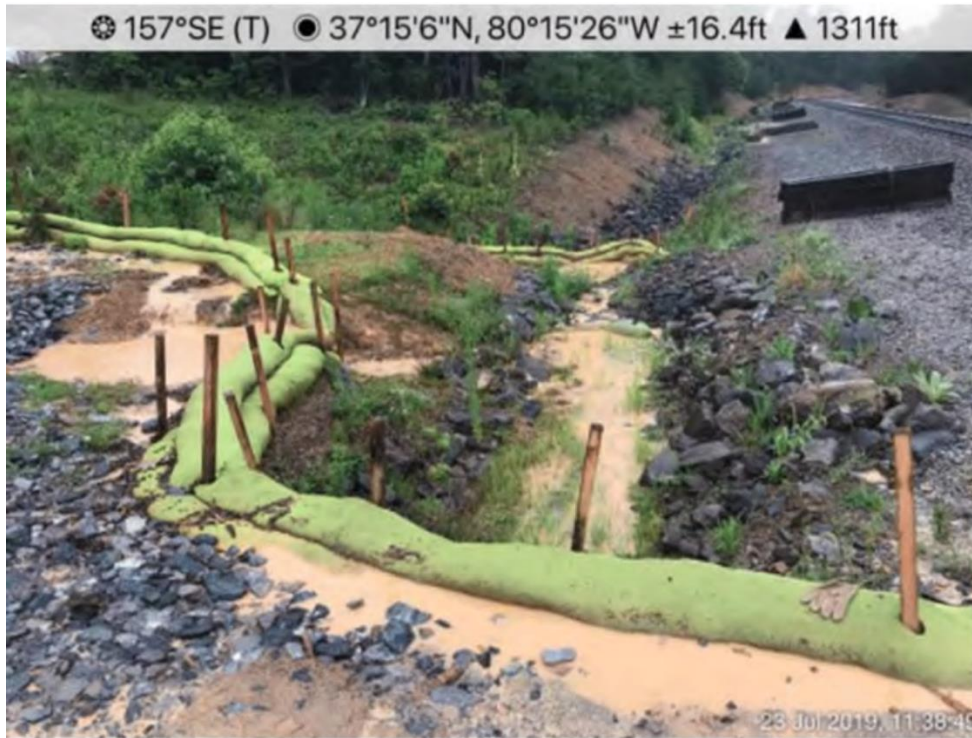
Figure 23 - Sediment-laden water undermining compost filters socks and discharging to a UT of Bradshaw Creek, July 23, 2019, DEQ Complaint inspection report, Source: DEQ [Bradshaw Creek is within the range of the Endangered Roanoke Logperch]

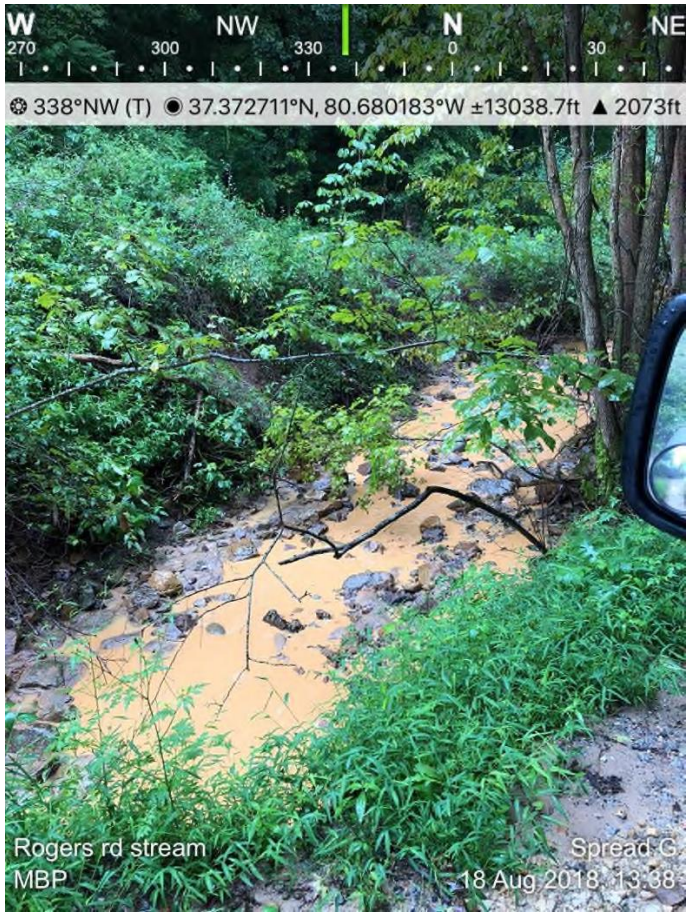
Figure 33 - Sediment deposited in Kimballton Branch, August 18, 2018, Action Log ID 604, Source: MBP

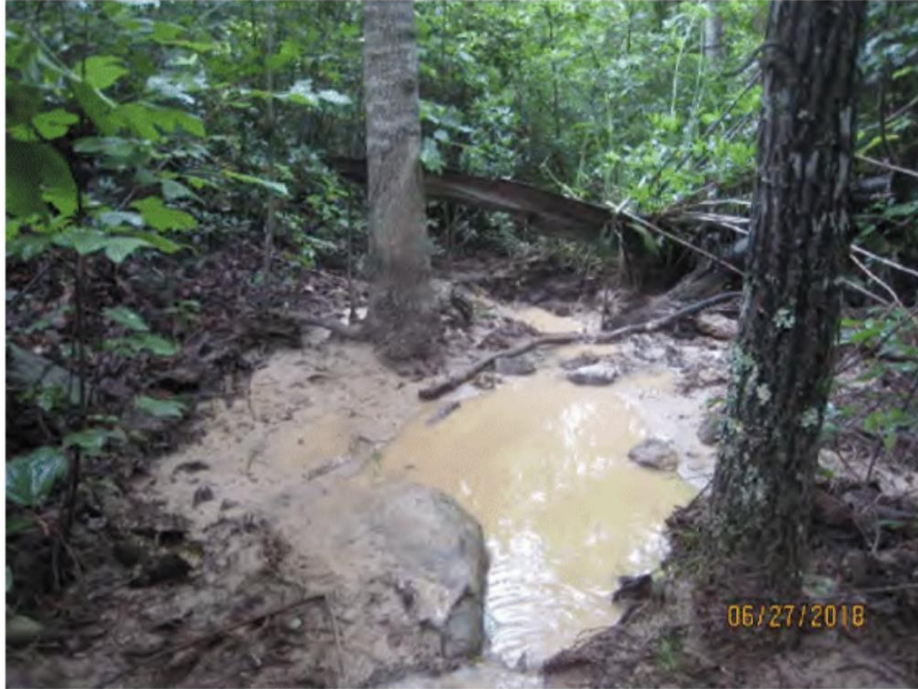
Photo 1: Sedimentation within “SMM-15” ~160’ downstream of LOD; Depth = 3”
Orientation: Downstream

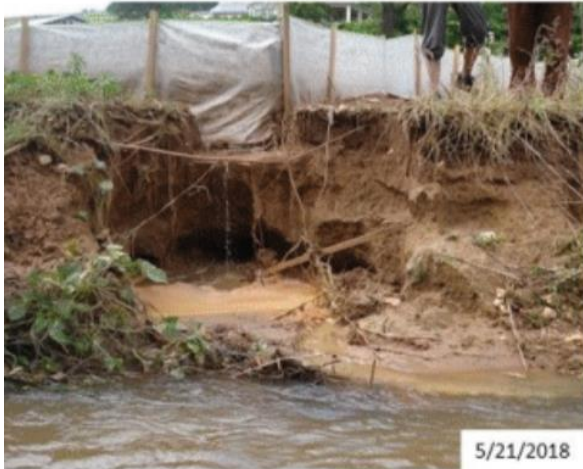
Figure 44 - A series of views of a collapsing stream bank on Teels Creek and Mountain Valley's attempts to repair the damage over several months in 2018. Source: Mountain Valley Watch Report, Appendix F to this report.

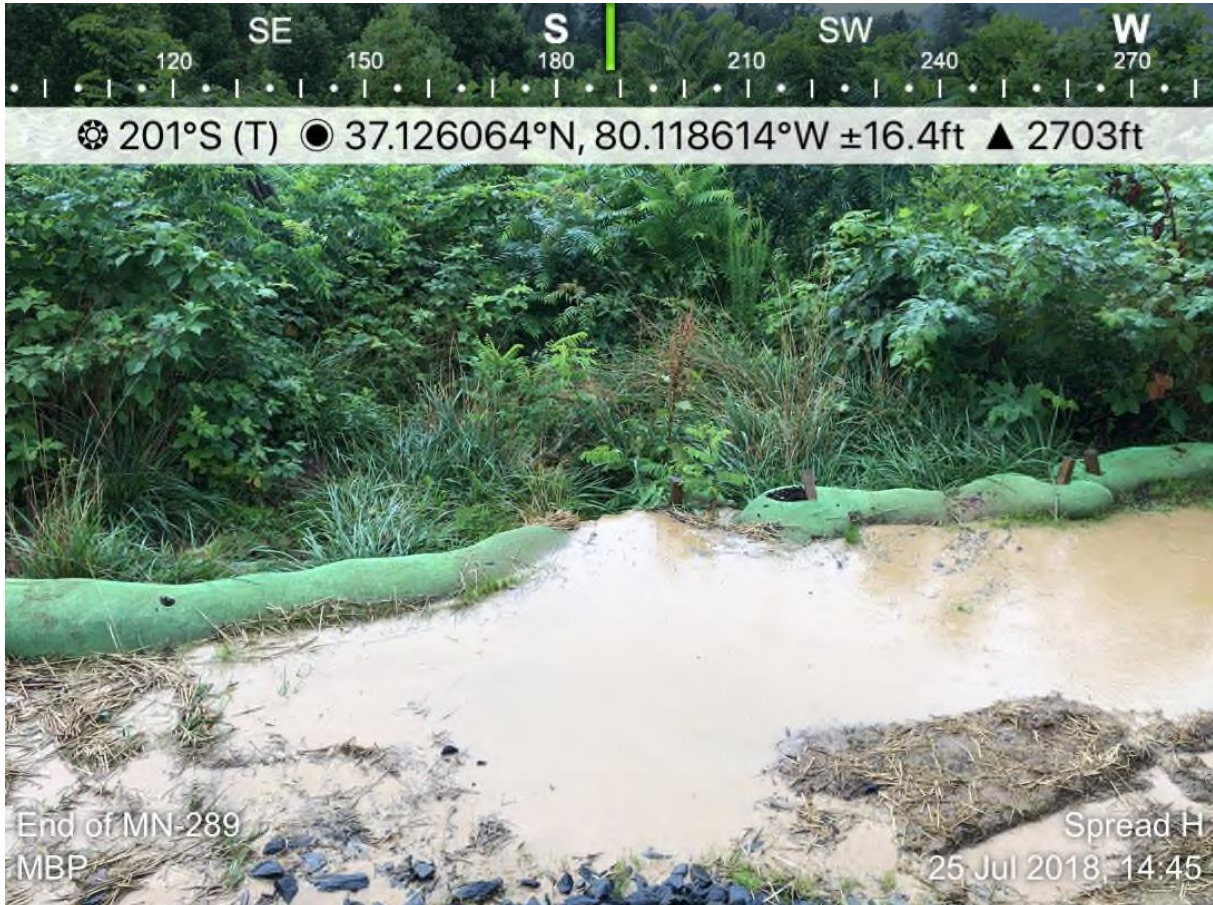
Figure 46 - Sediment-laden water overtopping perimeter control, July 25, 2018, Action Log ID 458, Source: MBP [an additional compost filter sock was added 10 days after this situation was observed]

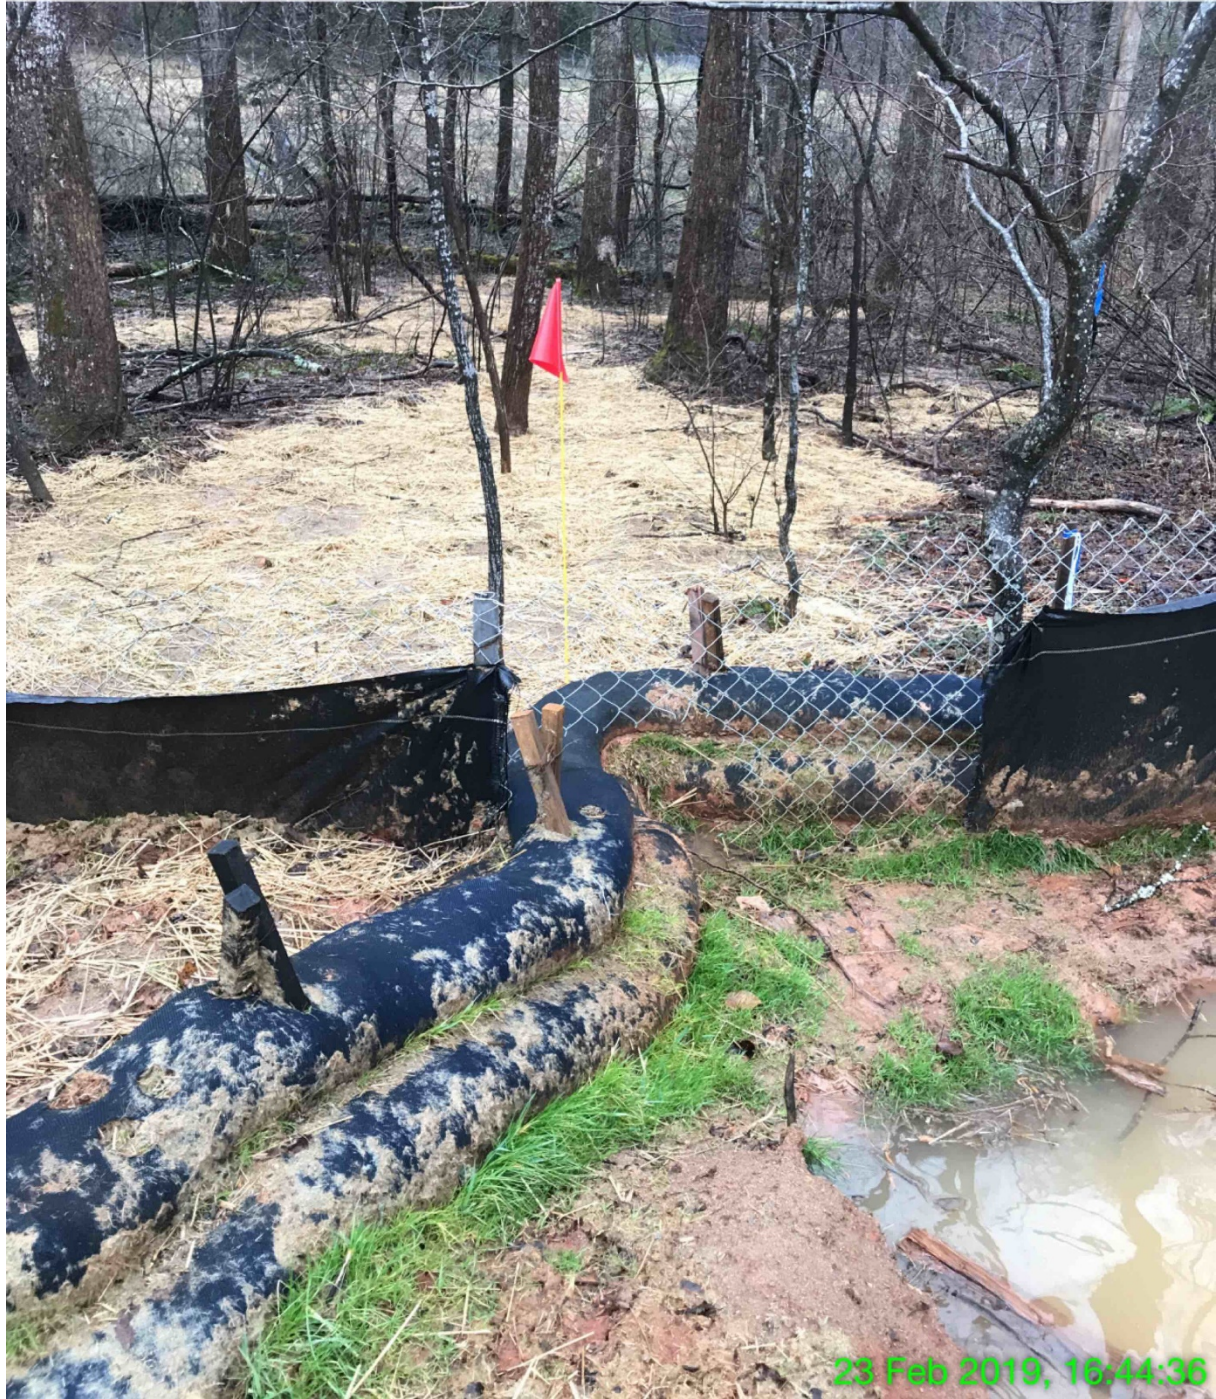
EXHIBIT N – Sediment-laden runoff has flowed from the construction corridor. MVP contractors have covered the sediment with straw. The photograph in Exhibit O shows what is typically found under the straw carpets.

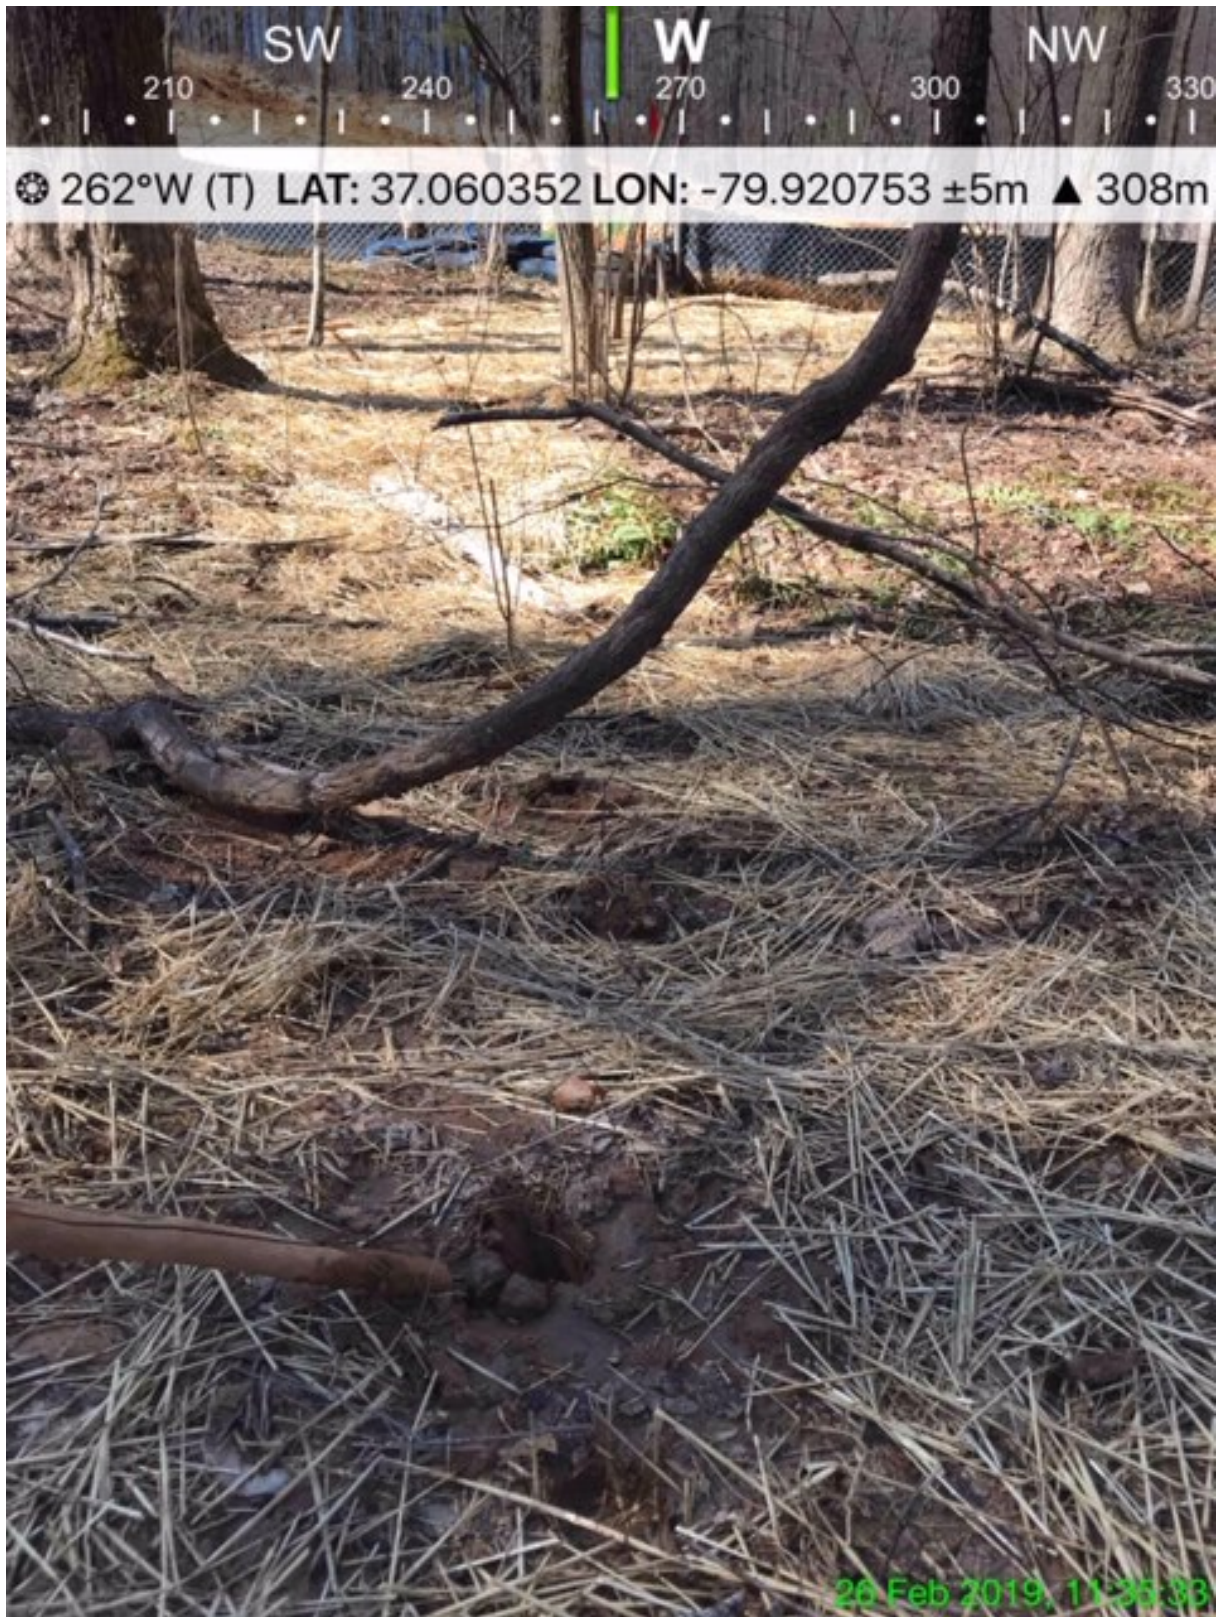
EXHIBIT O – MVP contractors cover sediment flows with straw.

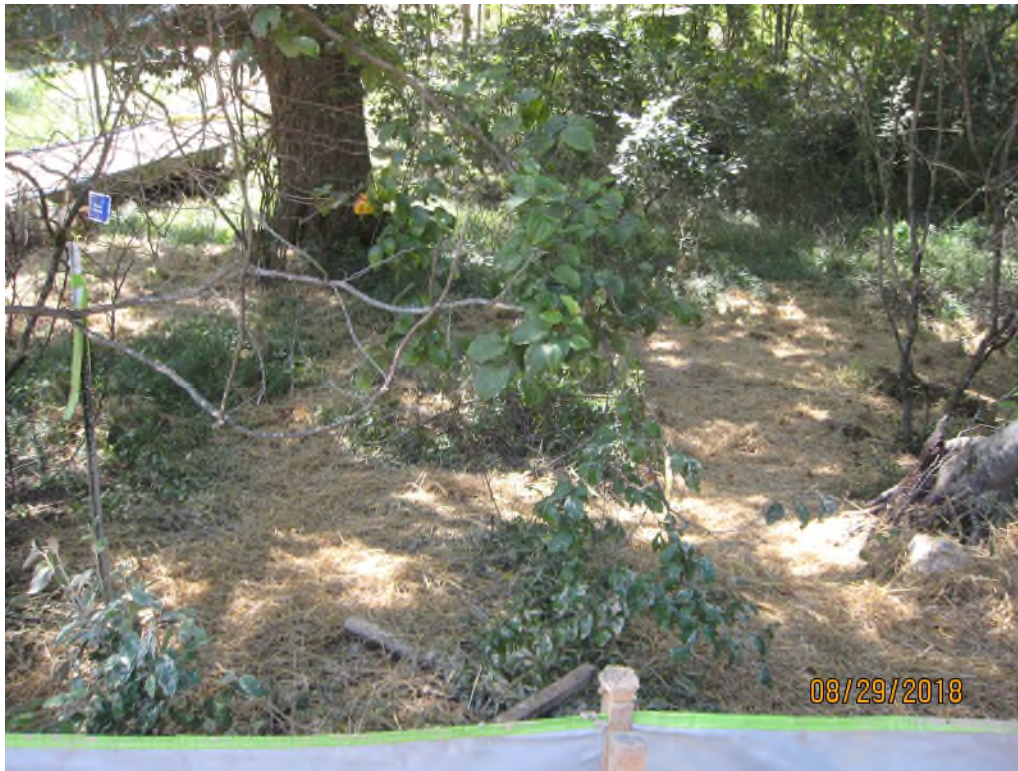
Photo 1: Seed/straw area within forested stream buffer downslope of ESC failure

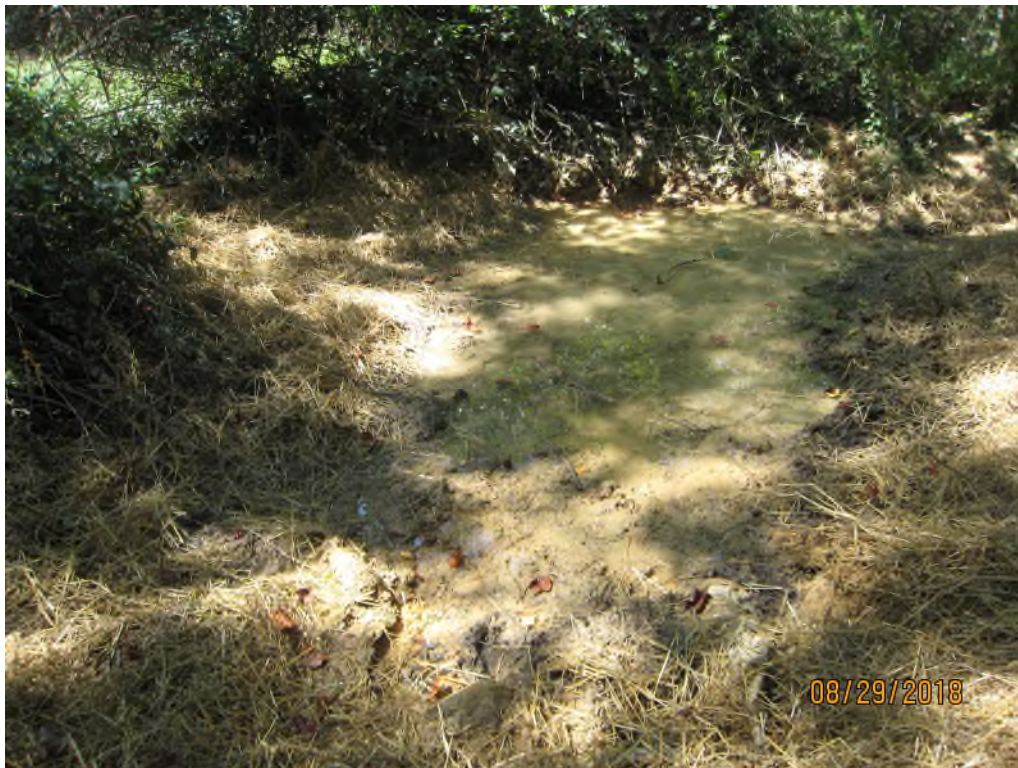
Photo 2: Sedimentation and seed/straw in small pool downslope of ESC failure

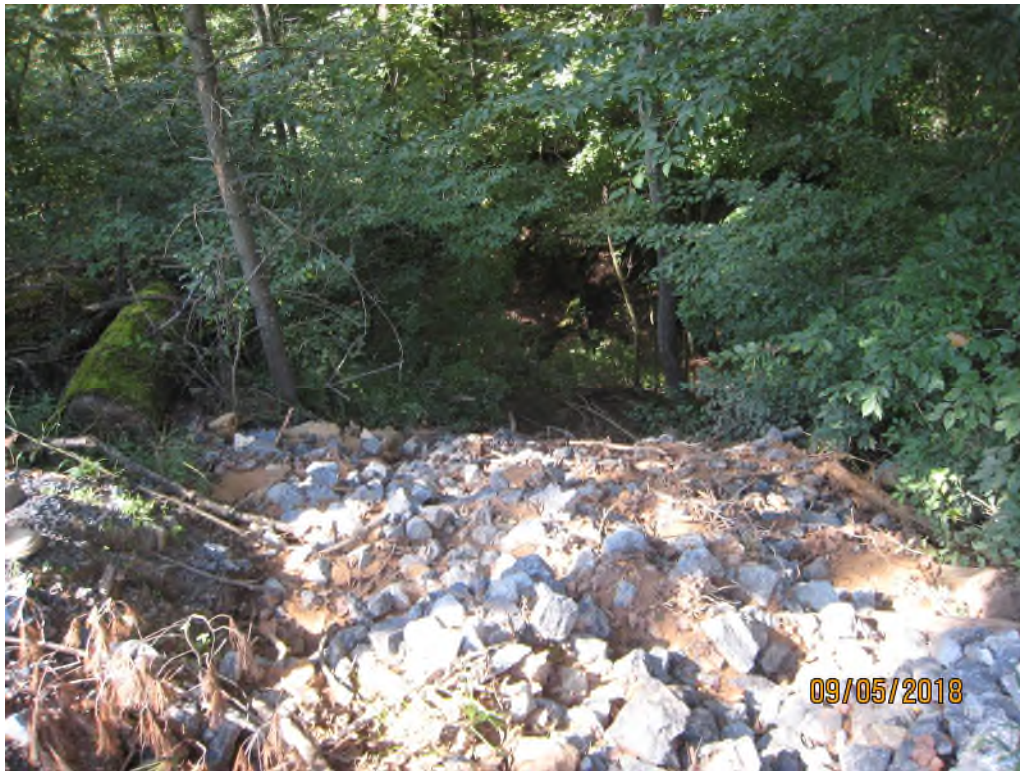
Photo 1: View from Access Road G/I 234 toward Kimballton Branch downslope of ESC failure
Orientation: N/A

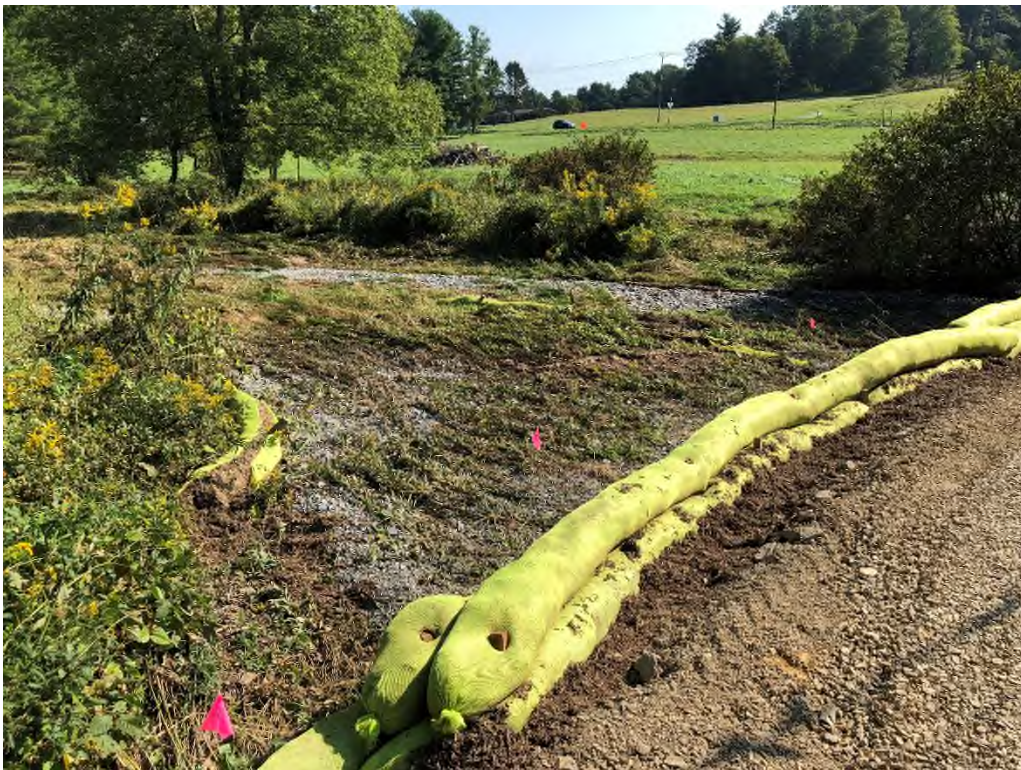
Photo 2: Gravel from Access Road 288 in Wetland IJ-10 due to ESC failure
Orientation: N/A

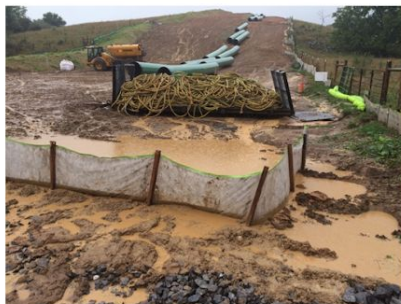
A. Pipeline centerline and working/parking area at southern terminus of MVP work site. Sediments were actively flowing from upslope pipeline areas. BMPs in place included oversized slope breaks with deeply dug sediment traps at the ends. Silt fencing and mulch-filled socks were in place to retain any sediment escaping from the primary control structures. (Figure 4)

Silt fence in photo failed and has been “reconstructed”, but still actively failing. Standing in approximate centerline, looking eastward toward highly sloping double bench system, and away from SGT.

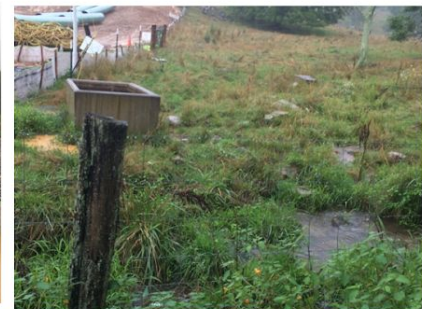
Stream coming from springs above the site is clear. Sediment above escaped the construction zone. Note position of cement water trough here and photo at left.

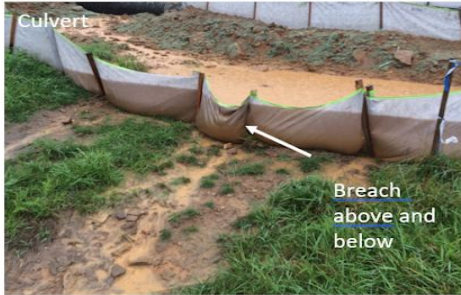
Recently installed ditch for moving sediment off worksite. Unfortunately, ditch is (purposefully) connected to a culvert intended to drain water from grassed bank (with no erosion). Now sediment entering culvert moves directly, with no BMPs in place, into the stream. Culvert is at the far end of this photo

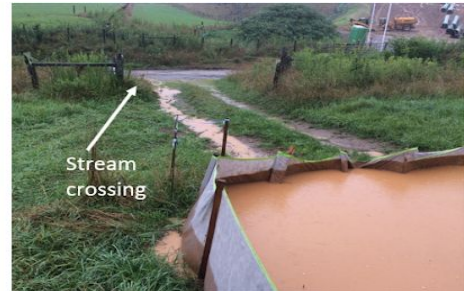
C. Another significant failure across the road. This one is pouring sediment off the LOD, into the stream and into SR 642 – SGT.

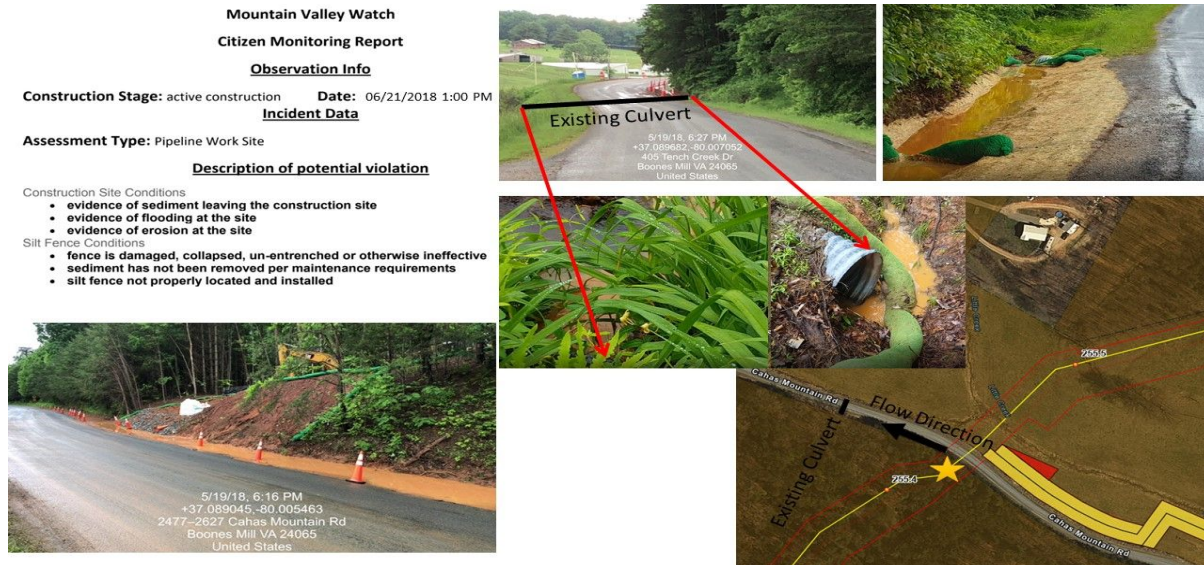
Figure 9: Cahas Mountain Road mudslide site showing location of sediment entry to Little Creek through an existing culvert beneath road.

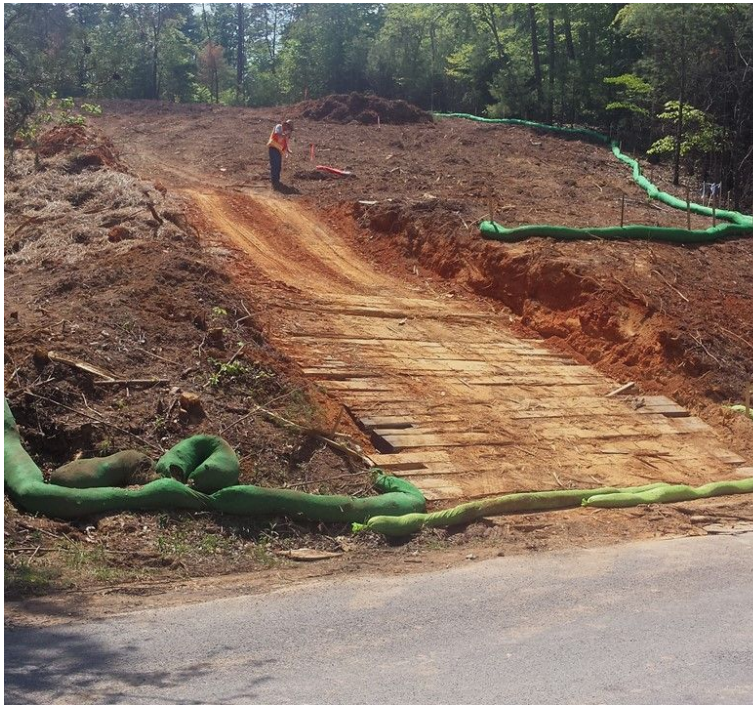
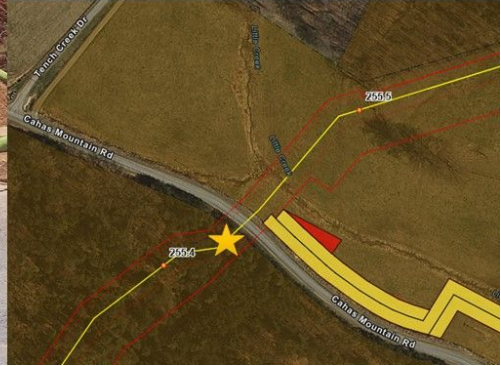
Figure 10: Potential violation reported - May 13, 2018

Lack of gravel, inadequate E&SC; mudslide; sediment leaving construction site; failed BMPs.

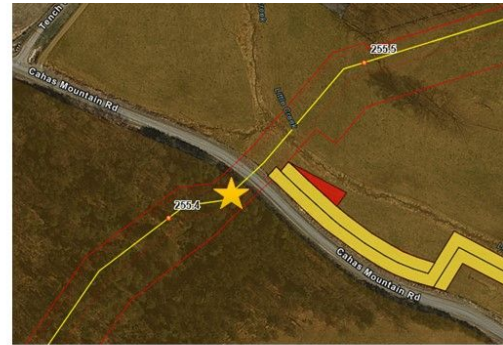
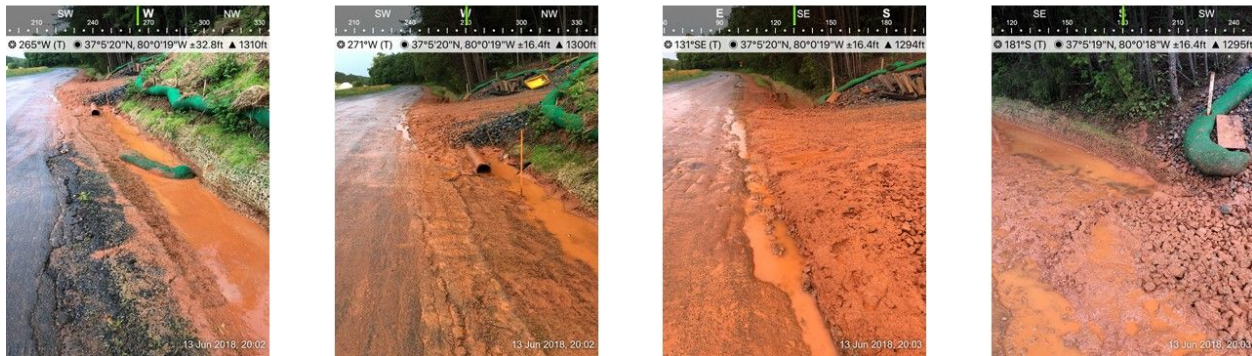
Figure 12: Potential violation reported - June 13, 2018

Lack of gravel, Mud or sediment on main road

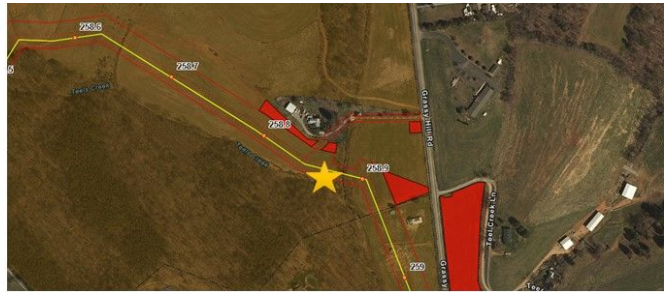
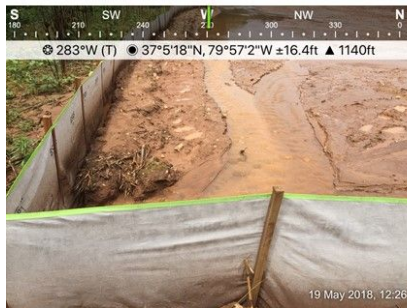
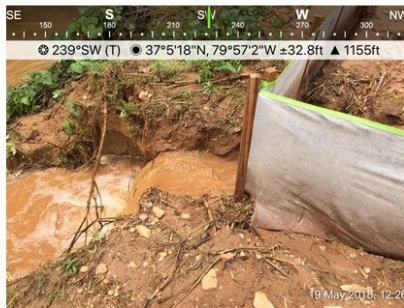
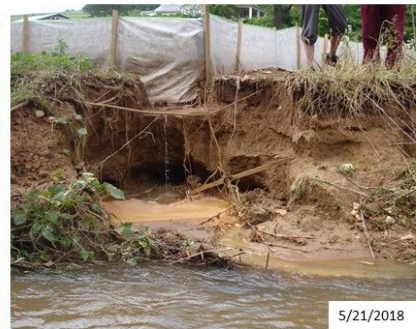
Figure 13: Potential violations reported - May 19 - 21, 2018

- fence is damaged, collapsed, un-entrenched or otherwise ineffective
- sediment has not been removed per maintenance requirements
- silt fence not properly located and installed

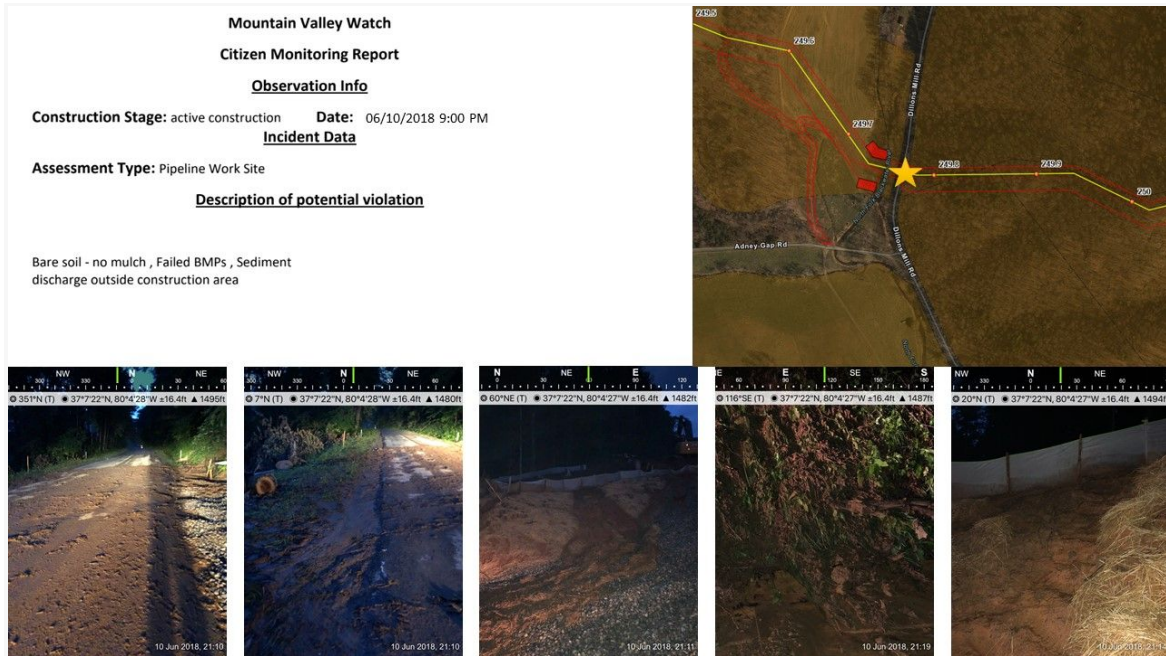
Figure 18: Violations reported - June 10, 2018

Temporary right-of-way diversions (RWD) were not properly installed. Per Std & Spec 3.11 of the Virginia Erosion Control Handbook. Violation reported - June 10, 2018

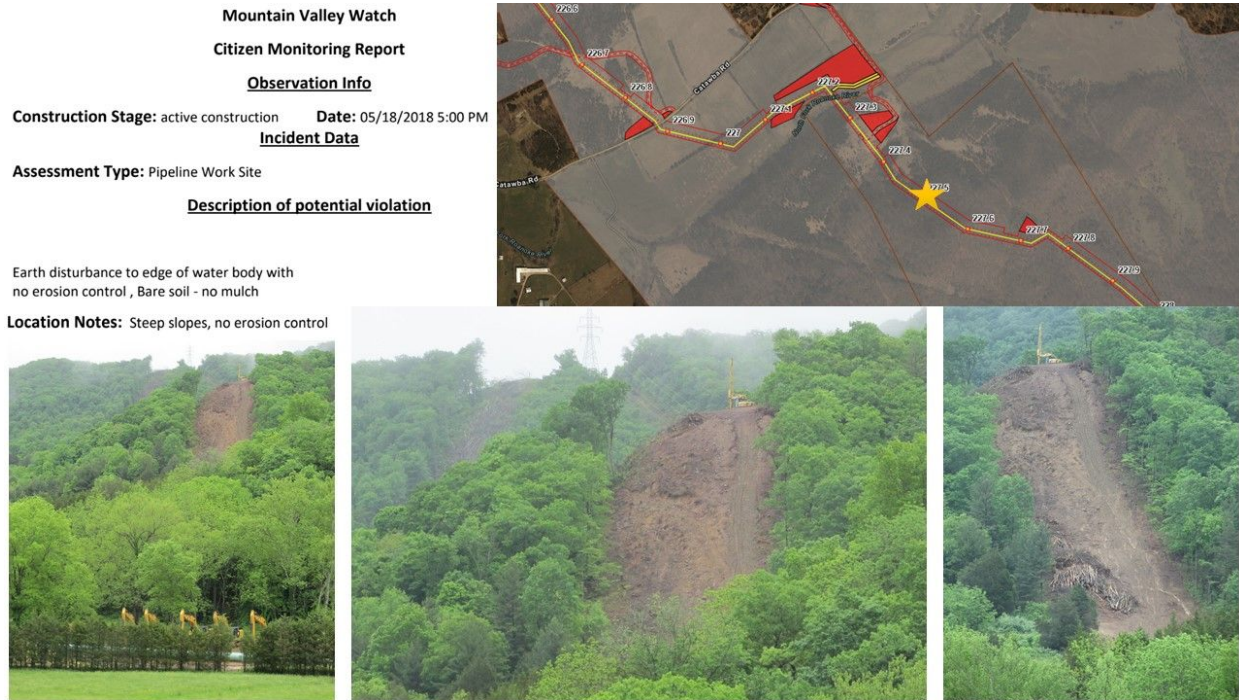
Photos in figure 24 show no erosion control devices installed on steep slopes after clearing of right of way. The North Fork Roanoke River crossing is below this slope. Downstream is habitat for endangered Logperch. Recent rain caused heavy sediment loading from construction in this location.

Figure 24: Images from incident reported on Paris Mountain May 15, 2018
 No E&S controls; Logperch habitat impacted.

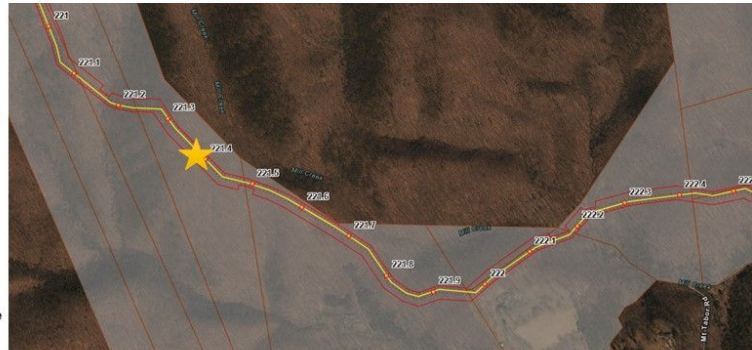
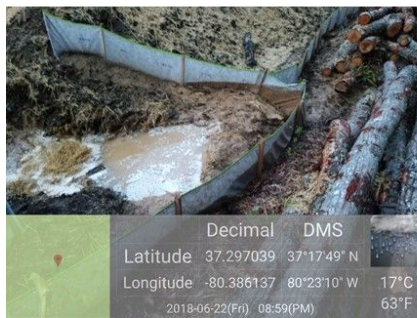
- fence is damaged, collapsed, un-entrained or otherwise ineffective
- sediment has not been removed per maintenance requirements
- silt fence not properly located and installed

Figure 26: Images from incident reported on June 22, 2018. SMN-21 impacted.

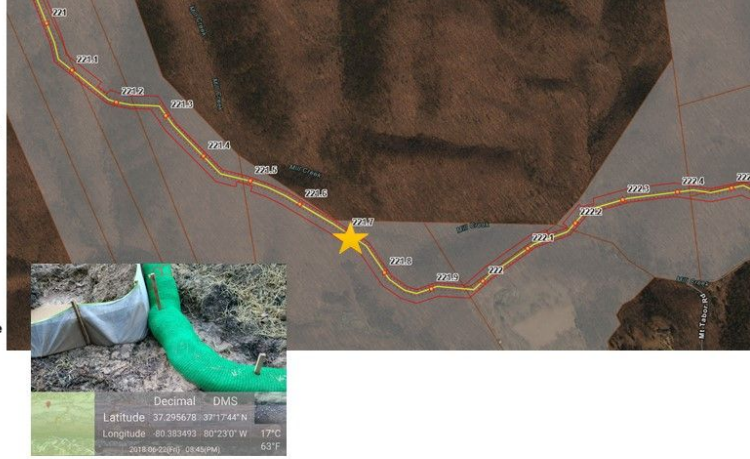
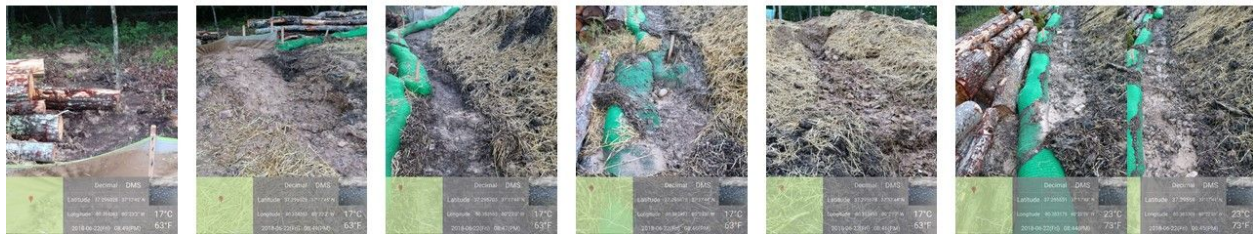
Figure 27: Photos from June 22, 2018 reported incidents on Slayton property

- mulch not distributed uniformly on all disturbed areas
- mulch not applied at an adequate rate

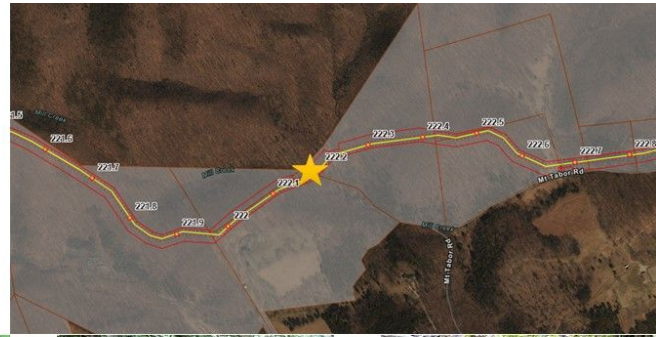
Figure 29: Photos from June 22, 2018 reported incident on Triplet property

- evidence of sediment leaving the construction site
- evidence of flooding at the site
- evidence of erosion at the site

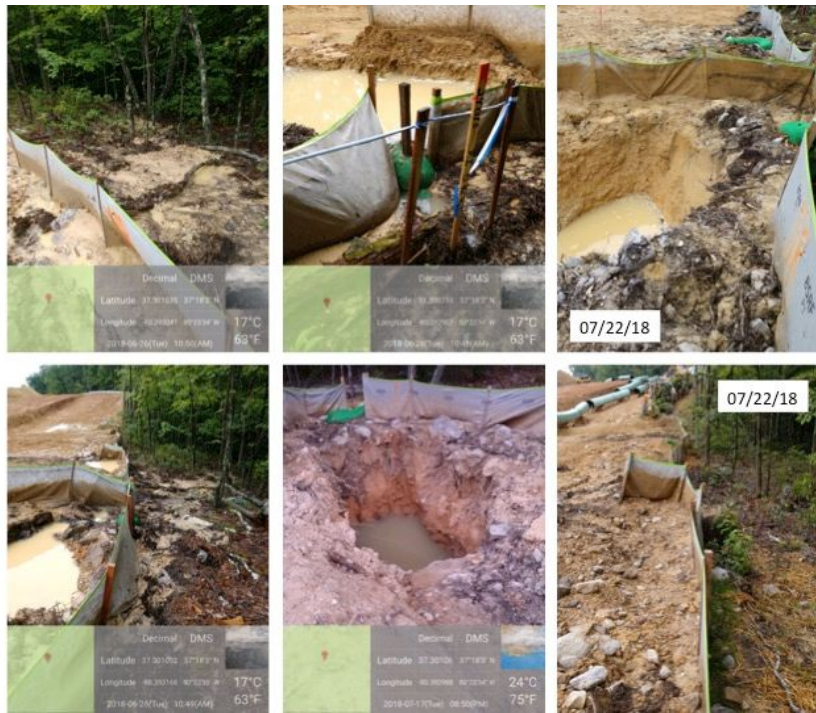
Figure 30: Photos from June 26, July 17, and July 22, 2018 reported incidents on Dyer property

Despite DEQ's issuance of a Notice of Violation July 9, 2018 and MVP's subsequent voluntary stop work to repair ESC measures, the Slusser's Chapel Conservation area continued to see erosion and sediment control incidents, with additional ESC failures reported on the Dyer property July 17 and July 22, and on the Slayton property July 22, 2018. The images shown below are from those reports. One image from the reported incident on the Slayton property shows the stream bed clogged with mud as a result of repeated failures.
