**The Wilderness Society et al. Comments on the  
U.S. Forest Service Mountain Valley Pipeline and  
Equitrans Expansion Project Draft Supplemental  
Environmental Impact Statement (#50036)**

**EXHIBIT 1**

Assessment of erosion, sedimentation, and water quality impacts of the Mountain Valley Pipeline and Equitrans Expansion Project's proposed crossing of the Jefferson National Forest as it pertains to the U.S. Forest Service's Draft Supplemental Environmental Impact Statement dated December 2022

Prepared by Jonathan A. Czuba, Ph.D., Licensed Professional Engineer

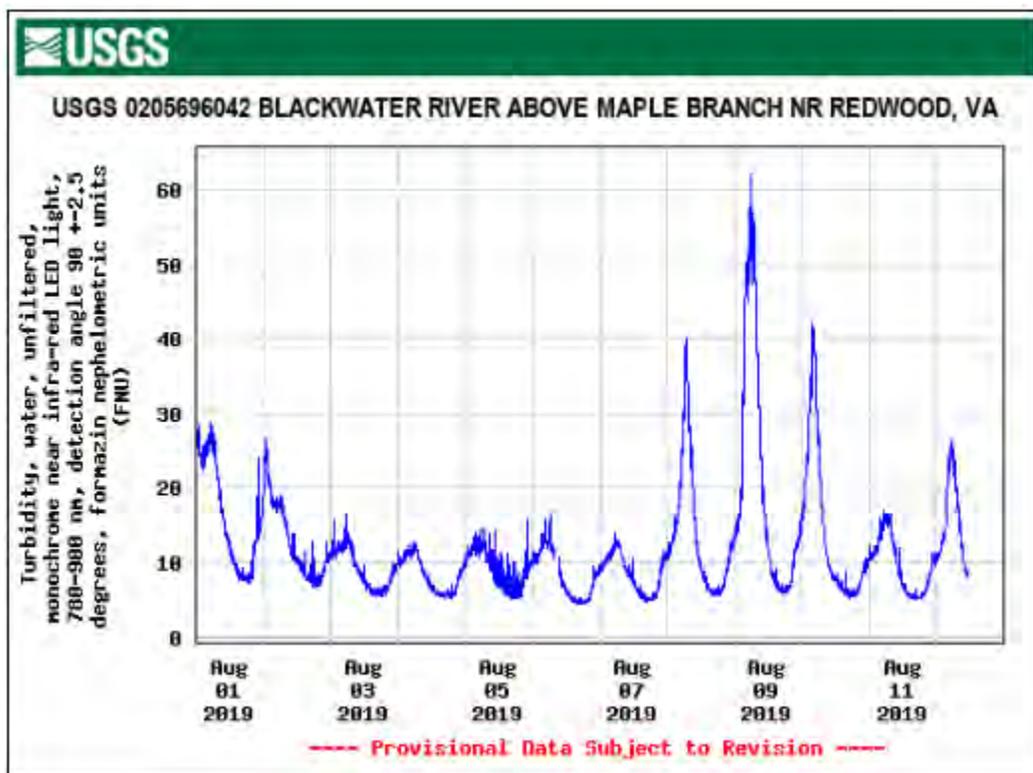
Before these recent events, high turbidity events on the river have been generally coupled in time with high River discharge (e.g. see elevated river gage height on Aug 1 and 2; Figure 3, and corresponding high turbidity shown in Figures 1 and 2). However, the high turbidity observed on Aug 9-12 occurred during a period of relatively stable and declining discharge. This indicates an increased likelihood that the source of the turbidity was a disturbance of the substrate within the watershed, rather than erosion of the river banks or movement of in-stream sediment.

Figure 1: Turbidity at the Blackwater River upstream of the MVP Crossing Site, Aug. 1- Aug. 12, 2019 (Lat: 37.05228, Long: -79.8268, [https://waterdata.usgs.gov/va/nwis/uv?site\\_no=0205696042](https://waterdata.usgs.gov/va/nwis/uv?site_no=0205696042)).

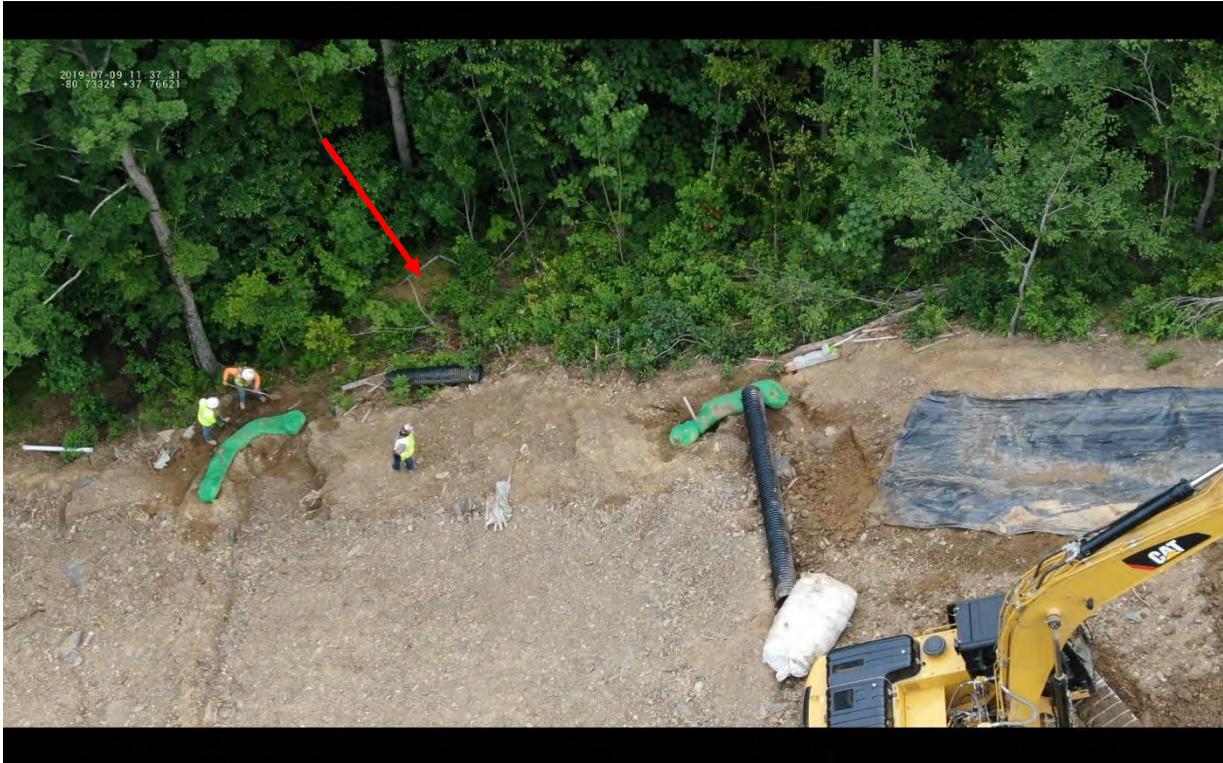
View above Stream S-T35A and station No. 8634+00 facing East side of LOD. Arrow depicts off site impacts observed.

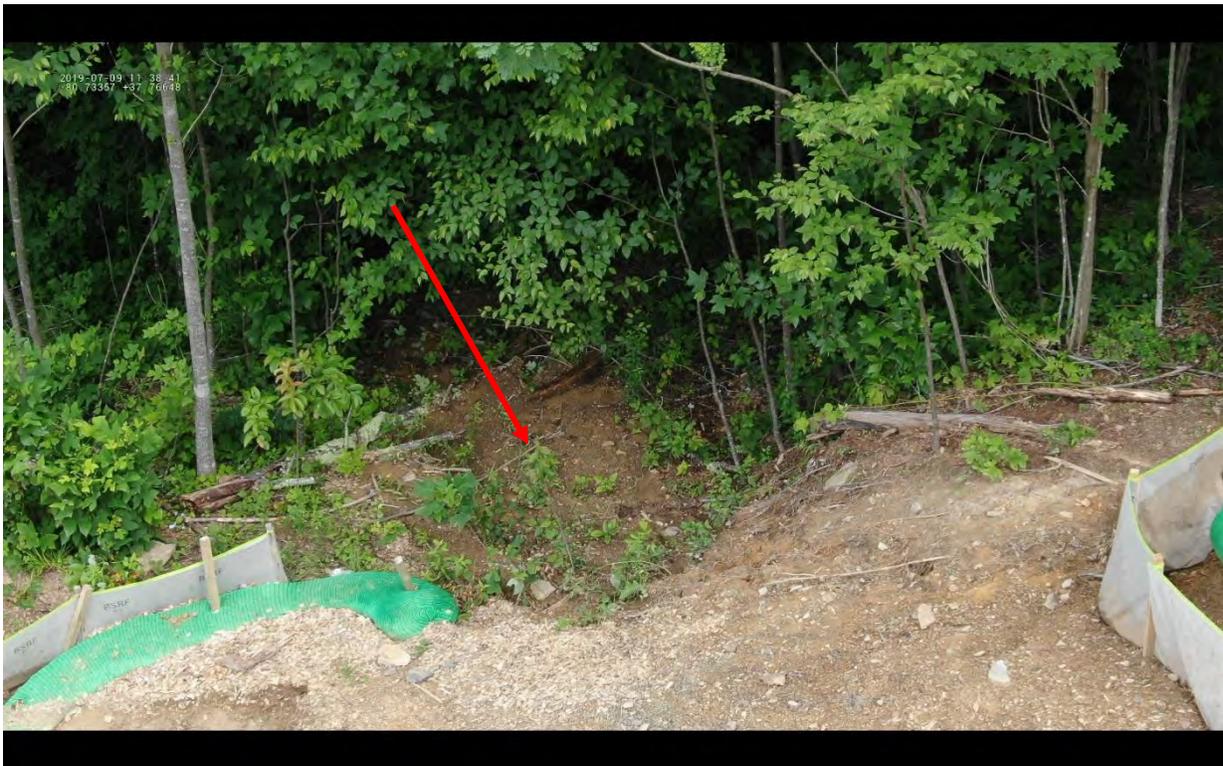
View above Stream S-T35A and station No. 8634+00 facing East side of LOD. Arrow depicts off site impacts observed.

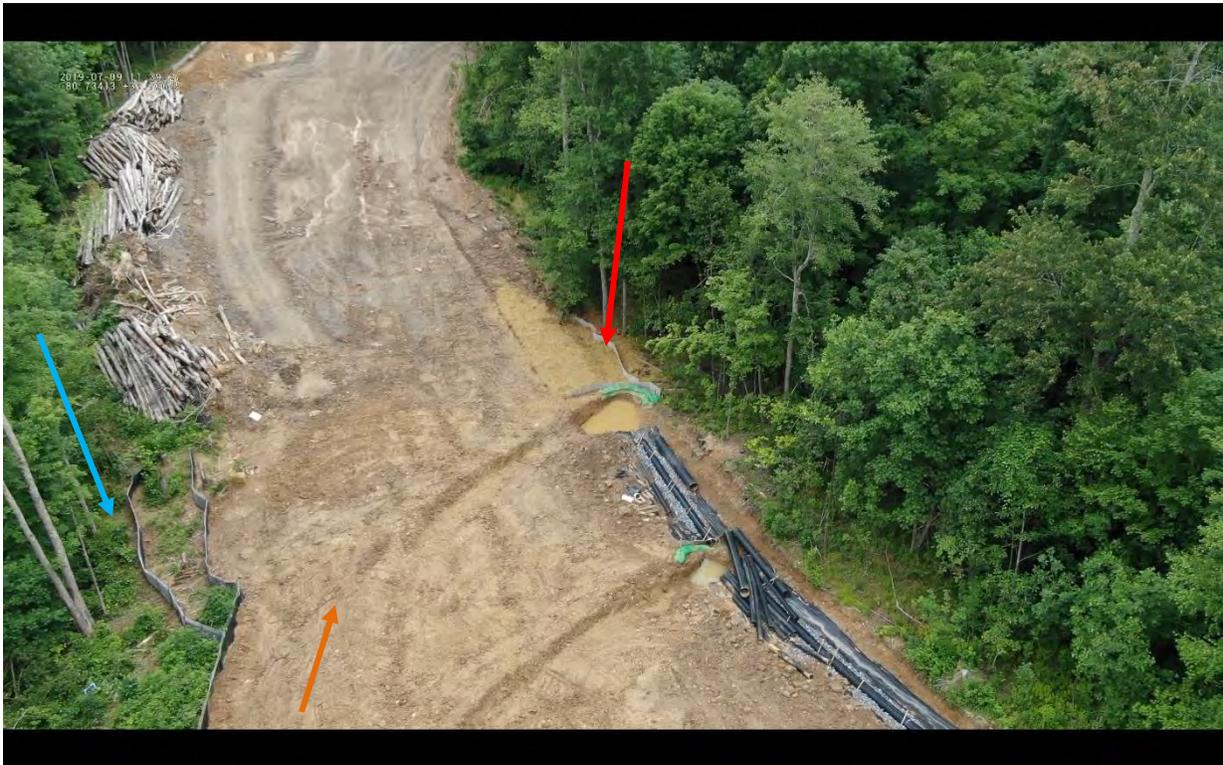
View of East and west side of MVP ROW and LOD. Red arrow depicts where last Waterbar at base of slope was overwhelmed and impacts occurred. Blue arrow depicts stream S-T35A. Orange arrow depicts where additional waterbars were installed to redirect run-off towards East side of LOD.

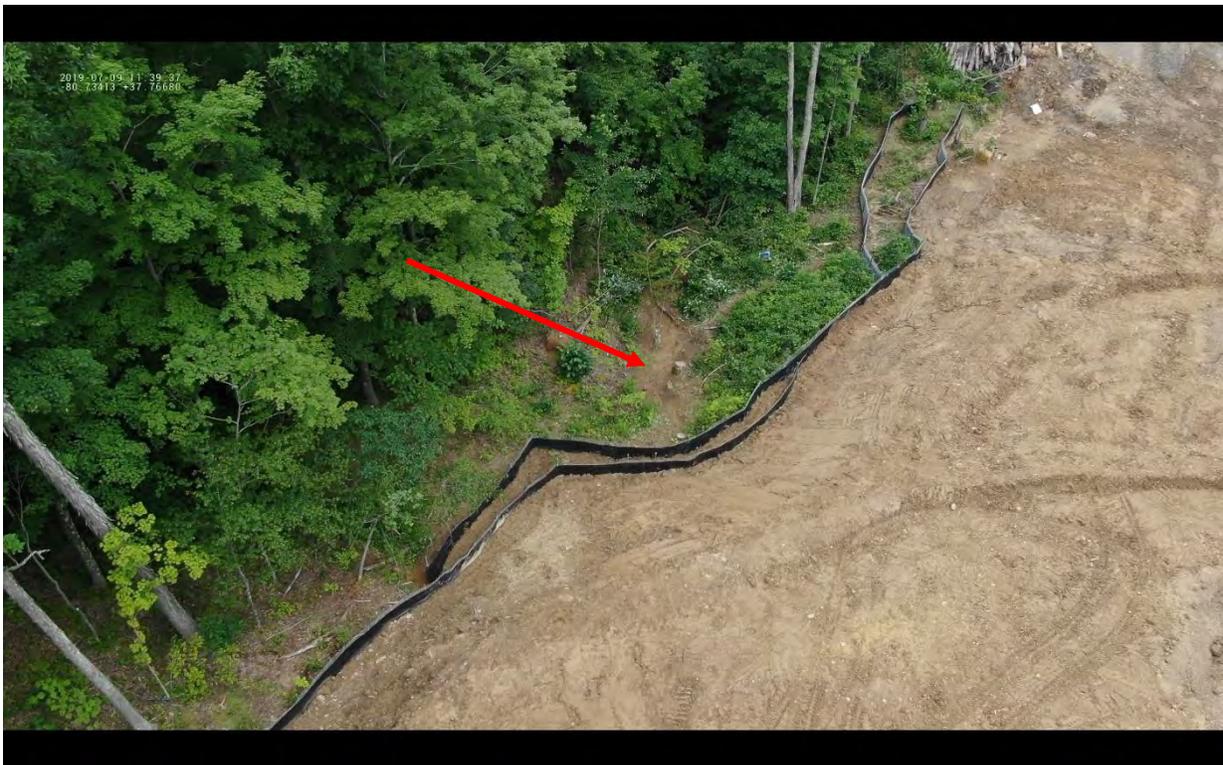
View of Stream S-T35A at station No. 8634+00 at the West side of the LOD. Arrow depicts additional super silt fence installed post impacts. Sediment deposits observed in Stream at time of inspection.

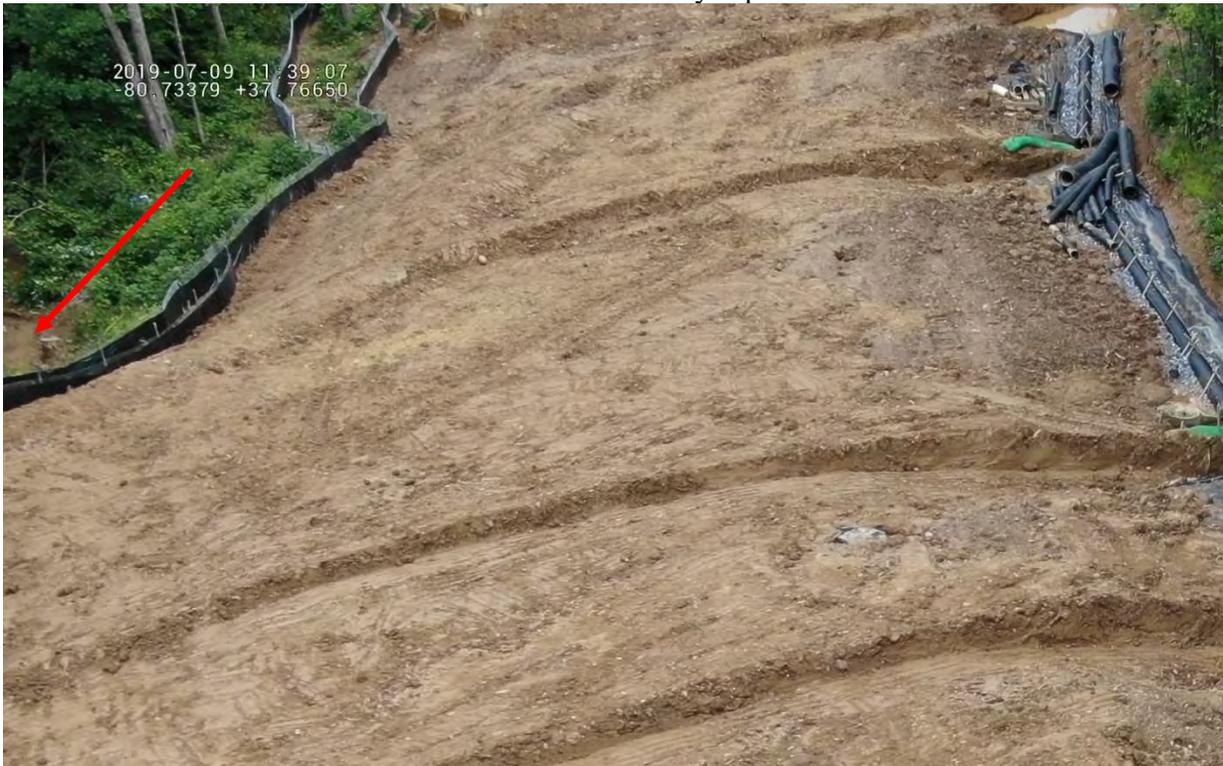
Close up view of additional waterbars added to re-direct run-off to East side of LOD. Arrow depicts deposits of sediment in stream S-T35A.

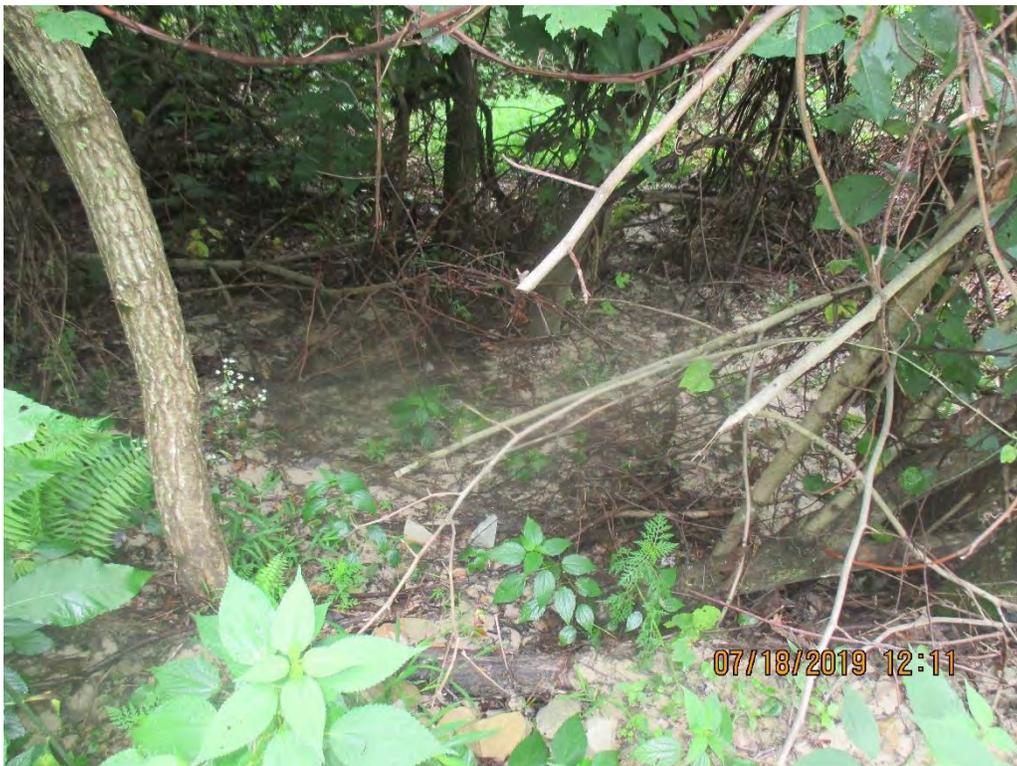
Section of MVP-WB-119 with no perimeter controls installed. Significant Sediment deposits were observed past the LOD throughout the vegetated area downslope of the road.

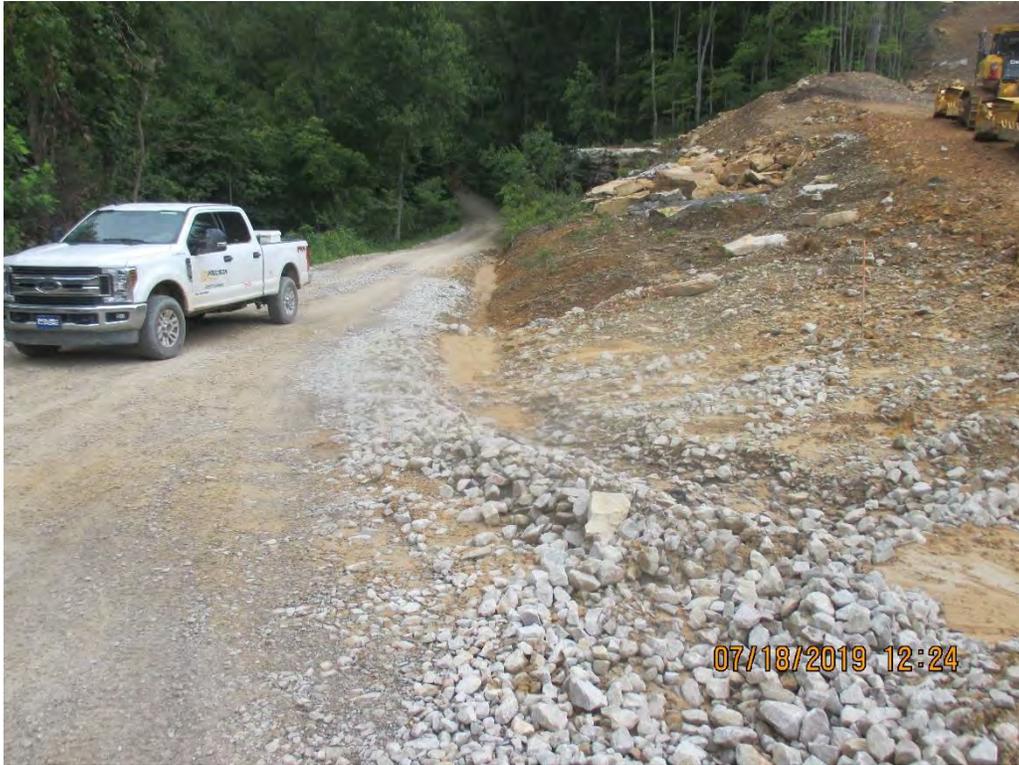
Standing at station No. 4559+96 facing Access Road MVP-WB-119. Sediment deposits present in roadside ditch.

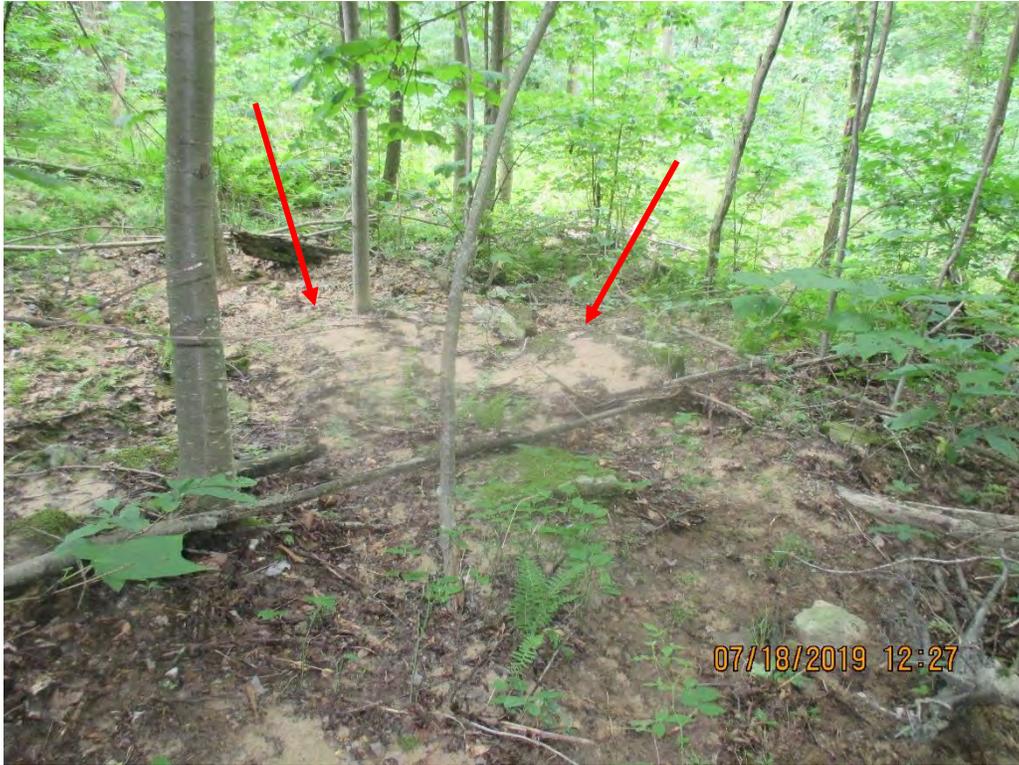
Downslope of culvert outlet. Significant sediment deposits present past controls and LOD. Arrow depicts examples of deposits observed.

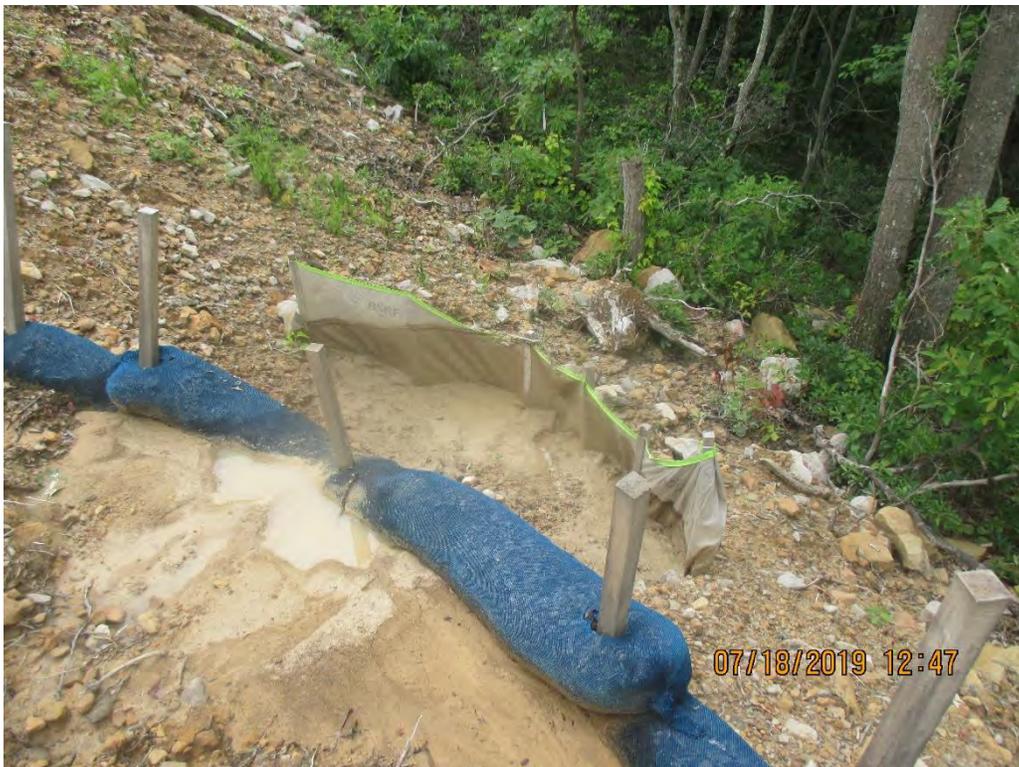
Waterbar outlet on opposite side of ROW at station no. 4559+96. Controls undercut and sediment deposits observed past controls and LOD.

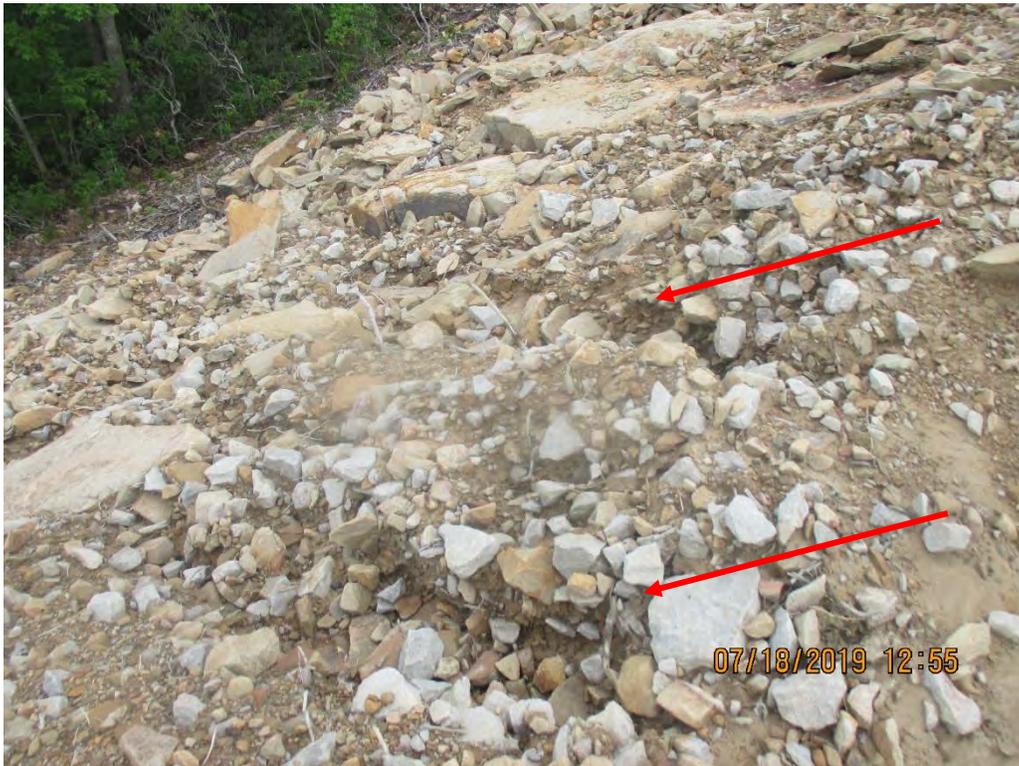
Near station No. 4559+96 erosion present on fill slope. Arrows depict erosion that was observed.

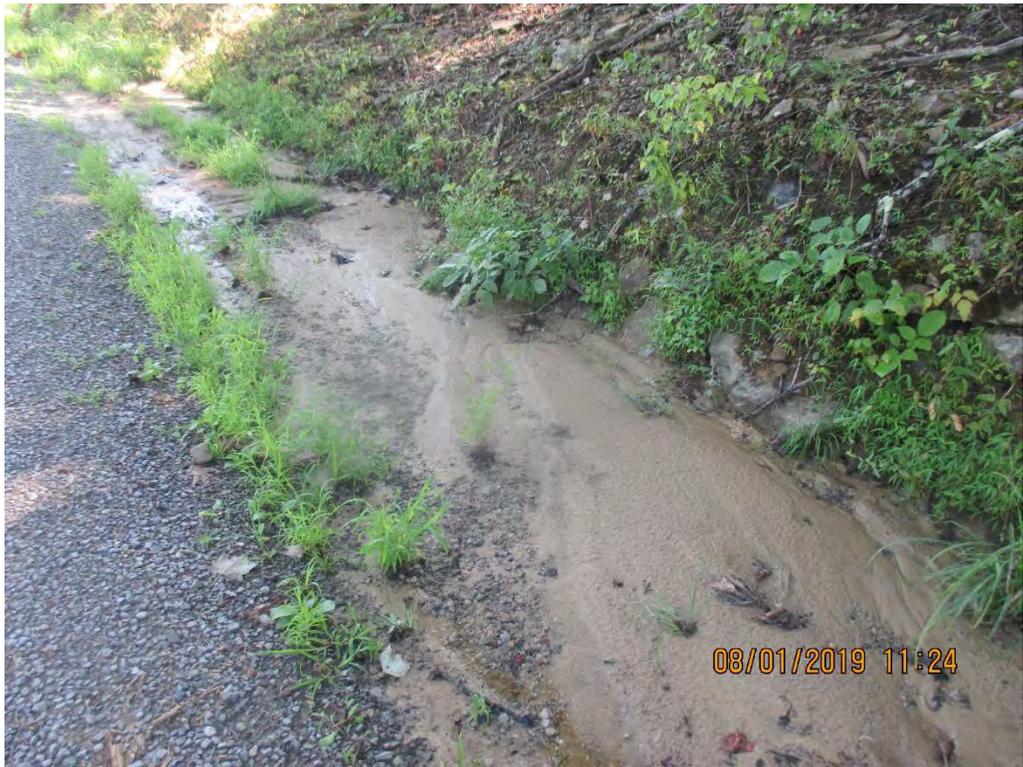
Sediment deposits observed along CR 24 downslope of Access Road MVP-BR-99 near station No. 3897+75.

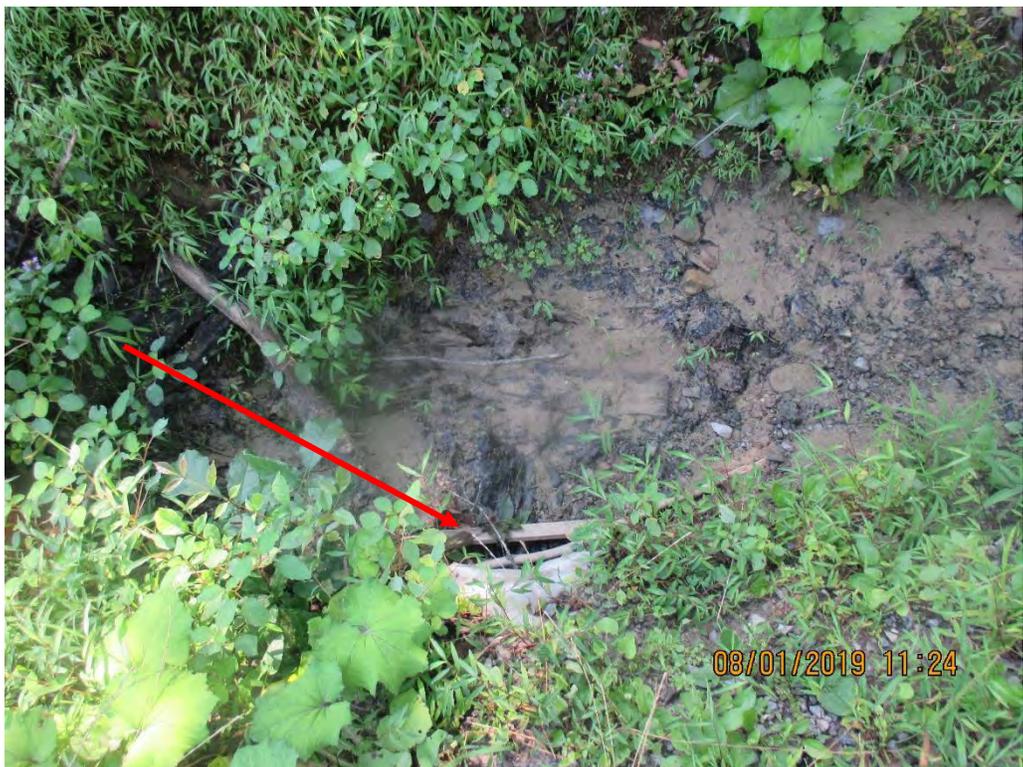
Sediment deposits observed along CR 24 downslope of Access Road MVP-BR-099 near station No. 3897+75. Arrow depicts culvert location that conveys under CR 24. Culvert inlet also demarcates where delineated stream S-K35 begins.

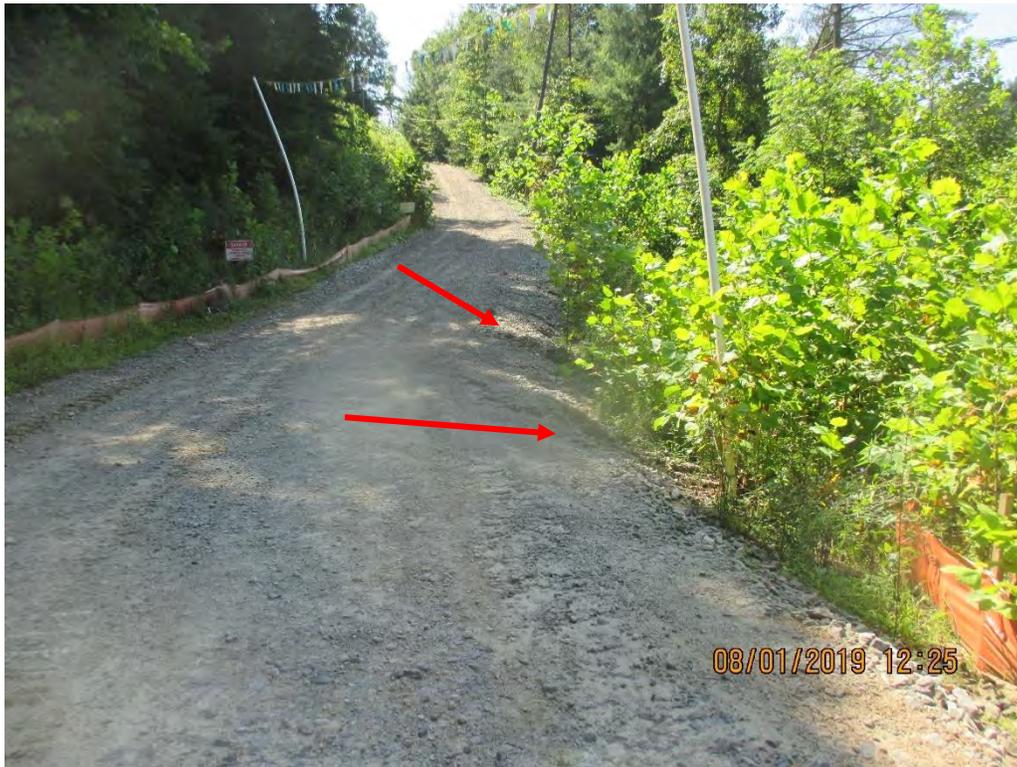
MVP-BR-095 facing upslope above US19/Hwy4. Arrow depicts where road was eroded out overwhelming downslope controls.

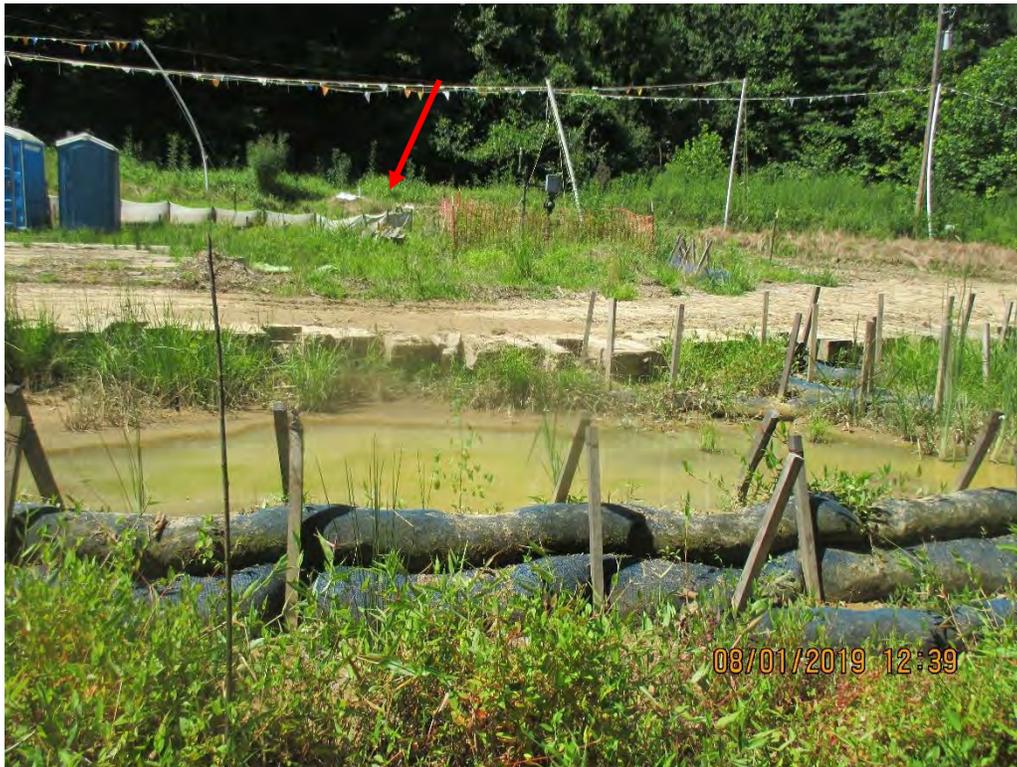
Facing upslope at MVP-BR-097. Arrow depicts where run-on was coming onto site. Sandbags had been installed to divert run-on away from site but had failed due to concentrated flow upslope of LOD.

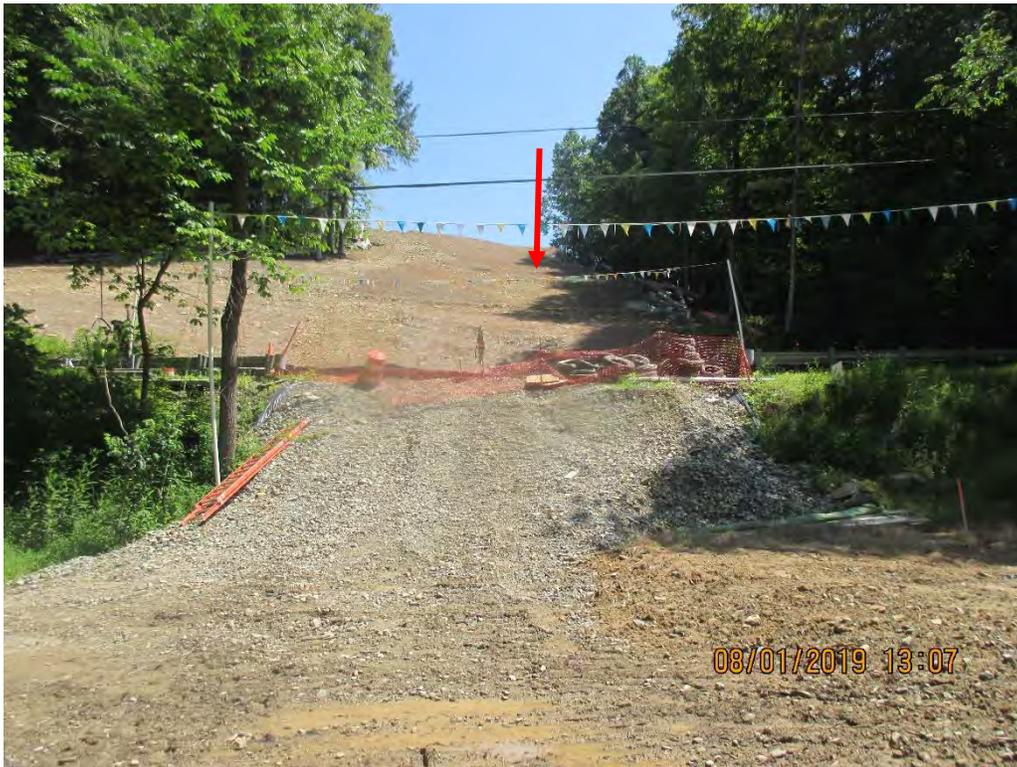
Standing above stream S-J70 and below US19/Hwy4 crossing near station No. 3829+00. Arrow depicts slope with lack of temporary stabilization.

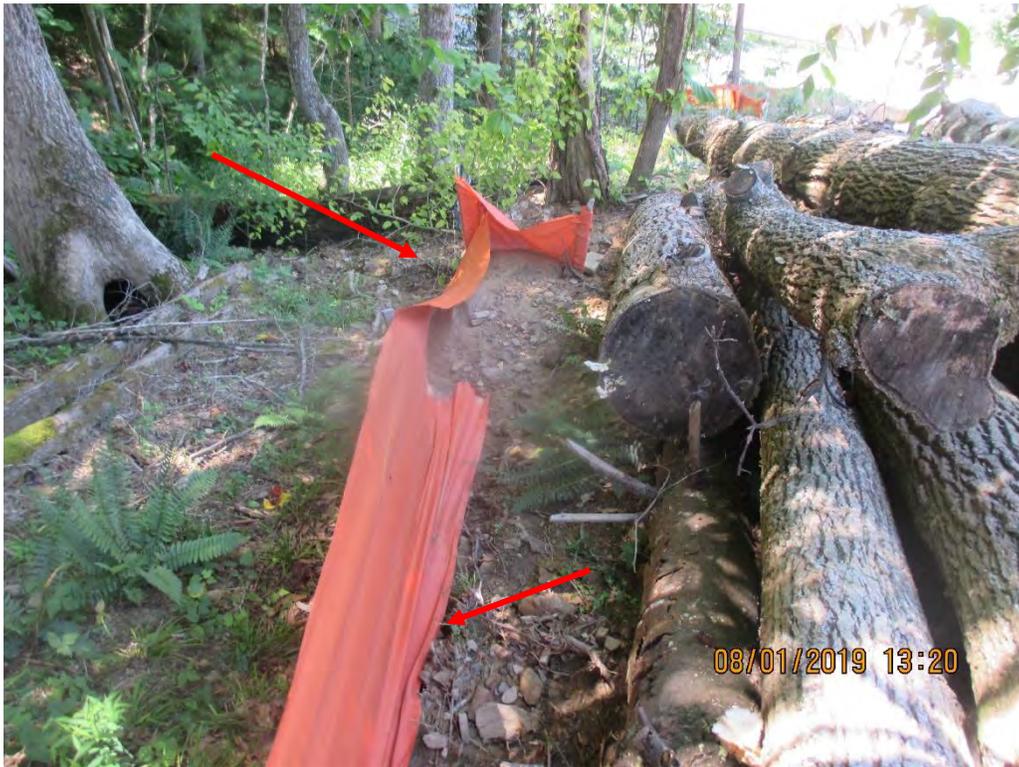
Downslope of Waterbar terminating onto ROW at station No. 3831+00. Arrow depicts where Perimeter controls were undercut from run-off and sediment deposits were observed past the LOD.

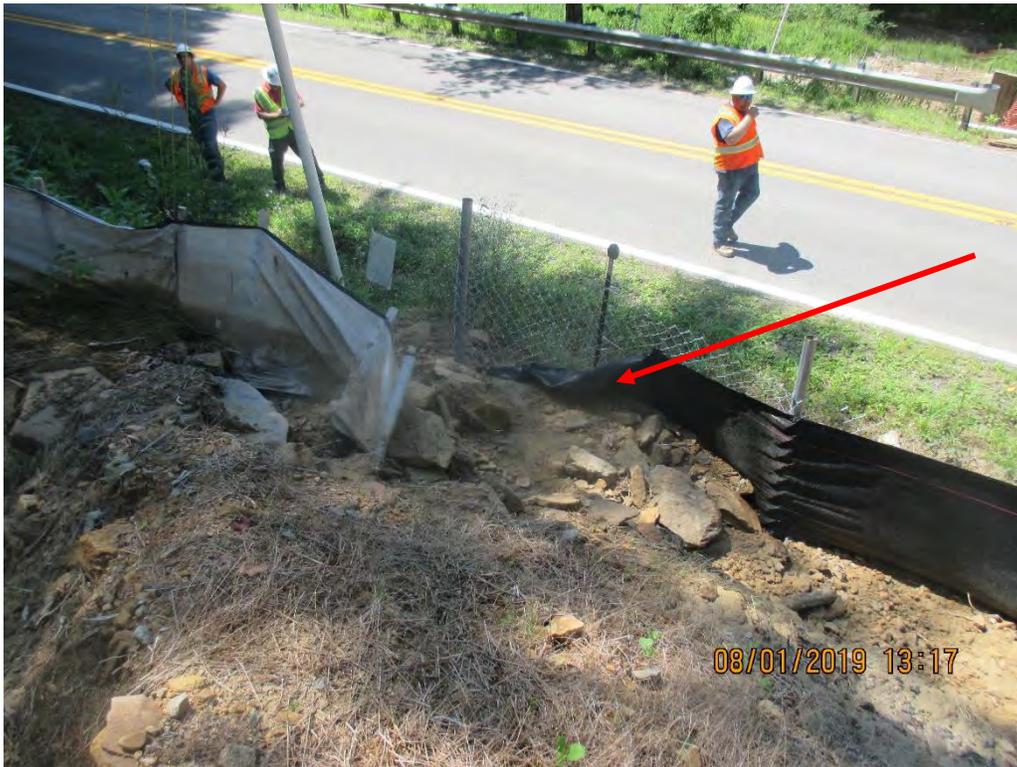
Perimeter controls at base of slope above US19/Hwy4 crossing. Controls overwhelmed with sediment causing control failure above roadside ditch.

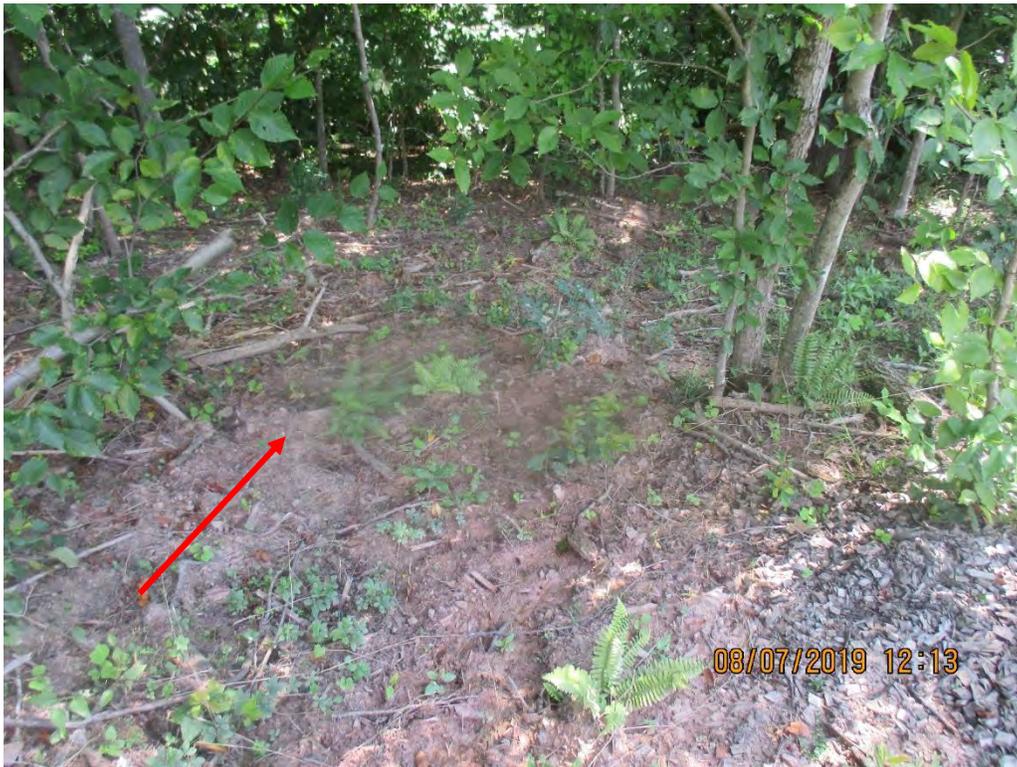
Further downslope near station no. 8951+00. Perimeter Controls below Waterbar termini with no outlet control terminating onto fill slope and above LOD. Sediment deposits observed past the LOD. Due to Barbwire fence the amount/extent of deposits couldn't be determined.

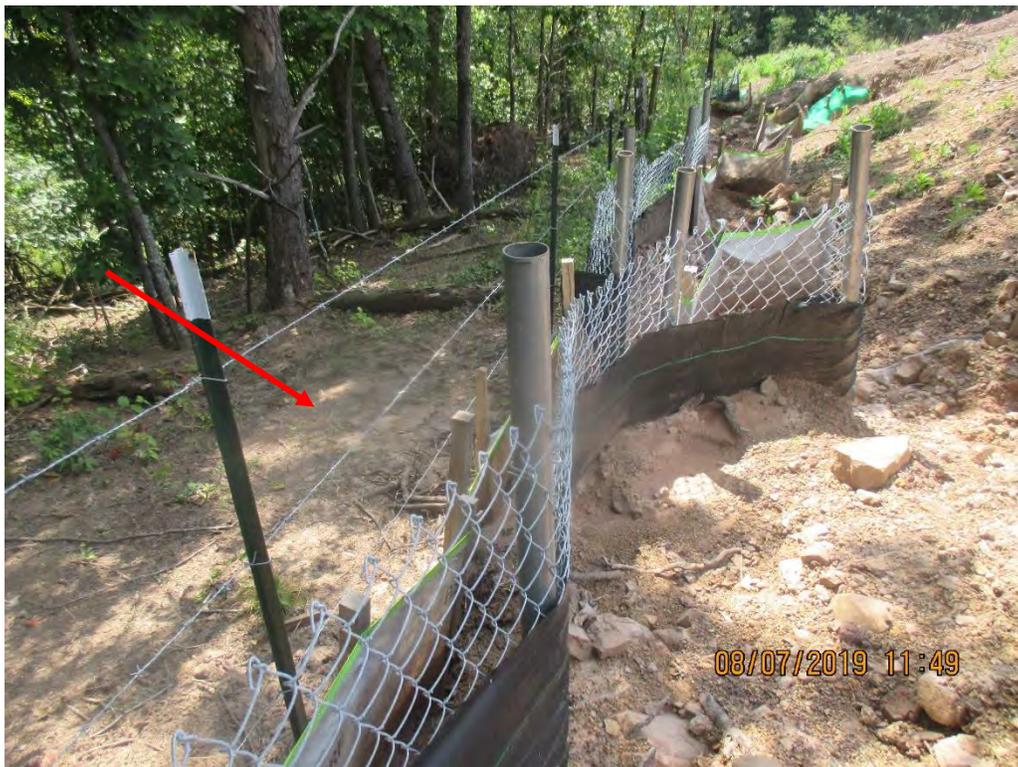
Perimeter controls below dewatering structure at station No. 8955+00. Arrow depicts where sediment deposits where observed.

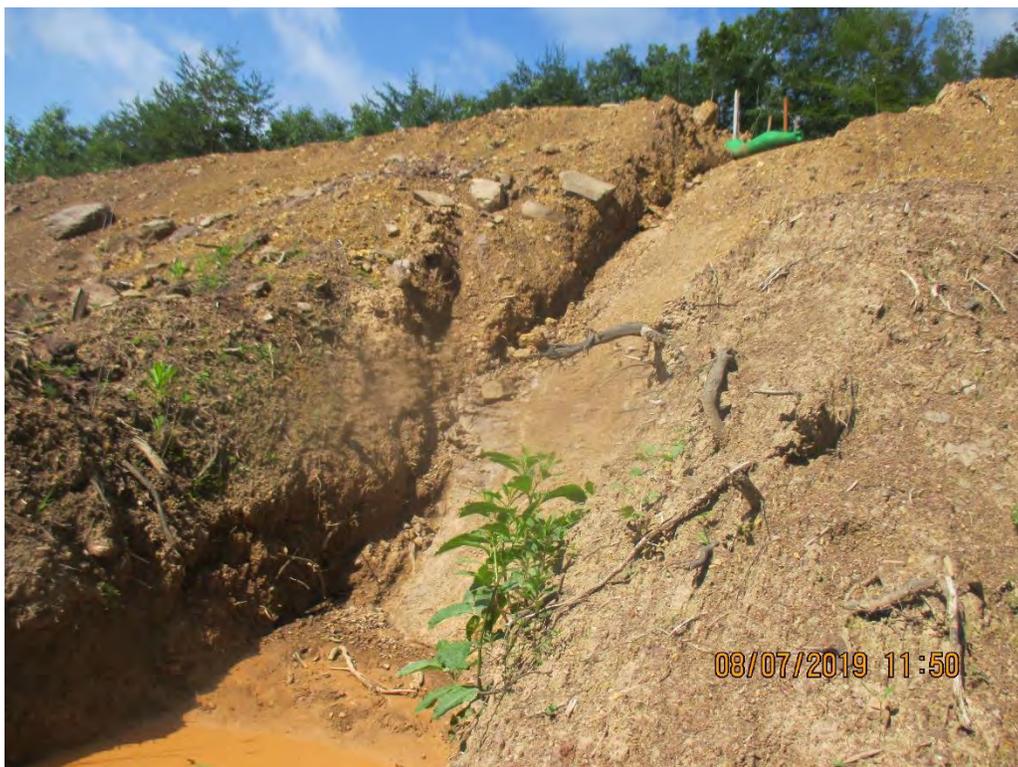
Waterbar terminating onto slope near station No. 8955+00. Erosion present on slope. Sump overwhelmed with sediment.

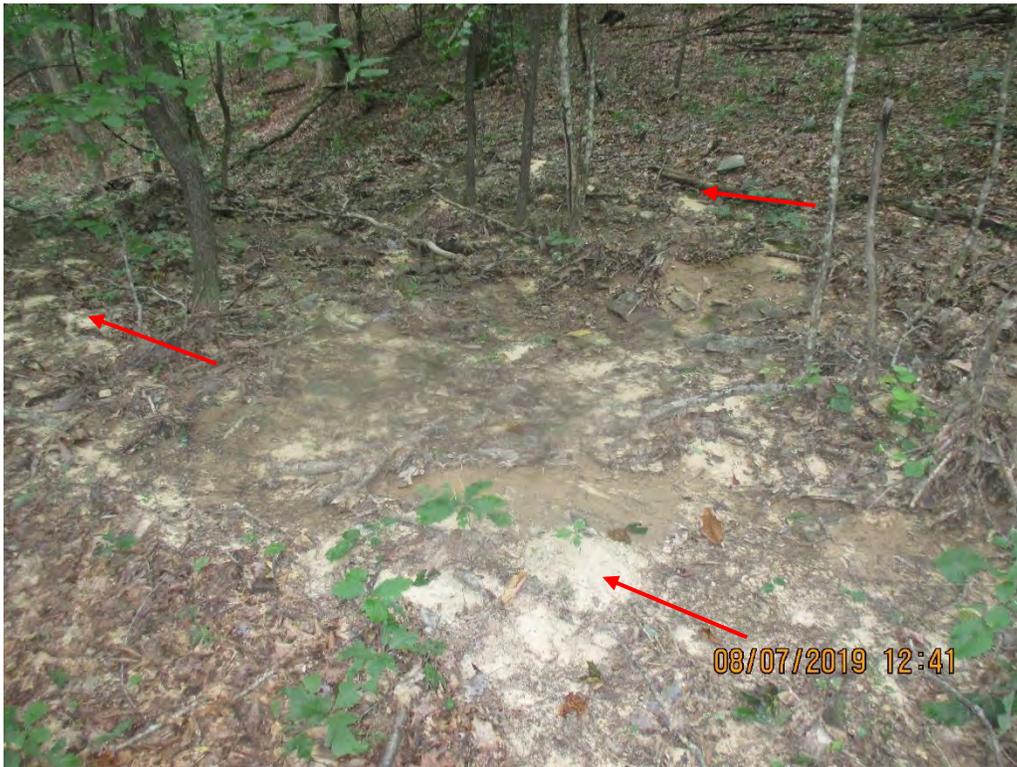
Approximately 200-foot past LOD near station no. 8929+00. Sediment deposits in Stream S-K16.

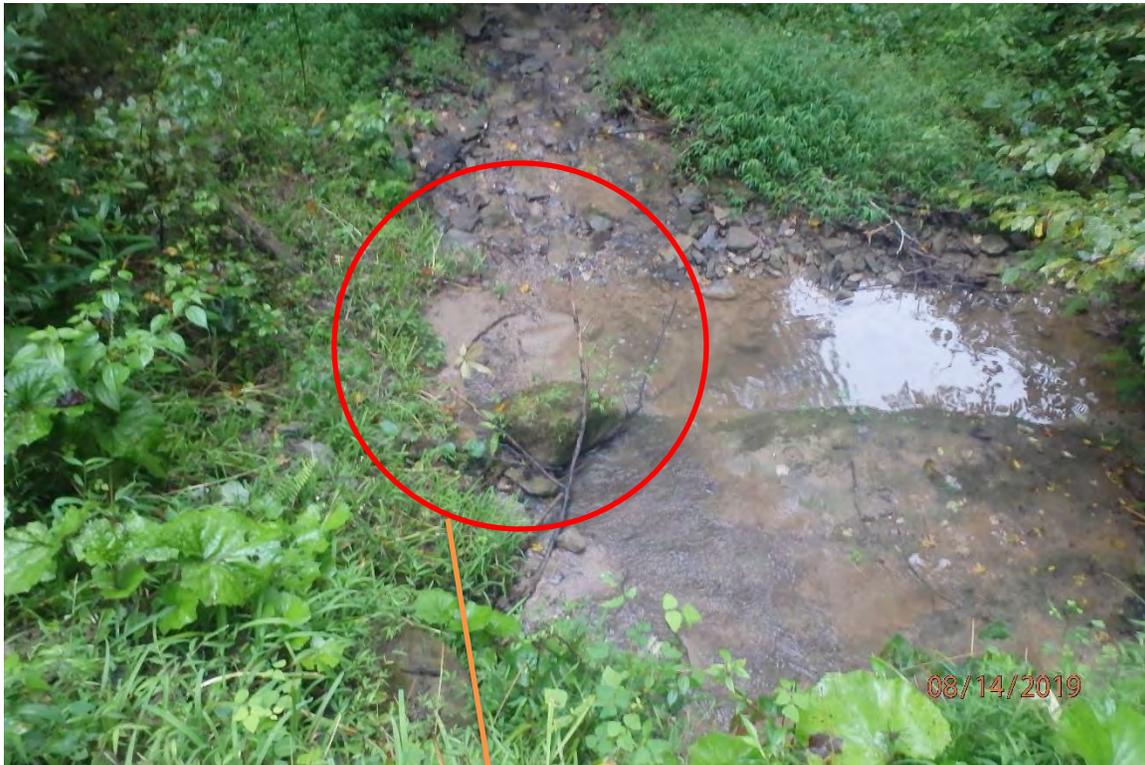
CNA deposits in Keith Run ( $38^{\circ} 47.179'$  X  $80^{\circ} 31.816'$ ) as a result of the previously pictured deficiencies.

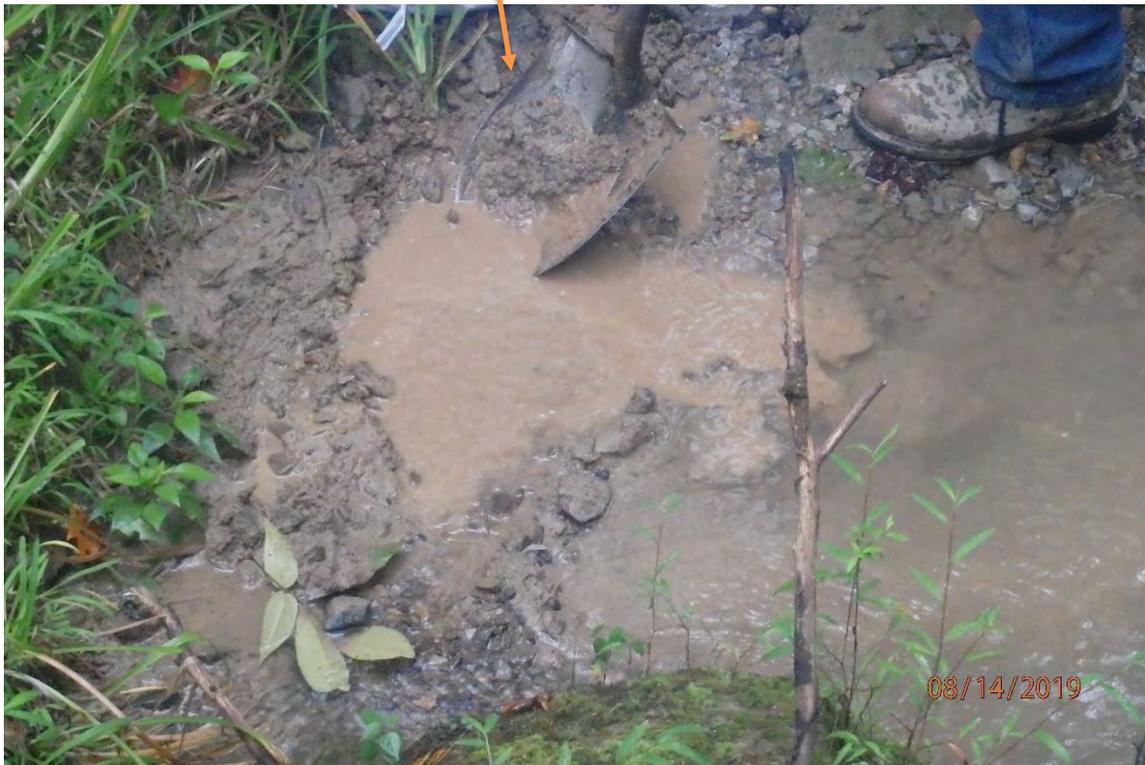
CNA deposits in Keith Run ( $38^{\circ} 47.179'$  X  $80^{\circ} 31.816'$ ) as a result of the previously pictured deficiencies. Picture shows contractor working on removing the deposits.

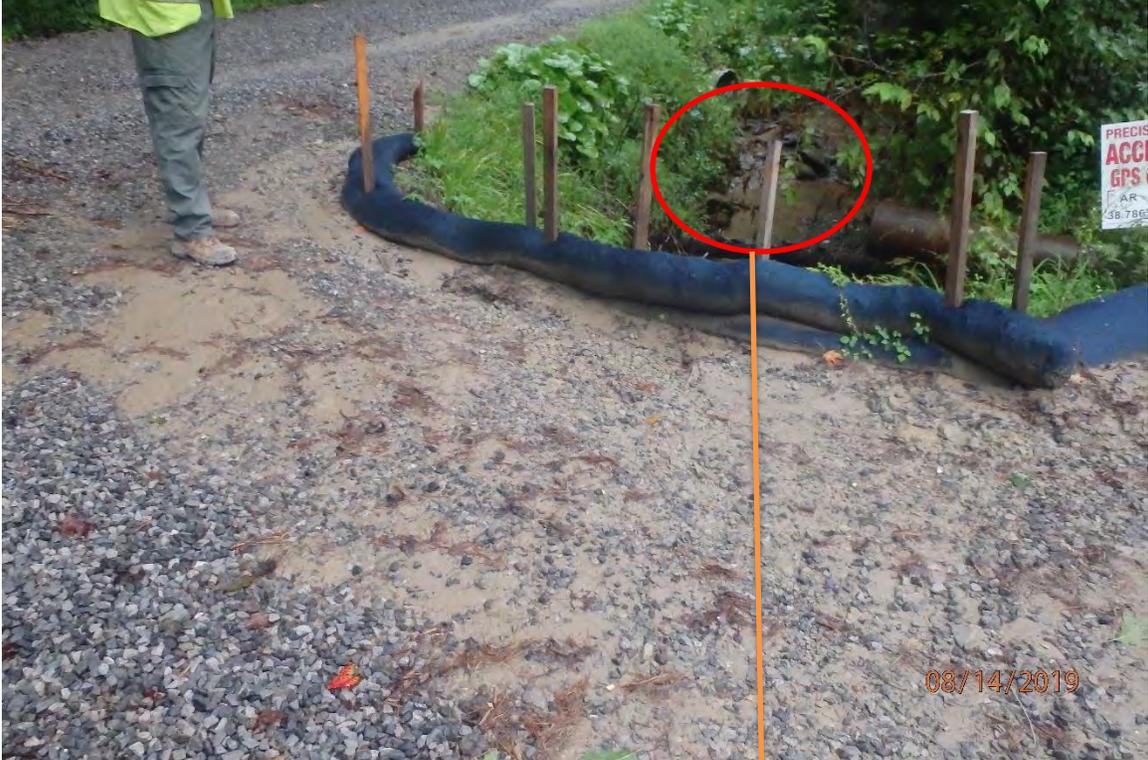
Trail of sediment from access road MVP-BR-092.01 that leads to Keith Run.

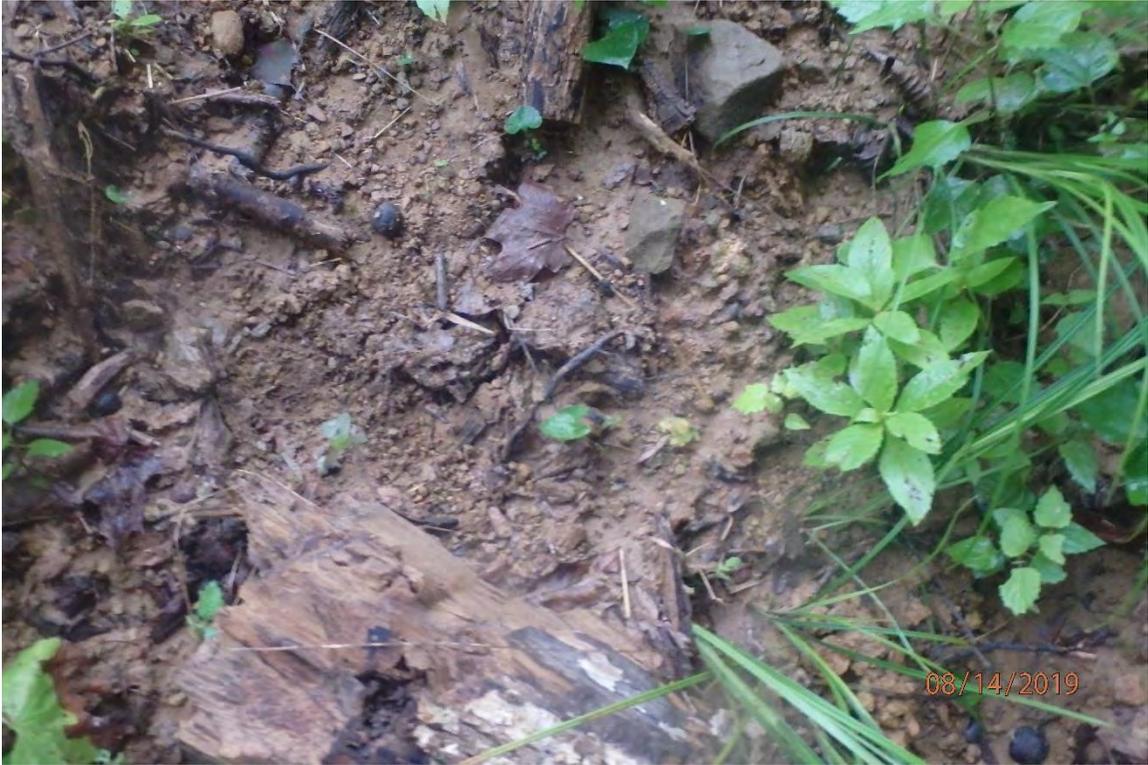
Offsite sediment deposits associated with the above pictured deficiency.
