**The Wilderness Society et al. Comments on the  
U.S. Forest Service Mountain Valley Pipeline and  
Equitrans Expansion Project Draft Supplemental  
Environmental Impact Statement (#50036)**

**EXHIBIT 1**

Assessment of erosion, sedimentation, and water quality impacts of the Mountain Valley Pipeline and Equitrans Expansion Project's proposed crossing of the Jefferson National Forest as it pertains to the U.S. Forest Service's Draft Supplemental Environmental Impact Statement dated December 2022

Prepared by Jonathan A. Czuba, Ph.D., Licensed Professional Engineer

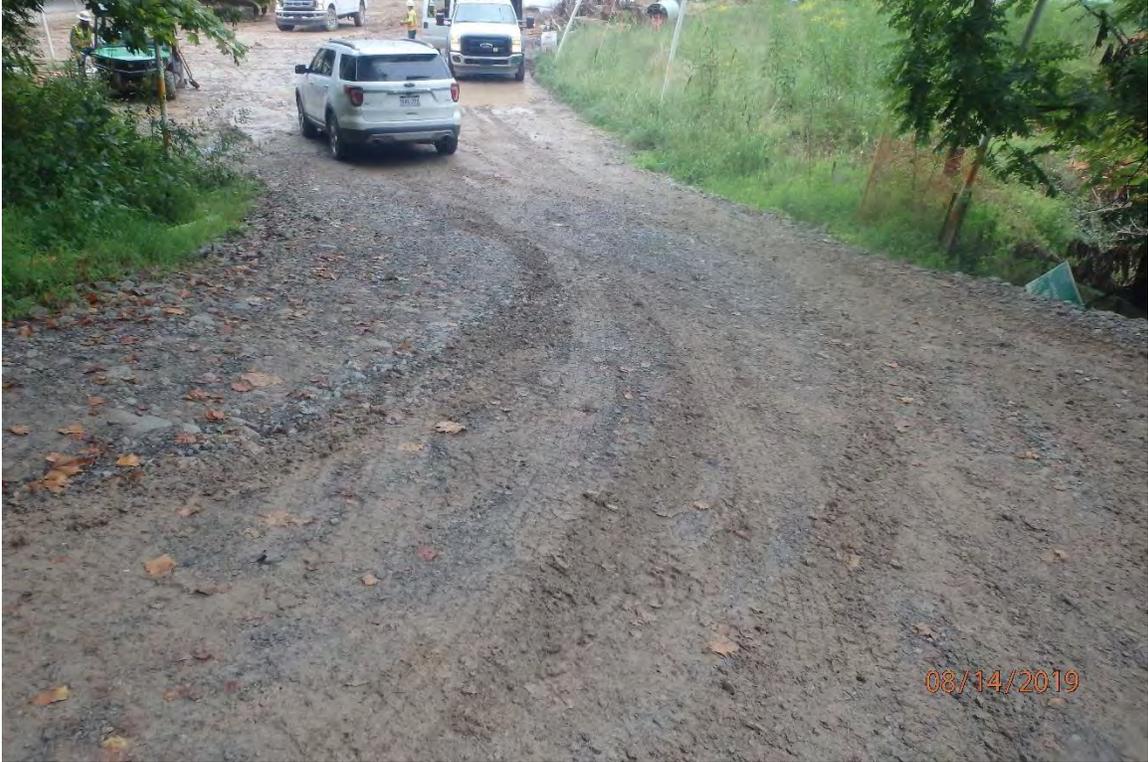
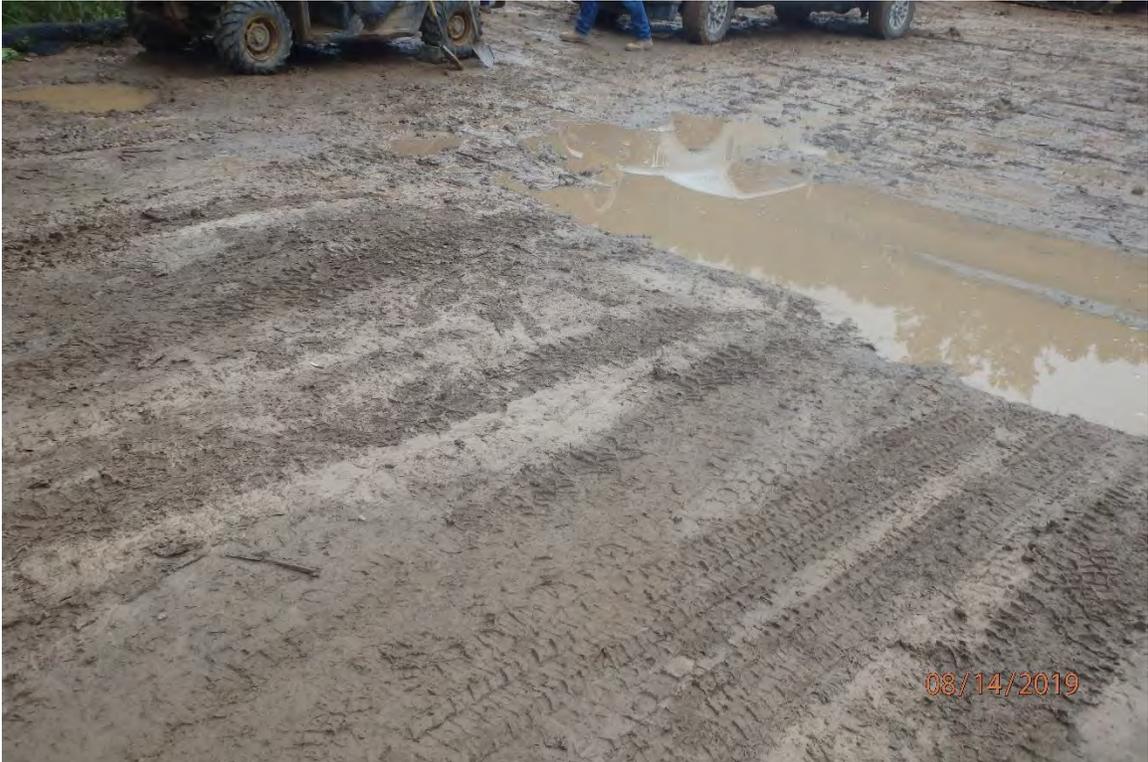
Access road MVP-BR-89.01 showing the need for maintenance to the installed rock construction entrance.

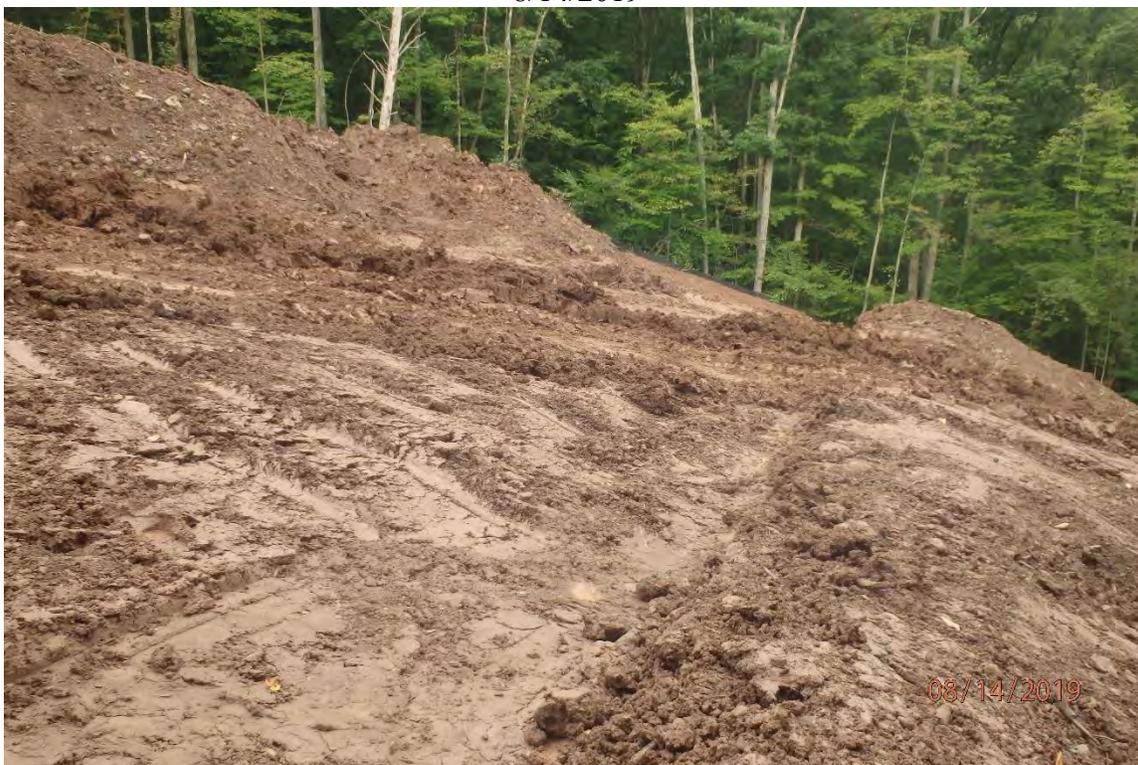
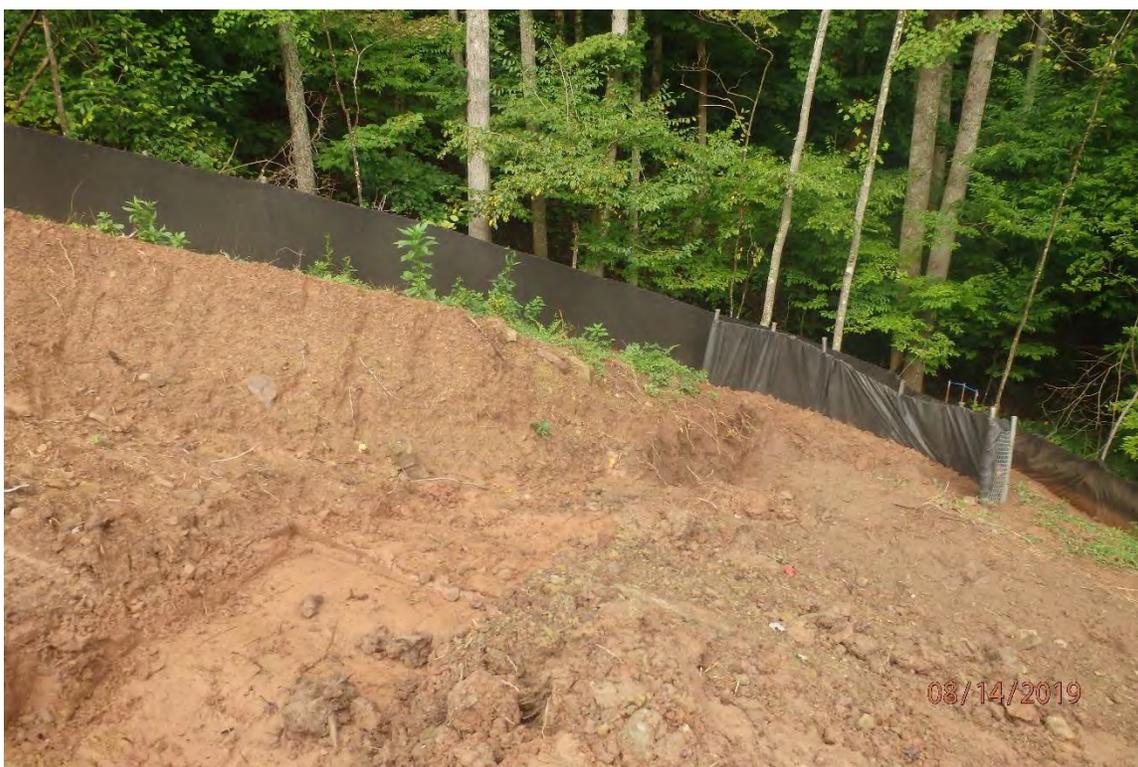
Improperly installed water bar in inspected area 1 showing it installed at a steep angle and discharging prior to the installed perimeter controls.

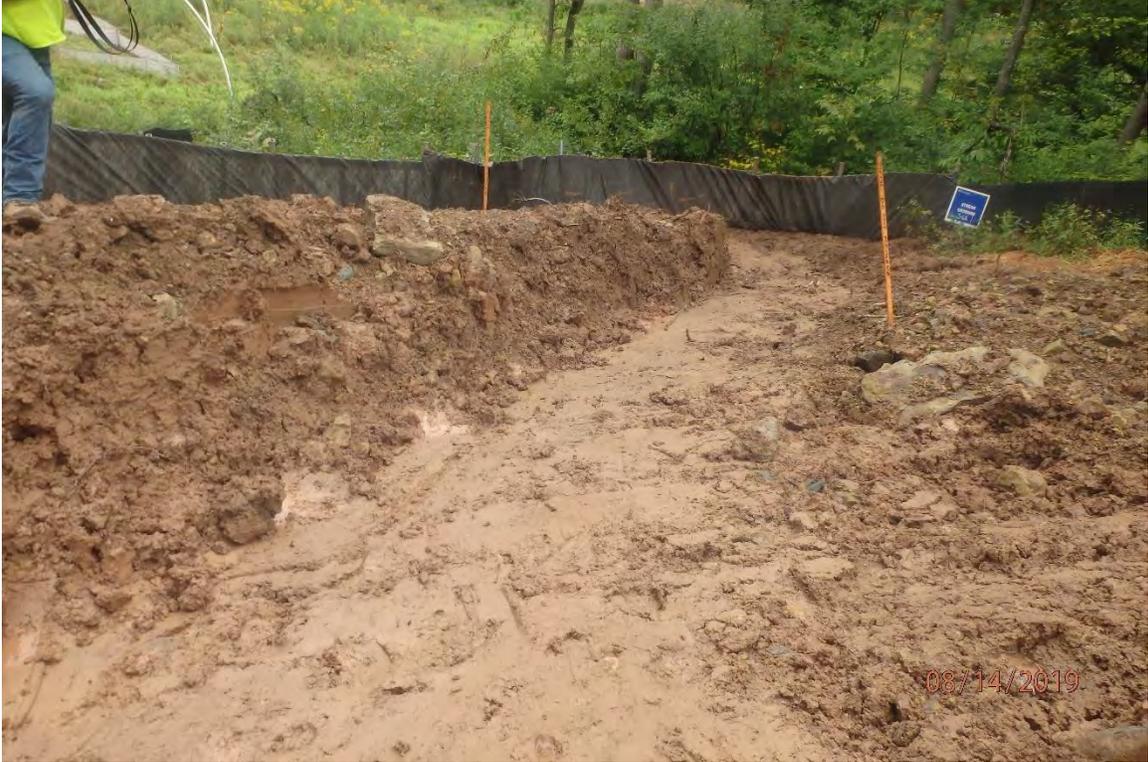
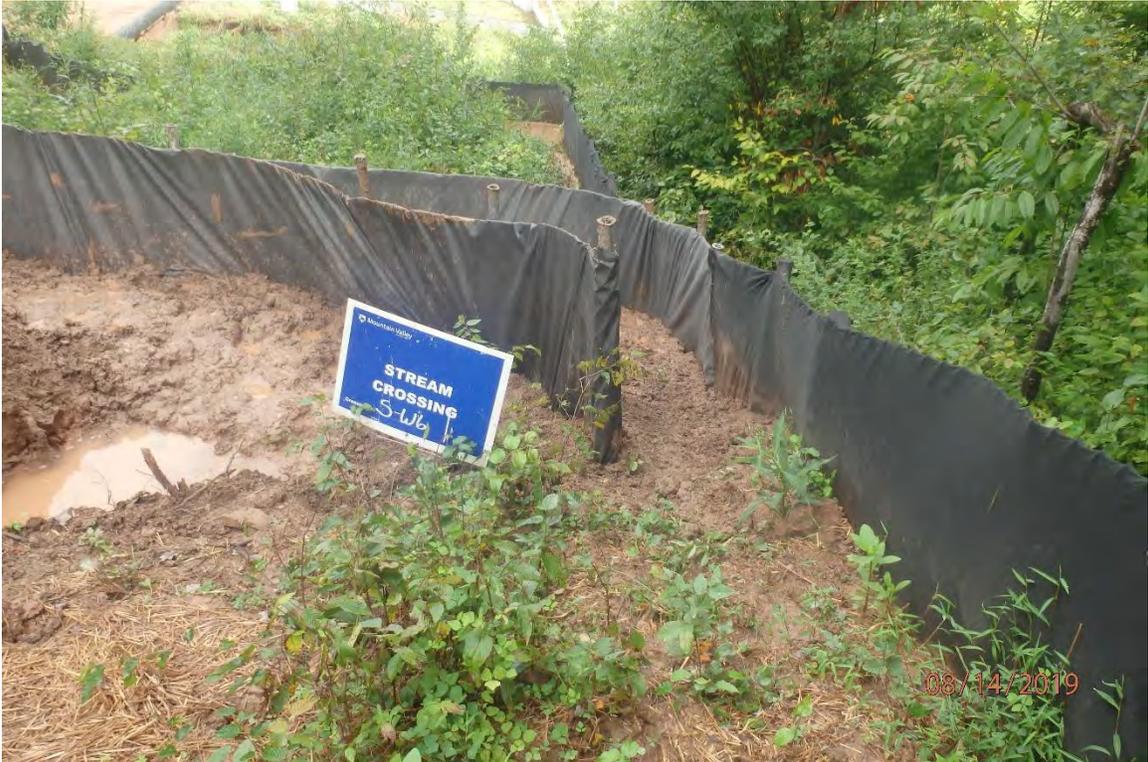
Improperly installed water bar in inspected area 1 showing it installed at a steep angle and discharging prior to the installed perimeter controls.

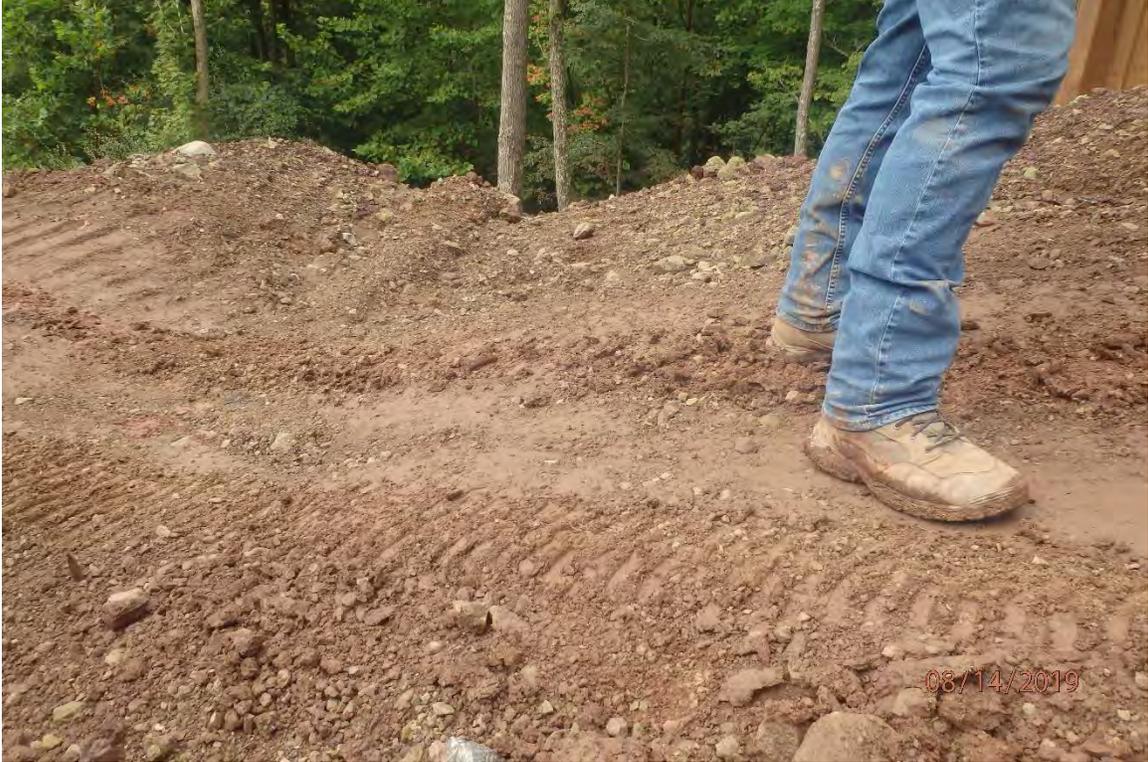
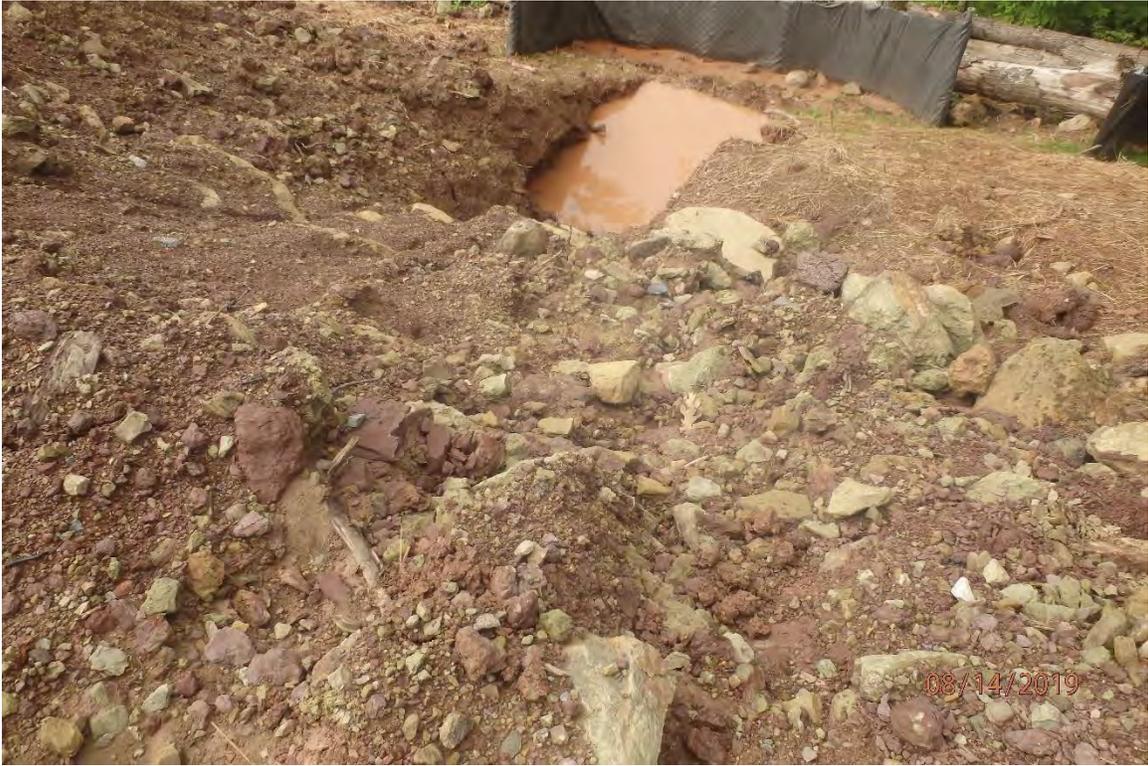
Improperly installed water bar in inspected area 2 showing it discharging over a steep slope with no fill slope protection in place.

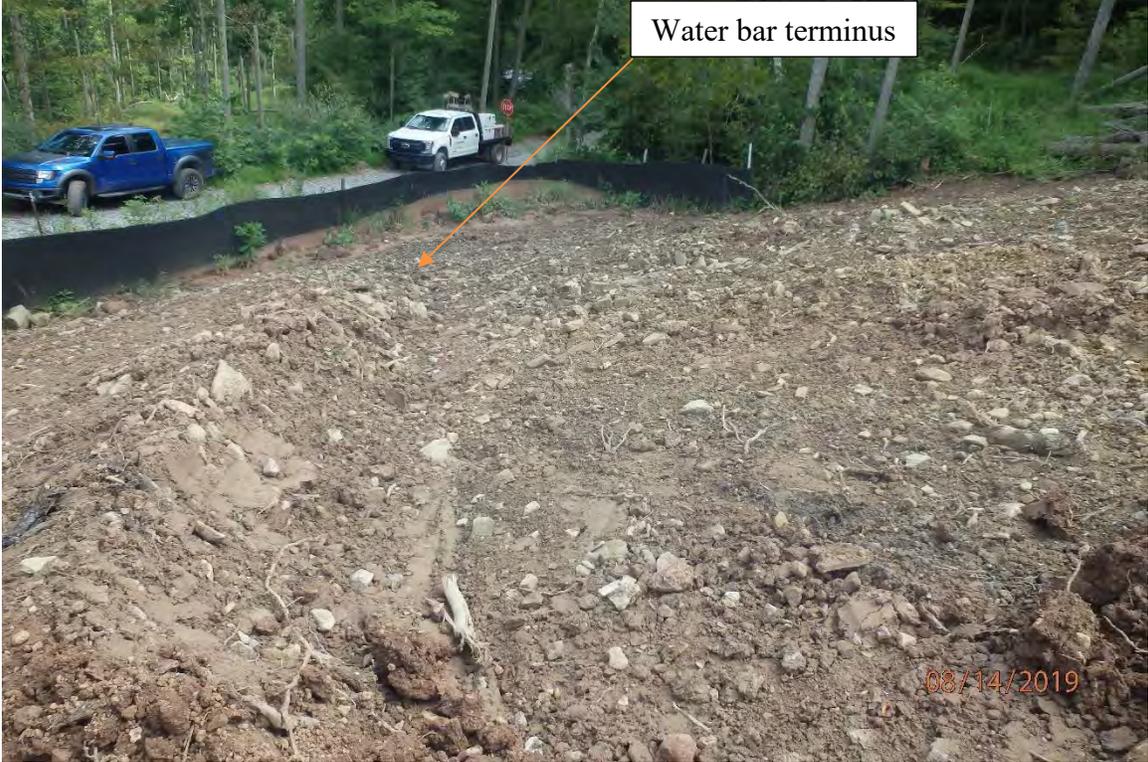
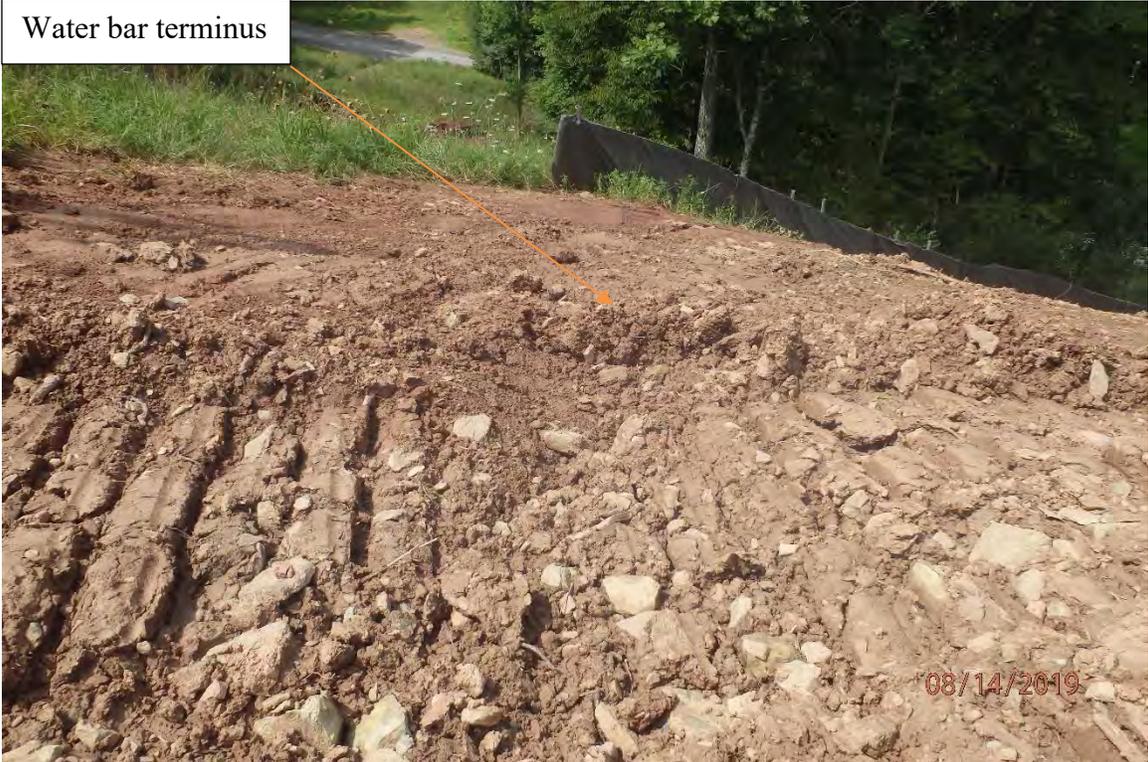
Improperly installed water bars in inspected area 5 showing them installed at a steep angle and discharging prior to the installed perimeter controls.

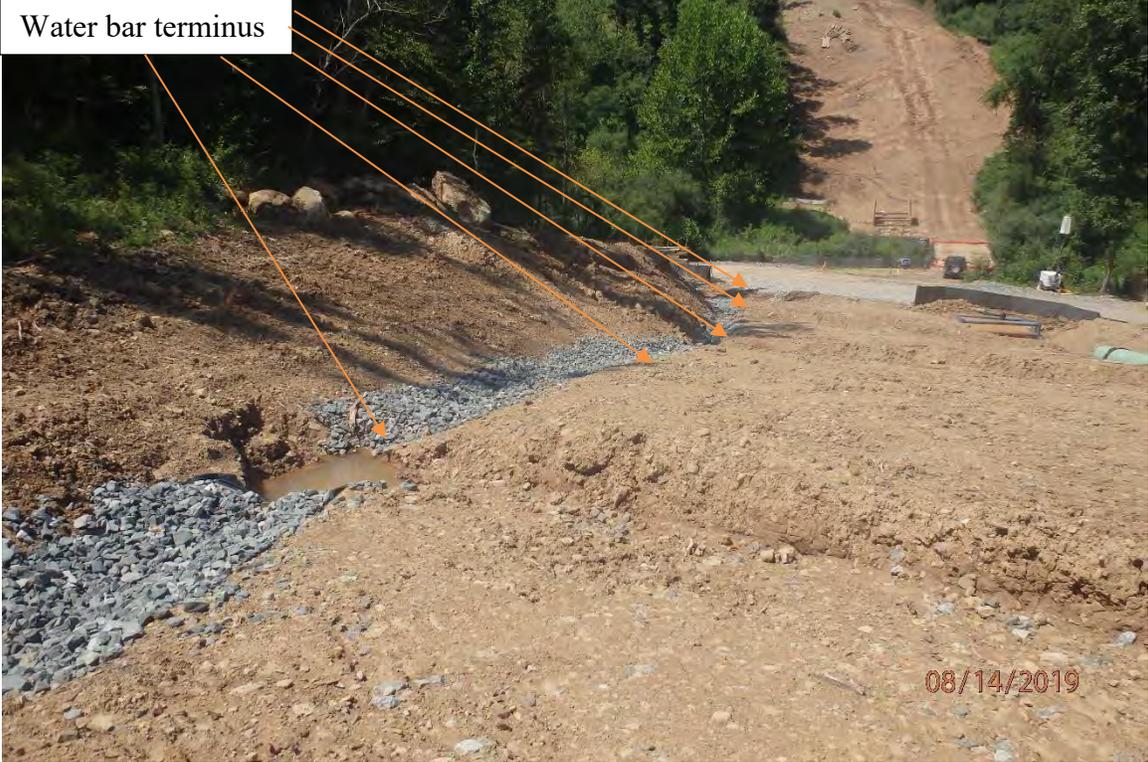
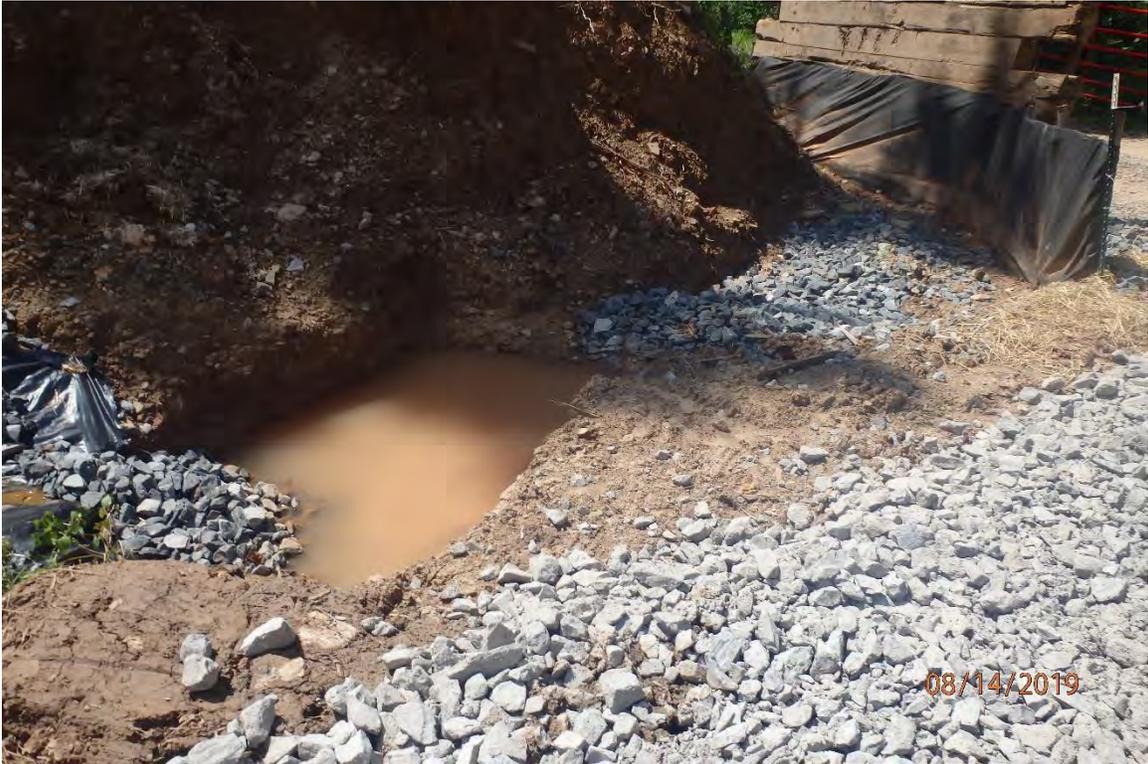
Improperly installed water bars in inspected area 8 showing water bars that are discharging into a diversion with stormwater from the diversion being directed at two pieces of installed perimeter controls.

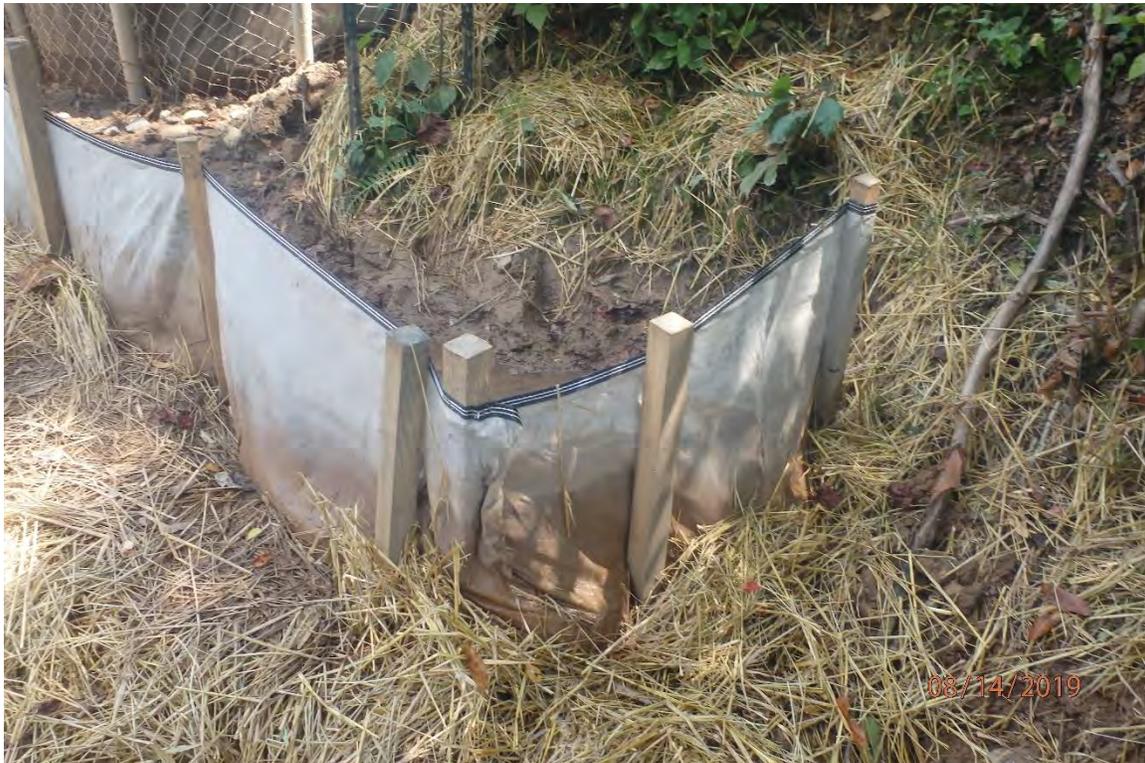
Recently maintained perimeter control that was utilized to treat stormwater from six water bars upslope of the pictured BMP.

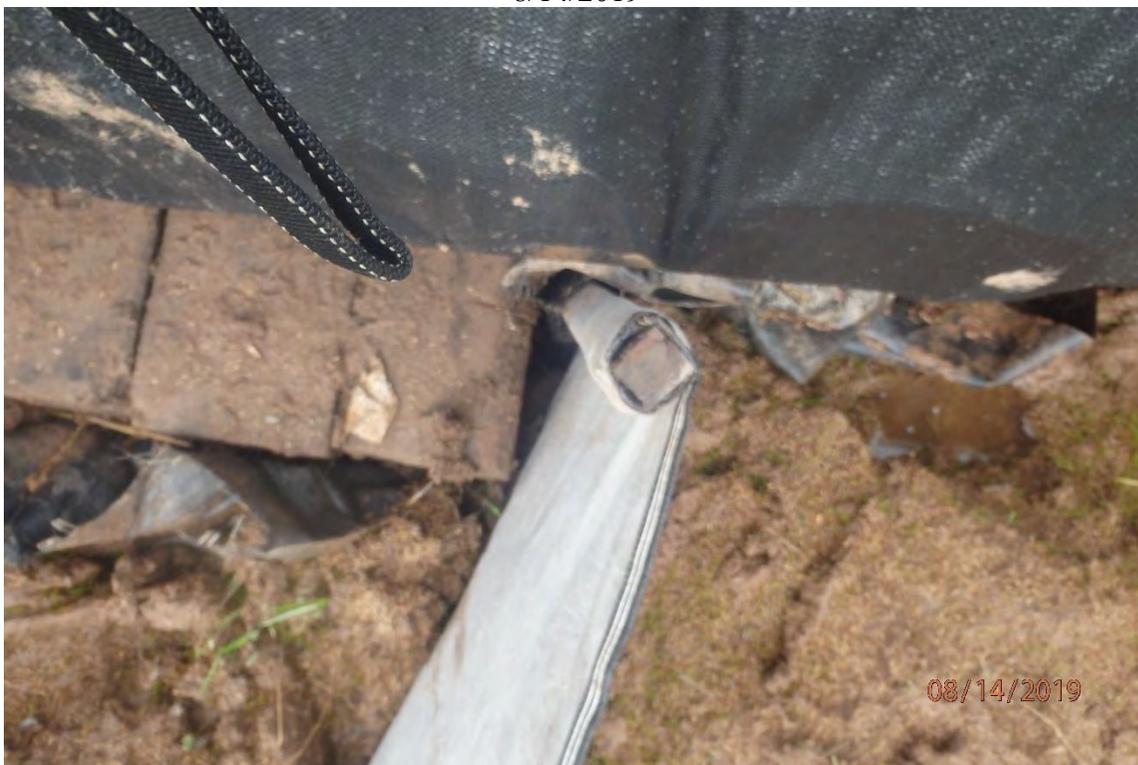
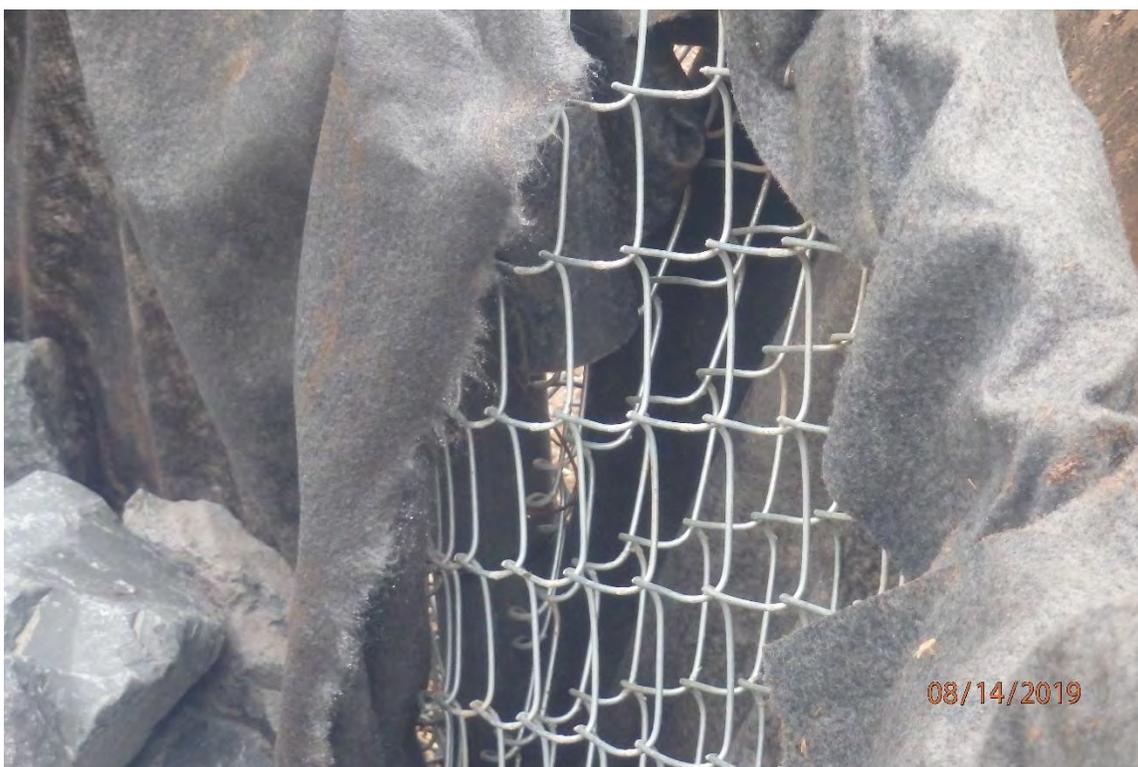
Improperly installed timber mat equipment bridge at the Clover Run (inspected area 1) crossing showing areas where sediment laden water can bypass treatment.

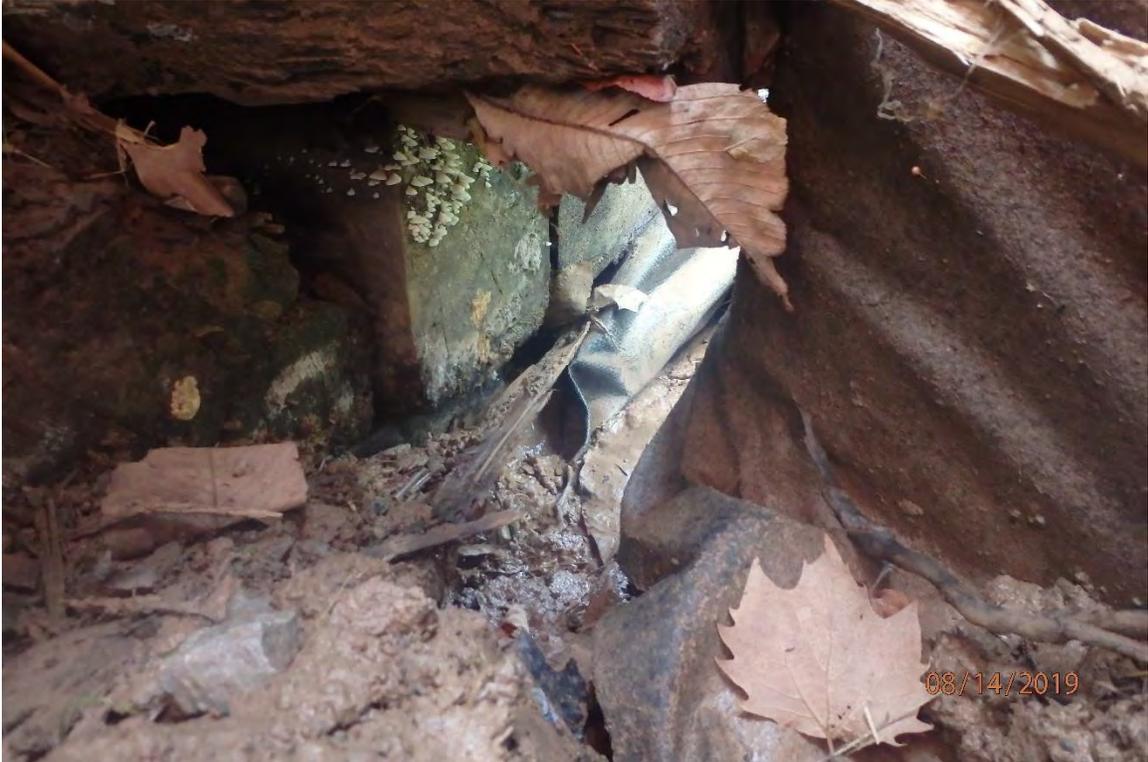
Improperly installed timber mat equipment bridge at the Oil Creek (inspected area 3) crossing showing an area where sediment laden water can bypass treatment.

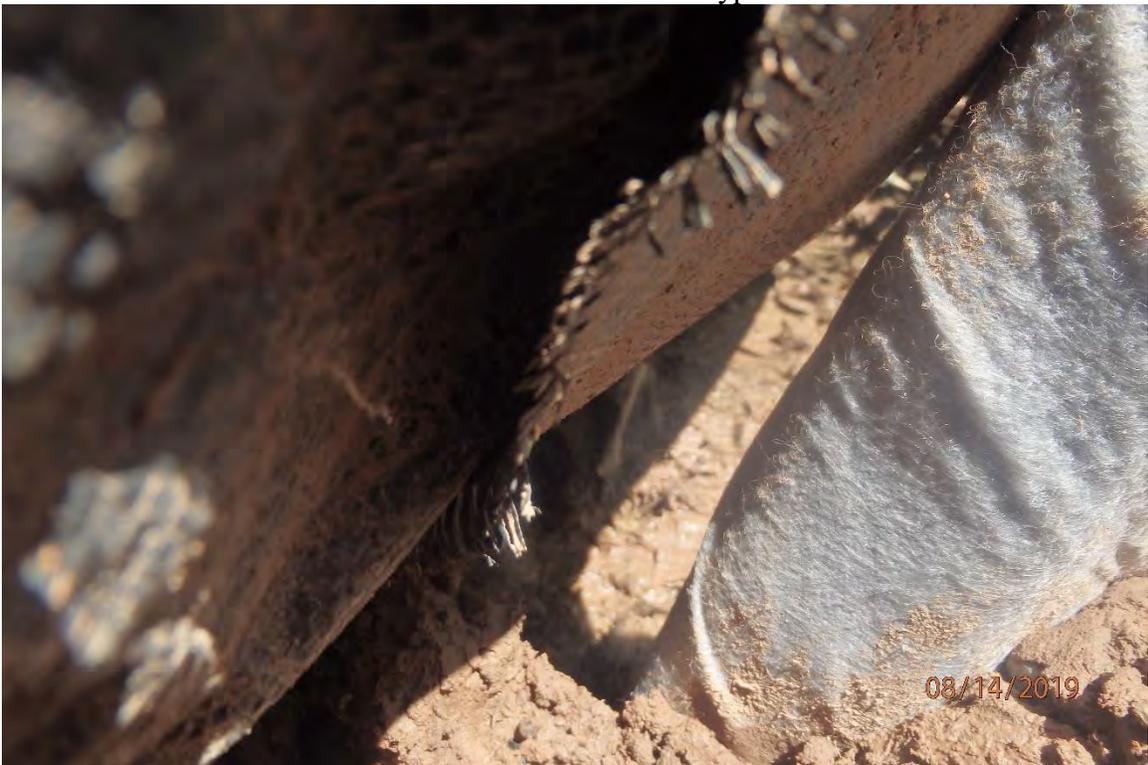
Improperly installed timber mat equipment bridge at the Cove Run (S-K-45) (inspected area 8) crossing showing an area where sediment laden water can bypass treatment.

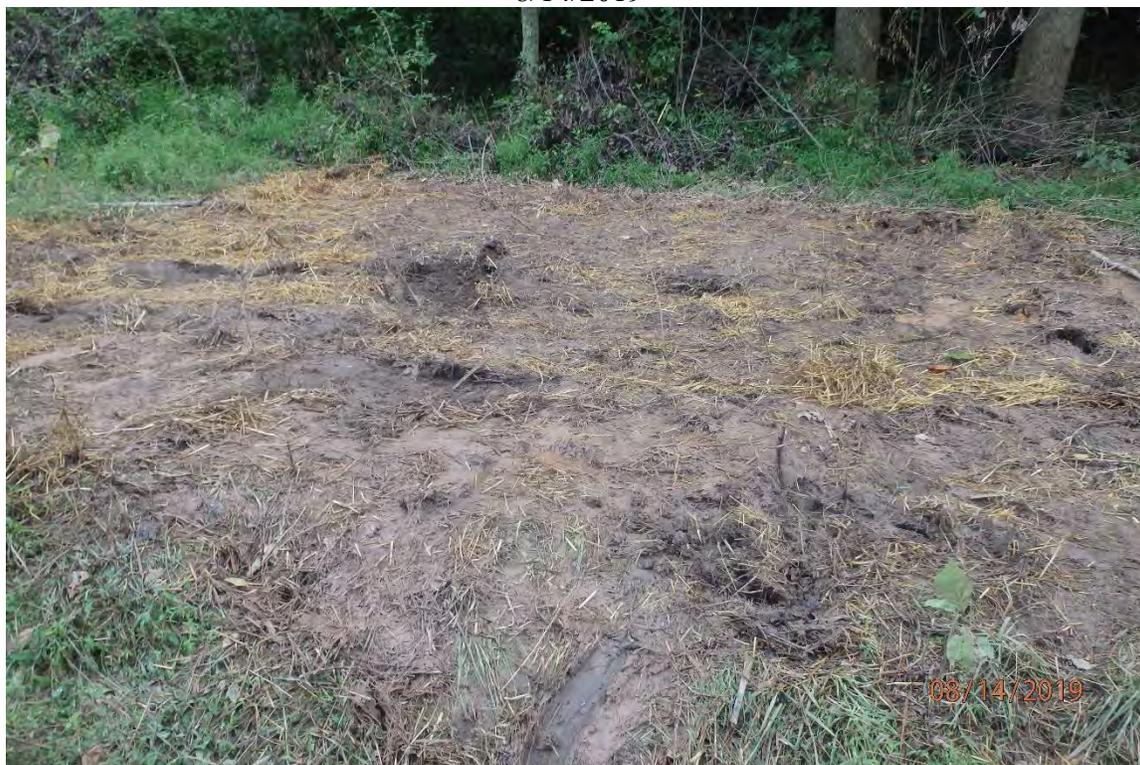
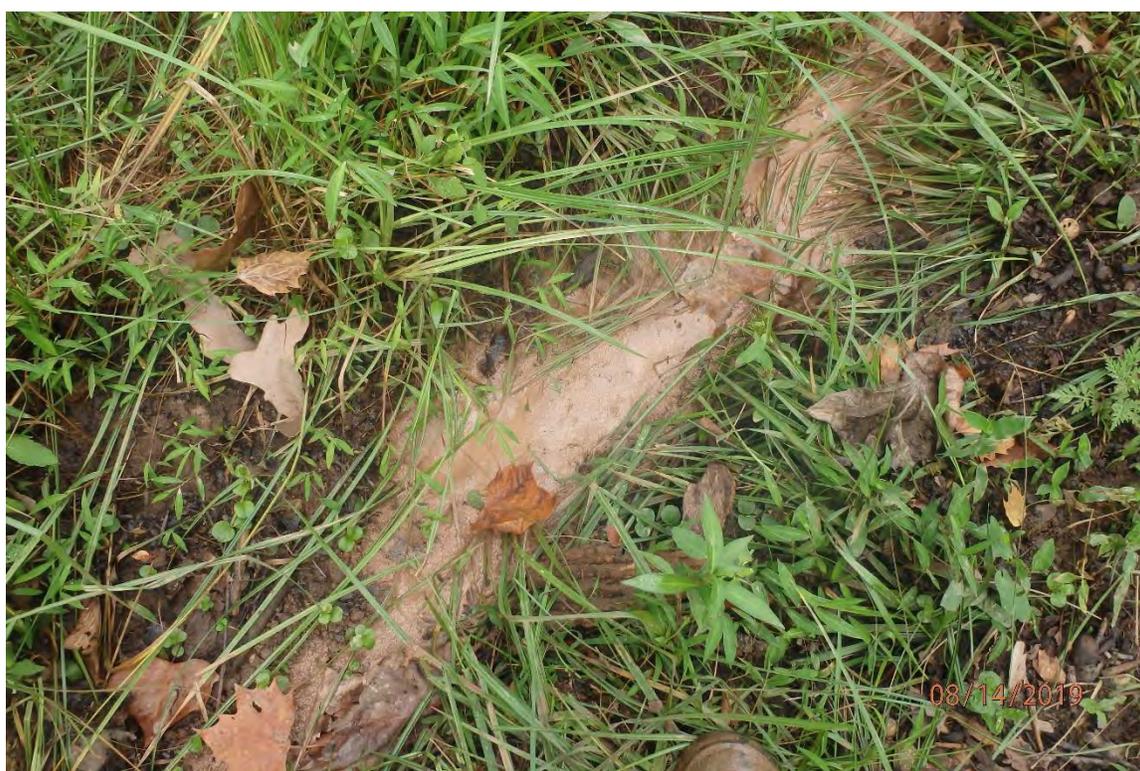
Offsite sediment deposits adjacent to inspected area 3 showing where a dewatering structure was placed offsite and caused offsite deposits.

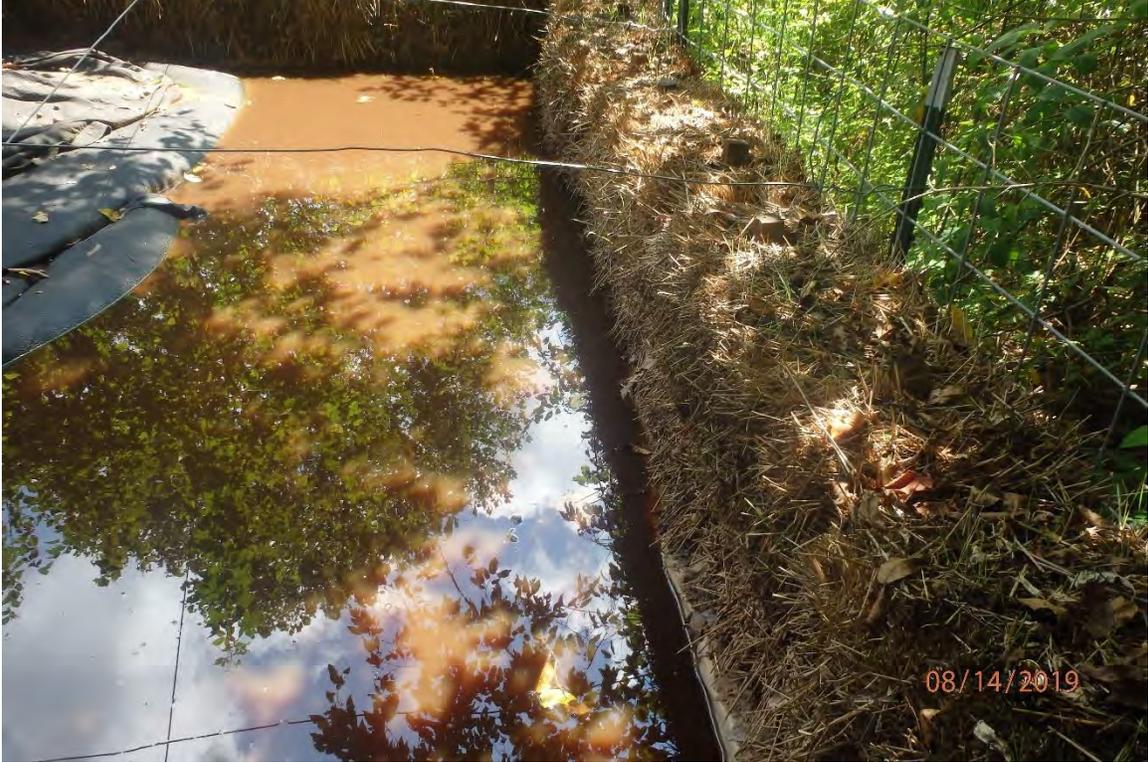
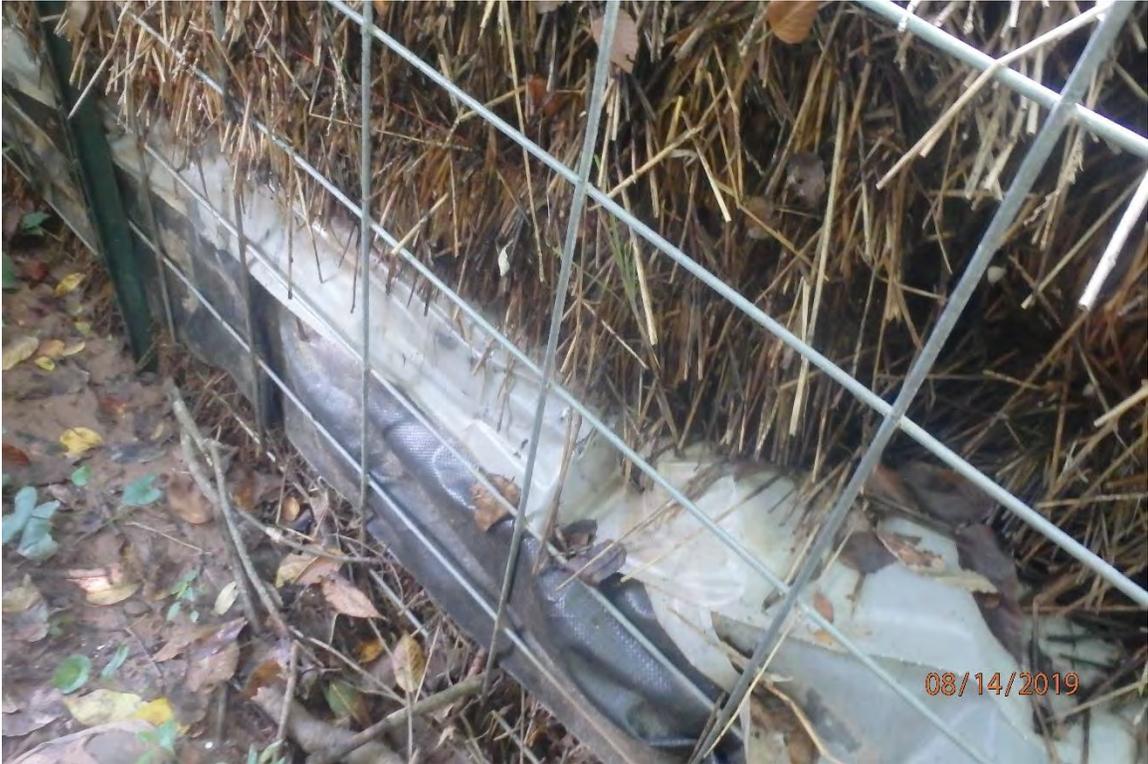
Dewatering structure with impermeable plastic installed causing it to not function as designed in inspected area 8.

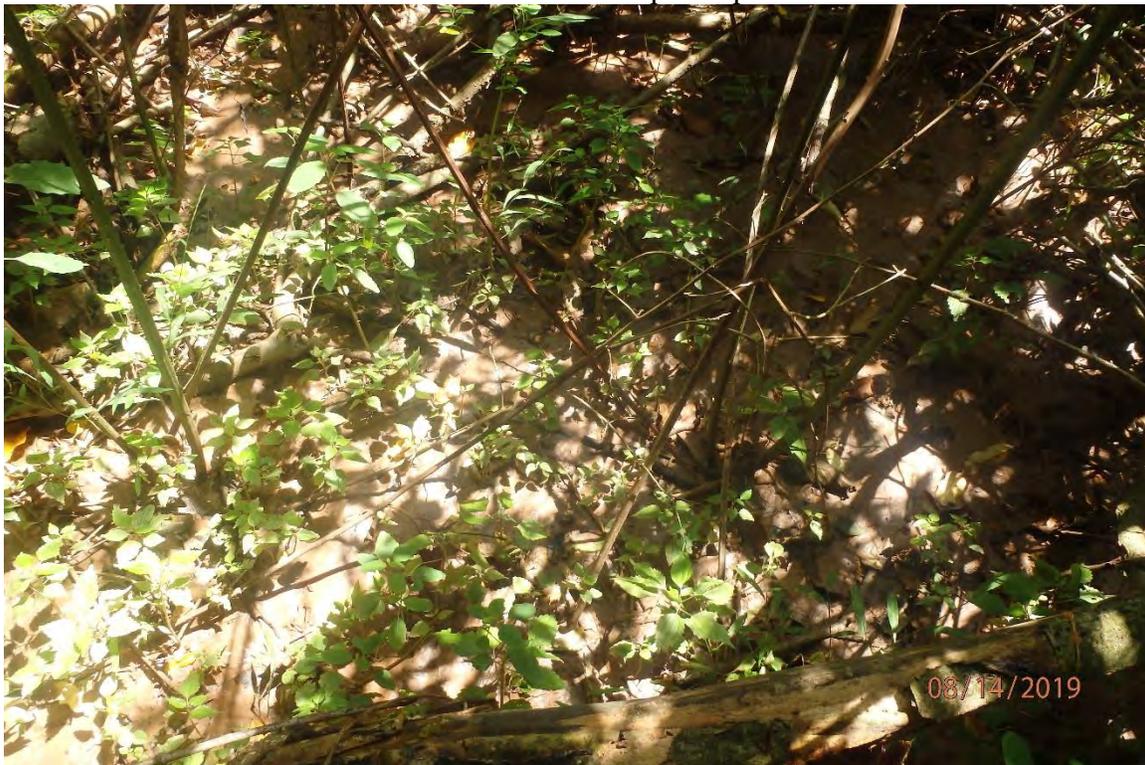
Offsite sediment deposits as a result of the above pictured deficiency.

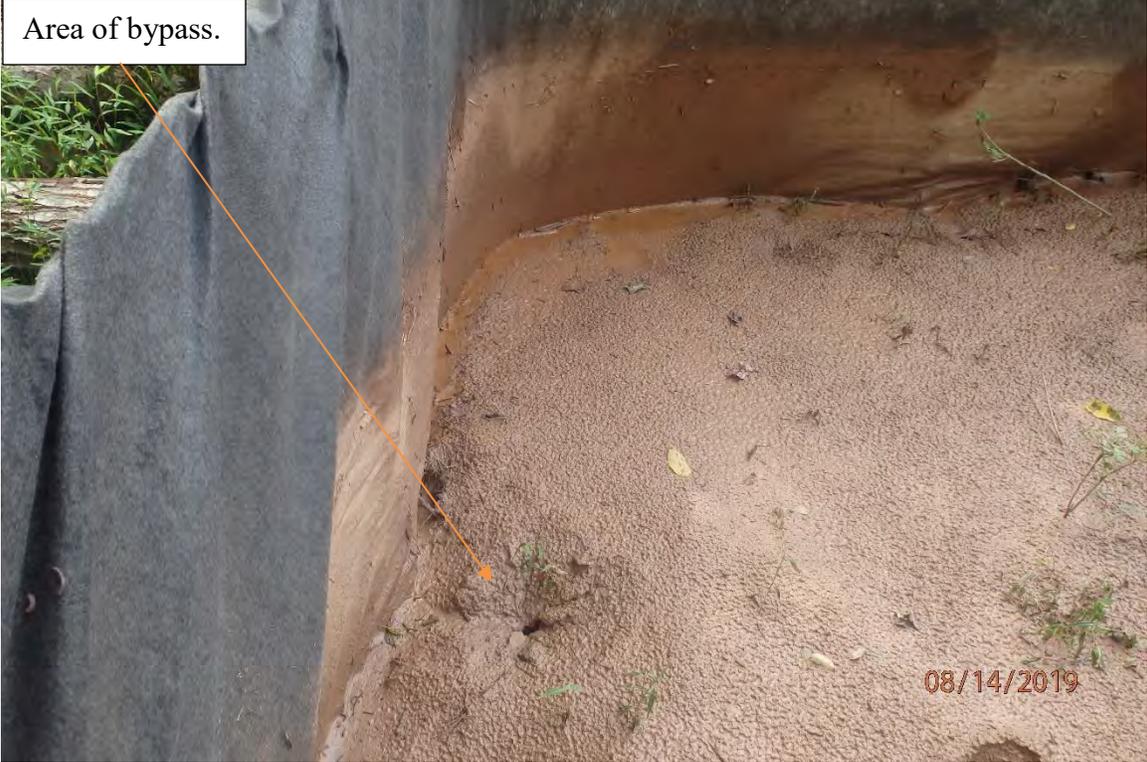
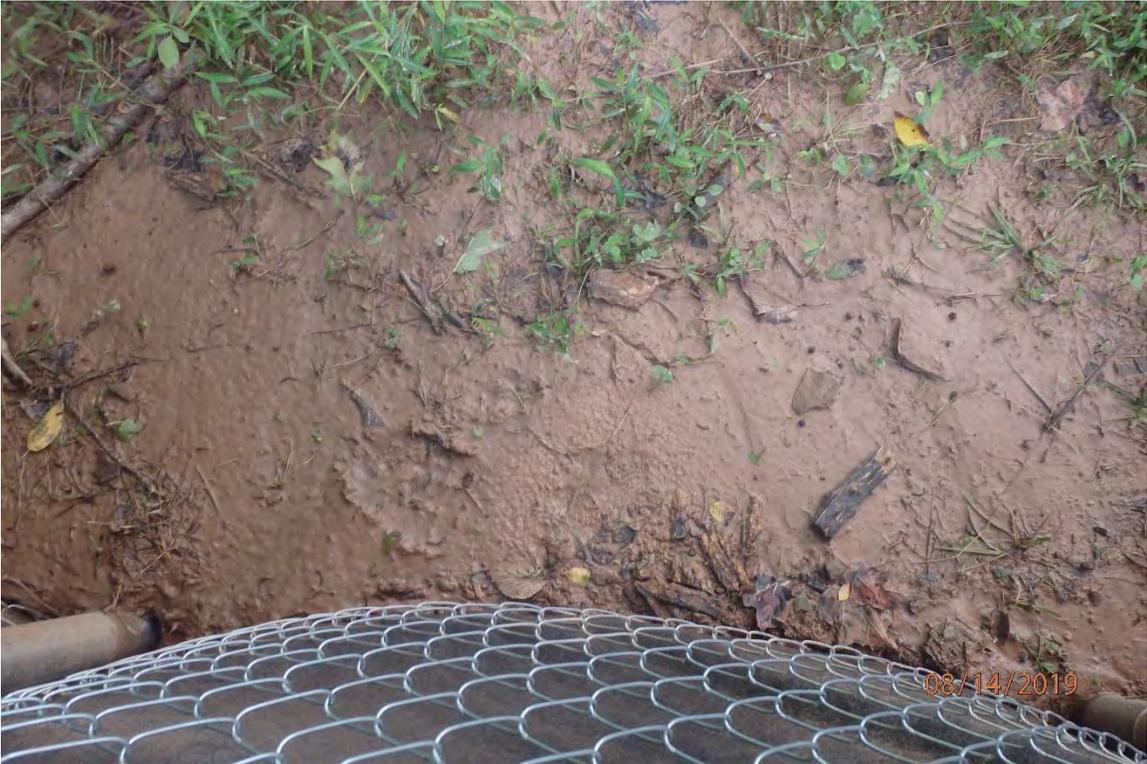
Sediment laden water that has bypassed under the installed perimeter control in inspected area 3 as a result of failure to properly operate and maintain the installed BMP. Offsite sediment deposits pictured.

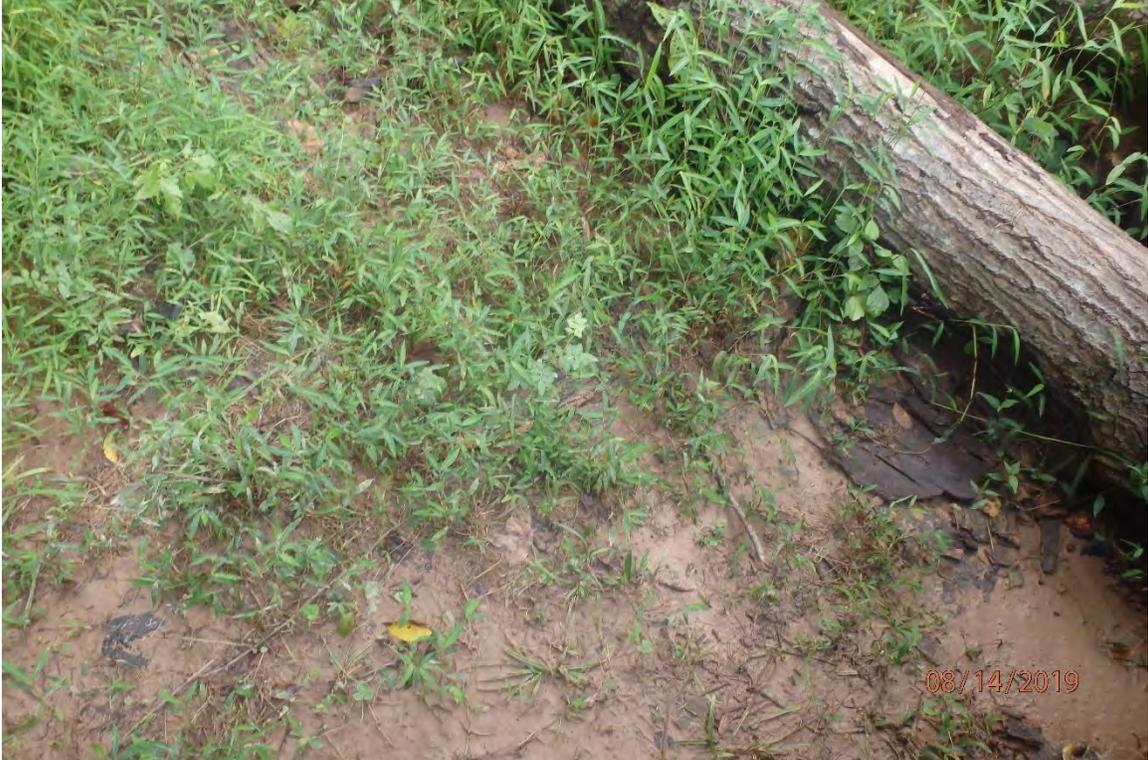
Offsite sediment deposits as a result of the previously pictured deficiency in inspected area 3.
