**The Wilderness Society et al. Comments on the  
U.S. Forest Service Mountain Valley Pipeline and  
Equitrans Expansion Project Draft Supplemental  
Environmental Impact Statement (#50036)**

**EXHIBIT 1**

Assessment of erosion, sedimentation, and water quality impacts of the Mountain Valley Pipeline and Equitrans Expansion Project's proposed crossing of the Jefferson National Forest as it pertains to the U.S. Forest Service's Draft Supplemental Environmental Impact Statement dated December 2022

Prepared by Jonathan A. Czuba, Ph.D., Licensed Professional Engineer

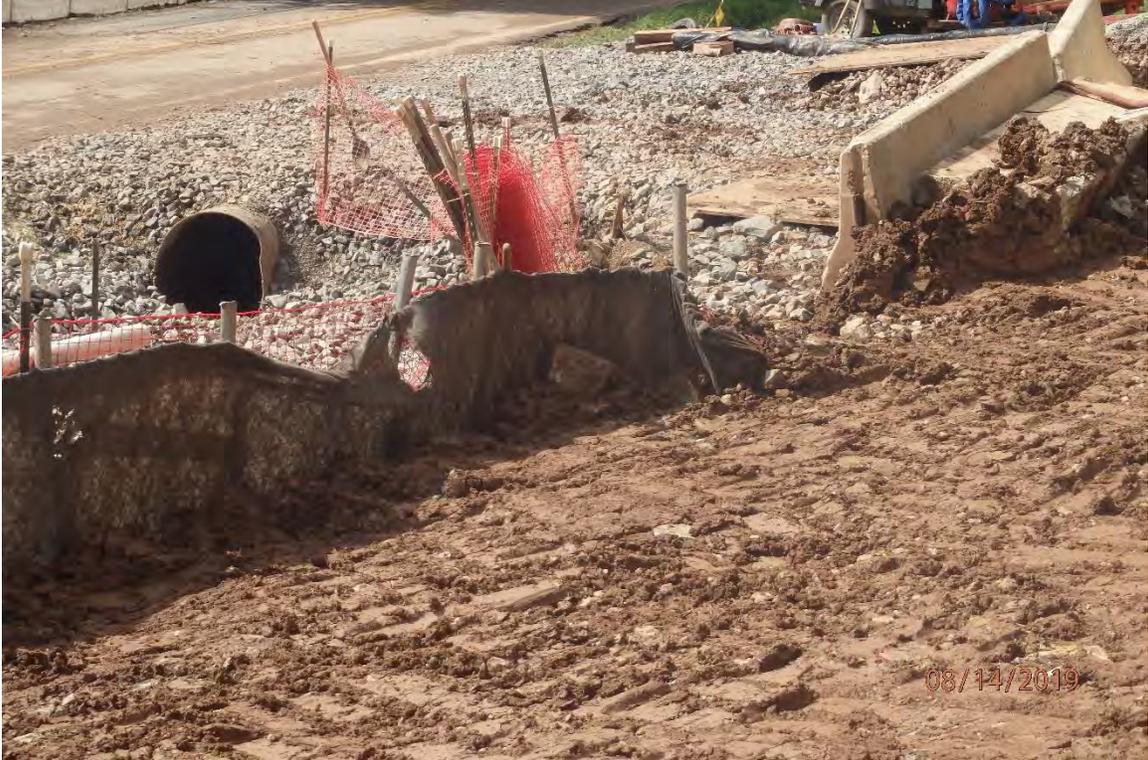
Perimeter controls in need of maintenance in inspected area 3.

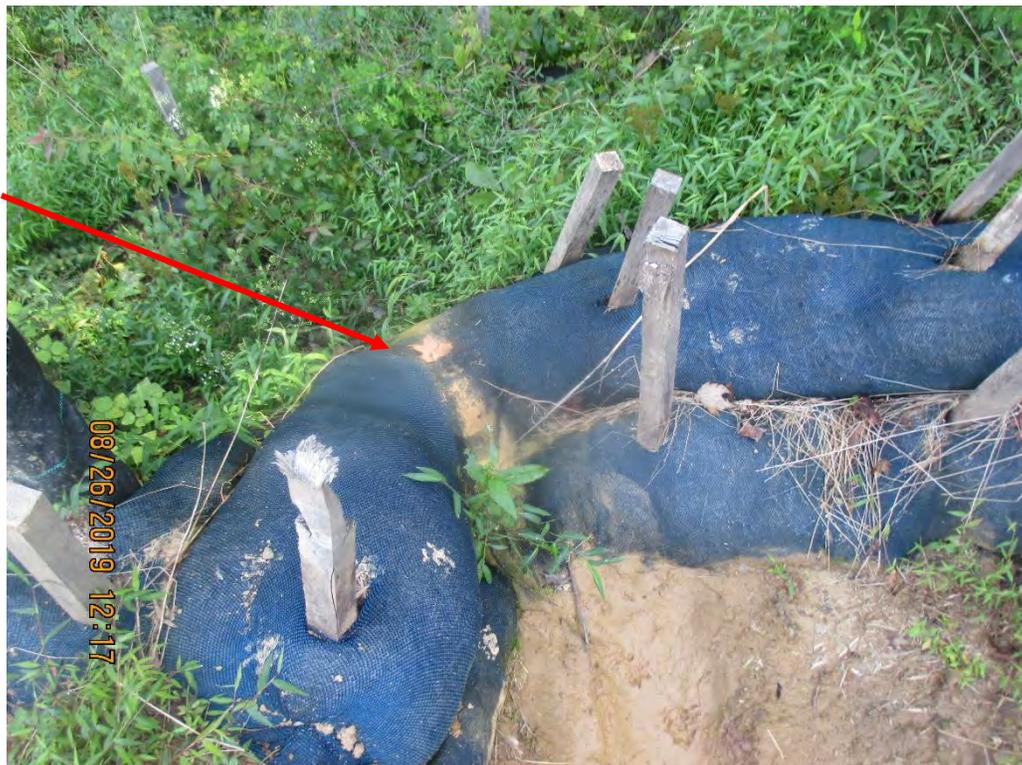
Perimeter outlet controls below sump and erosion on slope near station No. 1822+50. Arrow depicts where evidence of SLW overtopping control was observed.

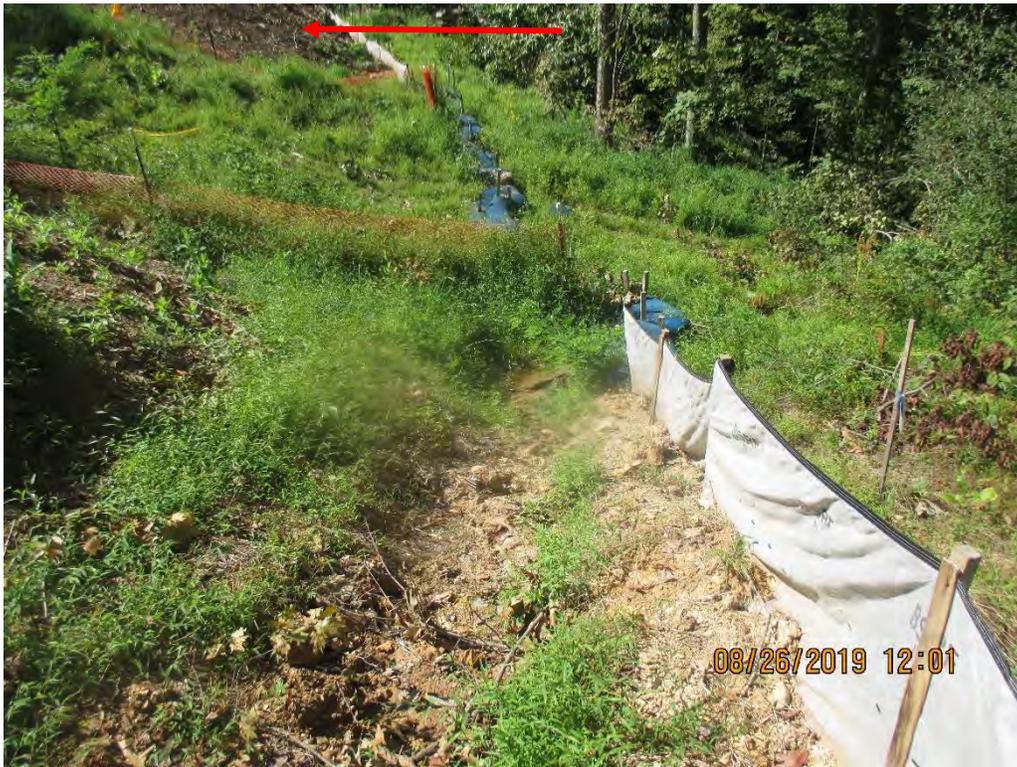
Near Station No. 1833+00. Perimeter controls overwhelmed due to erosion on slope. Arrow depicts where erosion was occurring.

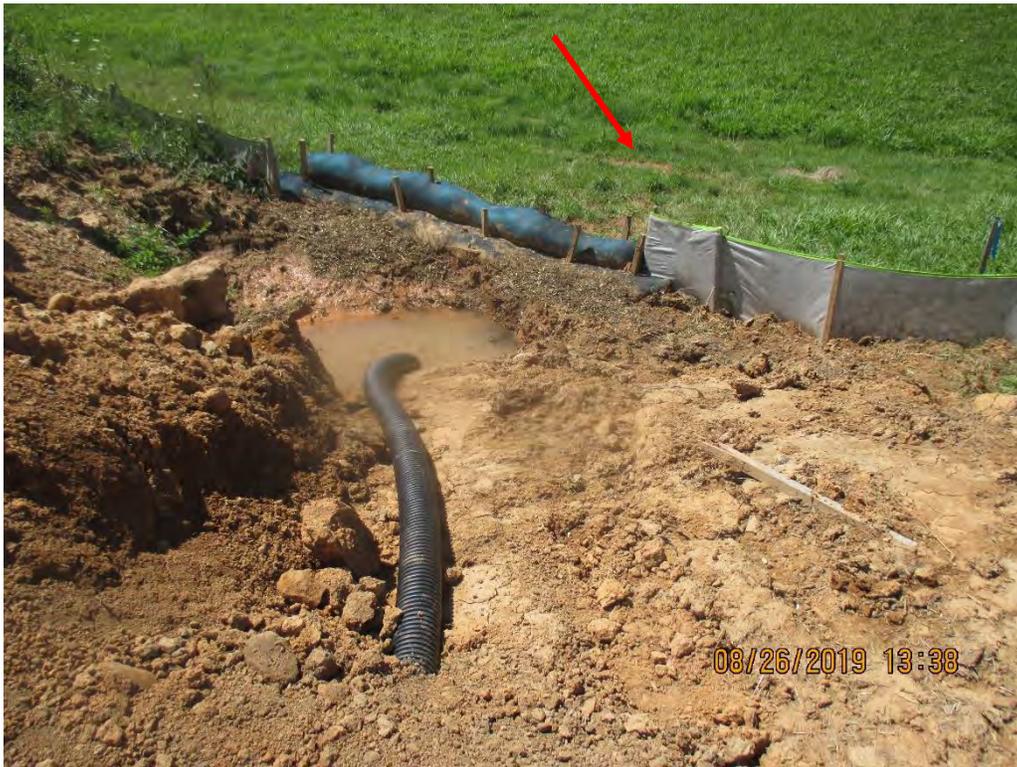
Slope drain extending from Waterbar outlet terminating into sump above perimeter controls. Arrow depicts where sediment deposits were observed above Wetland W-K48 at station No. 1730+00.

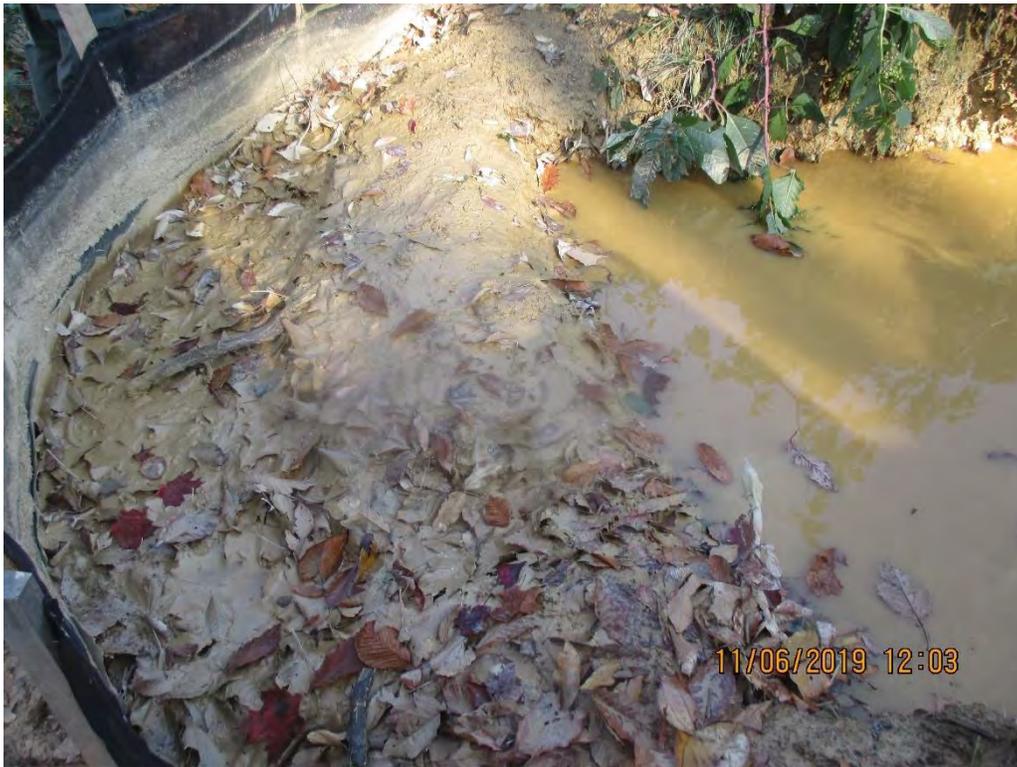
Waterbar outlet controls needing maintained at station No. 4082+00.

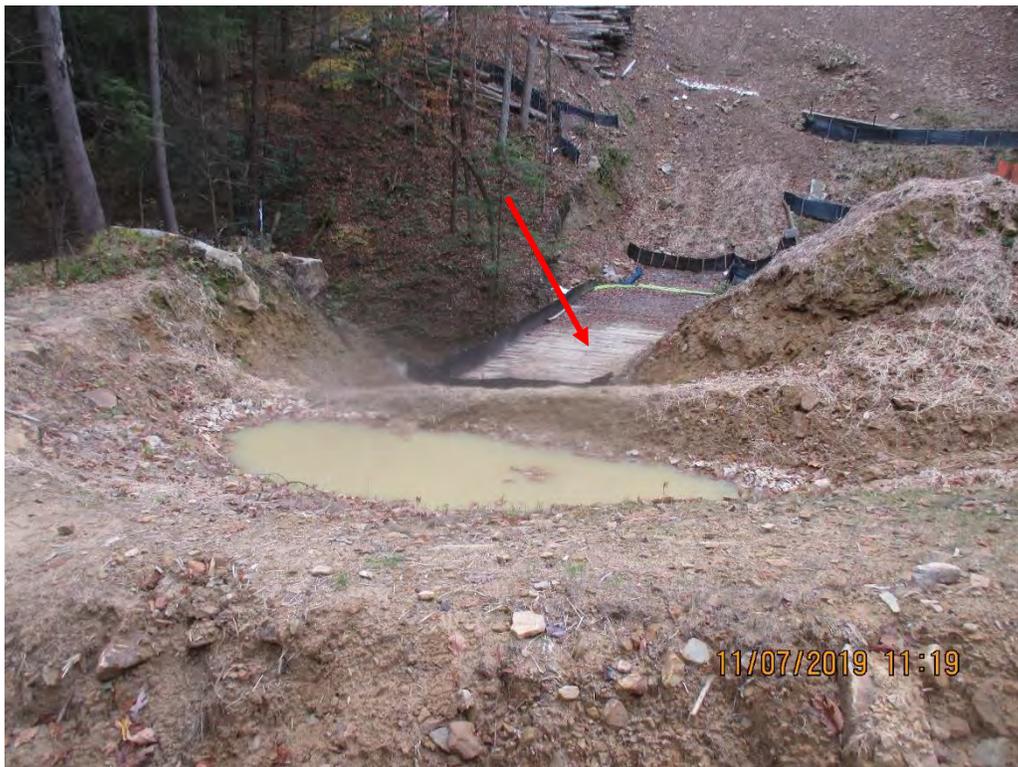
MVP Row facing North near MP 76.7. Air bridge crosses over Stream S-H117. Arrow depicts where pellet remnants were observed on air bridge.

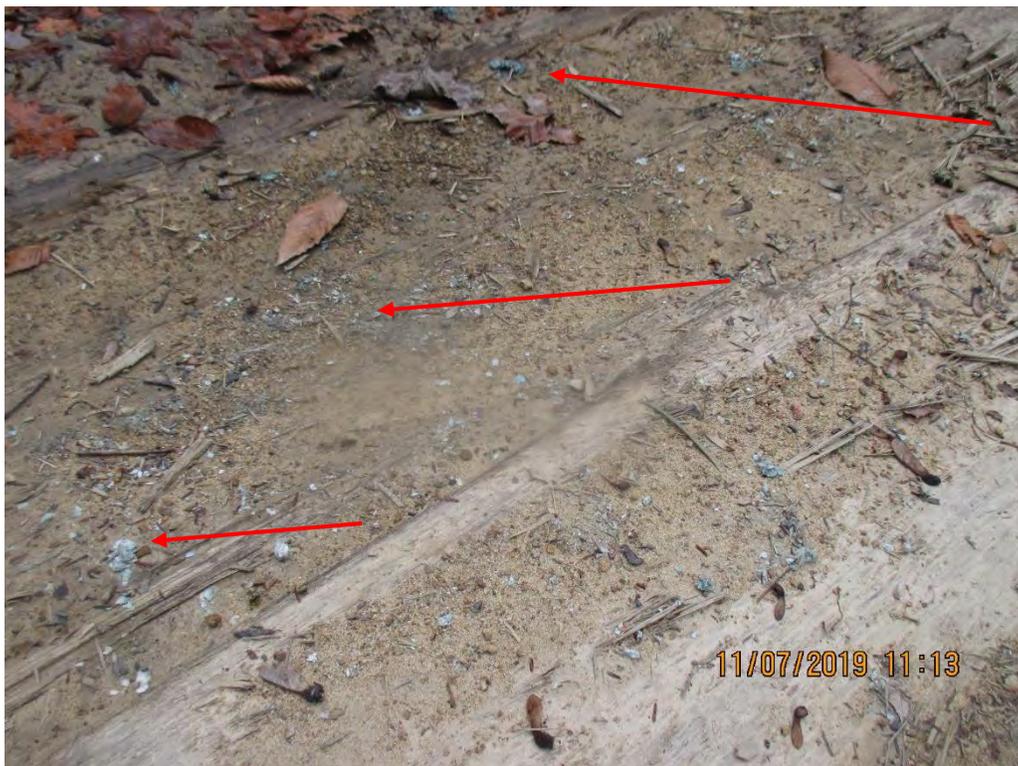
Air bridge located over Stream S-H117. Arrows depicts pellet remnants observed.

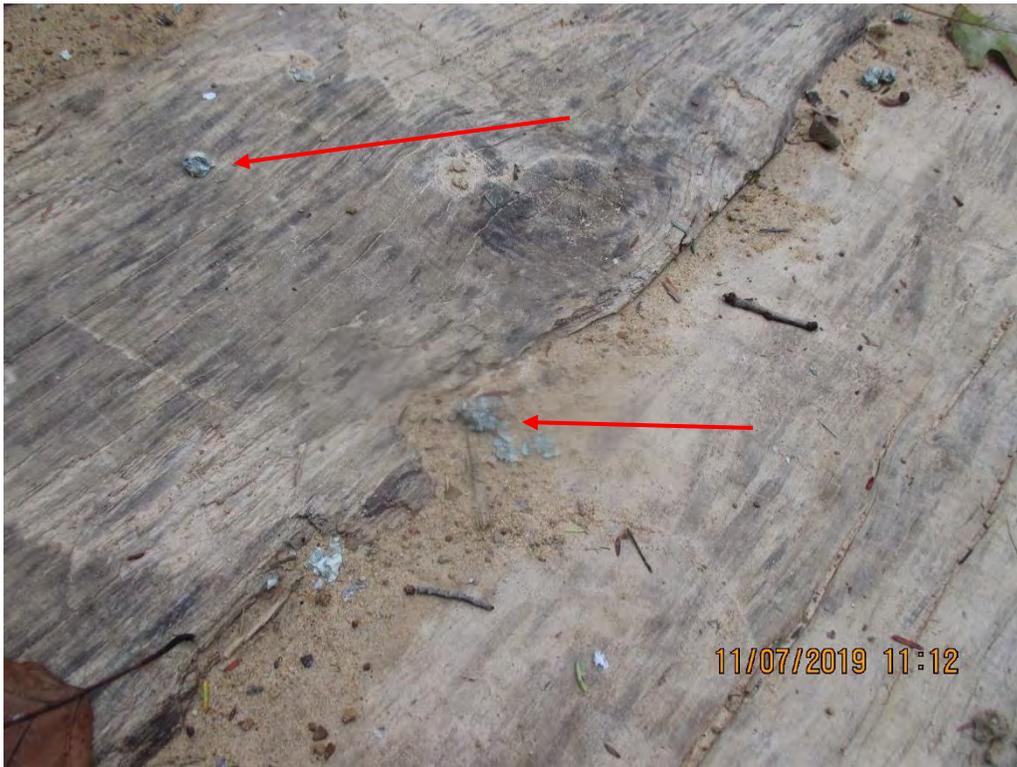
Air bridge located over Stream S-H117. Arrows depicts pellet remnants observed.

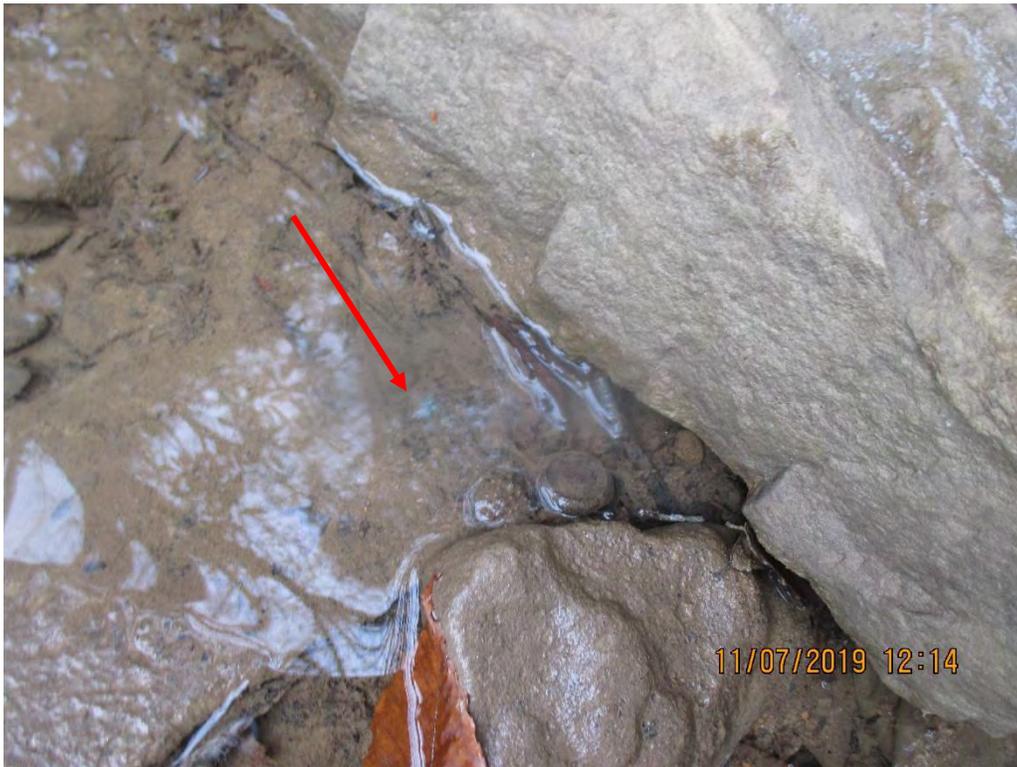
Erosion control pellet remnant observed in Elliott Run near Station No. 3946+00.

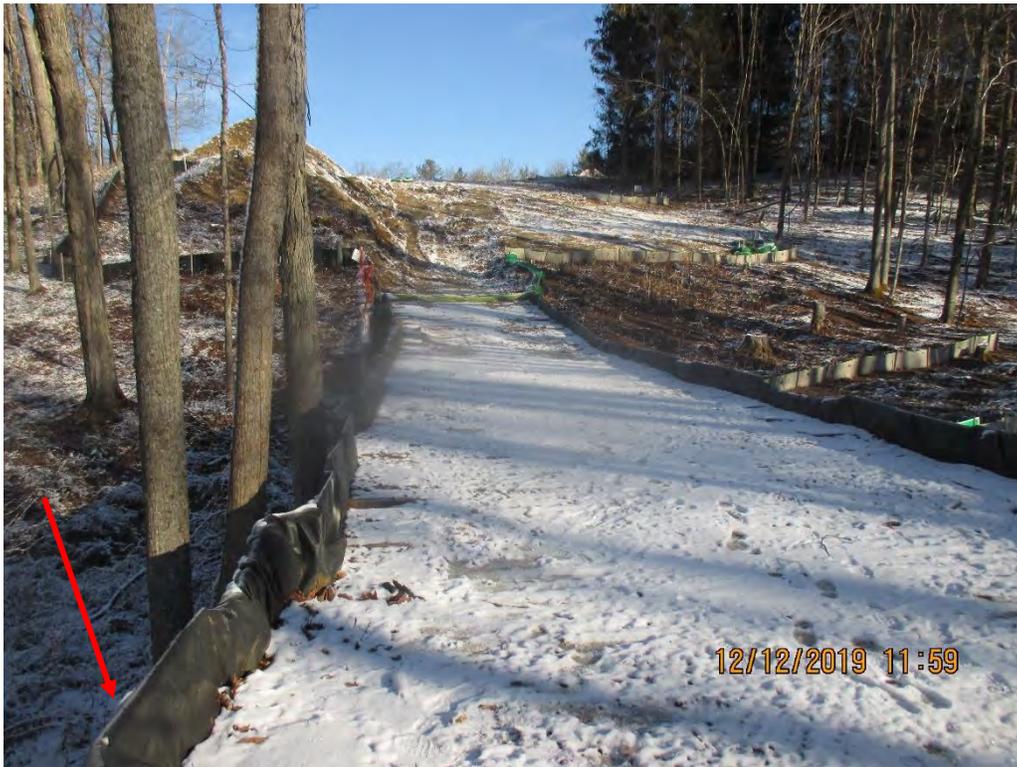
Wetland W-M2 crossing near station No. 8433+50. Arrow depicts where hole had been repaired on bridge controls.

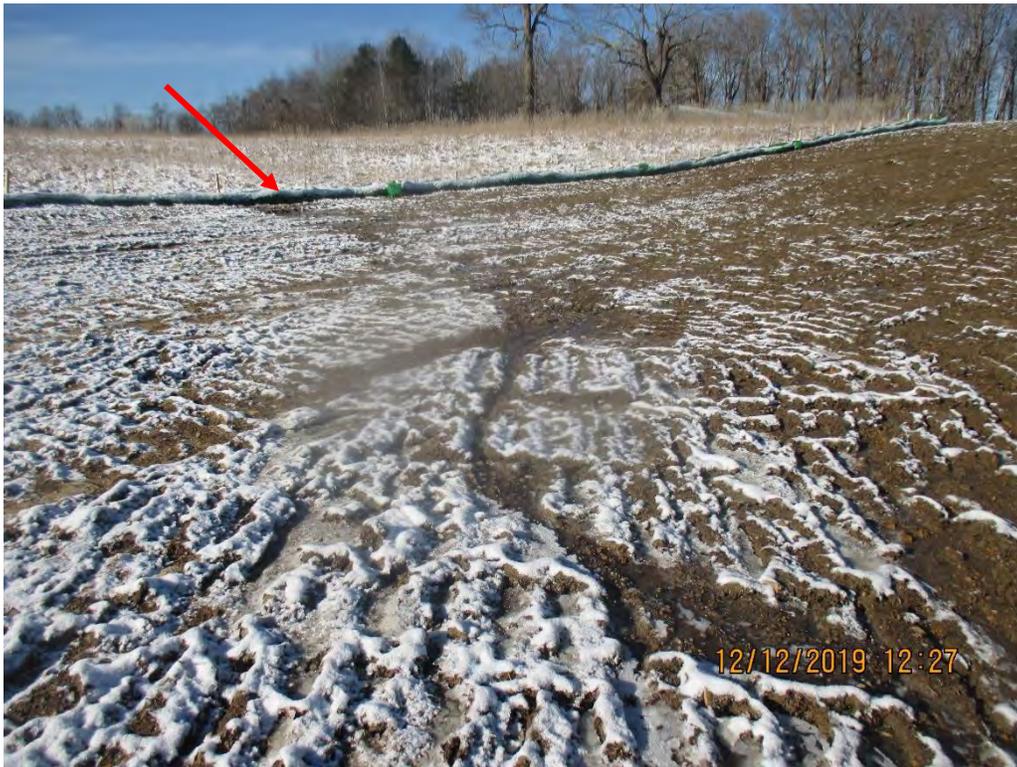
Run on originating from seep at edge of LOD upslope of controls. Erosion occurring on ROW. Arrow depicts seep.

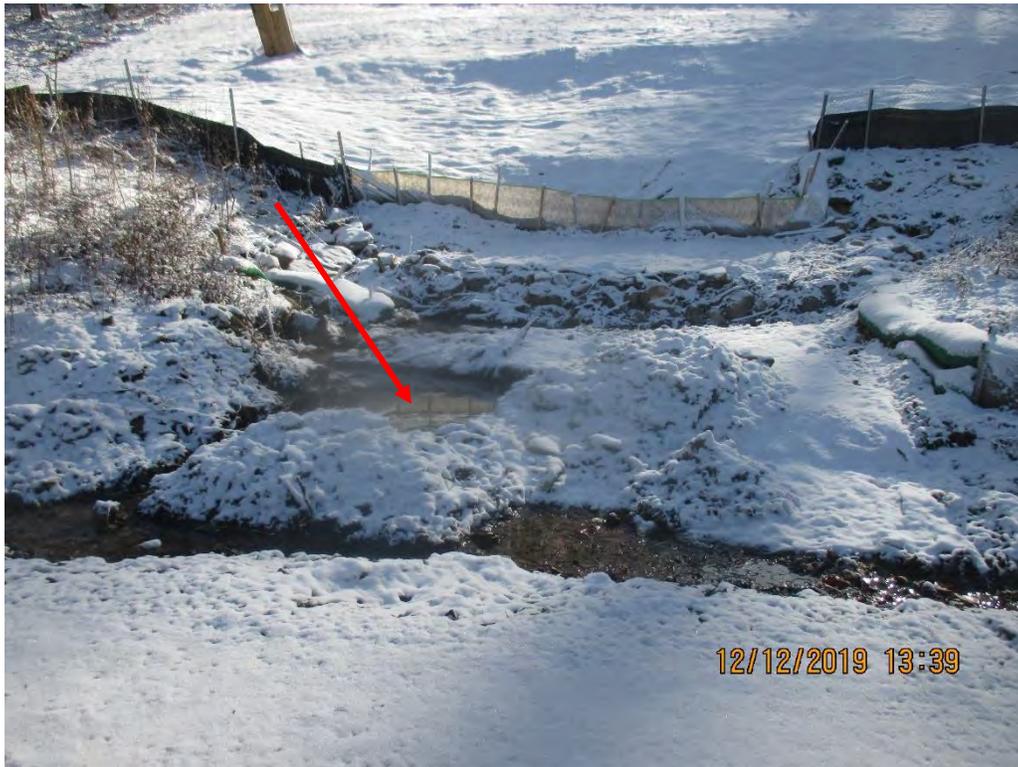
Standing at Keeney Bench MVP ROW crossing at station No. 8489+65 where air bridge was pulled per landowner request to access spring for water. Arrow depicts where landowner excavated. Excavation wasn't done in delineated stream.

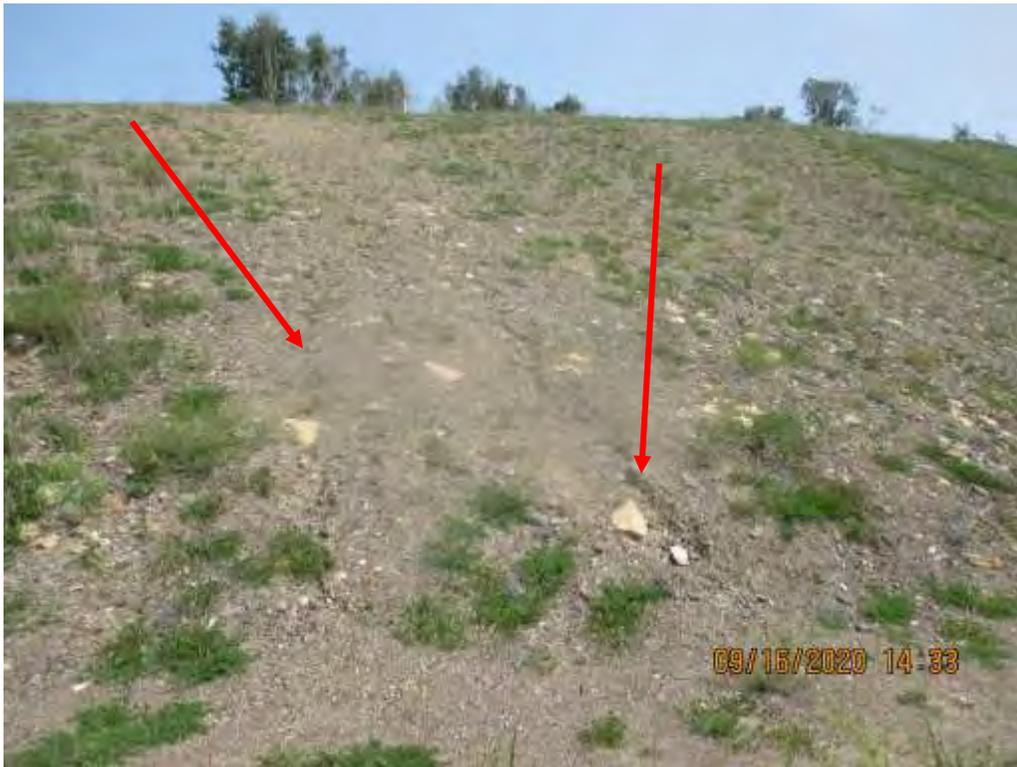
Rill erosion occurring on slope above AR-160.1 at Station No. 6698+00.
