**The Wilderness Society et al. Comments on the
U.S. Forest Service Mountain Valley Pipeline and
Equitrans Expansion Project Draft Supplemental
Environmental Impact Statement (#50036)**

EXHIBIT 12

**WEST VIRGINIA DEPARTMENT OF ENVIRONMENTAL PROTECTION
WV OIL AND GAS CONSTRUCTION STORMWATER PERMIT**

FACILITY NAME:	Mountain Valley Pipeline Project		REG. #	EXPIRE DATE:
PERMITTEE	MOUNTAIN VALLEY PIPELINE, LLC		WVR310667	5/13/2018 Extended: 12/31/2018
ADDRESS/PHONE:	Attn: MATTHEW HOOVER 625 LIBERTY AVE, ST 1700 PITTSBURG, PA 15222 7248733645			
LOCATION:	Harris Compressor Station		Entry Date/Time:	9/25/2018 1000
COUNTY:	Braxton		Exit Date/Time:	9/25/2018 1100
Site Representative /Phone	Brittany Dewitt (Lead EI)/330-987-1682, Matt Hoover MVP/ 412-258-5627 & Jason Hiles, Spread C Lead EI/740-334-7812		PHOTOS <input checked="" type="checkbox"/>	
CO-PERMITTEE:			ADDRESS:	
SITE OPERATOR:	MEC Construction LLC		ADDRESS:	19 RR Meadowbrook, WV 26404
PERMITTED ACREAGE	4311	WEATHER:	Cloudy	LAST INSPECTION: 8/21/2018
RECEIVING STREAM(S)	Trib of Elk/Kanawha R/ Ohio Rv			NOV: 1
Regular Mail <input type="checkbox"/> Certified Mail <input checked="" type="checkbox"/>	Tracking #			
OVERALL FACILITY R

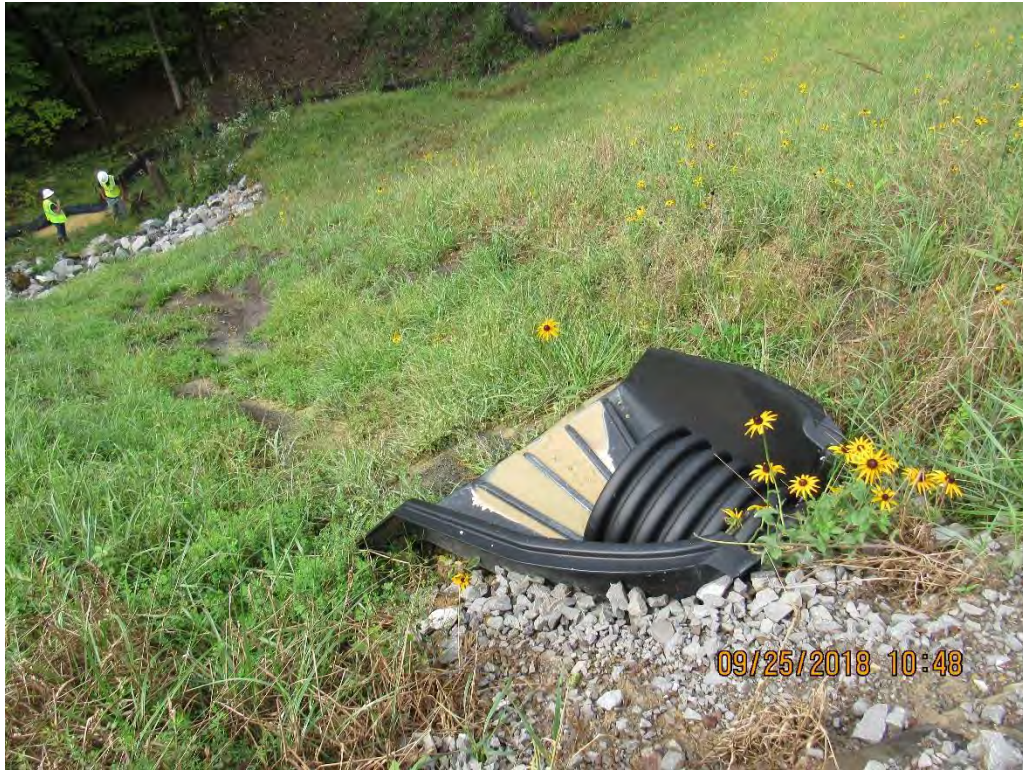
- 1, 13, 19, & 20.- Station 550 had sediment laden water leaving the site through failed perimeter controls creating conditions not allowable in UNT of Little Kanawha River (photos 1-3)
- 13. – Marginal evaluation notated- On northeastern side, 3 separate filter fabric bags were improperly installed, had rolled over edge of fill slope and dewatering continued. Slope was well vegetated, and sediment laden water was not leaving site (photos 4-5)
- All issues related to NOV# W18-52-007-CP issued 8/21/2018 have been abated and returned to compliance achieved (photos 6-9)

- Section G.4.e.2. - Permittee has failed to properly implement controls: inadequate perimeter controls installed at base of fill slope at station 550, which allowed sediment laden water to release into UNT of Little Kanawha River (photos 1-3).
- Section G.4.e.2.A.ii.j - Permittee has failed to prevent sediment-laden water from leaving the site without going through an appropriate device into UNT of Little Kanawha River (photos 1-3).

Photo 1: Station 550 outlet and sump at base of fill slope where perimeter controls failed allowing sediment laden water to leave site and create conditions not allowable in UNT of Little Kanawha.

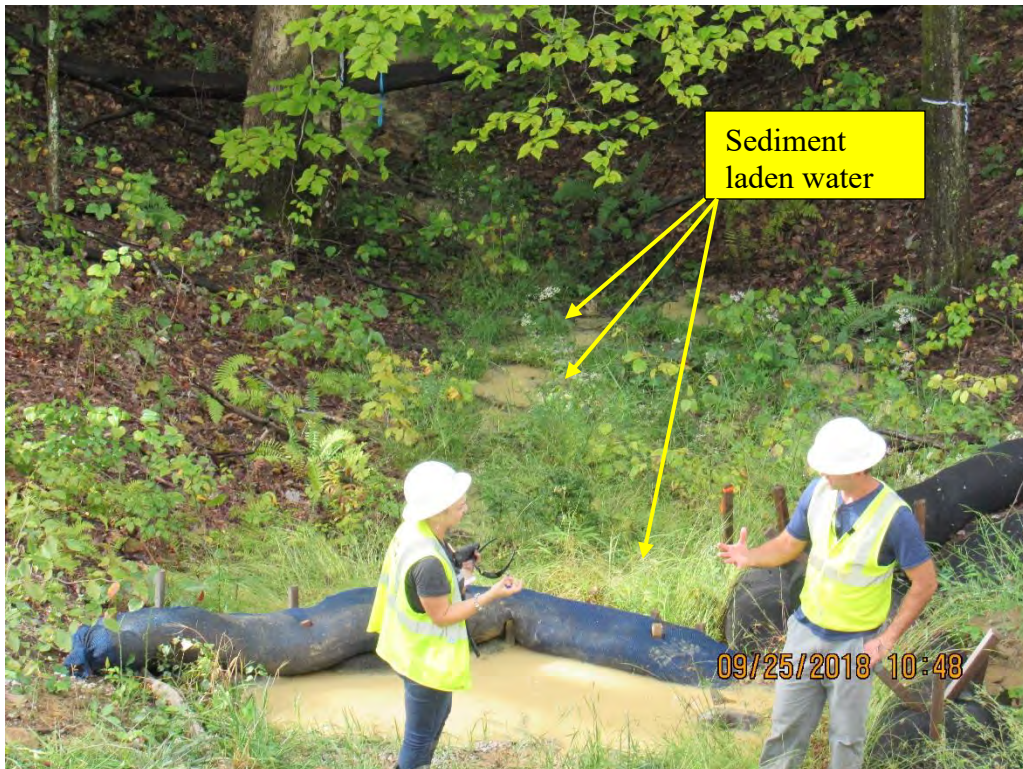
Photo 2: Station 550 sump at base of fill slope where perimeter controls failed and sediment laden water leaving site.

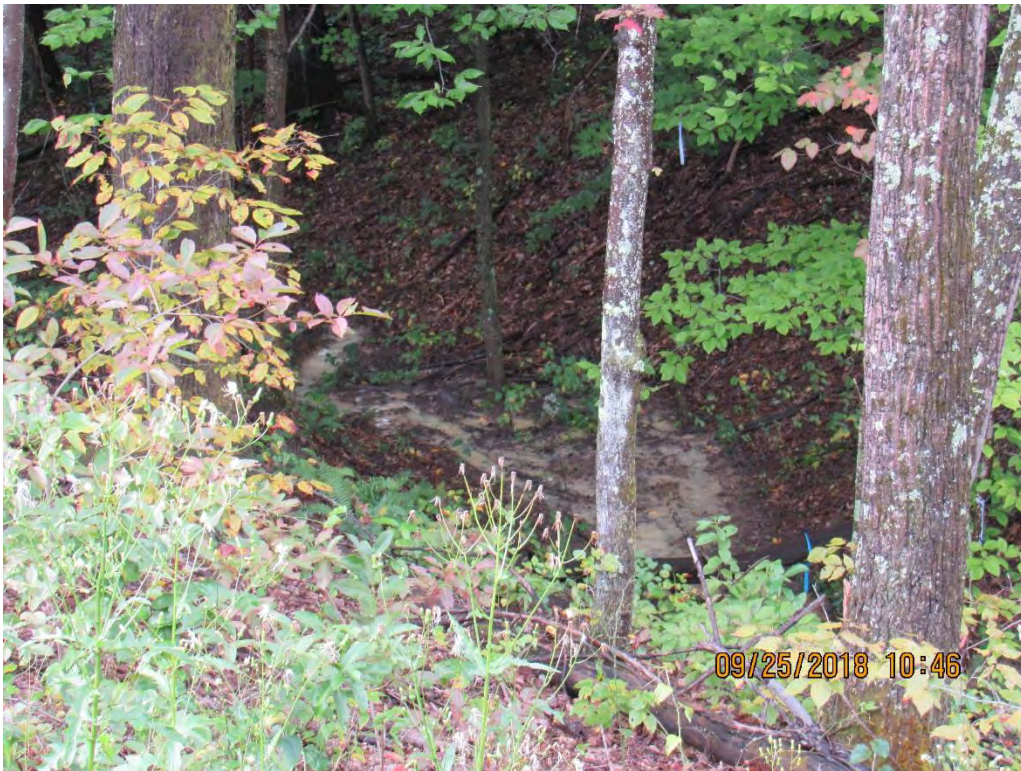
Photo 3: Conditions not allowable in UNT of Little Kanawha River down gradient of photo 2.

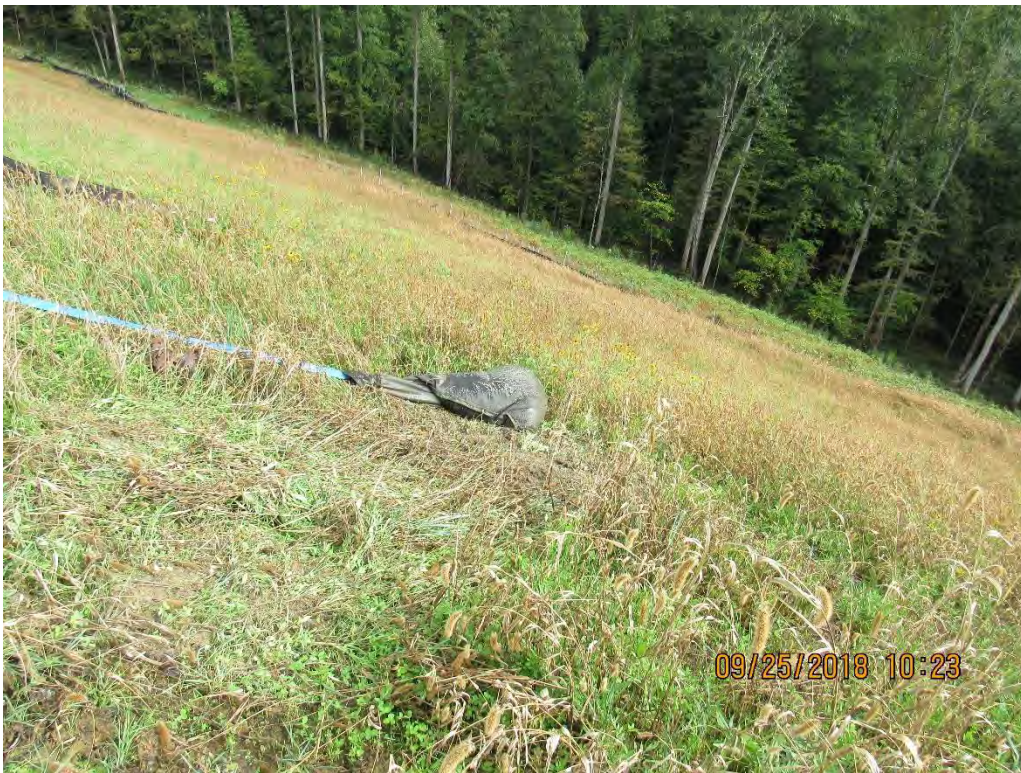
Photo 4: 1 of 3 improperly installed filter fabric bags still in use on north eastern side of site.

WARNINGS: Immediately take all measures necessary to comply with all terms and conditions of the WV/NPDES general permit. In accordance with permit section Section G.4.e.2., correctly install and properly use filter fabric bags for dewatering practices (photos 4-5).

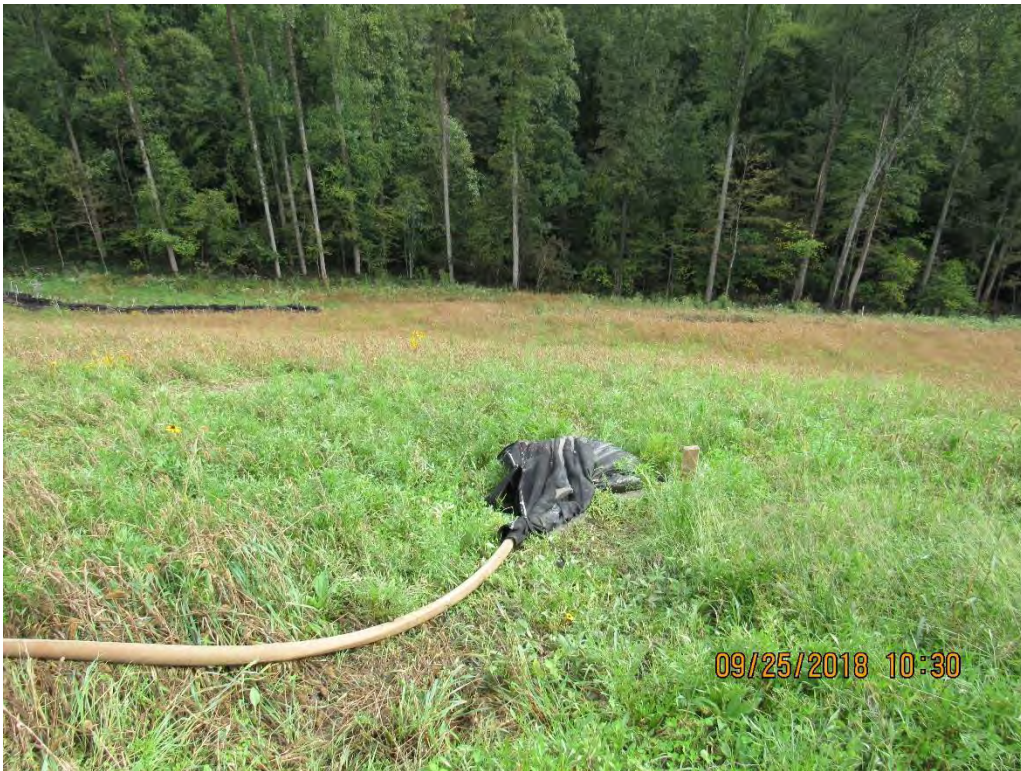
Photo 5: 2 of 3 improperly installed filter fabric bags still in use on north eastern side of site.

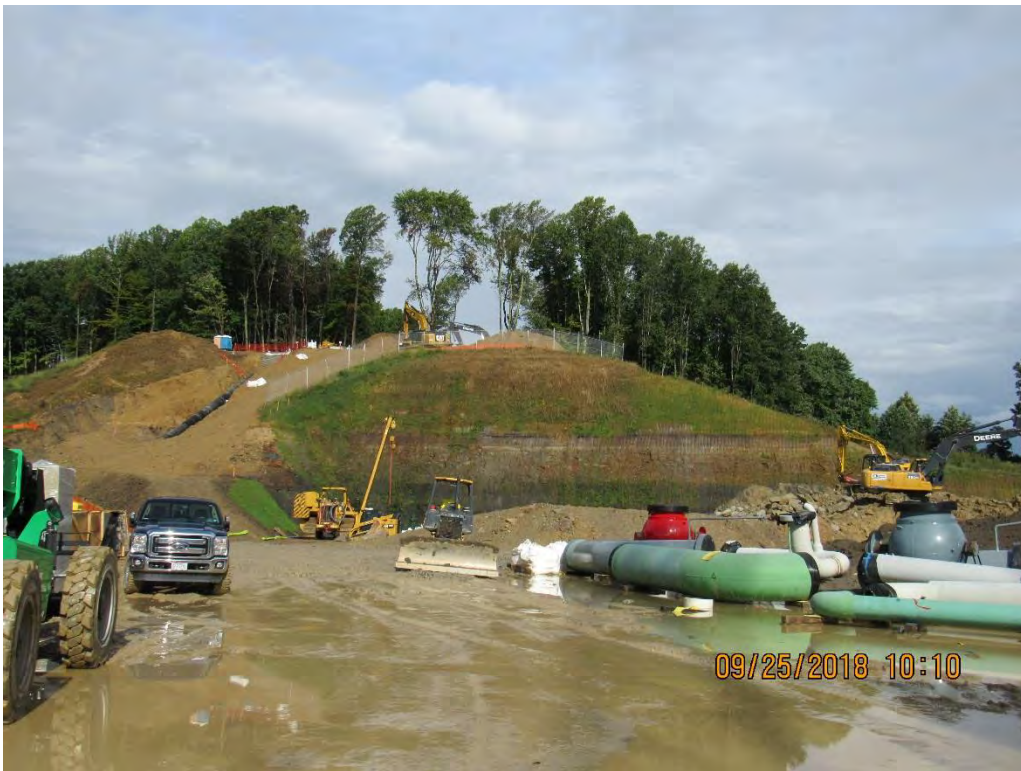
Photo 6: Vegetated slope on north western side of site abating NOV# W18-52-007-CP.

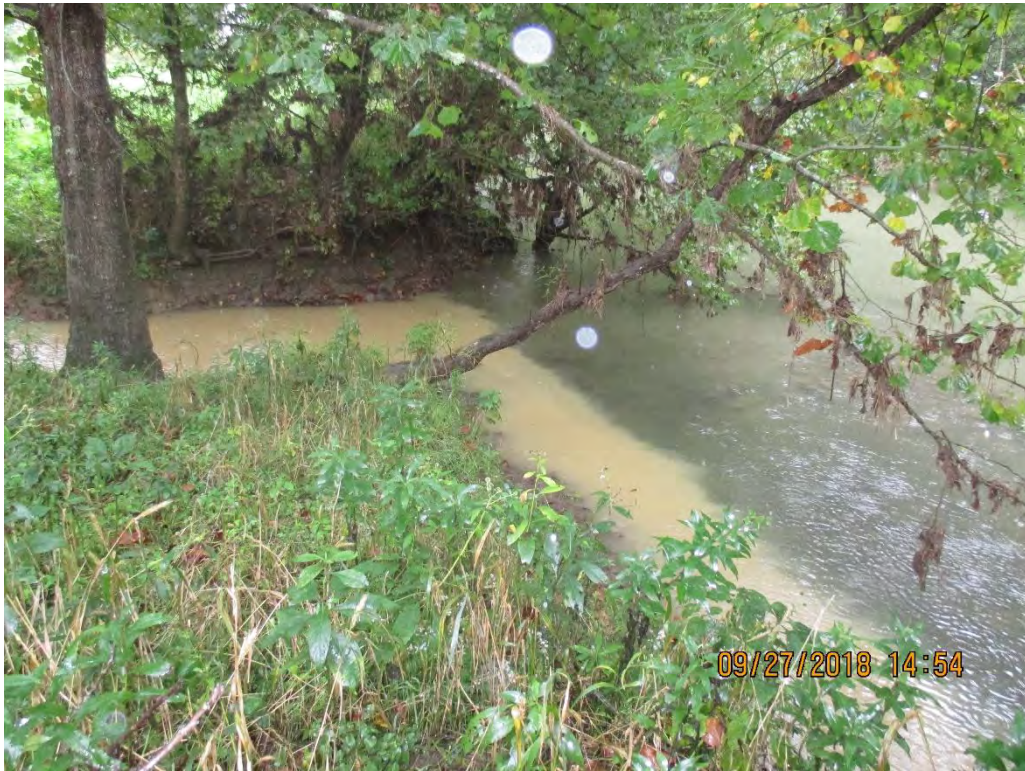
Sediment Laden Water observed entering Indian Creek on 9/27/18 via Stream (S-A60).

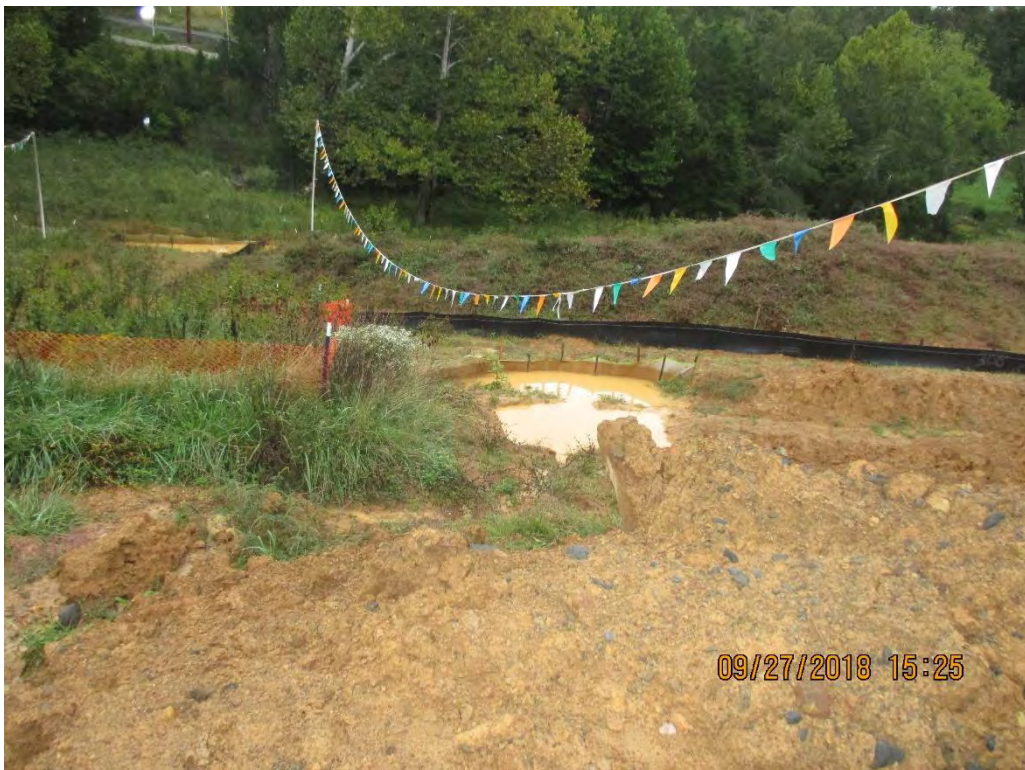
Overview of slope leading towards Stream (S-A60) near station number 9639+00.

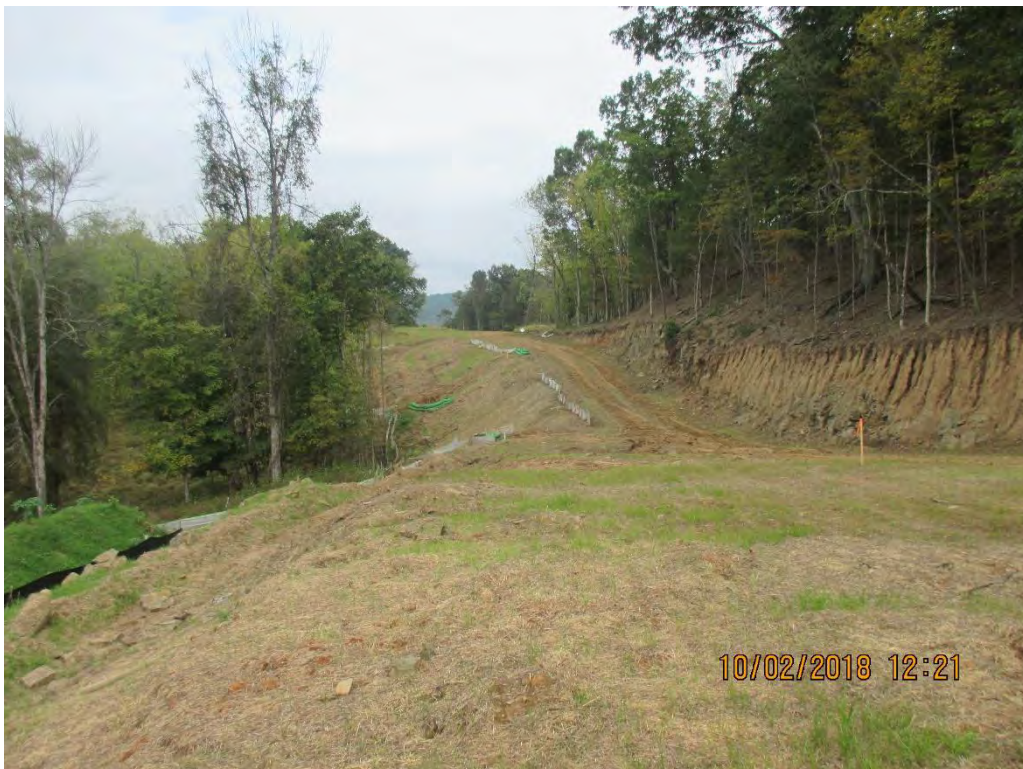
ROW near station #9687 where multiple BMP's are failing.

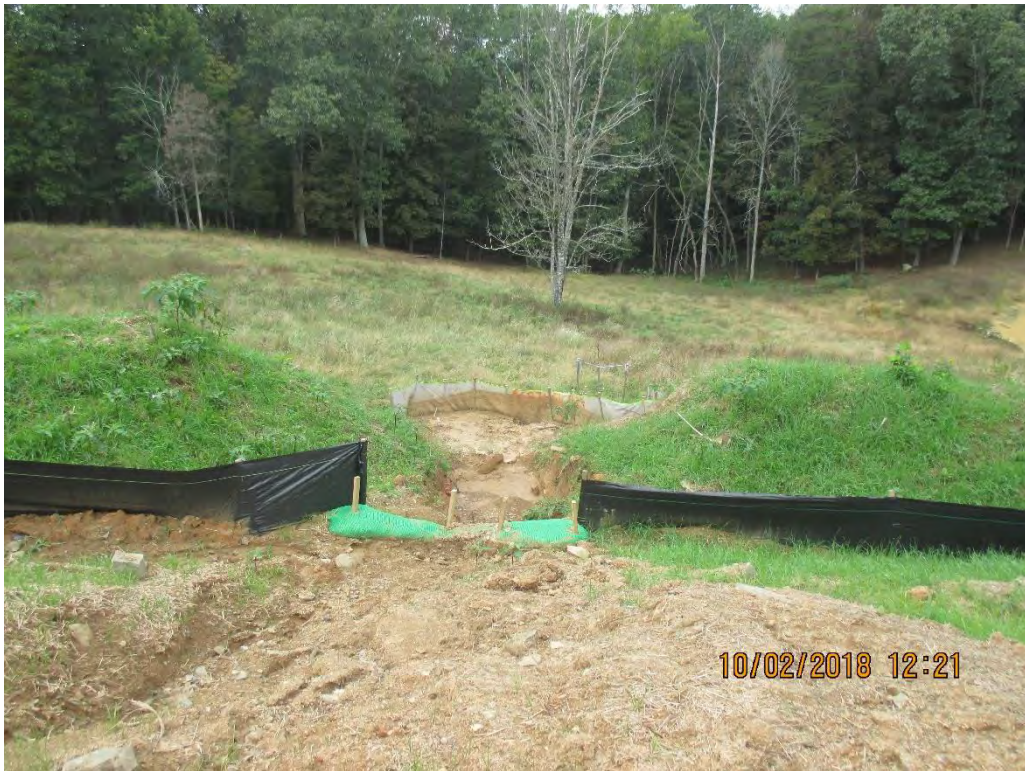
ROW near station #9687 where BMP is failing.

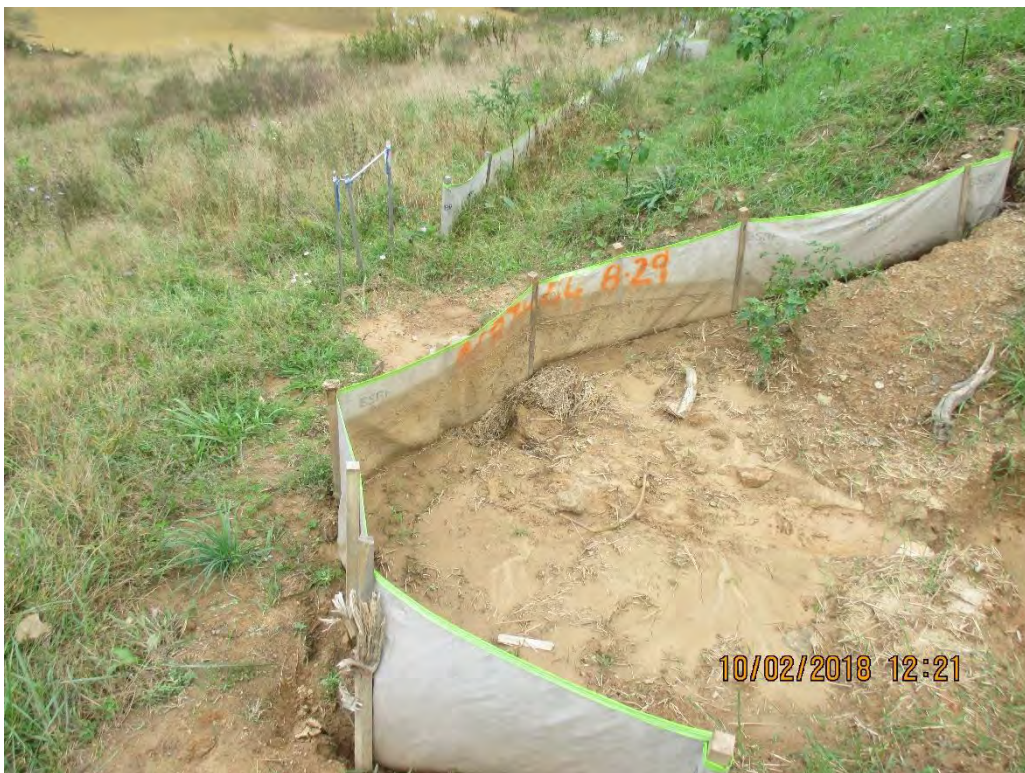
Off site sediment deposits past BMP near station number 9687.

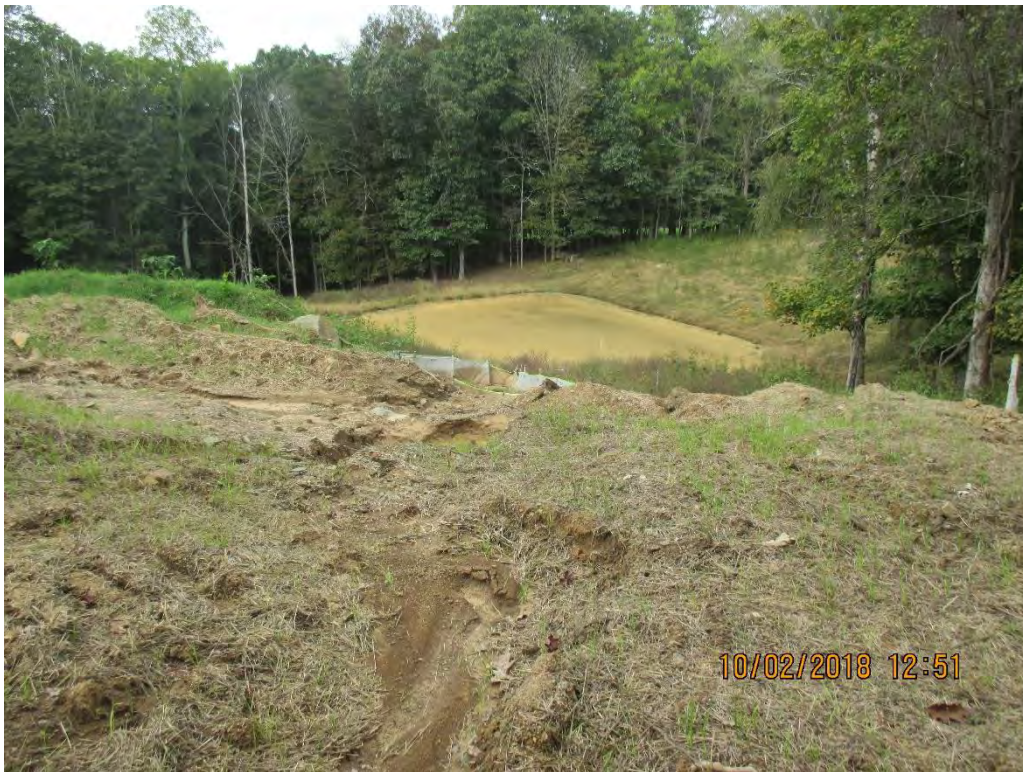
Gully erosion occurring near Station #9687 and flowing towards Pond (P-D2). BMP pictured was failing and off-site sediment deposits were present past the LOD.

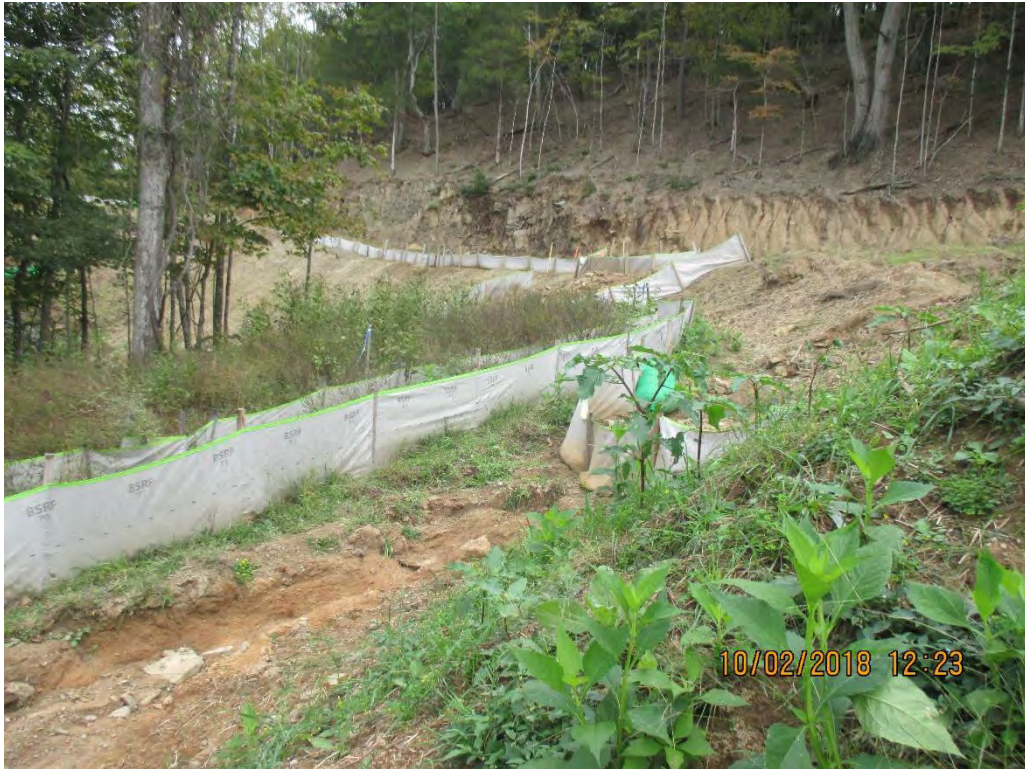
Lack of fill slope protection and channel stabilization enhancing erosion and causing BMP to be overwhelmed at station 9687.

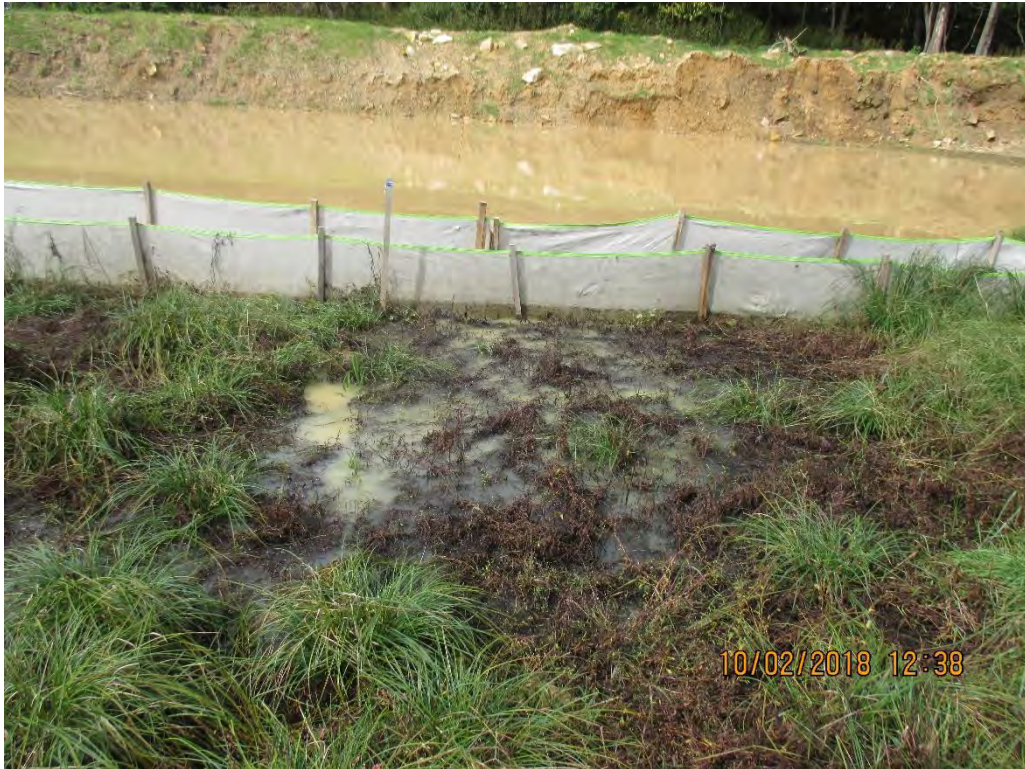
Sediment laden water infiltrating pond P-D2.

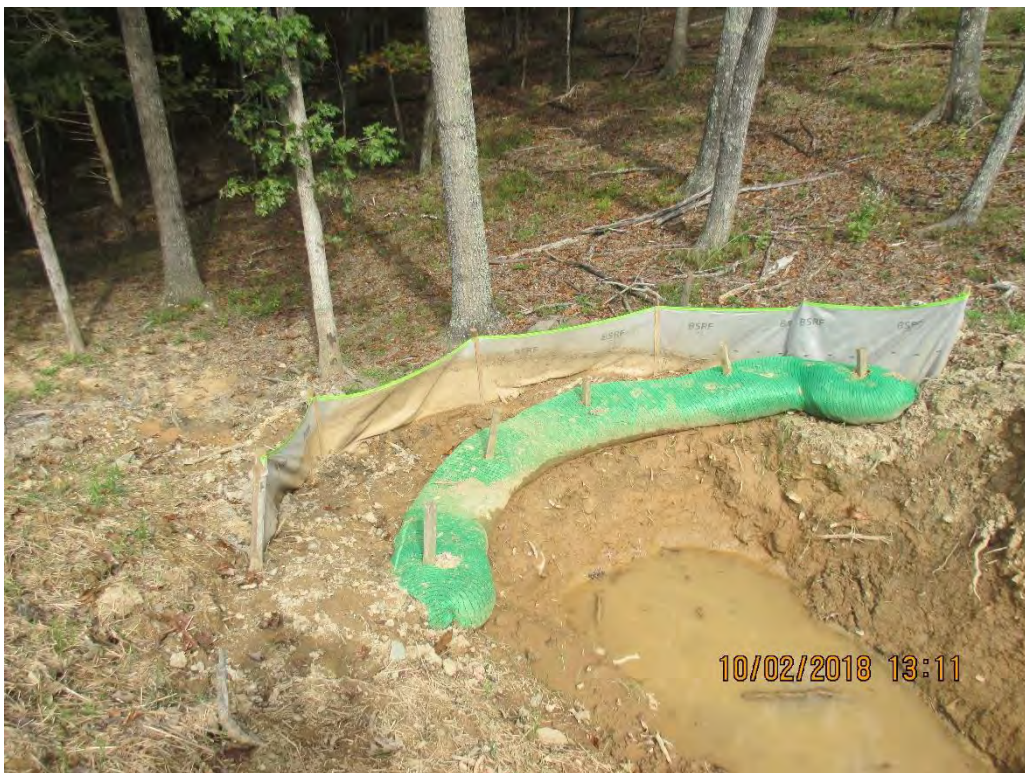
BMP outlet being overwhelmed near station number 9717+52.

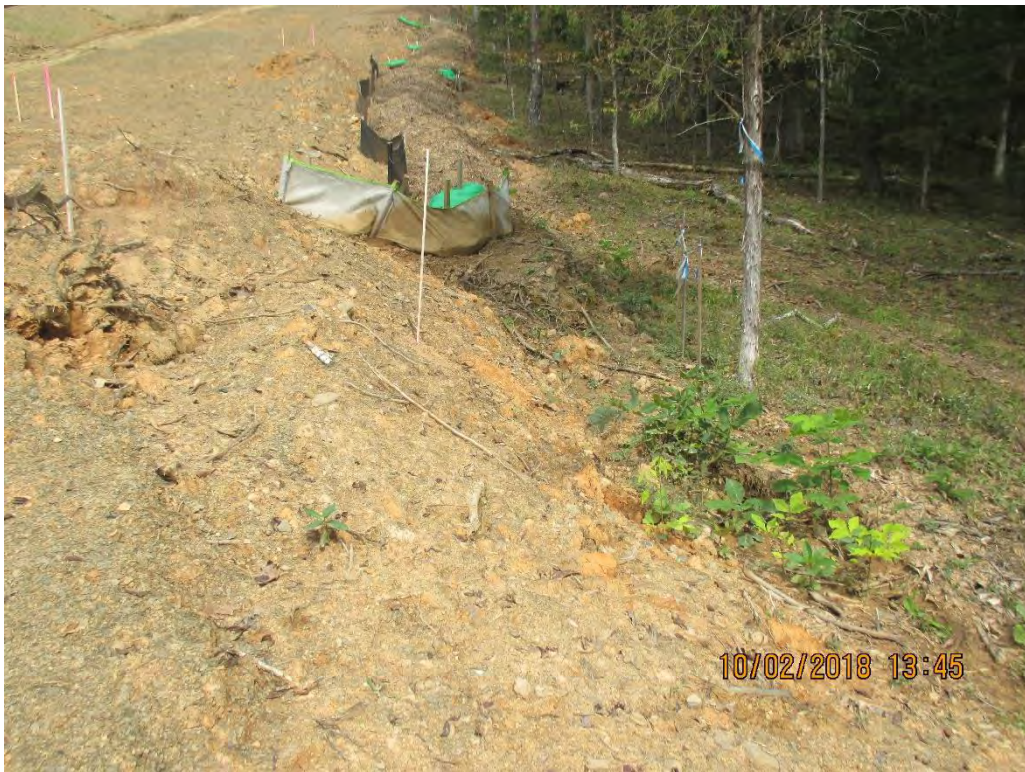
Waterbar outlet at station #9724+51 failing and off-site sediment deposits observed.

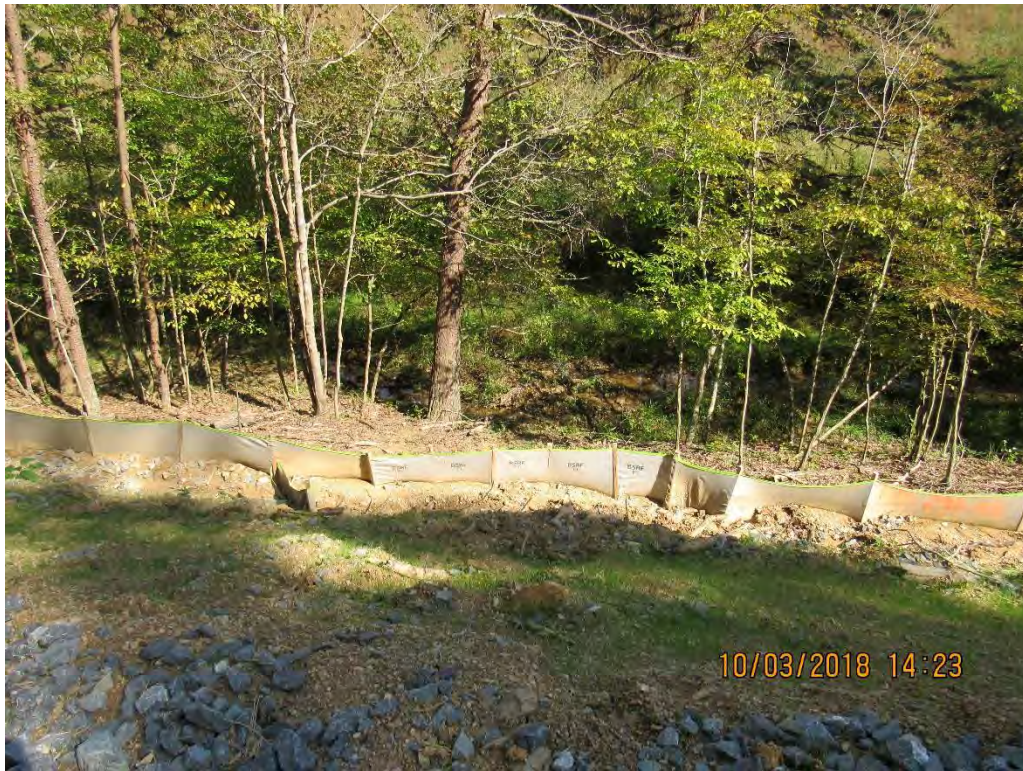
Photo 11: Repairs made to location of failure at Access Road 231.01 abating NOV# W18-52-009.

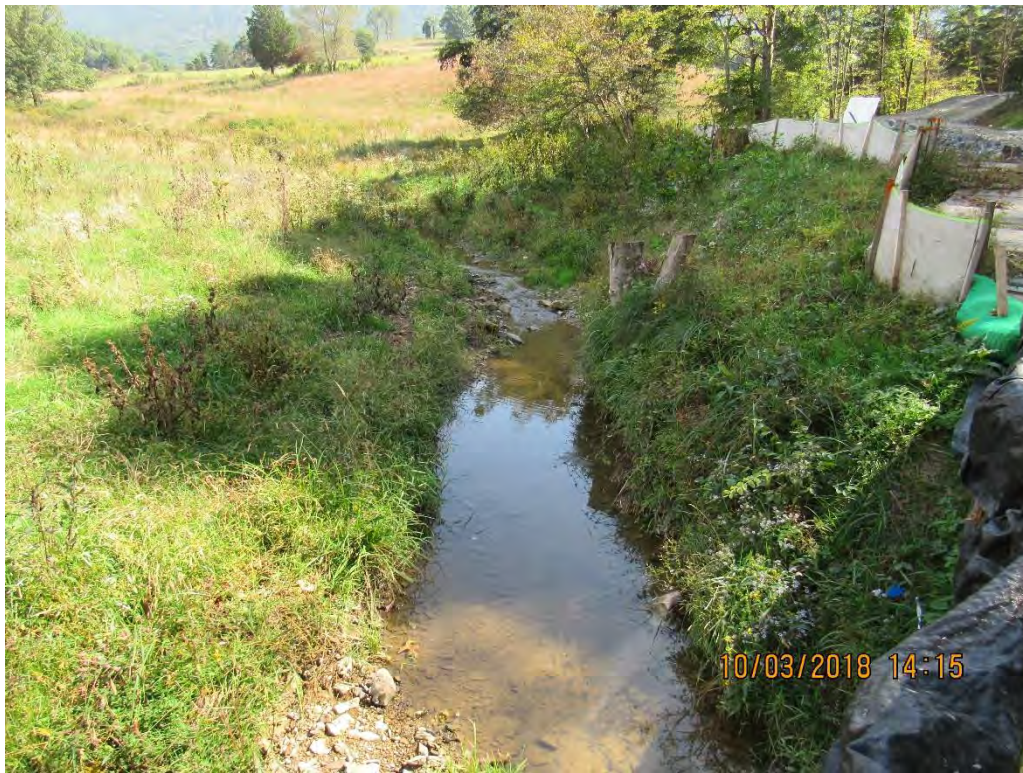
Photo 12: UNT of Painter's Run clear after repairs made. Abates NOV# W18-52-009.

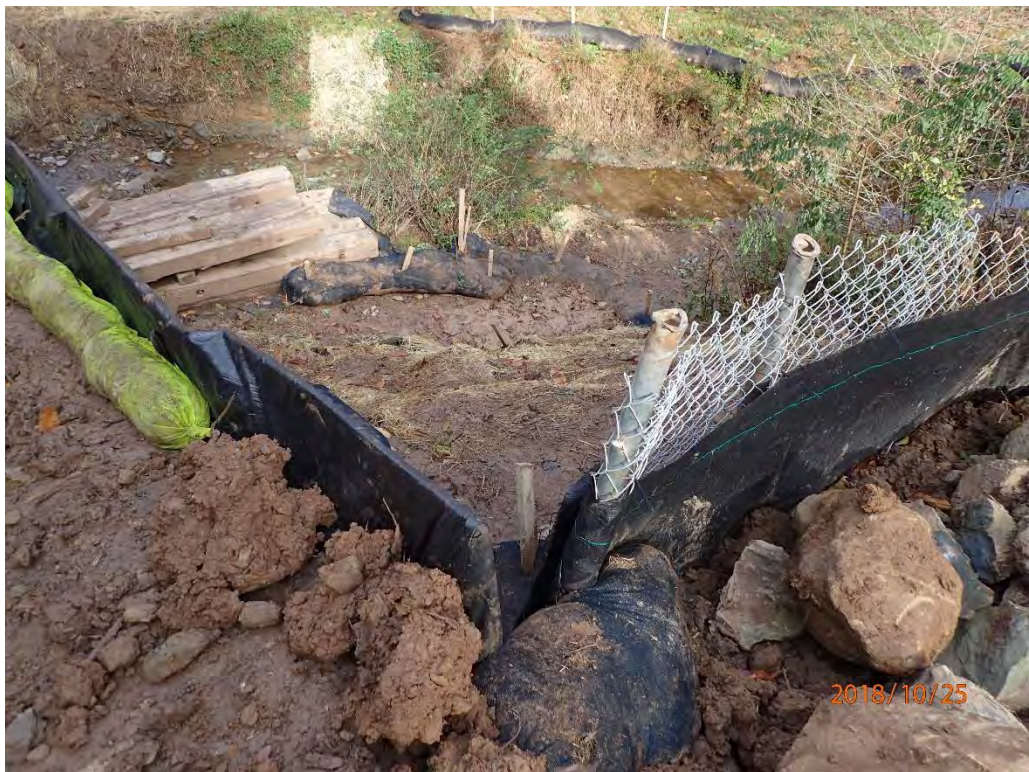
UNT of Mobley Run - There was sediment build up near the silt sock close to the stream. Contractors replaced the silt sock during the inspection.

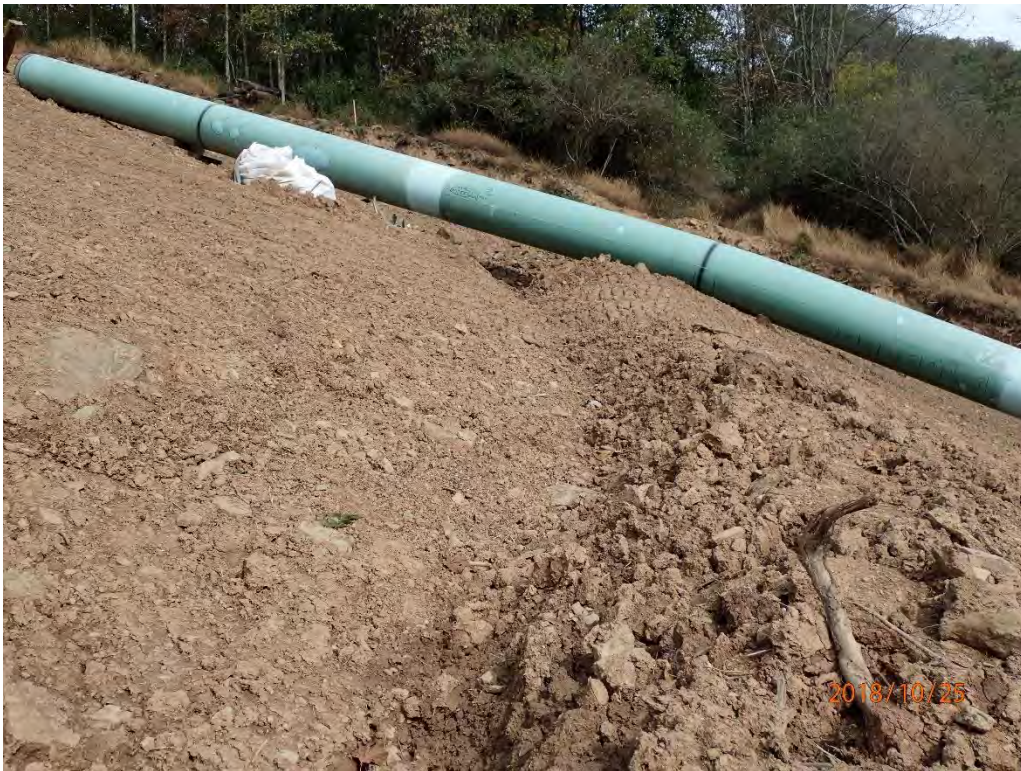
Damaged waterbar directly N of Sams Run.

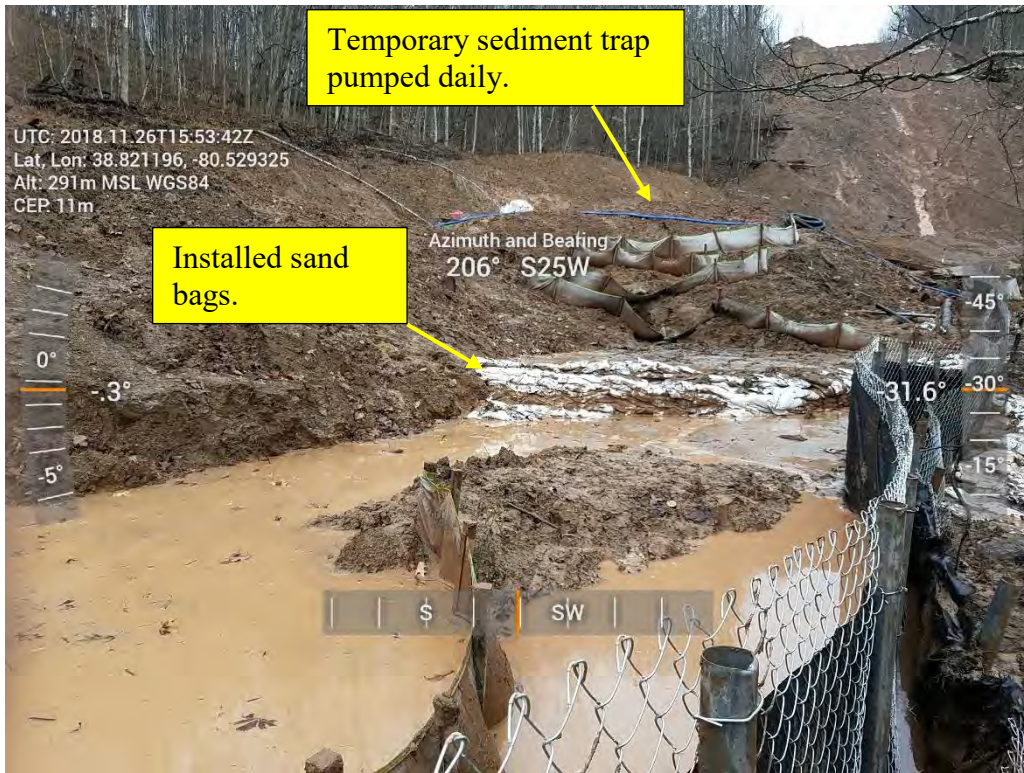
Photo 4: Temporary repairs installed prior to permanent repairs at reported slip. Photo supplied by EI Andy Pauley.

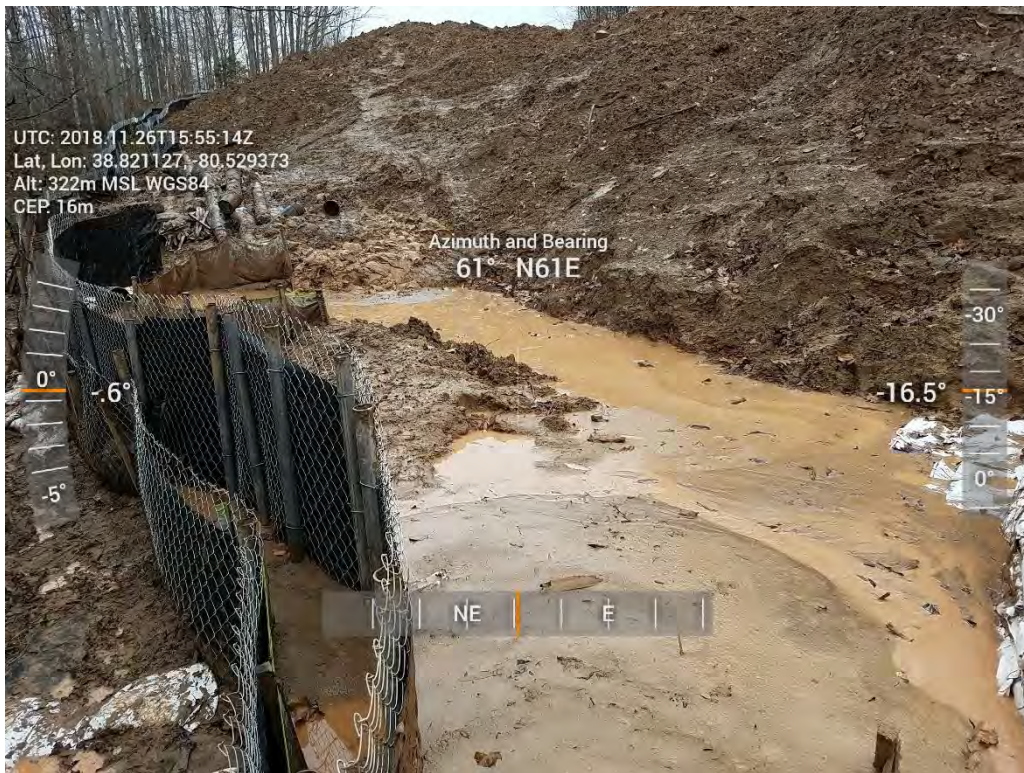
Photo 5: Temporary repairs installed prior to permanent repairs at reported slip. Photo supplied by EI Andy Pauley.

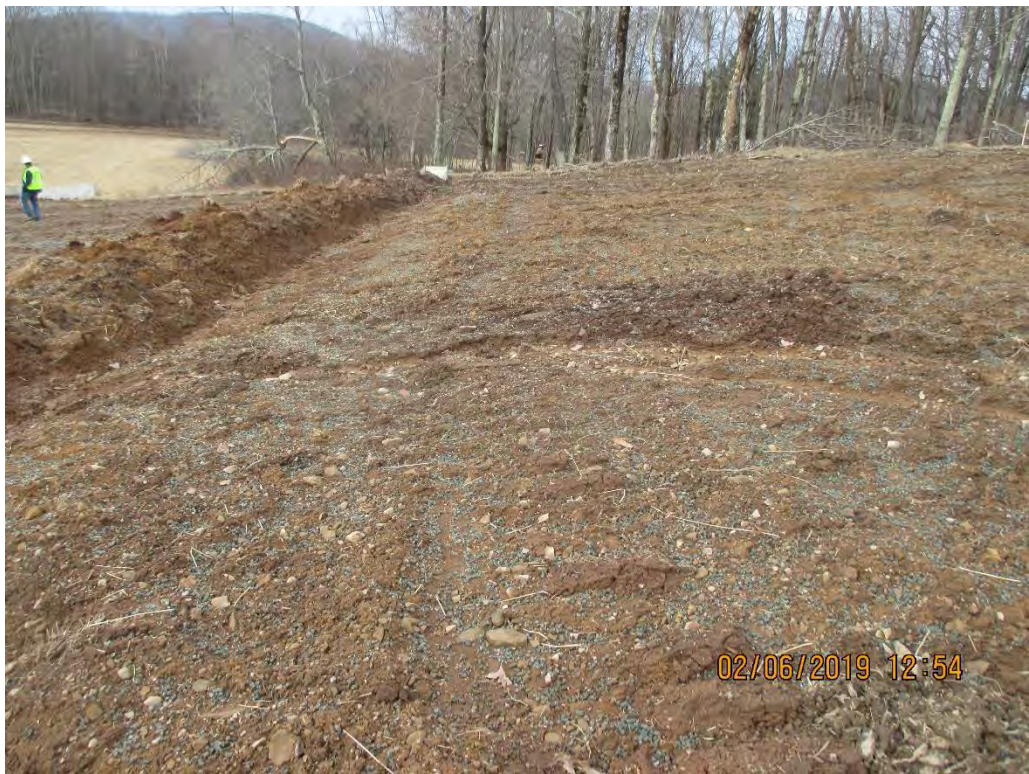
Facing West towards water bar terminus at station #8780+00. Rill erosion occurring between waterbars.

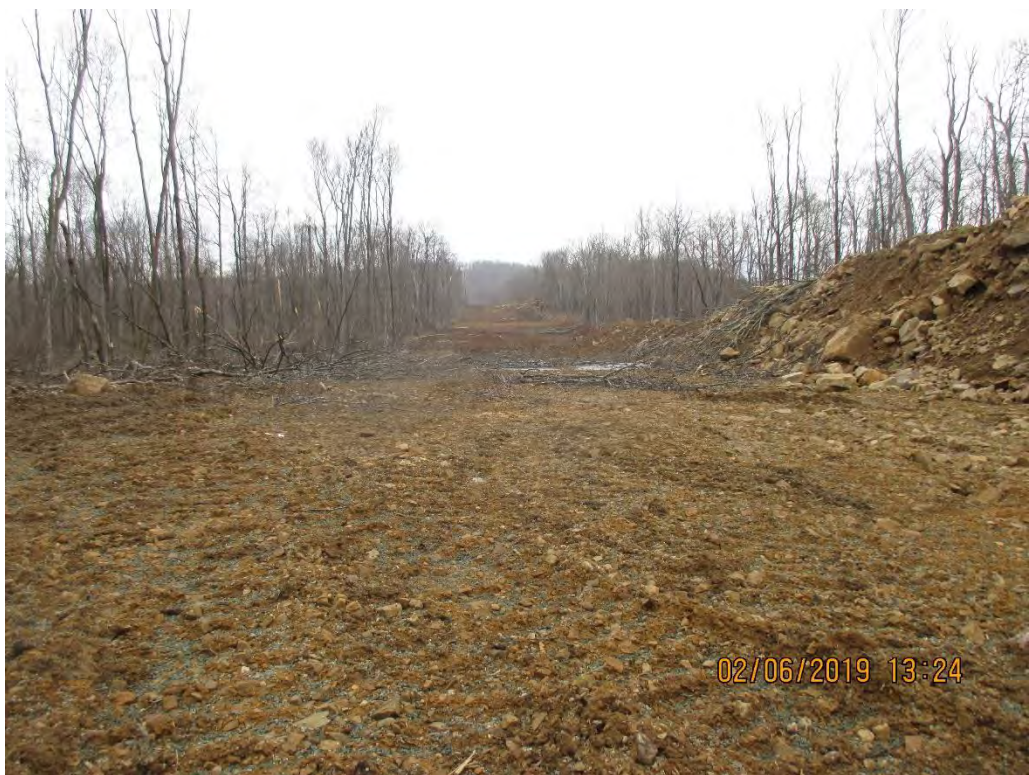
Facing North on MVP ROW back at storm damage near station number 8801+00.

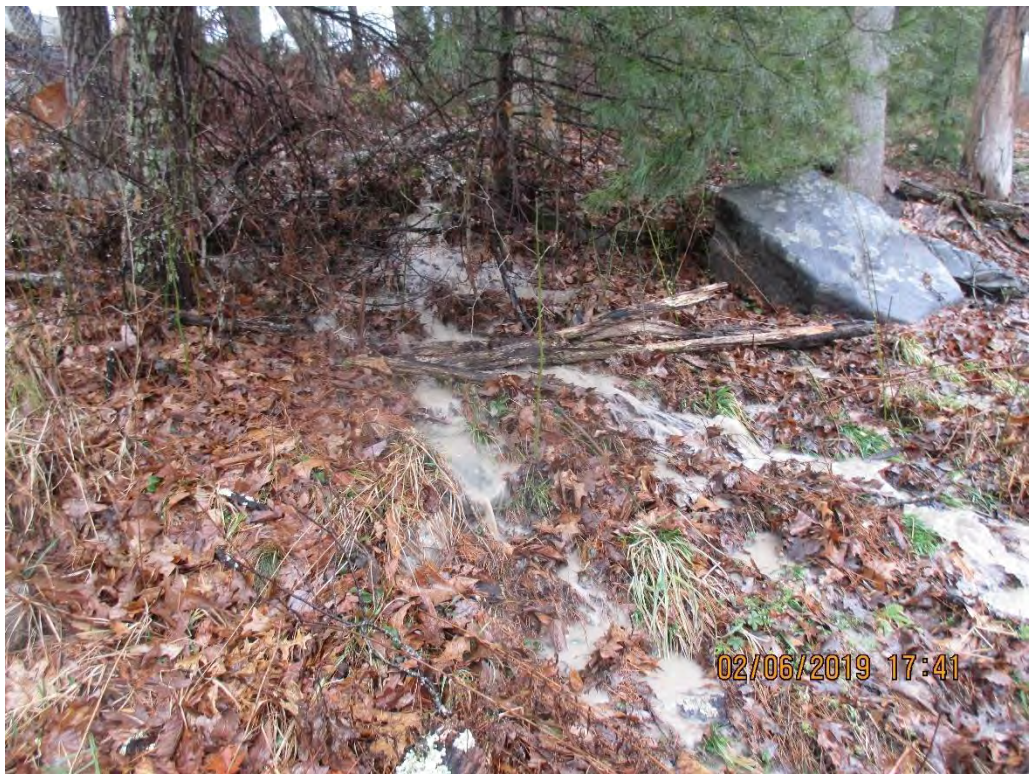
SLW flowing downslope towards UNT of Brammer Branch facing towards failing controls

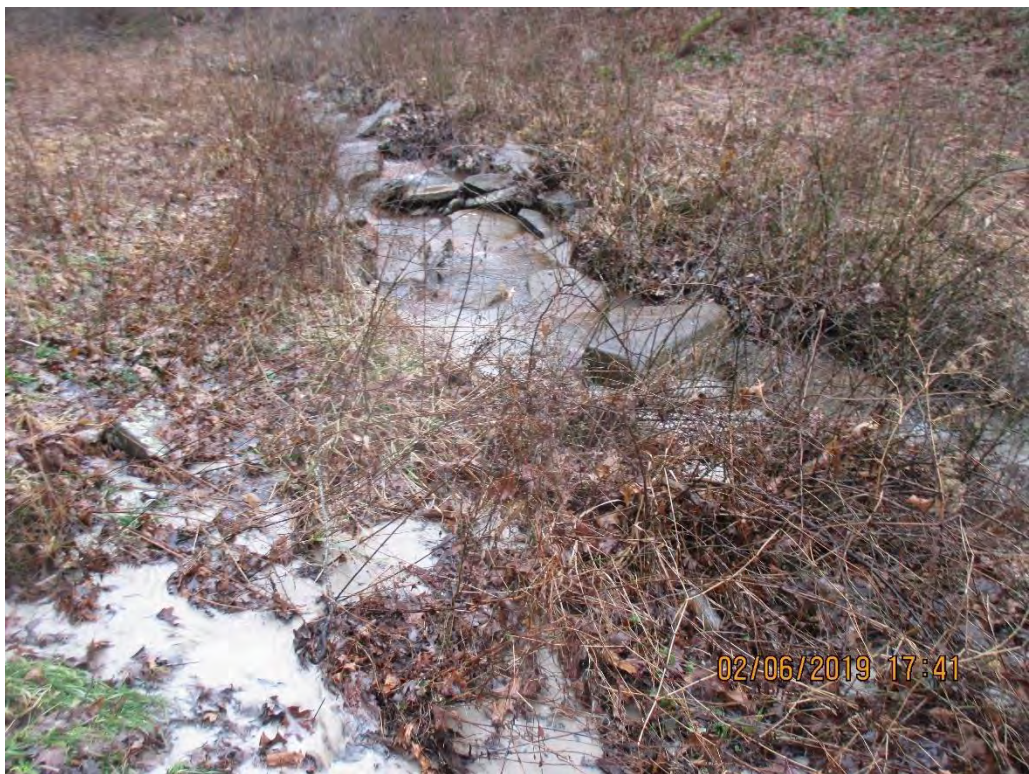
SLW flowing towards and entering UNT of Brammer Branch.

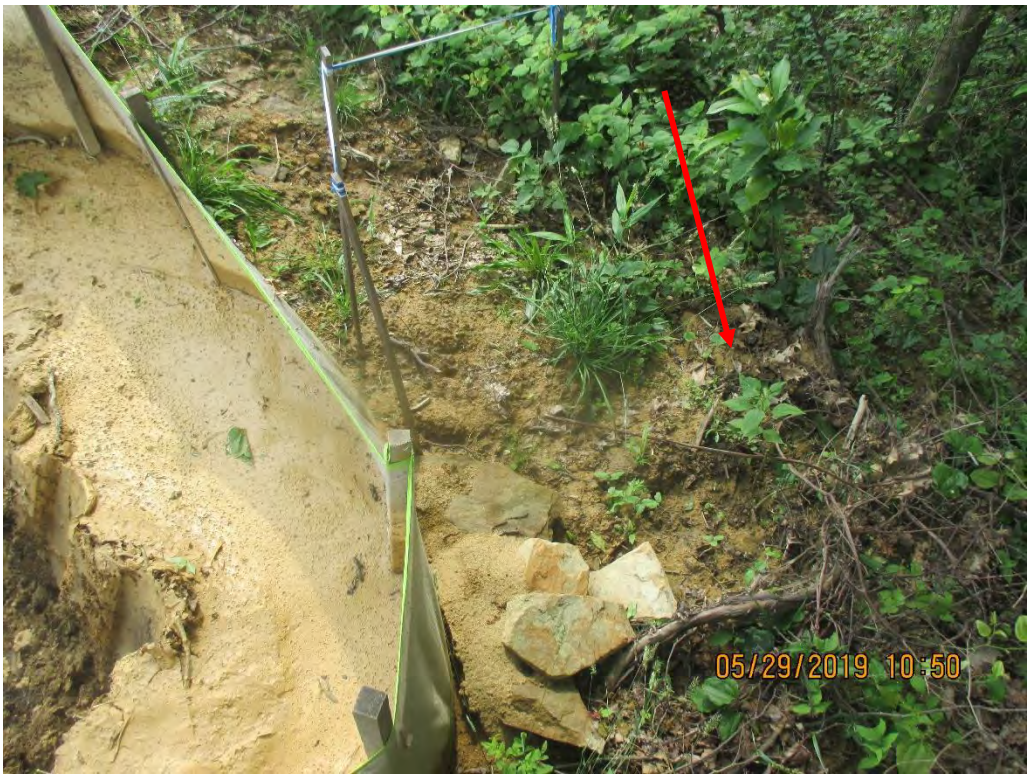
Waterbar outlet above fill slope at station no. 4031+00 facing downslope. Sediment deposits observed past LOD.
