**The Wilderness Society et al. Comments on the
U.S. Forest Service Mountain Valley Pipeline and
Equitrans Expansion Project Draft Supplemental
Environmental Impact Statement (#50036)**

EXHIBIT 12

**WEST VIRGINIA DEPARTMENT OF ENVIRONMENTAL PROTECTION
WV OIL AND GAS CONSTRUCTION STORMWATER PERMIT**

FACILITY NAME:	Mountain Valley Pipeline Project		REG. #	EXPIRE DATE:
PERMITTEE	MOUNTAIN VALLEY PIPELINE, LLC		WVR310667	5/13/2018 Extended: 12/31/2018
ADDRESS/PHONE:	Attn: MATTHEW HOOVER 625 LIBERTY AVE, ST 1700 PITTSBURG, PA 15222 7248733645			
LOCATION:	Harris Compressor Station		Entry Date/Time:	9/25/2018 1000
COUNTY:	Braxton		Exit Date/Time:	9/25/2018 1100
Site Representative /Phone	Brittany Dewitt (Lead EI)/330-987-1682, Matt Hoover MVP/ 412-258-5627 & Jason Hiles, Spread C Lead EI/740-334-7812		PHOTOS <input checked="" type="checkbox"/>	
CO-PERMITTEE:			ADDRESS:	
SITE OPERATOR:	MEC Construction LLC		ADDRESS:	19 RR Meadowbrook, WV 26404
PERMITTED ACREAGE	4311	WEATHER:	Cloudy	LAST INSPECTION: 8/21/2018
RECEIVING STREAM(S)	Trib of Elk/Kanawha R/ Ohio Rv			NOV: 1
Regular Mail <input type="checkbox"/> Certified Mail <input checked="" type="checkbox"/>	Tracking #			
OVERALL FACILITY R

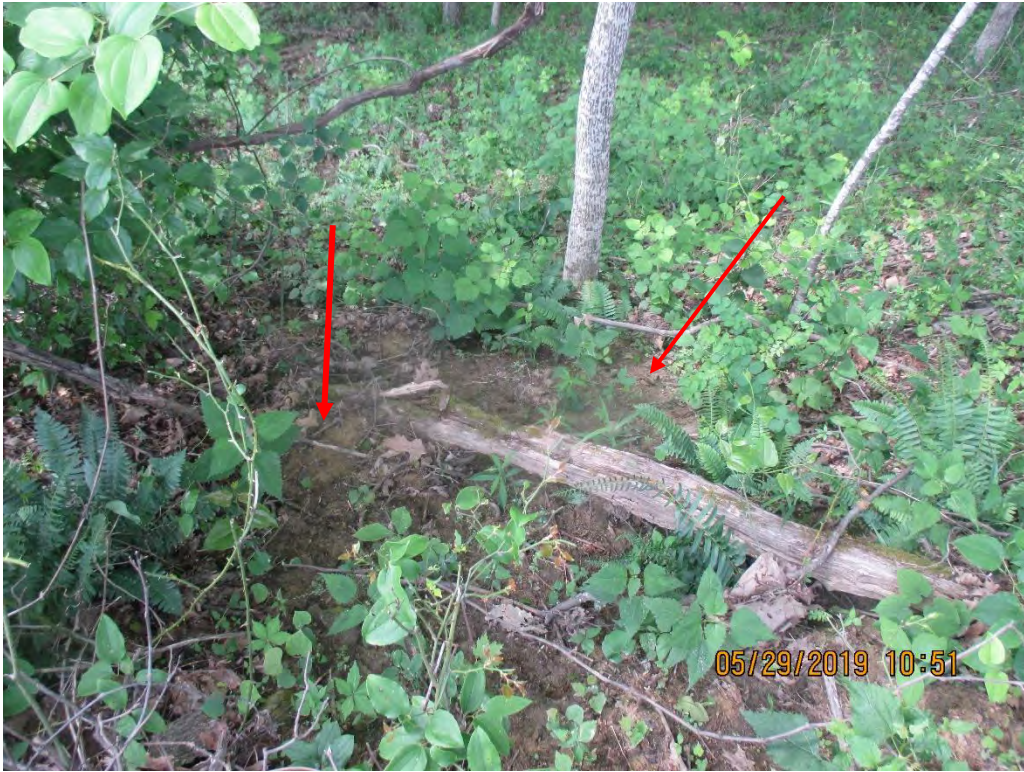
Waterbar outlet above fill slope at station no. 4031+00 facing downslope. Sediment deposits observed past LOD. Scouring from concentrated flow present.

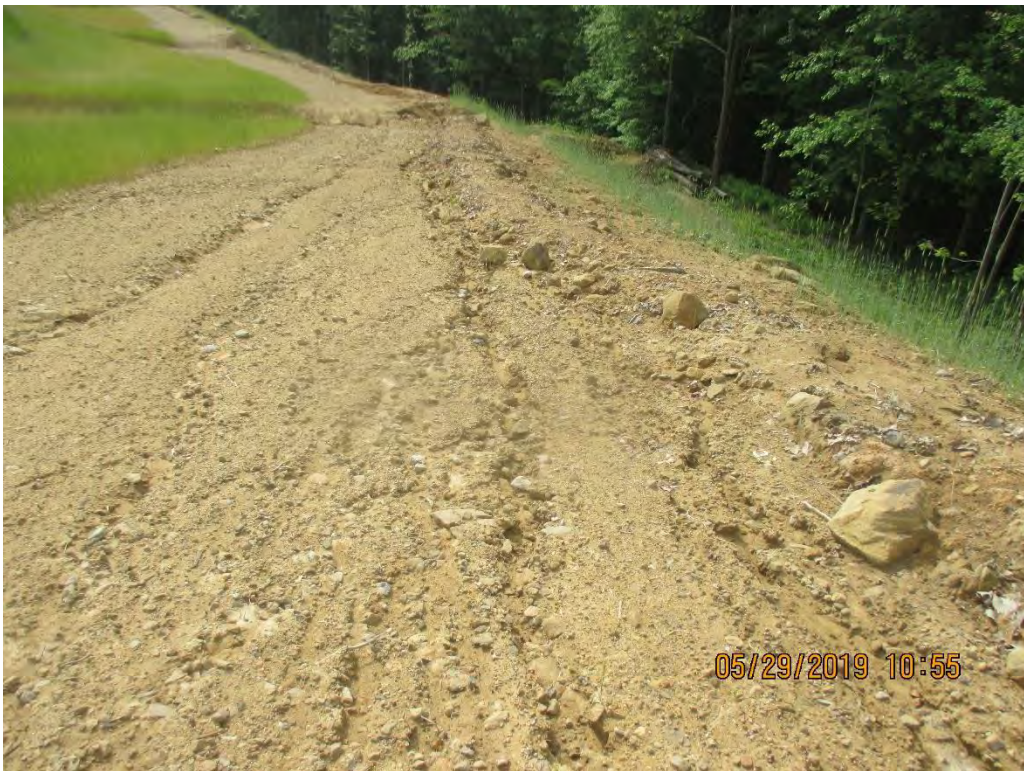
Near station No. 4031+00 facing downslope. Erosion present on ROW where grass hadn't germinated in travel lane.

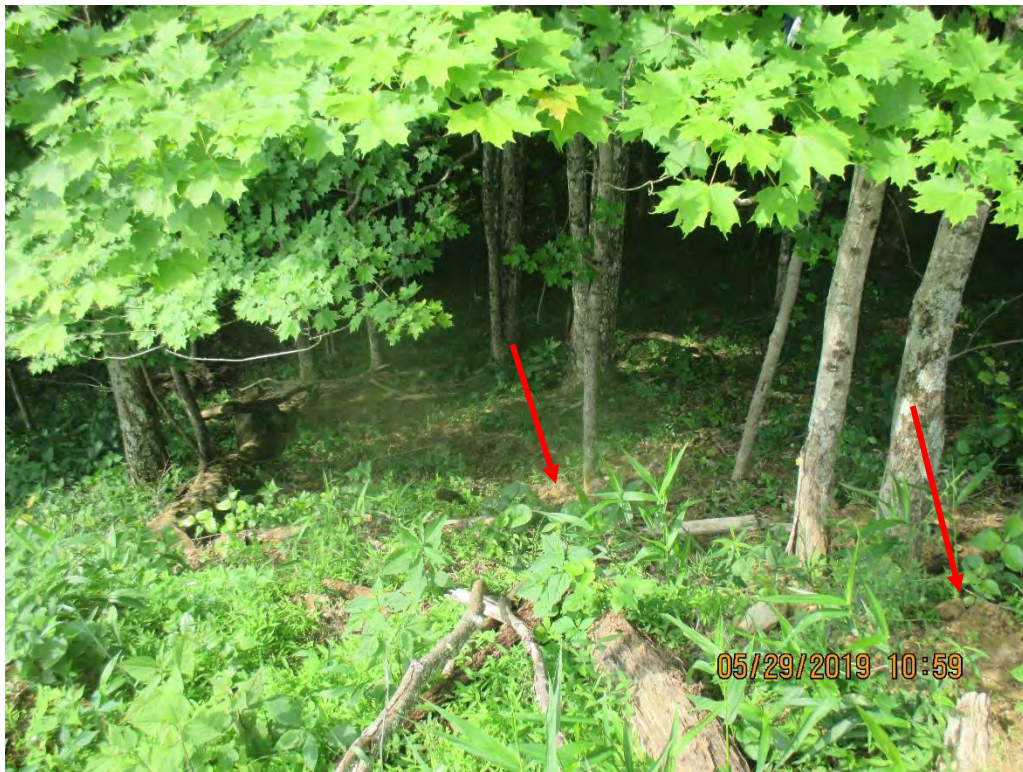
Downslope of Diversion berm outlet No. 1. Sediment deposits observed past LOD. Vegetation was also stained from SLW leaving site.

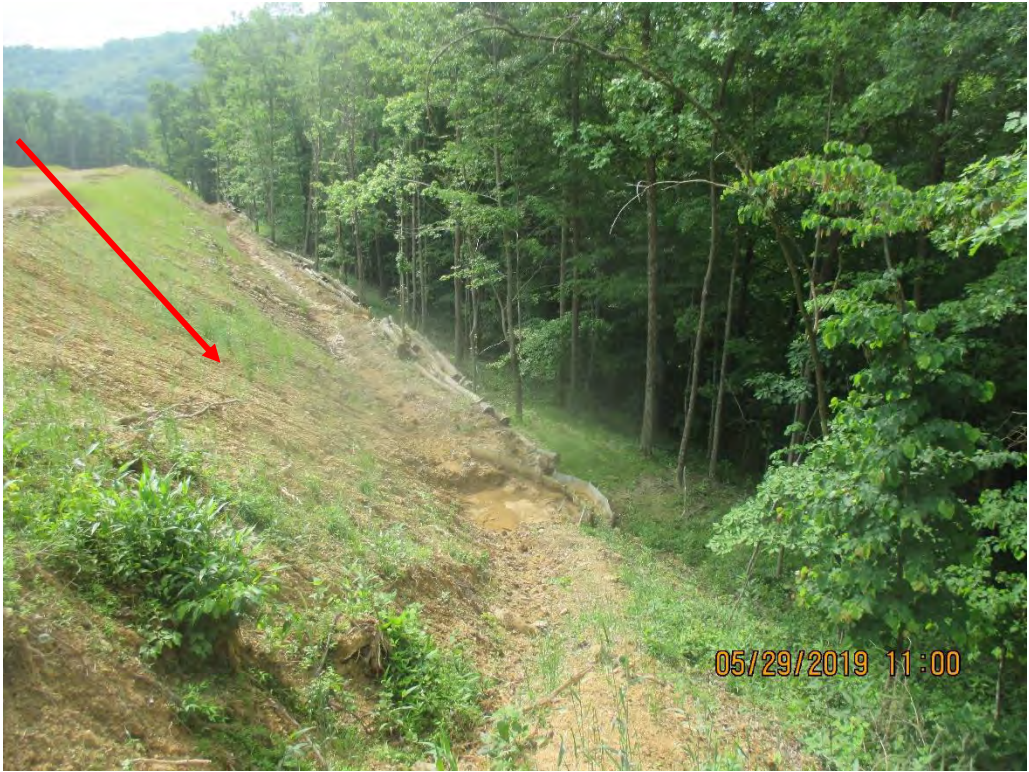
Near station No, 4031+00 facing downslope at diversion berm outlet No. 2. Arrow depicts Erosion present on fill slope.

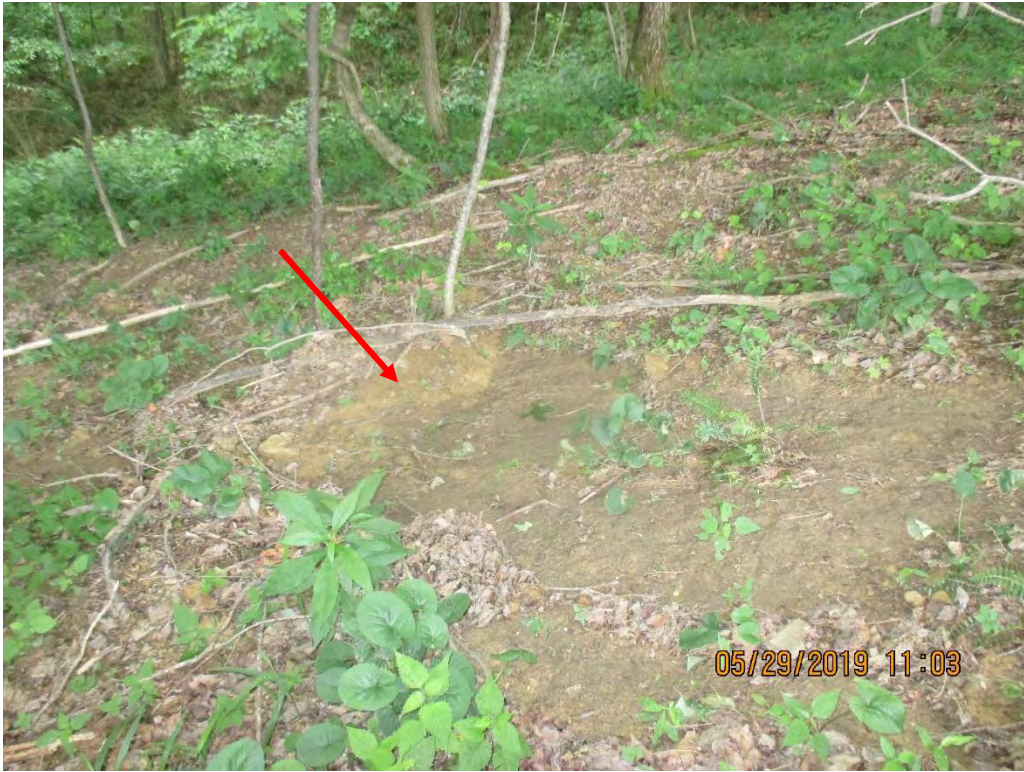
Standing further below diversion berm outlet No. 2 near 4031+00. Scouring of vegetation present below control. Sediment deposits were observed approximately 150-foot downslope of controls.

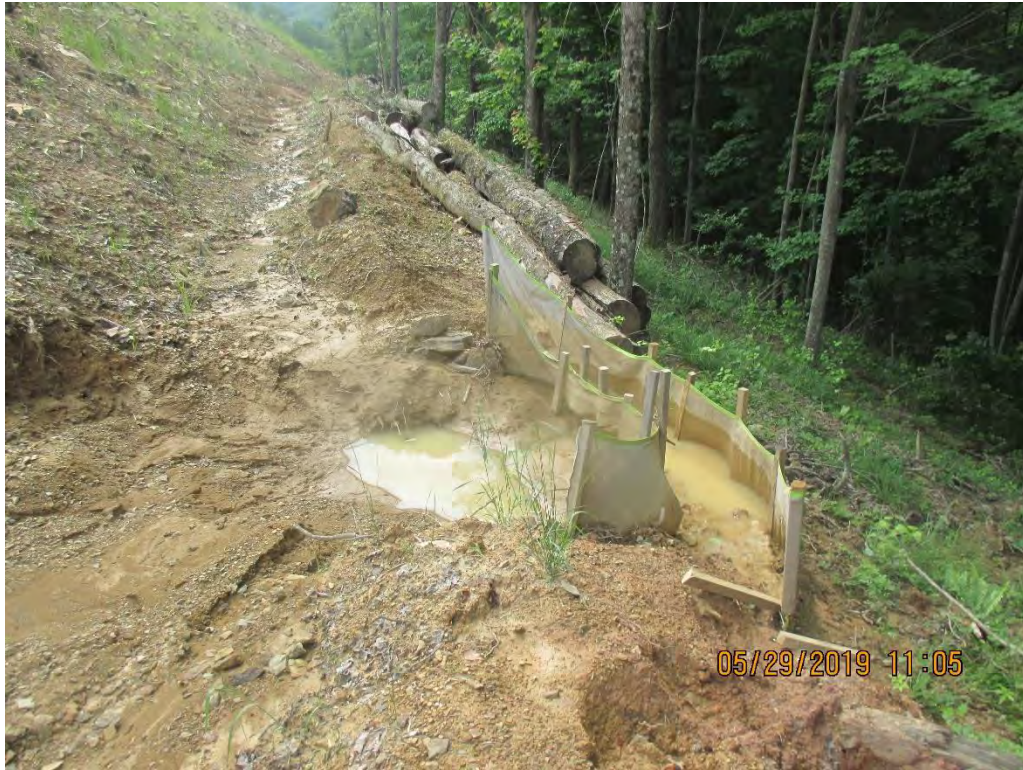
Diversion berm outlet No. 3. Sediment being deposited behind controls.

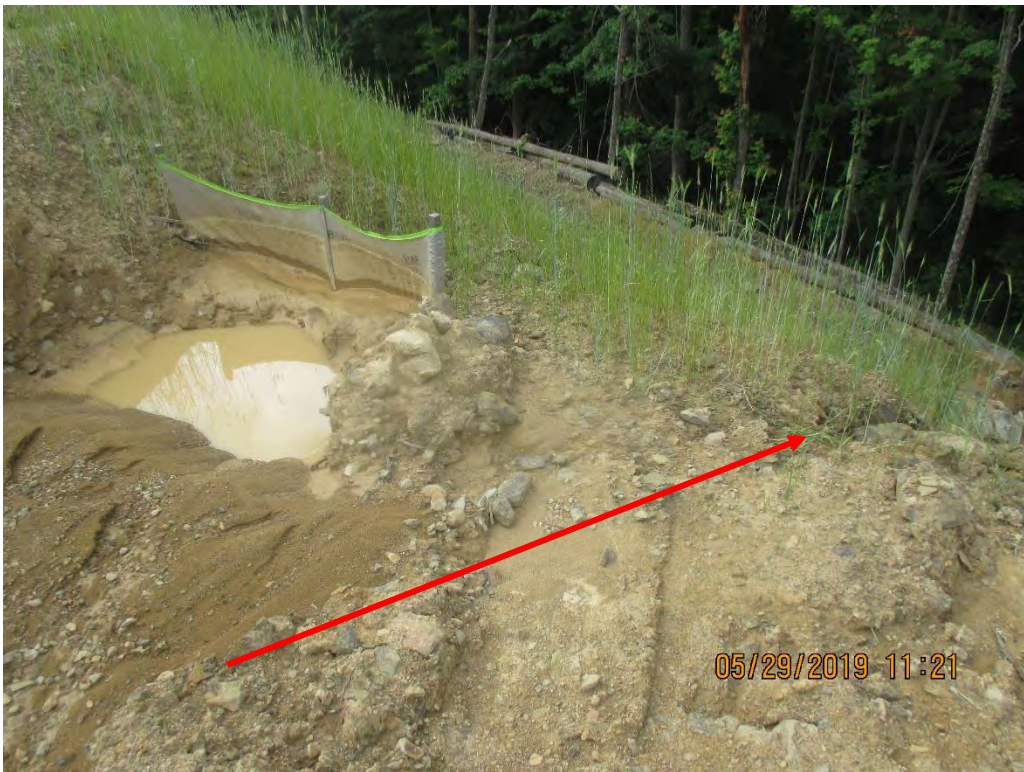
Waterbar outlet above diversion berm outlet No. 3. Sump full of sediment and evidence that concentrated flow on slope was observed due to controls not functioning as designed. Arrow depicts flow.

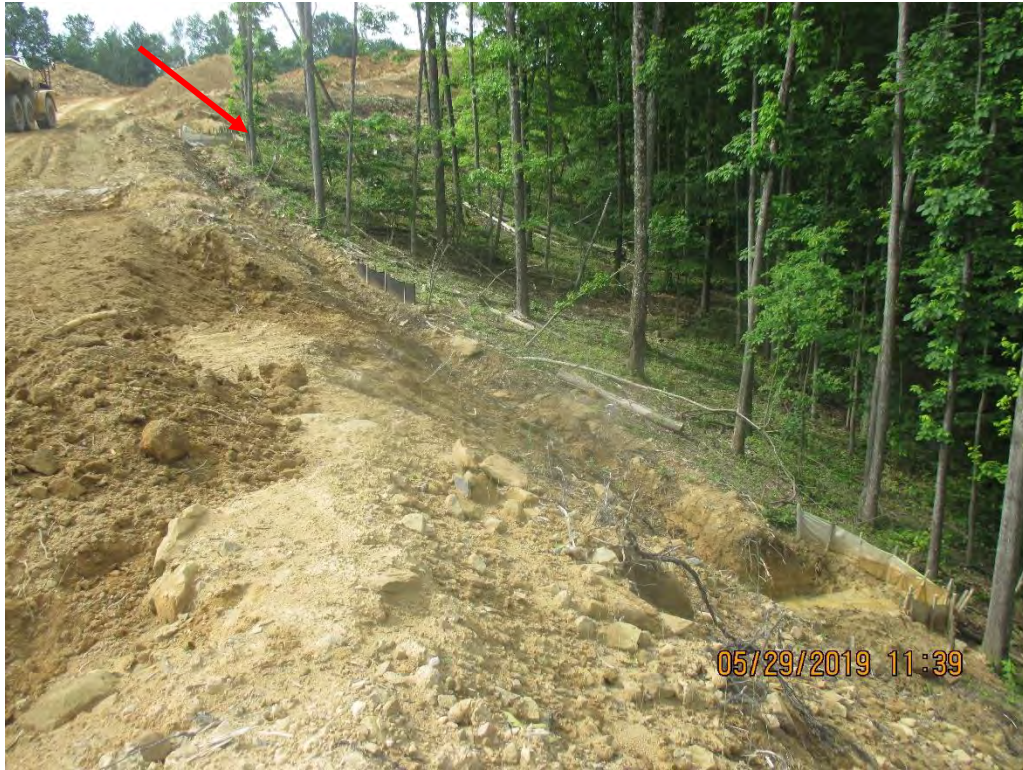
Facing upslope near station No. 4027+00. Arrow depicts Waterbar and where sediment deposits were observed. Diversion berm installed as perimeter control with multiple outlets present.

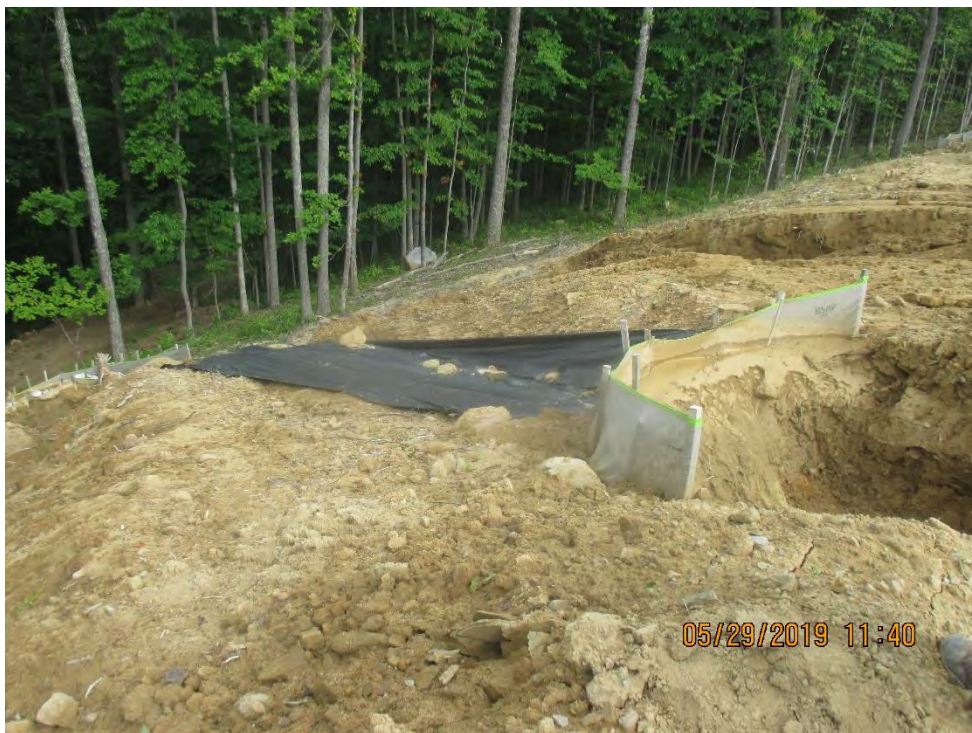
Waterbar outlet downslope of Station No. 4027+00. Waterbar terminating on slope. Fabric installed below control on slope above perimeter outlet.

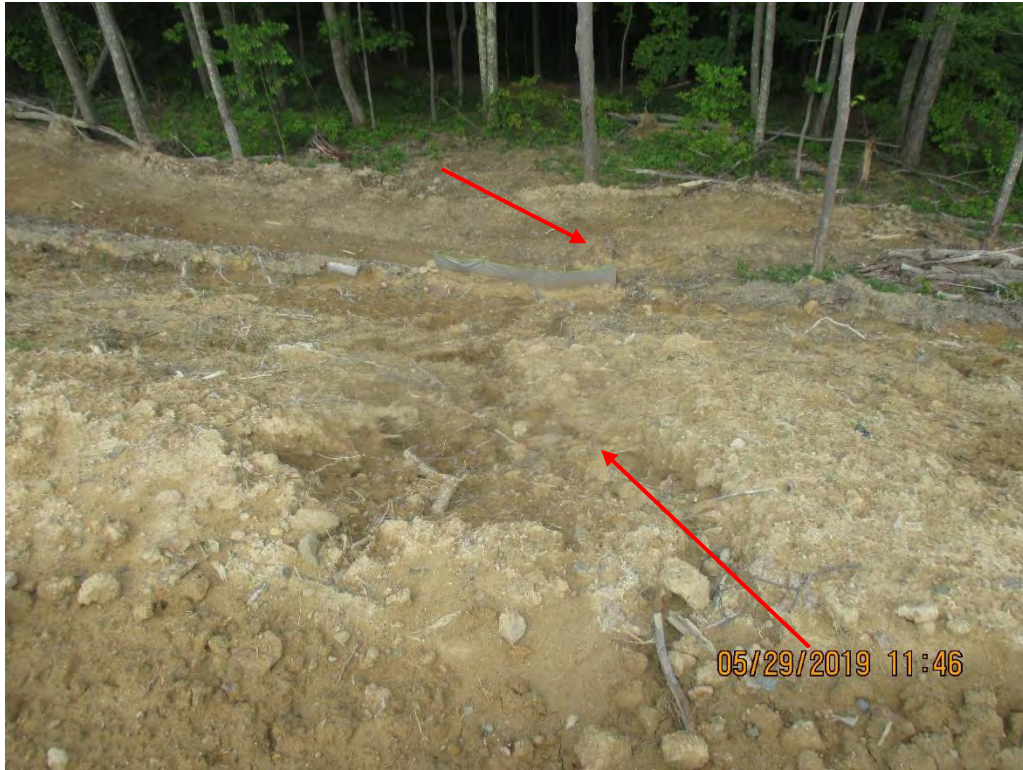
Standing near station 4027+00 facing downslope. Erosion present on fill slope. Perimeter control being overwhelmed with sediment. Evidence that Sediment laden water was observed due to deposits being present past controls. According to representative logging disturbance had taken place.

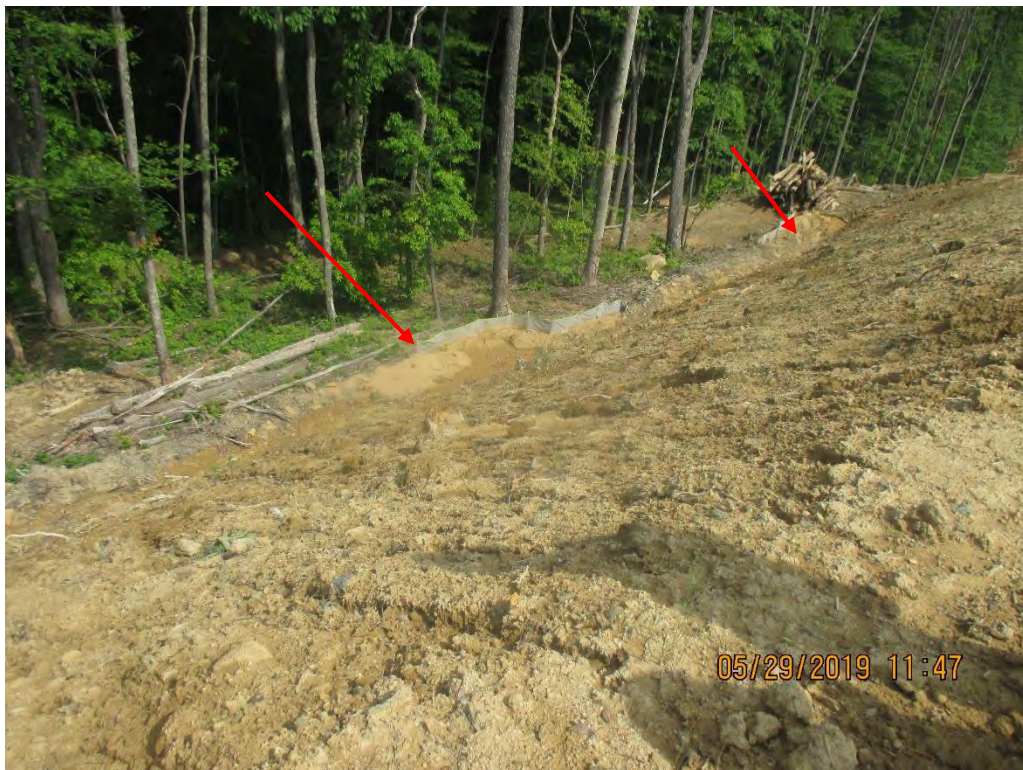
Erosion present on slope near Station No. 4017+00. Perimeter controls overwhelmed with sediment.

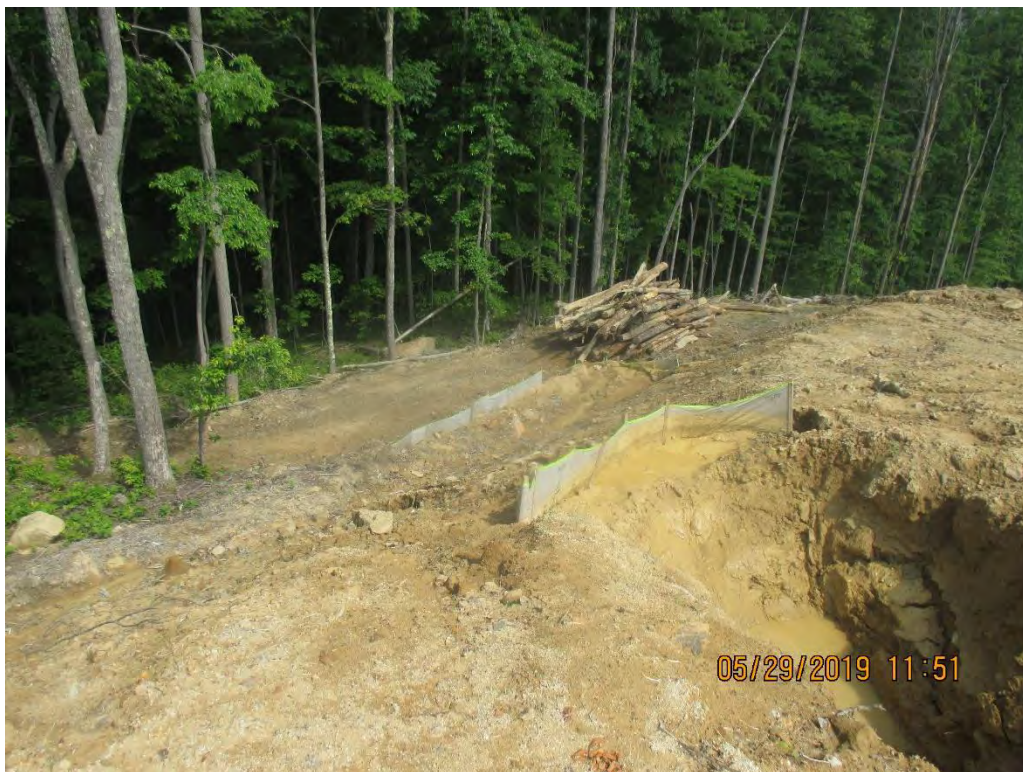
Below Waterbar outlet near station No. 4017+00. Evidence that sediment laden water flowed past LOD was observed.

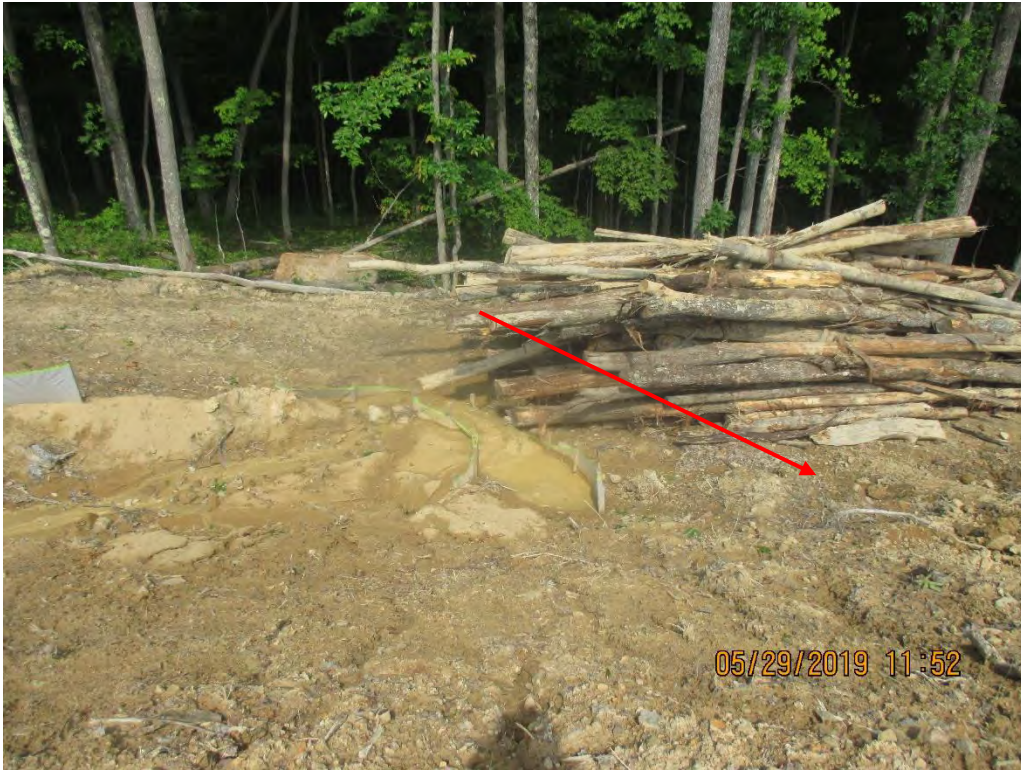
Below Waterbar outlet near station No. 4017+00. Evidence that sediment laden water flowed past LOD was observed. Arrow depicts where run-off was flowing.

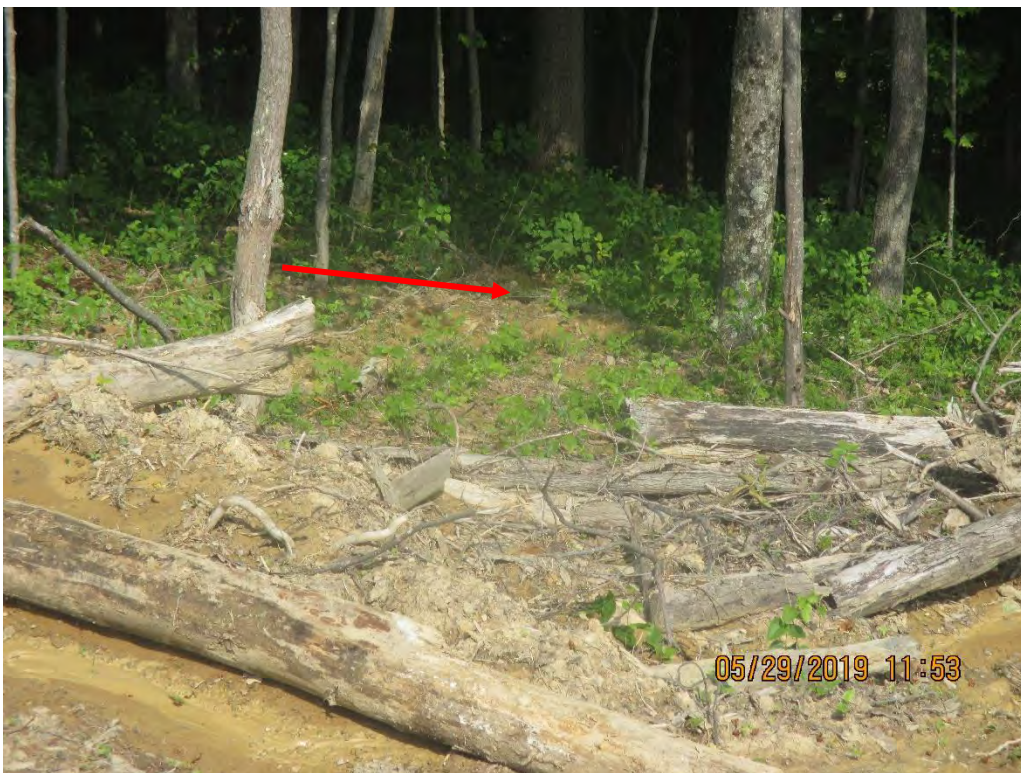
Below perimeter controls near station No. 4017+00. Sediment deposits were present past LOD.

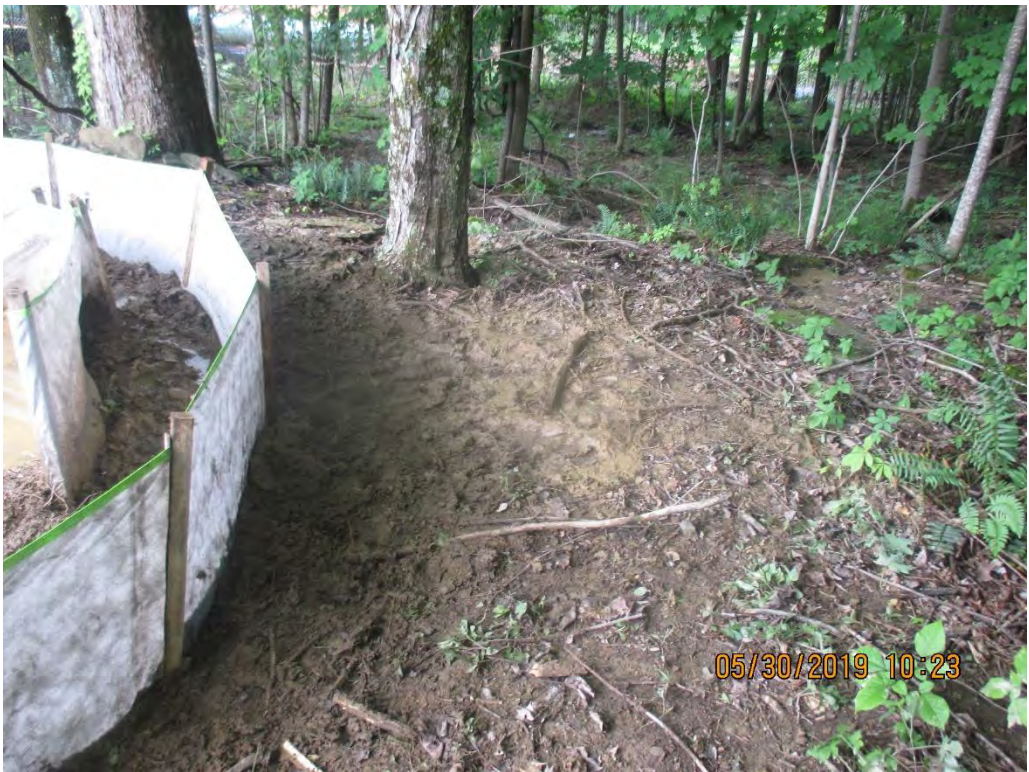
Facing downslope towards Stream S-N10. Scouring of vegetation and sediment deposits were observed below these controls.

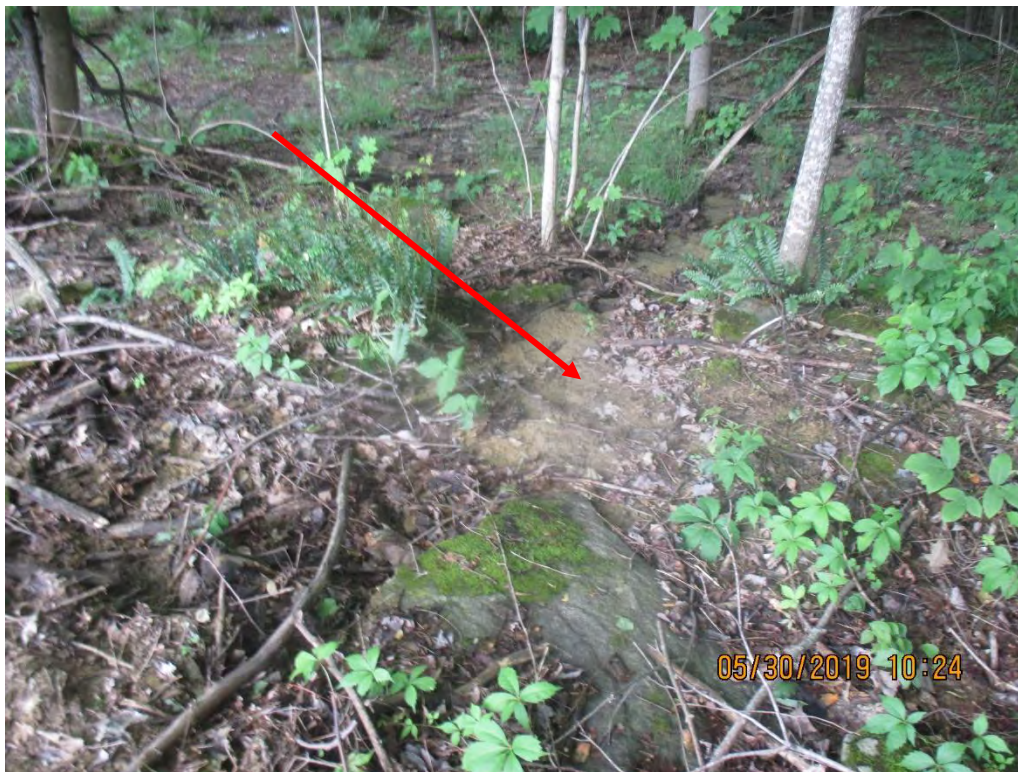
Sediment deposits past LOD and controls at station No. 6474+16. Arrow depicts deposits.

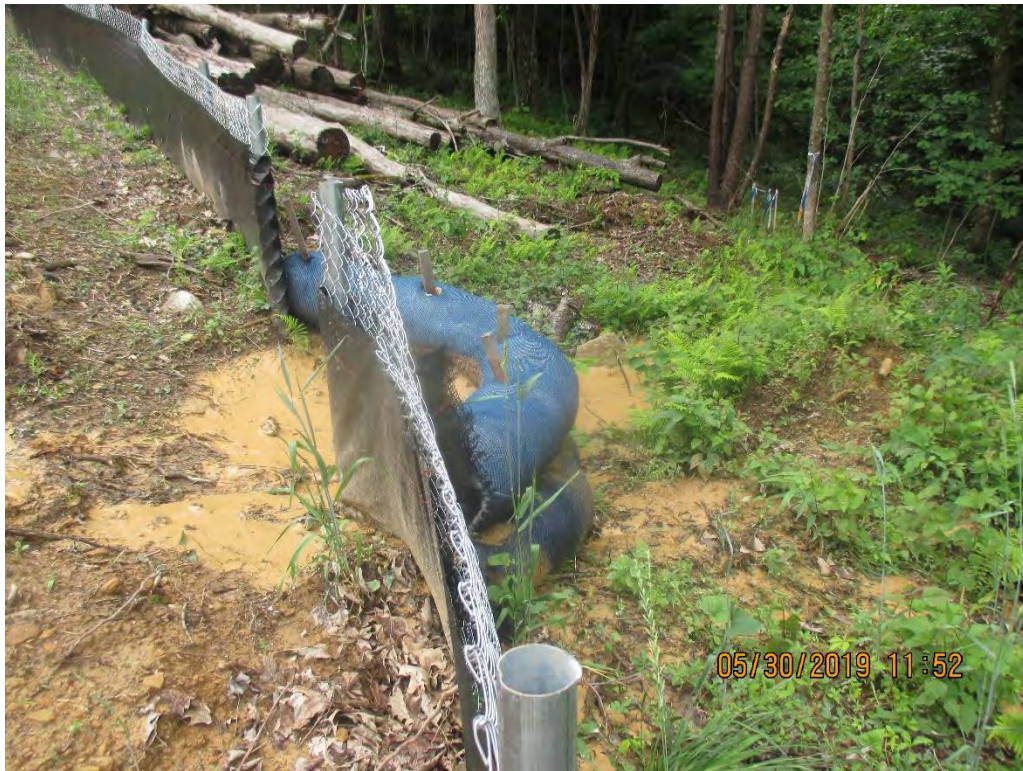
Waterbar outlet near station No. 6508+30. Sediment deposits past controls and LOD observed.

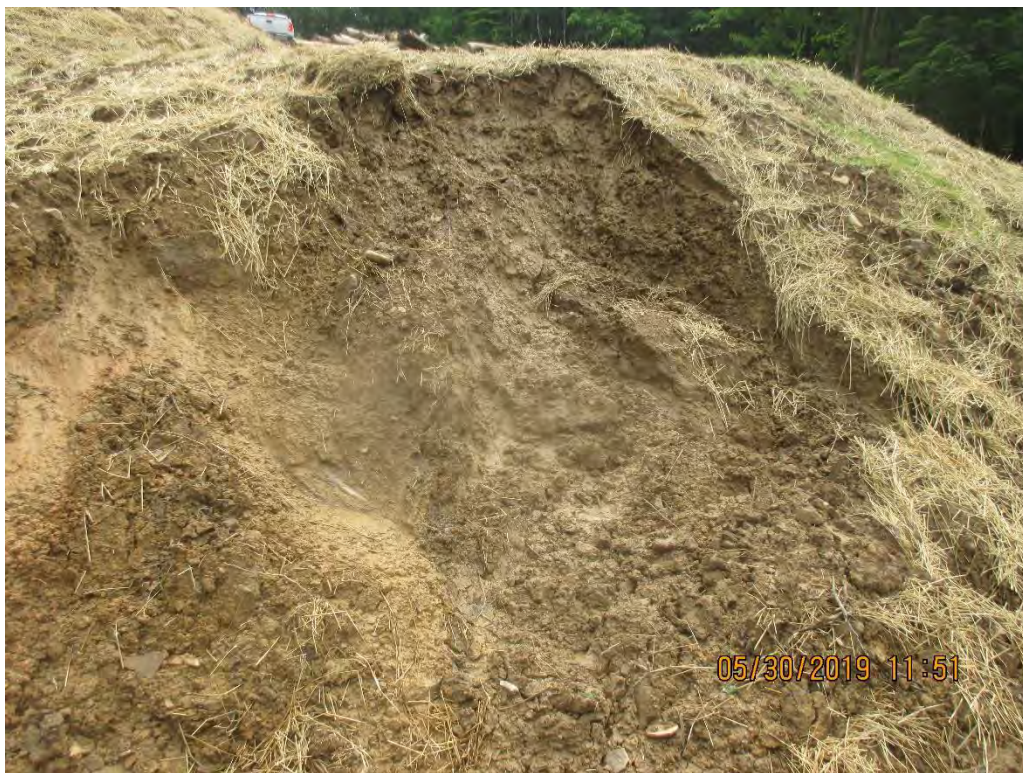
Topsoil pile slipping into Waterbar at station No. 6508+40.

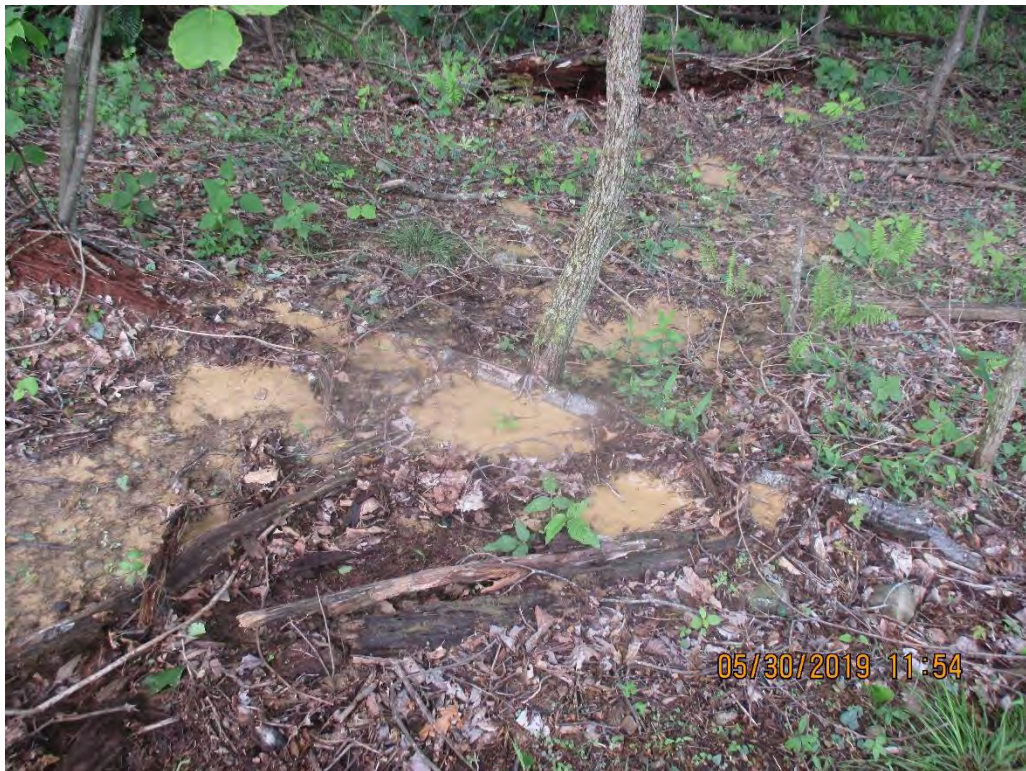
Sediment deposits observed past LOD and Controls below Waterbar and topsoil pile at station No. 6508+30.

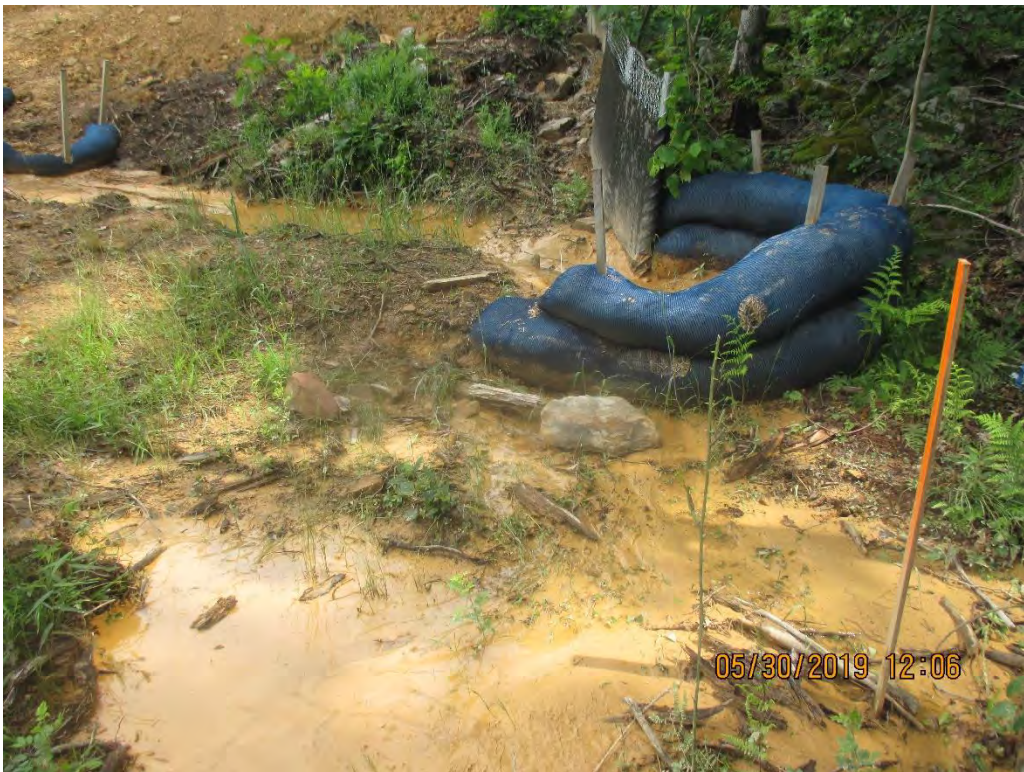
Waterbar outlet at station No. 6510+40 facing upslope. Sediment deposits were observed past LOD and conveying towards Wetland W-N18.

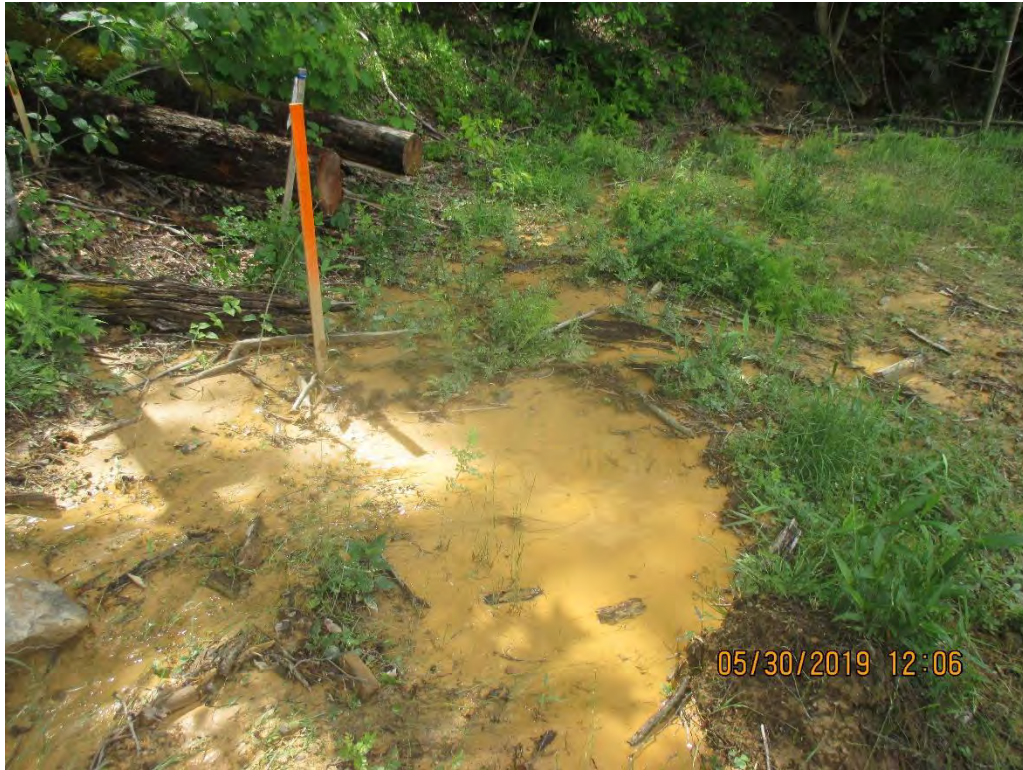
Sediment deposits downslope of Waterbar outlet at station No. 6510+40.

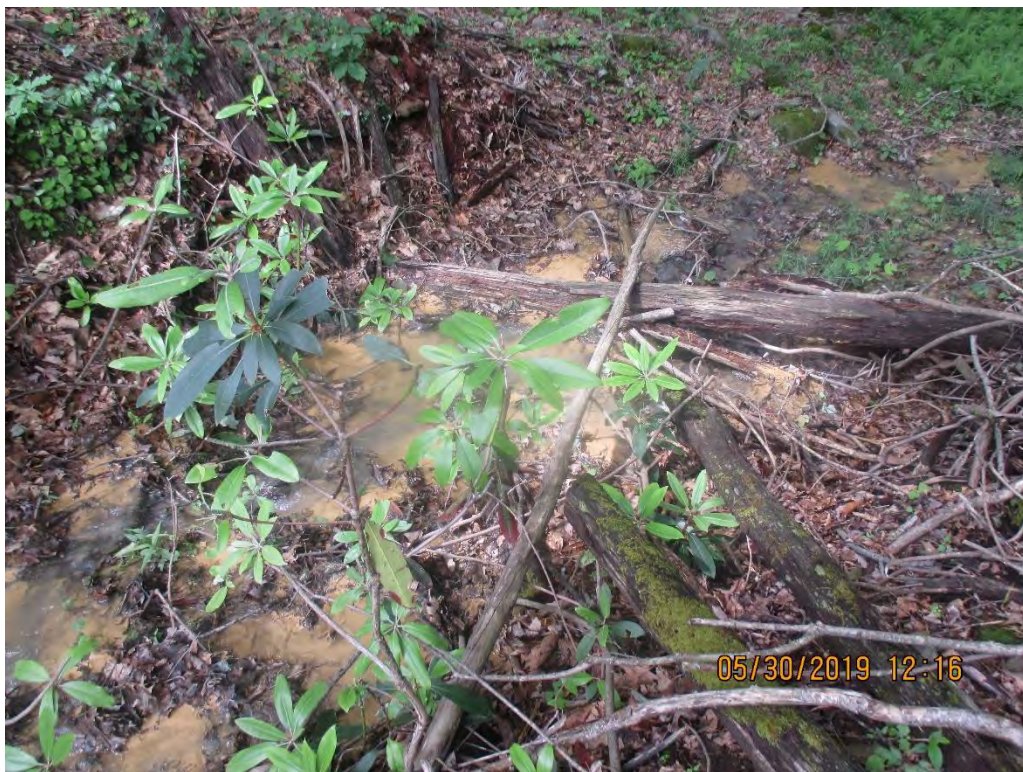
Sediment deposits and SLW observed past controls and LOD at station No. 6510+40.

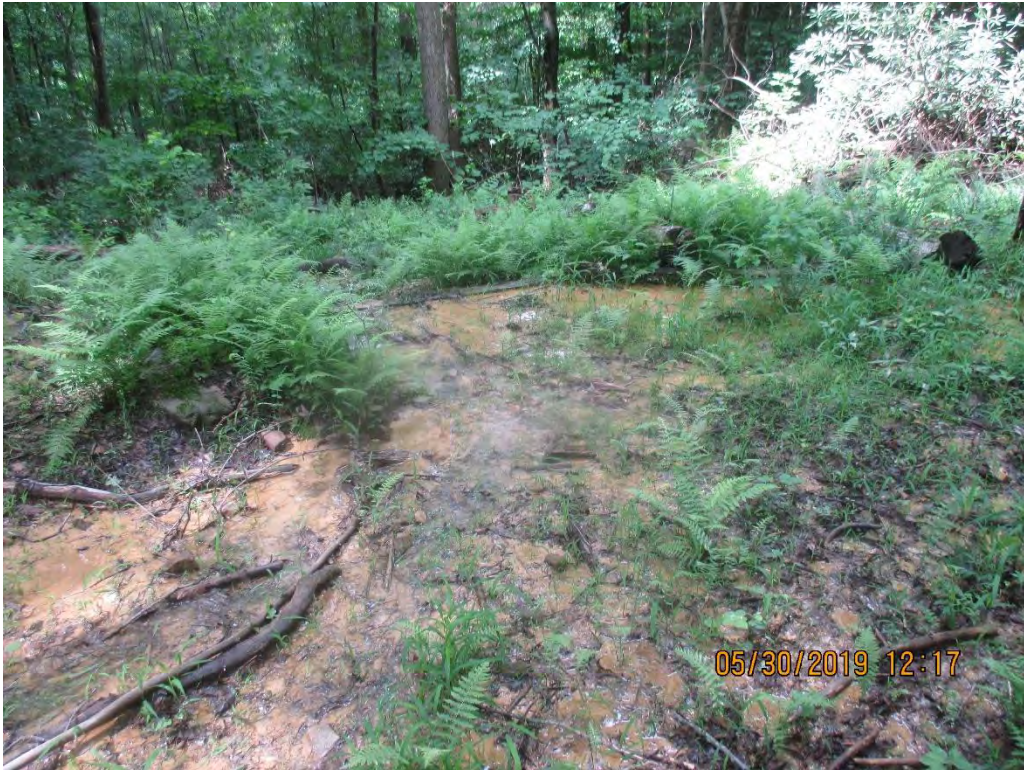
SLW and sediment deposits observed past controls and LOD near station No. 6510+40 approximately 200 feet past LOD.

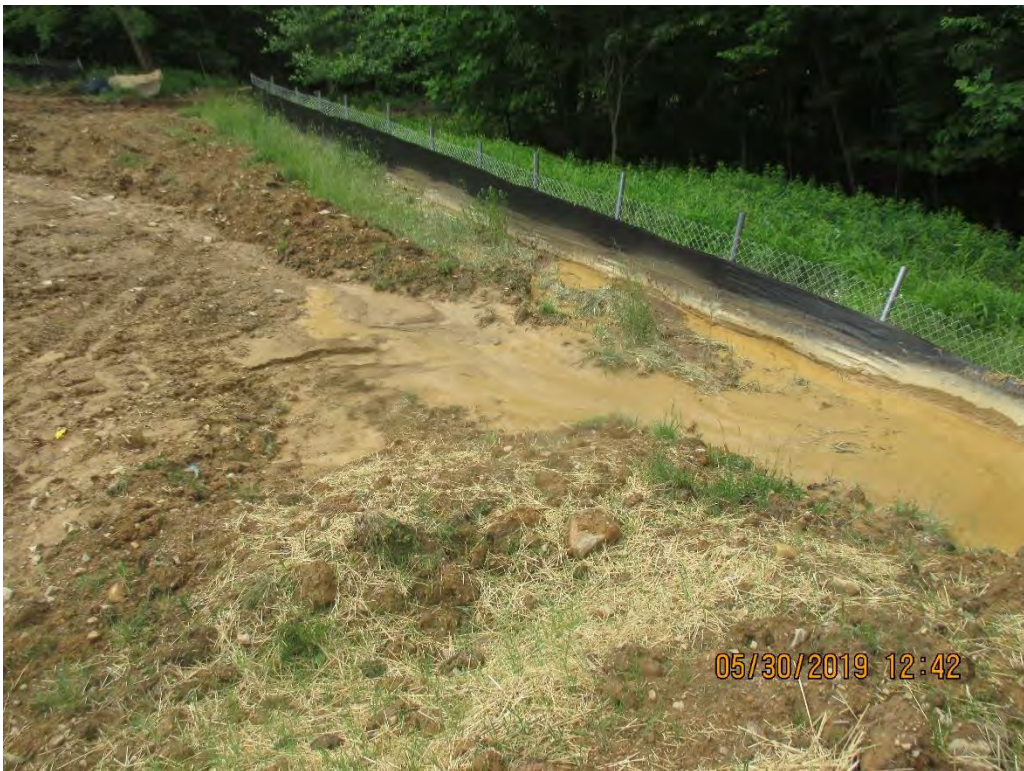
Erosion and sediment/SLW overwhelming perimeter controls at ATWS-22-7A at station No. 6514+60. Sediment deposits observed past controls and LOD.

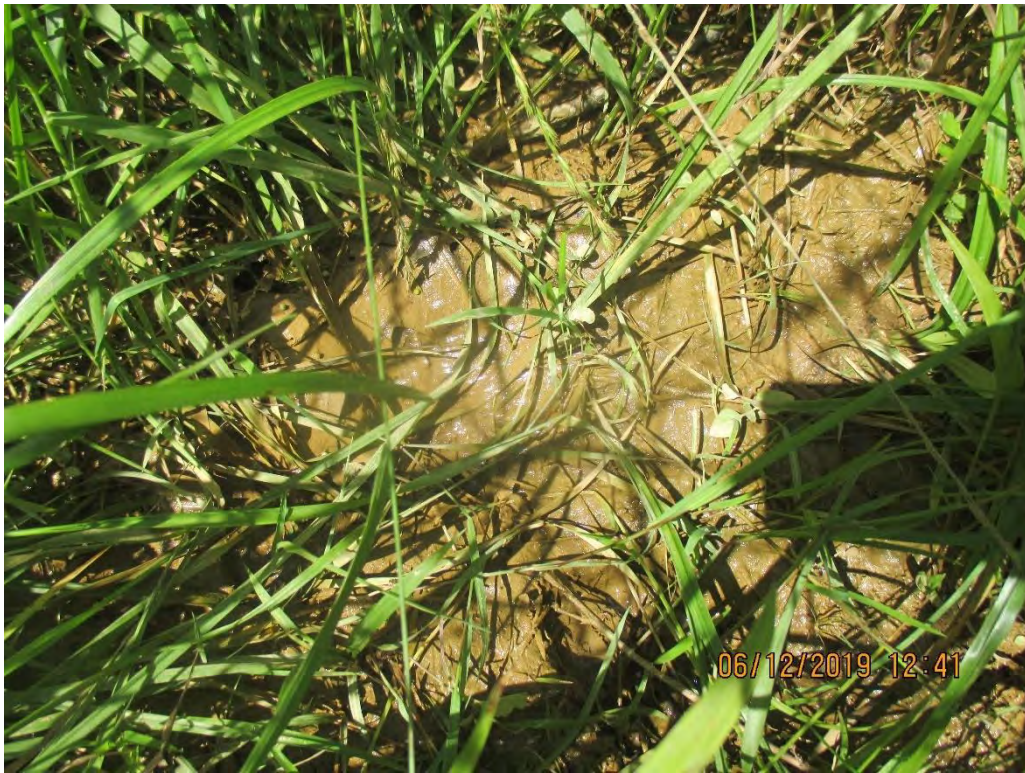
Below Dargo silt fence. Sediment deposits observed past LOD and low-lying area not delineated as a wetland.

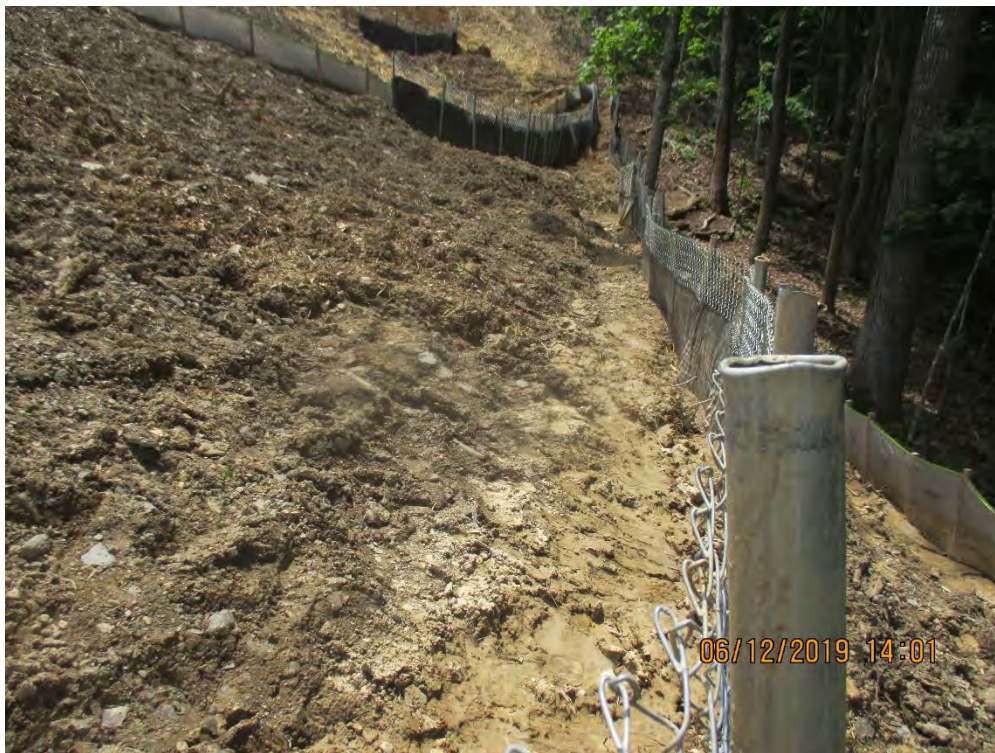
Controls below where dozer work was taking place. Sediment deposits observed below these controls at station No. 9780+00.

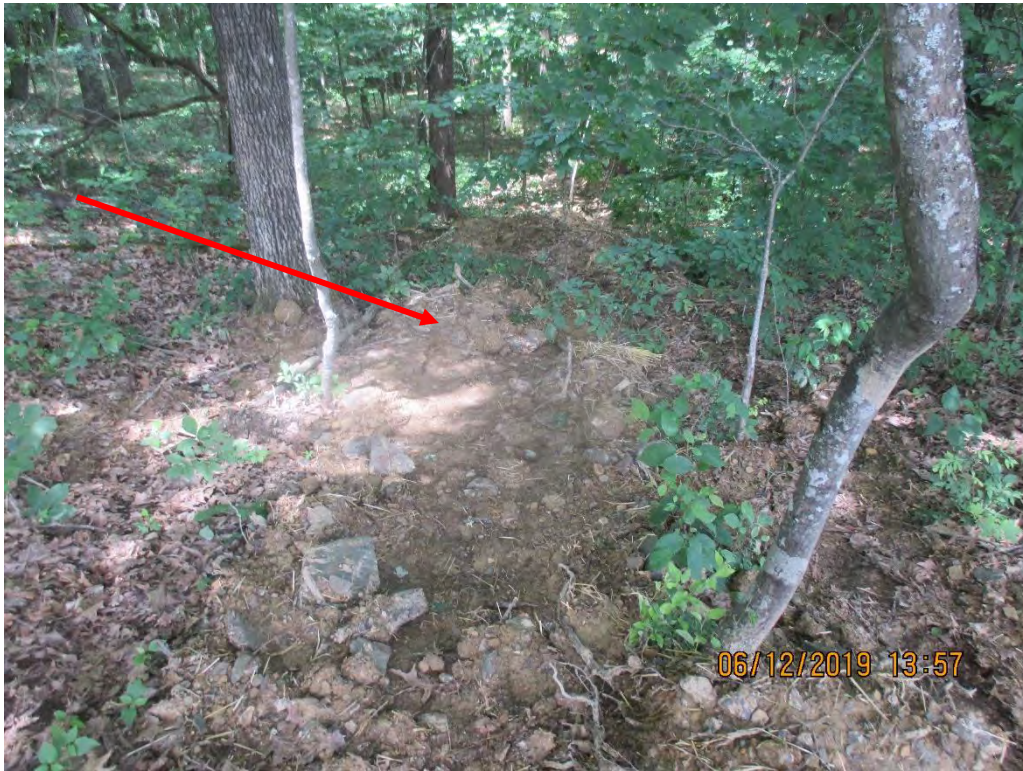
Below controls at station No. 9780+00 facing downslope at sediment deposits and scouring of leaf litter. Arrow depicts deposits.

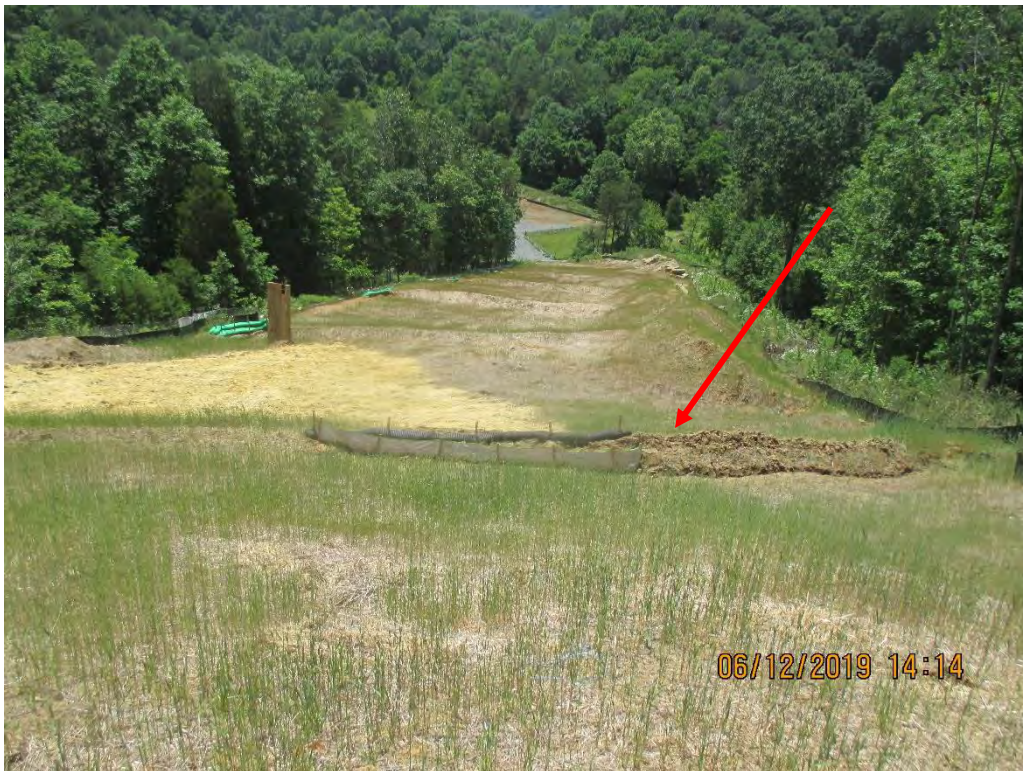
Facing South towards Ellison Ridge Road. Waterbar blow out and repair observed where AR-221 comes onto ROW.
