**The Wilderness Society et al. Comments on the
U.S. Forest Service Mountain Valley Pipeline and
Equitrans Expansion Project Draft Supplemental
Environmental Impact Statement (#50036)**

EXHIBIT 12

**WEST VIRGINIA DEPARTMENT OF ENVIRONMENTAL PROTECTION
WV OIL AND GAS CONSTRUCTION STORMWATER PERMIT**

FACILITY NAME:	Mountain Valley Pipeline Project		REG. #	EXPIRE DATE:
PERMITTEE	MOUNTAIN VALLEY PIPELINE, LLC		WVR310667	5/13/2018 Extended: 12/31/2018
ADDRESS/PHONE:	Attn: MATTHEW HOOVER 625 LIBERTY AVE, ST 1700 PITTSBURG, PA 15222 7248733645			
LOCATION:	Harris Compressor Station		Entry Date/Time:	9/25/2018 1000
COUNTY:	Braxton		Exit Date/Time:	9/25/2018 1100
Site Representative /Phone	Brittany Dewitt (Lead EI)/330-987-1682, Matt Hoover MVP/ 412-258-5627 & Jason Hiles, Spread C Lead EI/740-334-7812		PHOTOS <input checked="" type="checkbox"/>	
CO-PERMITTEE:			ADDRESS:	
SITE OPERATOR:	MEC Construction LLC		ADDRESS:	19 RR Meadowbrook, WV 26404
PERMITTED ACREAGE	4311	WEATHER:	Cloudy	LAST INSPECTION: 8/21/2018
RECEIVING STREAM(S)	Trib of Elk/Kanawha R/ Ohio Rv			NOV: 1
Regular Mail <input type="checkbox"/> Certified Mail <input checked="" type="checkbox"/>	Tracking #			
OVERALL FACILITY R

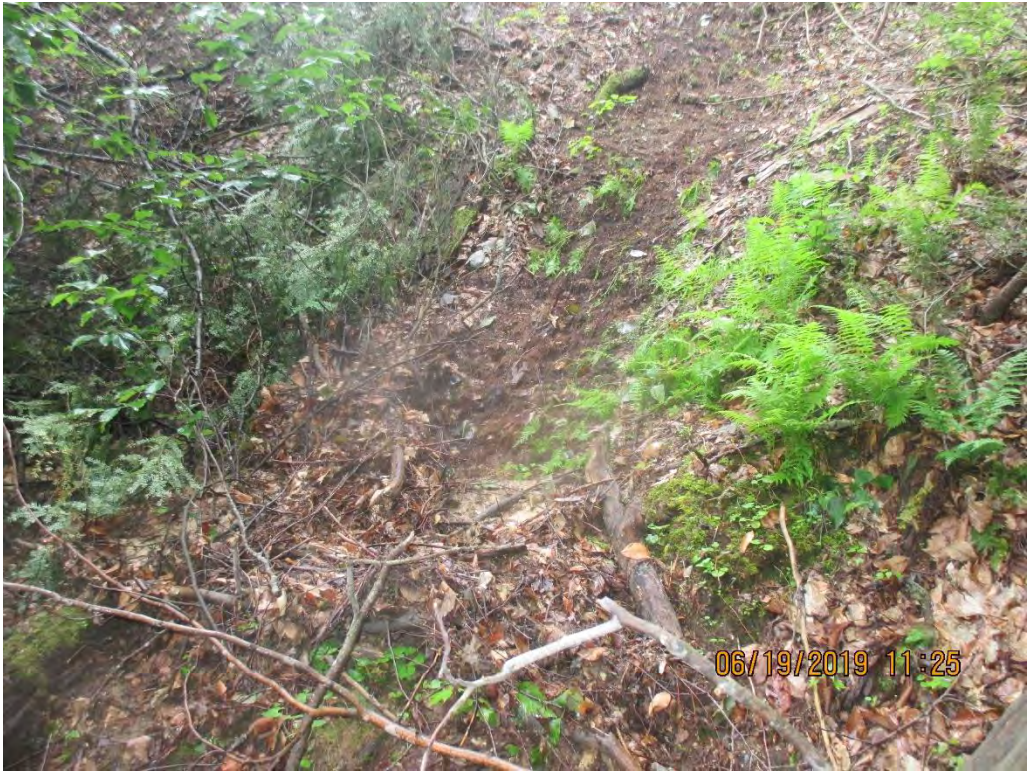
Scouring of stream bank below where sediment deposits were observed above Stream S-L38.

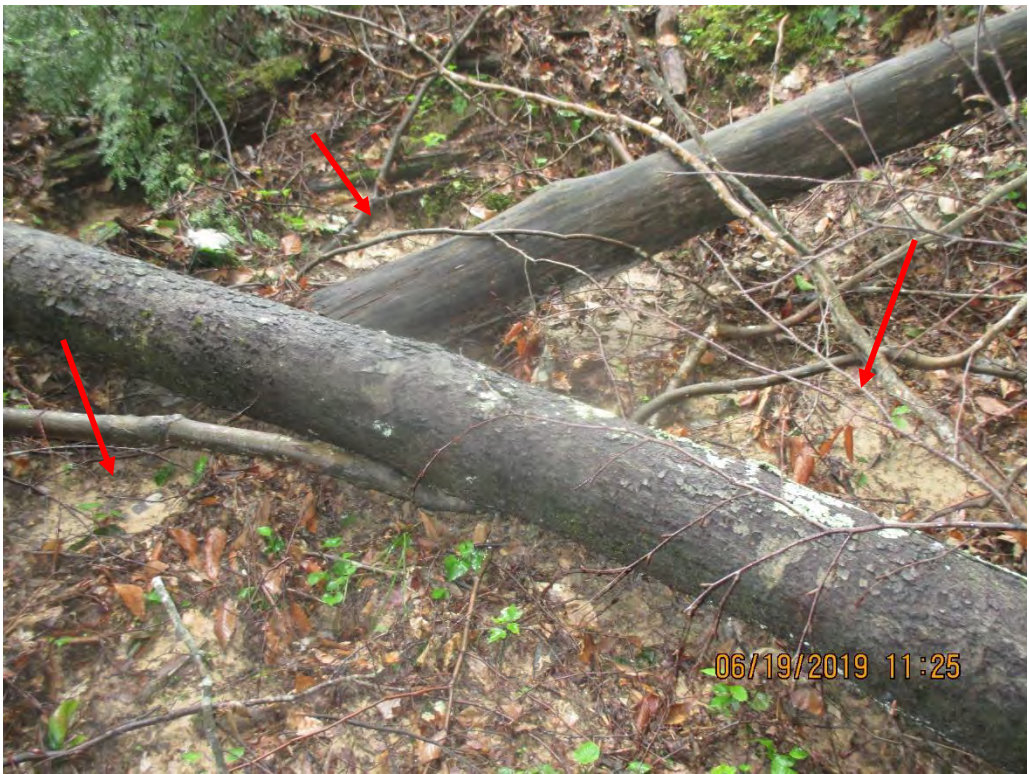
Sediment deposits below scouring on stream bank of S-L38 and below controls approximately 75 feet downslope of Station No. 6587+00. Arrow depicts sediment deposits.
