**The Wilderness Society et al. Comments on the
U.S. Forest Service Mountain Valley Pipeline and
Equitrans Expansion Project Draft Supplemental
Environmental Impact Statement (#50036)**

**WEST VIRGINIA DEPARTMENT OF ENVIRONMENTAL PROTECTION
WV OIL AND GAS CONSTRUCTION STORMWATER PERMIT**

FACILITY NAME:	Mountain Valley Pipeline Project			REG. #	EXPIRE DATE:
PERMITTEE	MOUNTAIN VALLEY PIPELINE, LLC			WVR310667	5/13/2018
ADDRESS/PHONE:	Attn: Matt Hoover 625 LIBERTY AVE, ST 1700 PITTSBURGH, PA 15222				
LOCATION:	Wileyville, WV			Entry Date/Time:	4/3/18 8:30am
COUNTY:	Wetzel			Exit Date/Time:	4/3/18 1:37pm
Site Representative /Phone	Matt Hoover Sr. Environmental Coordinator (412) 258-5627			PHOTOS <input checked="" type="checkbox"/>	
CO-PERMITTEE:				ADDRESS:	
SITE OPERATOR:	Precision Pipeline			ADDRESS:	
PERMITTED ACREAGE	4214	WEATHER:	Rain	LAST INSPECTION:	N/A
RECEIVING STREAM(S)	Mobley Run > Ohio River				NOV: 1
Regular Mail <input type="checkbox"/> Certified Mail <input checked="" type="checkbox"/>	Tracking #				
OVERALL FACILITY RATING:	Unsatisfactory		COMPLIANCE OUTCOME	Not Immediately Corrected

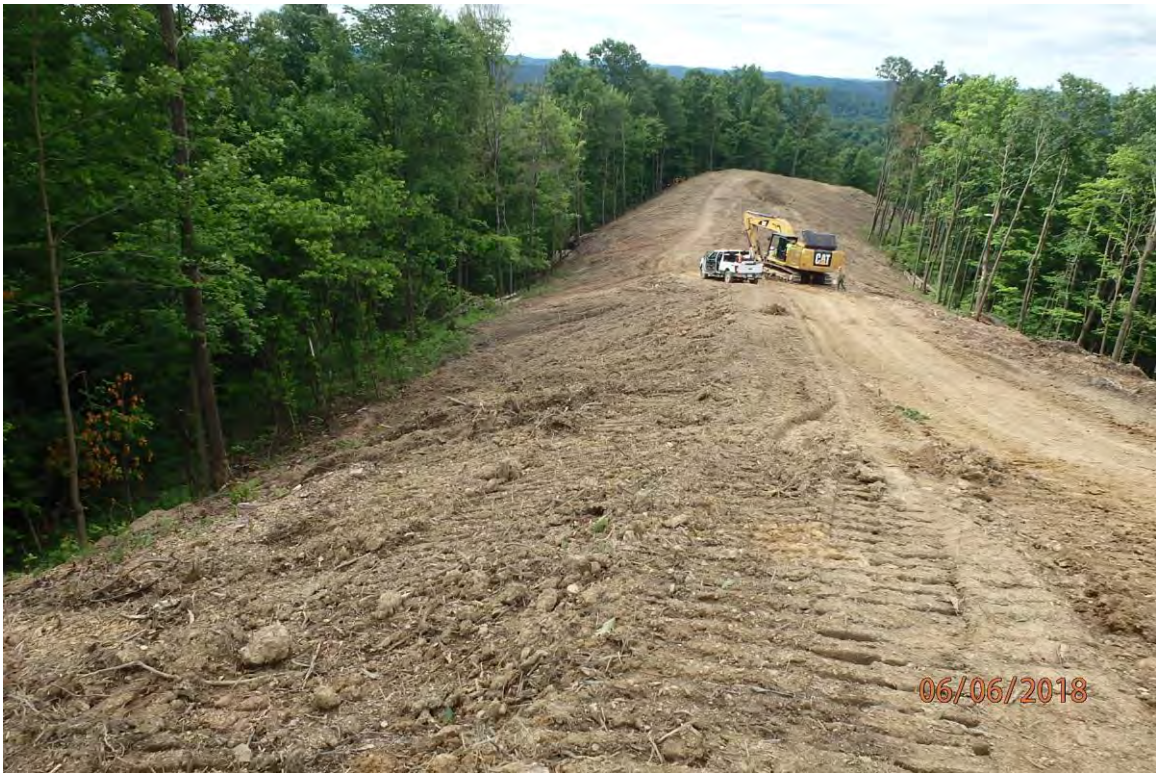
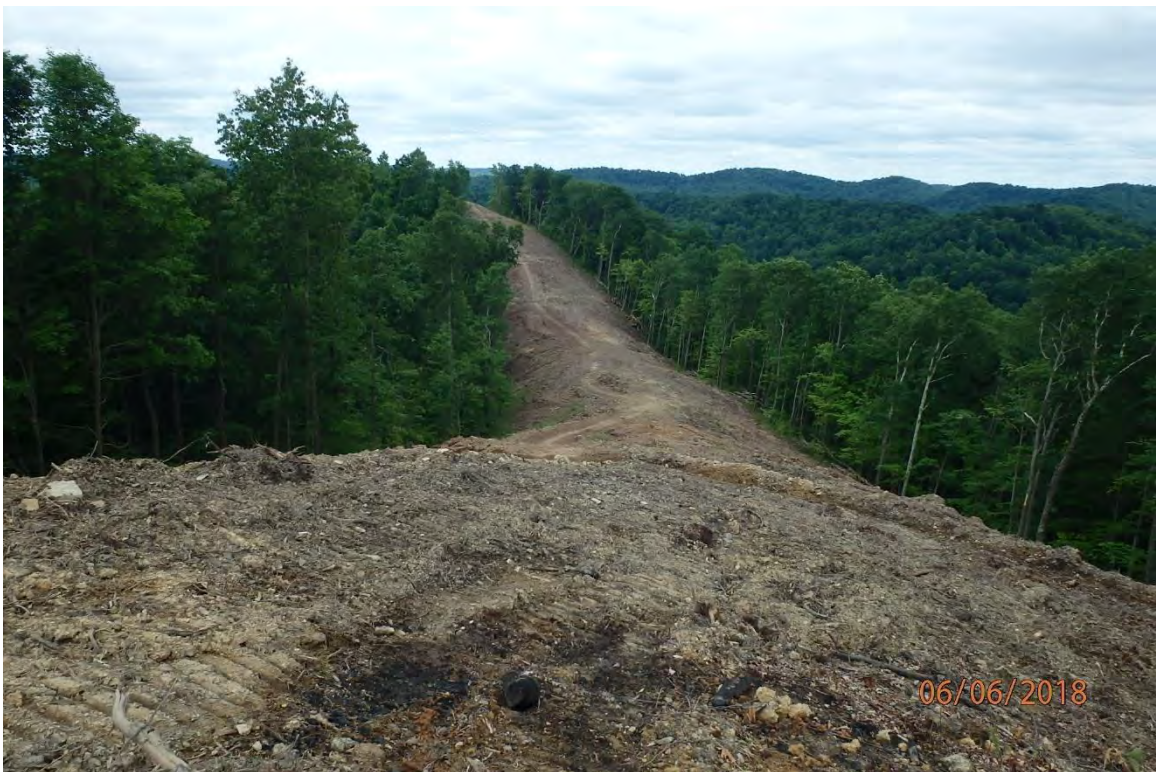
Areas of the project that have been cleared to mineral soil and BMPs are not in place as indicated in the SWPPP. Deficiencies in site evaluation item numbers 1, 7, 8, 13, 15, 19 & 21 pictured.

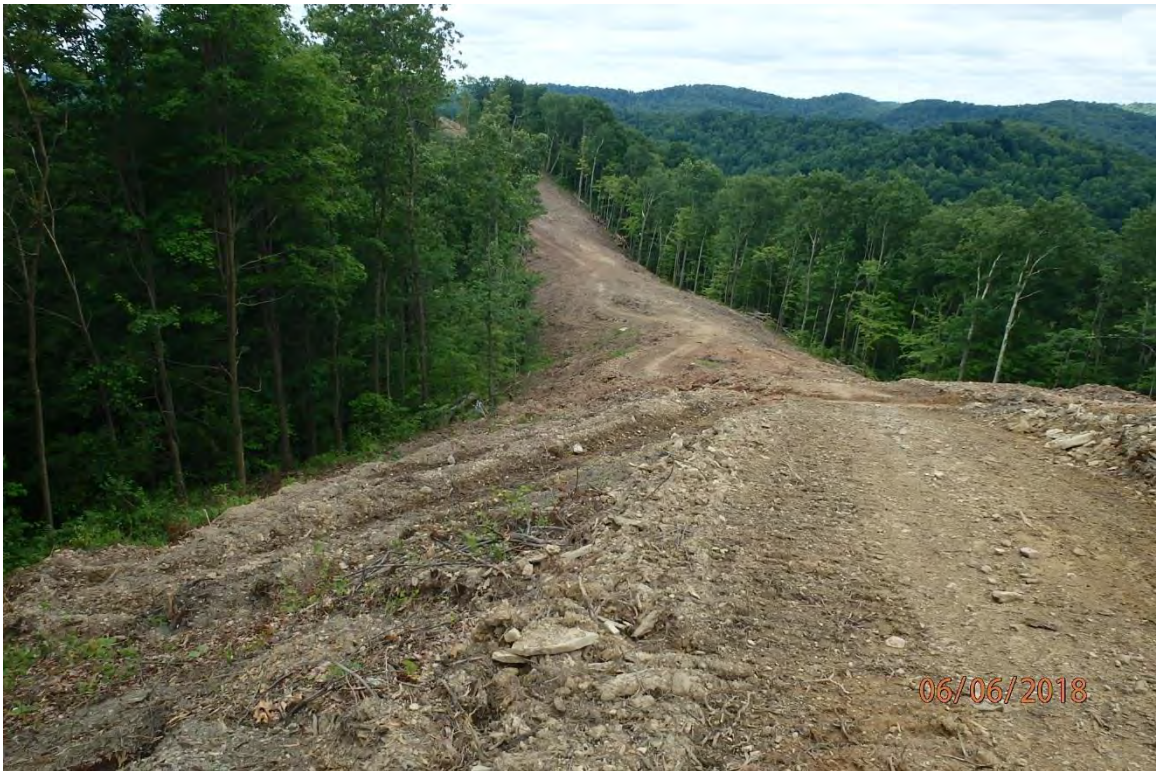
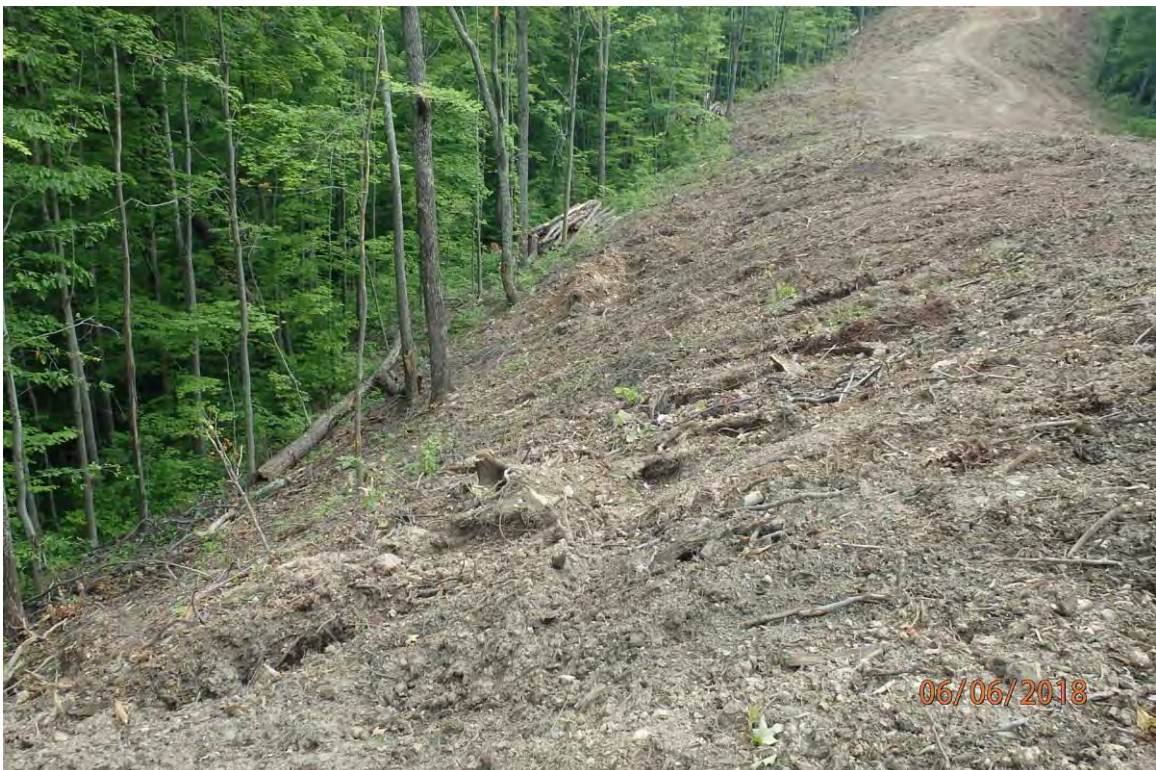
Areas of the project that have been cleared to mineral soil and BMPs are not in place as indicated in the SWPPP. Deficiencies in site evaluation item numbers 1, 7, 8, 13, 15, 19 & 21 pictured.

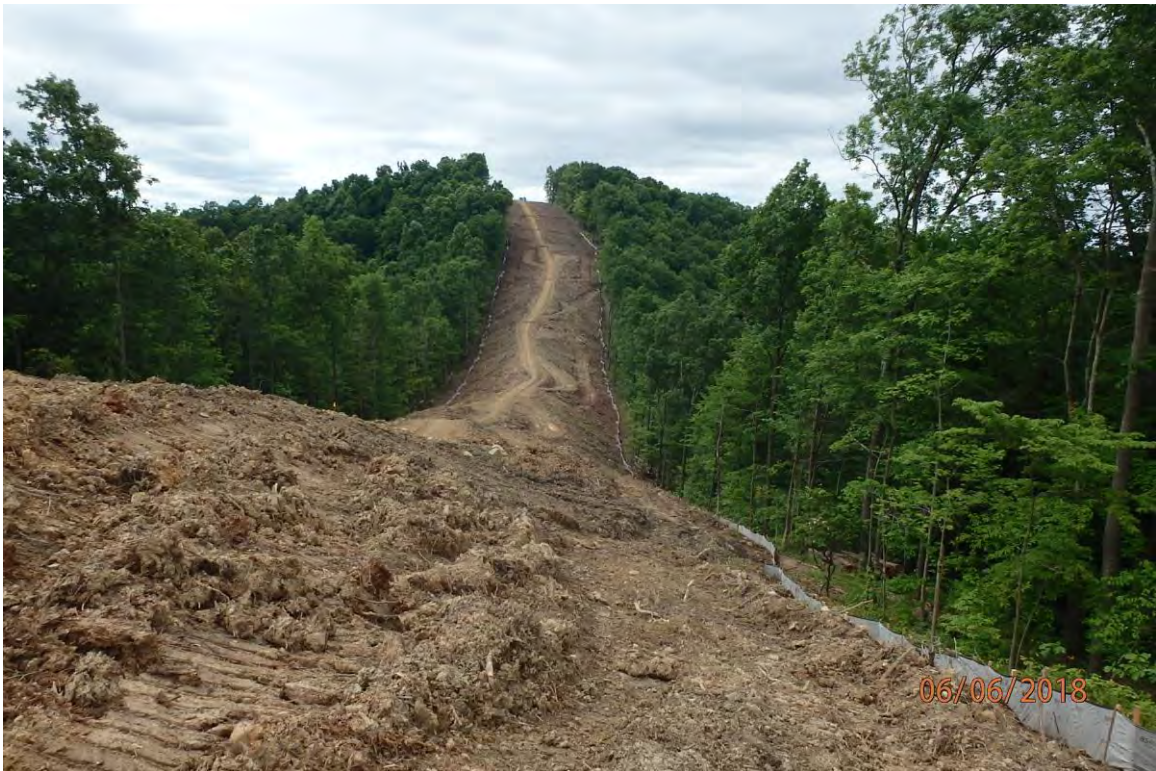
Area adjacent to 498+06 showing controls in place.

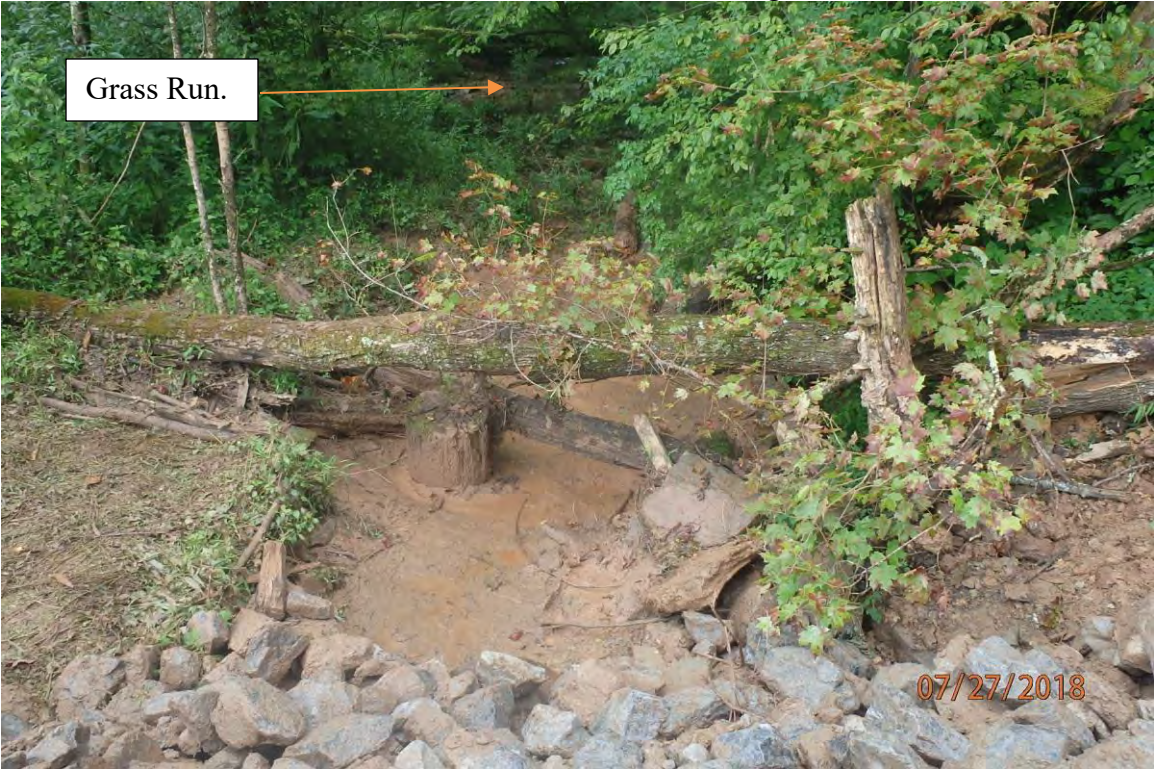
Point where sediment leaves the site. Deficiencies in site evaluation item numbers 15, 19, 20 & 21 pictured.

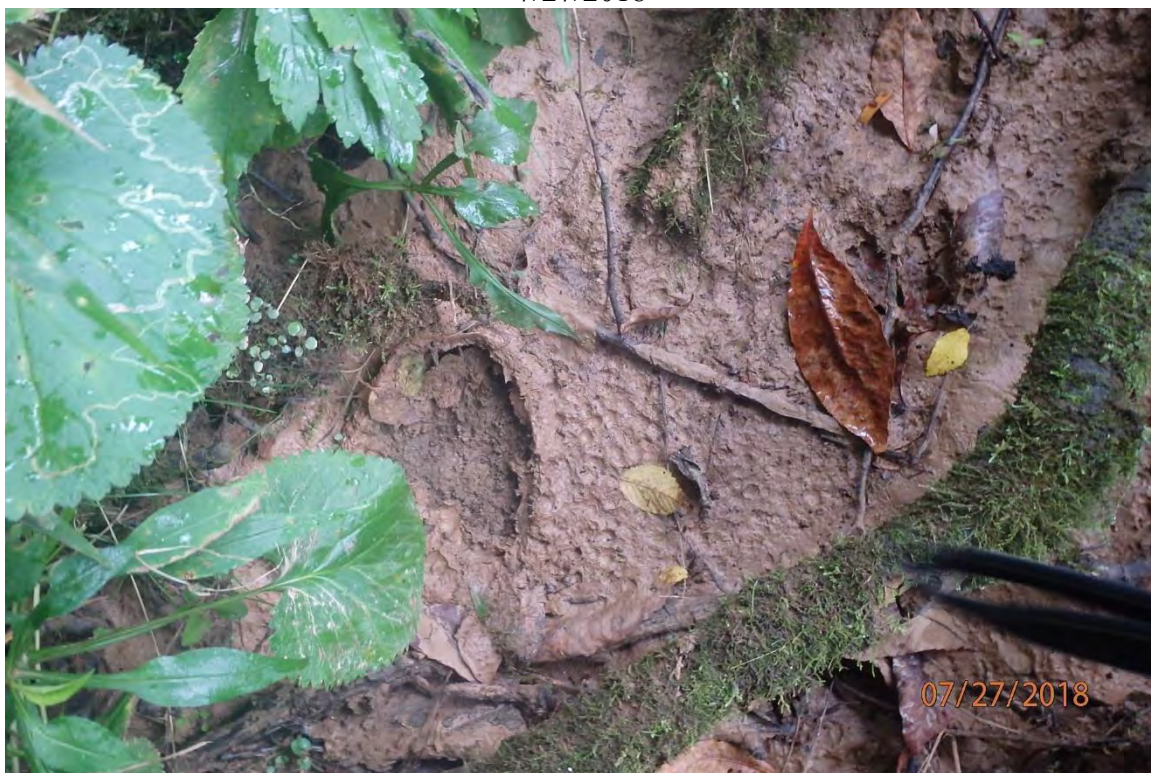
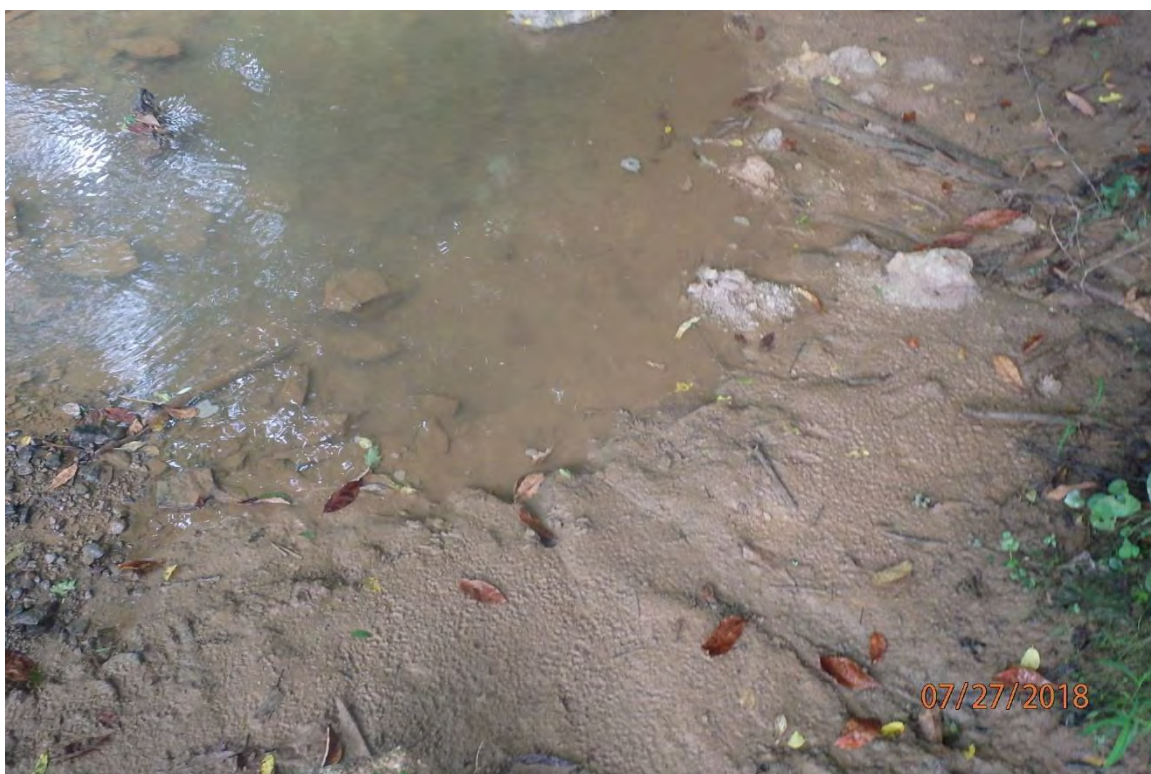
Offsite sediment deposits in Grass Run (S-A11a) that originate from site. Deficiencies in site evaluation item numbers 15, 19, 20 & 21 pictured.

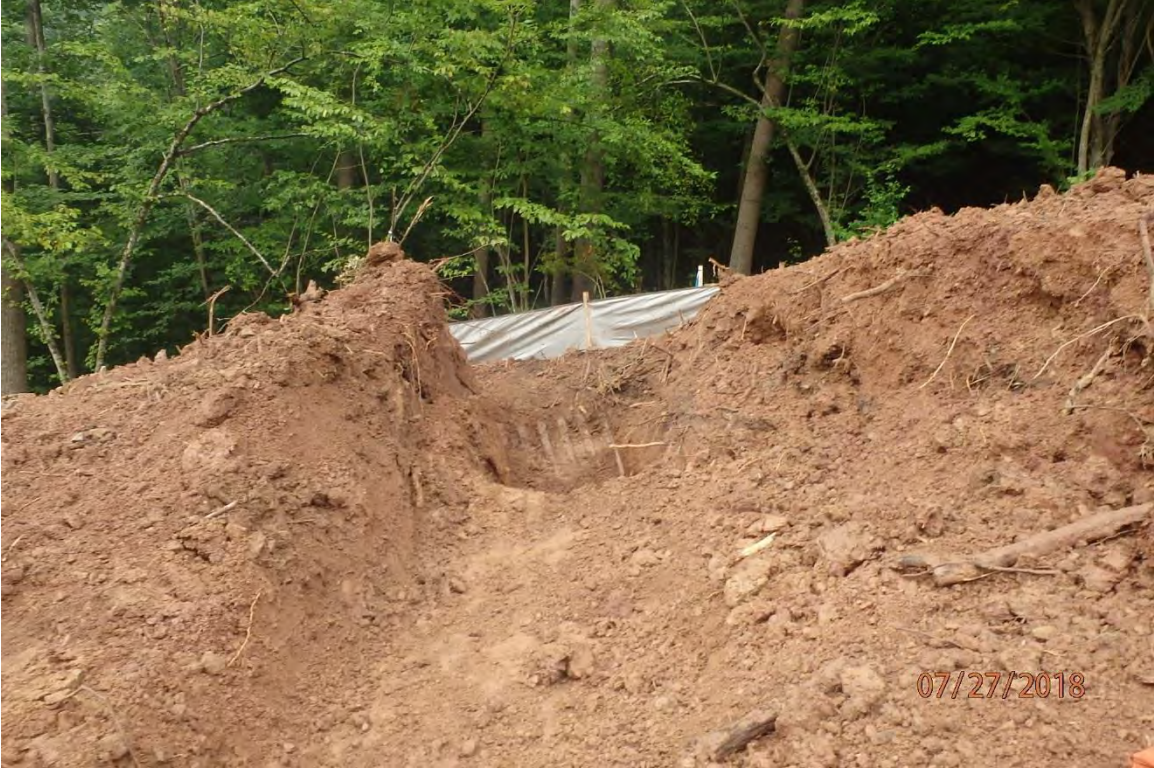
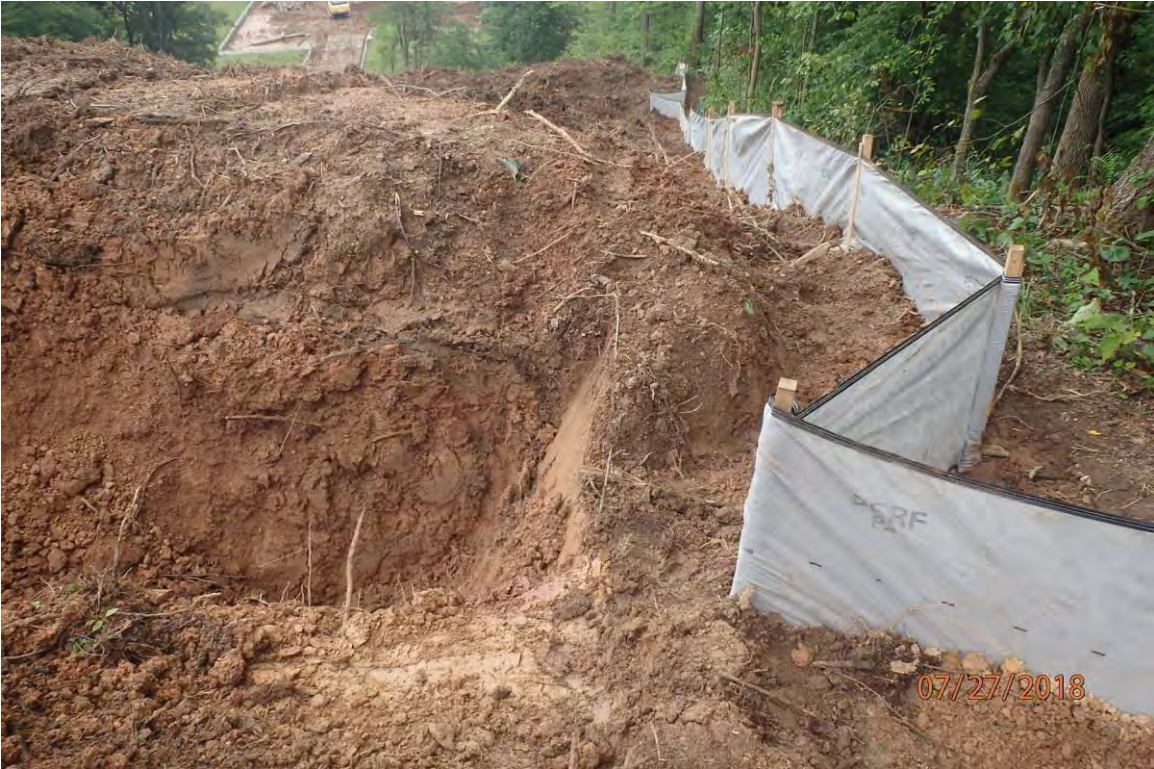
Improperly installed water bars that do not shed stormwater off site as designed. Deficiencies in site evaluation item numbers 7, 14, & 21 pictured.

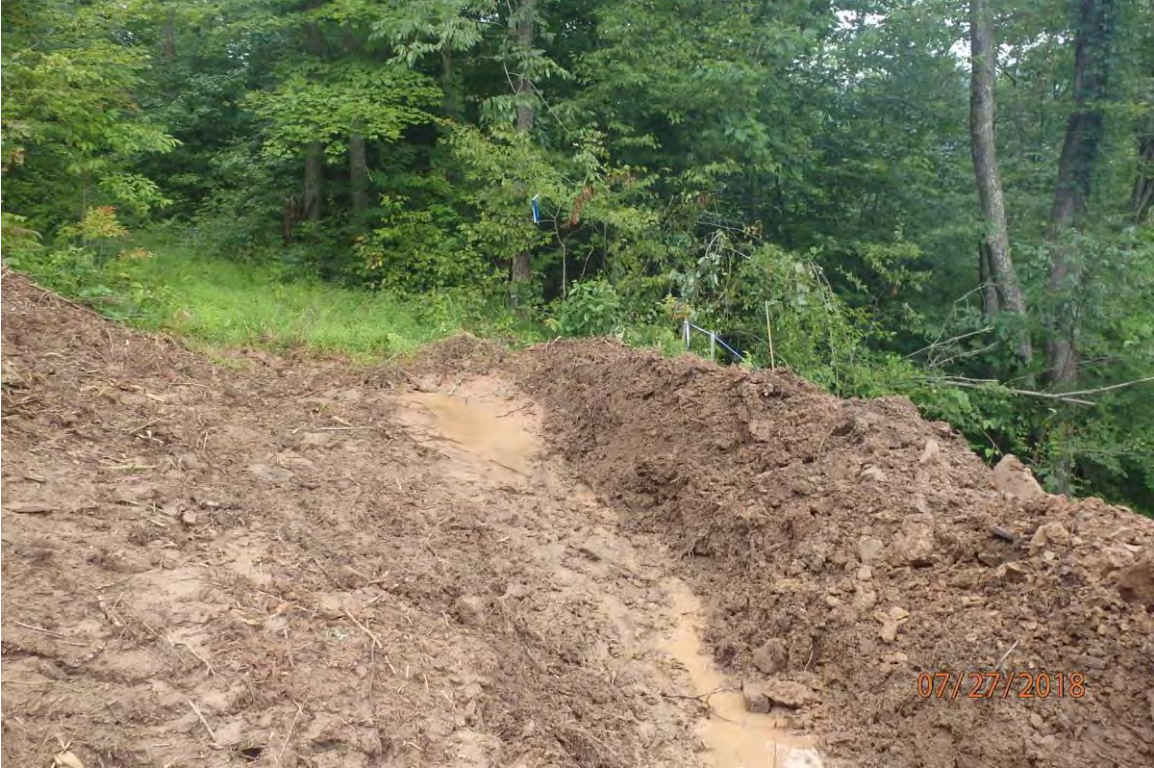
Water bar that lacked outlet protection was noted upslope of grass run adjacent to 1142+00. Marginal deficiencies in site evaluation item numbers 7, 15, 19 & 21 pictured.

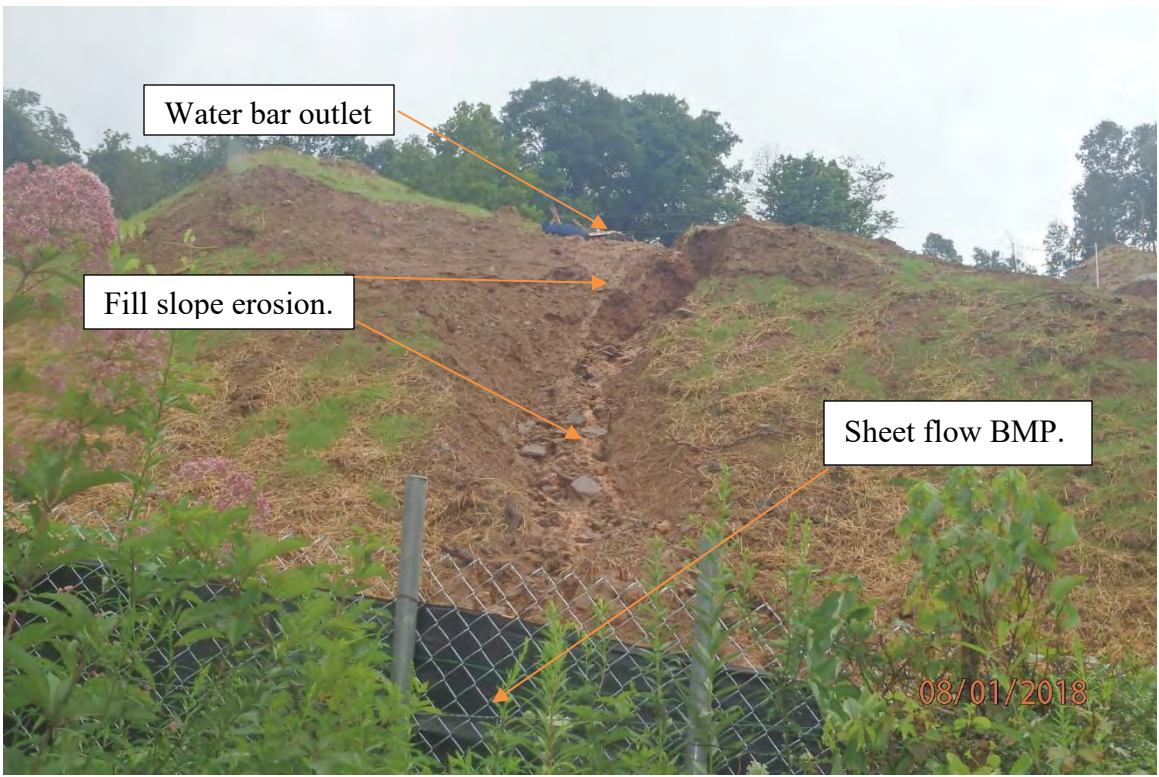
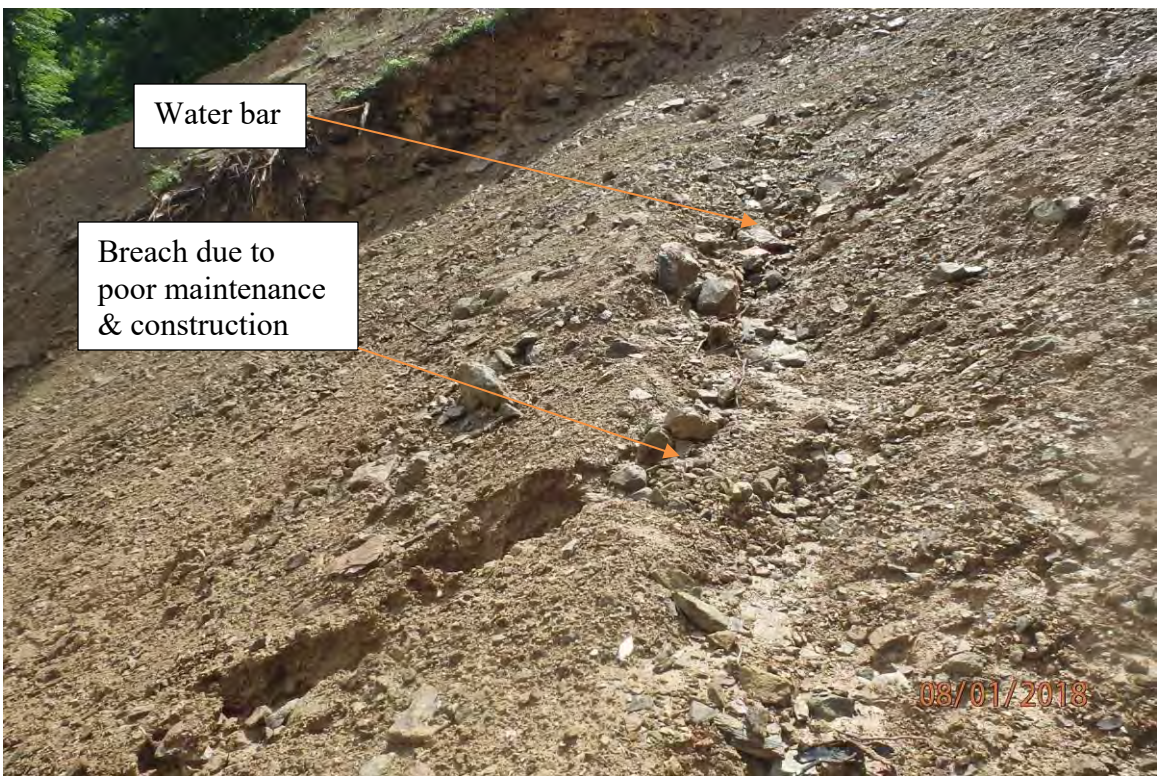
Improperly installed water bars in Big Elk Creek watershed. Improperly installed water bars that have caused fill slope erosion in the Big Elk Creek watershed. Deficiencies in site evaluation item numbers 1, 6, 7, 8, 13, 14, 19, 20 & 21 pictured.

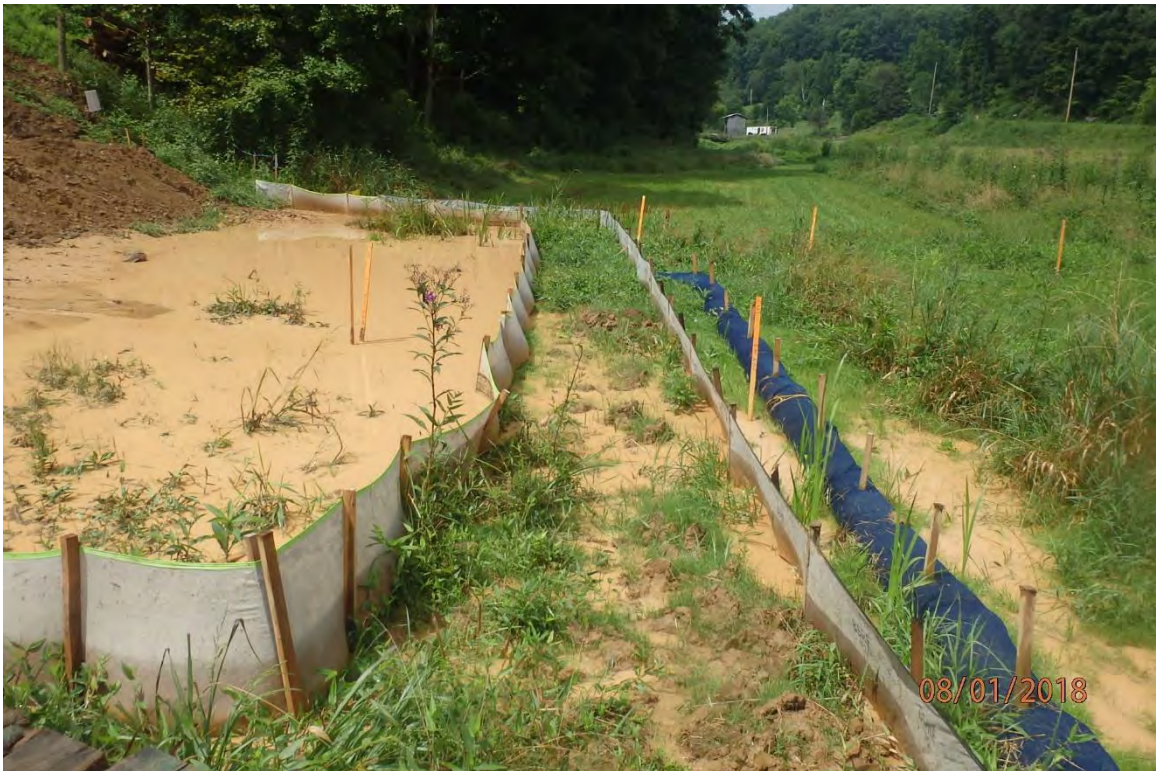
Perimeter controls adjacent to Big Elk Creek that are overwhelmed due to improperly installed water bars.

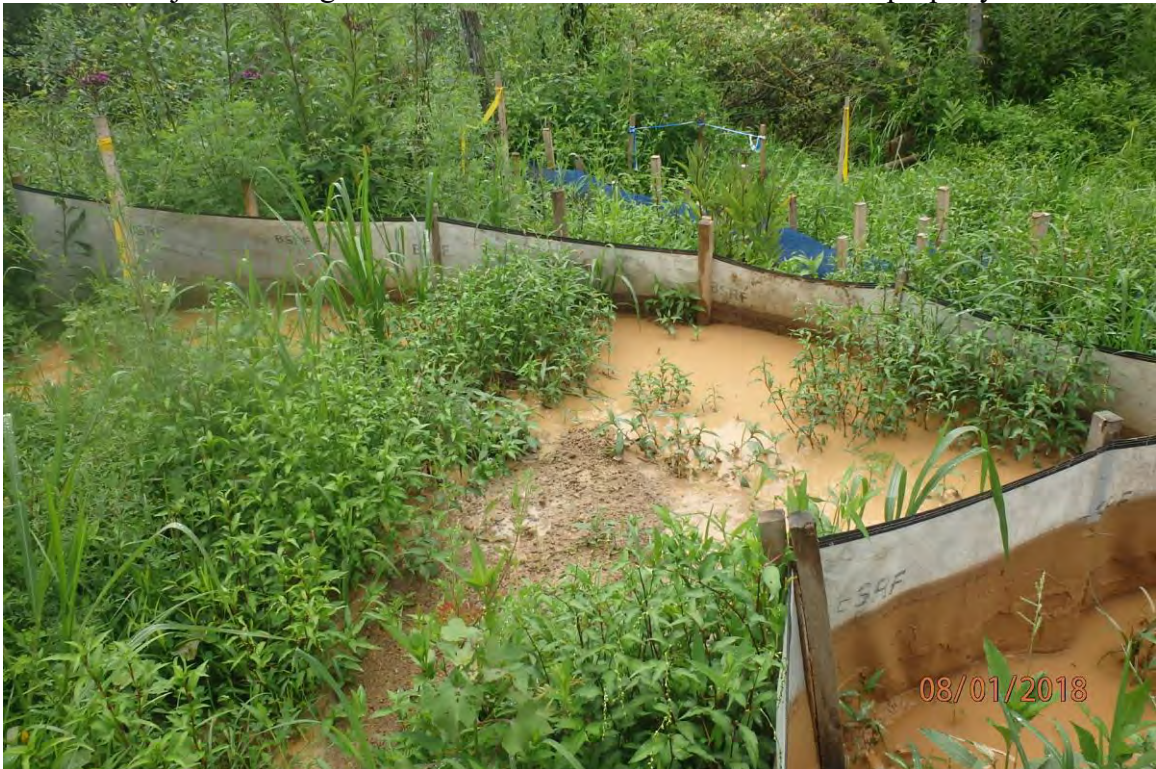
Perimeter controls adjacent to Goose Run that are overwhelmed due to improperly installed water bars.

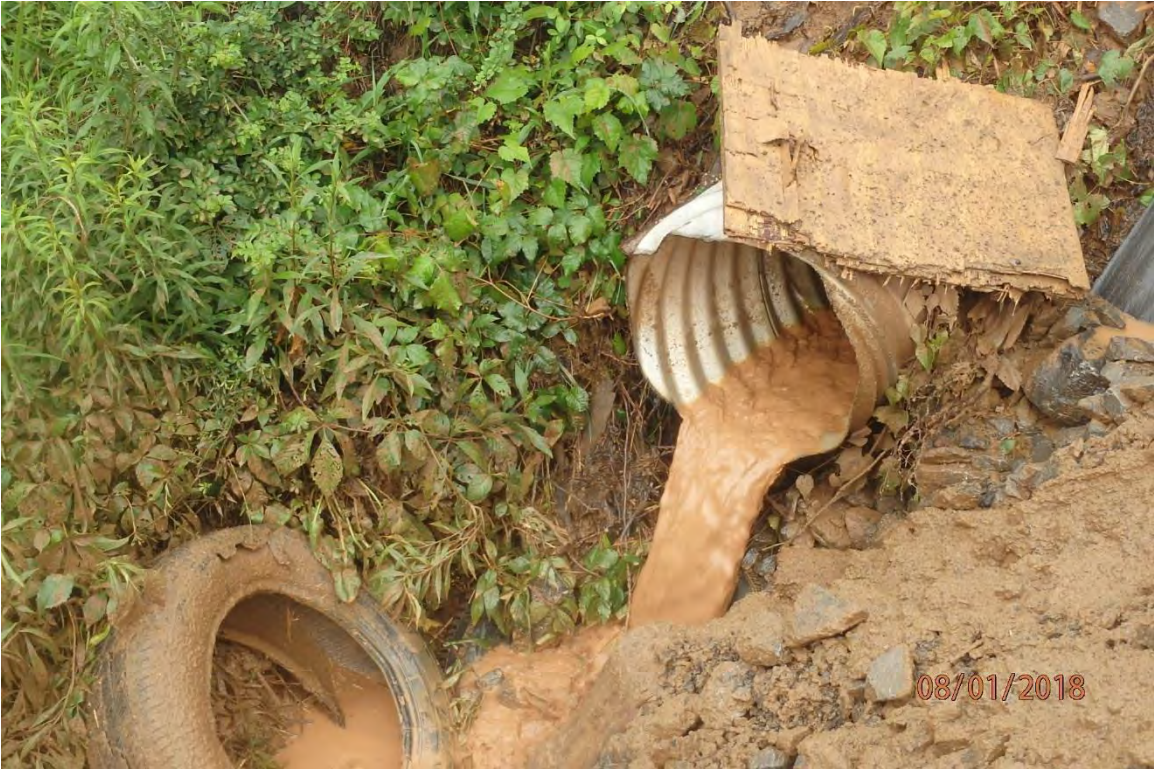
Sediment laden water that is bypassing the installed BMPs due to improper BMP operation and installation. Deficiencies in site evaluation item numbers 1, 6, 7, 13, 14, 19, 20 & 21 pictured.

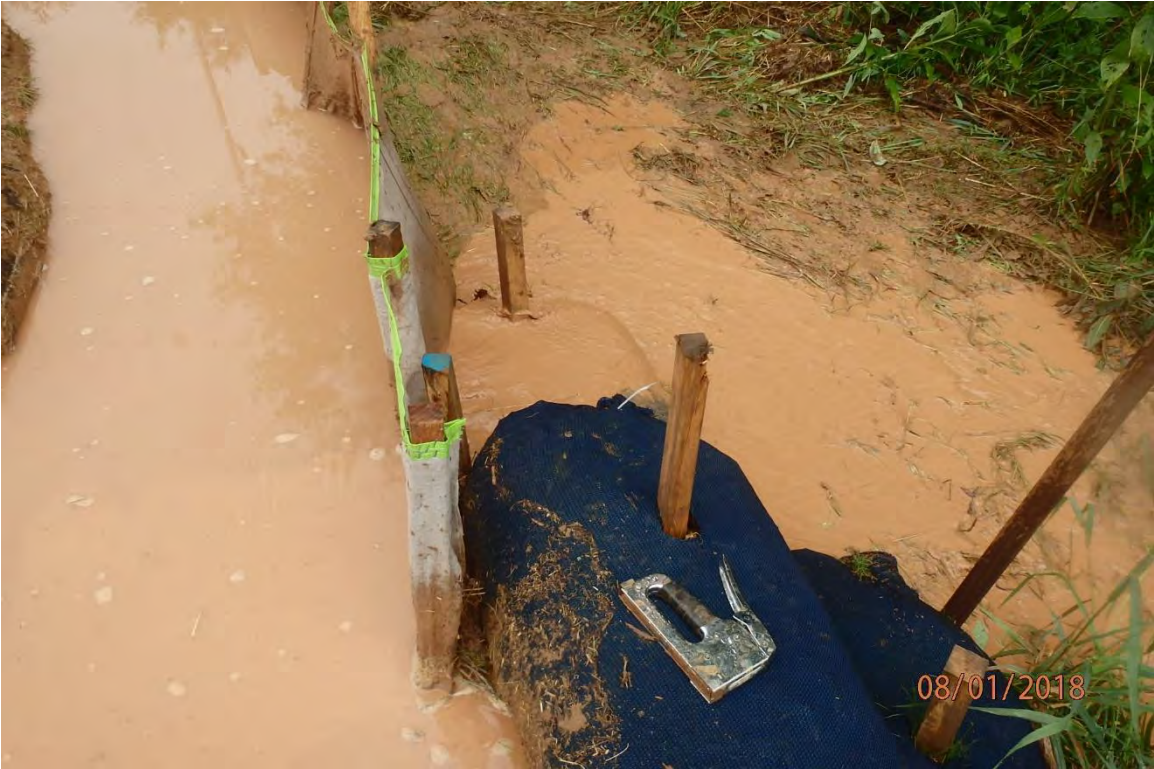
Improperly operated BMP that is causing sediment laden water to leave the site and CNA visible in Big Elk Creek. Deficiencies in site evaluation item numbers 1, 6, 19, 20 & 21 pictured.

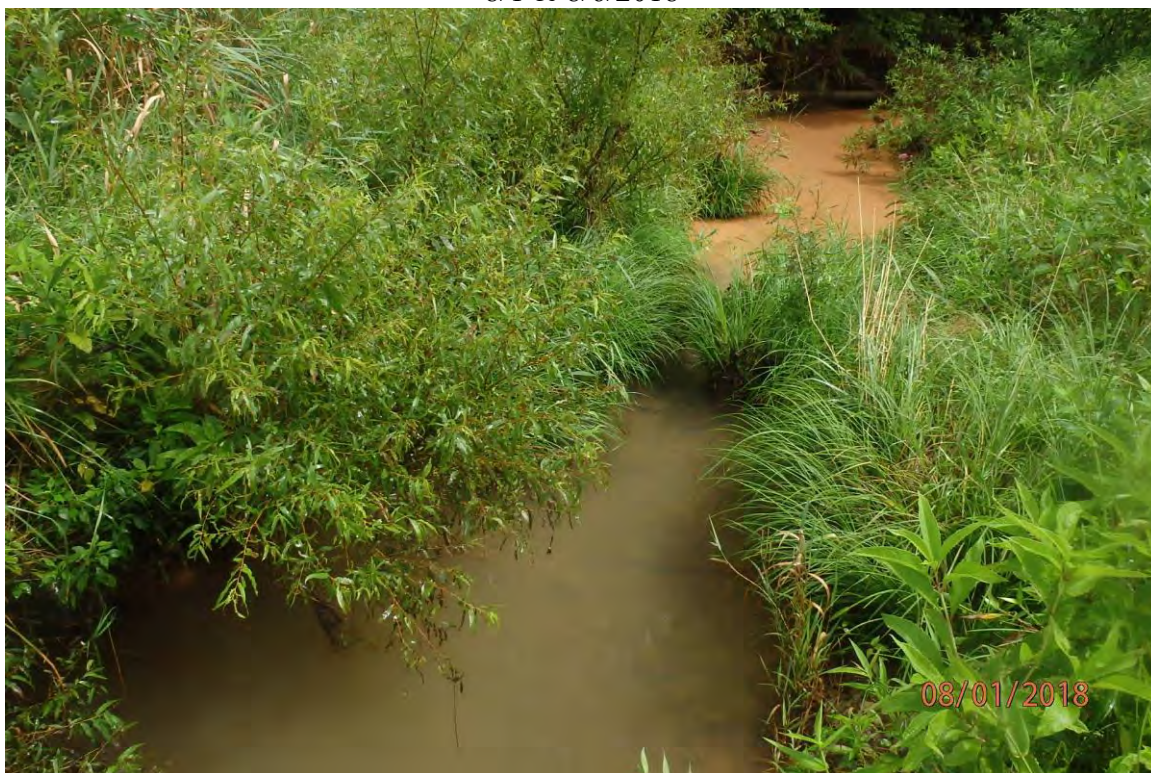
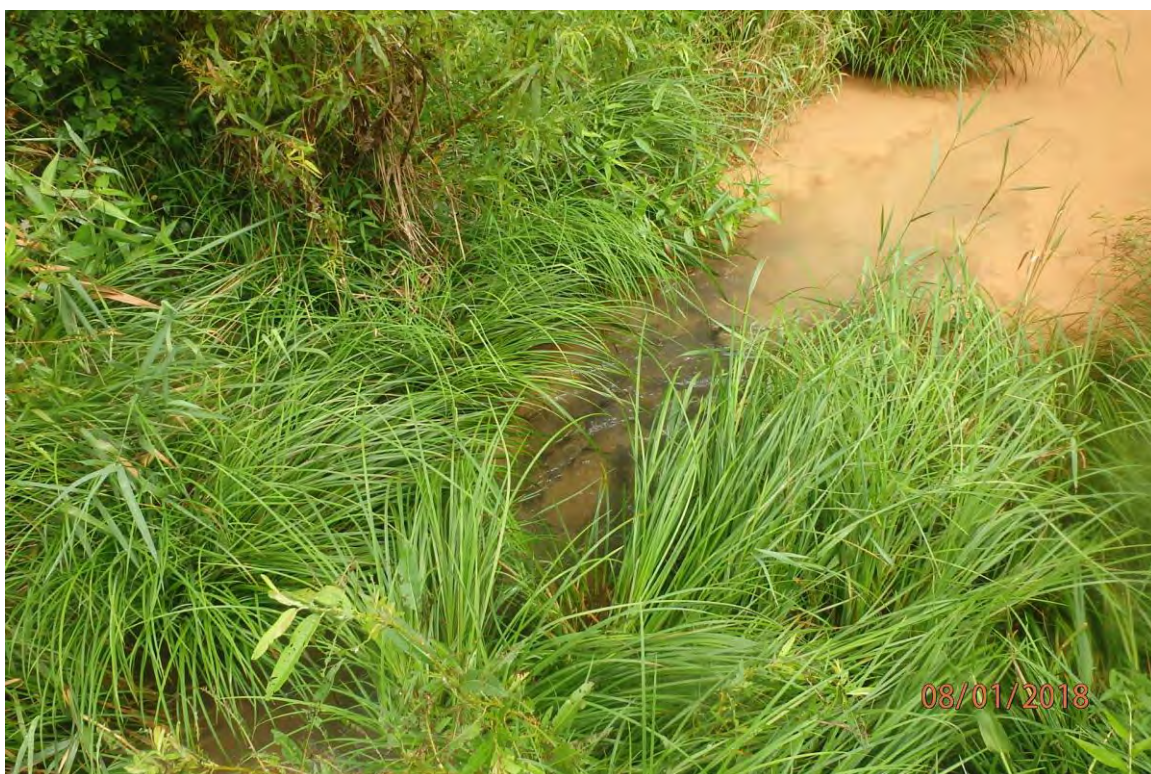
CNA visible plume in in Right Fork of Big Elk Creek (39° 26.6589' X 80° 28.9724'). Deficiencies in site evaluation item numbers 19, 20 & 21 pictured.

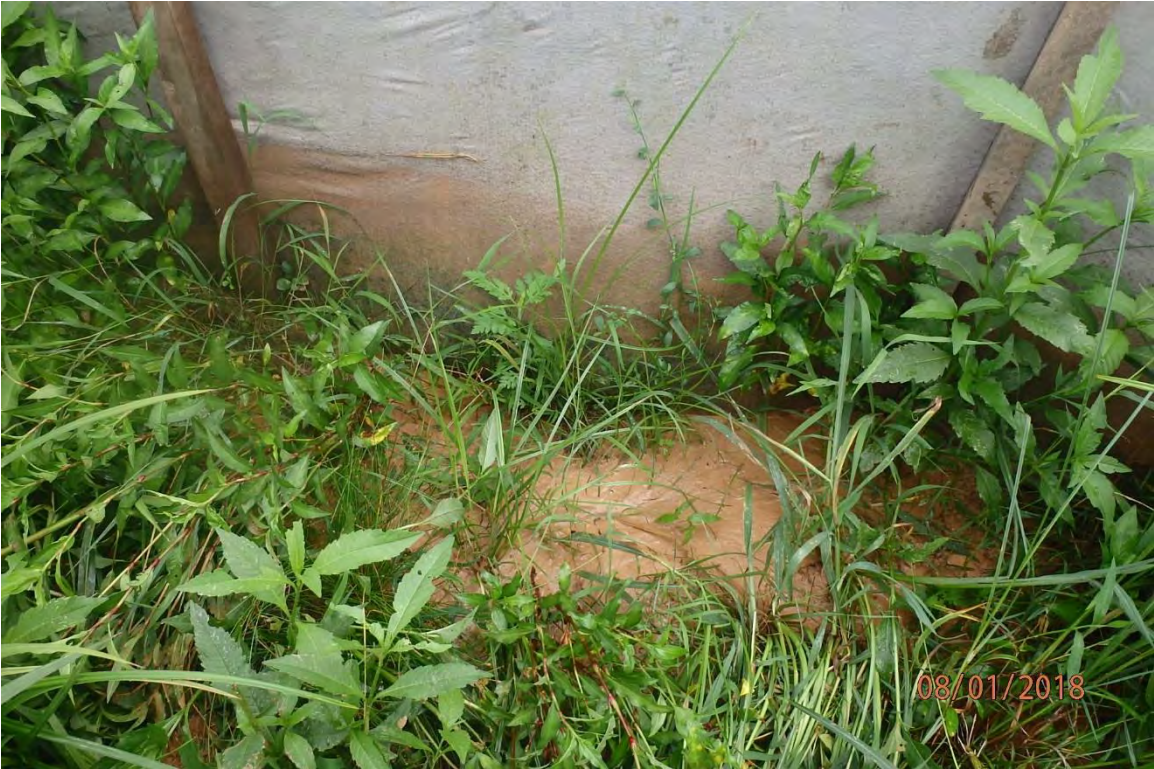
Perimeter controls adjacent to Goose Run that are undermined and allowing sediment laden water to leave the site. Deficiencies in site evaluation item numbers 1, 6, 19, 20 & 21 pictured.

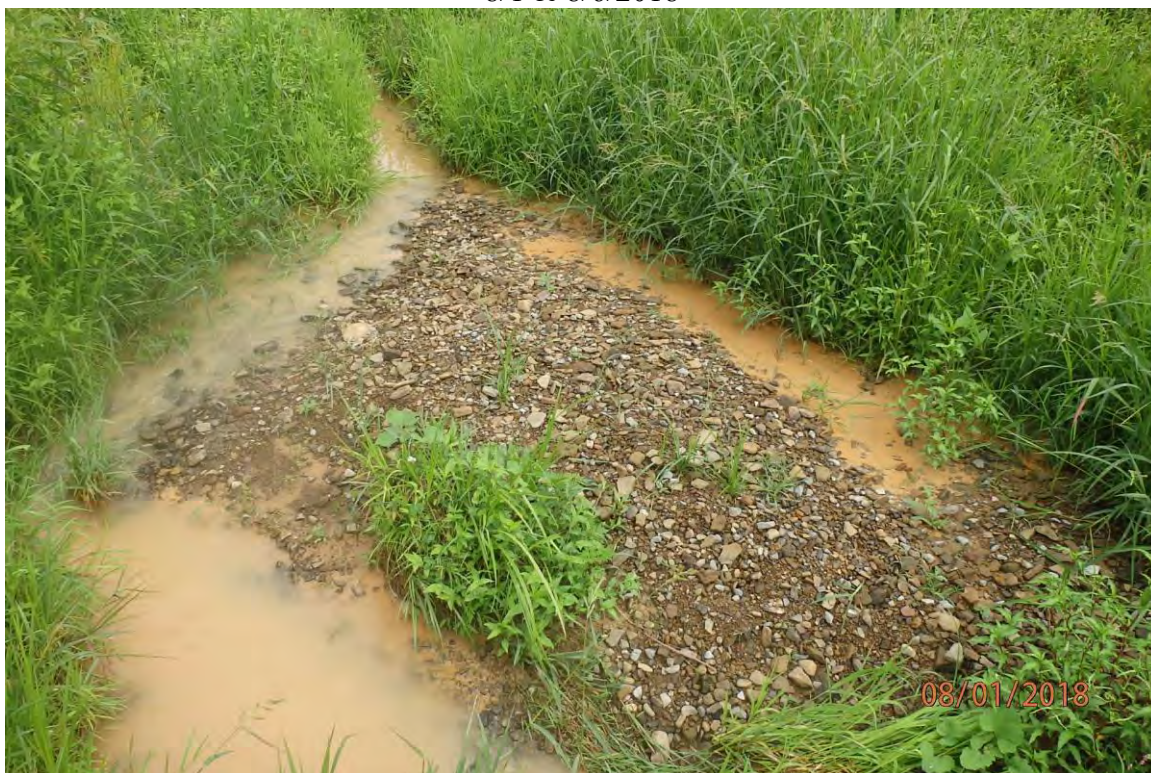
Visible plume in Goose Run (39° 26.17952' X 80° 28.5256') originating from site.

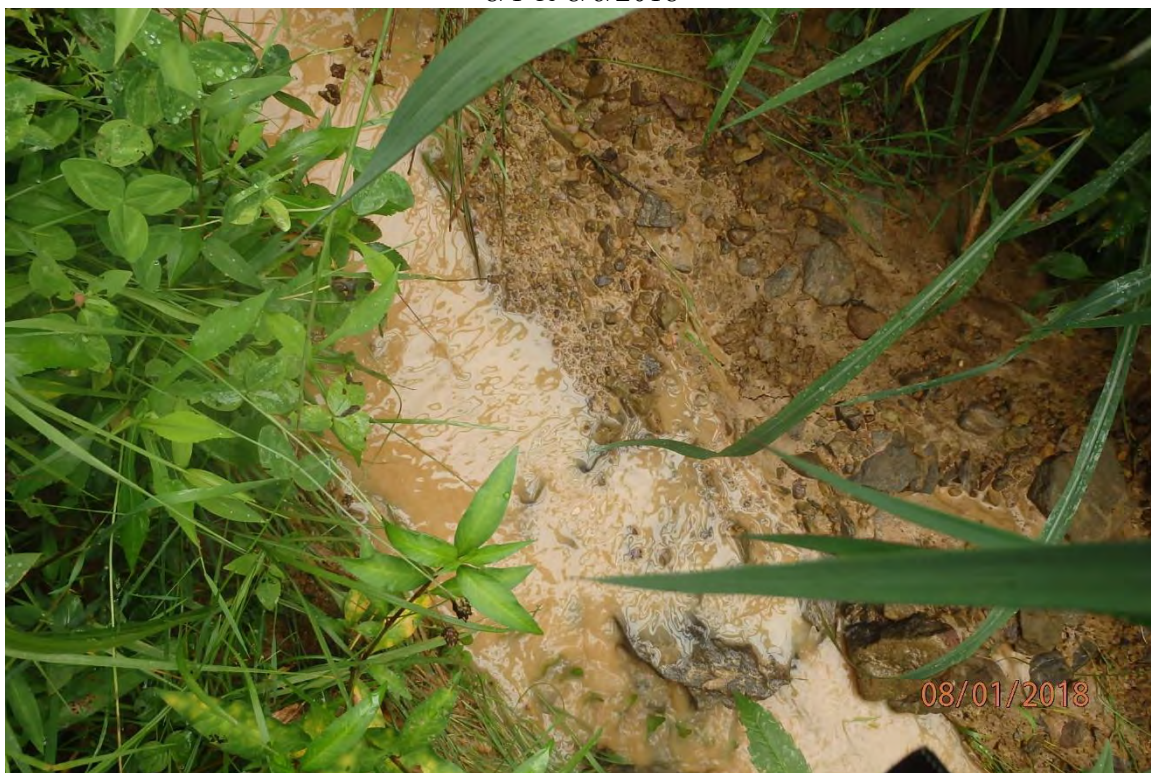
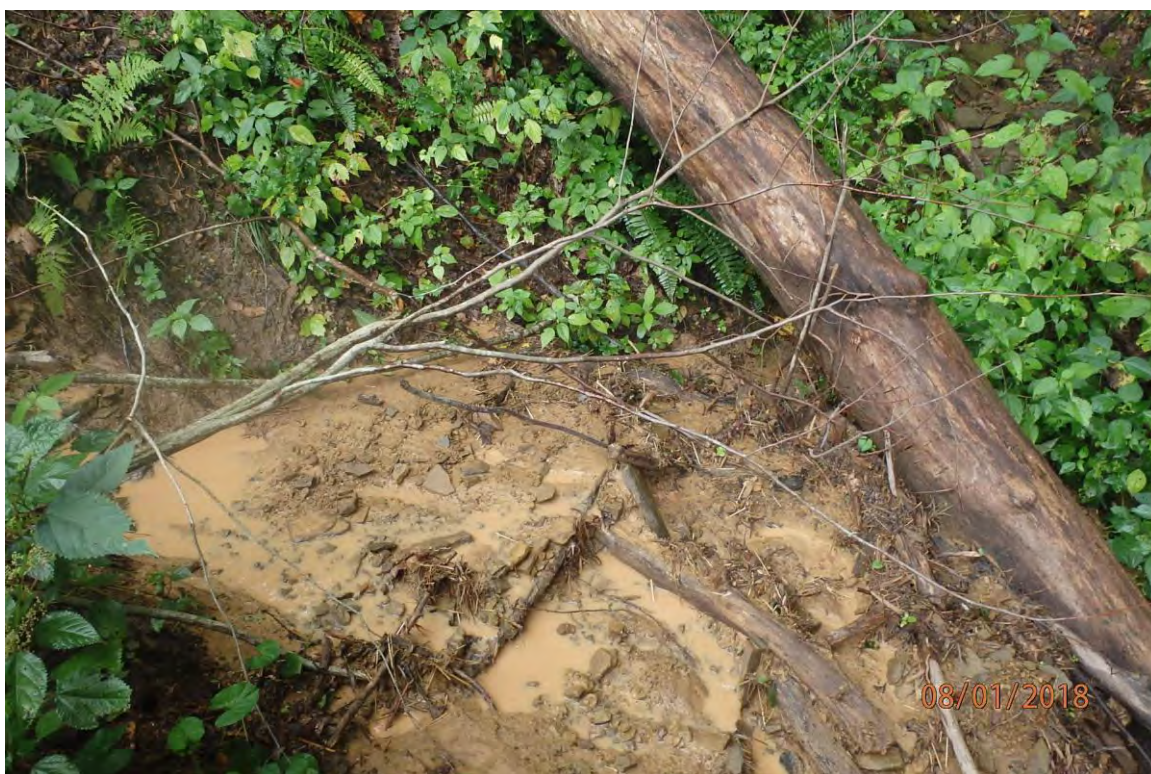
CNA offsite sediment deposits and visible plume in UNT Goose Run (39° 26.100' X 80° 28.4922') originating from site. Deficiencies in site evaluation item numbers 19, 20 & 21 pictured.

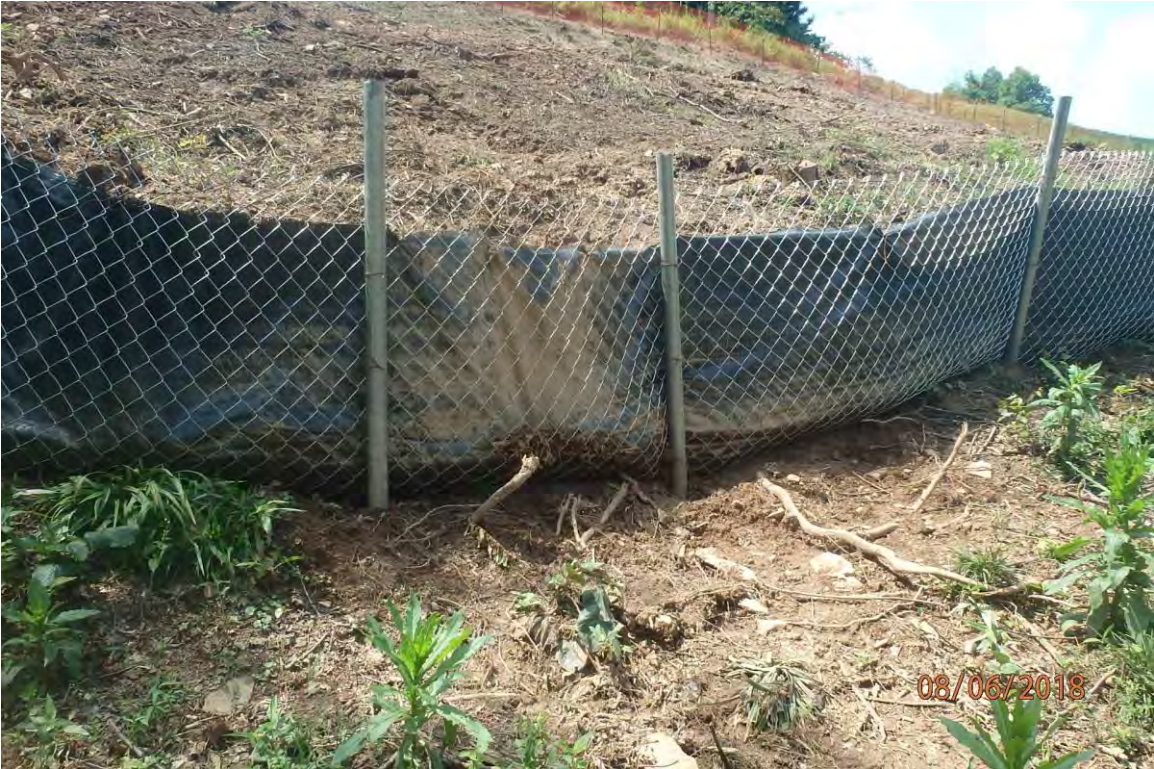
Perimeter control that was overwhelmed by concentrated flow and caused CNA deposits in Seal Run. Deficiencies in site evaluation item numbers 1, 2, 6, 7, 13, 14, 19, 20 & 21 pictured.
