**The Wilderness Society et al. Comments on the
U.S. Forest Service Mountain Valley Pipeline and
Equitrans Expansion Project Draft Supplemental
Environmental Impact Statement (#50036)**

**WEST VIRGINIA DEPARTMENT OF ENVIRONMENTAL PROTECTION
WV OIL AND GAS CONSTRUCTION STORMWATER PERMIT**

FACILITY NAME:	Mountain Valley Pipeline Project			REG. #	EXPIRE DATE:
PERMITTEE	MOUNTAIN VALLEY PIPELINE, LLC			WVR310667	5/13/2018
ADDRESS/PHONE:	Attn: Matt Hoover 625 LIBERTY AVE, ST 1700 PITTSBURGH, PA 15222				
LOCATION:	Wileyville, WV			Entry Date/Time:	4/3/18 8:30am
COUNTY:	Wetzel			Exit Date/Time:	4/3/18 1:37pm
Site Representative /Phone	Matt Hoover Sr. Environmental Coordinator (412) 258-5627			PHOTOS <input checked="" type="checkbox"/>	
CO-PERMITTEE:				ADDRESS:	
SITE OPERATOR:	Precision Pipeline			ADDRESS:	
PERMITTED ACREAGE	4214	WEATHER:	Rain	LAST INSPECTION:	N/A
RECEIVING STREAM(S)	Mobley Run > Ohio River				NOV: 1
Regular Mail <input type="checkbox"/> Certified Mail <input checked="" type="checkbox"/>	Tracking #				
OVERALL FACILITY RATING:	Unsatisfactory		COMPLIANCE OUTCOME	Not Immediately Corrected

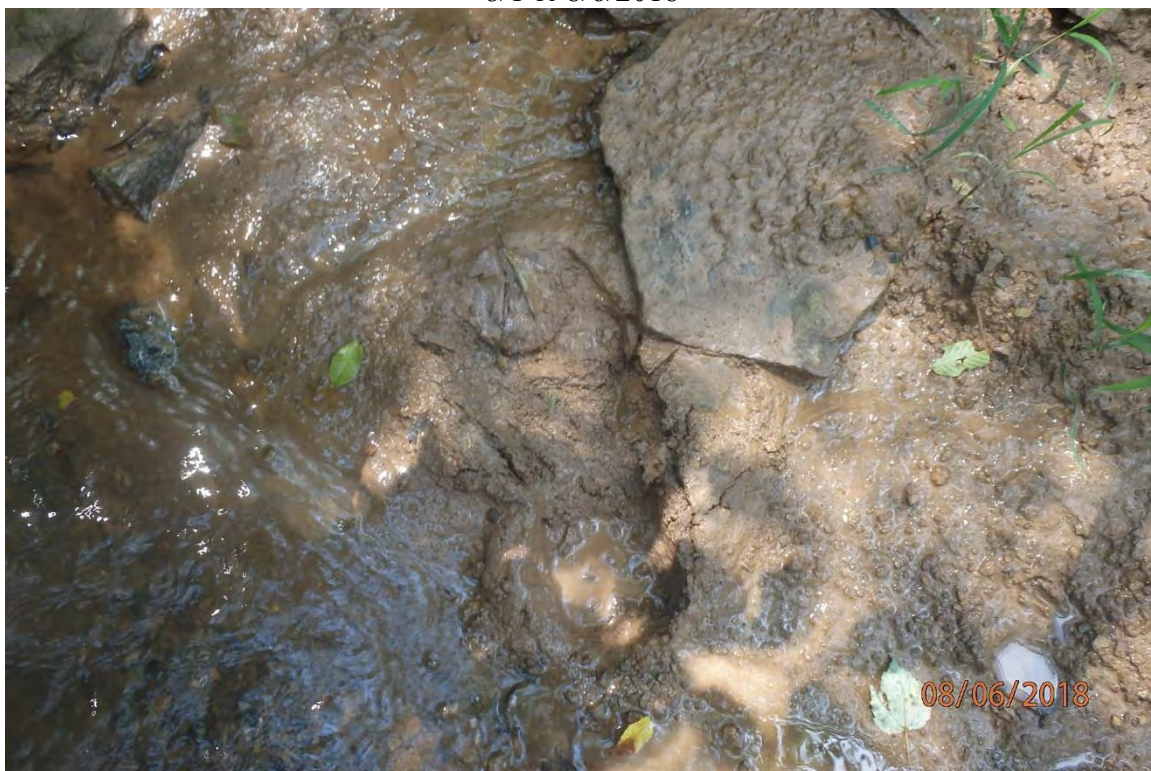
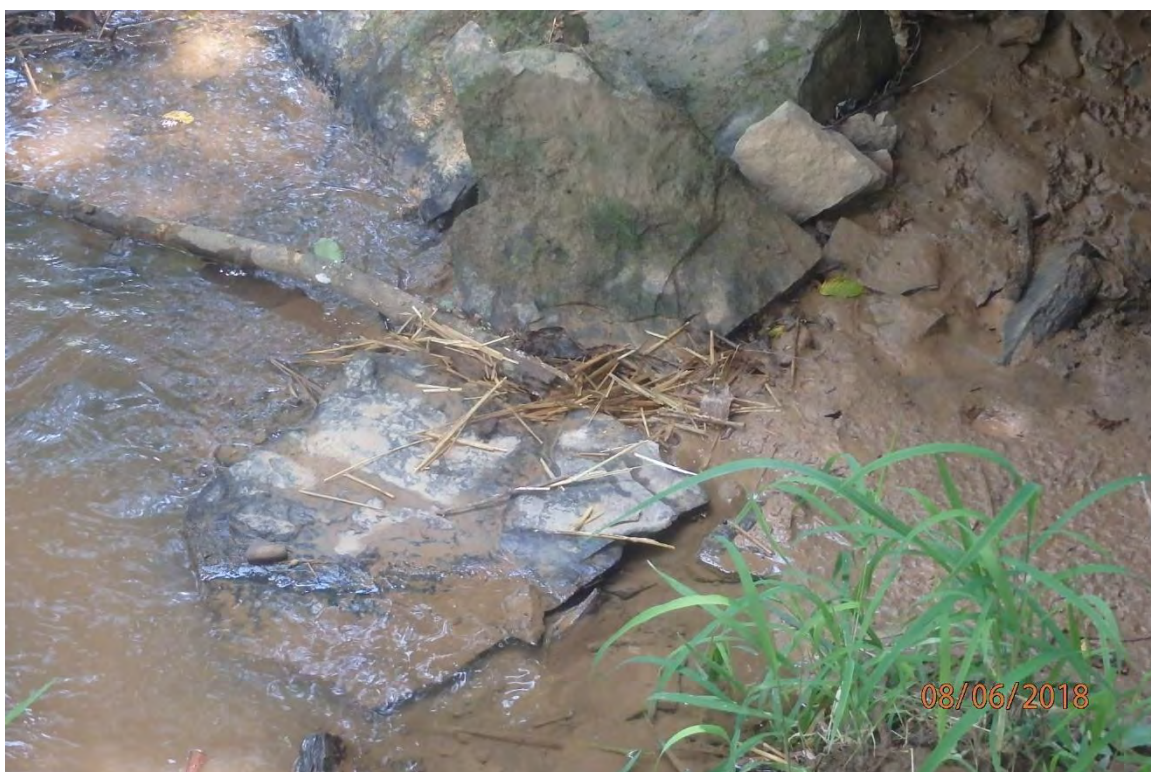
CNA offsite deposits in Seal Run (39° 20.4891' X 80° 30.7324') that originate from site. Deficiencies in site evaluation item numbers 19, 20 & 21 pictured.

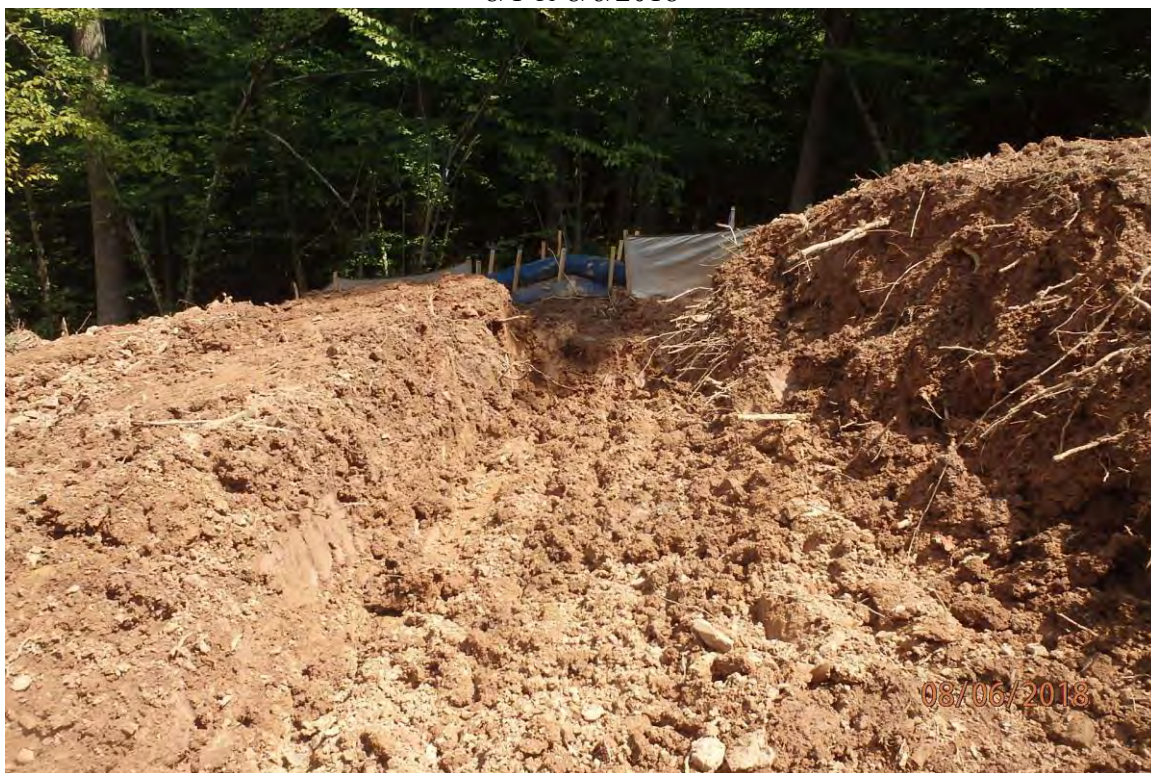
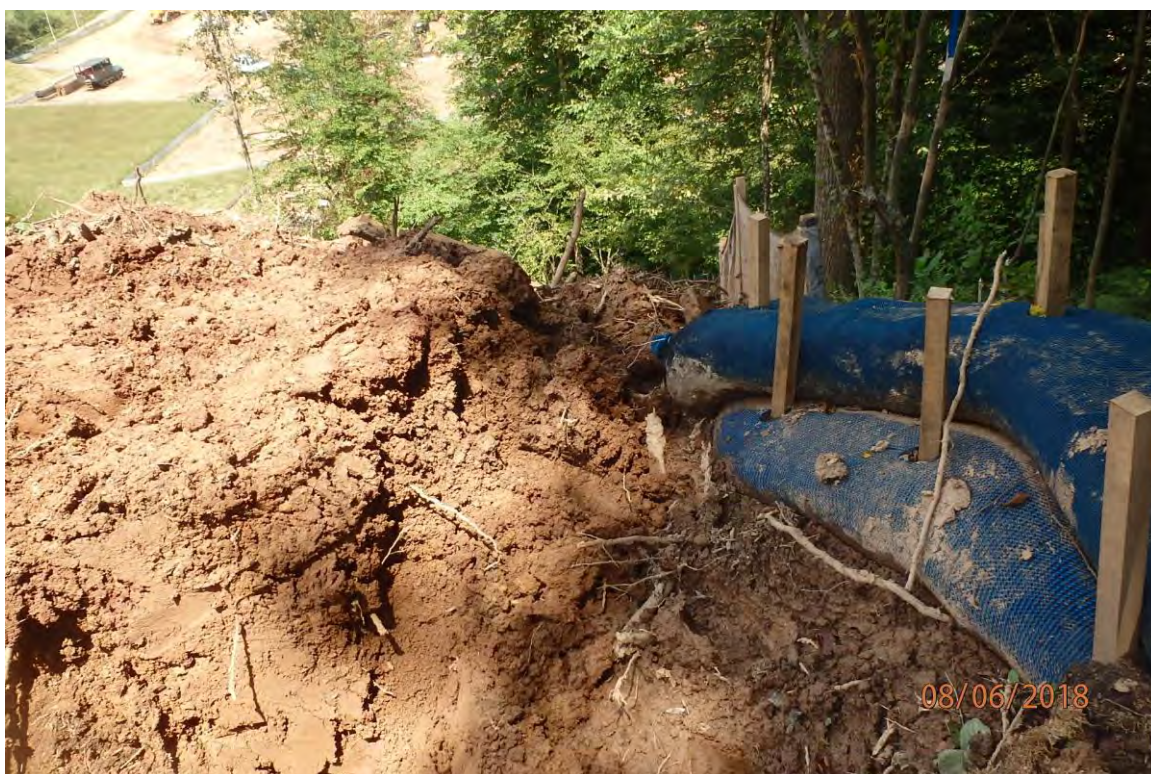
Water bar in Grass Run watershed that is improperly installed and led to CNA deposits in the stream.
Deficiencies in site evaluation item numbers 1, 2, 6, 7, 8, 14, 19, 20 & 21 pictured.

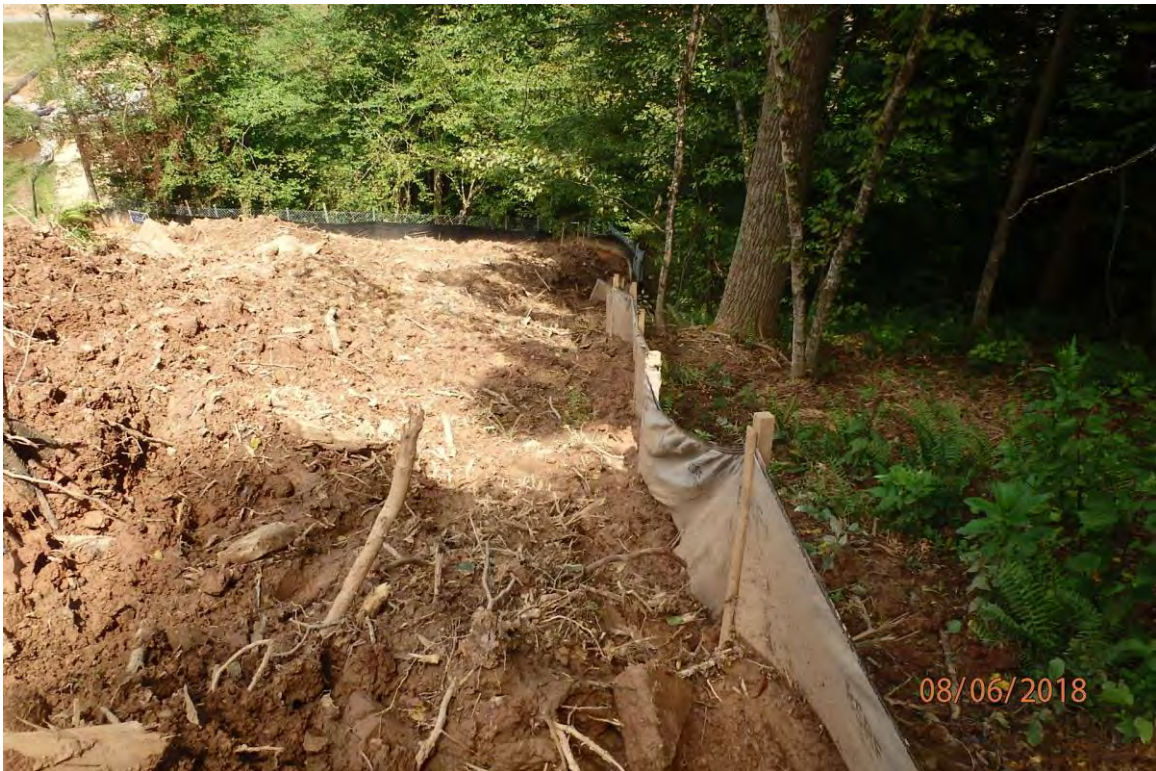
Concentrated flow being directed over fill slope into a sheet flow super silt fence from improperly installed water bars in Grass Run.

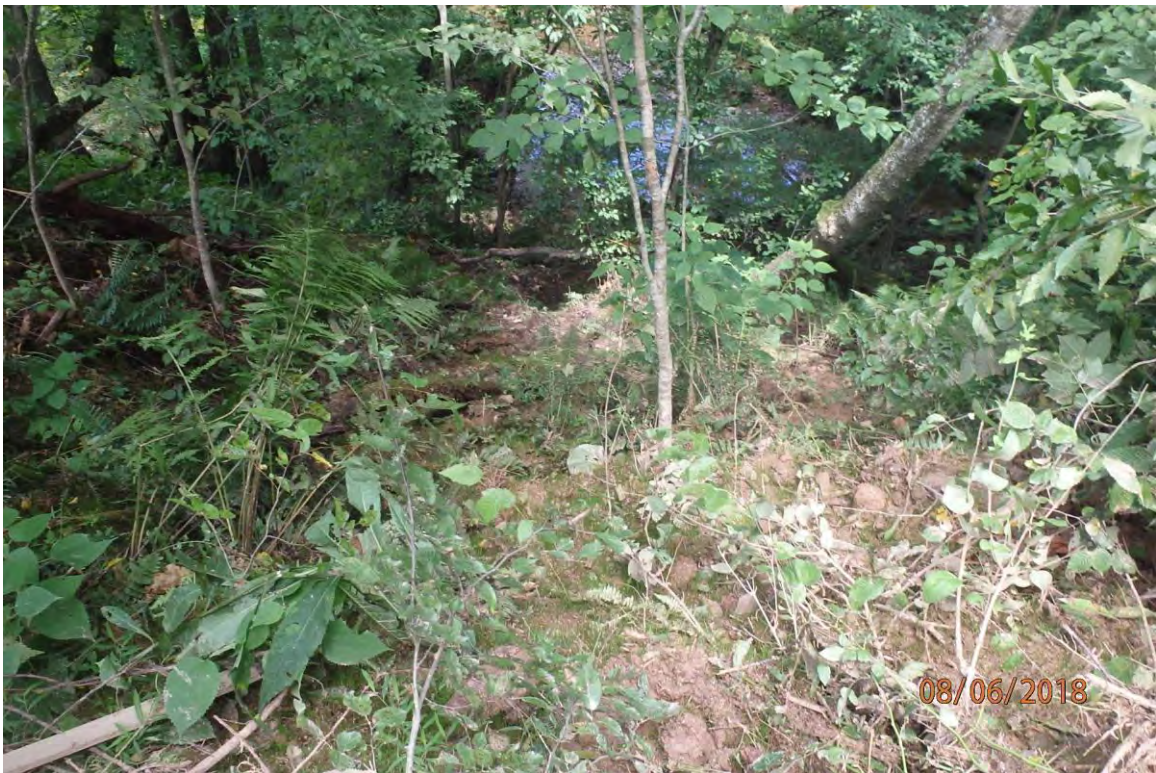
Offsite sediment deposits in Grass Run watershed that lead from site to the receiving stream due to above pictured issue. Deficiencies in site evaluation item numbers 1, 2, 6, 7, 13, 14, 19, 20 & 21 pictured.

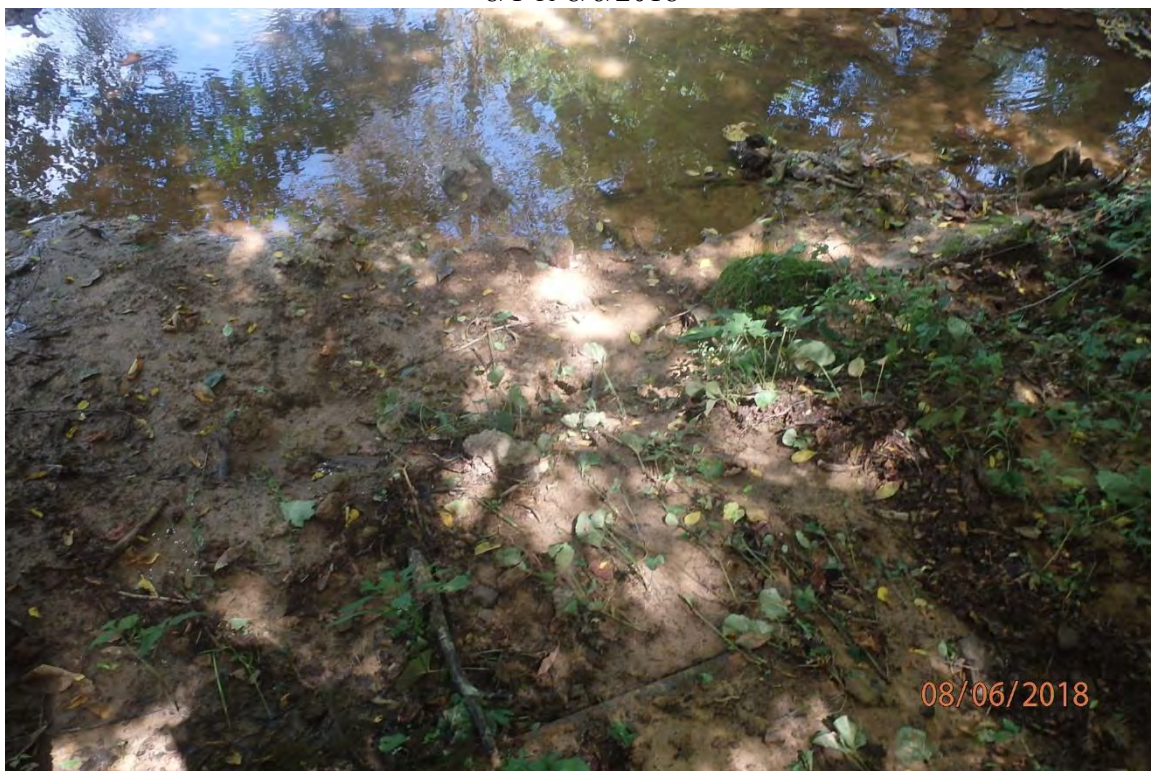
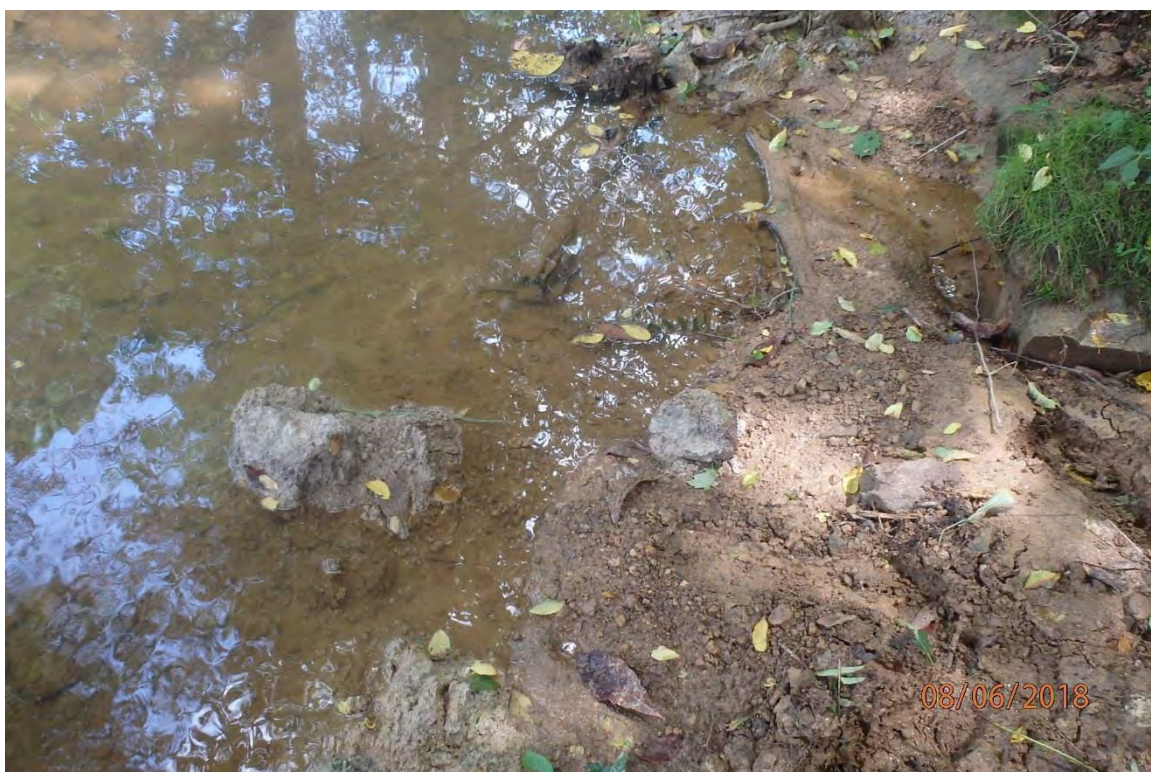
Offsite CNA deposits in Grass Run (39° 20.1127' X 80° 31.3233') that originate from site. Deficiencies in site evaluation item numbers 19, 20 & 21 pictured.

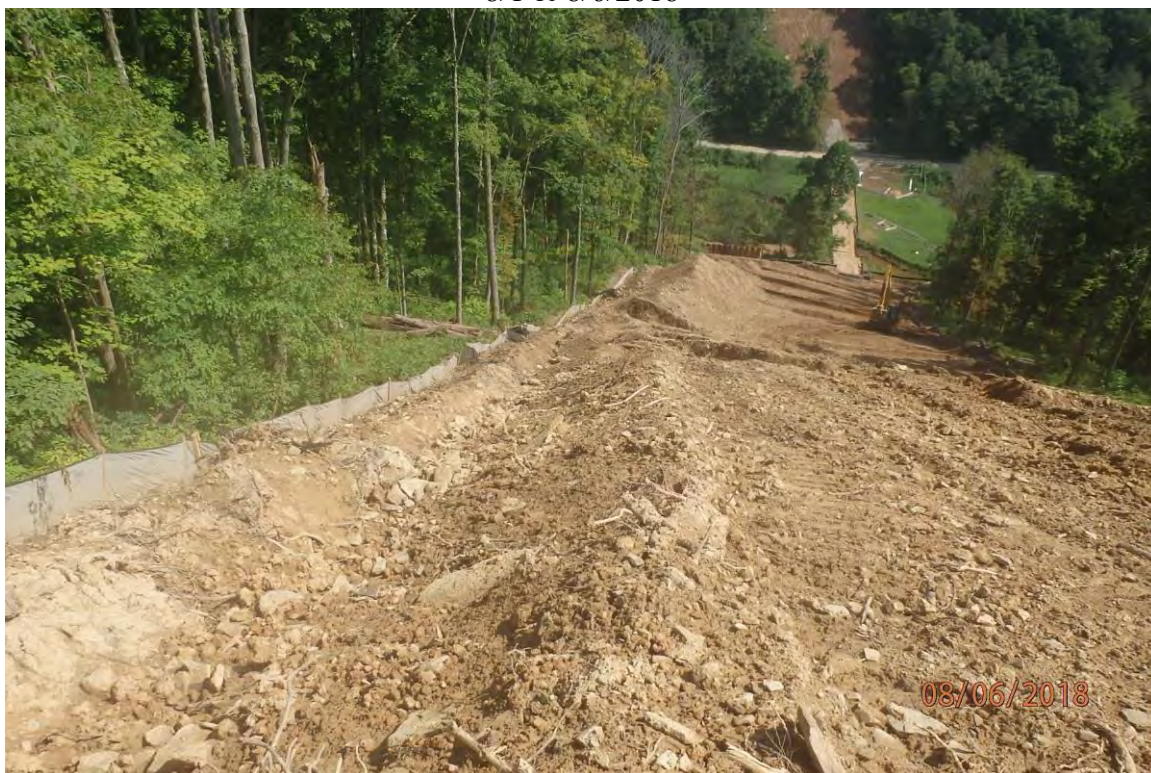
Rockcamp Run watershed.

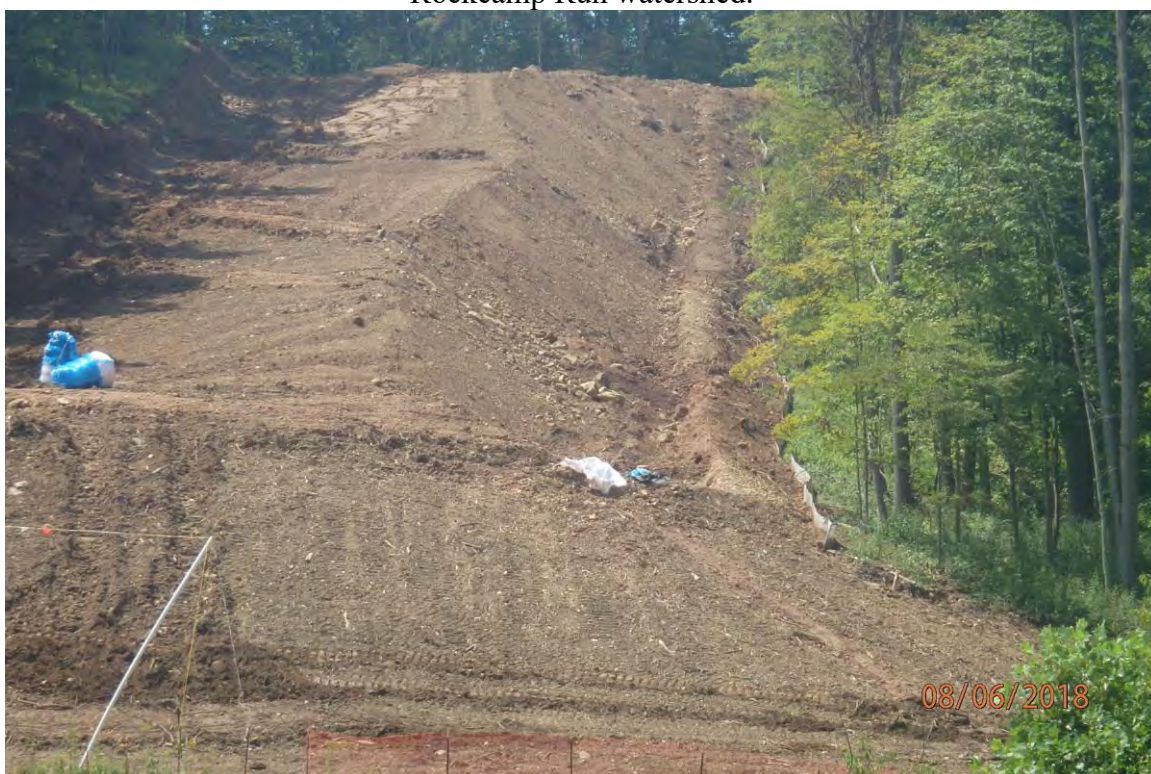
Seal Run watershed.

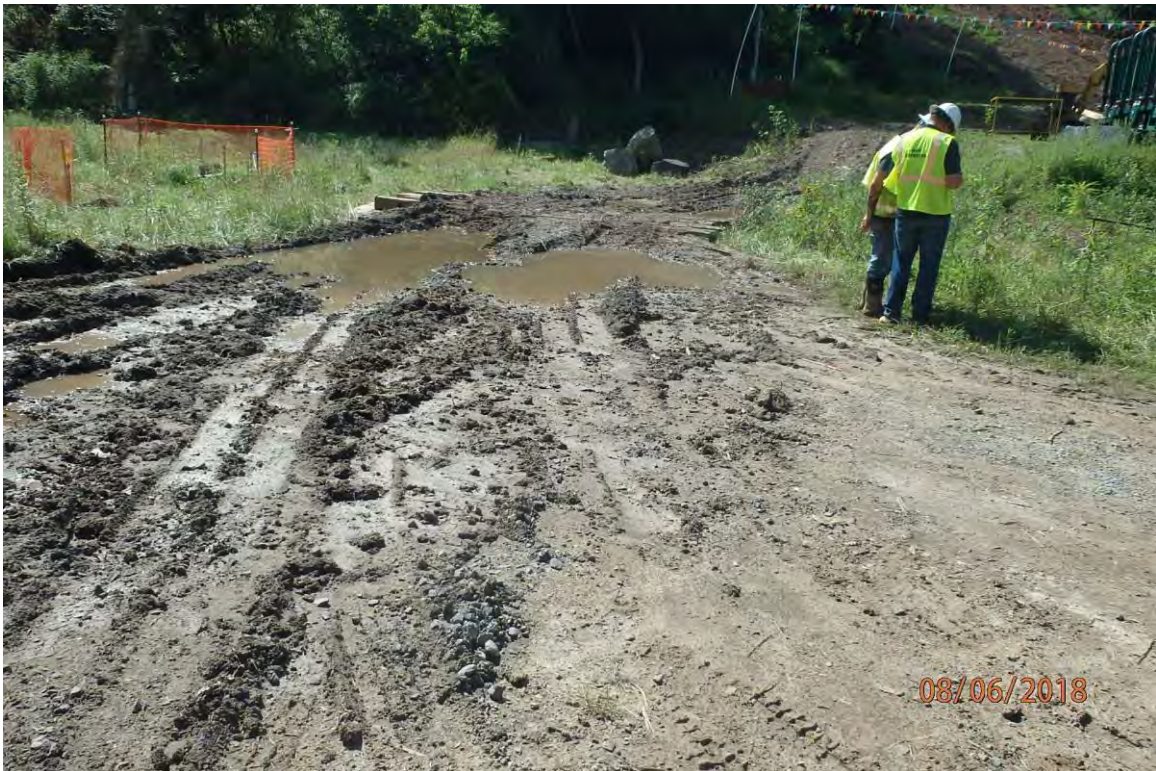
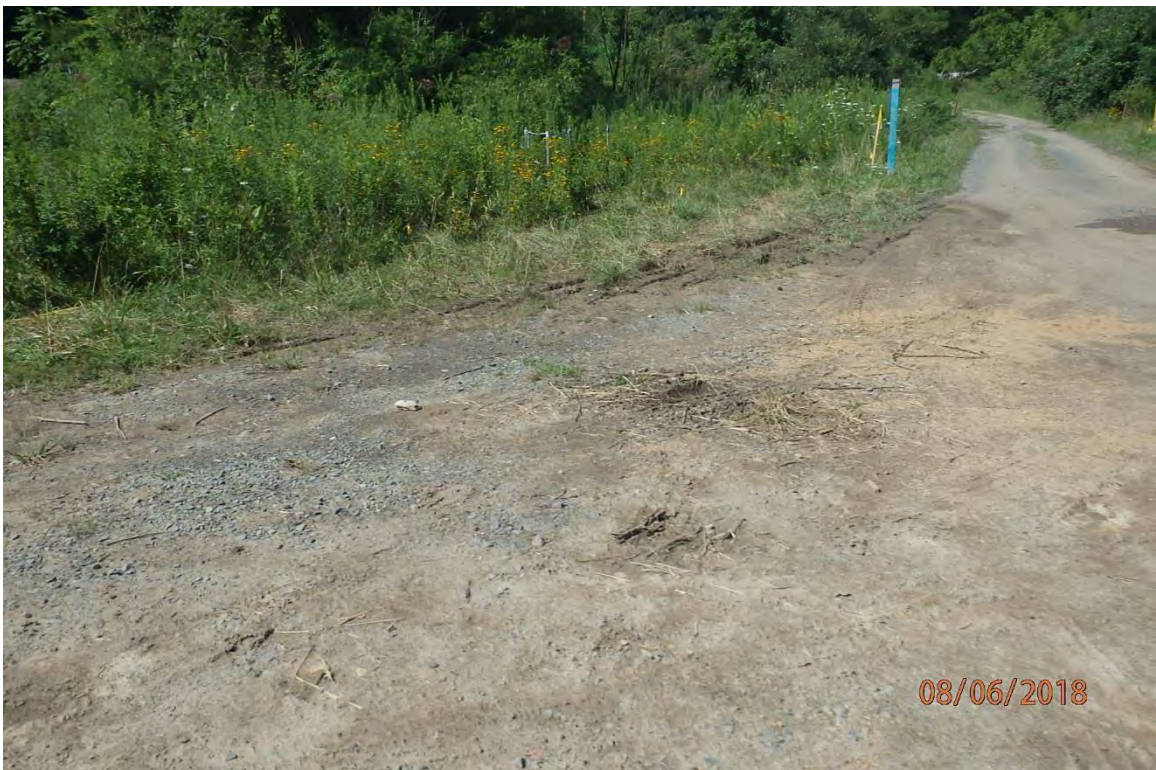
Area adjacent to wetland (W-UU1) in the Salem Fork watershed that lacks the BMPs that are indicated in the approved SWPPP. Marginal deficiencies in site evaluation item numbers 1, 13, 15, 19 & 21 pictured.

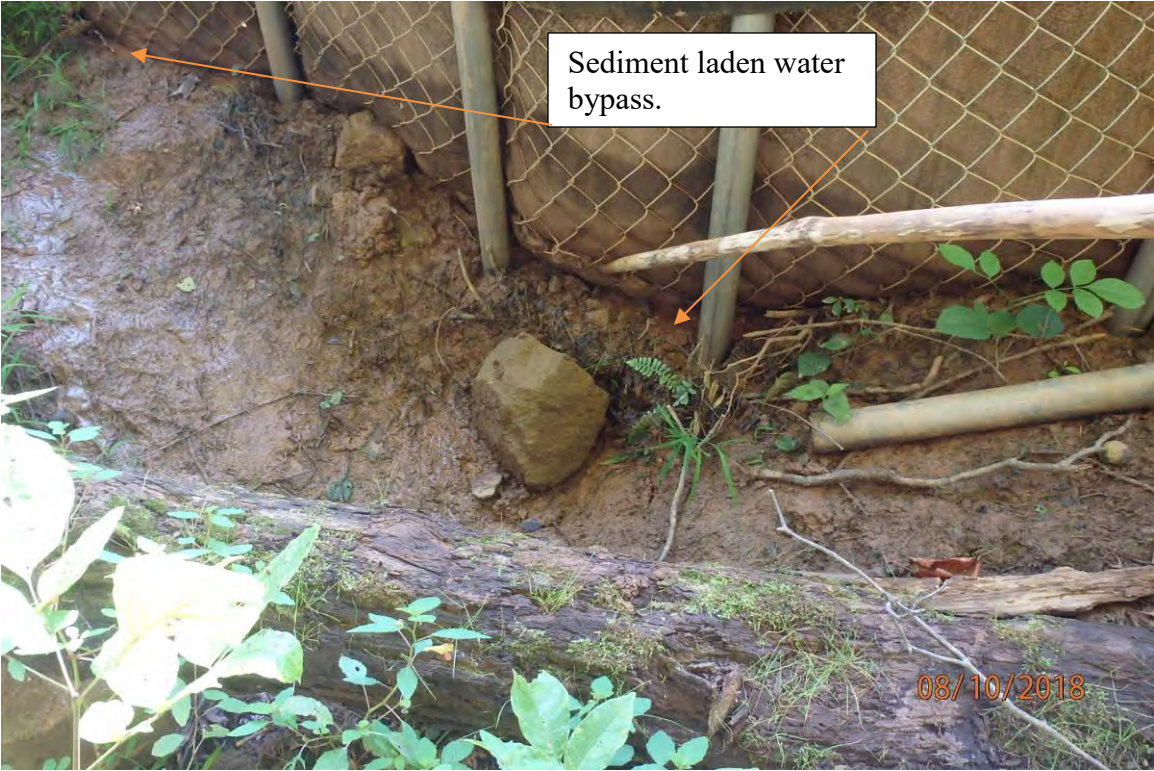
Improperly operated and maintained BMP at a water bar terminus in the Meathouse Fork watershed that led to CNA deposits and distinctly visible settleable solids in UNT Meathouse Fork (39° 11.891' X 80° 33.209'). Deficiencies in site evaluation item numbers 6, 7, 19, 20 & 21 pictured.

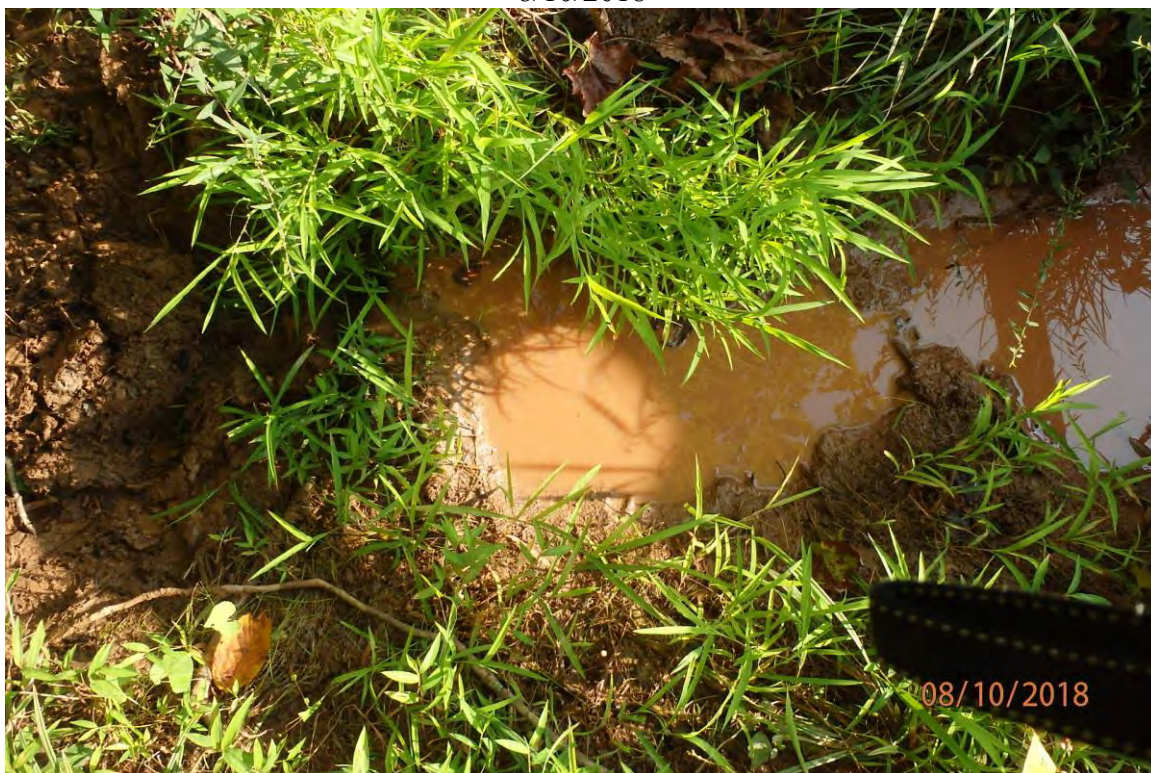
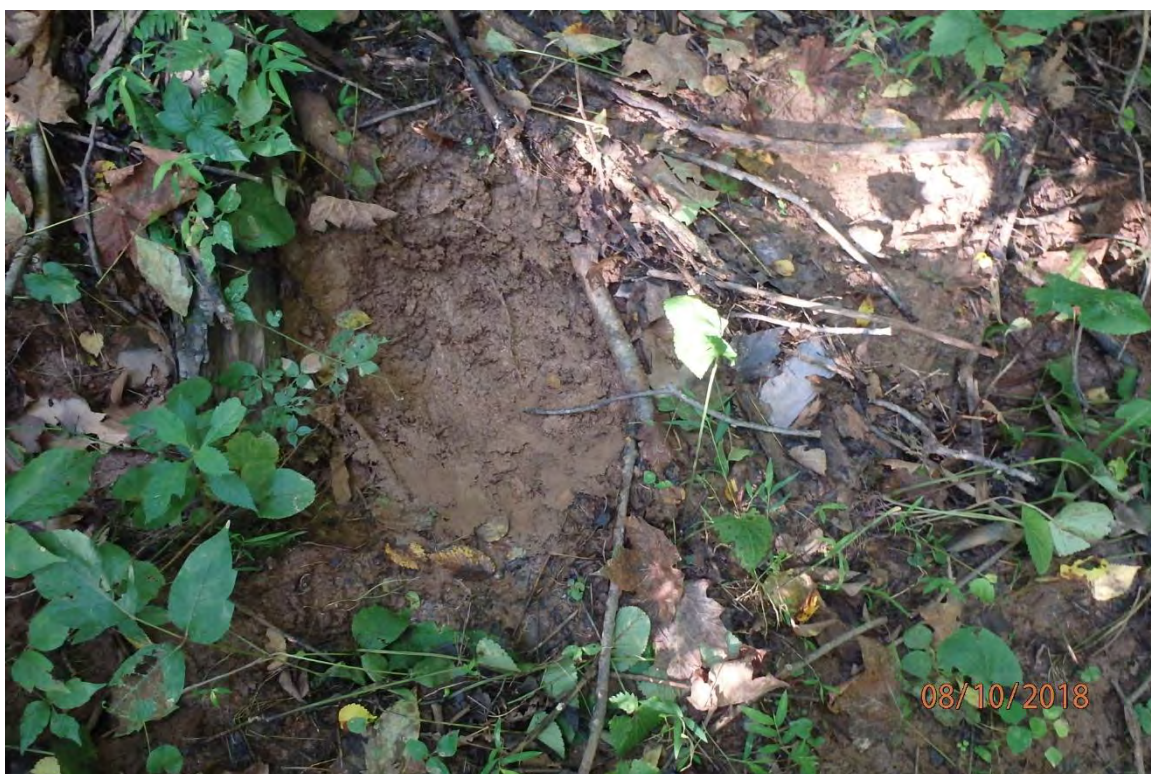
CNA deposits and distinctly visible settleable solids in UNT Meathouse Fork (39° 11.891' X 80° 33.209') that originate from site because of the previously pictured deficiencies. Deficiencies in site evaluation item numbers 6, 7, 19, 20 & 21 pictured.

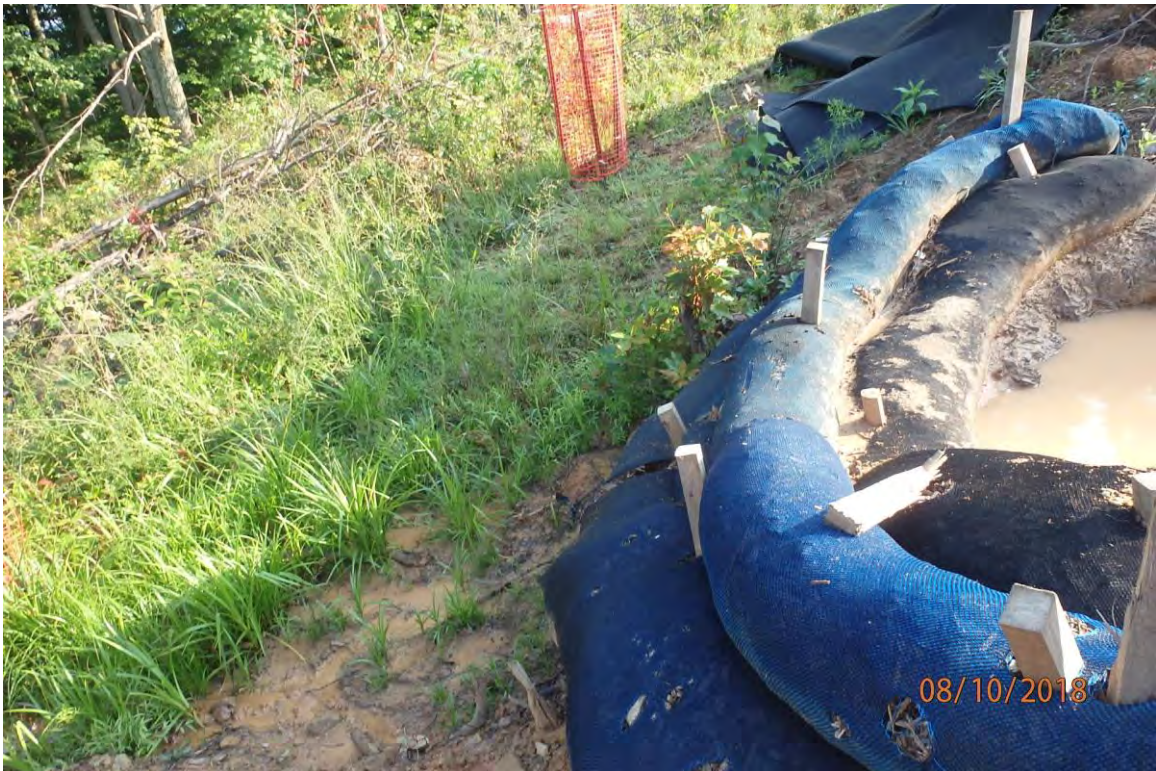
Water bar terminus that discharges onto MVP-DO-049 access road.

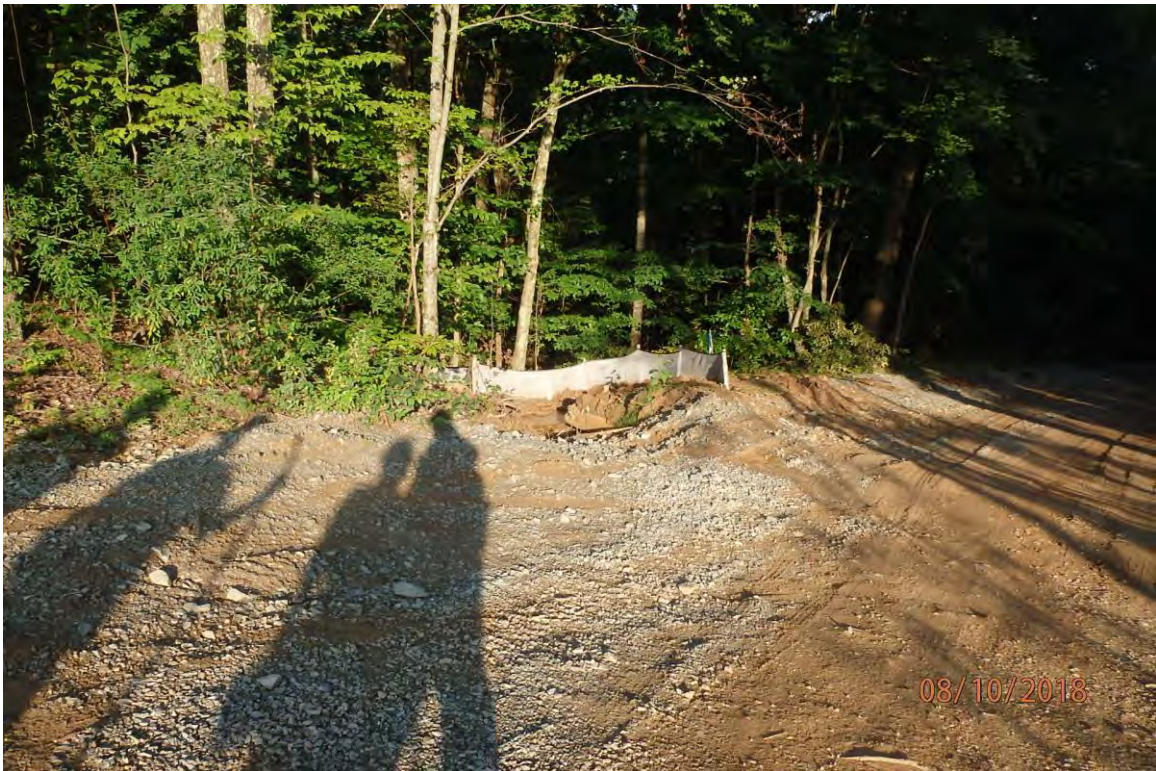
BMP that is handling stormwater from the above pictured drainage area (recently replaced).

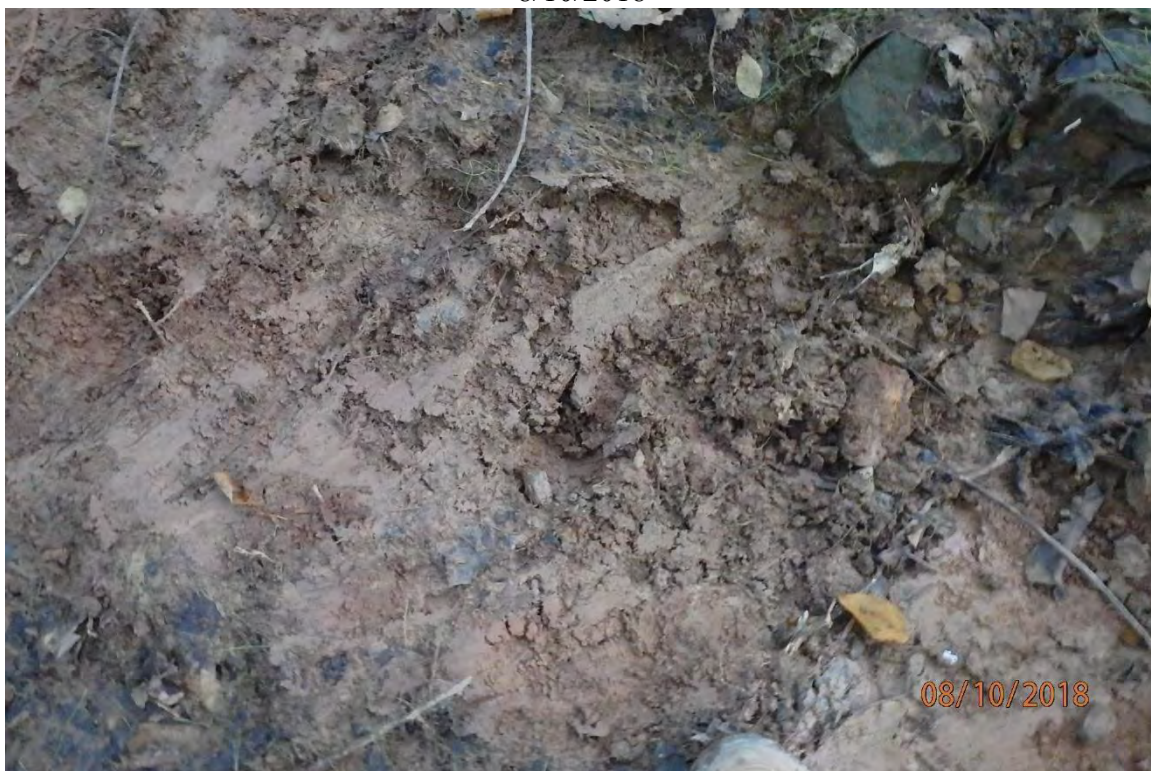
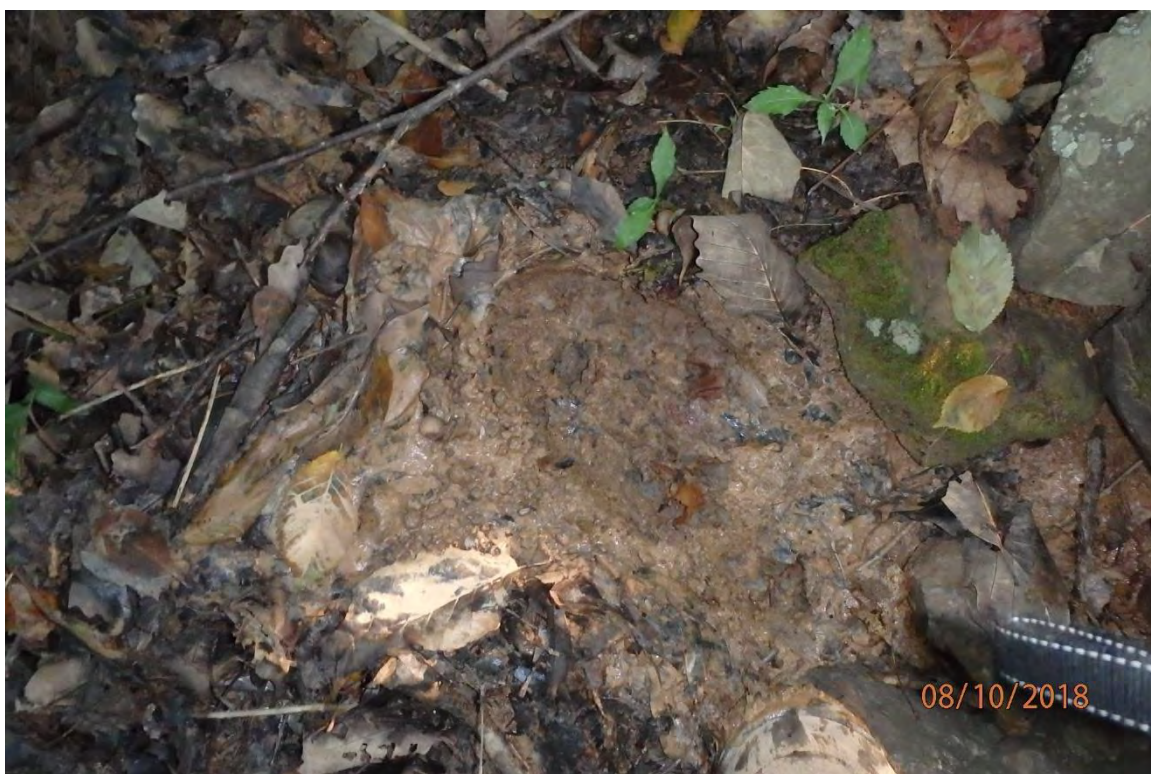
CNA deposits in UNT Dry Fork (39° 11.377' X 80° 33.566') that originate from site. Evidence of a portion of the deposits being removed by shovel was noted. Deficiencies in site evaluation item numbers 6, 7, 19, 20 & 21 pictured.

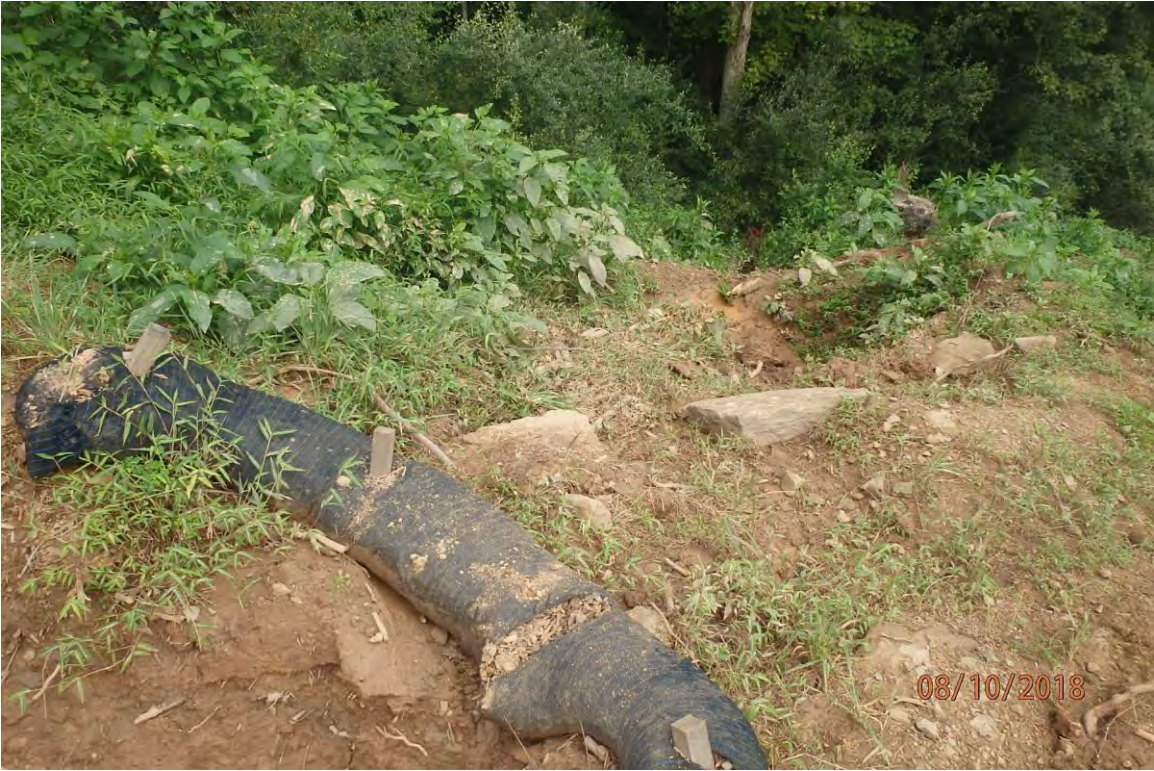
Water bar outlet indicated in above picture that allowed sediment laden water to leave the site and cause CNA in UNT Kincheloe Creek (39° 10.006' X 80° 34.736'). Deficiencies in site evaluation item numbers 2, 6, 7, 8, 14, 19, 20 & 21 pictured.

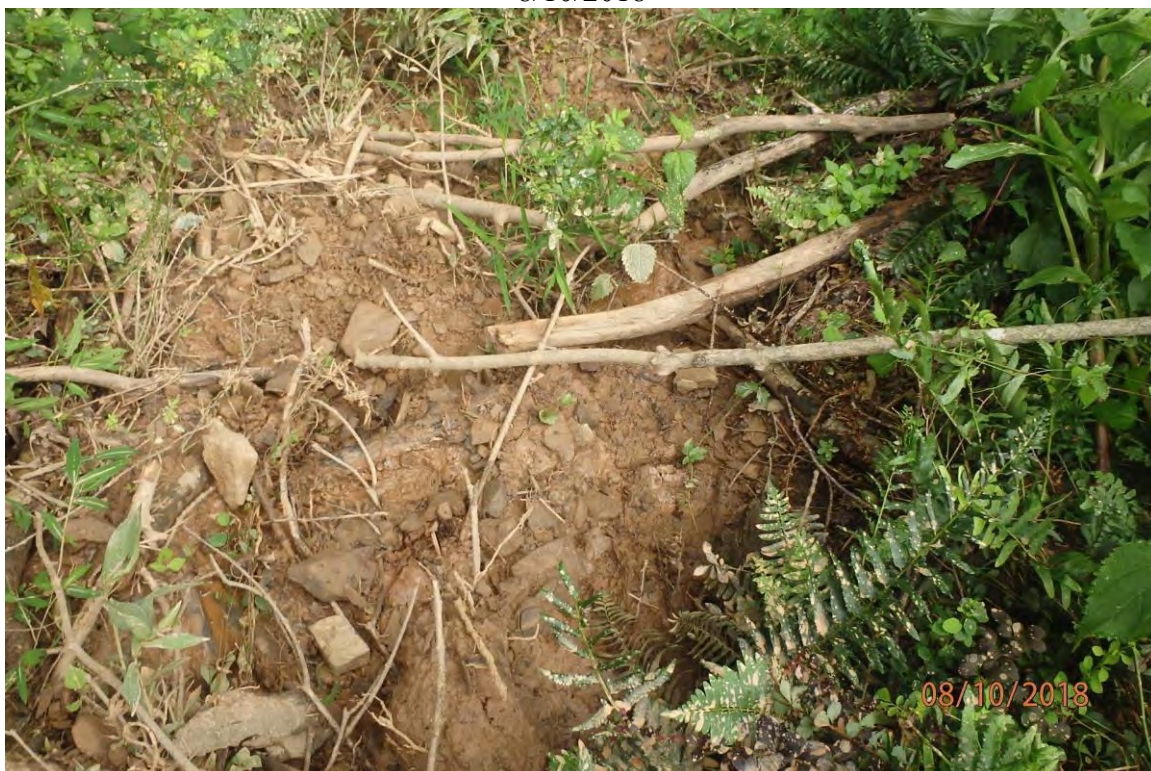
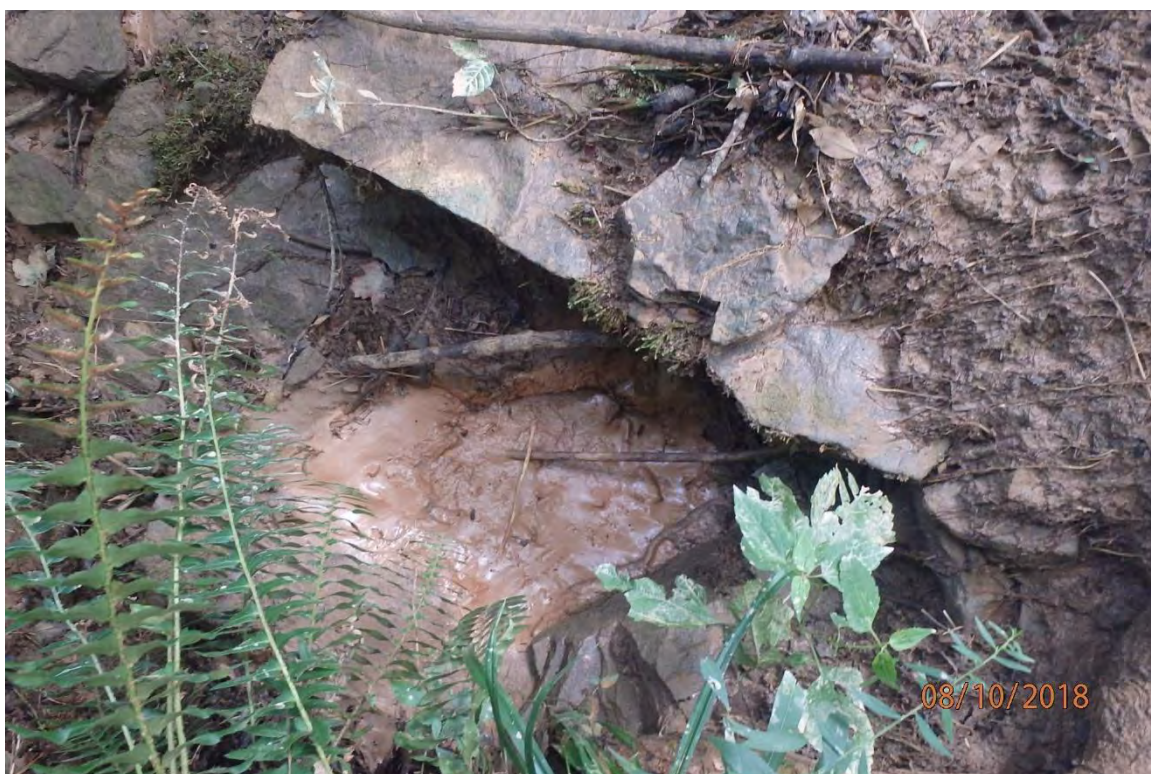
CNA deposits in UNT Kincheloe Creek (39° 10.006' X 80° 34.736') that originate from site. Deficiencies in site evaluation item numbers 2, 6, 7, 8, 14, 19, 20 & 21 pictured.

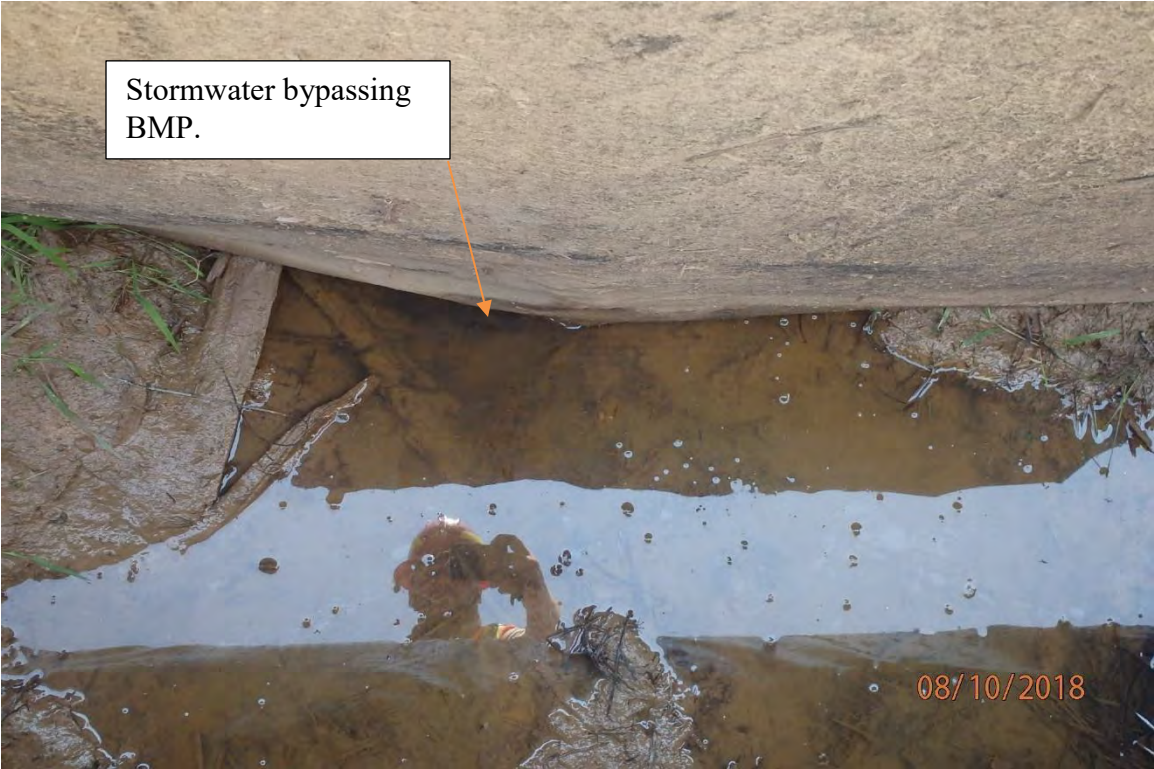
Improperly operated and maintained perimeter controls adjacent to the WJ-40 crossing led to offsite sediment deposits and CNA deposits in Wetland UNT Kincheloe Creek (WJ-40) (39° 10.060' X 80° 34.626'). Deficiencies in site evaluation item numbers 1, 6, 19, 20 & 21 pictured.

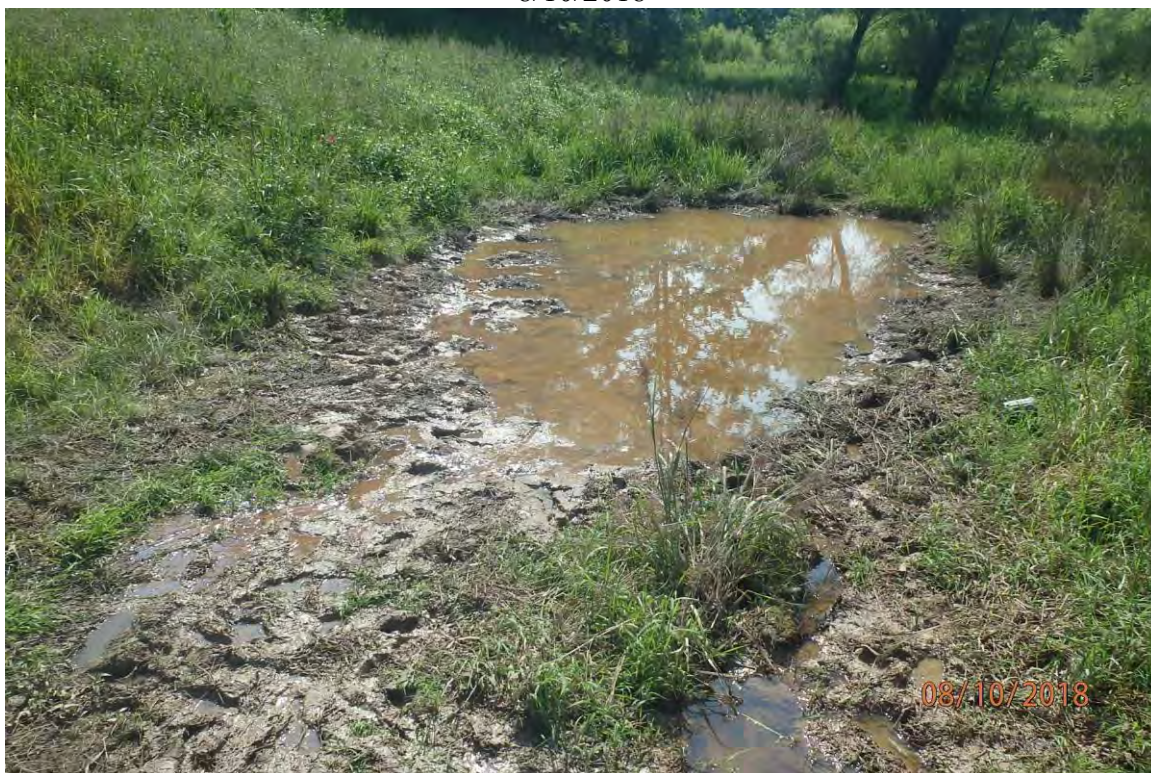
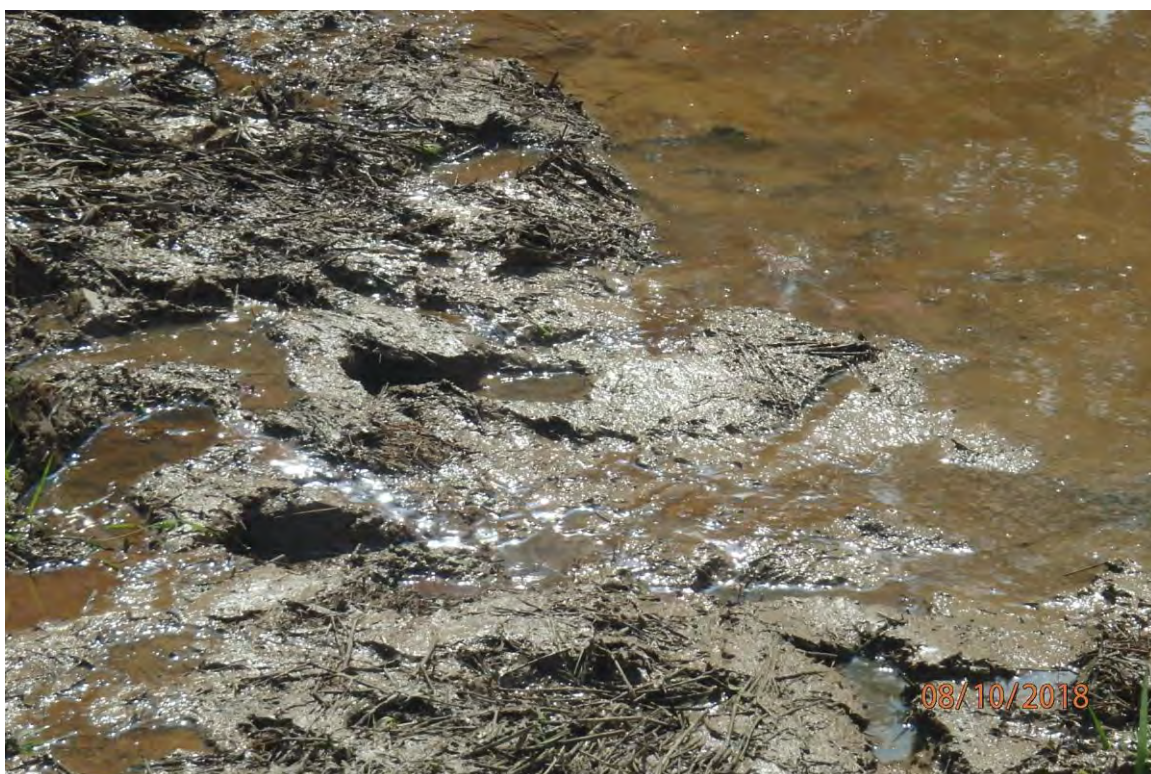
CNA deposits in Wetland UNT Kincheloe Creek (WJ-40) (39° 10.060' X 80° 34.626') that originate from site. Deficiencies in site evaluation item numbers 1, 6, 19, 20 & 21 pictured.
