**The Wilderness Society et al. Comments on the
U.S. Forest Service Mountain Valley Pipeline and
Equitrans Expansion Project Draft Supplemental
Environmental Impact Statement (#50036)**

**WEST VIRGINIA DEPARTMENT OF ENVIRONMENTAL PROTECTION
WV OIL AND GAS CONSTRUCTION STORMWATER PERMIT**

FACILITY NAME:	Mountain Valley Pipeline Project			REG. #	EXPIRE DATE:
PERMITTEE	MOUNTAIN VALLEY PIPELINE, LLC			WVR310667	5/13/2018
ADDRESS/PHONE:	Attn: Matt Hoover 625 LIBERTY AVE, ST 1700 PITTSBURGH, PA 15222				
LOCATION:	Wileyville, WV			Entry Date/Time:	4/3/18 8:30am
COUNTY:	Wetzel			Exit Date/Time:	4/3/18 1:37pm
Site Representative /Phone	Matt Hoover Sr. Environmental Coordinator (412) 258-5627			PHOTOS <input checked="" type="checkbox"/>	
CO-PERMITTEE:				ADDRESS:	
SITE OPERATOR:	Precision Pipeline			ADDRESS:	
PERMITTED ACREAGE	4214	WEATHER:	Rain	LAST INSPECTION:	N/A
RECEIVING STREAM(S)	Mobley Run > Ohio River				NOV: 1
Regular Mail <input type="checkbox"/> Certified Mail <input checked="" type="checkbox"/>	Tracking #				
OVERALL FACILITY RATING:	Unsatisfactory		COMPLIANCE OUTCOME	Not Immediately Corrected

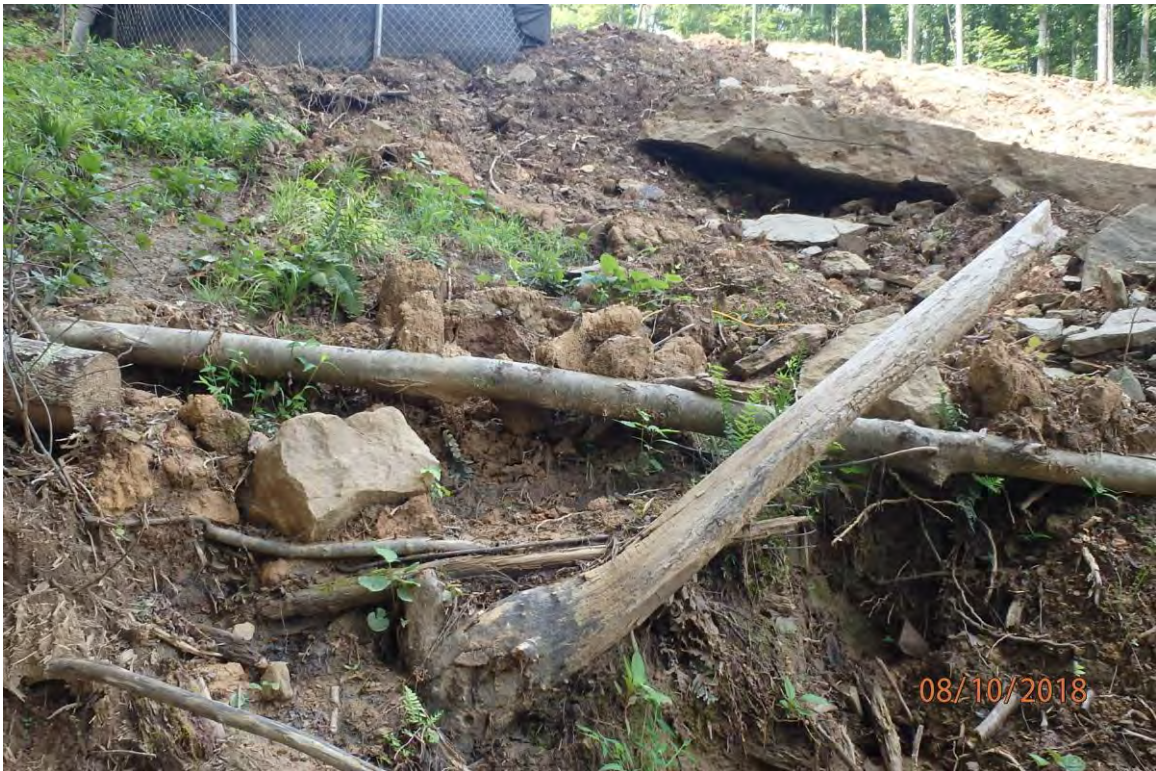
Water bar terminus BMP that was previously overwhelmed and led to CNA deposits pictured below. Water bar was altered to shed stormwater away from this area at the time of inspection.

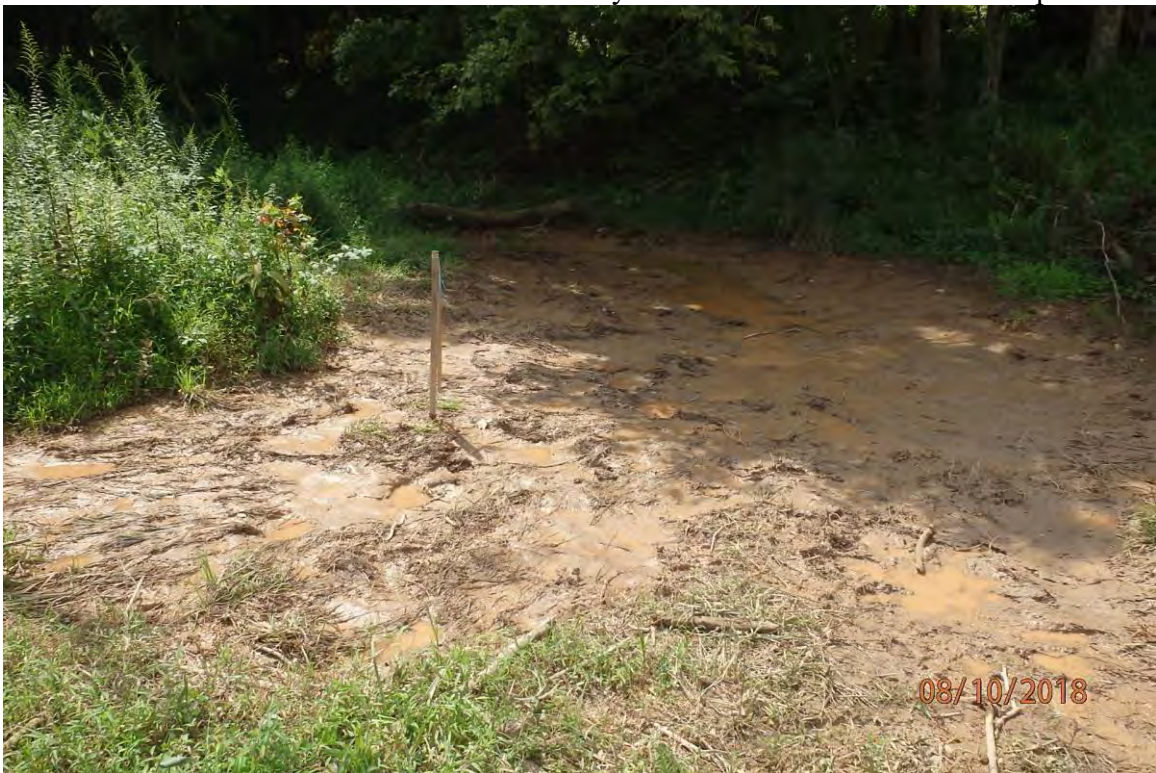
CNA deposits in wetland UNT Smoke Camp Run (W-I26) (39° 08.208' X 80° 34.610') that originate from site. Deficiencies in site evaluation item numbers 6, 7, 8, 14, 19, 20 & 21 pictured.

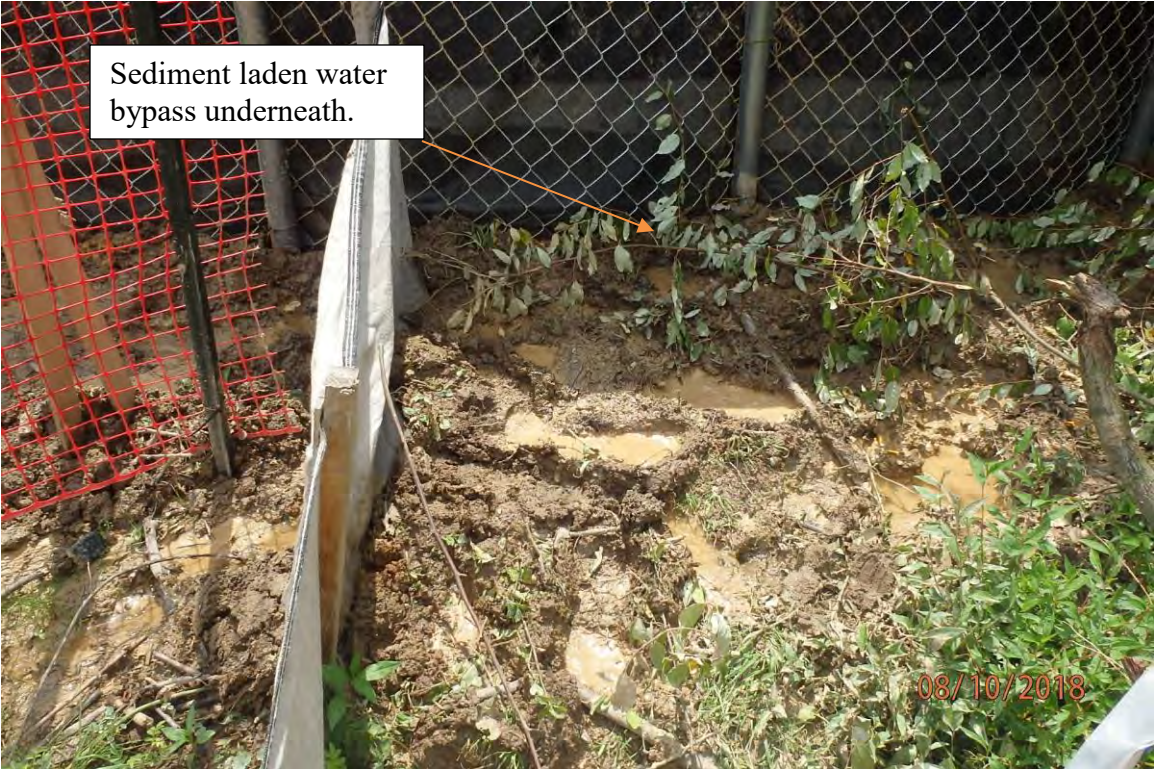
Water bar terminus BMP that was improperly operated and allowed sediment laden water to leave the site. This caused CNA deposits in wetland UNT Left Fork of Freemans Creek (W-B47) (39° 04.744' X 80° 34.904). Deficiencies in site evaluation item numbers 6, 7, 19, 20 & 21 pictured.

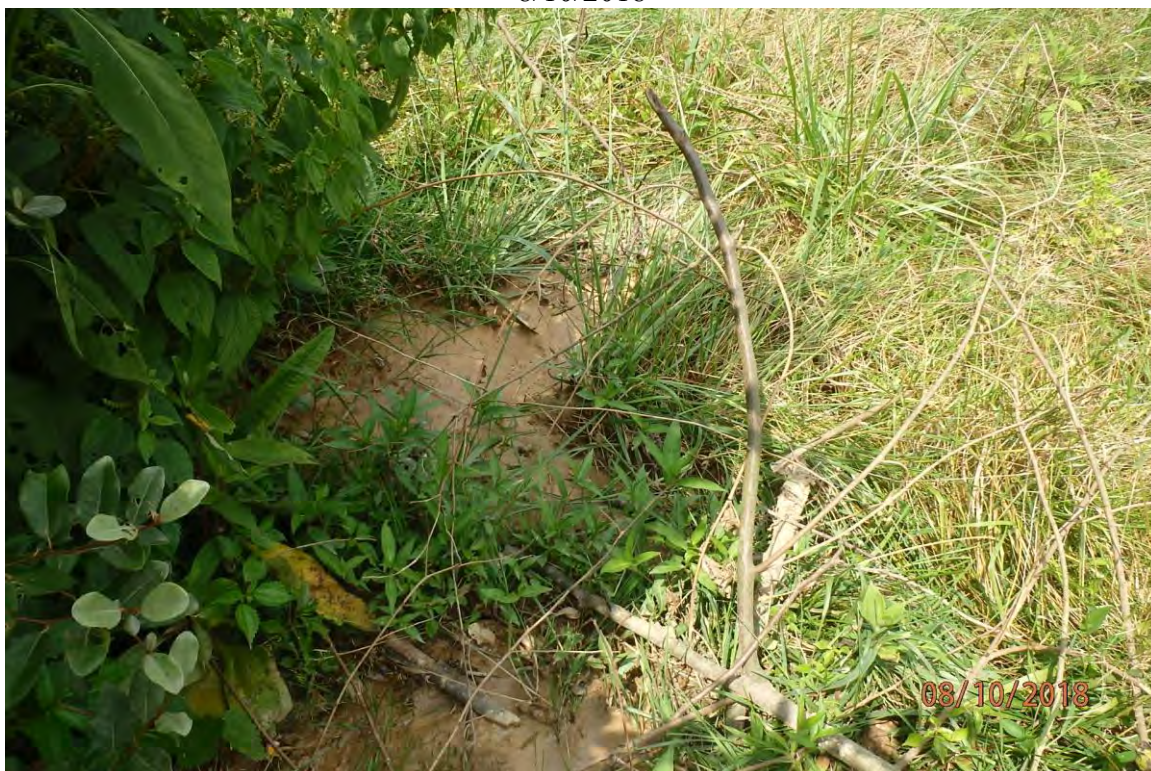
Offsite sediment trail leading to wetland W-B47 from the above pictured BMP.

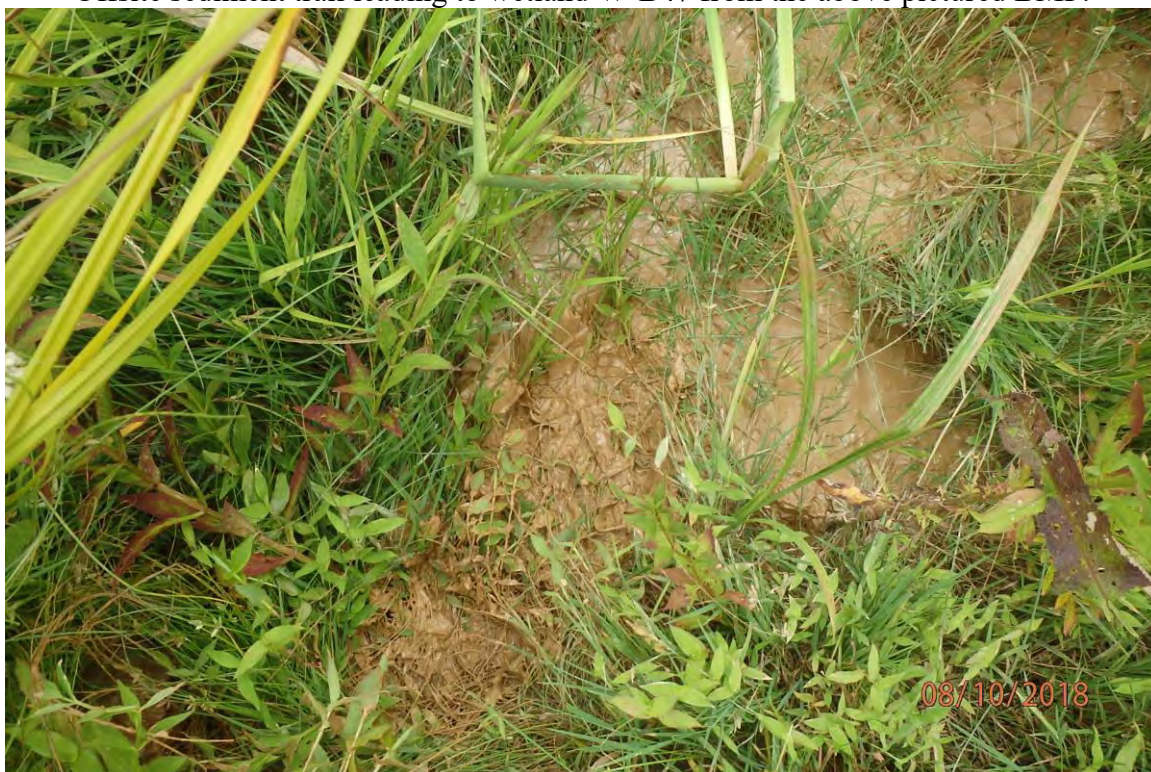
CNA deposits in wetland UNT Left Fork of Freemans Creek (W-B47) (39° 04.744' X 80° 34.904) that originate from site. Deficiencies in site evaluation item numbers 6, 7, 19, 20 & 21 pictured.

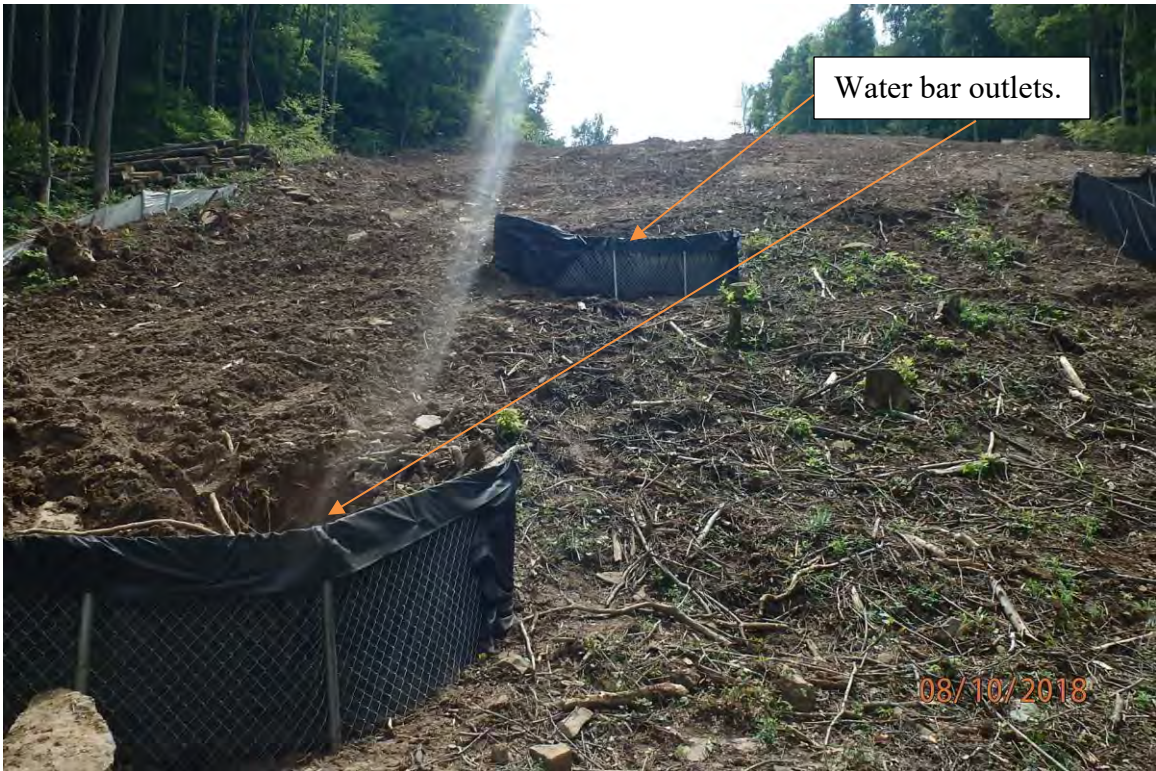
Improperly constructed water bars that do not shed stormwater off of the LOD in small quantities.

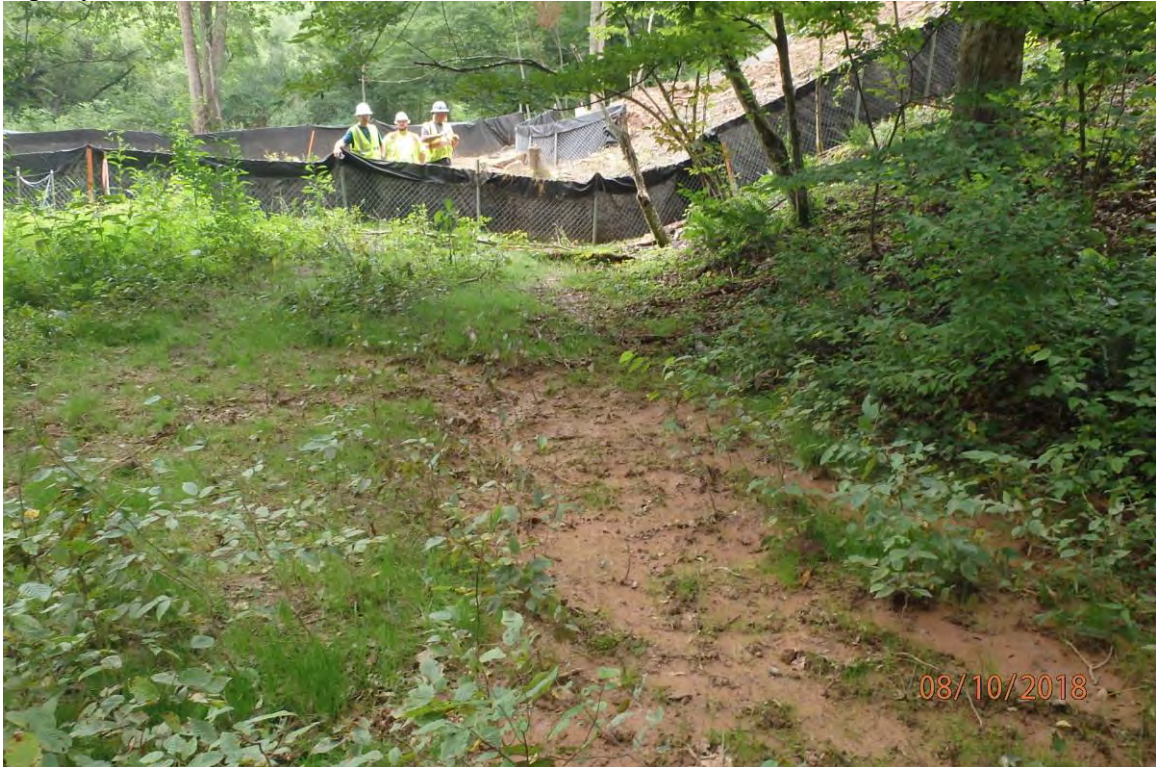
Sediment trail leading to Laurel Run (39° 01.043' X 80° 35.867') from the site as a result of perimeter controls that have been overwhelmed due to improperly installed water bars and being not properly operated. Deficiencies in site evaluation item numbers 6, 7, 14, 19, 20 & 21 pictured.

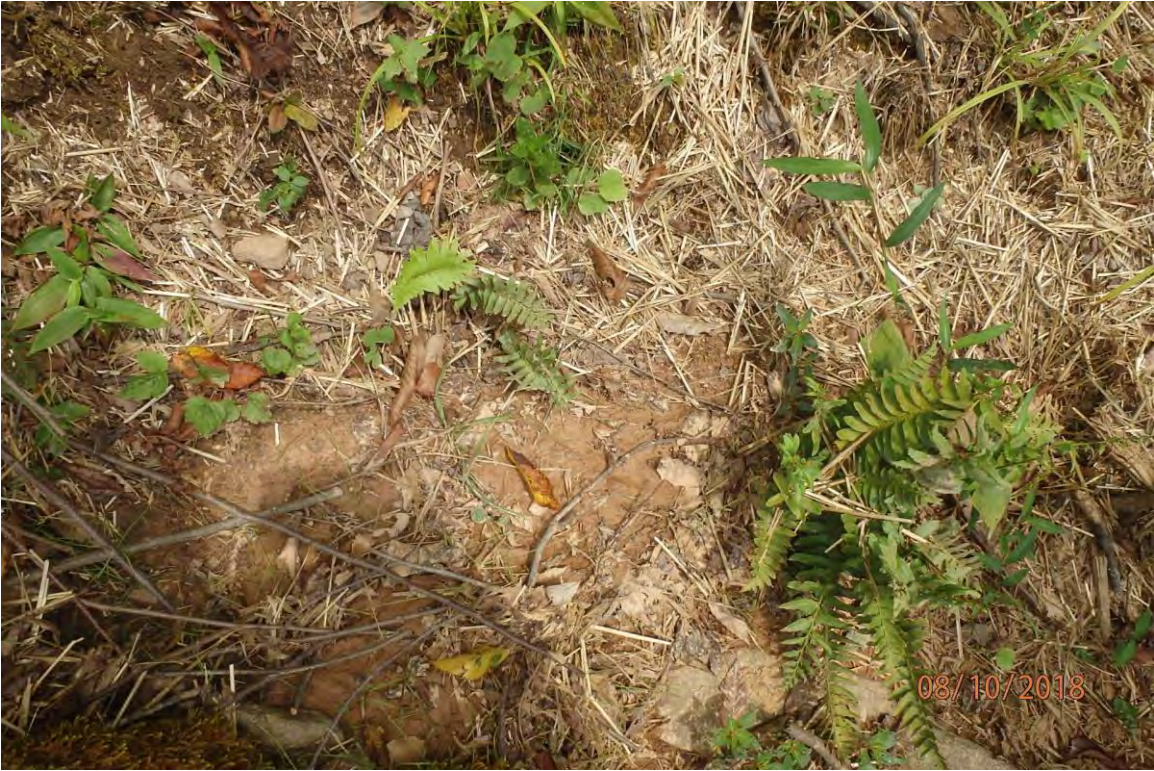
Close up of concentrated flow area where sediment laden water is leaving the site with no BMP in place. Deficiencies in site evaluation item numbers 1, 13, 15, 19, 20 & 21 pictured.

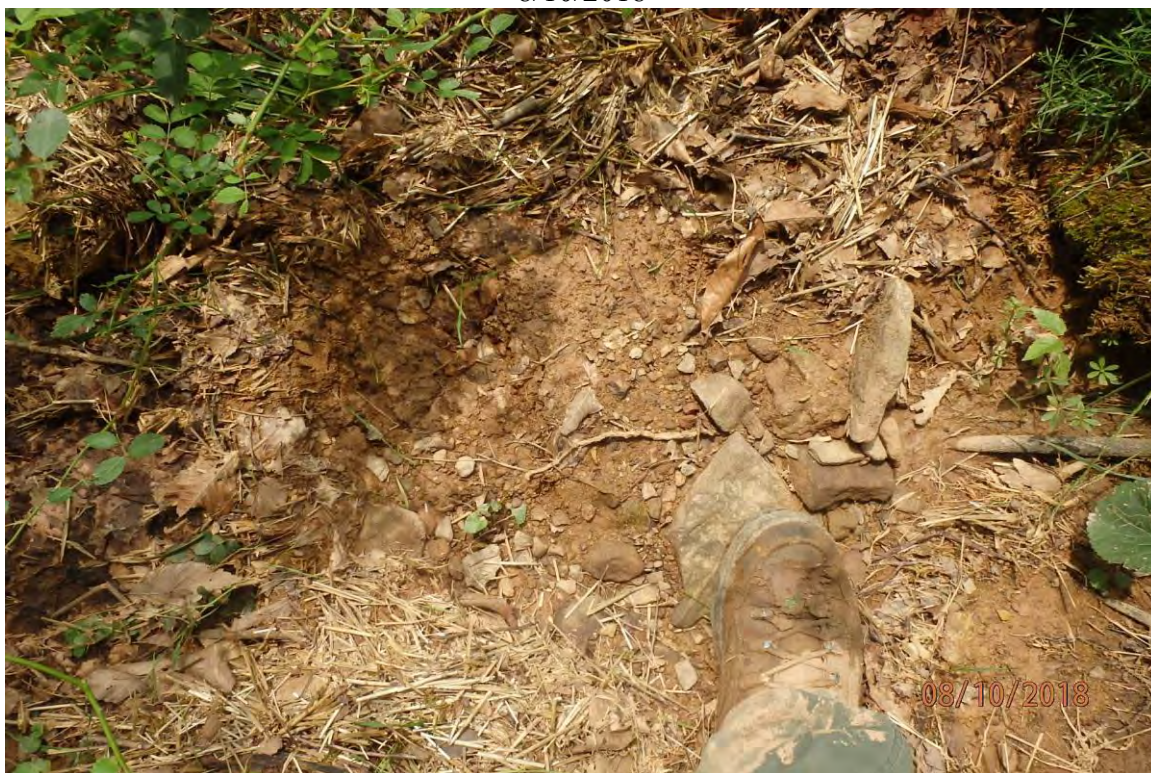
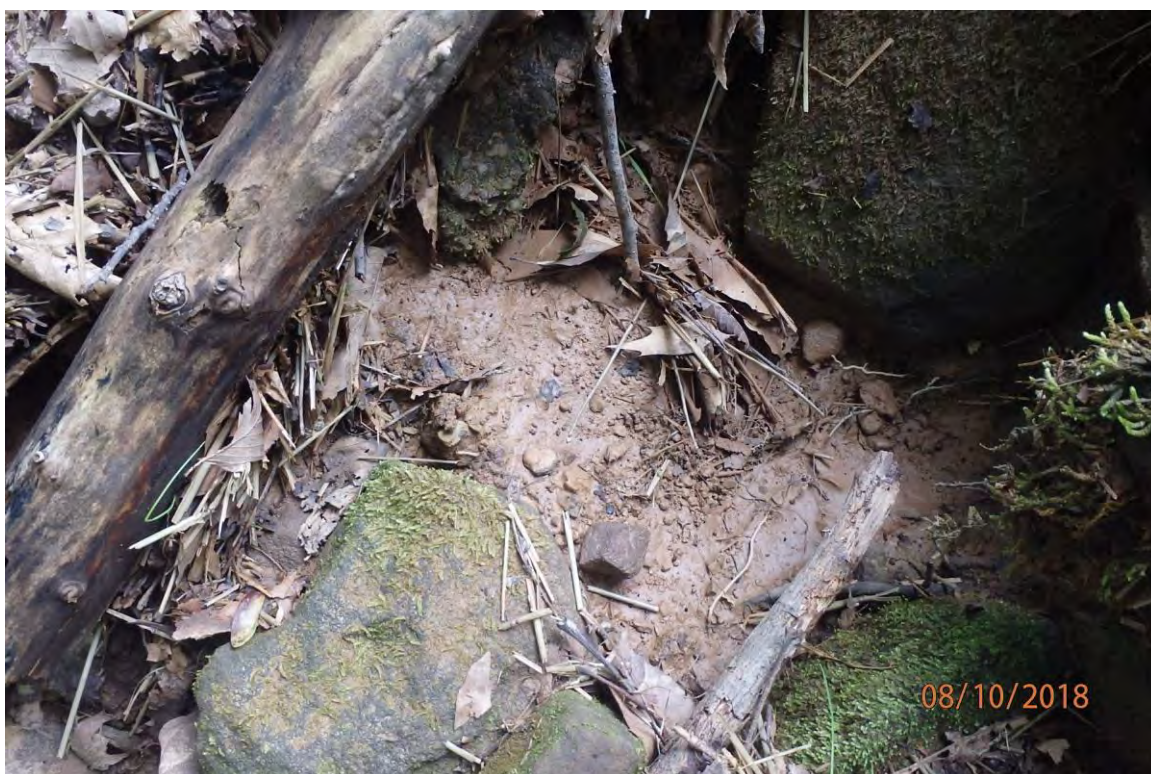
CNA deposits and associated straw mulch that originate from site in UNT Laurel Run (39° 01.133' X 80° 35.813'). Deficiencies in site evaluation item numbers 1, 13, 15, 19, 20 & 21 pictured.

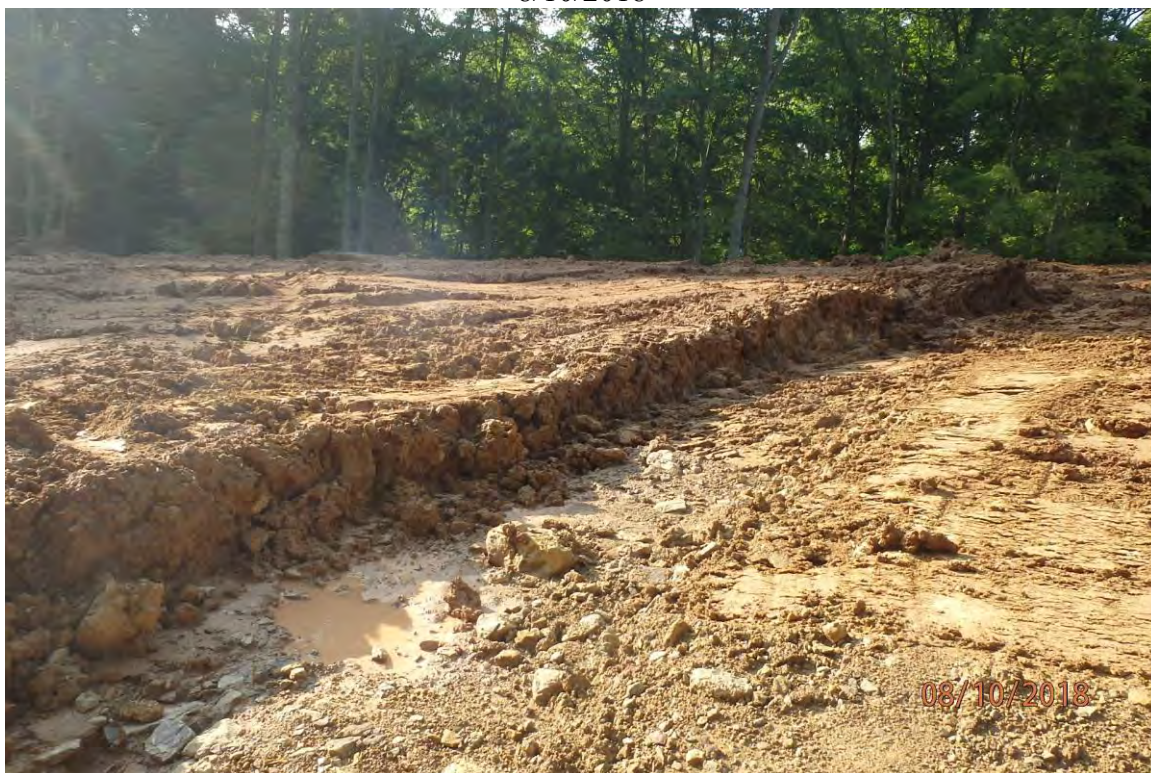
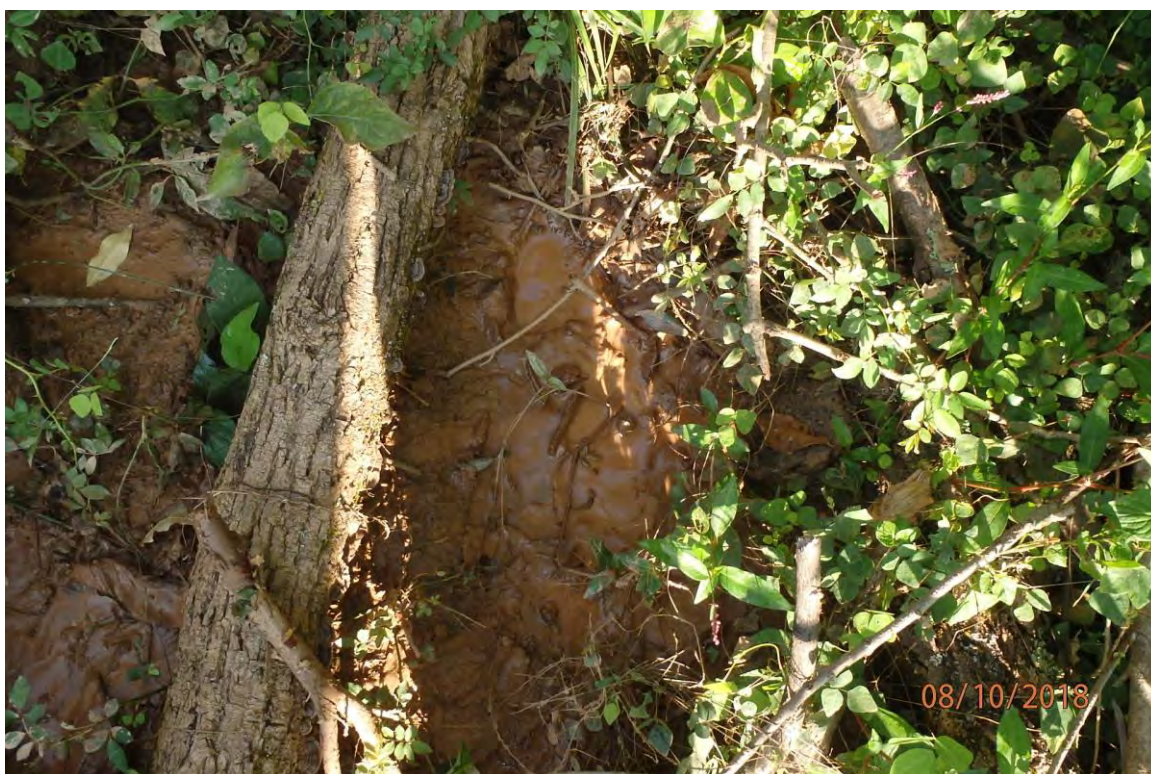
A water bar installed at a steep angle in the Meathouse Fork watershed and the resulting offsite sediment deposits. Deficiencies in site evaluation item numbers 6, 7, 14, 19 & 21 pictured.

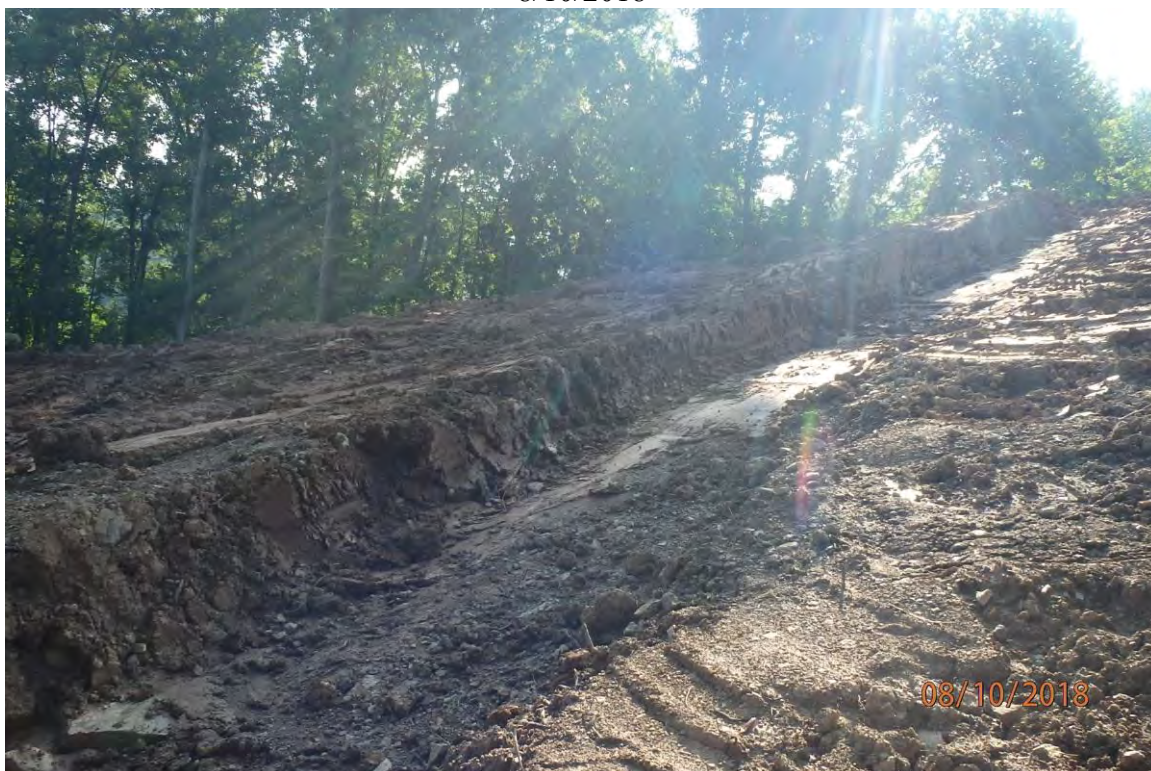
Water bar installed at a steep angle in the Meathouse Fork watershed.

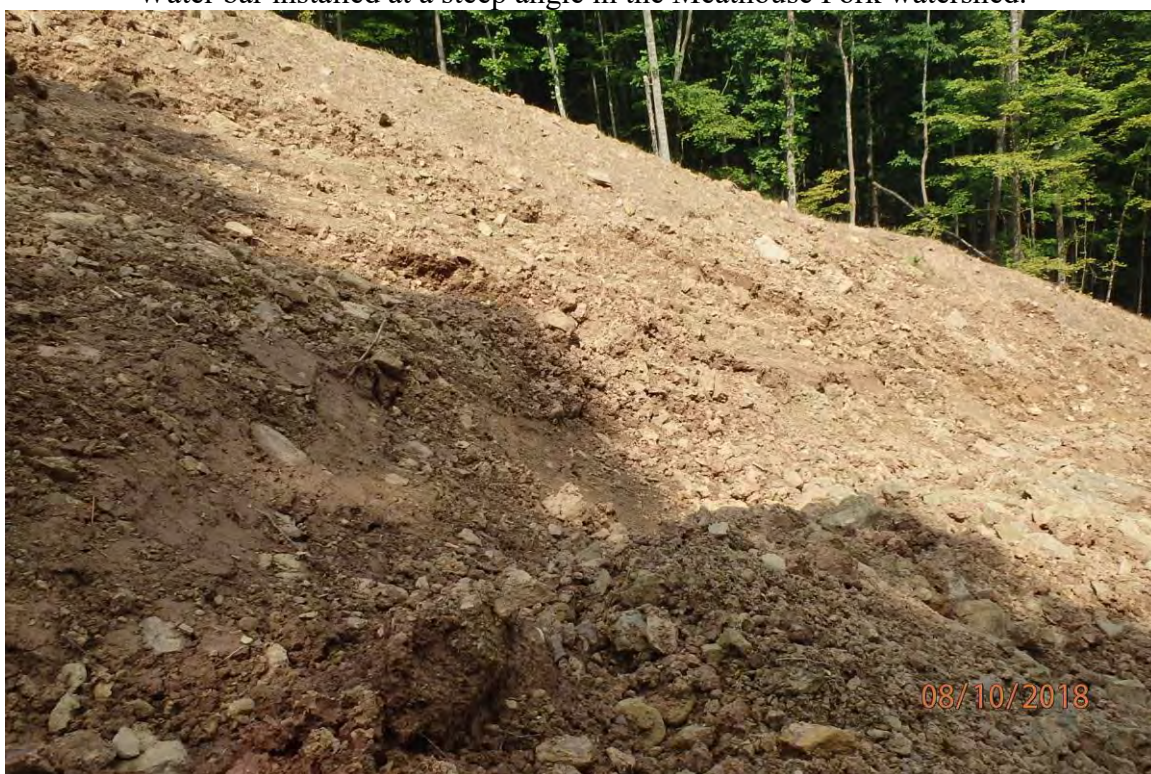
Water bar installed at a steep angle in the Smoke Camp Run watershed. Deficiencies in site evaluation item numbers 6, 7, 14, 19 & 21 pictured.

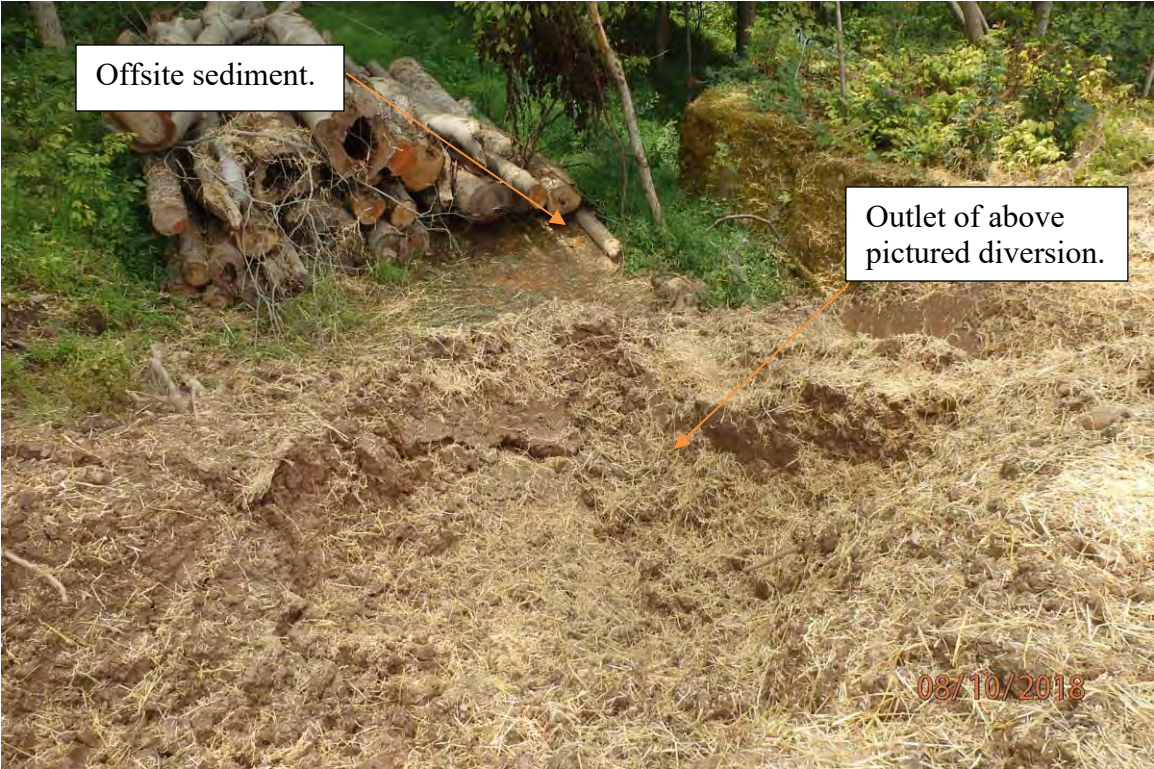
Unstable diversion that runs parallel to the slope and the associated erosion and offsite sediment deposits in the Cove Lick watershed. Deficiencies in site evaluation item numbers 2, 6, 8, 14, 19 & 21 pictured.

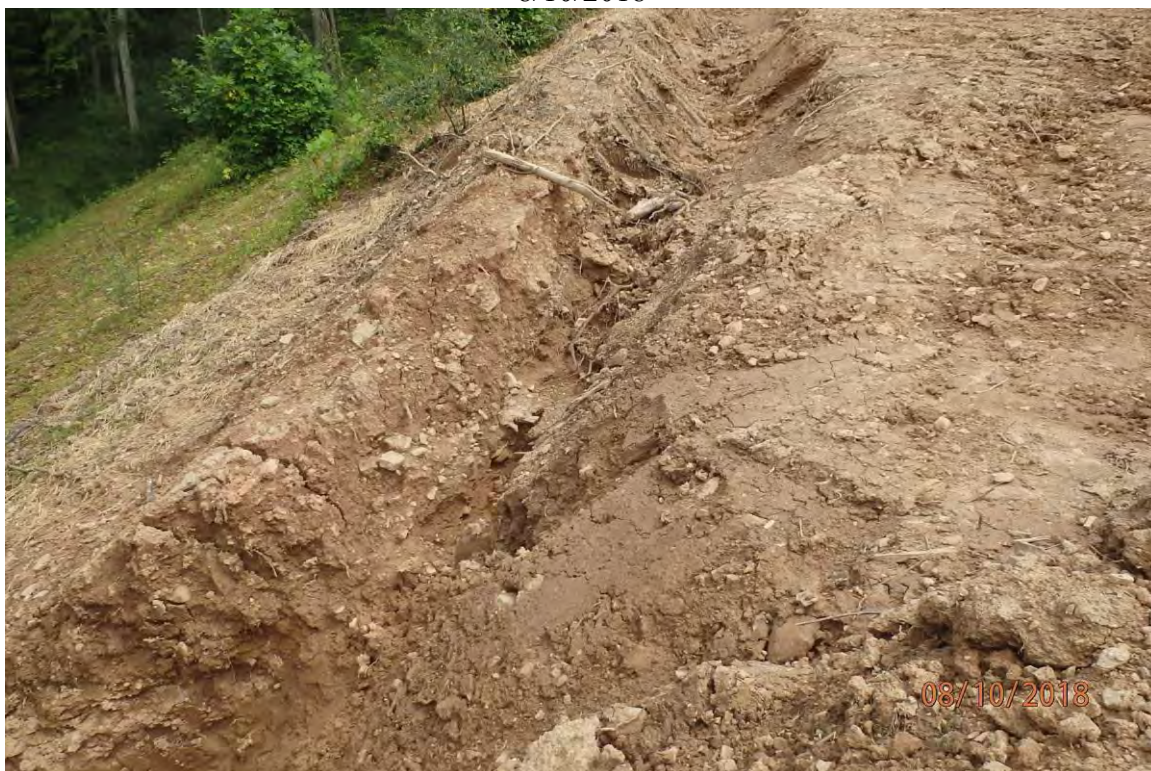
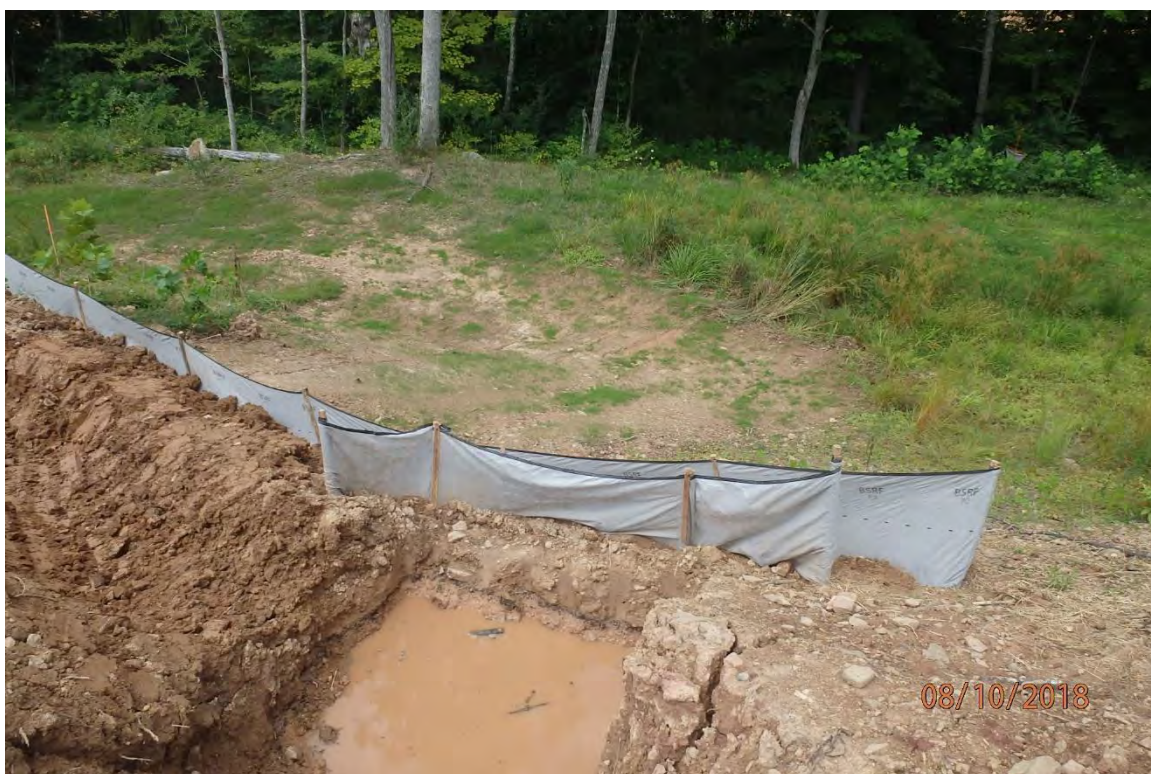
Unstable diversion that runs parallel to the slope and the associated erosion and offsite sediment deposits in the Cove Lick watershed. Deficiencies in site evaluation item numbers 2, 6, 8, 14, 19 & 21 pictured.

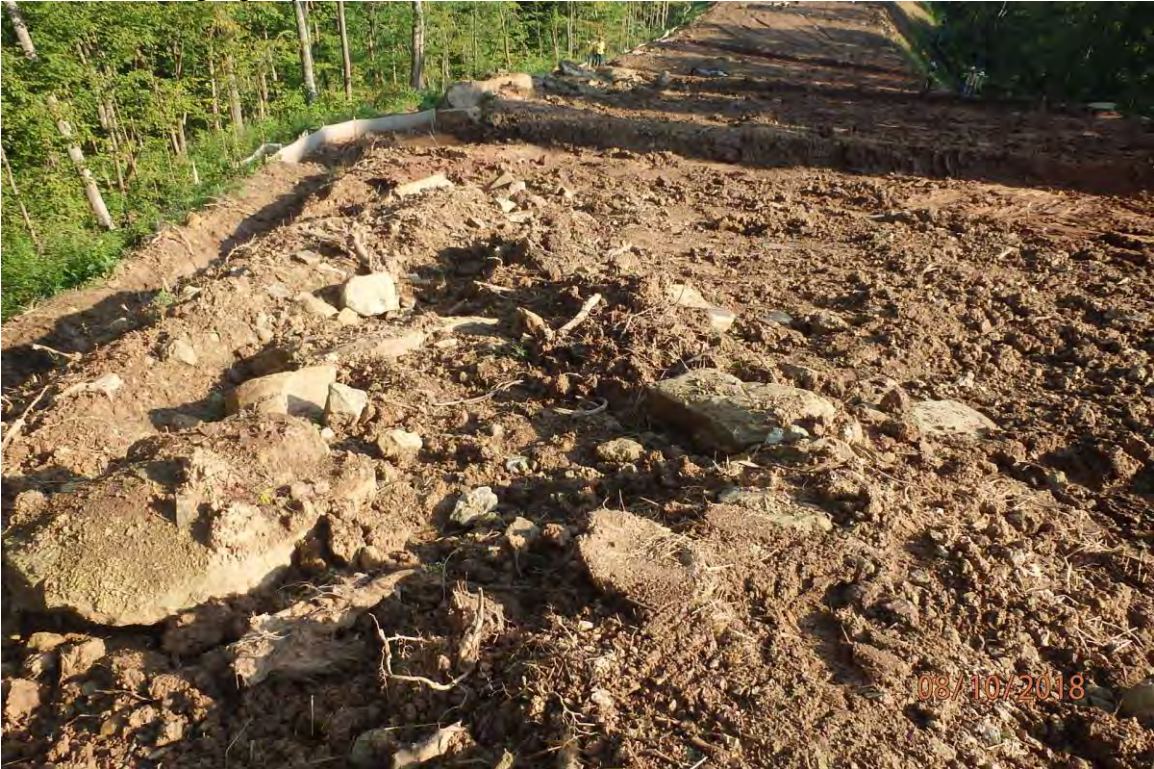
Fill slope erosion downslope of the above pictured area due to pipe trench outlet and water bar that is not installed properly in the Meathouse Fork watershed. Deficiencies in site evaluation item numbers 2, 6, 8, 14, 19 & 21 pictured.

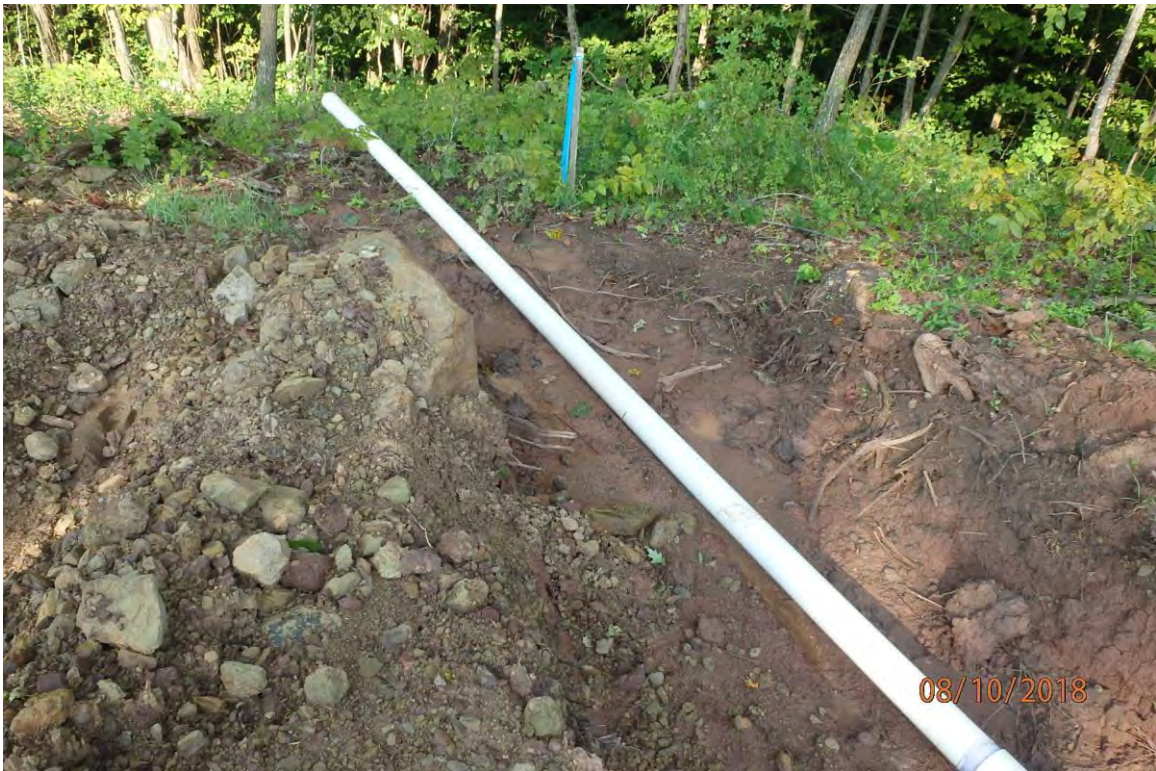
Water bar terminus BMPs that have been removed in the Meathouse Fork watershed due to trench plug drain installation that were not in place at the time of inspection.

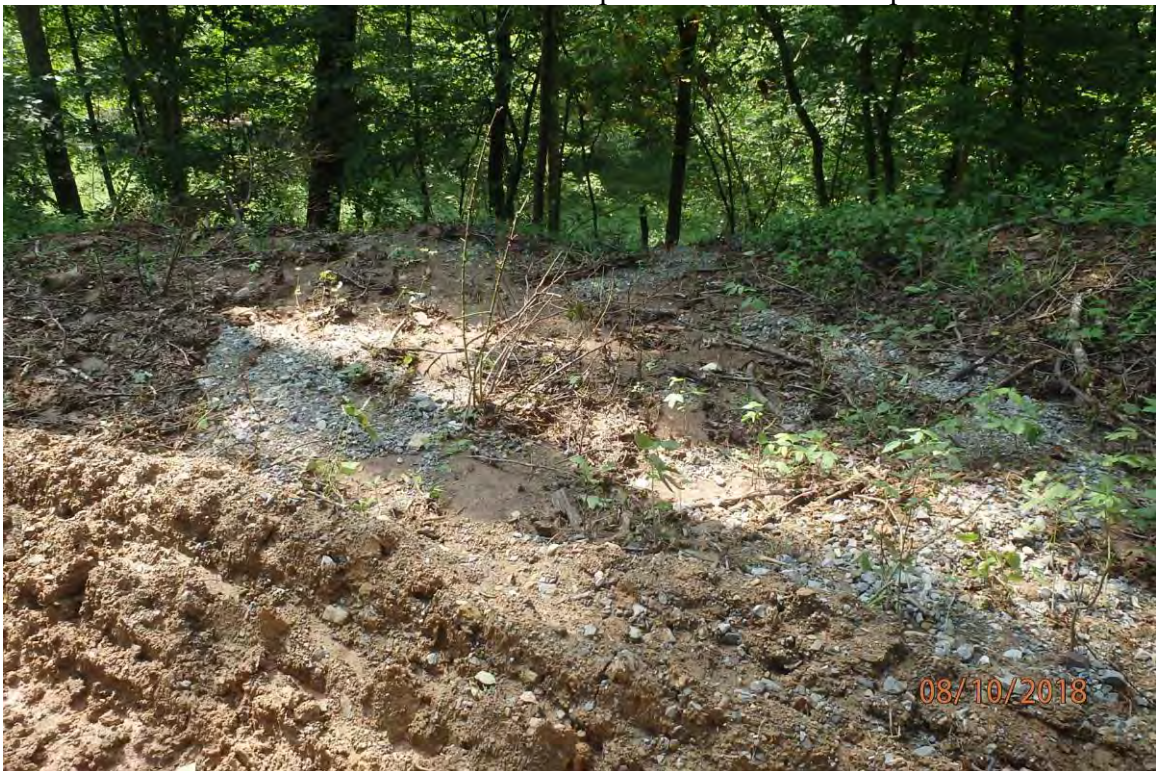
Access LE-73.01 in the Sand Fork watershed that does not have water bar terminus BMPs installed as indicated in the SWPPP. Marginal deficiencies in site evaluation item numbers 7, 13, 15, 19 & 21 pictured.

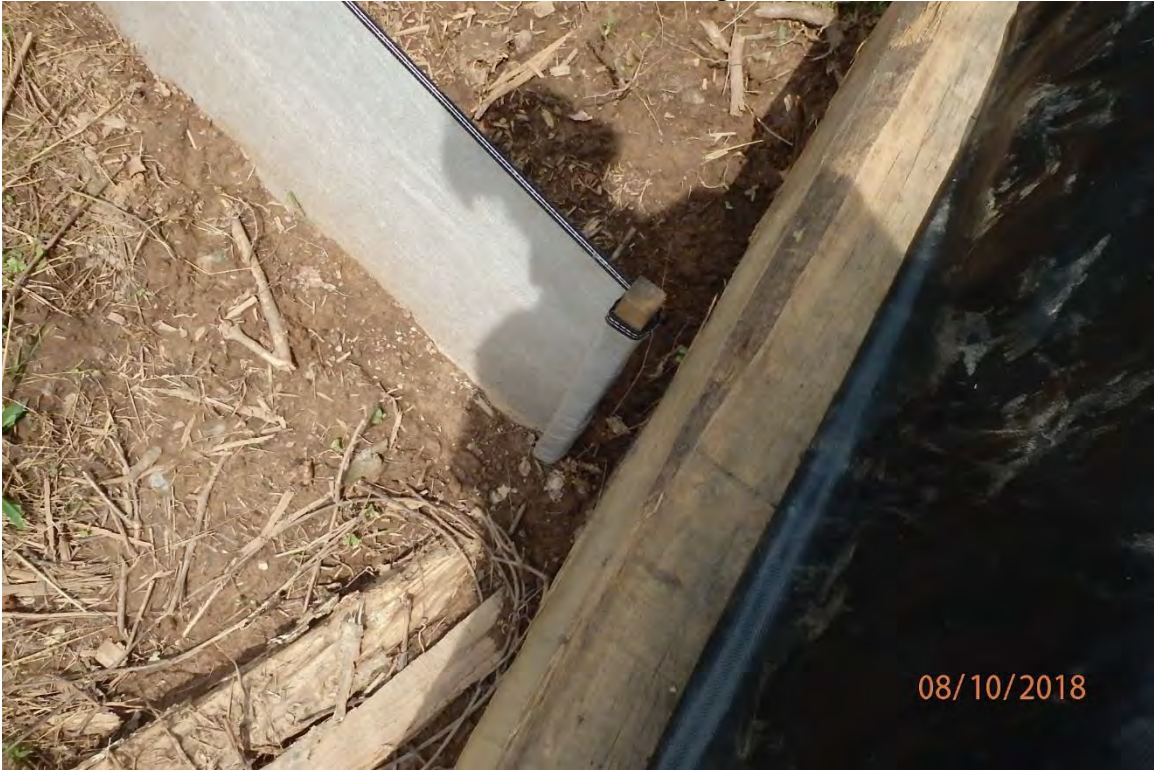
Laurel Run of Cove Lick (SKK6) crossing showing perimeter control not properly tied in to timber mat crossing. Marginal deficiencies in site evaluation item numbers 1, 19 & 21 pictured.
