Road	Field Checking Notes
000	Fuels treatment:
	 A mix of young and mature forest; some of the young forest is quite dense but the mature forest is widely spaced Many of the trees are burn scarred but most are alive, green. The downslope is steep in many parts—70 to 80 degrees in certain areas.
	Fall and leave:
	A more severe burn section. Little understory, mostly grass. Most trees are dead.

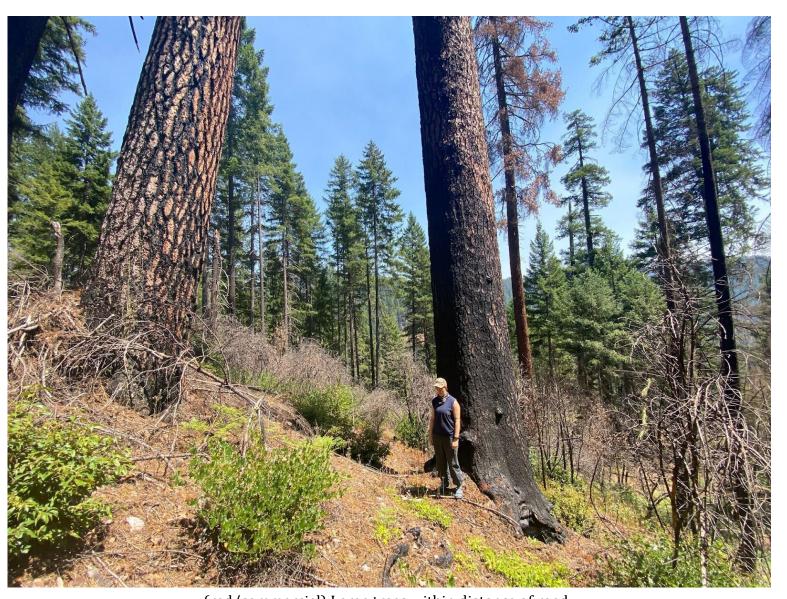
2719-	(red/commercial → purple/fuels treatment)
720	Steep upslope on the east side of the road. Minimal exposed bedrock; ground cover = soil/grass where there are no trees or moss and ferns where there are trees. Maples in poor health here—scorched leaves due to drought or heat stress?
2719- 800	
	(red/commercial)

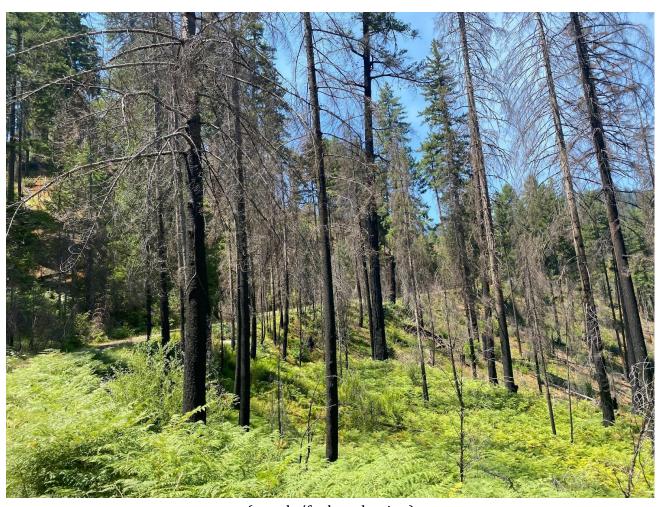
(red/commercial) Large trees within distance of road.

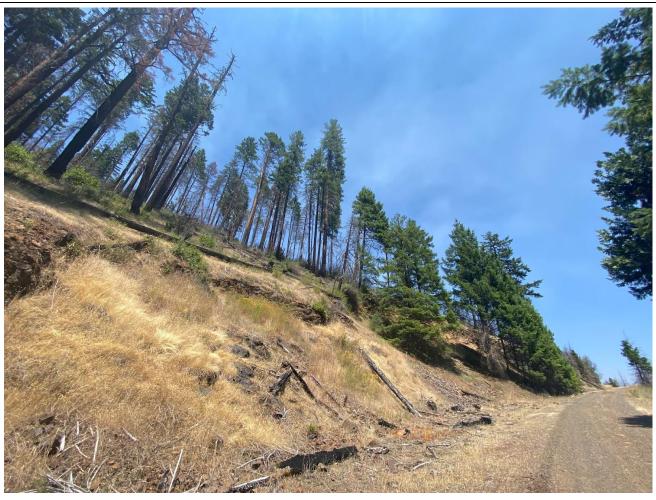
(purple/fuels reduction)

Shrubby maples growing back along roadside. Grassy undergrowth; horsetail; ferns growing in areas with canopy cover. East side is relatively open, mature forest. Older trees with burn scars. **Maintain large trees without indicators of failure here.**

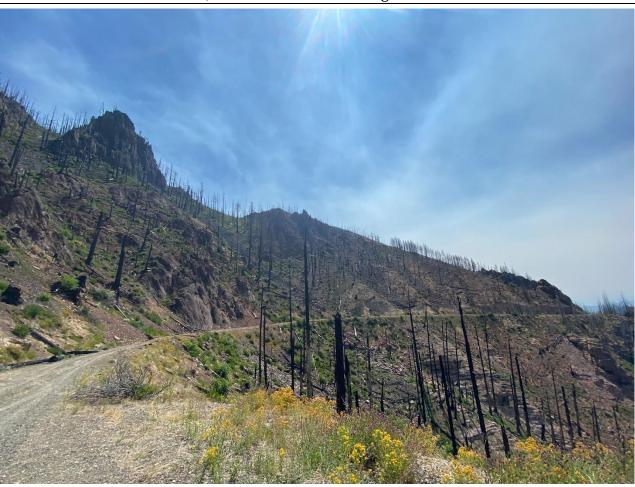
2759-425

Landslide blocks the road leading into 2759-400. High severity, spindly young trees with not much commercial value. Steep, rocky soils susceptible to future landslides. Road gives access to and goes along Cavitt Ridge. Access notes: "Planting Access" and "PODs." The ridge has already burned significantly—how do high severity fire impacted areas play into the PODs model and fire mitigation goals? Other than some potentially interesting rock features for recreational interest, my recommendation would be to remove this road and 2759-426, 400 from the project.
