## RE: CLAIM #24970 - LOSS AND DAMAGE CLAIM FOR WILLIAM BROWN/ELIZABETH GIBBONS PARCEL @2 TRACT "A" OF THE H.E.S. NO. 445 SITUATED IN SECTION 7 T17N; R14E NMPM, (former DEARTH Property) CALF CANYON, SAN MIGUEL COUNTY, NM

CALF CANYON BROWN/GIBBONS PARCEL #2 TRACT "A" OF THE H.E.S. NO. 445 SITUATED IN SECTION 7 T17N; R14E NMPM, SAN MIGUEL COUNTY, NM

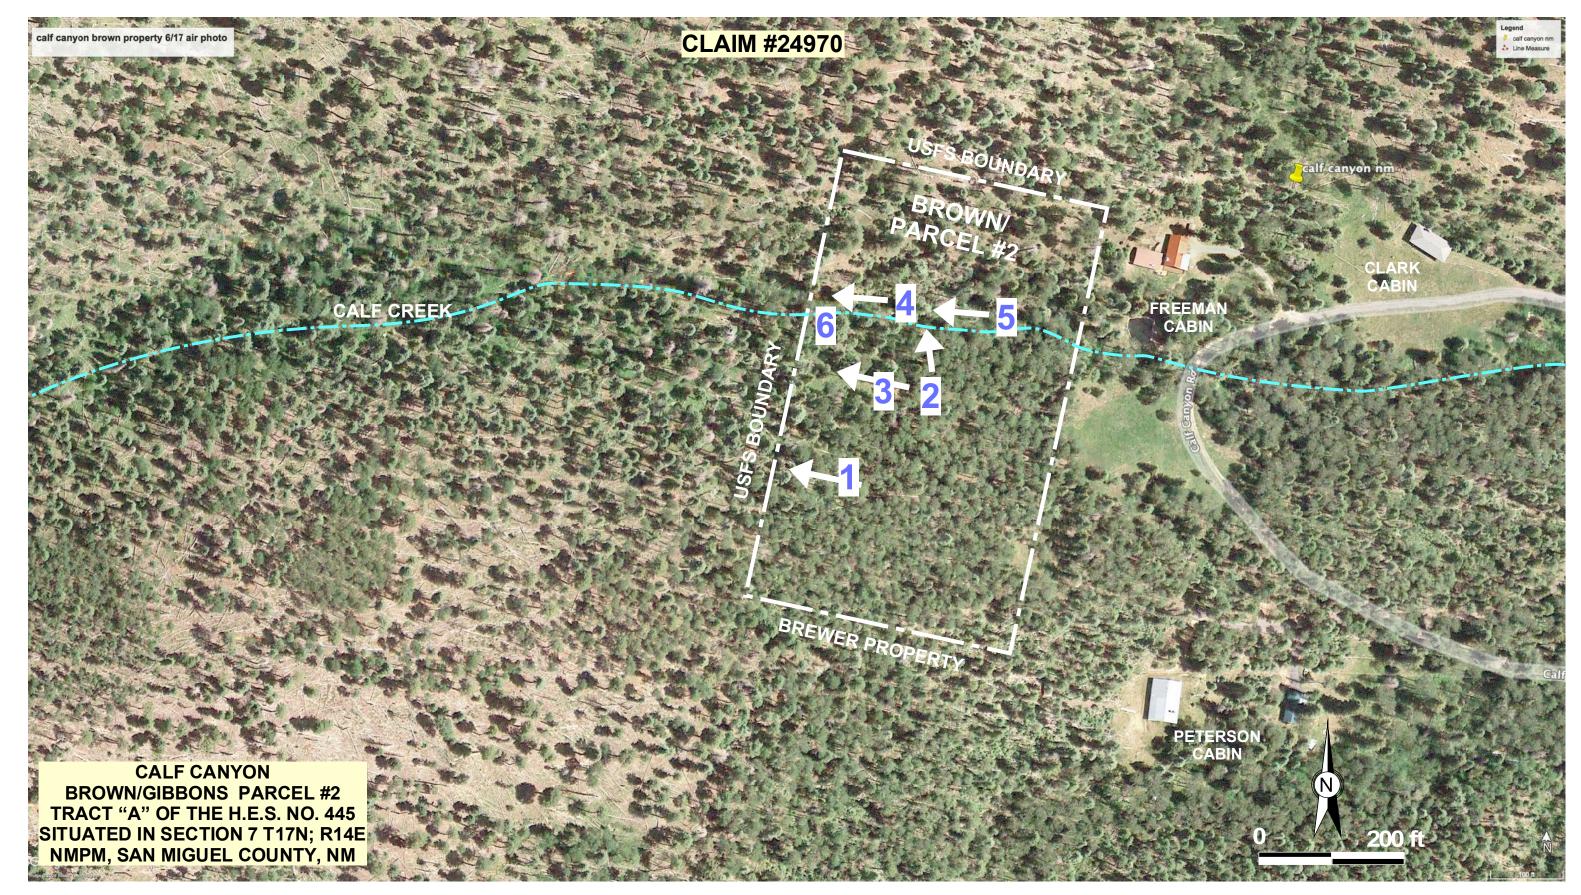
# FIGURE 2

- Pre-fire vegetation and stream conditions are highlighted in Figure 2 (June 2017 aerial photograph) and the photographic log shown in Figure 5.
- Figures 3 and 4 present post-burn aerial photographs (June 2023) highlighting the extent of the burn and the location of post burn/flooding ground photographs which are shown in Figures 6, 7, and 8.
- Approximately 64% of the property was burned by the fire based on air photo data confirmed by ground inspection.
- Extensive erosion occurred along Calf Creek during post fire flash flooding combined with deposition of large gravel bars and wood debris piles. Hydrologic evaluation of flood depositional characteristics indicate water flows on the order of 10<sup>2</sup> greater than normal.
- A small structure on the property was burned and destroyed.
