The photos on the following 11 pages were taken in the Monarch Pass logging project area on the San Isabel Forest, Salida Ranger District, September 28, 2024, by Allison N. Henderson.

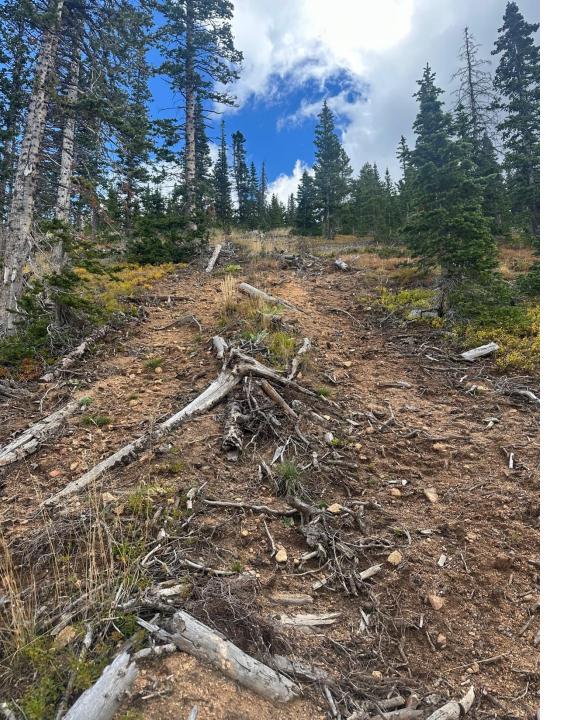
Left: Visible tire tracks and erosion.

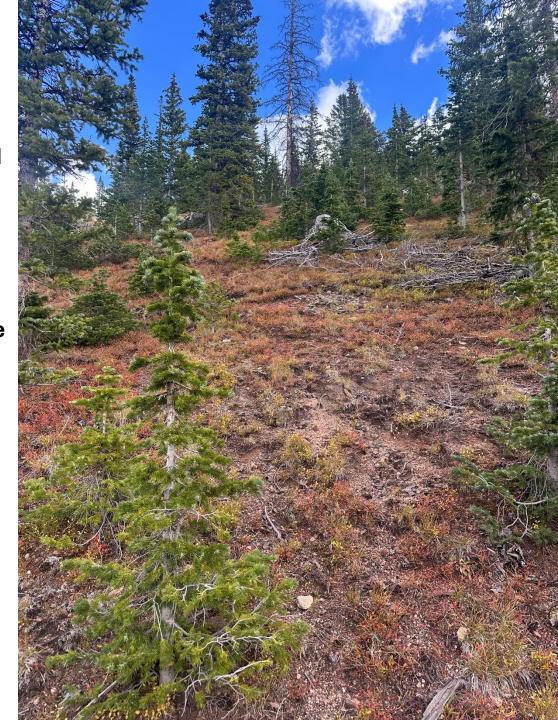
Right: Undisturbed area adjacent to photo of the left.

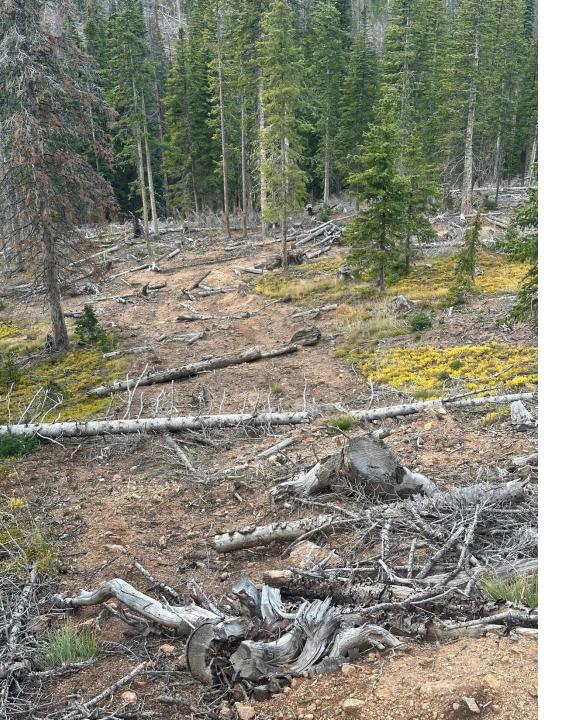
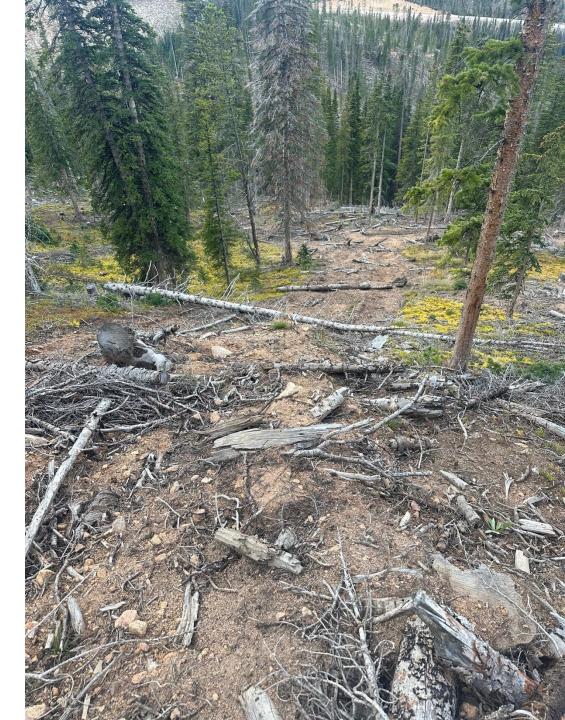
**Erosion and** bare, scarred soil where heavy machinery was operated.Gul ly and rill formation is visible. Highway 50 is visible in the distance in the photo to the right.

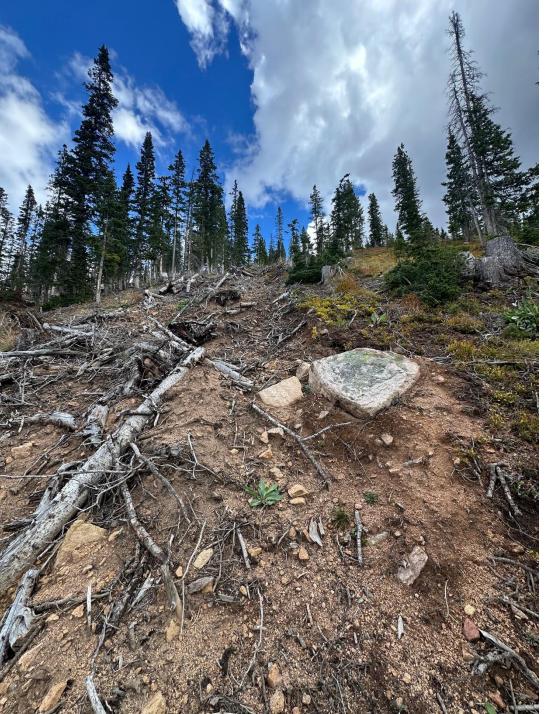
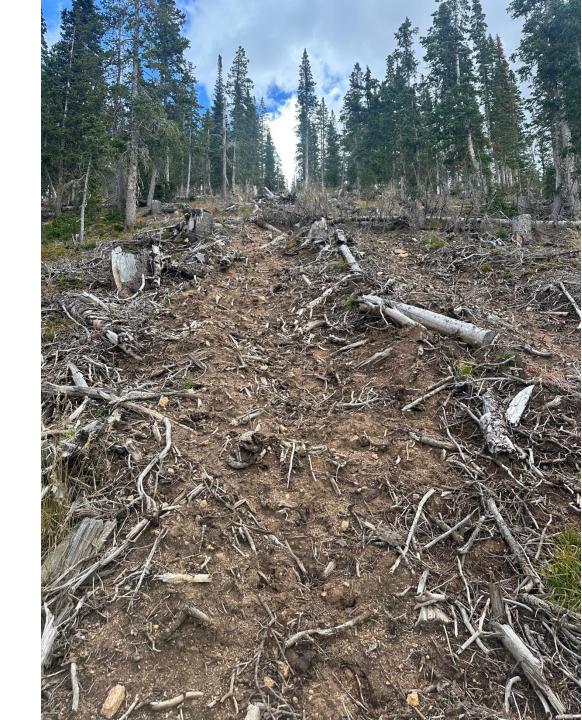
Additional examples of significant erosion, scarring, and loss of vegetation.

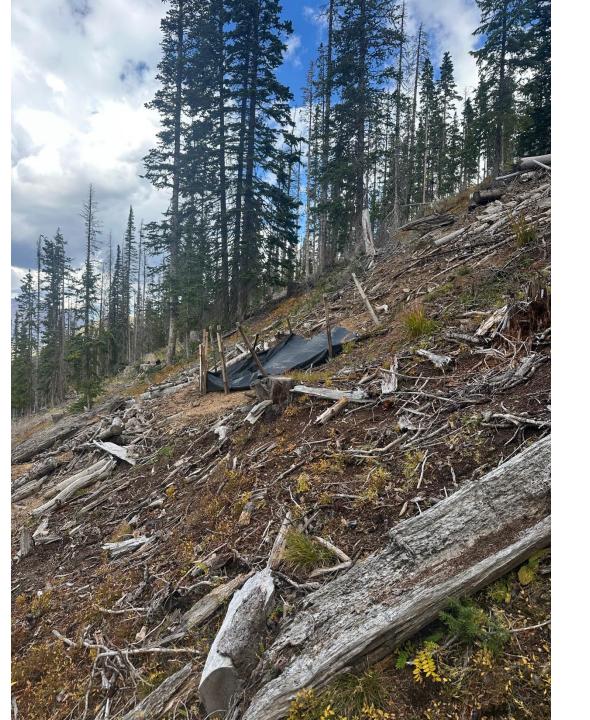
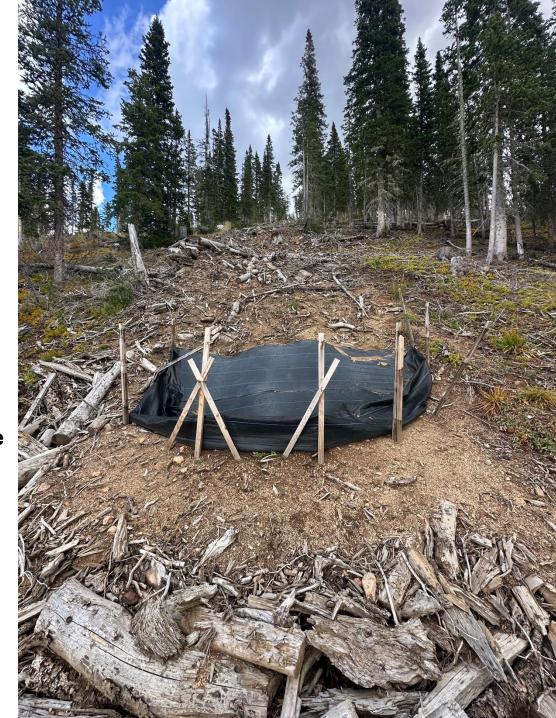
"Erosion control" tarp and stakes. Below the tarp and stakes rill developme nt may be occurring.

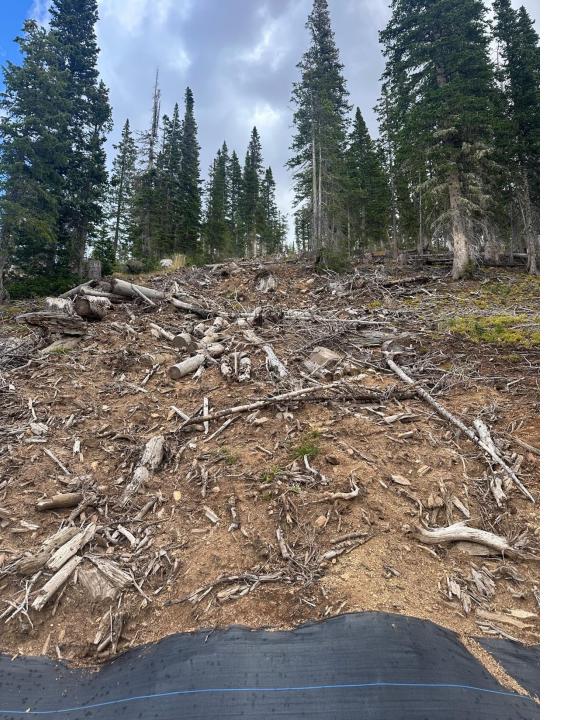
Left: Lack of ground cover, erosion, and soil damage looking upslope from the tarp and stakes on the previous page. Areas not disturbed still show ground cover and do not have same appearance.

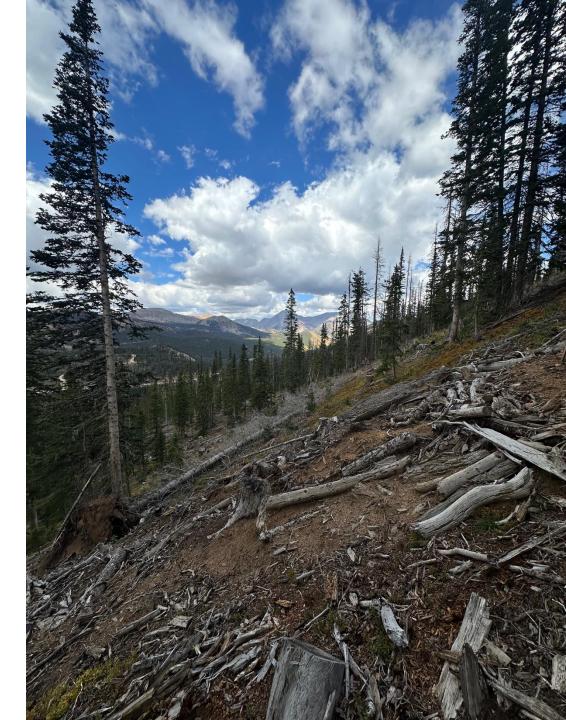
Right: Erosion where machinery was v. wasn't.

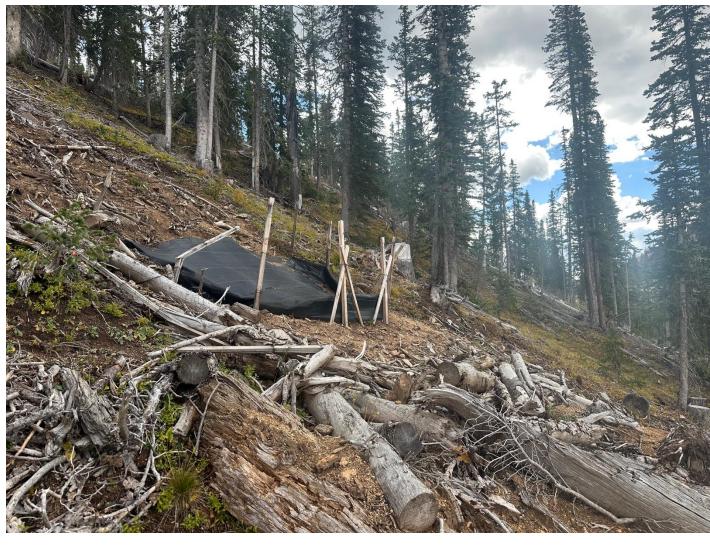
Another tarp and stake "mitigation" measure.

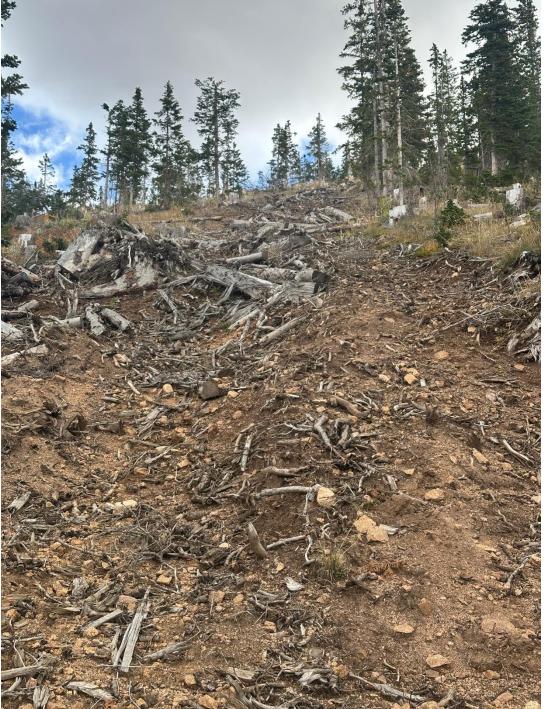
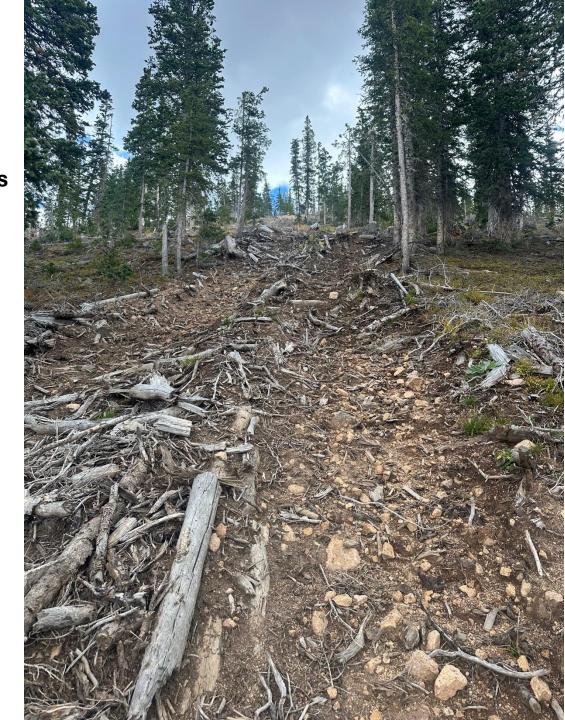
Both photos show tire tracks and significant erosion, including gully formation.

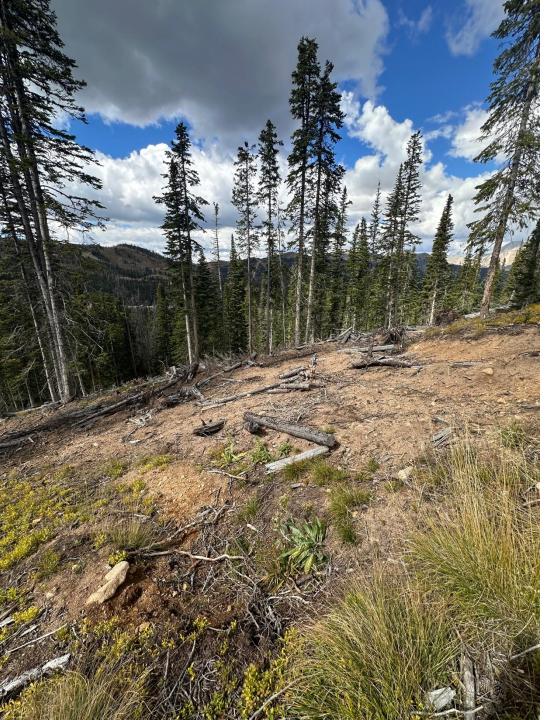
Left: deep headcut from heavy machinery tracks on steep slope and exposed, eroded soil.

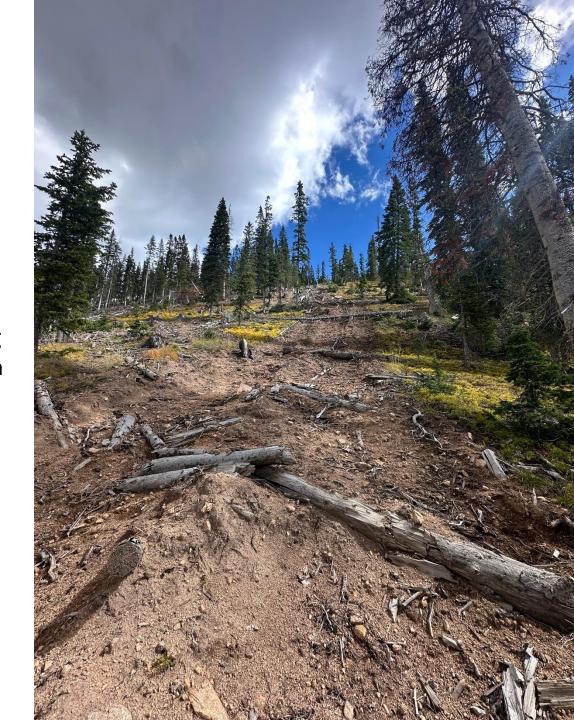
Right: looking up slope from the same spot.
