# *Swan View Coalition* Nature and Human Nature on the Same Path

Re: West Reservoir PA

## **Wheeler Creek Road 895F**

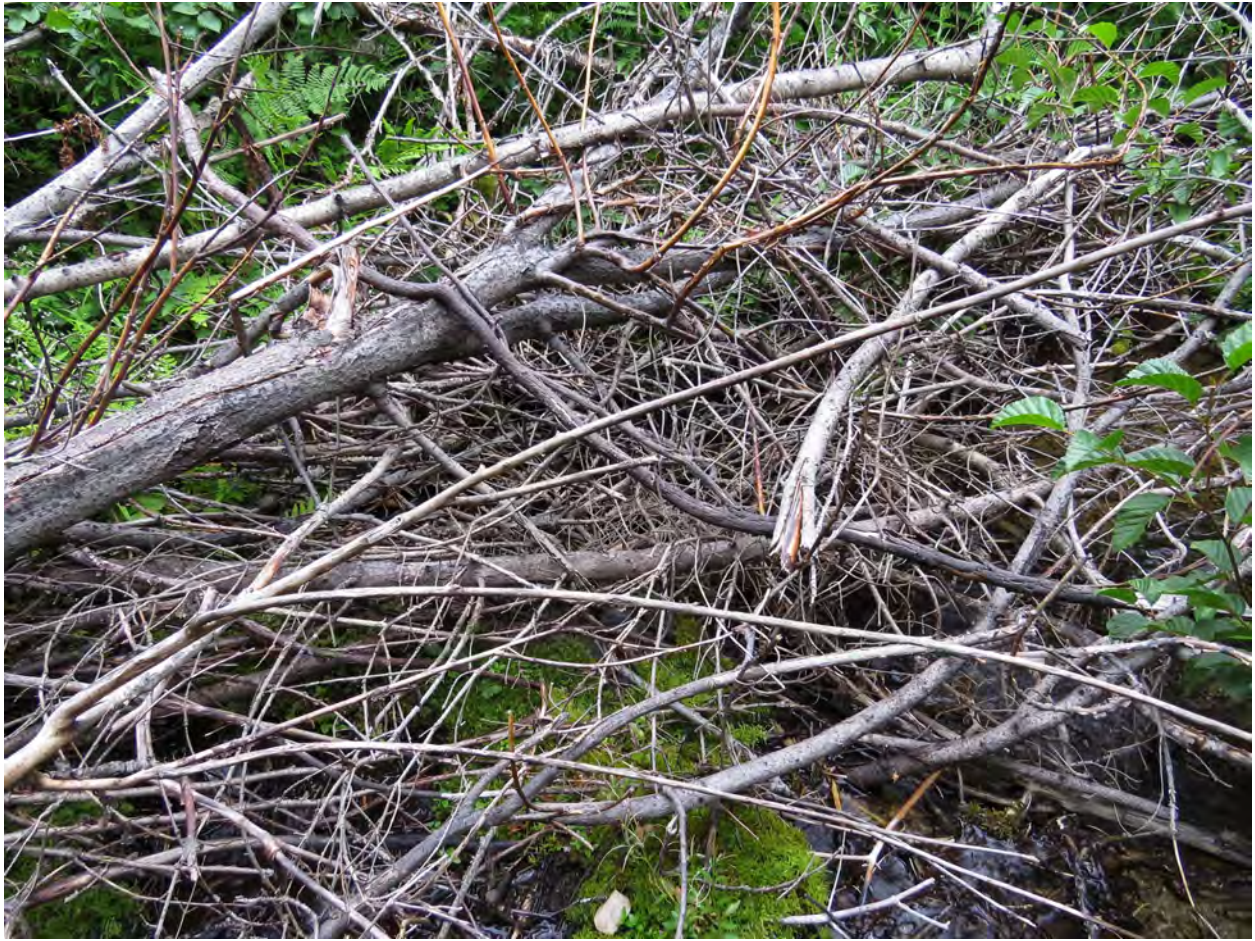
We hiked this trail in July of 2015 and found four stream-aligned culverts that had been left in place, largely in avalanche chutes. We took photos of these four culverts and the brush and avalanche debris that was largely blocking the culvert inlets. We reported these culverts to the Flathead NF as a violation of then-Amendment 19's requirement that all stream-aligned culverts be removed from reclaimed/decommissioned roads.

We include a photo of the first culvert inlet past the trailhead on the following page:

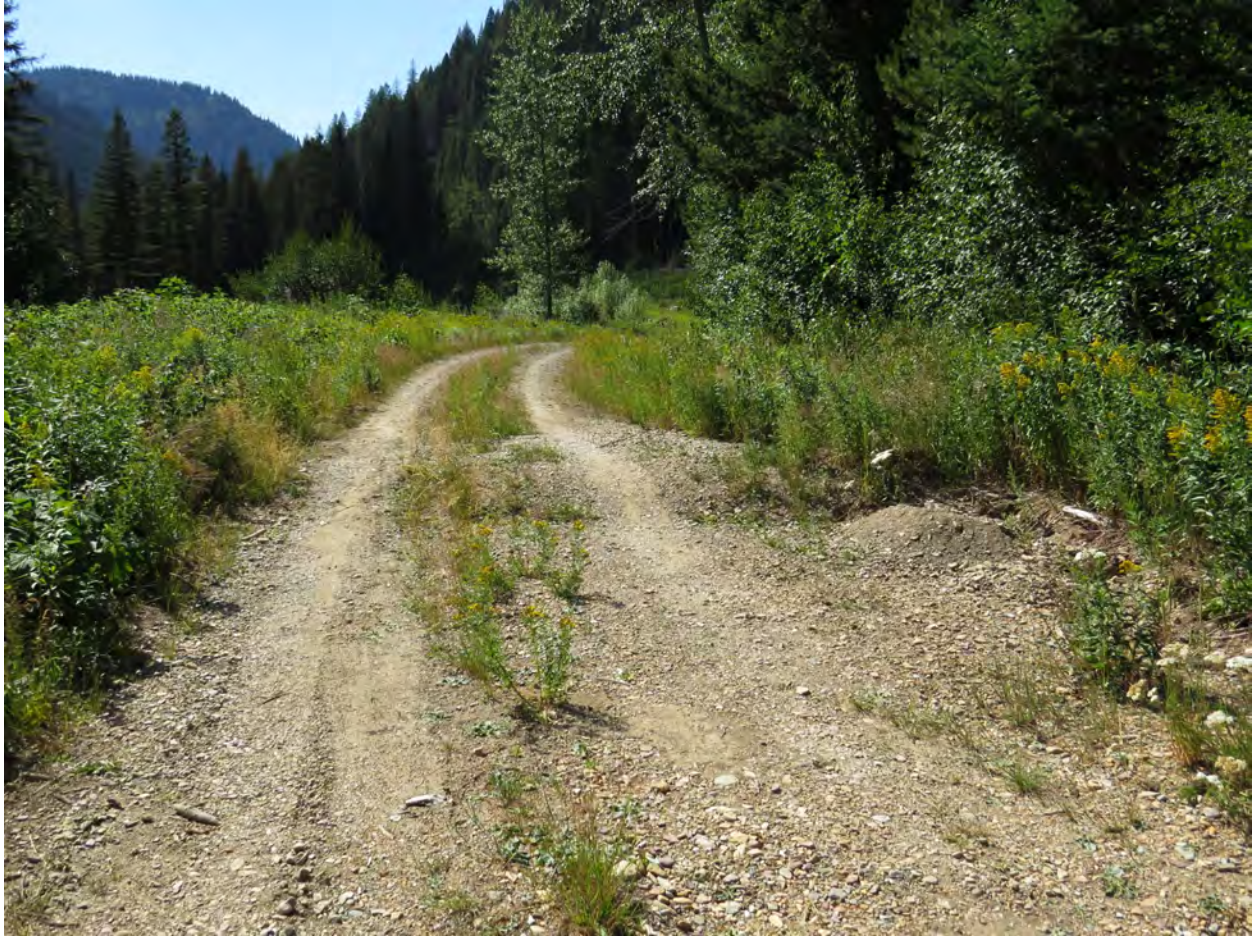
We also reported a culvert on the open portion of the road that had plugged and was depositing gravel onto the road surface, as shown in the photo on the following page:
