Date: July 27, 2007

Participants: Alma Winward  
Don DeLong  
Geoffory Anderson

#### Purpose of Trip:

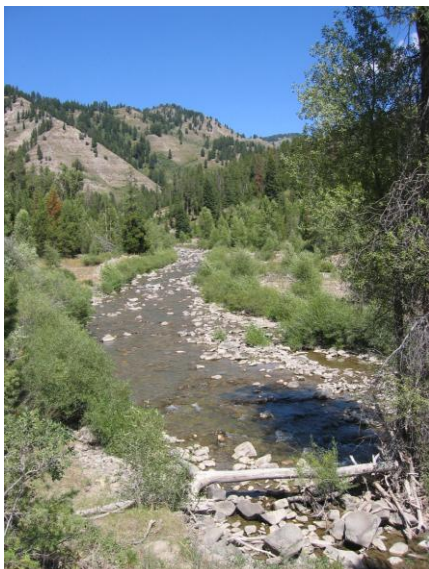
Picture 1. UTM coordinates 0510430 N, 4777140 E

We stopped briefly along the Little Greys River just above the confluence with the main-stem. I asked his opinion of the river at this point. The stream channel and associated annual floodplain was dominated by cobble-size and larger rocks, with some willows and other vegetation (Picture 1). Alma responded that it is likely suitable condition here relative to potential.

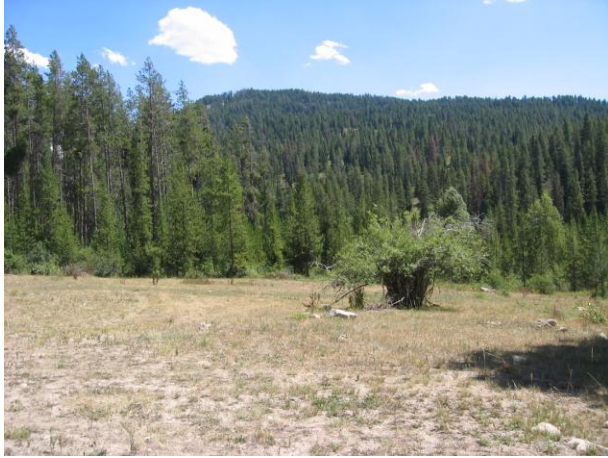
Picture 2. UTM coordinates 0510630 N, 4777734 E

We then stopped about where Skull Creek passes under the road where there are grassy areas on both sides of the road. At the sight of a willow situated a little ways into the opening on the south side of the road (Picture 2), away from the willows bordering Skull Creek, Alma pointed out there are three classes of willows. I only wrote down two of them: clumpy willows and willows that spread by their root systems

e went on to say that stems in clumpy willows typically live about 9-19 years, while their roots may live several hundred years. This means that an older plant will have numerous dead stems with a large number of various-aged live stems intermixed with the dead stems. Therefore, the presence of dead stems is a natural and expected part of willows of this type, and they help protect growing stems from browsers and from mechanical damage from cattle.

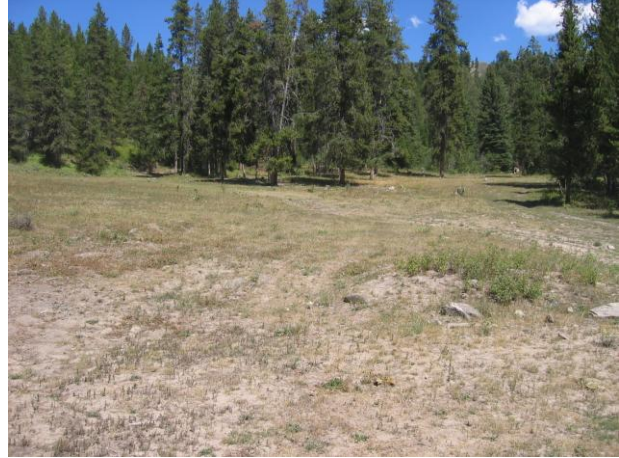
Picture 3. UTM coordinates 0511474 N, 4777740 E

We briefly stopped at another opening where recreationists and cattle were having obvious effects (Picture 3). He observed that grazing pressure was high.

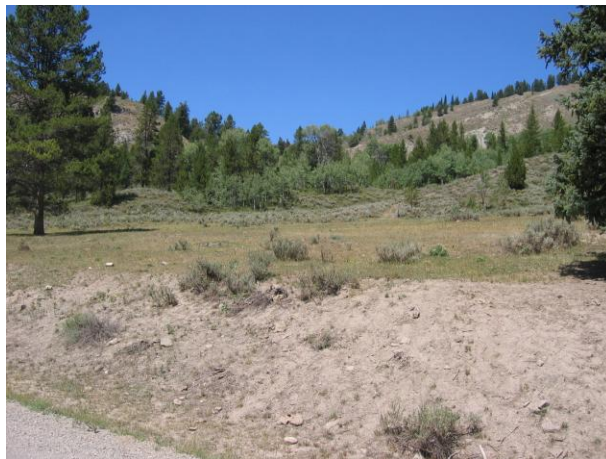
Picture 4. UTM coordinates 0512368 N, 4777514 E

and 5) tells us there is probably a seep of some sort that keeps the ground too wet for sagebrush. This assumes that the lack of sagebrush is natural and not caused by livestock or recreationists. If sagebrush is kept out due to higher soil moisture, *Deschampsia* and associated vegetation should dominate the site. The presence of geranium tells us that the site is not totally soaked. At present,

the grassy area appears to be dominated by bluegrass species, indicating past over-use by livestock, and indications are the area was heavily used this year.

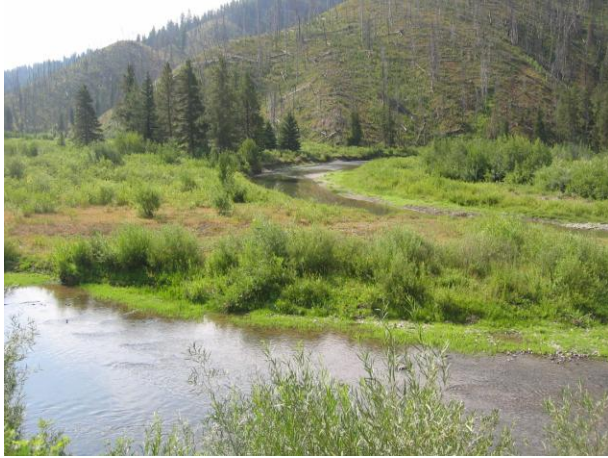
Picture 8.

We briefly looked over a meander in the river where cattle grazing effects were observed (Picture 8). Alma said willows looked to be okay, but the understory was still being affected. He said the banks should have more of a slope to them (i.e., they should not be as steep; see also Picture 9) and sedges should be prevalent on the green-line. There currently is little growing along the 'green-line.'

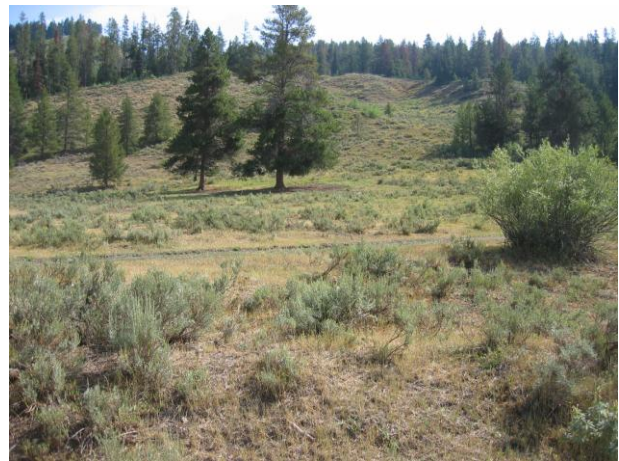
Picture 10.

At a site with silver sagebrush (Picture 10), Alma said silver sagebrush sites indicate high potential for production (e.g., 2,000 pounds/acre) and diversity (e.g., 35 or more plant species grow here. On the site we were looking at, Alma said it looks as though rizomatous species predominate and that cattle grazing has taken the vegetation down.

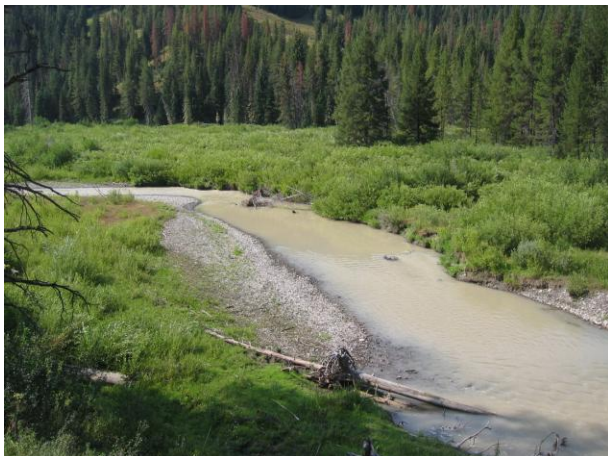
Picture 11.

At a site along the river (Picture 11), Alma said that sedges should be following the points down to the waters edge quicker than they appear to be, and

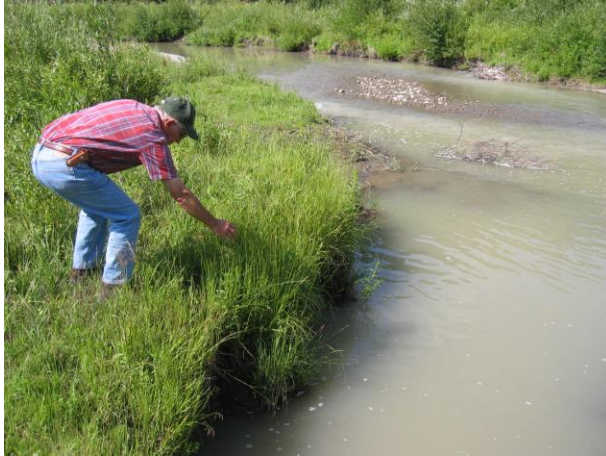
Picture 12. Alma Winward pointing out red-top. UTM coordinates: UTM coordinates 0511467 N, 4777742 E)

At the next stop, we spent a fair amount of time walking along the waters edge and out into the willow community. Alma first pointed out the prevalence of red-top (*Agrostis stolonifera*) (Picture 12), which as a shallow root system and the lower-than-expected prevalence of sedges and rushes. Alma pointed out three species of sedges: Nebraska (*Carex nebrascensis*), beaked

(*Carex rostrata*), and water (*Carex aquatilis*). He said all of these species should be doing much better on this site. Alma then pointed out some mannagrass (*Glyceria striata*), which he said is also good for the system (it has wavy ‘branches’ in the spikelet). A rush was also present, but it was not Baltic rush (*Juncus balticus*).

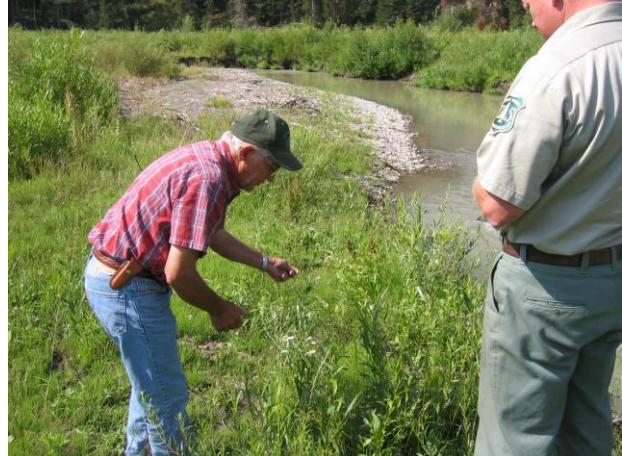
Picture 13. Alma Winward pointing out Drummond willow. Same UTM coordinates as Picture 12.

Alma observed Booth, whiplash, Geyer (*Salix geyeriana*), streambank, Drummond (*Salix subcoerulea*), and yellow (*Salix lutea*) willow on this site (Picture 13). He characterized the willow community as having no shortage of willows and good regeneration. However, he felt vegetation should be moving out to the waters edge a little quicker on point bars. Alma said that it is obvious this is a ‘violent’ system, but was not clear whether it was natural or whether it was caused by sheep-grazing effects higher in the watershed (he said he has not seen the upper watershed). He said there is too much sediment and that plants should be able to keep the ground covered away from the stream channel. Sedge species at drier end of spectrum may naturally occur in these situations (Picture 14), but sedges should be here. We are 2-3 feet above the water surface in the river. High flows make it harder for sedges to establish, but they should be here.

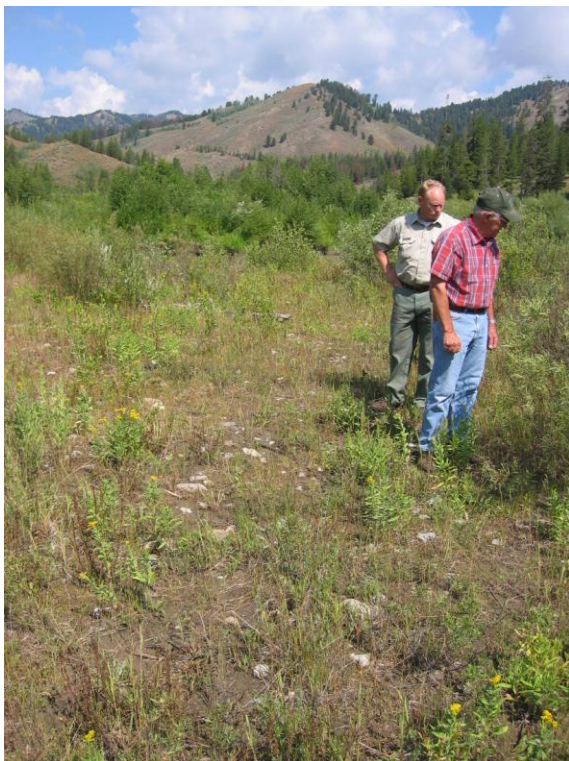
Picture 14.

Sedges are getting eaten off and young willows are being heavily browsed. Alma said that the area probably would benefit from a year of rest from cattle grazing periodically. Geoffroy said this was tried years ago, but it did not last long.

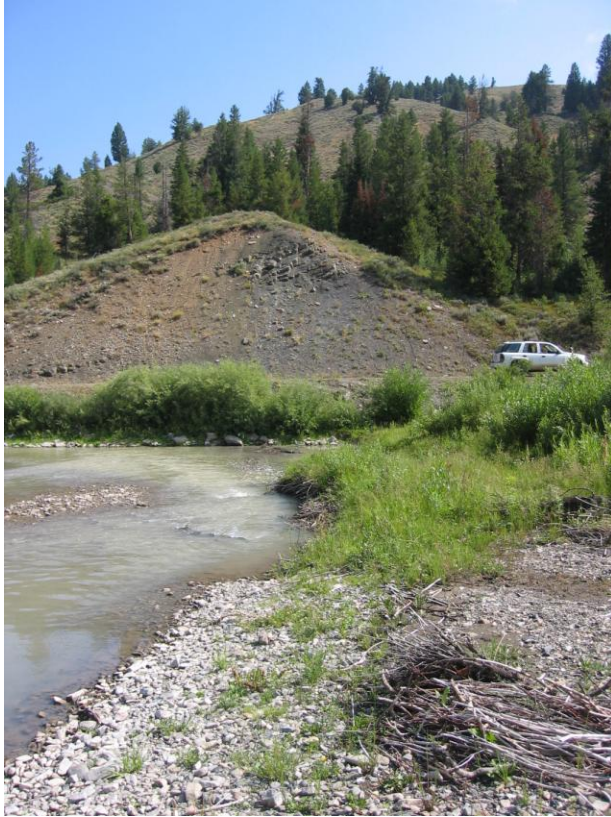
Picture 15.

Alma pointed out three stages of ‘succession’ from recently formed rock bar along river (foreground of Picture 15) to one on which vegetation appears to have been developing for 4-5 years (middle), and the oldest (furthest away in Picture 15). He observed that the oldest site should be well stabilized with sedges, rushes, and grasses such as mana grass. Picture 16 shows extensive root system of willows. Horsetail roots are shown in Picture 17. Picture 18 shows the force of water eating into bank, but willows are helping to hold the bank together. However, the point on the opposing shoreline needs to keep up in to keep the stream channel from widening. Point bars keeping up with erosion on the opposing bank is key in steeper gradients.

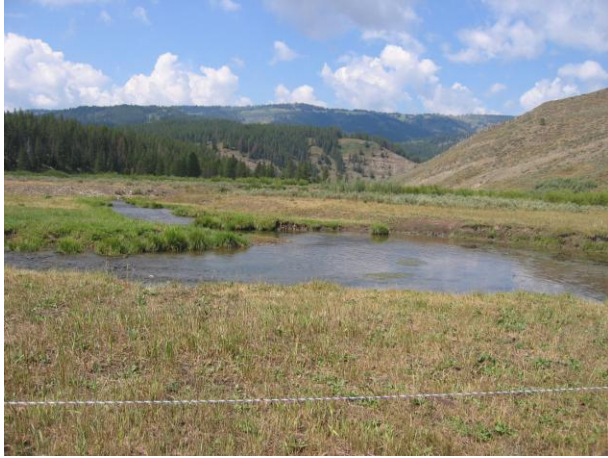
Picture 19. UTM coordinates 0522217 N, 4770793 E

At a site where the permittees put up an electric fence, there is a silver sagebrush (mountain silver sagebrush) flat with smooth brome (Pictures 19 and 20). Cattle are taking more vegetation than he remembers (he had made similar comments at other sites). Smooth brome apparently was seeded in the 1960s; it is okay in meadows, but does not provide any bank-holding benefits. Shrubby cinquefoil is also present; it indicates a slightly wetter situation than silver sagebrush. Alma saw Nebraska, water, and beaked sedge along the green-line. He felt this meadow has great potential, but that it is being held down.

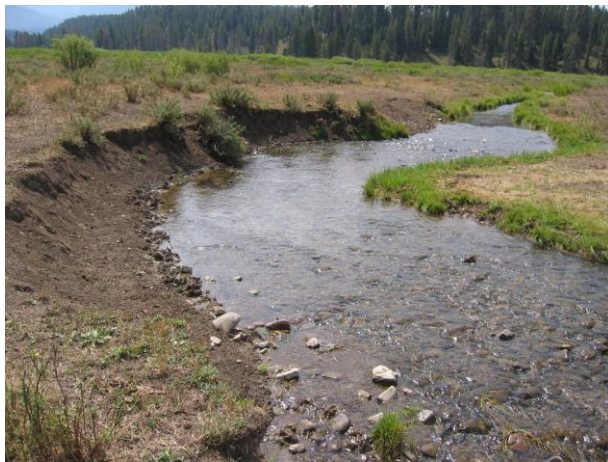
Picture 21.

Bank trampling was apparent as was a thin green-line of sedges (Picture 21). Alma pointed out water buttercup in the deposition zone up next to a bank; he said these plants are important for starting the process of plant colonization and the initial building of banks (Picture 22).

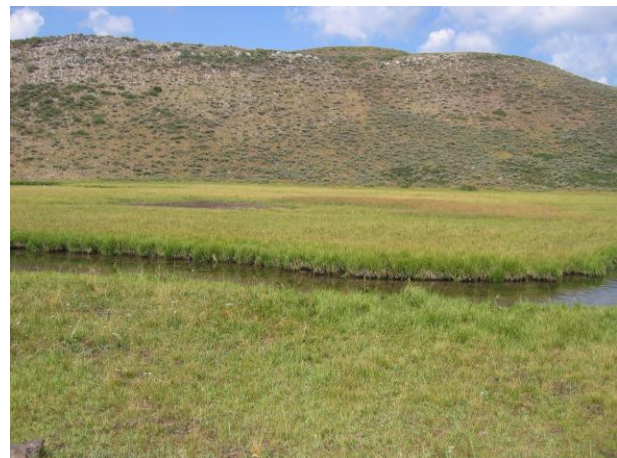
Picture 23. UTM coordinates: 0522937 N, 4770735 E.

We briefly stopped where the herder had erroneously placed salt blocks in the riparian area near the intersection of Little Greys River and McCain Roads (bare spots in Picture 23). Alma said the streambanks, stream channel, and off-channel areas are in good condition.

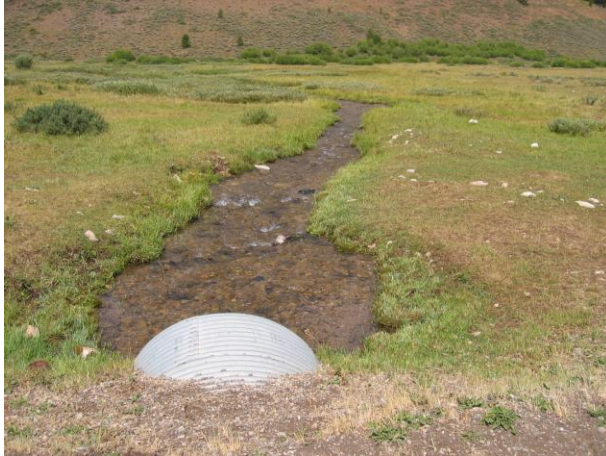
Picture 24. UTM coordinates: 0523266 N, 4771201 E.

At the first culvert on McCain Road, we stopped briefly and discussed the situation (Picture 24. Alma said vegetation was being grazed too closely, particularly on the streambanks.

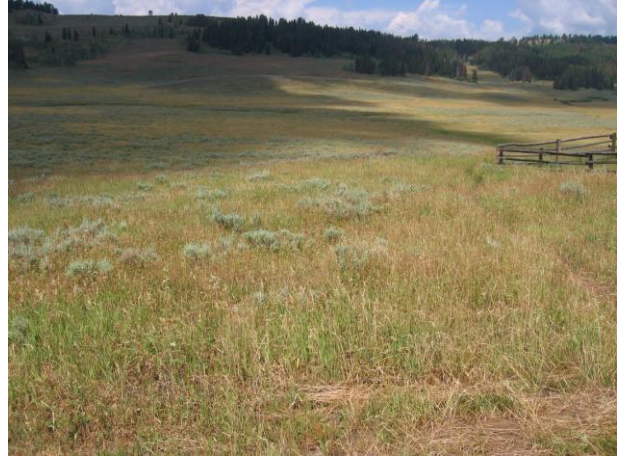
Picture 25.

Near the McCain guard station (Picture 25). Alma said the portion of the meadow near the road historically was likely a silver sagebrush/*Deschampsia* meadow. Now the understory is dominated by smooth brome.

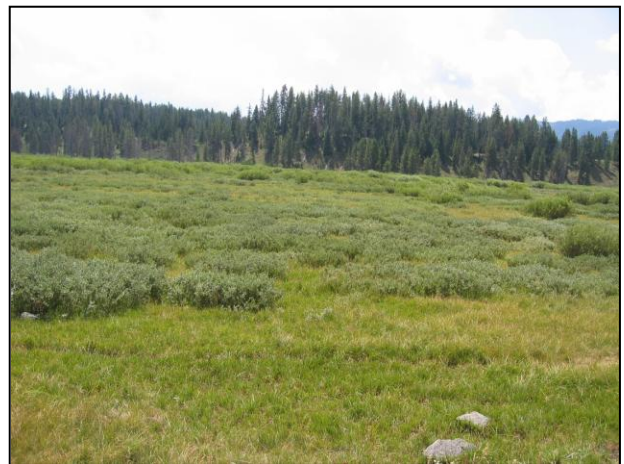
Figure 26. ; UTM coordinates: 0522408 N, 4770770 E.

On the way back down the river, we stopped to look at a Wolf's willow (*Salix wolfii*) stand and what appeared to be a relatively intact graminoid community (Picture 26). Alma thought these communities looked to be in fairly healthy condition.
