May 4, 2018
(Revised May 7, 2018)

Subject: Engineering Consultation
Golden Peak Improvements Project
Vail Ski Area
Vail, Colorado
Project No. GS06142.000-145

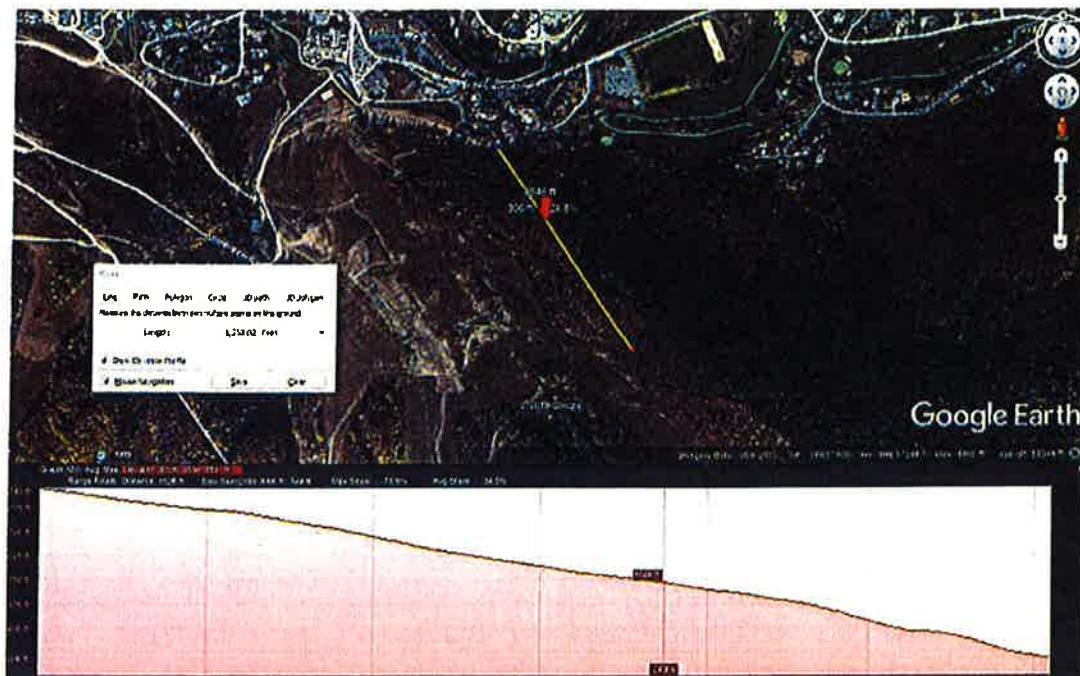
Our document review indicates that the potential volume and flow rate of water directed toward the slopes above Northwoods has not been analyzed. The amount of water and sediment loads may be significant, especially if the Golden Peak features are constructed as proposed. A profile of the slope from the bottom of the mogul course to the ridge top above Northwoods is shown below.

This slope profile, generated with Google Earth, indicates that surface and subsurface water at the base of the mogul course is likely to travel to the slopes directly above the Northwoods property. Tree clearing, reshaped surface grades, and additional manmade snow required for the course is likely to increase the amount of surface runoff and subsurface water to the slope directly above Northwoods. This could increase driving forces for slope failures and sediment loads resulting in mudfloods and mudflows.

The planned drainage improvements are positive, but not designed with the intent of mitigating risk of landslides, mudfloods, and mudflows that could affect Northwoods. Considering that a substantial degree of risk from flooding and mudflow currently exists and mogul course construction could increase the risk, we recommend this risk be evaluated. We can provide evaluation of the potential flood, mudflow and slope stability risks for the Northwoods HOA if desired. Potential mitigation may range from not constructing the mogul course, moving of the planned mogul course, or construction of berms, lined detention ponds and subsurface drains.

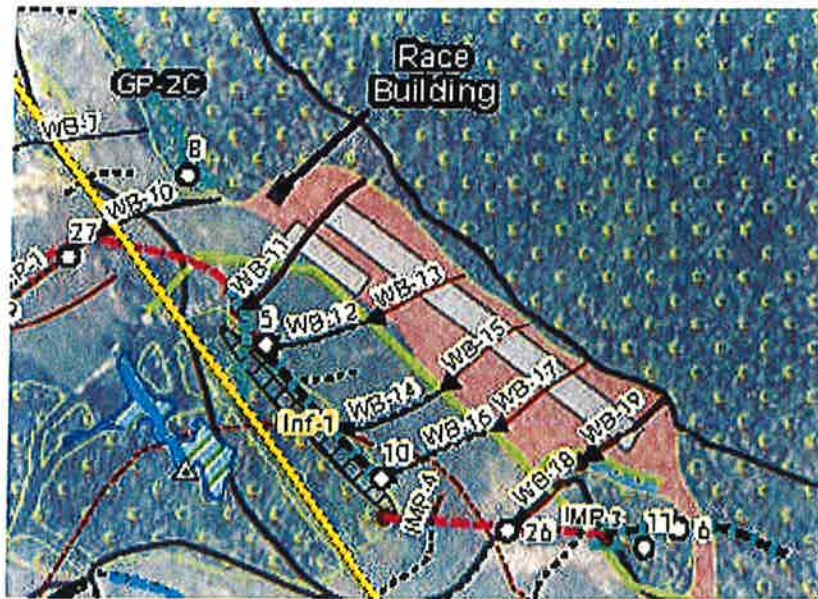
Drainage improvements related to basin GP-2G and the mogul course are indicated on the photograph below. New water bars (i.e., ditches) WB-11, WB-13, WB-15, WB-17 and WB-19 are proposed to be built. Existing water bars WB-7, WB-10, WB-12, WB-14 and WB-16 would be improved and enlarged. The existing drainage channel IMP-3 would be enlarged with enhanced erosion control.

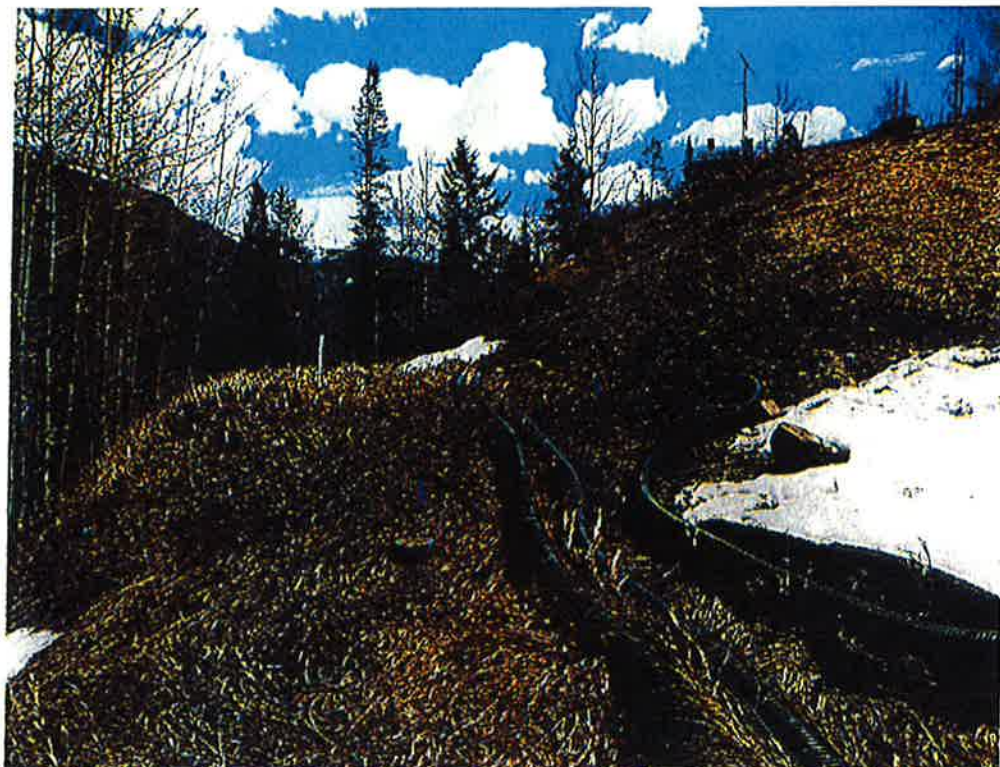
Buried Water Tank Above Northwoods

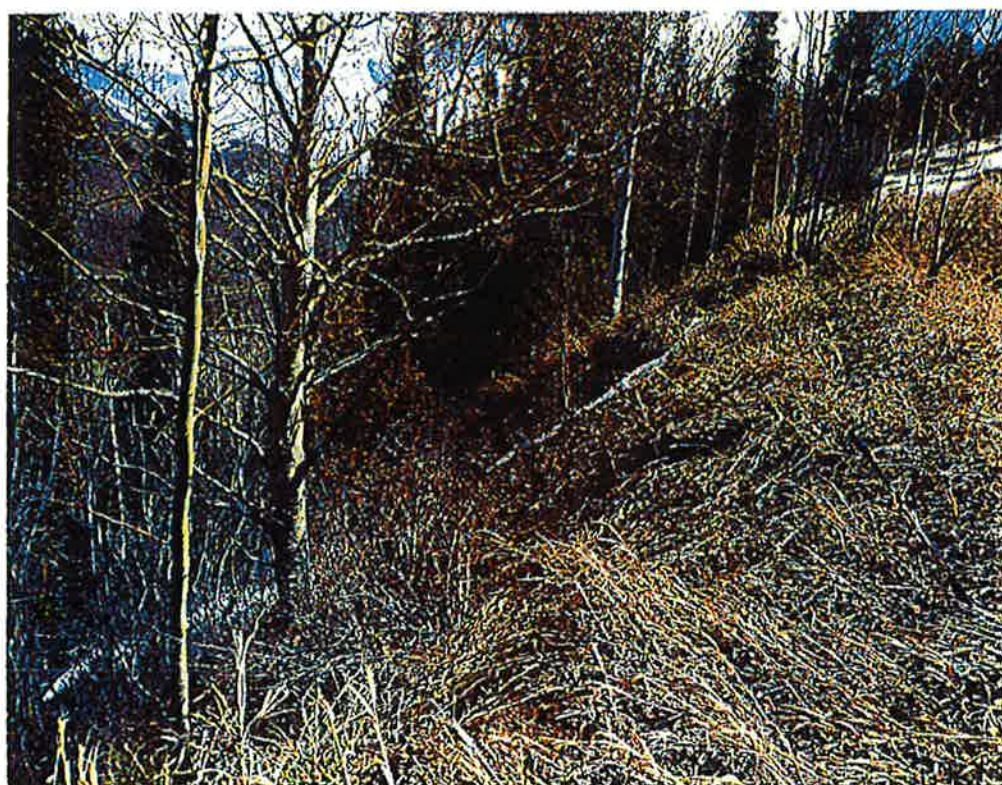
Crest of Slope Above Northwoods

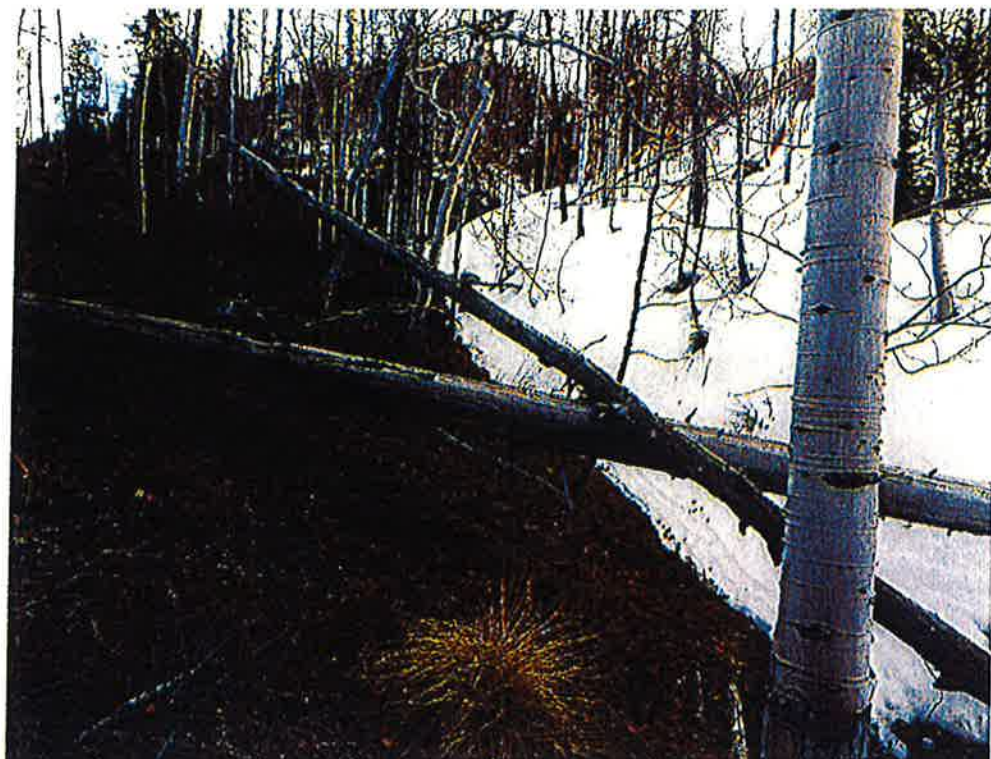
From a large-scale perspective, slopes appear to be stable above the Northwoods property. This is largely due to the strength of the limestone bedrock layers. The colluvial soils above the bedrock are erosion-prone and subject to shallow failures that include slumps, as well as mudflood and mudflow. Drainage courses that are currently incised into the slope appear to transport surface flow toward the Northwoods property.

Incised Drainage Channel Above Northwoods

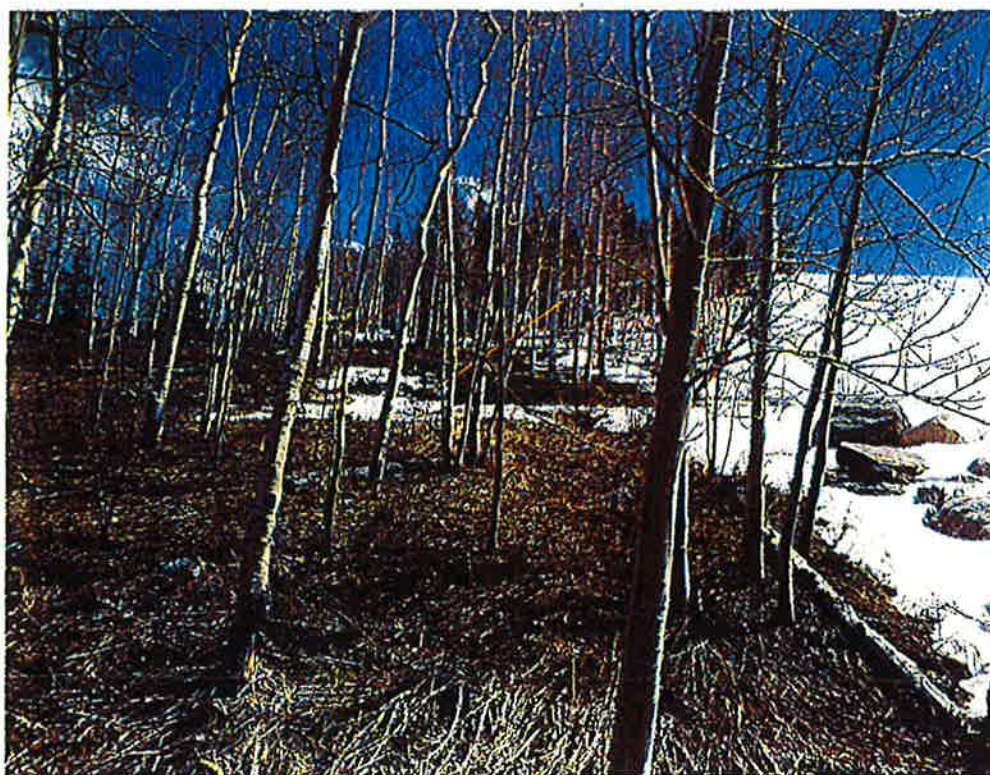
Proposed Mogul Course Location

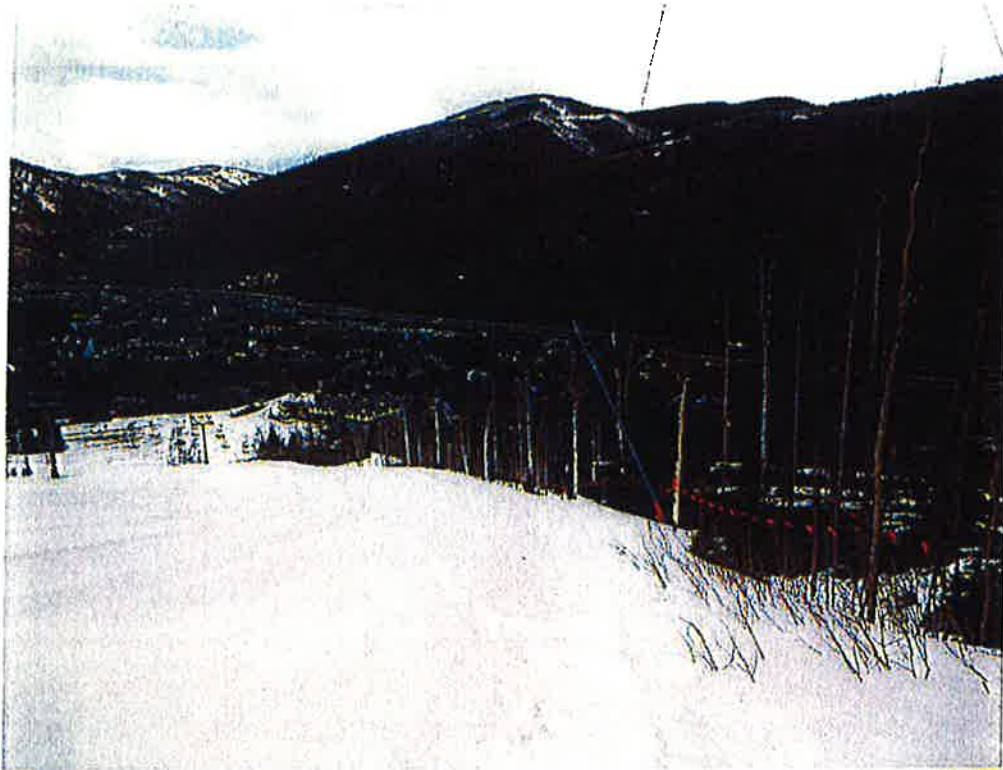
Ski Trial/Mogul Course Boundary

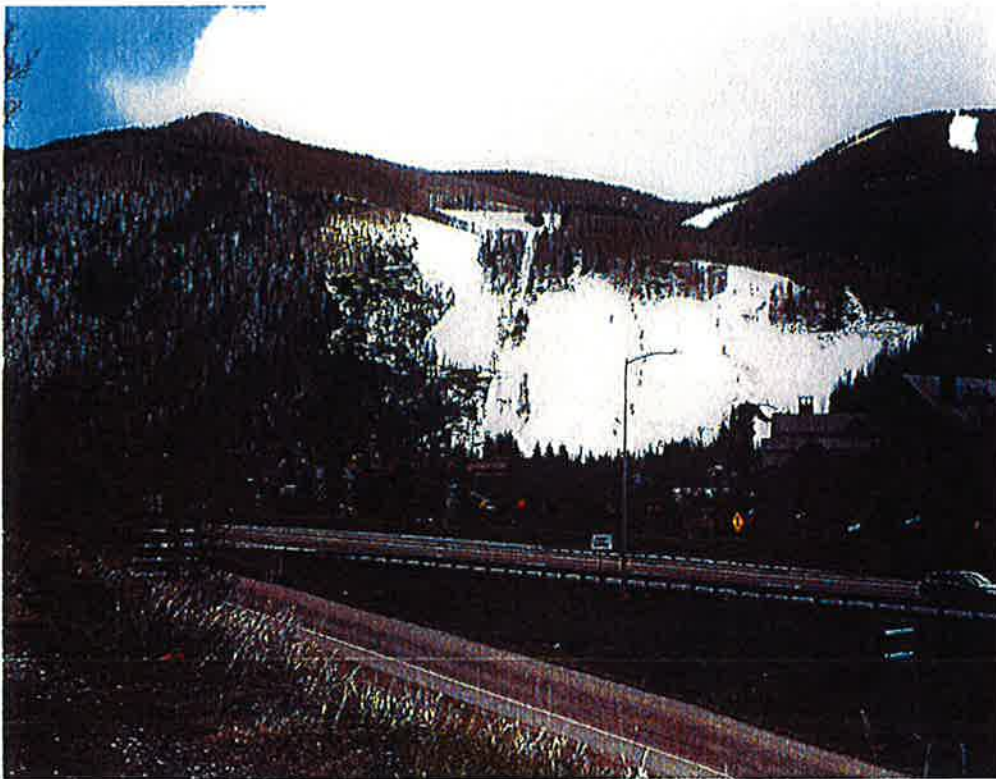
Golden Peak Improvement Area (left of existing ski run)
