Observations of Mining Activities in Siskiyou National Forest Riparian Reserves and Probable Impacts to Aquatic Organisms

March 7, 2002

Richard K. Nawa
Siskiyou Project
213 SE "H" Street
Grants Pass, Or 97526
541-476-6648
rich@siskiyou.org

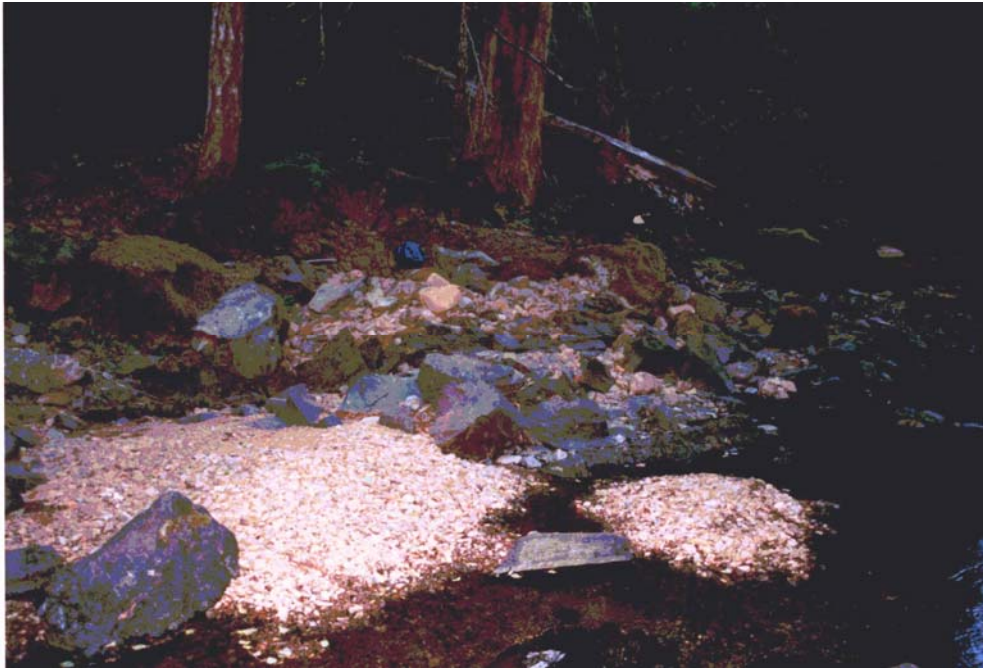
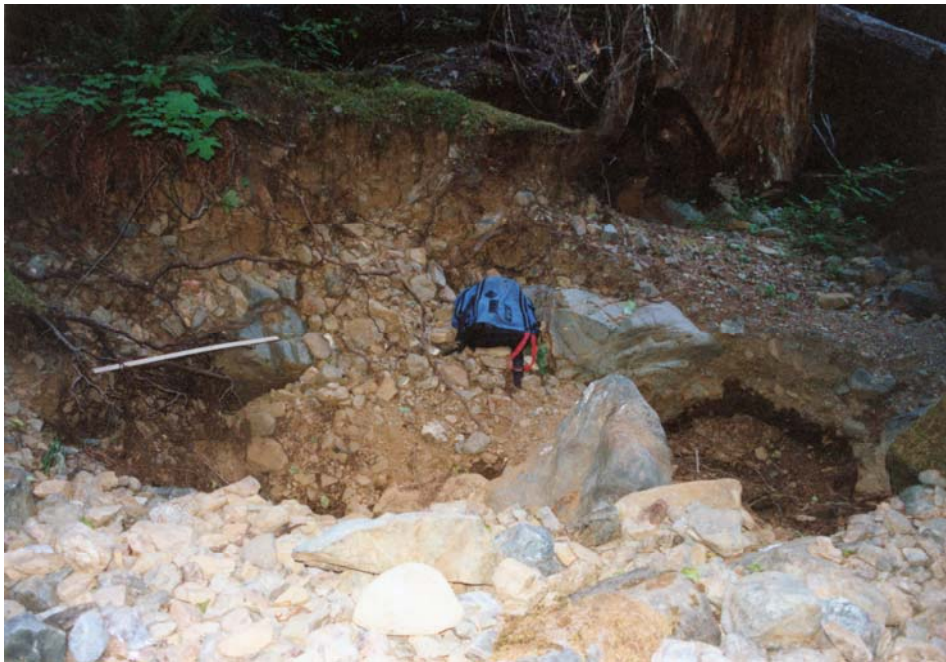
Streambank excavations were the most common kind of physical impact found, but streambed excavations had higher total volumes (Table 1, Figures 2-5). Most streambank excavations followed the streambank contour but in at least four locations trenches up to 12 ft long were excavated perpendicular to the streambank. Streambank excavation length ranged from 3-88 ft and averaged 18 ft. Estimated volumes of streambank excavations ranged from 0.3-27 yds³ and averaged 6.1 yds³.

Figure 3. During summer 2001, an estimated 7 cubic yards of soil was excavated from 20 ft of streambank (bottom photo) and 5 cubic yards placed directly into Briggs Creek (top photo).

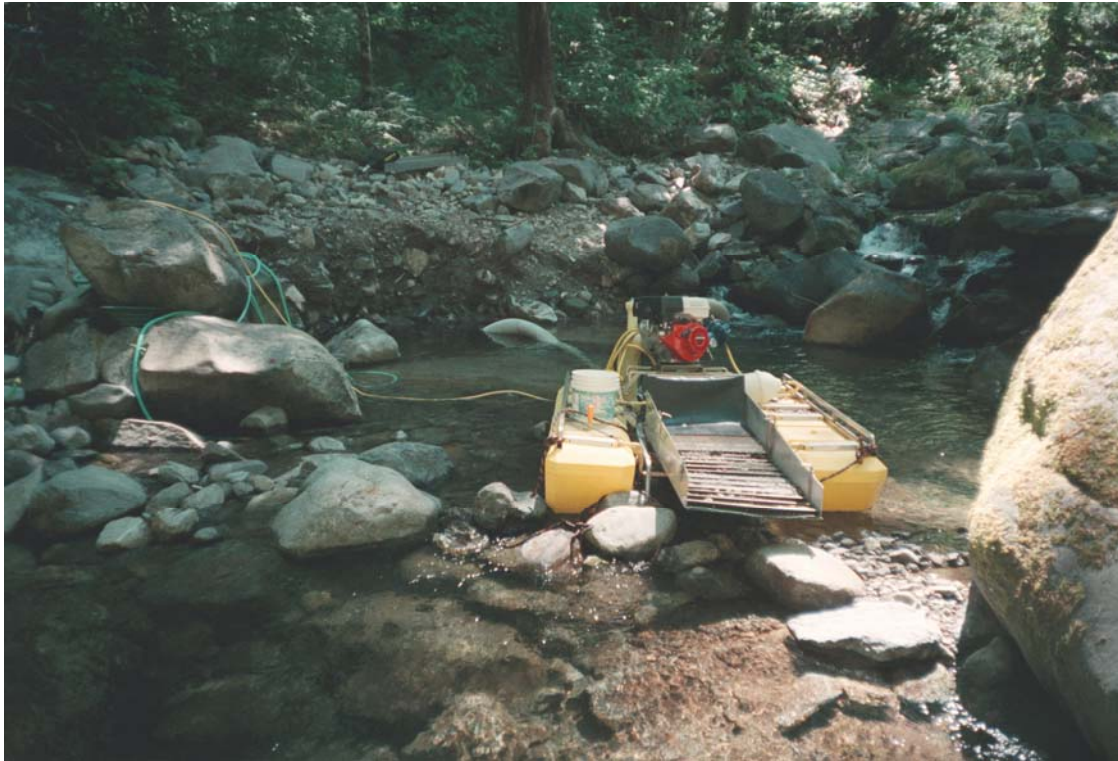
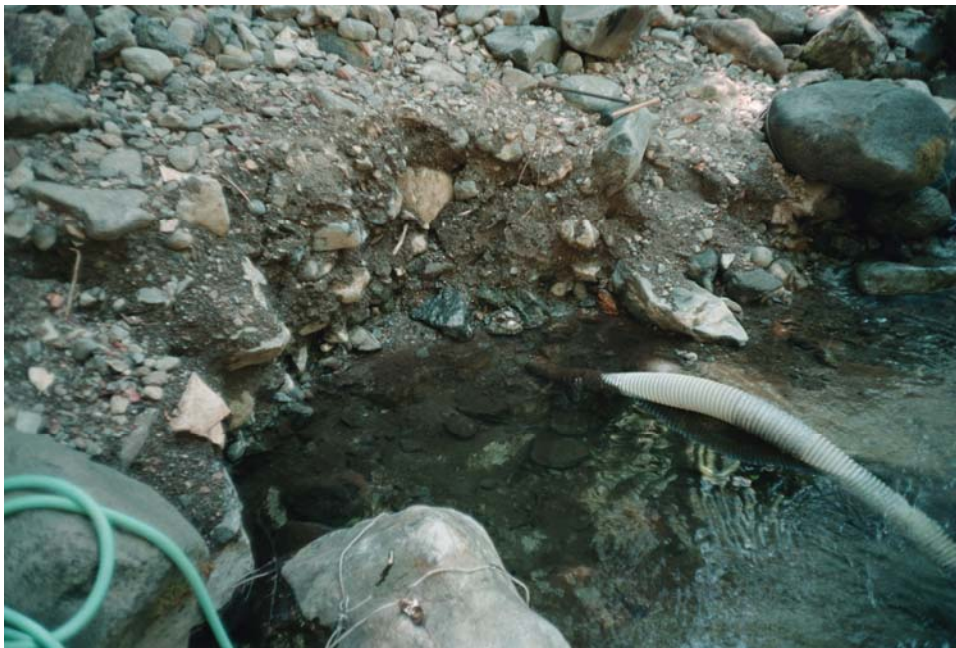
Figure 4. During June/July 2001 about two cubic yards of streambank was excavated into Left Fork Sucker Creek (bottom photo) and about 15 ft of streambank destabilized (top photo).

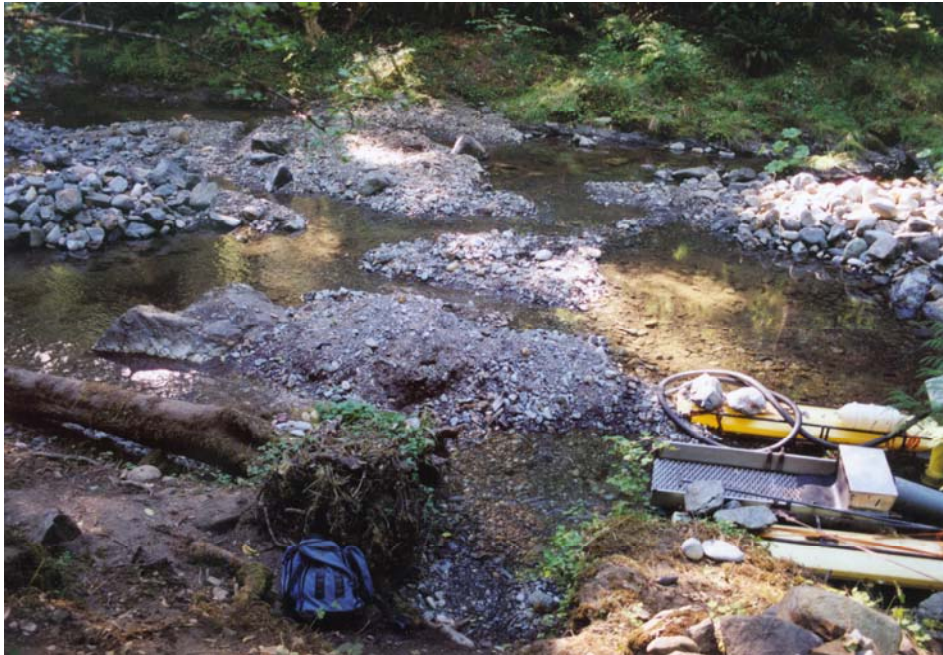
Area of streambed excavations ranged from 3-277 yds² (Avg=77yds²). Estimated volumes of sediment moved in the streambed ranged from 2-93 yds² (Avg=27yds³). Depth of excavation had to be estimated at most locations making it the biggest source of error. Volume estimates are probably within 50% of actual.

Figure 5. Approximately 370 square yards of streambed was disturbed making it unsuitable or unsafe for salmon spawning.

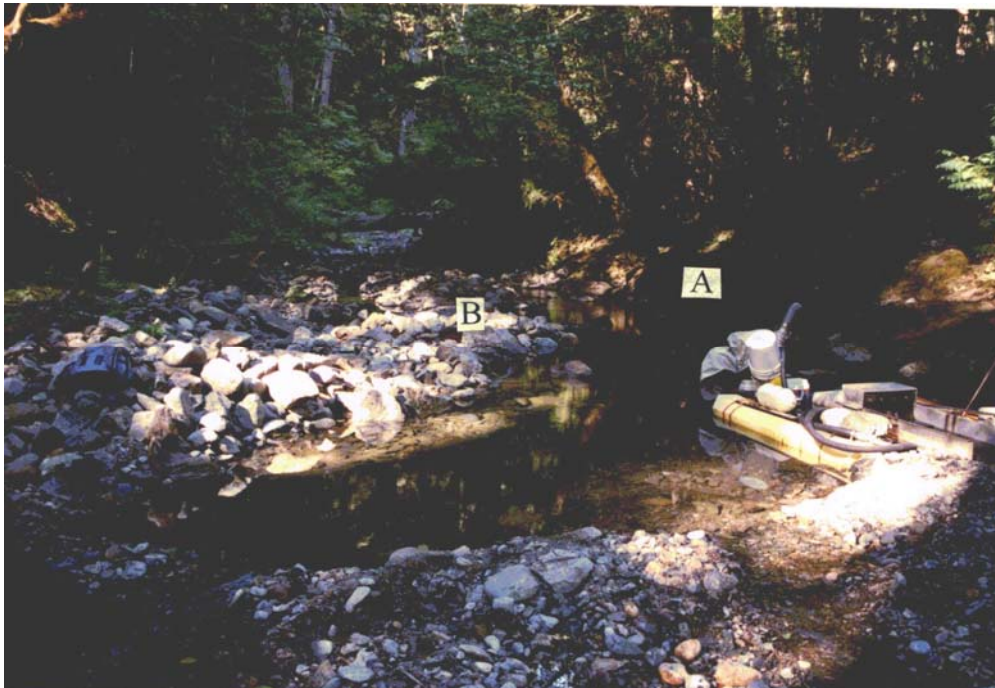
Figure 6. Streambed sediment excavated from right bank (A) of Briggs Creek was deposited as a mid-channel bar (B) which now directs flows towards unprotected and undercut streambank (A).

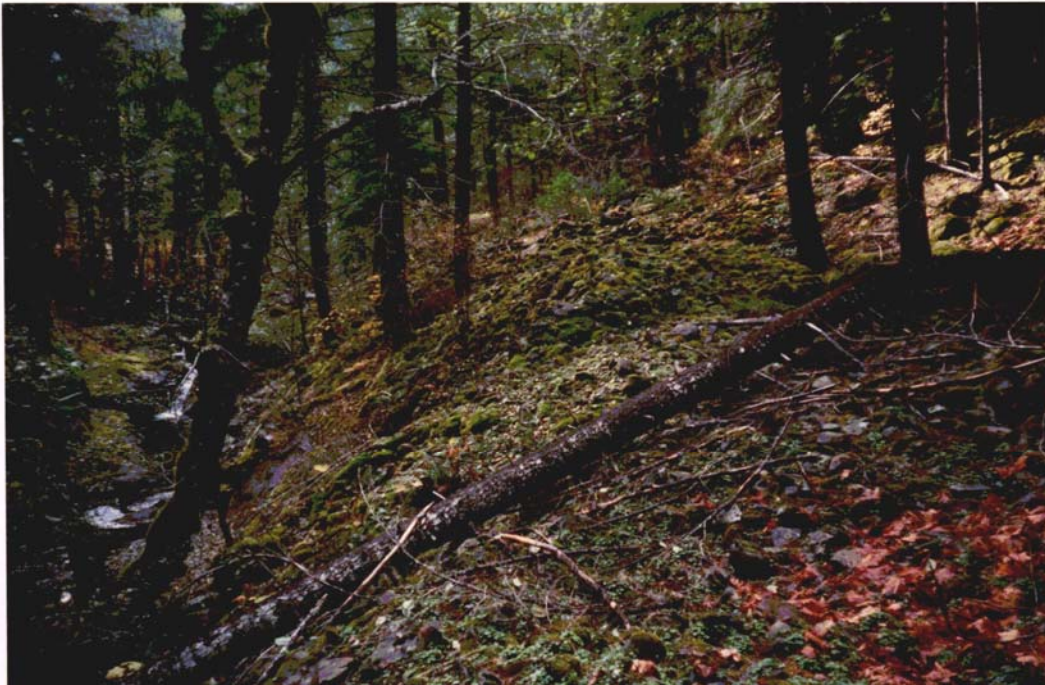
Tailing piles from alluvial excavations prior to 1950 were found along Briggs Creek and Sucker Creek. Two of these moss-covered tailing piles immediately adjacent to Briggs Creek covered 0.5 and 0.2 acres. Five extensive tailing piles along Sucker Creek totaled an estimated 12,000 cubic yards of boulders and cobble (Figure 6). Besides these older (pre 1950) tailings, five smaller piles of boulders and cobble were found on upper Sucker Creek that appeared to be from streambed excavations between 1990 and 1997. These newer tailing piles totaled 134 cubic yards (Map 1 Location F, Figure 7).

Figure 7. Estimated 4,400 cubic yards of cobble/boulder tailings excavated about 40-60 years ago. Sucker Creek at left remains scoured to bedrock.

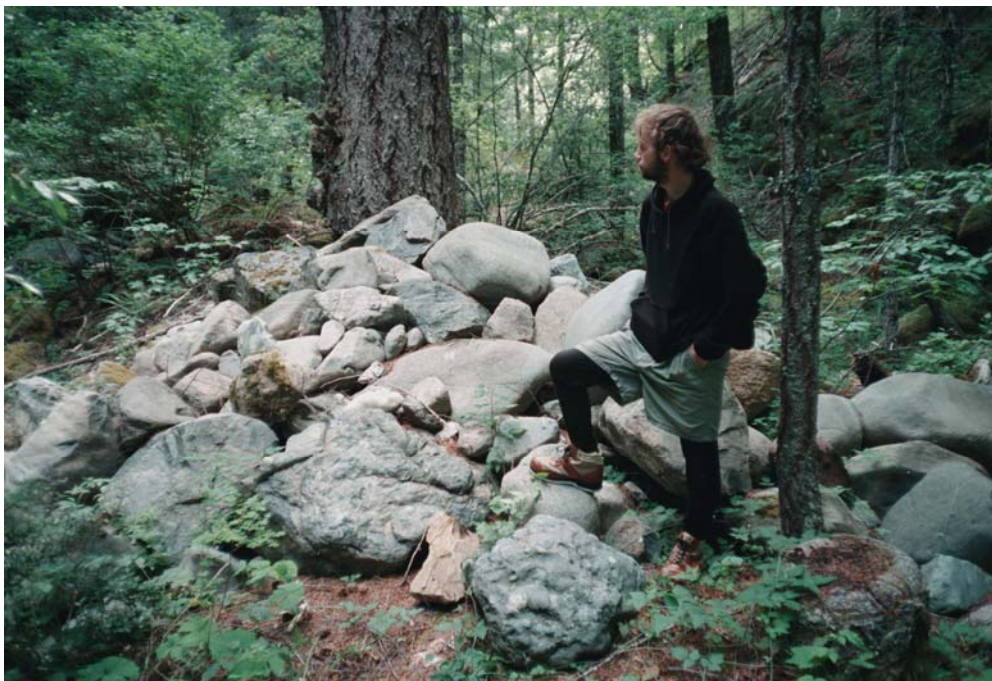
Figure 8. An estimated 23 cubic yards of boulders were removed from the streambed to the floodplain of Sucker Creek sometime between 1990-1997.

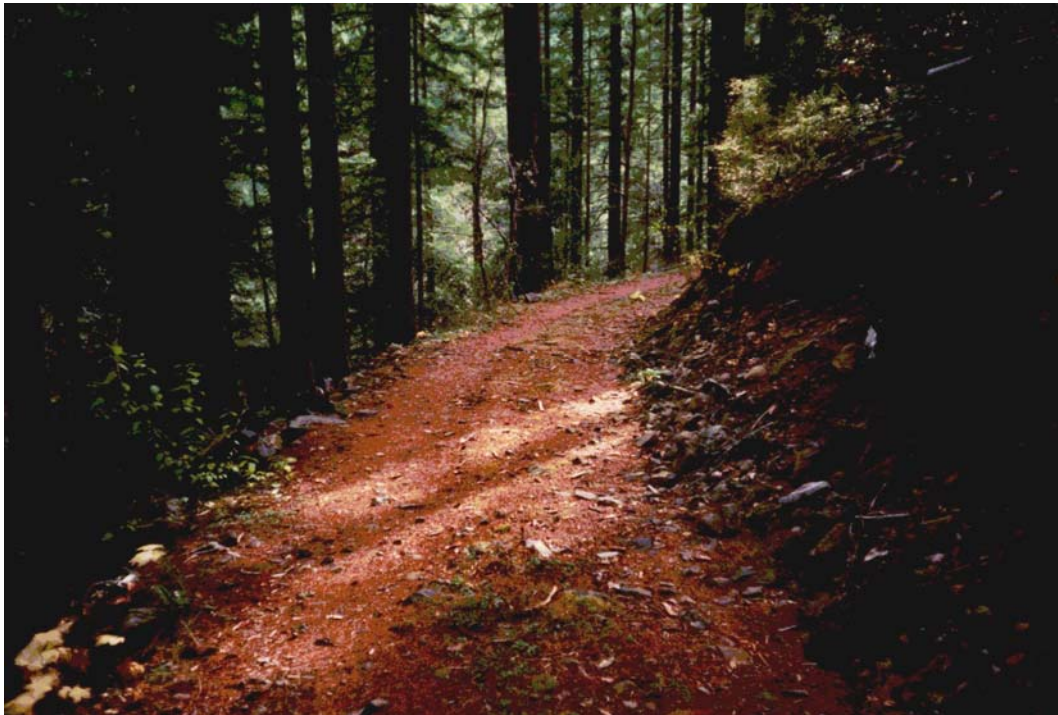
At least 30 percent of the road miles I found in riparian reserves were not on Galice or Illinois Valley Ranger District administrative maps or USGS 7.5' quadrangle maps. Missing roads on recent maps suggests that roads have been constructed or reconstructed since these maps were made and field investigations are needed to avoid underestimating road densities within riparian reserves (Figure 8). For analysis purposes, the riparian reserve was assumed to be a 700-ft wide band containing the stream's active channel. Road densities for each stream's riparian reserve ranged from 0.0 for Left Fork Sucker to 7.5 mi/mi² for Briggs Creek (Avg=4.8mi/mi²).

Figure 9. Sometime during 1975-1990 about 0.4 miles of mining road was bulldozed into very steep slopes above Sucker Creek. Road is not on Illinois Valley District administrative maps or USGS maps.

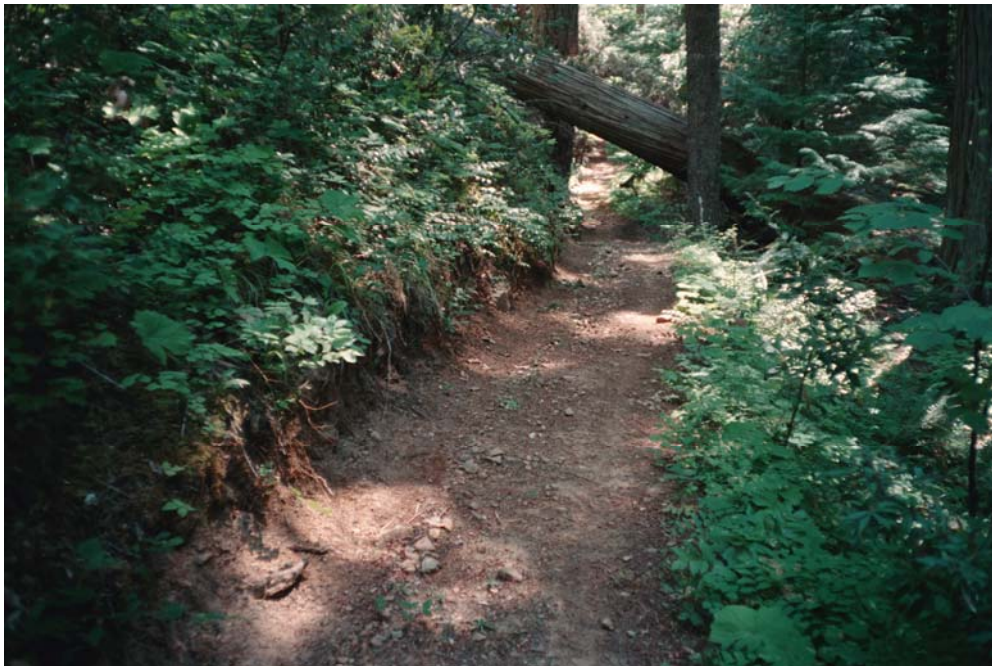
Approximately 1.6 miles of trail along Left Fork Sucker was widened or reconstructed to accommodate ATV's (Figure 9). Similarly about 0.6 miles of the Briggs Creek Trail was used by motorbikes to access mining operations.

Figure 10. During summer 2000, a hiking trail along Left Fork Sucker Creek was widened by excavating soil from hillslope to accommodate all-terrain-vehicles (ATVs) used by miners.

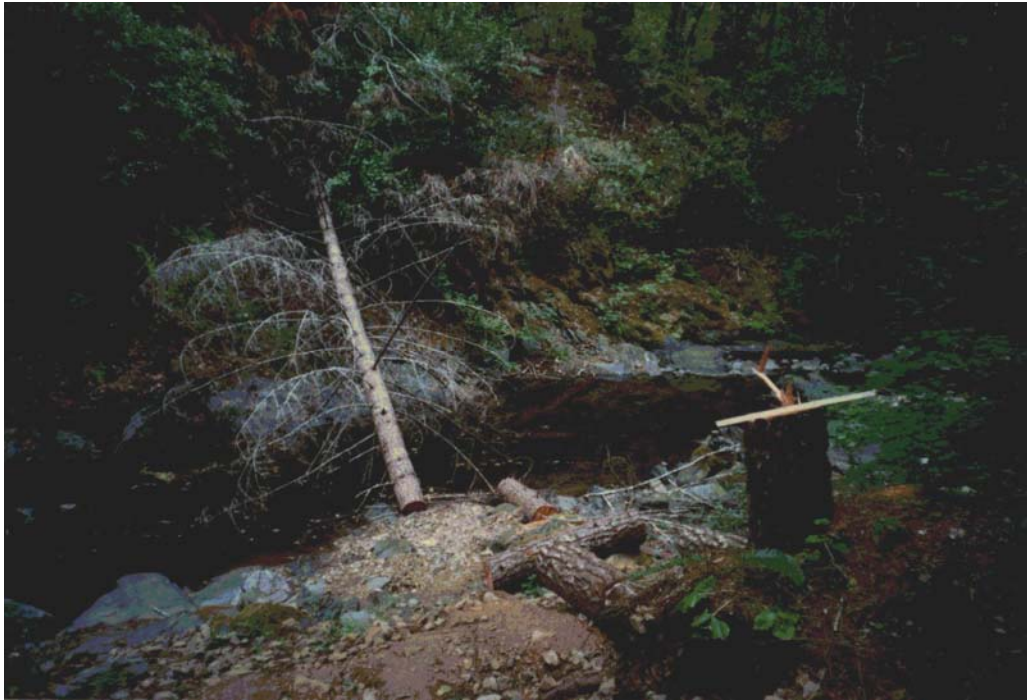
Most trees felled were alders less than 12 inches diameter, although one 14-inch diameter Douglas-fir was felled into Briggs Creek and bucked during summer 2001 (Figure 10). At the same location on Briggs Creek a fallen 24-inch diameter maple was bucked and removed from the active channel during 2000-2001 (Figure 11). A 36-inch diameter 20-ft high snag on Briggs Creek had its roots sawn through and its base excavated (Figure 12). Most of the trees felled and bucked along Sucker Creek occurred prior to 2000.

Figure 11. During summer 2001, a live 14-inch diameter Douglas-fir tree was felled into Briggs Creek and bucked. Streambank below fallen tree was excavated.

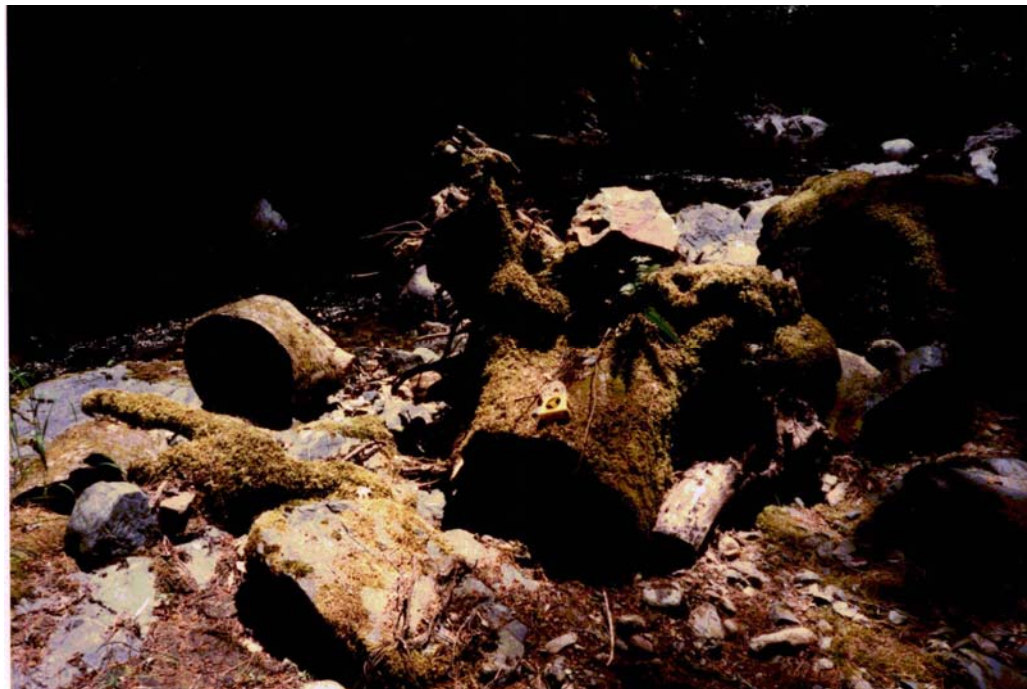
Figure 12. During summer 2000 a fallen 24-inch diameter bigleaf maple in the active channel of Briggs Creek was cut into 2-ft pieces. At the same location a streambank was excavated.

Most tree felling and bucking of fallen trees during 2000- 2001 was done in conjunction with streambank excavations (Figs 10,11). Miners apparently remove streamside trees and cut roots while excavating streambanks. Removal of streamside trees and shrubs, and subsequent streambank excavation makes streambanks vulnerable to accelerated erosion and channel widening. Channel widening and resulting shifting thalweg destabilizes the streambed. Some maples and alders appear to have been cut for fire wood. Cumulative effects of tree removal would eventually reduce shade and cause stream temperature increases or retard progress towards cooler, pre-mining conditions. Similar destruction of riparian vegetation has been reported from Alaska (Prussian et al. 1999). During summer 2001, the roots of a 4ft-diameter snag were severed and soil dug out from its base (Figure 12). This snag is certain to fall prematurely, thus reducing available habitat for cavity nesting birds and bats. Anyone who ventures near this snag is in danger of being crushed because most of its support has been cut or undermined.

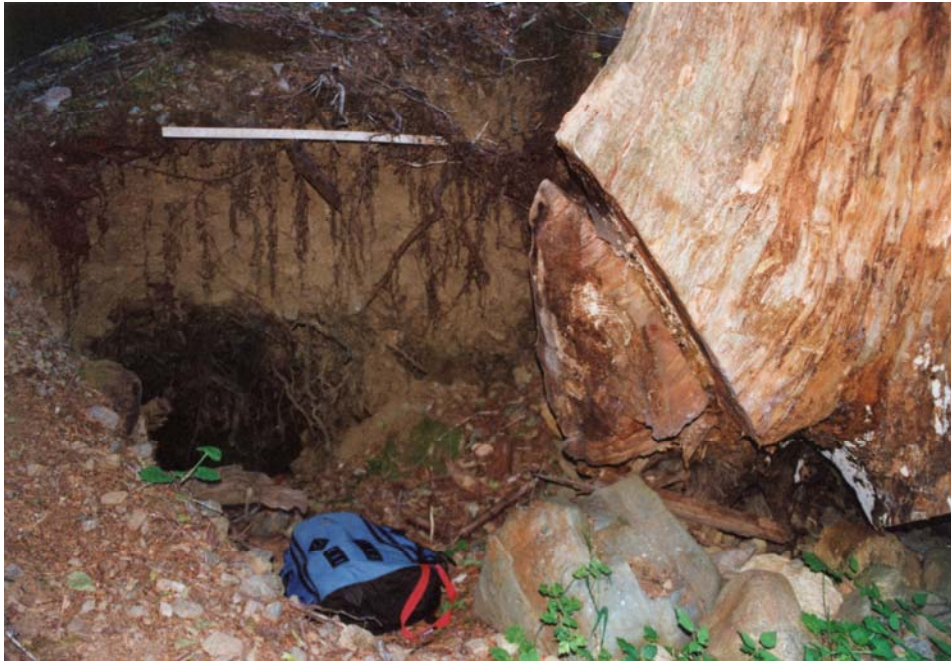
Figure 13. During summer 2001, the roots of a 4 ft. diameter snag were severed and soil dug out from its base.

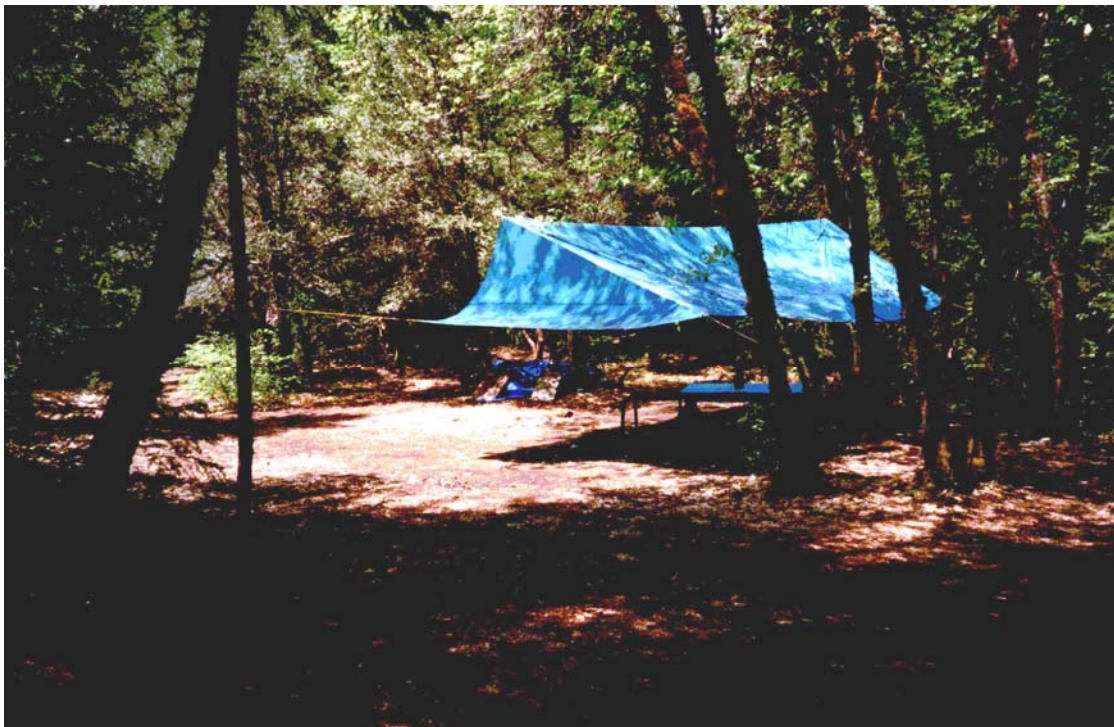
Denuded and compacted soils at 12 mining camps ranged from .05 to .25 acres (Figure 13). The total compacted area in mining camps was 1.4 acres. Seven outhouses were found at mining camps (Figure 14). Sheds, tables and tents were often found at mining camps but were not enumerated.

Figure 14. Year-long mining camp on mining claim along Soldier Creek.

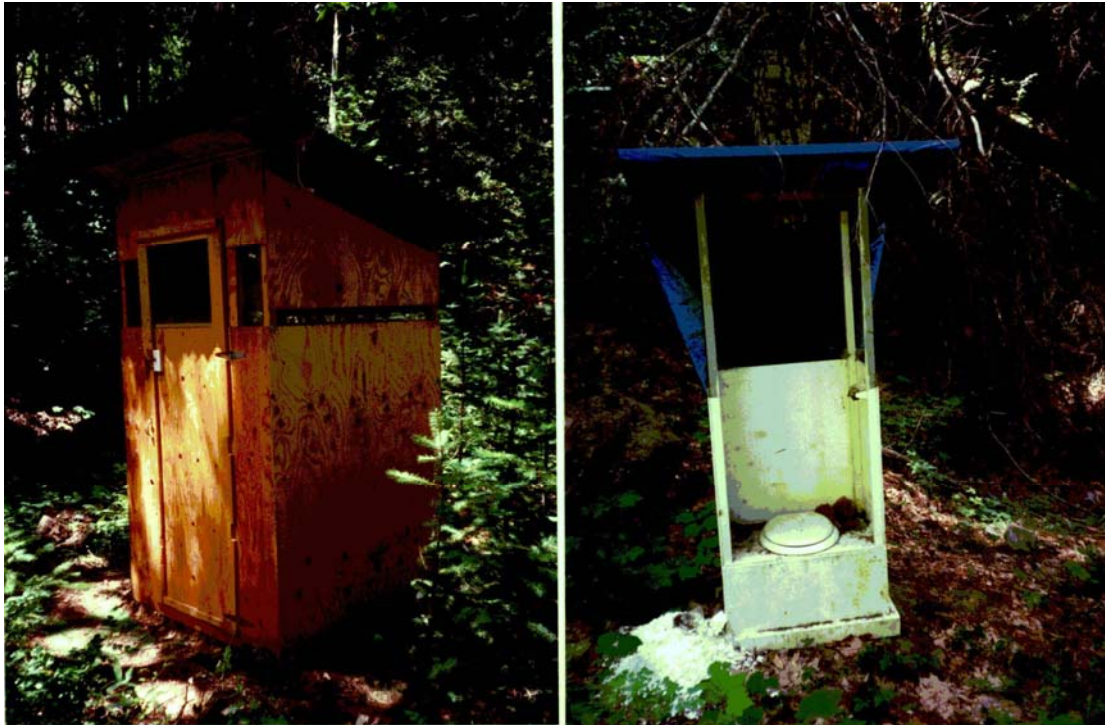
Figure 15. Two adjacent out houses located within 80 ft of Sucker Creek. One on left appears to have been constructed summer 2000.

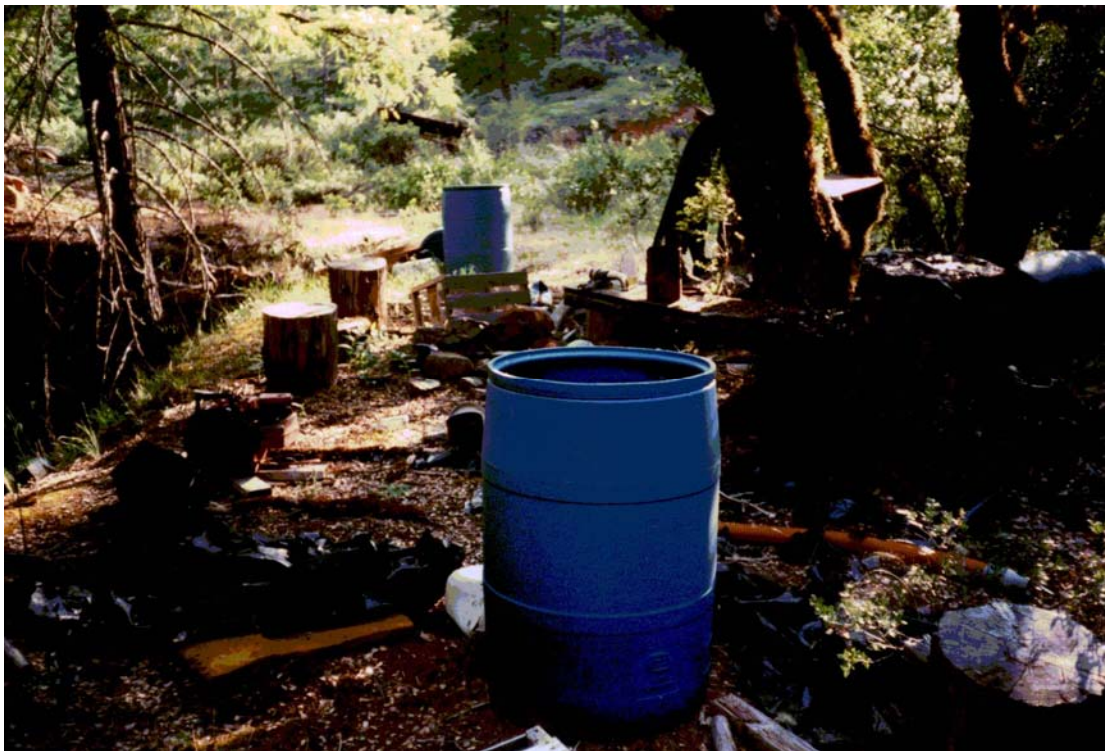
Examples of solid waste were collapsed structures, car batteries, tires, tarps, petroleum containers, plastic buckets, empty food containers, plastic pipe, and abandoned mining equipment (Figure 15). Volumes of solid waste were not recorded.

Figure 16. Discarded plastic barrels, motors, tarps, plastic pipe.

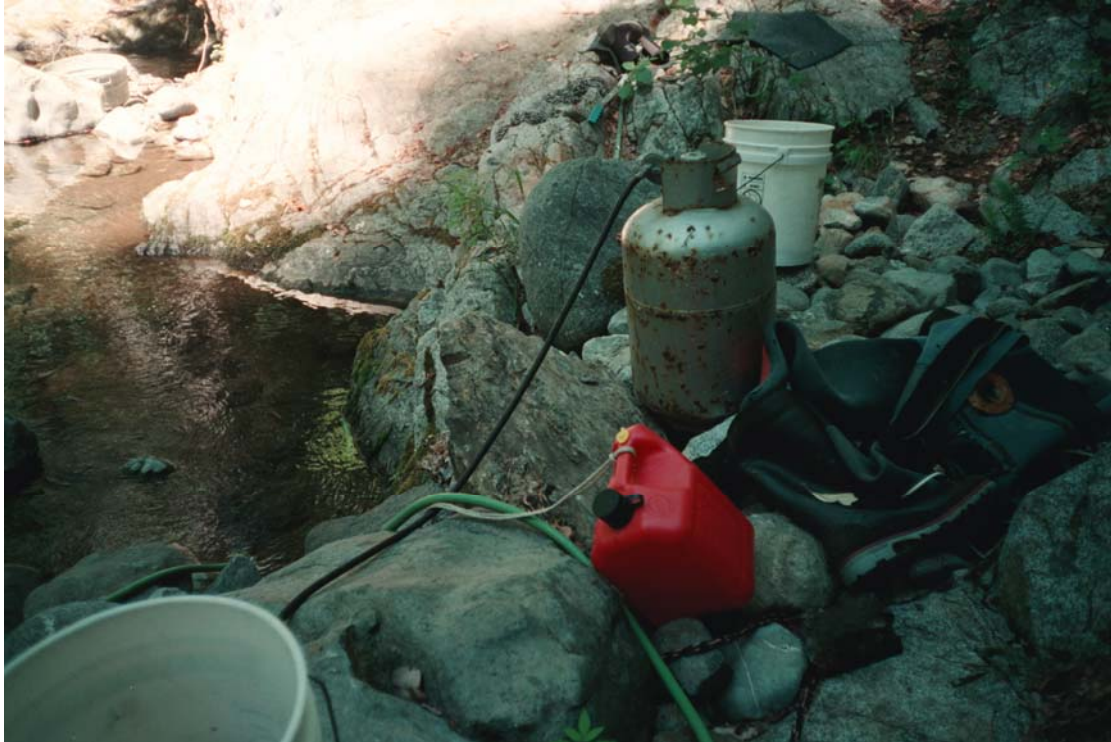
Petroleum containers ranged in size from 1 qt to 2-gallon plastic jugs. All were at least half-filled with oil or gasoline. Five of six containers were located 4-25 ft from the wetted stream (Figure 16).

Figure 17. Two gallons of gasoline left 4 ft from Left Fork Sucker Creek, July 2001.

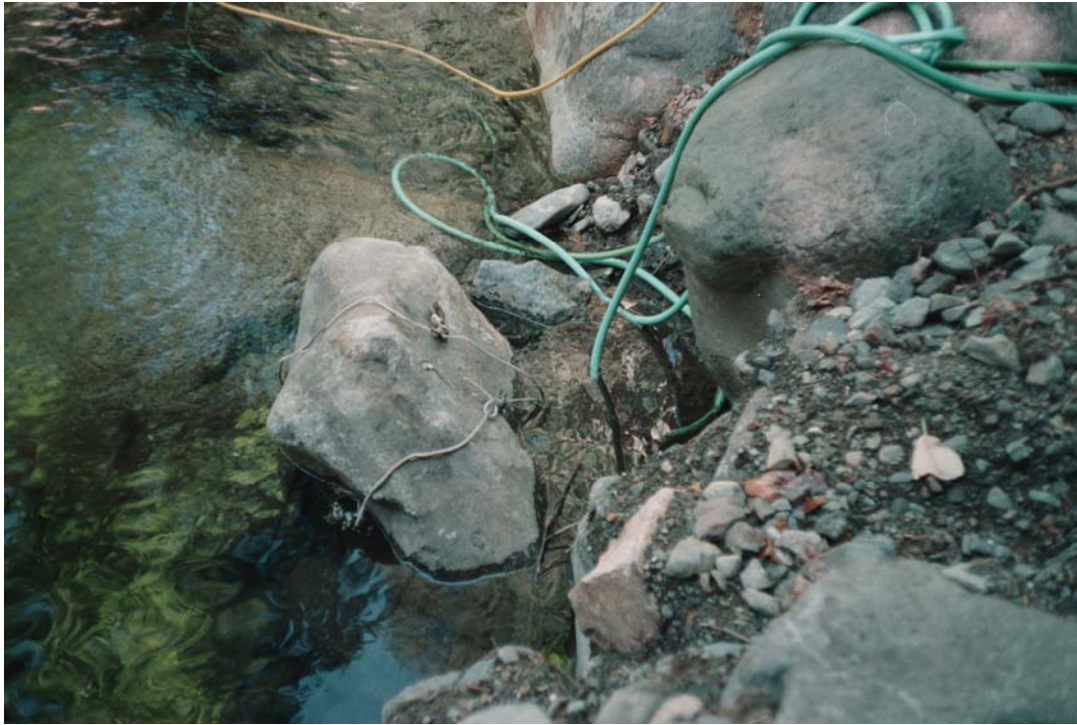
Figure 18. During June/July 2001 several 2-3 ft diameter boulders were winched from a streambank to expose fine textured soil, Left Fork Sucker Creek.

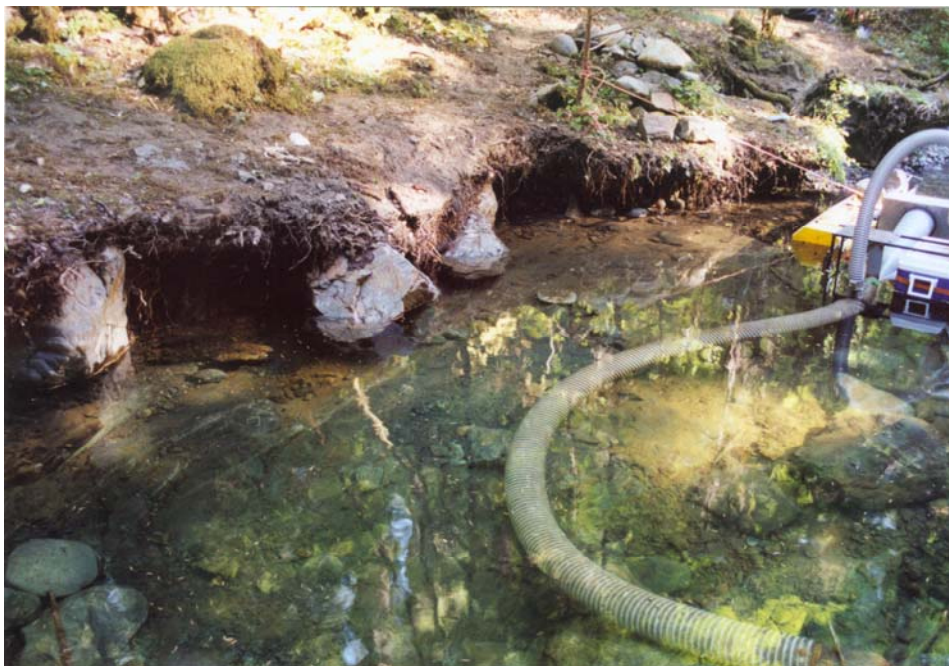
Figure 19. Nearly all protective armoring has been removed from this streambank making it vulnerable to increased erosion from winter floods. Briggs Creek, 5 Sept 2001.

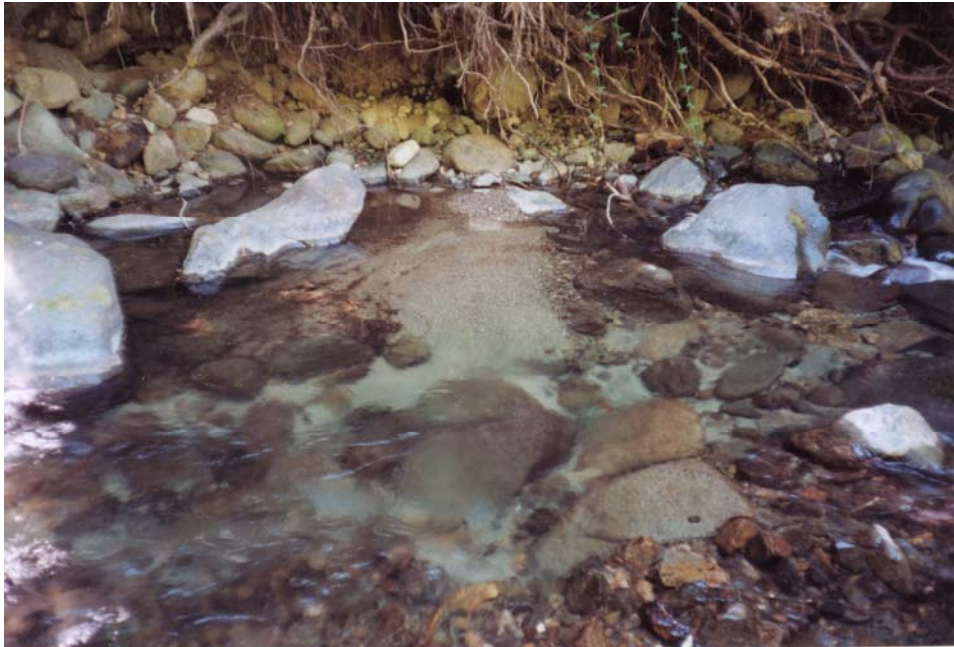
Undisturbed streambeds are armored with coarse rock that requires relatively high (bankfull) flows to activate bedload movement of underlying fine sediment (Jackson and Bestcha 1982). Streambed excavations removes the coarse protective armoring and allows the underlying finer sediments to be mobilized by modest (less than bankfull) flows (Figure 19). In other words mining makes the streambed more susceptible to streambed erosion, turbidity, and increased surficial deposition of fines. Increased sediment, unstable eroding streambanks, loss of coarse textured armoring, and mid-channel bars all combine to destabilize streambeds.

Figure 20. Streambed excavations removes coarse textured rocks and exposes underlying fine sediment to bedload transport during winter flows. Left Fork Sucker Creek, 17 July 2001.

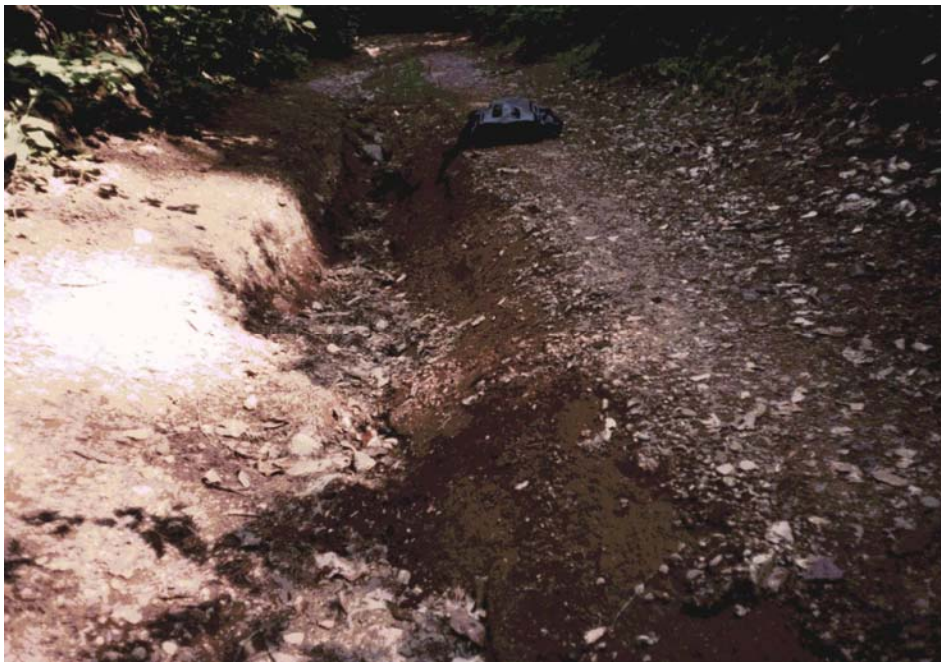
Figure 21. During heavy rainfall, soil from this 1 ft deep gully on a mining access road goes directly into Briggs Creek. Gully is actively headcutting uphill on 20 percent grade.

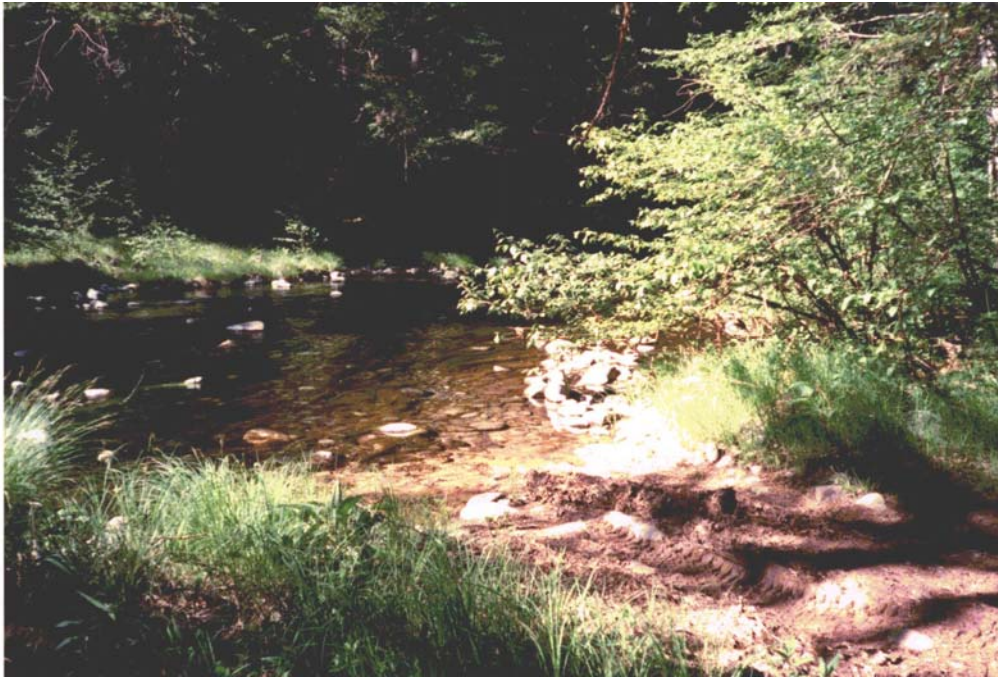
Figure 22. Mining access road across Briggs Creek has destroyed riparian vegetation. Exposed soil erodes directly into the stream. Wet stream crossings increases risk of contaminating the stream with Port Orford Cedar root disease.

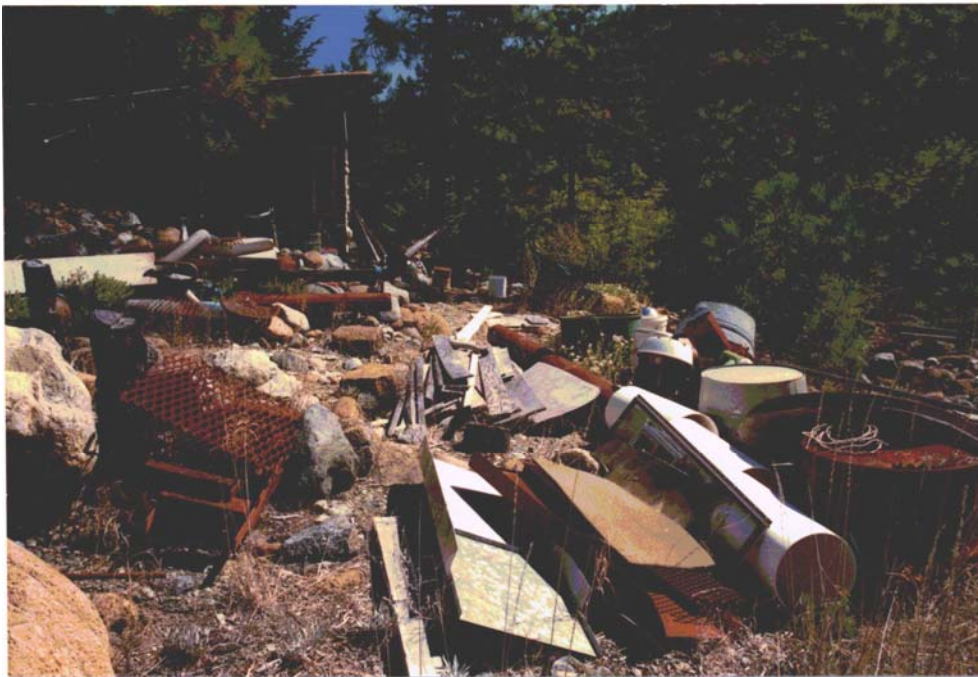
Figure 23. The cumulative effect of allowing miners to discard unwanted items onto public lands for decades. Josephine Creek, Siskiyou National Forest.

Cans, plastic containers, tires, tarps, car batteries, and mining equipment are abandoned to become unsightly solid waste. Wooden structures eventually collapse and expose unsuspecting hikers to harm from rusting nails. Some streamside areas resemble junkyards because of concentrations of rusting metal machinery and abandoned equipment (for example, Josephine Creek and Canyon Creek, Figure 22). Plastic sheeting and pvc pipe is often left in the stream to deteriorate.

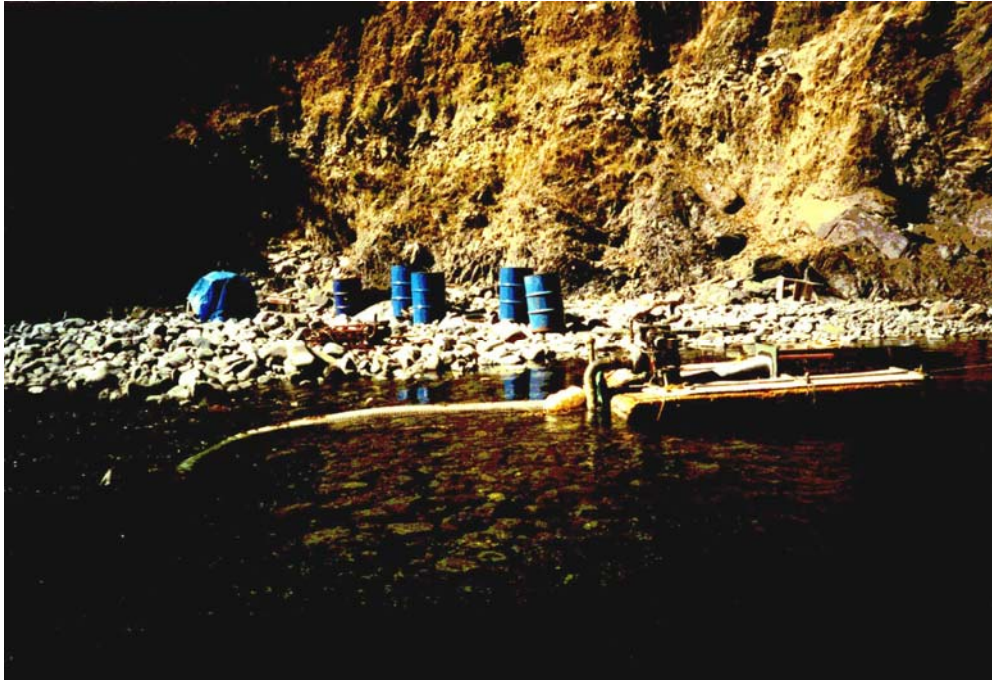
Gasoline or oil containers left unattended increases the risk of a spill or wild fire. Containers left on gravel bars could be swept into the stream during a summer freshet (Figure 23). During summer 1998, miners abandoned several partially filled and leaking 55 gallon barrels adjacent to Silver Creek (Figure 24, Map 1 Location R).

Figure 23. Miners used helicopters to place 55 gallon barrels of gasoline in the streambed of Silver Creek. Siskiyou National Forest. August 1998.

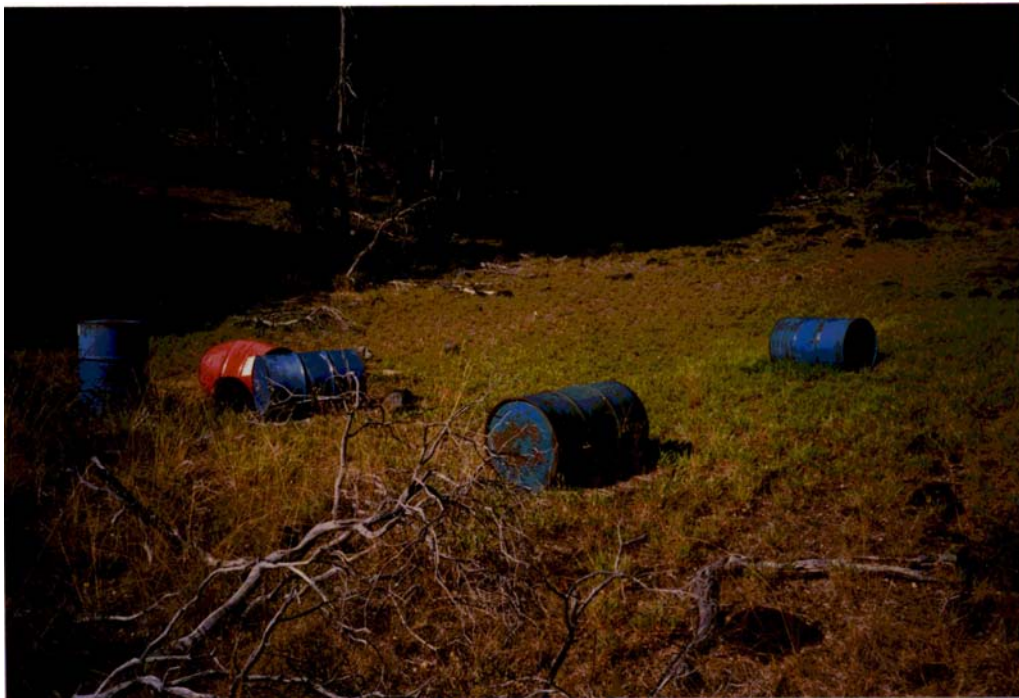
Figure 24. Miners using helicopters abandoned these leaking barrels of gasoline on a terrace above Silver Creek. August 1998.
