Comments on Phase 2 of the Cibola National Forest “Potential Wilderness Inventory and Evaluation Process”

Bear Mountains, Magdalena Ranger District

September 23, 2015

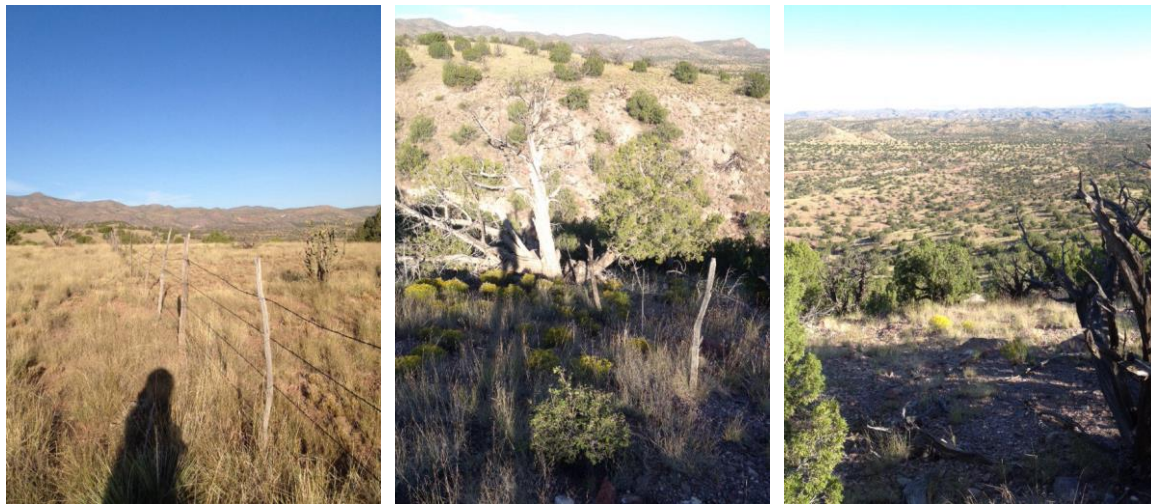
Figure 5. Left: origin of fence at 354 (34°19'4.86"N, 107°14'6.97"W). Middle: within about 100 feet, the fence descends steeply into the first canyon. Heavy vegetation and topography almost completely obscure it from view. Right: The fence is not visible from a few feet away as it drops into Baca Canyon (34°19'5.58"N, 107°14'16.36"W). All photos taken 9/13/15.

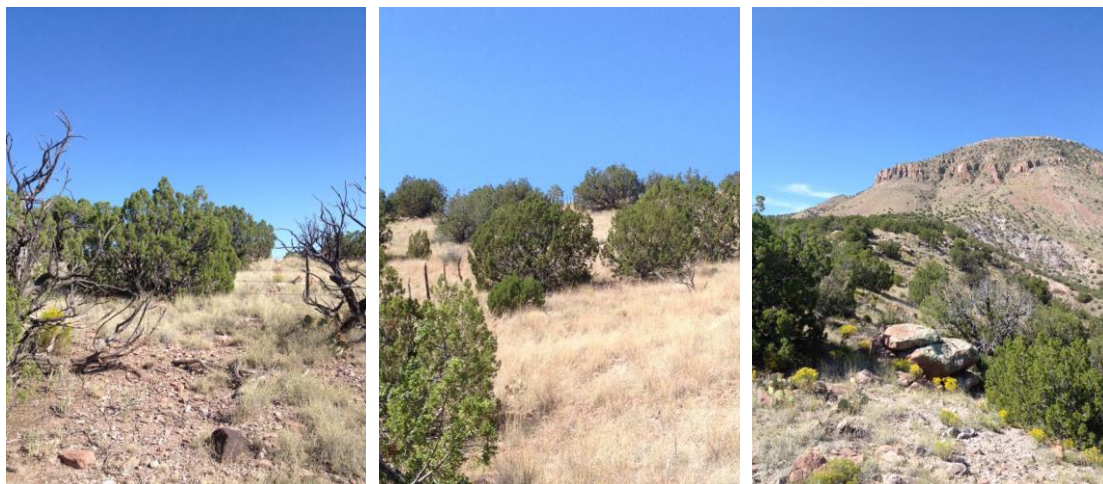
Figure 6. Left: typical stretch of fence through trees (34°18'45.66"N, 107°15'13.45"W). Middle: a little further on (34°18'36.07"N, 107°15'59.55"W). Right: further still, fence not visible at all from a few feet away, or looking up the ridge to Hell's Mesa (34°18'30.23"N, 107°16'9.60"W). All photos taken 9/13/15.

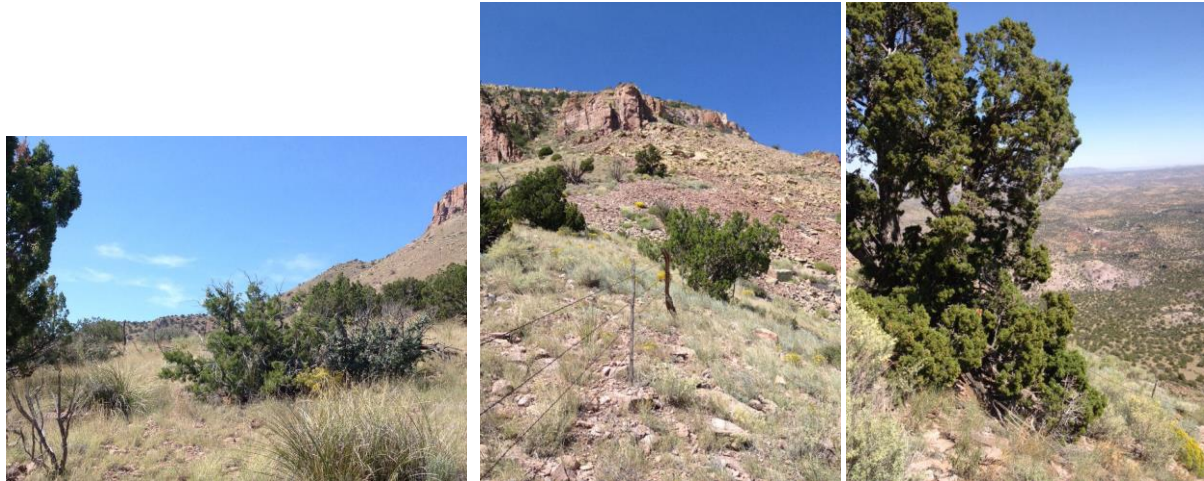
Figure 7. Left: Closer to Hell's Mesa, the all wood fence is difficult to see except from a few feet away. On the scale of these mountains it is insignificant ($34^{\circ}18'24.27''\text{N}$, $107^{\circ}16'19.29''\text{W}$). Middle: Approaching Hell's Mesa: only a few posts are visible. Right: the fence ends with this magnificent juniper as its last post, just before the cliffs of Hell's Mesa ($34^{\circ}18'20.80''\text{N}$, $107^{\circ}16'38.58''\text{W}$). All photos taken 9/13/15.

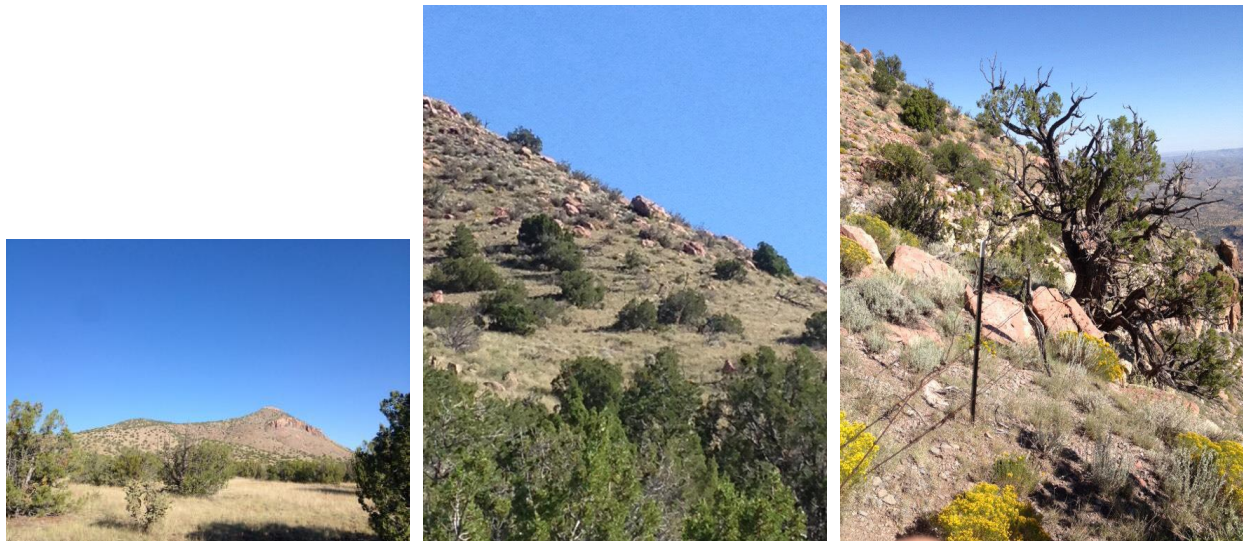
Figure 8. Left: I started the hike near the end of 354P. From this vantage point, the fence over the shoulder of Hell's Mesa is not visible, even with binoculars. ($34^{\circ}17'34.47''\text{N}$, $107^{\circ}16'9.49''\text{W}$). Middle: the old wood fence finally comes into view over the shoulder of Hell's Mesa when I'm about 50 feet away ($34^{\circ}18'3.60''\text{N}$, $107^{\circ}16'49.92''\text{W}$). Right: Broken down fence ends at this juniper, just above cliffs. ($34^{\circ}18'13.69''\text{N}$, $107^{\circ}16'44.97''\text{W}$). All photos taken 9/12/15.

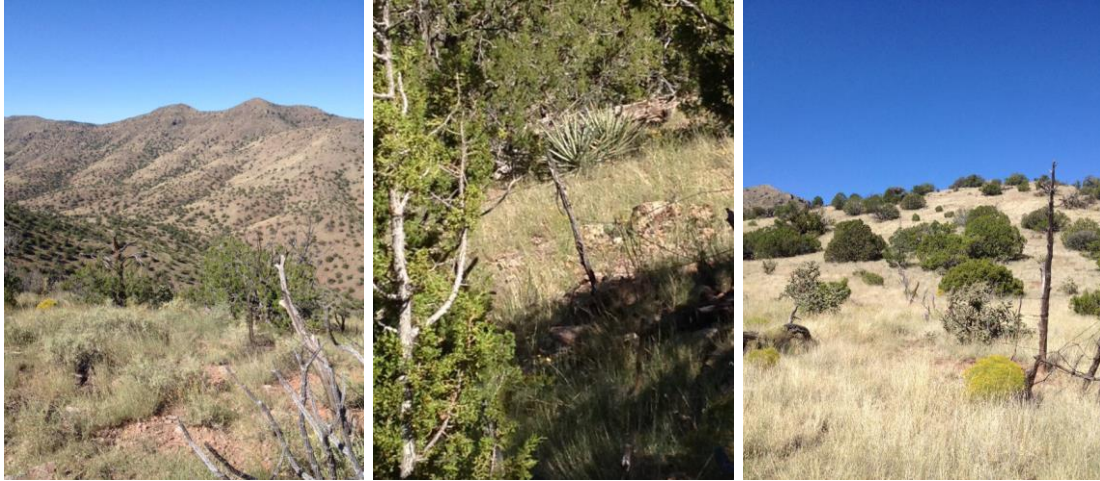
Figure 9. Left: Contrary to the data provided by the Forest Service, the fence does not follow the ridge as it heads west from Hell's Mesa. Here a couple of posts are visible as it drops into the canyon ($34^{\circ}18'9.79''\text{N}$, $107^{\circ}16'48.48''\text{W}$). The ridge of the Bears is in the background. Middle: I lost the fence after it went over the edge because of the steep terrain. I finally found it here, rickety wood and partially broken down ($34^{\circ}18'4.98''\text{N}$, $107^{\circ}16'56.14''\text{W}$). Right: Fence heading west is unmaintained. Grass is knee high and very healthy ($34^{\circ}17'58.61''\text{N}$, $107^{\circ}17'10.00''\text{W}$). All photos taken 9/12/15.

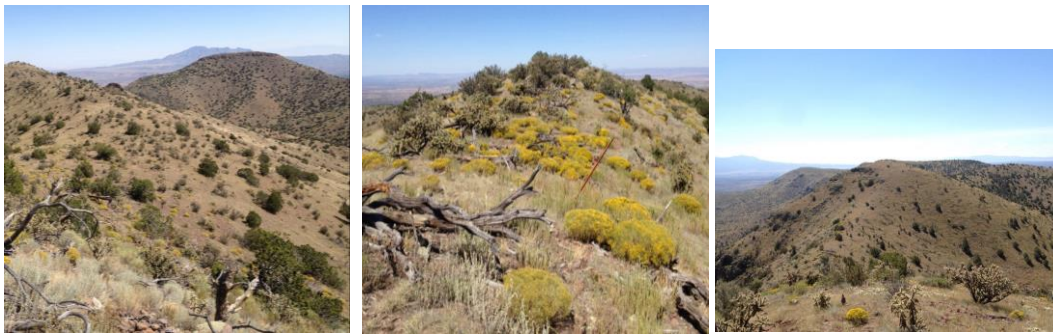
Figure 10. Left: Looking back toward Hell's Mesa (Ladron in the background), the all wood fence is barely visible on the side of the hill (however, this is as noticeable as it gets!) Not a wilderness-disqualifying feature in my opinion. Middle: Fence as it crosses over the ridge is broken down and open. ($34^{\circ}17'49.16''\text{N}$, $107^{\circ}17'51.04''\text{W}$). Right: The fence drops into the canyon and does not follow the ridge of the Bears south, as shown by the lack of a fence in this photo looking south ($34^{\circ}17'46.42''\text{N}$, $107^{\circ}17'48.16''\text{W}$). All photos taken 9/12/15.

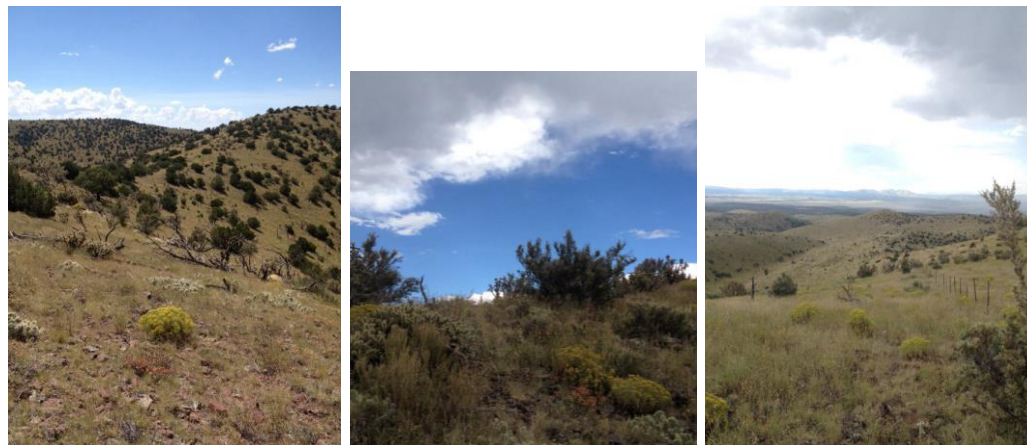
Figure 11. Left: Fence reappears, coming up from the west ($34^{\circ}17'29.14''\text{N}$, $107^{\circ}17'49.29''\text{W}$). Middle: fence not visible from a few feet off the ridge to the east ($34^{\circ}16'56.40''\text{N}$, $107^{\circ}17'49.59''\text{W}$). Right: fence visible for a short distance as it descends to the west (down to meet 123FB). Not particularly obtrusive, even here at its most visible. Note the beautiful views and healthy grass ($34^{\circ}16'47.68''\text{N}$, $107^{\circ}17'55.82''\text{W}$). Photos taken 9/12/15.

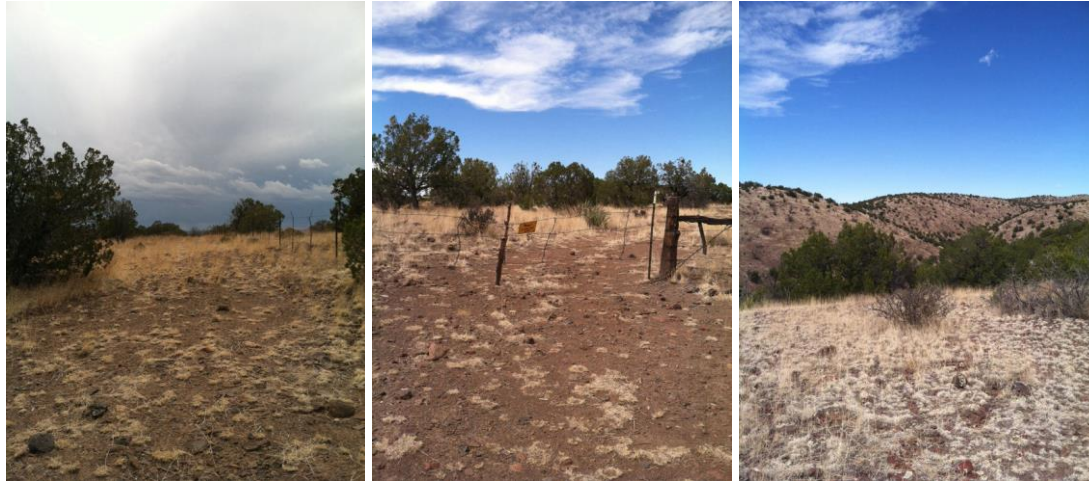
Figure 12. Left: Fence at end of 123FB (34°16'44.26"N, 107°19'11.70"W). Middle: Gate with Forest Service sign (34°16'44.59"N, 107°19'11.52"W). Right: there are no tracks or fences visible looking up into the Bears from the end of 123FB (34°16'46.17"N, 107°19'10.09"W). Photos taken 7/2/14.

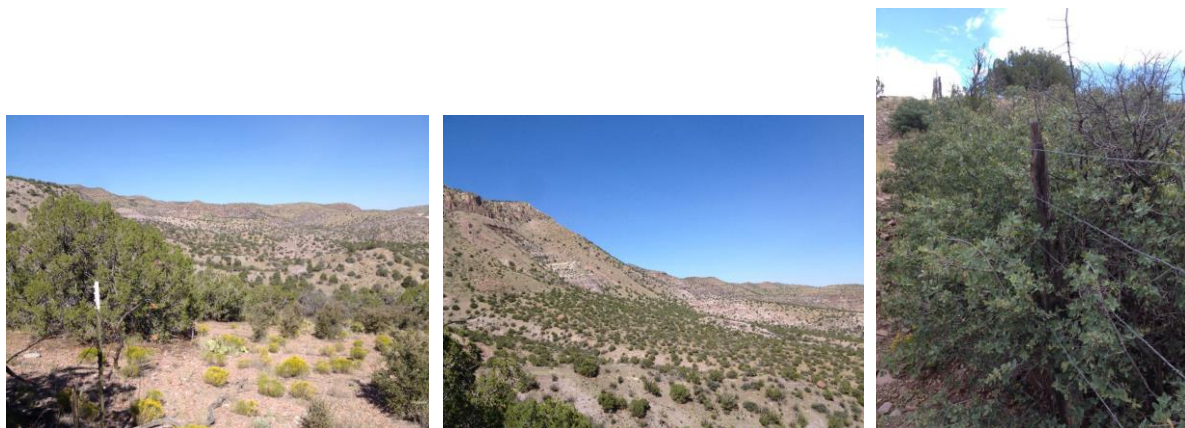
Figure 13. Left: Fence descending north towards Baca Canyon from the Hell's Mesa fence (34°18'43.11"N, 107°15'58.10"W). There are a few metal posts, but the fence is often broken down and hard to see from more than a few feet. Middle: No fences visible looking into the wild upper reaches of Baca Canyon (34°18'27.59"N, 107°16'13.72"W). Right: Fence vanishing into scrub oak (34°19'24.03"N, 107°16'1.29"W). All photos taken 9/13/15.

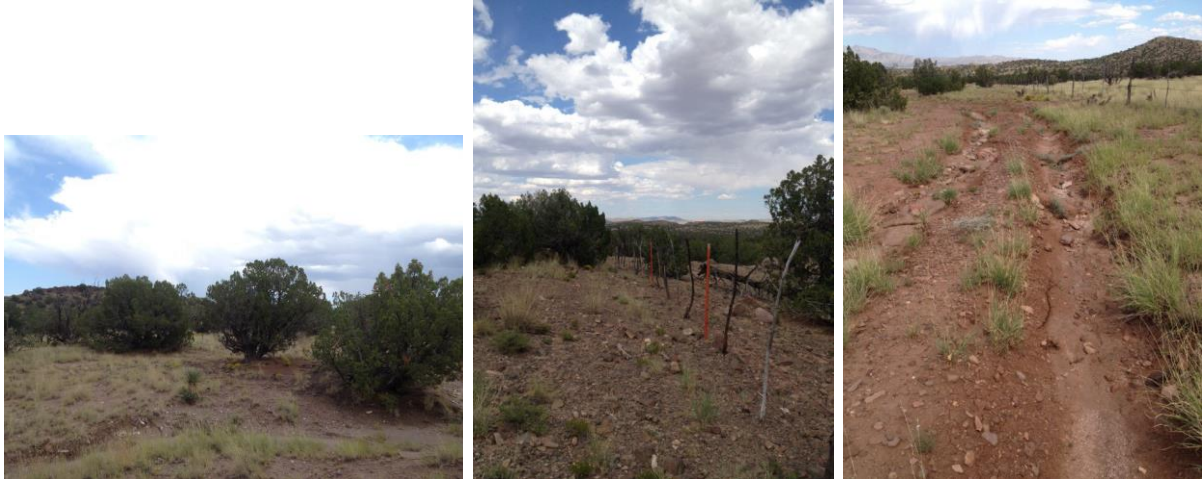
Figure 14. Left: As the fence heads east, huge junipers hide it from view ($34^{\circ}19'30.40''\text{N}$, $107^{\circ}15'42.05''\text{W}$). Middle: first fence branching north toward 354E, showing a couple of metal posts. Note that vegetation remains heavy enough to obscure fence over large areas ($34^{\circ}19'35.49''\text{N}$, $107^{\circ}15'27.87''\text{W}$). Right: Eroded and unused track coming up from 354V with wooden fence alongside ($34^{\circ}19'30.64''\text{N}$, $107^{\circ}14'41.68''\text{W}$). All photos taken 9/13/15.

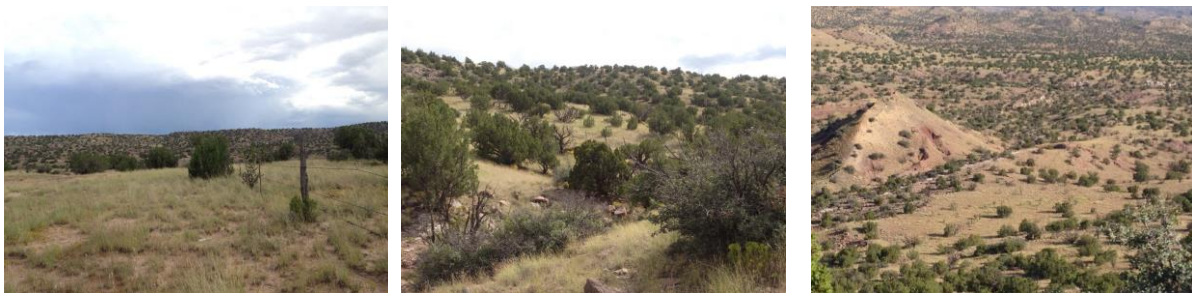
Figure 15. Left: fence heading south, quickly dropping into a canyon ($34^{\circ}19'35.63''\text{N}$, $107^{\circ}14'24.14''\text{W}$). Middle: a few posts are visible as the fence heads up towards the ridge ($34^{\circ}19'10.55''\text{N}$, $107^{\circ}14'21.61''\text{W}$). Right: Looking back down into Baca Canyon from the ridge above, the fence is not obvious ($34^{\circ}19'2.15''\text{N}$, $107^{\circ}14'24.39''\text{W}$). All photos taken 9/13/15.

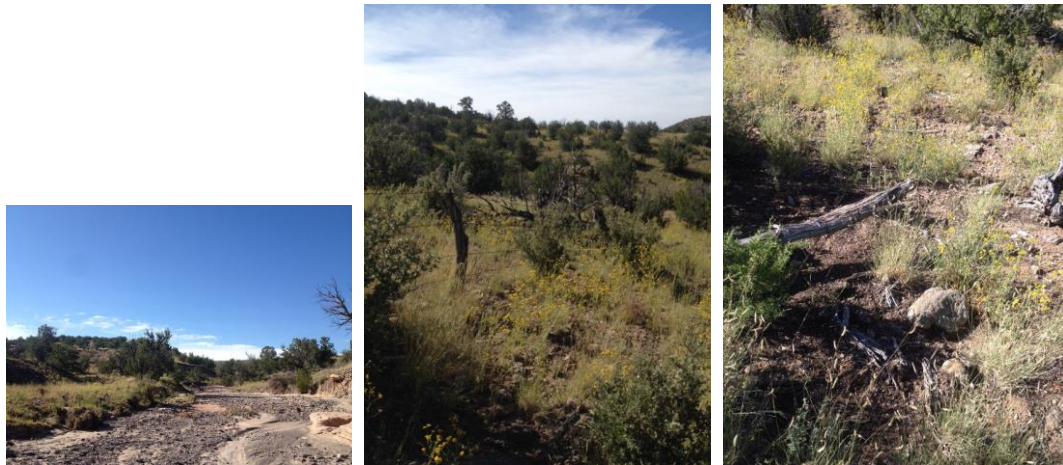
Figure 16. Left: Start of hike looking up Scott Springs Canyon, where there are no tracks, fences or other development (34°18'44.29"N, 107°21'1.54"W). Middle: The first sign of unmaintained fence heading south vanishing into arroyo amongst tall grass and wildflowers (34°18'5.69"N, 107°20'16.49"W). Right: a few feet away the fence is completely down.

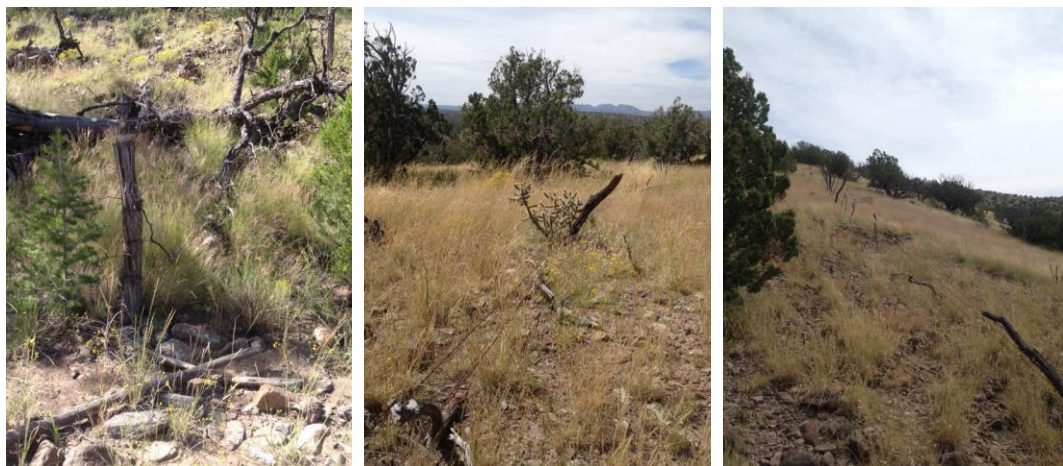
Figure 17. Left: fence down upstream of the spring (34°18'8.61"N, 107°20'6.70"W). Middle: Fence is hard to follow as it is easily obscured even by grass (34°18'13.03"N, 107°19'46.25"W). Right: Rare stretch of upright fence as it proceeds east (34°18'21.74"N, 107°19'24.24"W).

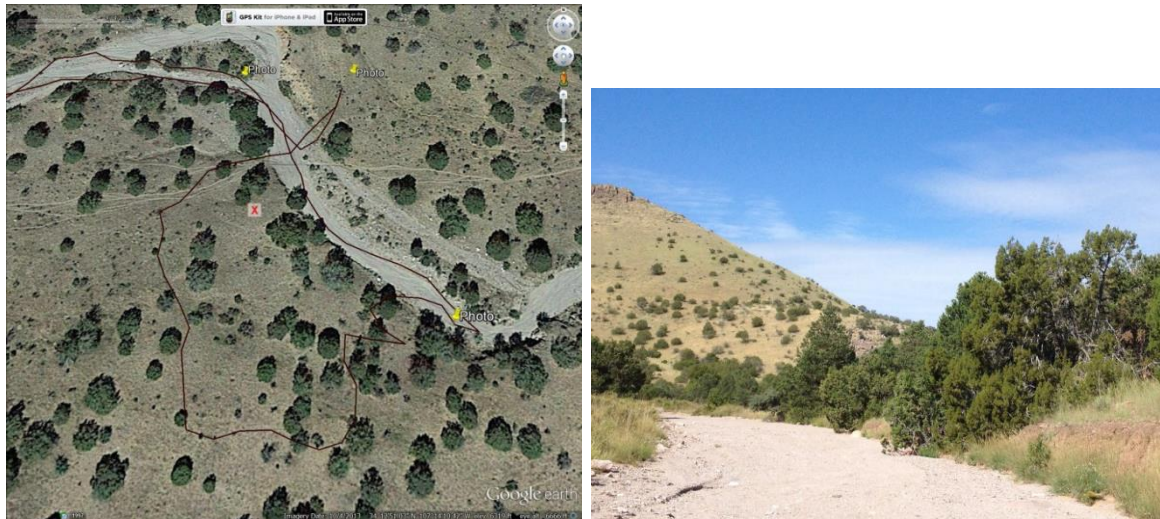
Although not obvious from the text, I concluded that this must be the storage tank and drinker near “Bear Mountain” just along 506 (although this would officially place it in D3_5K6). There is no development at the location provided by the Forest Service and there is also significant vegetative screening (see screen shot and photo below). Using Google Earth, I found what looks like a “storage/drinker” about 1000 feet to the east. However, this development is only 700 feet (within the buffer zone) from 506 and therefore would not interfere with wilderness designation of this area.

Figure 18. Figure 4. Left: Google Earth screen shot showing my tracks around the location of the SNF designated by the Forest Service by a red X. It wasn't there. GPS coordinates: 34°12'51.03"N, 107°14'10.42"W. Imagery date: 10/4/13. About 300 feet above ground. Right: View of healthy vegetation in arroyo just a few feet away from the site designated by FS by X in the screen shot above. Huge junipers and pinons offer significant screening, in contrast to their claim. (9/14/15).

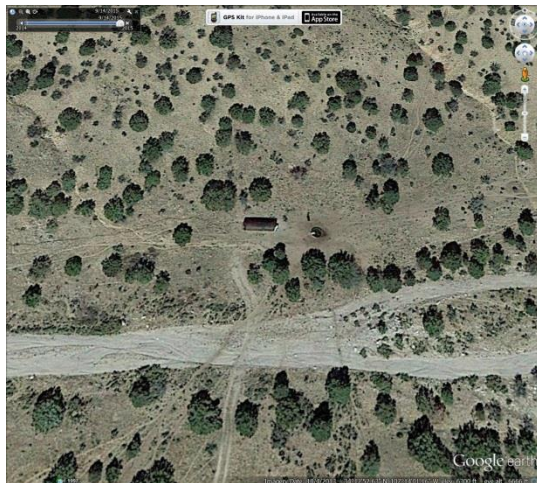
Figure 19. Storage tank and drinker located using Google Earth about 1000 feet west of site designated by Forest Service map. For scale, the “drinker” is about 10 ft diameter and the tank about 28 ft long. FS 506 is about 700 feet to the south. Because of its proximity to the road, this feature should not compromise the wilderness designation of the land to the north, as it could be included in buffer around the road. There is also significant vegetative screening except when viewed from above. GPS coordinates: 34°12'52.63"N, 107°14'01.16"W. Imagery date: 10/4/13. About 350 feet above ground.

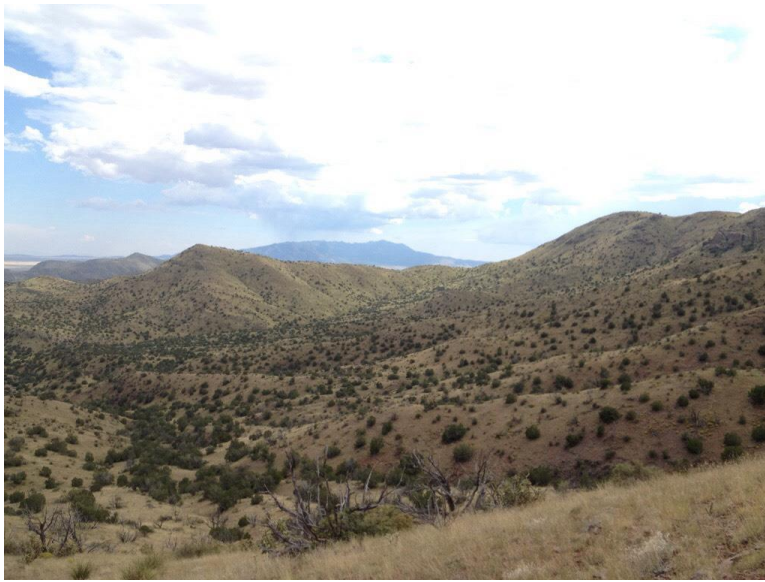
Figure 20. Photo taken from head of Cedar Springs Canyon with the Magdalena Mountains in the background. Although the supposed development at Cedar Springs is less than a half mile away and I'm looking straight towards it I see nothing at all. GPS coordinates: 34°17'29.98"N, 107°17'28.28"W. Photo date: 10/12/15.

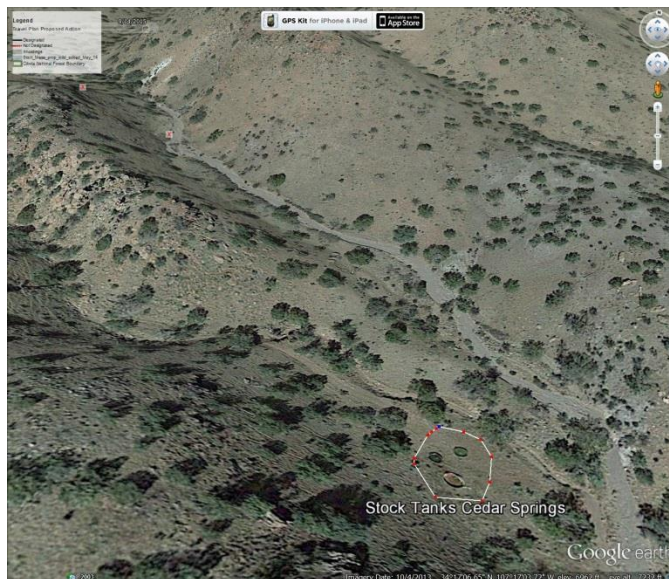
Figure 21. Stock tanks as seen using Google Earth. The red X's above are the locations identified by FS. No evidence of solar panel or windmill from Google Earth. GPS coordinates: 34°17'06.65"N, 107°17'03.72"W. Imagery date: 10/4/13. About 250 feet above ground.

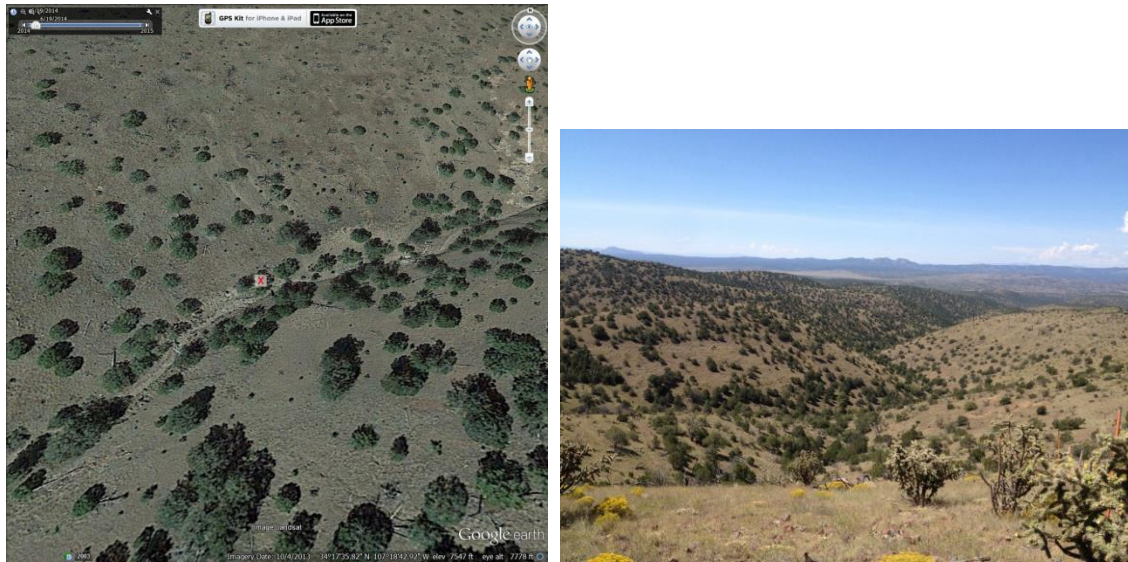
Figure 22. Left: Red X north of 123FB and SE of Scott Spring. I could find no development either here or up/down the canyon using Google Earth. GPS coordinates: $34^{\circ}17'35.82''\text{N}$, $107^{\circ}18'42.92''\text{W}$. Imagery date: 10/4/13. About 250 feet above ground. Right: I looked down on this area from the ridge above on September 12, 2015 and could see nothing from there either. GPS coordinates: $34^{\circ}17'45.6''\text{N}$, $107^{\circ}17'59/89''\text{W}$. Photo date: 9/12/15.

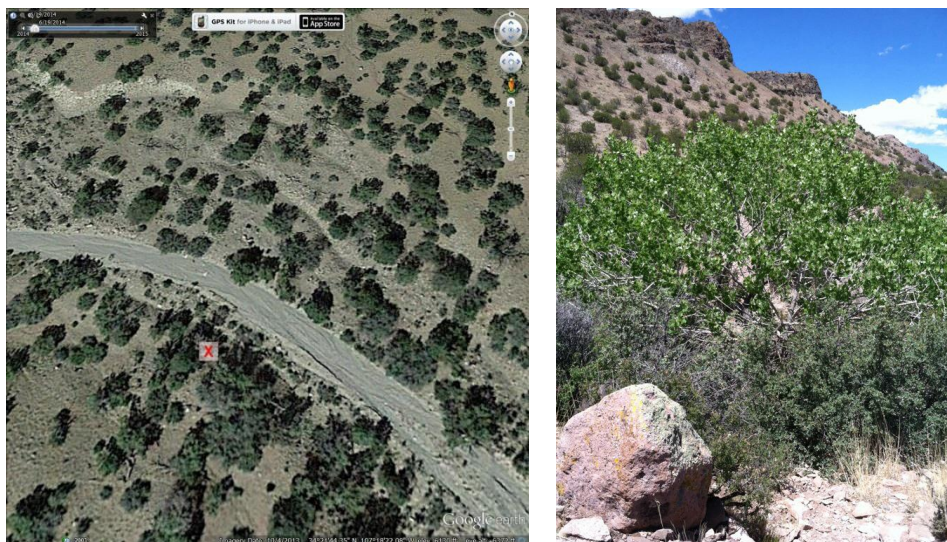
Figure 23. Left: Red X near top of CR12A. I can see nothing either here or up or down the arroyo using Google Earth. GPS coordinates: $34^{\circ}21'43.87''\text{N}$, $107^{\circ}18'22.43''\text{W}$. Imagery date: 10/4/13. About 250 feet above ground. Right: Cottonwoods near the area I surveyed on 6/19/14, about 0.3 miles up the canyon from the red X. I found no development here. Photo date: 6/19/14.

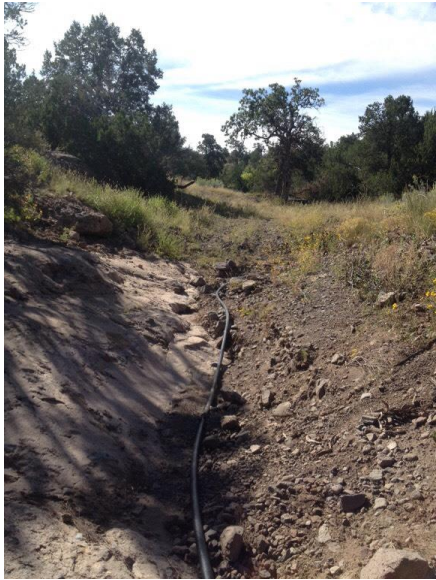
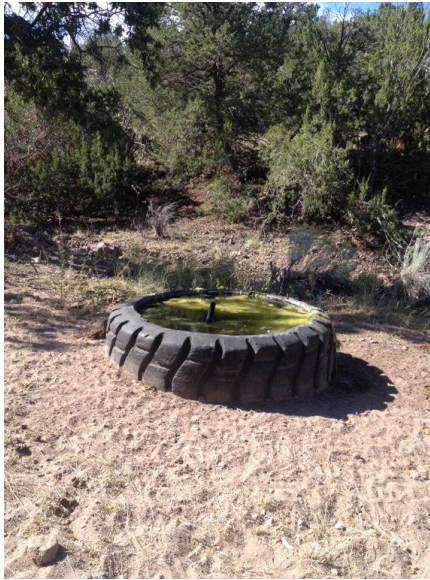
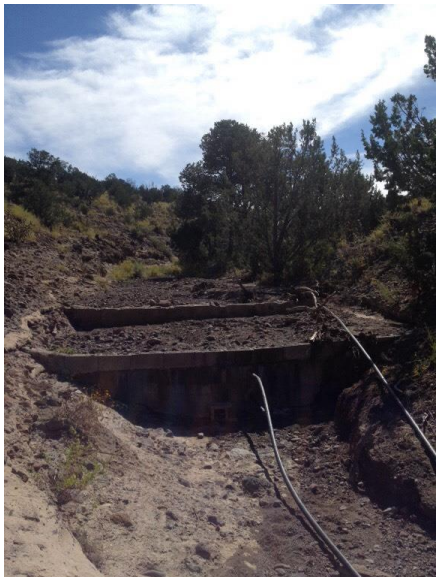
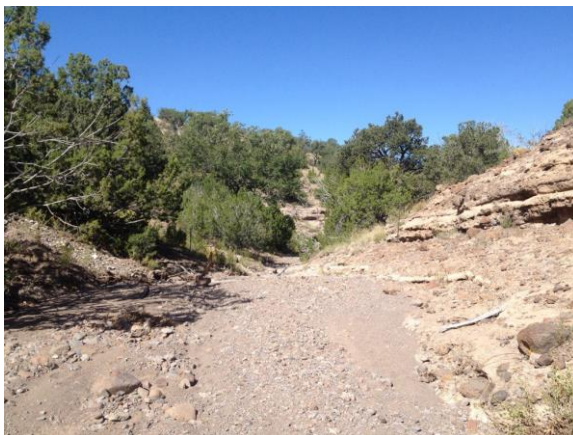
Figure 24. Top left: PVC pipe from Scott Spring. From this point on there has been no vehicle traffic, and it would not be feasible except with an ATV. Top right: the first sign of development is an old tire drinker with algae filled water. Visible only from a few feet away. GPS coordinates: 34°18'16.51"N, 107°20'14.22"W. Photo date: 10/4/13. Bottom left: remnants of concrete trough about 500 feet up the canyon from the tire. Not visible until you are right on top of it; bottom right: 20 feet upstream looking back the concrete is not visible at all.

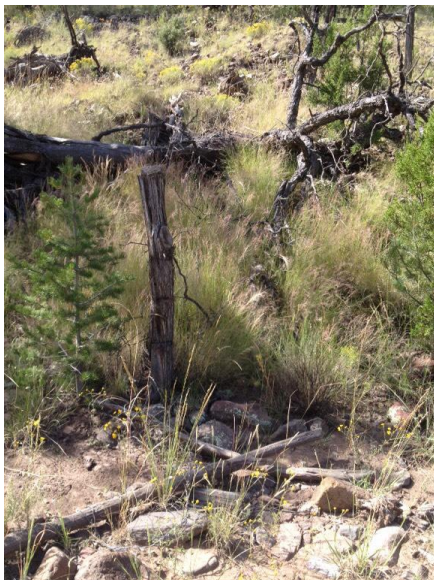
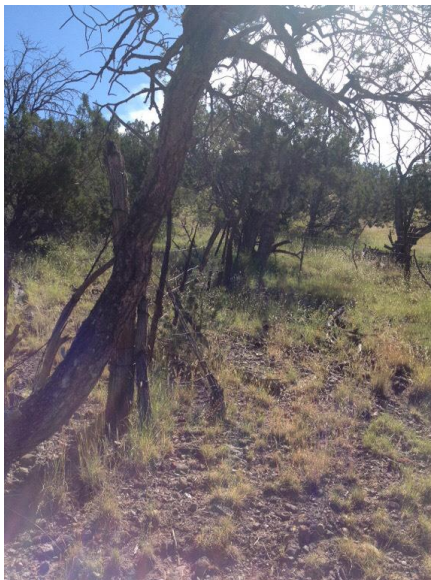
Figure 26. Left: the fences in the area are broken down and hard to find, even when you are looking for them. Right: what must have once been the corral.

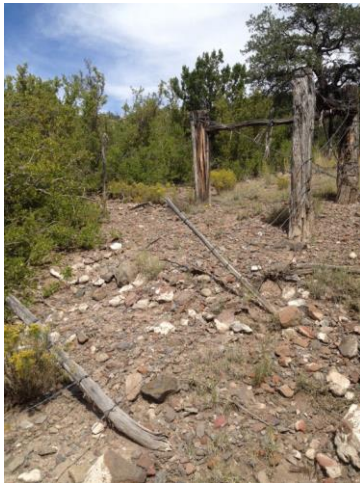
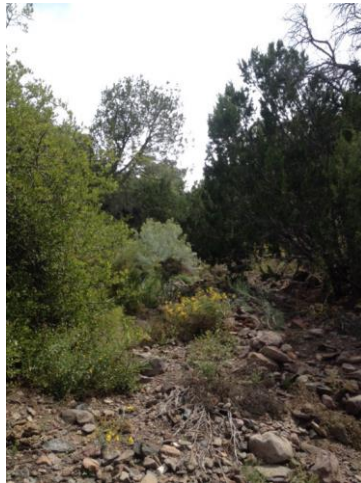
Figure 27. Left: Broken down enclosure (all wood) at Lumber House Spring 2. Right: Lovely riparian area just upstream. GPS coordinates: 34°18'52.93"N, 107°18.58"W. Photo date: 9/19/15.

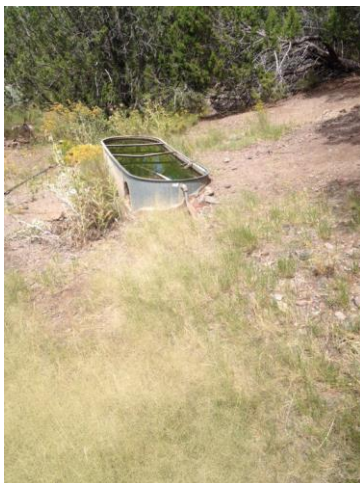
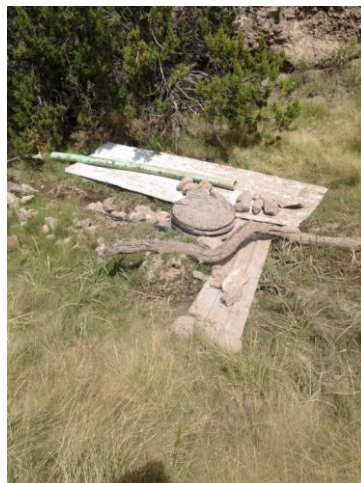
Figure 28. Stock tank and other features about 200 and 400 feet down canyon from the photos above. Heavy vegetation and topography obscure all these features except from a few feet away and prevents seeing them using Google Earth.

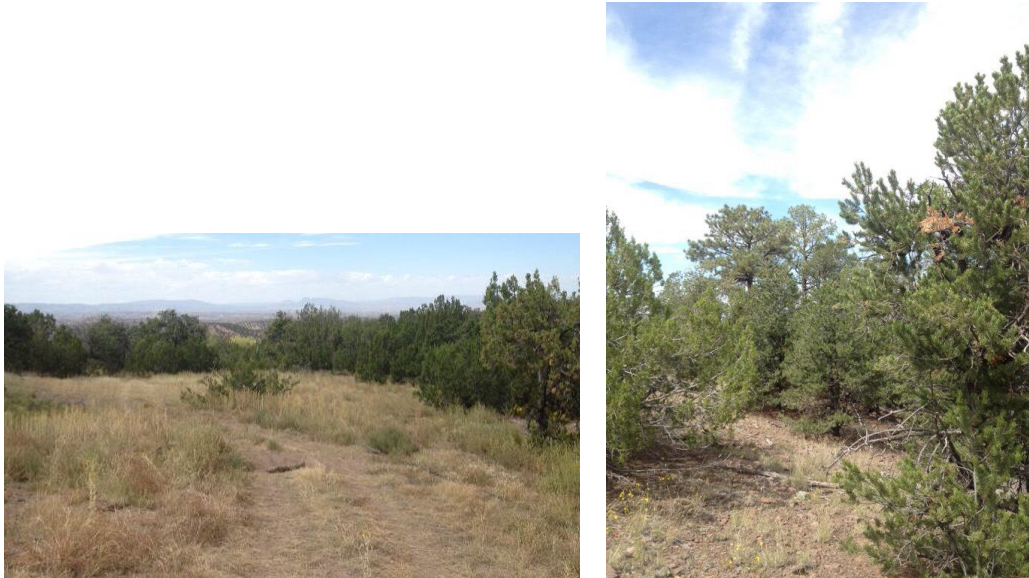
Figure 29. Vehicle tracks at end of 123BB (left). They do not extend to the developments shown in previous photos. Ponderosas rise above the canyon a few feet away from the tracks, where all is undisturbed. GPS coordinates: 34°18'57.73"N, 107°19'26.72"W. Photo date: 9/19/15.

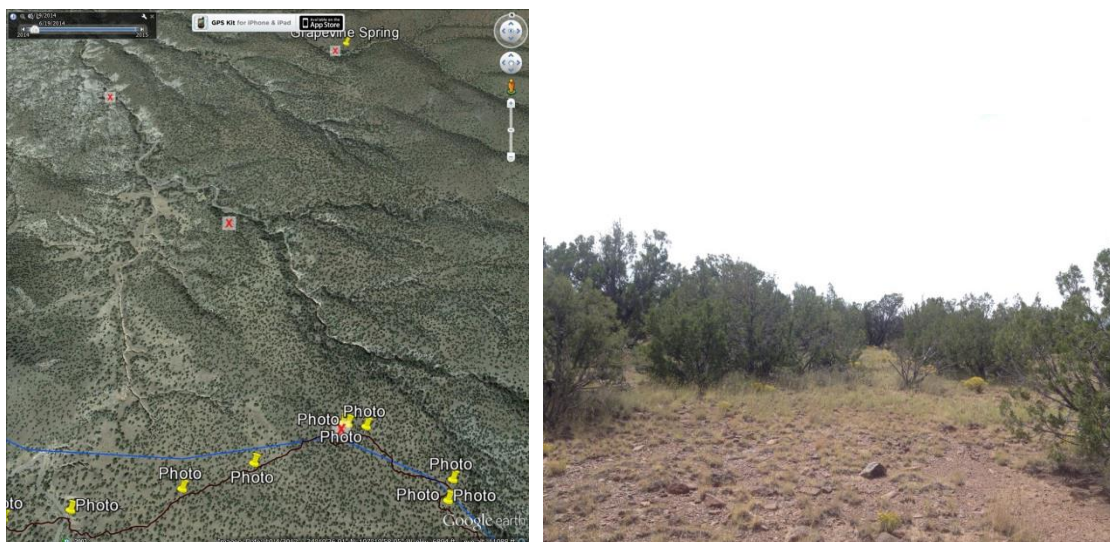
Figure 30. Left: I could find no development at these three locations, either in person (lower x) or using Google Earth (all three). My path and locations of photos is shown in the screen shot. The photo closest to the red X is shown on the right. GPS coordinates: 34°19'26.01"N, 107°19'58.05"W. Photo date: 9/19/15. Imagery date: 10/4/13. ~4,000 feet off ground.

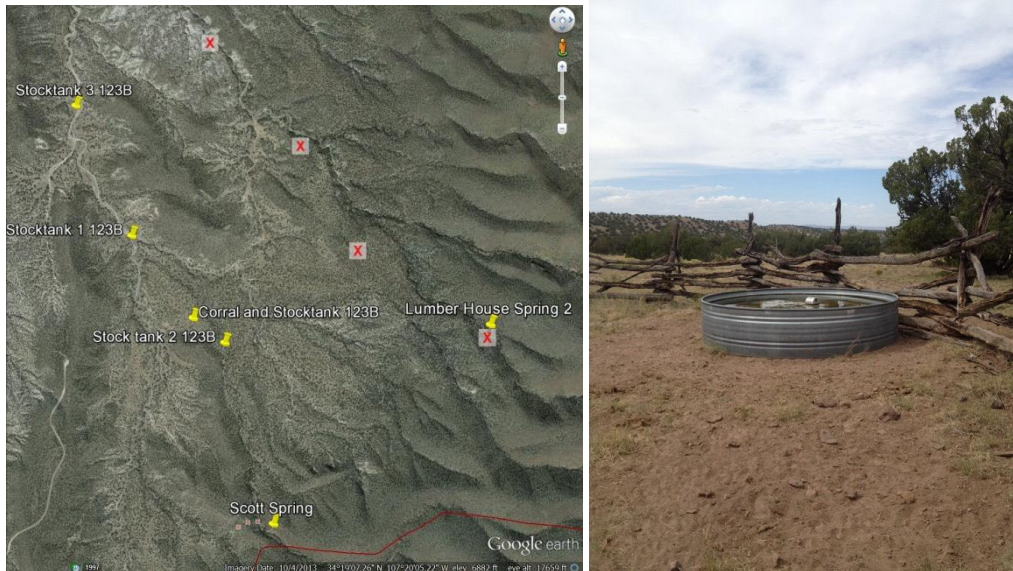
Figure 31. Left: Using Google Earth I identified three stock tanks in a line roughly parallel and about 0.75 miles west of the red Xs on Forest Service map as shown in this screen shot with yellow pins. These are likely the drinkers mentioned in the write-up. Again, the map locations are significantly wrong. Right: stock tank near end of 123B, about 0.75 miles WSW of the lowest red X shown above. This is also shown on the Google Earth screenshot as “corral and stocktank 123B.” GPS coordinates: 34°18'57.89"N, 107°20'28.43"W. Photo date: 9/19/15.

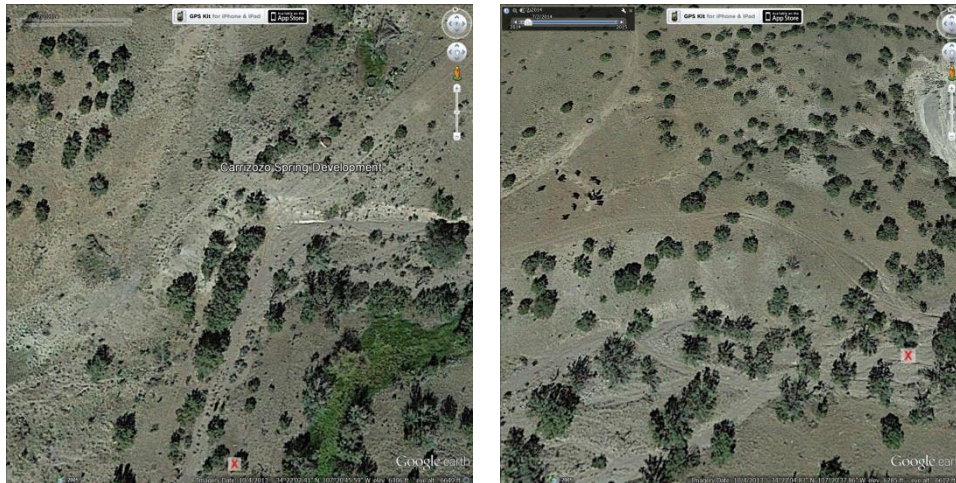
Figure 33. Development around Carrizozo Spring. GPS coordinates: 34°22'02.41"N, 107°20'45.59"W. Imagery date: 10/4/13. About 300 feet above ground. Features are very difficult to see, but zooming in to 200% makes them visible. The red X's are the FS SNFs.

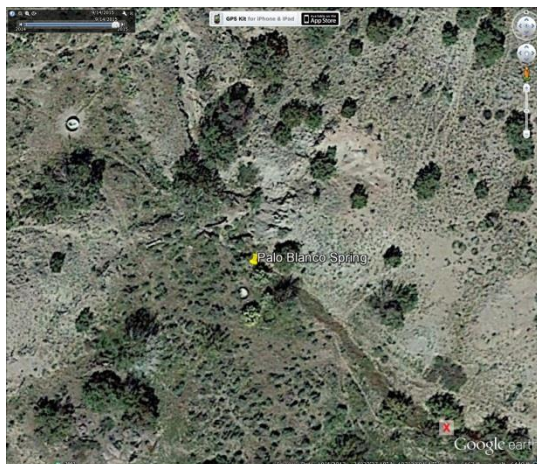
Figure 34. Two drinkers near Palo Blanco Spring. No evidence of concrete dam or spring box. GPS coordinates: 34°22'27.00"N, 107°20'1.65"W. Imagery date: 10/4/13. About 300 feet above ground.

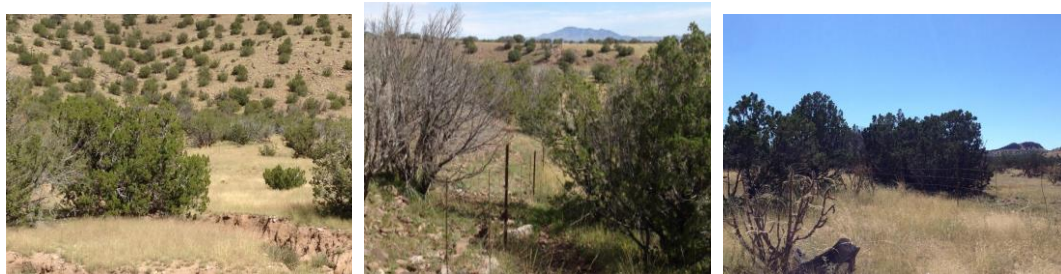
Figure 35. Left: Just above the private property, this is the first sight of the fence. Note the juniper cover and healthy grass (34°14'15.29"N, 107°15'25.06"W). Middle: Fence heading into arroyo among junipers. It is not visible 30 feet away. (34°14'27.16"N, 107°15'14.80"W). Right: Fence and junipers towards the north end (34°15'1.25"N, 107°14'45.51"W). Photos taken 9/14/15 and 9/18/15.

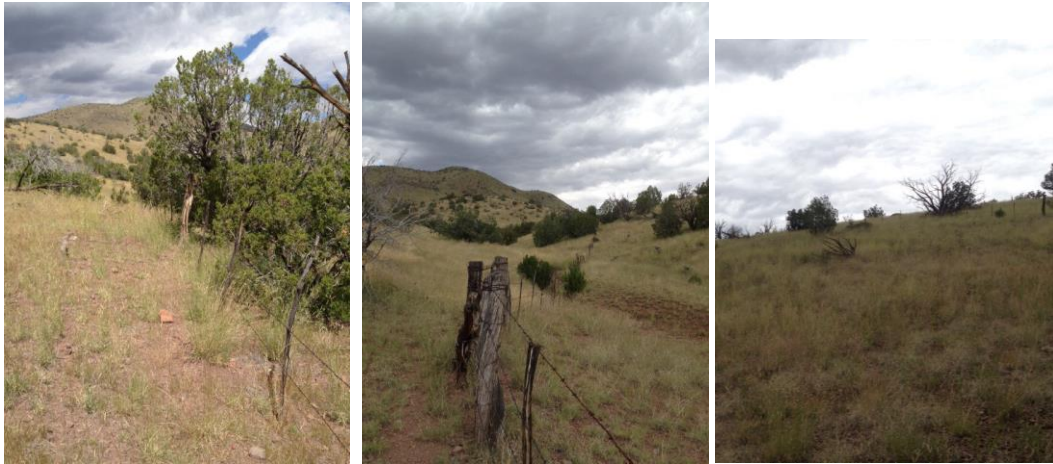
Figure 37. Left: all wood fence heading north (34°13'35.19"N, 107°18'4.71"W). Middle: Fence angles NE and does not go up the ridge (34°13'51.00"N, 107°18'7.34"W). Right: Past the supposed intersection with the fence from the SE, which I never found, the fence is barely visible (34°14'8.54"N, 107°18'2.21"W).

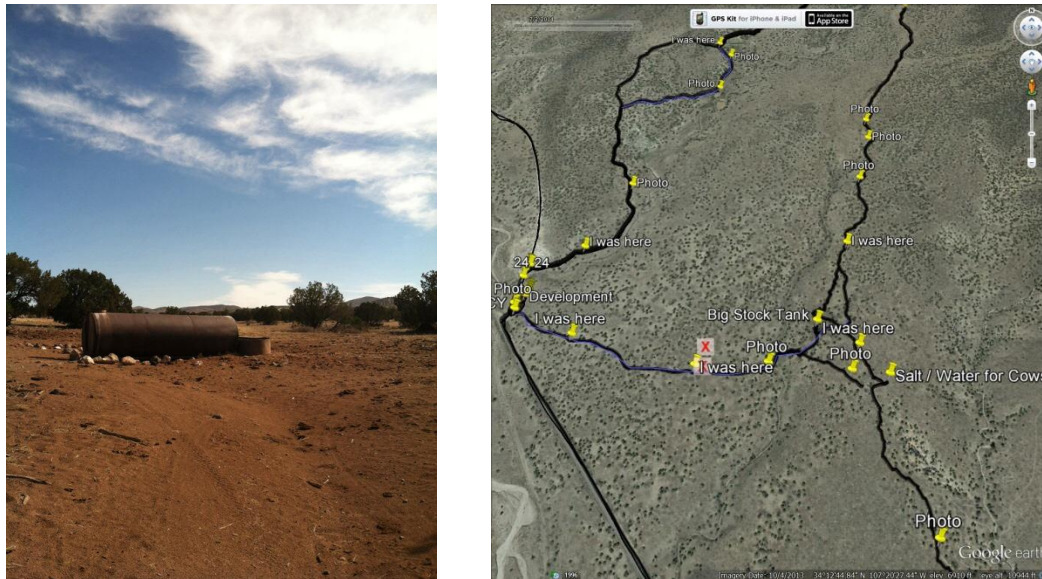
Figure 40. Developed area in the vicinity of 169 and 123 and 24. Not recommended as wilderness. GPS Coordinates: 34°12'44.84"N, 107°20'27.41". Photo date 7/2/14. Imagery date: 10/4/13.

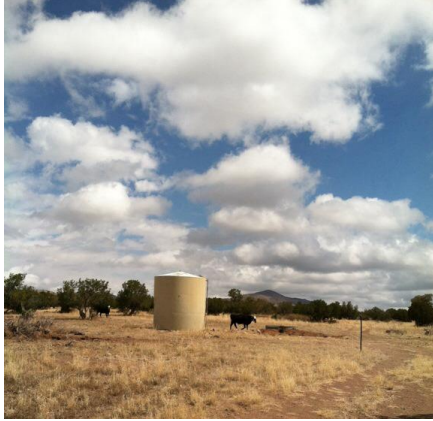
Figure 41. Storage tank and drinker about one third mile from 169 on 506L. GPS Coordinates: 34°11'25.68"N, 107°18'35.78"W". Photo date 5/23/14. I do not recommend this area around 506 L as wilderness.

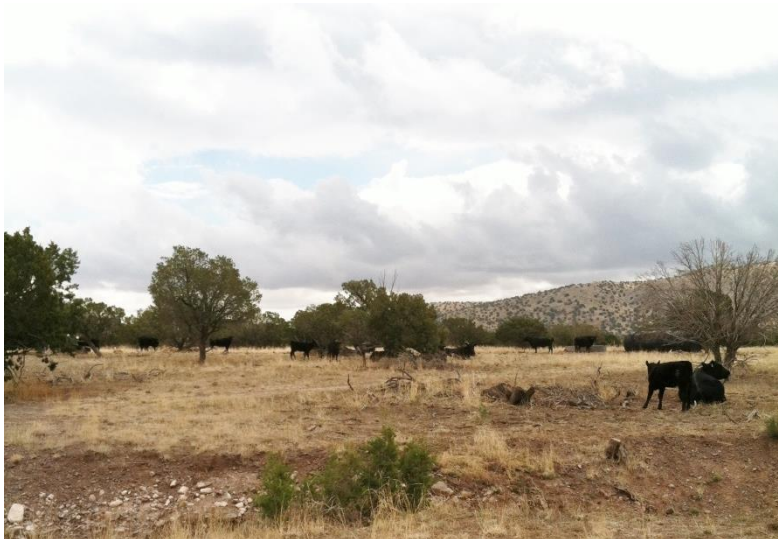
Figure 42. Could be the SNF mentioned as "psuedo drinker." Stock tank is barely visible in background. GPS Coordinates: 34°11'57.77"N, 107°18'23.96"W". Photo date 5/23/14. I do not recommend this area around 506 L as wilderness.
