KENTUCKY HEARTWOOD

March 3, 2022

RE: Hector Mountain Salvage project

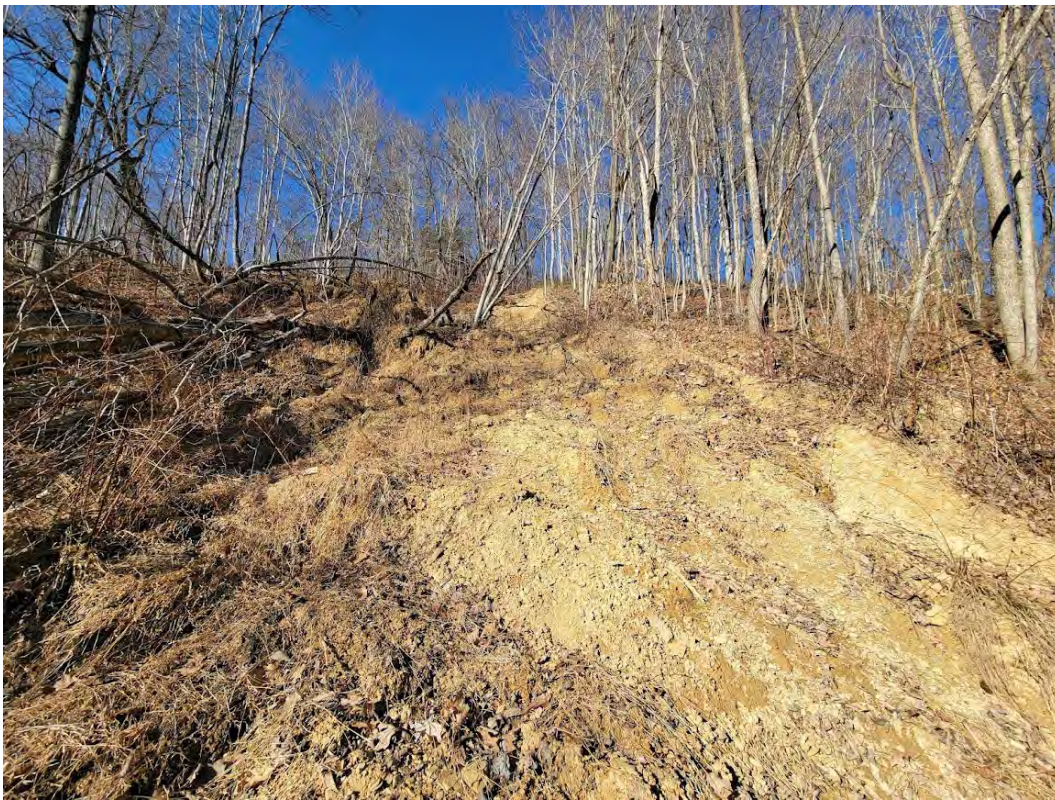
seam, the slope failures typically begin several hundred slope feet above the Fireclay. One such landslide in the Hector Mountain area, in a stand logged in 1994, was evidenced in the KYFromAbove 2019 LIDAR data but was found to be newly eroded with exposed mineral soil extending approximately 300 ft. of slope distance, with a width of 83 feet its widest point. Slope measurements taken on site provided a slope of 56%. Fresh sediment and debris were evident in the stream channel (a tributary of Bear Creek) for as far as we walked. The location of this landslide was 37.182799, -83.679902 and is one of the delineate landslides on the attached maps. Another active landslide was found in this same unit at 37.182814, -83.678717. These landslides are in addition to the active slump at the top of the landslide for which road reconstruction has been proposed in this project. Together these all demonstrate that the impacts to soil, water, and vegetation from logging on these steep and unstable slopes can continue for decades following completion of timber harvest.

Figure 1. Fresh landslide in 1994 harvest area (looking up) at 37.182799, -83.679902

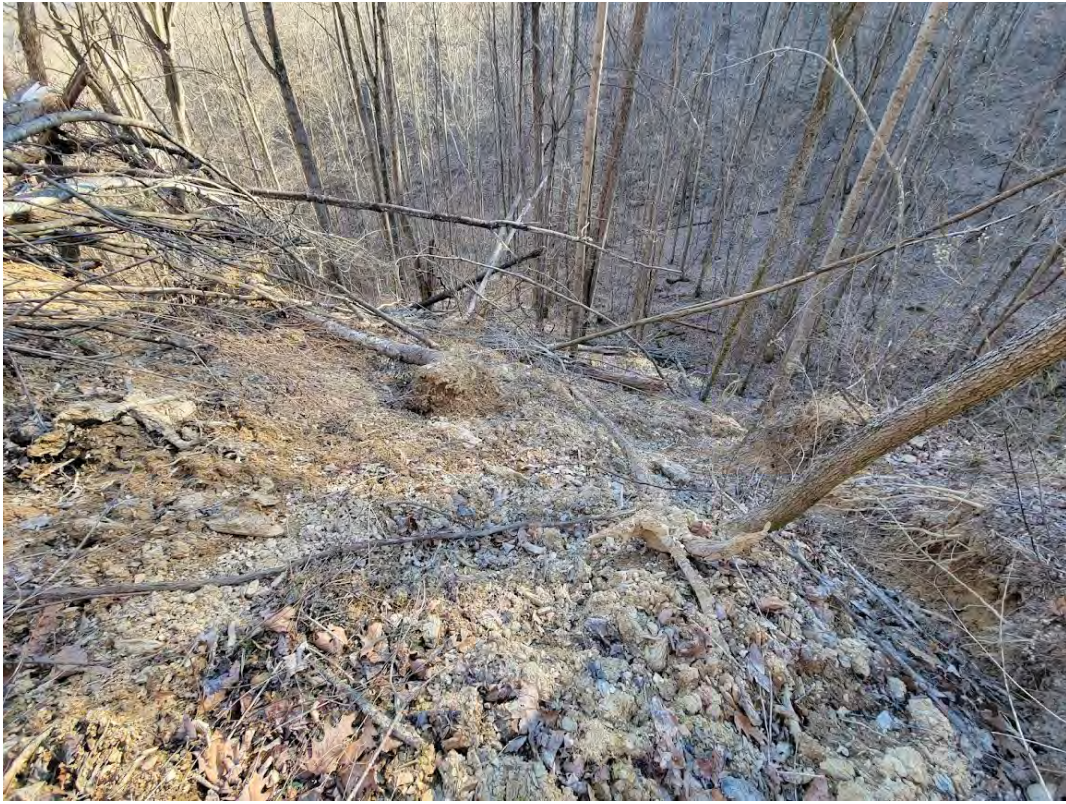
Figure 2. Fresh landslide in 1994 harvest area (looking down) at 37.182799, -83.679902

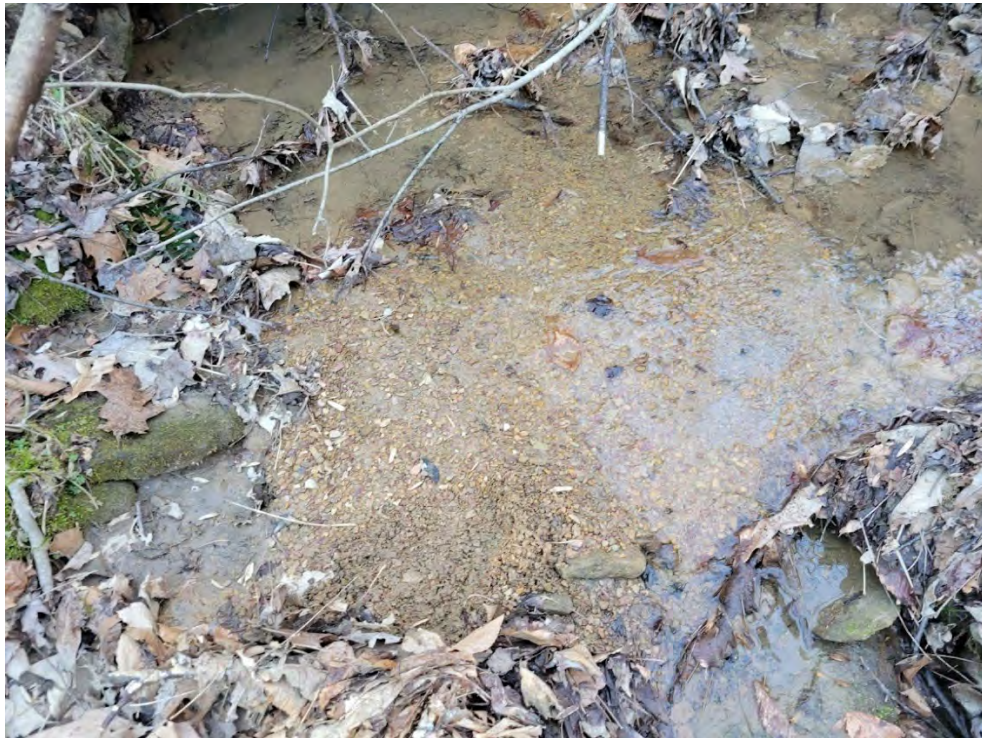
Figure 3. Sediment below landslide in 1994 harvest area

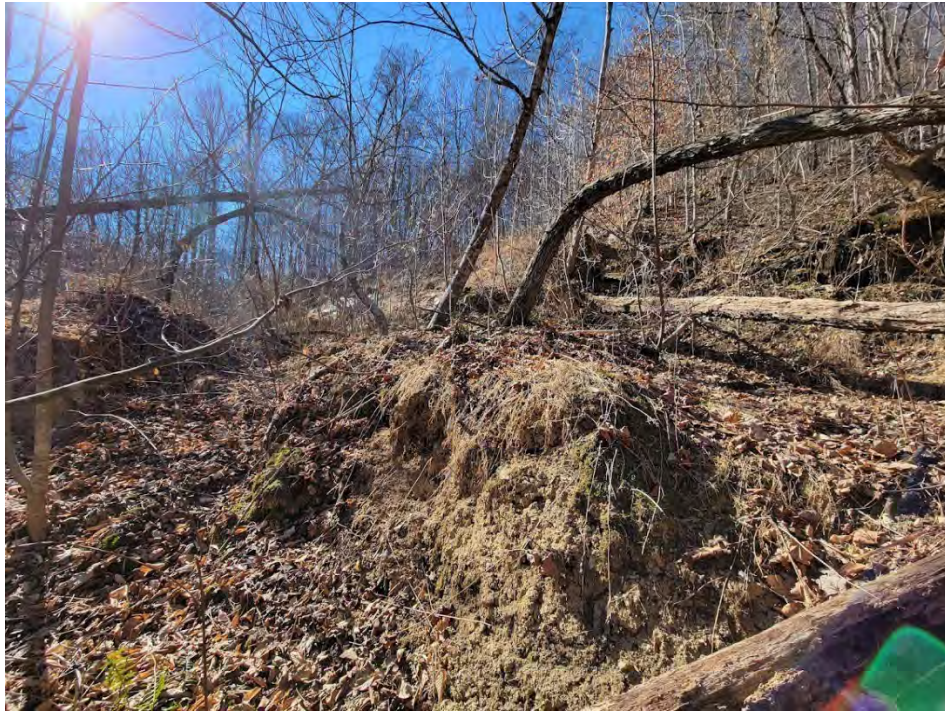
Figure 4. Active landslide in 1994 harvest unit at 37.182814, -83.678717

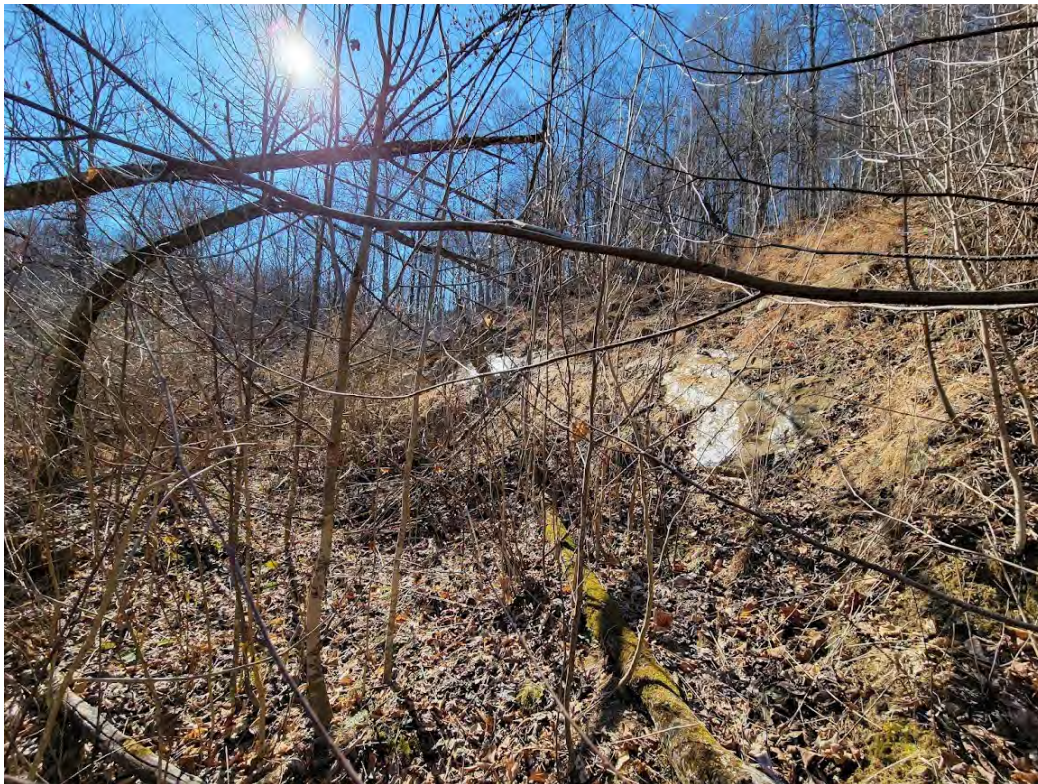
Figure 5. Active landslide in 1994 harvest unit at 37.182814, -83.678717

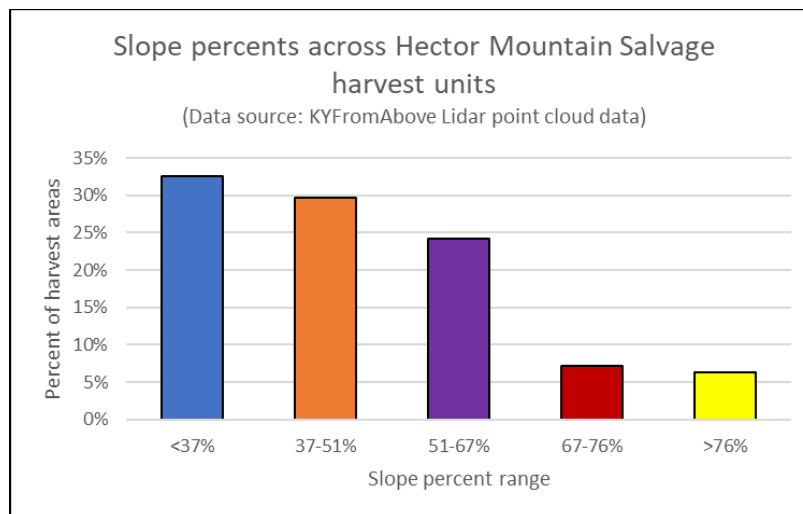
The Fireclay crosses through every harvest unit in the Hector Mountain project, and for the most part appears well above the SMZ. Kentucky Heartwood performed a slope analysis using LIDAR data from the Kentucky Geological Survey and estimated that 67% of the proposed harvest areas are on slopes $\geq 37\%$. More than a third of proposed harvest areas exceed 50% slope, with a mean slope of 45%.

Figure 6. Hector Mountain harvest area slopes

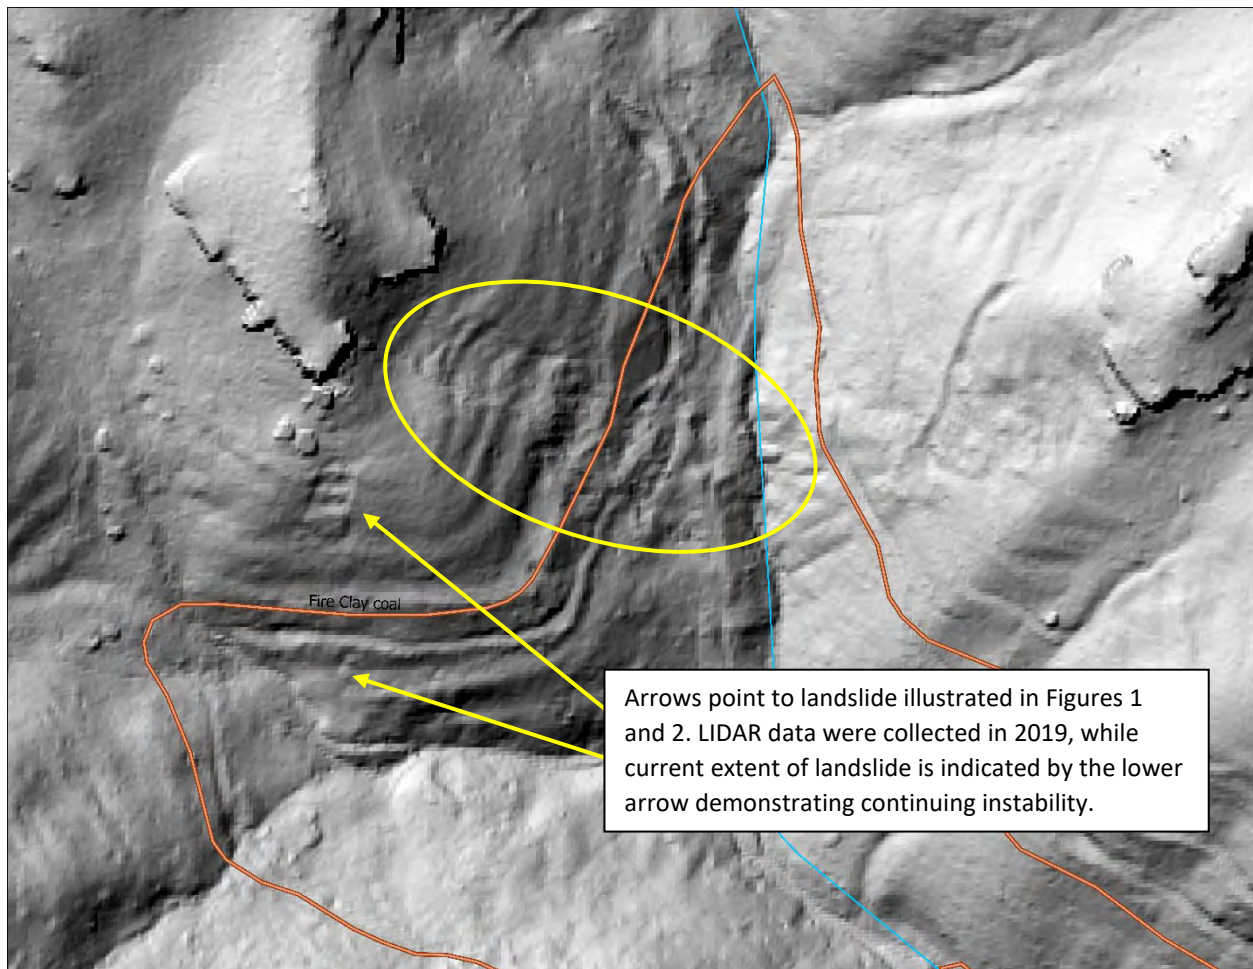
Figure 7. Example of LIDAR indicated landslides in 1994 harvest units in Hector Mountain project area. Landslides indicated here were all ground-truthed by Kentucky Heartwood in February 2022. Orange line indicates location of Fireclay coal seam.

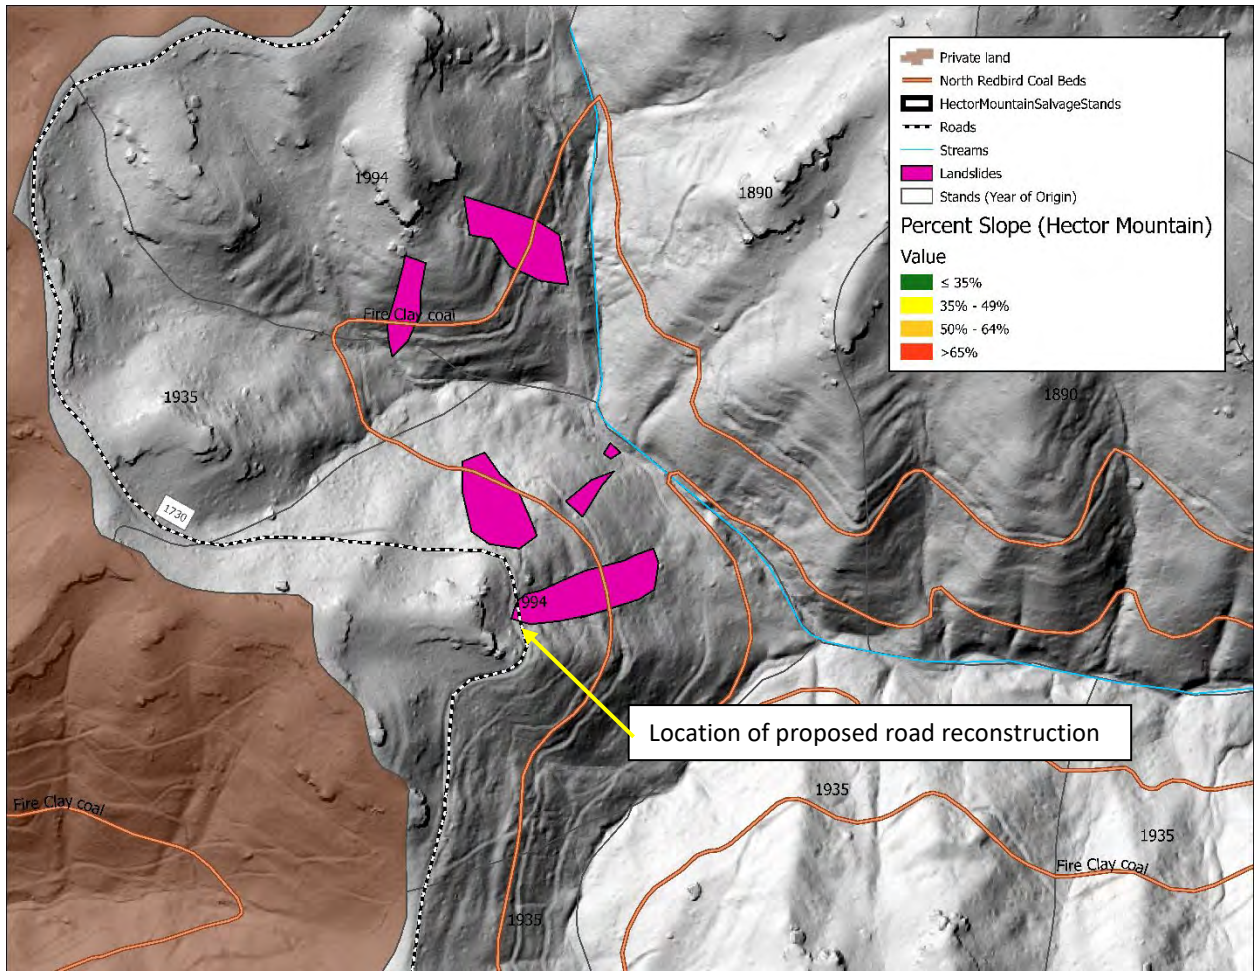
Figure 8. Locations of confirmed landslides in the Hector Mountain project area in relation to proposed road reconstruction and coal seams. Dates in stand polygons are “Year of Origin” data from the Daniel Boone National Forest GIS database.

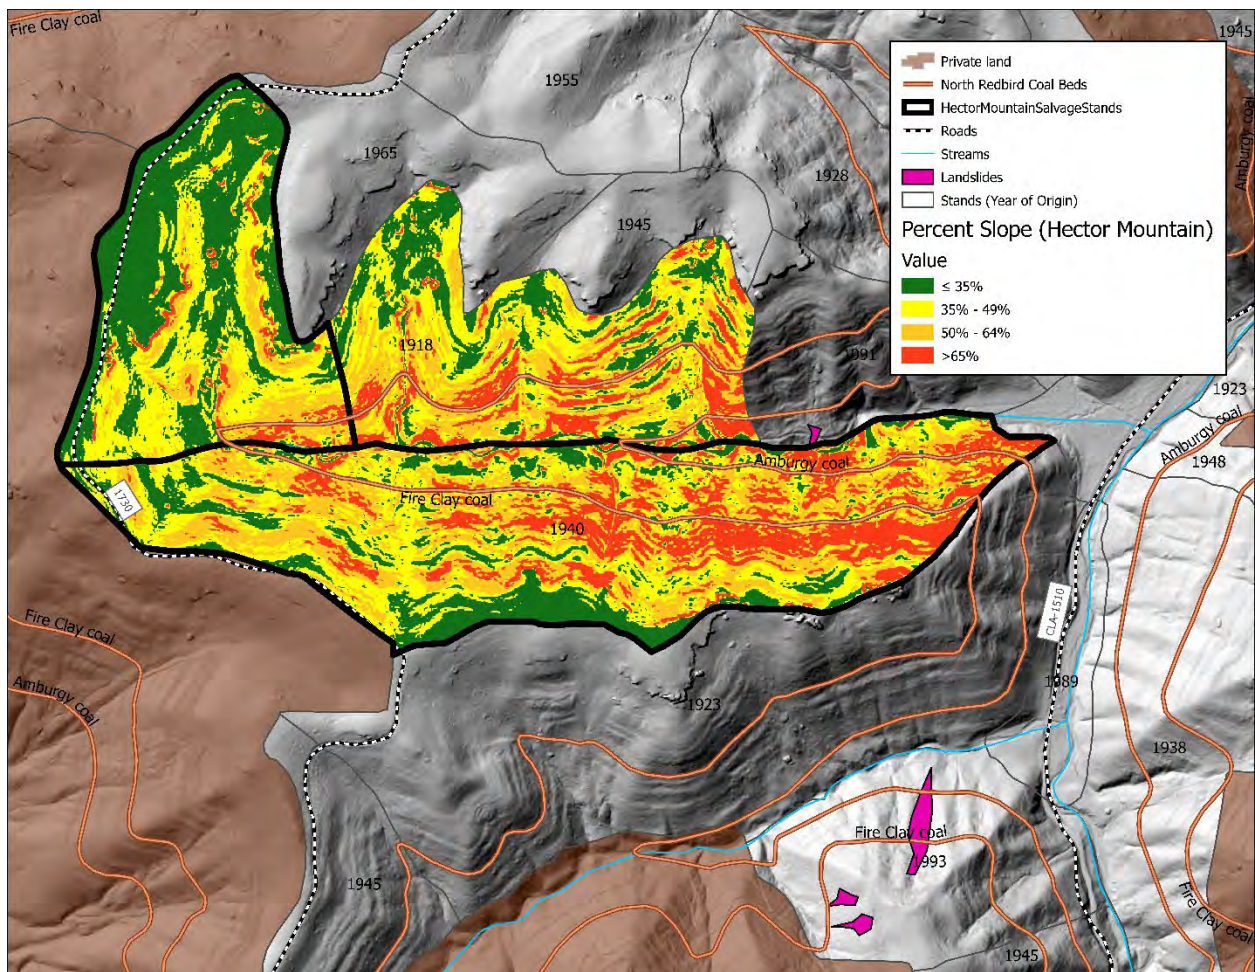
Figure 9. Hector Mountain salvage logging unit (South) slope data in relation to landslides and coal seams

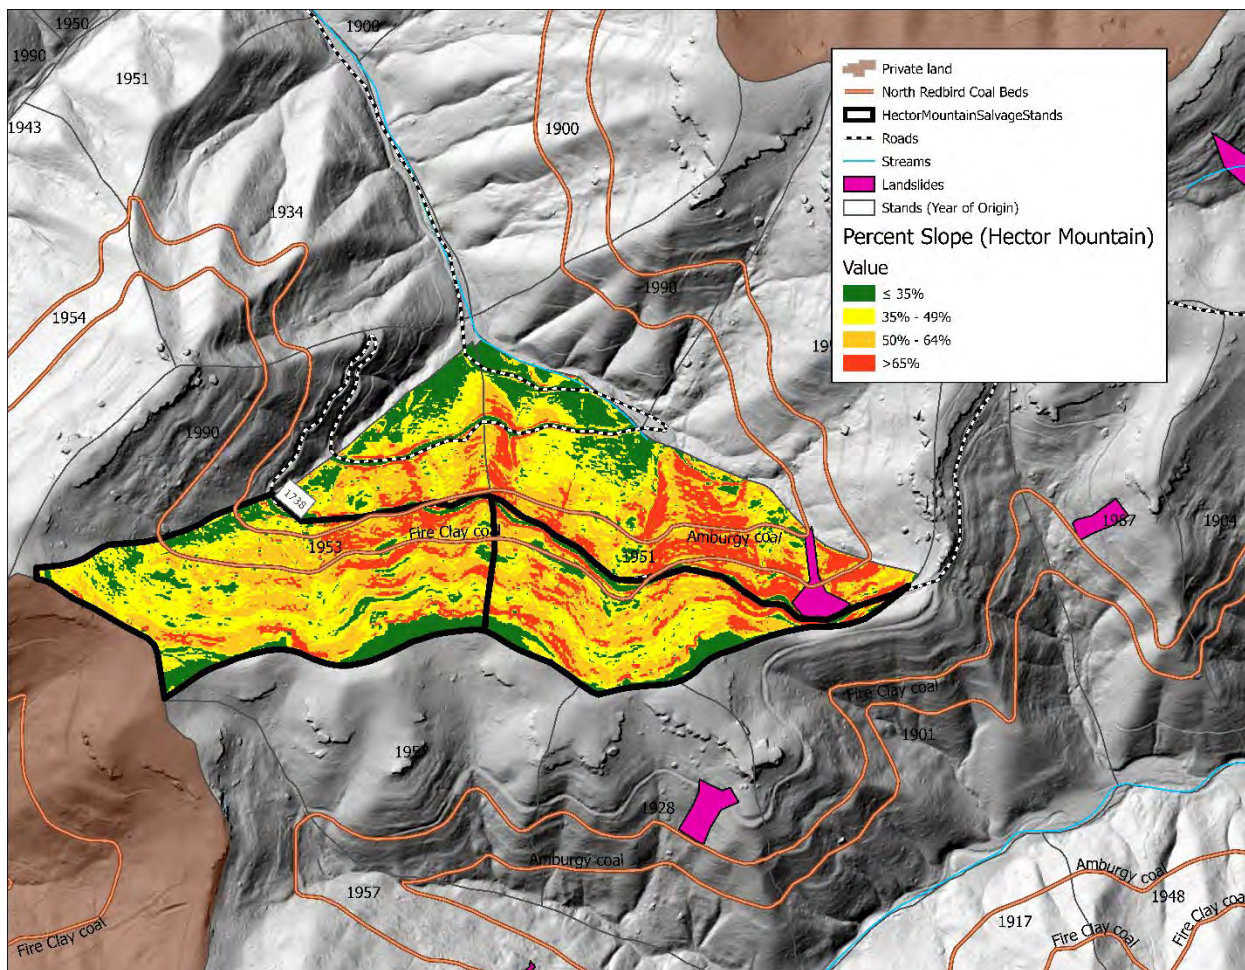
Figure 11. Hector Mountain salvage logging unit (North) slope data in relation to landslides and coal seams
