December 2024

Roads Revisited: A Revisit of Ten Ineffective Road Closures In the Flathead National Forest's Swan Valley Geographic Area

by Keith Hammer

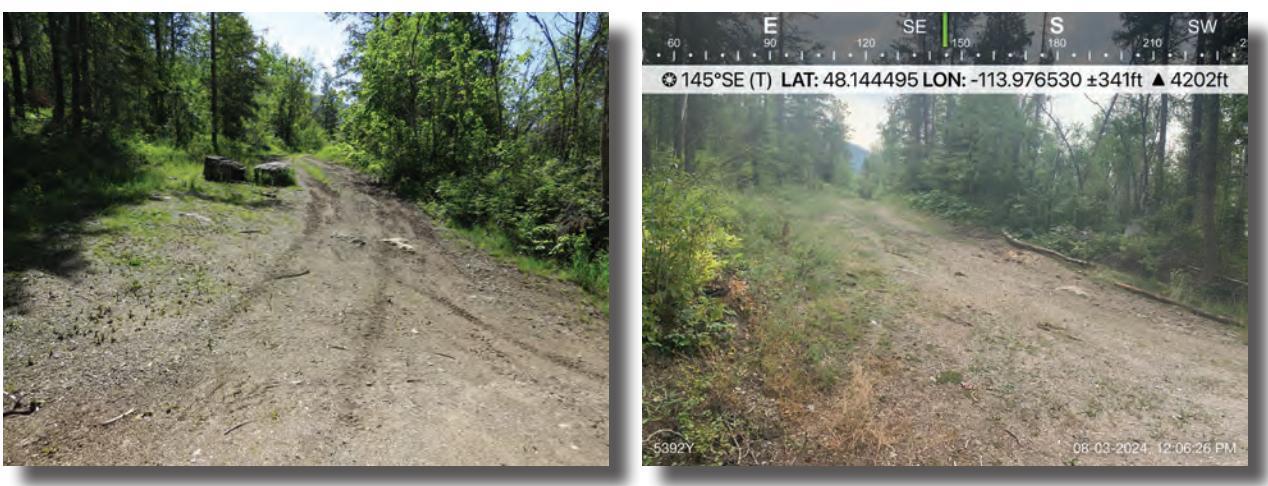
Fig. 1*a*: 6/17/22 view of closed road 5392Y from road 5392. *Fig.* 2*a*: 8/3/24 view of closed road 5392Y from road 5392.

The condition of the above boulder-closure of Road 5392Y went from bad to worse from 2022 to 2024, despite the Forest Service's 2022 finding that there was "lots of motorized traffic going past the rocks" and Fish and Wildlife Service's claim that the Flathead National Forest "corrects the situation as soon as they are able." (See page 3)

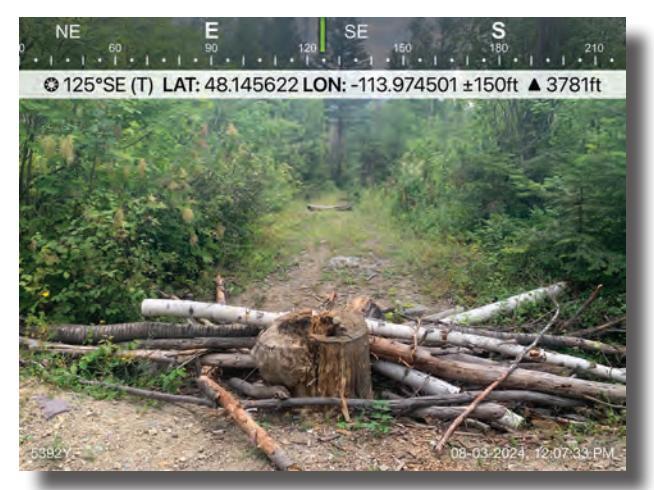
Fig. 3: 8/3/24 view of hand slash placed on road 5392Y.

aside, suggesting heavy equipment had been used to pick the boulders up and move them aside, as shown in Figure 2b. The well driven over berm and trench that had once bolstered this boulder closure was found with a wood block and other handmoveable slash inserted, as shown in Figure 3. A sprinkling of more hand-moveable slash was found for some distance down the road, none of which could not simply be removed by hand or driven over.

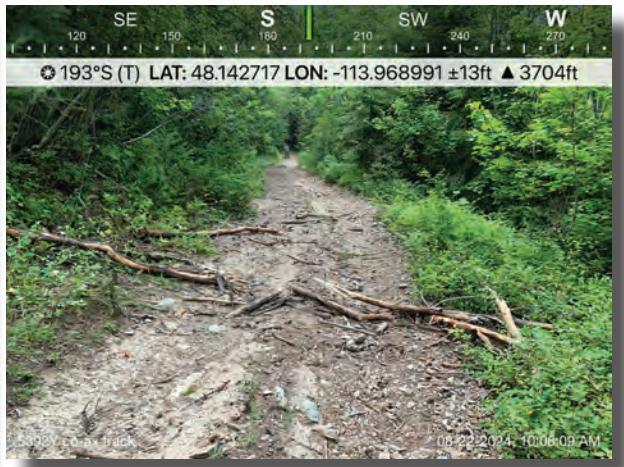
Fig. 4: 8/22/24 ATV tracks on road 5392Y detour.

used by ATVs to access Road 5392A near its midpoint. On 8/22/24 we found that detour being used by ATVs, in spite of some skimpy dead mountain maple having been used to lightly litter the trail, as shown in Figure 4. We also found disturbed soils and vegetation where an ATV had turned around on Road 5392A most of the way toward Birch Creek. Why the boulders already on-site were not utilized and why no substantial blocking of the utility corridor detour has occurred remains a mystery. This closure remains ineffective.

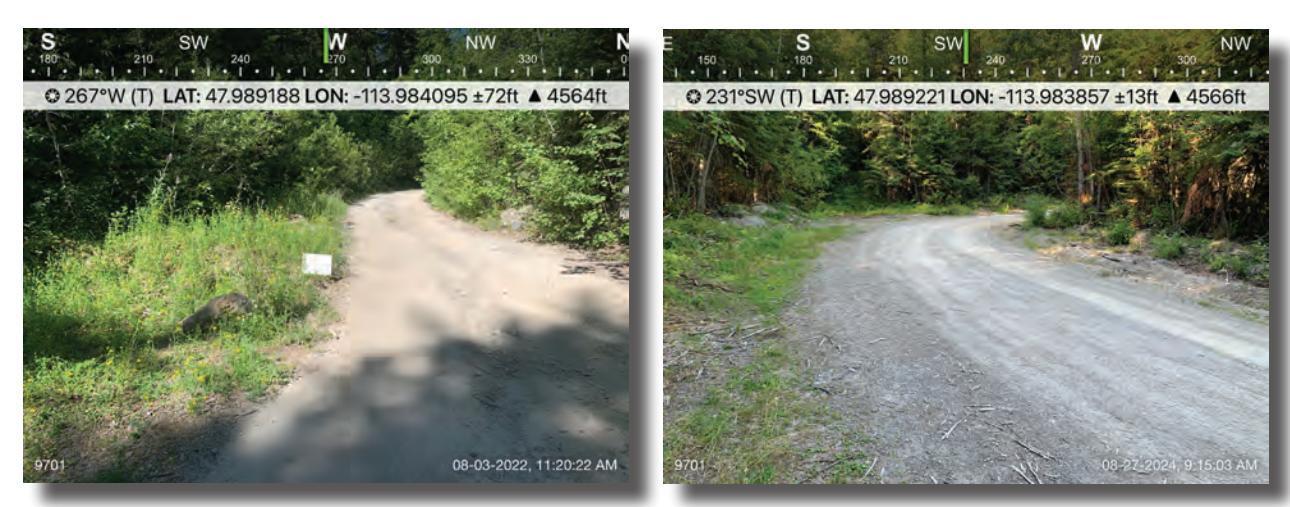
Road 9701

Fig. 5: 8/3/22 view of the flatted earth berm on road 9701.

Fig. 6: 8/27/24 view of the closure location on road 9701.

Road closure 9701 was featured on page 10 of Road Hunt as a worn-down berm reported as ineffective by the FS in 2020, as shown in Figure 5. On 8/27/24 we found what little of the earth berm that remained in 2022 had been totally bladed away and it

appears the road was being used for a logging contract in 2024, as shown in Figure 6. No road closure device exists. [5] The "closure" is ineffective at preventing use by motor vehicles, as described on page 11 of Road Hunt.

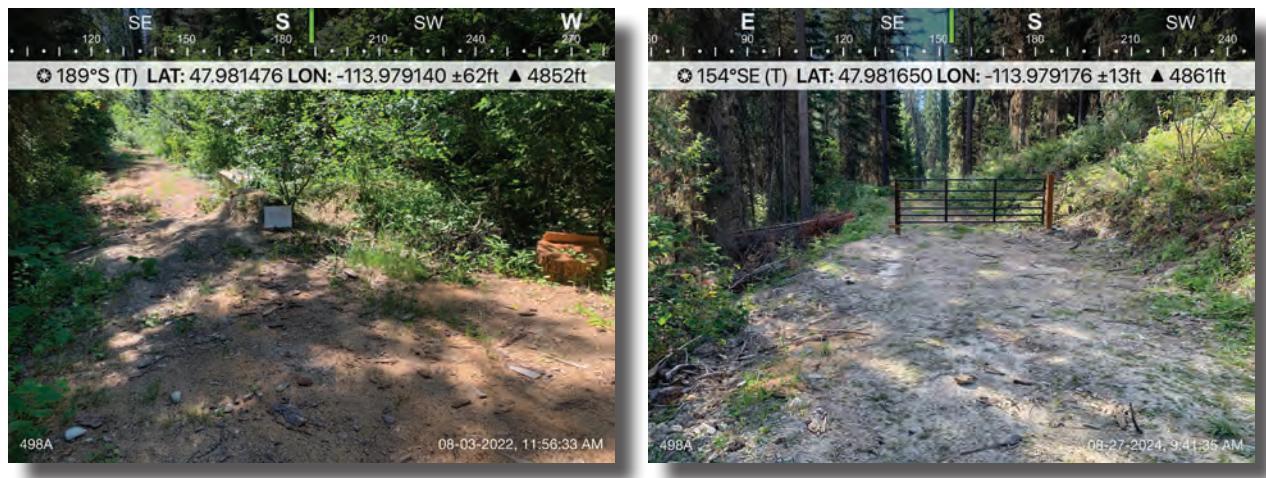
Road 498A

Fig. 7: 8/3/22 view of driven-over berm on road 498A.

Road closure 498A was featured on page 12 of Road Hunt as an ineffective run-over berm, as shown in Figure 7. On 8/7/24 we found the earth berm bladed away and replaced by a temporary cattle-type gate,

Fig. 8: 8/27/24 view of the closure location on road 498A. apparently to accommodate a logging contract, as shown in Figure 8. We found this closure to still be ineffective. How we make

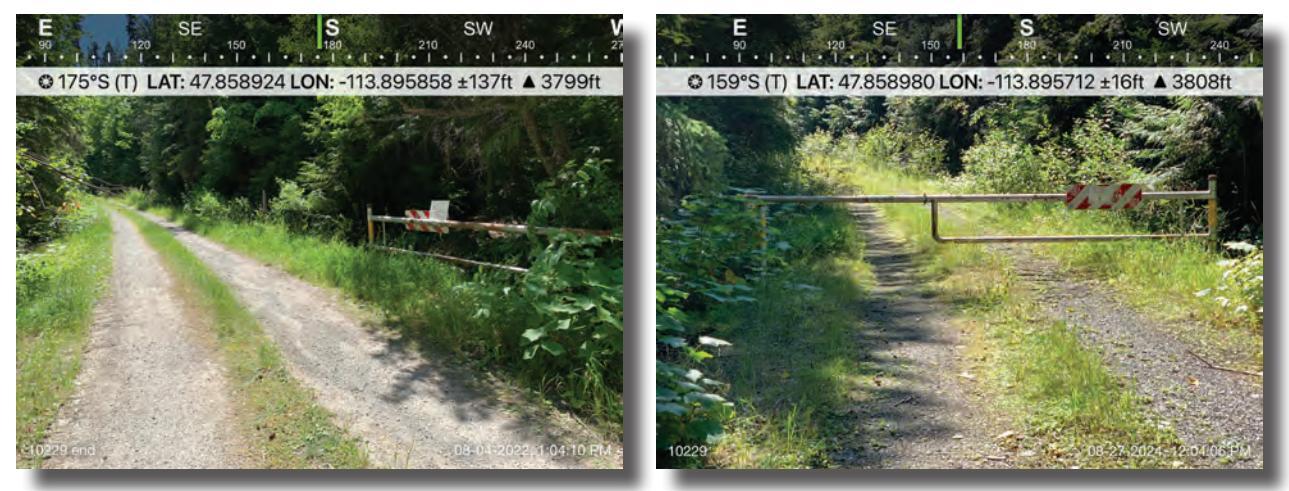
Road 10229

Fig. 9: 8/4/22 view of year-round closure gate 10229.

Fig. 10: 8/27/24 view of year-round closure gate 10229.

Road closure 10229 was featured on page 10 of Road Hunt as a year-round gate left wide open with no vegetation in the tire tracks, as shown in Figure 9, indicating the gate may have been left open in prior years as well. On 8/27/24 we found the gate closed and locked, as shown in Figure 10. There was a sign posted on the gate indicating the road is "CLOSED TO ALL WHEELED VEHICLES" and open to

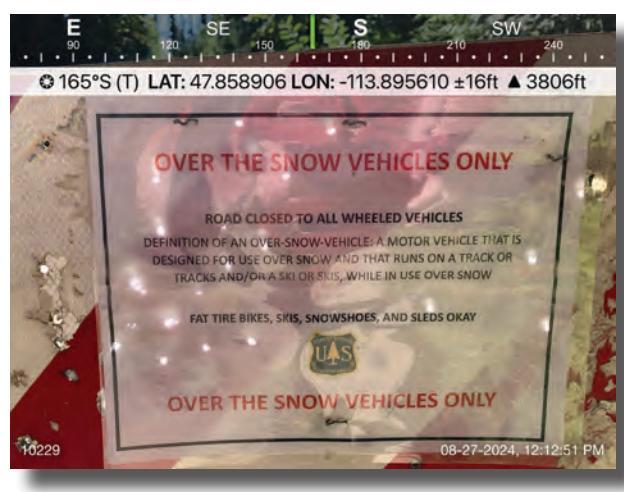
Fig. 11: 8/27/24 view of sign posted on gate 10229.

"OVER THE SNOW VEHICLES ONLY," as shown in Figure 11.

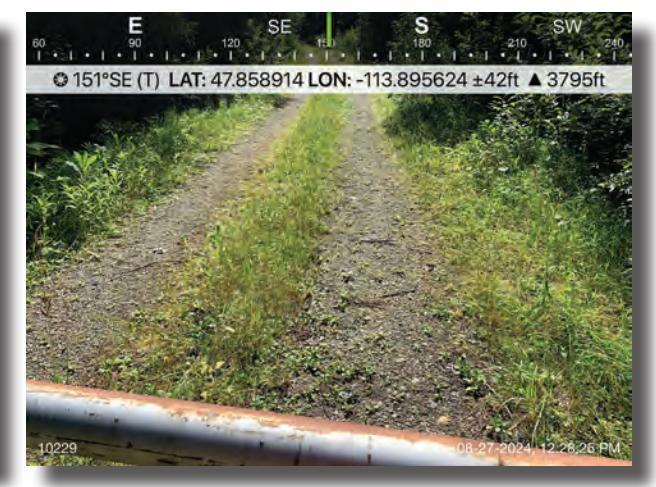
Fig. 12: 8/27/24 new vegetation behind gate 10229.

We found new vegetation growing in the previously well-worn tire tracks, as shown in Figure 12, and no indication of wheeled vehicle use that would have crushed or prevented the new vegetation growth. We listed this closure as effective but also noted an unused potential detour space wide enough for motorcycle trespass exists

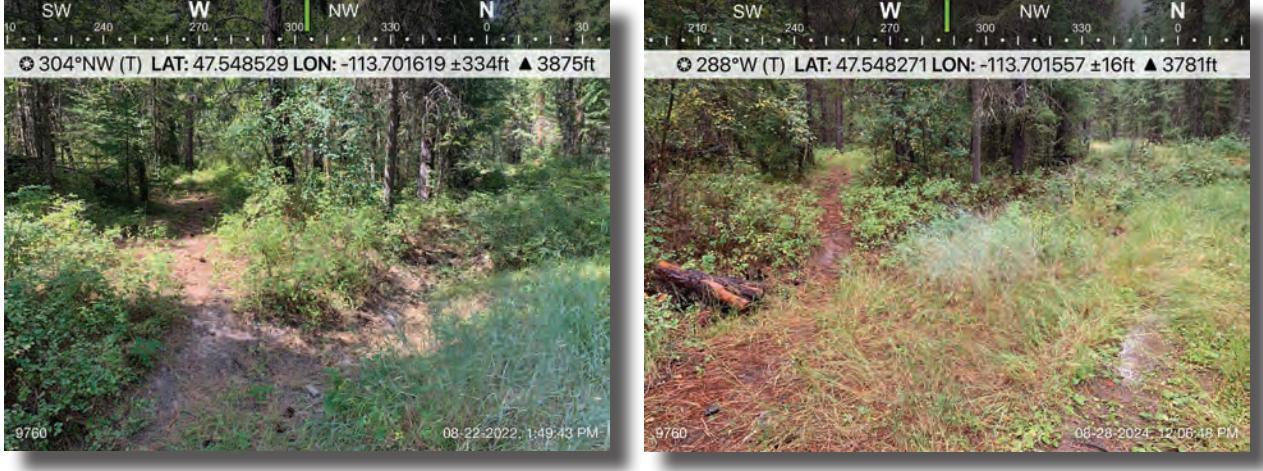
Fig. 13: 8/22/22 ATV detour around closure berm 9760.

Road closure 9760 was featured on page 13 of Road Hunt as an earth berm with a wide detour around its left side showing evidence of use by ATVs, as shown in Figure 13. On 8/28/24 we found evidence of

Fig. 14: 8/28/24 ATV detour around closure berm 9760.

ATVs still using this detour to trespass behind the earth berm. We found no evidence the FS has tried to correct this problem since 2022 and again listed the closure as ineffective at preventing motorized use.

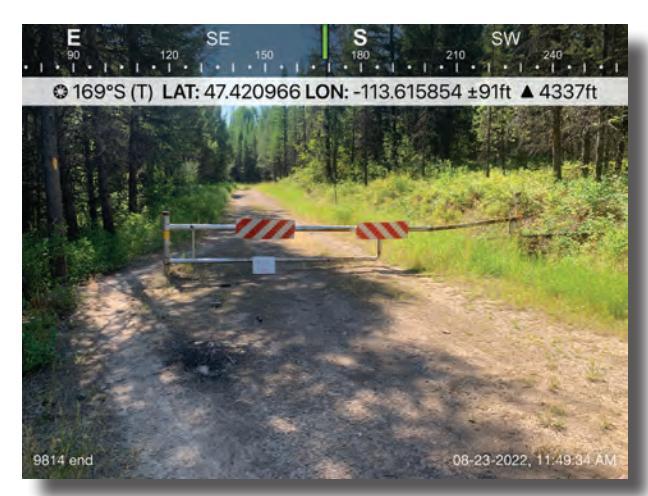
Fig. 15: 8/23/22 mountain bike and motorcycle detour.

Road closure 9814 was featured on page 15 of Road Hunt as a gate circumvented by a high-use mountain bike detour that also showed motorcycle tracks behind the gate, as shown in Figure 15. On 8/28/24, we found the same situation, as shown in Figure 16. We again found a motorcycle

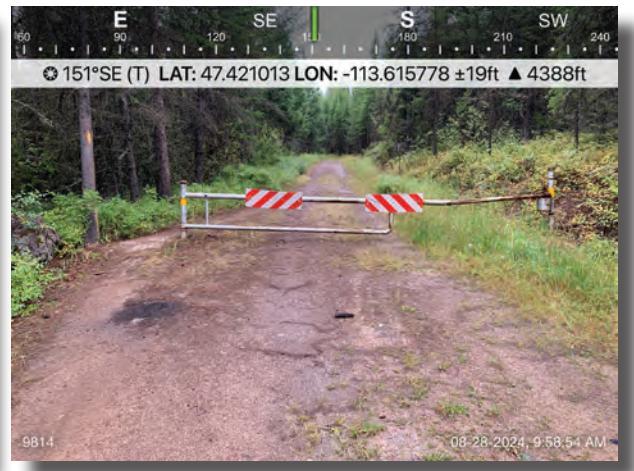
Fig. 16: 8/28/24 mountain bike and motorcycle detour.

track behind the gate and wondered how many of the bicycle tracks might have been motorized e-bikes, which are prohibited from closed roads and trails. We found no indications that the FS had attempted to enhance the effectiveness of this gate and we again listed it as ineffective.

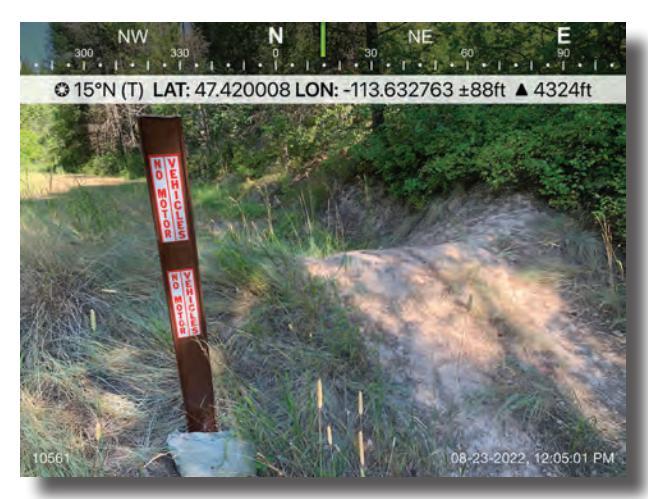
Fig. 17: 8/23/22 driven-over earth berm with sign.

Road closure 10561 was featured on page 1 of Road Hunt as an earth berm heavily driven over by ATVs in spite of the bermand-pit combination accompanied by a closure sign, as shown in Figure 17. On

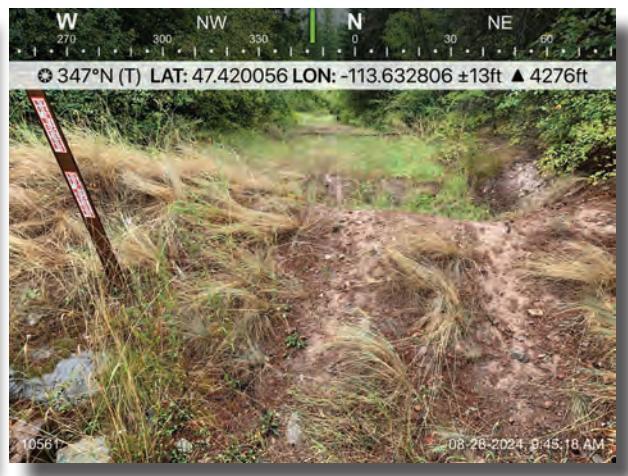
Fig. 18: 8/28/24 driven-over earth berm with sign.

8/28/24 we found the situation unchanged and ATV tracks over and behind the berm, as shown in Figure 18. We found no evidence the FS had attempted to enhance the effectiveness of this road closure device.

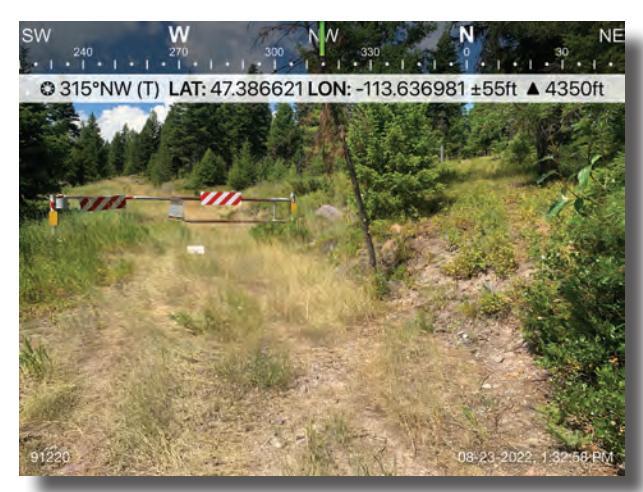
Fig. 19: 8/23/22 ATV detour around gate 91220.

Road closure 91220 was featured on pages 2 and 17 of Road Hunt as a gate-with-closure-sign circumvented by ATVs going up the right bank and back down it behind the gate, as shown in Figure 19. On 8/28/24 we found the situation unchanged. We found

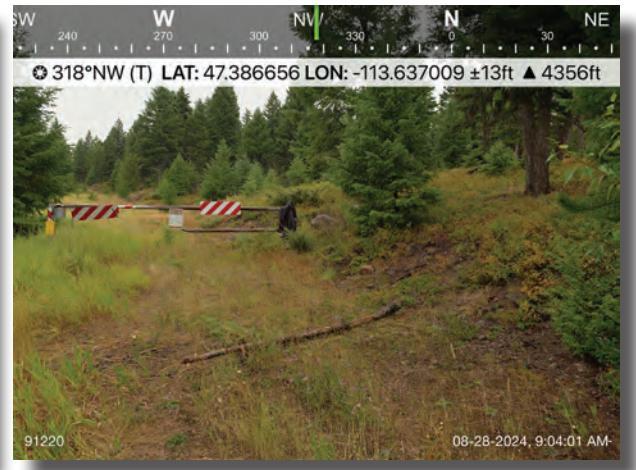
Fig. 20: 8/28/24 ATV detour around gate 91220.

fresh ATV tracks having used the detour, as shown in Figure 20, though the tracks do not show as well in the latter wet-weather photo. We found no evidence the FS had attempted to enhance the effectiveness of this road closure device.

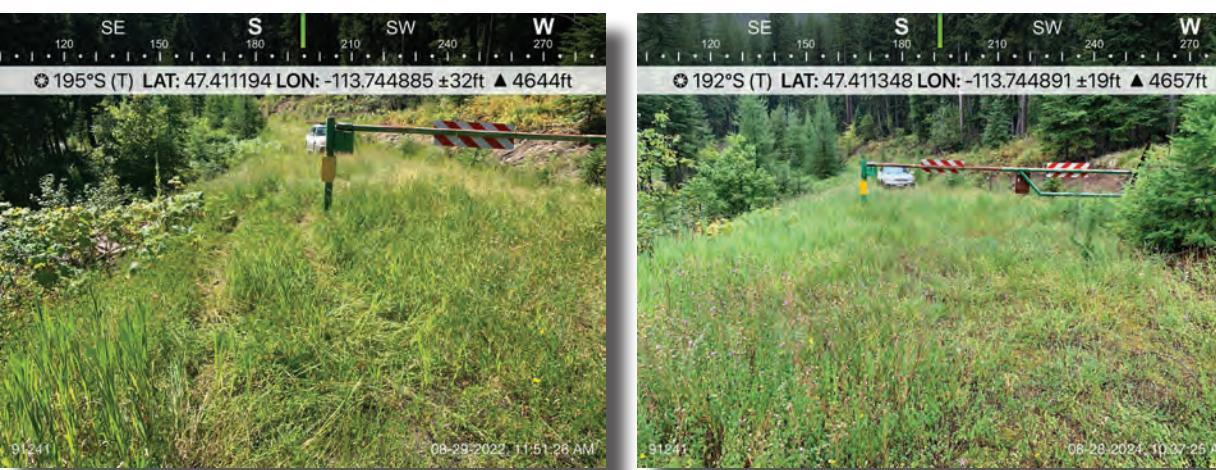
Road 91241

Fig. 21: 8/23/22 ATV detour around gate 91241.

Road closure 91241 was featured on page 13 of Road Hunt as a gate circumvented by an ATV going around the right/locking side of the gate, as shown in Figure 21. The FS noted in 2022 the gate needs "a rock installed on the right side to keep out atv/ dirt bikes." On 8/28/24 we found the situ-

Fig. 22: 8/28/24 ATV detour around gate 91241.

ation unchanged, as shown in Figure 20, but trespassing ATV tracks were not visible so we listed the closure as effective per our protocols in Appendices A, B and C. We found no evidence the FS had attempted since 2022 to enhance the effectiveness of this road closure device.

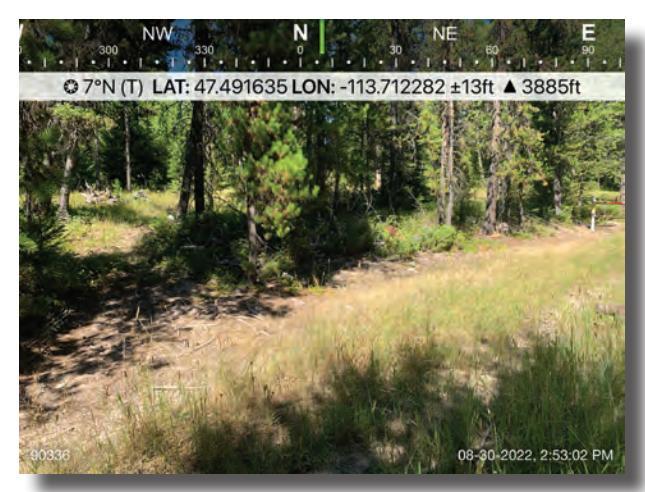
Road 90336

Fig. 23: 8/30/22 ATV detour around gate 90336.

Road closure 90336 was featured on pages 14 and 17 of Road Hunt as a gate circumvented by ATVs going around the left/ hinge side of the gate, as shown in Figure 23. On 8/28/24 we found the situation unchanged, as shown in Figure 24. ATV use

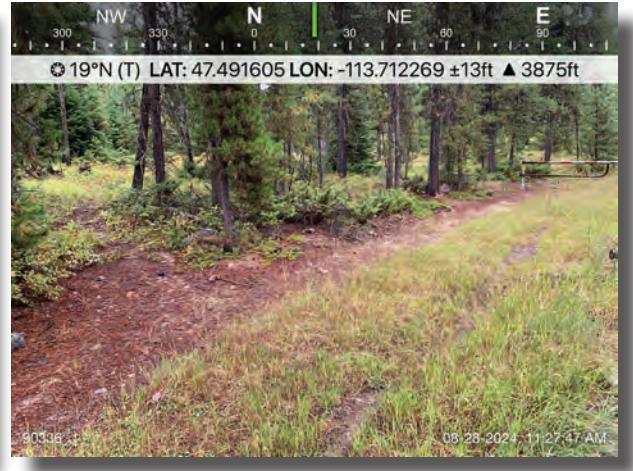
Fig. 24: 8/28/24 ATV detour around gate 90336.

of the detour and the road behind the gate was again evident and we again listed the closure as ineffective. We found no evidence the FS had attempted since 2022 to enhance the effectiveness of this road closure device.
