## **Comment on Plantation Thin & Potential Control Line Treatments EA**

**Collin Neuhauser**

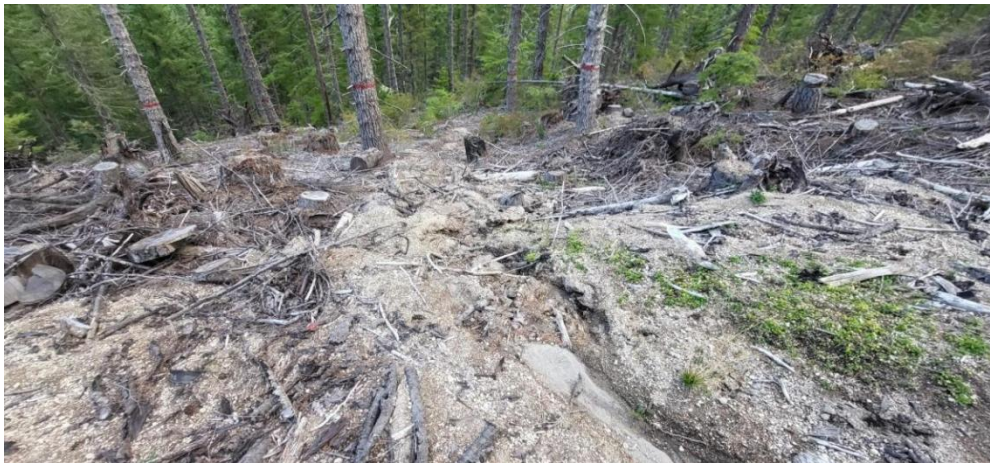
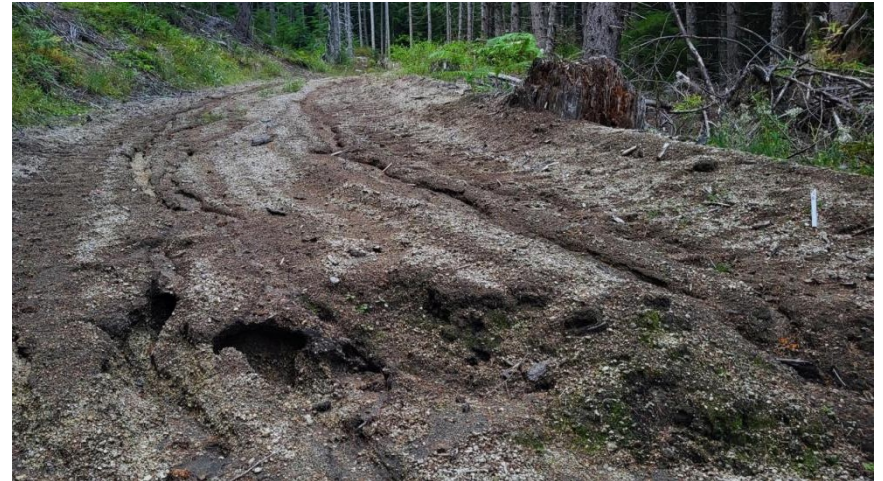
- The public has breached barriers installed on the 2500-224 road system. There is similar erosion in that area as is shown in the photos below. Please have contractors do a better job of installing barriers.

Erosion on temp road accessing Ben4 unit 45. This temp road should have been outsloped, decompacted, and covered with slash. The soils on the west side of Iron Creek are very erodable due to their volcanic composition. I hope that temp roads are restored after use more effectively than they were under the Iron Crystal EA.

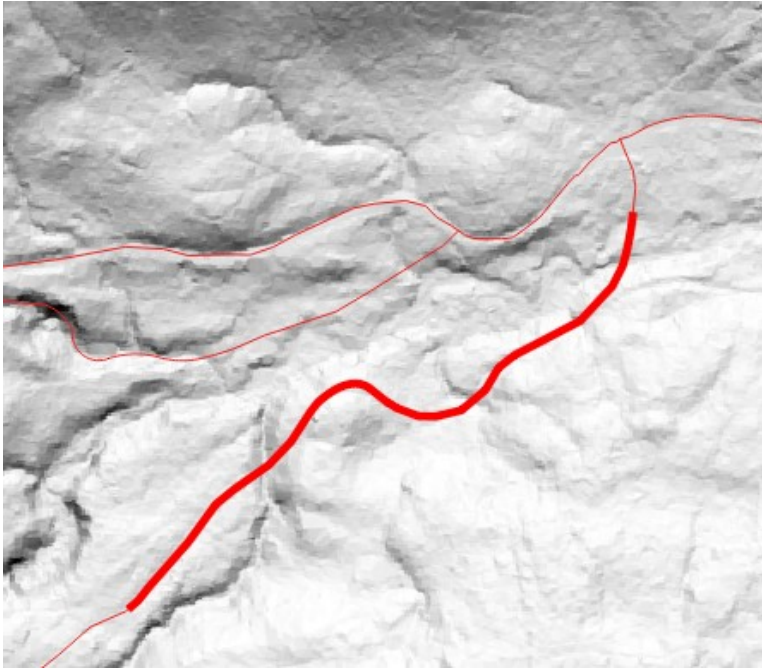
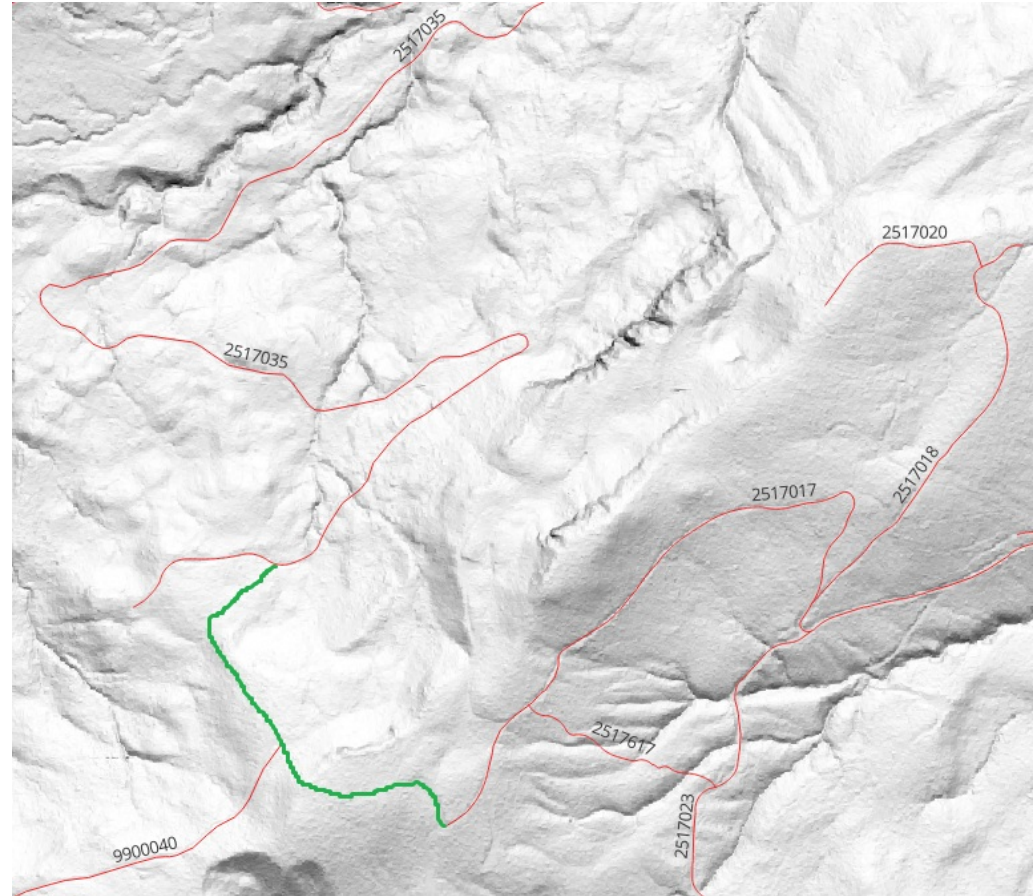
The northern portion of the 2517-035 has been decommissioned and has multiple large creek crossings. I have found that there is alternate access by building a temp road from the 2517-017 or the 9900-040. The route, indicated in green, crosses through only plantations and has no creek crossings. The 2517-017 was recently rebuilt for the ferrous sale. Also of note are the 2517-617 and 2517-678. Neither of these roads exist and should be removed from the roads layer. The selected portion of the 2517-035 should also be removed with how thoroughly decommissioned it is.

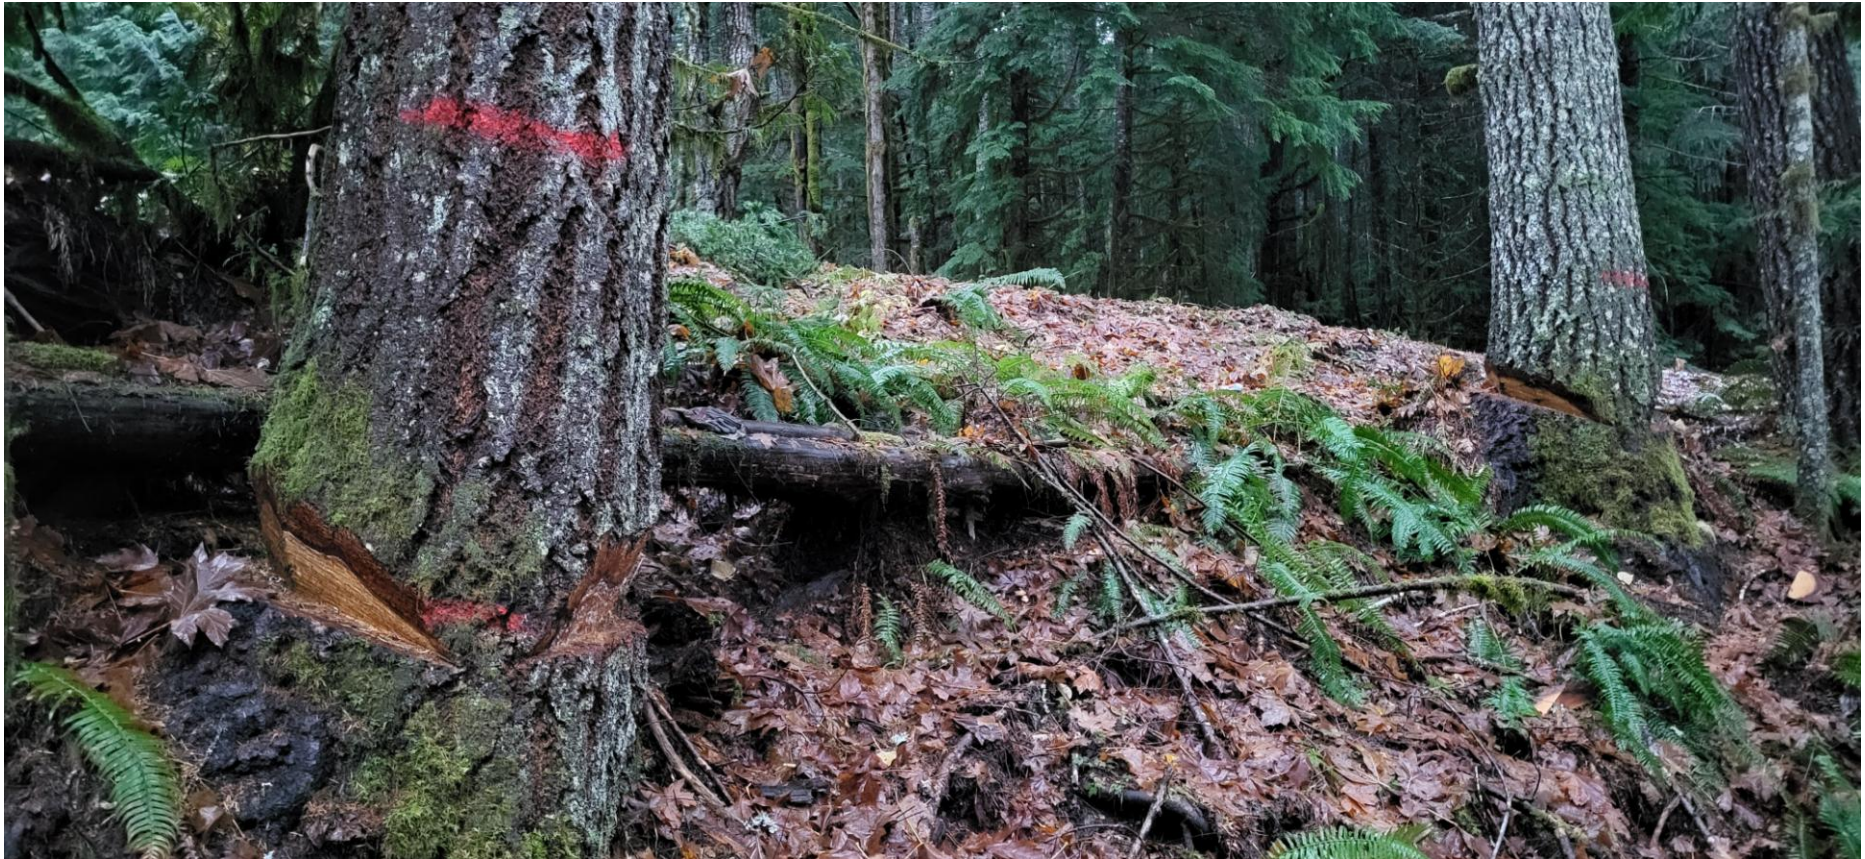
Girdling leave trees adjacent to a ML5 road to use them as tailholds does not make sense. Now there will be large snags along one of the primary routes in the forest. This was in Nash unit 17. Please avoid allowing this in the future.

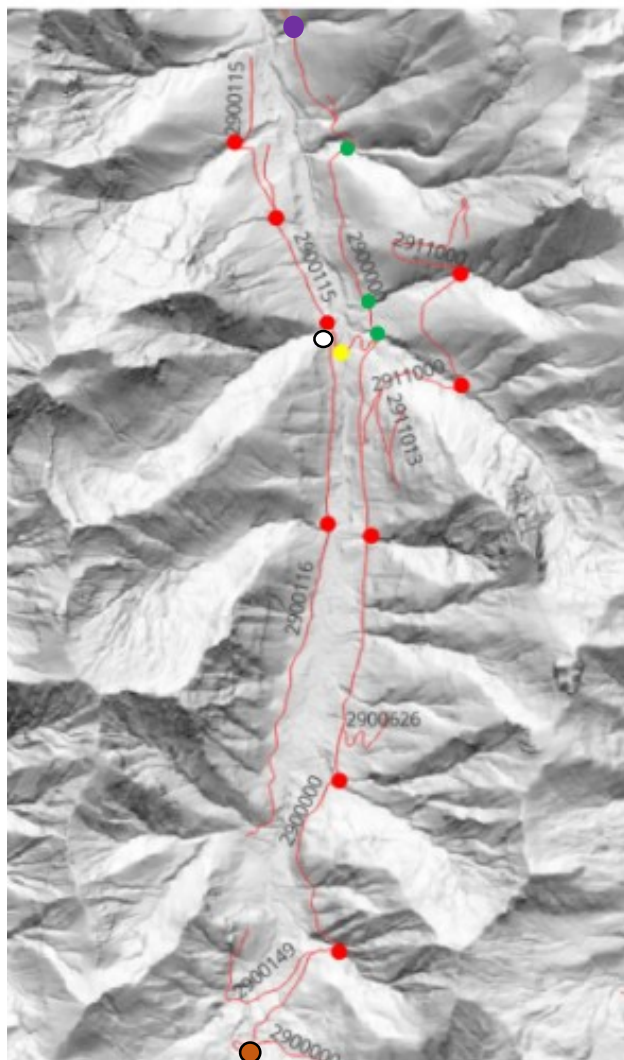
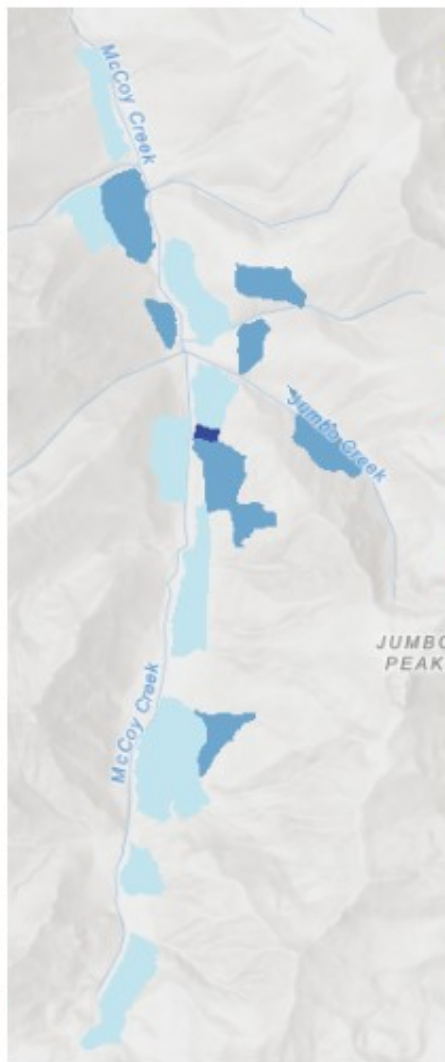
- McCoy Creek culvert. This culvert is on the forest's list of top 40 AOP barriers. I would like the forest to analyse the option of replacing the culvert with a motorized trail bridge. This watershed is very prone to flood events that cause large road washouts. After the timber sale here, the road system west of McCoy creek will not be needed and ought to be decommissioned. A trail bridge would provide access to the motorized trail. The trail is not used much and there is an alternate trailhead on the 2809. If there is no funding, maybe having no access to the trailhead is acceptable.

- Culvert with rusted out bottom that will cause a road failure soon.
- Road washouts. I am unsure how many of these make sense to repair because many are deep fill locations that are susceptible to washing out again. The forest should consider leaving the road system as is and considering it decommissioned beyond the current washouts.

- Recently repaired washouts from 2016-17 flood event
- Trailhead for motorcycle trail that climbs up to the Langile Ridge trail. Usage is low due to lack of maintenance.

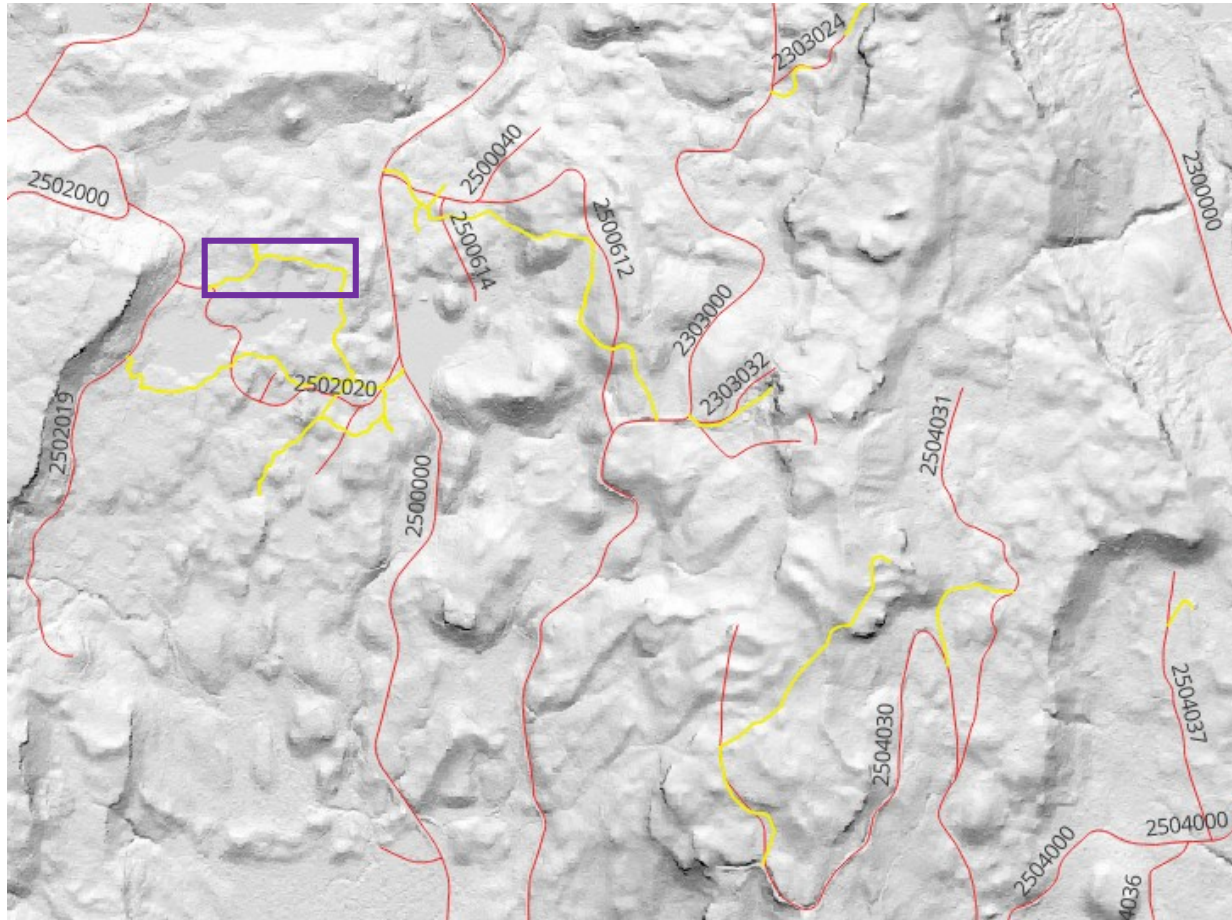
This map shows where I found road mapping errors in this area. The true locations are yellow. I groundtruthed road 2500-612 and the 2502-020 area.

The 2502-020 and 2500-612 do not exist as mapped. They are actually old skid roads built to access wind blown salvage. I believe the 2304-031 is a similar situation but did not ground truth it like the others. I think the 020 spur does exist and is the highlighted portion only. The rest of the 020 and 612 spurs should be deleted from the roads layer to reduce further confusion.

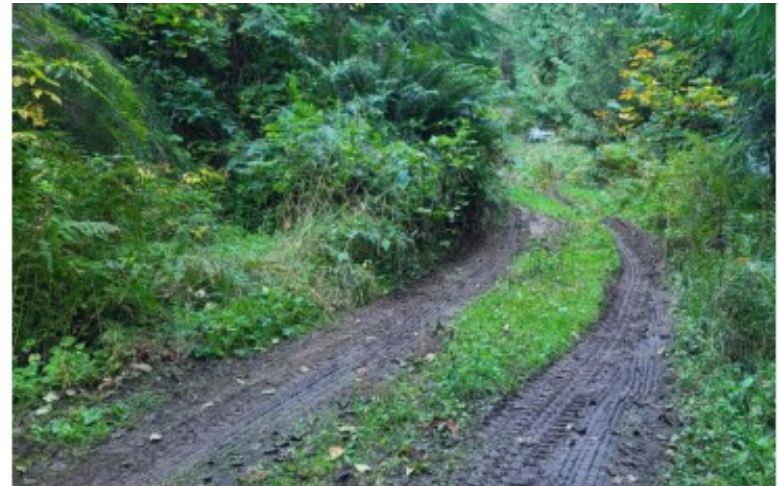
The northern end of the 2303. The landslide is visible to the left. The public created an unsafe path through it. Another portion of the 2303 crosses through the headwaters of Spears Creek and the road surface is cronically saturated with water. I think the 2303 should be closed, stabilized, and decompacted from the forest boundary to Judd Pit.

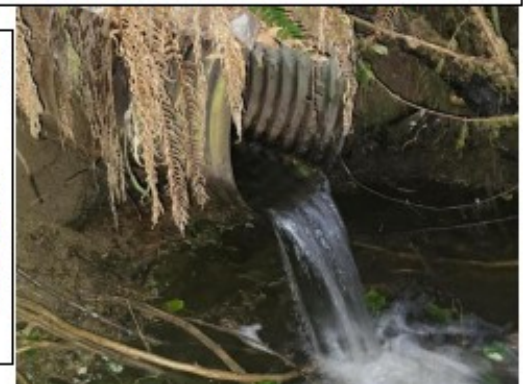
This AOP barrier on the 2300-065 is one of over a dozen in the Siler Creek watershed.

One priority ought to be the Squire Creek culvert on the 2305. It is rusted out and will fail soon. The road has a buried powerline and accesses private land.

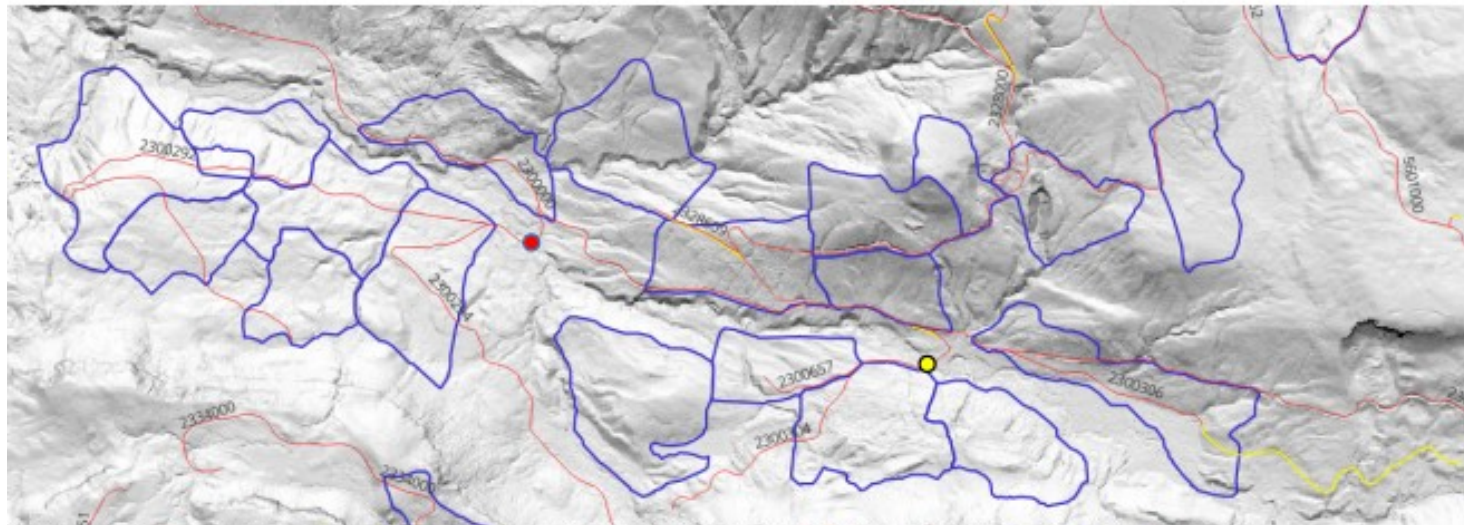
## ● Road 2300-292

The culvert was blocked and the Creek cut a new channel around it. I would like to see the existing culvert reused for the sale and for it to be removed afterward. I think the rest of the road after the creek should be put into storage.

## ● Road 2300-304

The log stringer bridge is falling off its abutments here. I would like to see it removed and a temporary bridge used for the sale. The road beyond the creek should be put into storage.

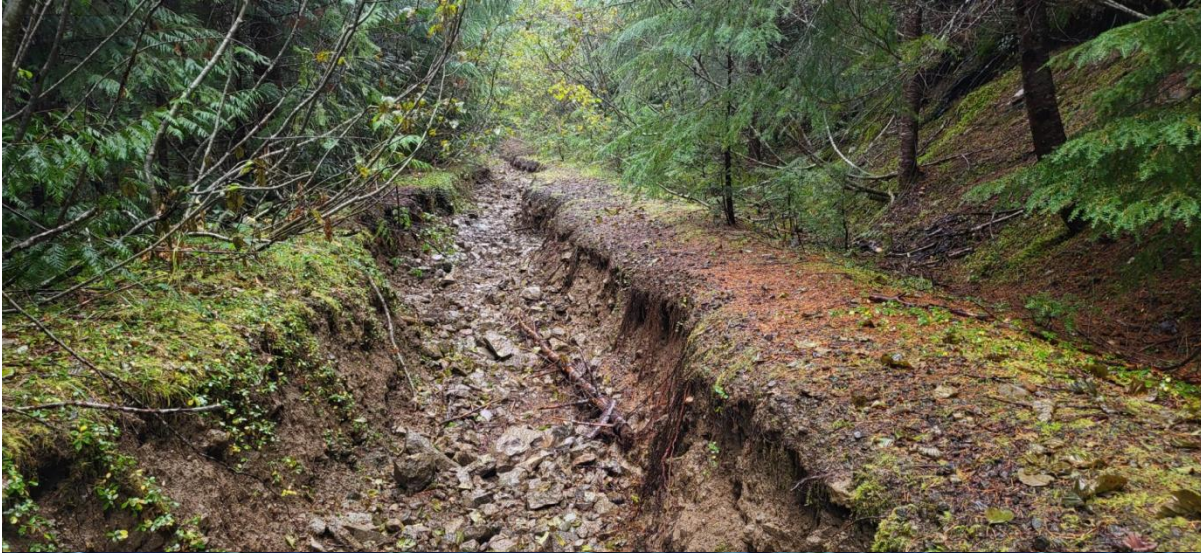
● Severe washout for 1/4 mile on 5603017. An entire creek has been diverted onto the road and joins the next creek to the east.

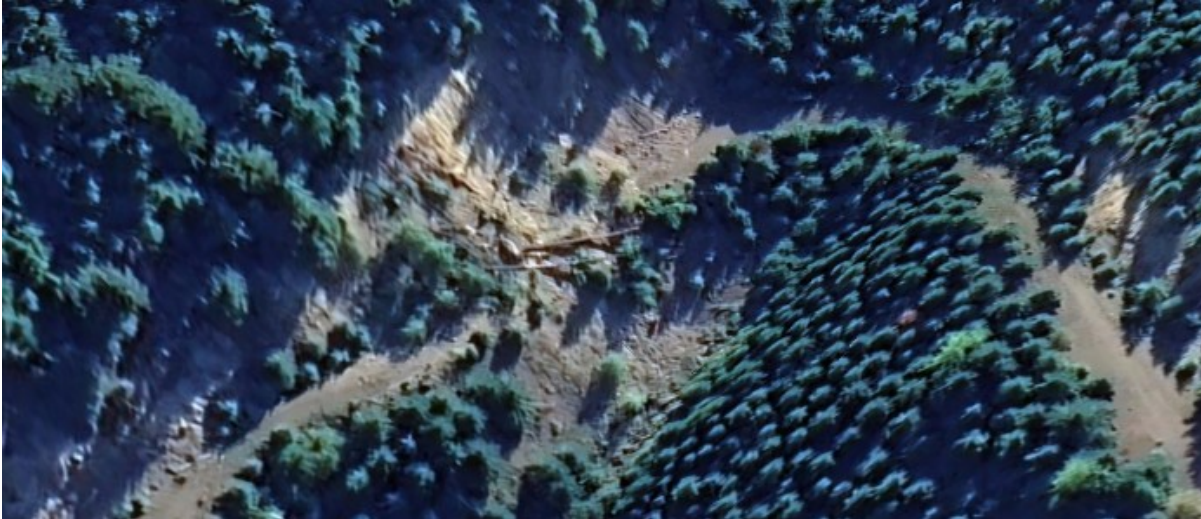
● Landslide on 5603017

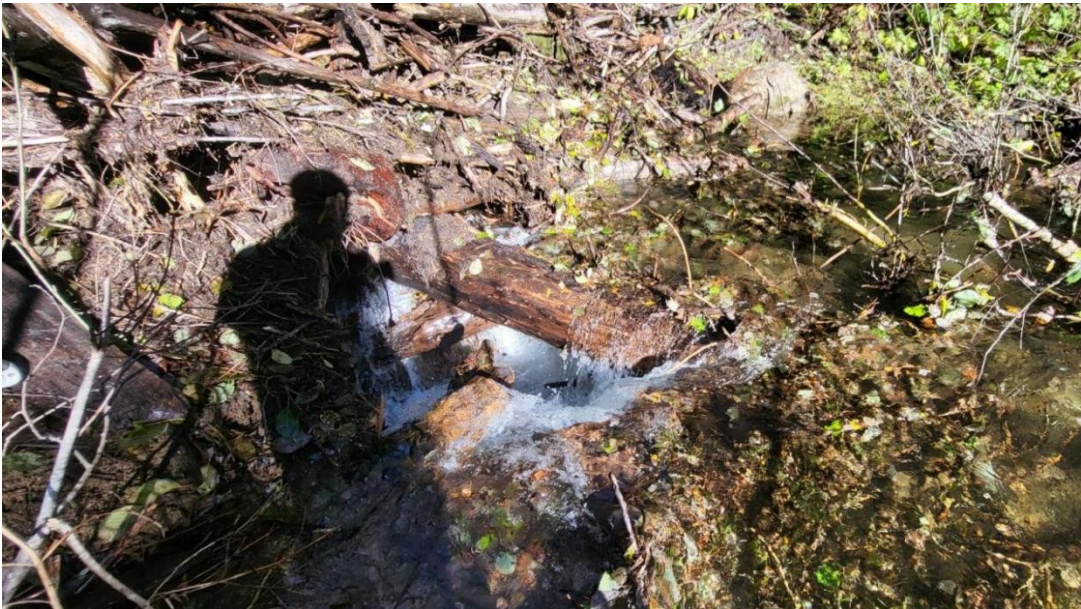
This is the log jam at the inlet of the first 10-12 foot culvert for Deception Creek. The log jam should be removed ASAP to prevent further damage from the road overtopping.

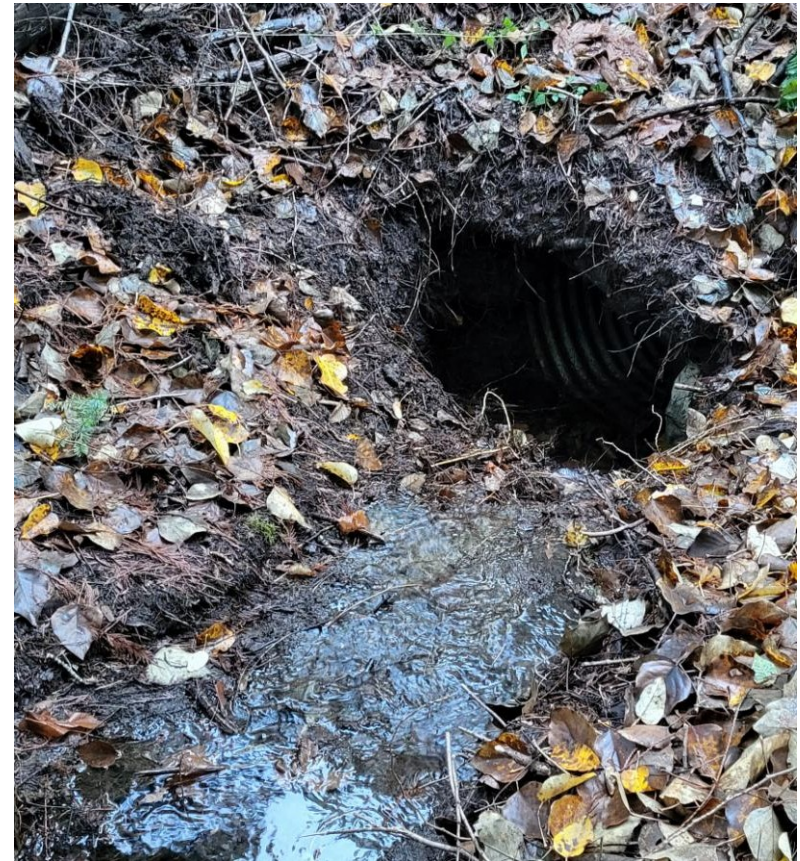
- Culvert that became plugged on 5290-082. I cleared it in 2024 but it needs to be upsized.

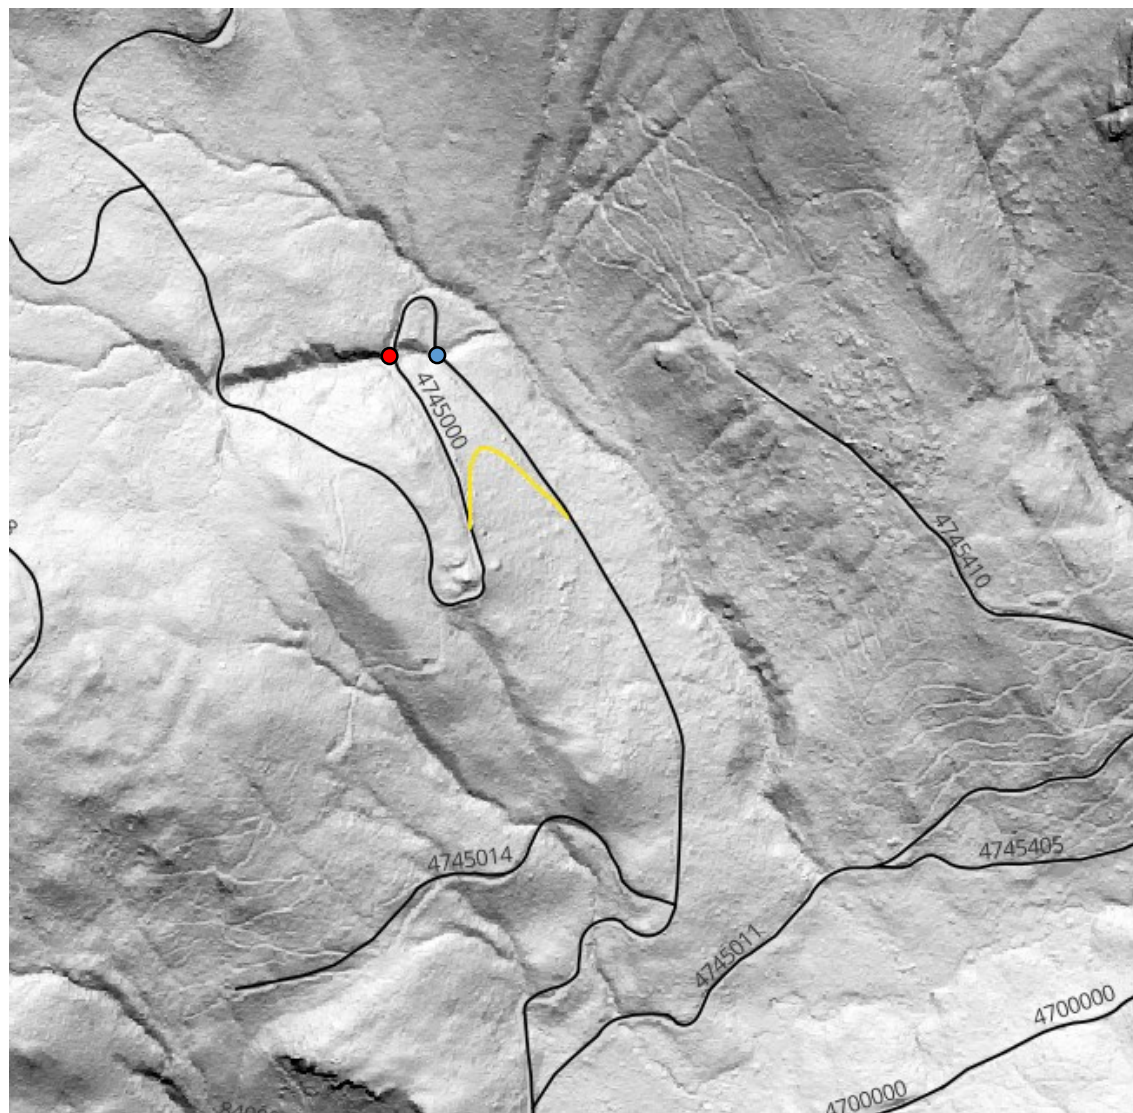
- Possible reroute of 4745
- Plugged culvert where creek diverts into ditch
- Culvert that was over 60% plugged before I cleaned the inlet in 2024

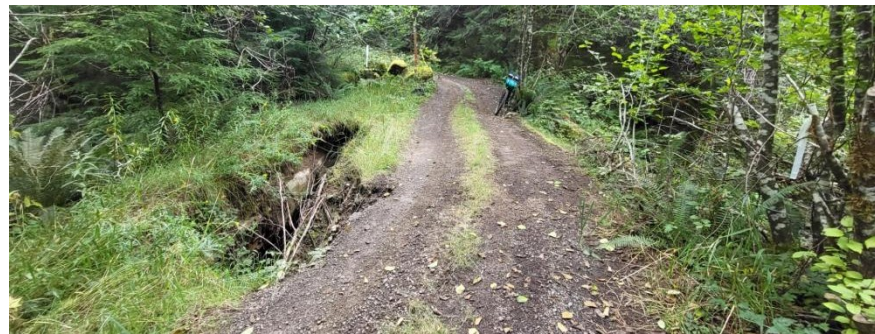
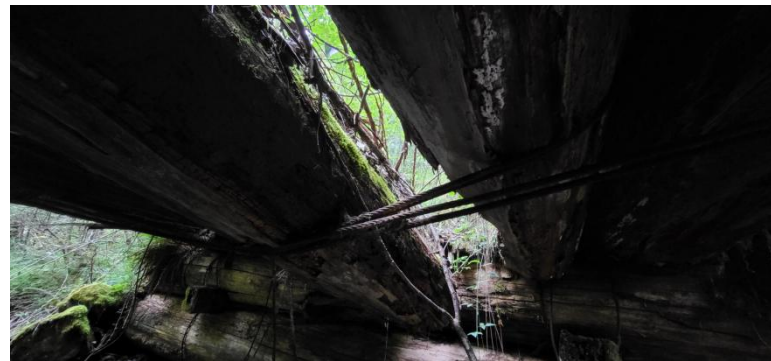
Failed bridge that needs replacement ASAP. It is a public safety hazard because the public keeps removing the barriers blocking it.

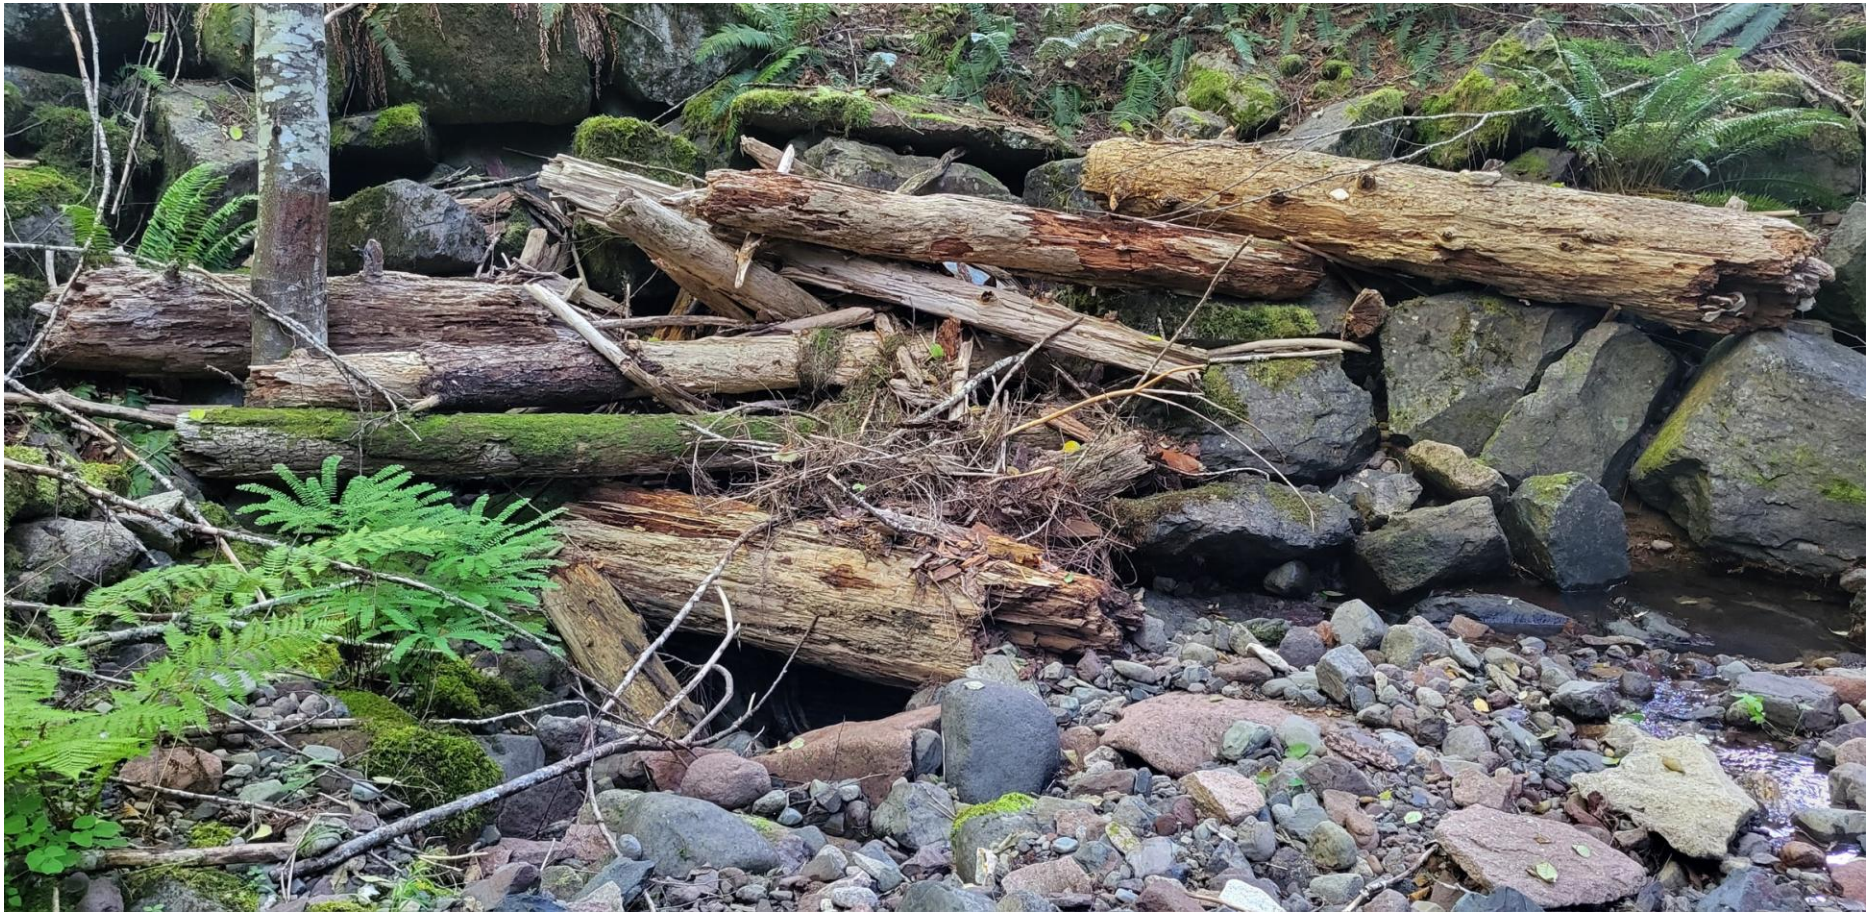
- A major culvert upgrade is needed where the 93 road crosses Platinum Creek. Large woody debris is getting caught at the inlet. I think that a box culvert would be the best option to allow the wood to pass through during storms.
- Culvert upgrades are also needed in the Spencer Creek headwaters. The 93 road is an important corridor to stormproof.
- *Lathyrus sylvestris* needs to be treated along the 93 road to prevent its spread. It has heavily infested the Quartz Creek trailhead.

Culvert inlet where the 93 road crosses Platinum Creek. I removed some of the woody debris after taking this photo but the culvert is clearly not adequate for the location.

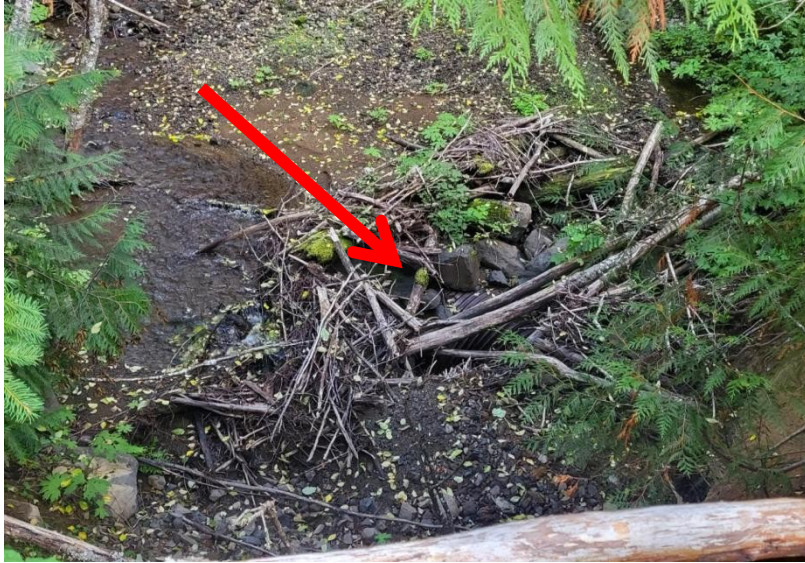
Plugged inlet at South Fork Swampy Creek. Arrow is pointed at inlet.

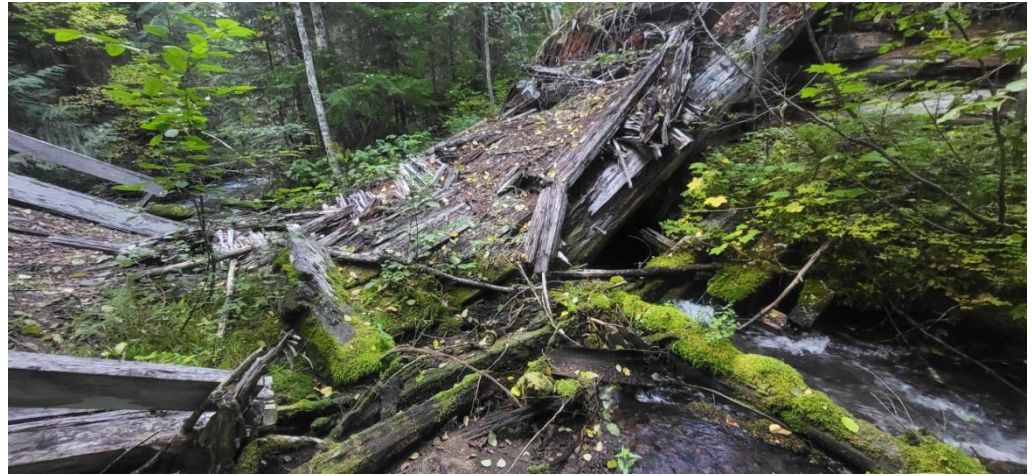
Collapsed bridge in Twin Falls Creek
