Re: Golden Peak Improvements Project DEIS

Subject: Engineering Consultation  
Golden Peak Improvements Project  
Vail Ski Area  
Vail, Colorado  
Project No. GS06142.000-145

CTL/Thompson, Inc. provided you a letter (dated June 14, 2017) with our observations regarding geologic and geologic hazards observations of the slopes and ski area property above Northwoods Condominiums. Subsequent to our letter, the United States Forest Service (USFS) released the Draft Environmental Impact Statement (DEIS) for the Golden Peak Improvements Project for public comment which we have reviewed. We reviewed pertinent documents within the DEIS (see Documents Reviewed). The document was compiled by SE Group Inc. for Vail Ski Area and the USFS. The Golden Peak Improvements Project will include a new surface lift, Men's Super G, Women's Downhill, mogul and skier cross courses. Lift operating shacks, race start buildings, and maintenance buildings are proposed. Significant tree clearing, and new snowmaking capacity would be required. The planned mogul course would be located above Northwoods Condominiums. Photographs are provided in Appendix A.

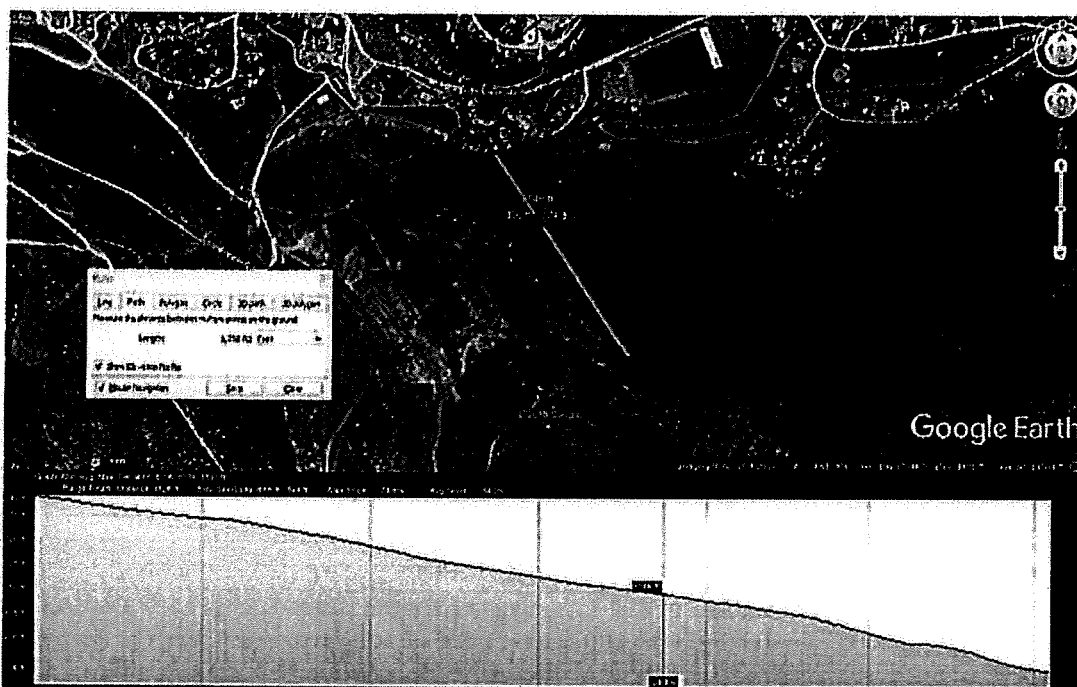
ment loads may be significant, especially if the Golden Peak features are constructed as proposed. A profile of the slope from the bottom of the mogul course to the ridge top above Northwoods is shown below.

This slope profile, generated with Google Earth, indicates that surface and subsurface water at the base of the mogul course is likely to travel to the slopes directly above the Northwoods property. Tree clearing, reshaped surface grades, and additional manmade snow required for the course is likely to increase the amount of surface runoff and subsurface water to the slope directly above Northwoods. This could increase driving forces for slope failures and sediment loads resulting in mudfloods and mudflows.

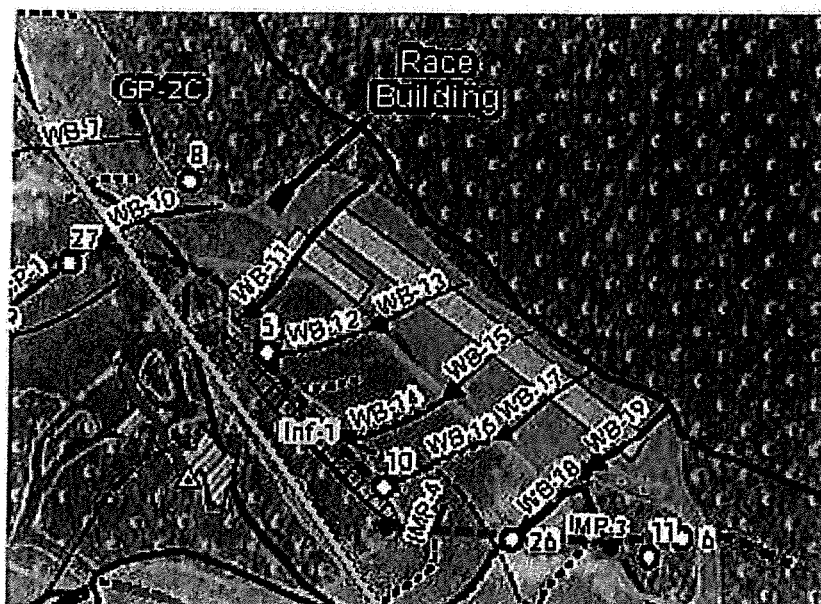
Drainage improvements related to basin GP-2G and the mogul course are indicated on the figure below taken from the LRE report. New water bars (i.e., ditches) WB-11, WB-13, WB-15, WB-17 and WB-19 are proposed to be built. Existing water bars WB-7, WB-10, WB-12, WB-14 and WB-16 would be improved and enlarged. The existing drainage channel IMP-3 would be enlarged with enhanced erosion control.

The planned drainage improvements are positive, but not designed with the intent of mitigating risk of landslides, mudfloods, and mudflows that could affect Northwoods. Considering that a substantial degree of risk from flooding and mudflow currently exists and mogul course construction could increase the risk, we recommend this risk be evaluated by the Forest Service in a supplemental DEIS. Potential Project Design Criteria or new alternatives may range from not constructing the mogul course, moving of the planned mogul course, or construction of berms, lined detention ponds and subsurface drains, none of which have been analyzed in the DEIS or associated reports.

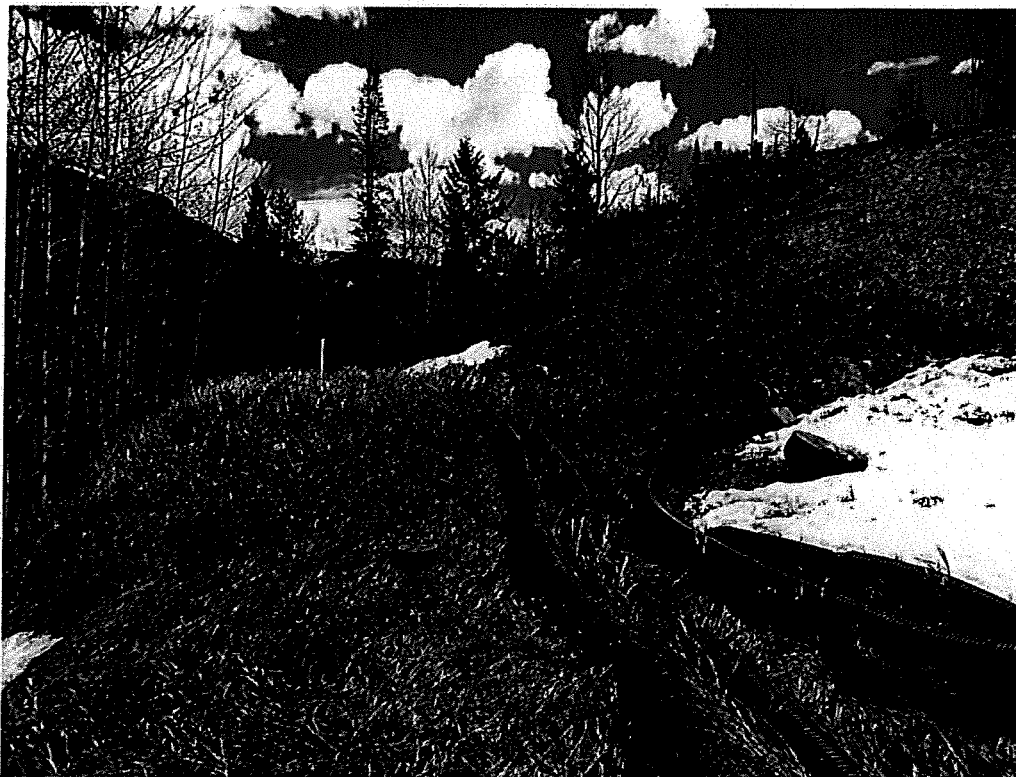
Buried Water Tank Above Northwoods

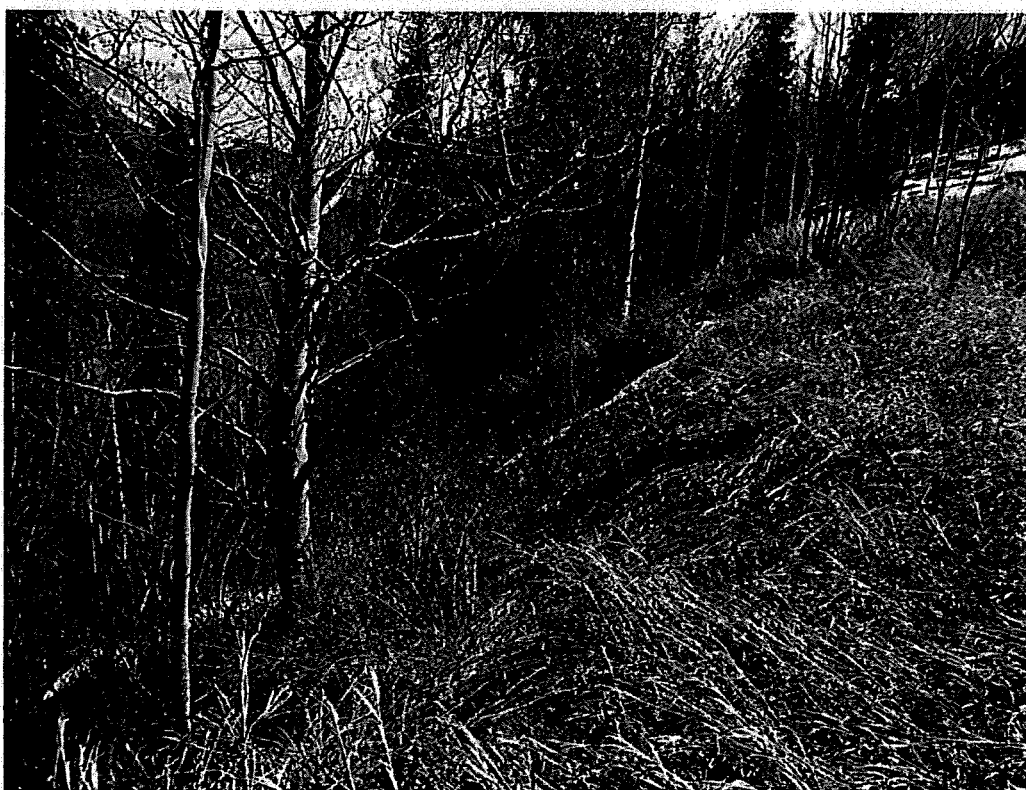
Crest of Slope Above Northwoods

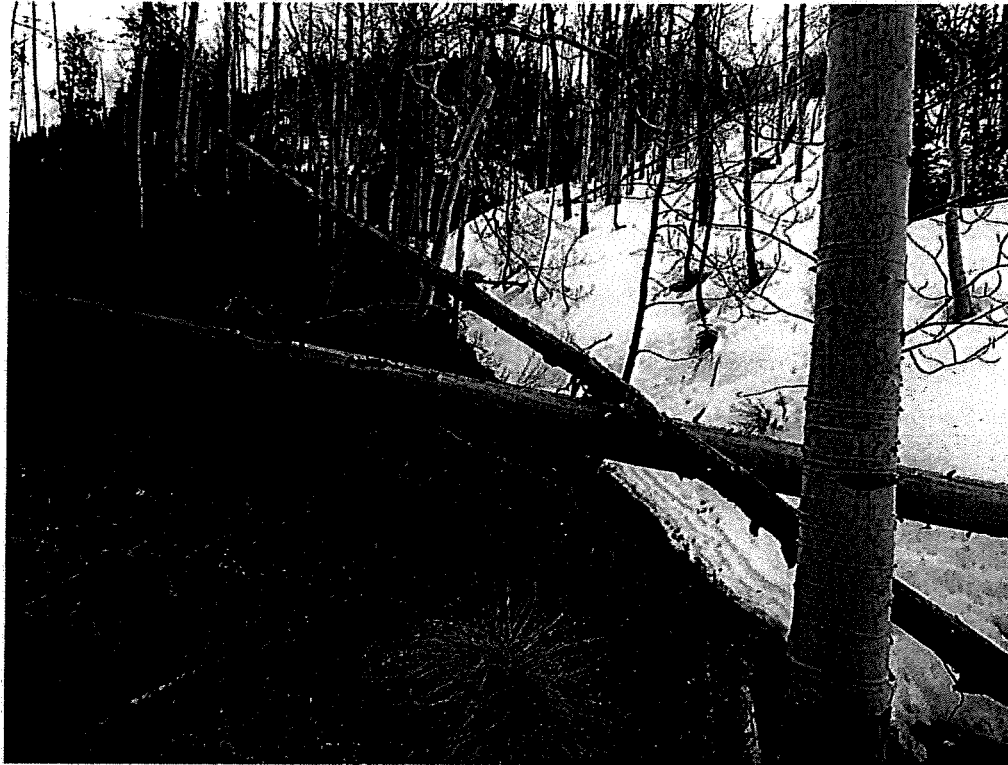
Incised Drainage Channel Above Northwoods

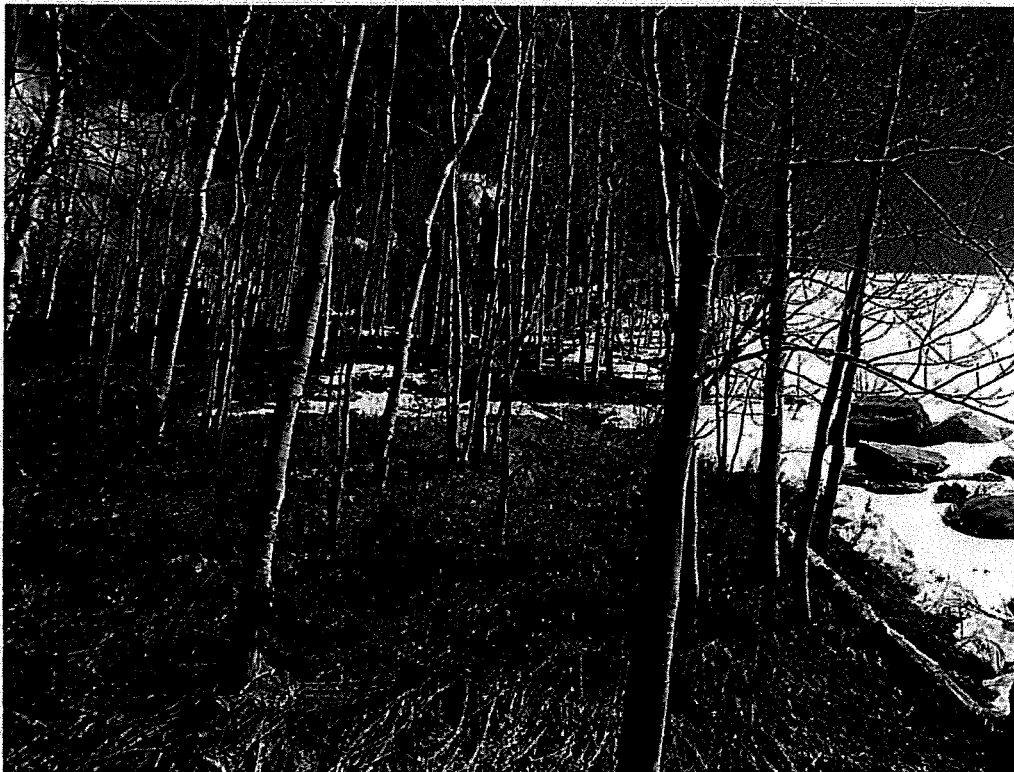
Proposed Mogul Course Location

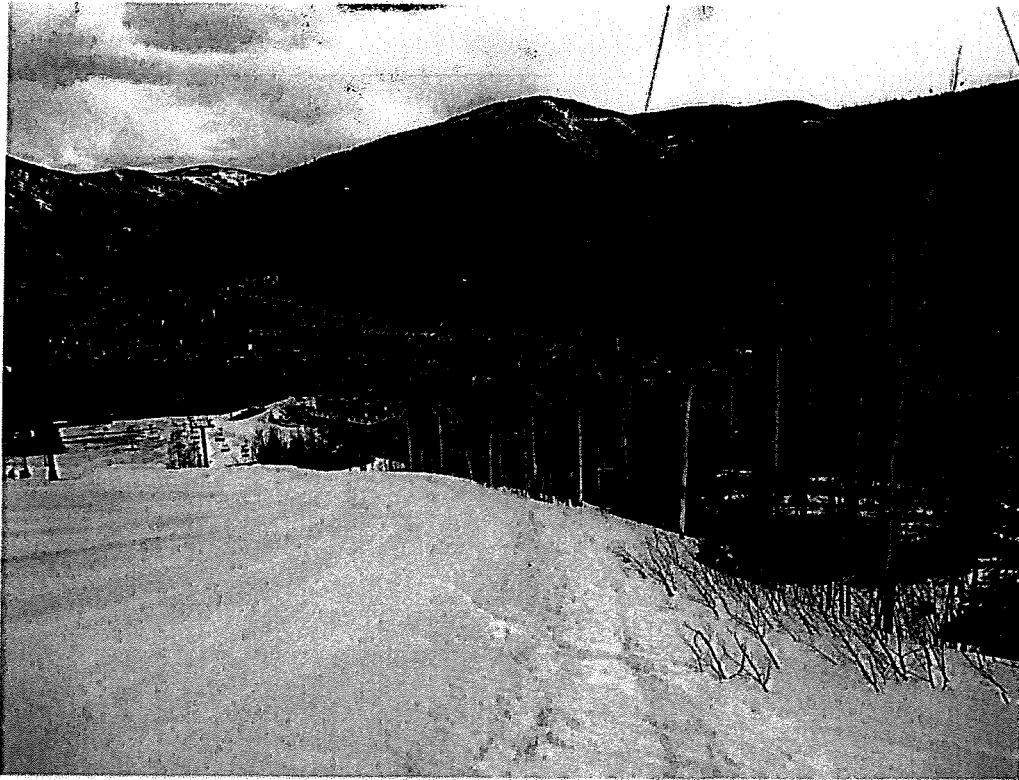
Ski Trial/Mogul Course Boundary

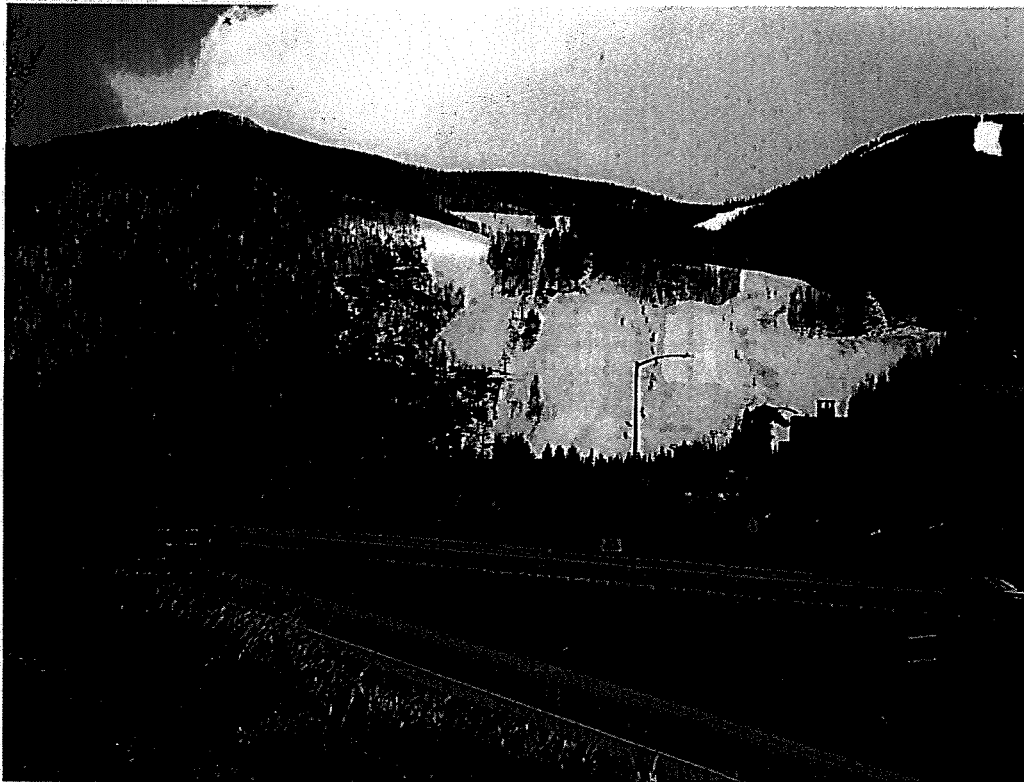
Golden Peak Improvement Area (left of existing ski run)
