# **SALMON AND STEELHEAD HABITAT LIMITING FACTORS IN WRIA 1, THE NOOKSACK BASIN**

July, 2002

This report is the habitat limiting factors project for WRIA 1, the Nooksack Basin. It provides a consolidation of existing habitat information in a Statewide consistent format, and rates various categories of habitat conditions. The habitat categories include fish habitat access, floodplain, sediment, streambed, riparian, water quality, flow, estuarine and nearshore conditions. Each of those conditions are rated as either “poor”, “fair”, “good”, or “data gap”, based upon a set of standards that are described in the Assessment Chapter. This Executive Summary presents only an overview of the worst habitat problems, but all the habitat ratings are provided in Tables 15 and 16 in the Assessment Chapter. More importantly, detailed discussions for each of these habitat conditions can be found within the Habitat Limiting Factors Chapter of this report. Maps of updated salmon and steelhead trout distribution and nearshore conditions are located in a separate electronic file on this disc.

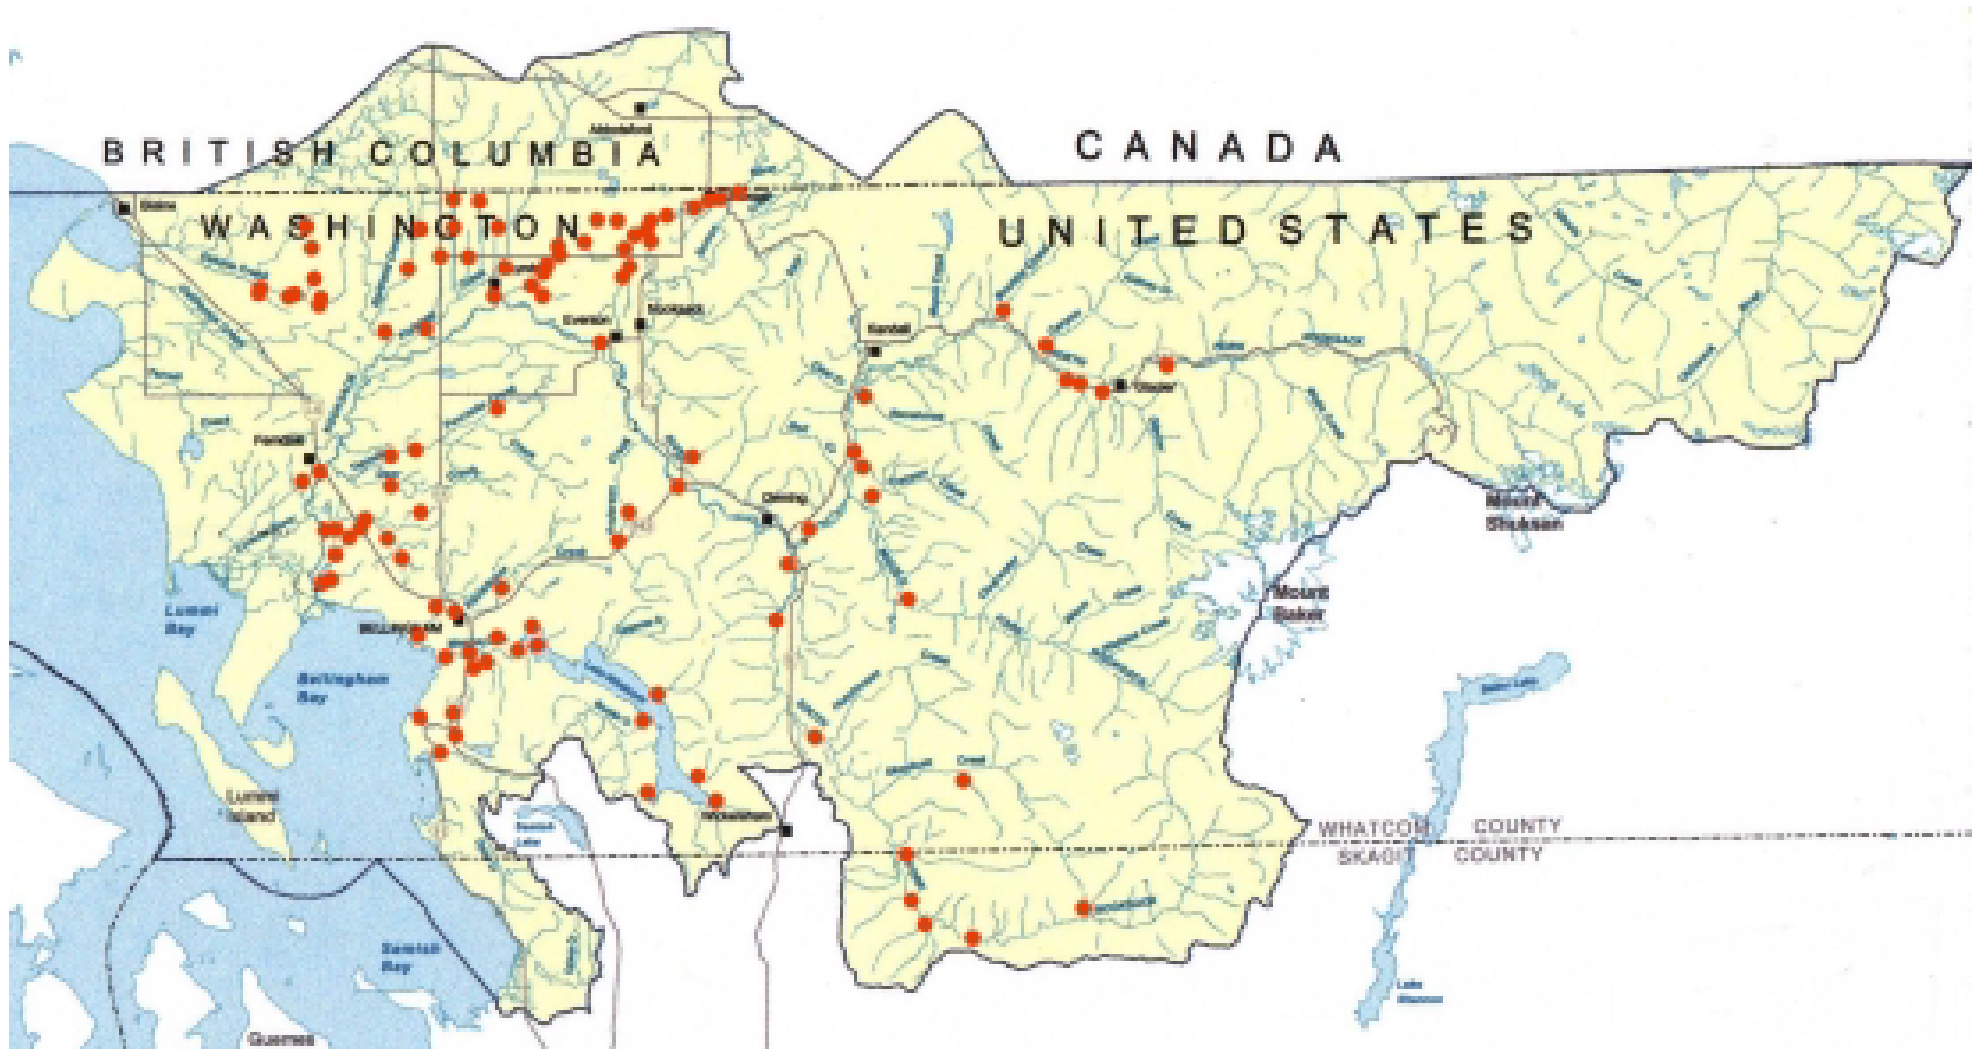
**Figure 33. Sites of known water quality impairments within WRIA 1 are marked with red circles. These impairments include those that directly impact salmonids, such as water temperature, dissolved oxygen, sediment, ammonia, and nitrate (data from various sources described in text).**

Water quality problems are abundant throughout WRIA 1 (Figure 33). At least 33 water bodies in the WRIA do not meet federal water quality standards (DOE 1995). In the forestlands, warm water temperatures are the greatest water quality concern caused by excess sedimentation and a loss of riparian vegetation (DOE 1995). With the new forest practice regulations, these conditions are expected to improve. However, restoration actions might be necessary to assure that riparian re-growth includes adequate conifer for future LWD recruitment. In the lowlands, water quality impacts are more varied and numerous. Problems with ammonia, phosphorous, dissolved oxygen, and fecal coliform levels are common, as well as violations in pH and water temperatures. Agriculture, failing septic systems, and urban storm water runoff are major causes (DOE 1995), particularly because Whatcom County has the highest concentration of dairy farms in Washington State (Dickes 1992). Industrial and commercial activities have increased heavy metals and toxins, especially in the estuarine environment (discussed in the Estuary/Nearshore Chapter). Some of these

Other water quality problems have also been documented in the Lake Whatcom streams (Figure 33). Some of the samples have shown high levels of phosphorous, nitrogen, and fecal coliform levels (Scott and McDowell 1994), and problems with turbidity and dissolved oxygen have also been noted (DOE 1995). Anderson Creek has had elevated turbidity and suspended solids levels in the summer due to inputs from the Middle Fork Nooksack River, and the other streams have higher turbidity in the winter due to storm water runoff (Matthews et al. 2001).

much of the stream length up to RM 8.0 (Figure 33). High levels of ammonia have also been detected in Johnson Creek (Erickson et al. 1995). Although turbidity decreased after implementation of Best Management Practices (BMP) for livestock management, nitrate, total phosphate, and fecal coliform increased after BMPs were implemented. This indicates that livestock waste is still entering Johnson Creek, and could be due to non-participating farms and/or improper techniques (Erickson et al. 1995). Waste load allocations have also been recommended for the Sumas wastewater treatment plant and for non-point ammonia, BOD, and fecal coliform (Erickson et al. 1995). Additional water quality monitoring is needed to determine if these recommendations are being implemented and are adequate.

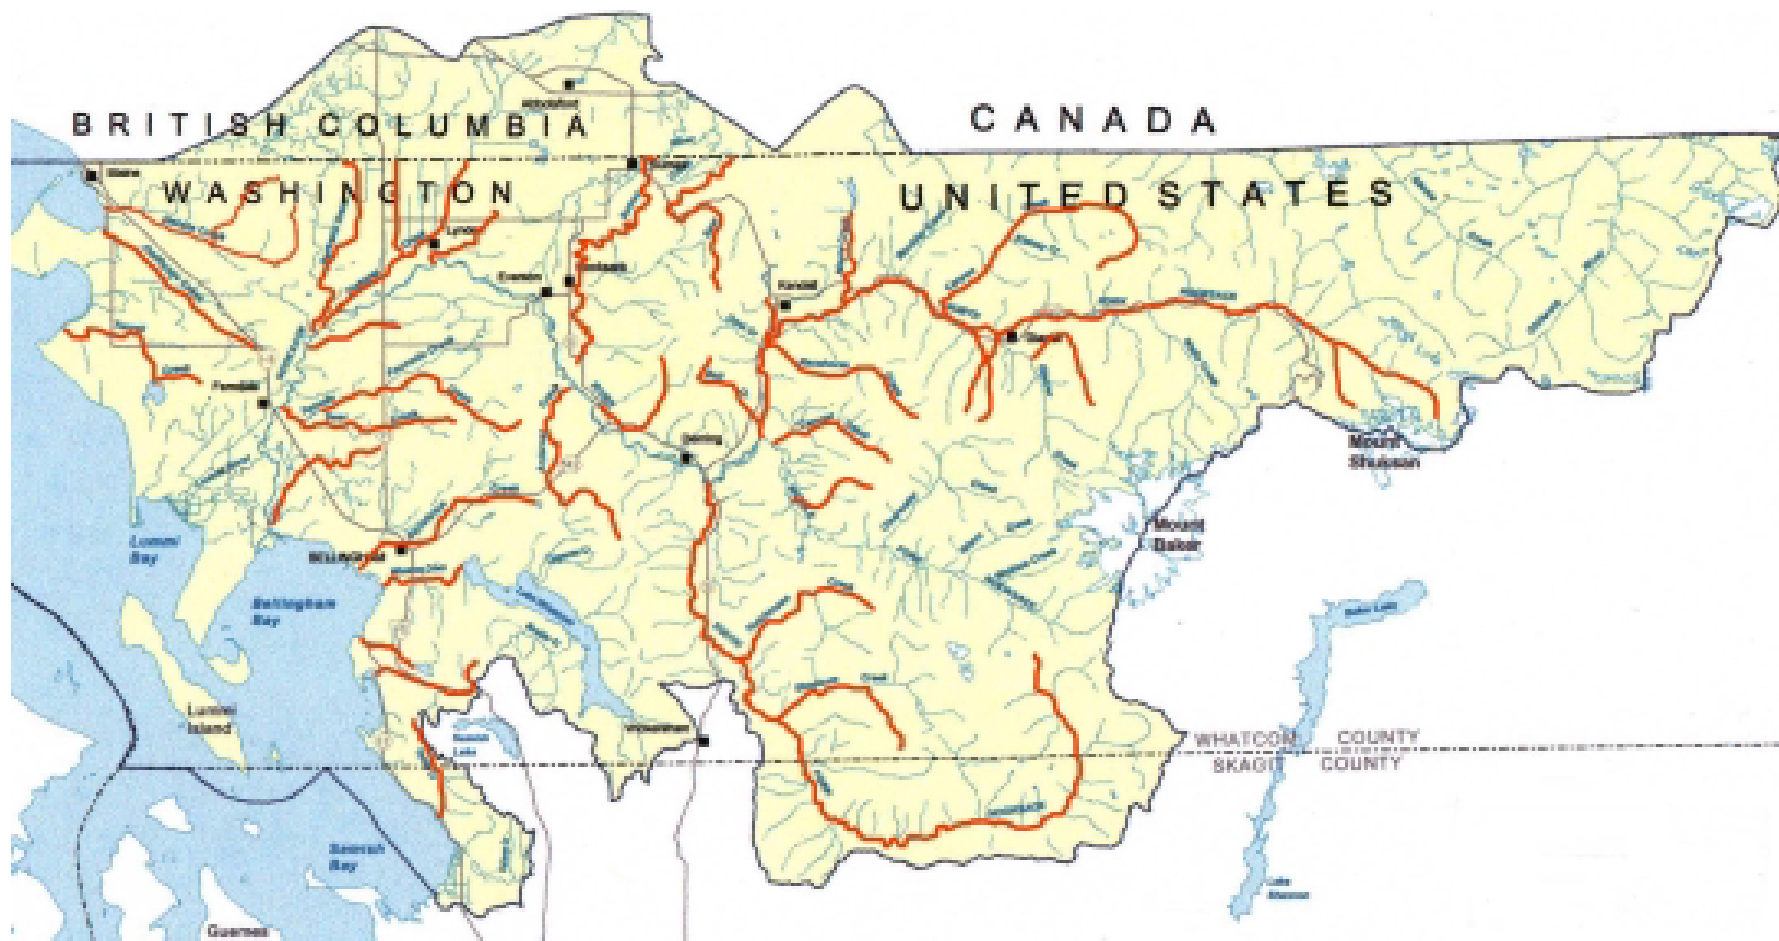
**Figure 35. Streams outlined in red denote waters that are closed to further water allocations (data from DOE 1995).**
