# Sedimentation In The Chattooga River Watershed

Department of Forest Resources  
Technical Paper No. 19  
February 1995

D. H. Van Lear, G. B. Taylor,  
and W. F. Hansen\*

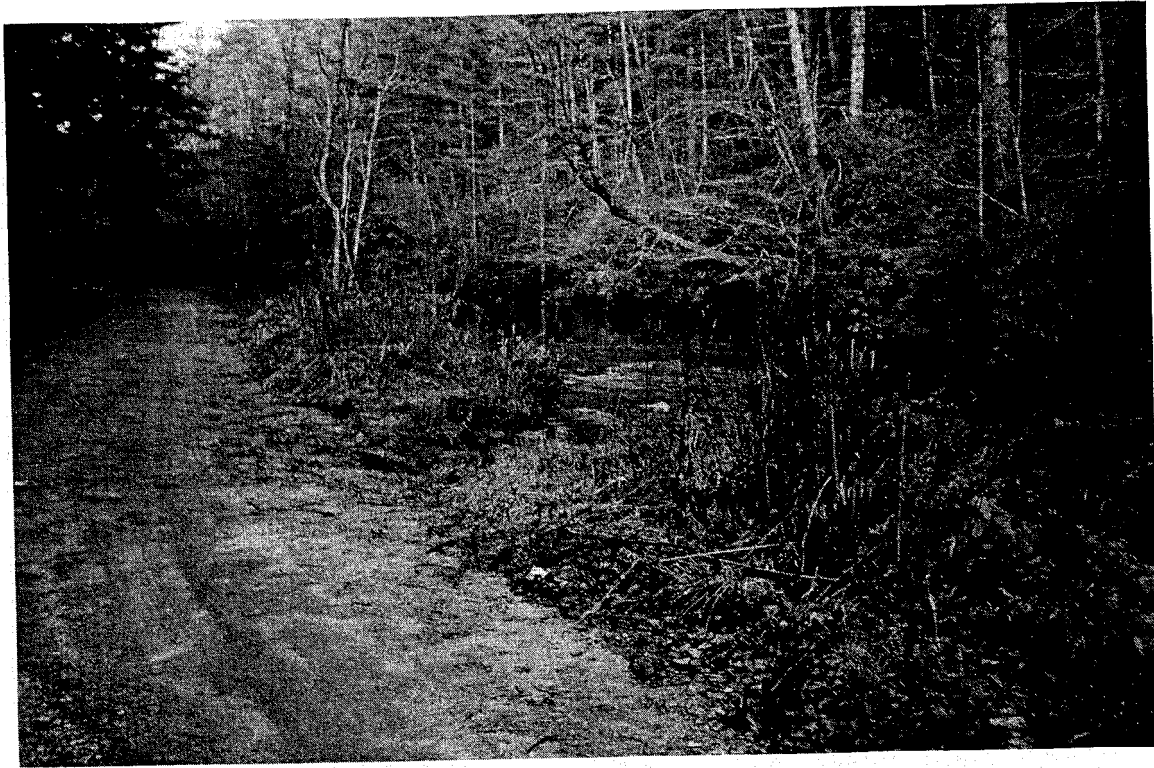
Figure 6. Location of unpaved road adjacent to Warwoman Creek—break in road berm allows sediment to enter directly into creek.

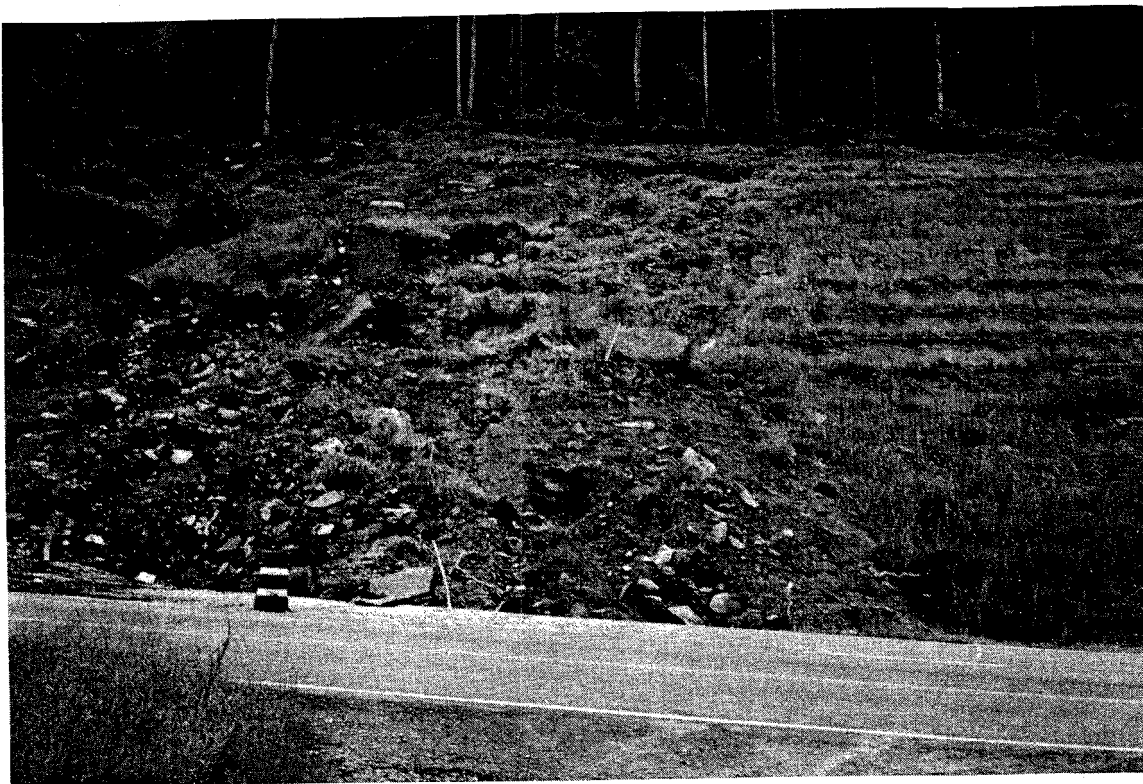
Figure 10. A slumping road cut during reconstruction of Highway 76 near Clayton, GA, impacting Chechero Creek, a tributary of Stekoa Creek.

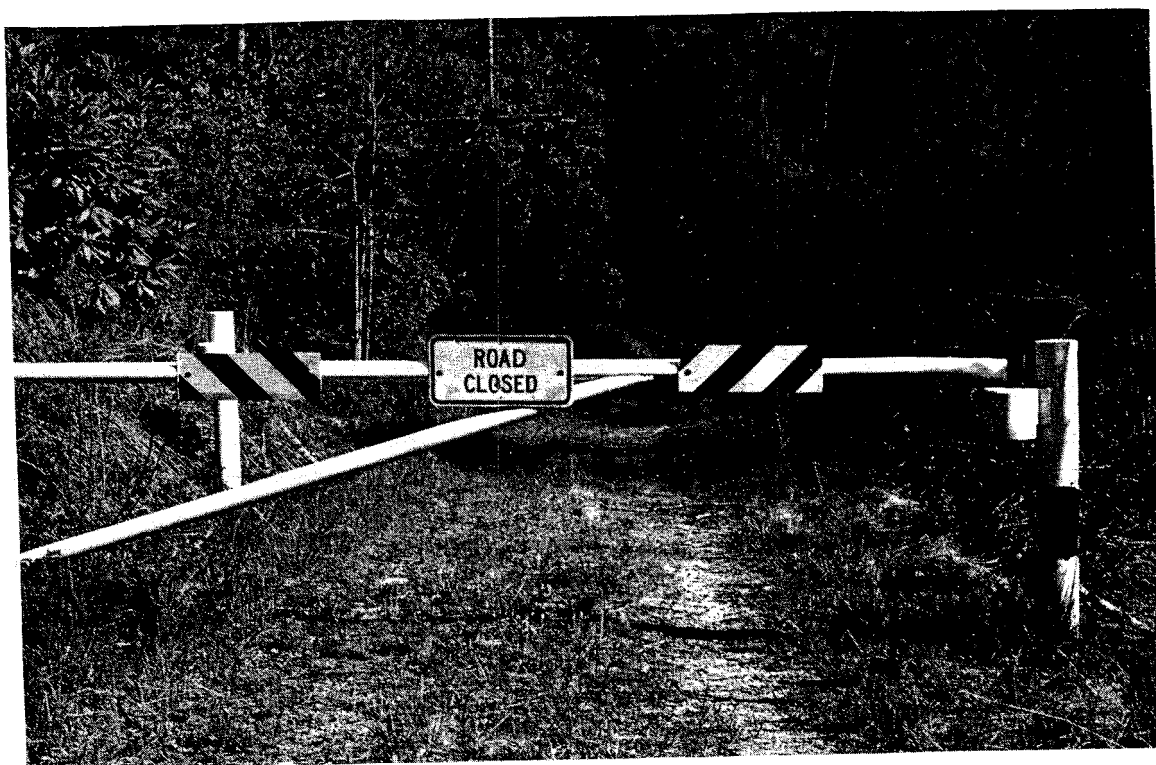
Figure 11. Restored roads that are gated to restrict vehicles provide wildlife habitat and contribute minimum sediment to streams.

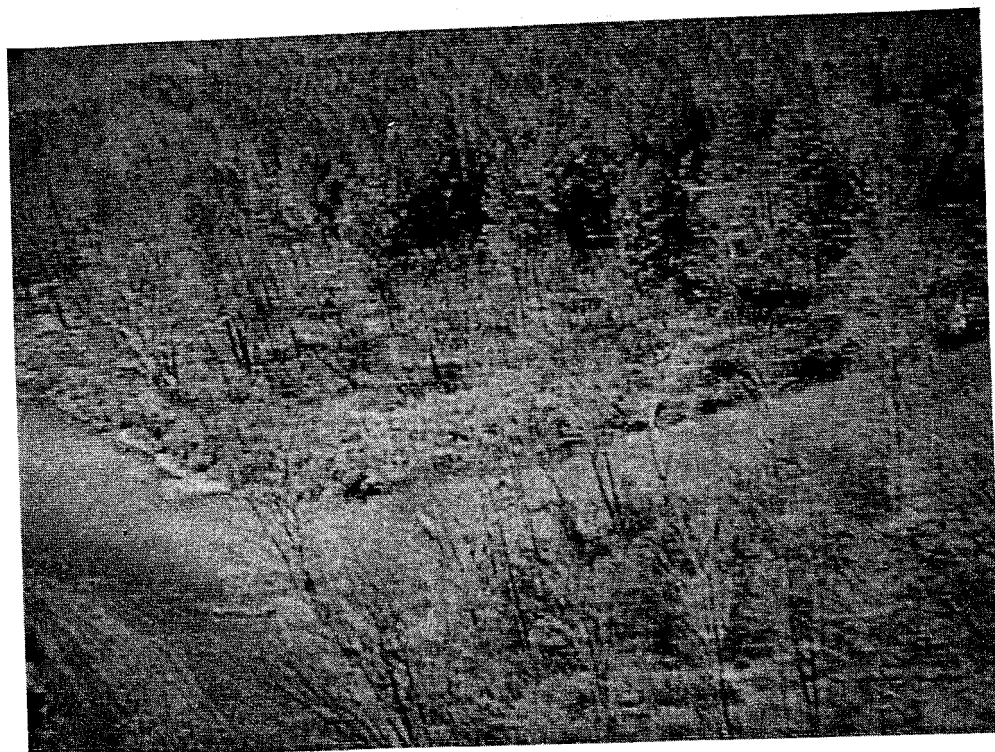
Figure 14. Fine bedload sediments entering the Chattooga River from the West Fork. Water in both main river and tributary was clear when aerial videotaping occurred.

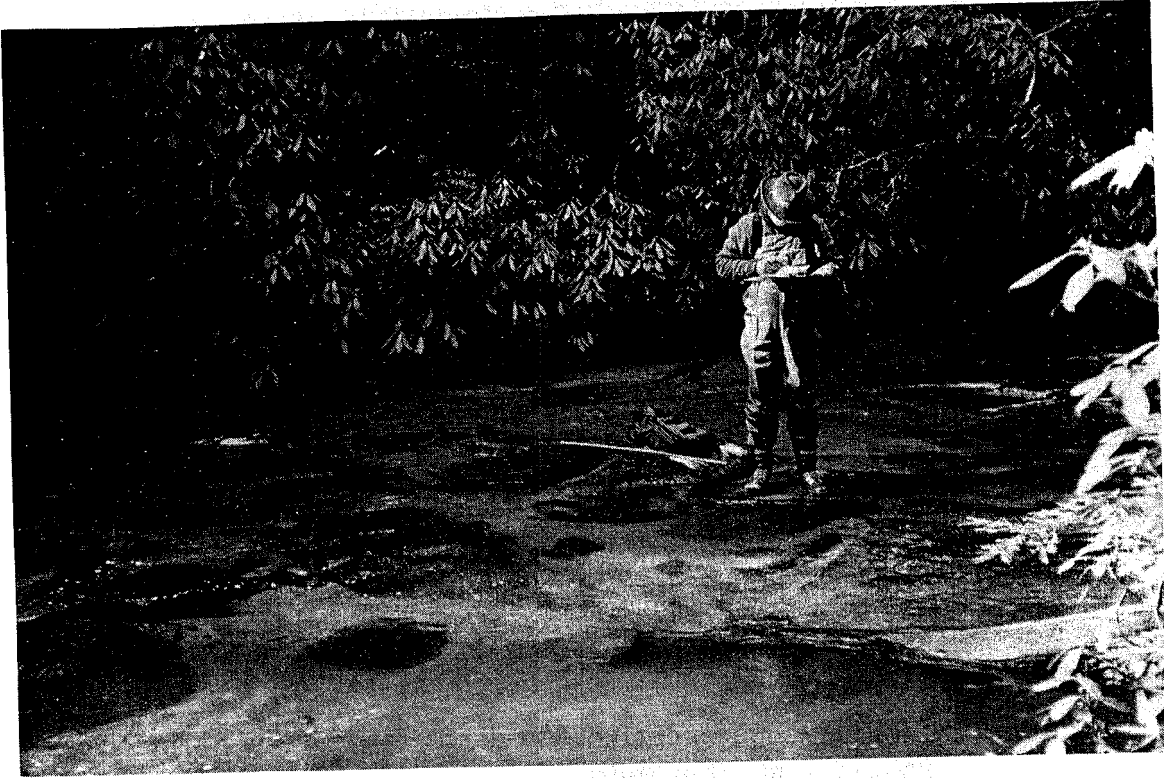
Figure 16. Excessive fine bedload sediments in Big Creek, a major tributary of the West Fork of the Chattooga River.
