## Notes

10:00 am Met at Glacier Ranger Station and carpooled up FS 3700 road.

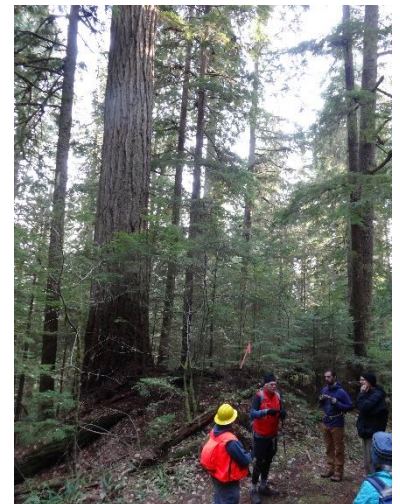
*Old Growth forest habitat in roadless area*

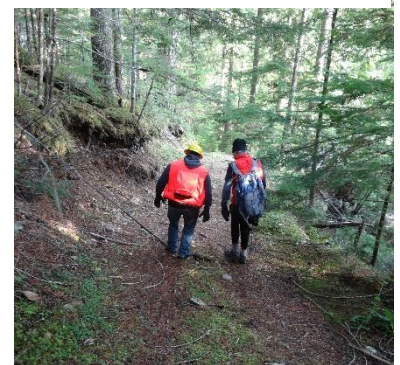
10:45 am Hiked the unclassified "Upper Road" which immediately enters the Mt Baker North Inventoried Roadless Area into an impressive old growth forest stand. The Upper Road (dirt, no gravel) runs about ½ a mile ending at the mine portal and is very steep, extremely narrow and poorly constructed. Within the first ¼ mile the road descends at a slope in excess of 25% straight down the hill. This raised serious questions as to the cost and aquatic impacts of constructing a road that would sustain vehicle traffic for up to 10 years. The Forest Service Geologist confirmed that the road had never been a Forest Service system road and pre-dates any recent agency road inventory in the last few decades. It is reasonable to assume that the current road network dates back to the 1970's when exploratory drilling was occurring on the site.

There was obvious evidence of recent clearing and maintenance of the unclassified road. The Forest Service geologists confirmed that the miner was caught improving the road in 2012 in order to gain jeep access to the site without any authorization. He was told to stop any additional activities. Flagging was evident at parts of the road which the Forest Service Geologist confirmed was from Forest Service engineering and fisheries specialists marking water bar locations and other potential construction features.

*Steep poorly engineered unclassified Upper Road*

We discussed what minimum engineering and aquatic standards would be applied to the road if it was allowed to be reconstructed further as part of the pending EA. It seemed clear that it would not be required to meet the Forest Service standards of an ML1 or ML2 road but would be held to some lower not well articulated standard. This raised serious concerns about impacts to the watershed due to the steep slope, insufficient engineering of the road and location of spotted owl and murrelet habitat as well as proximity to Wells Creek down slope.

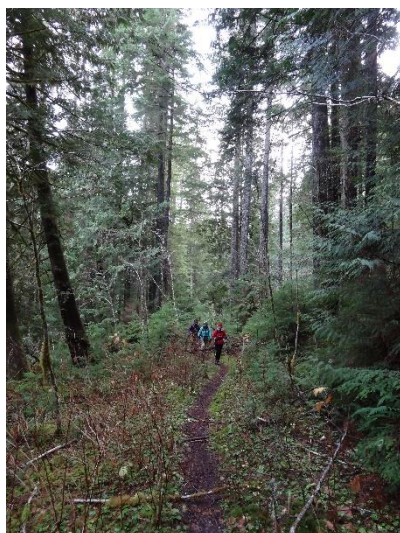
We left the mine portal via FS Road 3700-031. The section closest to the mine portal is akin to a trail, having been decommissioned in the early 1990's. At the site of where the Forest Service removed a log stringer bridge the road is not recognizable for a 500-foot stretch. The last ¼ mile of the road is passable by passenger vehicle.

*FS RD 3700-031 closest to the mine portal resembles a trail*

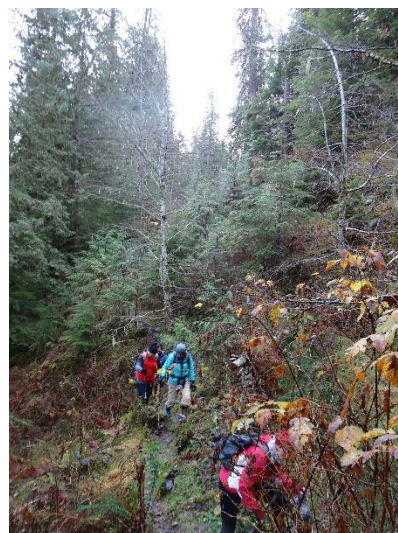
*FS RD 3700-031 at washout site (500 ft)*

We discussed the concern that the agency dismissed an alternative that would have analyzed repairing the FS RD 3700-031 and restoring the original access to the mine portal on a Forest Service system road completely outside of the inventoried roadless area. It was also revealed that the miner in question is not looking to do any drilling or significant work that would necessitate vehicle access. Instead he intends to identify and hand pick individual rocks to be sold and processed off site. As a result, a much more limited road reconstruction could be possible across the 500-foot wash out area.
