Impacts of the Carbondale to Crested Butte Trail on health of the Crystal River

Mark Beardsley¹, EcoMetrics November 8, 2017

Purpose and Approach

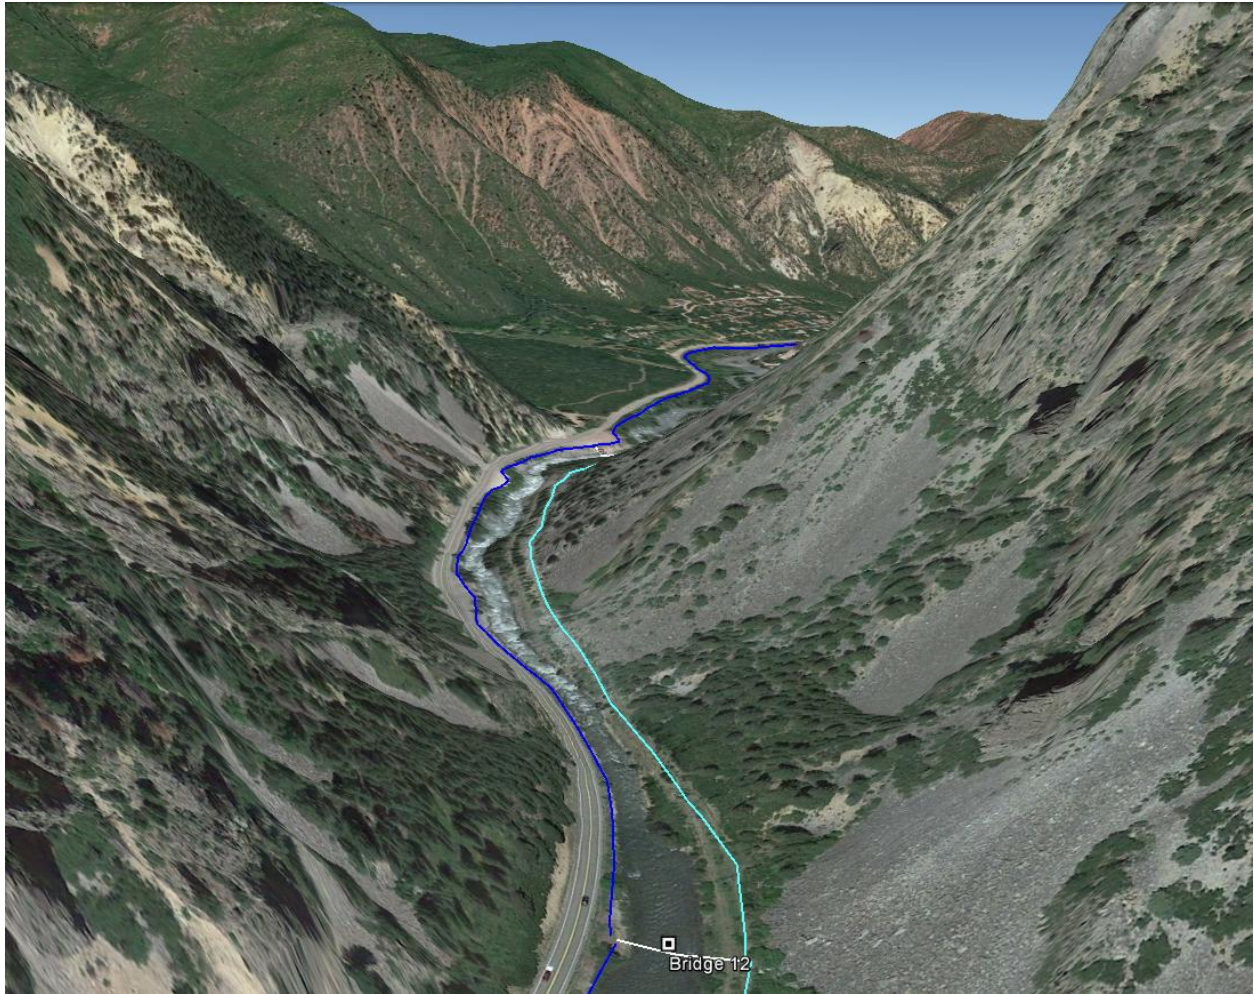
Figure 1 A typical reach through a very confined valley on the Narrows section. Encroachment and armored banks from Highway 133 (left) and the abandoned railroad (right) extend the length of this reach. Bridge option 2 is in the foreground.

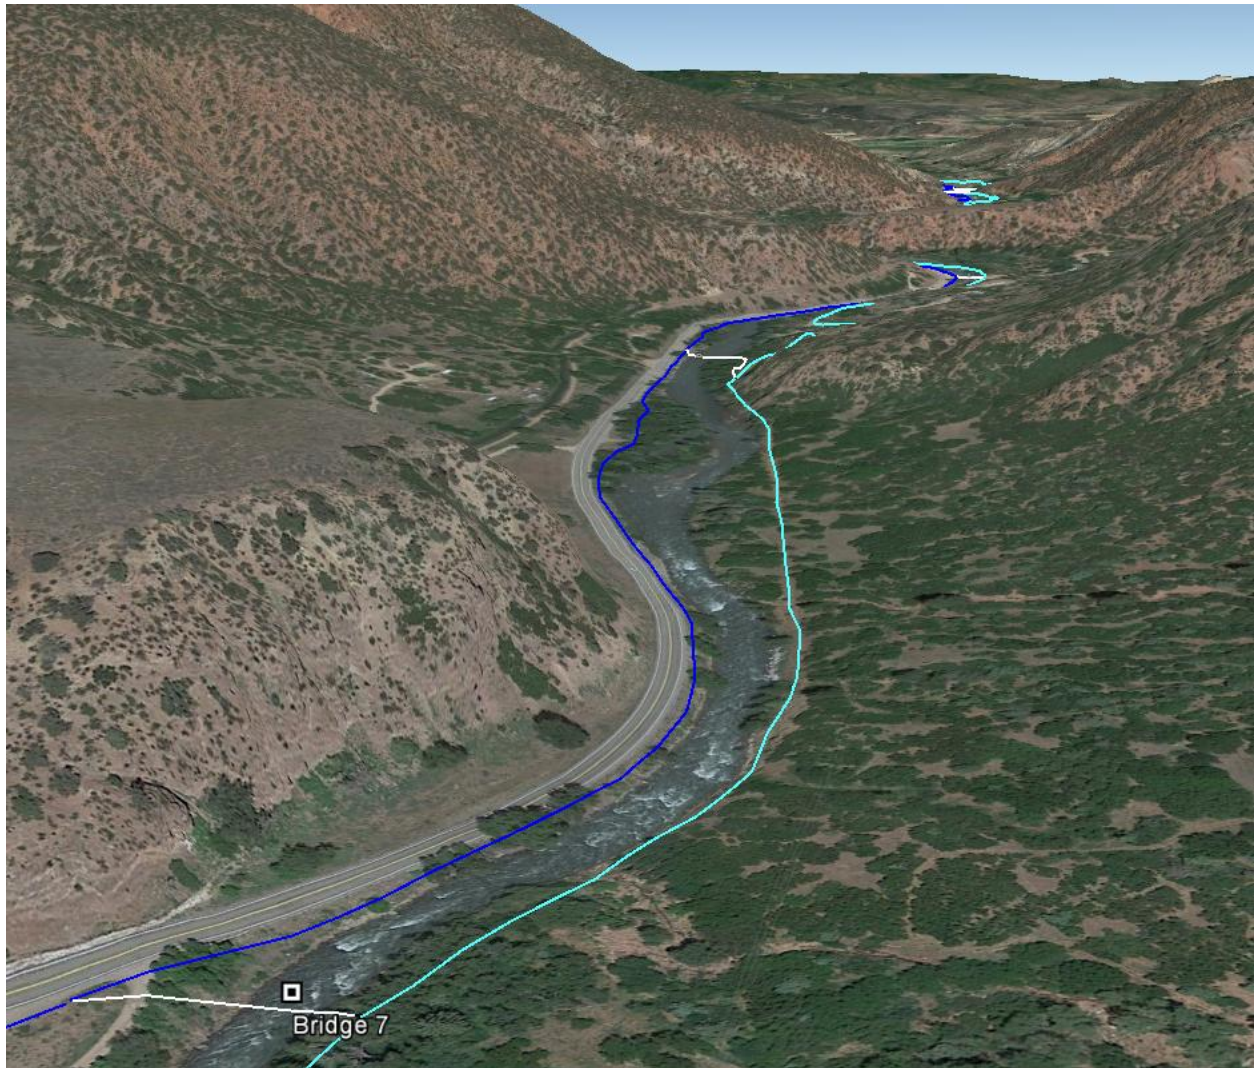
Figure 2 Typical confined reach on the Andrews section. The photo shows encroachment on the left where Highway 133 is constructed on armored fill on the valley bottom in the riparian zone and the abandoned railroad line on the right. Trail Alignment A follows the highway and B follows the railroad line. Bridge option 7 is in the foreground, and bridge option 6 is farther downstream.

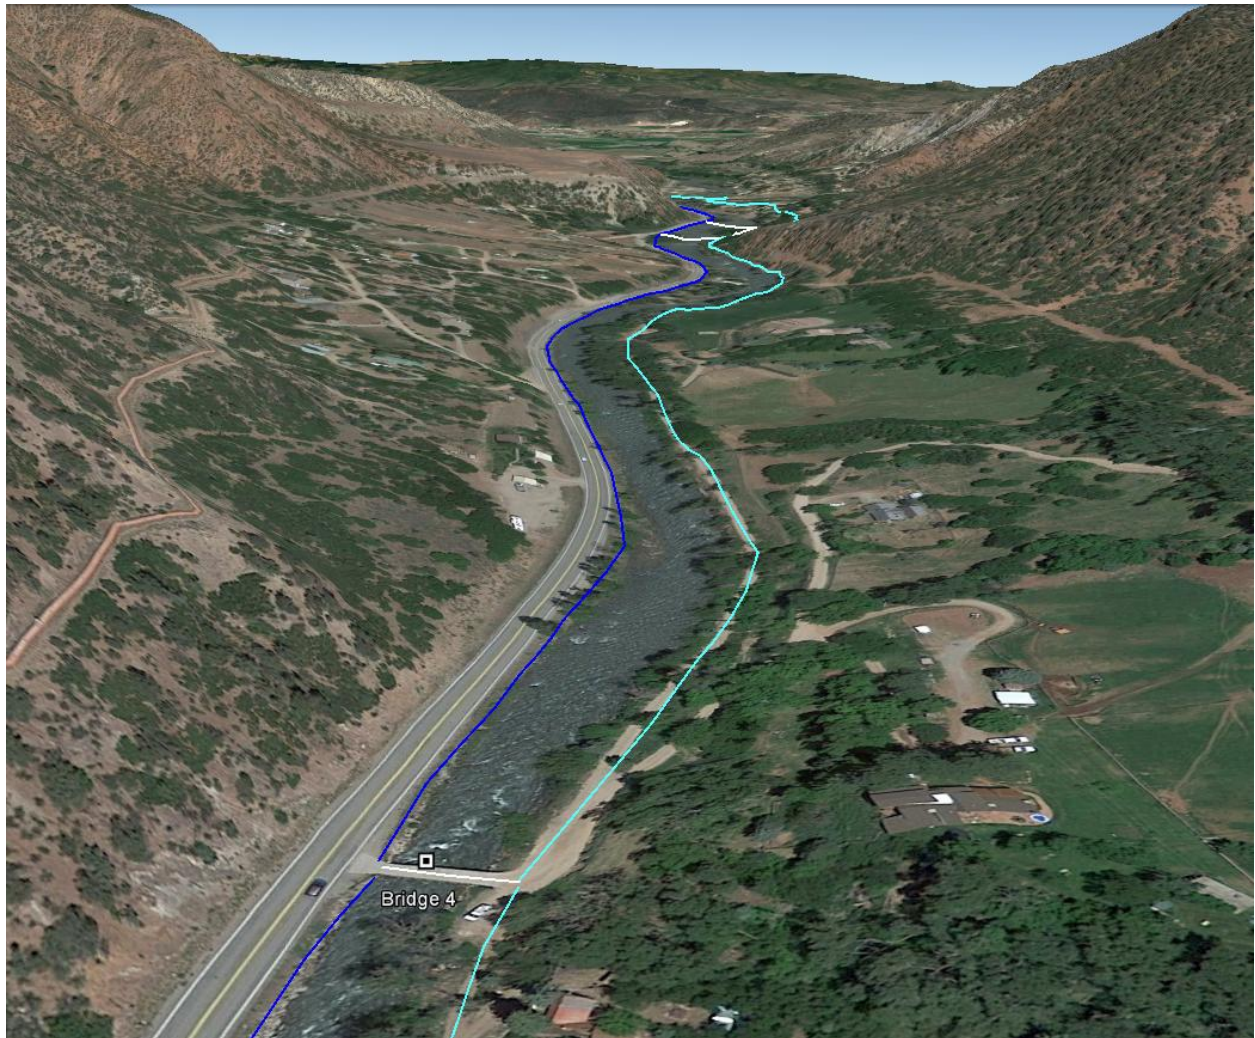
Figure 3 Another typical confined reach on the Nettle Creek section. Highway 133 is again on the left, and here the old railroad line on the right has been repurposed as a road. Bridge option 4 in the foreground is an existing bridge between the Crystal River Country Estates section (upstream) and the Nettle Creek section.

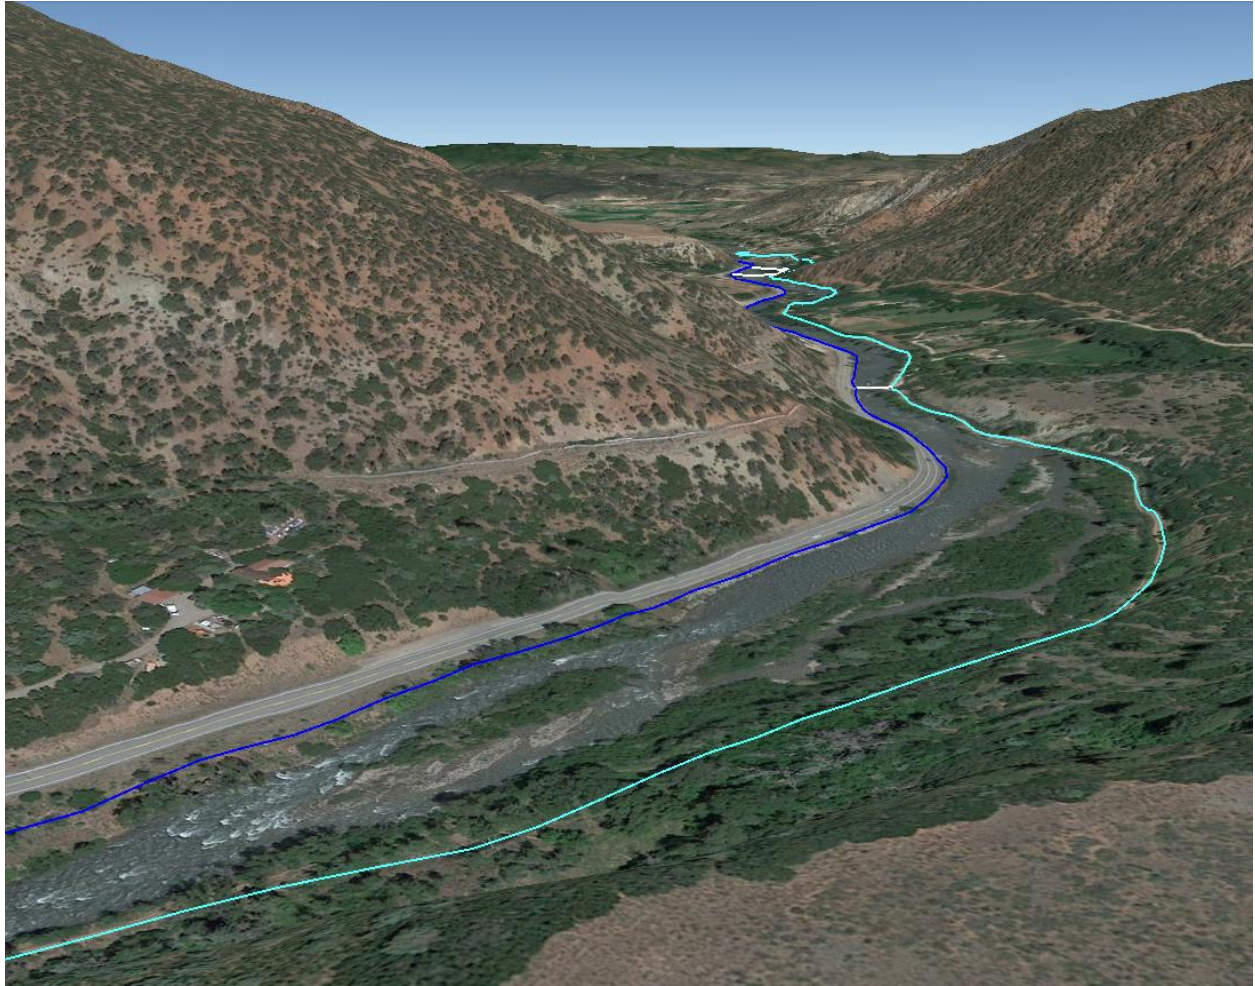
Figure 5 The Red Wind Point section is another example of the transitional confined valley and river type. Alignment B follows the abandoned railroad grade which runs up the right riparian area, effectively isolating a portion of the floodplain and riparian area from the river. If the railroad line is not repurposed, it could potentially be remediated for river and riparian restoration.

For most of its length through the Redstone segment of the Carbondale to Crested Butte Trail (from 7 Oaks to McClure Pass) the Crystal River runs through a narrow valley that is geologically confined. This geological setting supports a naturally entrenched plane-bed river form with rapids, cascades, and step-pools. River morphology, stability, and physical structure are conferred by highly resistant bed and bank material. The confined river is a threshold channel that rarely moves or erodes except during extreme events. Some reaches, such as the appropriately named Narrows section (Figure 1), are so narrowly confined that there is no natural floodplain, and riparian vegetation is limited to thin strips along the banks. Very confined reaches have flood-prone area width less than about 1.5 times the bankfull width of the river. Moderately confined reaches, however, have natural floodplain "benches" that support bands of riparian habitat on valley bottoms between the canyon walls that are between 1.5 and 2.2 times the river's bankfull width. The Andrews (Figure 2) and Nettle Creek sections (Figure 3) are examples of typical confined river reaches on this segment of the Crystal. Reaches where flood-prone area approaches 3 times bankfull river width are still considered confined, but they have marginally wider floodplains and riparian areas, and the river tends to be braided. Portions of the Castle, Janeway North, Avalanche (Figure 4), and Red Wind Point sections (Figure 5) meet this transitional classification.

Every one of the confined reaches on this segment of the Crystal River has been encroached upon, to some degree, by Highway 133. The highway is constructed on top of armored (rip-rap or concrete) fill placed within the already-narrow valley bottom (Figure 5). Given that the river types in these sections are naturally resistant threshold channels adapted to confined valleys, the effects of encroachment and armoring on river geomorphology and riparian condition are not as great as they would be on unconfined rivers which need wide floodplains and riparian zones to maintain form, function, stability, and ecological function. On the partially confined reaches of the McClure Pass, Filoha, and Janeway South sections, Highway 133 encroachment is less since the road is cut into upland rather than as fill in the valley bottom (Figure 6). In addition to its geomorphic impacts, the highway is a migration and dispersal barrier that inhibits terrestrial habitat connectivity and limits buffer capacity on both confined and partially confined reaches. In addition to being migration barriers, paved roads and paths are impermeable surfaces that do not allow infiltration, so runoff during storms or snowmelt happens much faster. Water running off of pavement can be much warmer than normal and concentrated with chemical contaminants, increasing the risk of water quality impairment. While there are some small

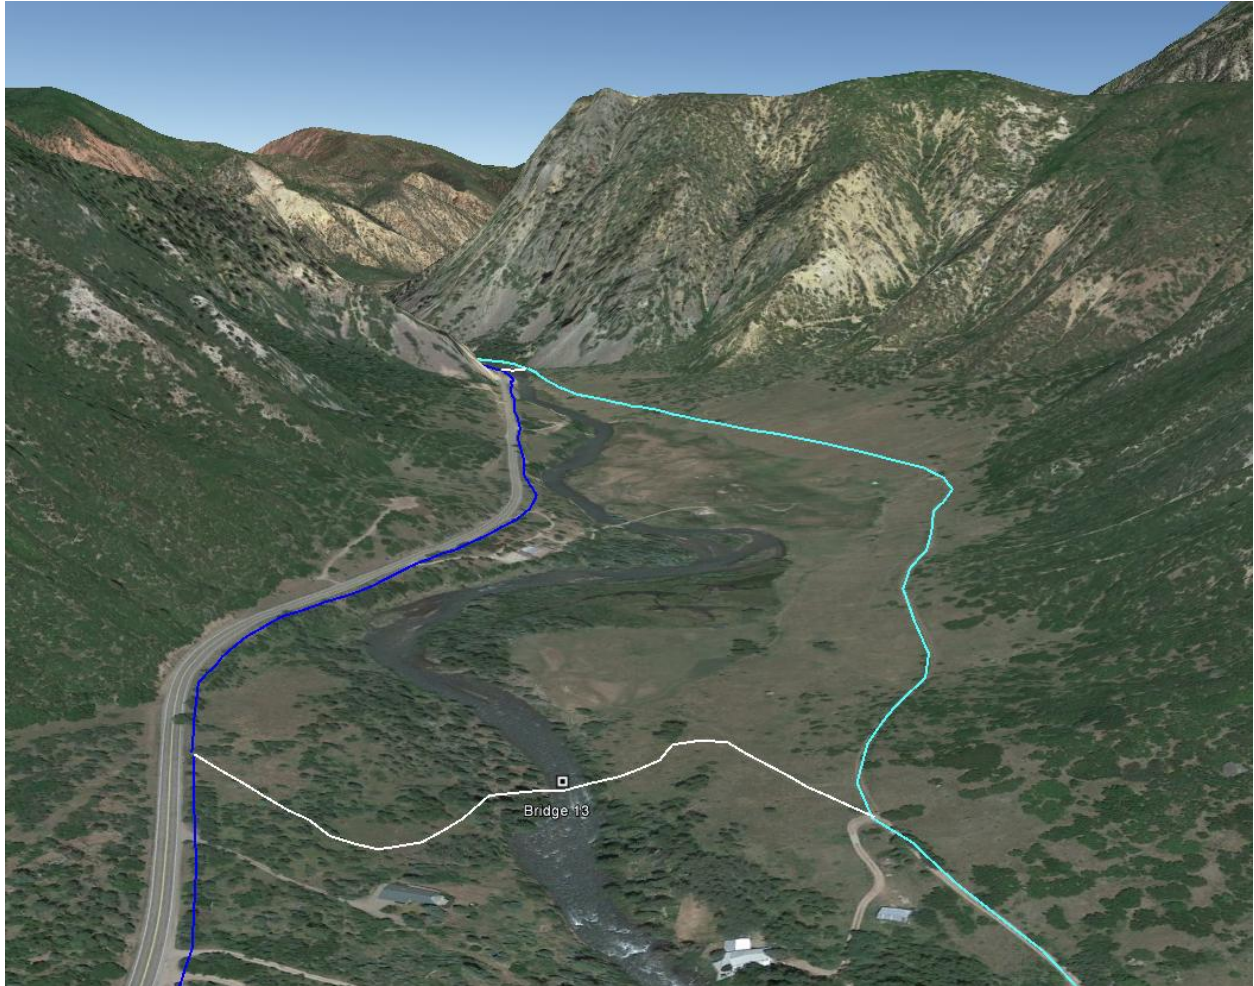
Figure 6 An example of the partially confined valley type on the Filoha section. Most of the east (right) riparian area has been cleared for land use, though patches of native vegetation and wetland remain intact. The highway and east-side railroad line along this reach are on upland hillsides, above the valley bottom. Neither of the trail alignments on this section have much impact on the river, but the proposed bridge option 13 and its 0.3-mile spur trail would be highly impactful.

The McClure Pass section and portions of Filoha (Figure 6) and Janeway South (Figure 7) are classified as partially confined. The valley floor is wider on these reaches, and flood-prone area is between about 3 and 7 times the river's bankfull width. These reaches are lower-gradient sections of the canyon that have filled with alluvial sediment over geologic history to create relatively flat, wider floodplains that support a very different river type that is naturally unentrenched, sinuous, branching and braided. These alluvial rivers regularly migrate across broader floodplains and vegetated riparian wetland areas, adjusting to changes in sediment and water flows in dynamic equilibrium. As a result, they are much more sensitive to disturbance than confined reaches.

Development is the other important stressor on this segment of the Crystal. The river was channelized and riparian areas east of the channel were cleared for agricultural use on both the Filoha (Figures 6, 10, and 11) and Janeway sections (Figures 7 and 12), causing impairment to habitat connectivity, floodplain function, riparian condition, river morphology, stability, and structure. Residential development affects most of the river sections, but the effects are minimally impactful except where high-density development occurs along the river on the Hawk Creek (Figure 9), Castle, Wild Rose (Figure 13), Crystal River Country Estates (Figure 14), Nettle Creek, and 7 Oaks sections, and where it occurs within the riparian zone on the Filoha, Avalanche (Figure 15), Janeway North, and Perham sections. In addition to floodplain encroachment and riparian degradation, riverside development impairs terrestrial habitat connectivity and buffer capacity.

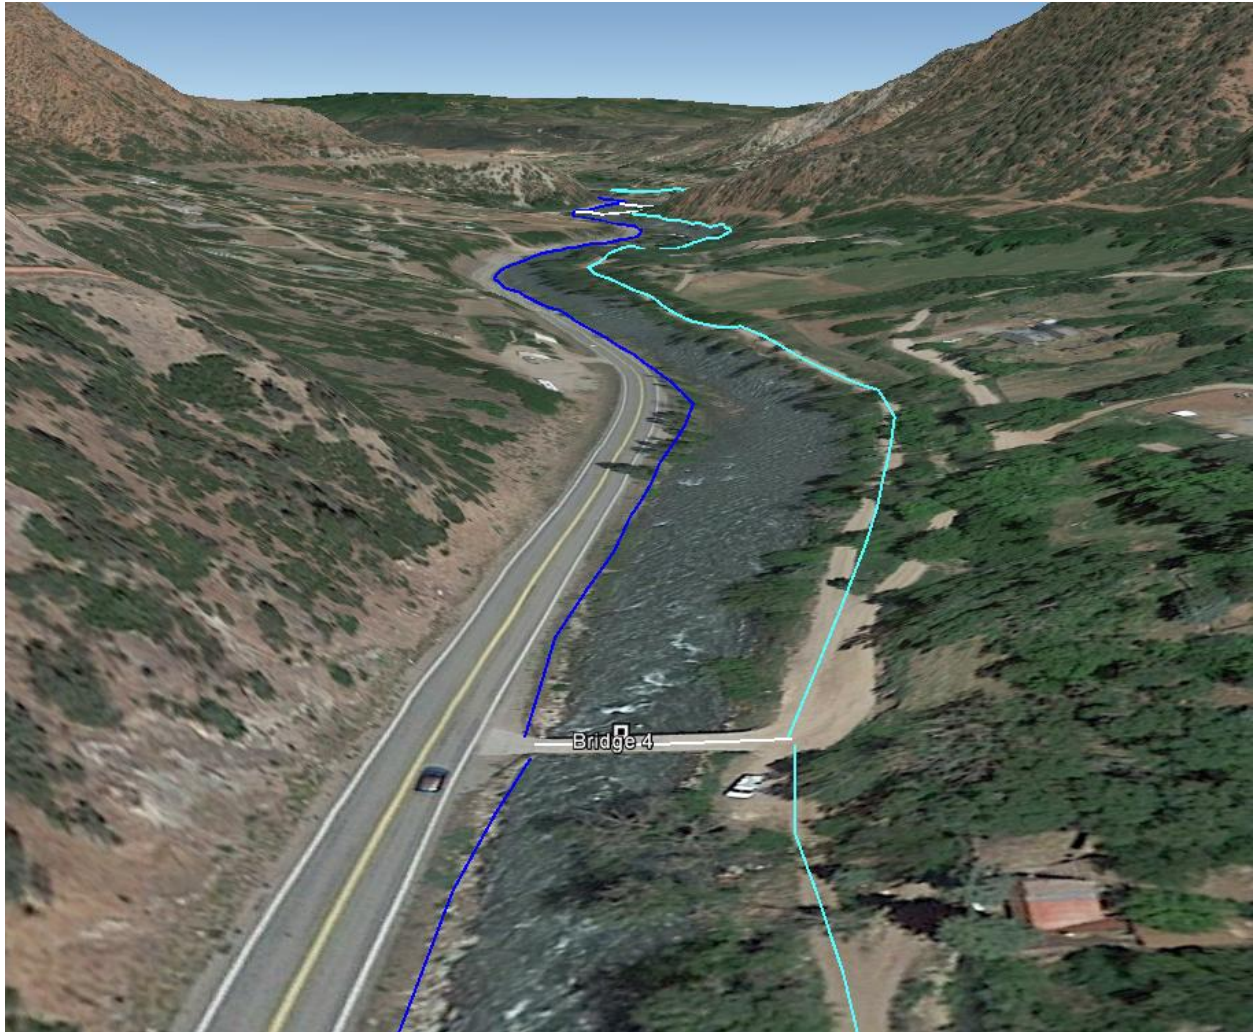
Figure 8 Existing bridge on a confined reach between the Red Wind Point and Nettle Creek sections. Alignment B uses follows the abandoned rail line, portions of which have been repurposed as roads, through the Nettle Creek segment.

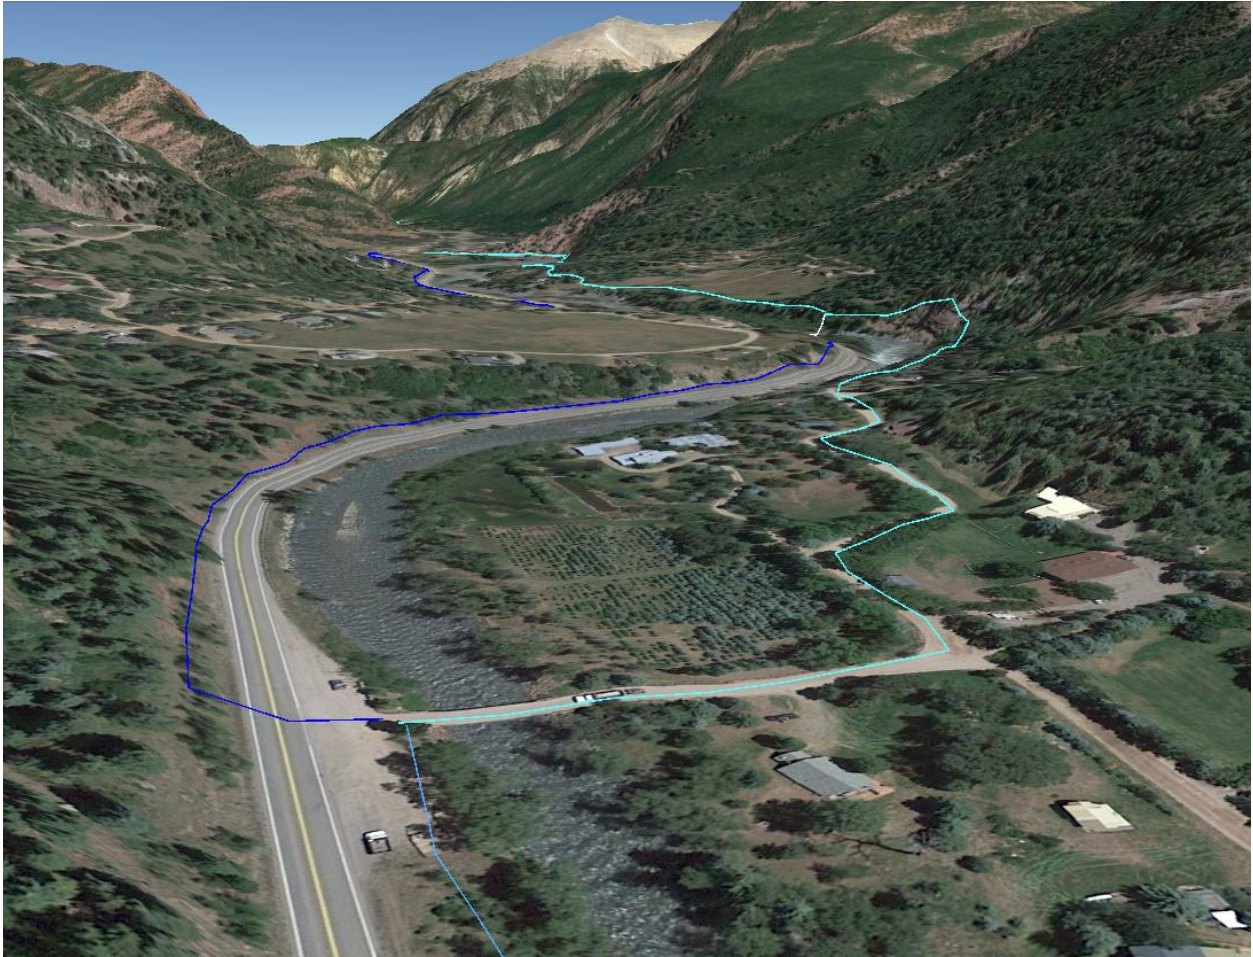
Figure 9 Existing bridge on an intermediate confined/partially confined reach between the Hays Falls and Hawk Creek sections. High-density residential development and development on historical riparian area are also significant stressors on the Hawk Creek section.

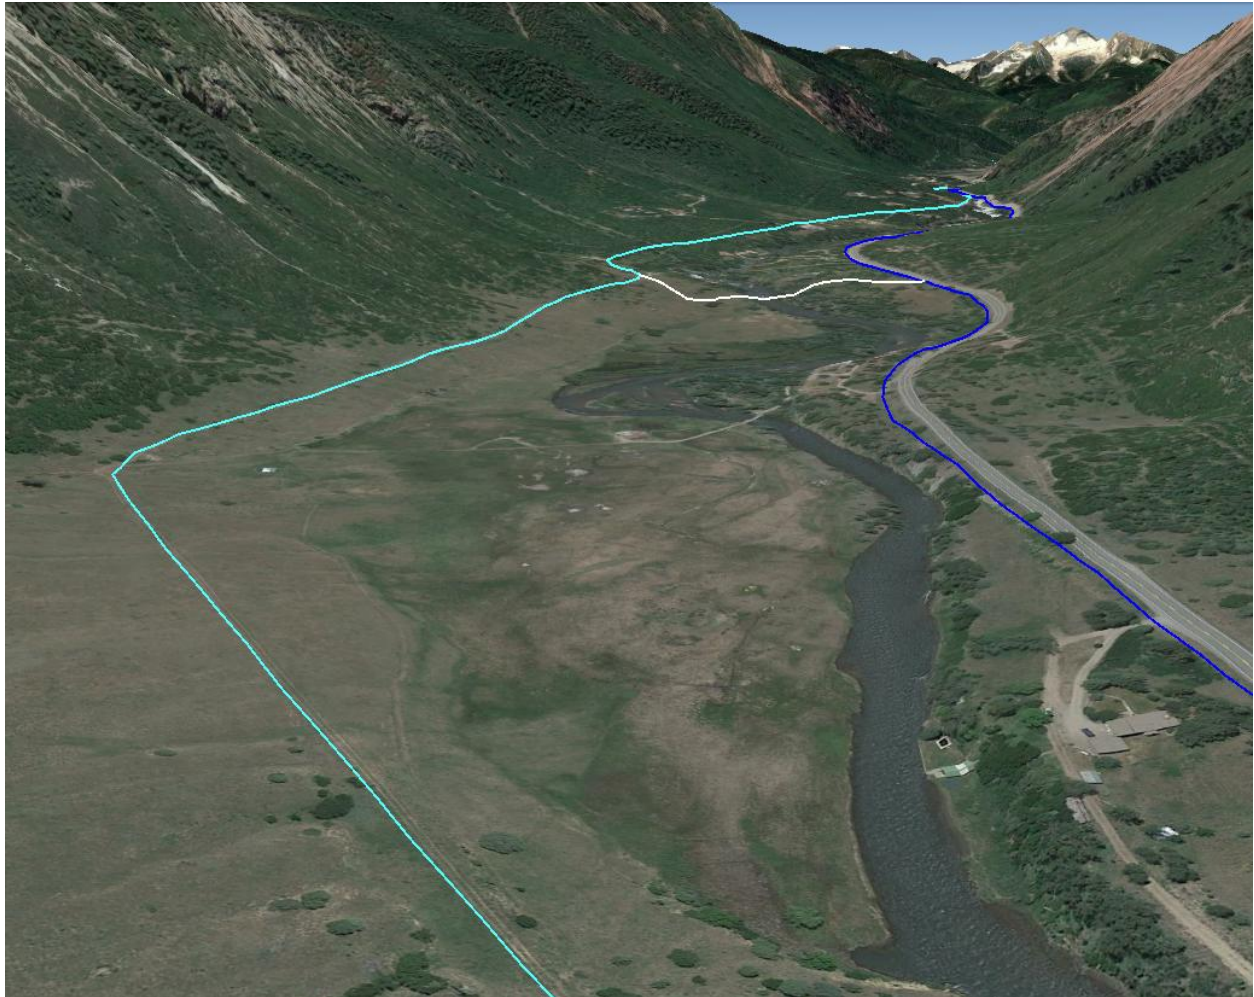
Figure 11 Looking upstream at the Filoha section where the river in the foreground is channelized and riparian vegetation on the east side (left in photo) has been cleared for agricultural use. Alignment B follows the old rail line on the upland hillslope above valley bottom.

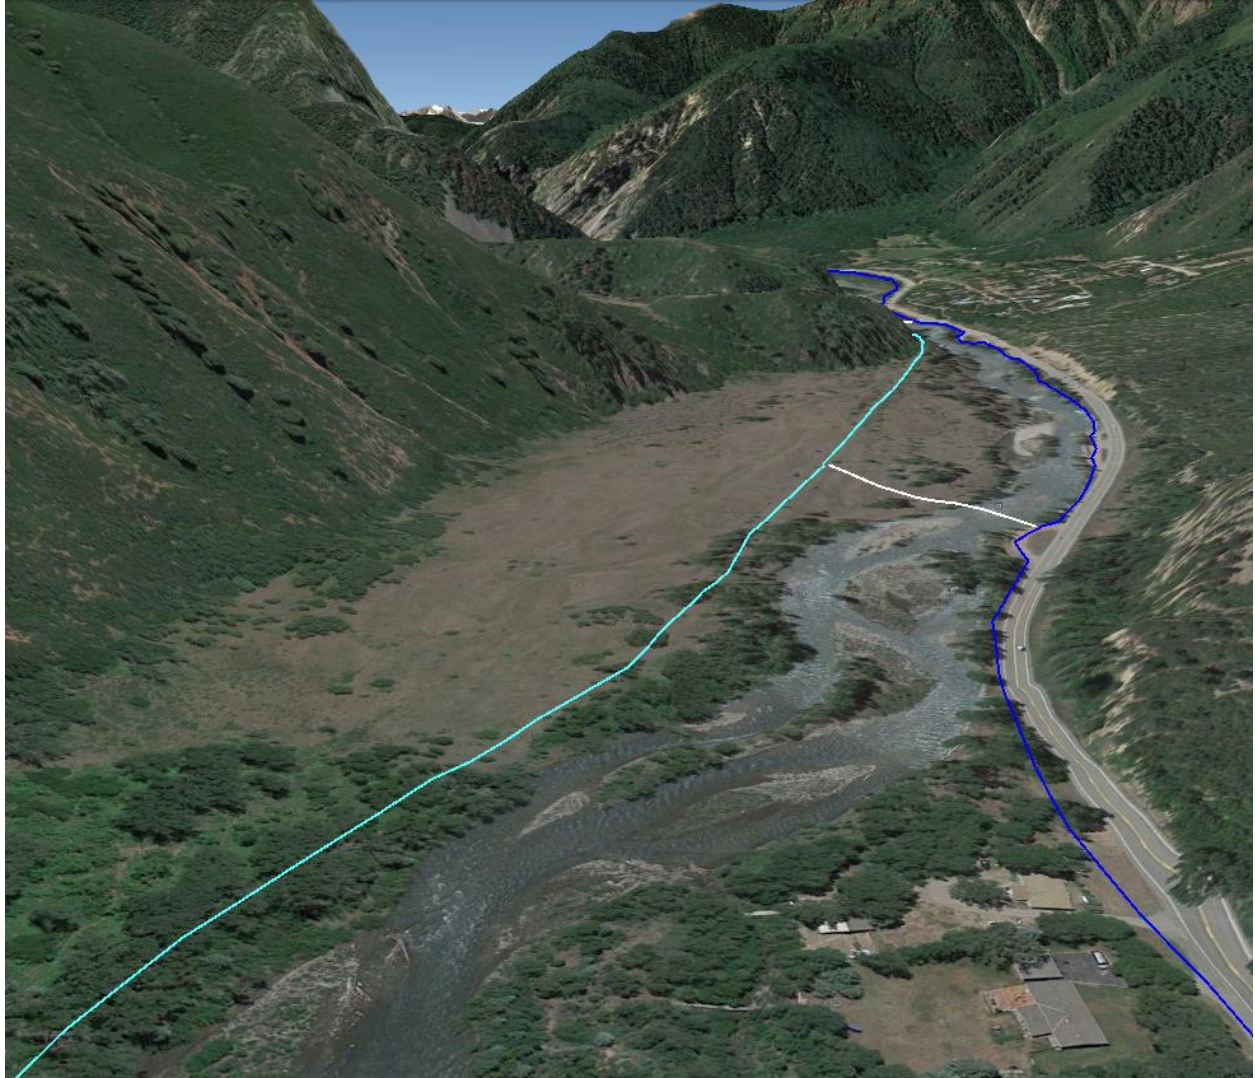
Figure 12 On the Janeway South section, riparian vegetation was cleared from the east side riparian area (left in photo) which is also disconnected from the river by the abandoned railroad line that runs through the center of the valley bottom. Routing the trail along this line in Alignment B would probably eliminate river and riparian restoration potential on this impaired reach.

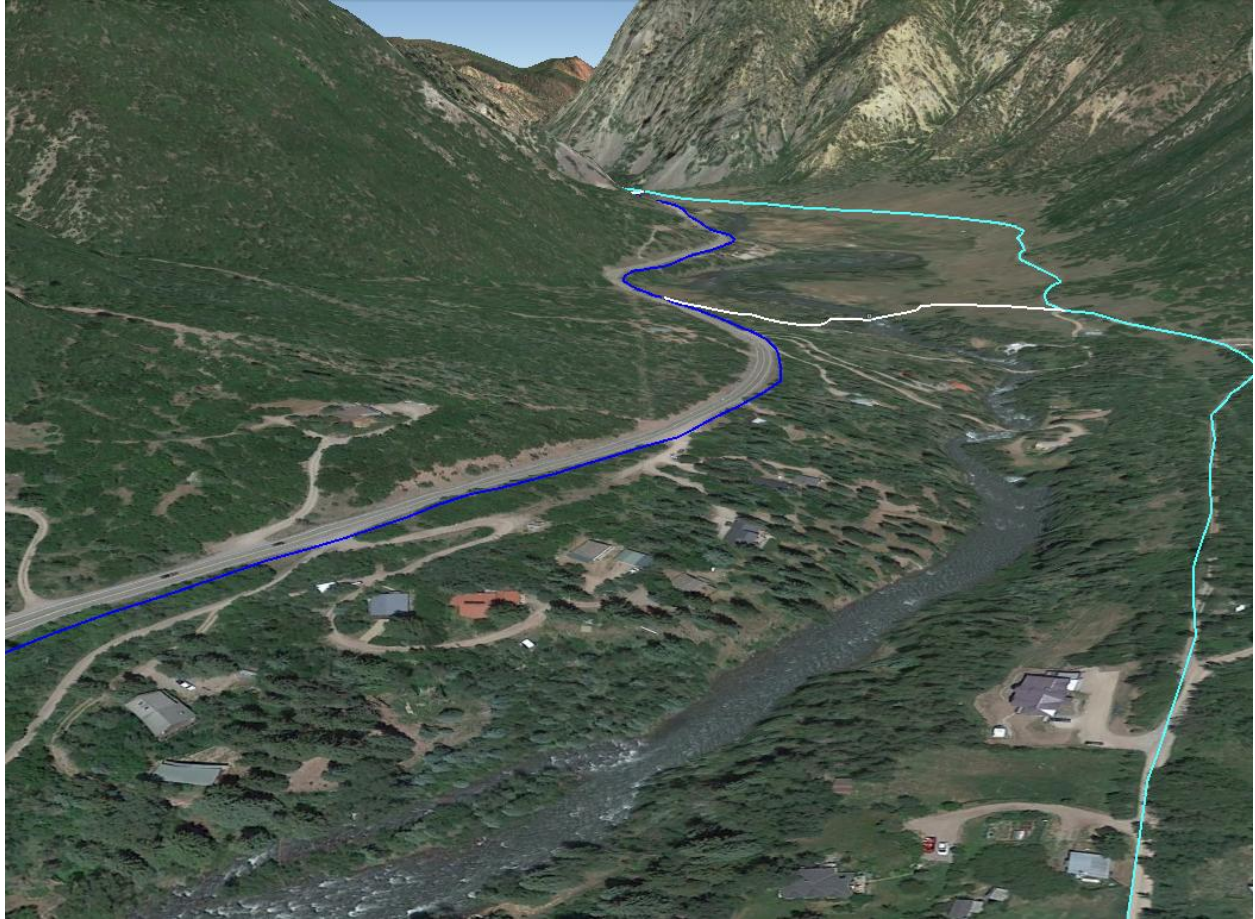
Figure 13 High density residential development on the Wild Rose section. Alignment A and B are both on upland hillslopes above the valley bottom through this section.

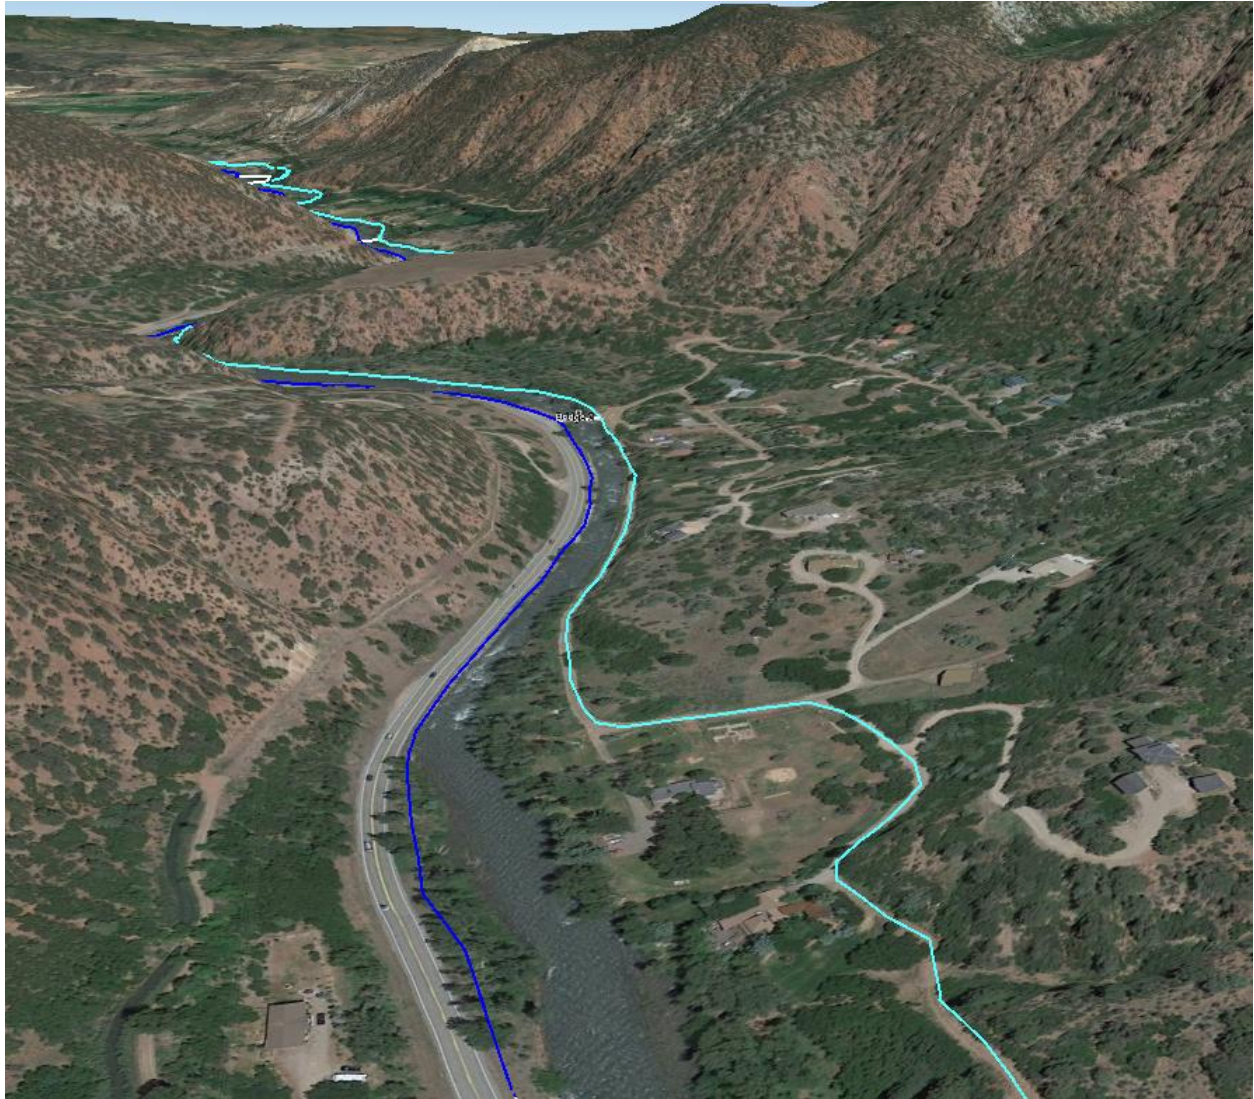
Figure 14 High density residential development on the Crystal River Country Estates section. Alignment B follows existing roads through the developed areas on this section.

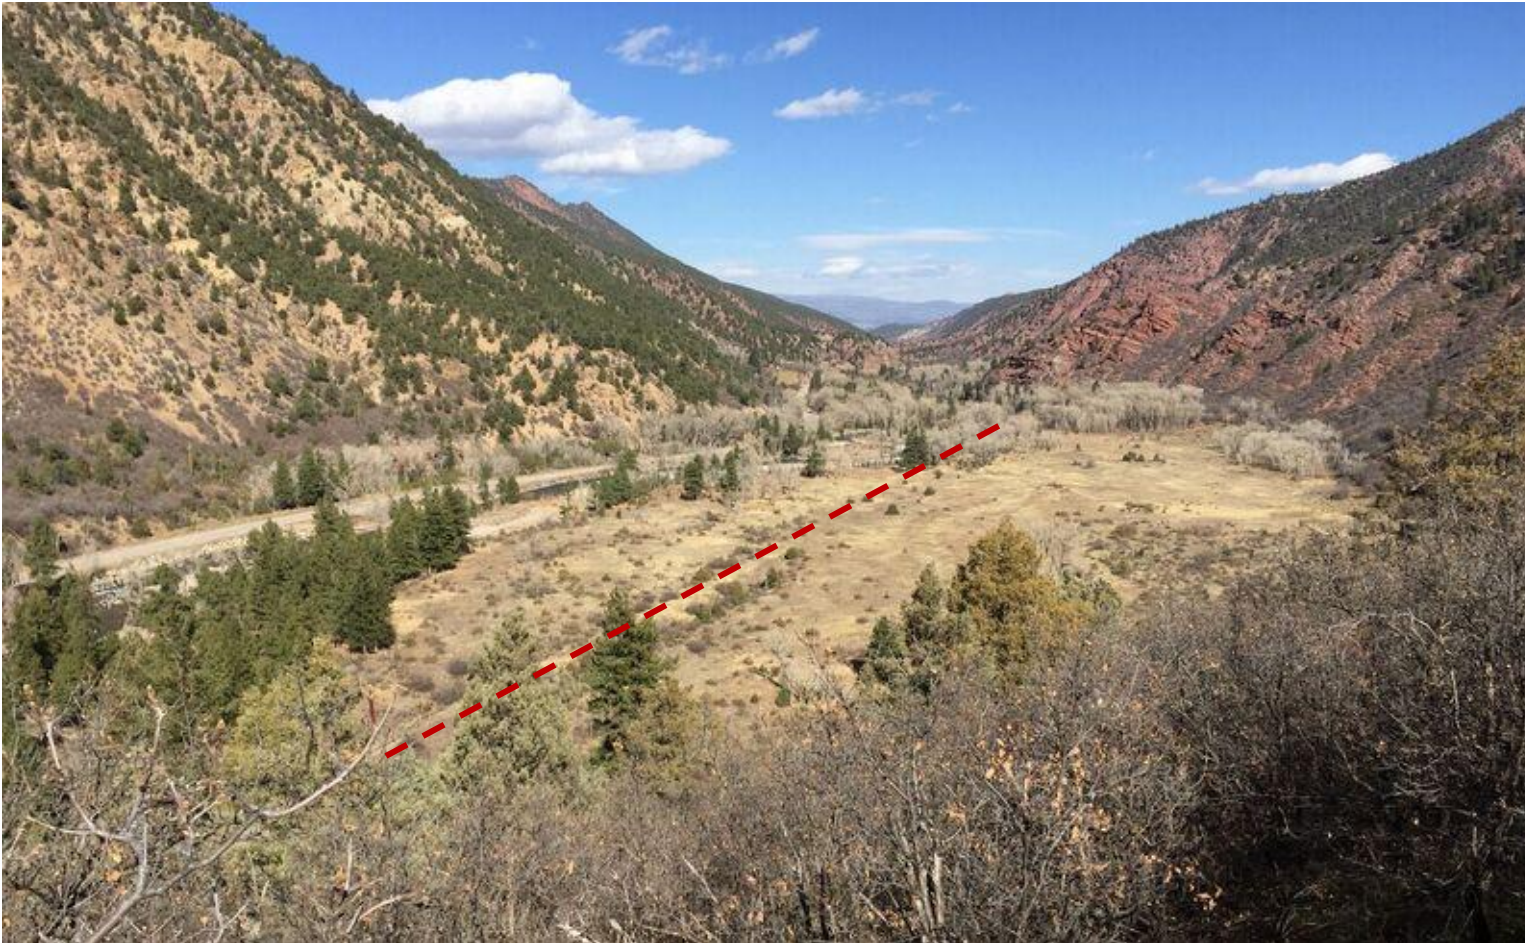
Figure 20 For Alignment B on the Janeway North section, a 10-foot-wide paved path would be constructed on the abandoned rail line that runs through the middle of the wide riparian area east of the river.

Alignment B also follows the abandoned rail line on the Janeway and Red Wind Point sections, but constructing a trail on these sections would involve significantly greater impact to floodplain function and riparian condition (Figures 20-. On these sections, the old rail line runs through the middle of floodplain benches and riparian zones, rather than along the edge, effectively cutting off large areas from the river. The cutoff riparian areas are marginally functional and could be restored to improve both the river and wetland. Terrestrial habitat connectivity is currently excellent on the right side of the river through these sections, but this condition would be significantly decline if the trail was routed along Alignment B since it would introduce a new migration barrier where none currently exists.

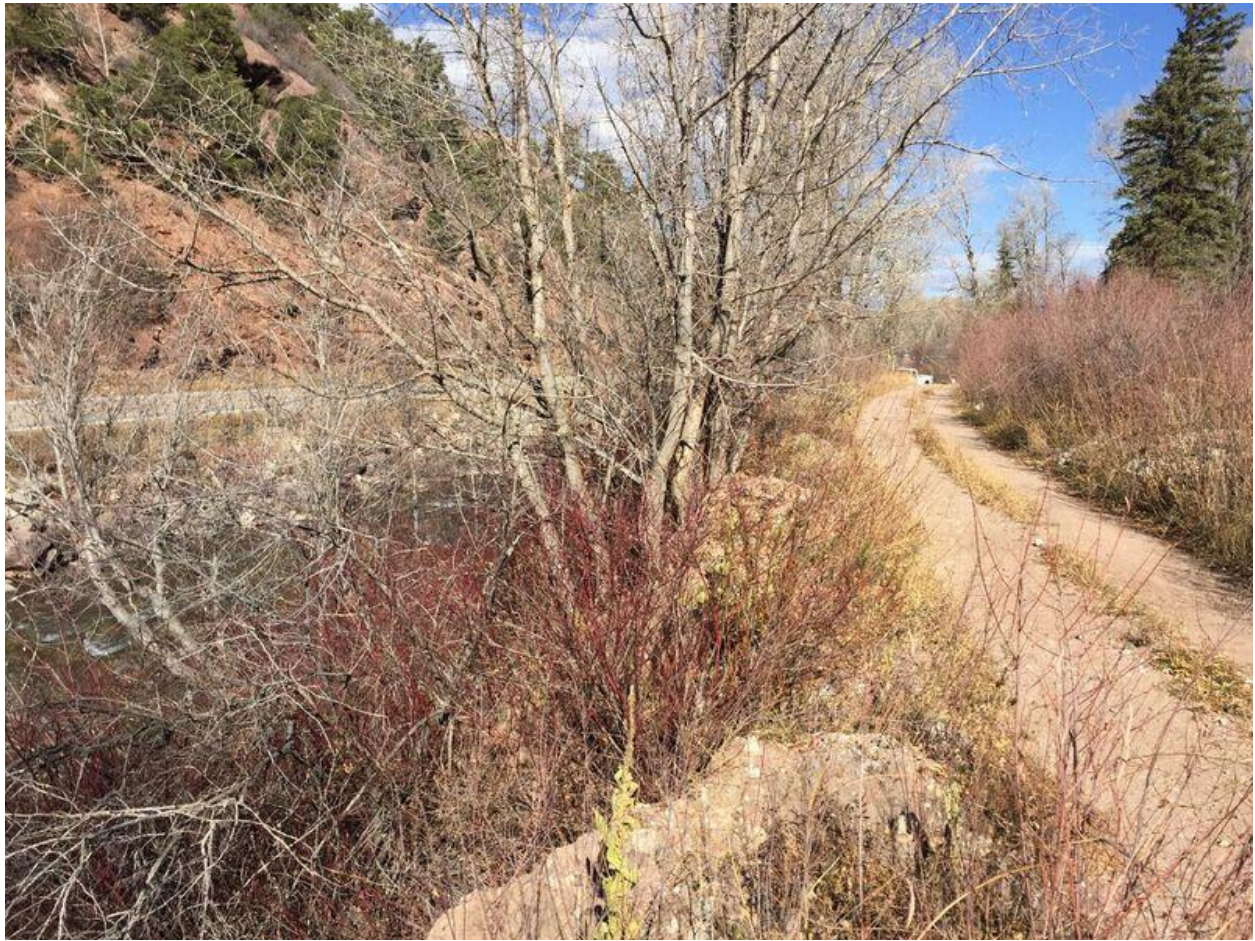
Figure 22 The rail line east of the river on the Red Wind Point section is now used as an un-surfaced access road that isolates the floodplain and riparian area (right) from the river (left). For Alignment B, a paved path would be constructed.

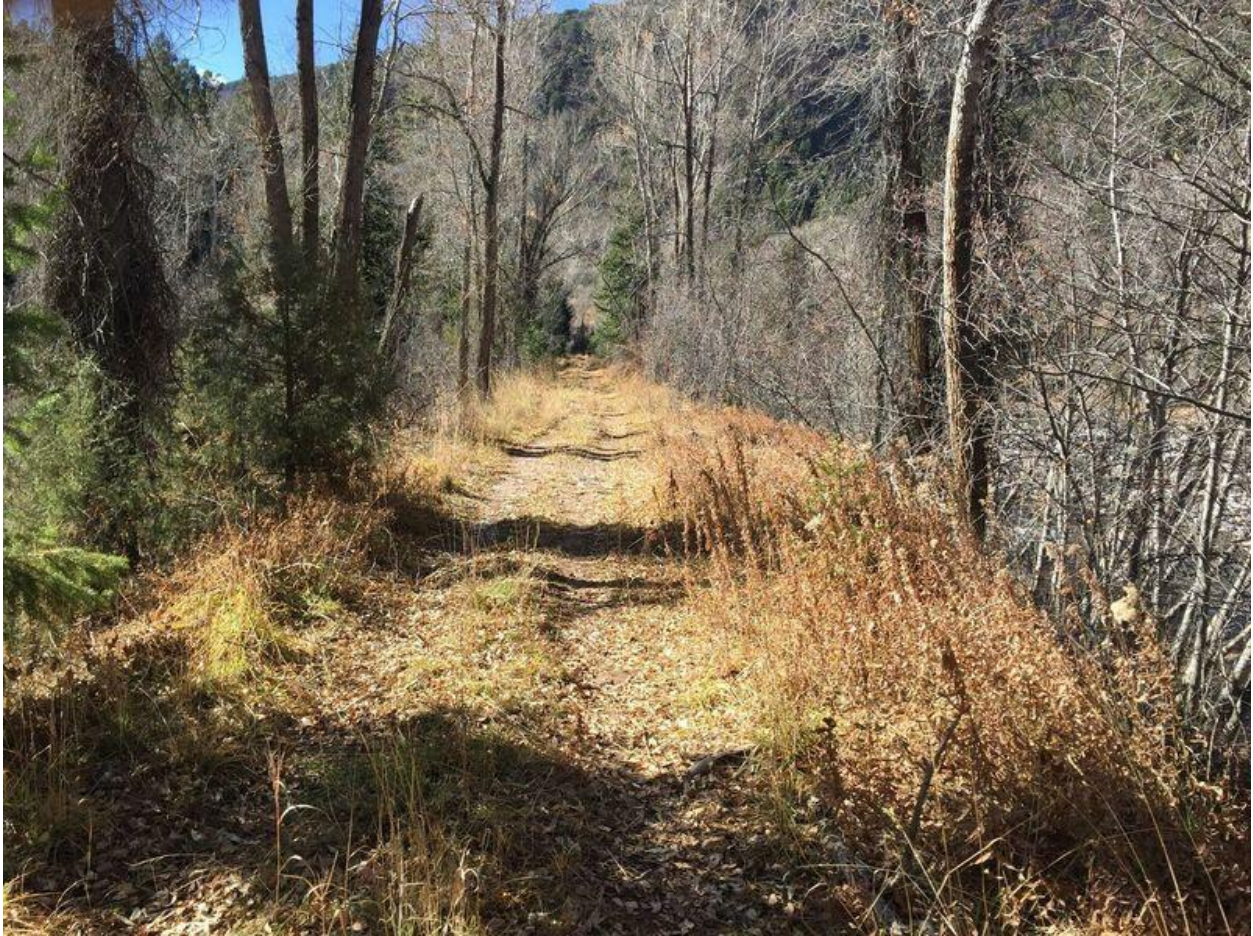
Figure 23 Another section of the rail line upon which a paved path would be constructed for Alignment B on the Red Wind Point section. The rail line fill cuts off the floodplain and riparian area from the river. Constructing a paved path would introduce significant impacts and probably eliminate any future opportunity to restore connectivity.

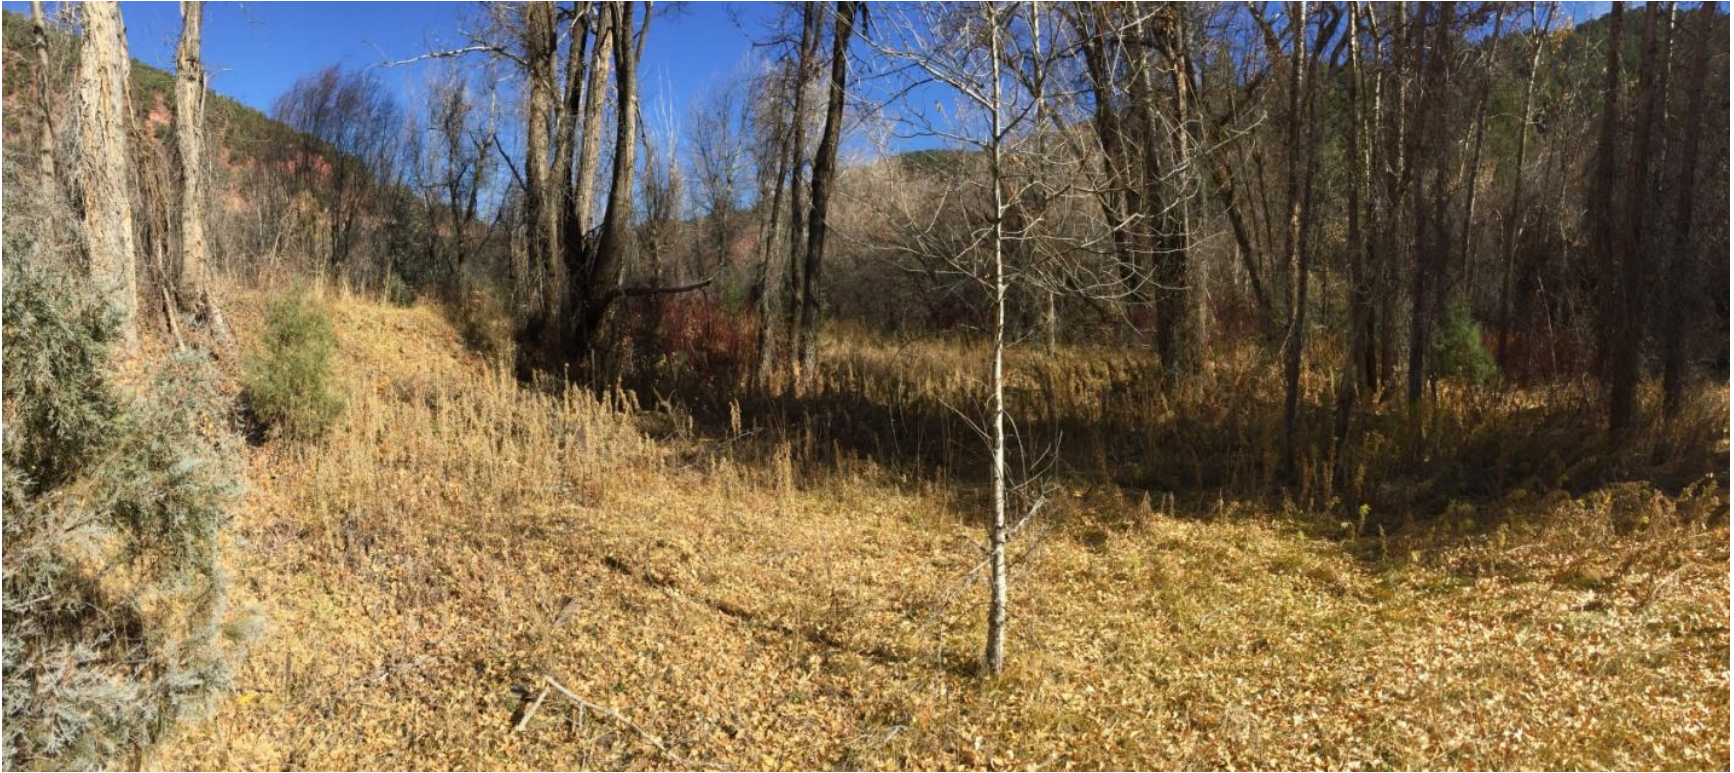
Figure 24 Riparian area isolated from the river on the Red Wind Point section. The elevated rail-bed is seen on the left.

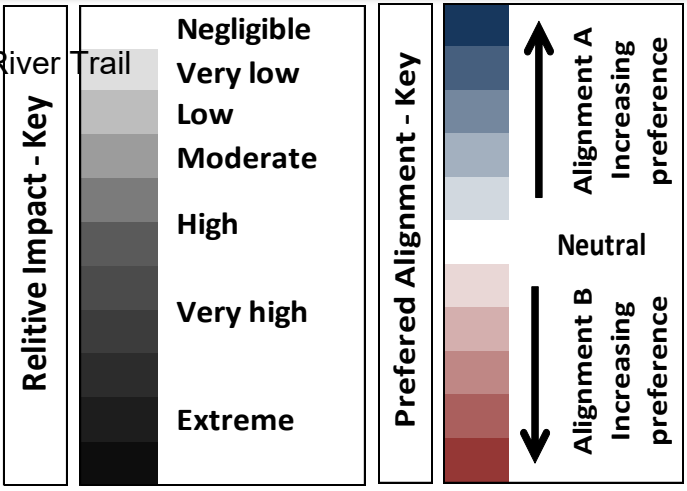
Degree of shading on the left chart below indicates the relative level of impact for the two proposed trail alignments. The ecologically preferred alignment (A or B) was determined by comparing impacts for each of the 19 trail sections. Blue shading indicates a river health preference for alignment A, and red for B. The keys at right provide interpretation.

The proposed trail along the Crystal River would pose new impacts to river health on all sections, but the degree of impact varies according to the type of new trail proposed and its location relative to the river, floodplain, riparian zone, buffer, and other infrastructure. Trail impacts associated with proposed alignments A and B are summarized for each of the 19 sections in Table 3, and a detailed impact analysis is provided in Sheet 3.
