Technical Report TR09-04

## Environmental Effects of Magnesium Chloride- Based Dust Suppression Products on Roadside Soils, Vegetation and Stream Water Chemistry

*In cooperation with Larimer County Road and Bridge Department and Grand County, Colorado.*

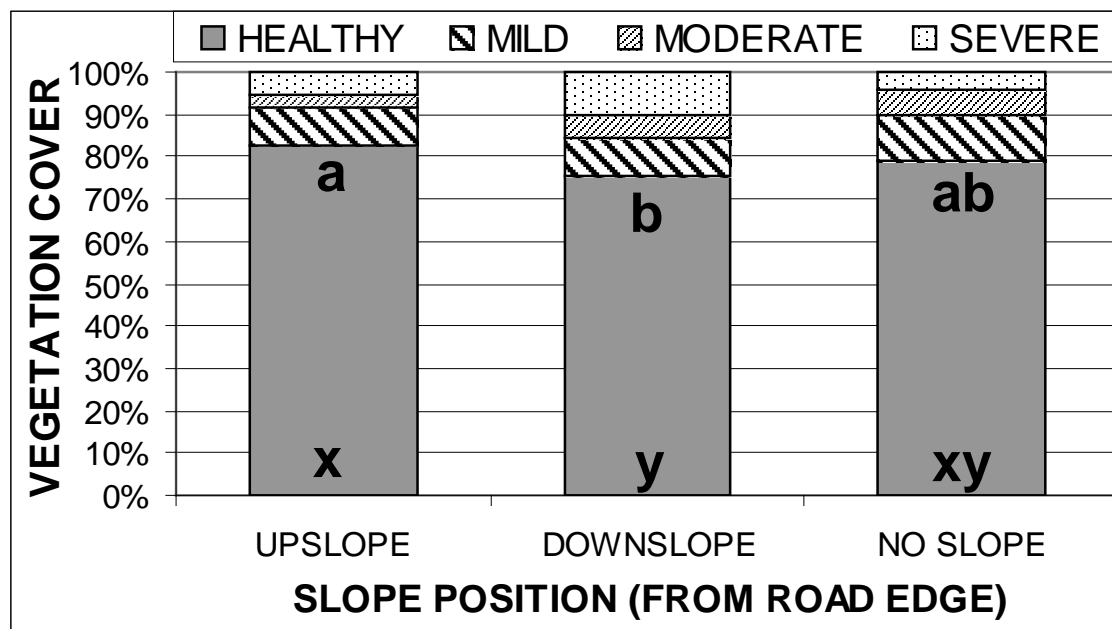
Figure 1.1. Roadside vegetation health condition adjusted means along non-paved roads both treated and non-treated with  $MgCl_2$ -based dust suppression products in Larimer and Grand Counties by slope position from road edge (healthy = < 5% damage, mild = 5 to 25% damage, moderate = 26 to 50% damage, severe > 50% damage to crown or stem,  $n = 2,583$  plots). Letters (a, b, ab) signify significant differences ( $p < 0.05$ ) between percent of severely damaged vegetation between upslope, downslope and no slope positions. Symbols (x, y, xy) signify significant differences ( $p < 0.05$ ) between percent of healthy vegetation between upslope, downslope and no slope positions.

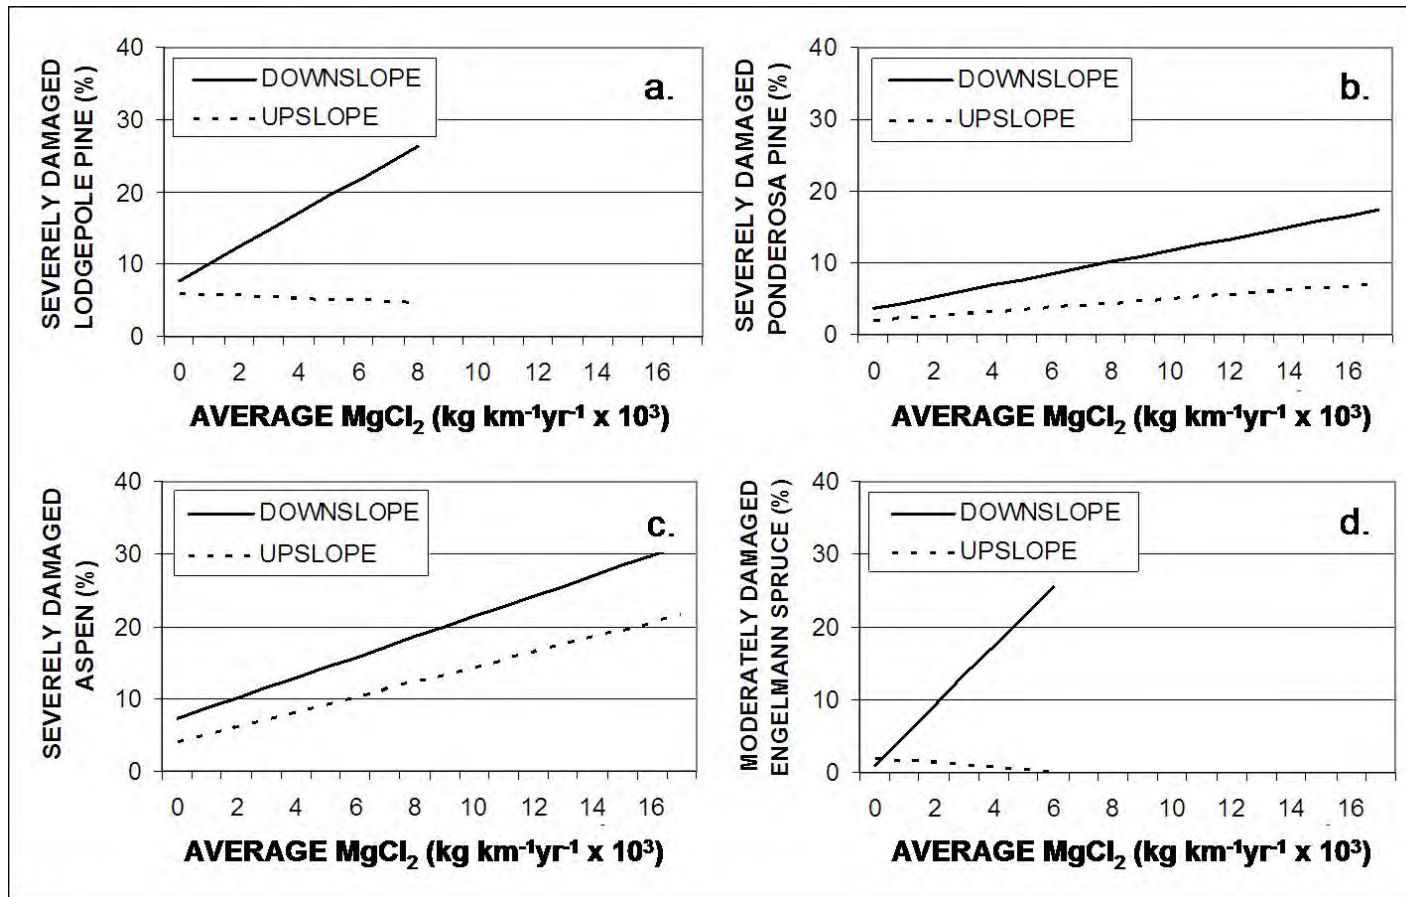
Figure 1.2a-d. Modeled percent severely damaged (a) lodgepole pine , (b) ponderosa pine, (c) trembling aspen and moderately damaged (d) Engelmann spruce adjusted means along non-paved roads both treated and non-treated with  $MgCl_2$ -based dust suppression products in Larimer and Grand Counties by slope position and increasing amount of  $MgCl_2$  applied per year ( $kg \cdot km^{-1} \cdot yr^{-1}$ ). The Solution Function in SAS 9.1 used to generate slopes for each species and slope position and only site factors significant at  $p < 0.05$  were illustrated.

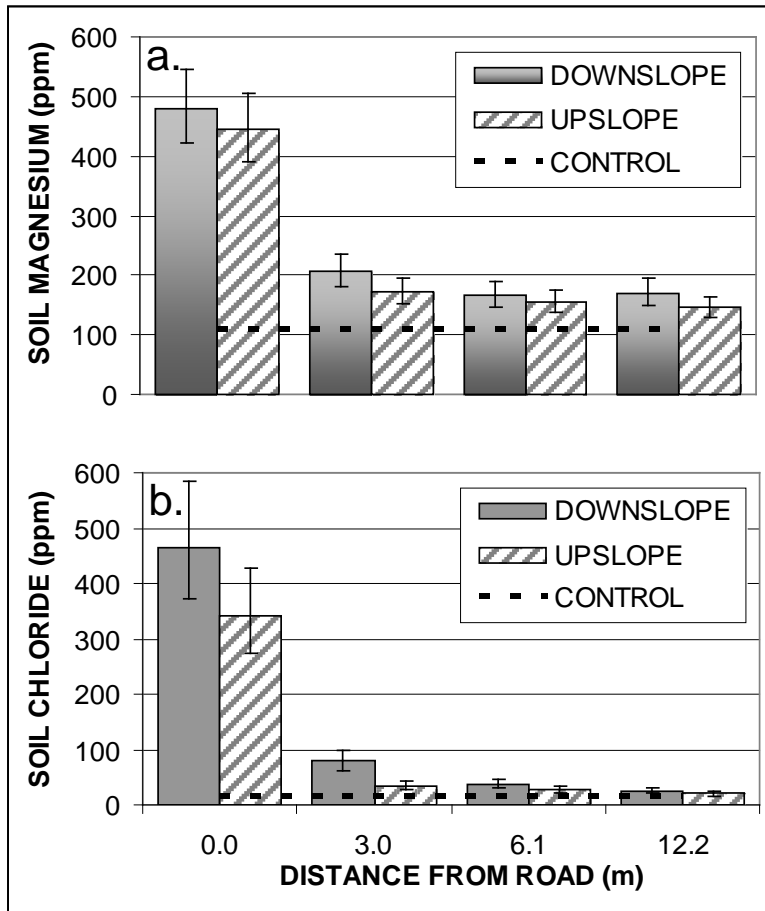
Figure 2.1a-b. Soil (a) chloride and (b) magnesium adjusted mean concentrations along roads in Larimer and Grand Counties, Colorado at four distances, both soil sampling depths, and both slope positions from the road (1429 total soil samples,  $n = 171$  to 195 samples collected at each sampling distance separated by slope). Dotted line indicates control plot soil concentrations at each distance combining both slope positions (225 total soil samples,  $n = 53$  to 58 samples collected at each distance). NOTE: Concentrations back-transformed from  $\log_{10}$  values and error bars indicate  $\pm 1.4$  back-transformed standard errors (approximately  $\pm \frac{1}{2}$  Fisher's Least Significant Difference [LSD]).

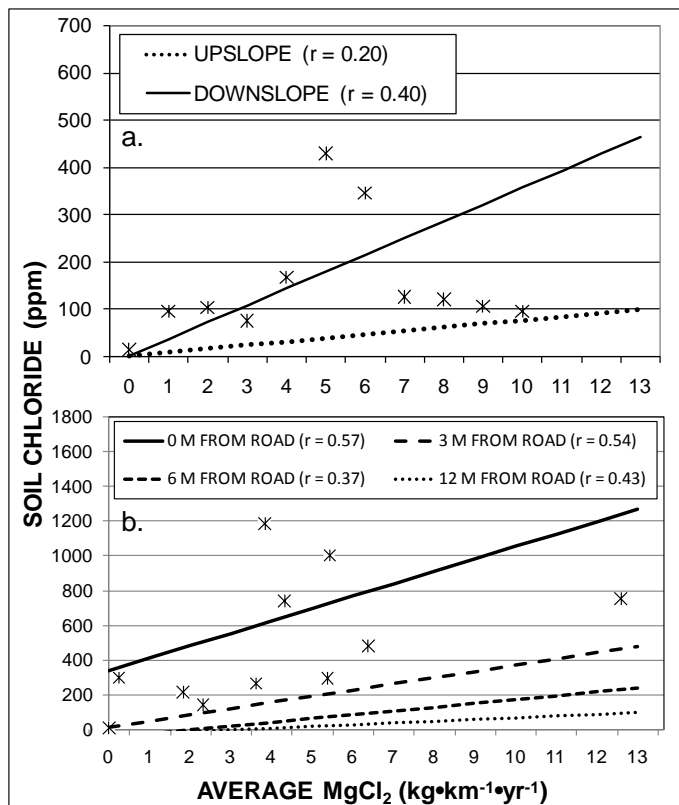
Figure 2.2a-b. Modeled increase in soil chloride concentration with average  $MgCl_2$  applied to roads in Larimer and Grand Counties, Colorado at (a) two slope positions from the road (1694 total soil samples,  $n = 819$  samples upslope and  $n = 875$  samples downslope) and (b) in downslope plots only at four distances from the road (875 total soil samples,  $n = 212 - 225$  samples per distance from the road). Asterisks indicate  $\bar{x}$  means of downslope soil chloride at all distances from the road for each study road (averaged across all distances, transects and plots for each study road) in Figure 3a and  $\bar{x}$  means of downslope soil chloride at 0 m from the road for each study road (averaged across all transects and plots for each study road) in Figure 3b, used in statistical modeling. NOTE: chloride concentrations modeled using least adjusted mean chloride concentrations from plots sampled in 2004 and 2005 using the Solution Function (The Mixed Procedure, SAS 2001). All Pearson correlation coefficients ( $r$ ) reported are significant at  $p < 0.0001$ . Soil concentrations were not  $\log_{10}$  transformed to create predictive models.

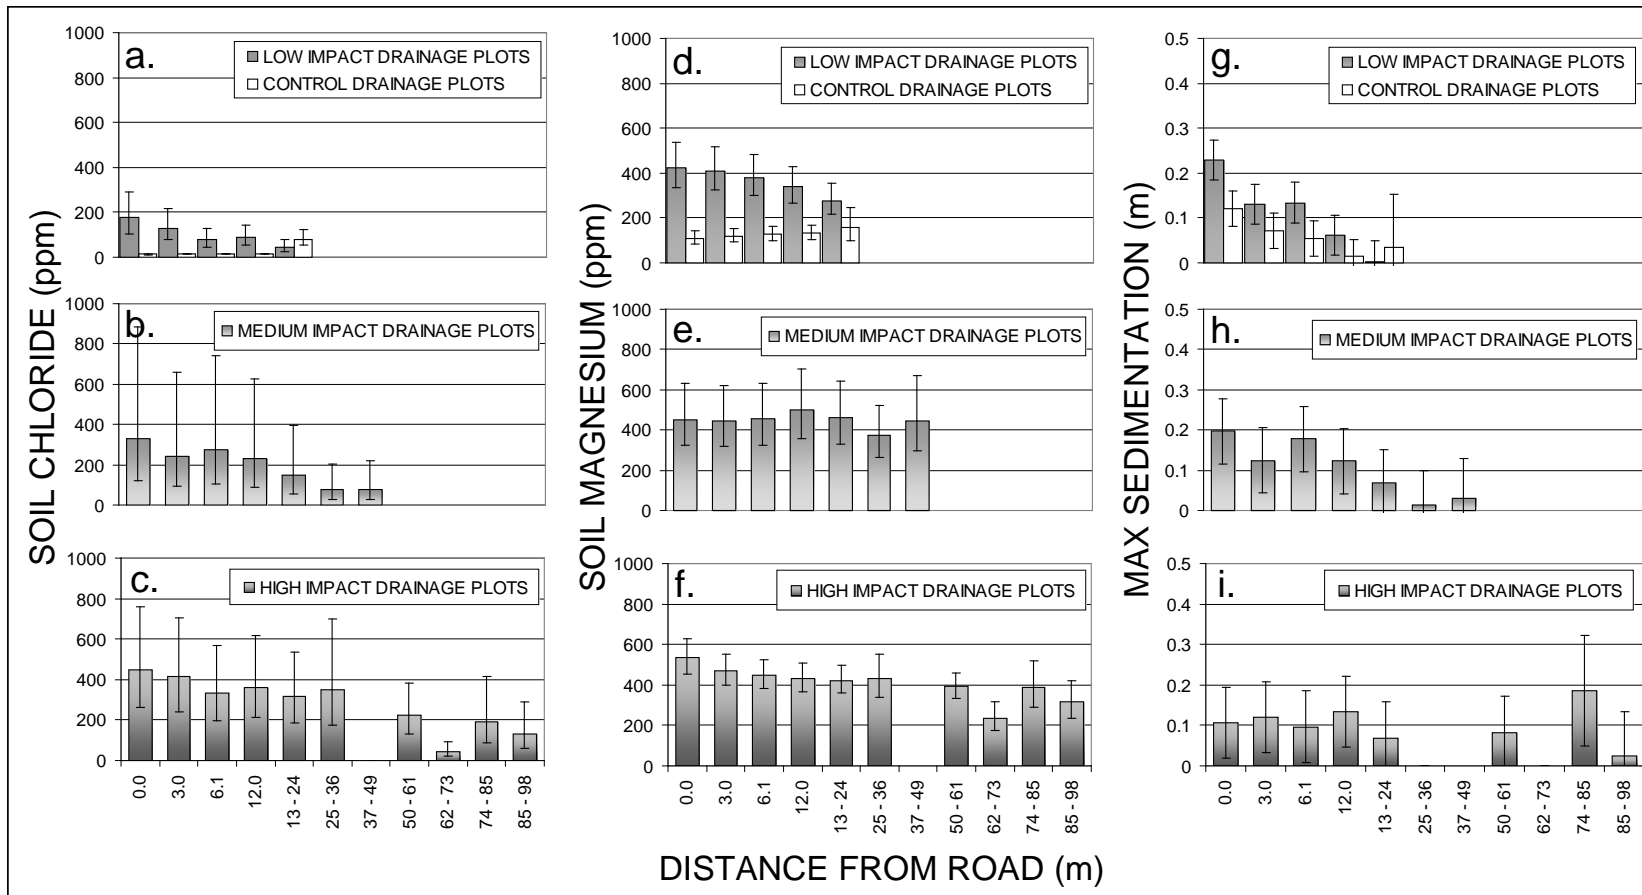
Figure 2.3a-i. Soil (a-c) chloride, (d-f) magnesium, and (g-i) maximum sedimentation adjusted means measured in control ( $n = 26$ ), low ( $n = 24$ ), medium ( $n = 19$ ) and high ( $n = 10$ ) impact drainage plots along roads in Larimer and Grand Counties, Colorado sampled in 2005 or 2006. NOTE: Concentrations back-transformed from  $\log_{10}$  values and error bars indicate  $\pm 1.4$  back-transformed standard errors (approximately  $\pm \frac{1}{2}$  Fisher's Least Significant Difference).

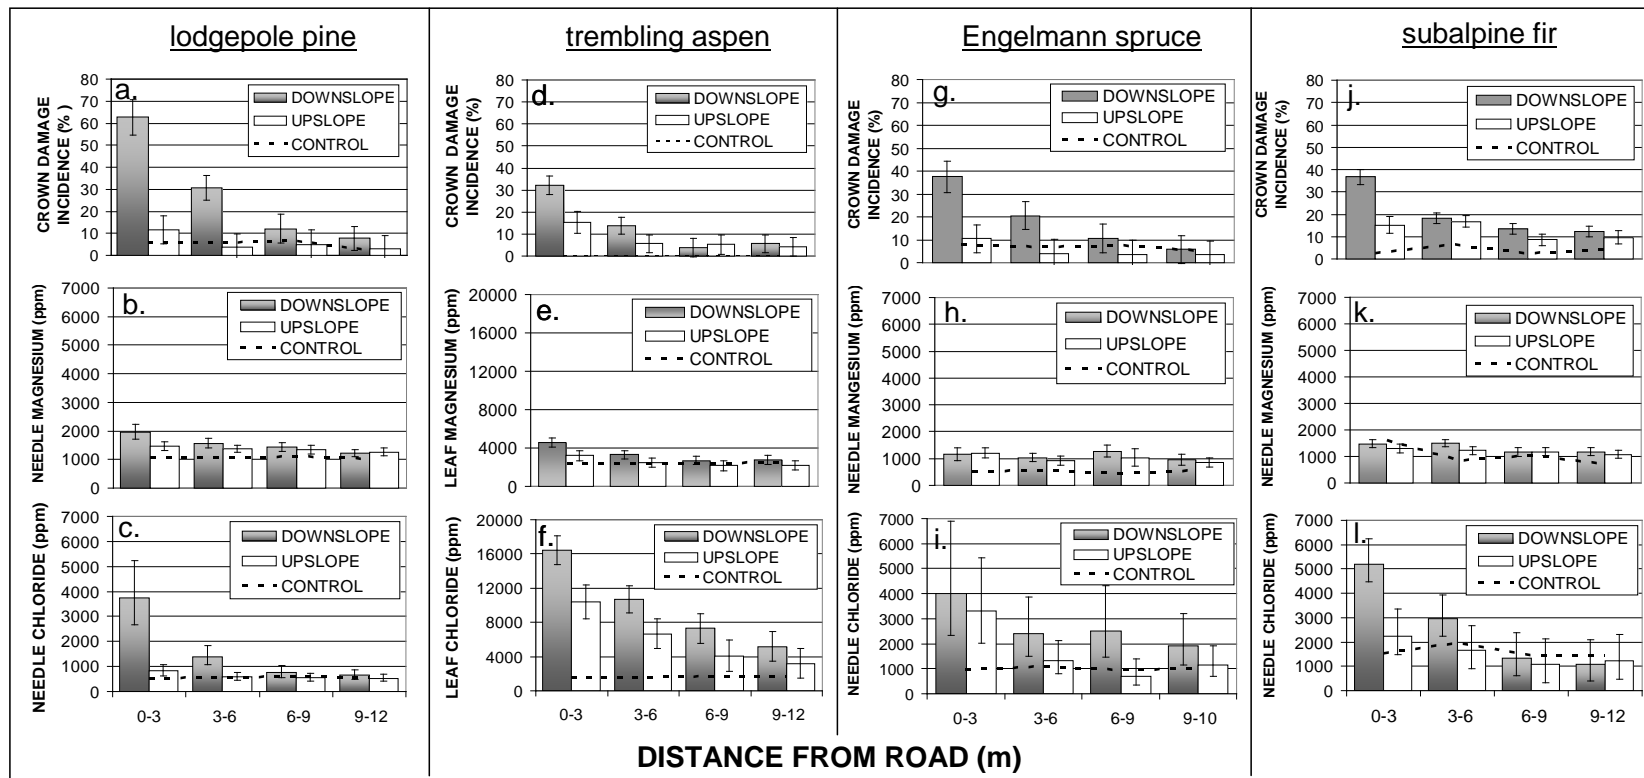
Figure 2.4a-l. Lodgepole pine (a-c,  $n = 2024$  trees visually assessed along treated roads and 487 trees along control roads,  $n = 471$  treated road foliar samples collected and  $n = 141$  control road foliar samples, respectively), trembling aspen (d-f,  $n = 2851$  and 521 trees and  $n = 420$  and 42 samples), Engelmann spruce (g-i,  $n = 1748$  and 55 trees and  $n = 68$  and 27 samples) and subalpine fir (j-l,  $n = 431$  and 96 trees and  $n = 207$  and 13 samples) adjusted mean crown damage incidence, foliar magnesium and foliar chloride along roads in Larimer and Grand Counties, Colorado. Dotted lines indicate crown damage incidence, foliar magnesium and foliar chloride concentrations measured in control plots. NOTE: Concentrations back-transformed from  $\log_{10}$  values and error bars indicate  $\pm 1.4$  back-transformed standard errors (approximately  $\pm \frac{1}{2}$  Fisher's Least Significant Difference).

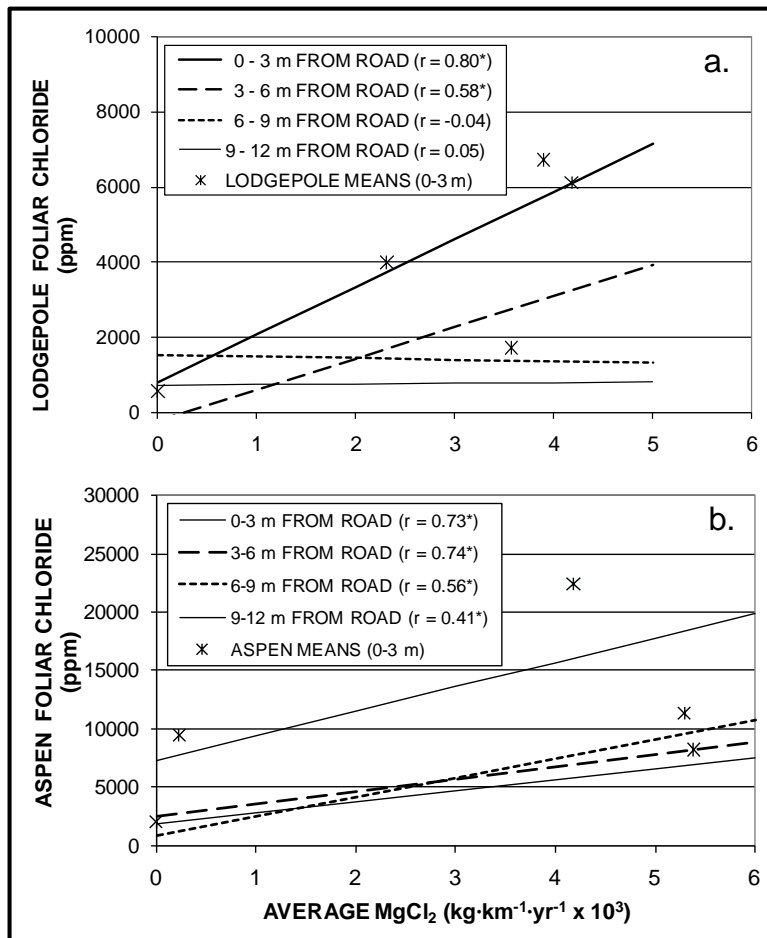
Figures 2.5a-b. Modeled increase in (a) lodgepole pine and (b) aspen foliar chloride concentrations with increasing average  $MgCl_2$  applied to roads in Larimer and Grand Counties, Colorado in downslope plots only at four distance intervals from the road. Asterisks indicate means of foliar chloride for each species at 0 to 3 m downslope from the road along each study road (averaged across all samples, transects and plots on each road), used in statistical modeling. NOTE: Chloride concentrations modeled using least adjusted mean chloride concentrations from plots sampled in 2004 and 2005 using the Solution Function (The Mixed Procedure, SAS 2001). Pearson correlation coefficients ( $r$ ) reported with a (\*) are significant at  $p < 0.0001$ . Foliar concentrations were not  $\log_{10}$  transformed to create predictive models.

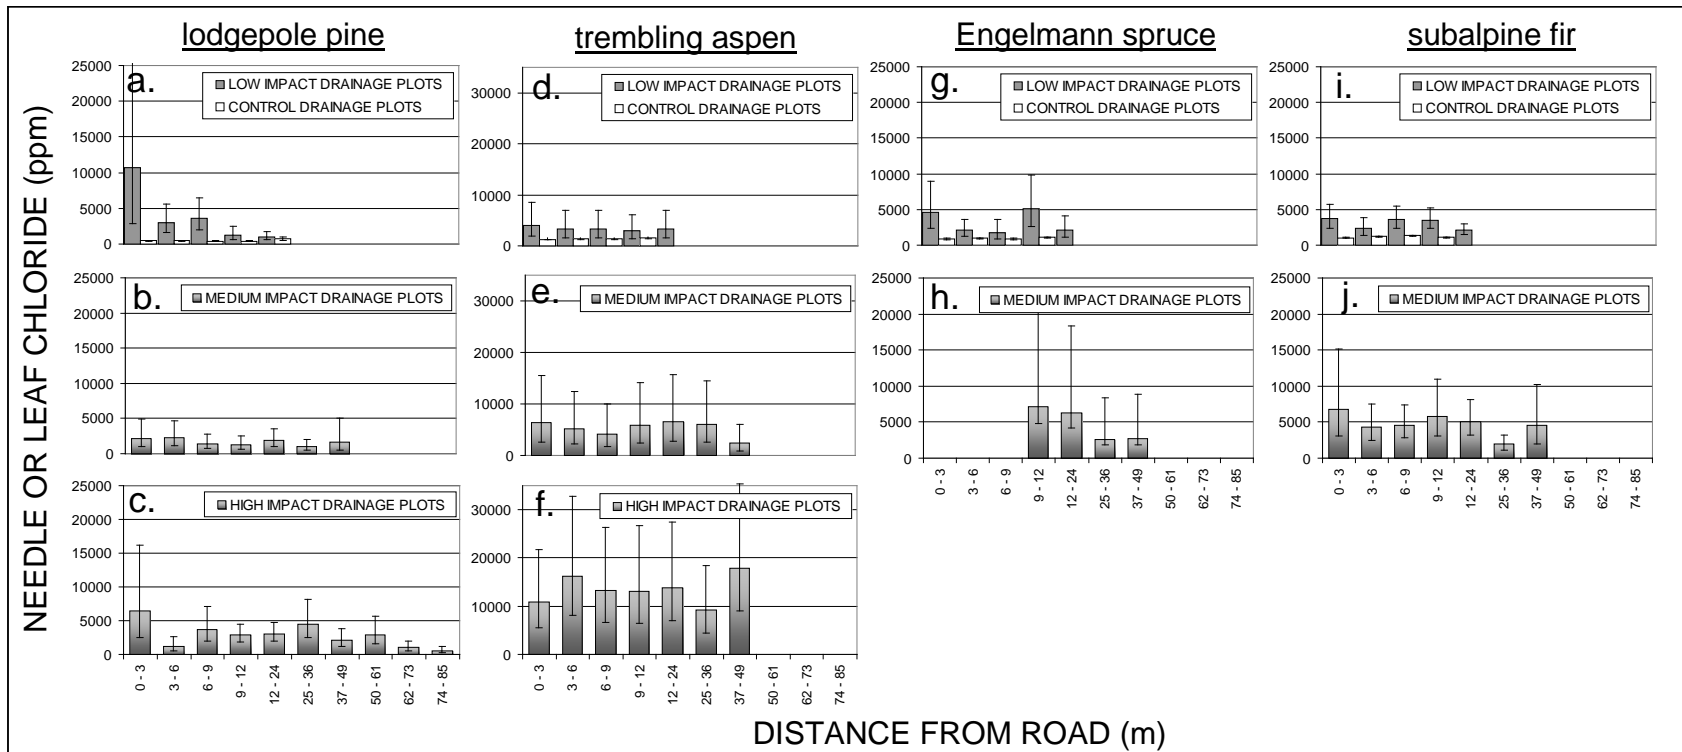
Figure 2.6a-j. Lodgepole pine (a-c) adjusted foliar chloride means at various distance intervals in control (a. 82 foliar samples), low (a. 43 samples), medium (b. 73 samples), and high (c. 49 samples) drainage plot impact classes. Trembling aspen (d-f) adjusted foliar chloride means at various distance intervals in control (d. 49 samples), low (d. 64 samples), medium (e. 50 samples), and high (f. 21 samples) drainage plot impact classes. Engelmann spruce adjusted foliar chloride means at various distance intervals in control (g. 25 samples), low (g. 12 samples), and medium (h. 7 samples) impact drainage plots classes. Subalpine fir adjusted foliar chloride means at various distance intervals in control (i. 28 samples), low (i. 43 samples), and medium (j. 32 samples) impact drainage plots. Drainage plots sampled in Grand and Larimer Counties, Colorado in 2005 and 2006. Means back-transformed from  $\log_{10}$  data transformations, error bars indicate  $\pm 1.4$  back-transformed standard errors ( $\pm$  approximately  $\frac{1}{2}$  Fisher's Least Significant Difference).

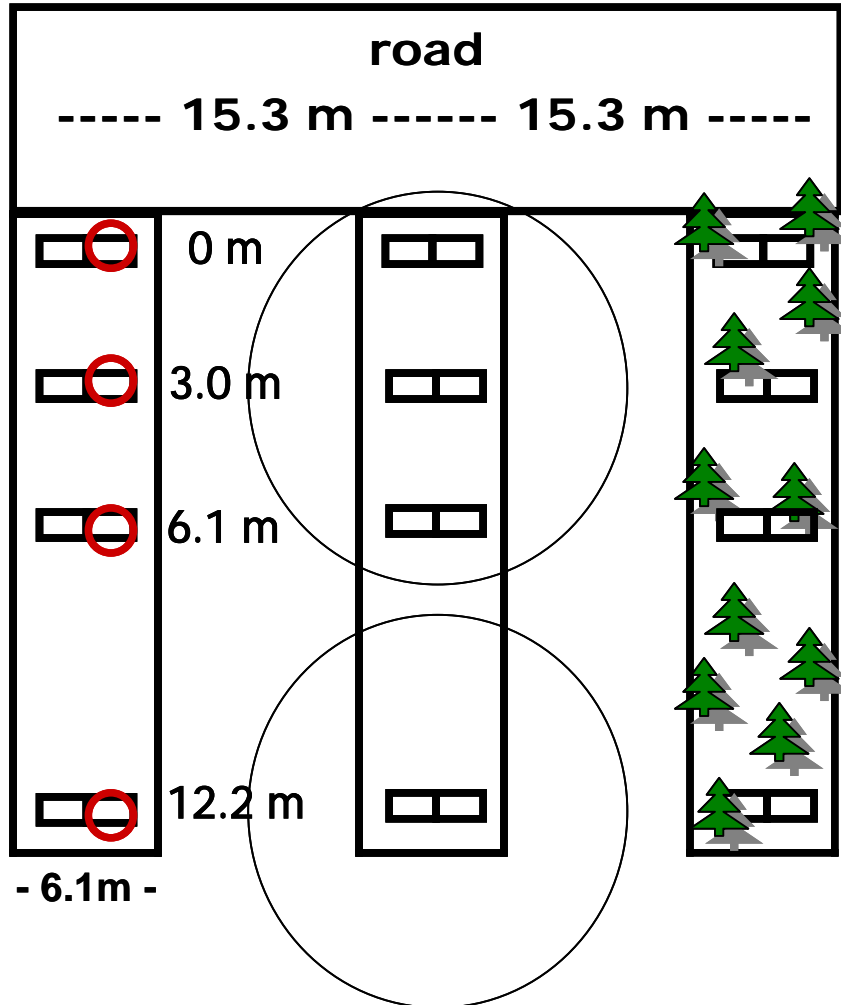
Figure A1. Plot Type 1: Roadside vegetation health plot design established and sampled along treated and control roads in Larimer and Grand Counties, Colorado in 2004 and 2005 ( $n = 60$ ). Plots paired as upslope and downslope plots from the road edge in similar habitats, slopes and stand structures. Large rectangles perpendicular to road = subplots. Small rectangles inside subplots parallel to roads = ground cover plots. Large circles within subplot = 11.5 m radius shrub cover subplots. Small, red circles inside subplots = soil sampling locations.

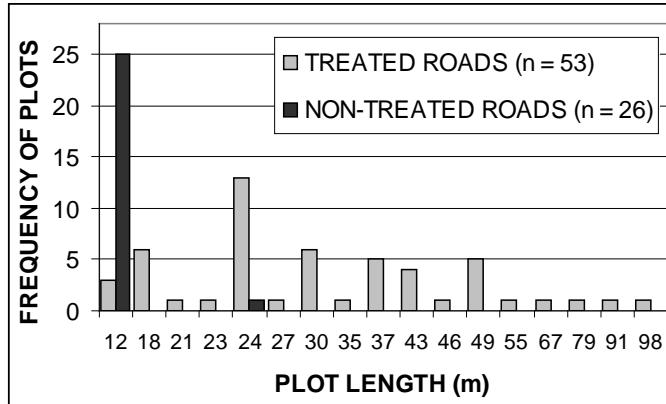
Figure A2. Frequencies of drainage vegetation health plot lengths along non-paved roads both treated and control with MgCl<sub>2</sub> based dust suppression products in Larimer and Grand Counties, Colorado in all habitat types. Plots were established and sampled in summers 2005 and 2006.

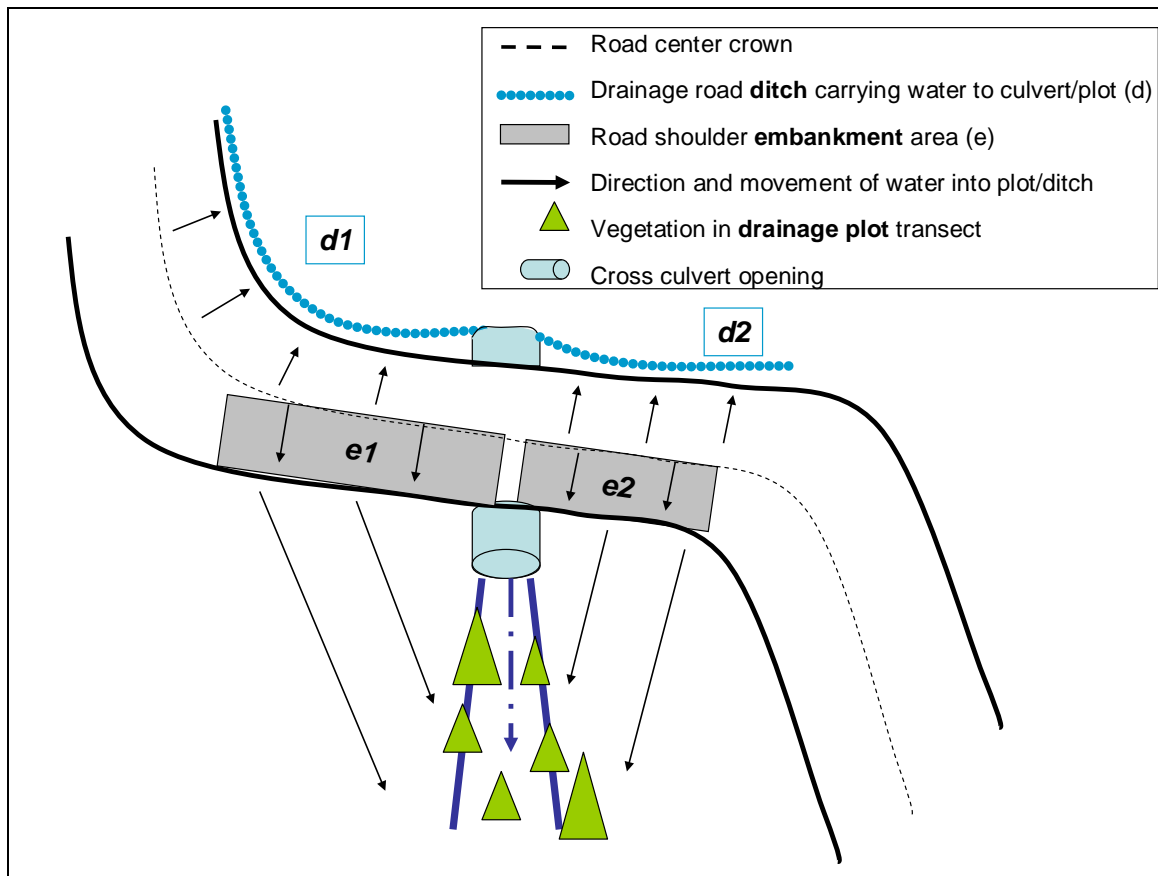
Figure A3. Illustration of potential water movement due to drainage plot surface area from non-paved roads impacted by ditches (d1 and d2) and embankments (e1 and e2) into downslope culvert channels and Plot Type 2: Drainage vegetation health plots.

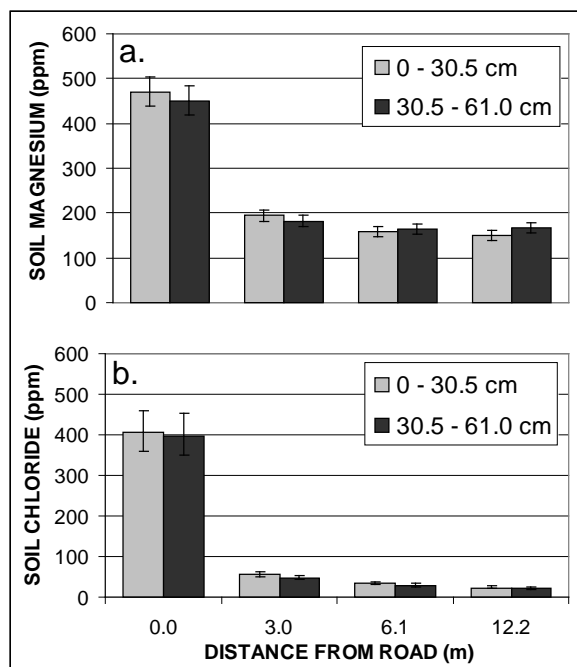
Figures C2a-b. Soil (a) magnesium and (b) chloride adjusted mean (lsmean) concentrations along roads treated with  $MgCl_2$  based dust suppressants at two sampling depths (0 to 30.5 cm and 30.5 to 61.0 cm) in Larimer and Grand Counties, Colorado at four distances from the road (1411 total soil samples,  $n = 194$  to 197 at each distance in upper soil sampling depth and  $n = 159$  to 182 at each distance in lower soil sampling depth with slope positions from the road combined at each distance). Least square means back transformed from  $\log_{10}$  values,  $\pm$  back transformed 1.4 standard errors (approximately  $\pm \frac{1}{2}$  Fisher's Least Significant Difference).

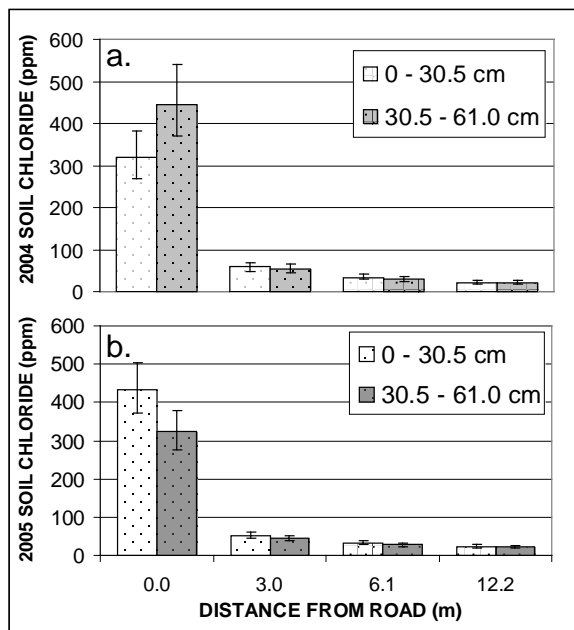
Figures C3a-b. Adjusted mean soil chloride concentrations in (a) 2004 and (b) 2005 along roads treated with  $MgCl_2$  based dust suppressants at two sampling depths (0 to 30.5 cm and 30.5 to 61.0 cm) in Larimer and Grand Counties, Colorado at four distances from the road (upslope and downslope samples combined at each distance). Data only taken from plots sampled for two consecutive years. Soils sampled in late summers 2004 (523 total soil samples,  $n = 74$  to 75 samples from upper sampling depth at each distance and  $n = 56$  to 65 samples from lower sampling depth at each distance) and 2005 (583 total soil samples,  $n = 73$  to 75 samples from upper sampling depth at each distance and  $n = 69$  to 74 samples from lower sampling depth at each distance). Least square means back transformed from  $\log_{10}$  values,  $\pm$  back transformed 1.4 standard errors (approximately  $\pm \frac{1}{2}$  Fisher's Least Significant Difference).

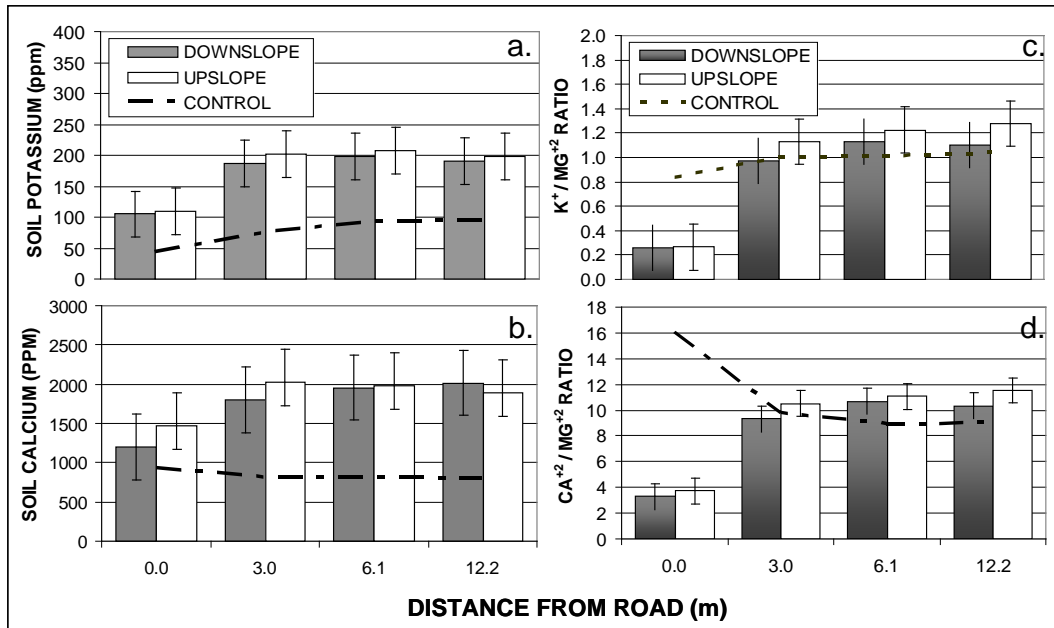
Figures C8a-d. Exchangeable (a) potassium, (b) calcium, (c) K/Mg , and (d) Ca/Mg ratios adjusted mean concentrations (lsmeans) along roads treated with MgCl<sub>2</sub> based dust suppression products in Larimer and Grand Counties, Colorado at four distances and two slope positions from the road (1,411 total soil samples,  $n = 171$  to 195 samples collected at each sampling distance separated by slope). Dotted line indicative of control soil concentrations (225 total soil samples,  $n = 26$  to 30 samples collected at each sampling distance separated by slope,  $n = 53$  to 58 samples collected at each distance). Least square means back transformed from  $\log_{10}$  values,  $\pm$  back transformed 1.4 standard errors (approximately  $\pm \frac{1}{2}$  Fisher's Least Significant Difference).

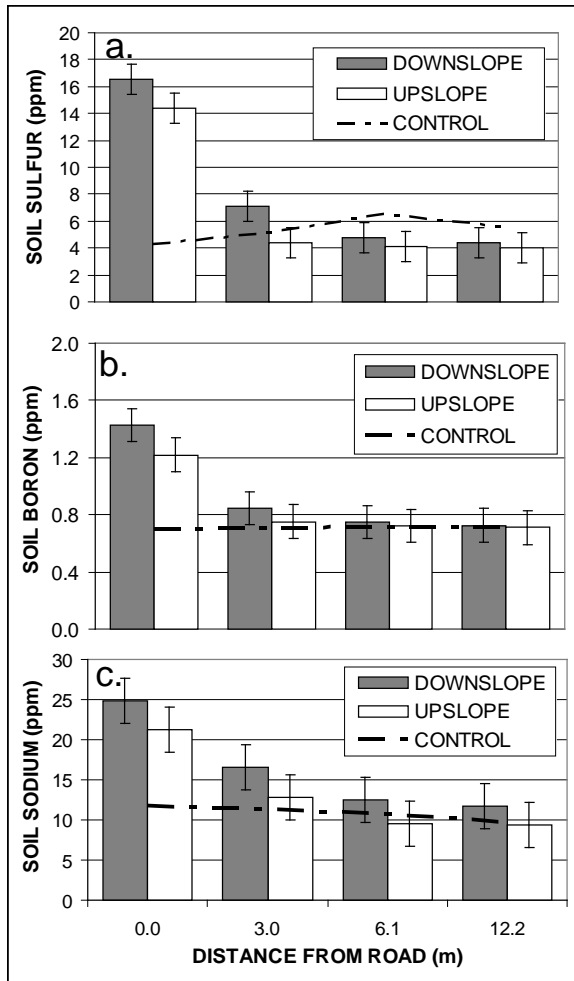
Figures C9a-c. Soil (a) sulfur, (b) boron and (c) sodium adjusted mean concentrations (lsmeans) along roads treated with  $MgCl_2$  based dust suppression products in Larimer and Grand Counties, CO at four distances and two slope positions from the road (1,411 total soil samples,  $n = 171$  to 195 samples collected at each sampling distance separated by slope). Dotted line indicative of control soil concentrations (225 total soil samples,  $n = 26$  to 30 samples collected at each sampling distance separated by slope,  $n = 53$  to 58 samples collected at each distance). Least square means back transformed from  $\log_{10}$  values,  $\pm$  back transformed 1.4 standard errors (approximately  $\pm \frac{1}{2}$  Fisher's Least Significant Difference).

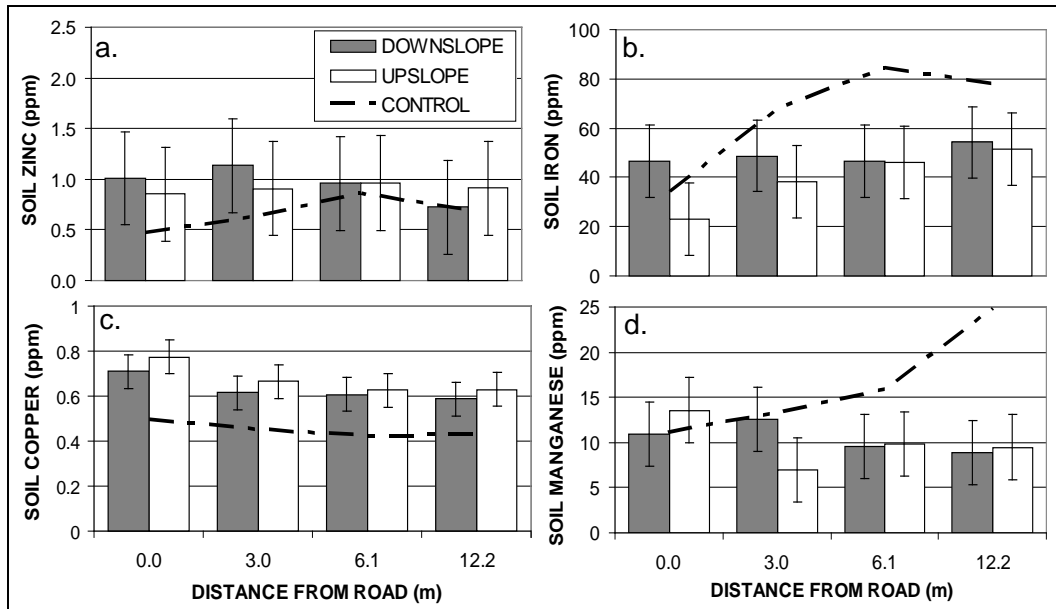
Figures C10a-d. Soil micronutrient (a) zinc, (b) iron, (c) copper and (d) manganese adjusted mean concentrations (lsmeans) along roads treated with  $MgCl_2$  based dust suppression products in Larimer and Grand Counties, CO at four distances and two slope positions from the road (1,411 total soil samples,  $n = 171$  to 195 samples collected at each sampling distance separated by slope). Dotted line indicative of control soil concentrations (225 total soil samples,  $n = 26$  to 30 samples collected at each sampling distance separated by slope,  $n = 53$  to 58 samples collected at each distance). Least square means back transformed from  $\log_{10}$  values,  $\pm$  back transformed 1.4 standard errors (approximately  $\pm \frac{1}{2}$  Fisher's Least Significant Difference).

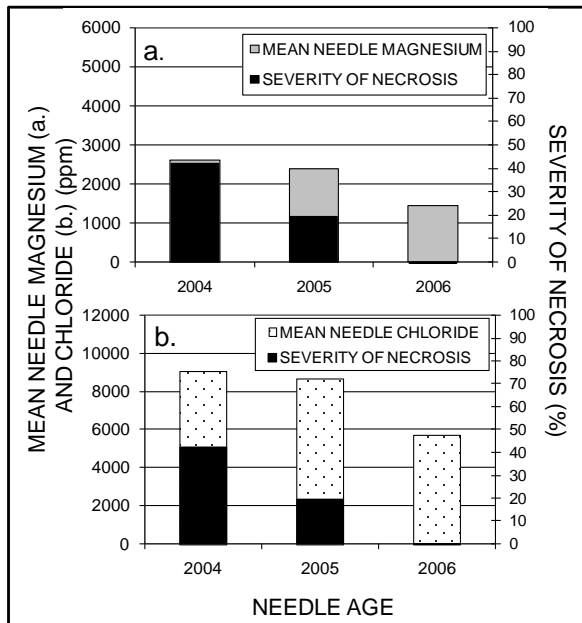
Figures C13a-b. Mean needle (a) magnesium concentrations, (b) chloride concentrations and severity of needle damage in three age classes of lodgepole pine needles sampled from three downslope plots along one non-paved road treated with  $MgCl_2$  dust suppression products in Larimer County, Colorado (County Road 162.234). Nine trees samples with each of three different aged needles (2004, 2005 and 2006 flushed needles) for each age class.

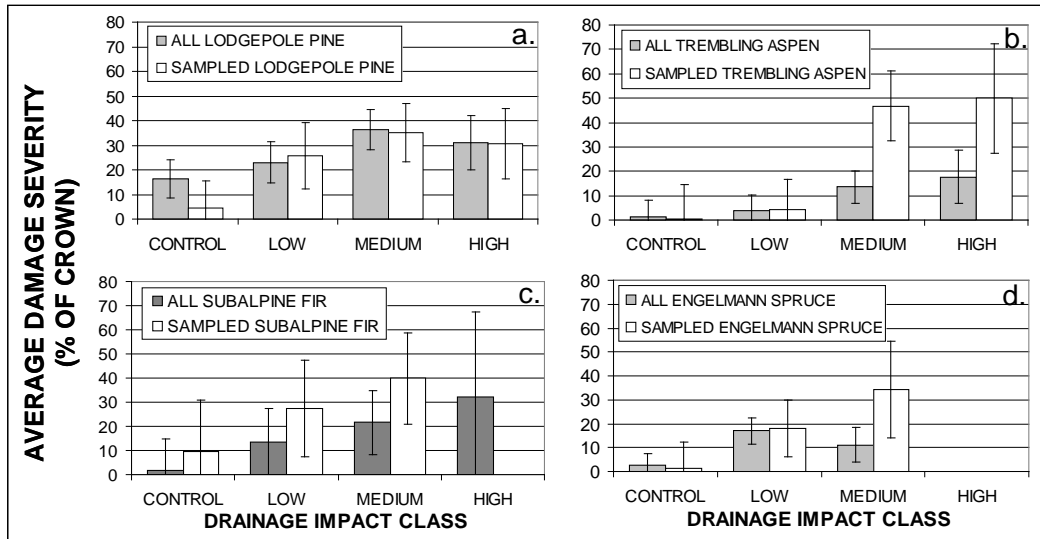
Figures C14 a-d. Mean crown damage severity in drainage plots separated by drainage impact class in all trees visually assessed (grey bars) and sampled for foliar ion content (white bars) of (a) lodgepole pine ( $n = 1,532$  trees visually assessed and 247 trees sampled for ions), (b) trembling aspen ( $n = 2,292$  trees and 192 sampled), (c) Engelmann spruce ( $n = 243$  trees and 44 sampled), and (d) subalpine fir ( $n = 593$  trees and 103 sampled). All roads, plots and distance intervals combined in each drainage impact class. No observations in high impact drainages for Engelmann spruce. Least square means  $\pm 1.4$  standard errors (approximately  $\pm \frac{1}{2}$  Fisher's Least Significant Difference).

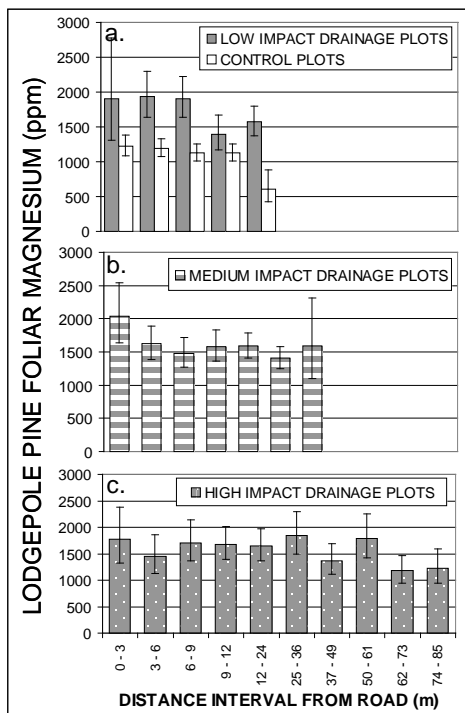
Figures C15a-c. Lodgepole pine adjusted foliar magnesium means (lsmeans) at various distance intervals in (a) control ( $n = 82$  foliar samples), (a) low ( $n = 43$  samples), (b) medium ( $n = 73$  samples), and (c) high ( $n = 49$  samples) drainage plot impact classes along  $MgCl_2$  treated and control roads in Larimer and Grand Counties, Colorado Least square means back transformed from  $\log_{10}$  values,  $\pm$  back transformed 1.4 standard errors (approximately  $\pm \frac{1}{2}$  Fisher's Least Significant Difference).

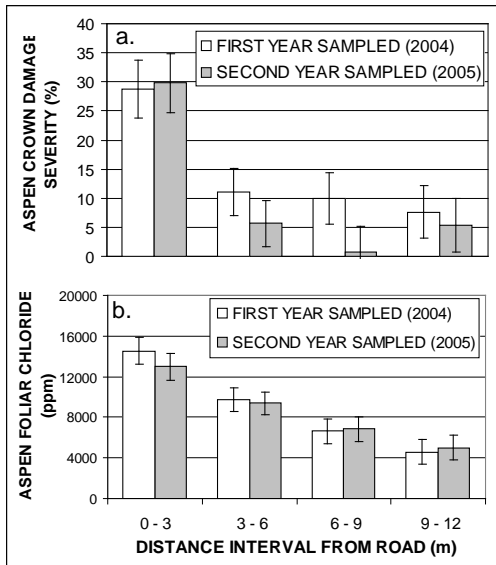
Figures C16a-b. Trembling aspen (a) crown damage and (b) chloride adjusted mean concentrations (lsmeans) along treated roads in Larimer and Grand Counties, Colorado at four distances and two slope positions in permanent plots sampled in 2004 and 2005. Two hundred eight-six total foliar samples and trees visually assessed,  $n = 51$  to 103 samples in both years per distance interval from the road). Least square means back transformed from  $\log_{10}$  values,  $\pm$  back transformed 1.4 standard errors (approximately  $\pm \frac{1}{2}$  Fisher's Least Significant Difference).

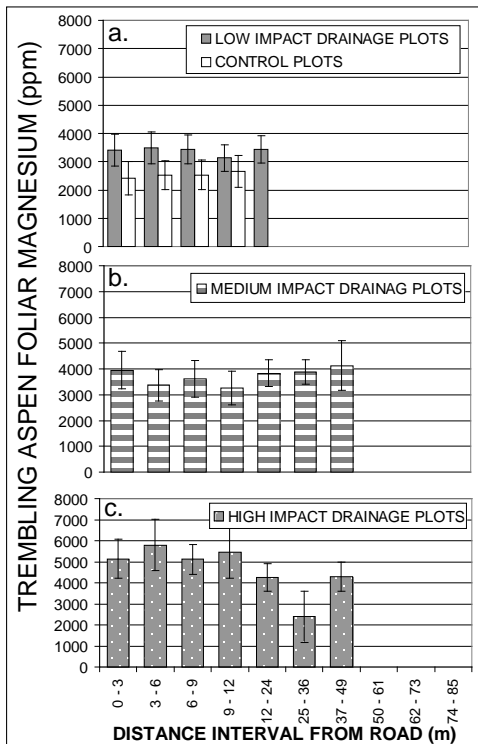
Figures C17a-c. Trembling aspen adjusted foliar magnesium means at various distance intervals in (a) control ( $n = 49$  foliar samples), (a) low ( $n = 64$  foliar samples), (b) medium ( $n = 50$  foliar samples), and (c) high ( $n = 21$  foliar samples) drainage plot impact classes along treated and control roads in Larimer and Grand Counties, Colorado sampled in 2005 or 2006. Least square means back transformed from  $\log_{10}$  values,  $\pm$  back transformed 1.4 standard errors (approximately  $\pm \frac{1}{2}$  Fisher's Least Significant Difference).

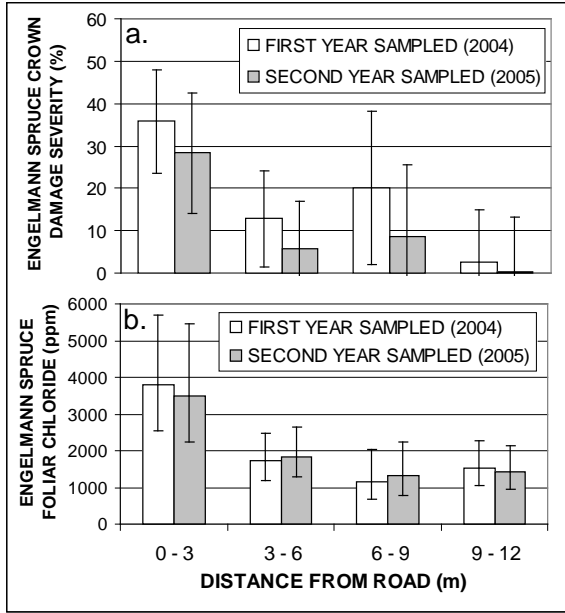
Figures C18a-b. Engelmann spruce (a) crown damage and (b) foliar chloride adjusted mean concentrations (lsmeans) along treated roads in Larimer and Grand Counties, Colorado. Sixty-eight total foliar samples and trees visually assessed,  $n = 8$  to 28 foliar samples in both years per distance interval from the road). Least square means back transformed from  $\log_{10}$  values,  $\pm$  back transformed 1.4 standard errors (approximately  $\pm \frac{1}{2}$  Fisher's Least Significant Difference).

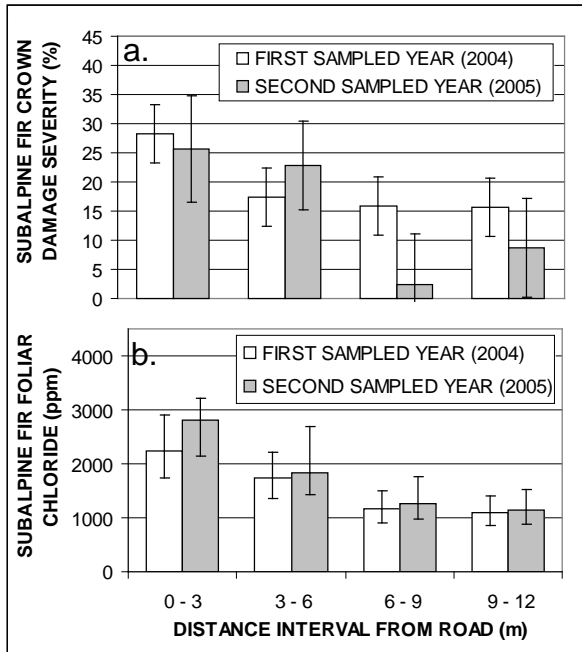
Figures C19a-b. Subalpine fir a) crown damage and (b) foliar chloride adjusted mean concentrations (lsmeans) along treated roads in Larimer and Grand Counties, Colorado. Two hundred six total foliar samples and trees visually assessed,  $n = 46$  to 72 samples in both years per distance interval from the road). Least square means back transformed from  $\log_{10}$  values,  $\pm$  back transformed 1.4 standard errors (approximately  $\pm \frac{1}{2}$  Fisher's Least Significant Difference).

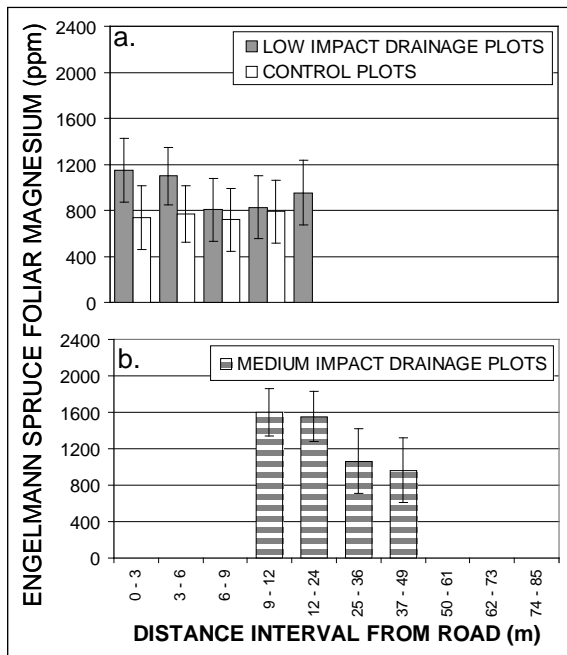
Figures C20a-b. Engelmann spruce adjusted foliar magnesium means at various distance intervals in (a) control ( $n = 25$  foliar samples), (a) low ( $n = 12$  foliar samples), and (b) medium ( $n = 7$  foliar samples) impact drainage plots classes along treated and control roads in Larimer County, Colorado sampled in 2005 or 2006. Least square means back transformed from  $\log_{10}$  values,  $\pm$  back transformed 1.4 standard errors (approximately  $\pm \frac{1}{2}$  Fisher's Least Significant Difference).

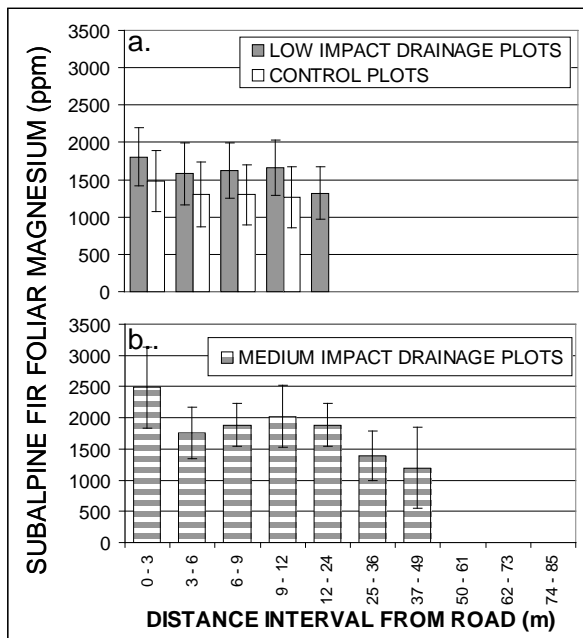
Figures C21a-b. Subalpine fir adjusted foliar magnesium means at various distance intervals in (a) control ( $n = 28$  foliar samples), (a) low ( $n = 43$  foliar samples), and (b) medium ( $n = 32$  foliar samples) impact drainage plots classes along treated and control roads in Larimer County, Colorado sampled in 2005 or 2006. Least square means back transformed from  $\log_{10}$  values,  $\pm$  back transformed 1.4 standard errors (approximately  $\pm \frac{1}{2}$  Fisher's Least Significant Difference).

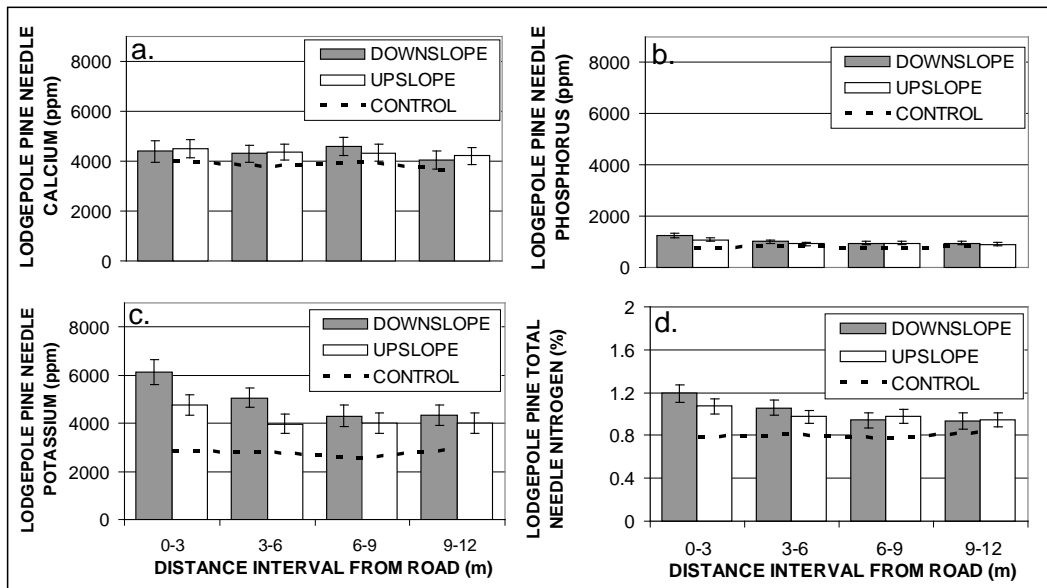
Figures C22a-d. Lodgepole pine needle (a) calcium, (b) phosphorus, (c) potassium and (d) total nitrogen adjusted mean concentrations (lsmeans) at four distances and two slope positions from the road along  $MgCl_2$  treated roads in Larimer and Grand Counties, Colorado (471 total samples collected, downslope plots ranged from 28 to 74 samples collected per distance interval, upslope plots ranged from 47 to 69 samples collected per interval). Dotted line indicative of control foliar concentrations (141 total foliar samples, 25 to 36 samples collected per distance interval). Least square means back transformed from  $\log_{10}$  values,  $\pm$  back transformed 1.4 standard errors (approximately  $\pm 1/2$  Fisher's Least Significant Difference).

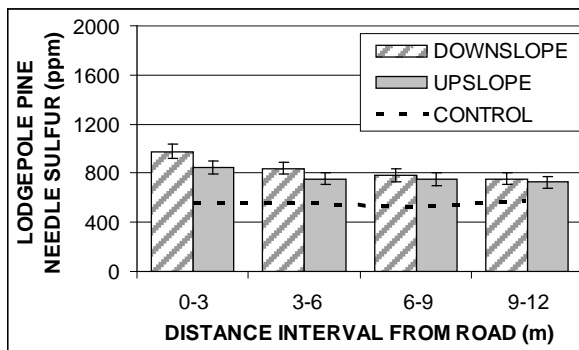
Figure C23. Lodgepole pine needle sulfur adjusted mean concentrations (lsmeans) at four distances and two slope positions along  $MgCl_2$  treated roads in Larimer and Grand Counties, Colorado (471 total foliar samples collected, downslope plots ranged from 28 to 74 samples per distance interval, upslope plots ranged from 47 to 69 samples per distance interval). Dotted line indicative of control foliar concentrations (141 total foliar samples,  $n = 25$  to 36 samples collected per distance interval). Least square means back transformed from  $\log_{10}$  values,  $\pm$  back transformed 1.4 standard errors (approximately  $\pm 1/2$  Fisher's Least Significant Difference).

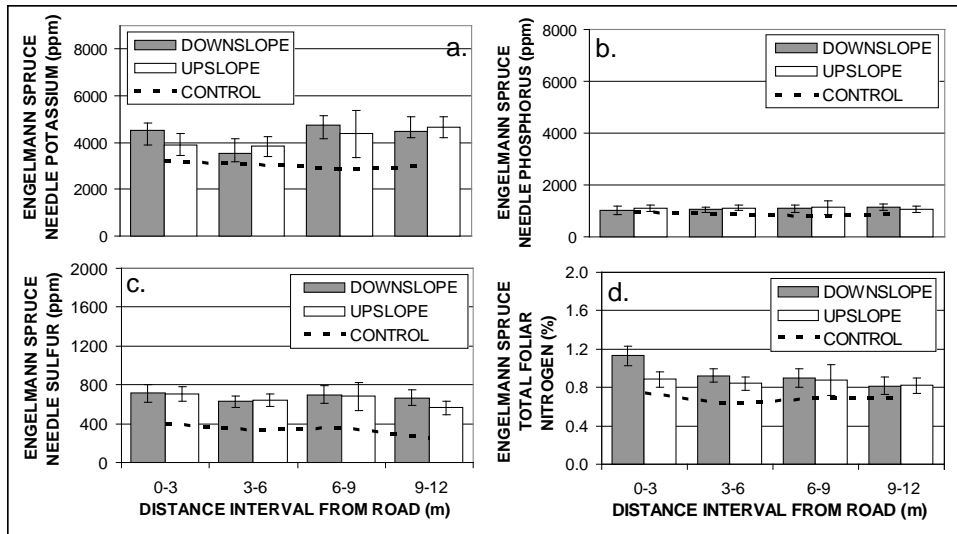
Figures C26a-d. Englemann spruce needle (a) potassium, (b) phosphorus, (c) sulfur, and (d) total foliar nitrogen adjusted mean (lsmeans) concentrations, 68 total foliar samples collected, downslope plots: 6 to 15 samples per distance interval, upslope plots: 2 to 13 samples per interval. Dotted line indicative of control concentrations of each ion (27 samples,  $n = 2$  to 11 samples per distance interval). Least square means back transformed from  $\log_{10}$  values,  $\pm$  back transformed 1.4 standard errors (approximately  $\pm \frac{1}{2}$  Fisher's Least Significant Difference).
