Technical Report TR09-04

## Environmental Effects of Magnesium Chloride- Based Dust Suppression Products on Roadside Soils, Vegetation and Stream Water Chemistry

*In cooperation with Larimer County Road and Bridge Department and Grand County, Colorado.*

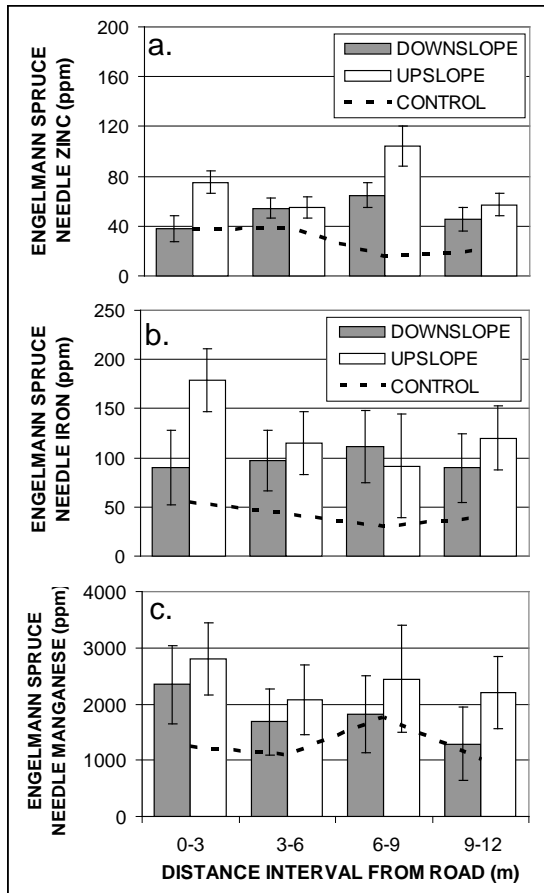
Figures C27a-c. Engelmann spruce needle (a) zinc, (b) iron and (c) manganese adjusted mean concentrations, 68 total foliar samples collected, downslope plots ranged from 6 to 15 samples collected per distance interval, upslope plots ranged from 2 to 13 samples collected per interval along treated road. Dotted line indicative of control concentrations of each ion (27 foliar samples,  $n = 2$  to 11 samples collected per distance interval). Least square means back transformed from  $\log_{10}$  values,  $\pm$  back transformed 1.4 standard errors (approximately  $\pm \frac{1}{2}$  Fisher's Least Significant Difference).

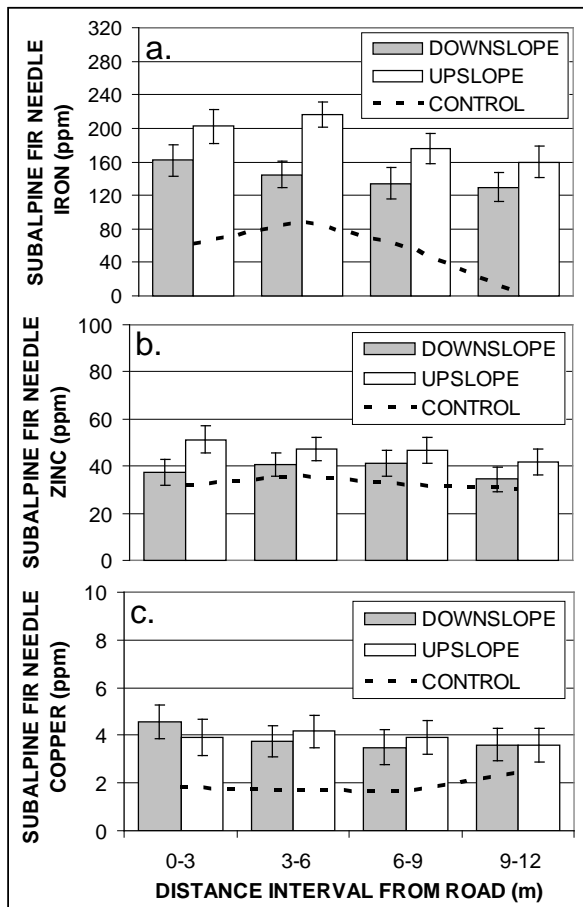
Figures C29a-c. Adjusted mean needle (a) iron, (b) zinc and (c) copper in subalpine fir trees, 207 foliar samples collected, downslope plots: 21 to 34 samples per distance interval, upslope plots:  $n = 17$  to 38 samples per interval along one treated road in Larimer County, Colorado. Dotted line indicative of control concentrations of each ion (13 foliar samples,  $n = 1$  to 6 samples per distance interval). Least square means back transformed from  $\log_{10}$  values,  $\pm$  back transformed 1.4 standard errors (approximately  $\pm \frac{1}{2}$  Fisher's Least Significant Difference).

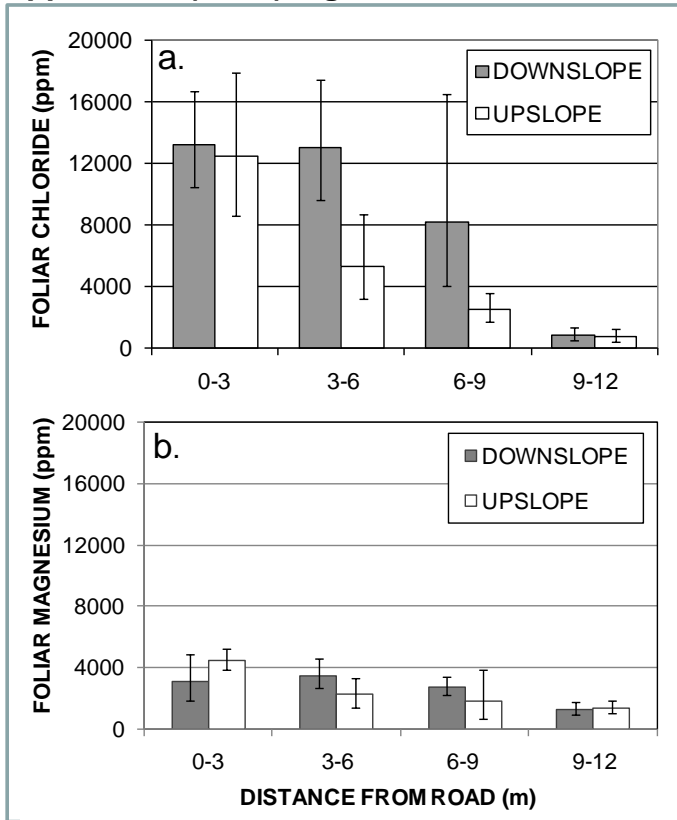
Figure F1a-b. Ponderosa pine foliar chloride adjusted means upslope and downslope from three non-paved roads treated with  $MgCl_2$  dust suppression products in Larimer County, Colorado ( $n = 35$  trees).

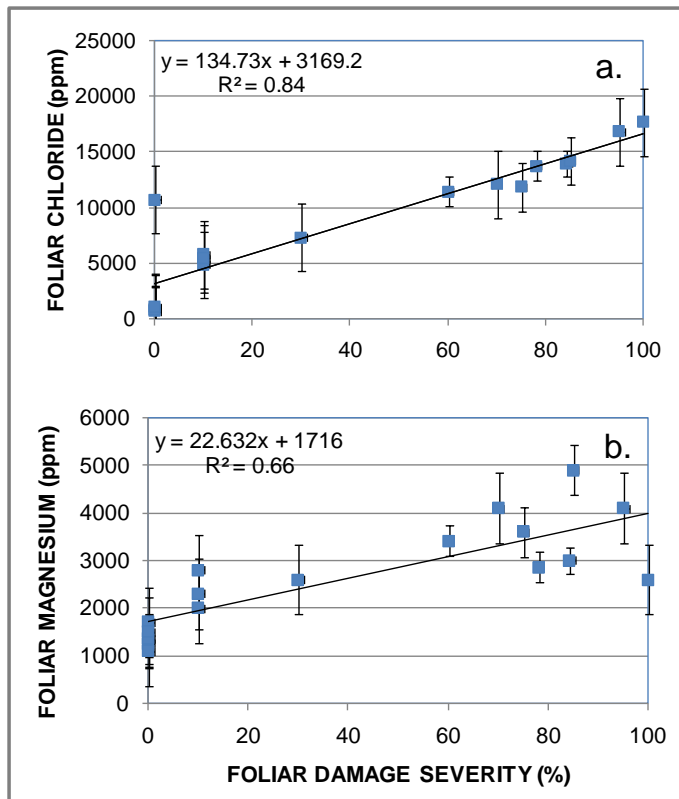
Figure F2a-b. Relationships between (a) foliar chloride and damage severity and (b) foliar magnesium and damage severity in roadside ponderosa pine trees along three  $MgCl_2$  treated roads in Larimer County, Colorado ( $n = 35$ ).

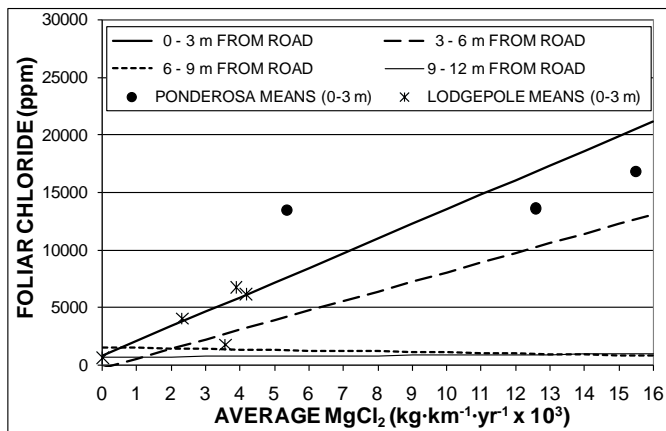
Figure F3. Lodgepole pine foliar chloride increase with average  $MgCl_2$  application rate, modeled from data collected along study roads ranging from 0 to 6,000  $kg \cdot km^{-1} \cdot yr^{-1}$  in Larimer and Grand Counties, Colorado in 2004 and 2005 field study ( $n = 615$  foliar lodgepole foliar samples) using the Solution Function (The Mixed Procedure, SAS 2001). Model “extended” to 16,000  $kg \cdot km^{-1} \cdot yr^{-1}$ . Study road lodgepole and ponderosa pine foliar chloride lsmeans (0 to 3 m downslope from the road [ $n = 5$  roads for lodgepole pine and 3 roads for ponderosa pines]) included to test field measurements with model extension.

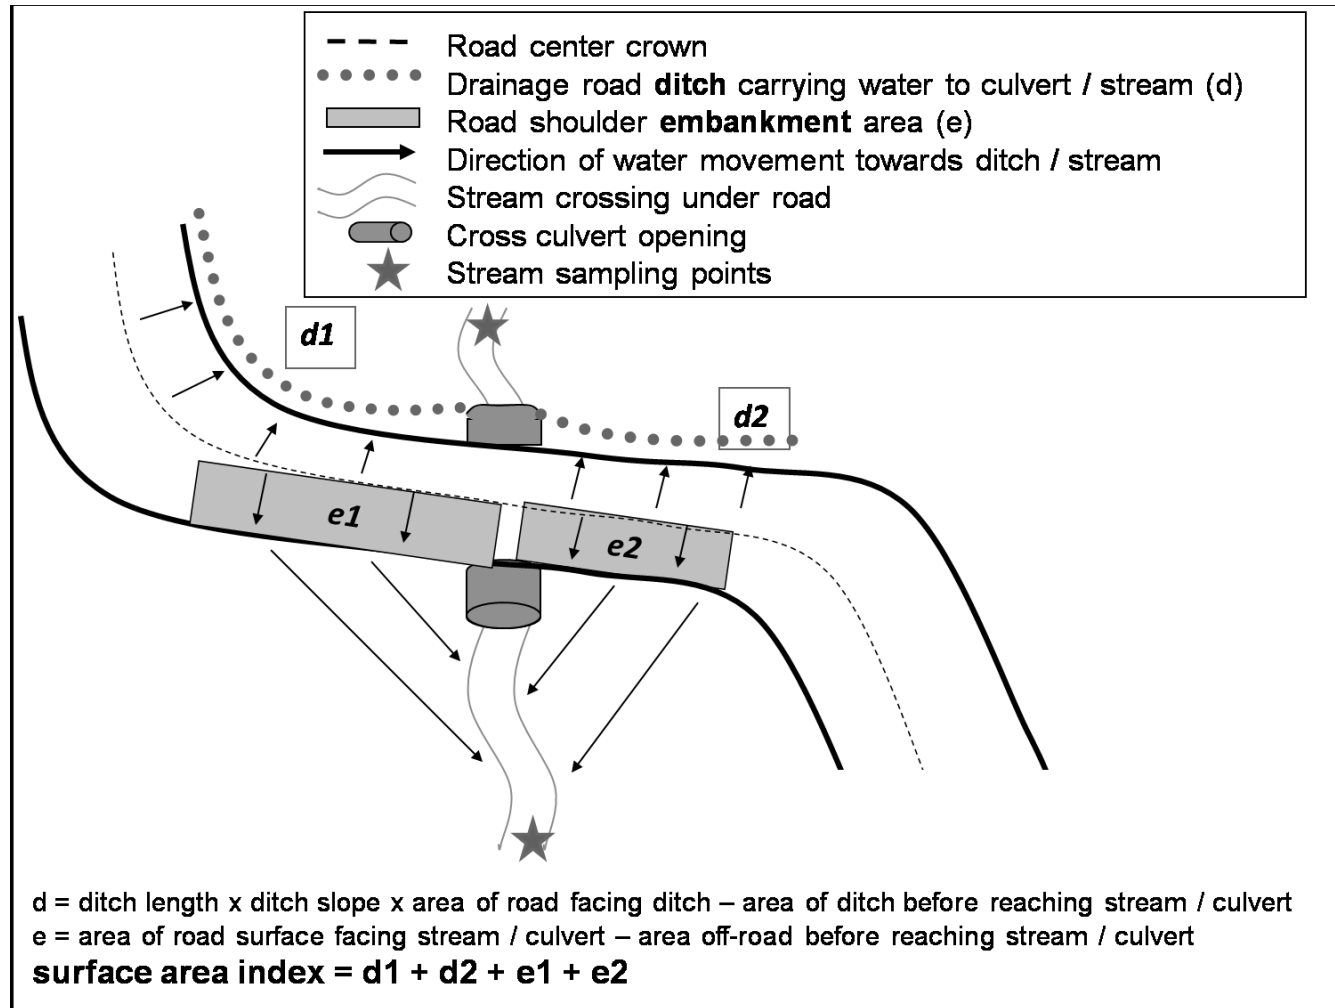
Figure 3.1 Measurements and equations used to calculate surface area index values for use in statistical models to predict downstream electrical conductivity (EC), chloride and magnesium concentrations of 16 stream sampling sites in Larimer and Grand Counties, Colorado sampled for surface water chemistry up and downstream of  $\text{MgCl}_2$  treated roads in 2004 and 2005.

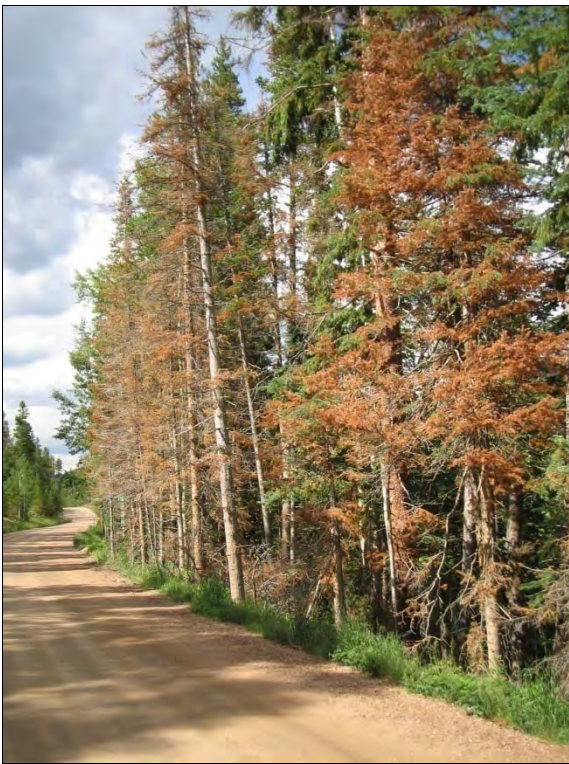
Figure 6.5. Downslope Engelmann spruce / subalpine fir roadside vegetation health plot with visible foliar damage.

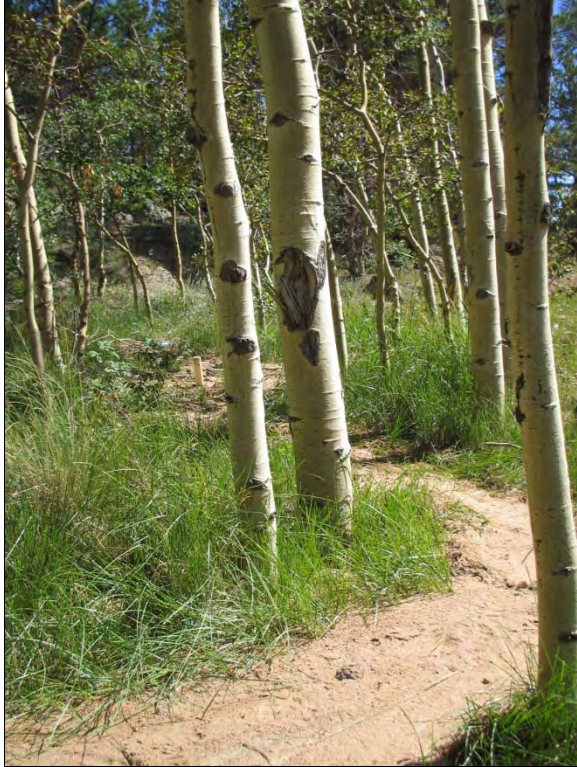
Figure 6.9. Trembling aspen drainage vegetation health plot with sediment on ground.

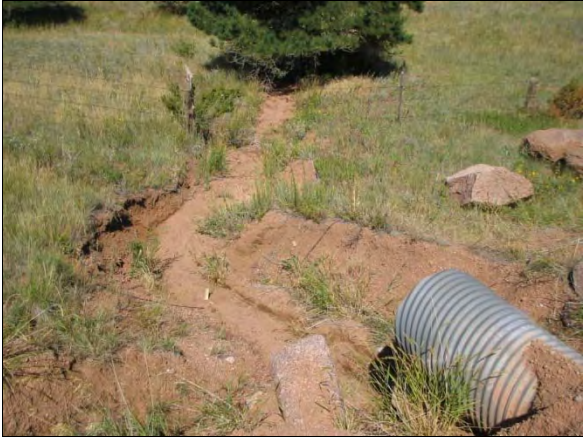
Figure 6.11. Non-forested, shrubland drainage plot with culvert.

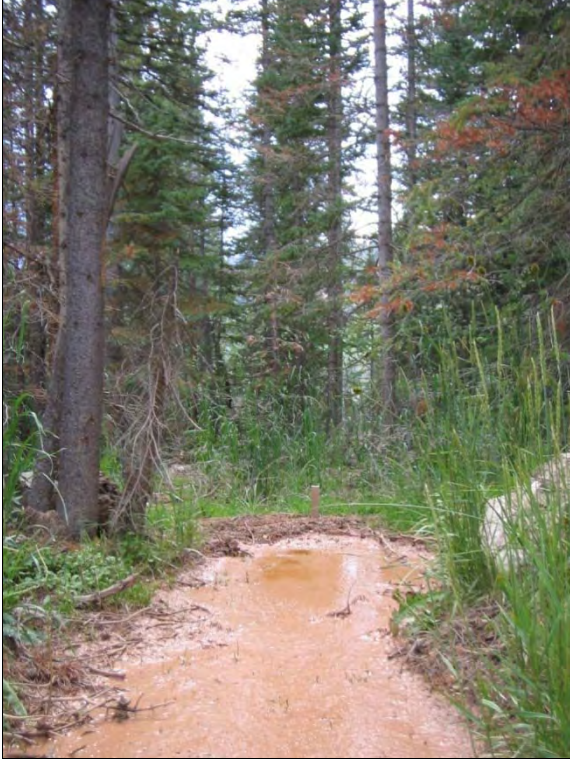
Figure 6.13. Sediment and water in Engelmann spruce / subalpine fir-dominated drainage vegetation health plot.

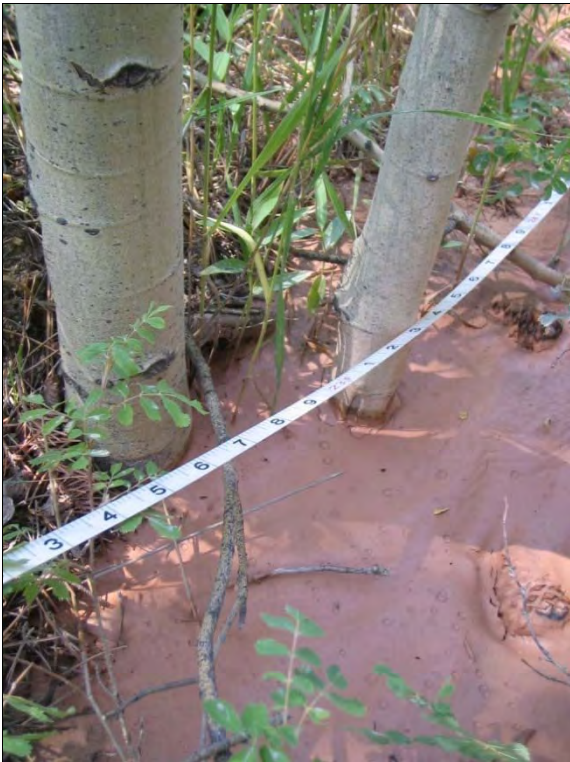
Figure 6.14. Sediment buildup from road material at bases of aspen trees in drainage vegetation health plot.

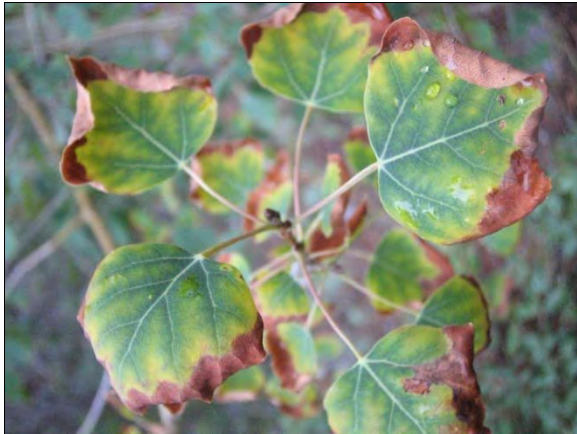
Figure 6.15. Marginal burning on trembling aspen leaves.

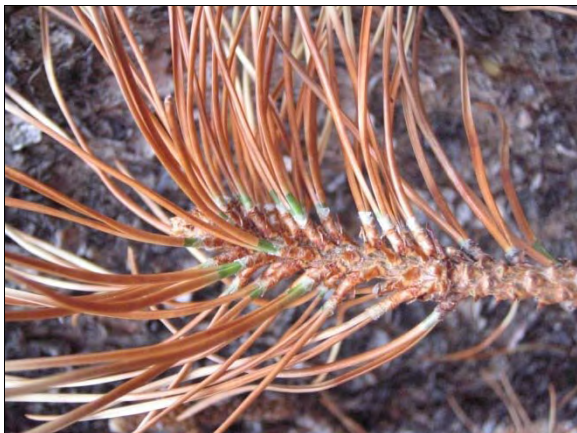
Figure 6.16. Close to complete needle burn on lodgepole pine.

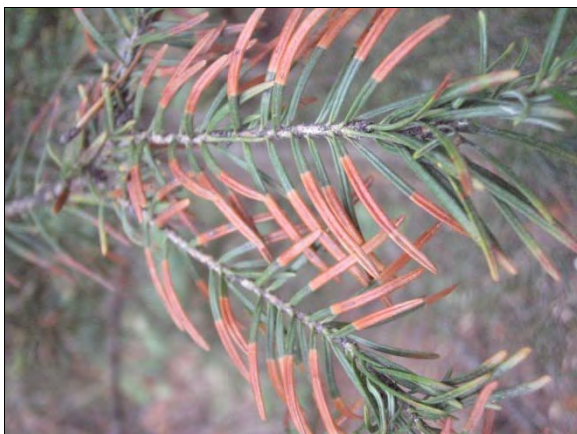
Figure 6.17. Needle tip burn on subalpine fir.

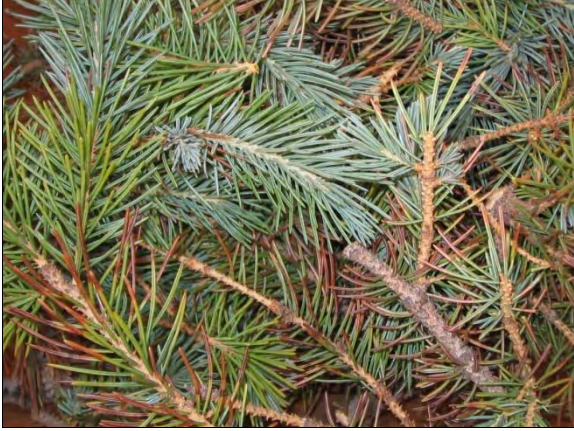
Figure 6.18. Needle burn on older needle growth of Engelmann spruce foliar samples.

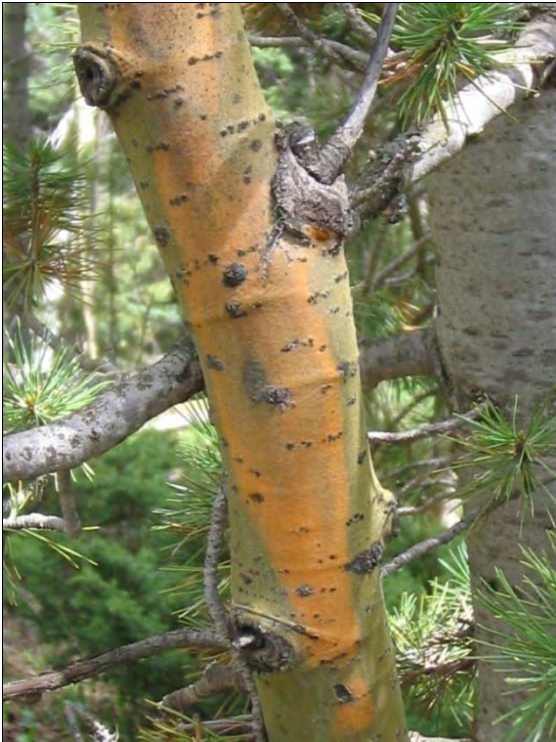
Figure 6.19. *Cytospora* canker on trembling aspen stem.

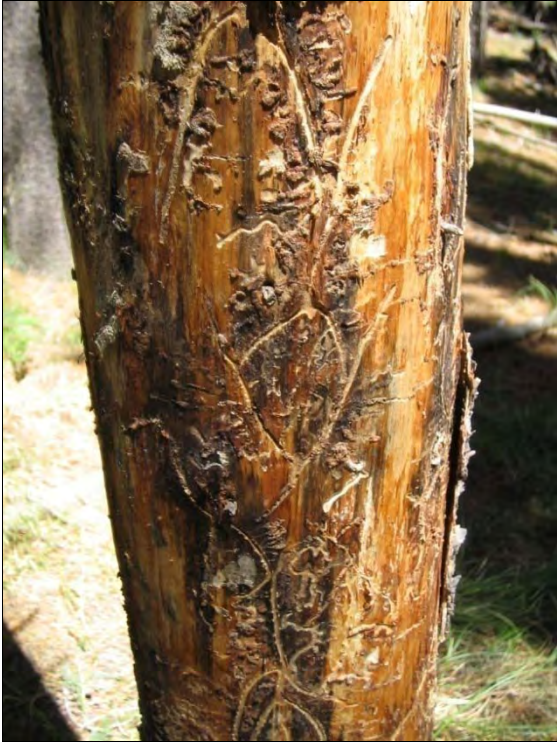
Figure 6.20. Bark beetle galleries on lodgepole pine stem.

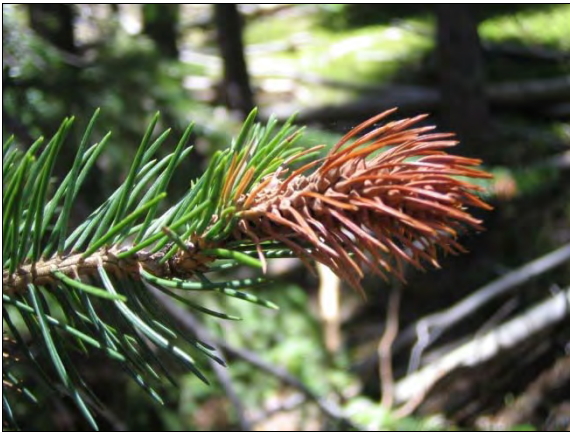
Figure 6.21. Symptoms of Cooley spruce gall adelgid on Engelmann spruce branch tip.

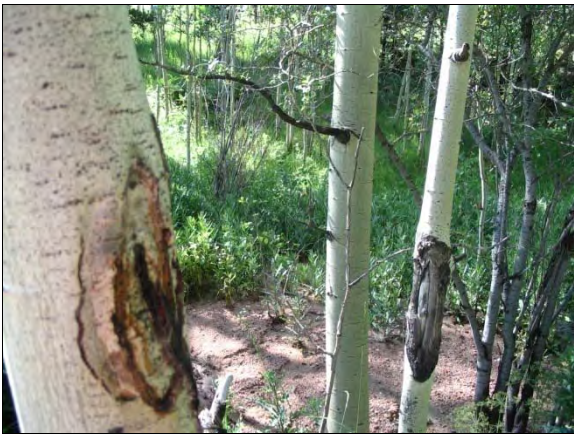
Figure 6.23. Stem cankers and animal damage on aspen stems.

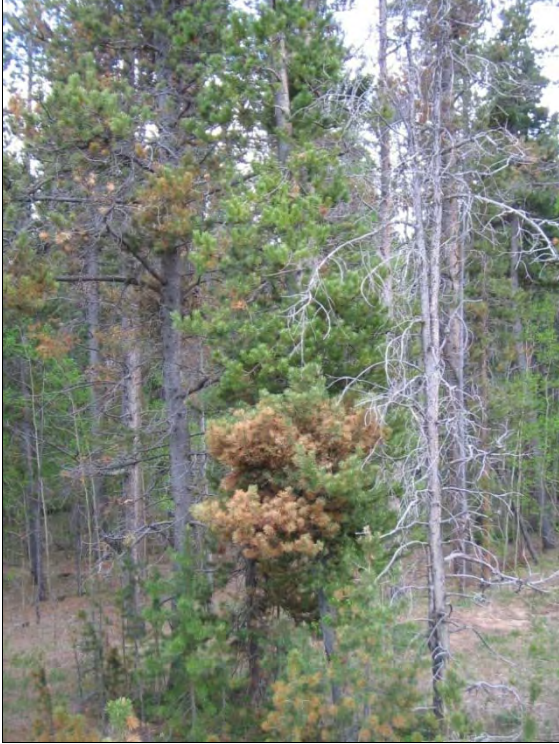
Figure 6.24. Dwarf mistletoe foliar brooms on lodgepole pine.

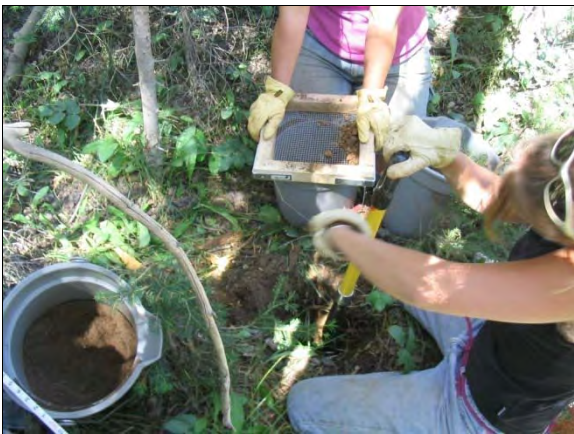
Figure 6.25. Collecting and sieving soil samples in the field.

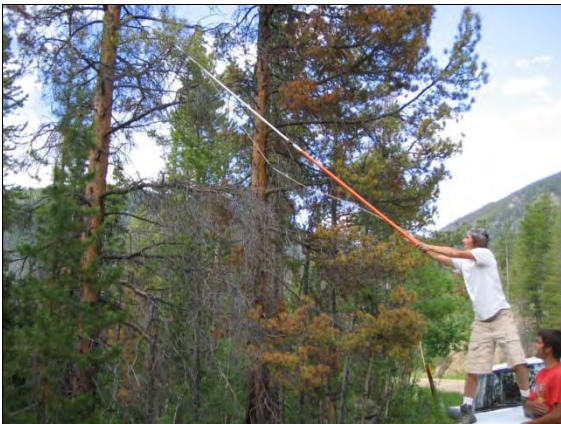
Figure 6.28. Collecting foliar samples with a pole pruner.

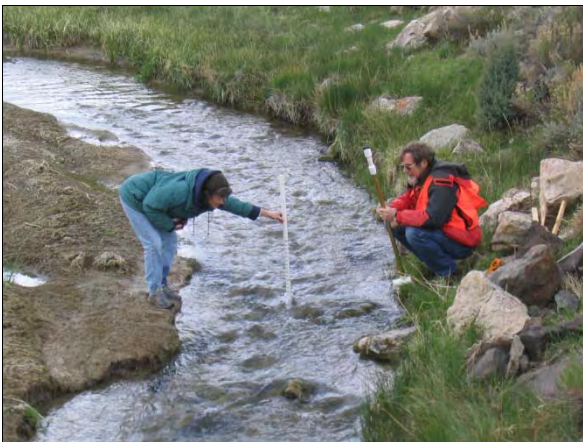
Figure 6.30. Measuring stream depth and water flow in the field.

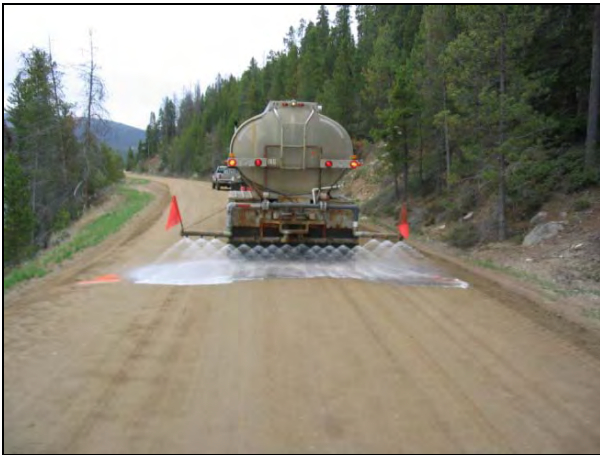
Figure 6.32. Magnesium chloride-based dust suppression product application.
