R5-TP-026b

# Home Destruction Examination

## Grass Valley Fire

Lake Arrowhead, CA

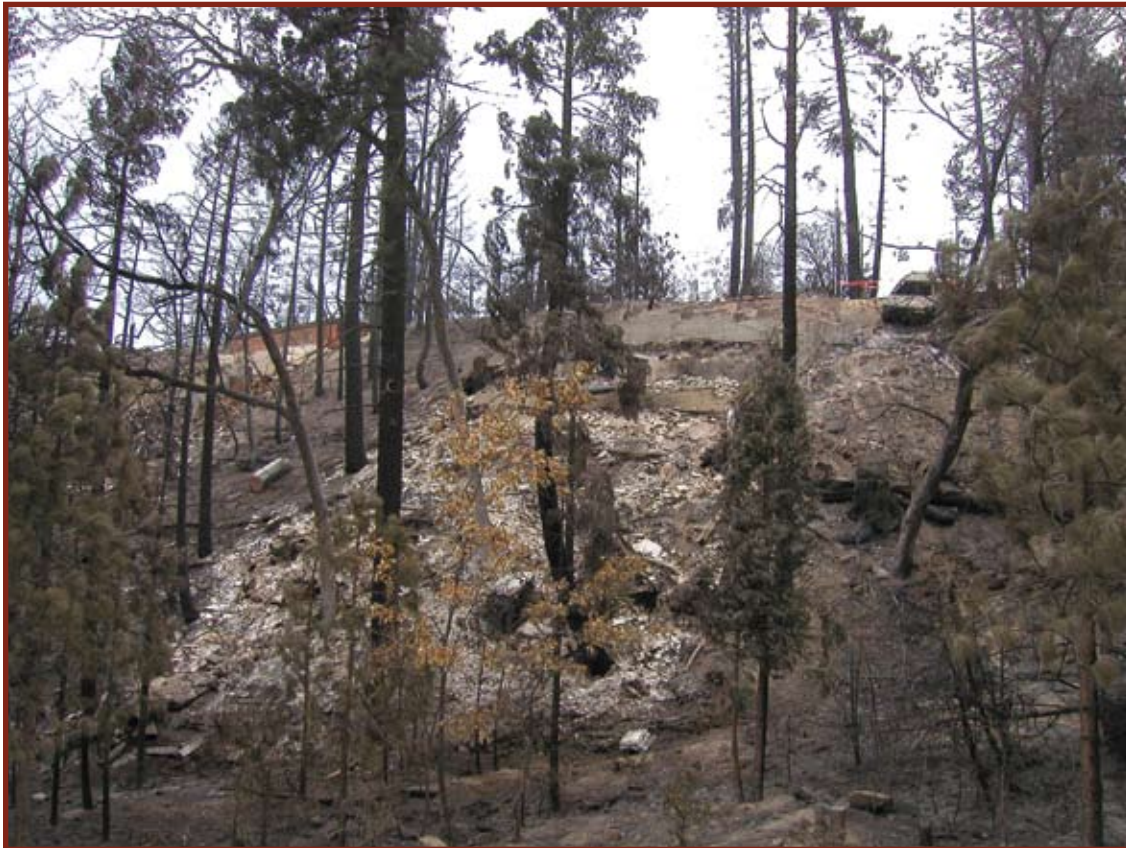
The steep terrain likely increased fire spread and firebrand production and lofting as well as the downhill cascade of collapsed burning debris (Figure 16). All of these factors result in a 'domino effect' of home destruction (Figures 17 and 18). Although there were significant tactical successes that stopped fire from spreading further along a street, the suppression forces were strategically overwhelmed, due to multiple homes burning simultaneously with little chance of preventing the disaster.

**Figure 16.** Photo of 26787 Merced Ln. from Trinity Dr. Note the steep slope (35-40°) with the remaining debris from the collapsed home spread down the hill.

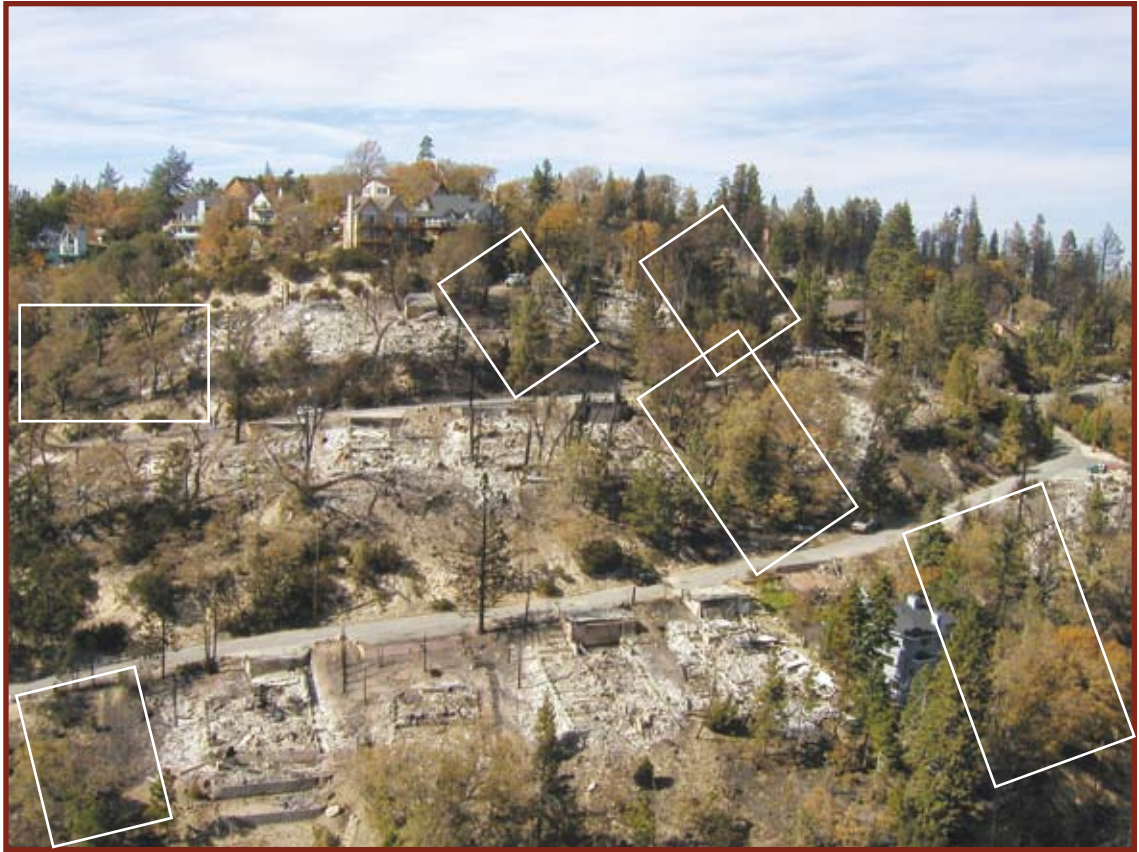
**Figure 20.** Aerial view facing west with Madera Ln. at the bottom, Del Norte Ln. in the middle, and Sonoma Dr. just below the homes at the top of the hill (Kings Ct.). Note the unconsumed vegetation between the destroyed homes, particularly in the vacant parcels that were burned by surface fire (framed areas).

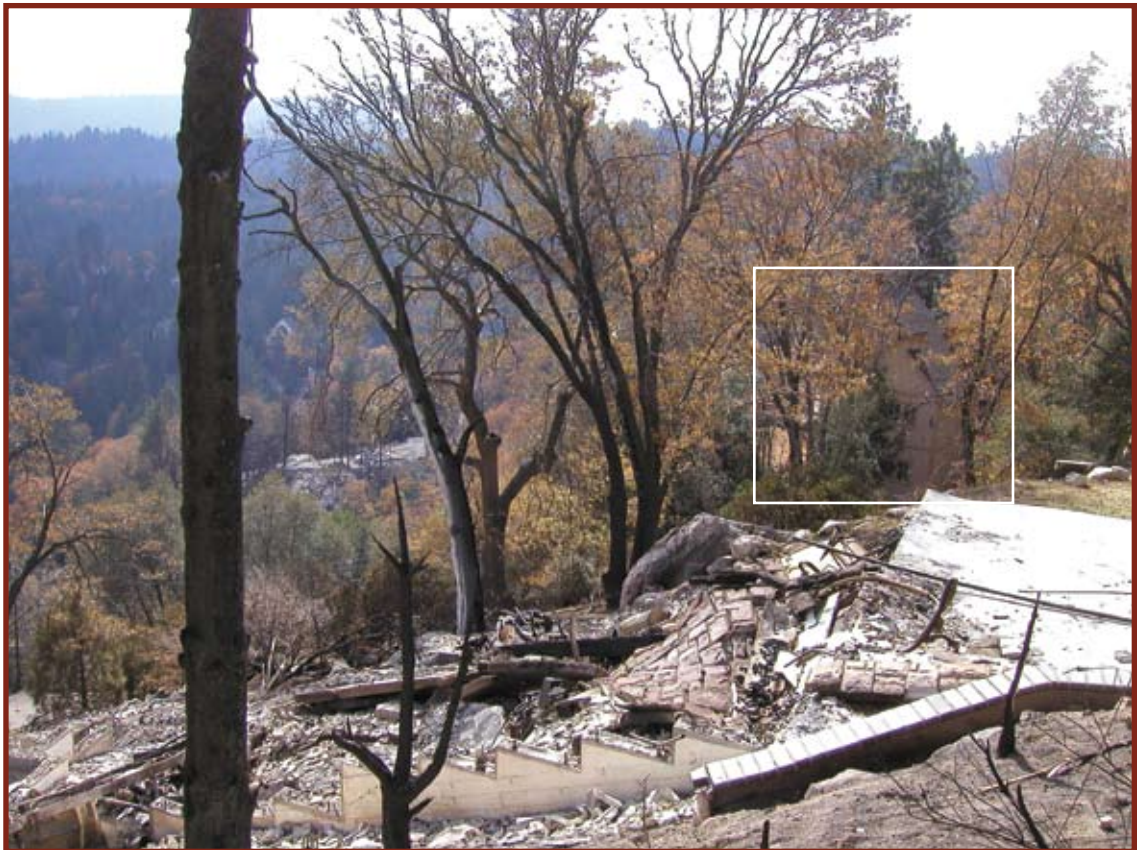
**Figure 21.** Destroyed homes at 899 and 905 Sonoma Dr. looking southwest through two vacant parcels that surface burned with an undamaged home (framed) in the background (875 Sonoma).

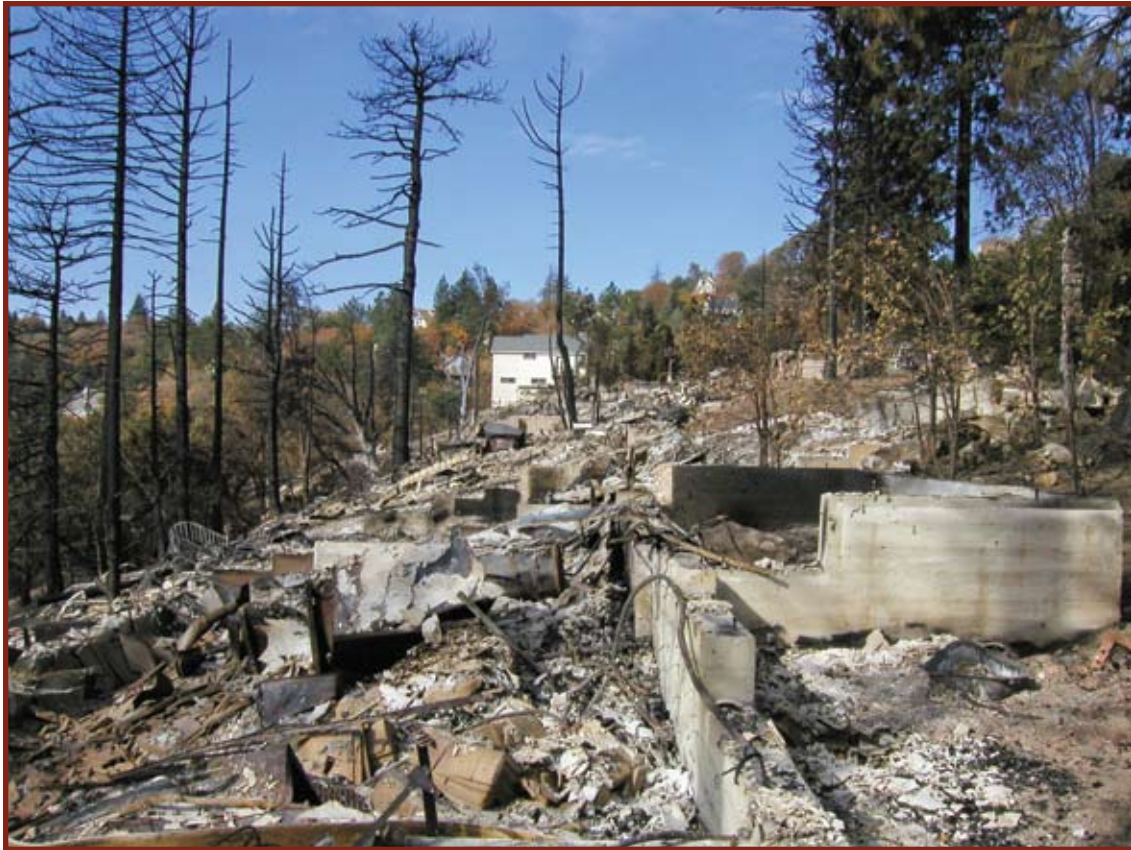
**Figure 26.** View looking west through seven destroyed homes on Merced Ln. to the white house at 26665.

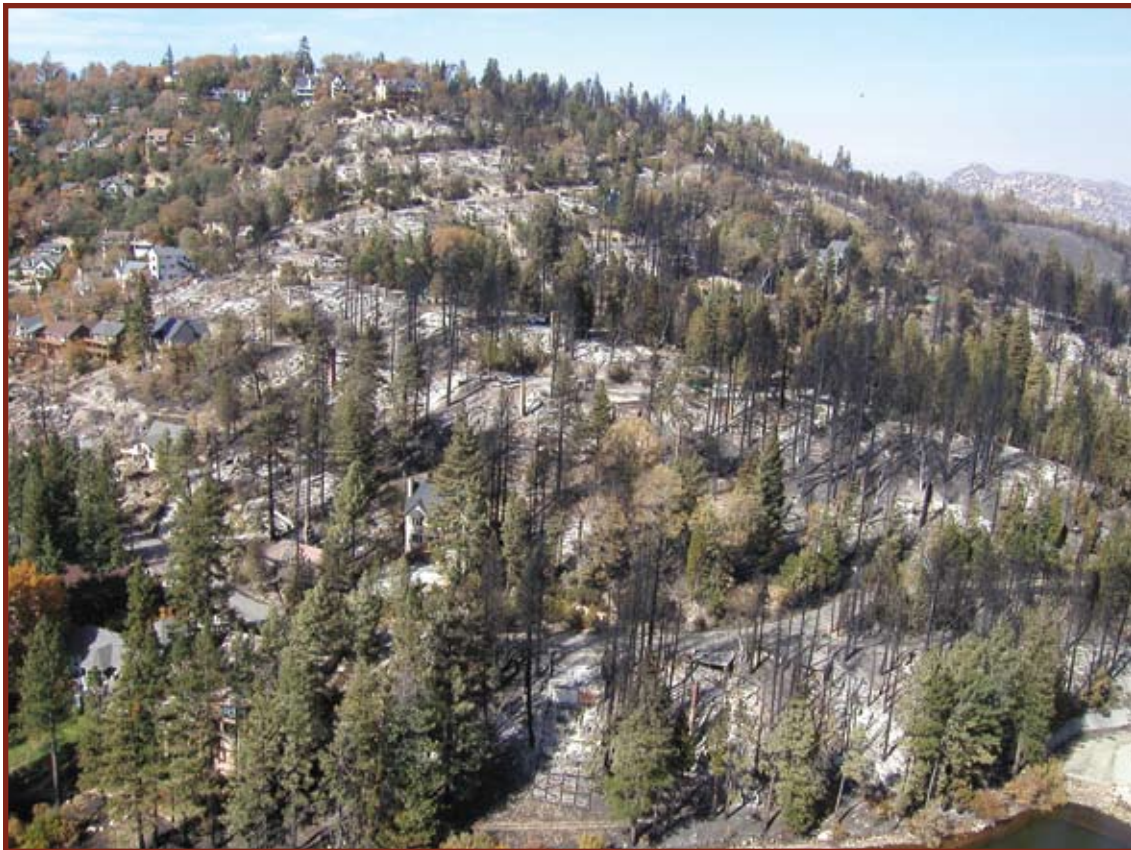
**Figure 27.** Aerial view to the northwest of homes on Brentwood Dr. (bottom) and Modoc Ln. (center). Areas with blackened trees are a result of the homes burning the vegetation. At about 1100, the wind shifted north-northwesterly, spreading fire and firebrands downhill to the southeast.

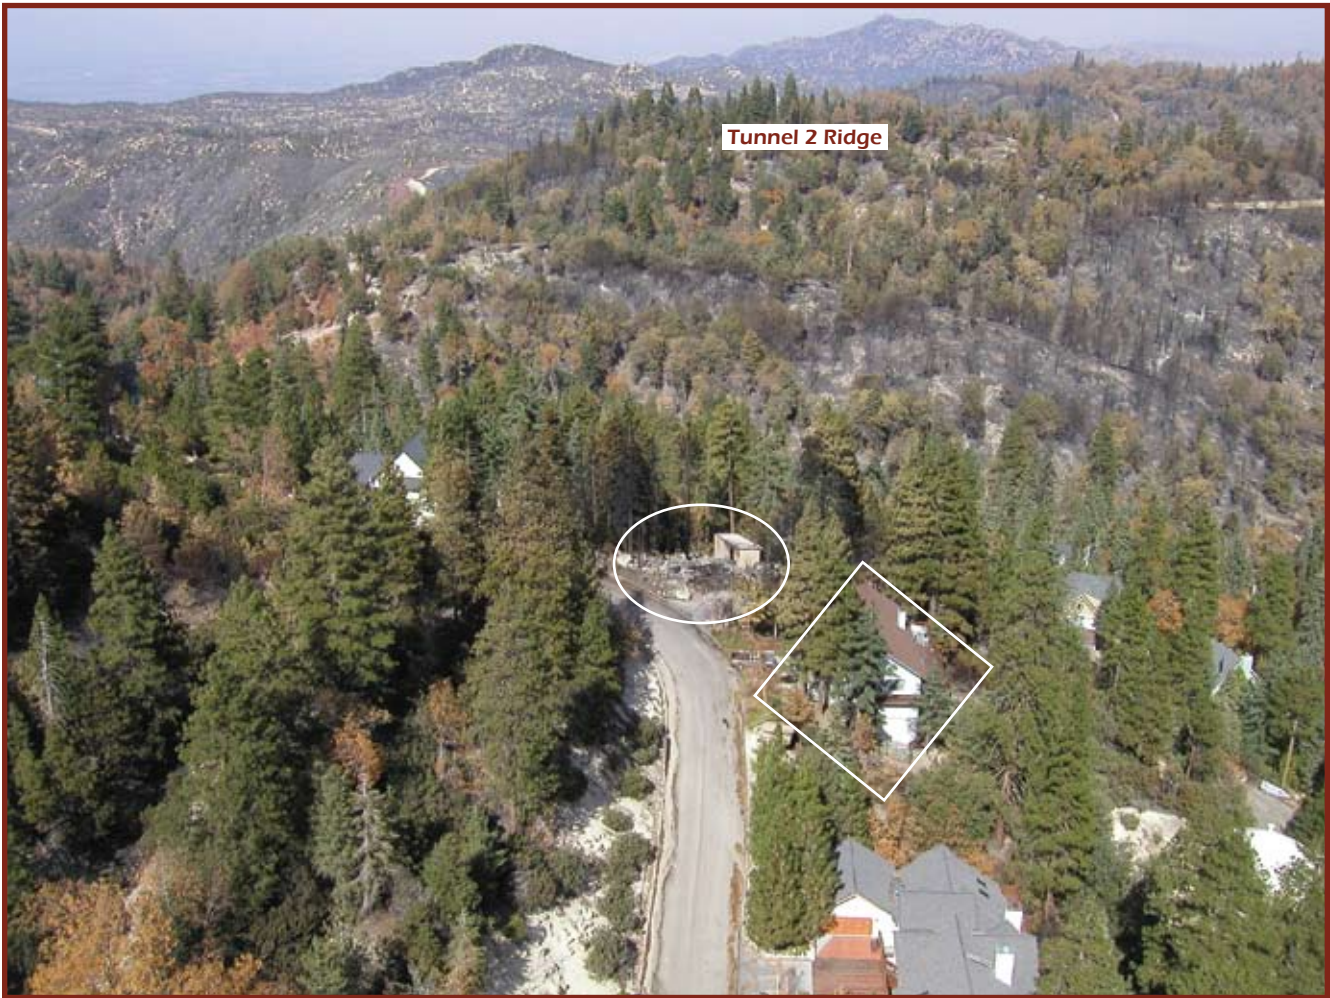
Firebrands, possibly from an area of torching across the drainage from Walnut Hills Dr. (Tunnel 2 Ridge) (Figure 31), started several spot fires upslope of Fairway Dr. Surface fire and/or firebrand(s) destroyed 26088 (Figure 33); 26142 (Figure 32). Surface fire and/or firebrand(s) destroyed 26088 (Figure 33); 26150 Walnut Hills (Figure 31) it was severely damaged on the sides exposed to 26142 (Figure 32). Surface fire and/or firebrand(s) destroyed 26088 (Figure 33); 26305 received minor exterior damage.

**Figure 31.** Aerial view looking northwest up Walnut Hills Dr. to destroyed home at 26142 (circled) and damaged home at 26150 (framed). Tunnel 2 Ridge is directly across drainage and shows evidence of group tree torching.
