RE: Ongoing landslides and sedimentation from logging in Daniel Boone National Forest

Observed Landslides in Logging Sites Group One Project Redbird Ranger District Daniel Boone National Forest

Lower Jack's Branch
Group One Redbird Project
Shelterwood Unit 18
Harvested 2018

Ulysses Creek
Group One Redbird Project
Shelterwood Unit 20
Harvested 2012

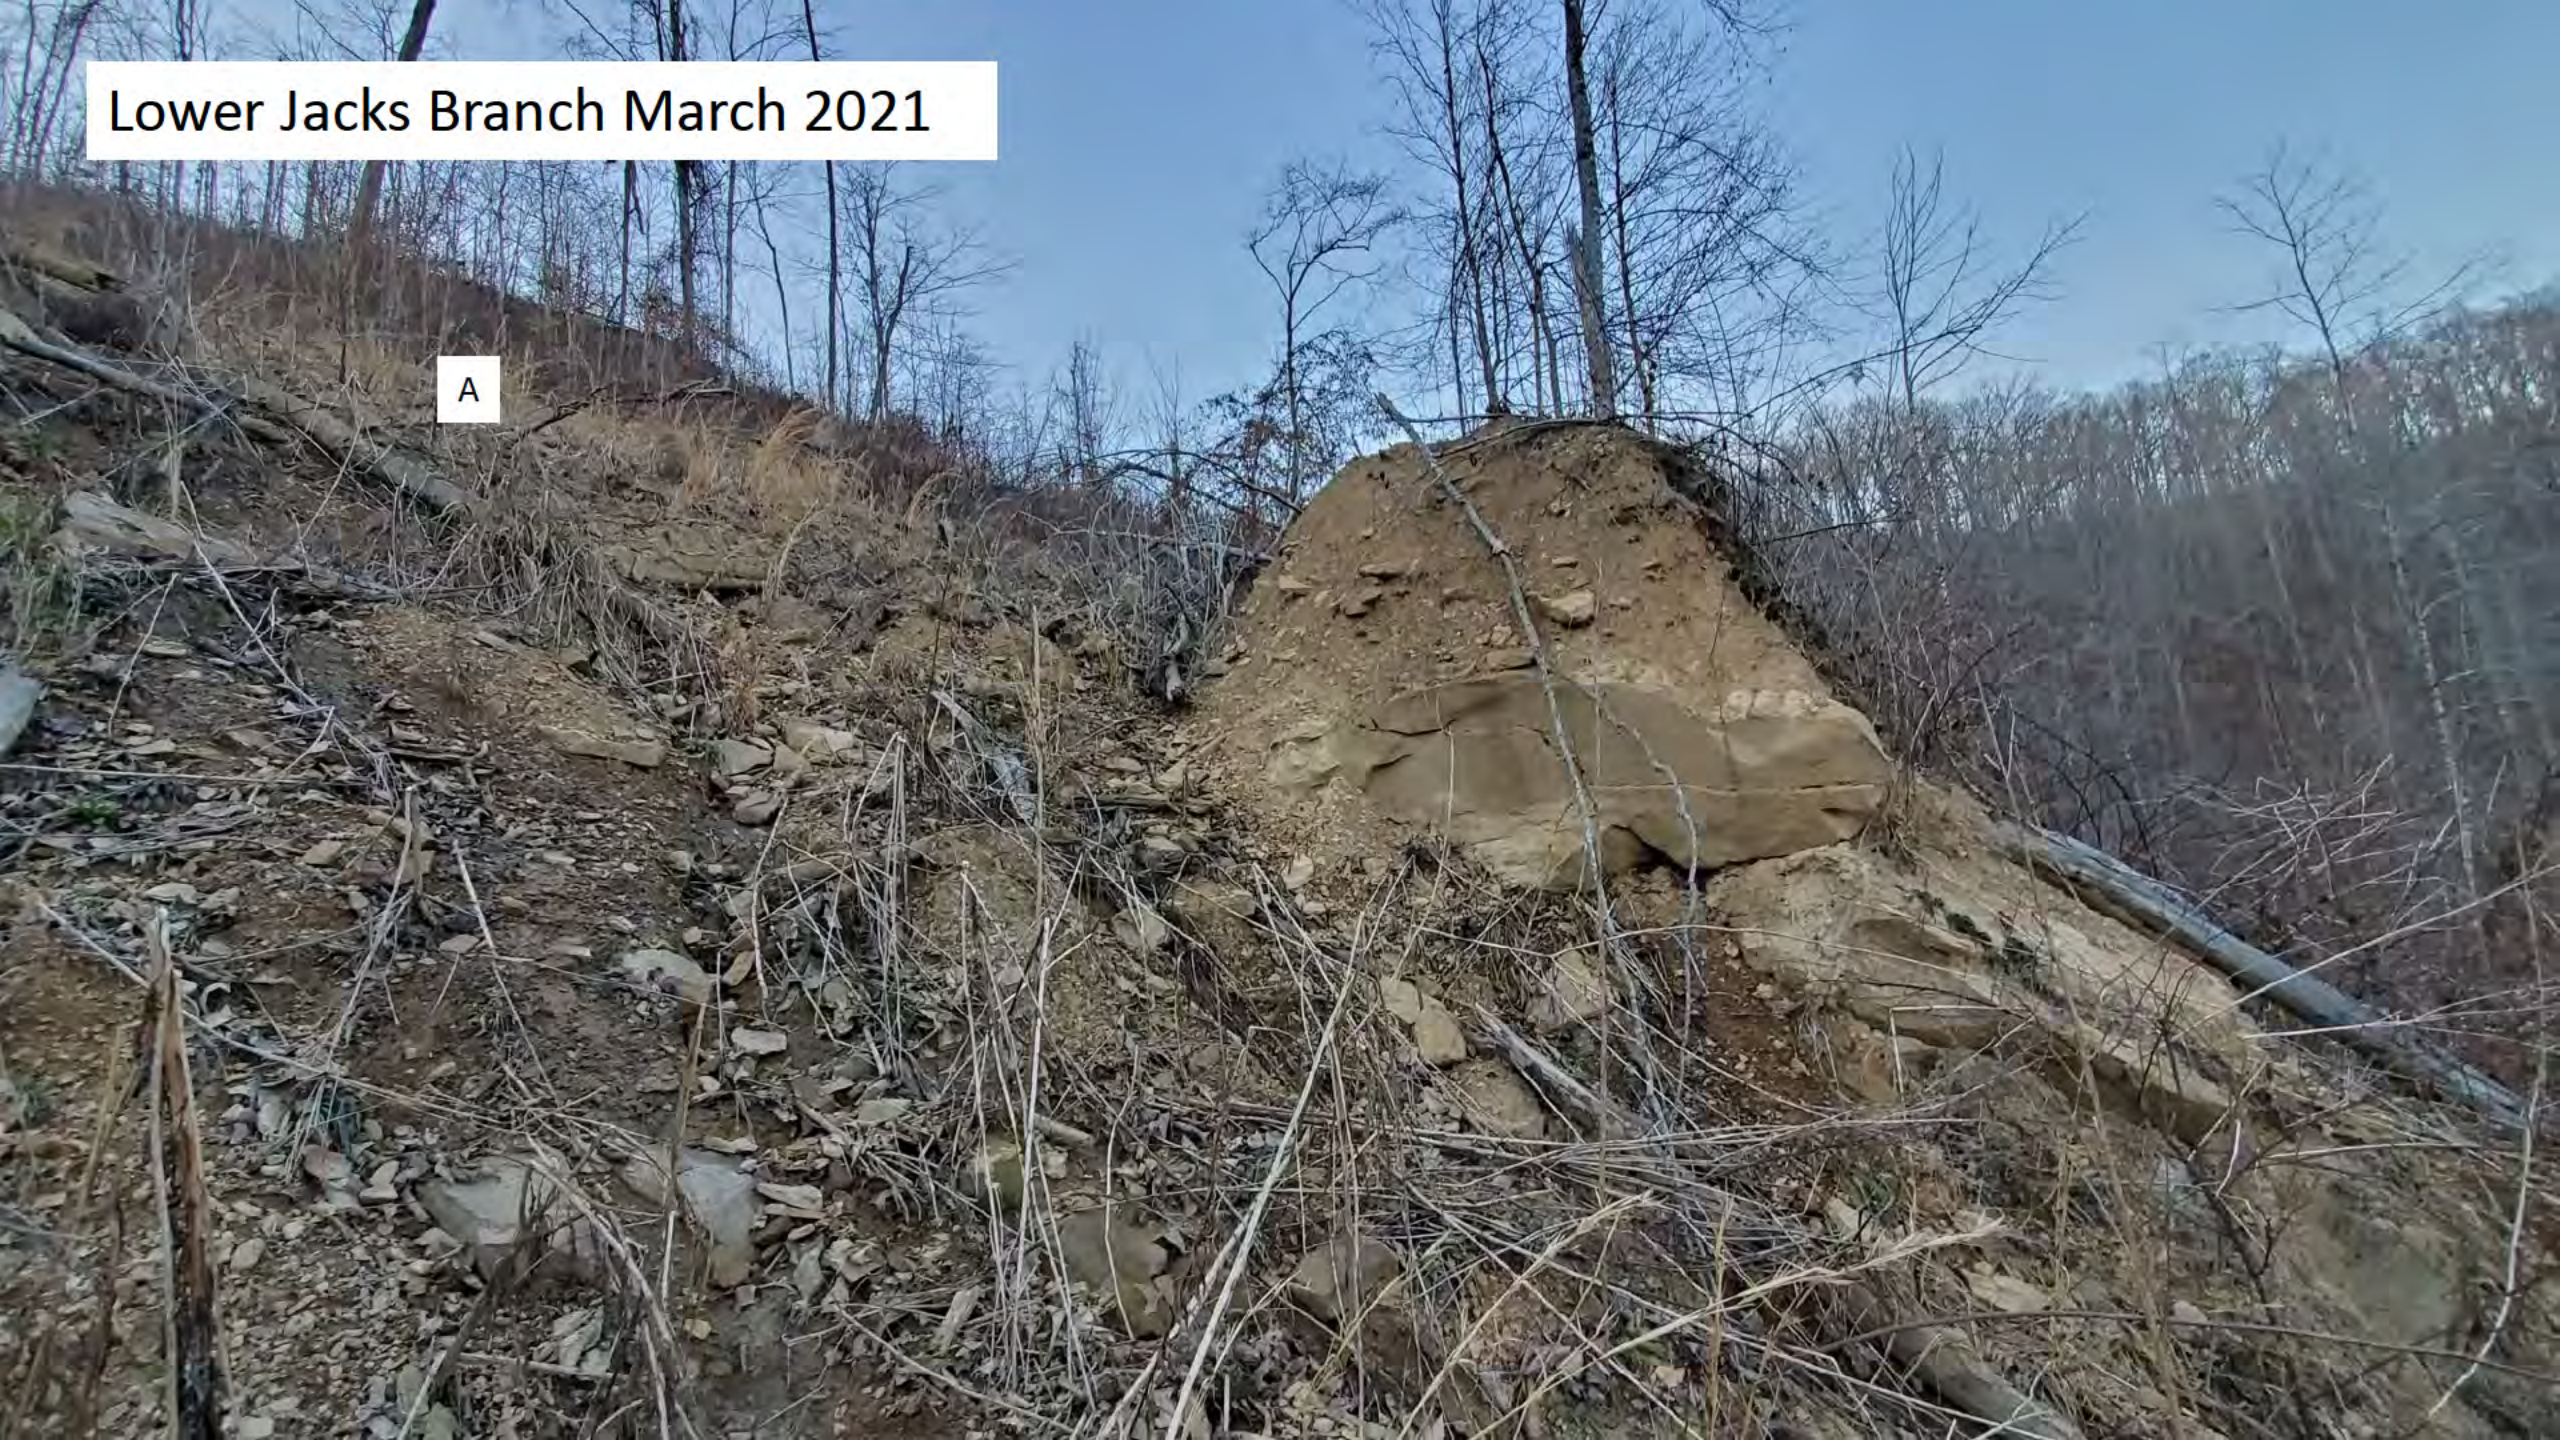
Ulysses Creek Unit 20 landslides first reported to Daniel Boone National Forest in March 2020
Landslides in Ulysses Creek Unit 14 (not pictured here) reported in December 2019

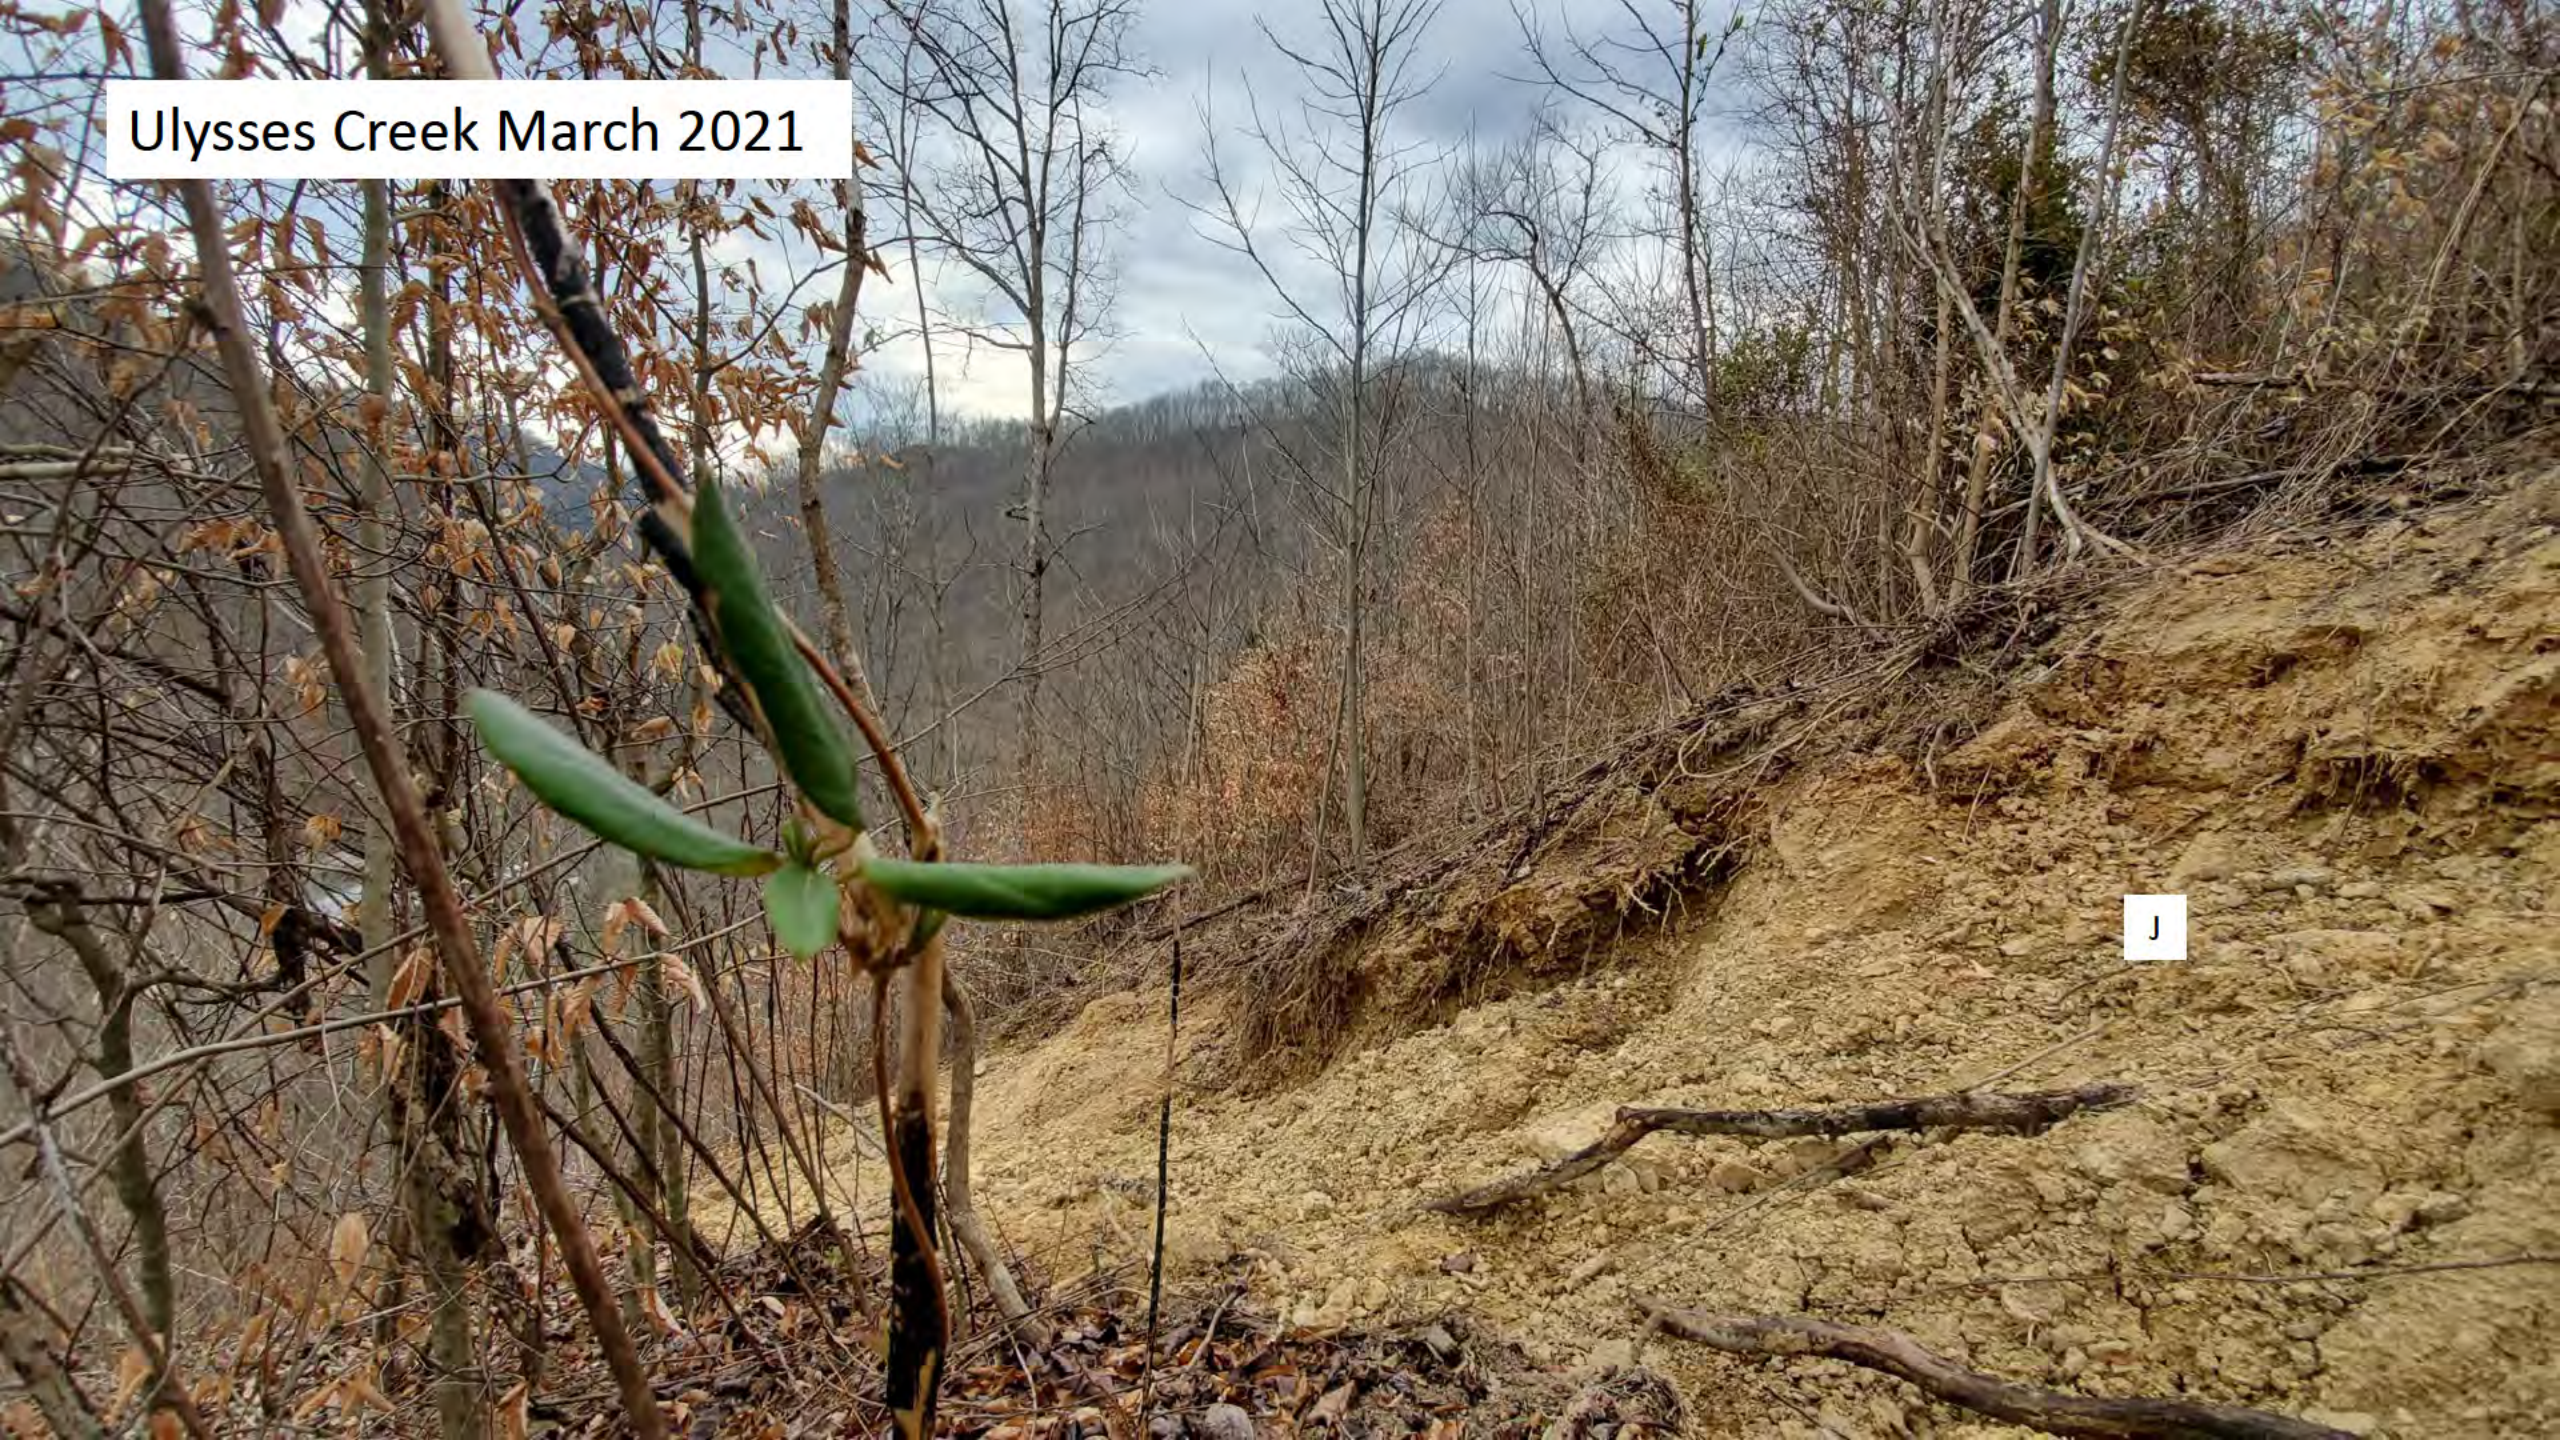
Ulysses Creek March 2021

A photograph of a steep, eroded bank of Ulysses Creek in March 2021. The bank is composed of light brown soil and numerous flat, layered rocks. A white label 'F' is placed on the bank. The top of the bank is lined with bare trees and a fallen log.

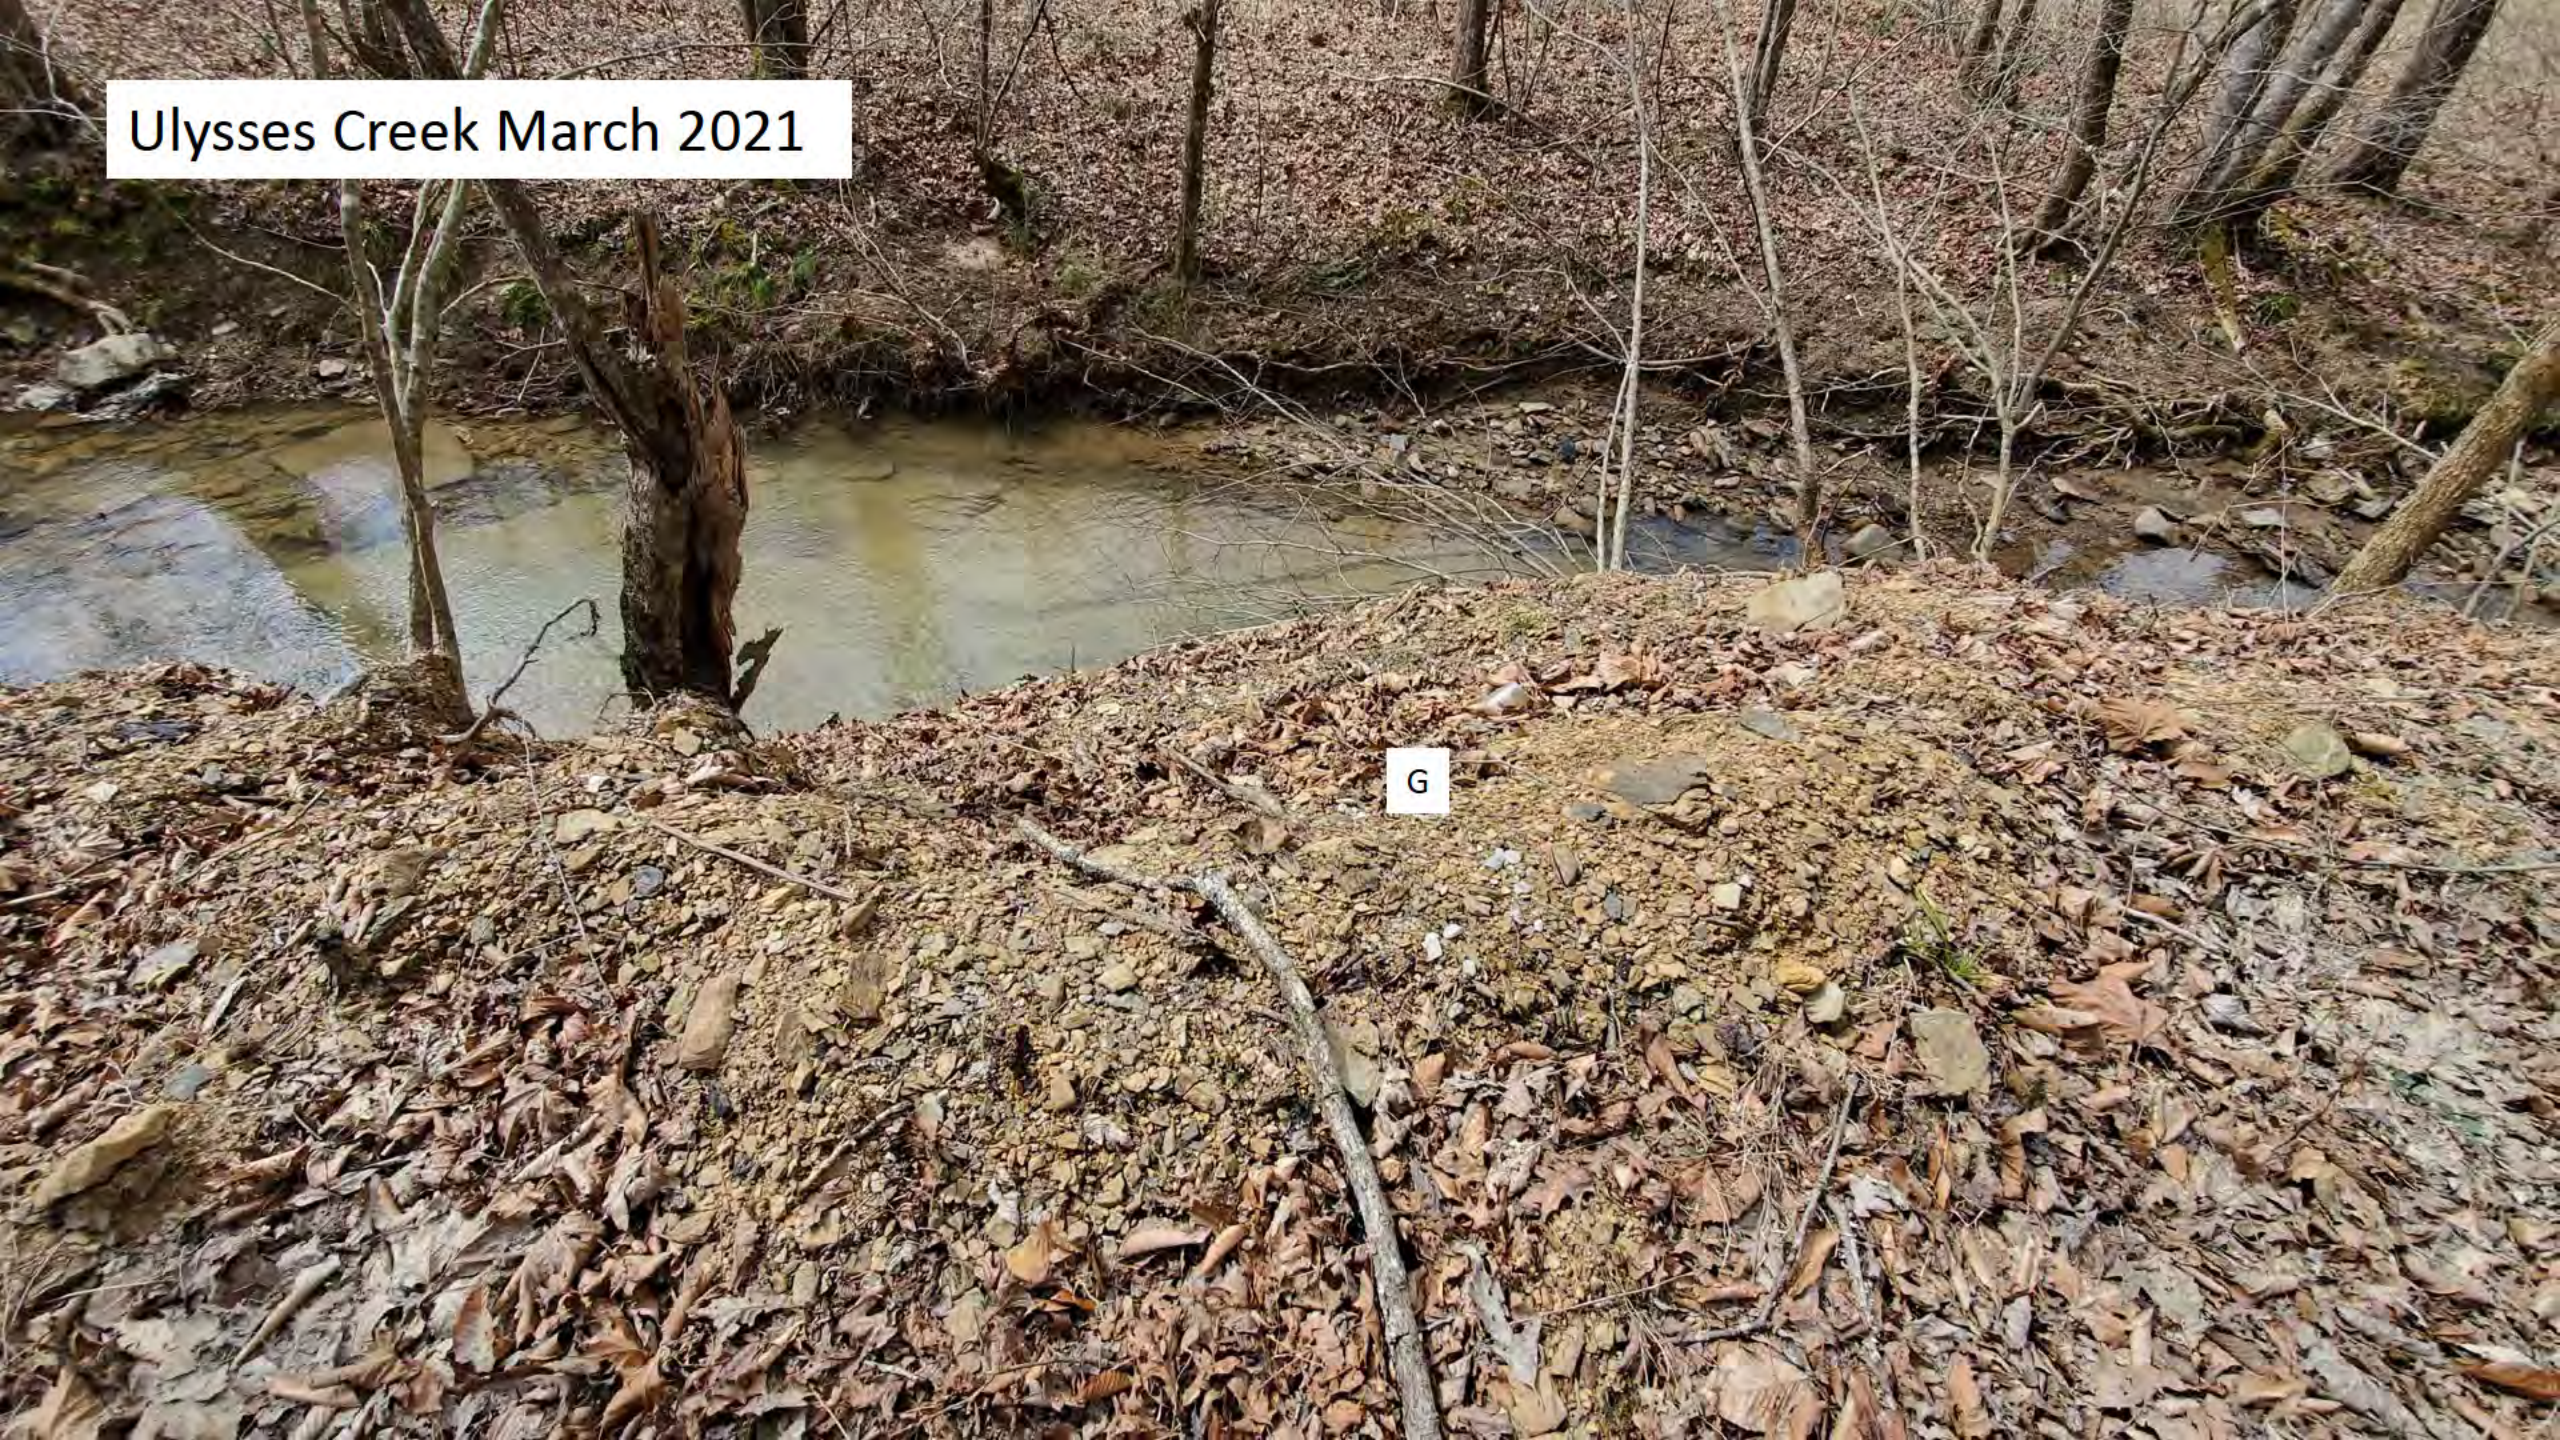
Lower Jack's Branch
Group One Redbird Project
Shelterwood Unit 17
Harvested 2017

Primary landslide measures over 1000 feet of slope distance. Observed sedimentation not completely denoted because of extreme amount of sediment transported in this landslide.

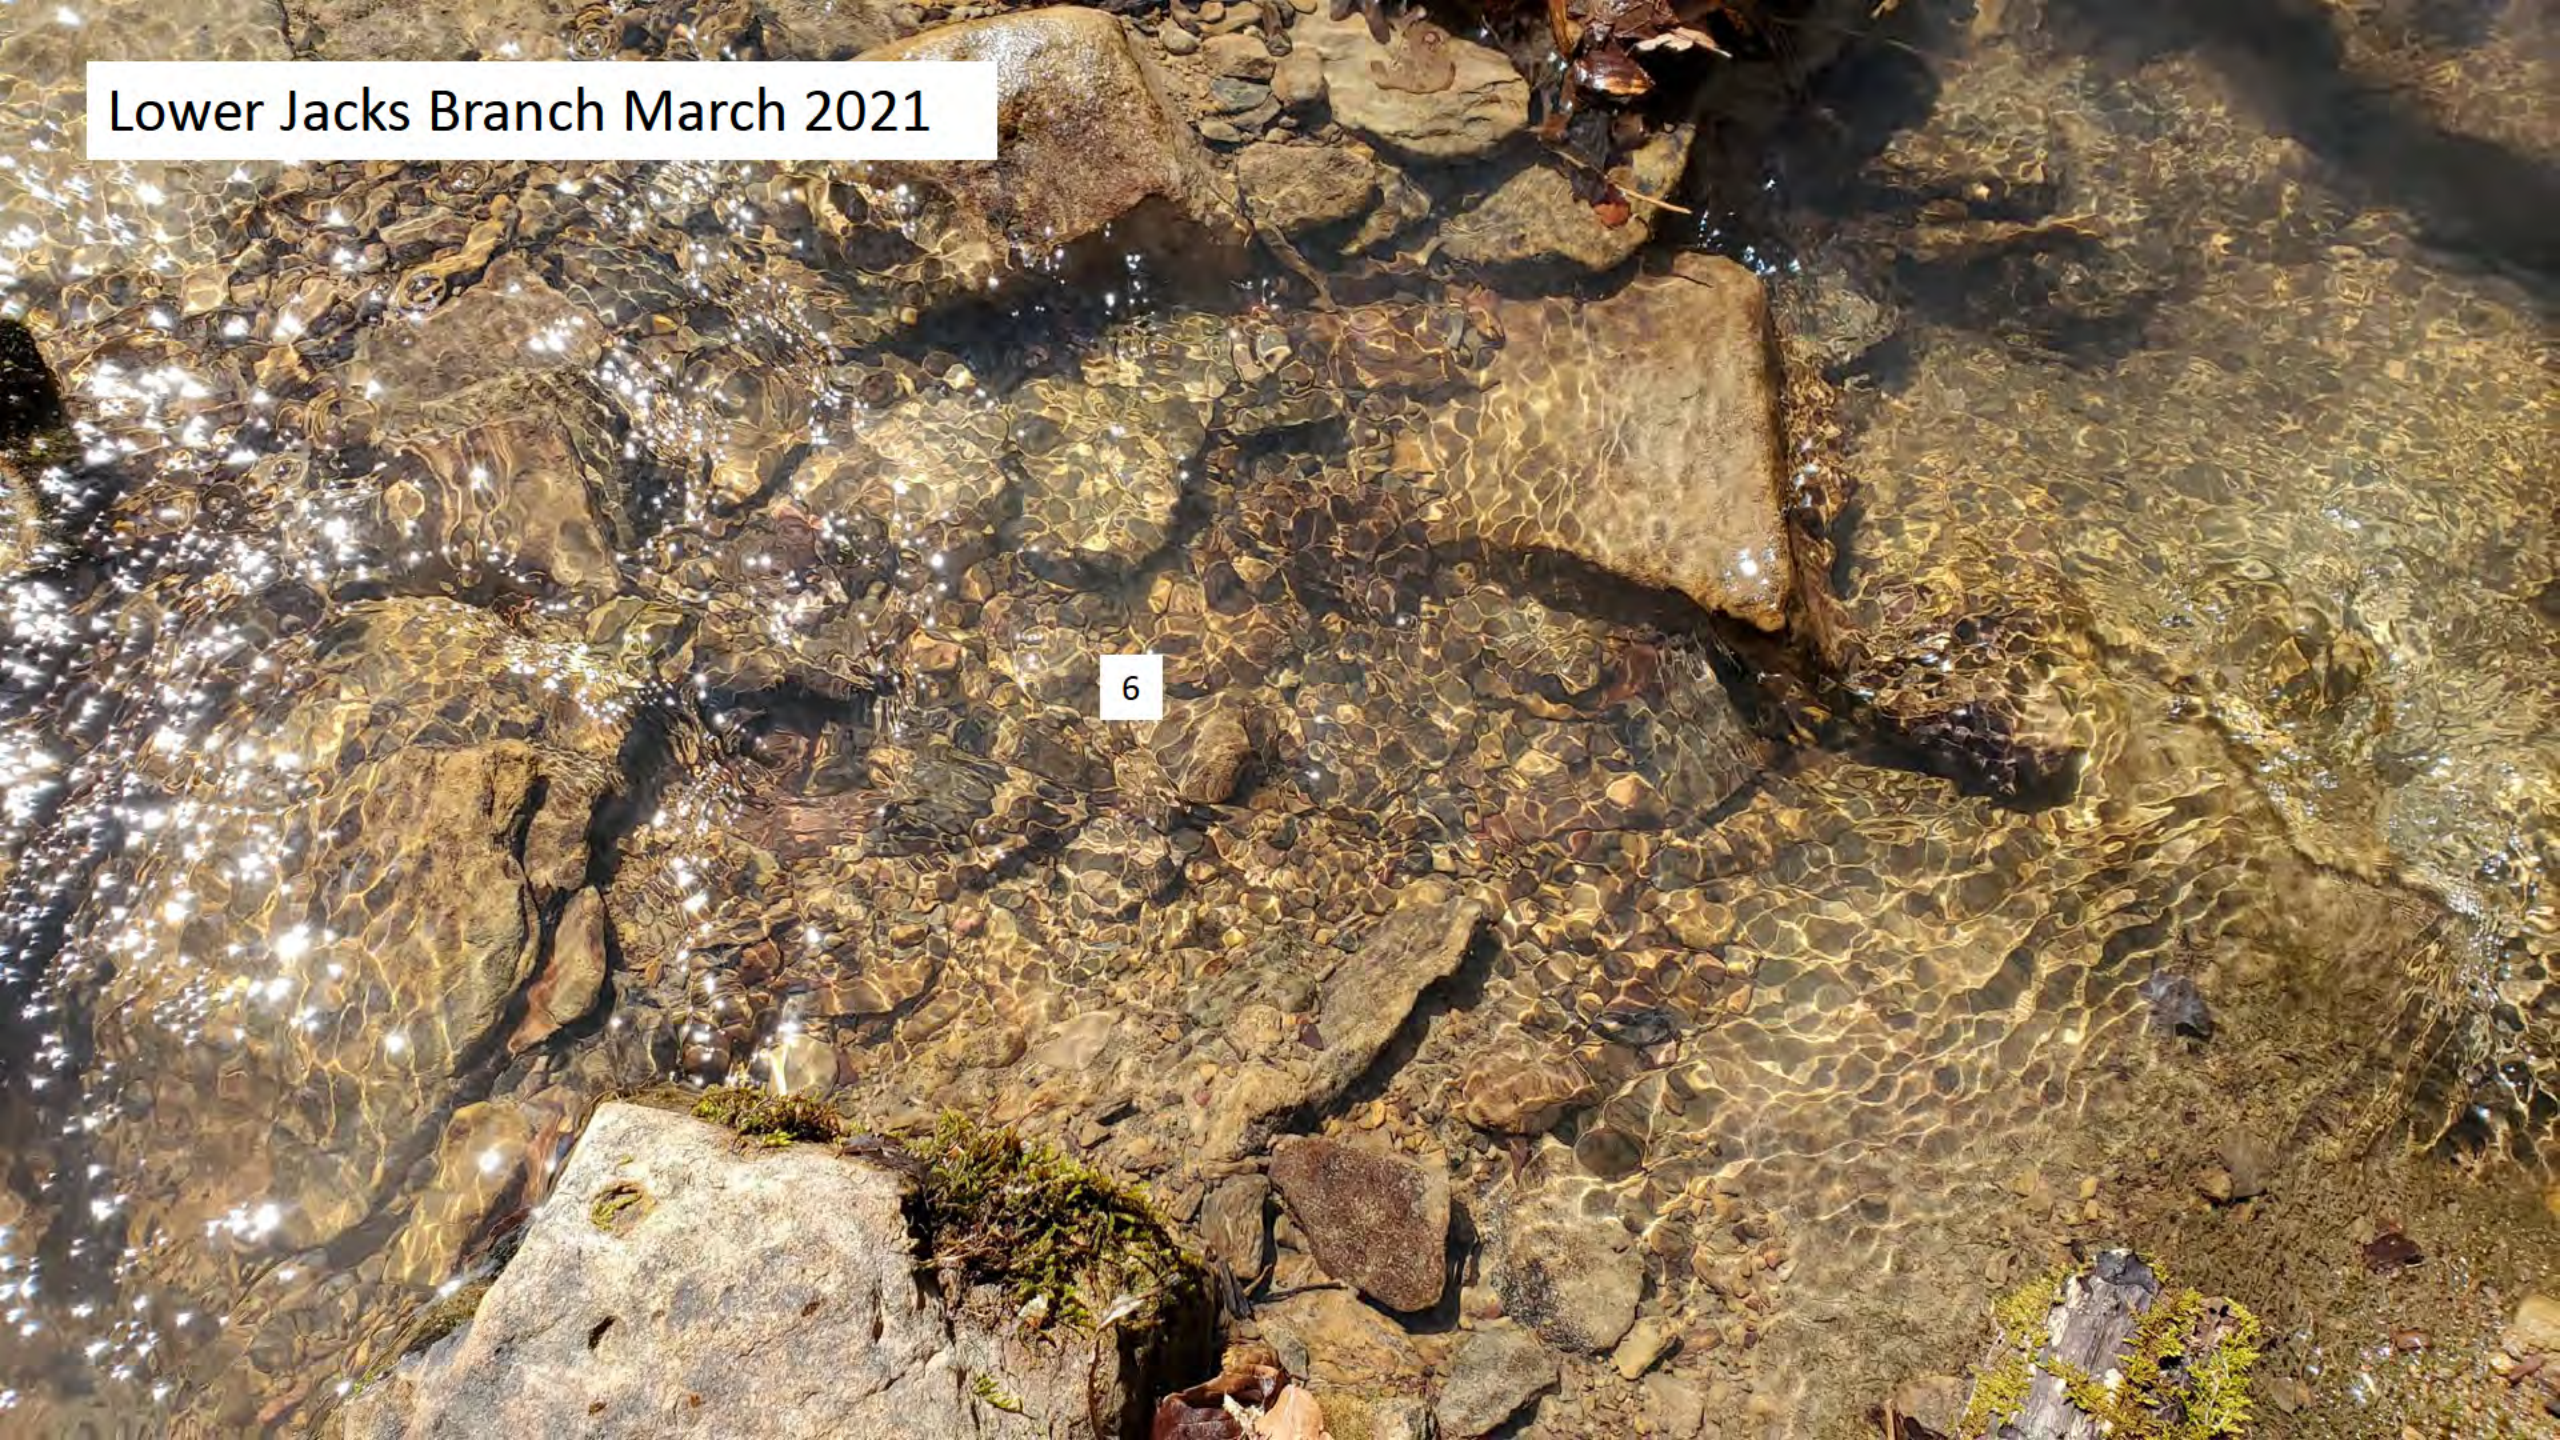
Granny's Branch
Group One Redbird Project
Shelterwood Unit 13
Harvested 2017

Harvest extends to the very edge of a bench mine wall, with slash and debris piled over the edge and sedimentation down wall at several points. Documented landslide flows into upper tributary of Granny's Branch.

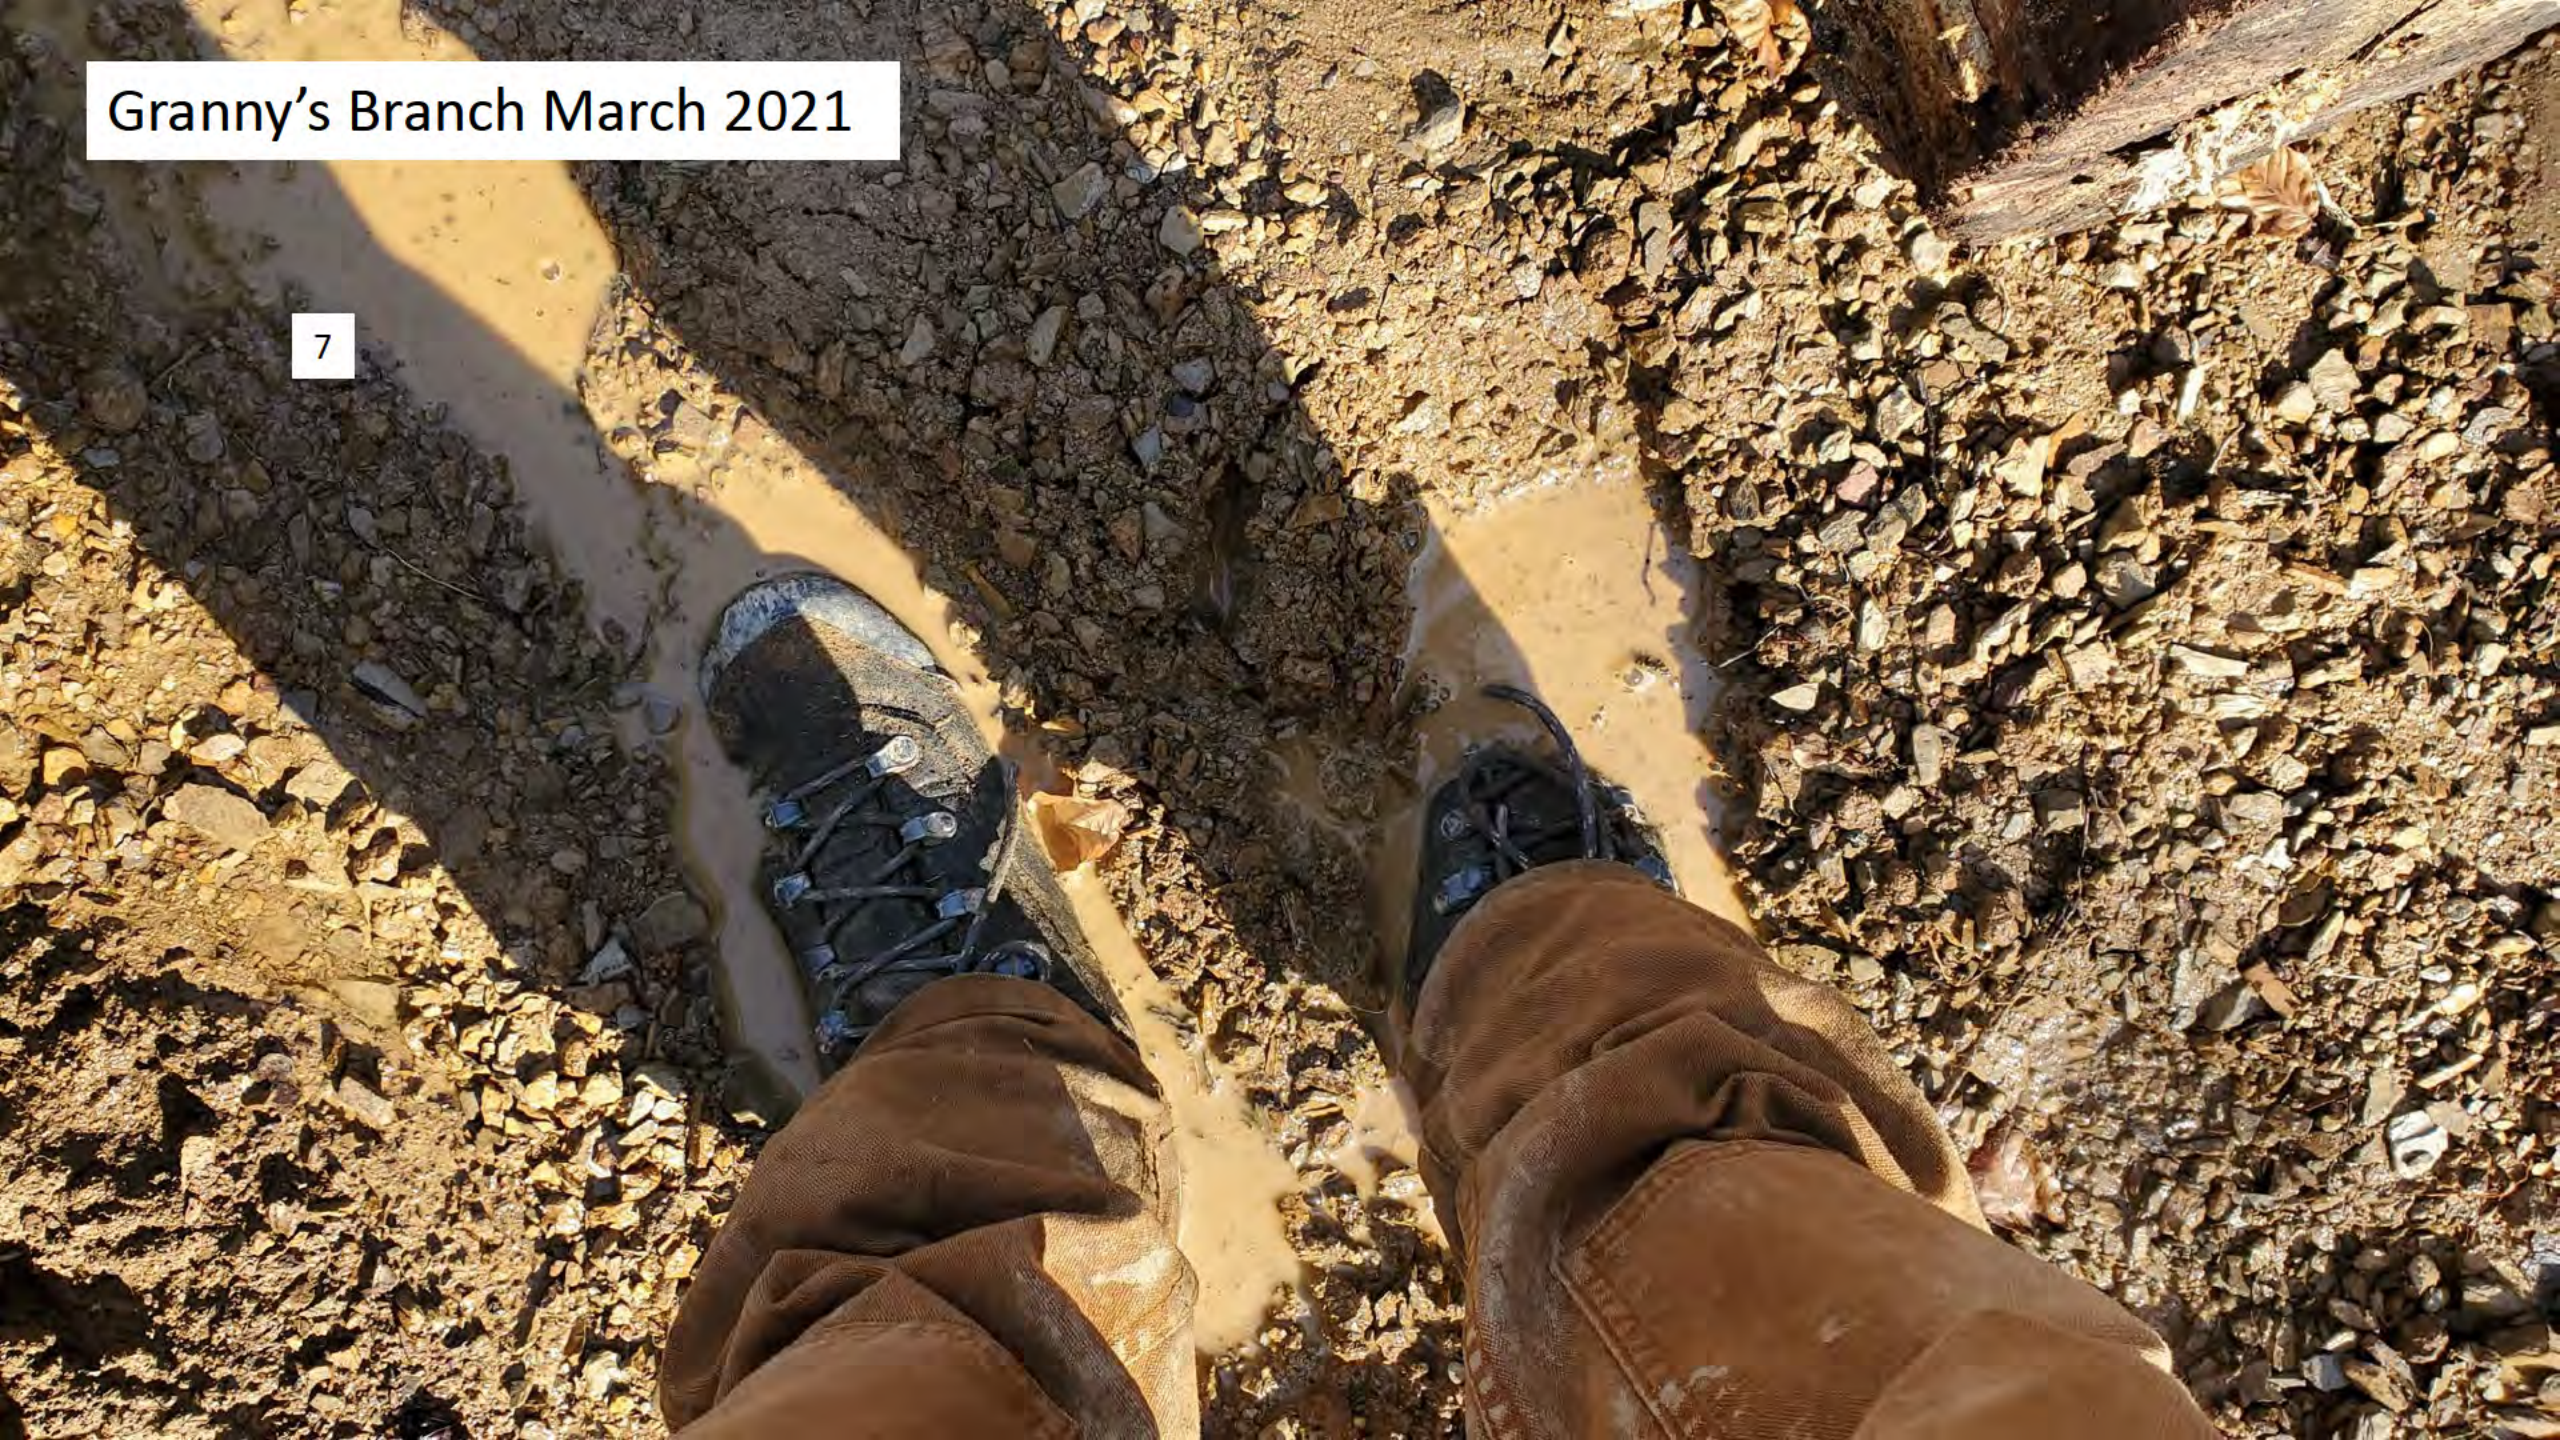
Granny's Branch March 2021

A photograph of a stream in a forest, labeled '8'. The stream is shallow and muddy, flowing through a wooded area with many bare trees and fallen branches. The ground is covered in fallen leaves and twigs. The background shows a steep bank with more trees and some green shrubs.
