EXHIBIT 11

HOW CREEK BOATING DEGRADES THE WATER QUALITY OF THE CHATTOOGA IN NORTH CAROLINA¹

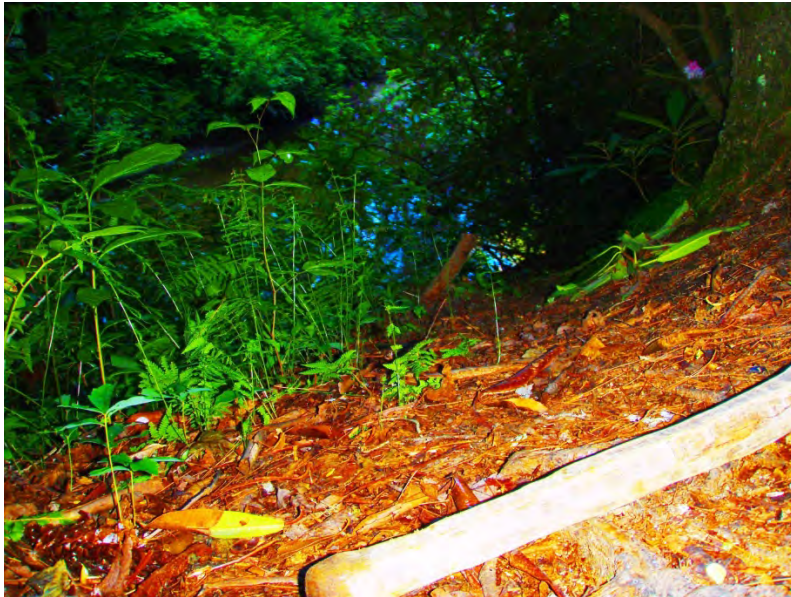
View is looking downhill at boater created portage trail where rhododendron has been sawed off.

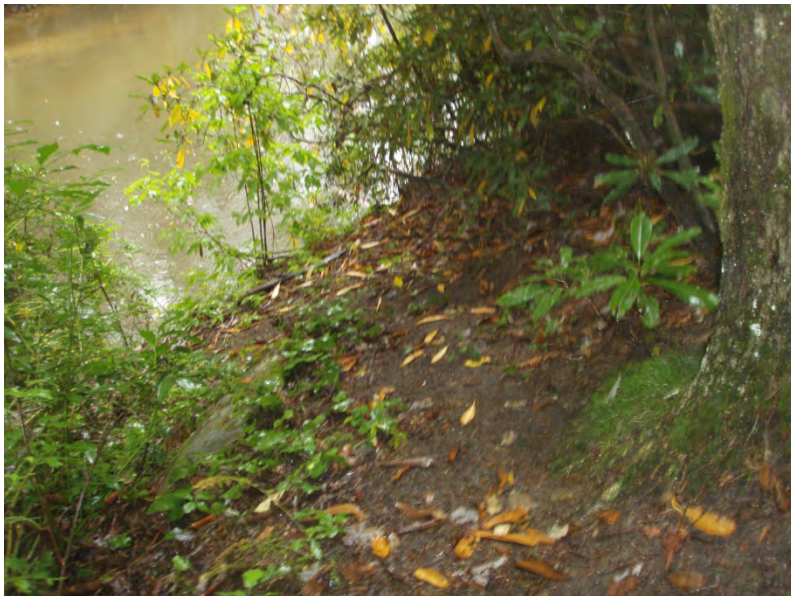
This photograph was taken several months later on September 25, 2015. It shows how the stub of the sawed off rhododendron *has now been unlawfully pulled out of the ground*—perhaps in an effort to conceal this unlawful activity by paddlers. The removal of the sawed off rhododendron

root occurred subsequent to my having identified this problem for the Forest Service via public comments made on July 7, 2015. This boater created portage trail has now been denuded of all ground cover and is channeling sediment into the creek—as a point source of water pollution.

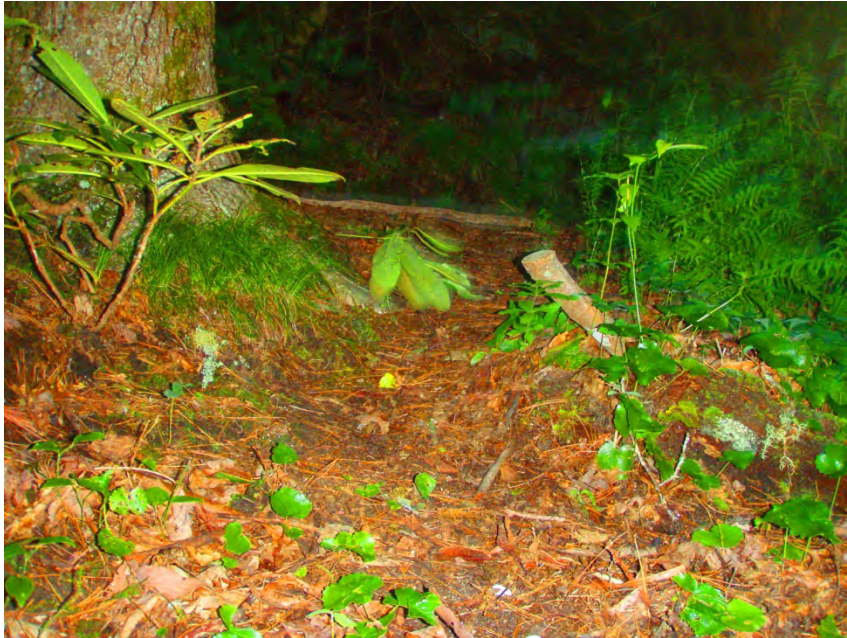
June 29, 2015 @ approx. 35 03 00.94 N 83 07 09.47 W

Here is another series of photographs with the point of view looking uphill instead of downhill.

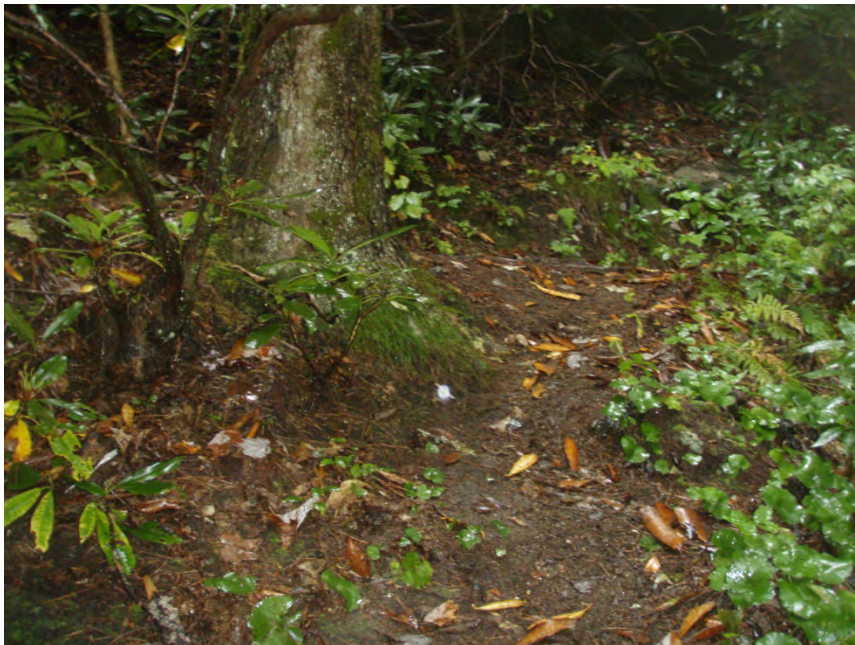
Same view on September 25, 2015. Note the bare soil of the portage trail caused by boaters dragging our pushing their boats up the hill from where they are evacuating the river.

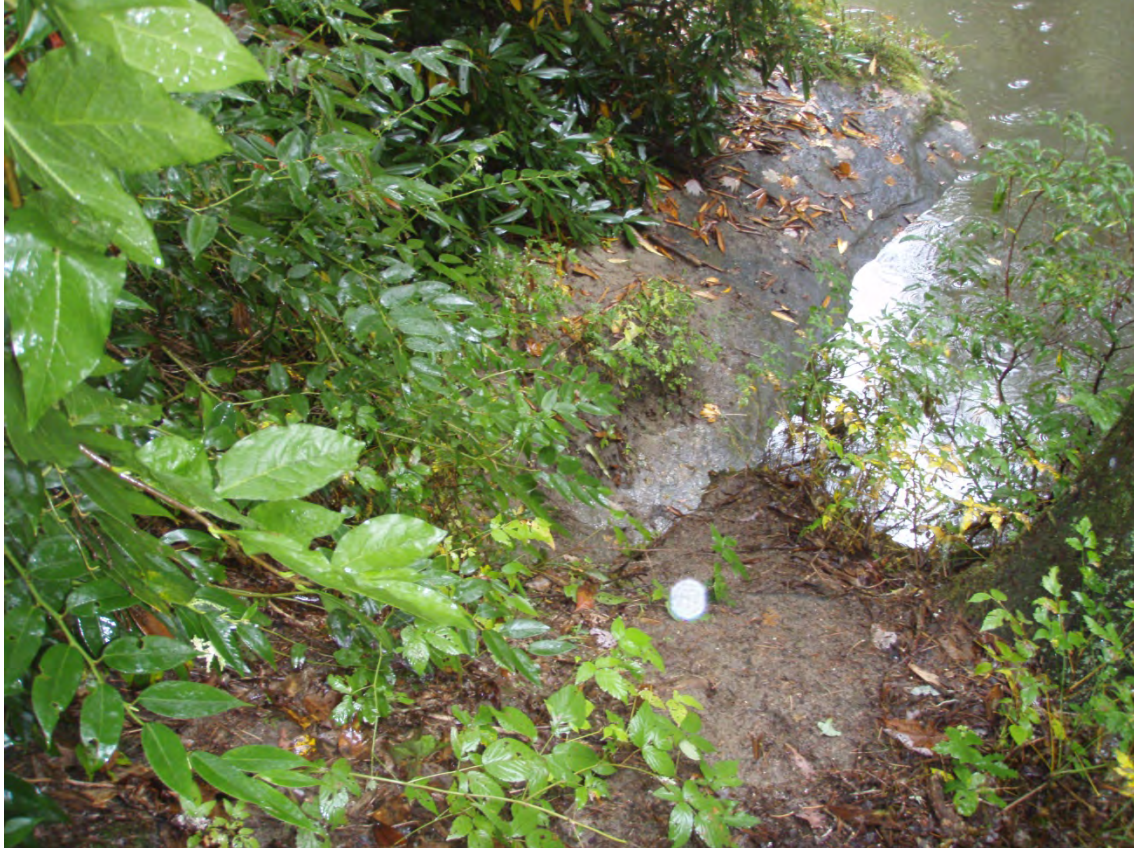
The photo below shows the eddy on river right which paddlers are using to evacuate from the river at Boater Created Erosion Site B-3.

Note the eddy spot on river right. This is where boaters are evacuating the river. This unpermitted development within the trout buffer now channels visible sediment flows into the creek as point source of pollution.

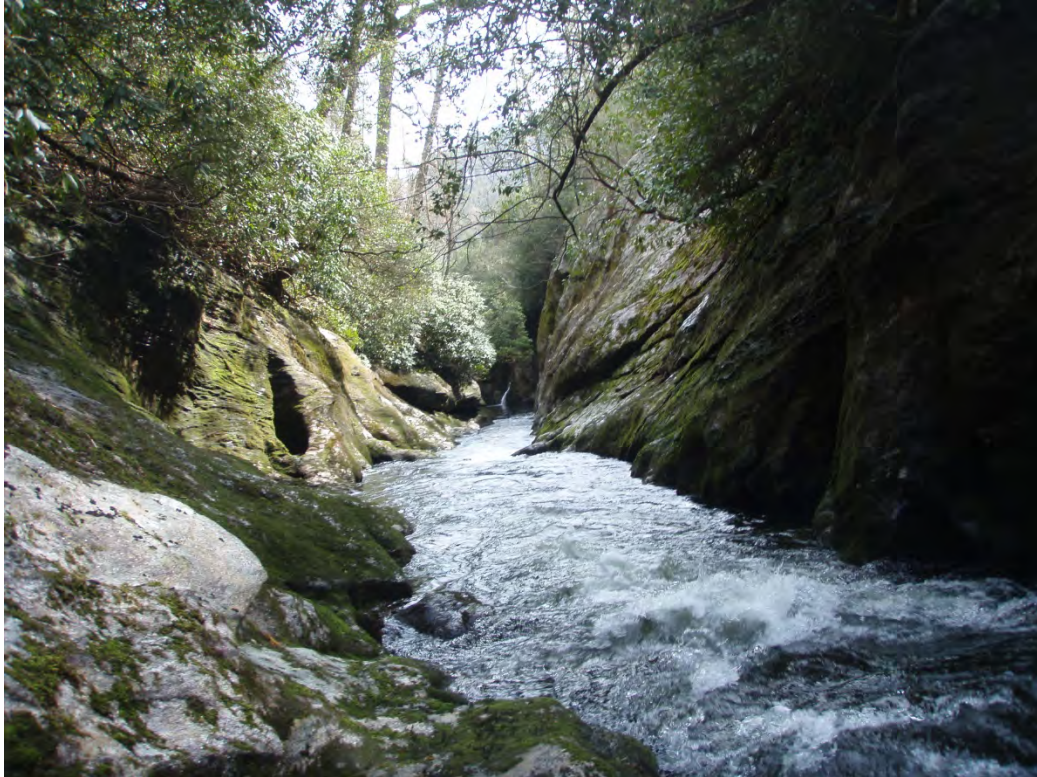
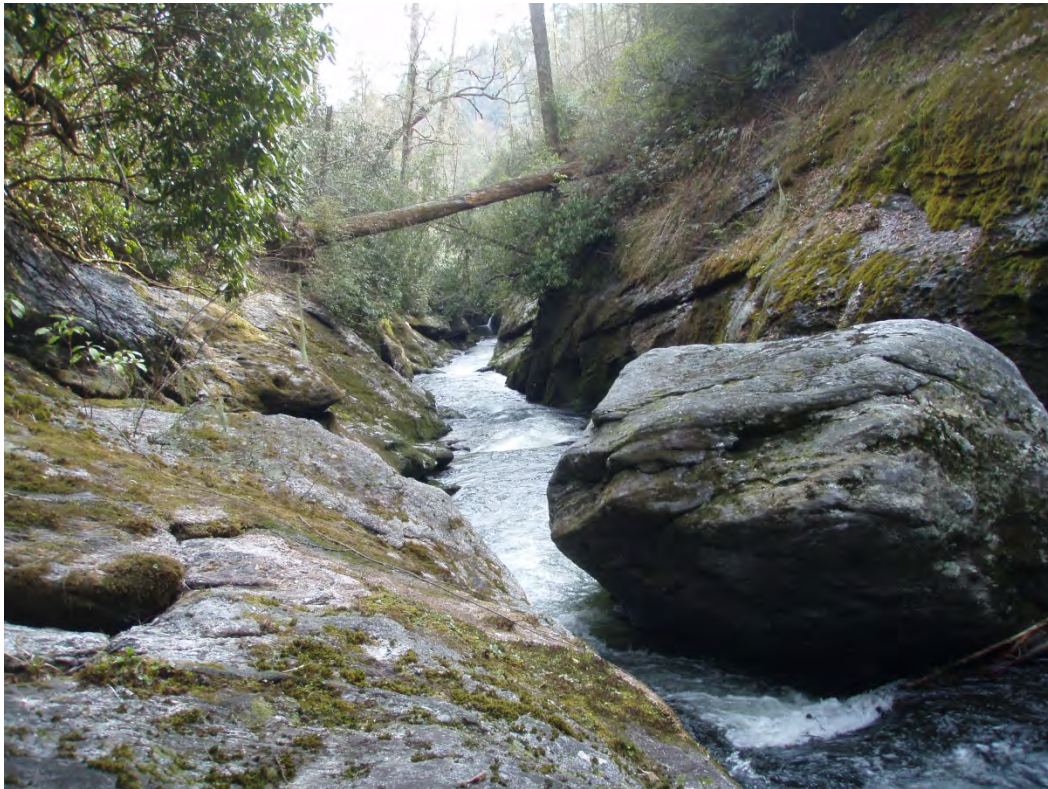
Of course, this expert panel of paddlers offered no report on how much damage was done to the bryophytes growing on the rocks from dragging or pushing boats across them or to the rhododendron growing on the top edge of the vertical walls. There is the implicit assumption that such damage is acceptable. Below are two photos of the “Alleyway” taken March 25, 2016.

These two photographs demonstrate the gorge conditions that exist on one part of the river in North Carolina. When a hemlock eventually blocks this channel, it is hard to see how paddlers

will be able portage without damaging the “*near natural*” condition of the riparian corridor, trout buffer and water quality.

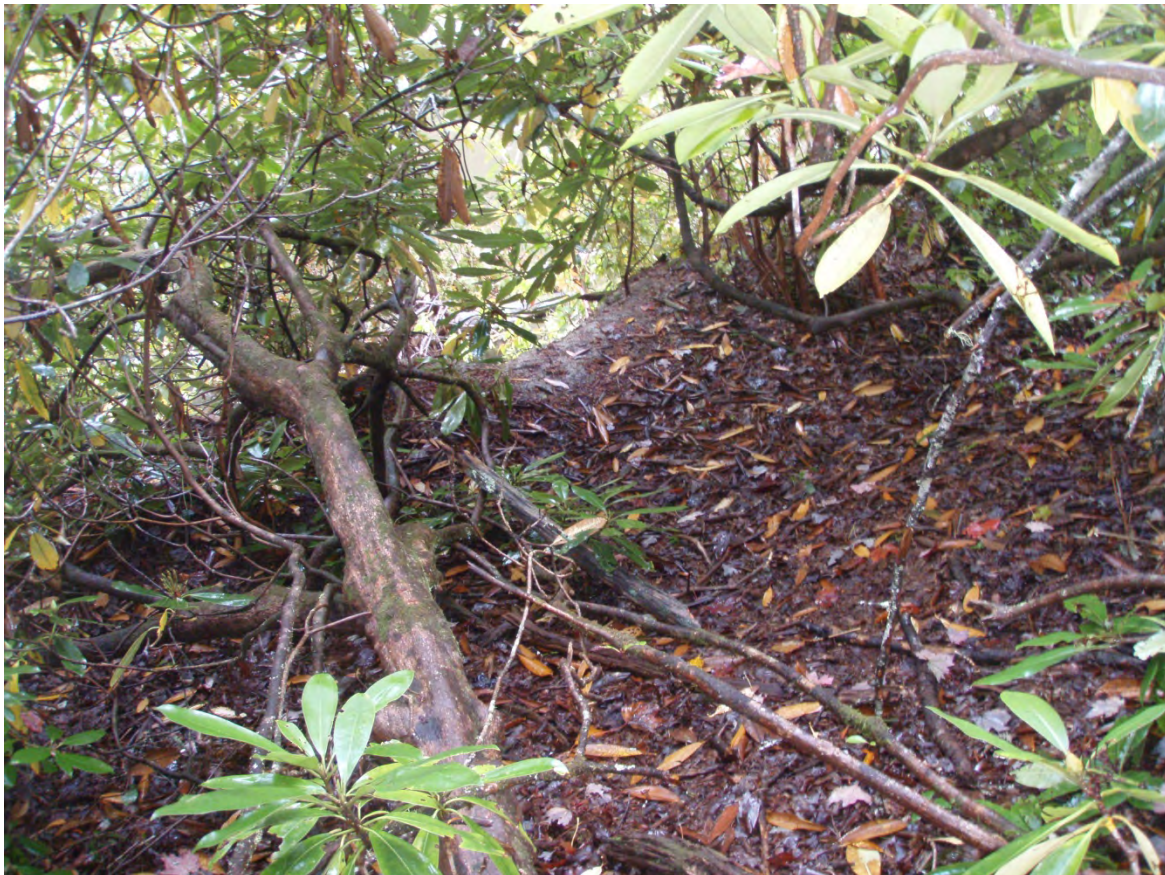
Boater Created Erosion Site B-2 & Unmaintained trail

Here are two photographs taken September 25, 2015 of the river right bank where boaters have created a river evacuation site (Boater Created Erosion Site B-2) *merely for the convenience of being able to repeat floating a small plunge pool located just above*. Boater Created Erosion Site B-2 can be found at approximately 35 03 03.91 N, 83 07 04.10 W.

This first photo evidences how boaters have created a new unmaintained portage trail—*not for safety*—but for mere convenience. This trail is channeling water to flow down the hill to this point where the top of the bank is being eroded away. You can see the edge of the top of the bank where the act of shoving the boat up onto the top of the bank has denuded the top of the bank of its ground cover.

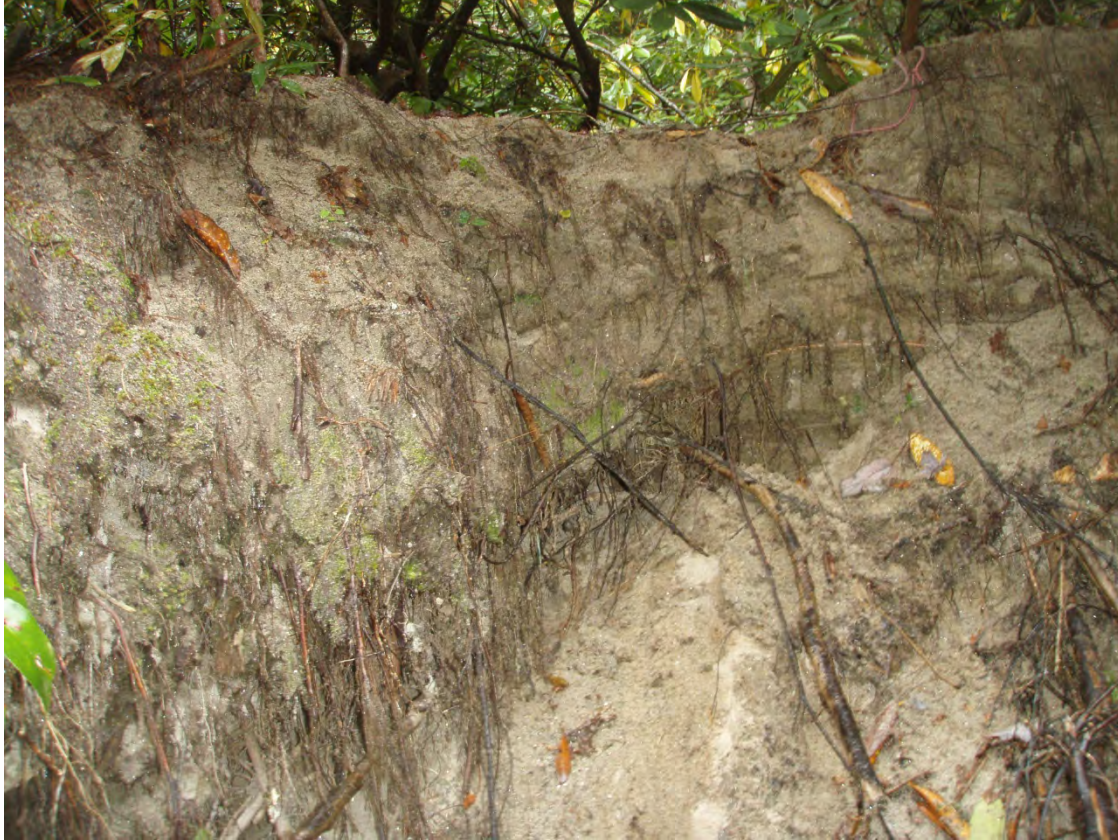
Boater Created Erosion Site B-2 Viewed From the Creek

The second photo was taken standing in the creek. It demonstrates how the paddler must lift the boat up two to three feet above the water to get it on top of the bank. The second photo evidences the extent to which the top edge of the riverbank is being destroyed by this activity—which is contributing to the head erosion that is occurring from the river side of the bank. Clearly, this soil is ending up in the creek.

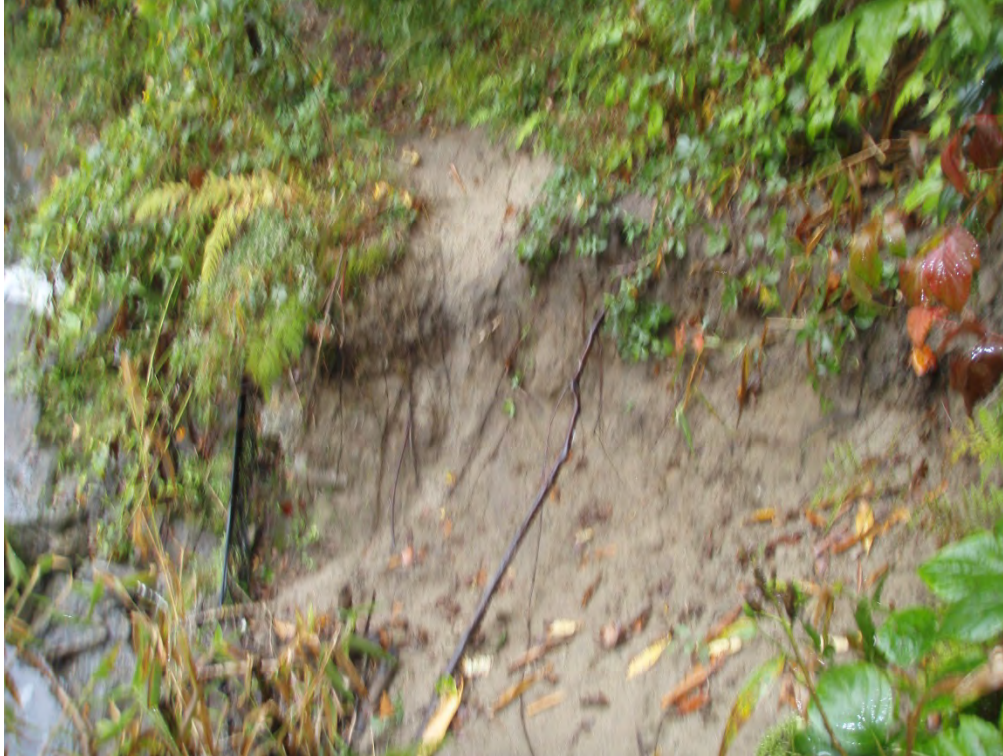
Boater Created Erosion Site B-5 @ 35 02 51.54 N 83 07 14.52 W on Sept. 25, 2015.

Boater Created Erosion Site B-5 constitutes the first place where the Chattooga River Trail, after departing from the Green Creek parking lot trailhead, runs adjacent to the creek. Up until reaching this point, the Chattooga Rive Trail runs along the ridge where it remains separated from the creek by thick tangles of rhododendron and mountain laurel. As a consequence, this represents the first *convenient location* where a paddler can drop his boat to the ground and launch without having to fight their way through a tangle of rhododendron, laurel, and briars—although this is not permitted under the restrictions put in place in 2012.

For decades, the Chattooga River Trail has existed in this same location without suffering any form of erosion. It was only subsequent to boats having seal launched off of the bank that this collapse occurred. After having caused the bank to collapse in the first location (Boater Created Erosion Site B-5), the paddlers simply moved several feet further down the Chattooga River Trail and dug out a narrow trench to facilitate their sliding their kayaks across the bank and over a rock shelf into the creek (Boater Created Erosion Site B-5-B).

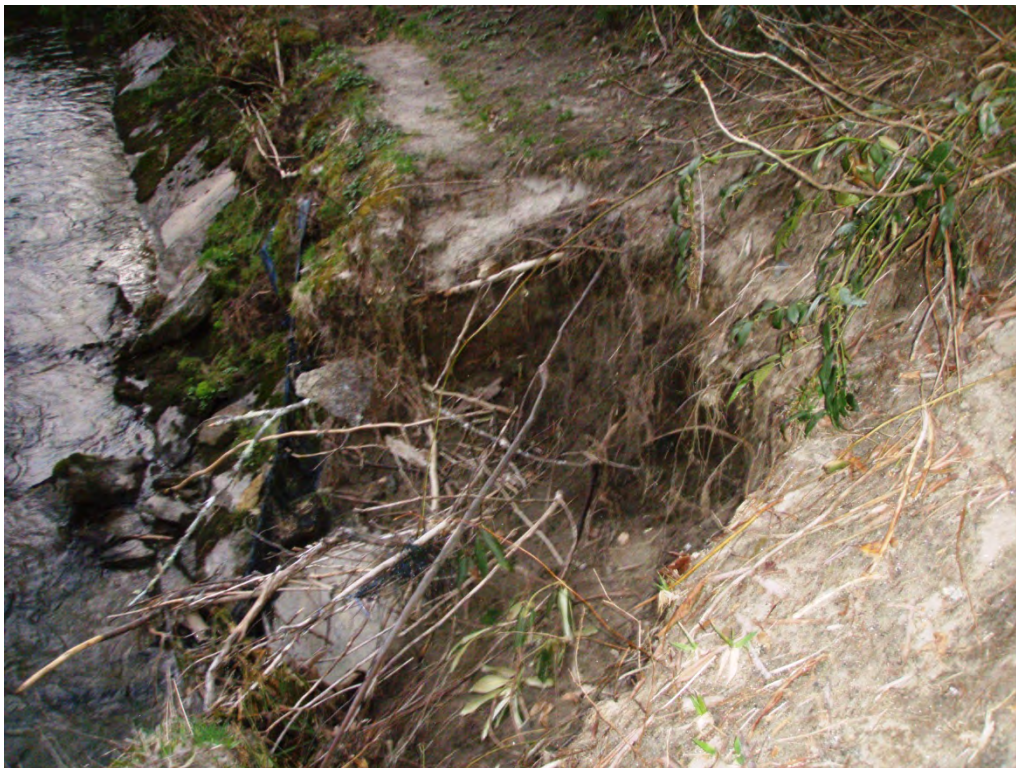
Boater Created Erosion Site B-5 on March 25, 2016. All ground cover now denuded and point source of pollution remains unaddressed. See the rock shelf on the left of the bottom photo.

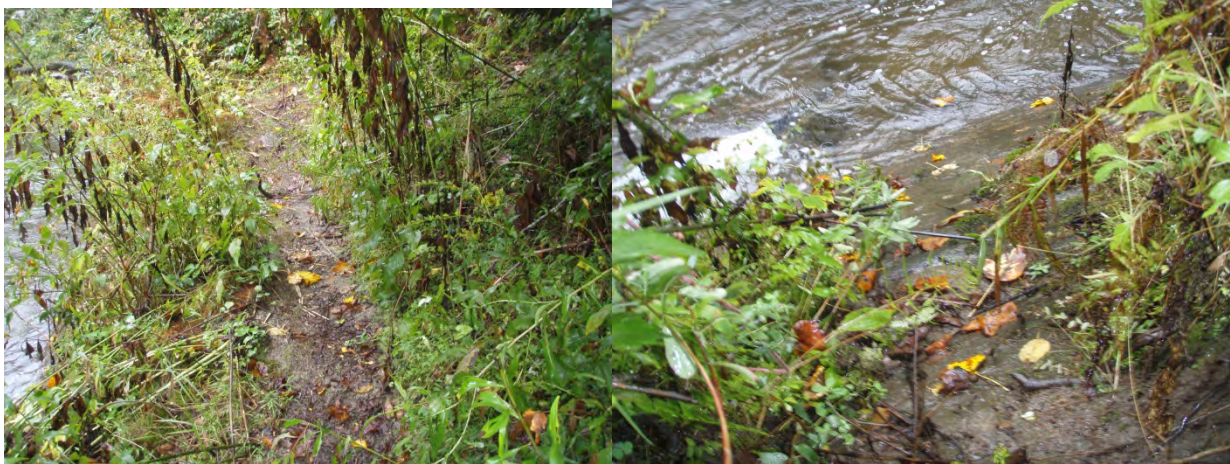
Boater Created Erosion Site B-5-B Sept. 25, 2015

These photographs show how paddlers used a digging tool to excavate a trench the width of a kayak to facilitate their sliding their boat across the rock shelf and into the water. The next series of photographs show what B-5-B looks like as of March 25, 2016. Conditions have become even worse. Visible sediment is being channeled into the creek by this boater created launch site.

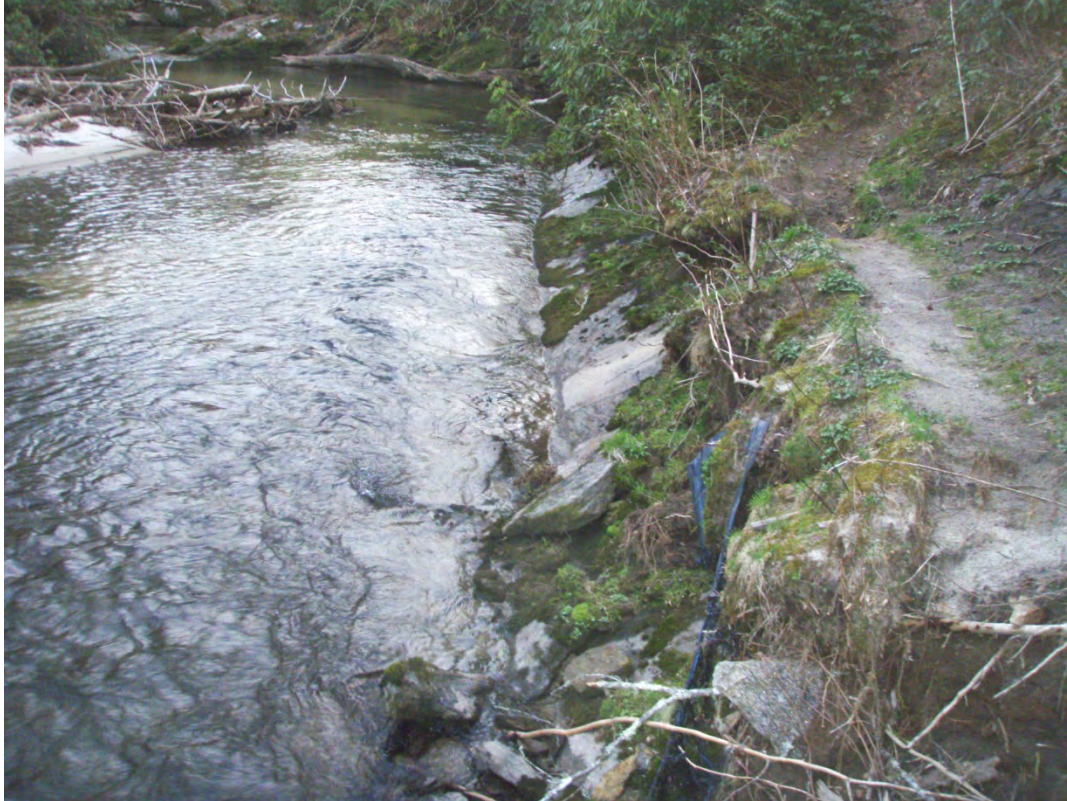
This photograph was taken on March 25, 2016 while standing at Boater Created Erosion Site B-5, and looking down the Chattooga River Trail at Boater Created Erosion Site B-5-B. Notice how all the ground cover, briars, etc., which was present in the photos taken on September 2015, has now been denuded during the course of the current paddling season. It looks like elephants have been using the trail and the area around the trail.

Technically, launching a boat from this site does not comply with the rules—but the rules are clearly not being enforced. Boats are clearly being launched from here—even after the Forest Service was advised of this damage with latitude and longitude precision in July 2015. Note the presence of the black silt fence. It will be interesting to find out who set this silt fence, since the Forest Service never acknowledged the existence of this boater created erosion site in its 2015 Environmental Assessment. This site existed prior to the publication of that document. The act of kayaks being seal launched into the creek led to the destabilization and collapse of the river bank.

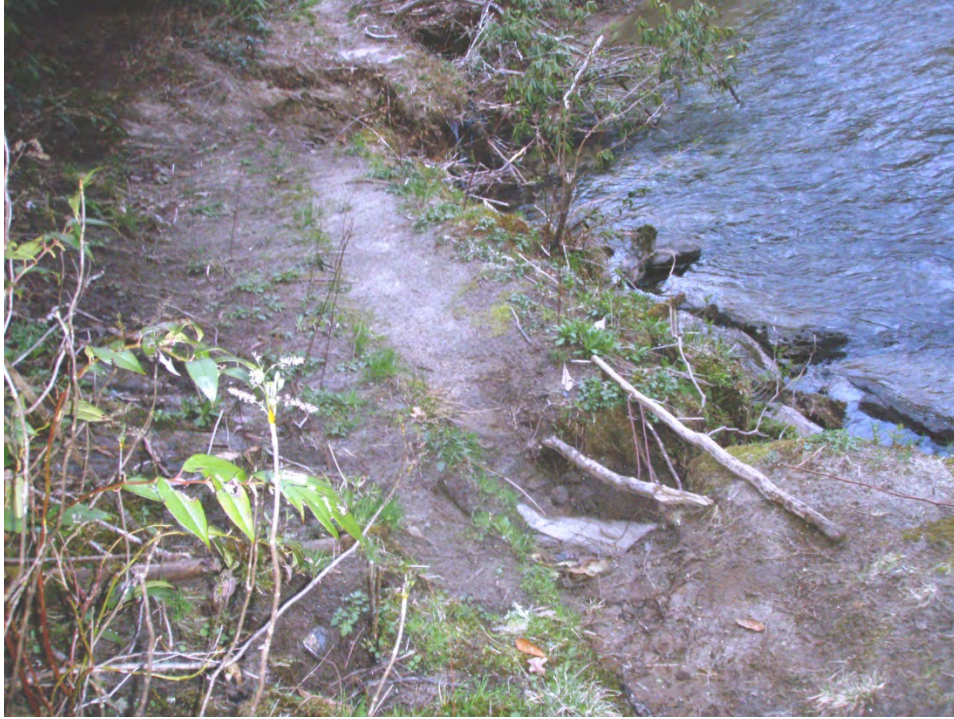
This photograph was also taken on March 25, 2016. It is looking back up the Chattooga River Trail, with Boater Created Erosion Site B-5-B *in the foreground*, and Boater Created Erosion Site B-5 in the background. See the hiking staff on the right. It marks the location of Boater Created Erosion Site B-5-B. In comparison to the photos taken on Sept. 25, 2015, it is clear that Erosion Site B-5-B has become larger. What is remarkable is how much of the area around the trail has been denuded of all ground cover—including briars. It appears that Boater Created Erosion Site B-5-B continues to be intensely used by paddlers launching at this location. The photo below shows where the kayakers are being launched across the rock shelf. Sediment is being channeled into the creek by boating activity.

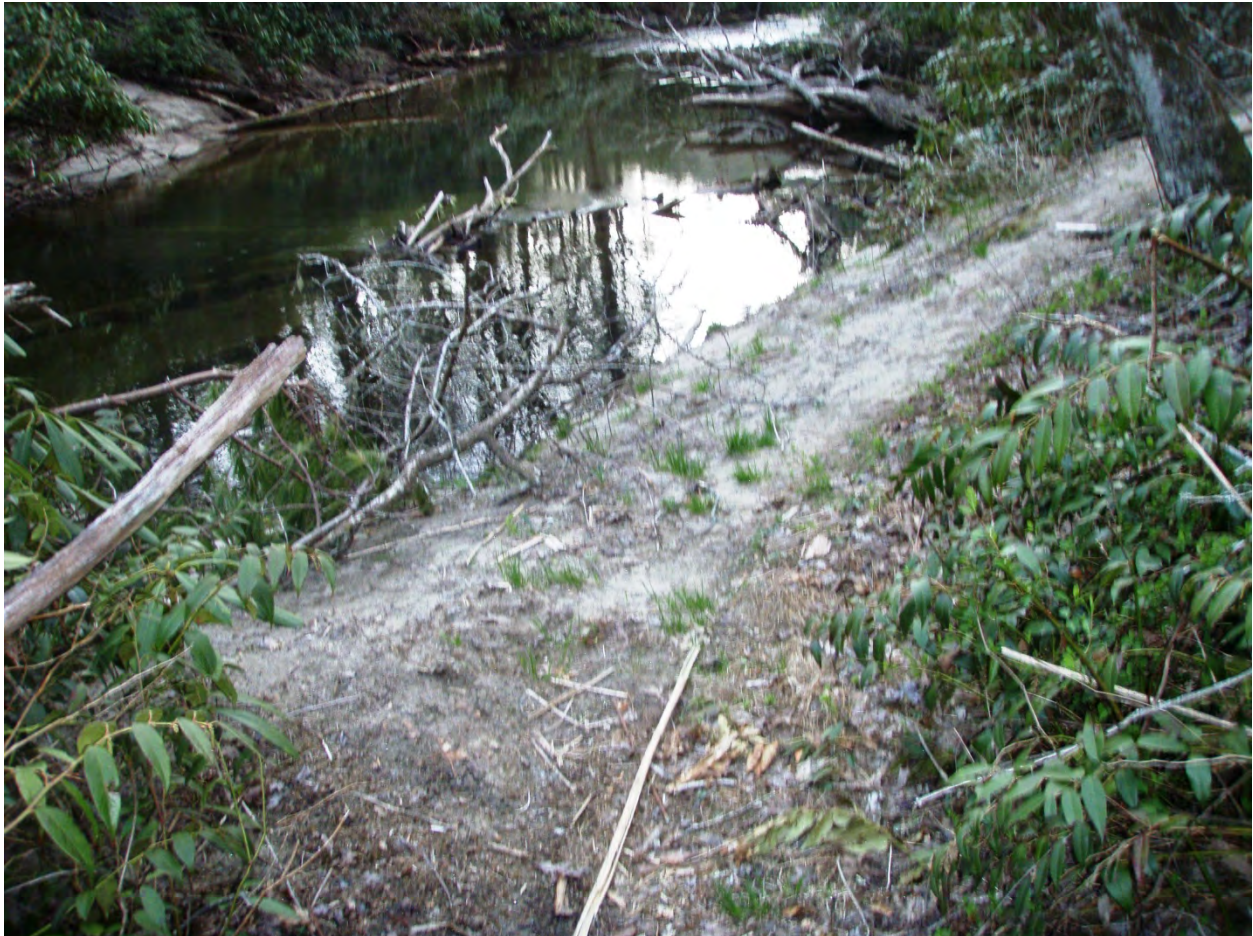
Here are three photographs evidencing another place further down the Chattooga River Trail where the riverbank has been denuded of all ground by some kind of intense human use of the bank. This bare ground did not exist on September 25, 2015. It did not exist when the 2007 Biophysical Inventory was conducted. It has occurred during the current boating season.

This photo was taken March 25, 2016, 16 minutes up trail, or approximately 1408 feet up trail from Norton Mill Creek Pool bridge, hiking at a pace of approximately 1 mph, and 12 minutes or approximately 1056 feet further down trail from Boater Created Erosion Sites B-5 & B-5-B. As shown in the photo, *the area has been entirely denuded of ground cover*. This erosion site has developed subsequent to September 25, 2015. It certainly did not exist when the 2007 Biophysical Inventory was compiled by the Forest Service.

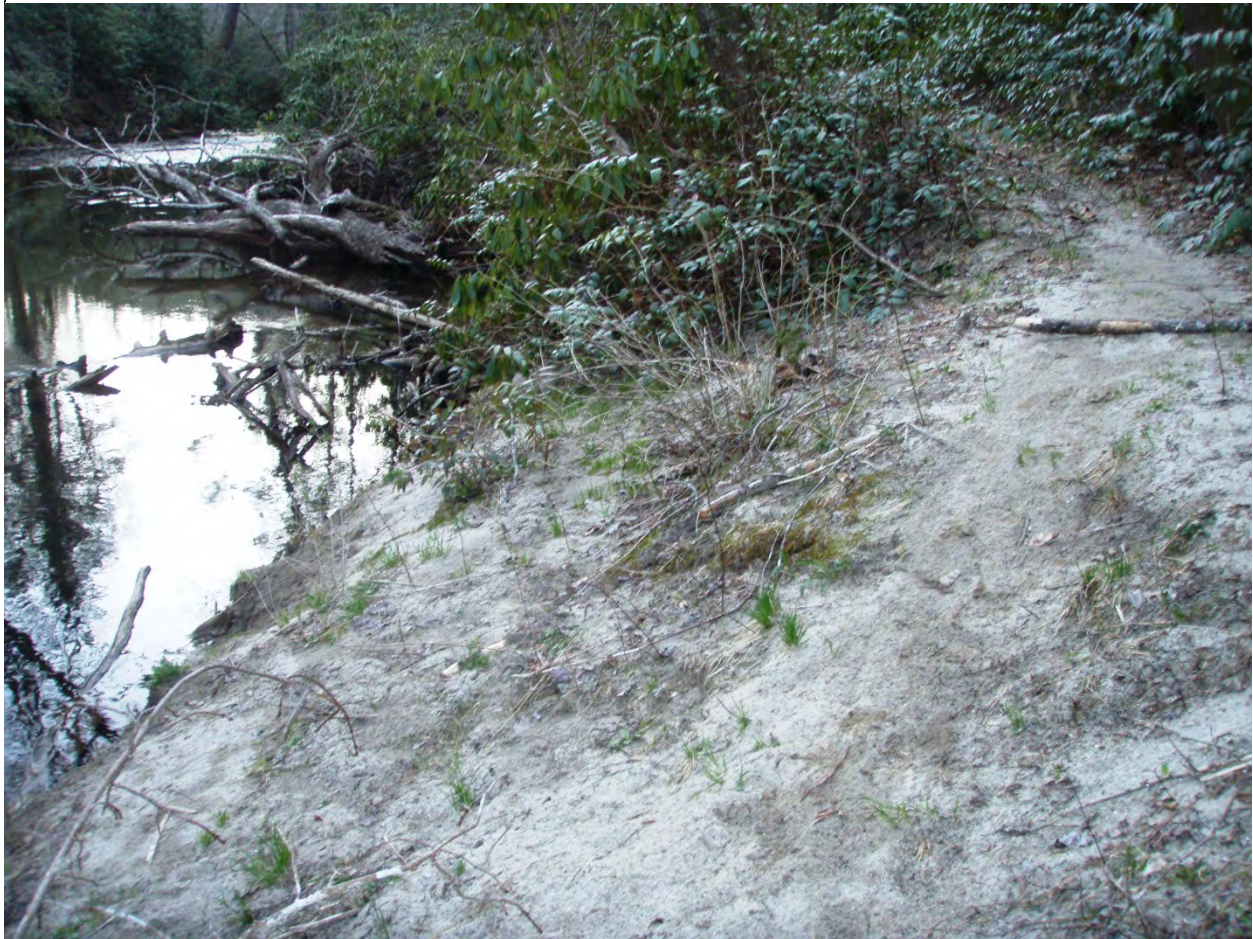
This photo taken on March 25, 2016 evidences the complete elimination of any ground cover on the creek side of the Chattooga River Trail. This now constitutes yet another Boater Created Erosion Site X-1 which did not exist either prior to the introduction of boating in December 2012, or at the time of the 2007 Biophysical Inventory.

Boater Created Erosion Site X-1 was developed subsequent to September 25, 2015 in order to facilitate portaging around a significant pile of hemlock strainers that must have developed just upstream of this point some time subsequent to September 25, 2015. Prior to March 25, 2016, this horizontal stream wide strainer obstacle was subsequently pushed more vertical but there still remains the risk of a paddler getting pinned against the lowest log.

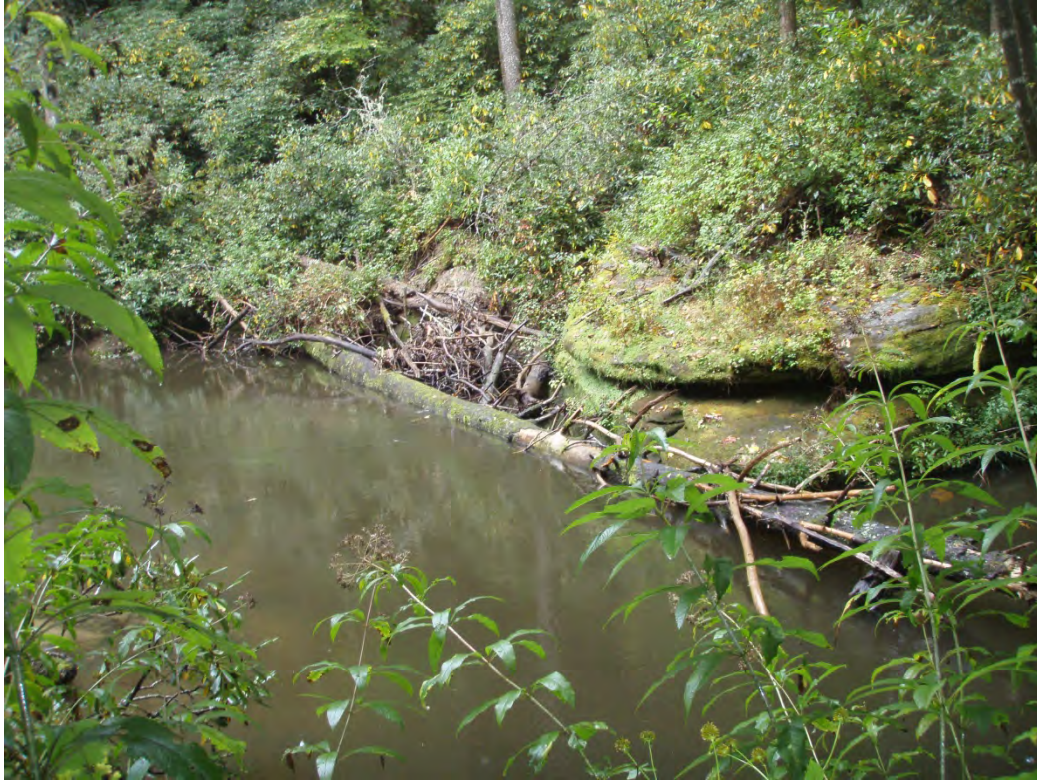
Photograph taken on September 25, 2015

The top photo shows a single log which was partially obstructing the channel on September 25, 2015. The photo was shot from the Chattooga River Trail from the same spot that now constitutes Boater Created Erosion Site X-1. Sometime subsequent to September 25, 2015, several additional logs fell into the creek and were pushed downstream by the force of the water to lodge themselves as obstacles within the creek channel. The bottom two photos were also taken standing on Boater Created Erosion Site X-1. At some point in time, these logs must have created a formidable enough obstacle within the creek channel that paddlers felt compelled to evacuate the creek upstream and re-launch their boats at Boater Created Erosion Site X-1—

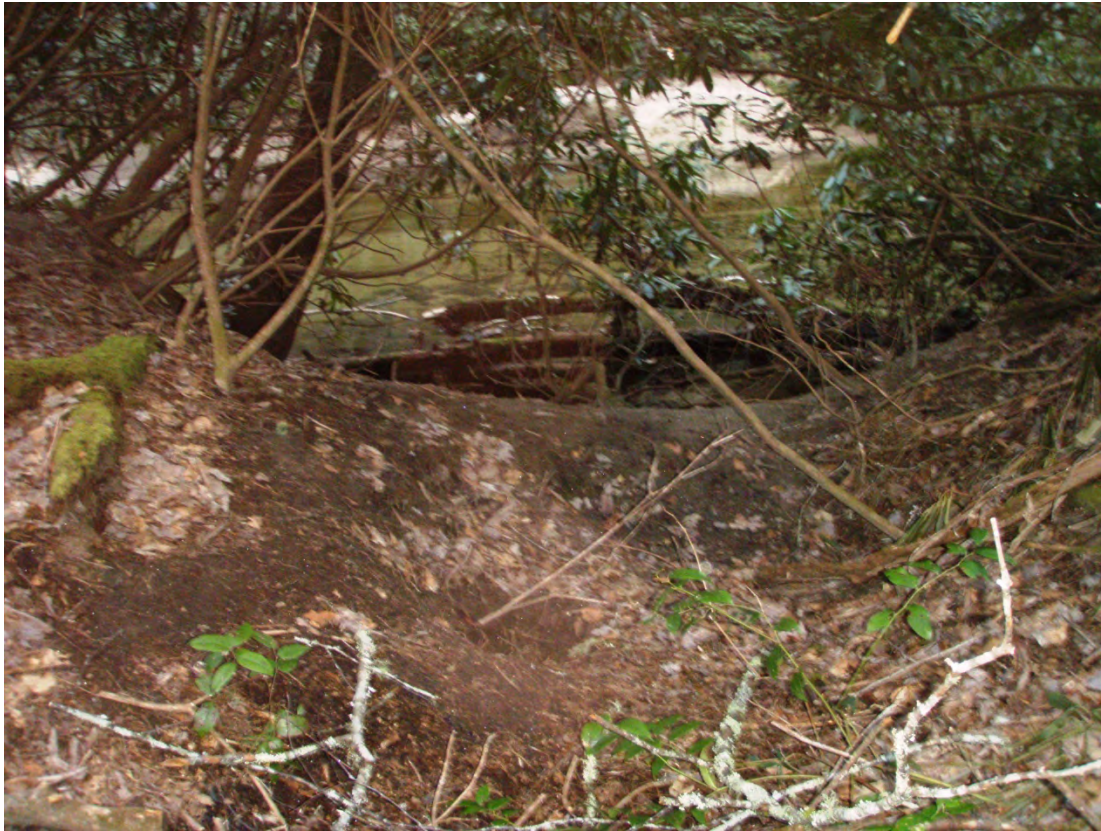
located just downstream of this obstacle. The photograph below evidences a new place along the river bank which has been degraded. The top of the bank appears to have been worn down as if a boat were being pushed across the top of the bank. This may be the place where boaters are evacuating the river to avoid the strainer logs which are jambed onto the rock on river left just above the location of Boater Created Erosion Site X-1.
