EXHIBIT 38

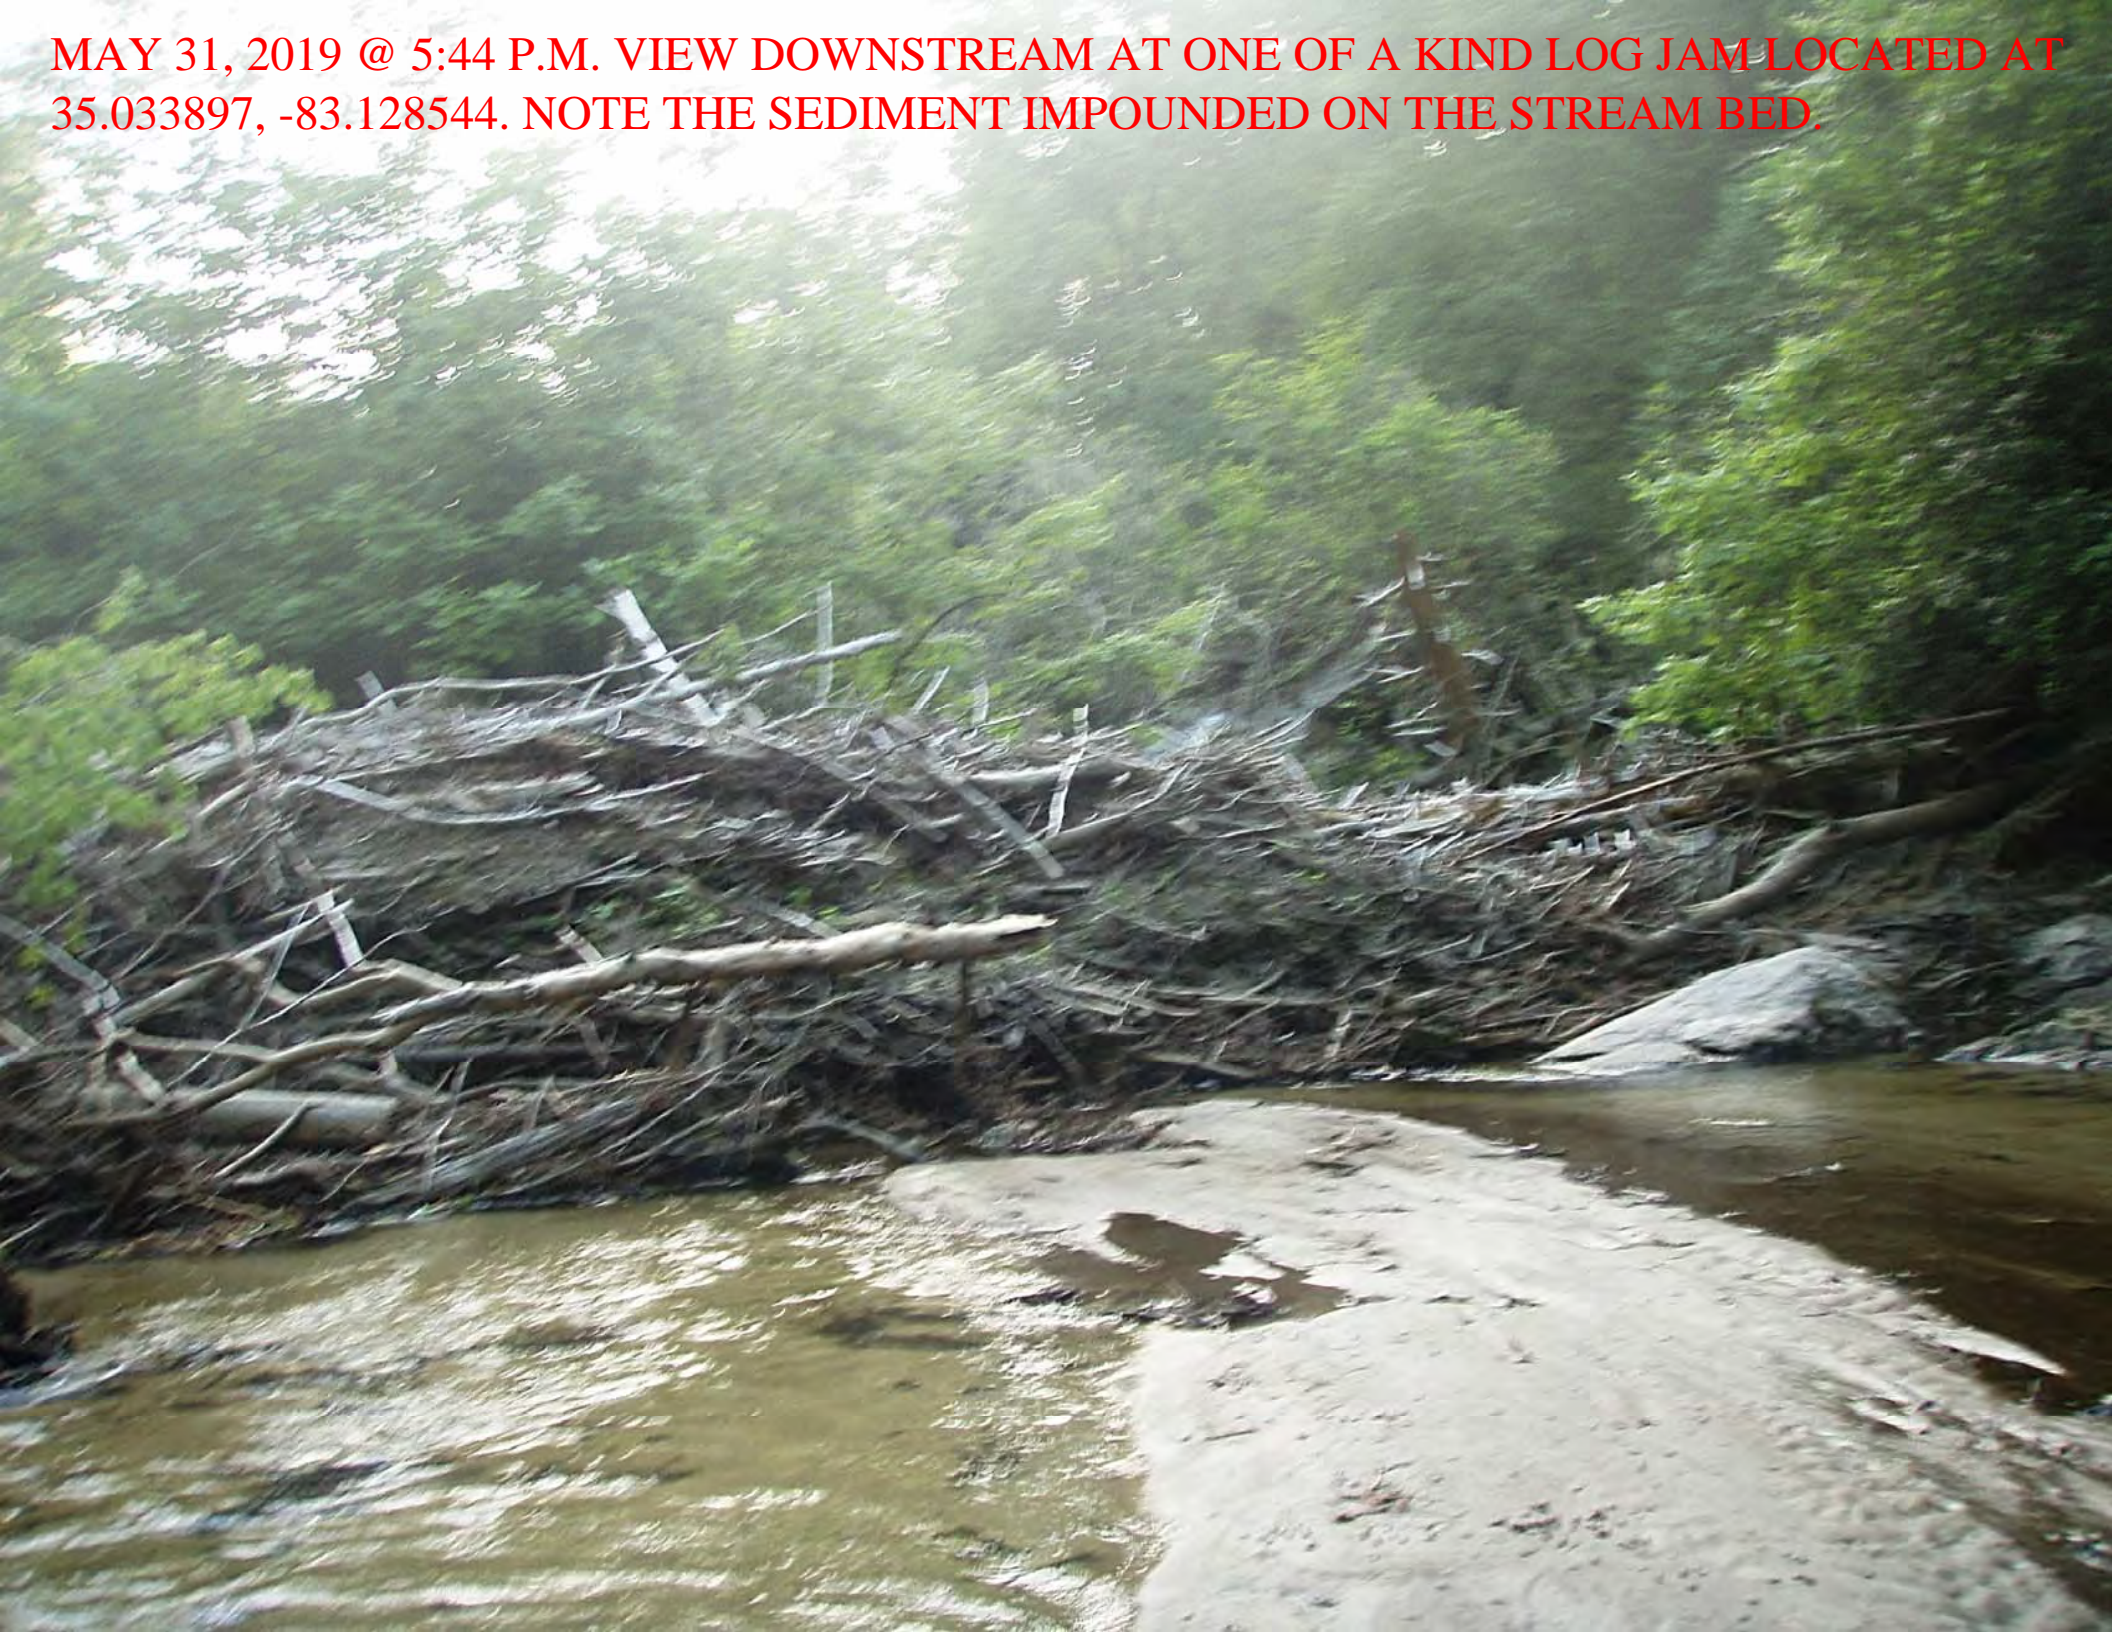
MAY 31, 2019 @ 5:44 P.M. VIEW DOWNSTREAM AT ONE OF A KIND LOG JAM LOCATED AT 35.033897, -83.128544. NOTE THE SEDIMENT IMPOUNDED ON THE STREAM BED.

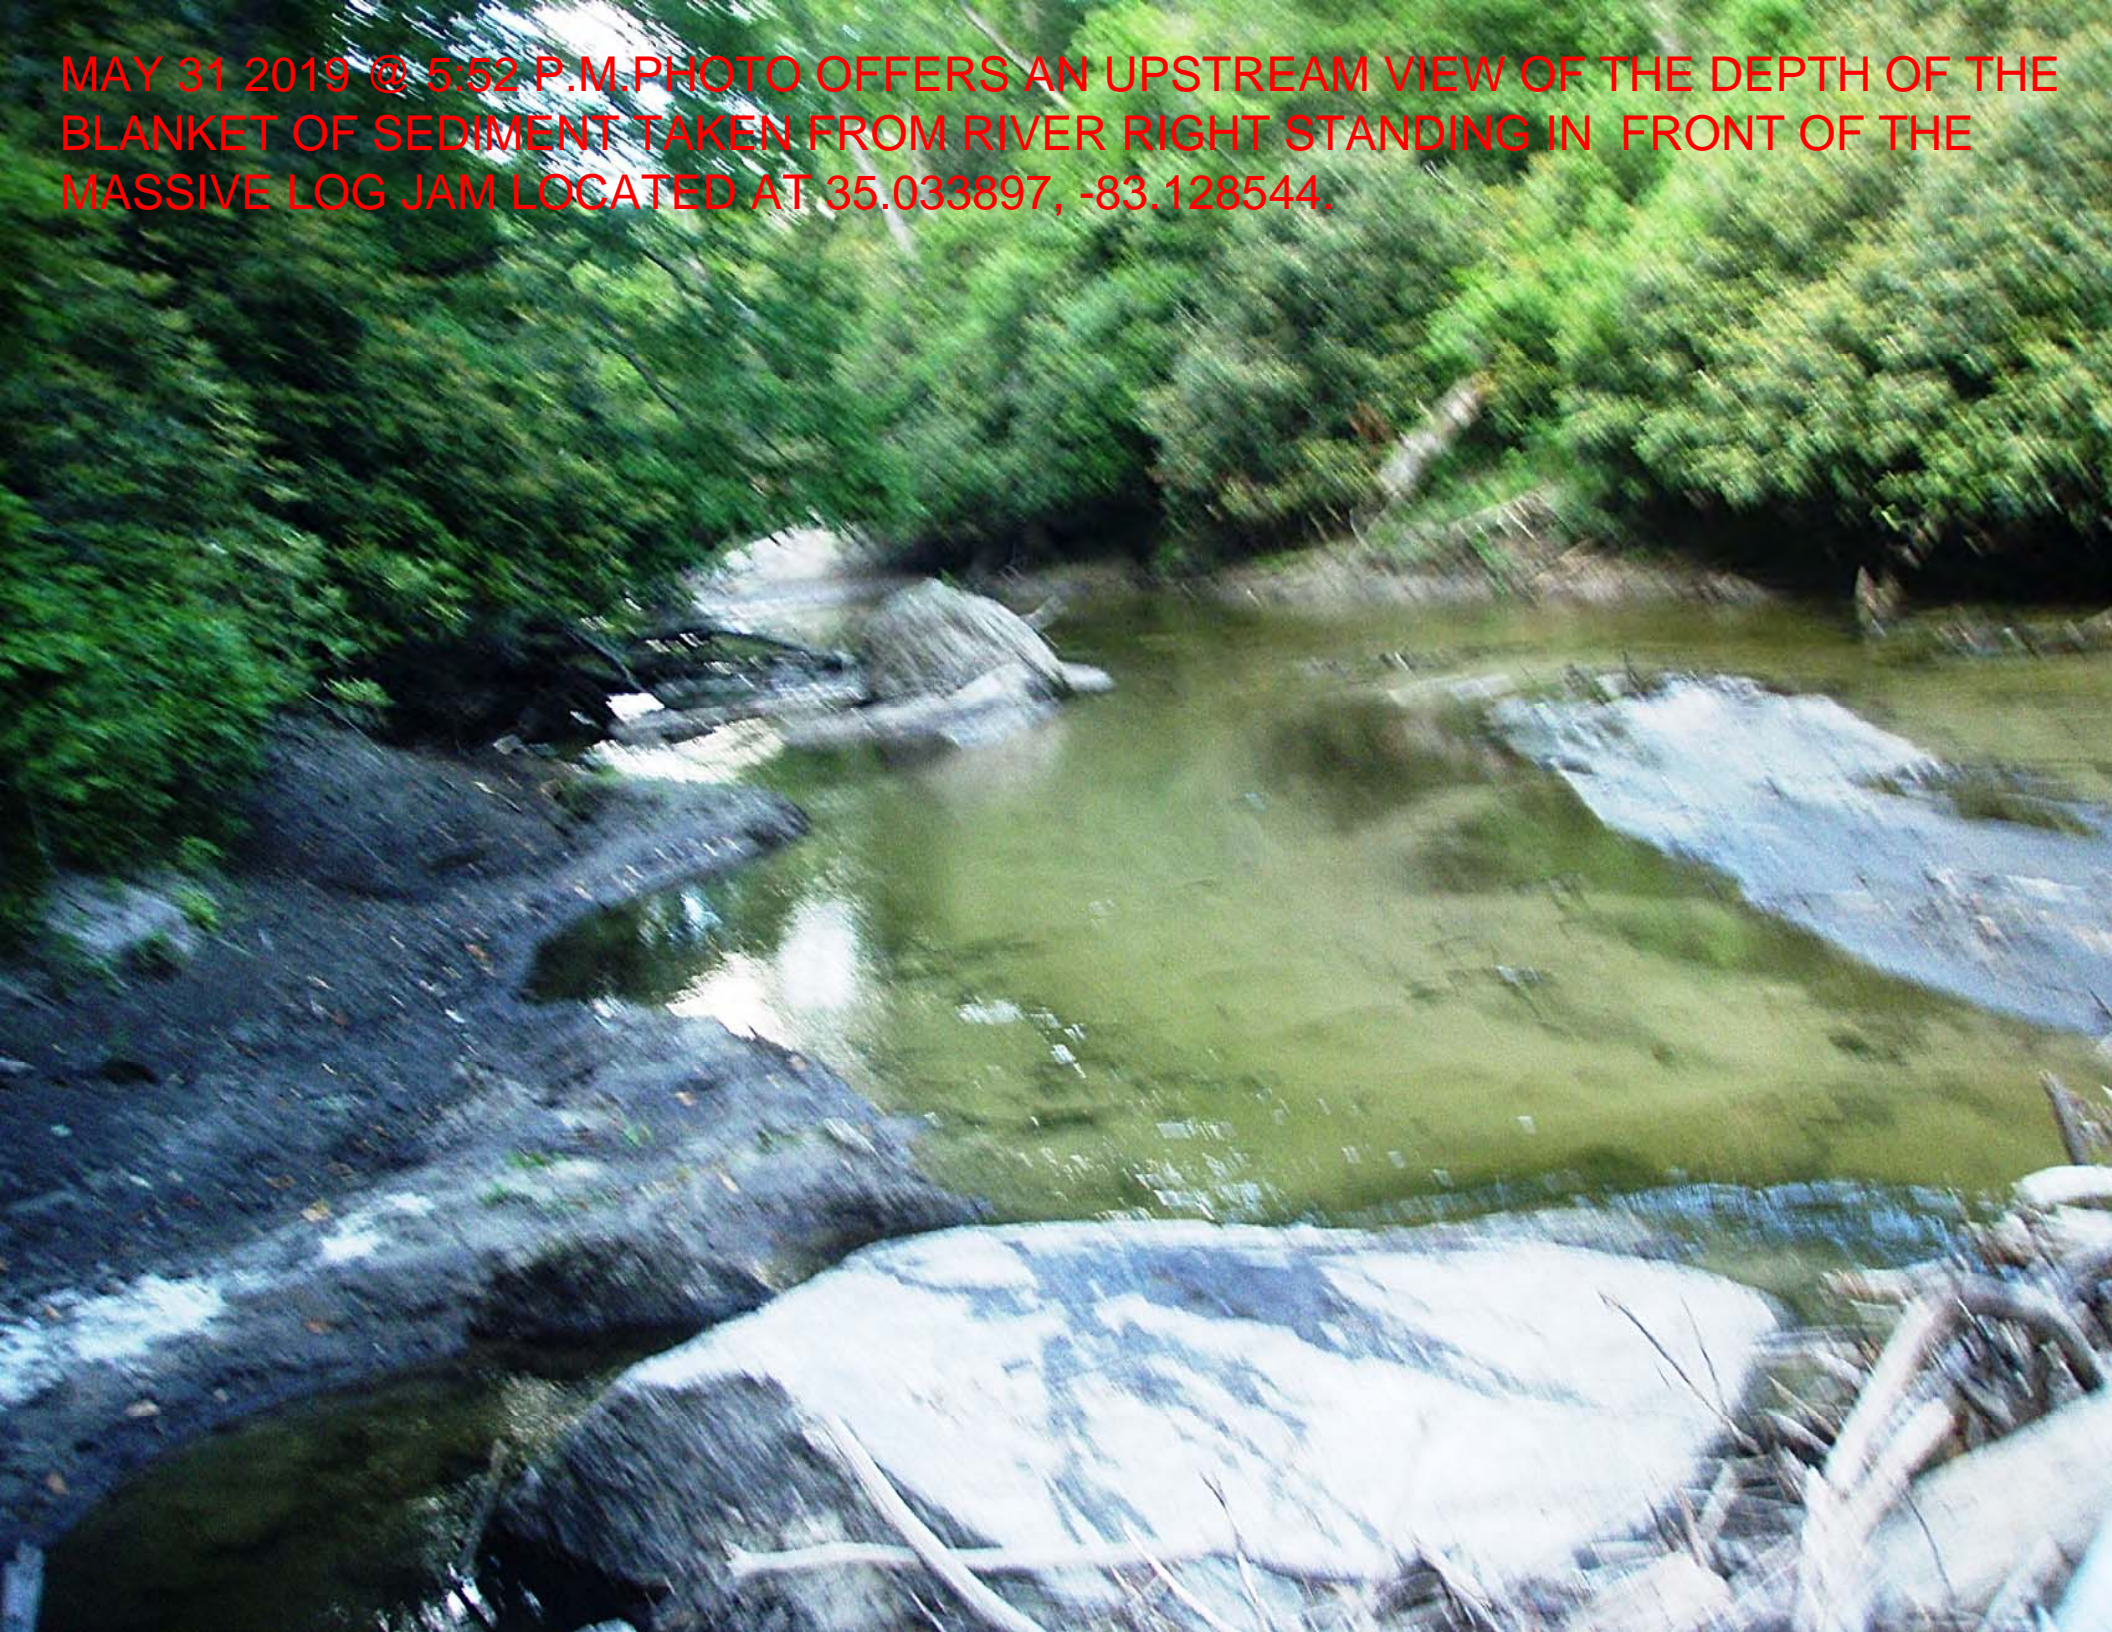
MAY 31 2019 @ 5:52 P.M. PHOTO OFFERS AN UPSTREAM VIEW OF THE DEPTH OF THE BLANKET OF SEDIMENT TAKEN FROM RIVER RIGHT STANDING IN FRONT OF THE MASSIVE LOG JAM LOCATED AT 35.033897, -83.128544.

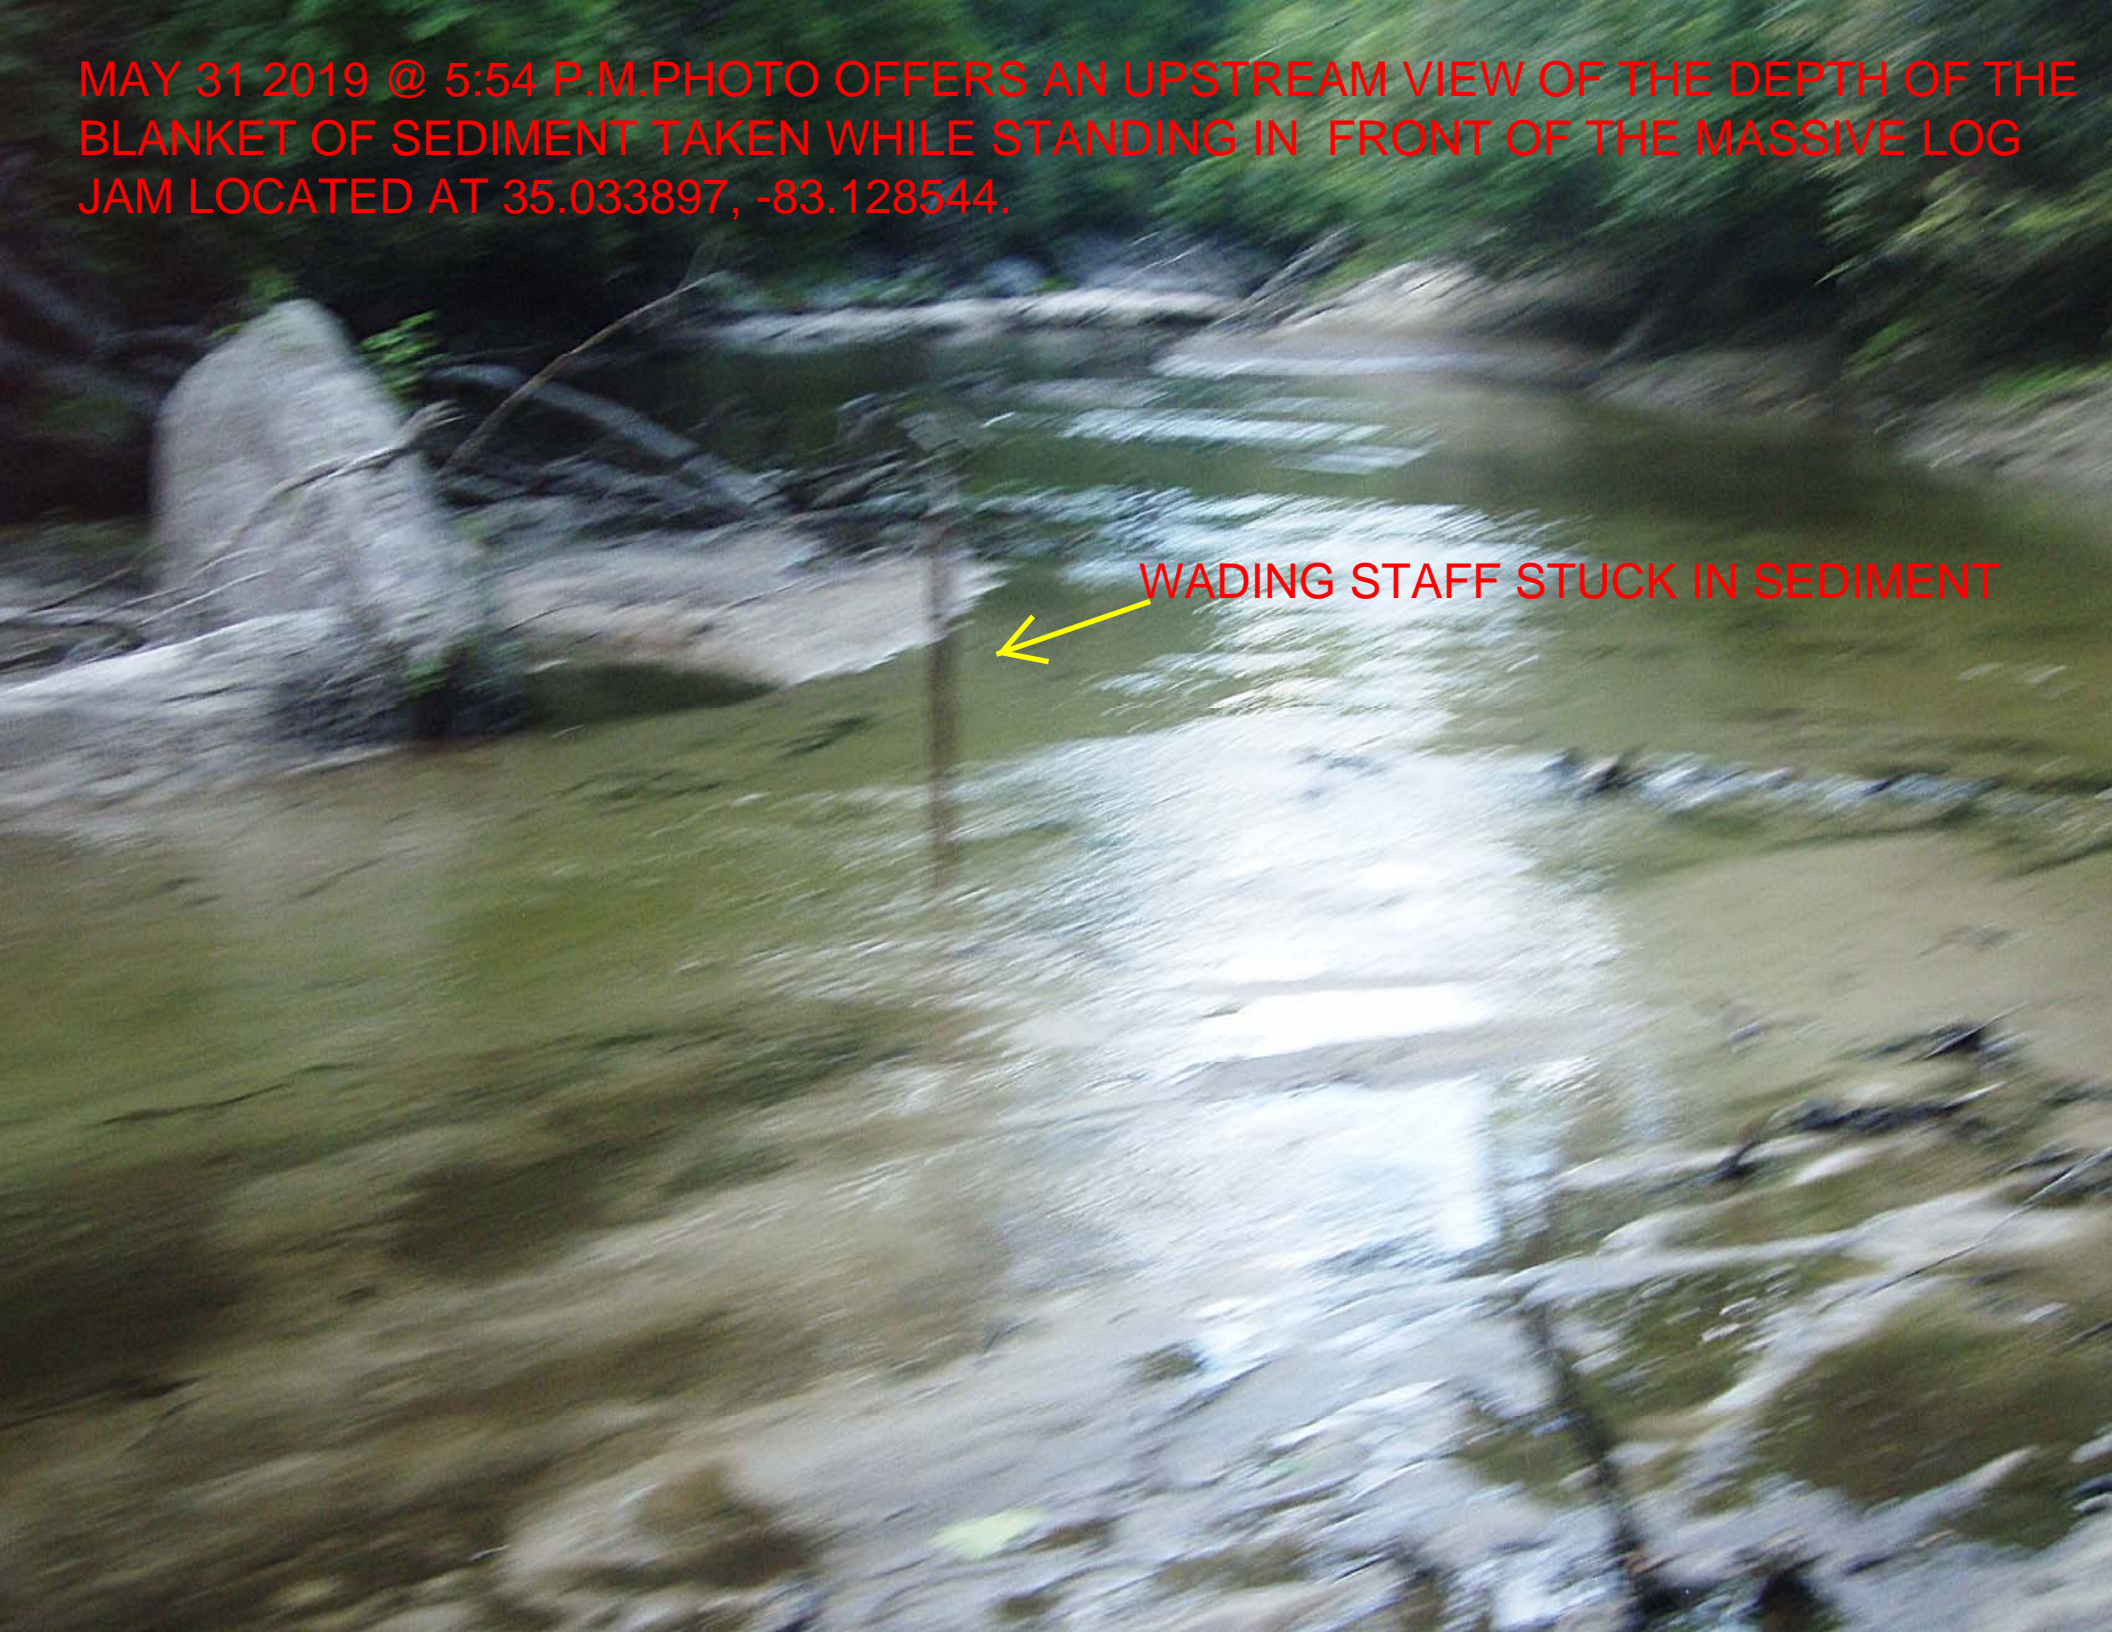
MAY 31 2019 @ 5:54 P.M. PHOTO OFFERS AN UPSTREAM VIEW OF THE DEPTH OF THE BLANKET OF SEDIMENT TAKEN WHILE STANDING IN FRONT OF THE MASSIVE LOG JAM LOCATED AT 35.033897, -83.128544.

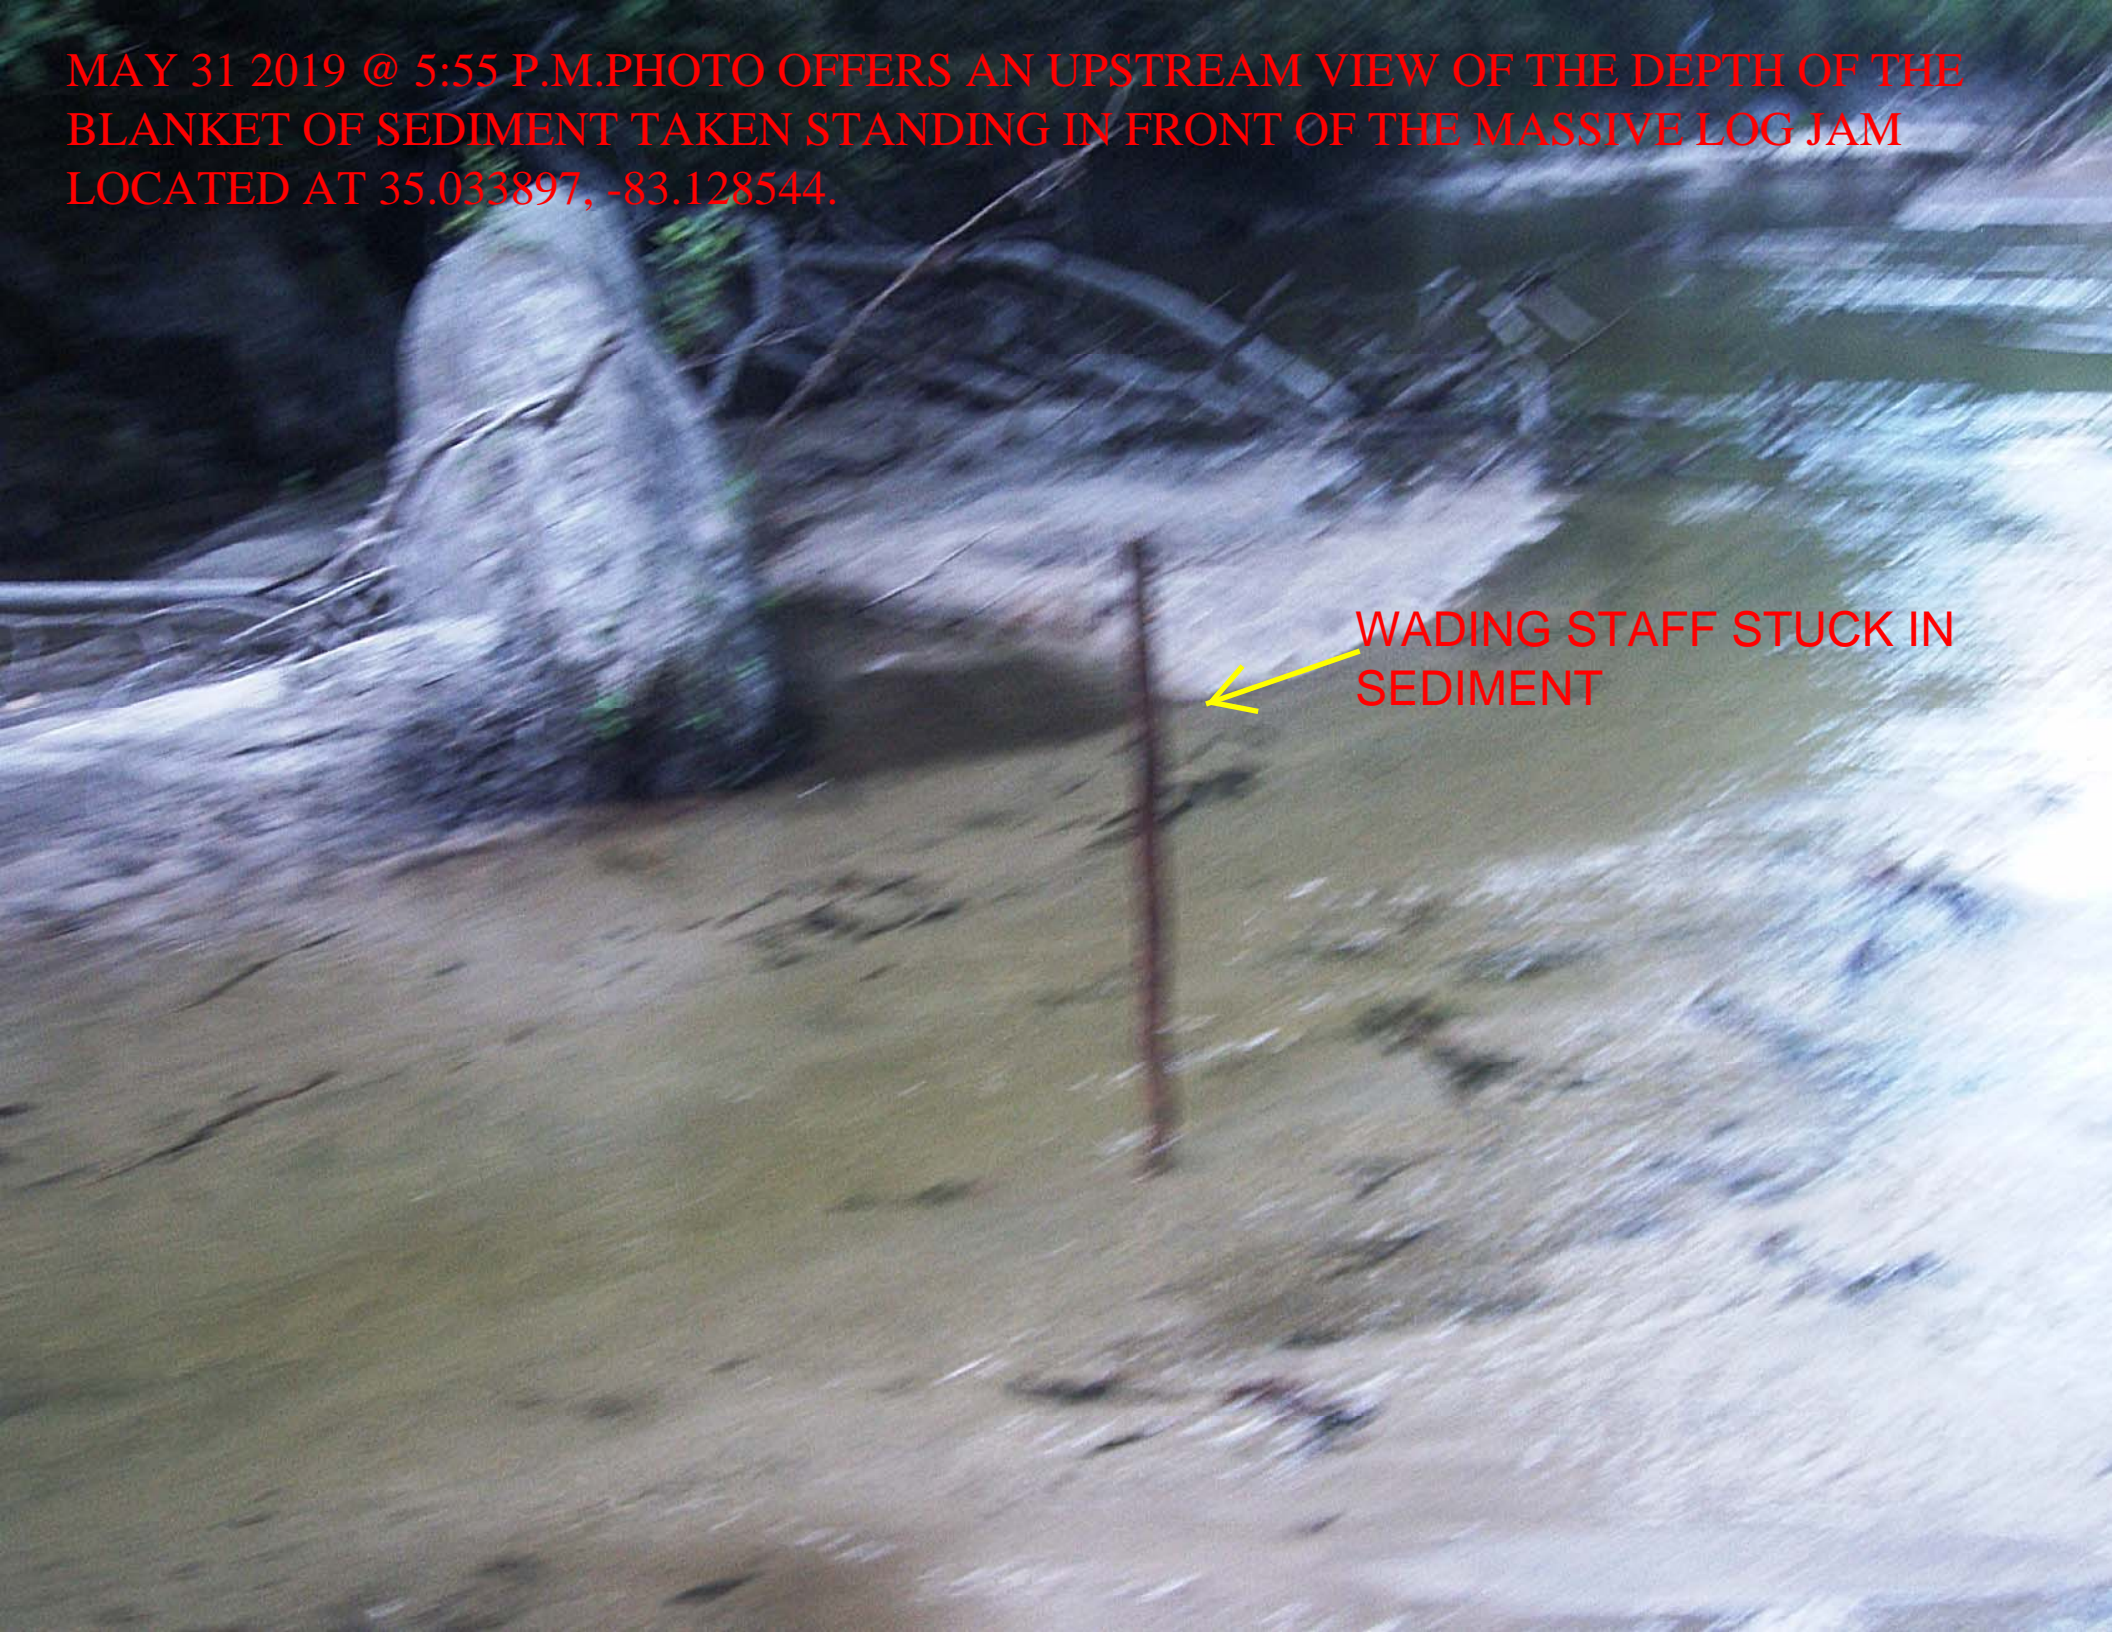
MAY 31 2019 @ 5:55 P.M. PHOTO OFFERS AN UPSTREAM VIEW OF THE DEPTH OF THE BLANKET OF SEDIMENT TAKEN STANDING IN FRONT OF THE MASSIVE LOG JAM LOCATED AT 35.033897, -83.128544.

WADING STAFF STUCK IN
SEDIMENT

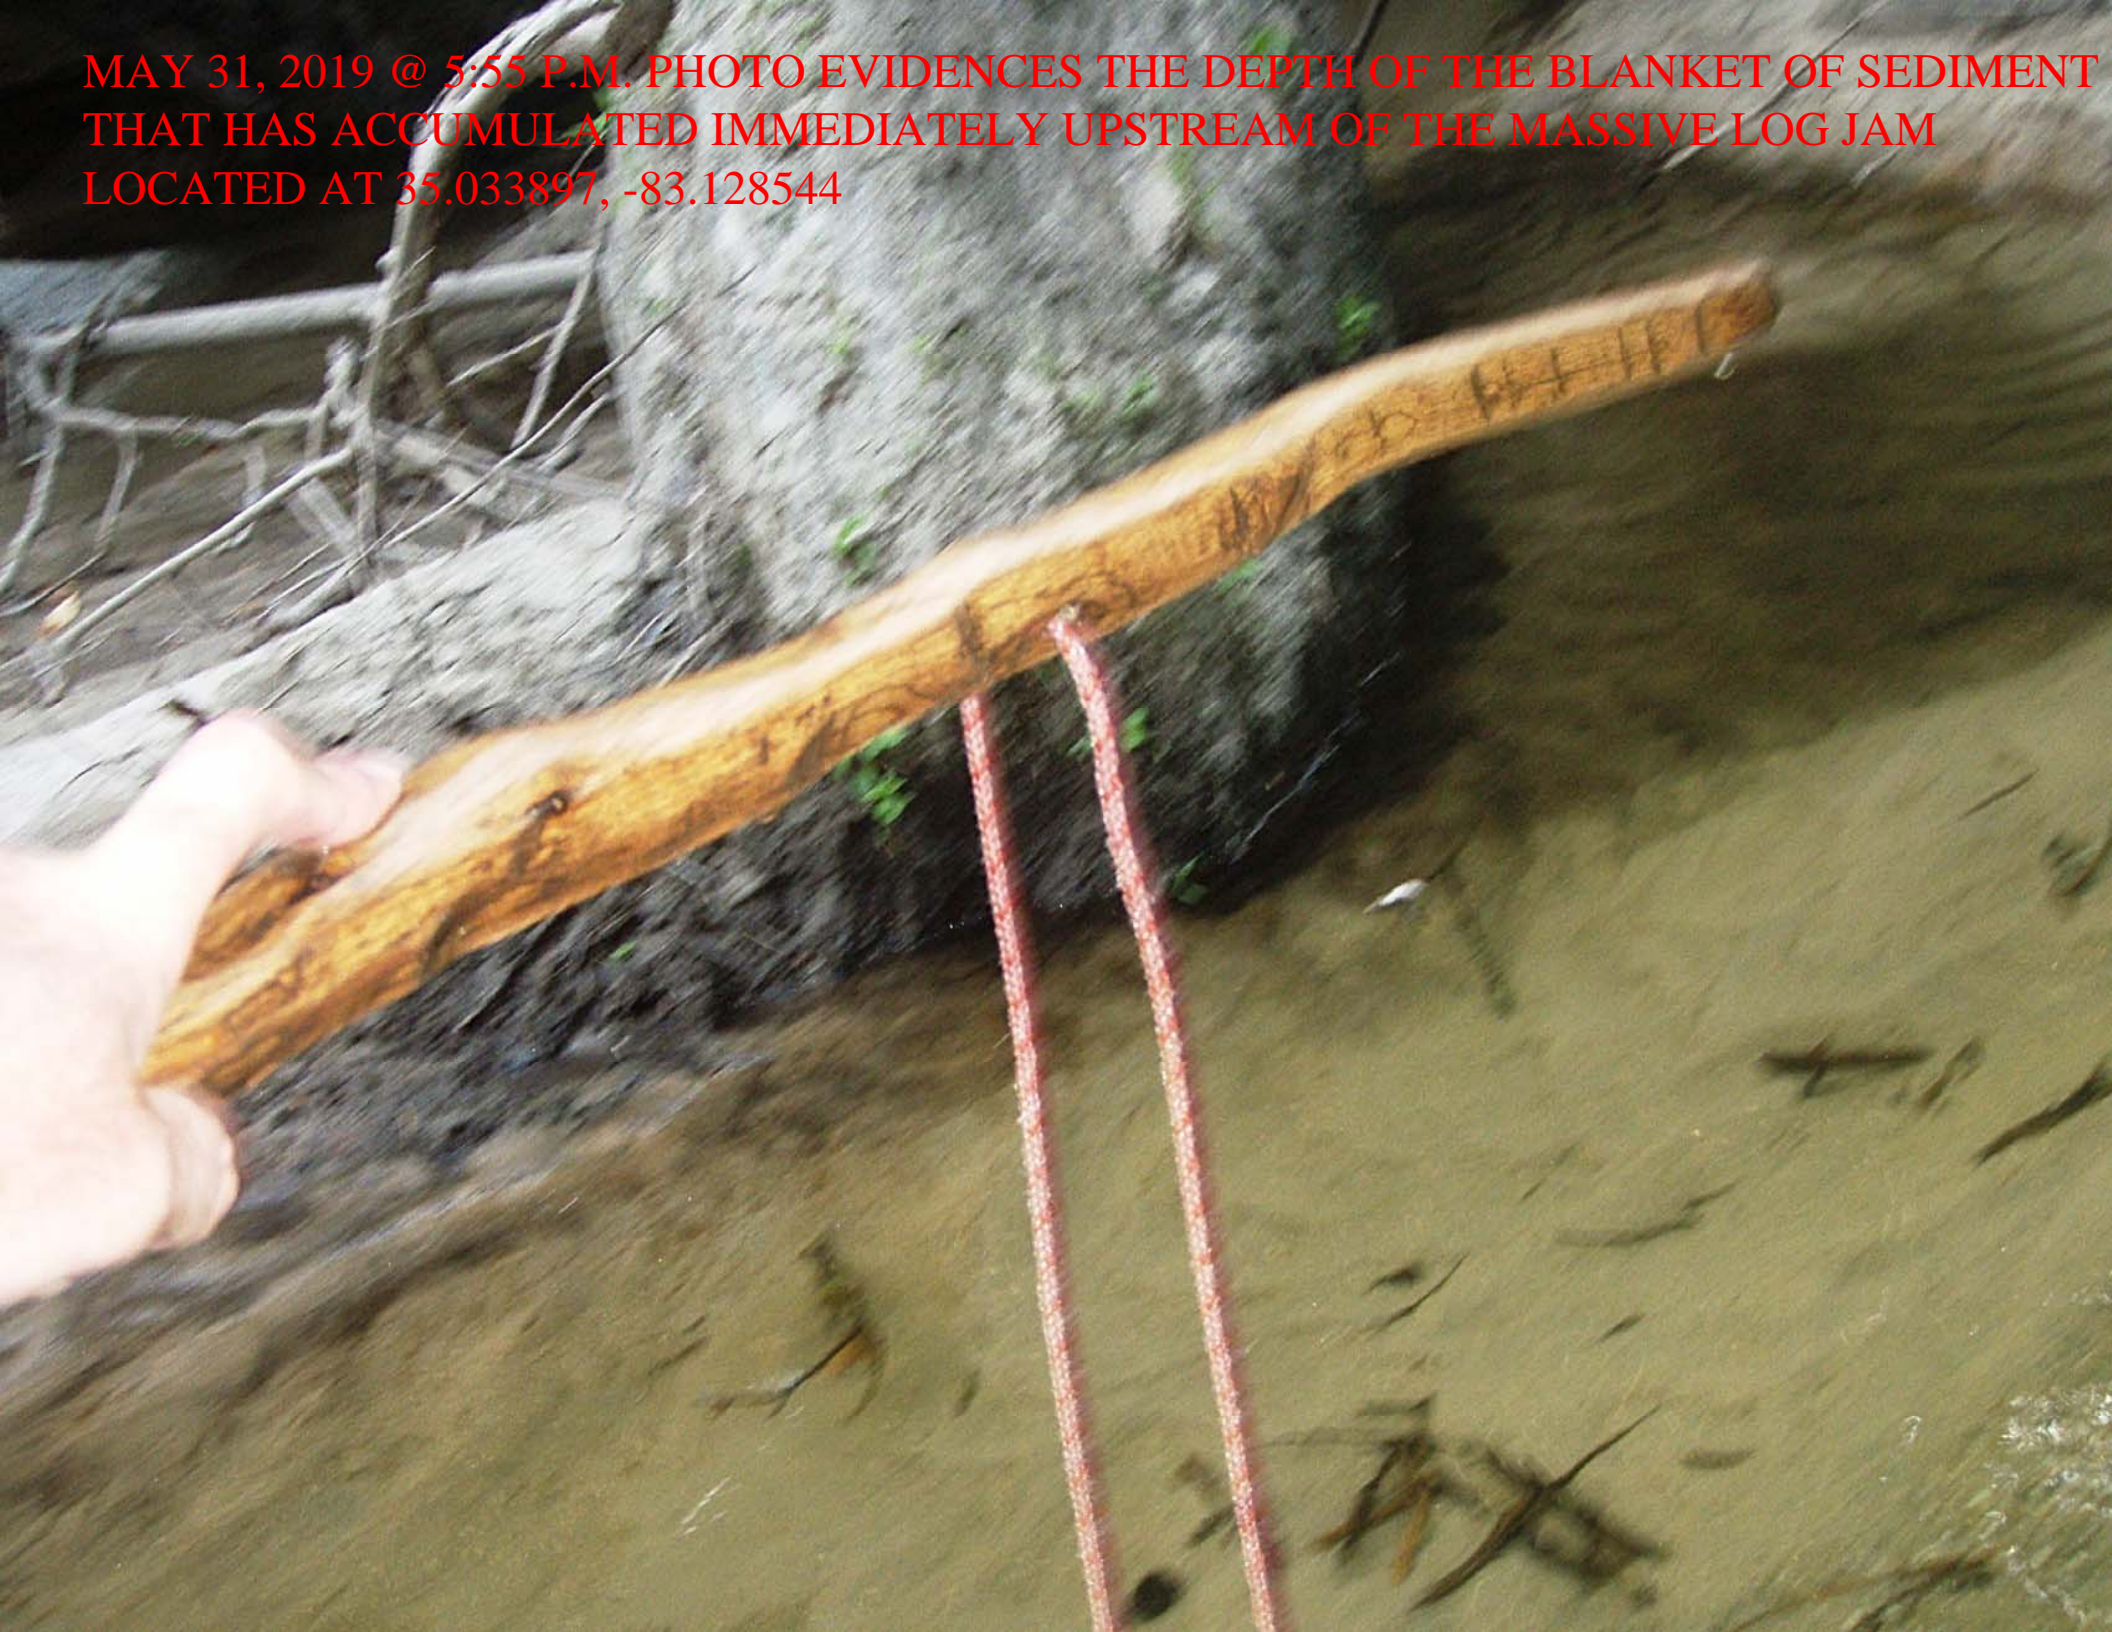
MAY 31, 2019 @ 5:55 P.M. PHOTO EVIDENCES THE DEPTH OF THE BLANKET OF SEDIMENT THAT HAS ACCUMULATED IMMEDIATELY UPSTREAM OF THE MASSIVE LOG JAM LOCATED AT 35.033897, -83.128544

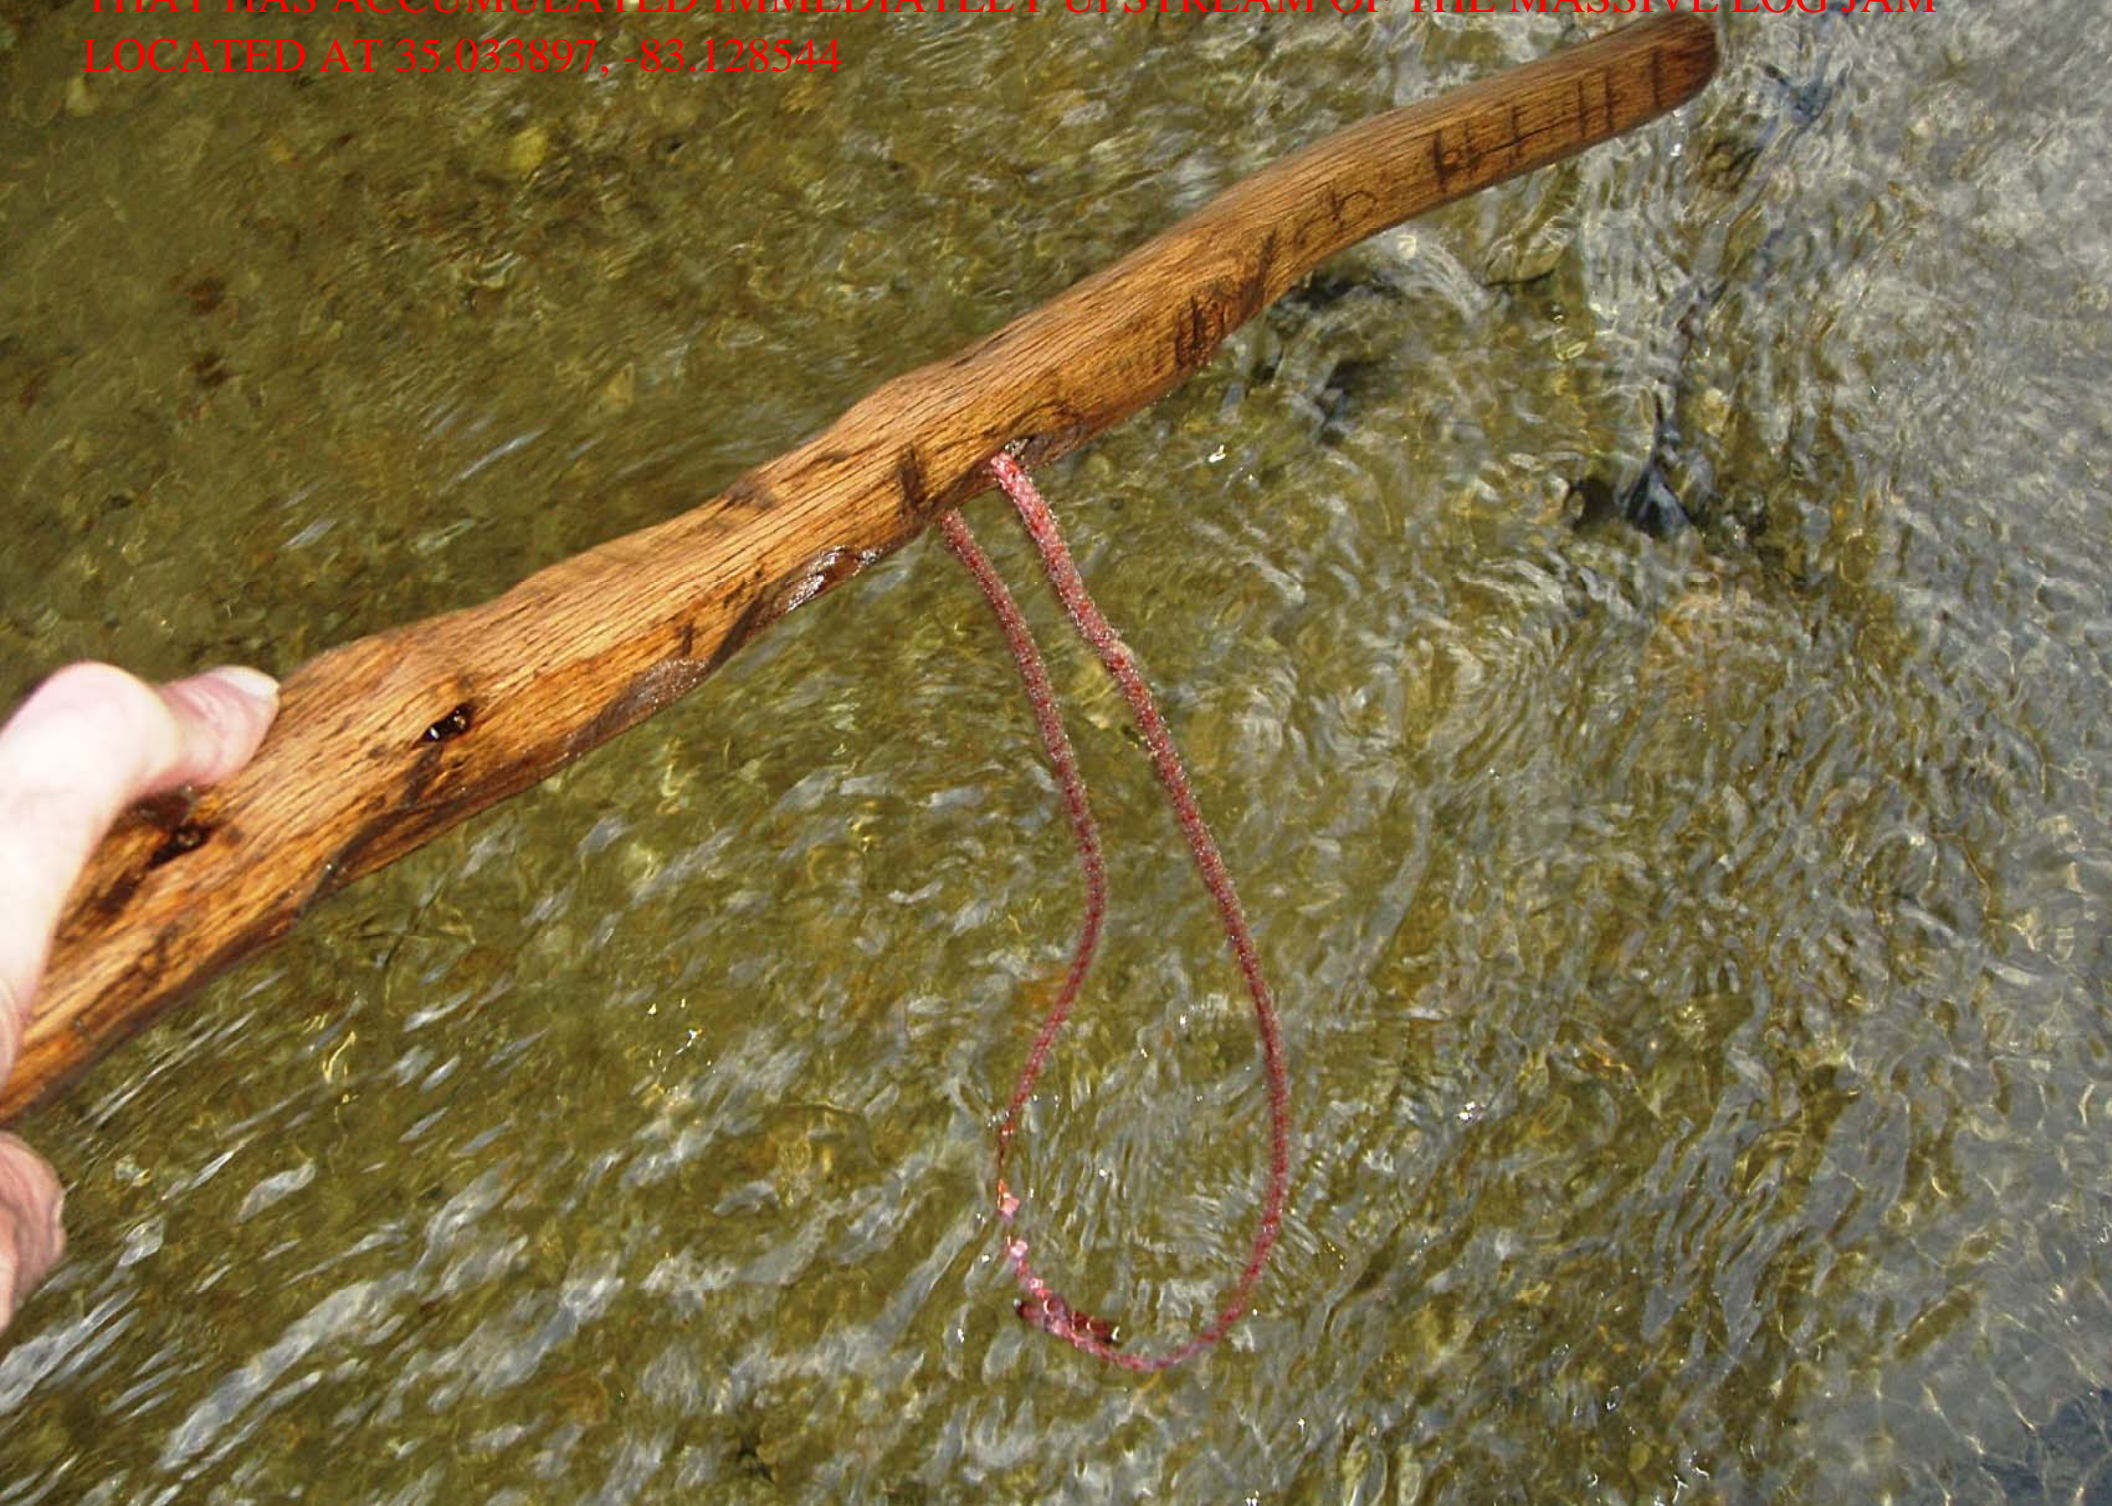
MAY 31, 2019 @ 5:55 P.M. PHOTO EVIDENCES THE DEPTH OF THE BLANKET OF SEDIMENT THAT HAS ACCUMULATED IMMEDIATELY UPSTREAM OF THE MASSIVE LOG JAM LOCATED AT 35.033897, -83.128544
