EXHIBIT 38

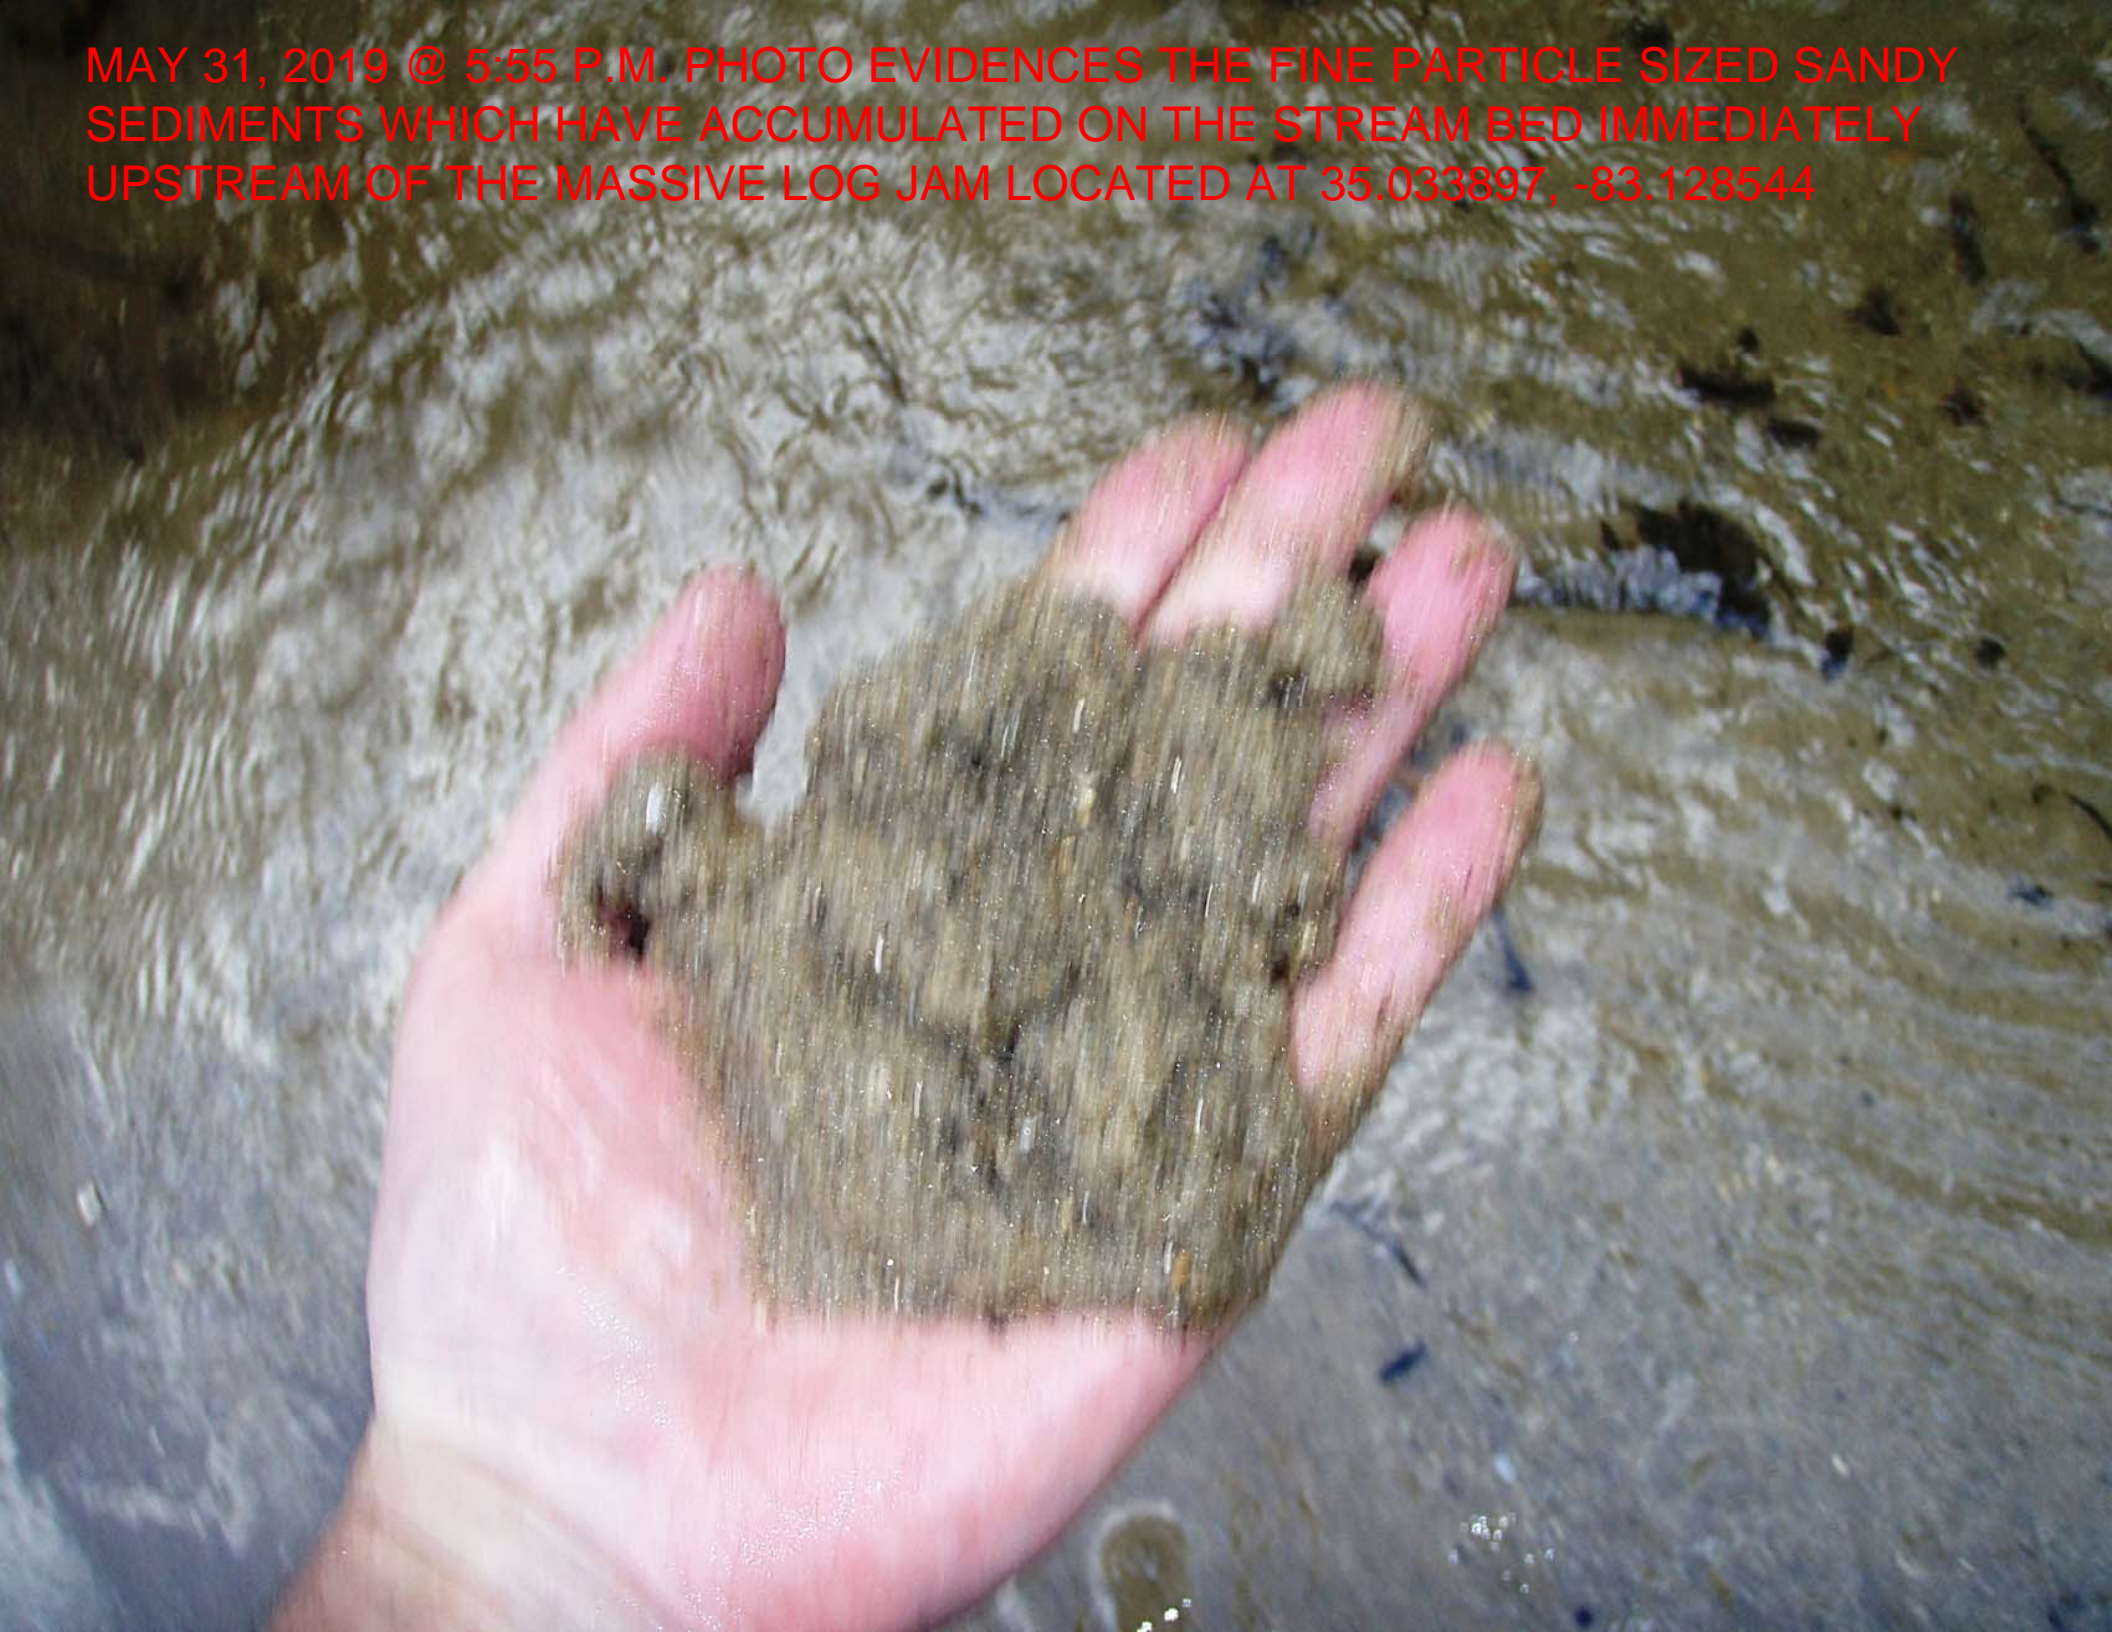
MAY 31, 2019 @ 5:55 P.M. PHOTO EVIDENCES THE FINE PARTICLE SIZED SANDY SEDIMENTS WHICH HAVE ACCUMULATED ON THE STREAM BED IMMEDIATELY UPSTREAM OF THE MASSIVE LOG JAM LOCATED AT 35.033897, -83.128544

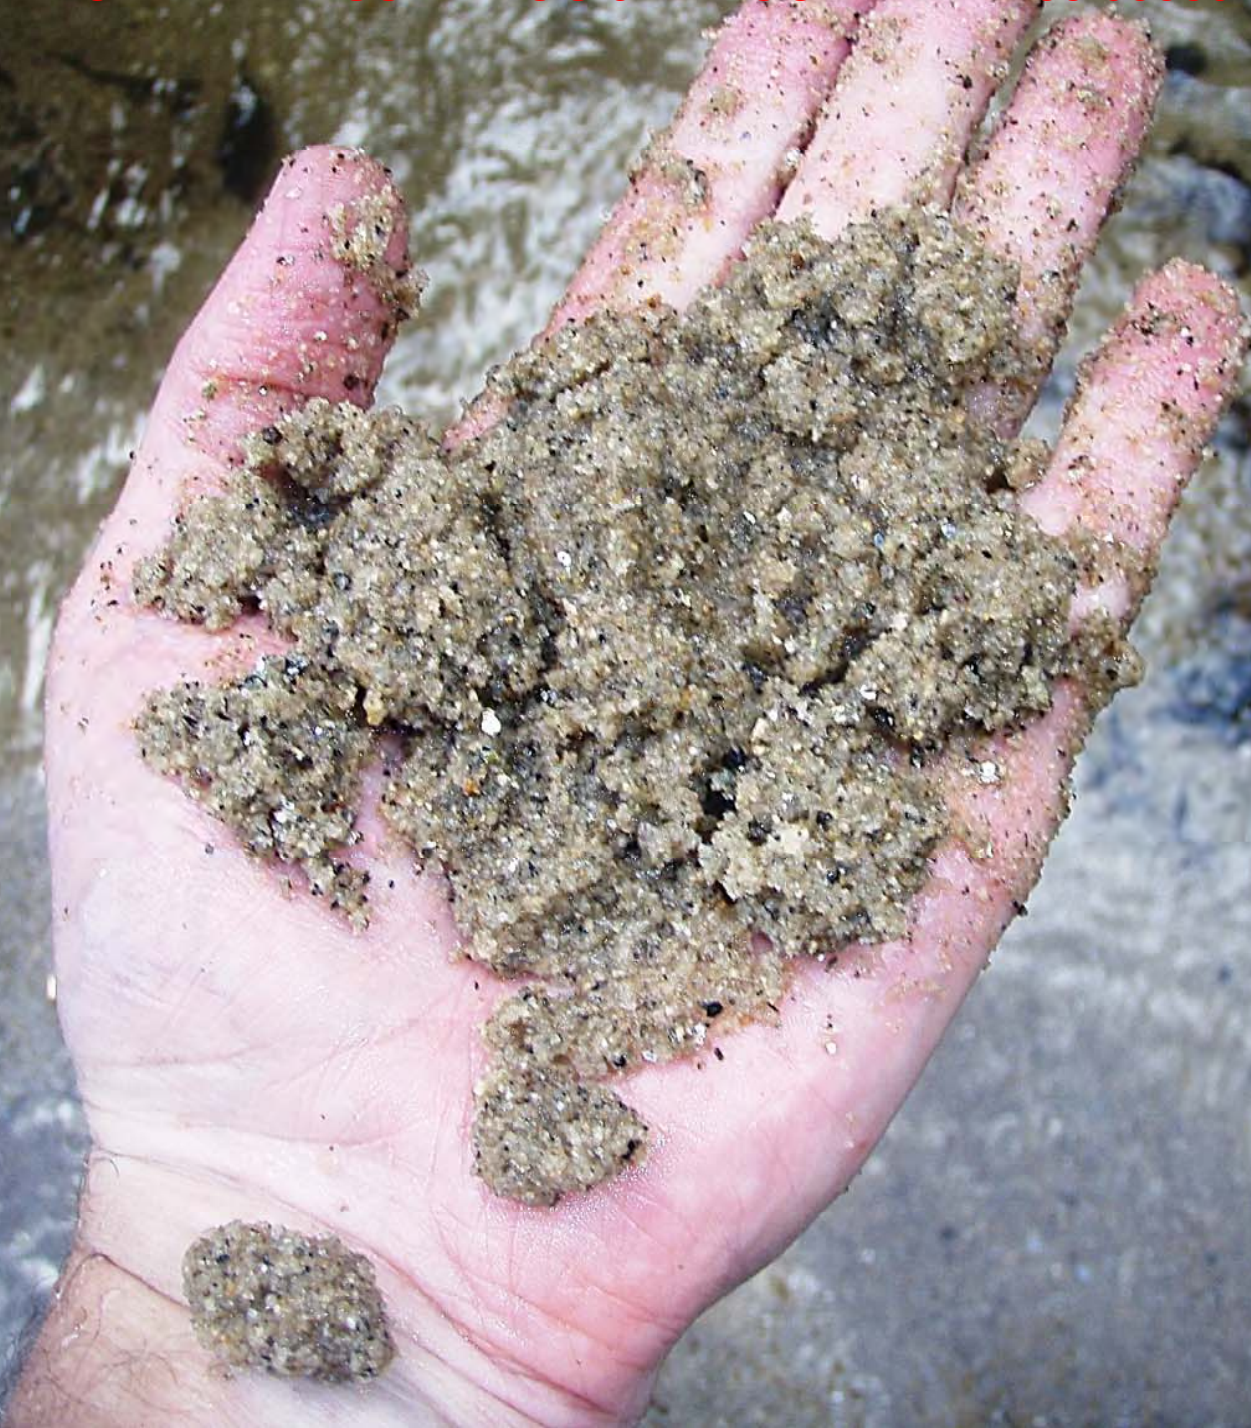
MAY 31, 2019 @ 5:56 P.M. PHOTO EVIDENCES THE FINE PARTICLE SIZED SANDY SEDIMENTS WHICH HAVE ACCUMULATED ON THE STREAM BED IMMEDIATELY UPSTREAM OF THE MASSIVE LOG JAM LOCATED AT 35.033897, -83.128544

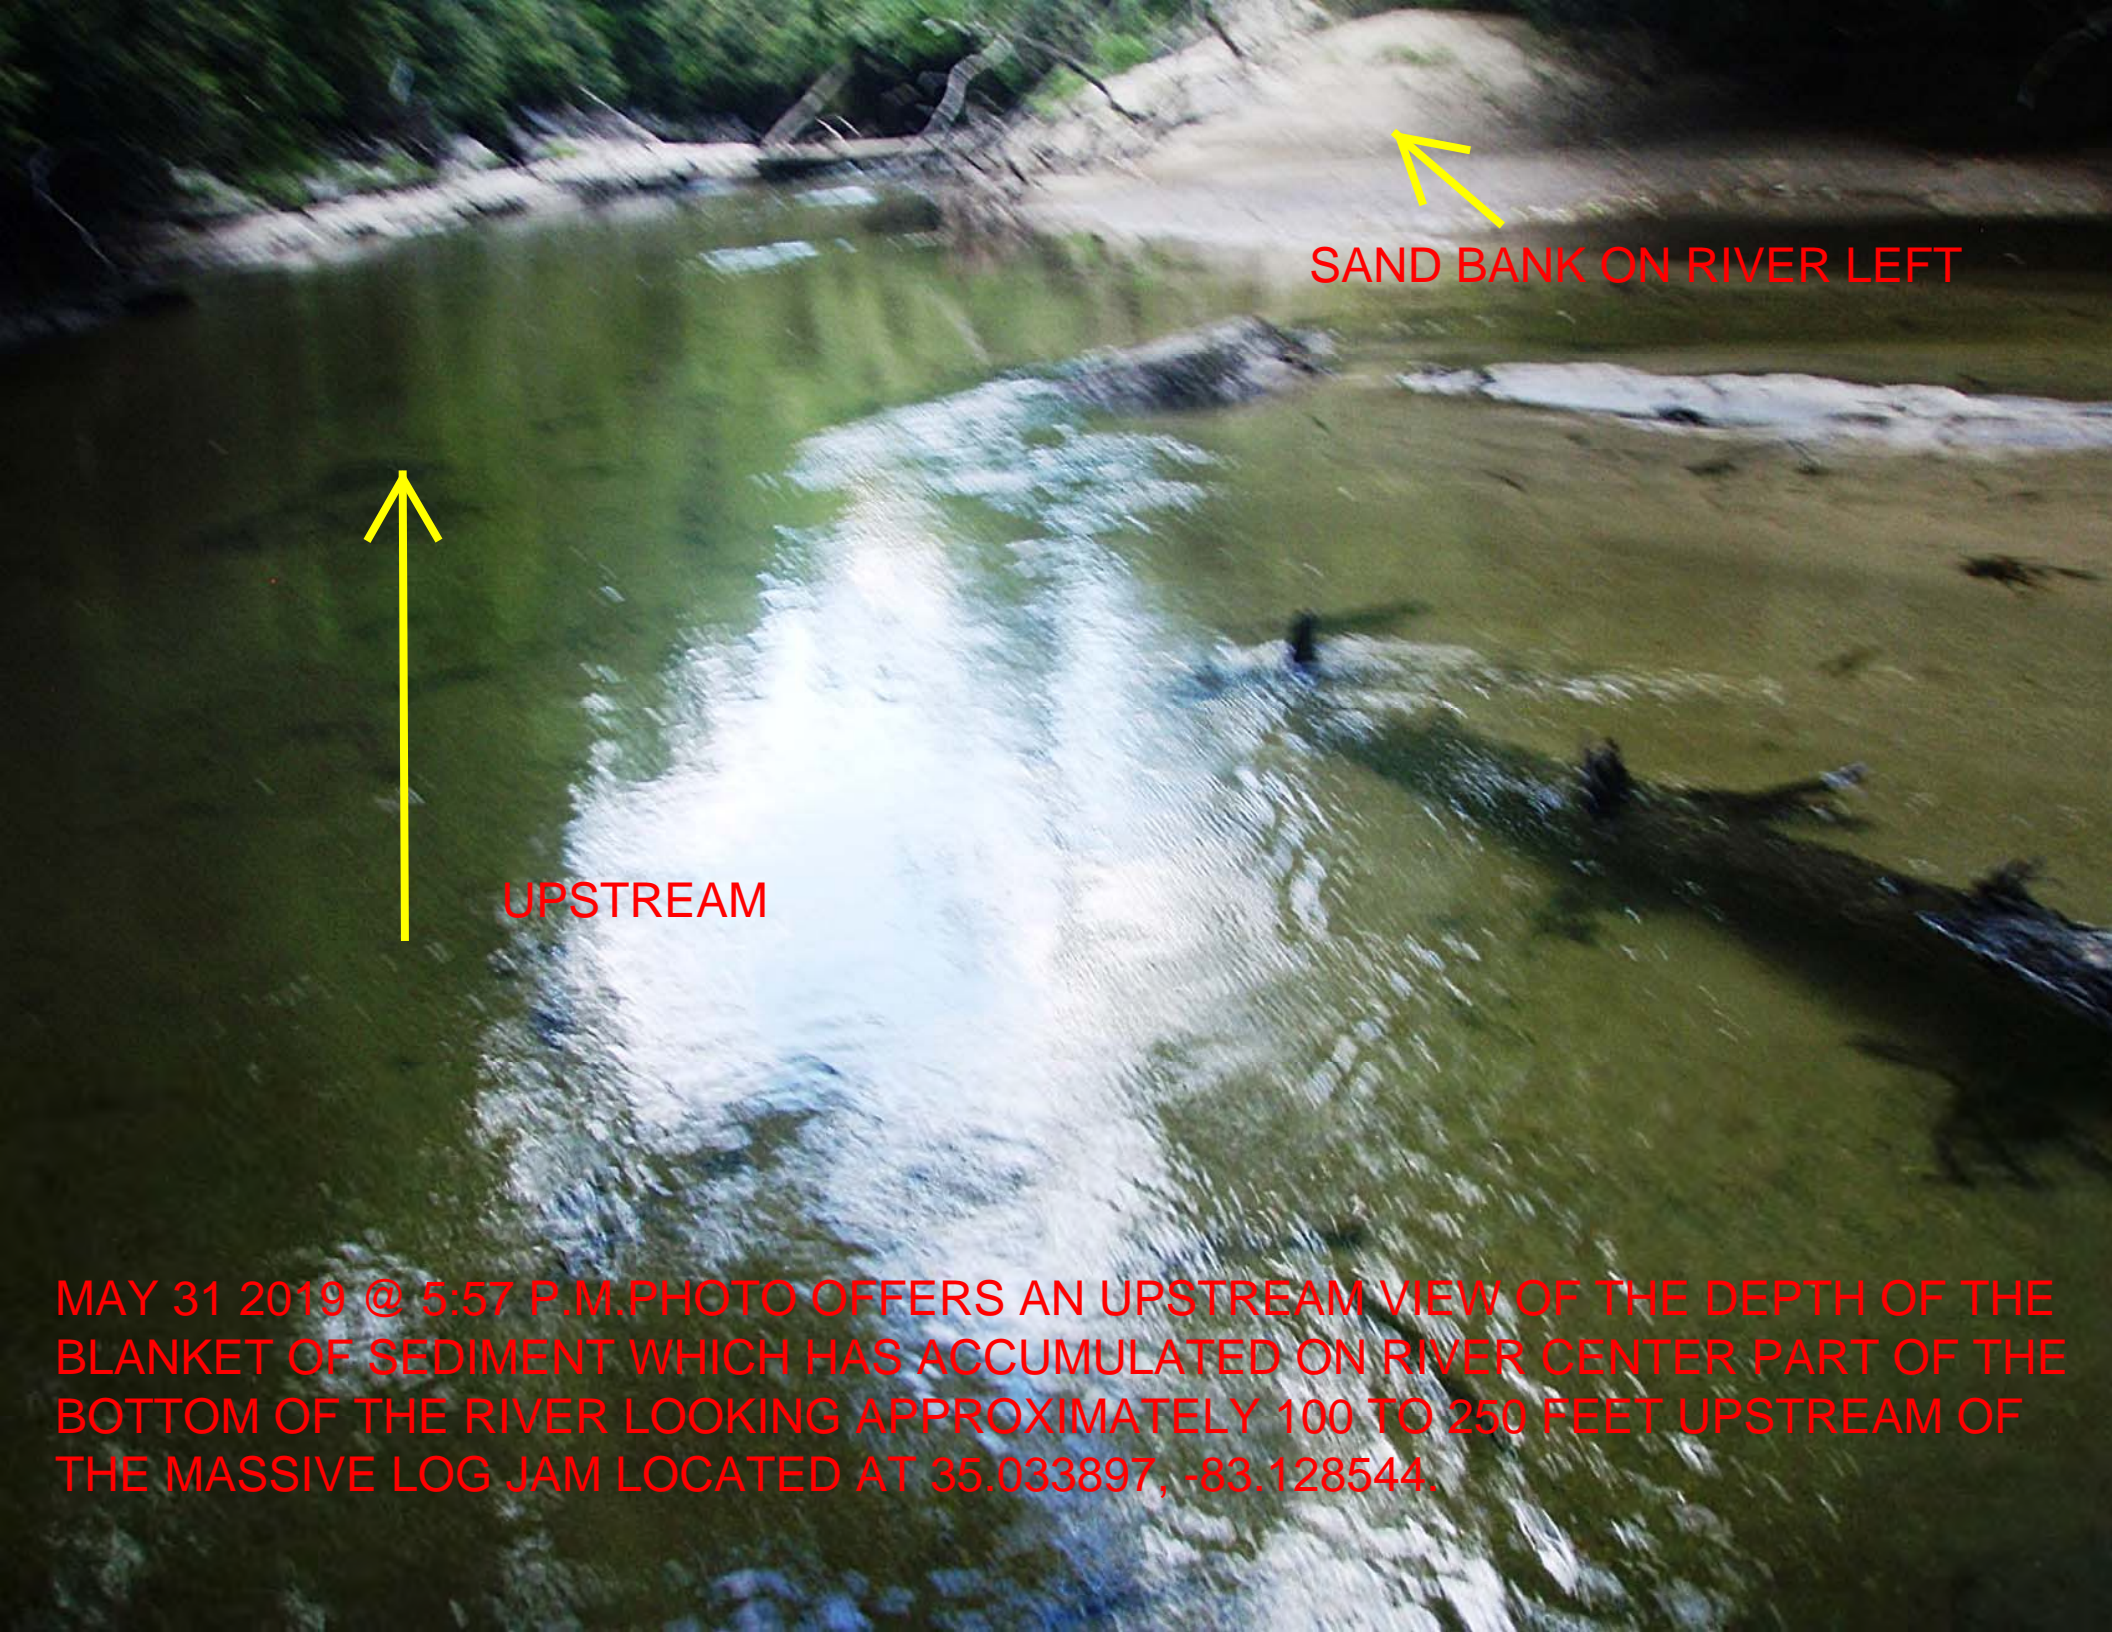
SAND BANK ON RIVER LEFT

UPSTREAM

MAY 31 2019 @ 5:57 P.M. PHOTO OFFERS AN UPSTREAM VIEW OF THE DEPTH OF THE BLANKET OF SEDIMENT WHICH HAS ACCUMULATED ON RIVER CENTER PART OF THE BOTTOM OF THE RIVER LOOKING APPROXIMATELY 100 TO 250 FEET UPSTREAM OF THE MASSIVE LOG JAM LOCATED AT 35.033897, -83.128544.

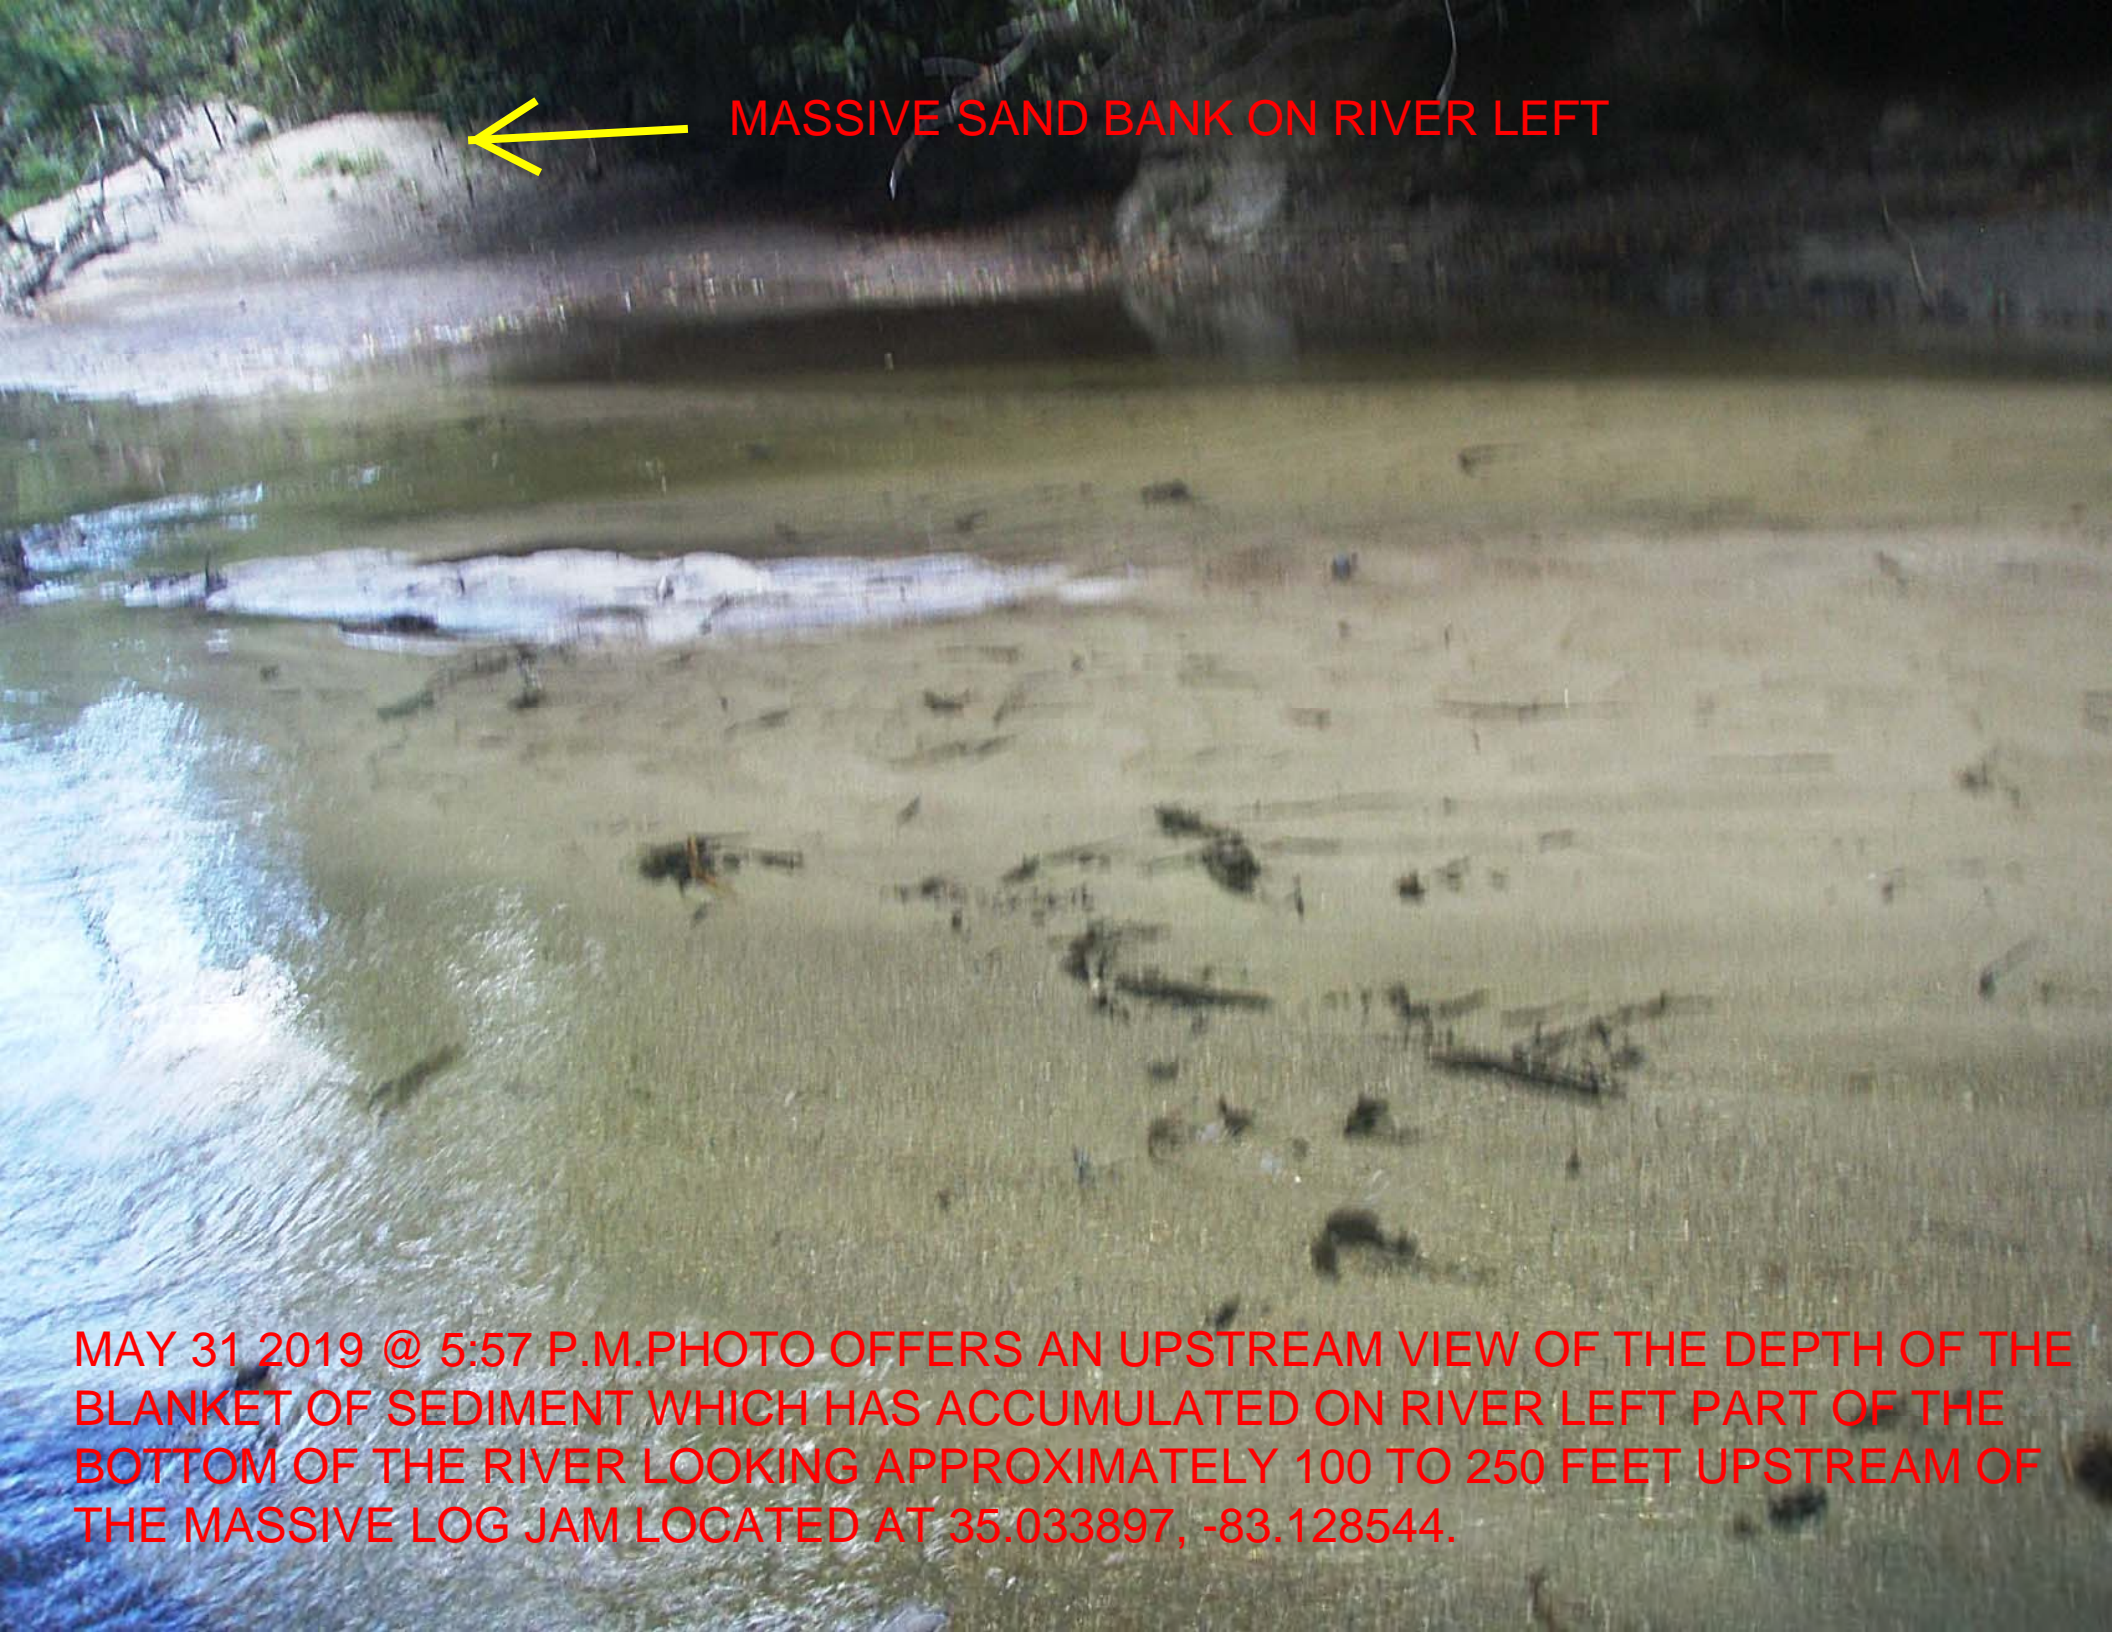
MASSIVE SAND BANK ON RIVER LEFT

MAY 31 2019 @ 5:57 P.M. PHOTO OFFERS AN UPSTREAM VIEW OF THE DEPTH OF THE BLANKET OF SEDIMENT WHICH HAS ACCUMULATED ON RIVER LEFT PART OF THE BOTTOM OF THE RIVER LOOKING APPROXIMATELY 100 TO 250 FEET UPSTREAM OF THE MASSIVE LOG JAM LOCATED AT 35.033897, -83.128544.

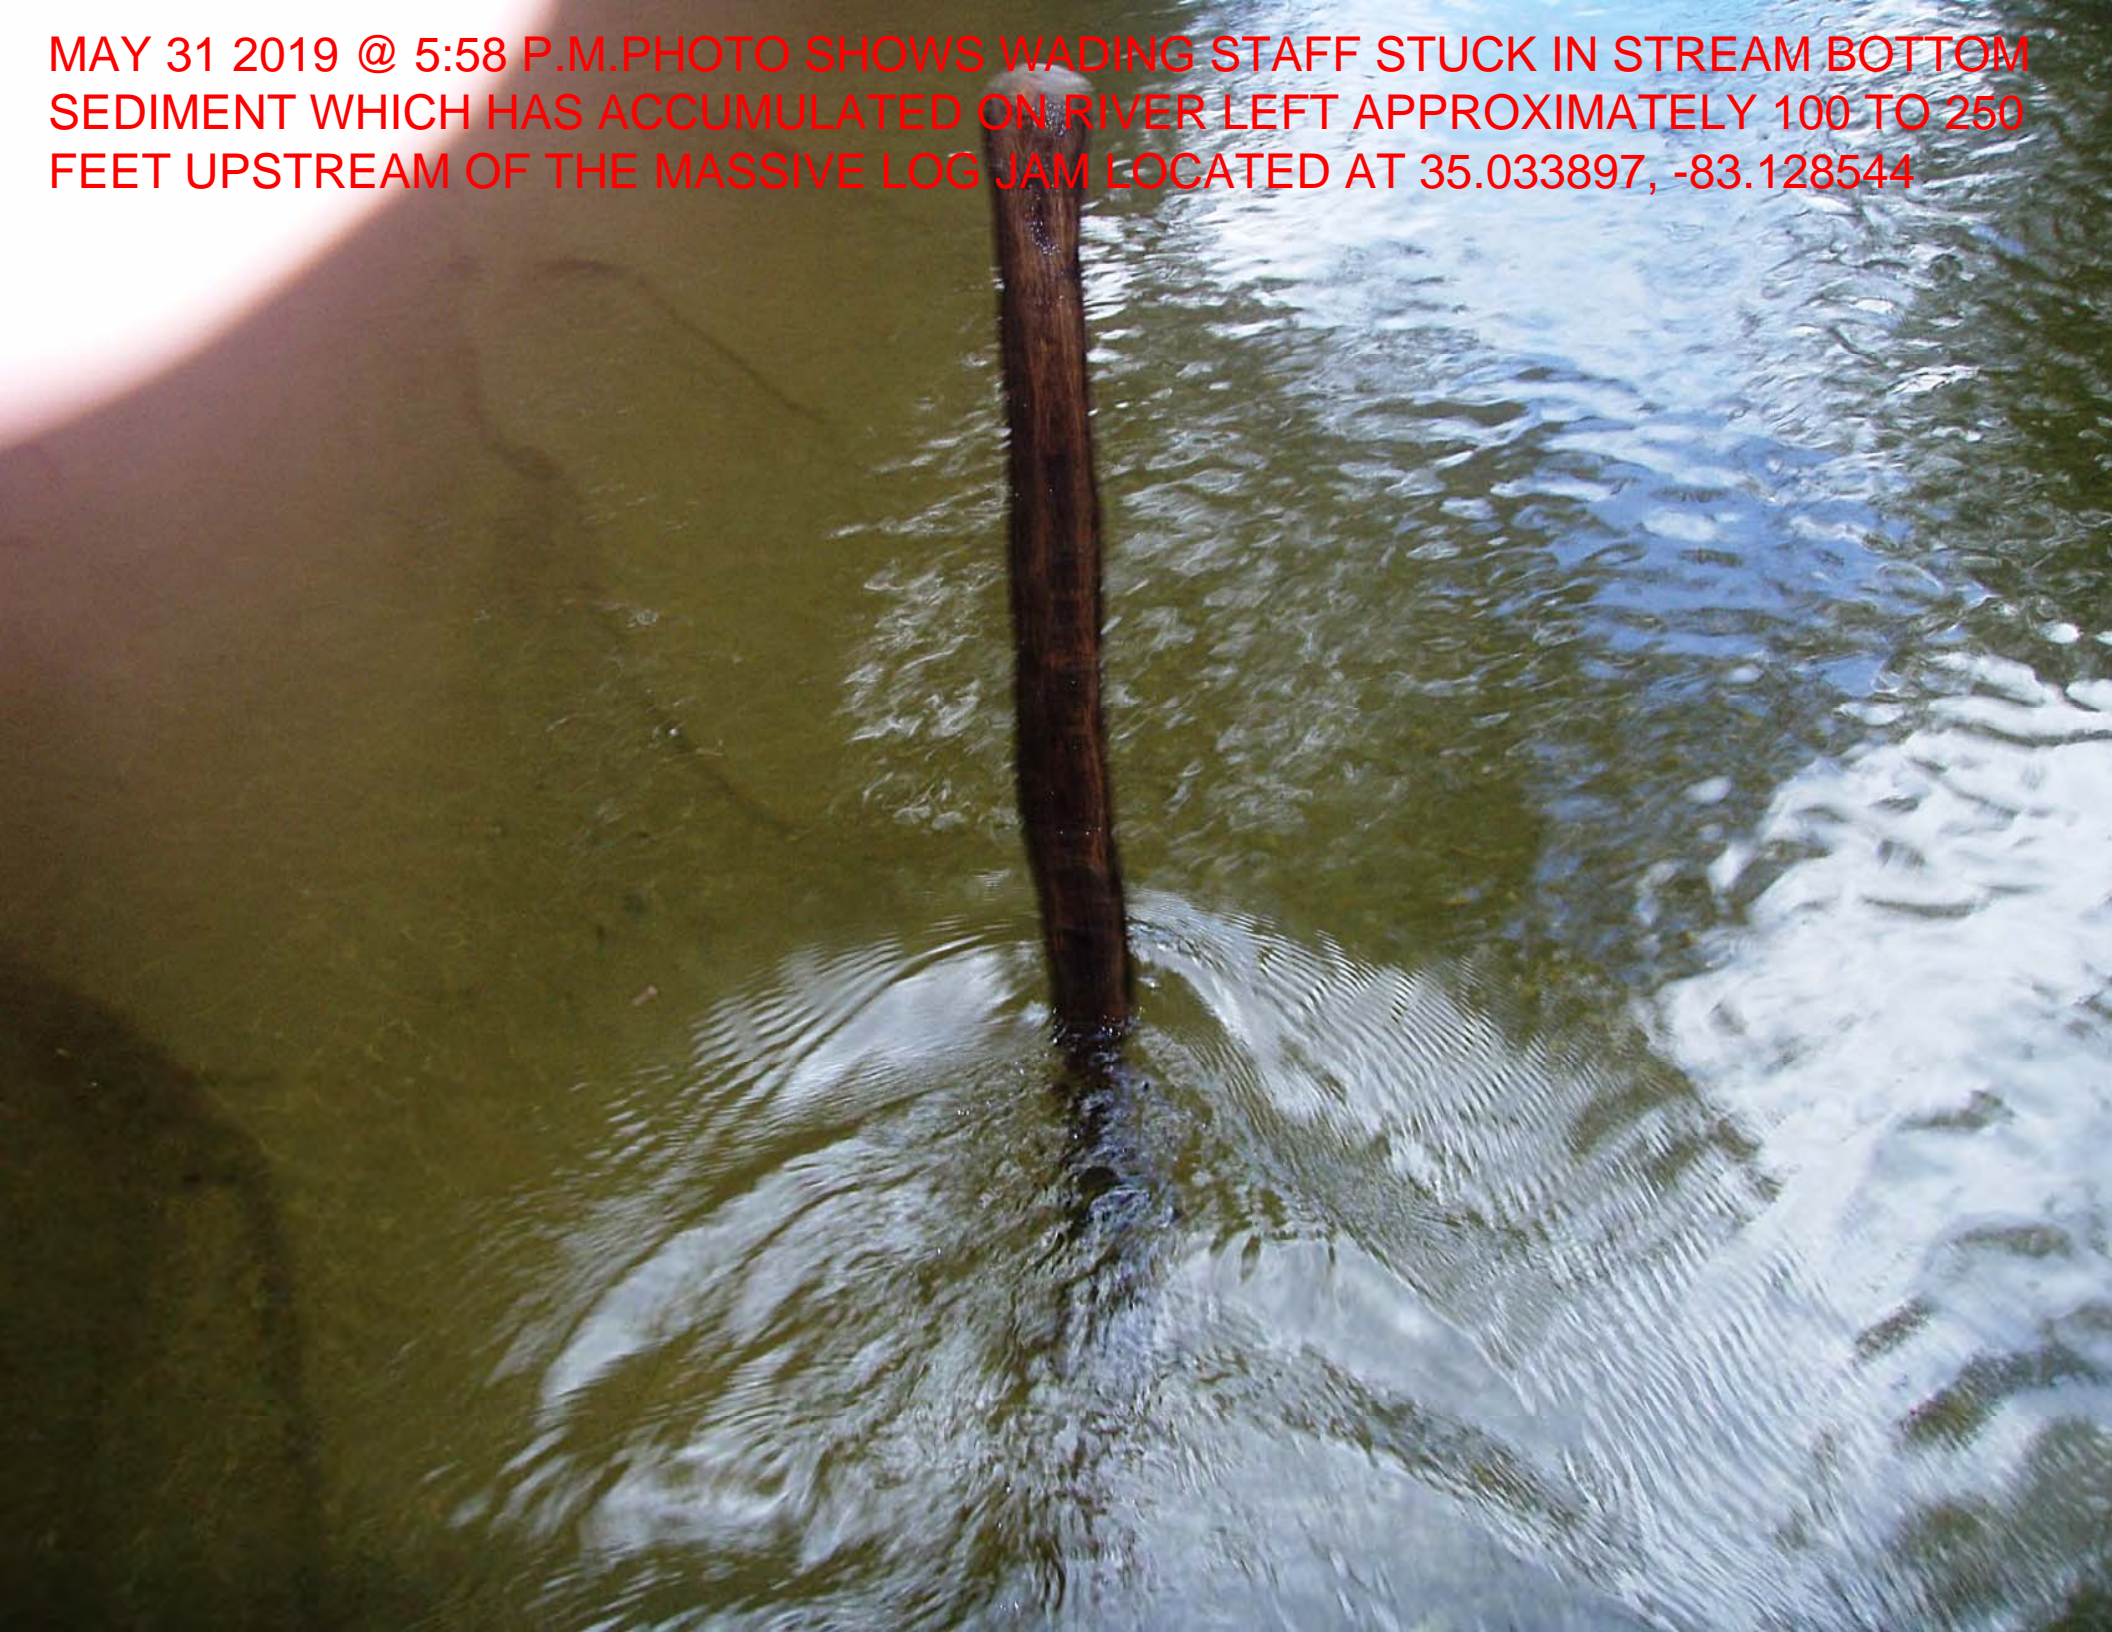
MAY 31 2019 @ 5:58 P.M. PHOTO SHOWS WADING STAFF STUCK IN STREAM BOTTOM
SEDIMENT WHICH HAS ACCUMULATED ON RIVER LEFT APPROXIMATELY 100 TO 250
FEET UPSTREAM OF THE MASSIVE LOG JAM LOCATED AT 35.033897, -83.128544

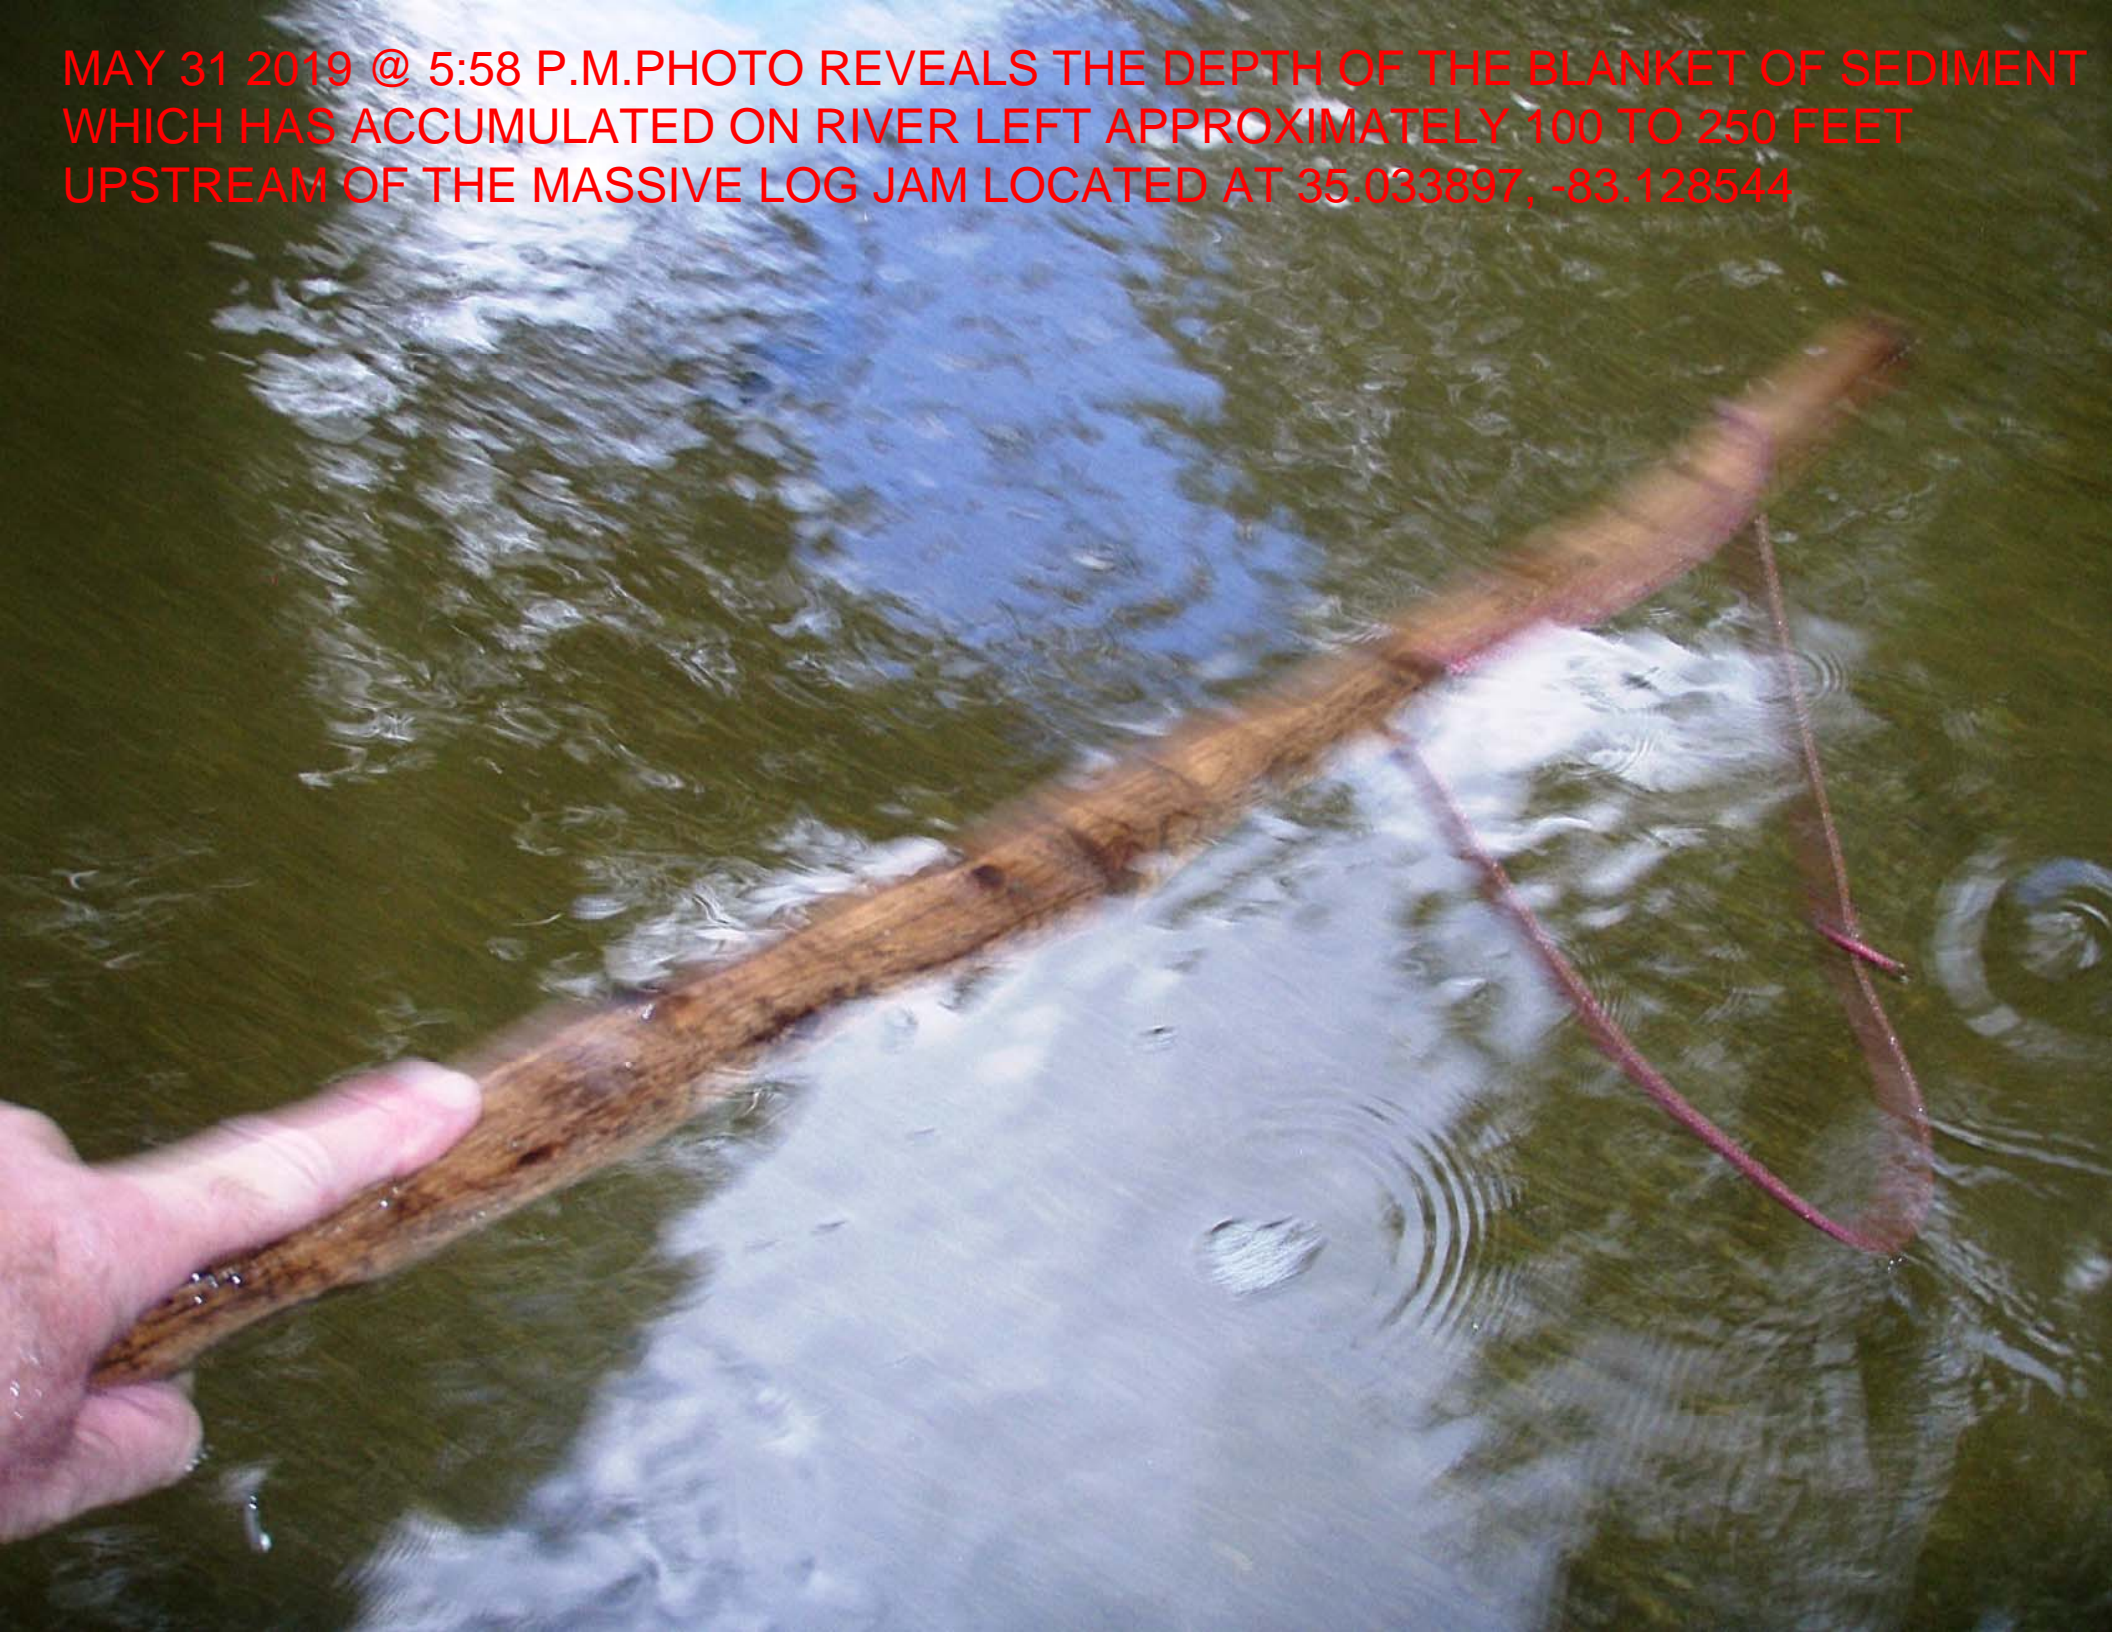
MAY 31 2019 @ 5:58 P.M. PHOTO REVEALS THE DEPTH OF THE BLANKET OF SEDIMENT WHICH HAS ACCUMULATED ON RIVER LEFT APPROXIMATELY 100 TO 250 FEET UPSTREAM OF THE MASSIVE LOG JAM LOCATED AT 35.033897, -83.128544

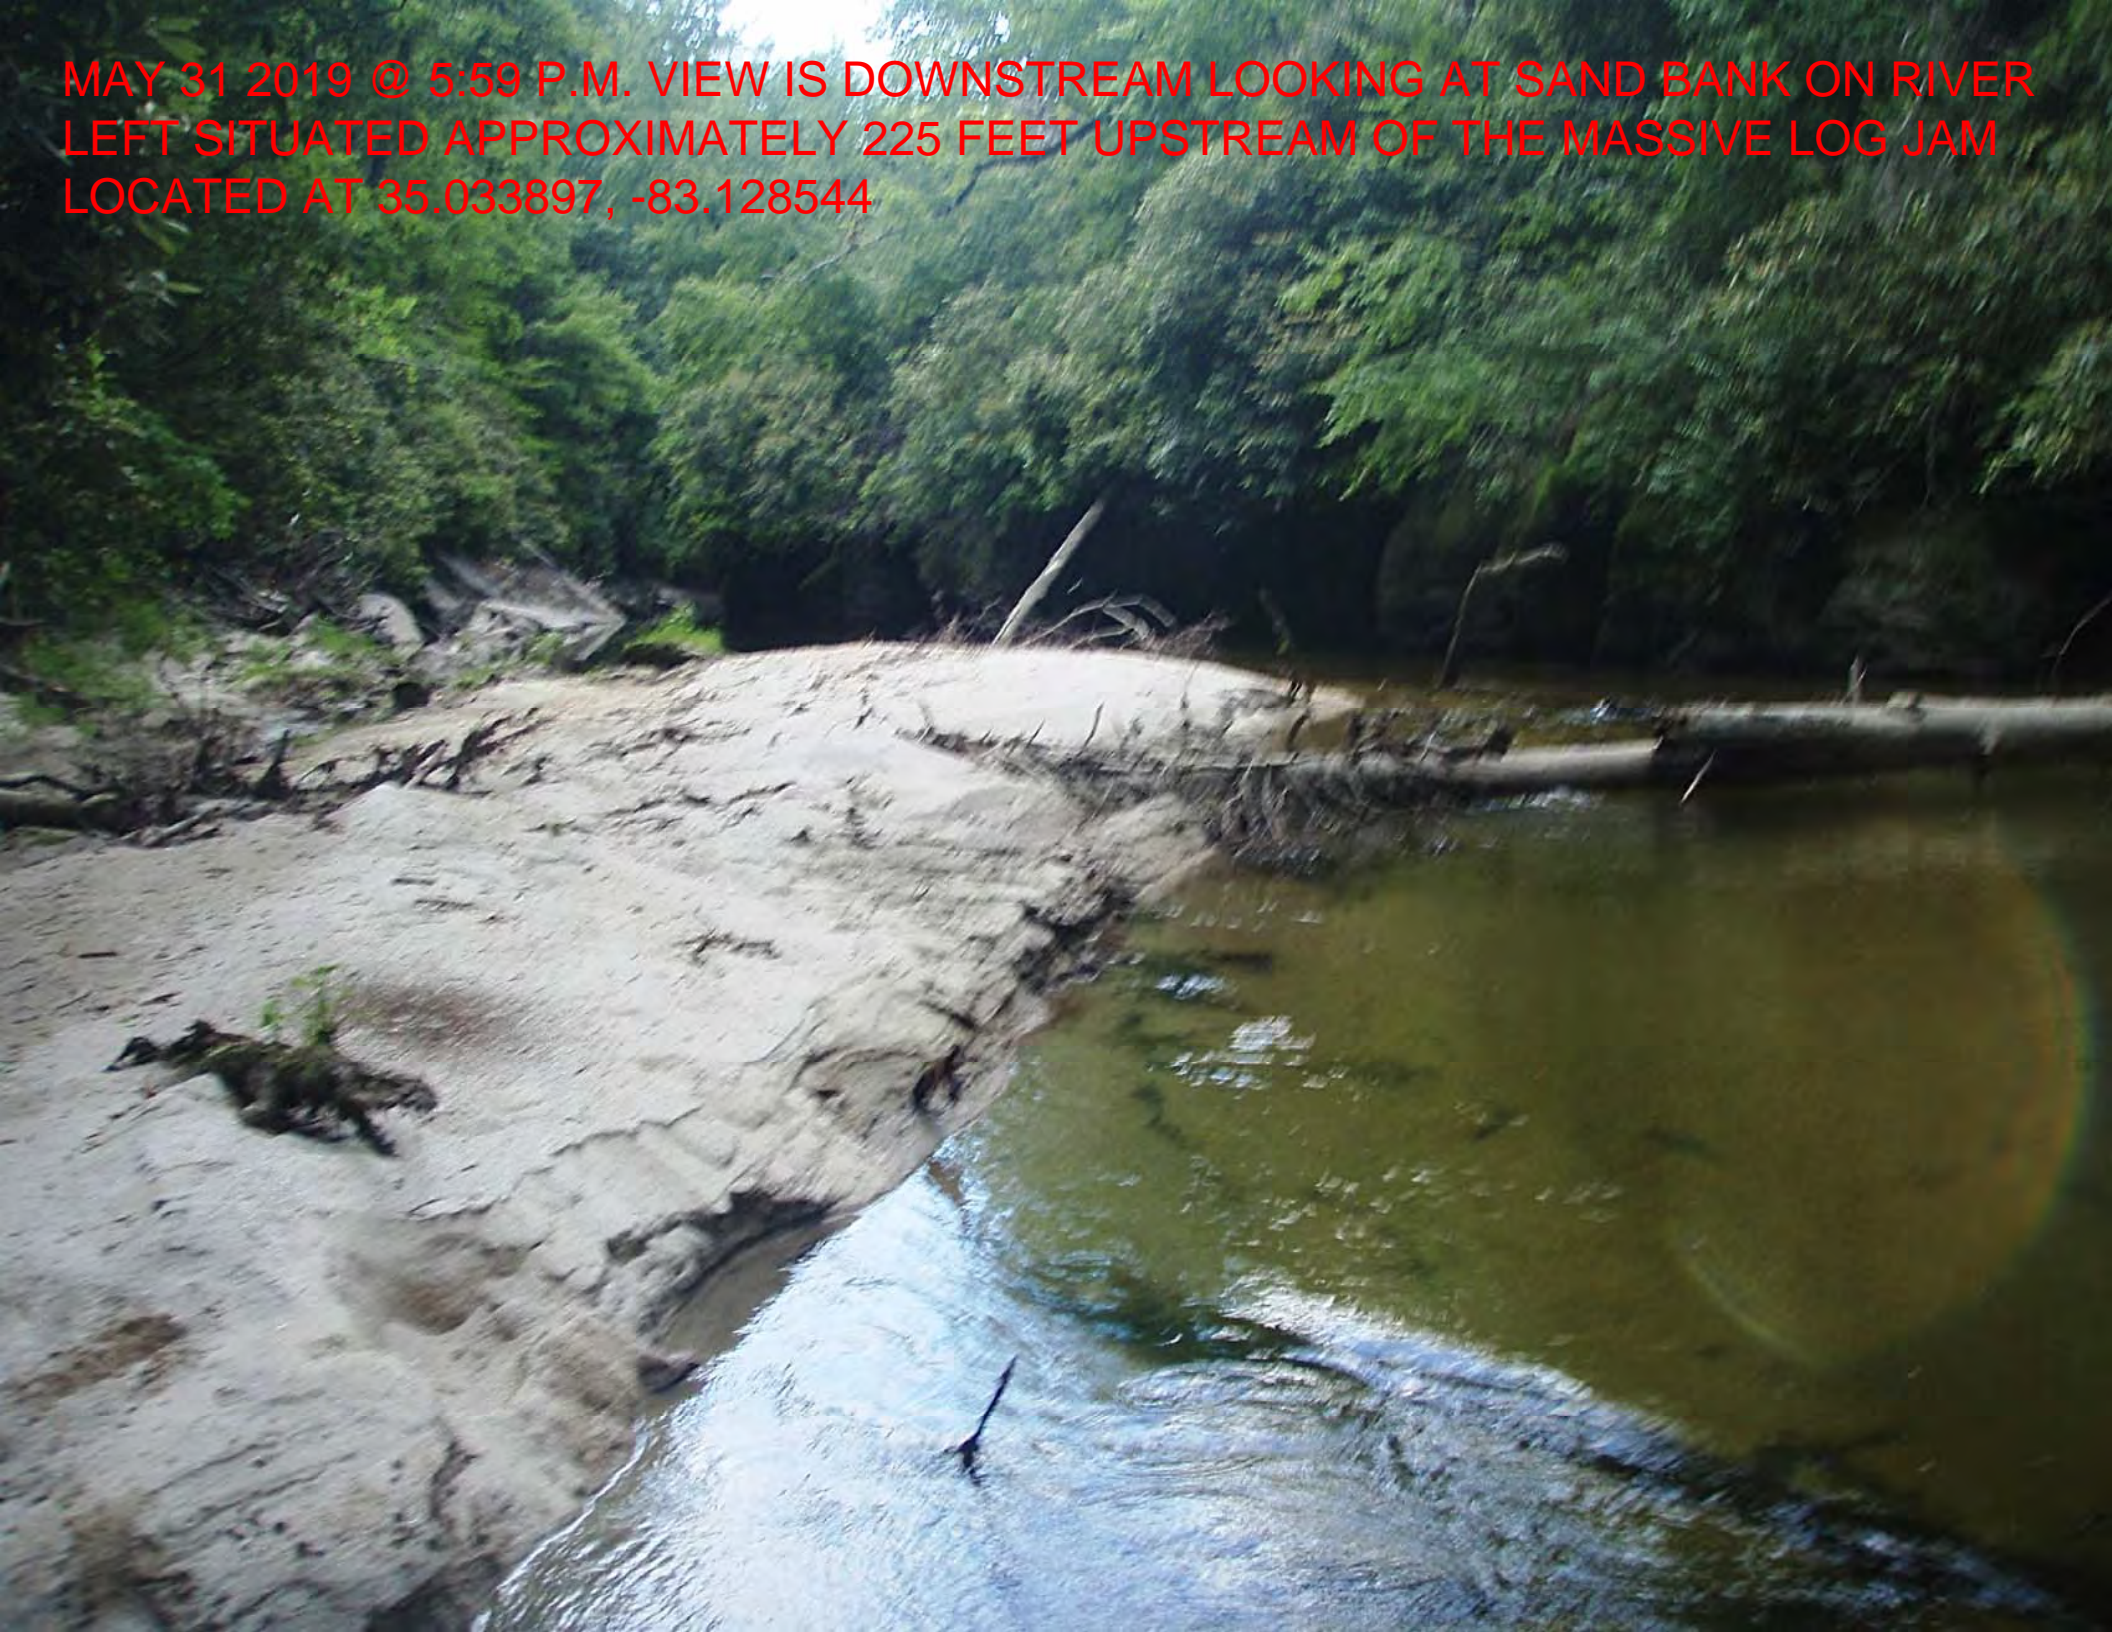
MAY 31 2019 @ 5:59 P.M. VIEW IS DOWNSTREAM LOOKING AT SAND BANK ON RIVER LEFT SITUATED APPROXIMATELY 225 FEET UPSTREAM OF THE MASSIVE LOG JAM LOCATED AT 35.033897, -83.128544
