EXHIBIT 38

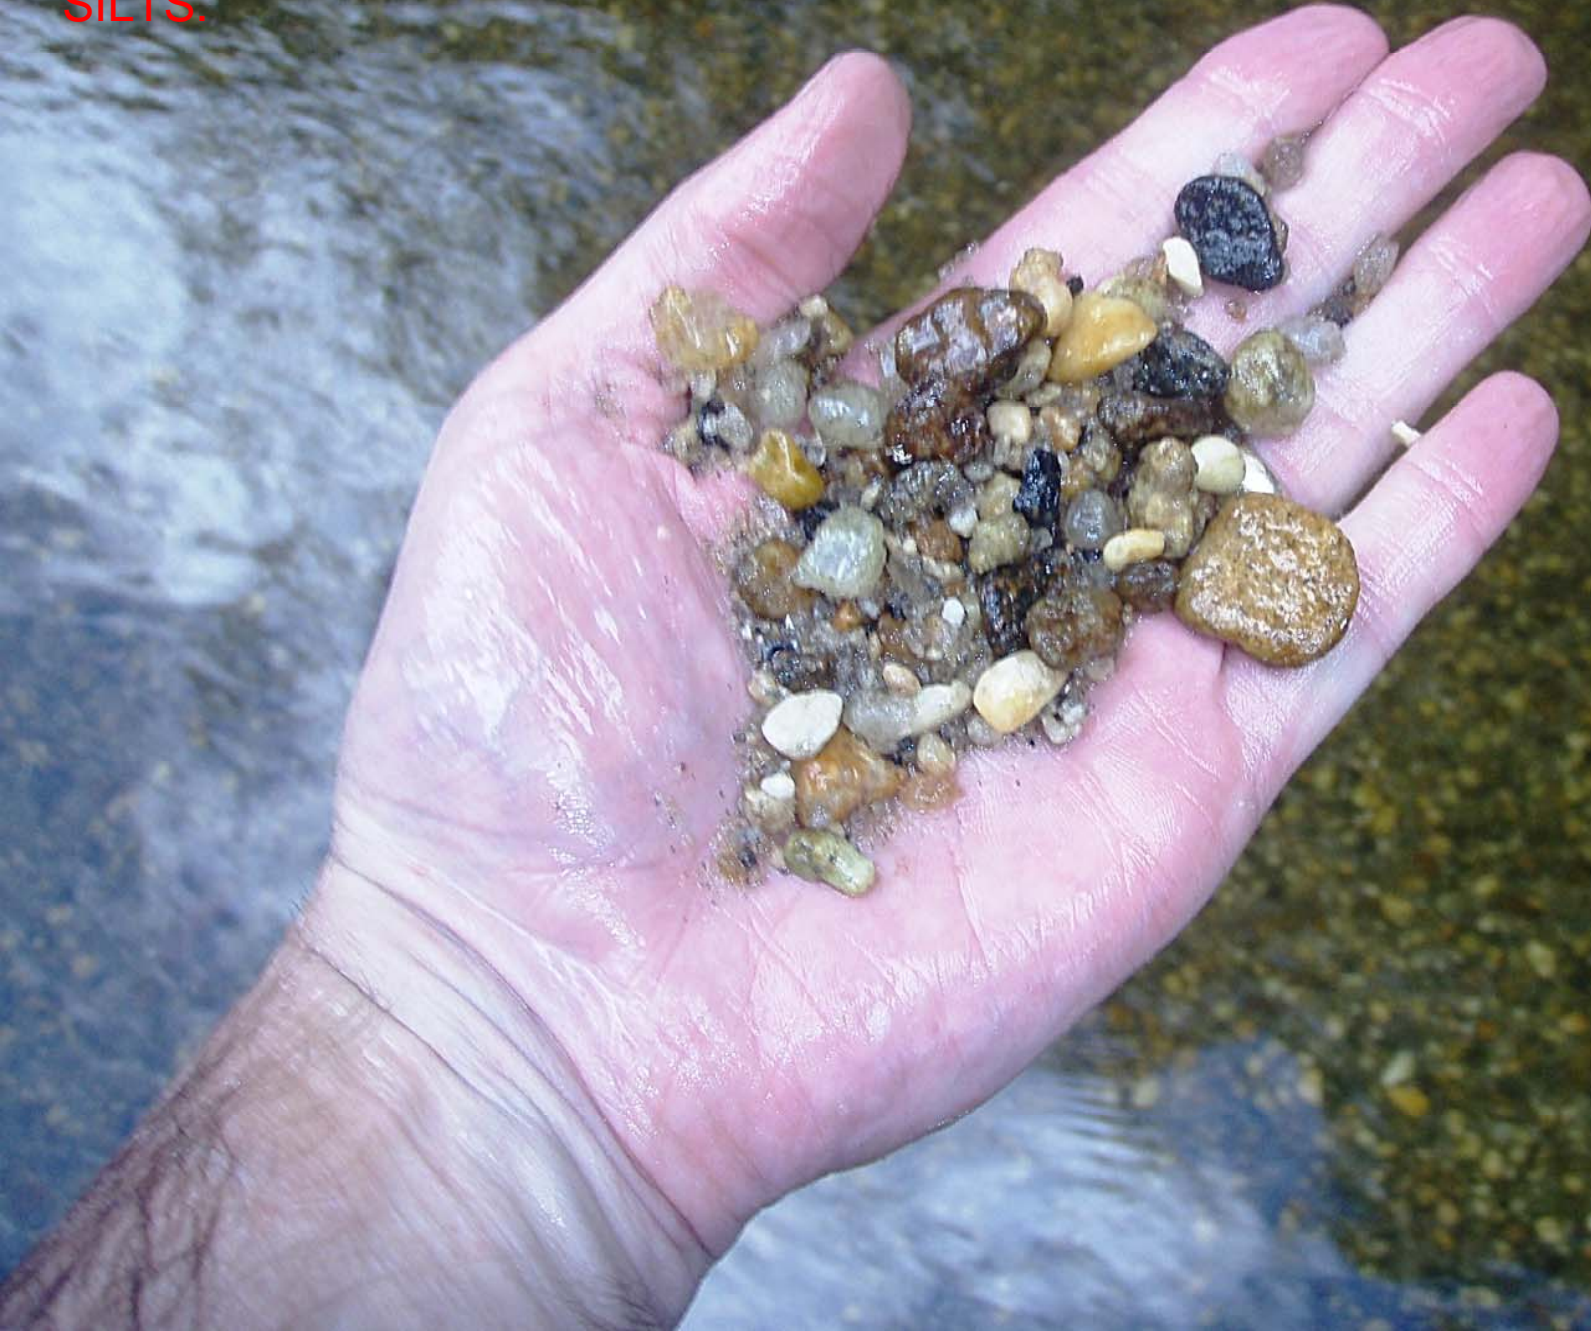
MAY 31, 2019 @ 6:00 P.M. PHOTO DEMONSTRATES HOW QUARTZ GRAVELS WHICH ARE SUITABLE FOR TROUT SPAWNING ARE PRESENT 225 FEET UPSTREAM OF THE MASSIVE LOG JAM LOCATED AT 35.033897, -83.128544 BUT HAVE BECOME BURIED UNDER A THICK BLANKET OF FINE PARTICLE SIZED SANDY SEDIMENTS AND ORGANIC SILTS.

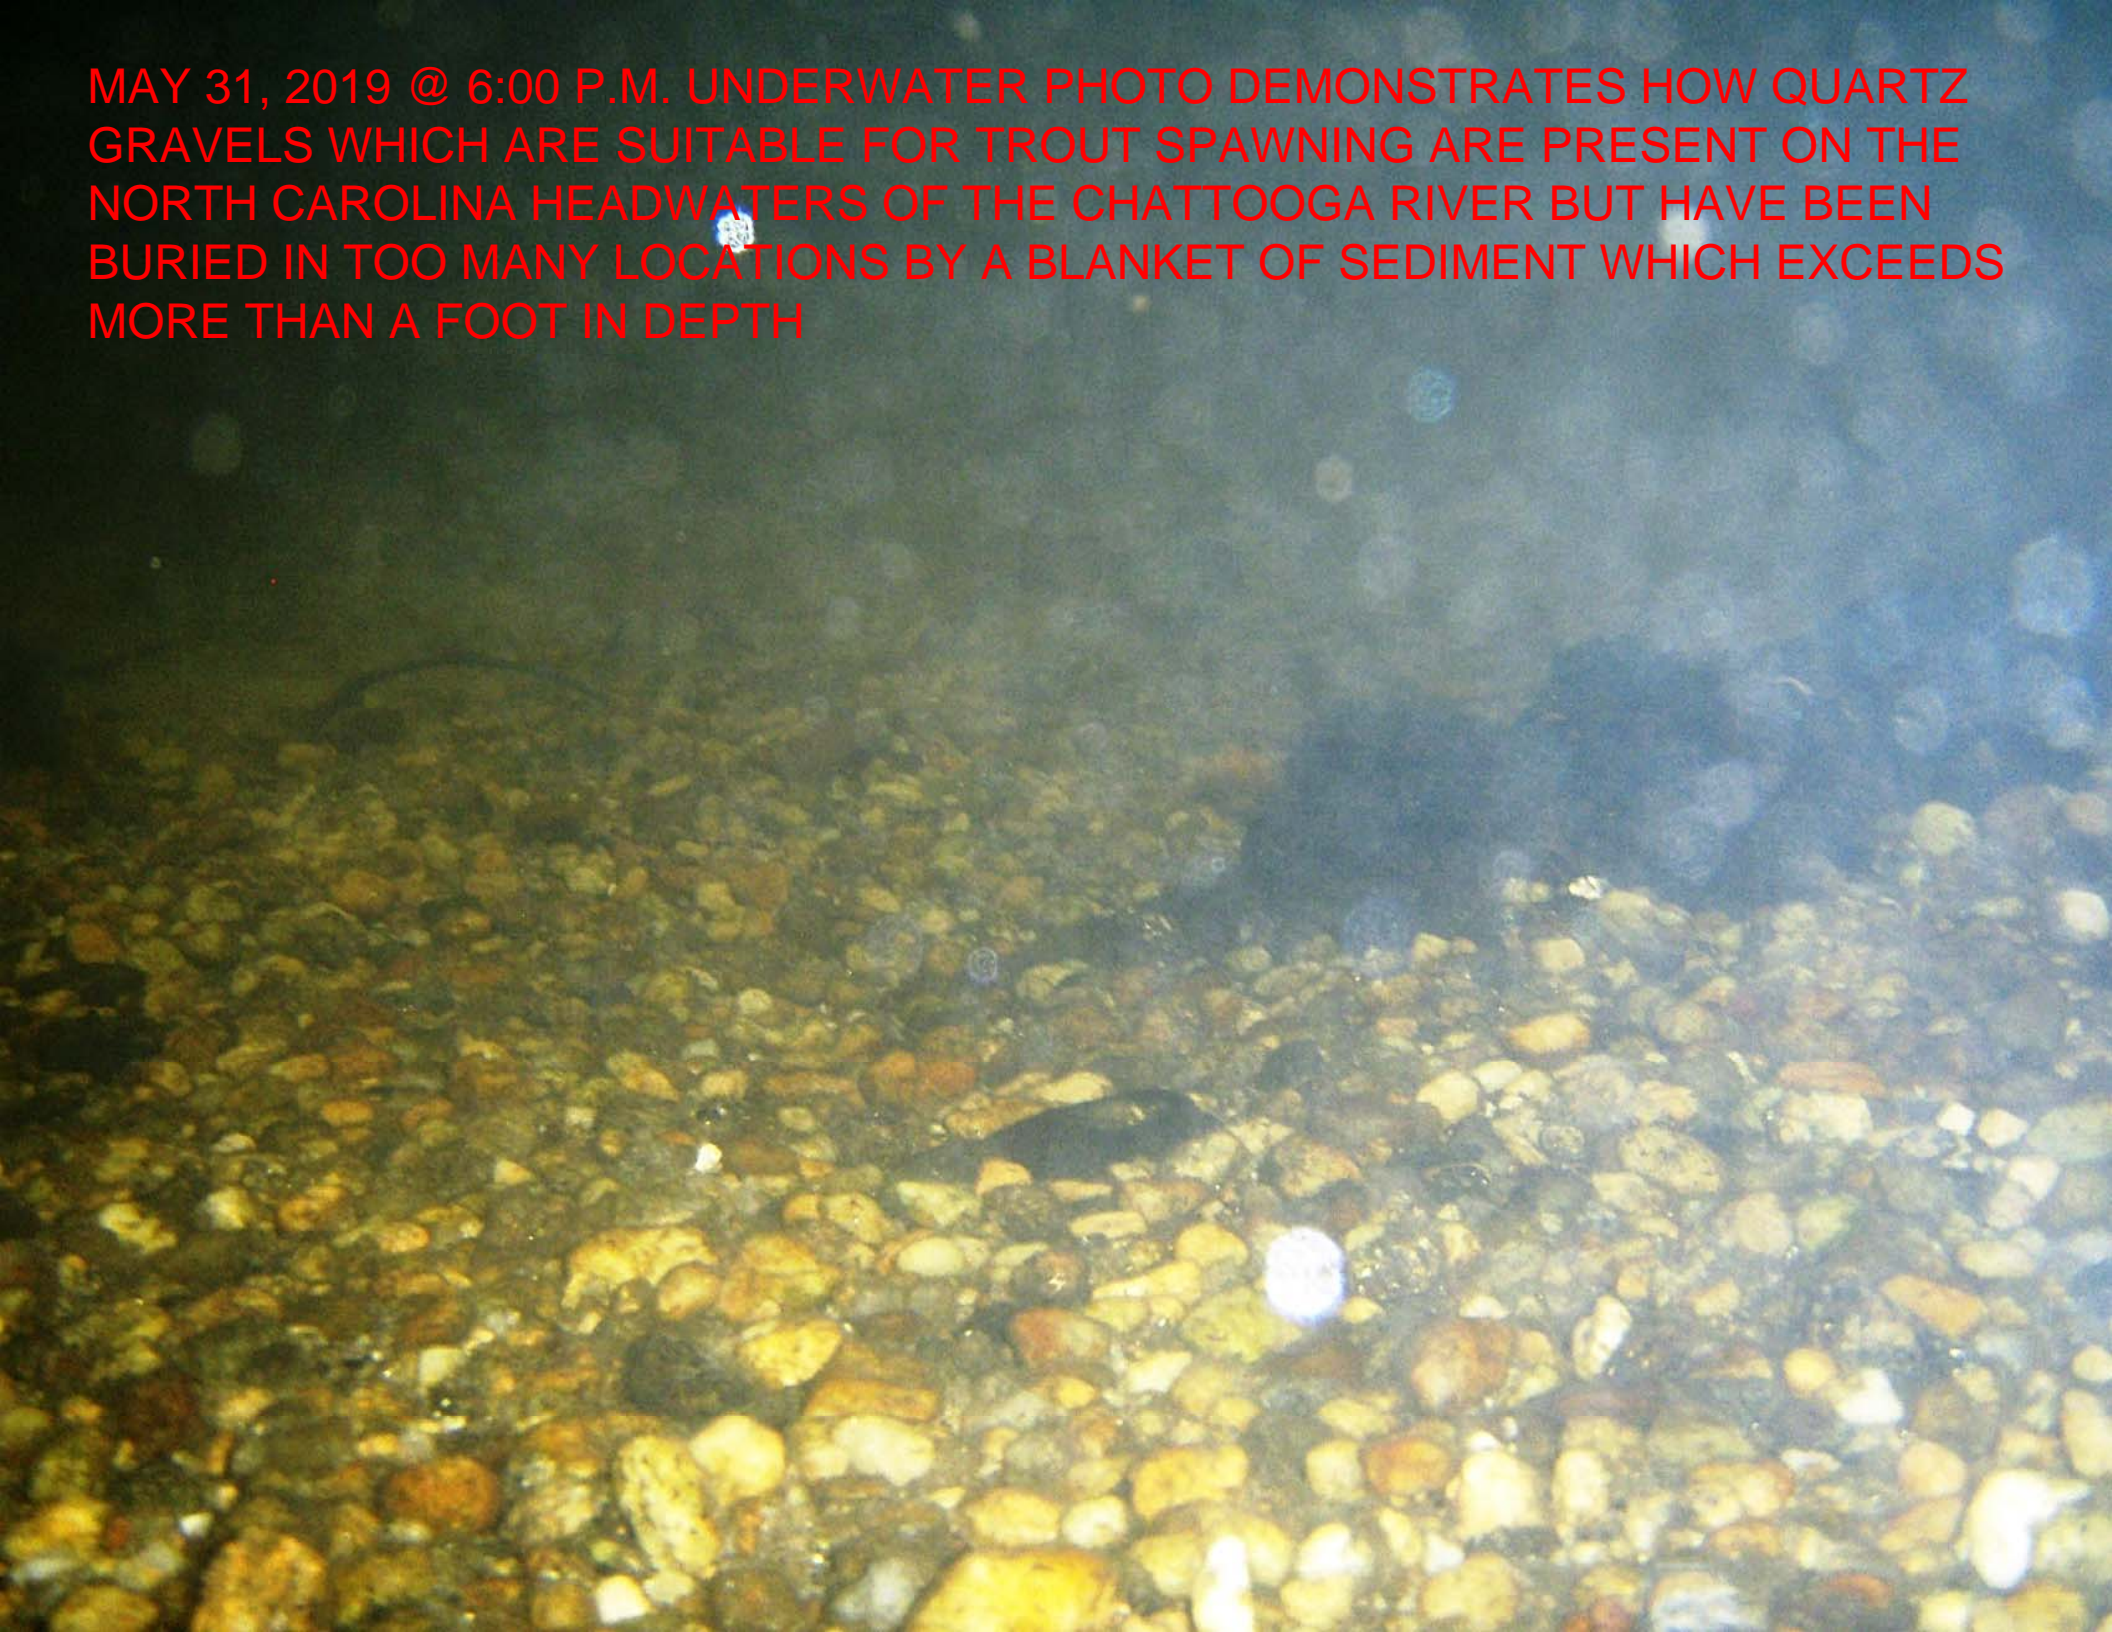
MAY 31, 2019 @ 6:00 P.M. UNDERWATER PHOTO DEMONSTRATES HOW QUARTZ GRAVELS WHICH ARE SUITABLE FOR TROUT SPAWNING ARE PRESENT ON THE NORTH CAROLINA HEADWATERS OF THE CHATTOOGA RIVER BUT HAVE BEEN BURIED IN TOO MANY LOCATIONS BY A BLANKET OF SEDIMENT WHICH EXCEEDS MORE THAN A FOOT IN DEPTH
