Landslides (2008) 5:107–120
 DOI 10.1007/s10346-007-0107-y
 Received: 12 March 2007
 Accepted: 18 September 2007
 Published online: 23 November 2007
 © Springer-Verlag 2007

Thomas K. Collins

Debris flows caused by failure of fill slopes: early detection, warning, and loss prevention

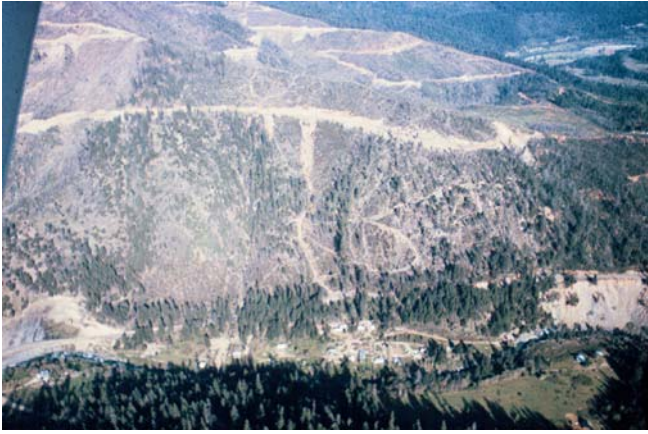
Fig. 1 Debris flows from fill-slope failures of road and log landing on Klamath National Forest near Happy Camp, California

Log landings are another type of construction associated with roads in timber harvest area in USA, Canada, and elsewhere in the world. Construction of log landings may leave fill or sidecast perched on a steep slope. Timber harvest operations may add woody debris to the top or sides of the fill or sidecast. The mass of unconsolidated material at log landings can be much larger than road fills. Failure of fills, sidecast, and woody debris at log landings can trigger debris flows (Figs. 1 and 7).

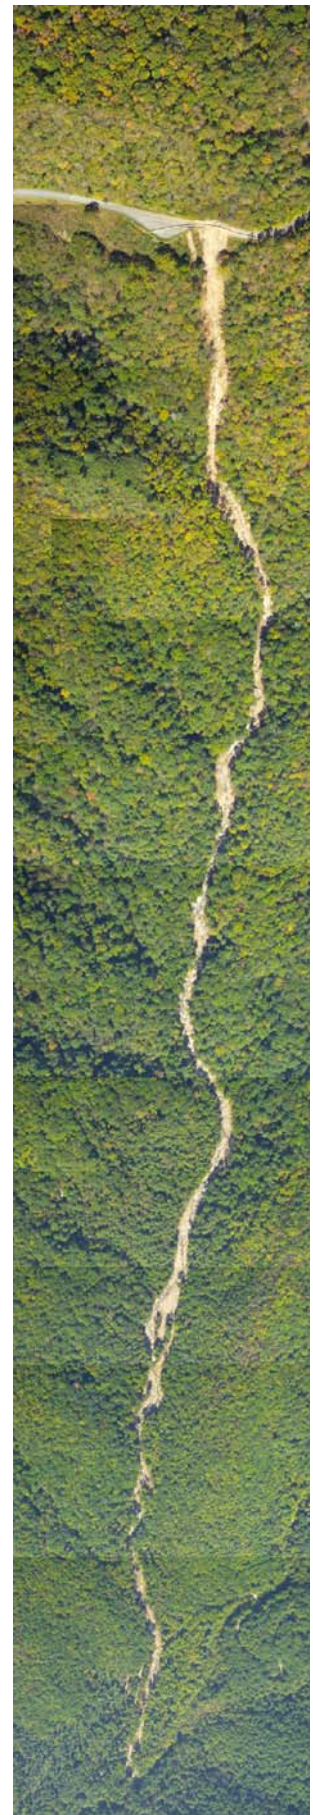
Fig. 3 Bear Drive Branch debris flow initiated at Blue Ridge Parkway fill-slope failure (Milepost 348) and traveled downslope 3 km (2 mi) across Pisgah National Forest, North Carolina (Hurricane Frances, September 8, 2004)

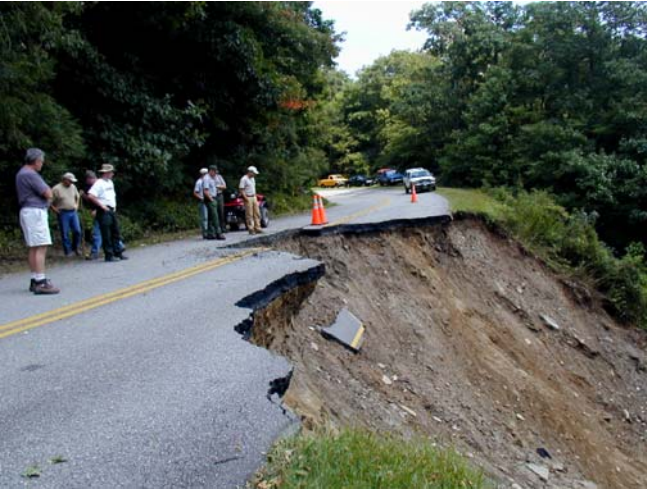
Fig. 4 Blue Ridge Parkway (Milepost 348) fill-slope failure that initiated Bear Drive Branch debris flow on Pisgah National Forest, North Carolina (Hurricane Frances, September 2004)

When a road-fill slope collapses completely and moves down slope as a debris flow, the upper edge of the failure forms an arc-shaped main scarp (Fig. 4). Knowing the general shape and extent of typical fill failures allows early detection of incipient or incremental failures. Field reconnaissance of cracks or scarps indicates a discrete mass of fill may be detaching from the hillside. The initiation of a fill failure may first appear as a crack or series of discontinuous cracks that outlines an arc-shaped area of fill (Fig. 9). Over time, tiny scarps (a few centimeters or less in height) may develop, indicating increasing instability of the fill (Fig. 10). Occasionally, as tension cracks or scarps expand, an elongate depression (graben) in the road bed or fill surface may develop (Fig. 11). The initial cracks and tiny scarps are easy to detect on paved roads; when maintenance crews apply crack sealant or asphalt patches, the evidence of these initial instabilities is preserved in the pavement and easily recognizable (Fig. 17). The

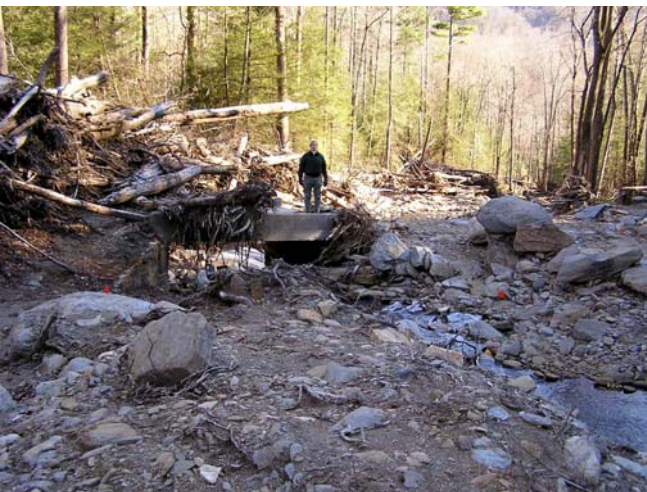
Fig. 5 Impact of September 8, 2004 debris flow at Curtis Creek road more than 2 km downslope from initiation site at Blue Ridge Parkway fill-slope failure (Milepost 348). View downstream to bridge crossing of Bear Drive Branch on Pisgah National Forest, North Carolina

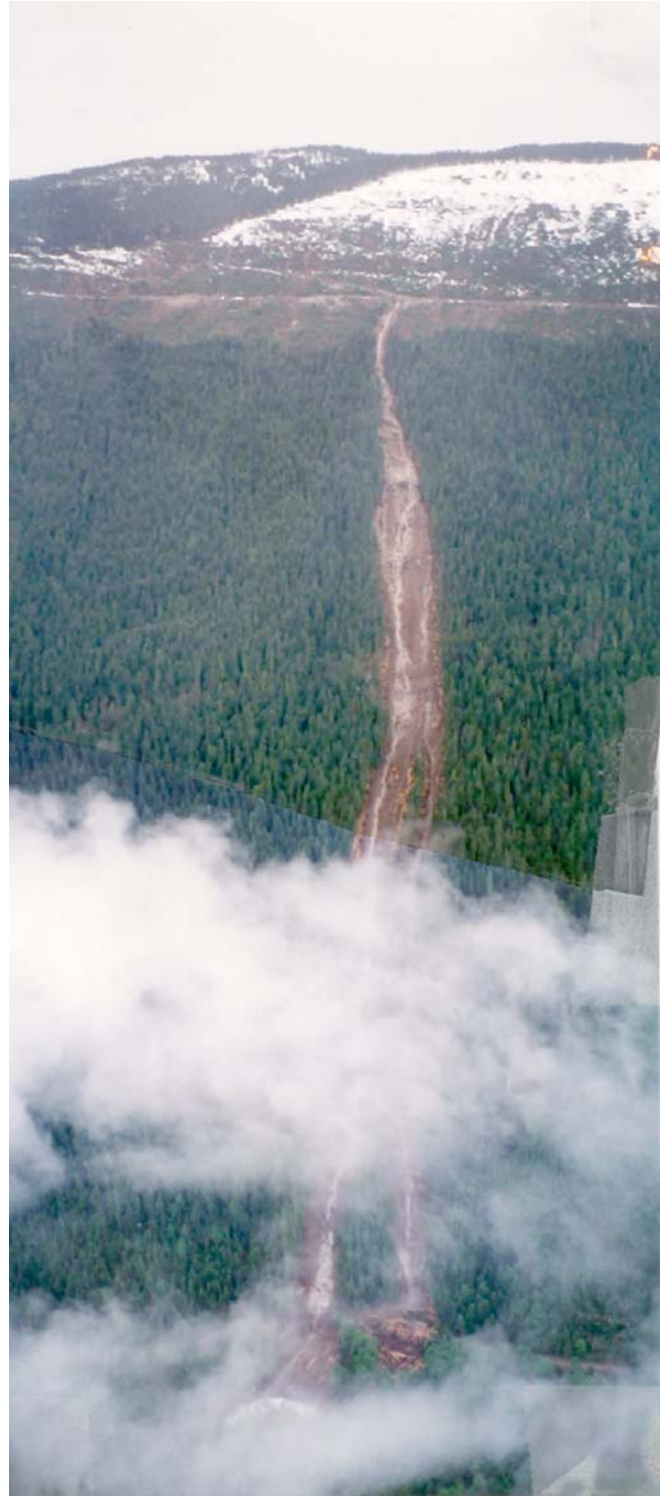
Fig. 6 May 31, 1997 Gowan Creek debris flow initiated as failure of road-fill slope about 80 km southeast of Pemberton, British Columbia (Bartle et al. 1997)

The section of road fill that failed was 17 m (56 ft) wide with a volume of 100 to 200 m³ (131 to 262 cubic yards). But this modest-size fill failure initiated a major debris flow of 61,000 m³ (80,000 cubic yards). This quantifies the “snowball

The fill failure initiated the debris flow on a smooth steeply-dipping (30–34°) granitic bedrock surface overlain by 0.5 m (1.6 ft) of till and 1.5 to 3 m (5 to 10 ft) of road fill. As the debris flow moved downslope, it scraped the thin colluvium (0.5–1 m; 1.6 ft 3.3 ft) and trees off of the steep bedrock surfaces and widened its path on the mountainside. Like the Blue Ridge Parkway debris flows, this debris flow initiated as a sidehill fill-slope failure, not in a channel; however, the end result of the debris flow scraping off the colluvium and trees was the creation of a channel incised into the mountainside (Fig. 6). When massive debris flow entered Gowan Creek, it may have temporarily dammed the stream. The potential for debris flows to create temporary dams that can also fail is another way, in addition to the snowball effect, that the destructive power of debris flows can be magnified.

The investigation of Gowan Creek road-fill failure found significant cracks in the road fill next to the failure and concluded that the failed section was likely fractured (cracked) prior to failure. The investigation report (Bartle et al. 1997) noted that “settlement and tension cracking of the roads surface and fills...is a common precursor to road failure. Road-fill failures typically result in debris slides involving a few hundred to perhaps a thousand cubic metres of material. When such failures occur upon moderate to steep slopes they may trigger debris flows similar to the recent event at Gowan Creek.”

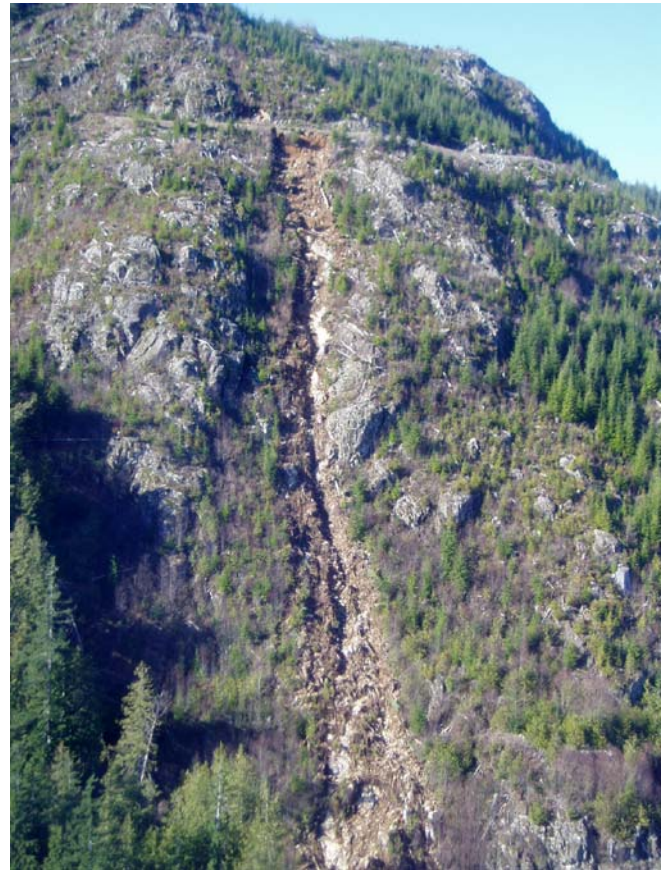
Fig. 7 Debris flow initiated as log-landing fill failure, Vancouver Island, British Columbia. Photo: Gino Fournier

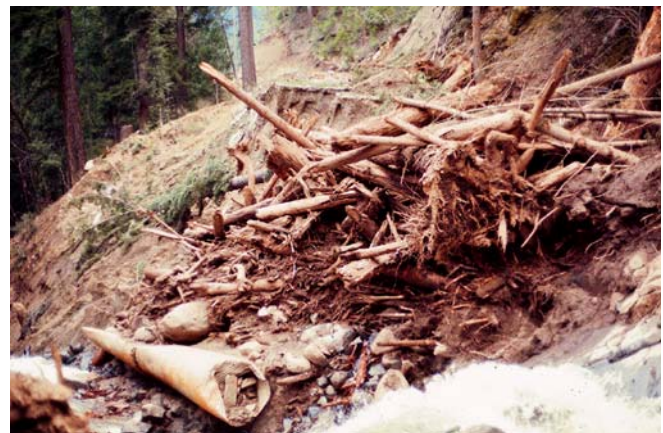
Fig. 8 Stream crossing fill failure initiates debris flow. Note broken culvert plugged with bed load (Klamath National Forest, California)

In addition to sidehill road fills, road fills that span stream channels (perennial, intermittent, ephemeral) are another major source for initiating debris flows. In steep terrain, road fills at channel crossings are, at best, an engineered fill with a culvert or other structure to allow water and bed load to pass downstream. At worst, the road fills, during intense rainstorms, are a nonengineered dam with no spillway. Some culverts cannot accommodate storm flows, particularly with significant bedload transport or large woody debris. The load transport during storms can block or plug a culvert and turn the fill into a dam. This action can potentially lead to a failure of the fill (dam) and turn the storm water and earthen fill into a debris flow (Fig. 8).

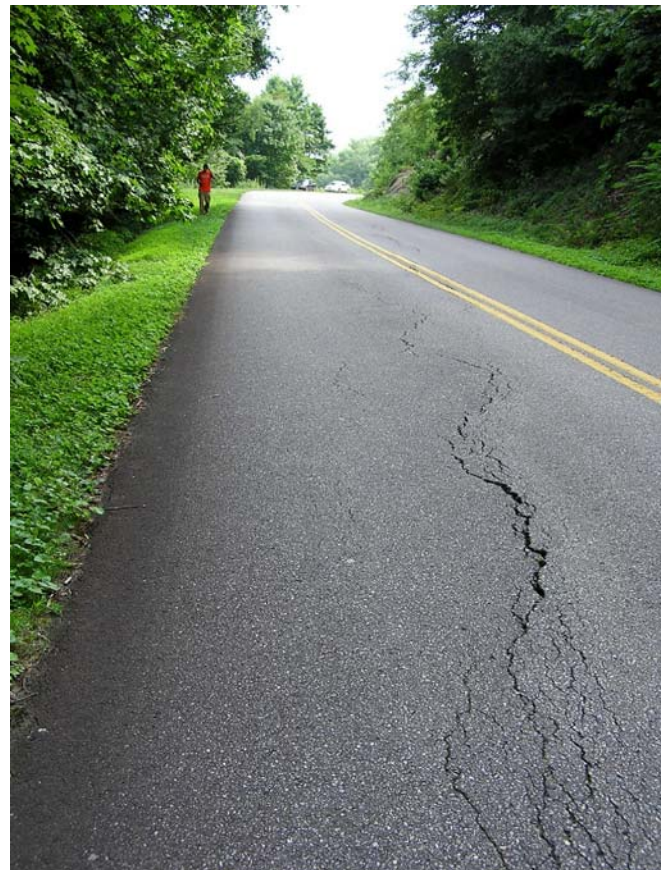
Fig. 9 Arc-shaped tension cracks in road fill on Blue Ridge Parkway near Mount Mitchell, North Carolina (August 1, 2005)

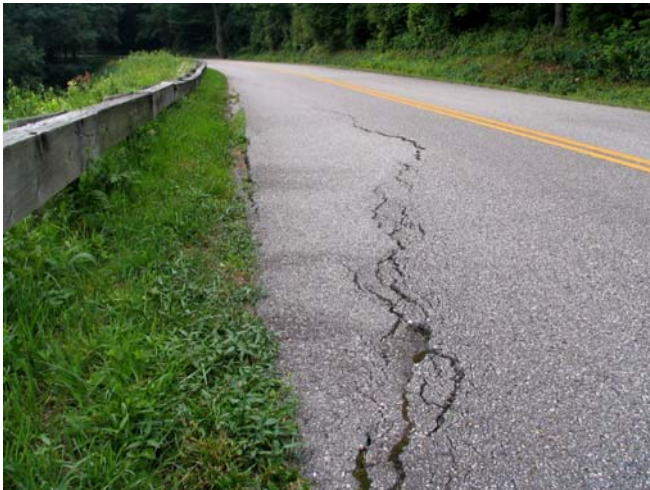
Fig. 10 Arc-shaped tension cracks in road fill on Blue Ridge Parkway south of Linville Falls, North Carolina (August 3, 2005). Photo: Scott Eaton and Bob Sas

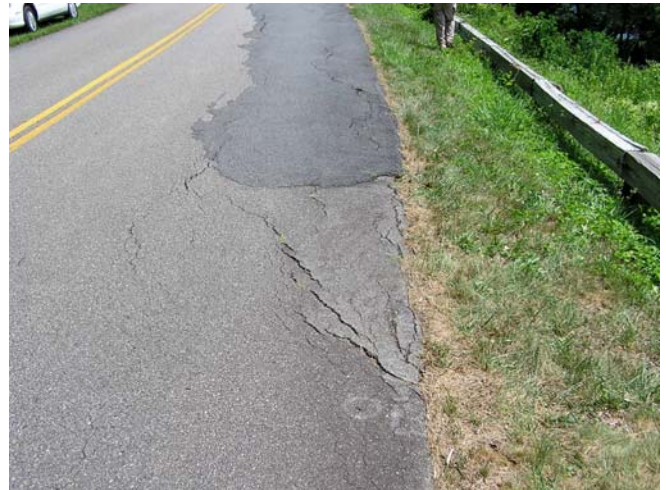
Fig. 12 Incremental failure evidence with asphalt patching in road fill on Blue Ridge Parkway north of Mount Mitchell, North Carolina (August 2, 2005)

Over time, the incremental failure of the fill may continue as small settlements that require repeated asphalt patching (or road grading on unpaved roads; Fig. 12). In some cases, the incremental failure of the fill may accelerate and result in one of more large slumps (several centimeters to meters or more) that require road closure until the fill is repaired (Figs. 13 and 14).

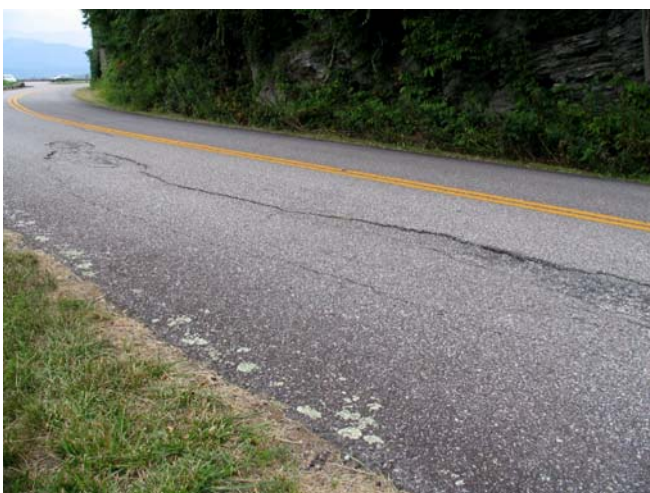
Fig. 11 Graben in road fill on Blue Ridge Parkway south of Linville Falls, North Carolina (August 3, 2005). Photo: Scott Eaton and Bob Sas

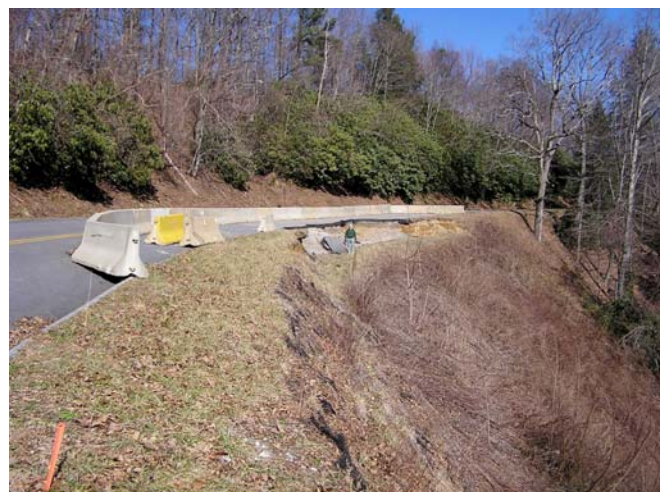
Fig. 13 Slump in road fill on Blue Ridge Parkway (MP345) north of Mount Mitchell, North Carolina (January, 2005). For scale, note person standing below road

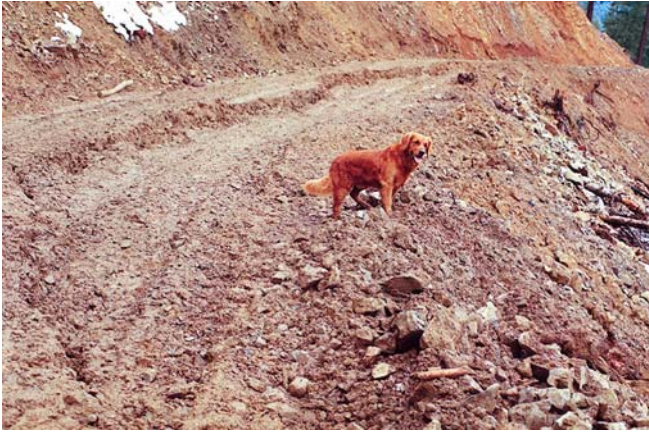
Fig. 14 Slump in road fill on logging road in Klamath National Forest, California

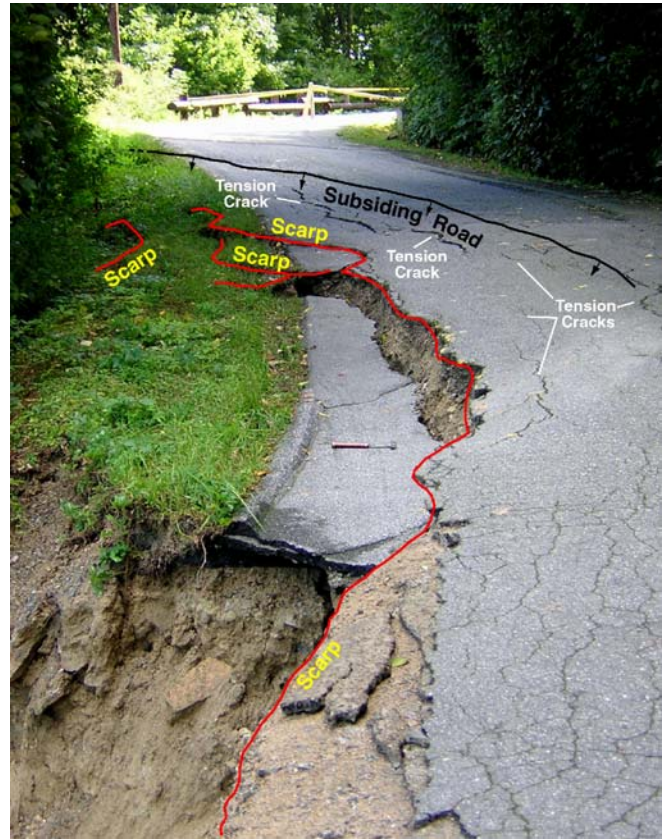
Fig. 15 Warnings signs of unstable fill (subsidence, tension cracks, scarps). Lower left corner of photo shows major scarp of road-fill failure that mobilized into a debris flow from heavy rain remnants of Hurricane Francis in 2004 in Bear Rock Estates subdivision, Henderson County, North Carolina. Photo: North Carolina Geological Survey

1. Type 1: Warning signs of unstable fill activity (Fig. 15), such as:
 - a) Subsidence
 - b) Tension cracks
 - c) Small scarps (less than a few centimeters)—passable by passenger car and may not require road closure prior to repairs
 - d) Slumps (large scarps)—not passable by passenger car and requires closure of traffic lane or entire road for repairs
 - e) Graben
 - f) Patched road pavement (including signs of repeated patching)

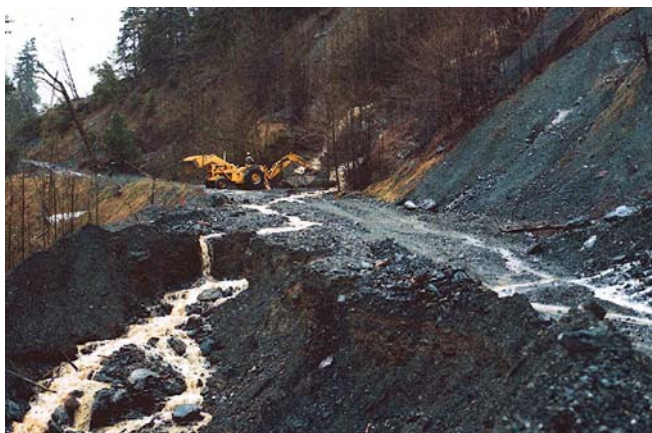
Fig. 16 Plugged culvert creates two fill-slope debris-flow hazards: (1) a temporary dam at the plugged culvert, and (2) overflow leading to failure of another fill. Road in Klamath National Forest, California

Identification of hazardous, high-risk fills can be used to set priority for maintenance work. When a fill shows cracks, scarps, and other evidence of instability, one cause of the instability may be related to maintenance (or lack of maintenance). For example, if a road culvert tends to plug up and overflow stormwater into a fill, it may cause the fill to become unstable (Fig. 16). Thus, when cracks or other warning signs of instability identify a hazardous, high-risk fill, then maintenance of a culvert near this fill may be a higher priority than other culverts.

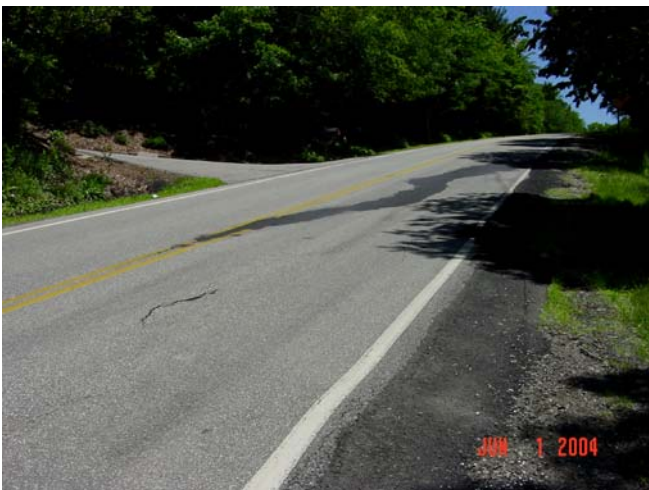
Fig. 17 Highland road fill before stabilization with launched soil nails, Summit County, Ohio. Note asphalt patch preserving evidence of incipient fill failure. Photo: Weber et al. 2005

Because this paper focuses on early detection and loss prevention, it is worth noting that the techniques, such as launched soil nails, that allow stabilizing a fill in the early stages of incremental failure, are extremely important. By repairing the problem early, the need for repeated and more costly repairs is avoided, and the hazard to people and infrastructure is abated. Weber et al. (2005) show before-and-after conditions of fill stabilization using soil nail launchers in Summit County, Ohio (Figs. 17 and 18). Barrett (2006)

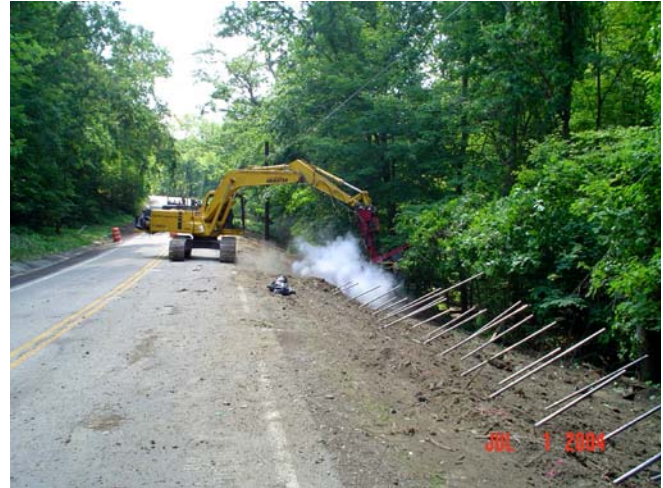
Fig. 18 Highland road fill after stabilization with launched soil nails, Summit County, Ohio. Photo: Weber et al. 2005

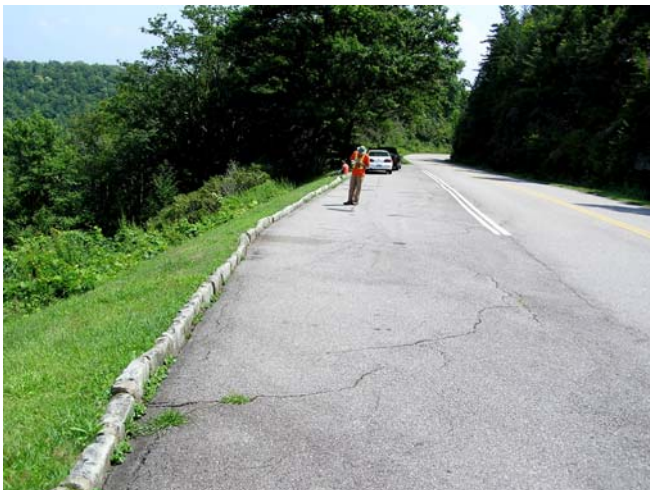
Fig. 19 Grass in cracks and curb separation in scenic overlook (fill) on steep slope on Blue Ridge Parkway in North Carolina: signs of long-term movement of fill appropriate for hazard/risk analysis and monitoring

The geotechnical staff can conduct periodic monitoring, e.g., once a year. The monitoring by geotechnical specialists is fundamental to a sound program of loss prevention. In addition, it provides an opportunity to provide feedback to, and coordinate with, the maintenance crews. Scenic overlook fills are larger fills than typical road fills and, thus, deserve careful hazard/risk analysis and monitoring when signs of fill distress are discovered (Fig. 19).

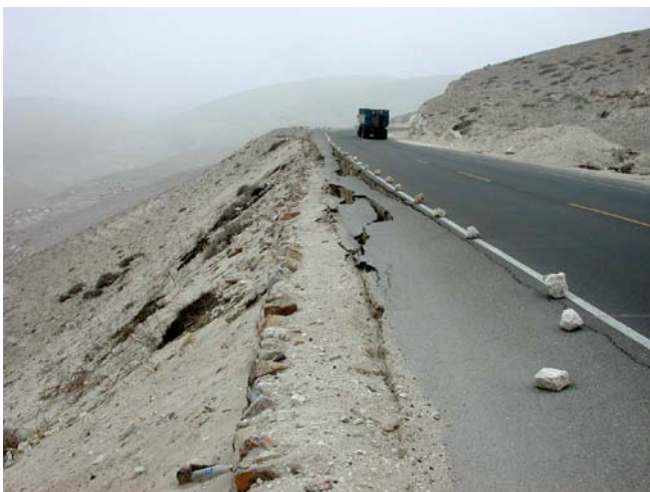
Fig. 20 Partial failure of fill slope on Pan American highway near the town of Tambillo, Peru, June 23, 2001 earthquake damage (Wartman et al. 2003). Photo: US National Science Foundation-sponsored geotechnical reconnaissance team
