# RAVAGED RIVER

## Cattle Damage to Endangered Species Habitat in Arizona's Verde River Watershed

## Ravaged River: Cattle Damage to Endangered Species Habitat in Arizona's Verde River Watershed

Joe Trudeau • March 2020

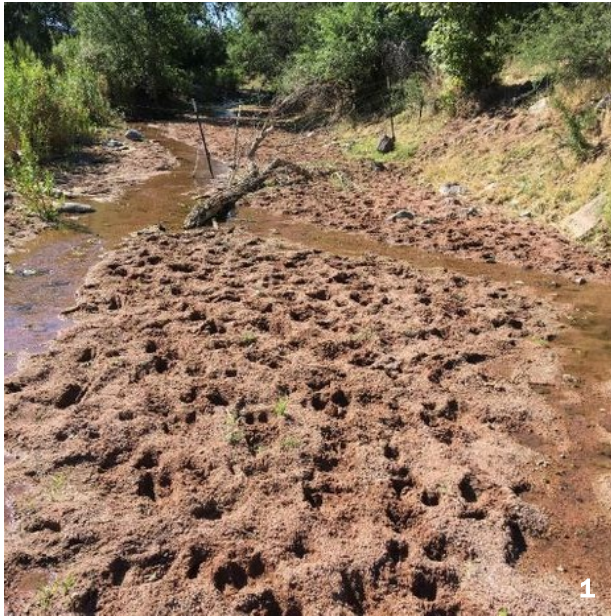
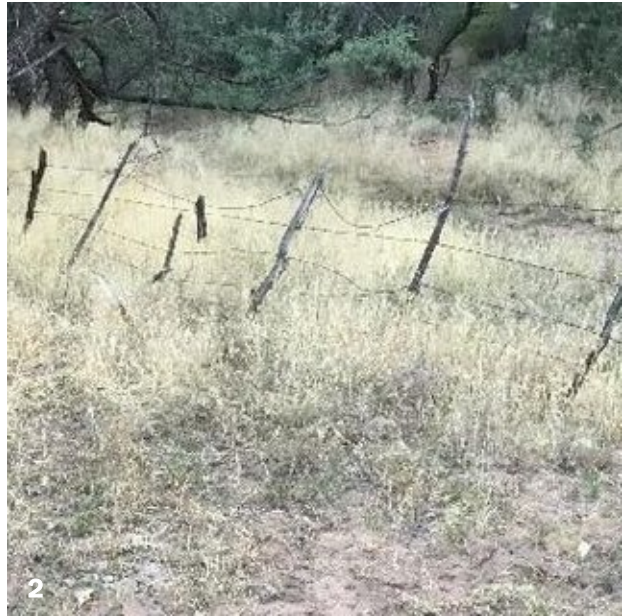
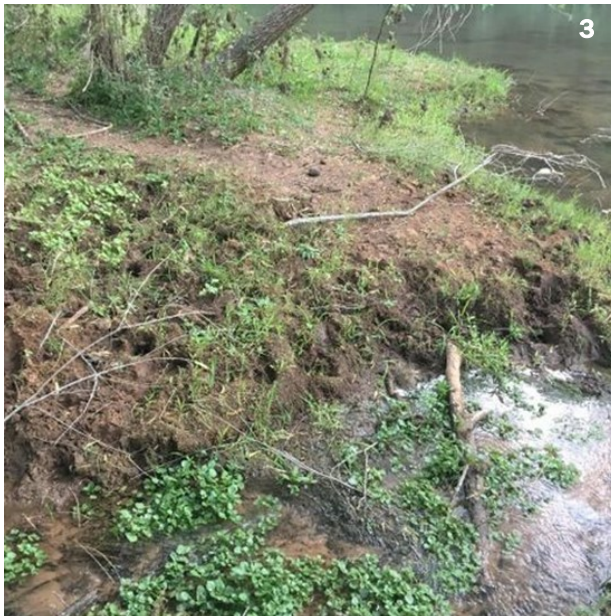
- 1) A trodden streambed along Tangle Creek, Red Creek Allotment, Tonto National Forest.
- 2) Unmaintained riparian enclosure fencing, Skeleton Ridge Allotment, Tonto National Forest.
- 3) A cow-trampled spring along the Verde River, Antelope Hills Allotment, Prescott National Forest.
- 4) Cow in the river between the Brown Springs and Hackberry Allotments, Prescott and Coconino National Forests.

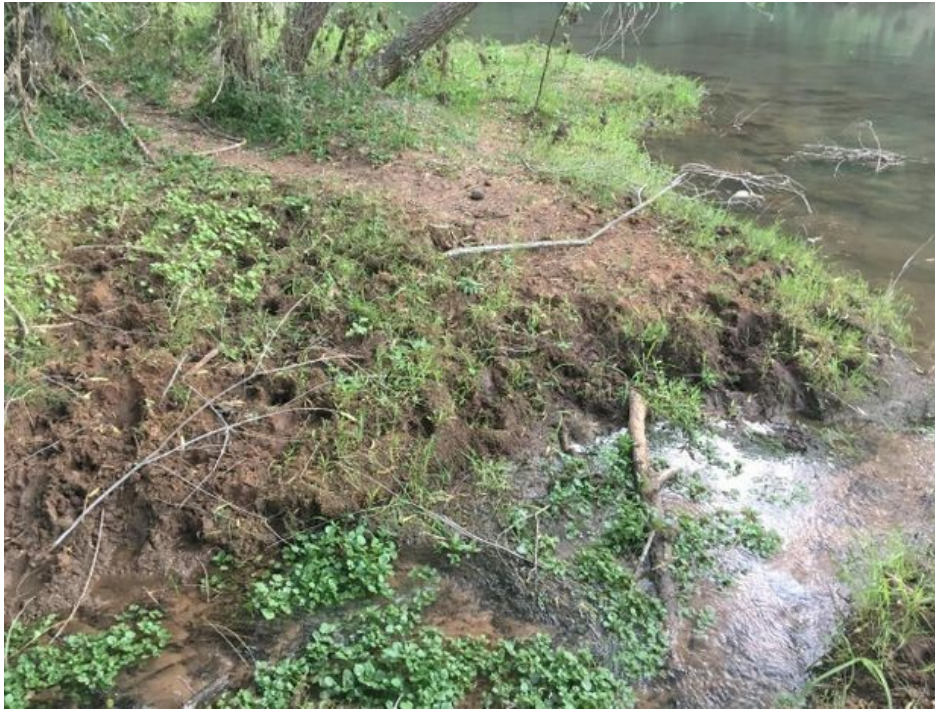
| Photo ID | 1417 |

### AREA GRAZED BY CATTLE

**Impacts:** Tracks, trails, bank shearing, erosion, sedimentation, feces at waters edge, grazed grasses and herbs, browsed shrubs and trees. Trails descend to river via side canyon to the north from the Windmill West Allotment.

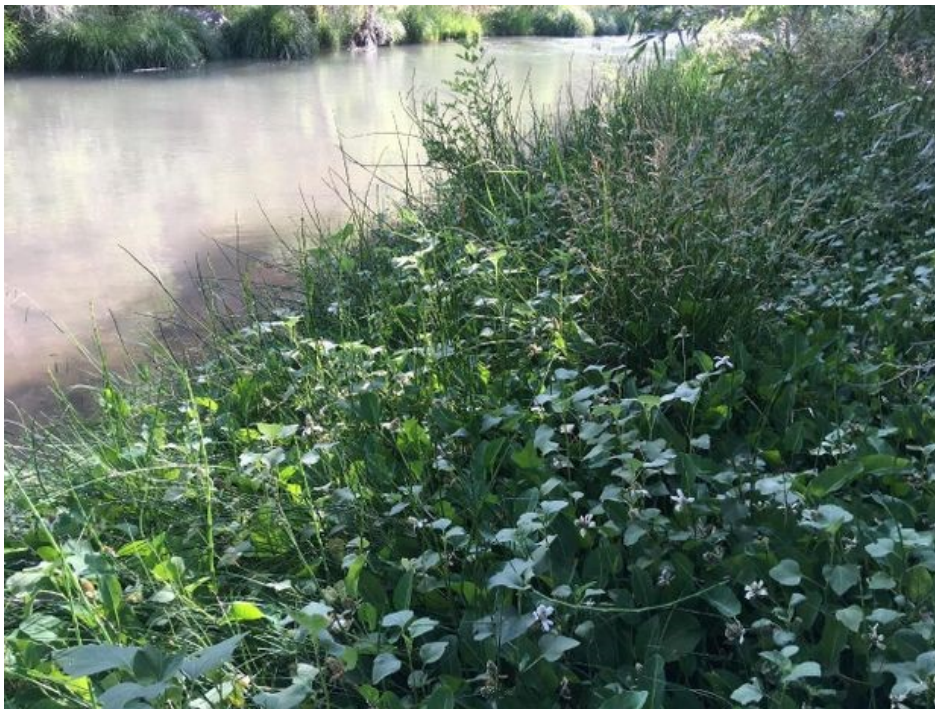
### AREA NOT GRAZED BY CATTLE

(2 miles downstream of photo above)

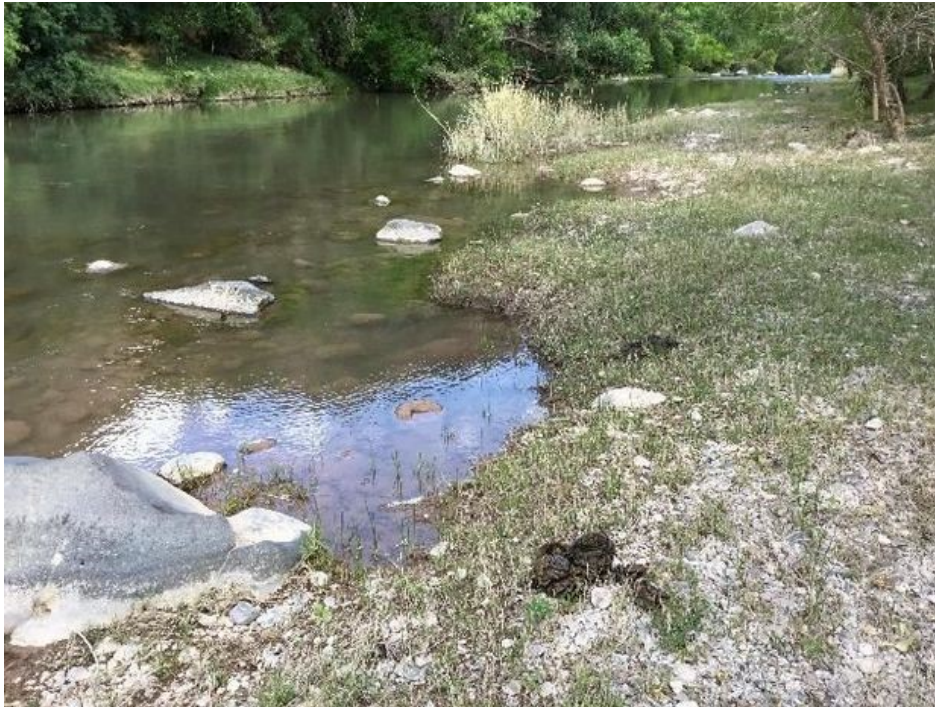
| Photo ID | 103 |

### AREA GRAZED BY CATTLE

**Impacts:** Tracks, trails, low angle bank shearing, erosion, sedimentation, fresh feces at waters edge, heavy grazing on grasses down to stubble, browsed trees, lack of any tree regeneration. Area smelled strongly of urine and feces.

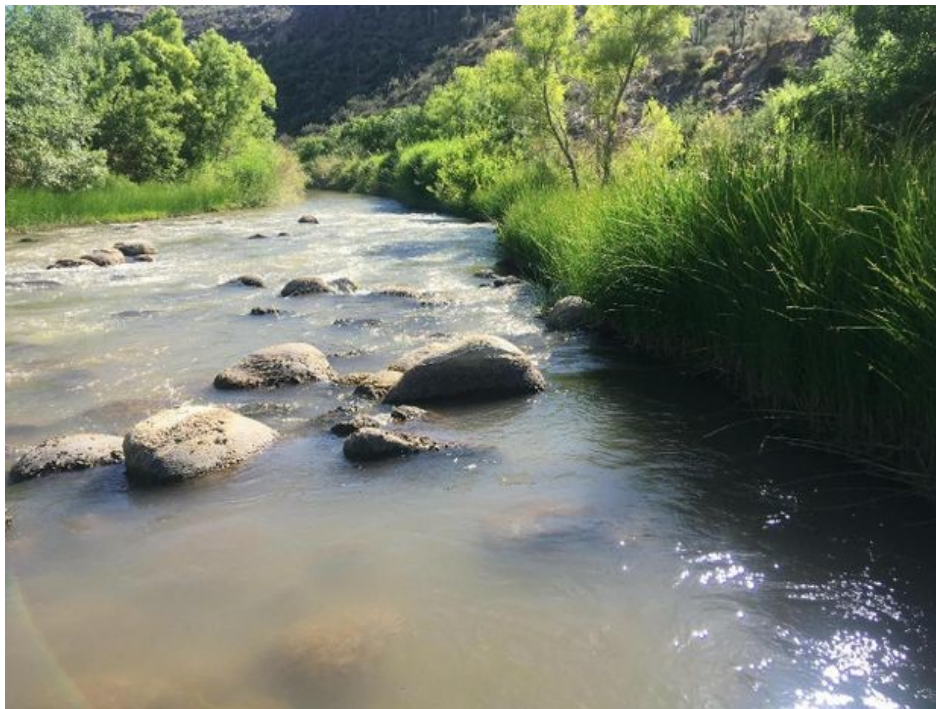
### AREA NOT GRAZED BY CATTLE

(27 miles downstream of photo above)

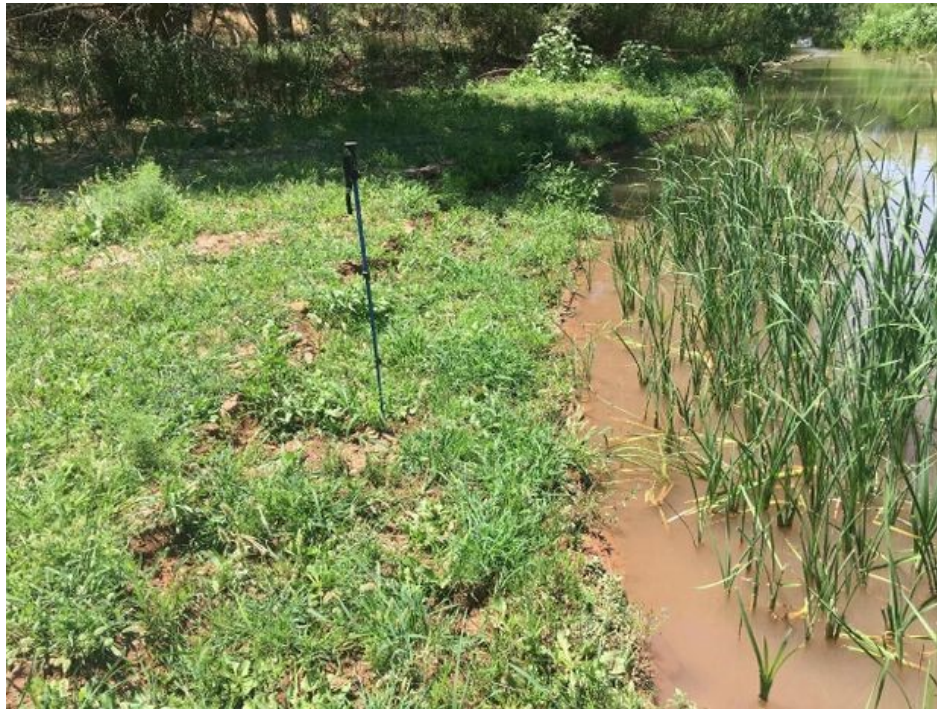
| Photo ID | 1311 |

**Impacts:** Tracks , trampled vegetation, feces in water and at waters edge, grazing on grasses and herbs, streambank shearing and degradation.

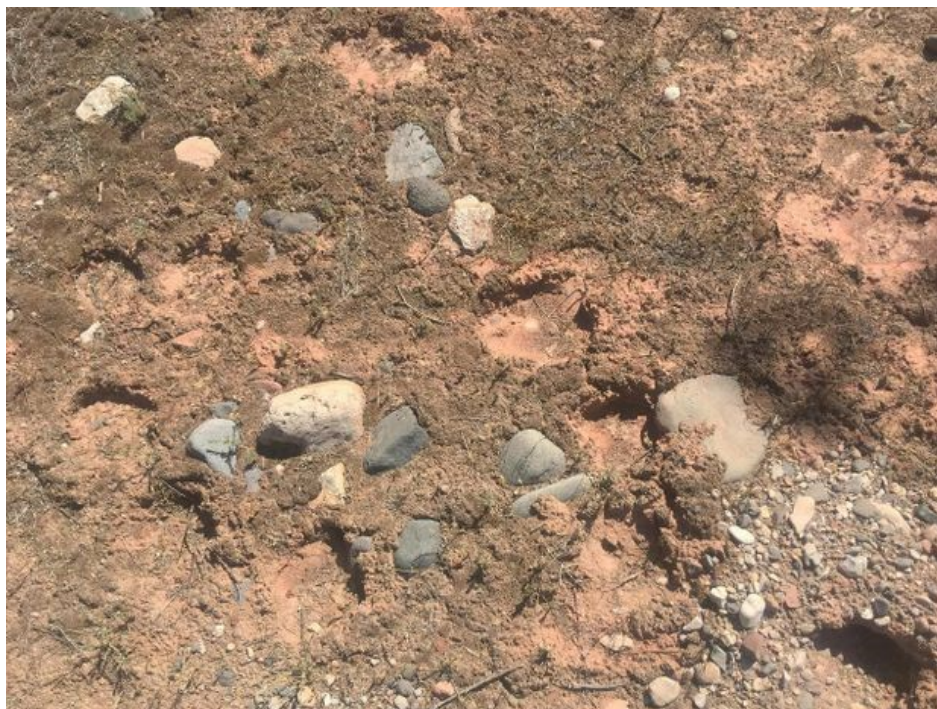
| Photo ID | 1192 |

#### AREA GRAZED BY CATTLE

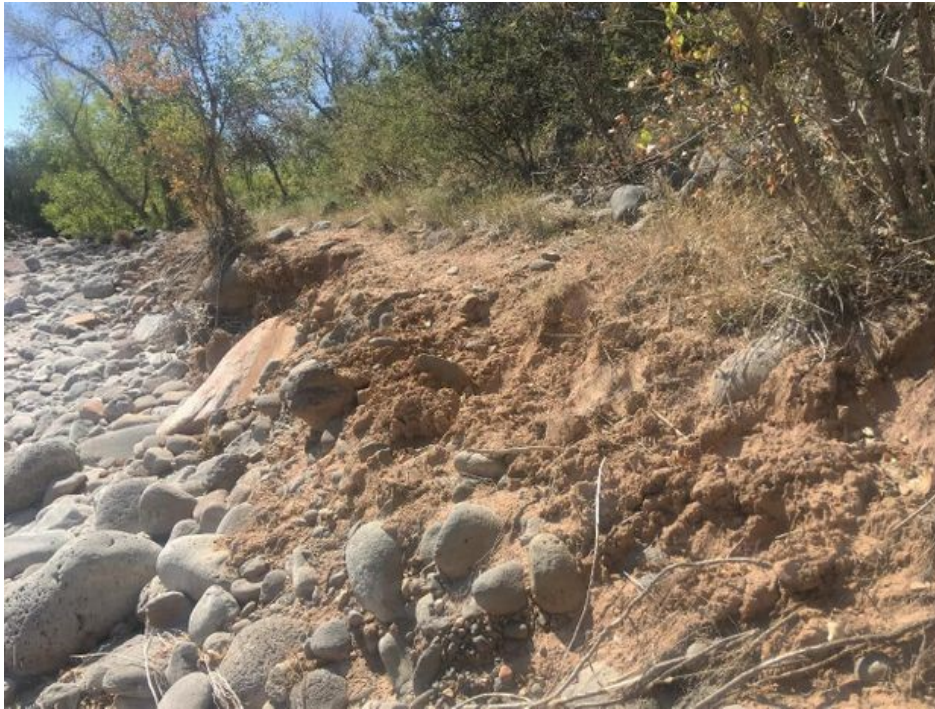
| Photo ID | 1695 |

**Impacts:** Tracks and trails along creeks edge, sheared and destabilized banks from cattle climbing out of creek leading to increased erosion and sedimentation.

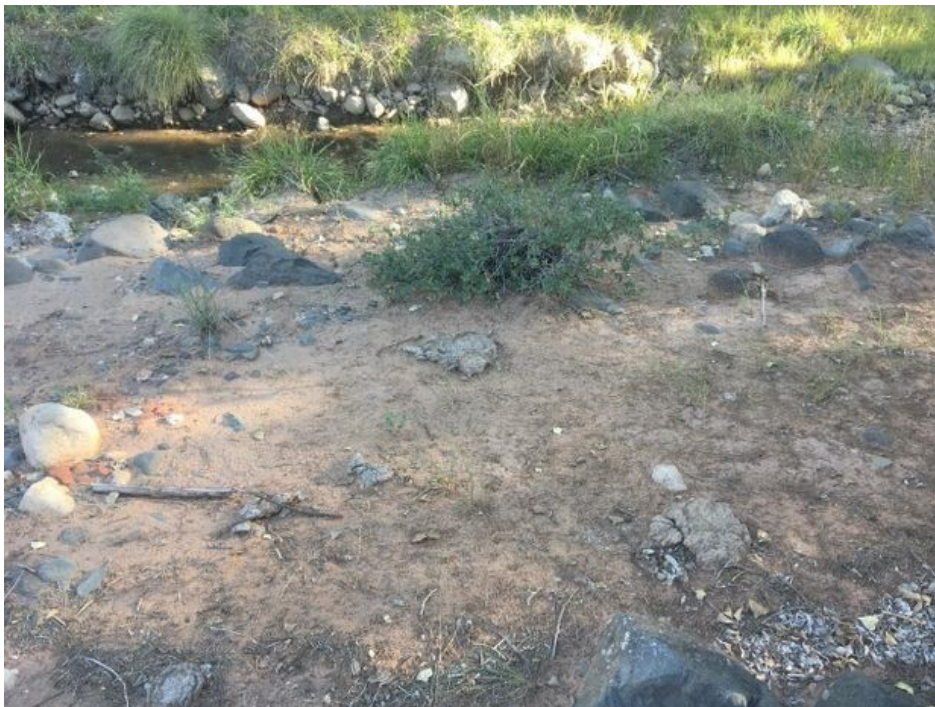
| Photo ID | 1646 |

### AREA GRAZED BY CATTLE

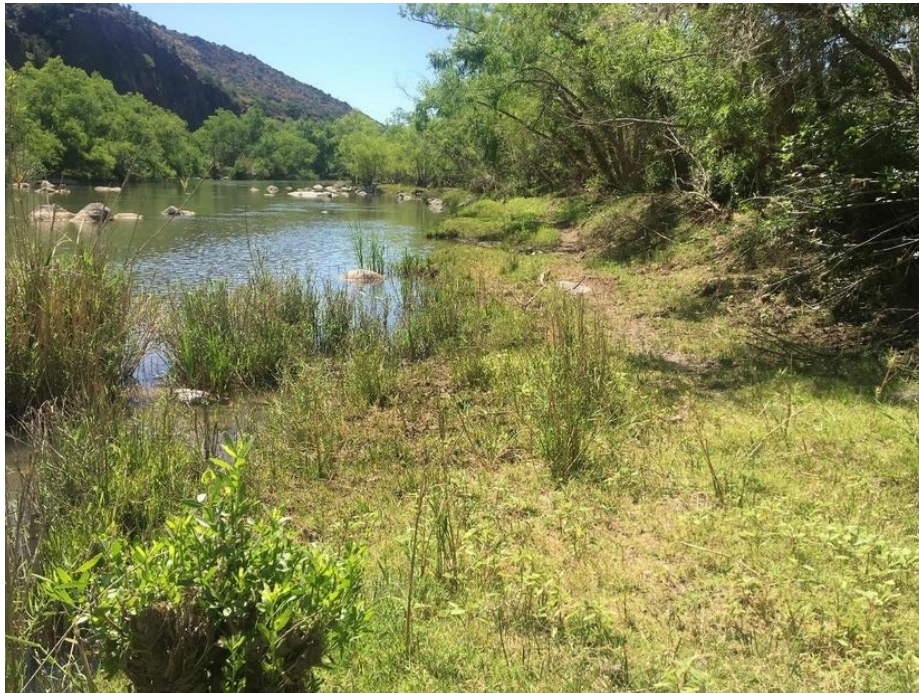
| Photo ID | 274 |

**Impacts:** Tracks and trails along rivers edge, sheared and trampled banks, browsing and grazing, feces in abundance.

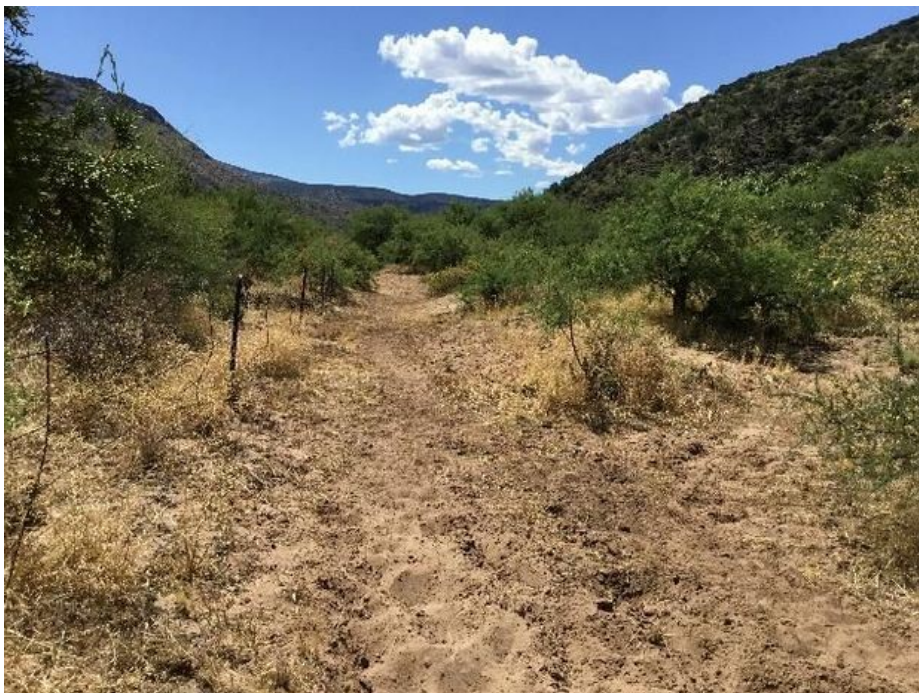
| Photo ID | 124 |

### AREA GRAZED BY CATTLE

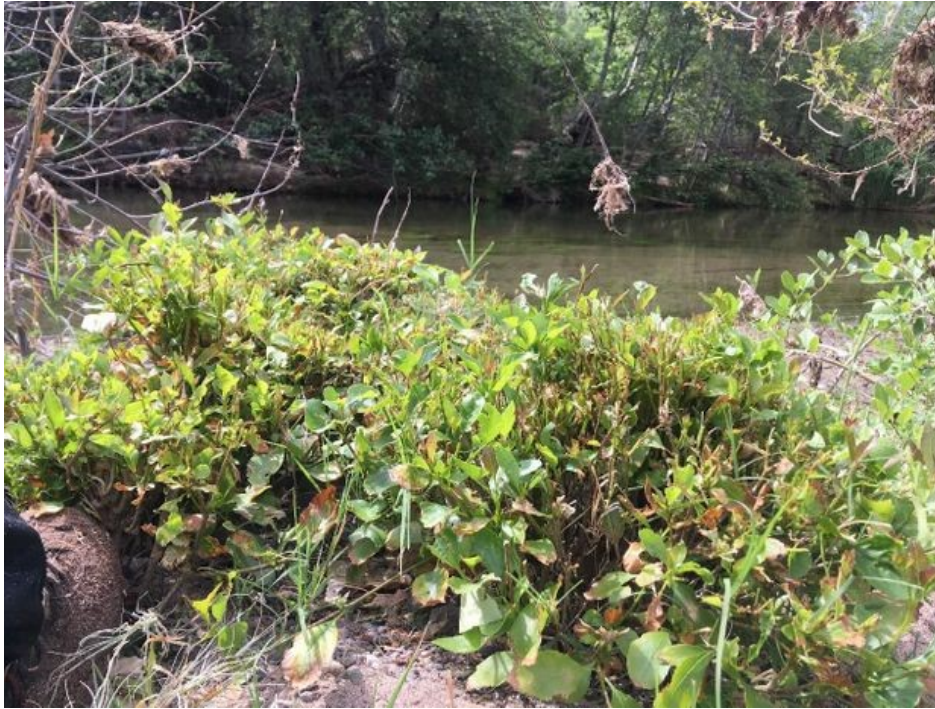
| Photo ID | 946 |

**Impacts:** Heavy browsing on *Alnus* regeneration. Also, feces at waters edge, tracks, trails, trampling, and streambank shearing in this location.

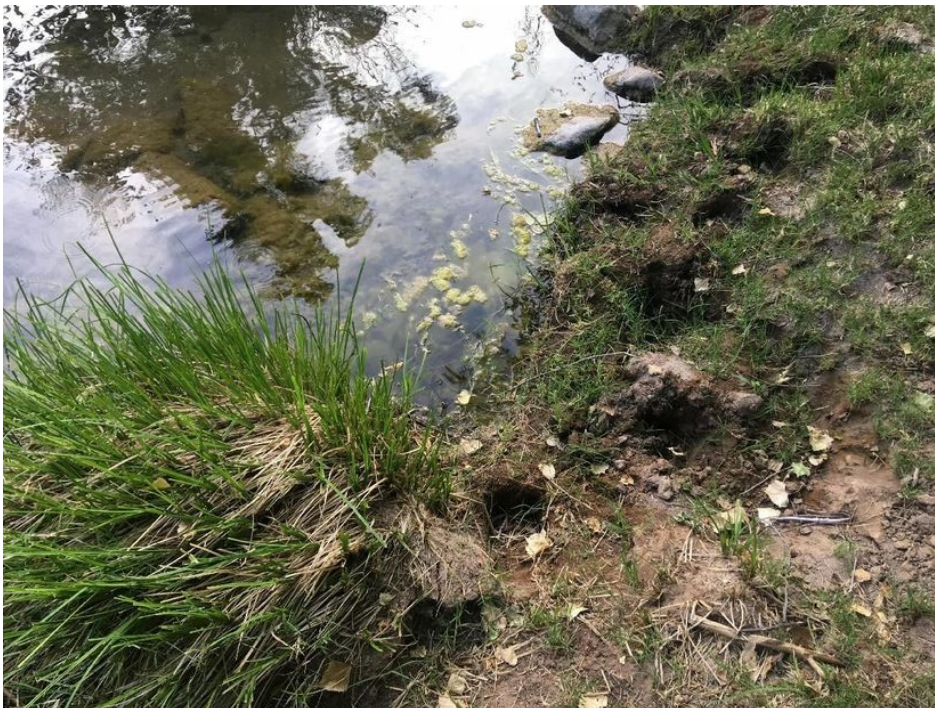
| Photo ID | 967 |

### AREA GRAZED BY CATTLE

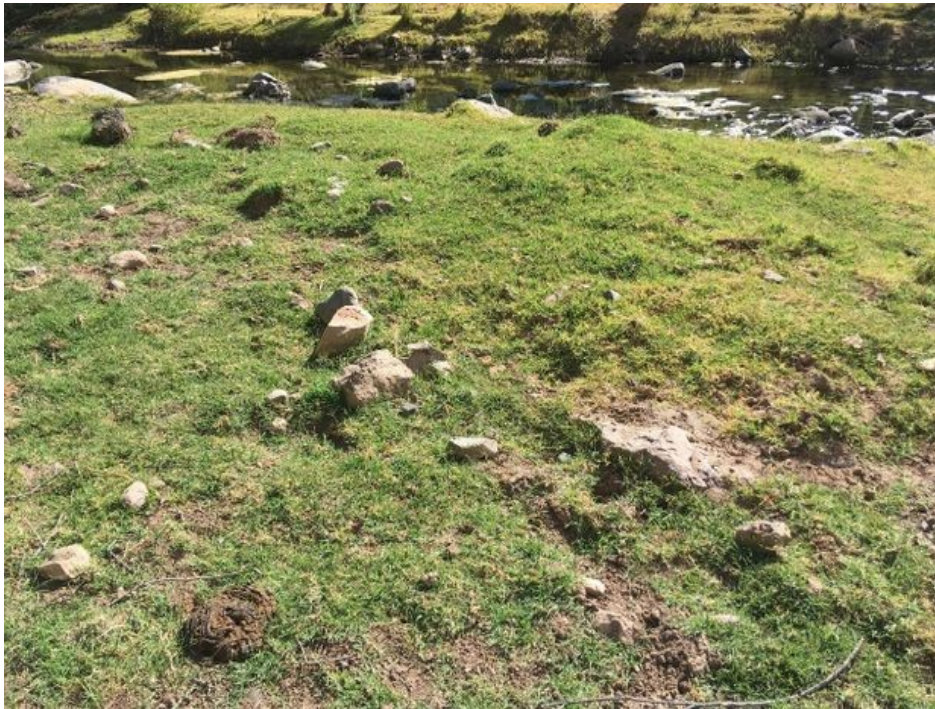
| Photo ID | 905 |

**Impacts:** Extreme grazing down to stubble, feces at water edge, heavy browsing on woody shrubs and trees, trampled and sheared streambanks.

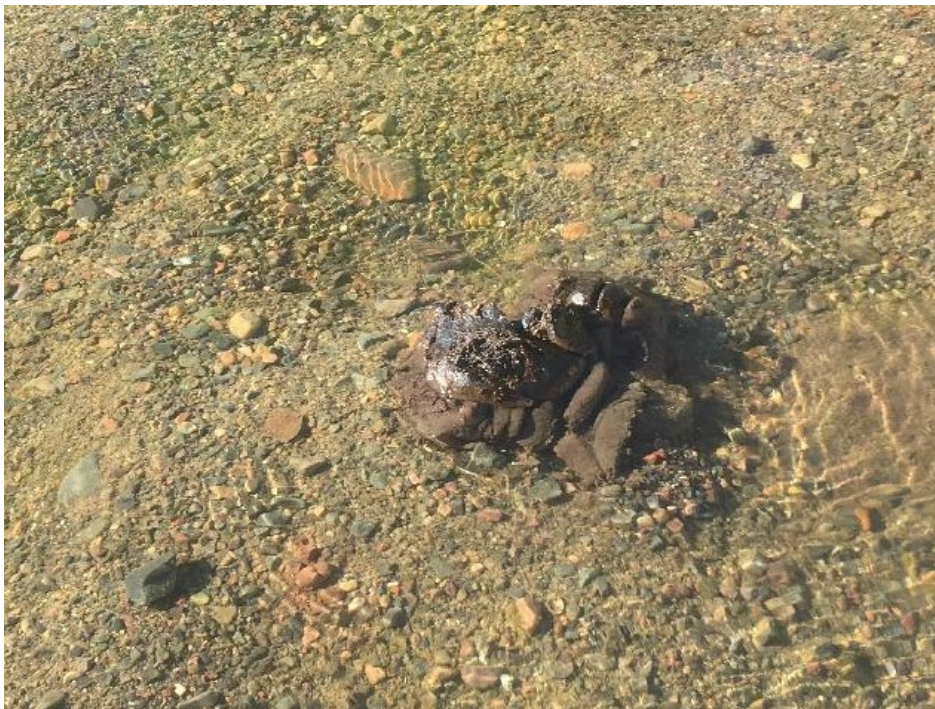
| Photo ID | 798 |

### AREA GRAZED BY CATTLE

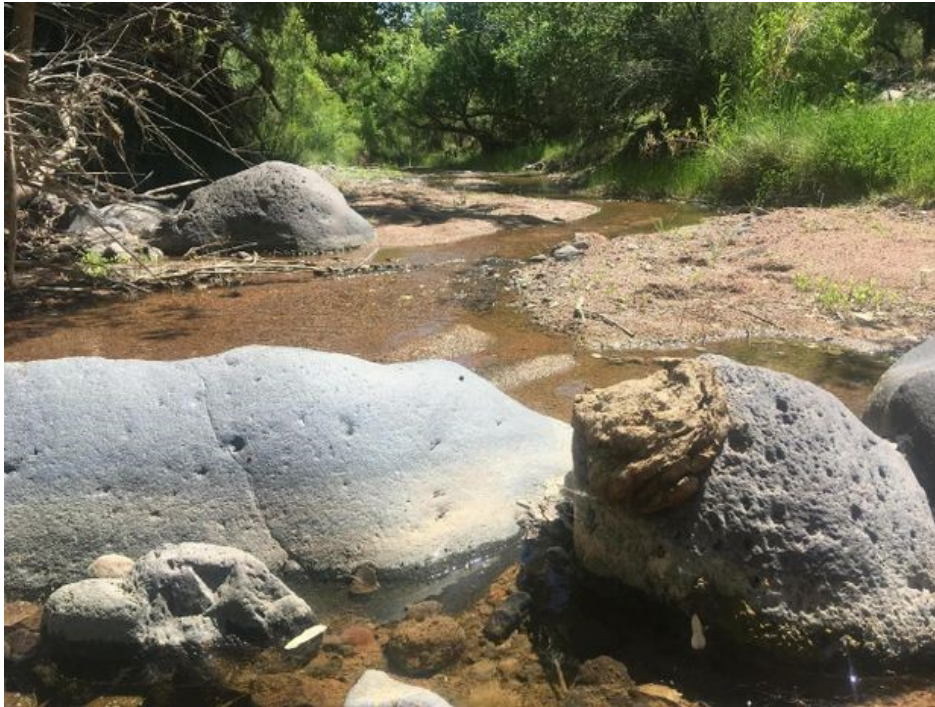
| Photo ID | 426 |

**Impacts:** Feces on a rock in the creek.

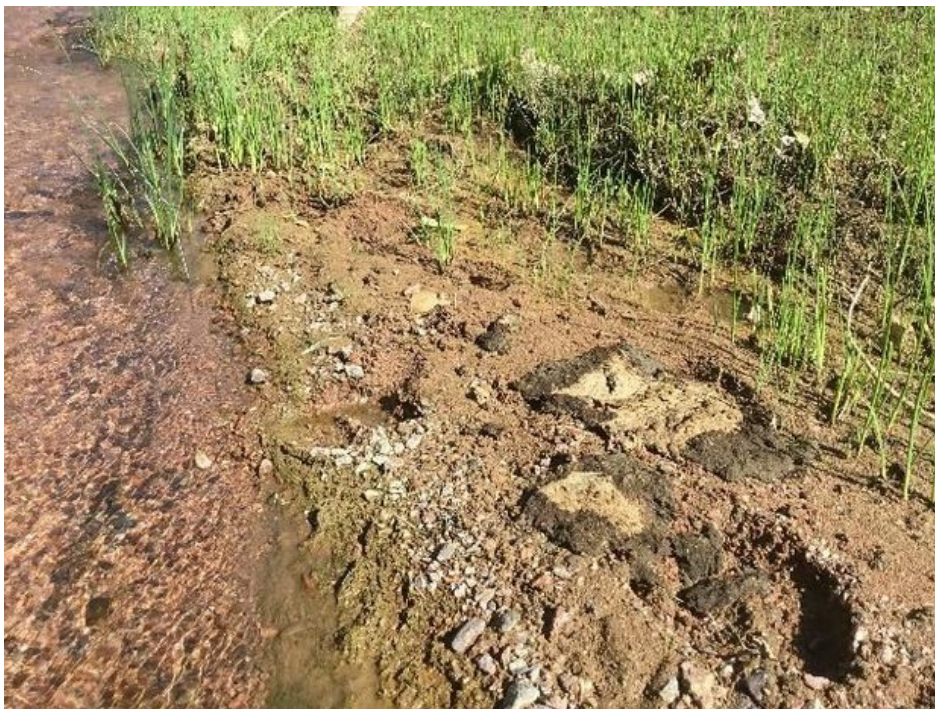
| Photo ID | 658 |

**Impacts:** Feces at the waters edge, tracks and trampled banks, and heavily grazed grasses, rushes, and sedges.

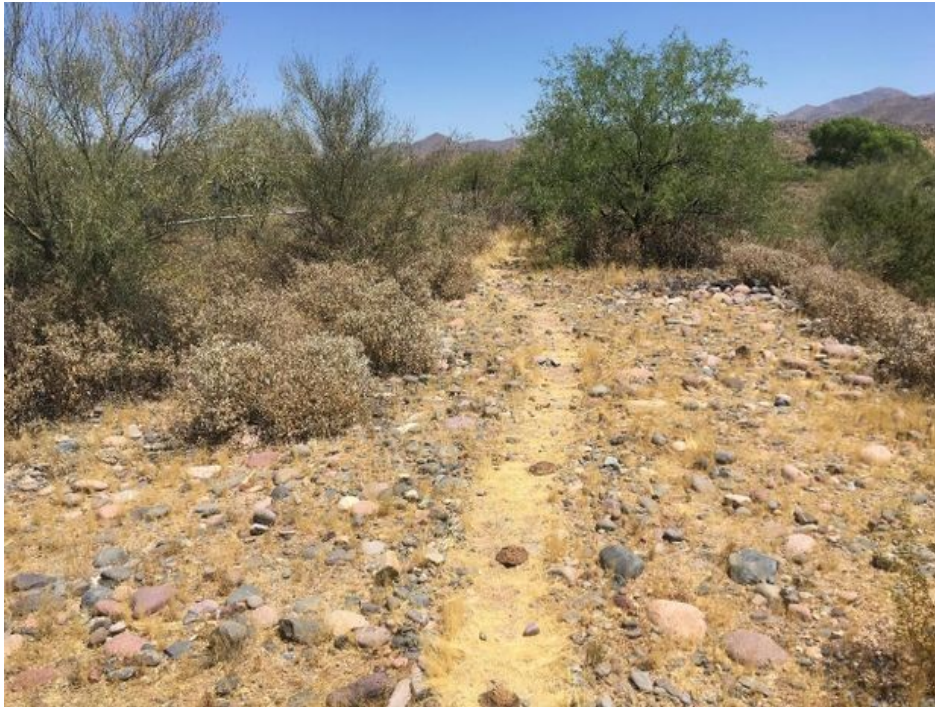
| Photo ID | 1033 |

**Impacts:** Feces along a heavily used trail leading from uplands to a break in the fence where cattle enter the riparian area.

Unmaintained or entirely missing fencing renders grazing exclosures useless across much of the study area. Many fences have been destroyed by flooding events, some apparently a decade ago or more, and there has been little effort to monitor or repair breaches. Areas where natural barriers such as cliffs were assumed to impair cattle movement have proven to be ineffective. Cattle move freely between uplands and riparian areas in most areas surveyed due to porous allotment boundaries and exclosure fences and barriers, as well as gates which appear to have been left open for years. Immediate removal of feral and unauthorized livestock is urgently needed. However, due to the prevailing condition of exclosure fencing, the problem will not be solved through animal removal alone. Hundreds of miles of fencing are in need of repair or replacement, and in many cases existing locations are insufficient and fencing should be moved further into the uplands to protect the full floodplain and flood-prone side canyons where fence failures are common.

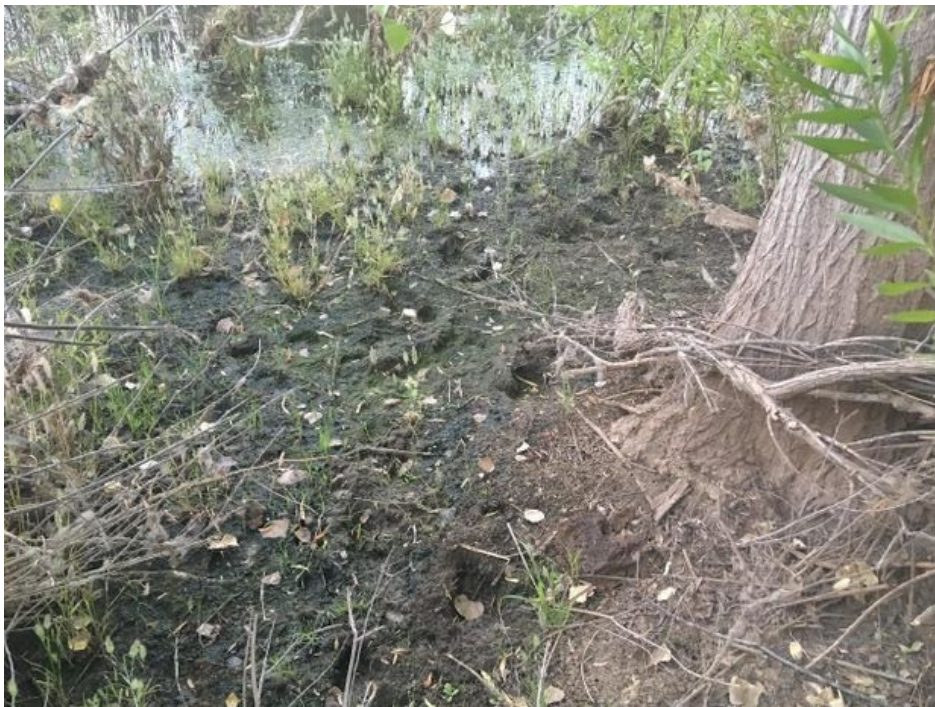
| Photo ID | 1083 |

### AREA GRAZED BY CATTLE
