| vs. |) | SECOND DECLARATION OF |
| |) | KEITH J. HAMMER |

by
Keith Hammer

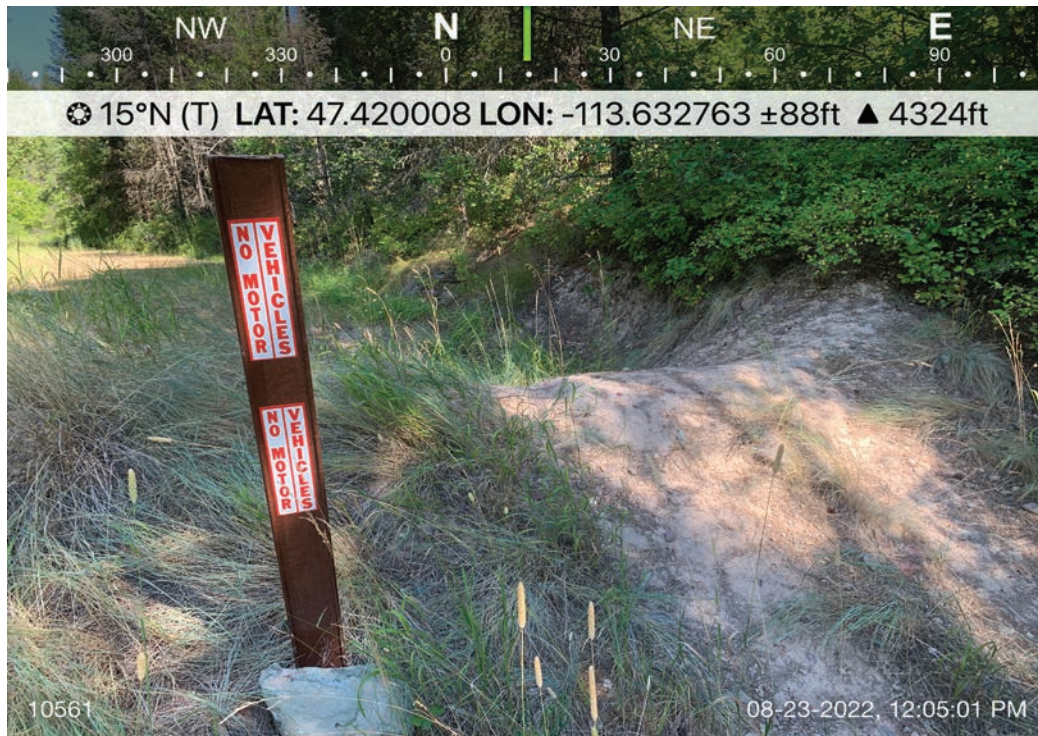
Fig. 1: Despite a sign, an earth berm, road closure maps, and promises, motorized use of closed road 10561 persists.

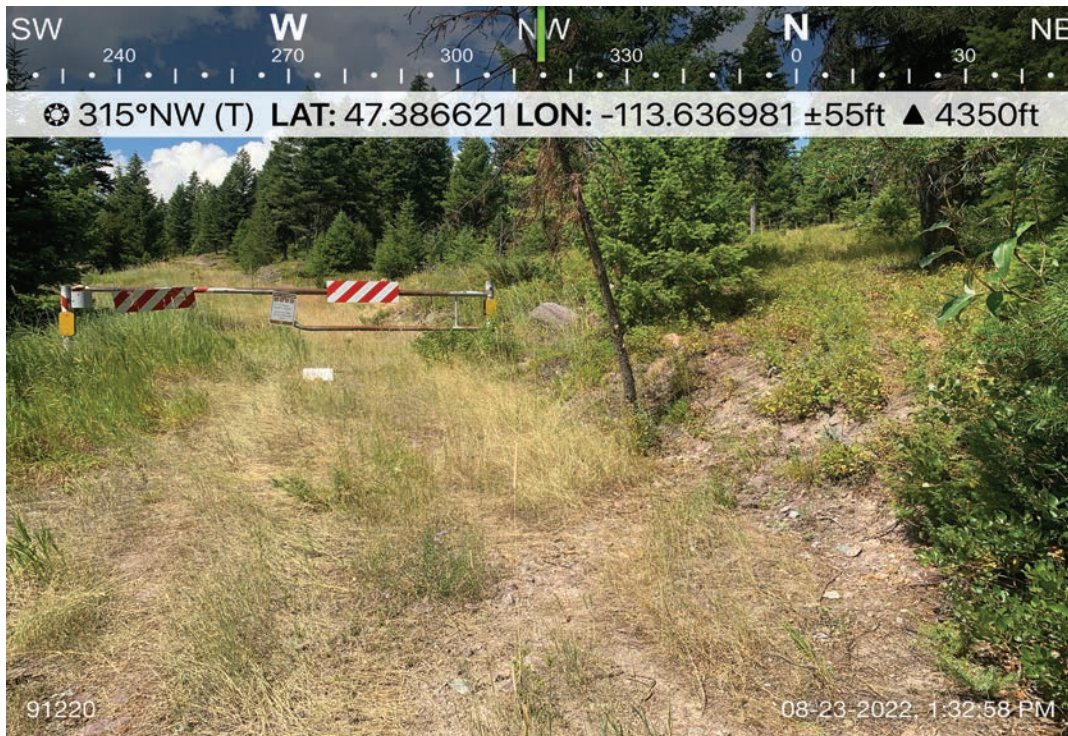
Fig. 2: A road closure gate on Flathead National Forest road 91220 shows tracks of large motorized vehicles detouring around the gate via the gentle hillside and open space between the trees.

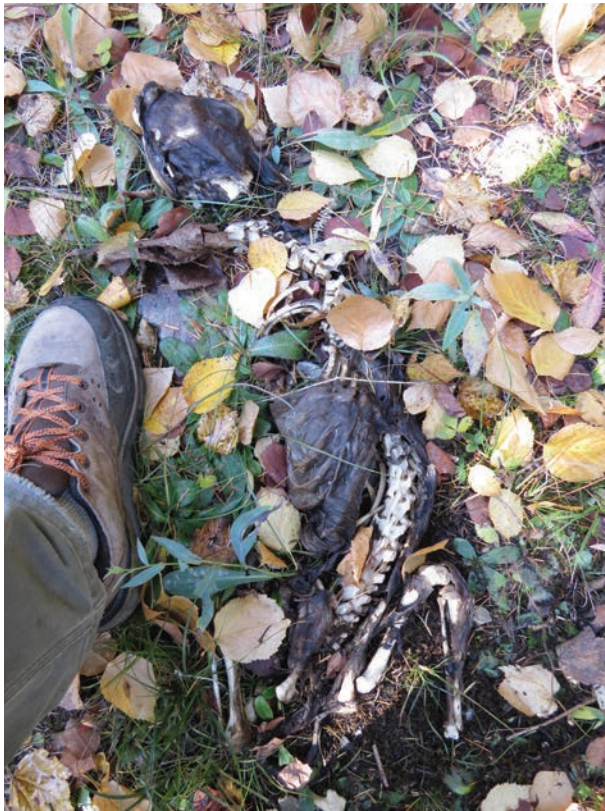
Figure 7 shows a decomposing wolverine carcass we discovered in the middle of closed road 5392Y, about a mile behind its ineffective closure device on 10/21/21. Research shows that wolverine tend to avoid roads and other human intrusions. [18, 19] We have been unable to find research showing that wolverine tend to leave forest cover and lie down in the middle of a road to die of natural causes. Wolverine

Fig. 7: 10/21/21 photo of dead wolverine on road 5392Y.

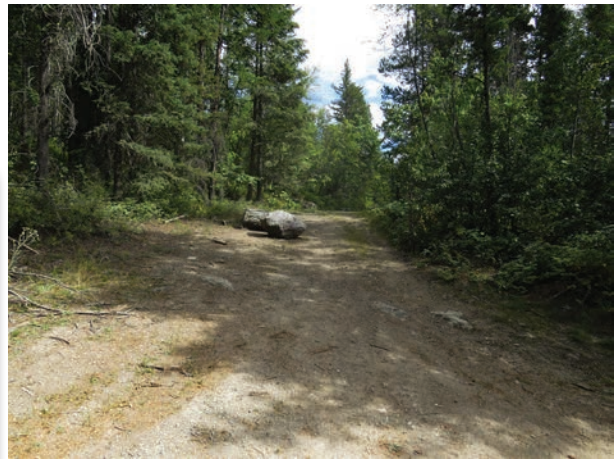
To add insult to the death of this particular wolverine, the ineffectiveness of the 5392Y road closure has been readily evident for years to Forest Service staff traveling Jewel Basin Road 5392 to reach a Forest Service cabin and trail heads servicing the most popular Hiking Area on the Flathead NF. Figure 8 shows the earliest (8/25/16) photo we have of boulders moved aside to allow passage of full size passenger vehicles to road 5392Y.

Fig. 8: 8/25/16 view of closed road 5392Y from road 5392.

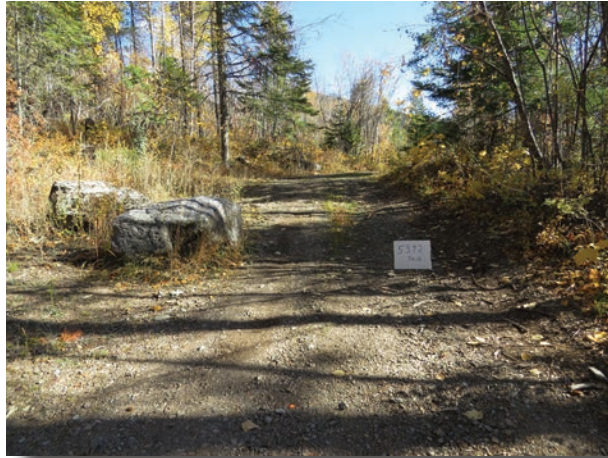
Figure 9 shows this road closure device still not repaired on 10/21/21, more than five years later. We inspected road 5392Y on foot on 10/21/21. Figure 10 shows an example of the cutting of deadfall that kept the road passable and exhibiting use by ATVs for about a mile to Birch Creek, where motorized use then appears to cease due to a rotten, caved in log bridge.

Fig. 9: 10/21/21 photo of road closure 5392Y.

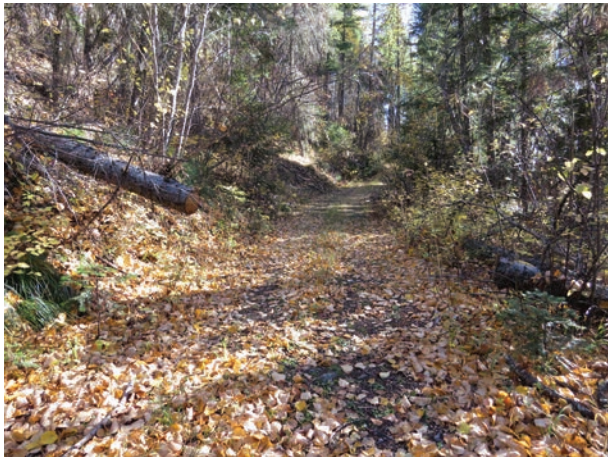
Fig. 10: Clearing of road 5392Y behind its closure device.

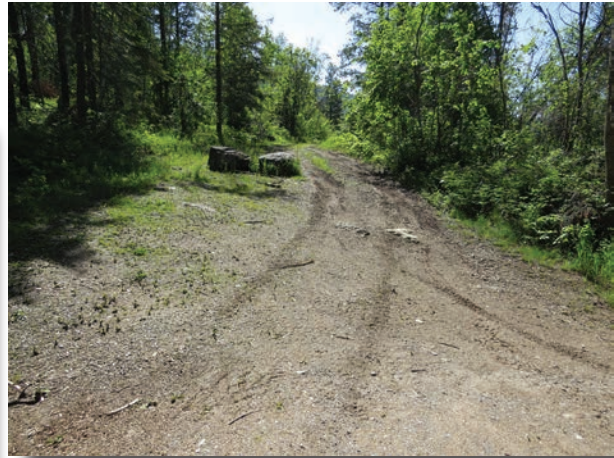
Figure 11 shows that the road closure had not been repaired by 6/17/22 and was continuing to be trespassed by motor vehicles. Nor had it been repaired by 7/27/22, when it was inspected as a part of this road closure survey, as shown in Figure 12.

Fig. 11: 6/17/22 photo of road closure 5392Y.

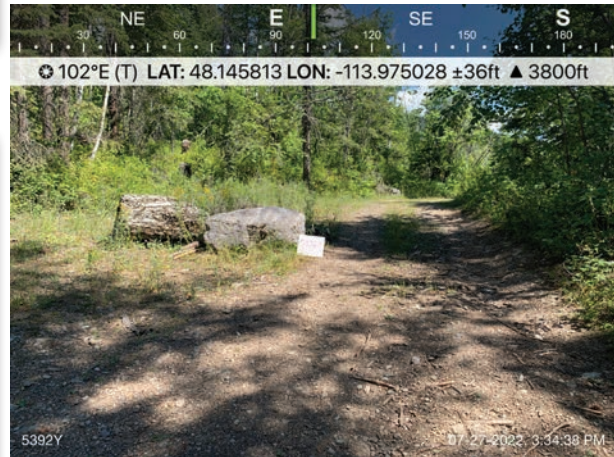
Fig. 12: 7/27/22 photo of road closure 5392Y.

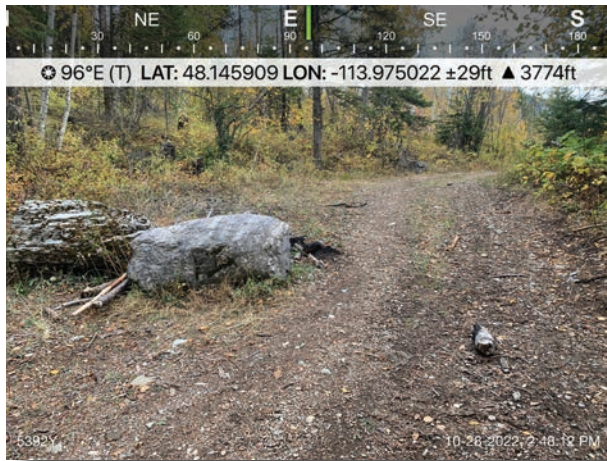
We inspected the closure again on 8/28/22 and 10/28/22, and it still had not been repaired, as shown in Figures 13 and 14, respectively. This although the FS inspected this closure on 9/1/22, reporting “Lots of motorized traffic going past the rocks.” [24] This serves as just one example of the many years the Flathead NF allows ineffective closures to persist without repair, with potentially fatal consequences to wildlife.

Fig. 14: 10/28/22 photo of road closure 5392Y.

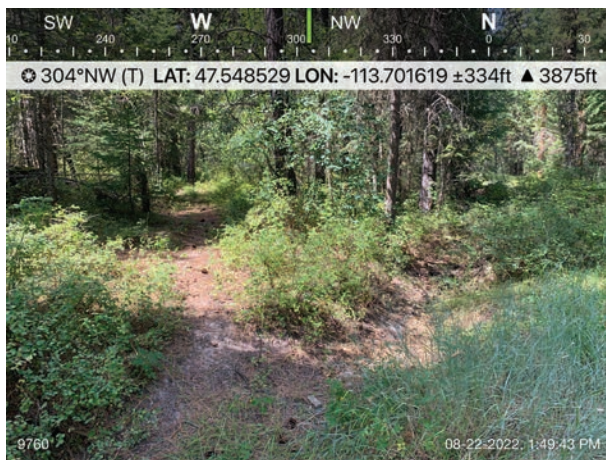
Figure 18 shows how we found road closure 9760 on 8/22/22, noting a wide detour with ATV tracks circumventing the berm closure. We deemed the closure ineffective at preventing motorized use beyond the berm. The FS inspected the closure on 9/20/22 and found the "Berm is functional but path cut to the left of berm where motorized trespassing is occurring." [47]

Fig. 18: ATV detour around road closure berm 9760..

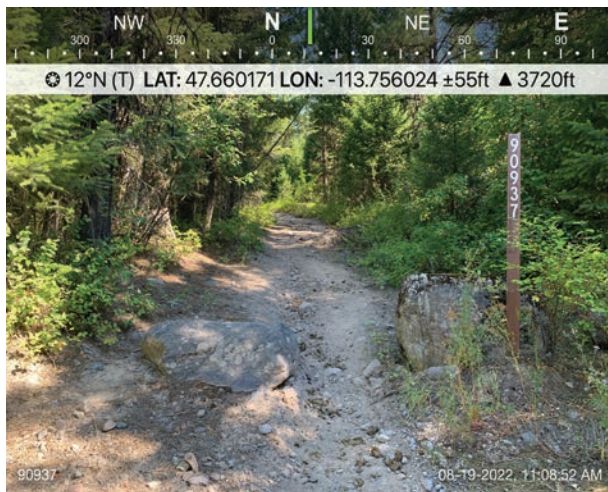
We note here that a number of closure devices showed so much human use behind them that it was difficult to determine whether there were motorized vehicle tracks among the horse or mountain bike tracks. Road closure 90937, for example (Figure 21), exhibited so much horse use that, if it was being violated by electric e-bikes or motorcycles, those tracks were obliterated by horse hooves. We deemed this closure “effective” according to our motorized use inspection protocol, but such closures beg the question of whether or not they are actually achieving the objective of securing wildlife habitat due to intense non-motorized human uses also known to displace wildlife. [59]

Fig. 21: Heavy horse use of road 90937.

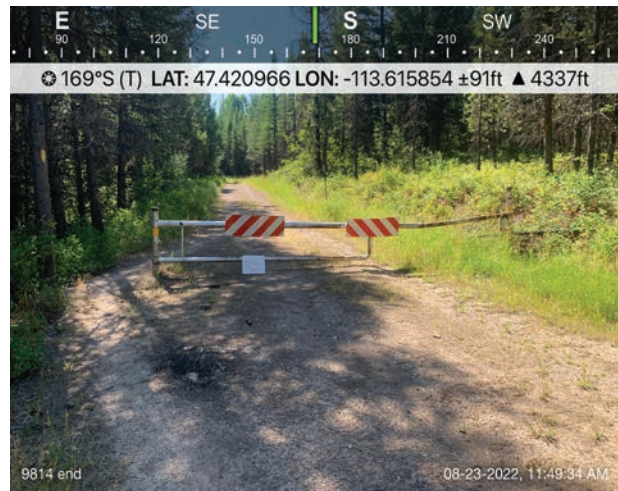
Our survey also inspected each closure for the presence of mountain bike tracks. We found significant mountain bike tracks circumventing the gate closure on road 9814 above Holland Lake near the Flathead/Lolo National Forests boundary (Figure 22). [60] We deemed this closure

Fig. 22: High-use mountain bike and motorcycle detour.

“ineffective” not because of the mountain bike tracks, but because there were car/truck tracks through the gate and motorcycle tracks going around the left side. It is of course impossible to tell which of the mountain bike tracks may have been electric e-bikes (currently considered motorized vehicles by the FS and prohibited from closed roads and trails). [61]
