# **Enterprise Group**

## **Preliminary Assessment Report**

Boise County  
State of Idaho

### **Idaho Department of Environmental Quality**

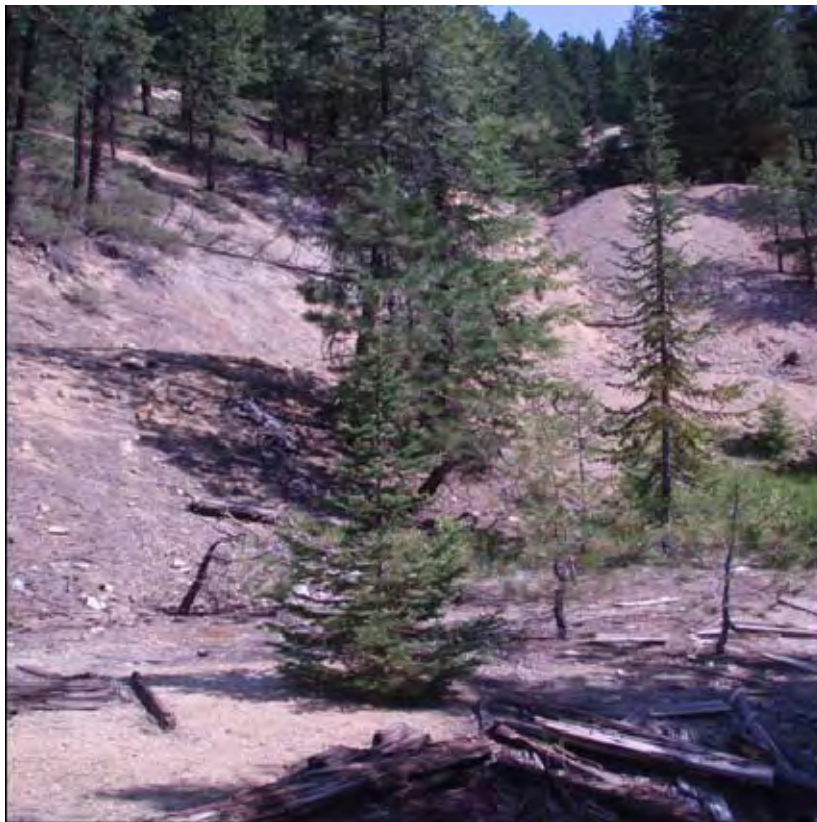
Photo No. 1: Looking NE up the hill towards several waste dumps from the main road near the main adit (collapsed).

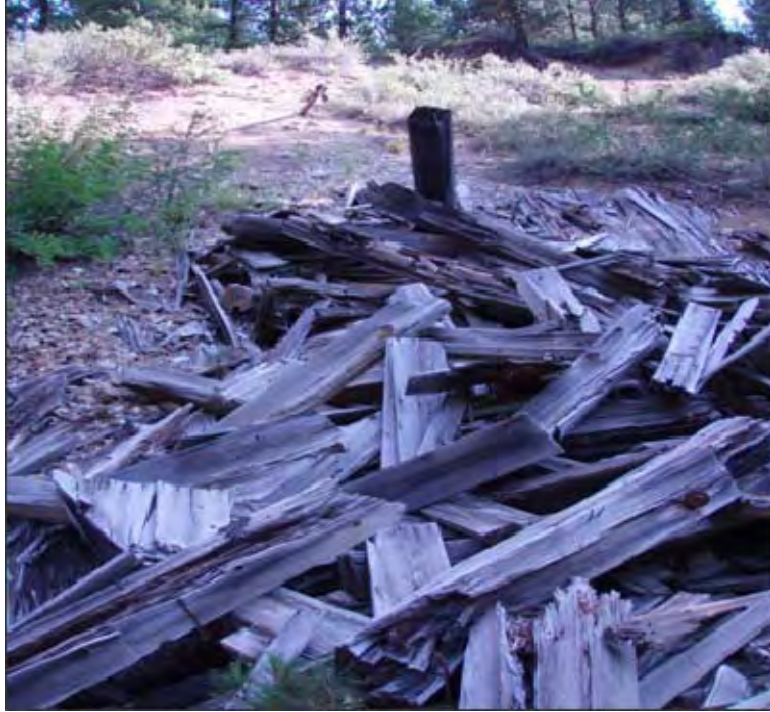
Photo No. 2: Looking NE towards collapsed structure (believed to be former mill) below main road. The piping for the hose bib in top of portion of the picture appears bent. Soil sample SS1 was collected below this point.

Blackbird millsite [SS-1]: Excess cancer risk for all receptors is greater than the acceptable level of 1E-05, as defined by the REM. The non-cancer hazard is greater than the acceptable level (Hazard Index = 1) for all receptors.

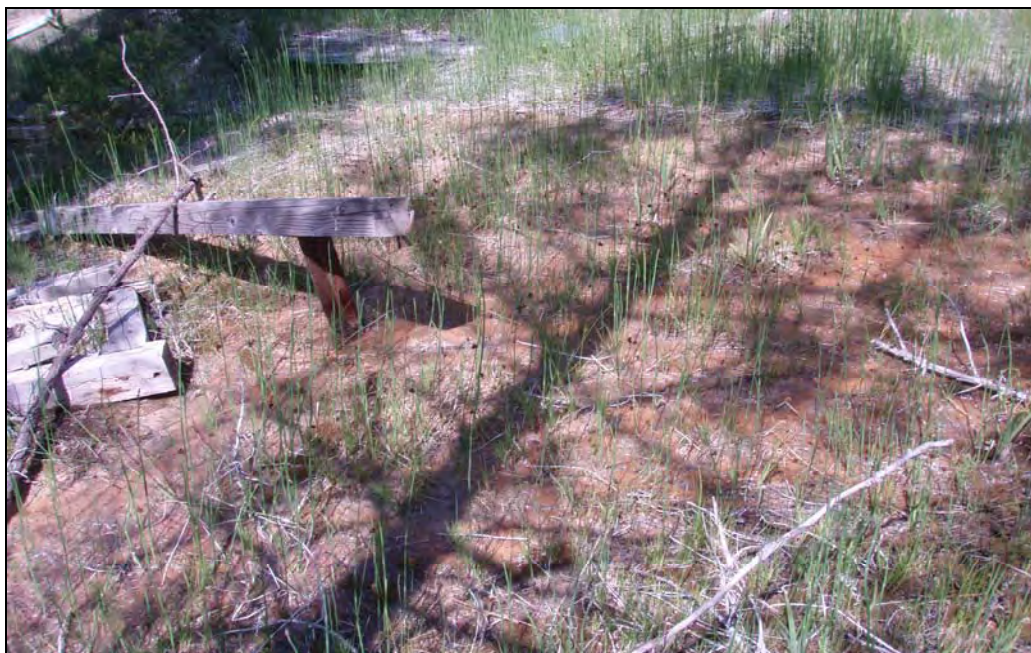
A ponded area with water several inches deep was apparent below the closed adit, allowing water-loving plants to grow. This water eventually discharges into Charlotte Creek. A water sample of the yellowish-brown liquid was collected as well as a sediment (soil) sample.

Photo No. 3: View of adit seep area. Minor ferric hydroxide precipitate noted in the boggy sediments.

Sediment below lower adit [SS-2]: Excess cancer risk and non-cancer hazard is exceeded for only residential receptors.

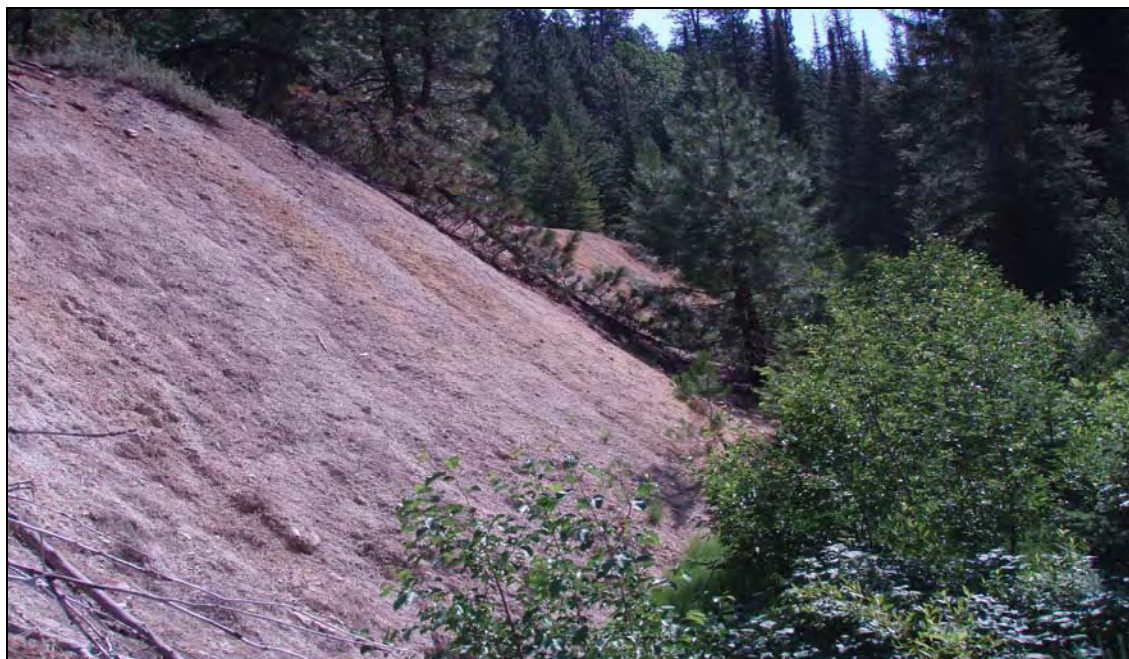
Brownish/ tan colored fine-grain tailings extend along the north side of Charlotte Creek below the millsite area.

Photo No. 4: View of eroding waste dump along northern bank of Charlotte Creek (looking east). Soil sample SS4 was collected along this lower waste dump.

Lower waste dump: Excess cancer risk for residential and non-residential receptors is greater than the acceptable level, while the non-cancer hazard is greater than the acceptable level for only residential receptors.

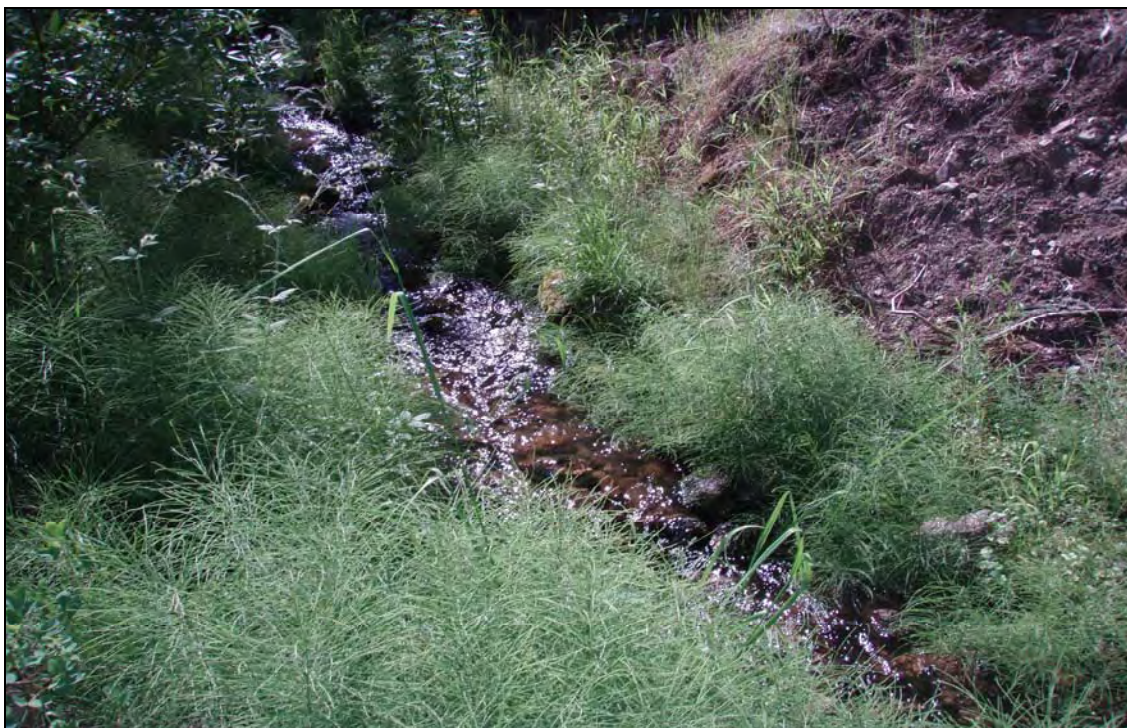
Photo No. 5: View of Charlotte Creek below waste dumps (looking west). Water sample SW1 was collected near here.

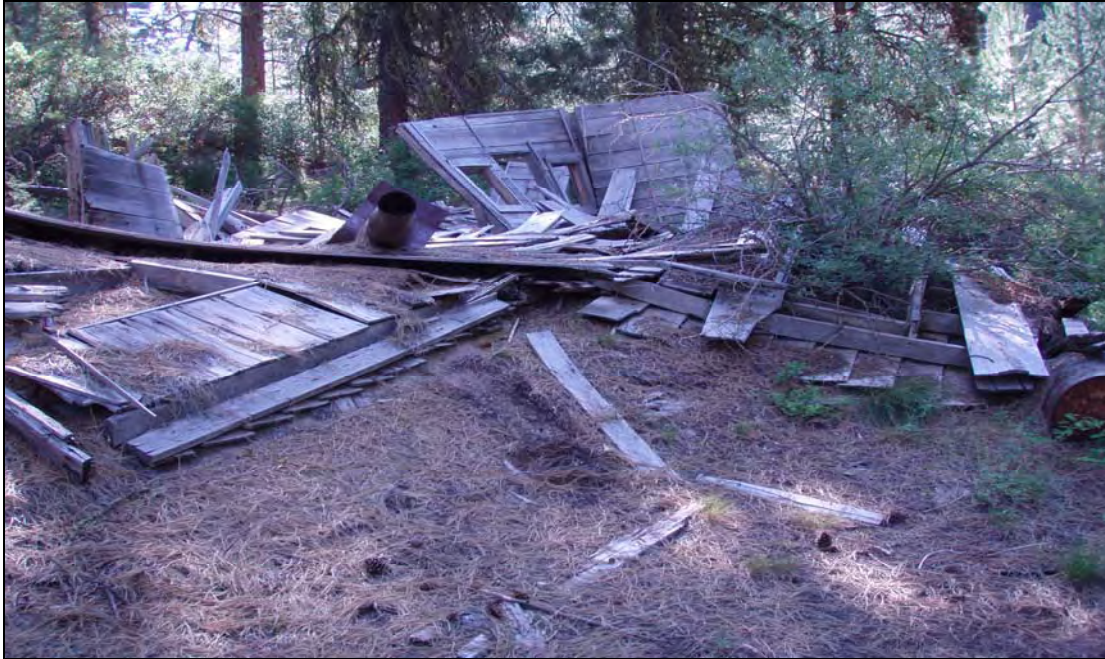
Former wooden structures including an ore bin and a small laboratory or sample processing area are located south of the road into the mine. One empty 55-gallon barrel was observed among the wooden debris.

Photo No. 6: View of former lab sample structure below main road (looking east). SS3 was collected near the bottom of the picture.

Lab area [SS-3]: Excess cancer risk for residential and non-residential receptors is greater than the acceptable level, while the non-cancer hazard is greater than the acceptable level for only residential receptors.

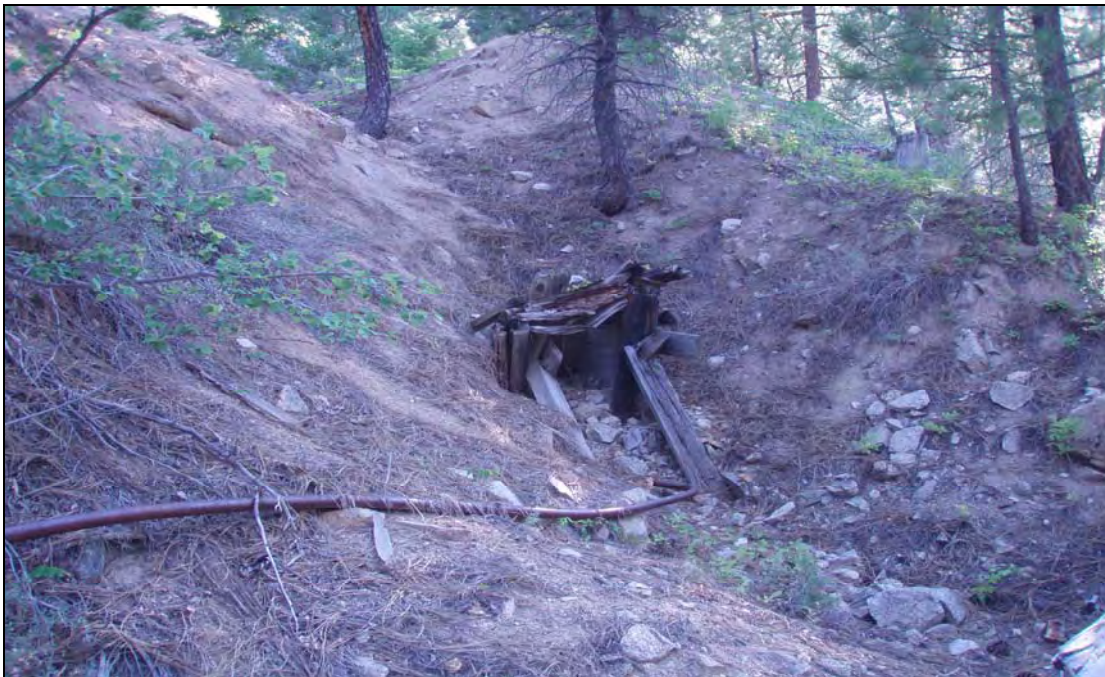
Photo No. 7: View of collapsed workings with hydraulic piping in middle portion of hillside (looking east). Possibly correlates to Blackbird No. 4 adit in historical records.

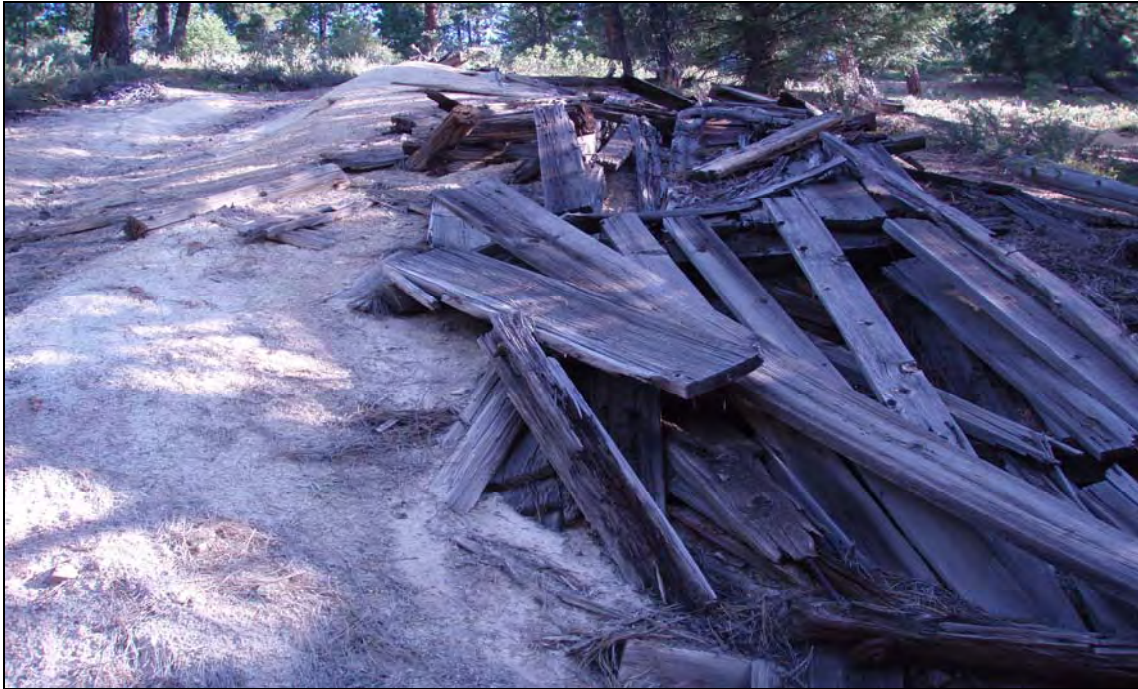
A series of waste dumps extend up the hill from the millsite. In total, the waste dumps appear to be approximately 3000 cubic yards in size. The waste dumps are relatively long, narrow and steep with few terraced areas of flat spots. As the waste dumps are not vegetated, significant erosion has occurred over time.

Photo No. 8: View of collapsed portal and waste dump located above the road on the western portion of the site (looking up to the north).

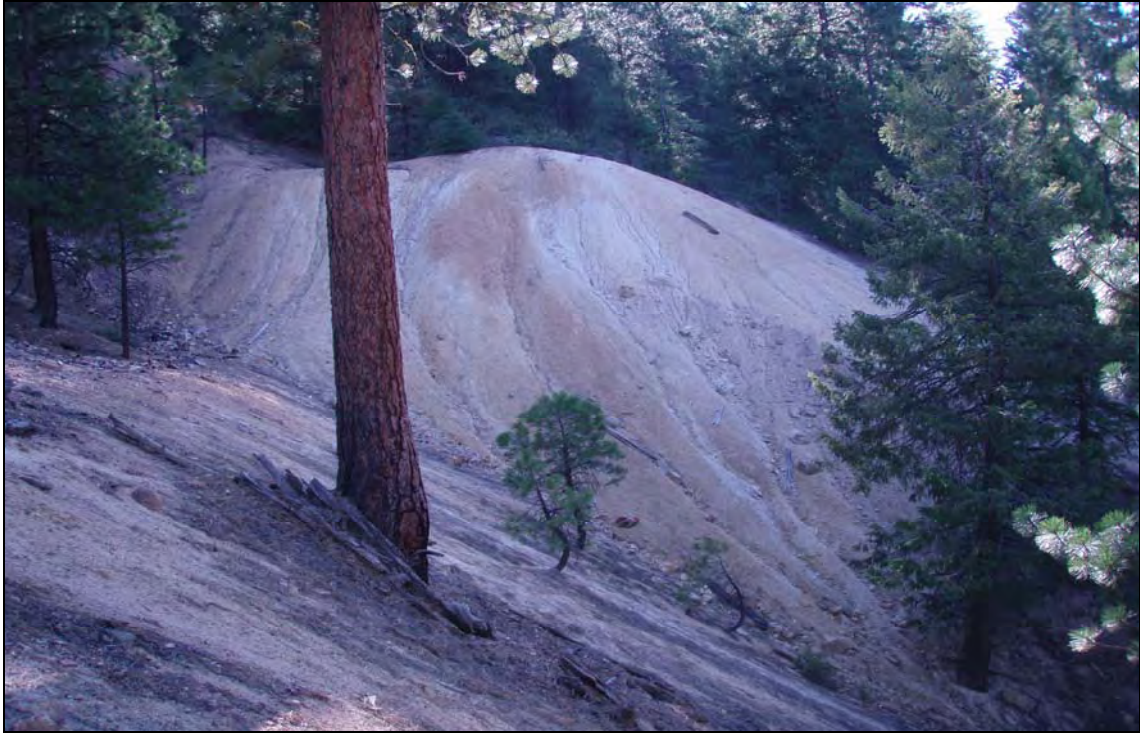
Photo No. 9: View of upper waste dumps showing signs of significant erosion (looking east).

Upper waste dump: Excess cancer risk for all residential receptors is greater than the acceptable level, while the non-cancer hazard is greater than the acceptable level for only residential receptors in the child age category.

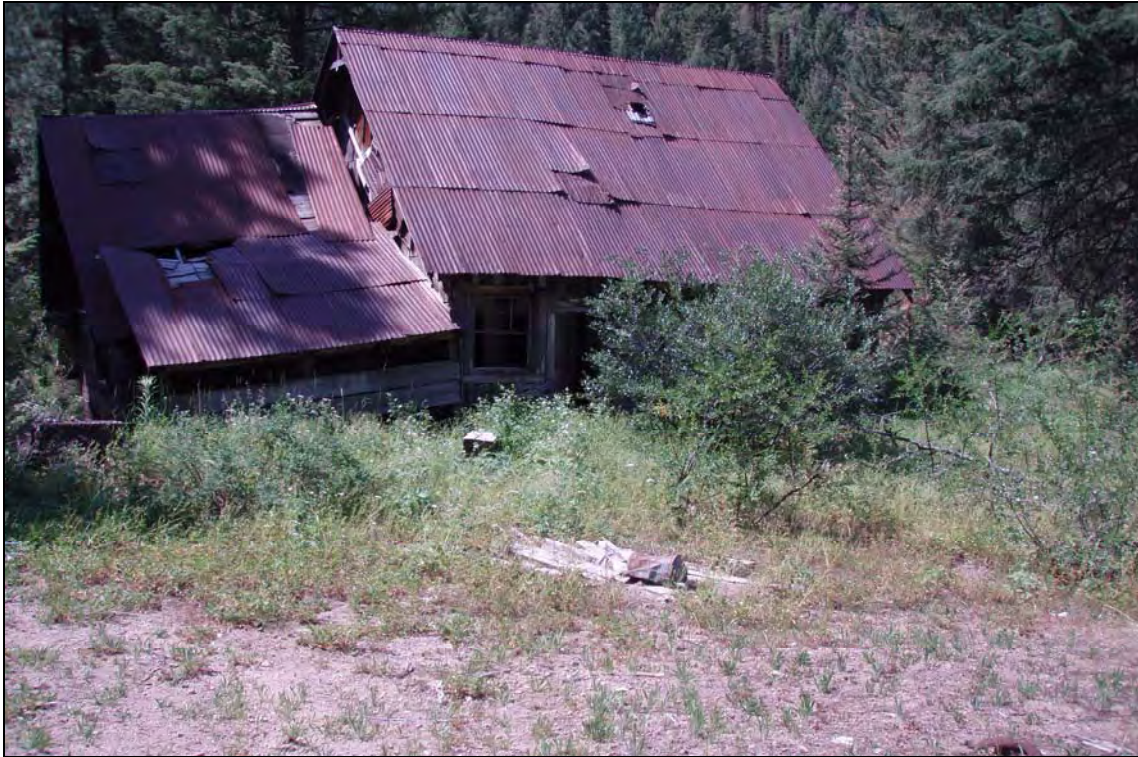
Further up Charlotte Creek is a cabin/former bunkhouse. Several hundred miners lived here at one time during active operations in the early 1900s.

Photo No. 10: View of former bunkhouse (circa 1930's), east of the working at top of the road.

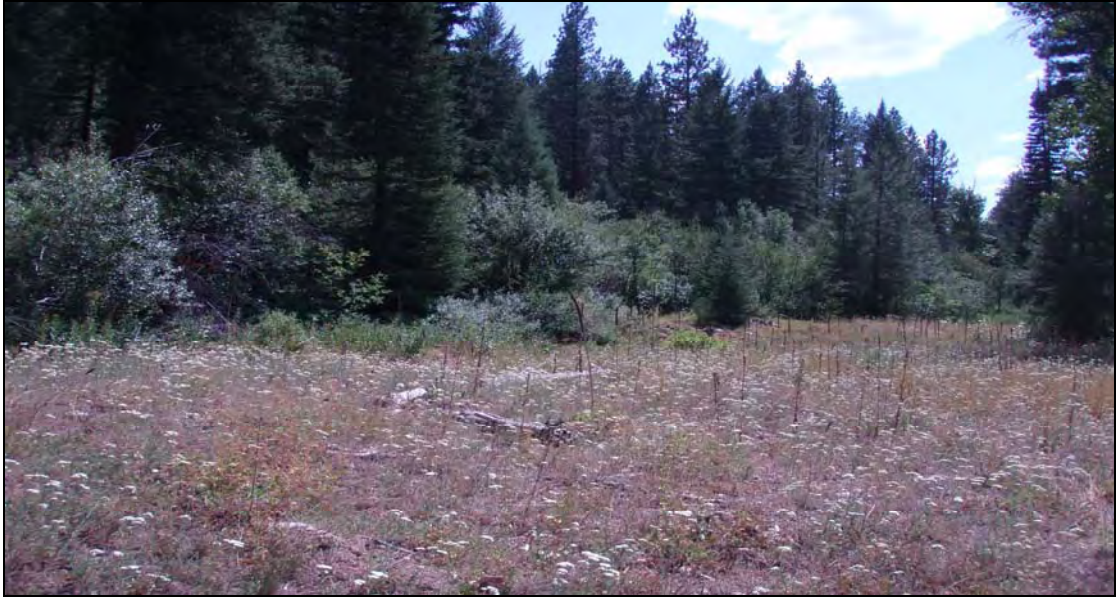
The patented Red Flag millsite does not appear to have supported any milling operations. It consists of approximately 6 acres of flat land covered with trees and shrubs located near the confluence of Charlotte Creek and Grimes Creek. No mill structures or waste materials were observed at this location during the site visit. A small cabin is located nearby.

Photo No. 11: View of clearing in middle portion of Red Flag millsite claim.
