## **Cub Creek Restoration Phase II**

### **Photomonitoring Points (Post-Project)**

Report prepared by USDA Forest Service and Clackamas River Trout Unlimited for OWEB  
Grant Number: 224-3004-23287  
October 2024

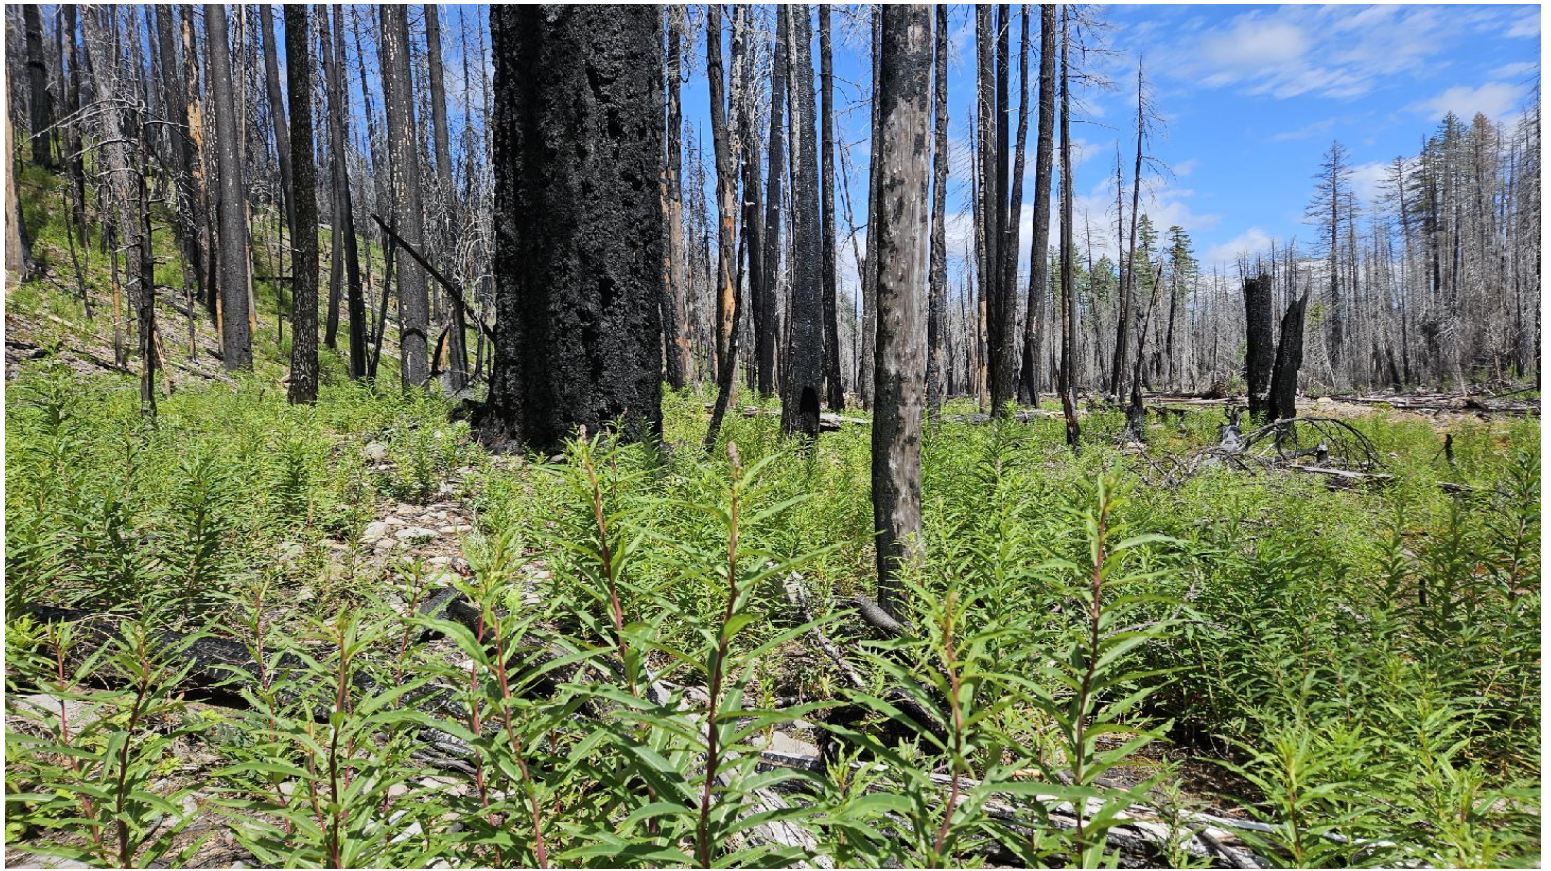
Cub Creek Phase II Pre-Project Photo Point 1 (looking north): alluvium (cut) and large wood will be redistributed from this site during Phase II.

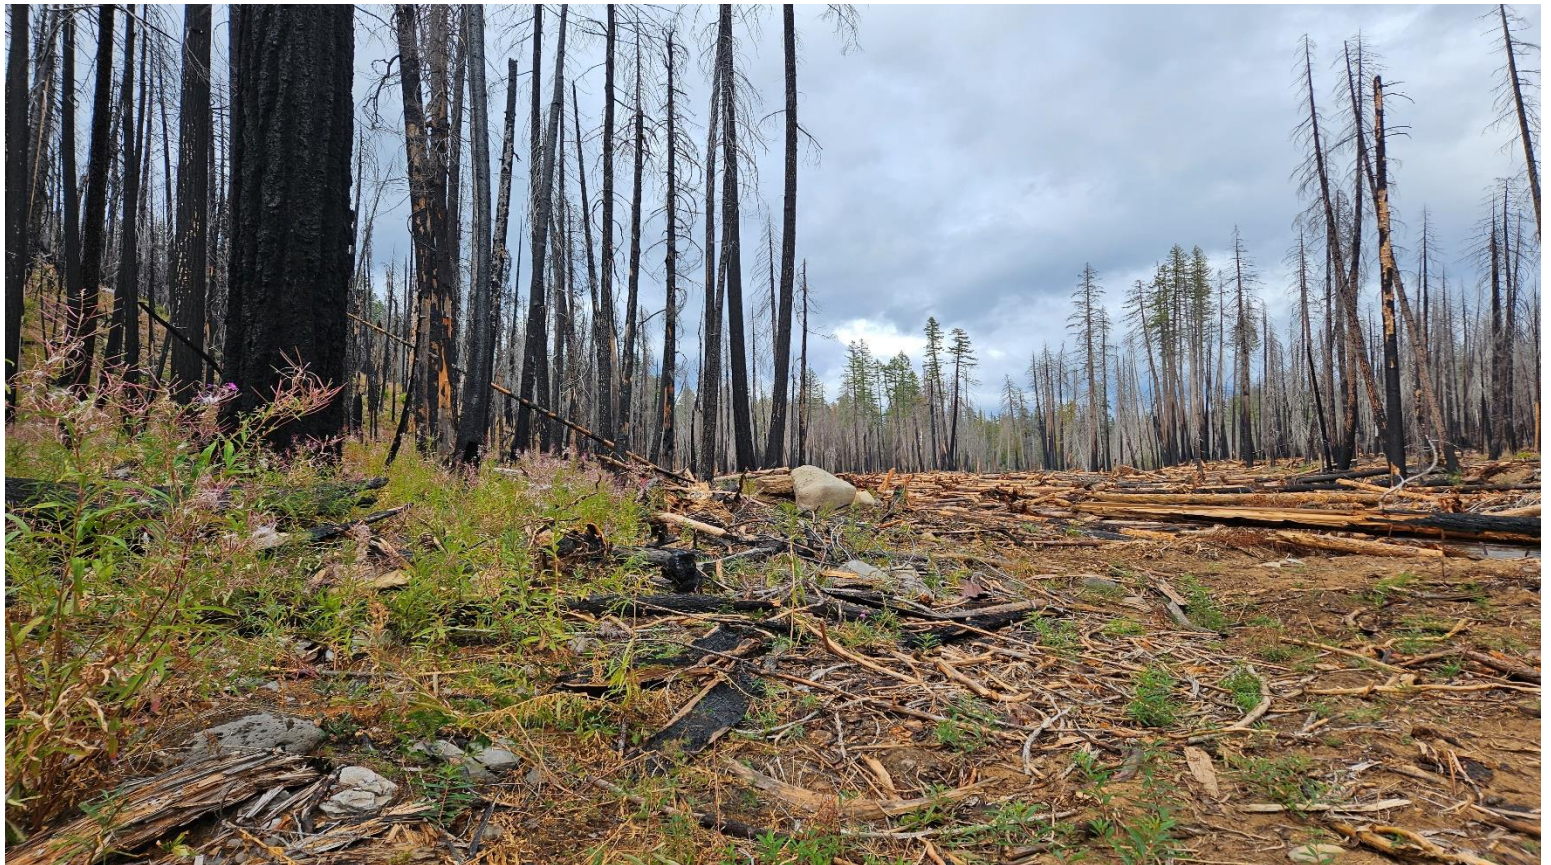
Cub Creek Phase II Post-Project Photo Point 1 (looking north): large wood and alluvium were redistributed from this site during Phase II.

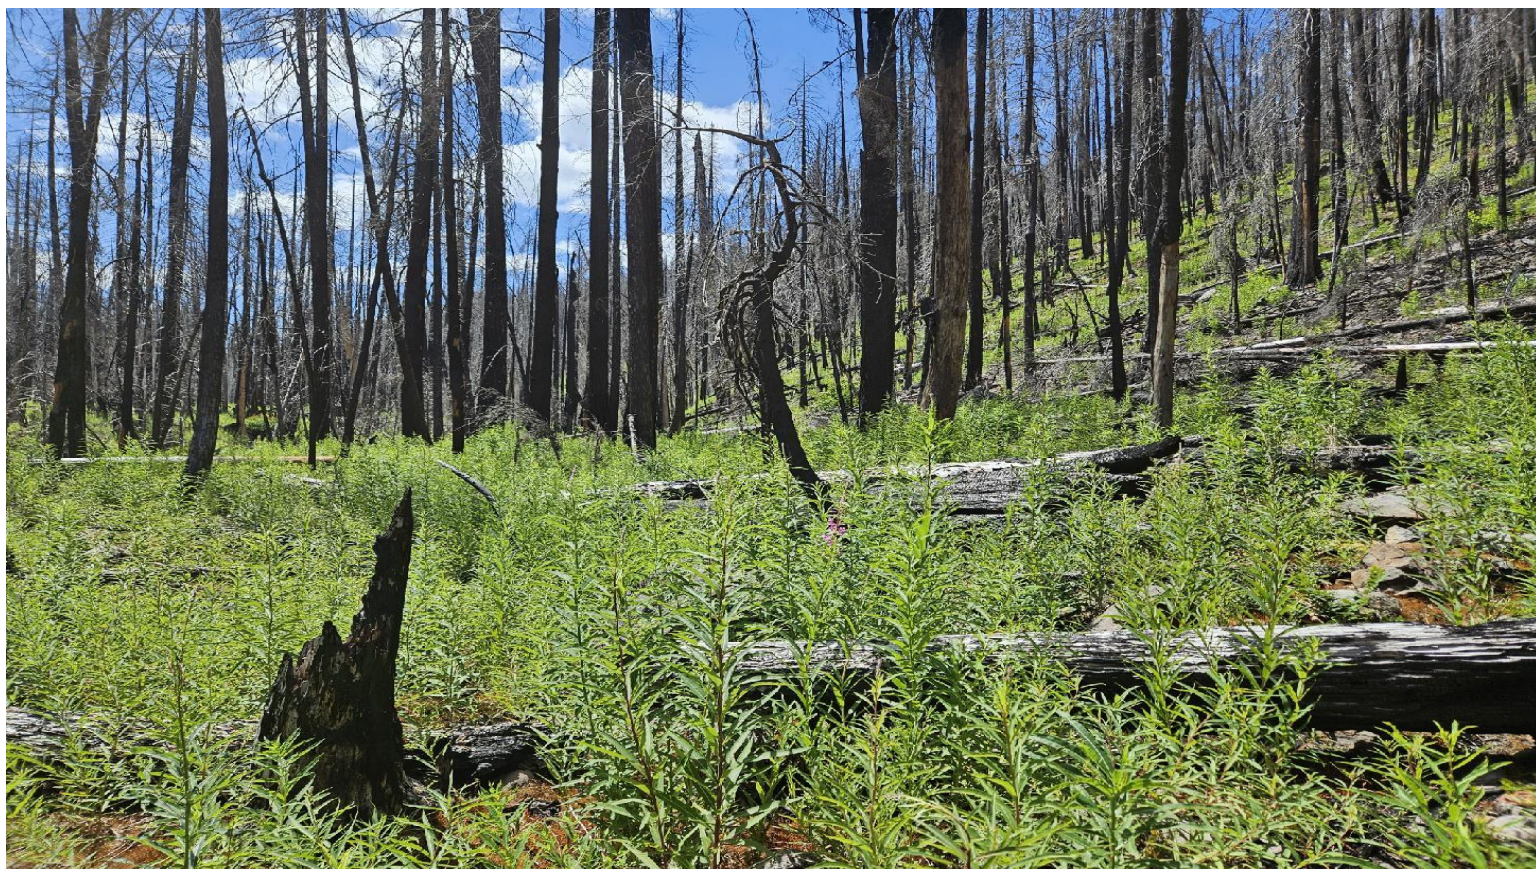
Cub Creek Phase II Pre-Project Photo Point 1 (looking south): alluvium (cut) and large wood will be redistributed from this site during Phase II.

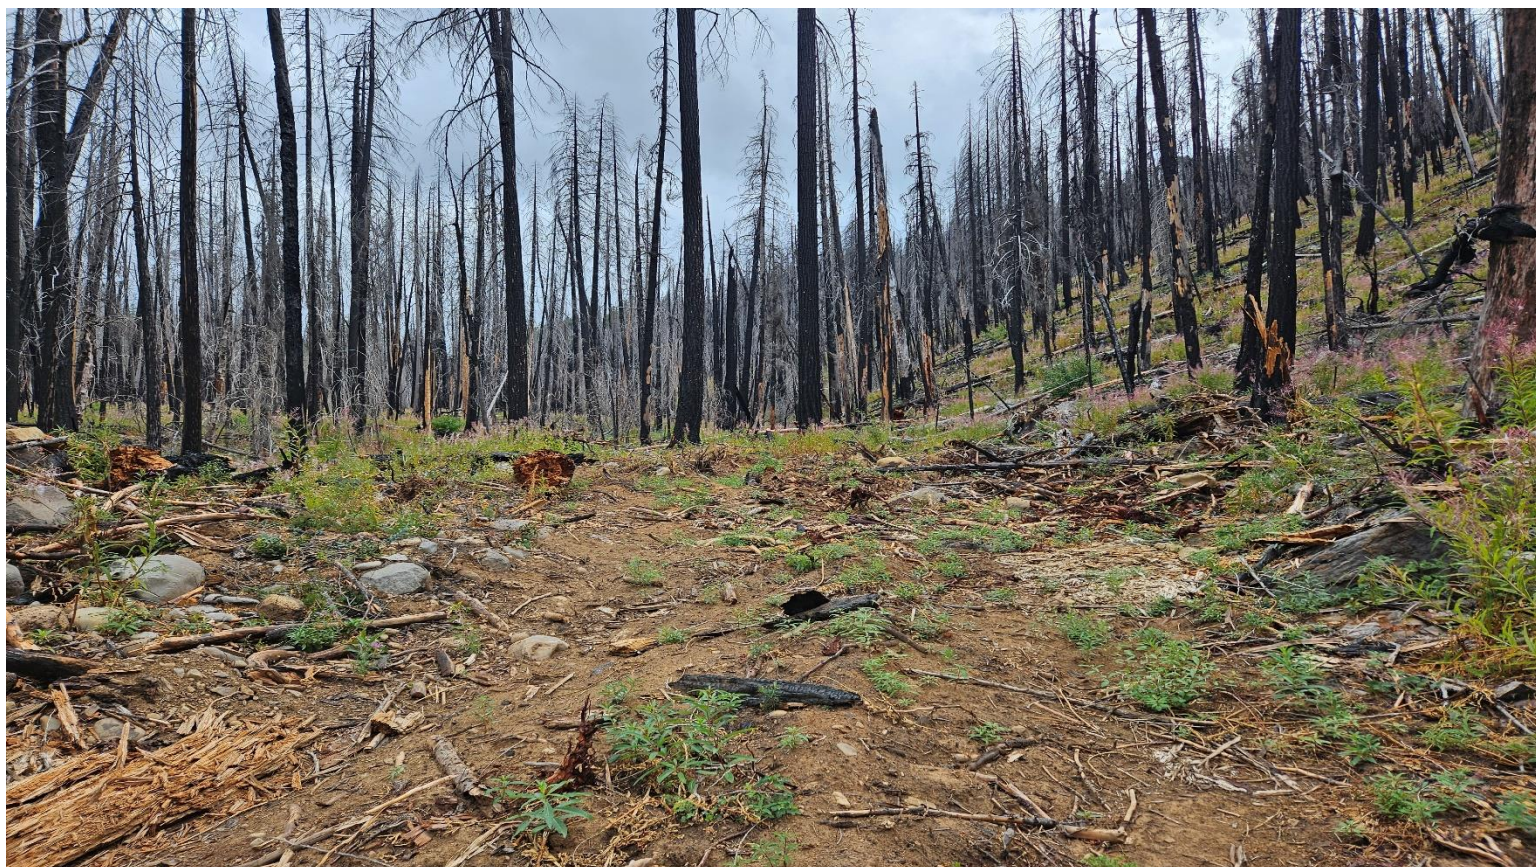
Cub Creek Phase II Post-Project Photo Point 1 (looking south): some large wood was redistributed from this site during Phase II.

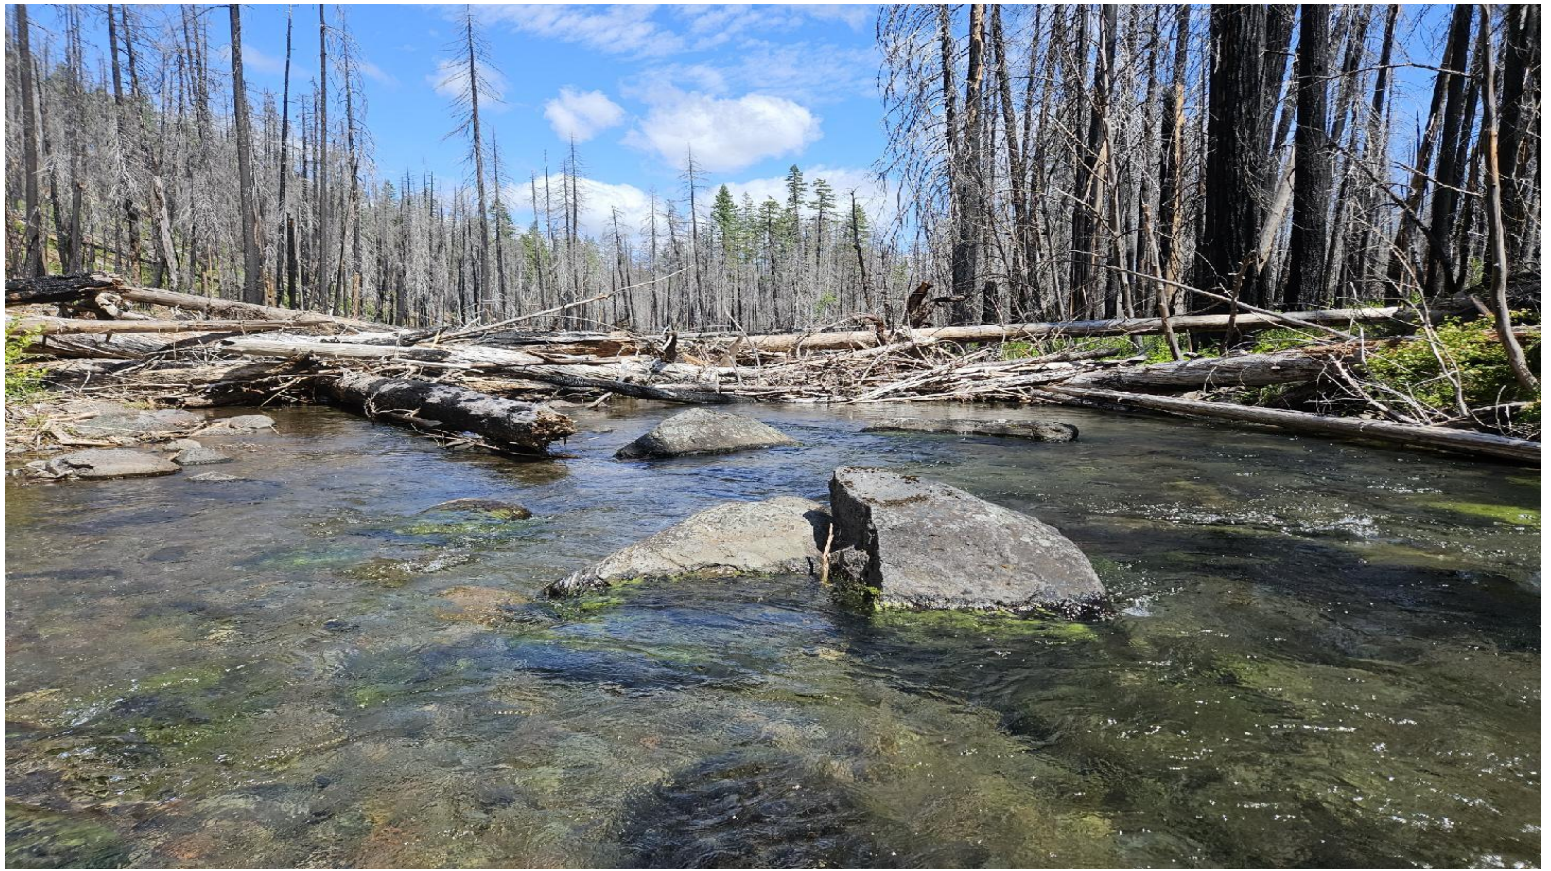
Cub Creek Phase II Pre-Project Photo Point 2 (looking downstream): alluvium (fill) and large wood will be added to the channel during Phase II.

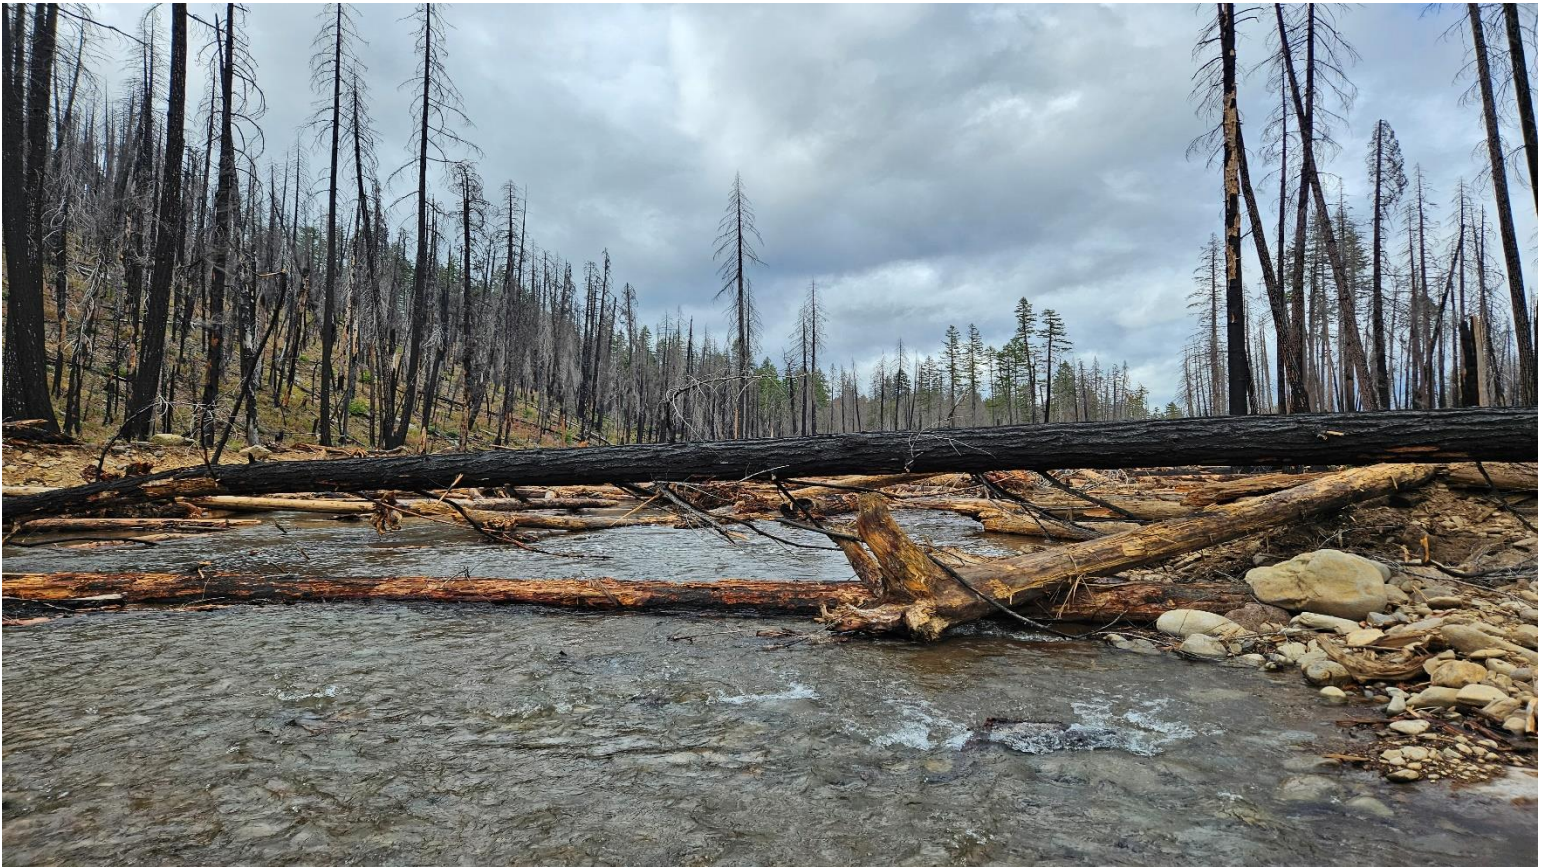
Cub Creek Phase II Post-Project Photo Point 2 (looking downstream): alluvium (fill) and large wood was added to the channel during Phase II.

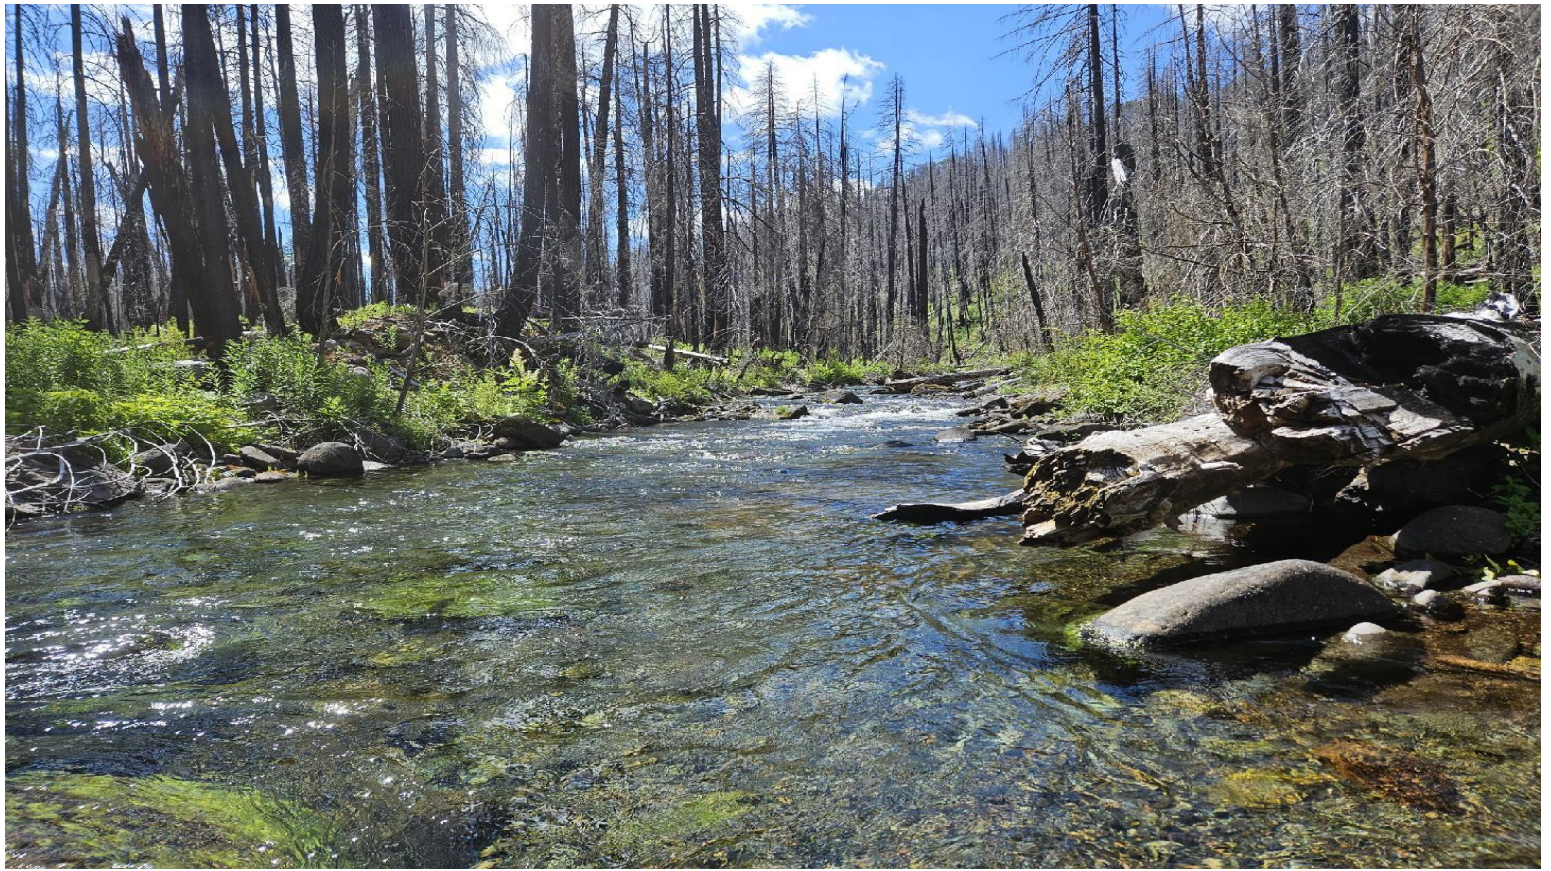
Cub Creek Phase II Pre-Project Photo Point 2 (looking upstream): alluvium (fill) and large wood will be added to the channel during Phase II.

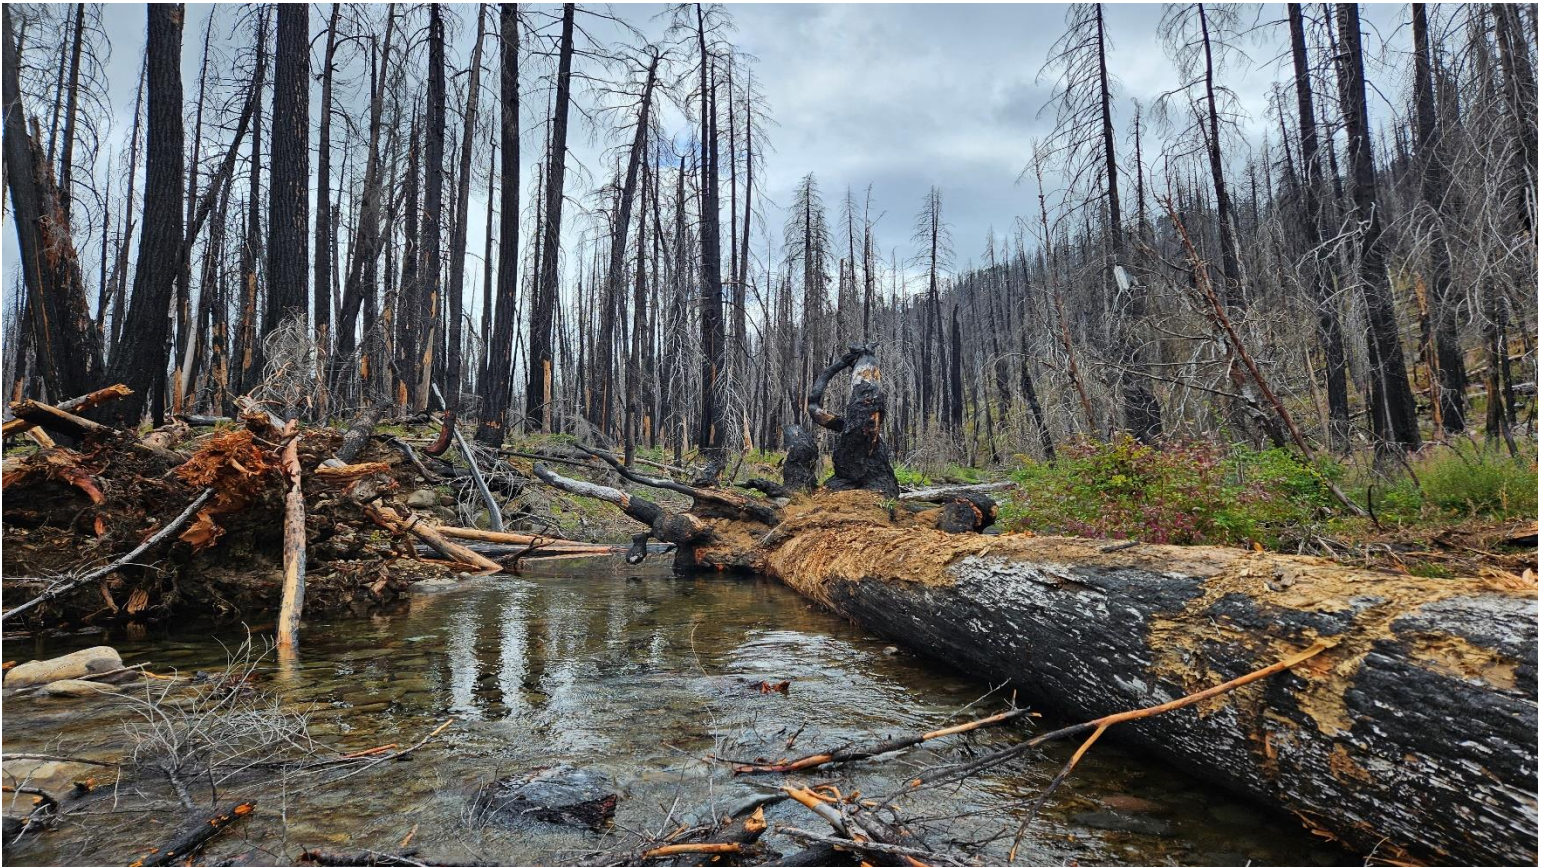
Cub Creek Phase II Post-Project Photo Point 2 (looking upstream): alluvium (fill) and large wood was added to the channel during Phase II.

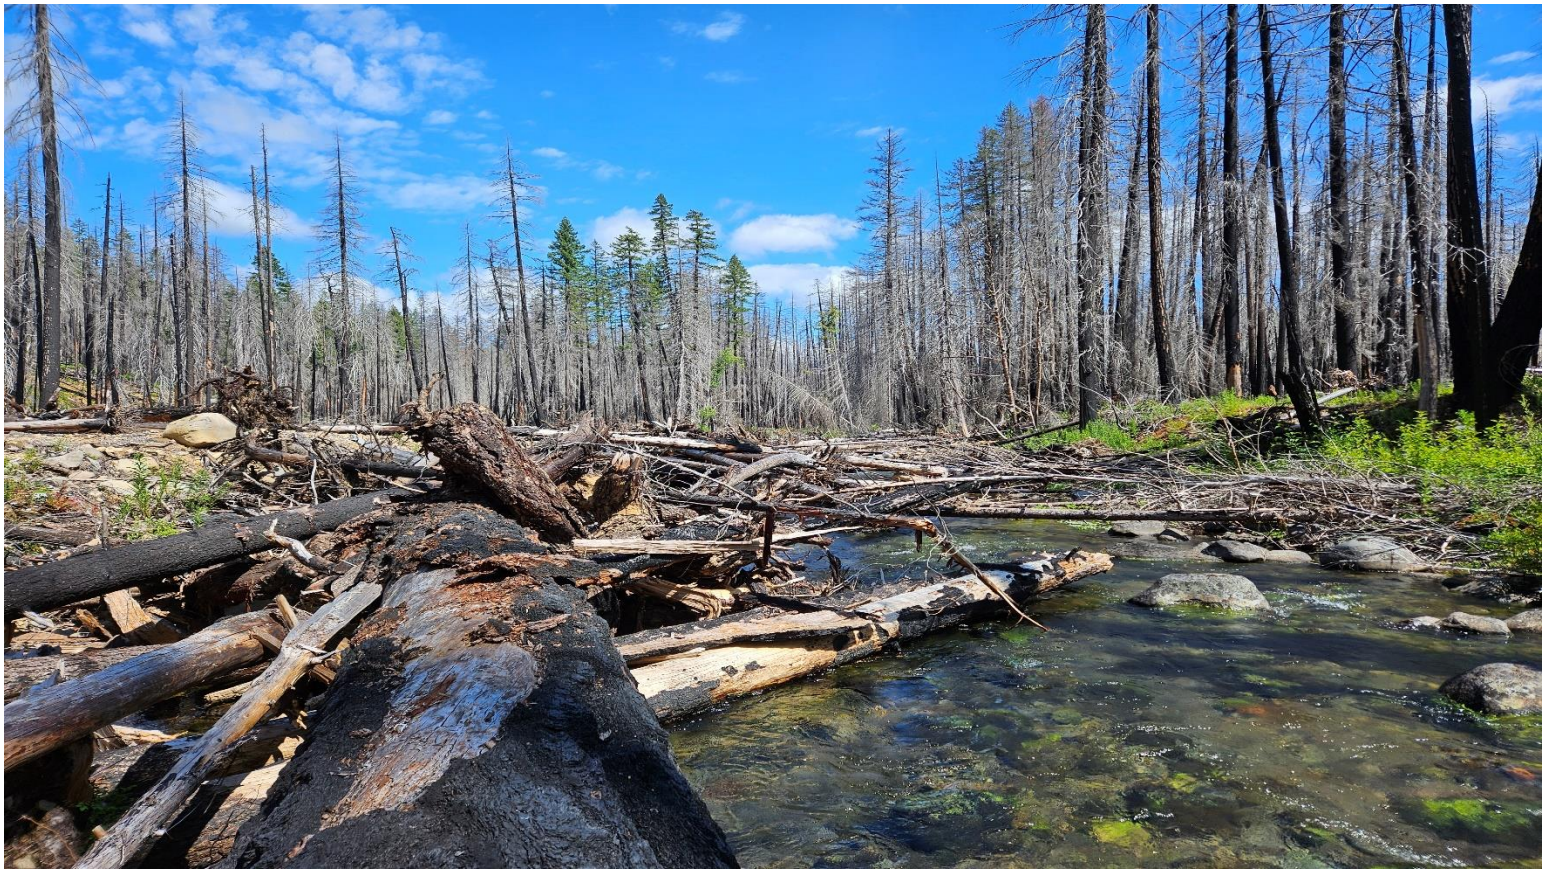
Cub Creek Phase II Pre-Project Photo Point 3 (looking downstream): large wood was added to the channel during Phase I. This same photopoint was utilized for pre- and post-monitoring of Phase I of the Cub Creek Restoration project.

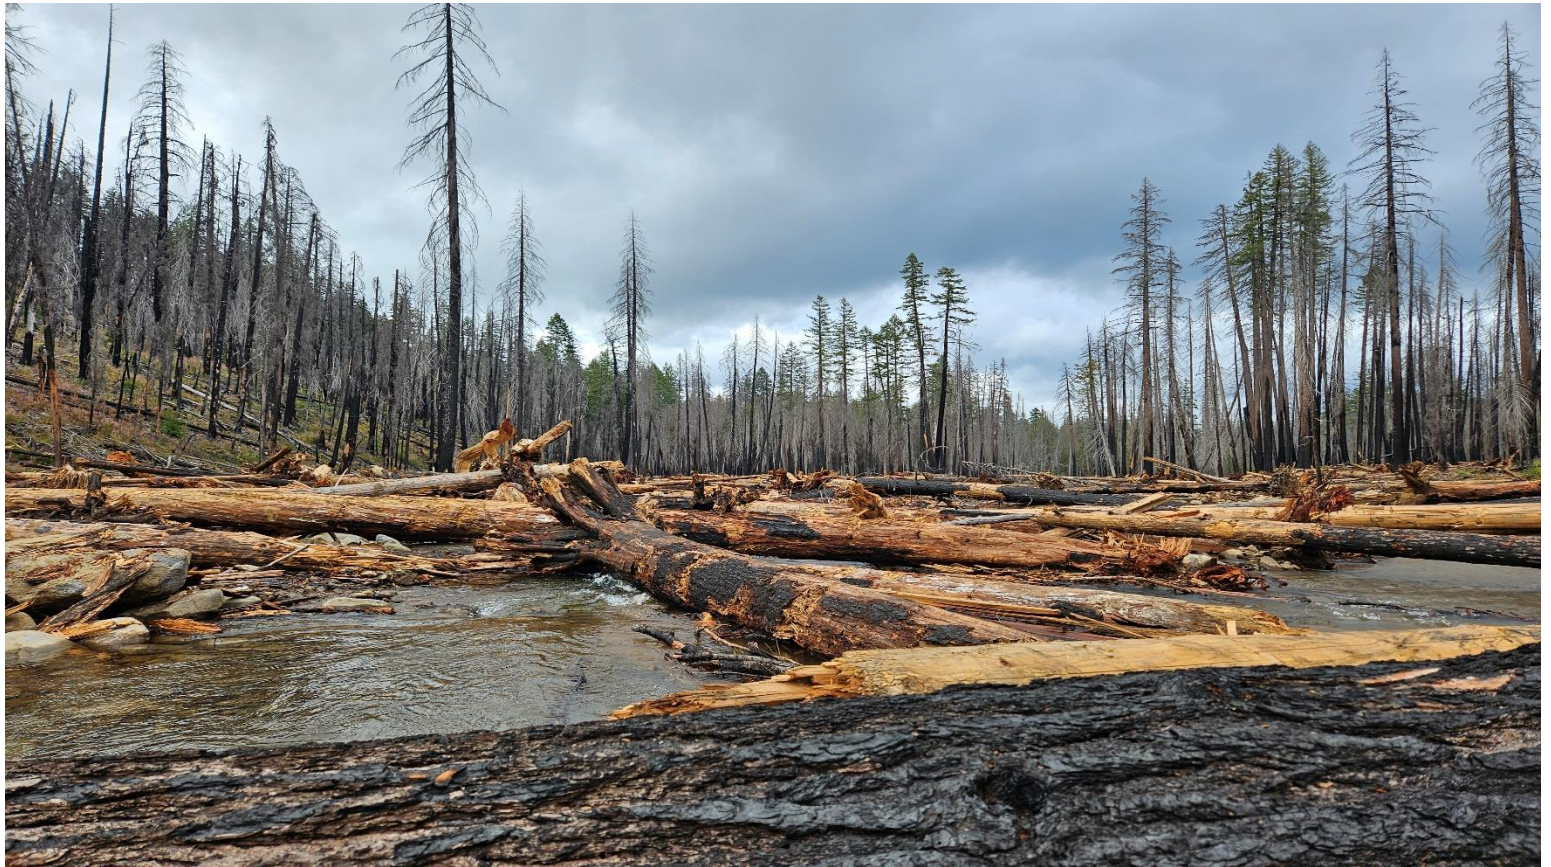
Cub Creek Phase II Post-Project Photo Point 3 (looking downstream): alluvium (fill) and large wood was added to the channel during Phase II.

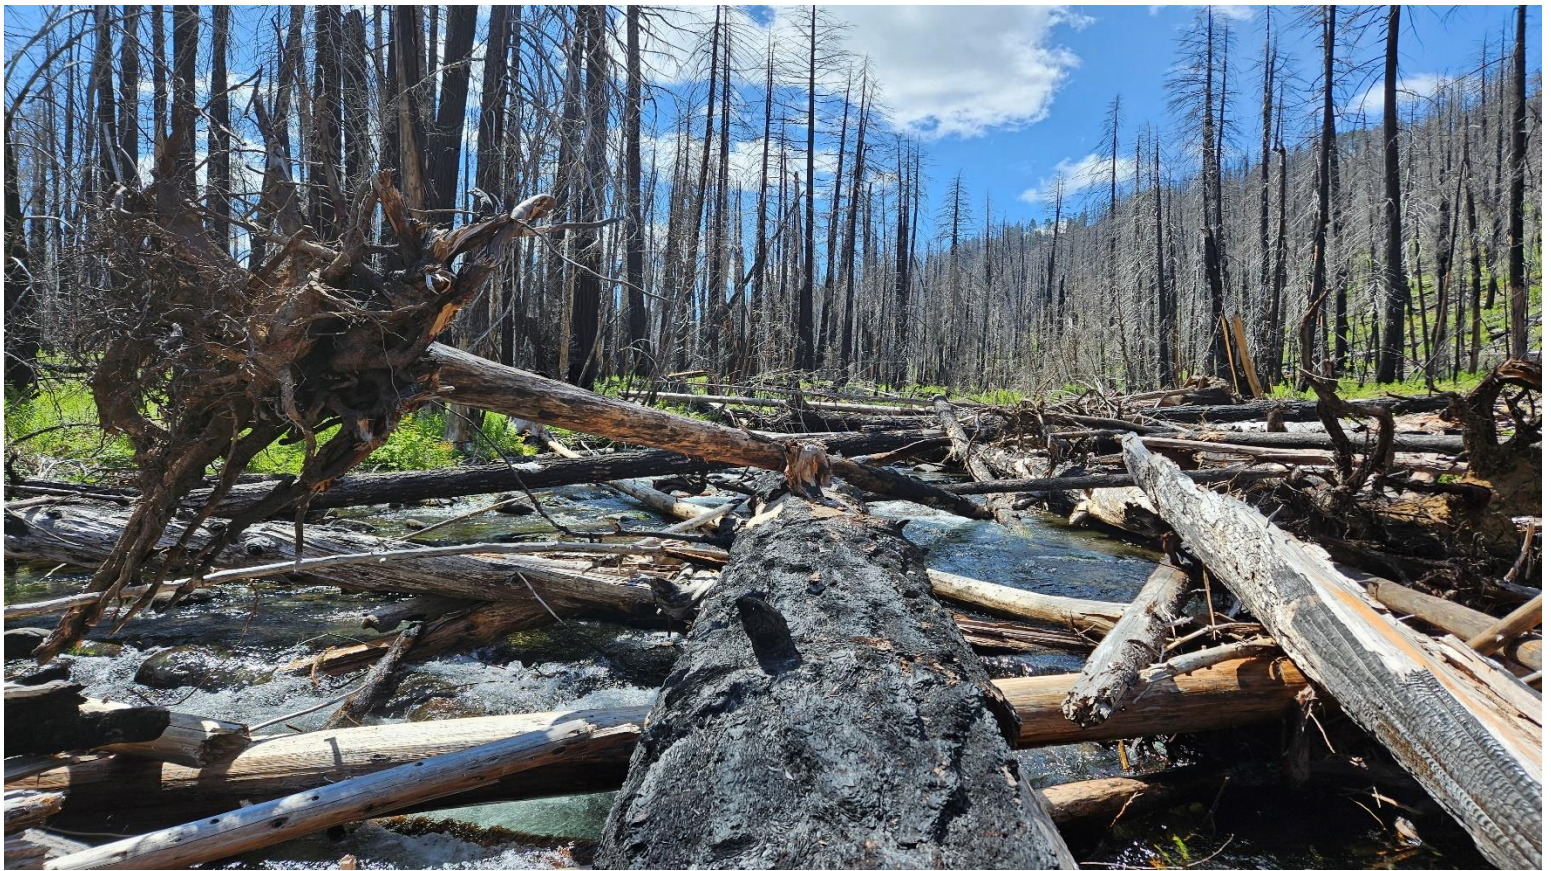
Cub Creek Phase II Pre-Project Photo Point 3 (looking upstream): large wood was added to the channel during Phase I. This same photopoint was utilized for pre- and post-monitoring of Phase I of the Cub Creek Restoration project.

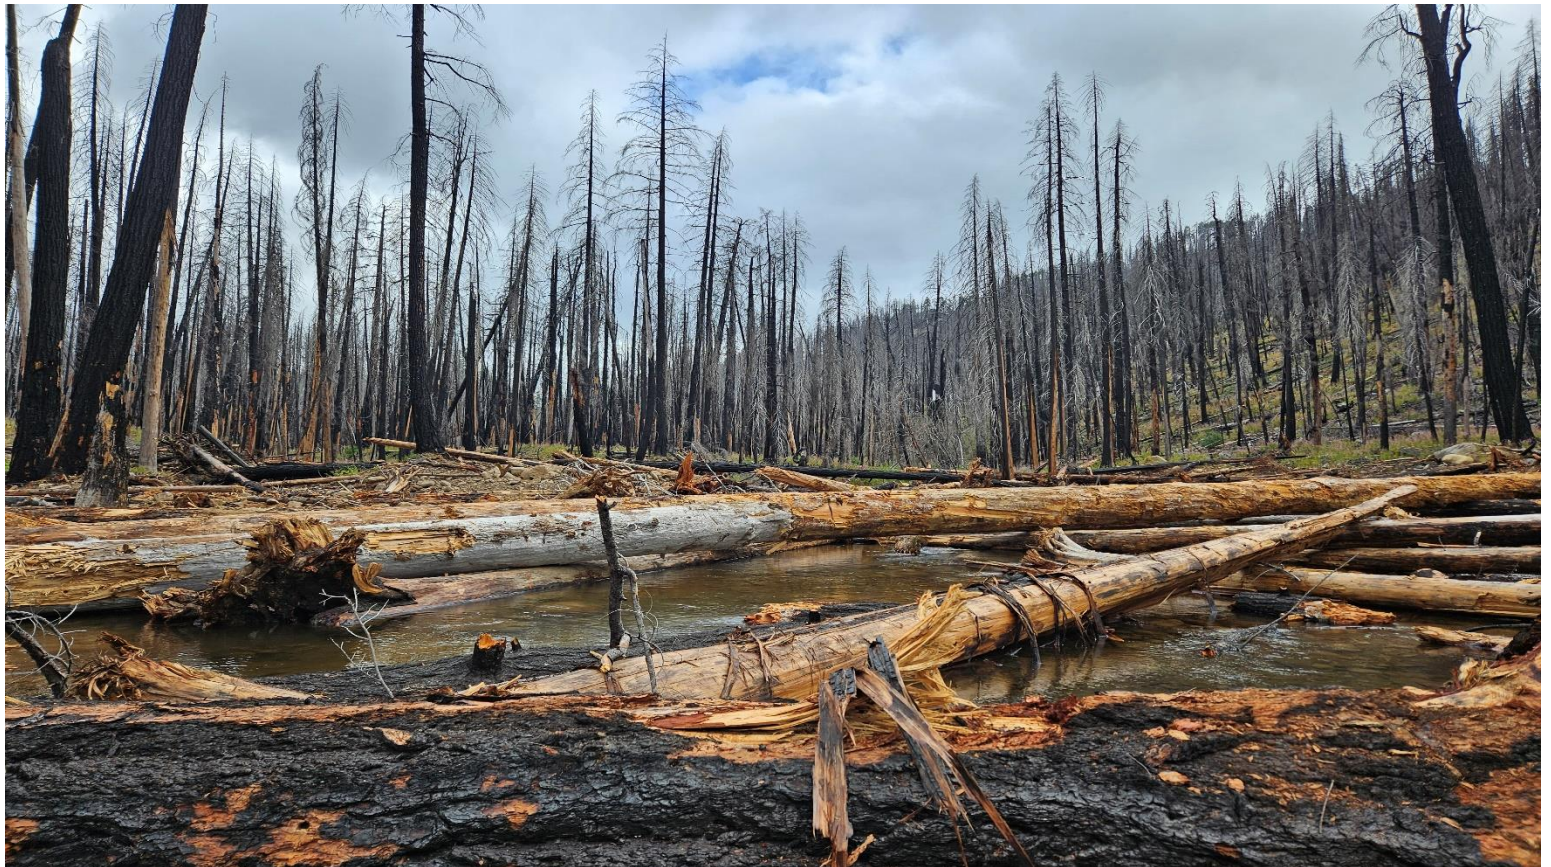
Cub Creek Phase II Post-Project Photo Point 3 (looking upstream): alluvium (fill) and large wood was added to the channel during Phase II.

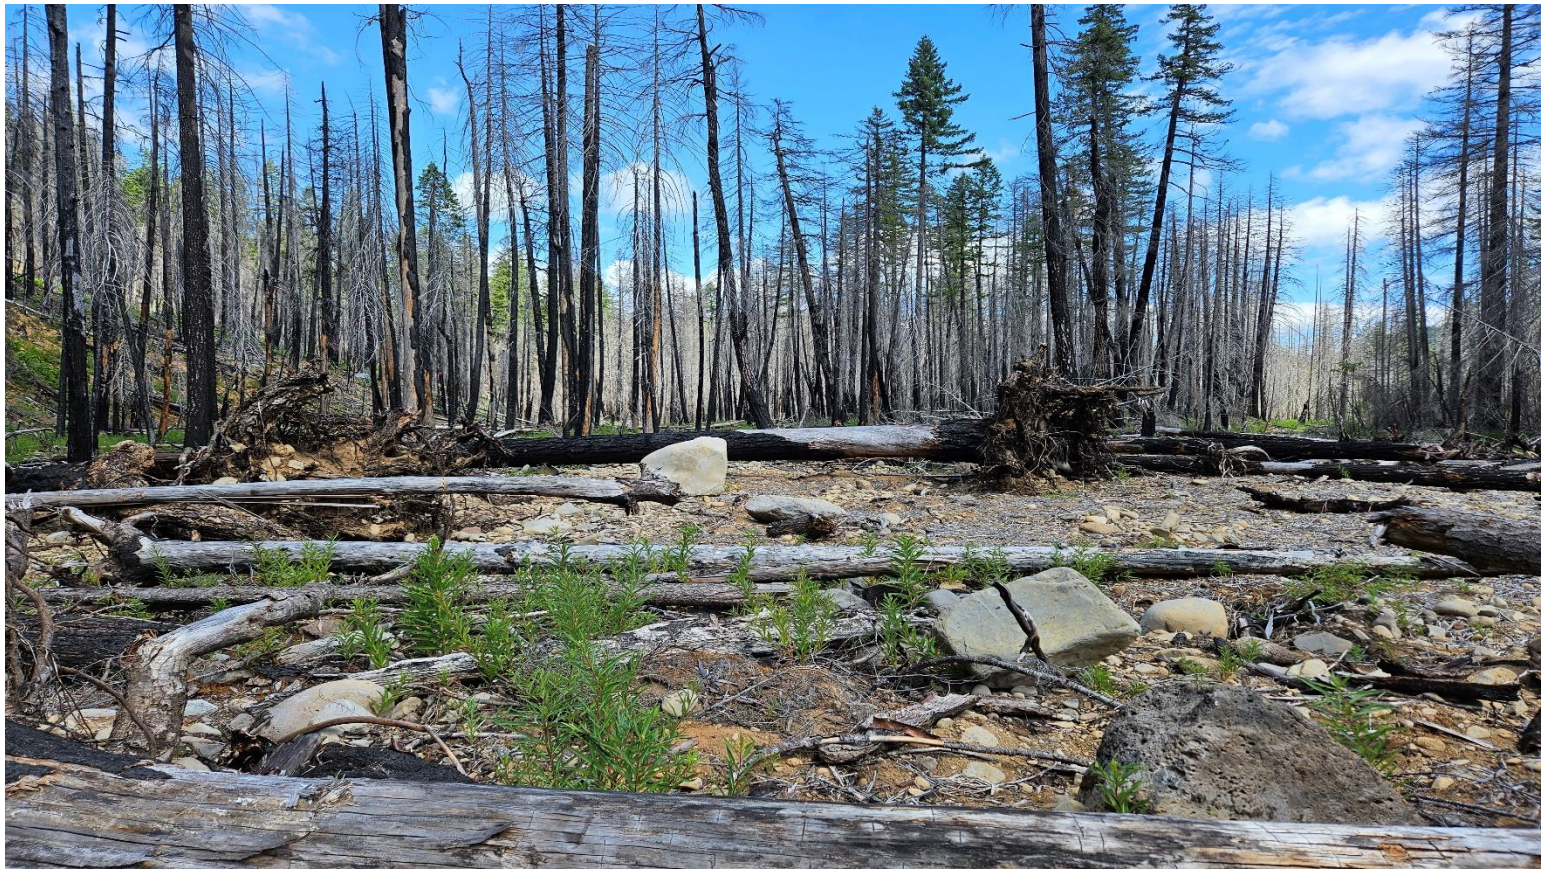
Cub Creek Phase II Pre-Project Photo Point 4 (looking north): alluvium was removed (cut) from this area and large wood was placed during Phase I. This same photopoint was utilized for pre- and post-monitoring of Phase I of the Cub Creek Restoration project.

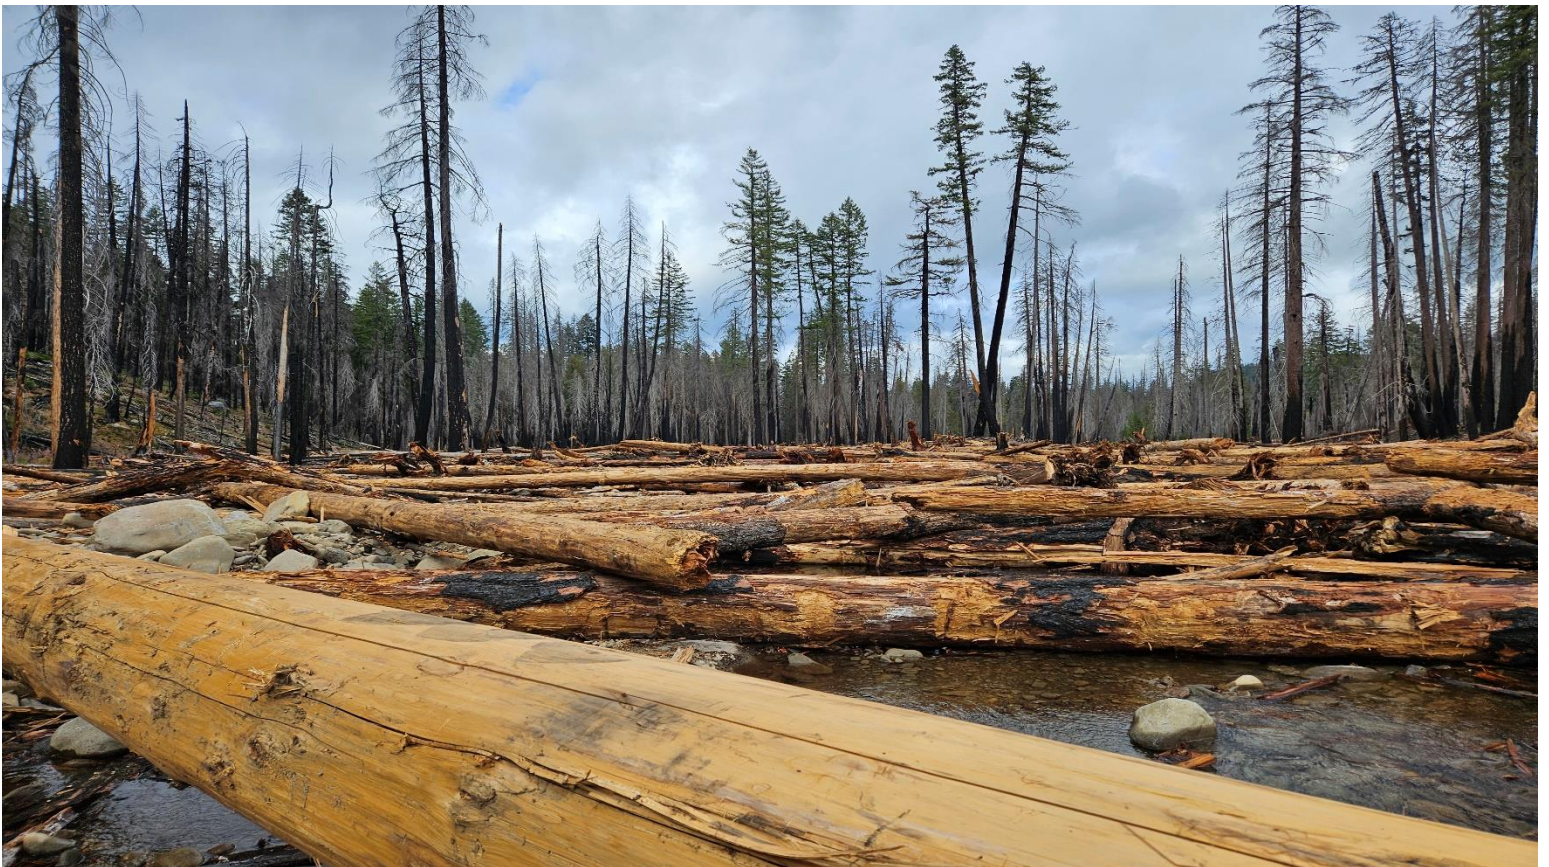
Cub Creek Phase II Post-Project Photo Point 4 (looking north): alluvium was removed (cut) from this area, redistributed to the main channel to match elevations, and large wood was added during Phase II.

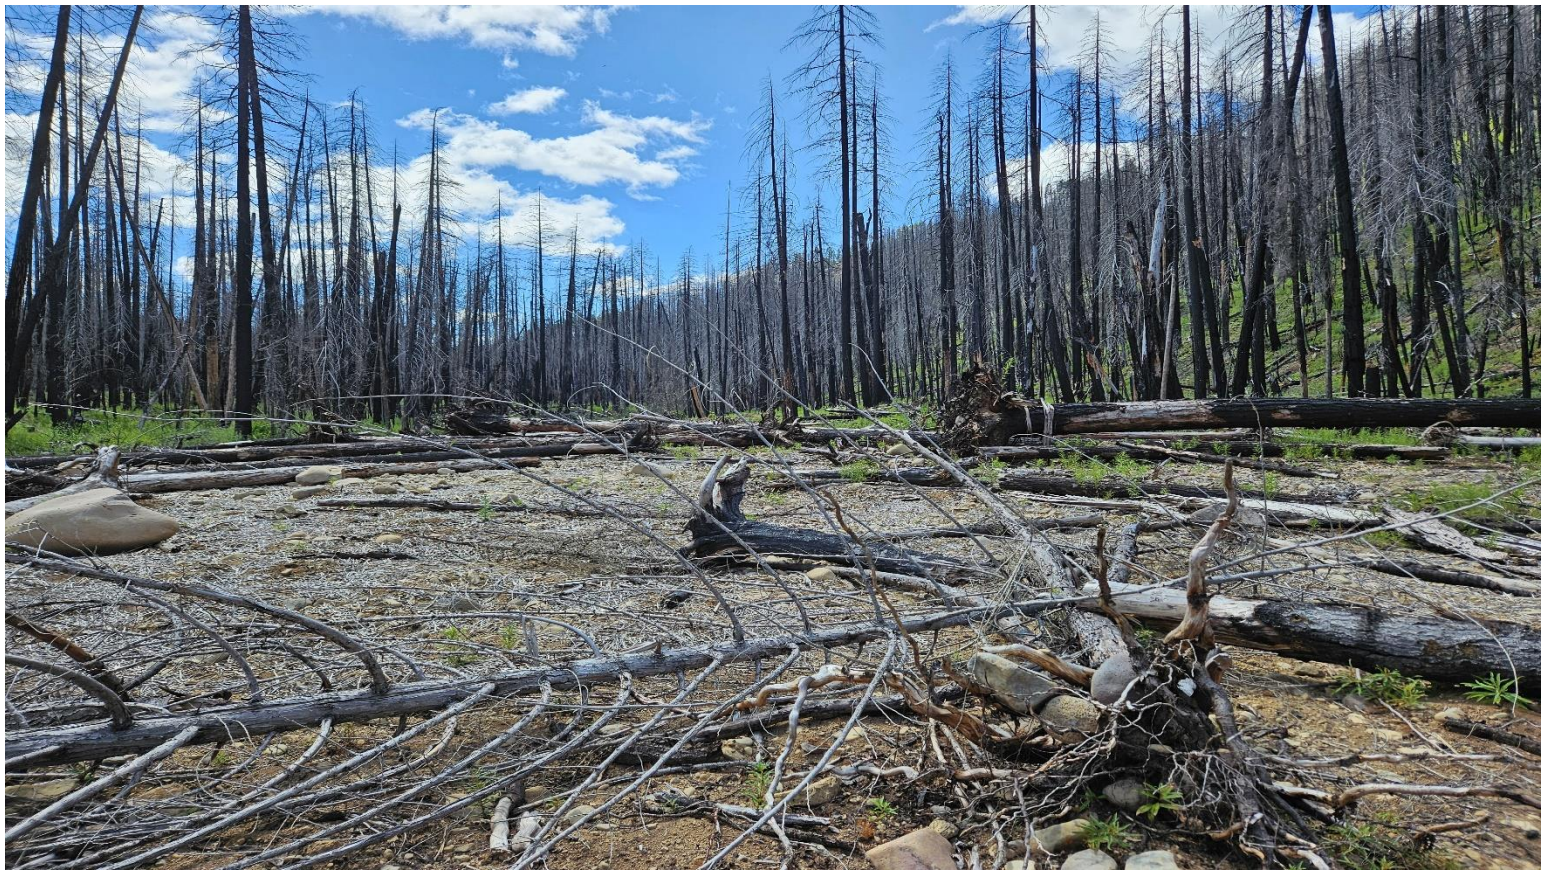
Cub Creek Phase II Pre-Project Photo Point 4 (looking south): alluvium was removed (cut) from this area and large wood was placed during Phase I. This same photopoint was utilized for pre- and post-monitoring of Phase I of the Cub Creek Restoration project.

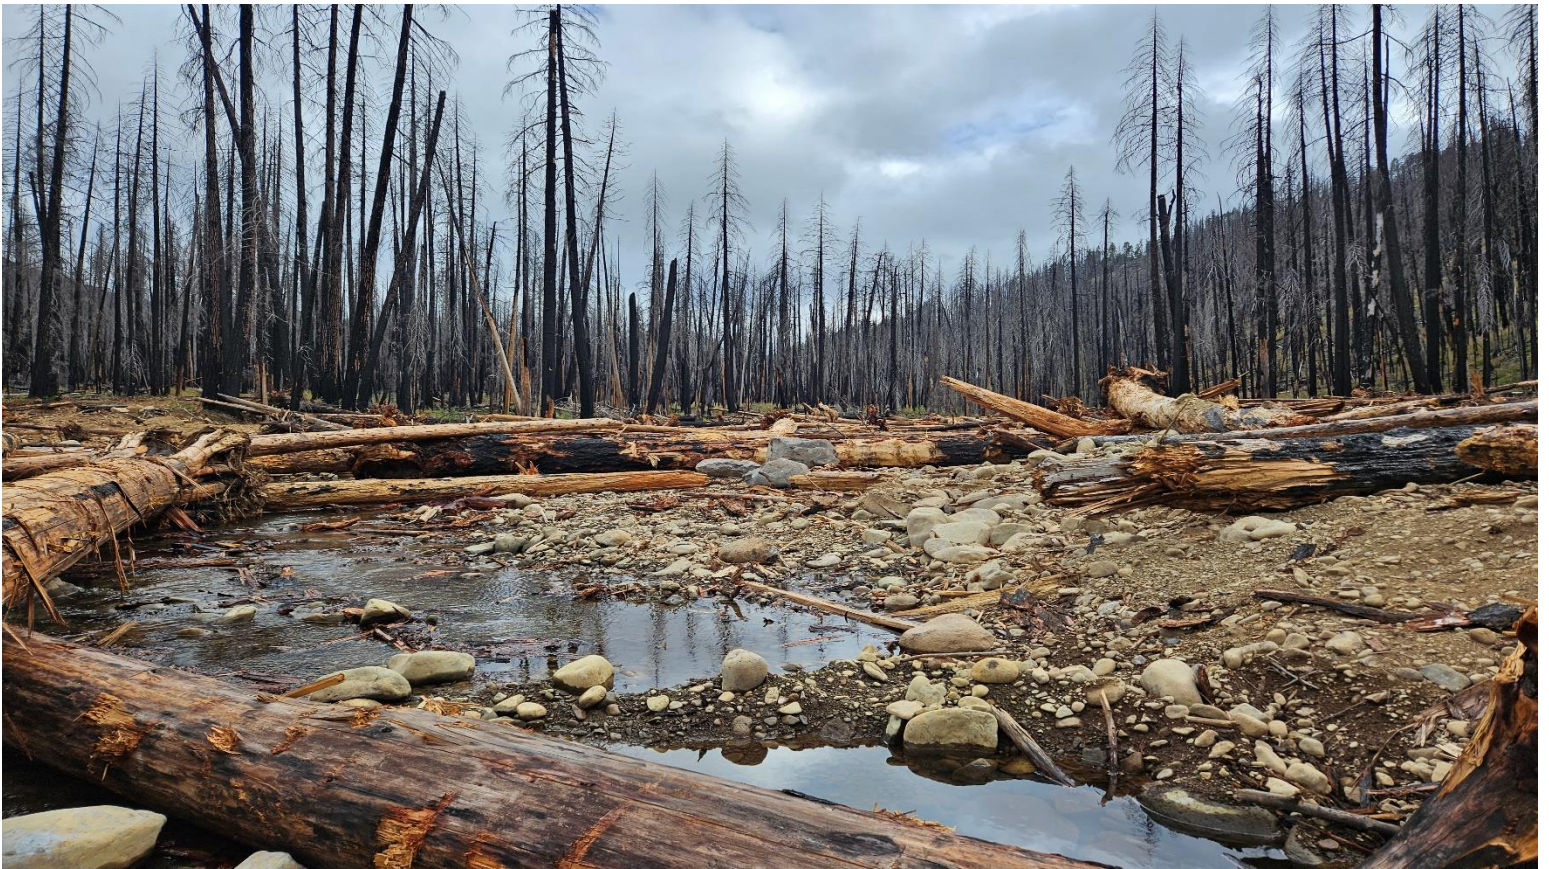
Cub Creek Phase II Post-Project Photo Point 4 (looking south): alluvium was removed (cut) from this area, redistributed to the main channel to match elevations, and large wood was added during Phase II.
