## **Cub Creek Restoration Phase II**

### **Photomonitoring Points (Post-Project)**

Report prepared by USDA Forest Service and Clackamas River Trout Unlimited for OWEB  
Grant Number: 224-3004-23287  
October 2024

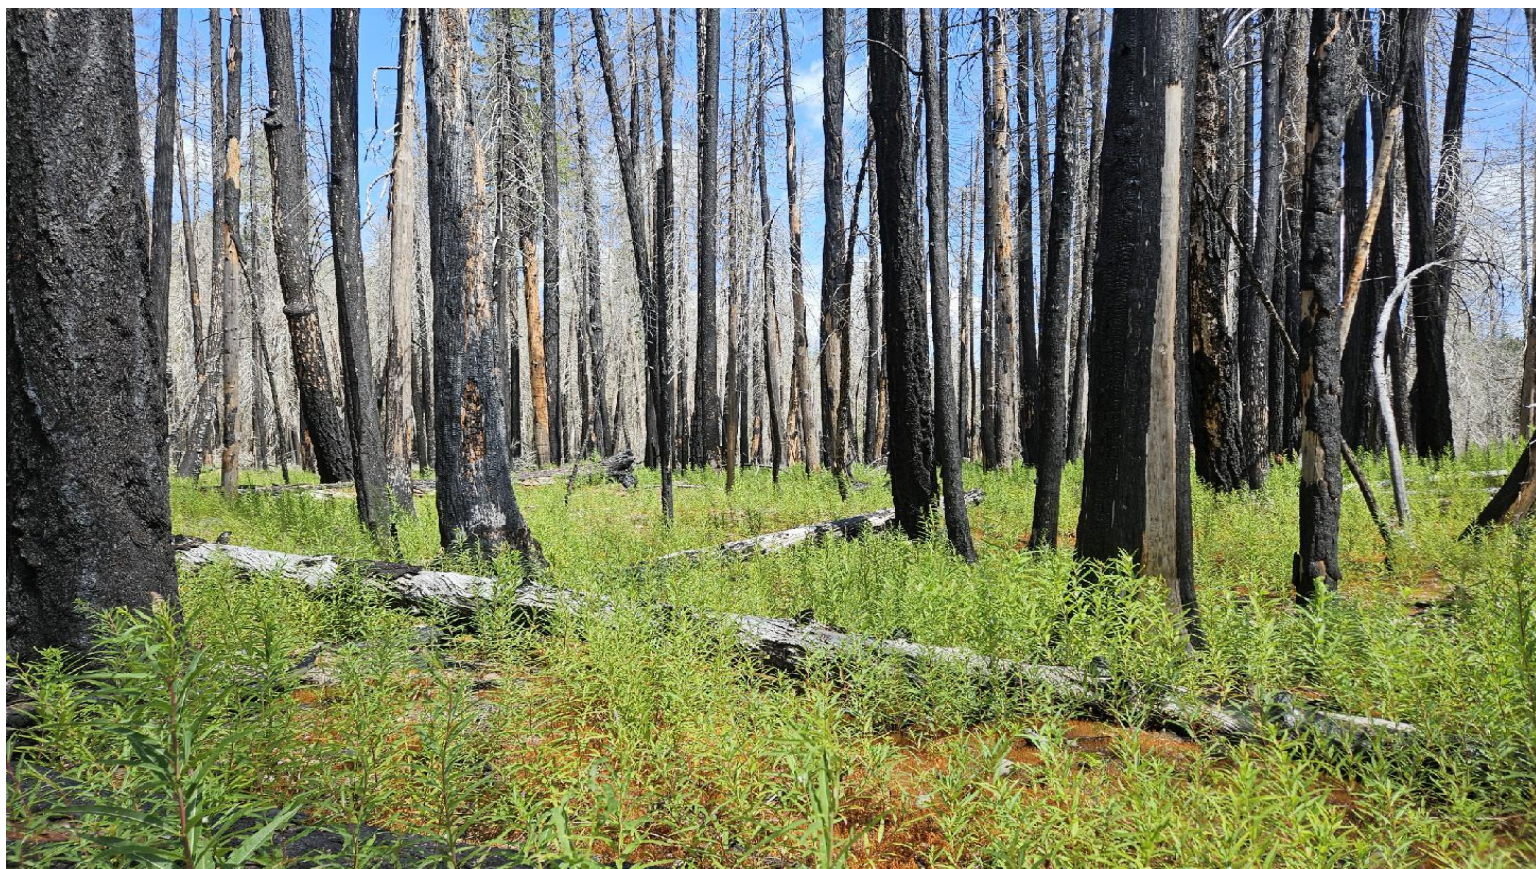
Cub Creek Phase II Pre-Project Photo Point 5 (looking north): alluvium (cut) and large wood will be redistributed from this site during Phase II.

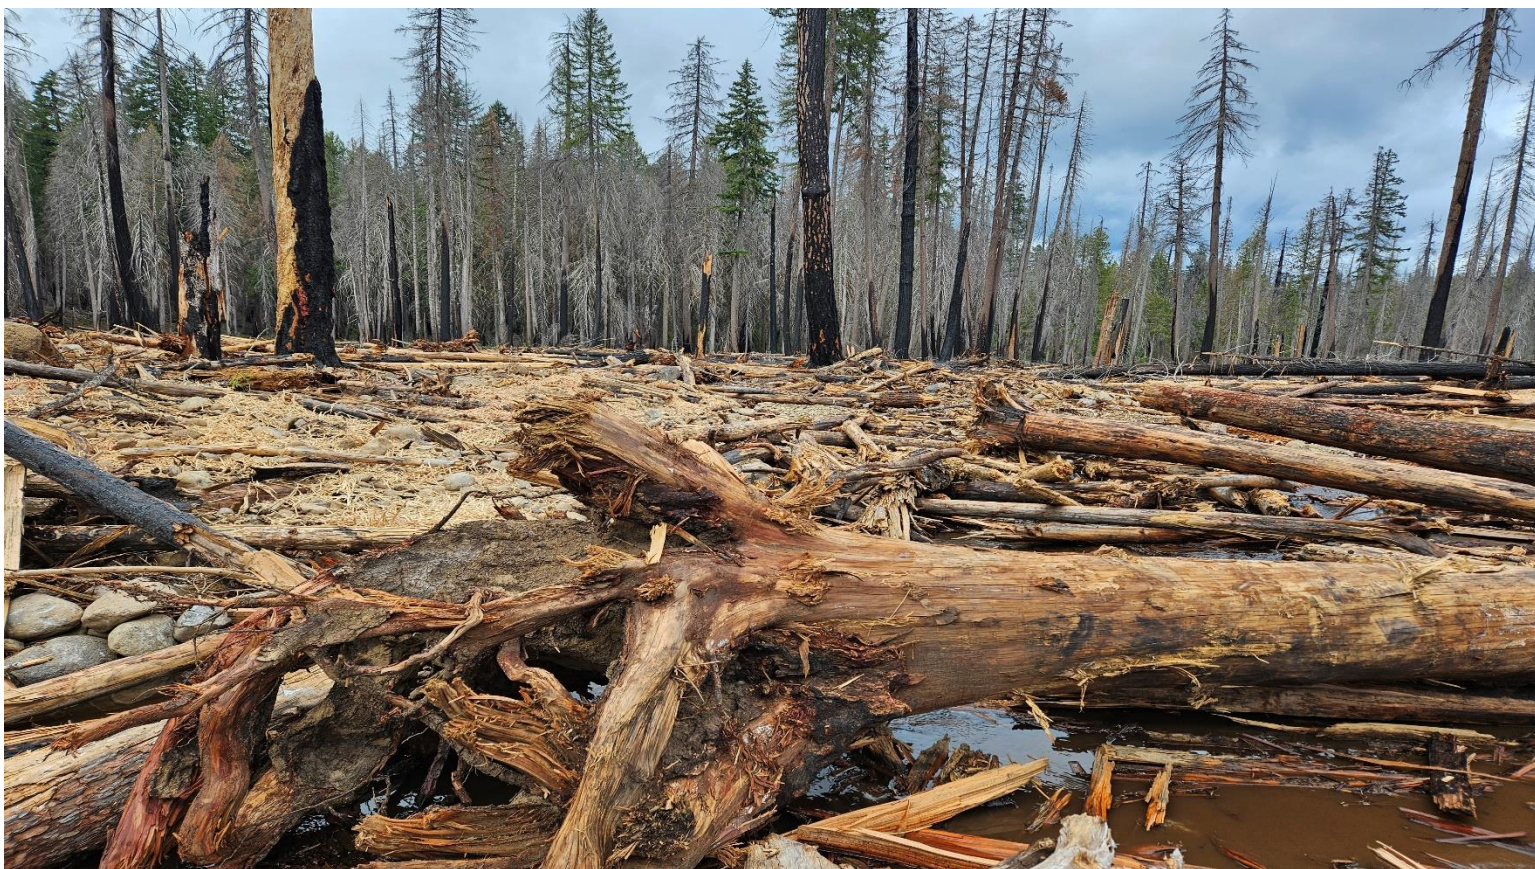
Cub Creek Phase II Post-Project Photo Point 5 (looking north): alluvium was removed (cut) from this area, redistributed to the main channel to match elevations, and large wood was added during Phase II.

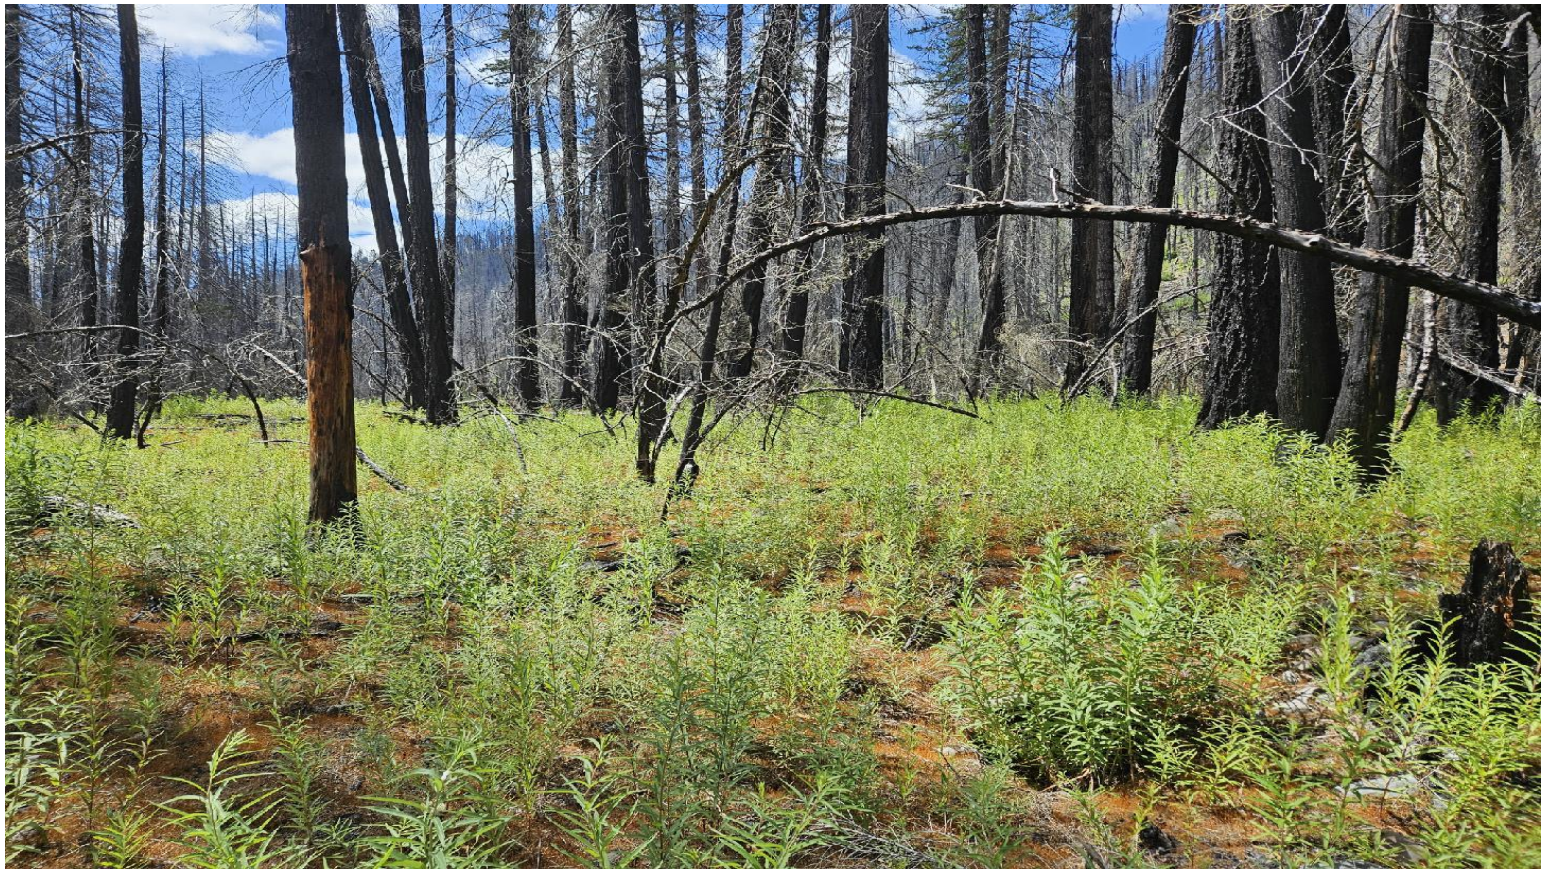
Cub Creek Phase II Pre-Project Photo Point 5 (looking south): alluvium (cut) and large wood will be redistributed from this site during Phase II.

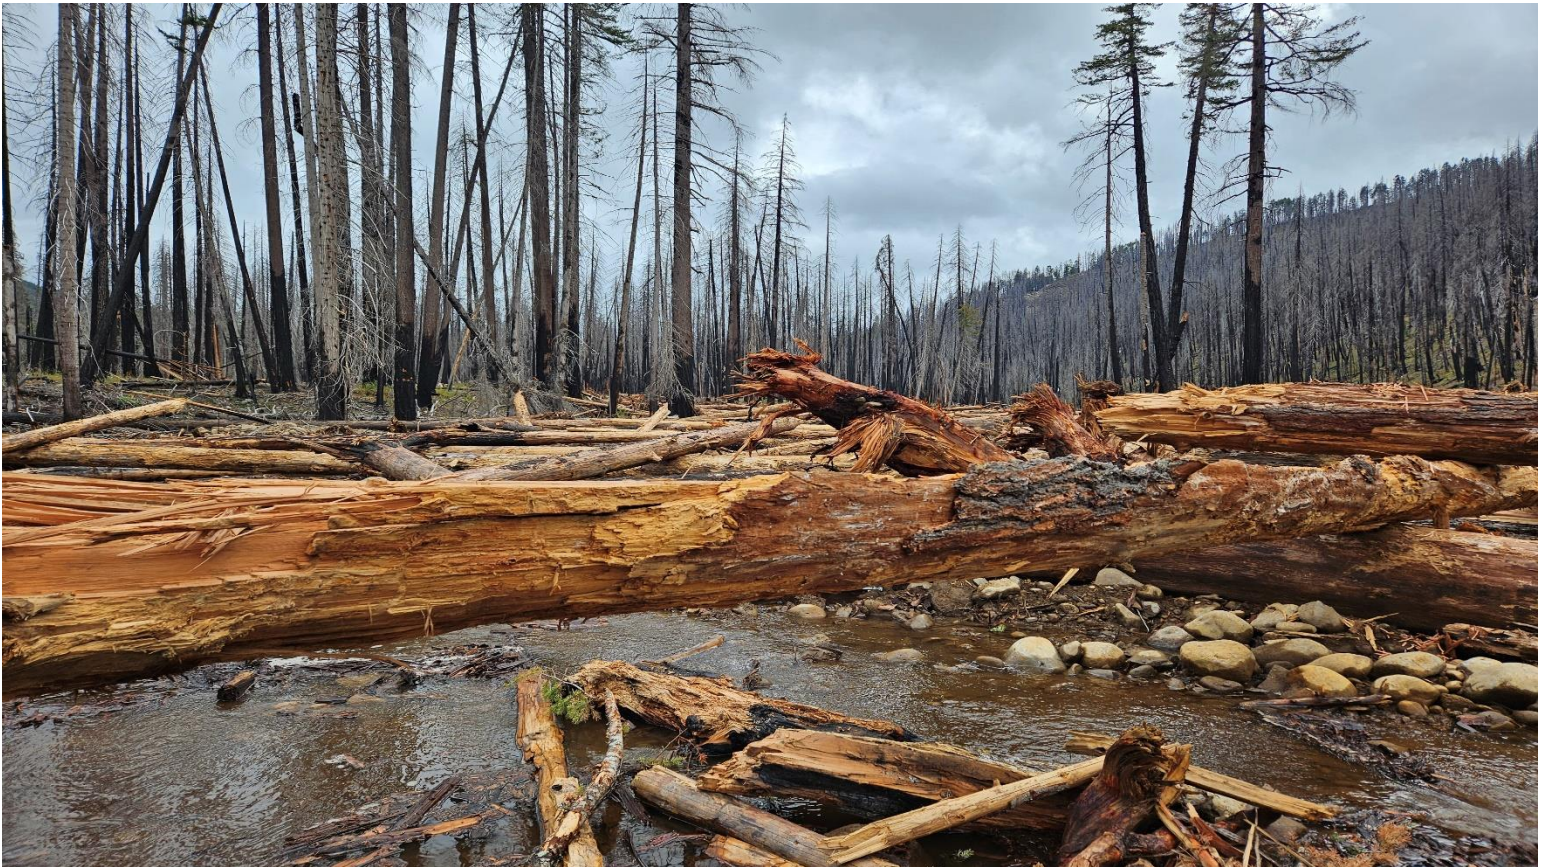
Cub Creek Phase II Post-Project Photo Point 5 (looking south): alluvium was removed (cut) from this area, redistributed to the main channel to match elevations, and large wood was added during Phase II.

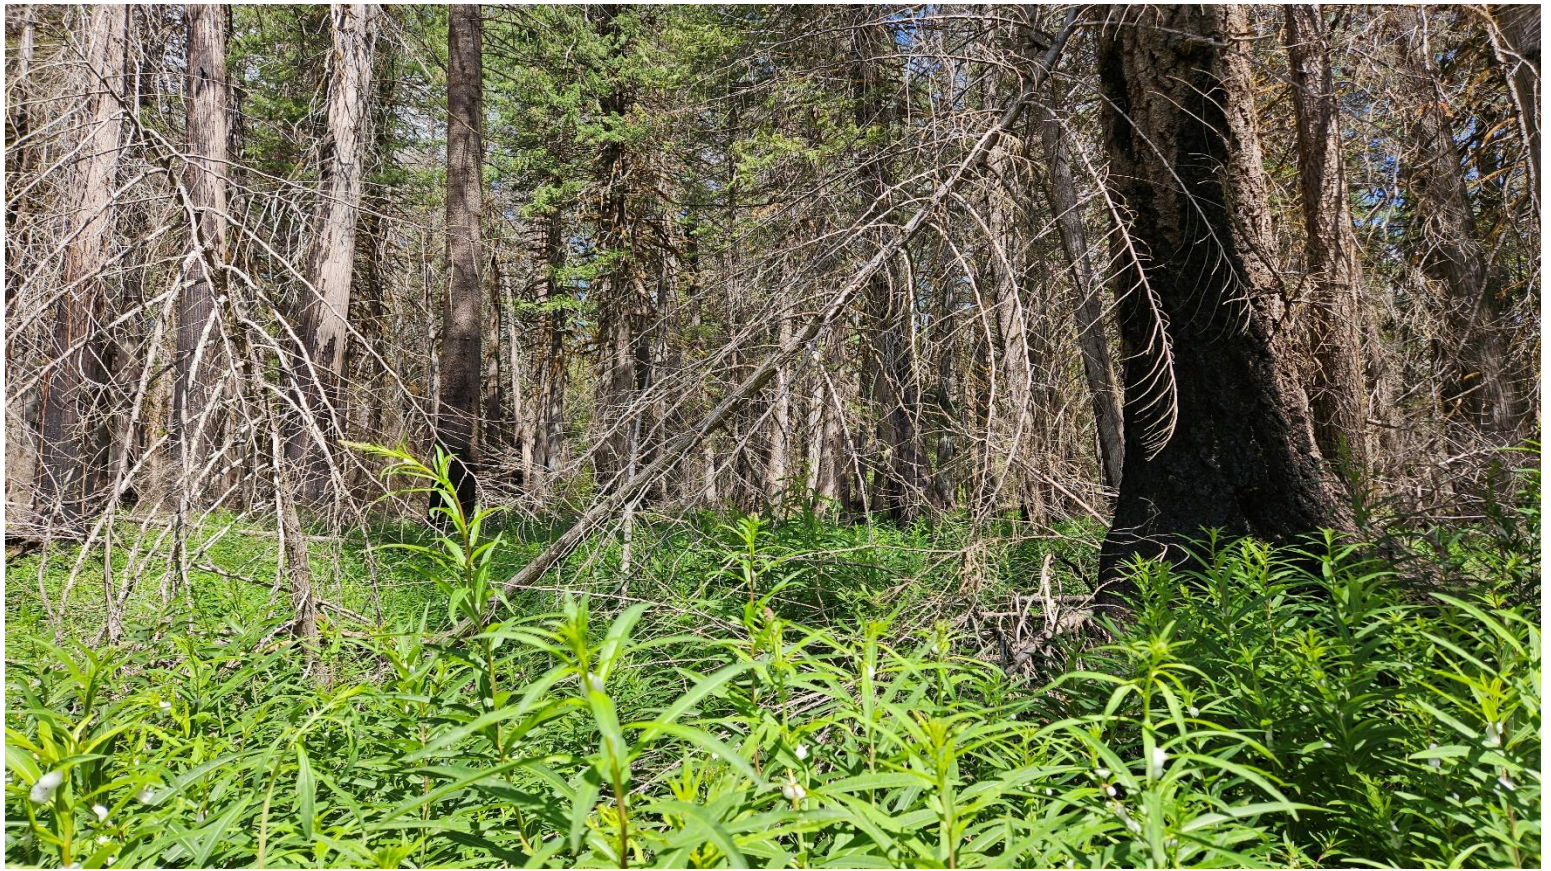
Cub Creek Phase II Pre-Project Photo Point 6 (looking north): alluvium was planned to be removed (cut) from this area, but no work was completed at this site during Phase I. This same photopoint was utilized for pre- and post-monitoring of Phase I of the Cub Creek Restoration project.

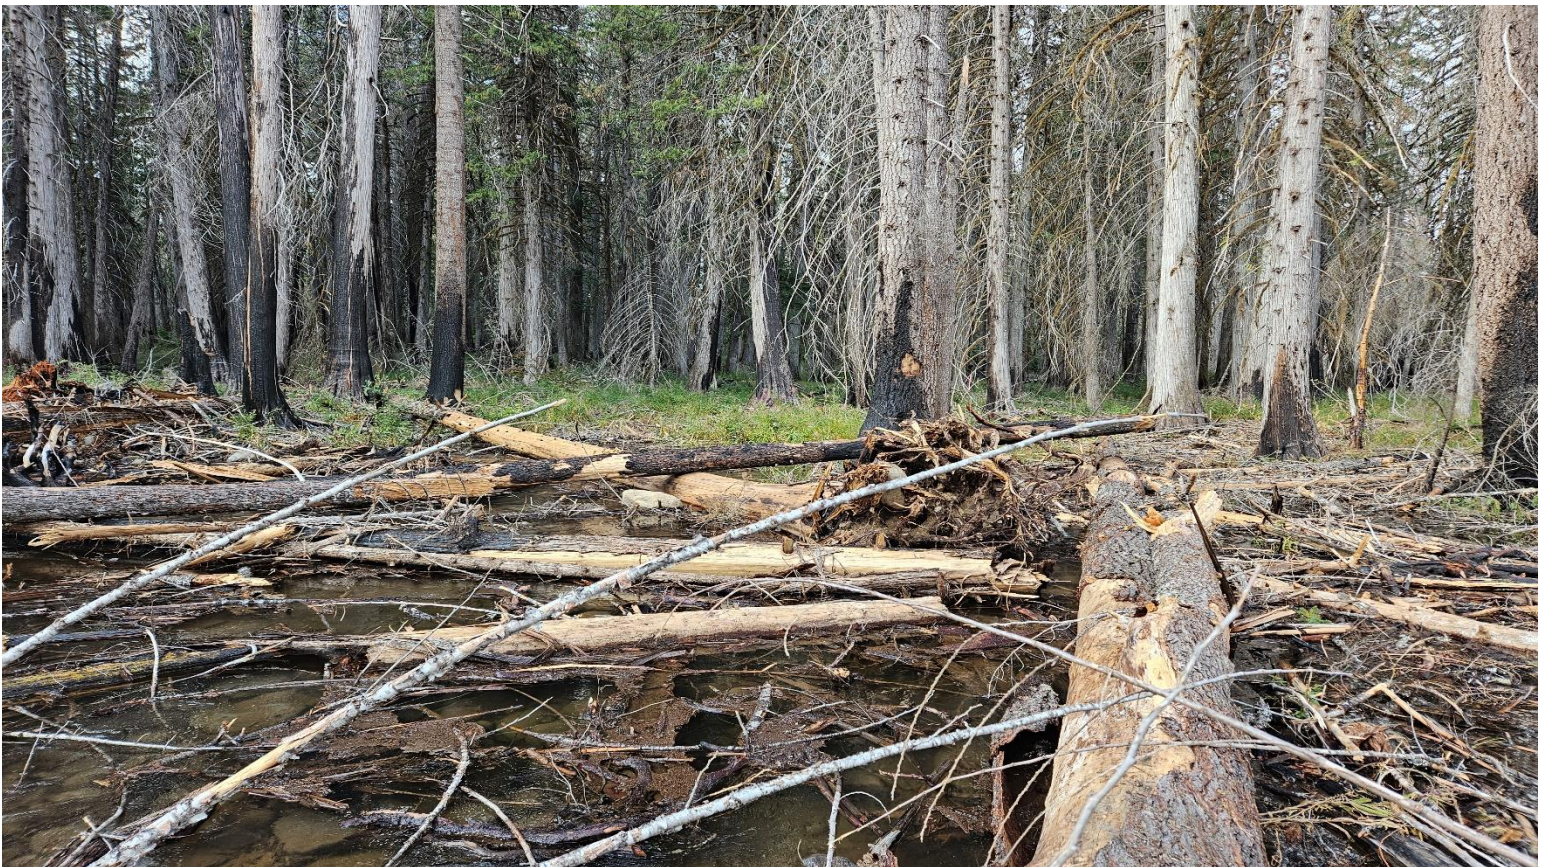
Cub Creek Phase II Post-Project Photo Point 6 (looking north): alluvium was removed (cut) from this area, redistributed to the main channel to match elevations, and large wood was added during Phase II.

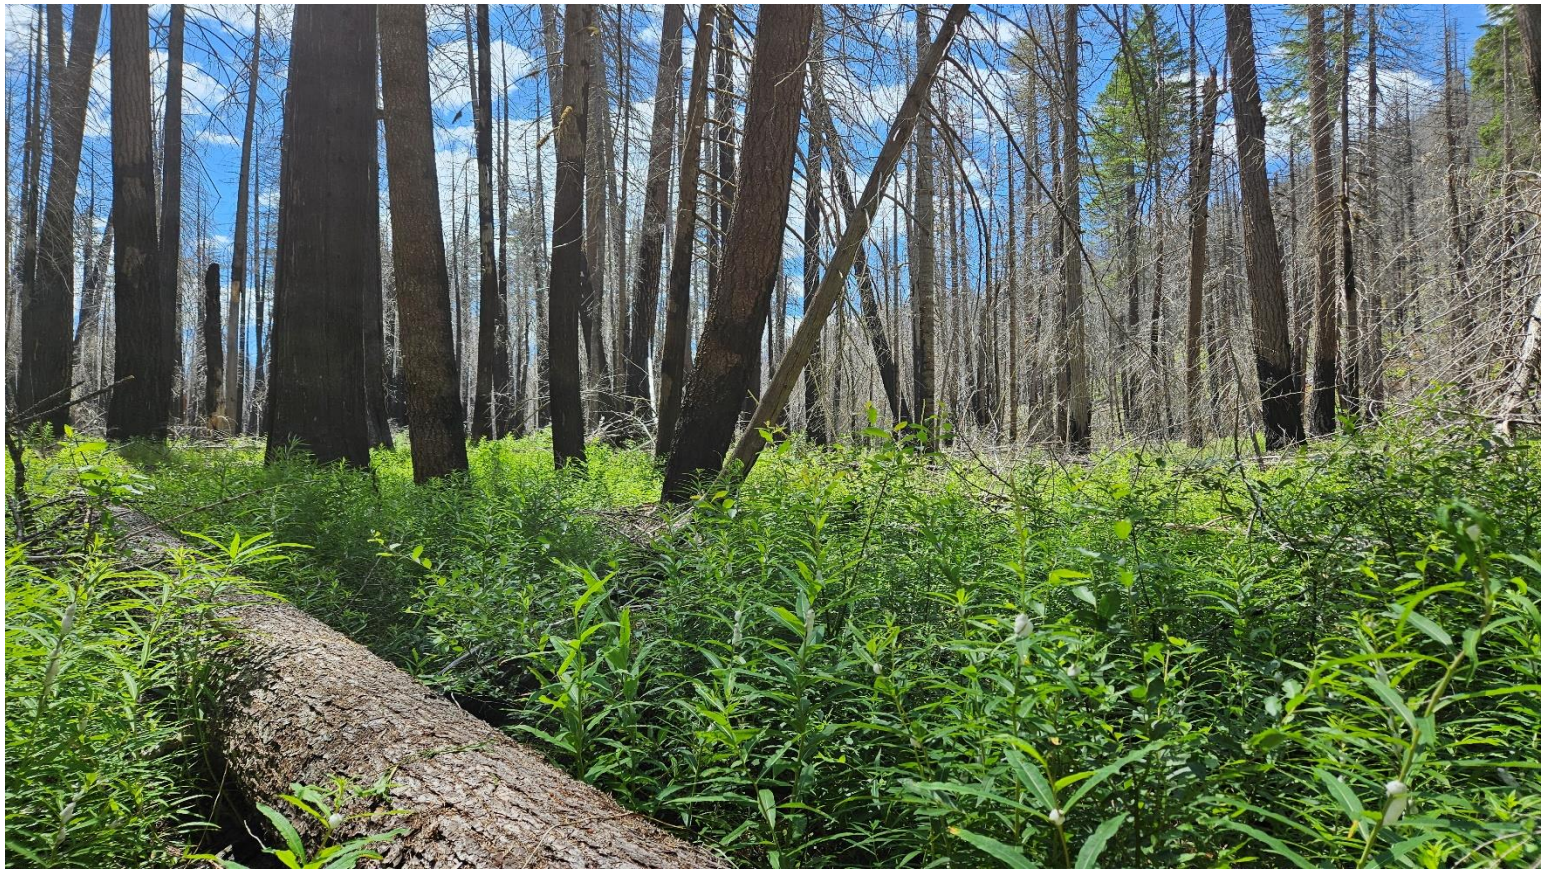
Cub Creek Phase II Pre-Project Photo Point 6 (looking south): alluvium was planned to be removed (cut) from this area, but no work was completed at this site during Phase I. This same photopoint was utilized for pre- and post-monitoring of Phase I of the Cub Creek Restoration project.

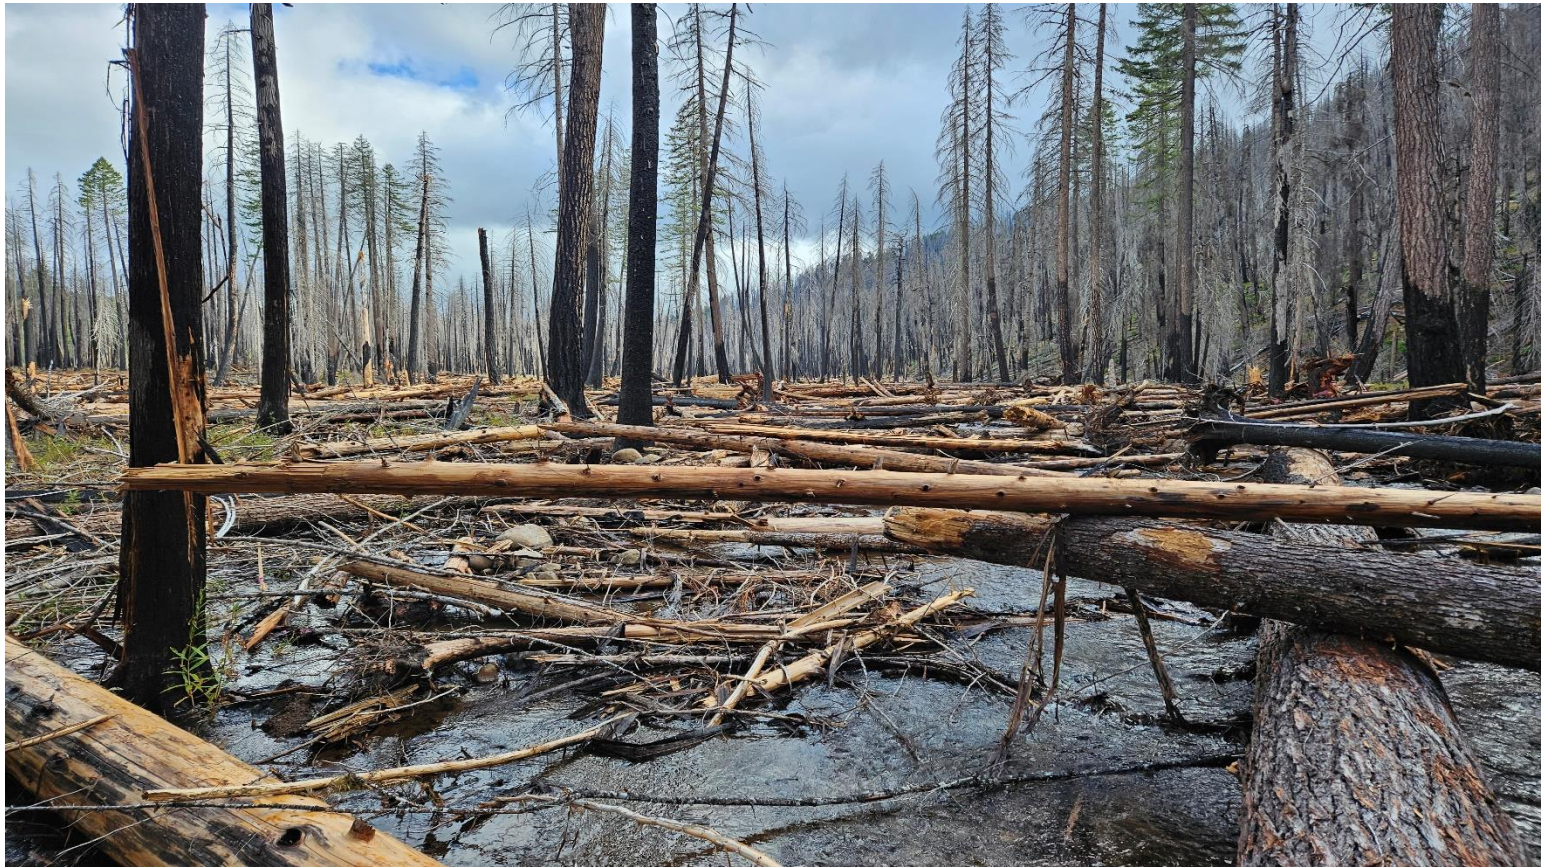
Cub Creek Phase II Post-Project Photo Point 6 (looking south): alluvium was removed (cut) from this area, redistributed to the main channel to match elevations, and large wood was added during Phase II.

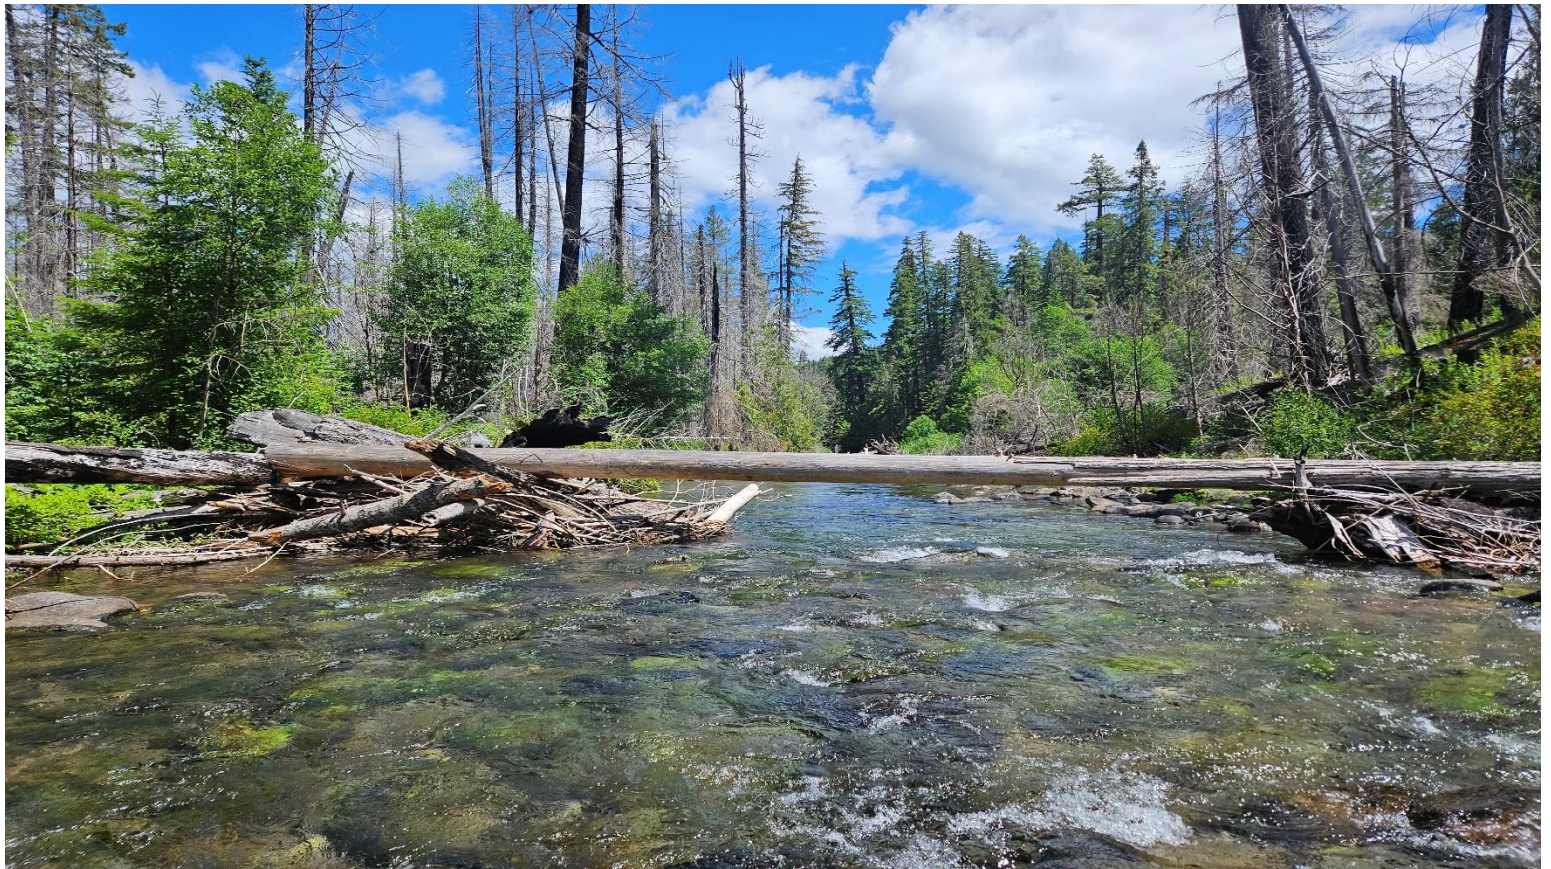
Cub Creek Phase II Pre-Project Photo Point 7 (looking downstream): large wood was not added to this channel during Phase I, but will be added during Phase II. This same photopoint was utilized for pre- and post-monitoring of Phase I of the Cub Creek Restoration project.

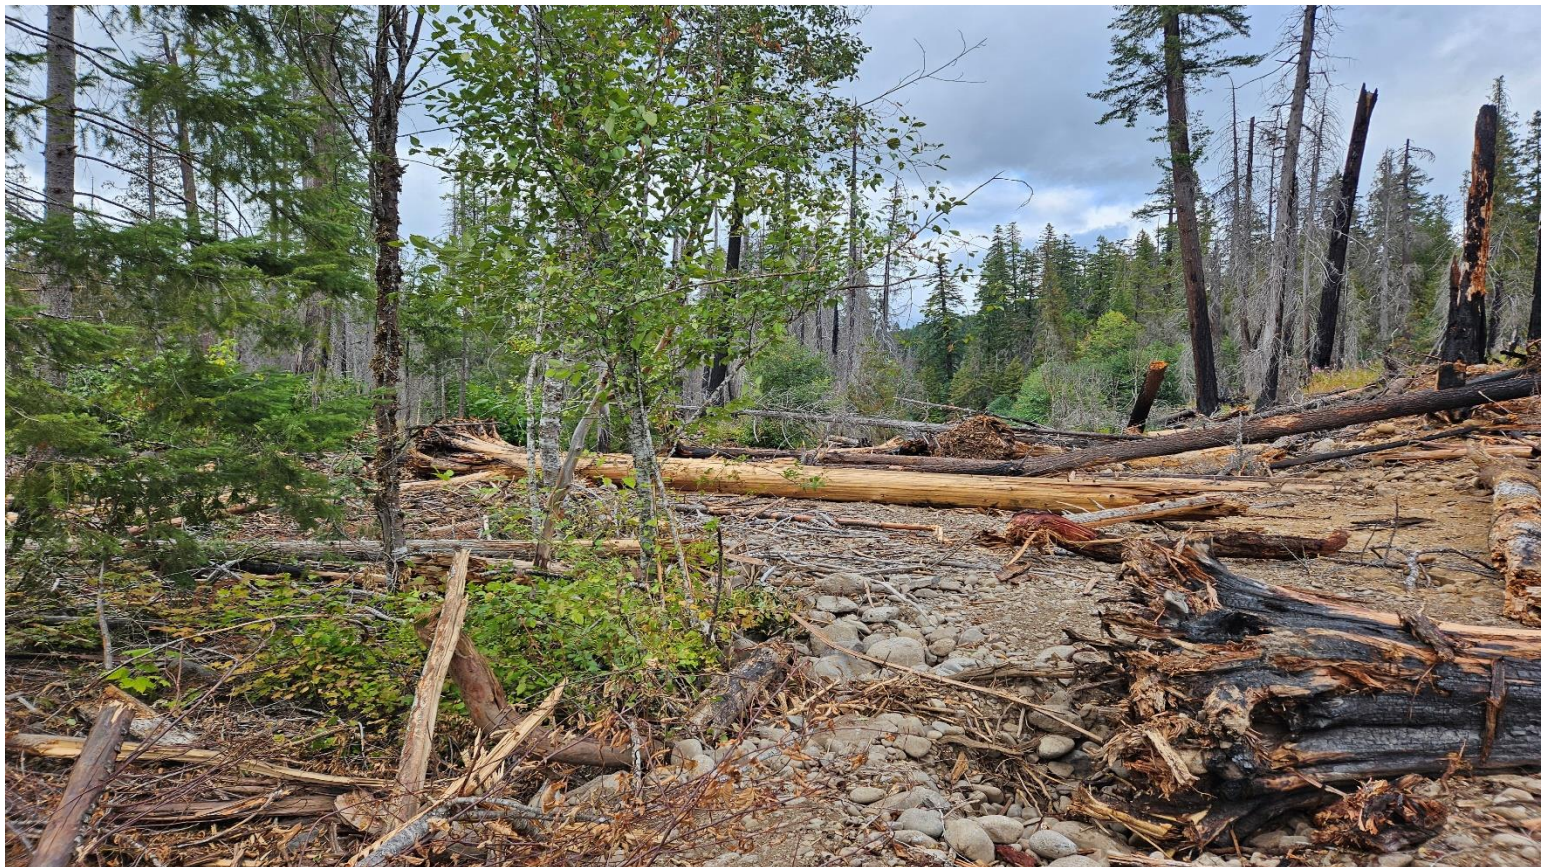
Cub Creek Phase II Post-Project Photo Point 7 (looking downstream): alluvium (fill) and large wood was added to the channel during Phase II. The floodplain was dry when photopoints were taken, but was wet on October 01, 2024.

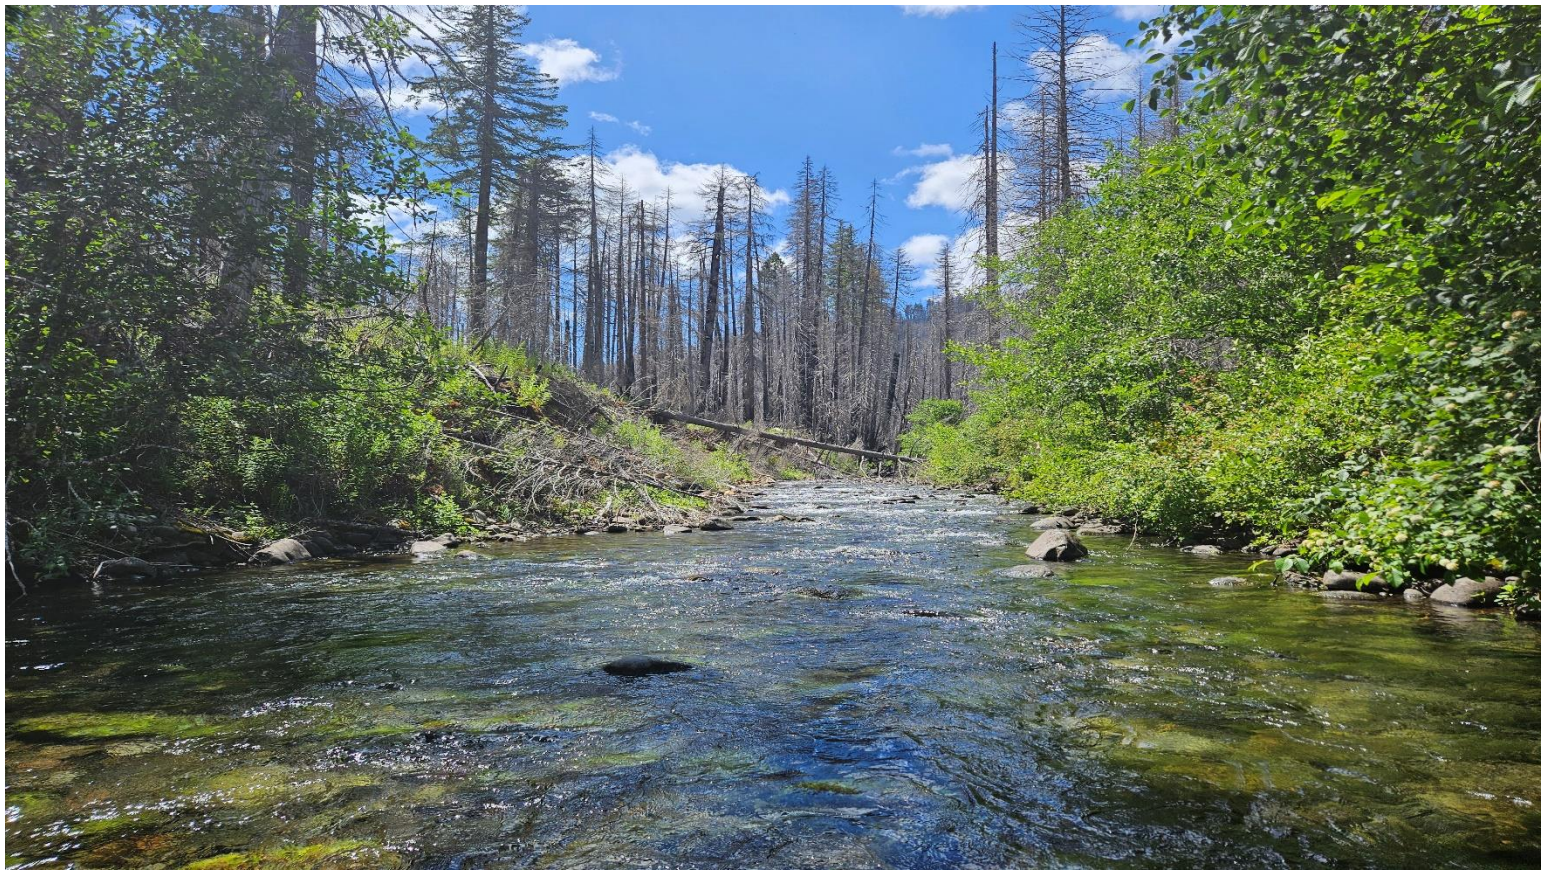
Cub Creek Phase II Pre-Project Photo Point 7 (looking upstream): large wood was not added to this channel during Phase I, but will be added during Phase II. This same photopoint was utilized for pre- and post-monitoring of Phase I of the Cub Creek Restoration project.

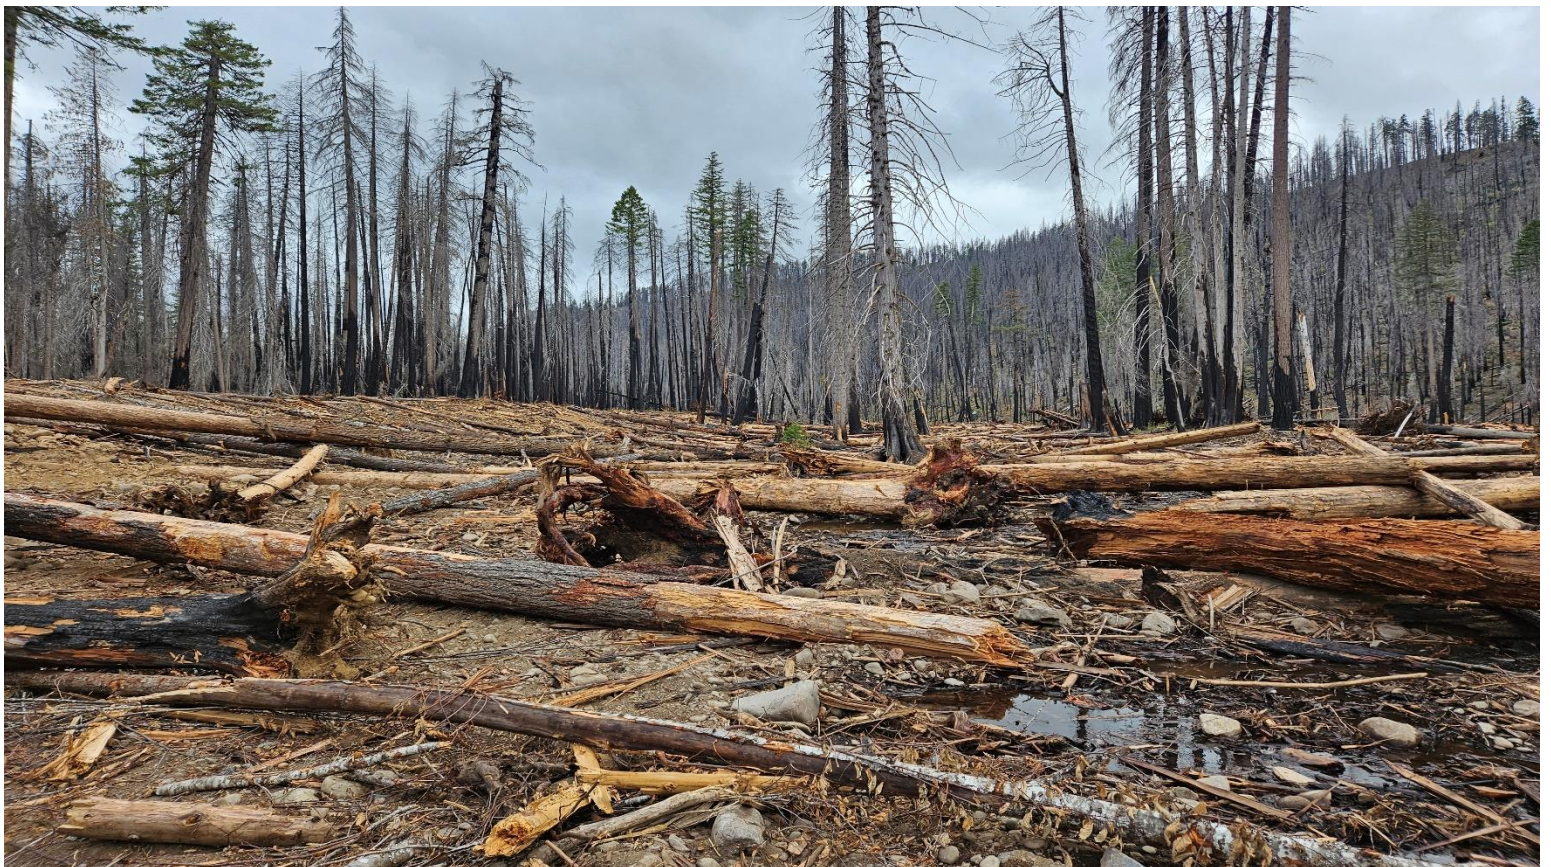
Cub Creek Phase II Post-Project Photo Point 7 (looking upstream): alluvium (fill) and large wood was added to the channel during Phase II.

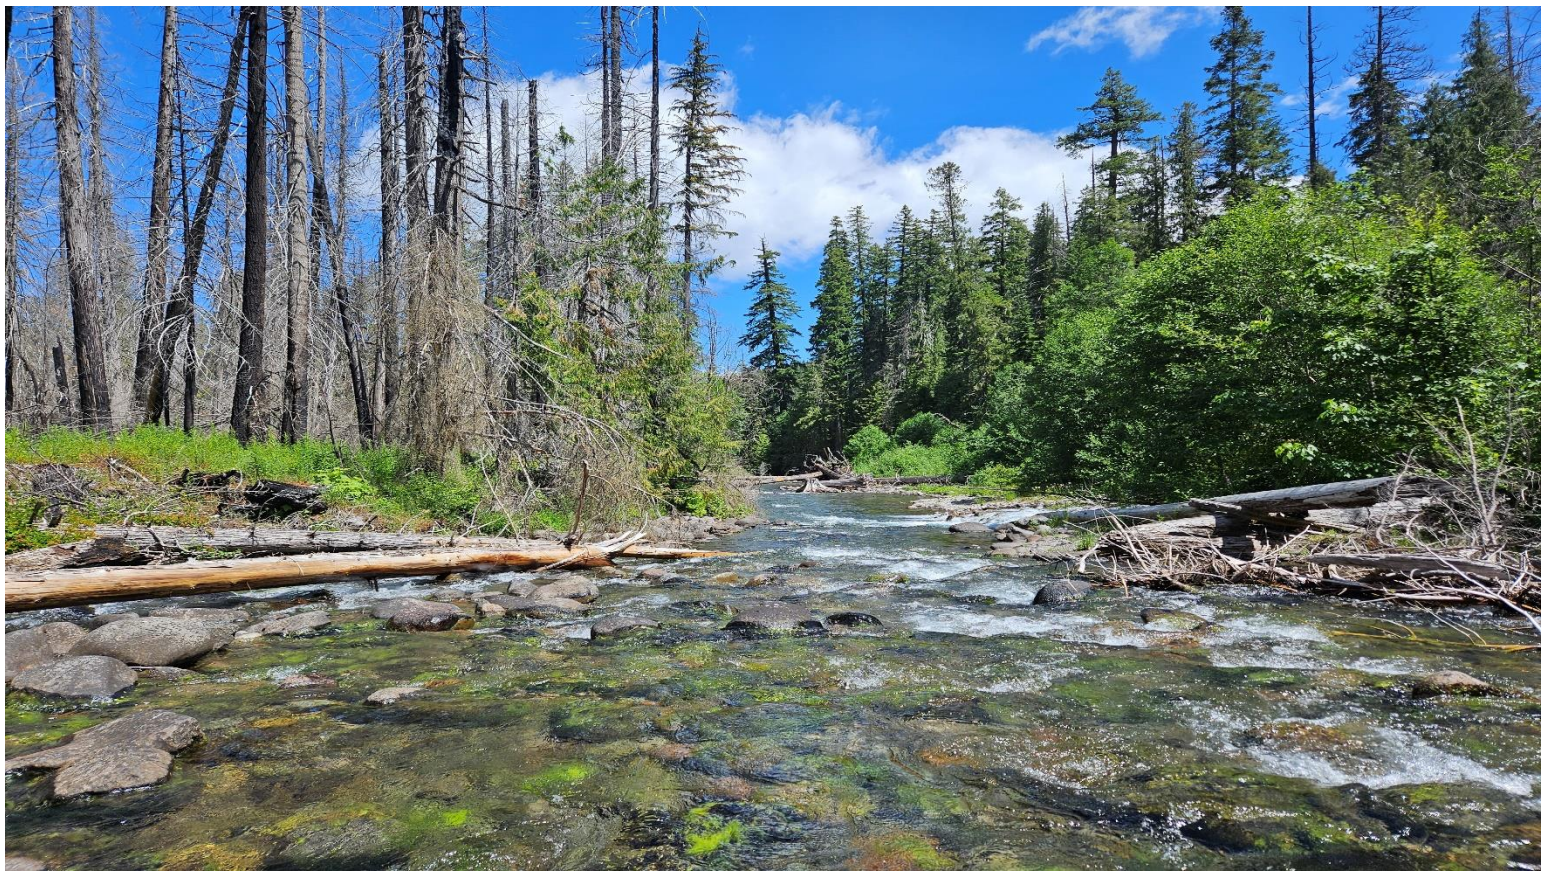
Cub Creek Phase II Pre-Project Photo Point 8 (looking downstream): large wood was not added to this channel during Phase I, but will be added during Phase II. This same photopoint was utilized for pre- and post-monitoring of Phase I of the Cub Creek Restoration project.

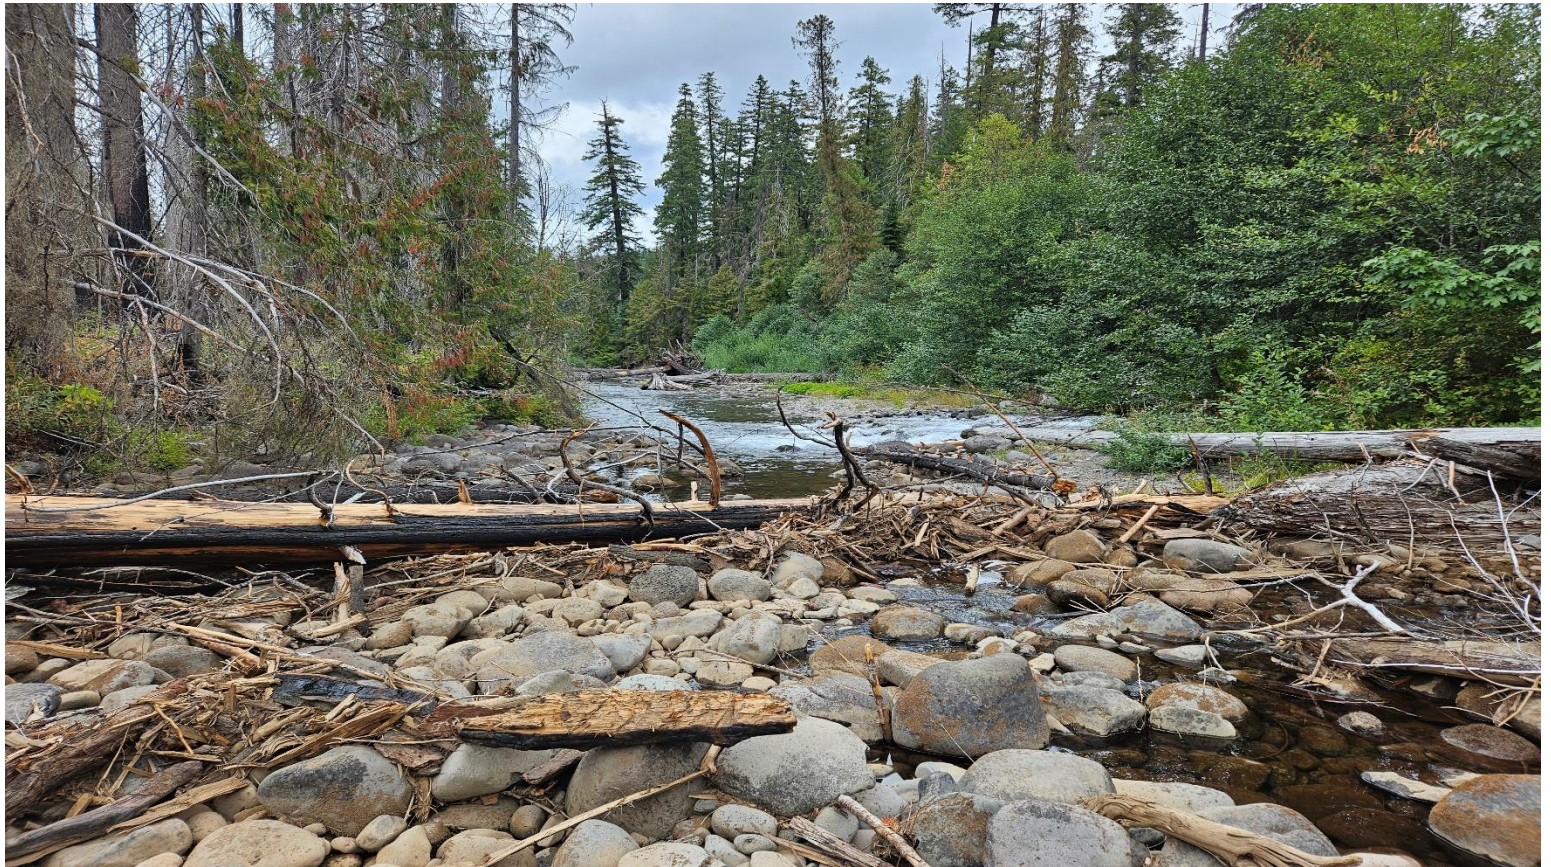
Cub Creek Phase II Post-Project Photo Point 8 (looking downstream): alluvium (fill) and large wood was added to the channel during Phase II.

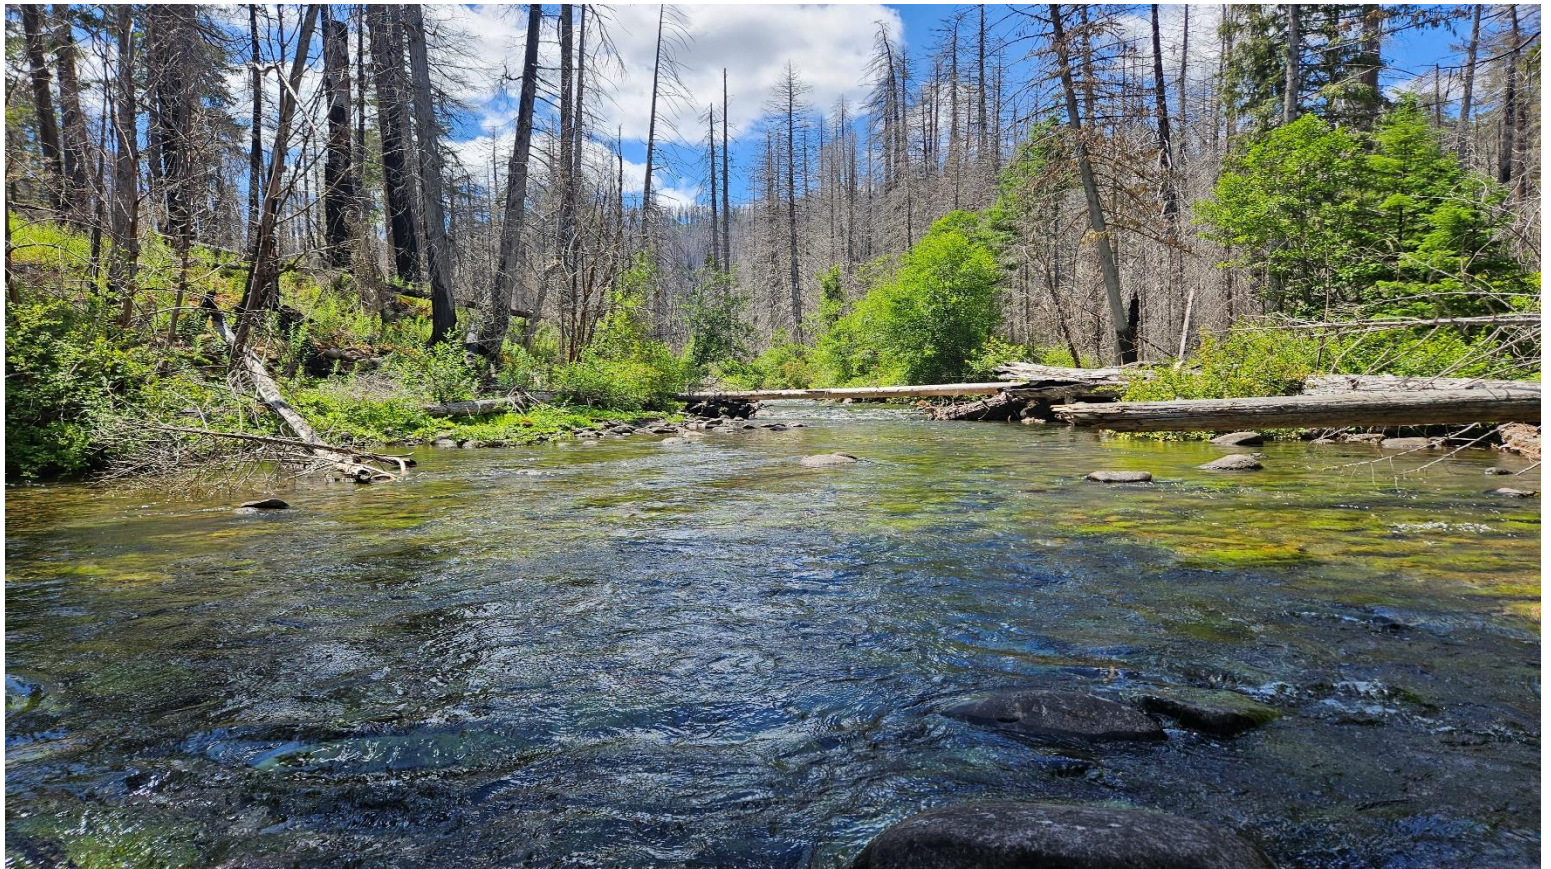
Cub Creek Phase II Pre-Project Photo Point 8 (looking upstream): large wood was not added to this channel during Phase I, but will be added during Phase II. This same photopoint was utilized for pre- and post-monitoring of Phase I of the Cub Creek Restoration project.

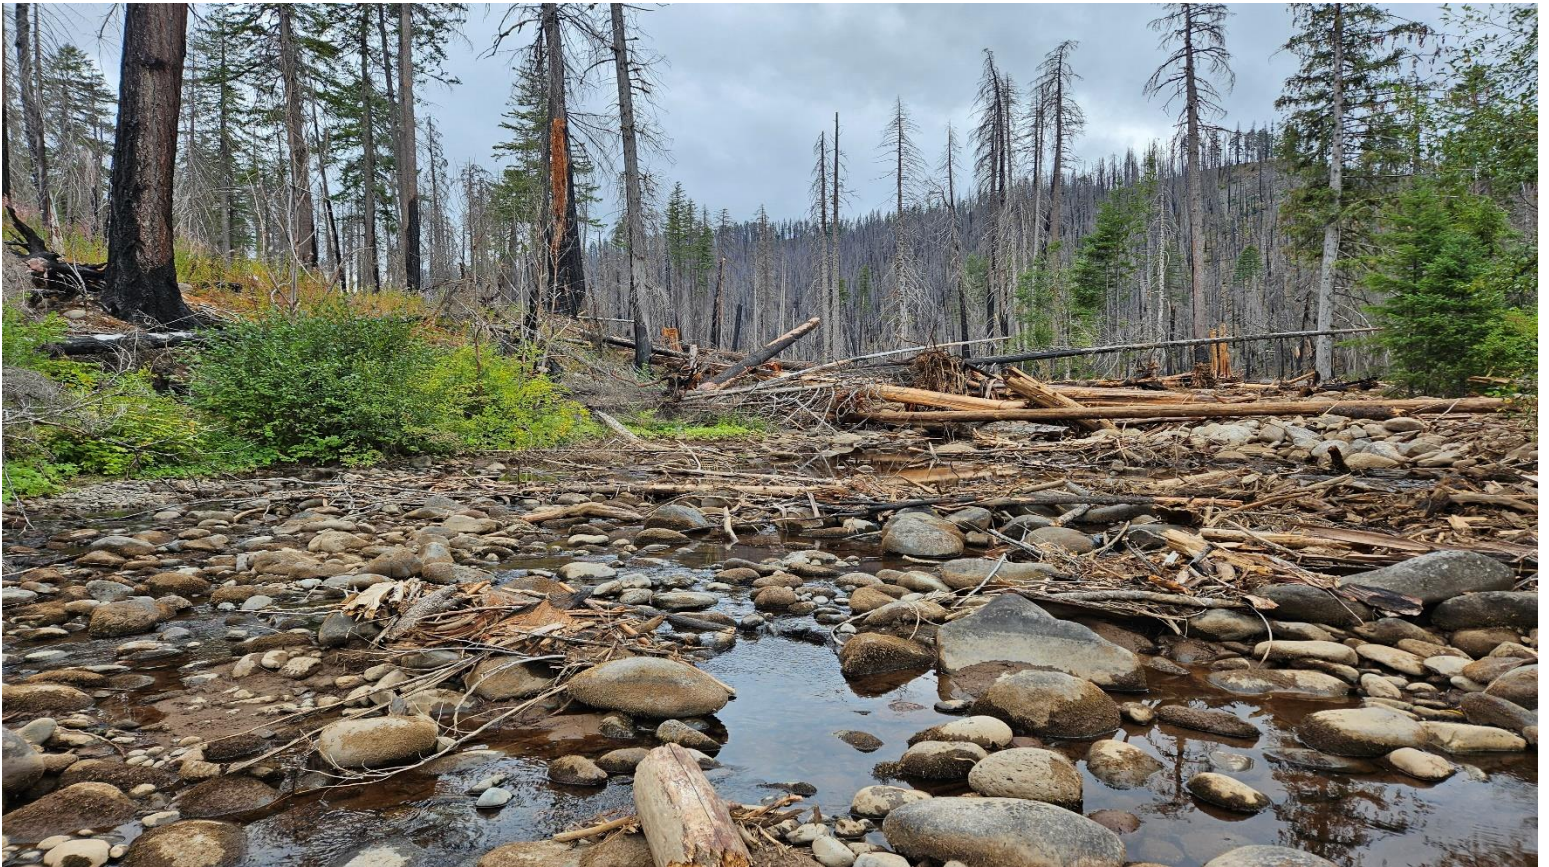
Cub Creek Phase II Post-Project Photo Point 8 (looking upstream): alluvium (fill) and large wood was added to the channel during Phase II.
