## Insufficient Grizzly Barrier Report 2020-2025

CYE BMU 12/Knotty Pine Project Area

Submitted July 2025

## **BMU 12-Knotty Pine Project Area**

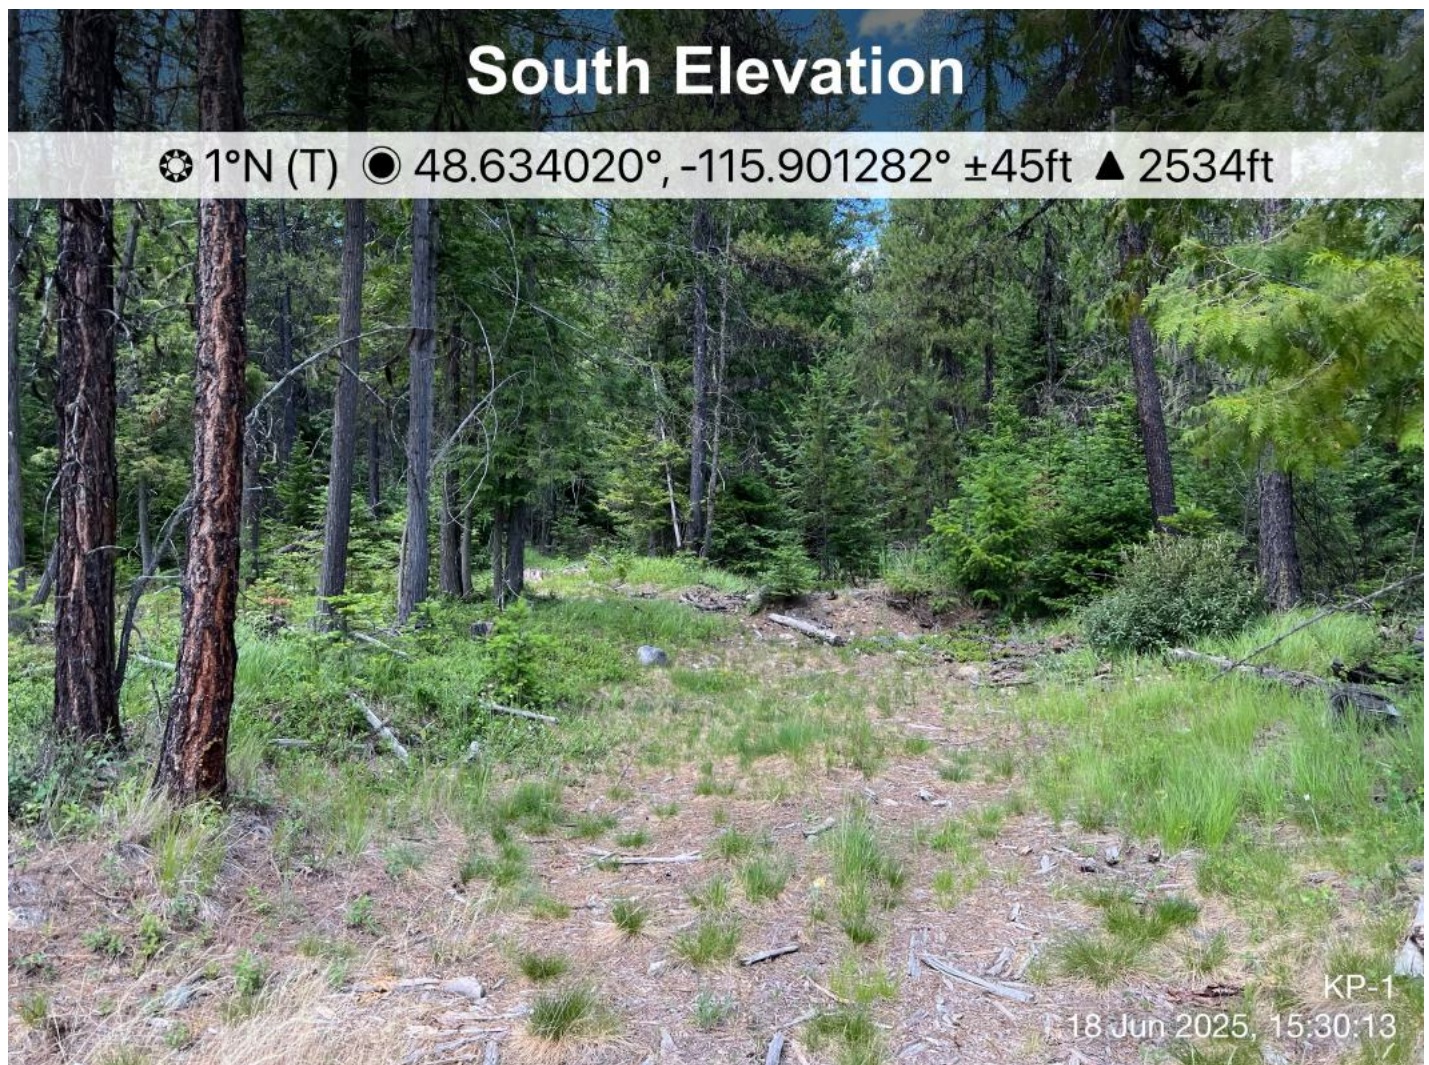
**KP 1- Coordinates: N 48.634020, W -115.901282**

The road is ineffectively blocked with a passable berm. The berm is overgrown with vegetation and degraded, allowing for easy bypass. Bypassing this berm provides access to the road that the berm is intended to block.

The ineffective barrier allows motor vehicle access to approximately\* 2.5 miles of "closed" road.

Remedy: rebuild berm with a tank trap or place large boulders blocking trespass.

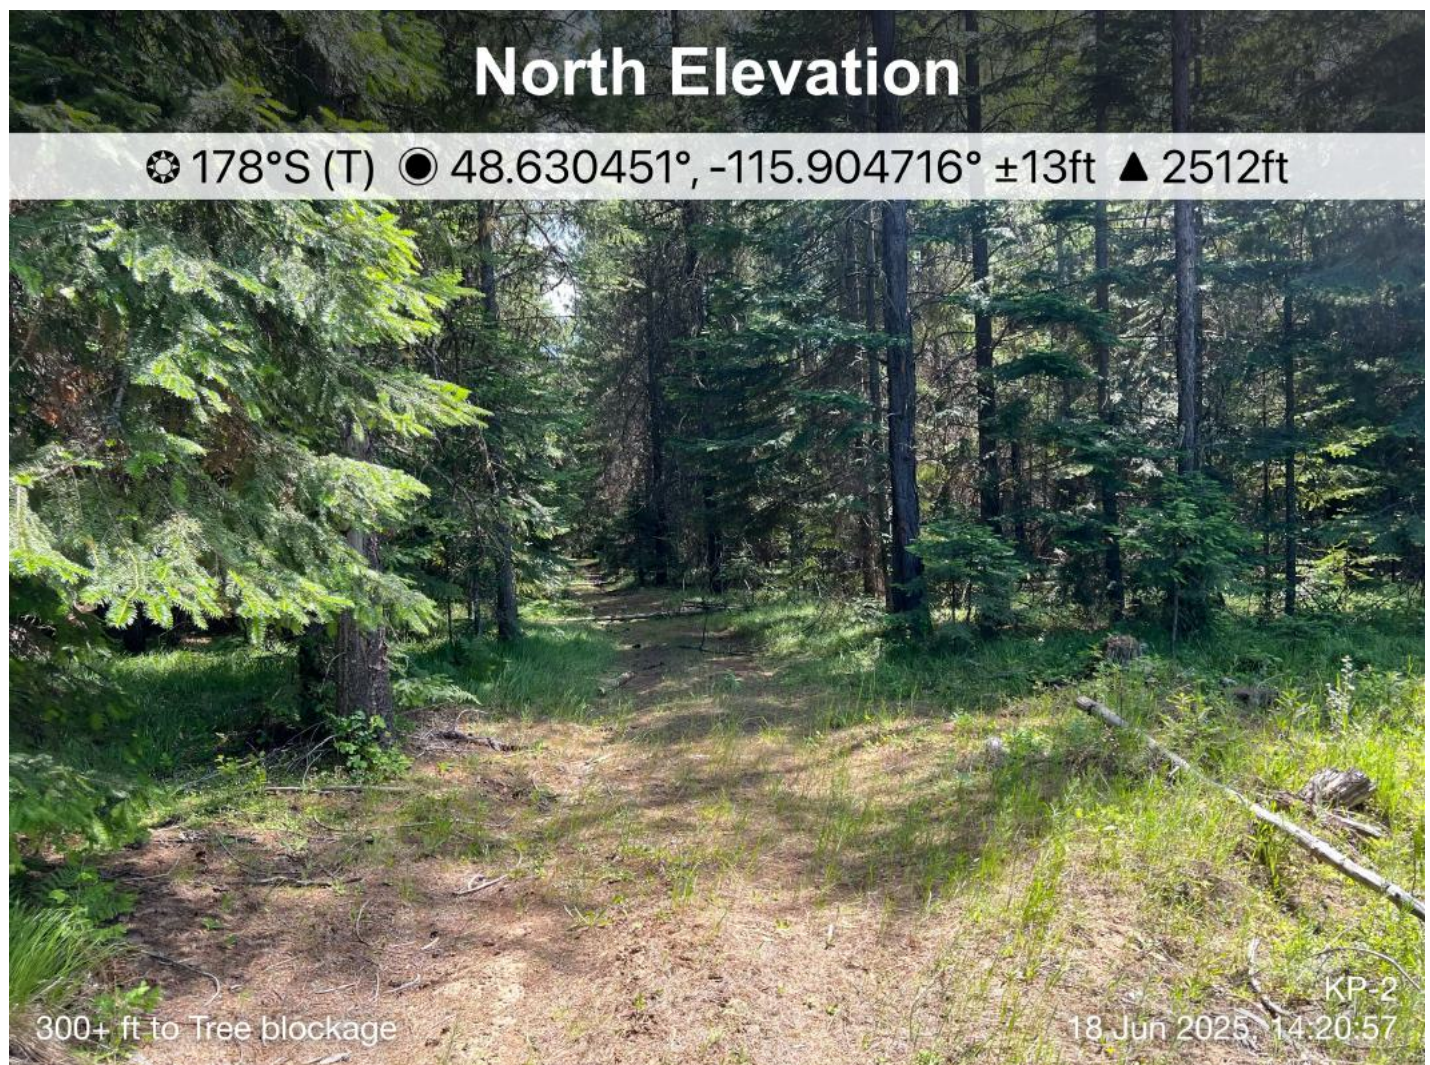
**KP 2- Coordinates: N 48.630451, W -115.904716**

The matrix of roads is ineffectively blocked; neither a berm nor a gate is present. The matrix of roads accessible here is accessible from two points on Hwy 508. See attached map.

The ineffective barrier allows motor vehicle access to approximately\* 1.6 miles of "closed" unmapped road.

Remedy: Effectively gate both access points off of Hwy 508, blocking trespass, boulders and signage.

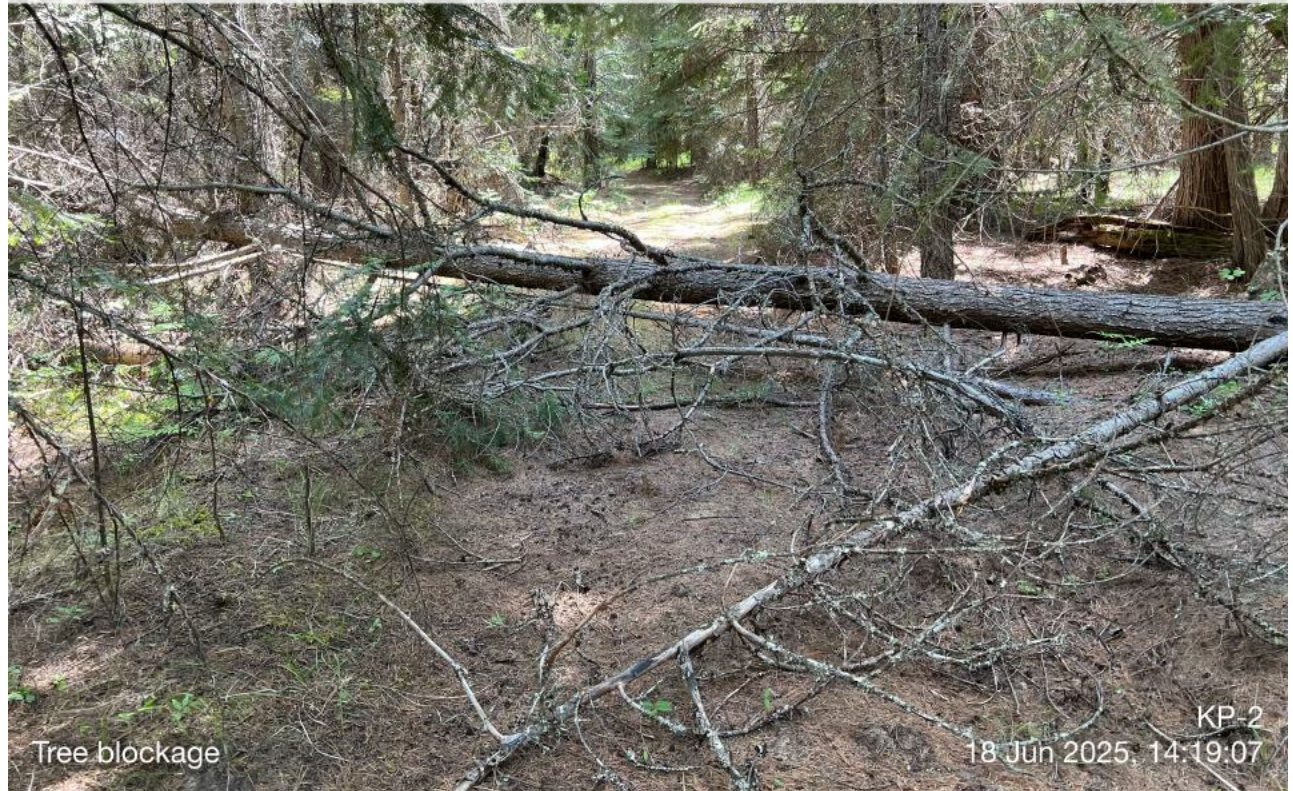
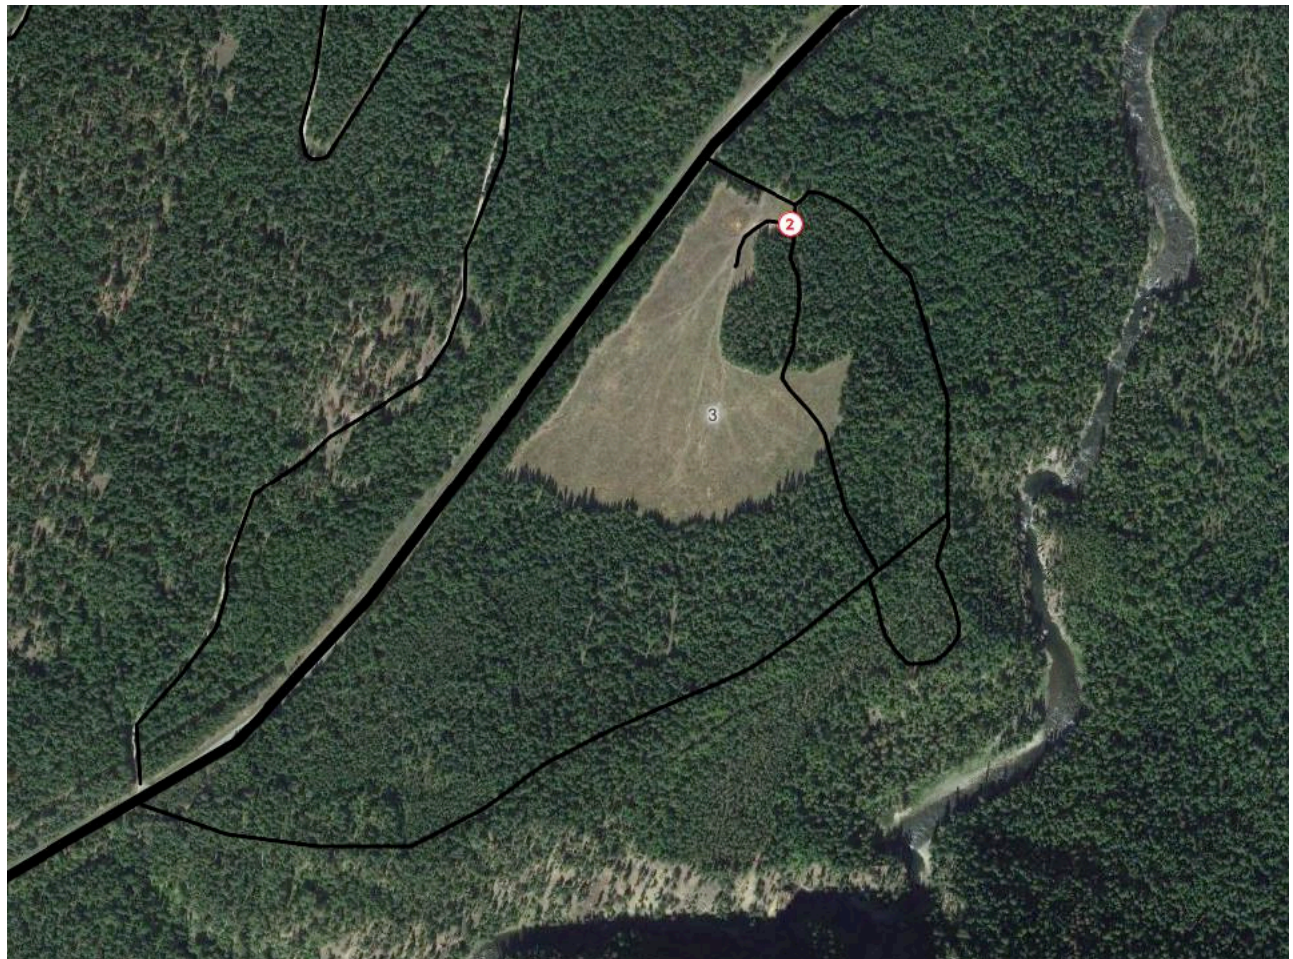
KP-2  
18 Jun 2025, 14:19:07

Tree blockage

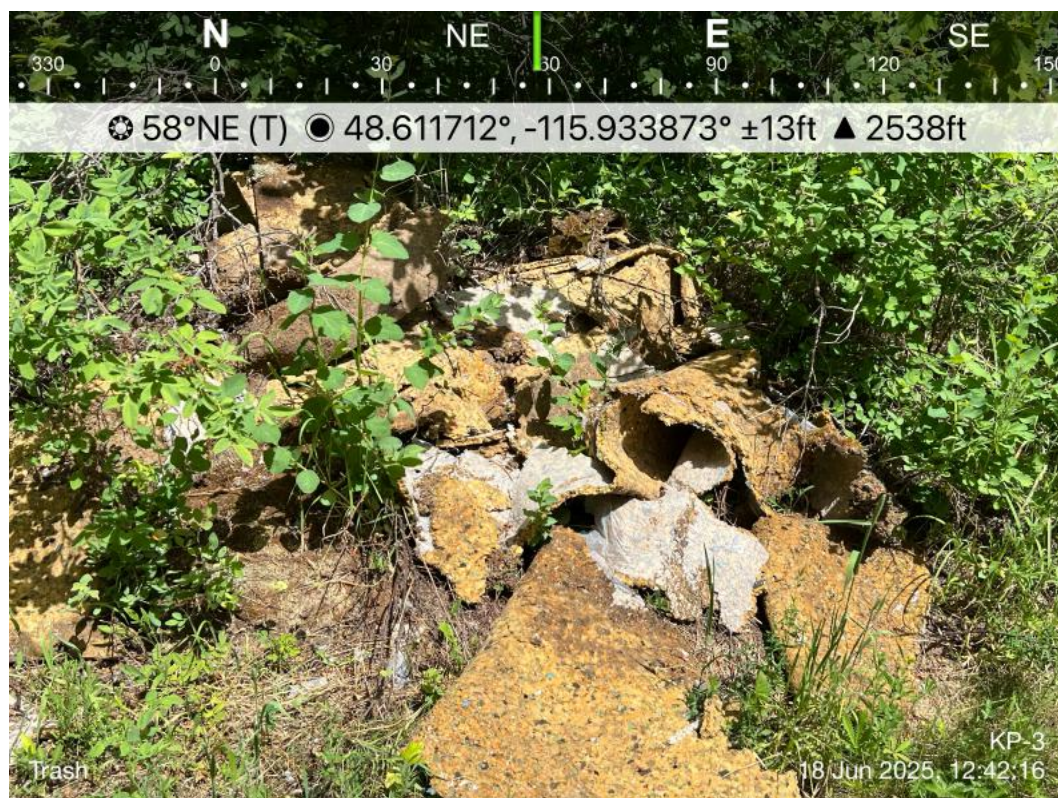
Trash is present on-site from illegal dumping.

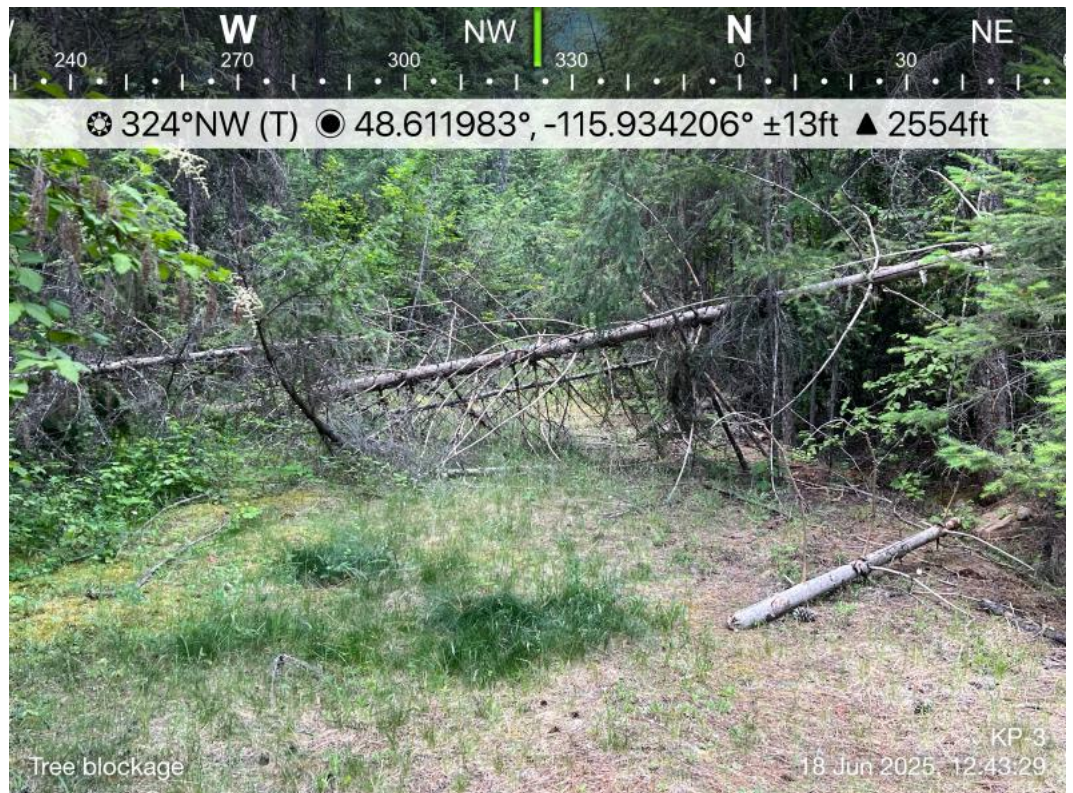
The berm designed to block road access is approximately 300 feet from the road, with an obvious two-track road leading off of Hwy 508 offering access. The forest on the right side of the berm allows bypass of the berm and motor-vehicle access to the “closed” road behind the berm. A user-created bypass begins approximately 60 feet before the berm. The bypass is approximately 10 ft wide and passable by a side-by-side vehicle or truck. The road is navigable behind the barrier, although it is obstructed by a recent tree fall about 300 ft behind the barrier. Truck tracks and rutting were visible and documented. Trash dumping was also present on the site.

The road is blocked over 300 feet from the main road access.

Remedy: Effectively gate access point off of Hwy 508, blocking trespass, boulders, and signage.

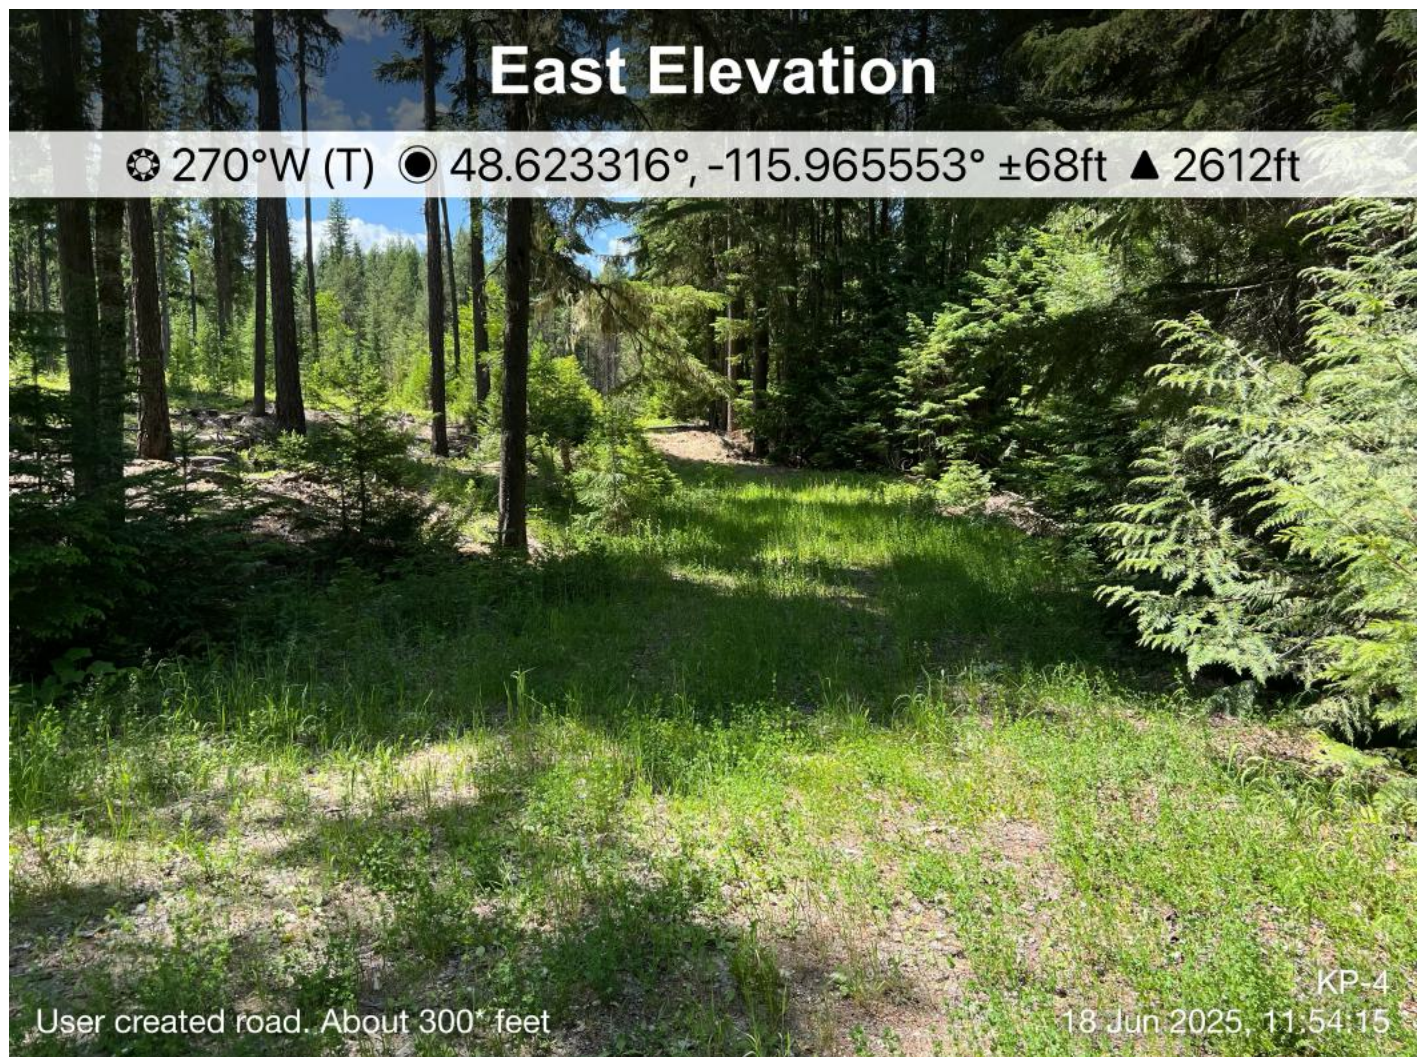
**KP 4- Coordinates: N 48.623316, W -115.965553**

In 2025, the road shows evidence of recent excavation work that created a tank trap, making the road impassable to four-wheeled traffic. It is, however, passable by a two-wheeled motorized vehicle.

Weathering will reduce its effectiveness.

The ineffective barrier allows motor vehicle access to approximately\* 2.95 miles of “closed” road, and connects through these “closed” roads to many more miles of open road.

Remedy: Deeper tank trap, boulders, or locked gate.

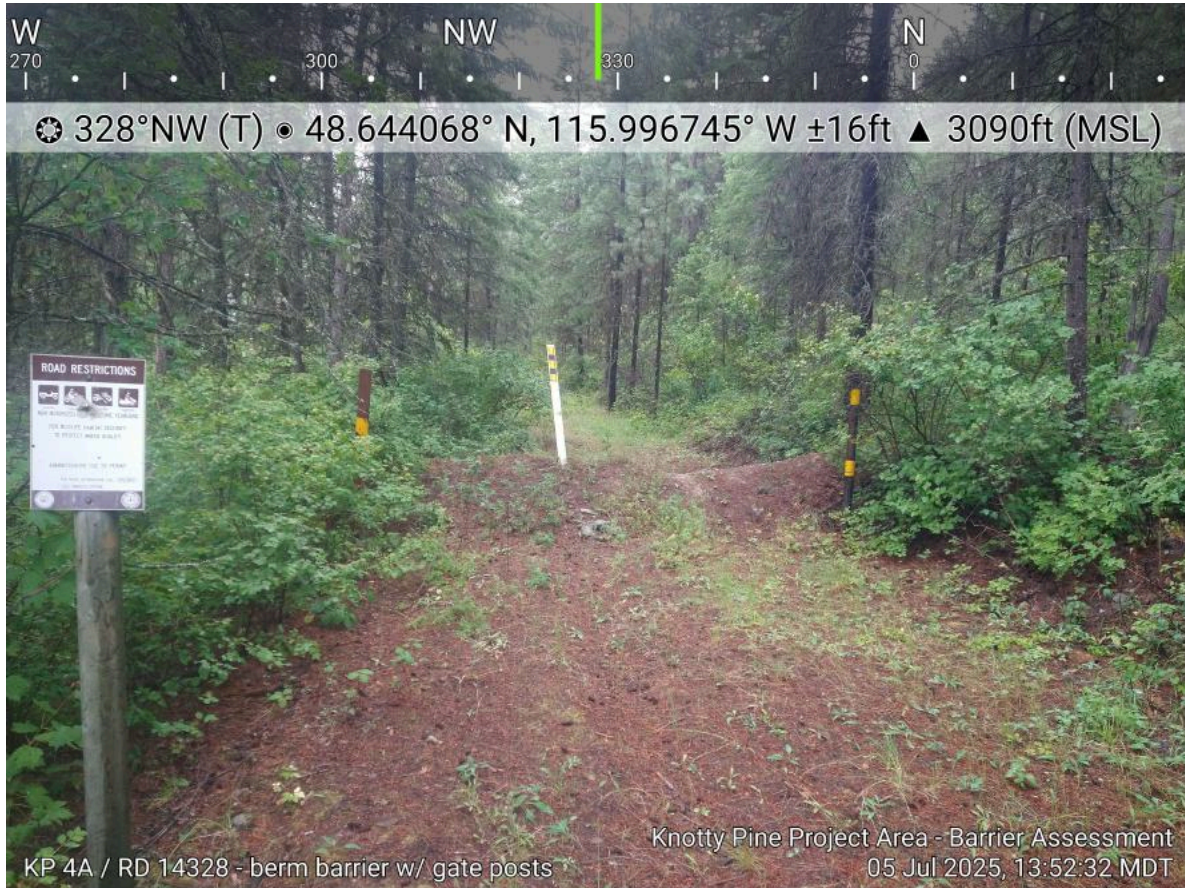
## KP 4A

Berm/ditch (tank trap) barrier present. The barrier has been traveled to the point of losing its effectiveness. The road is accessible for four-wheeler or dirt bike, so ineffective at blocking MV access. Signage present, ineffective.

The road connects in a matrix of roads exceeding 5 miles.\*

Remedy: Additional berm-boulders, signage

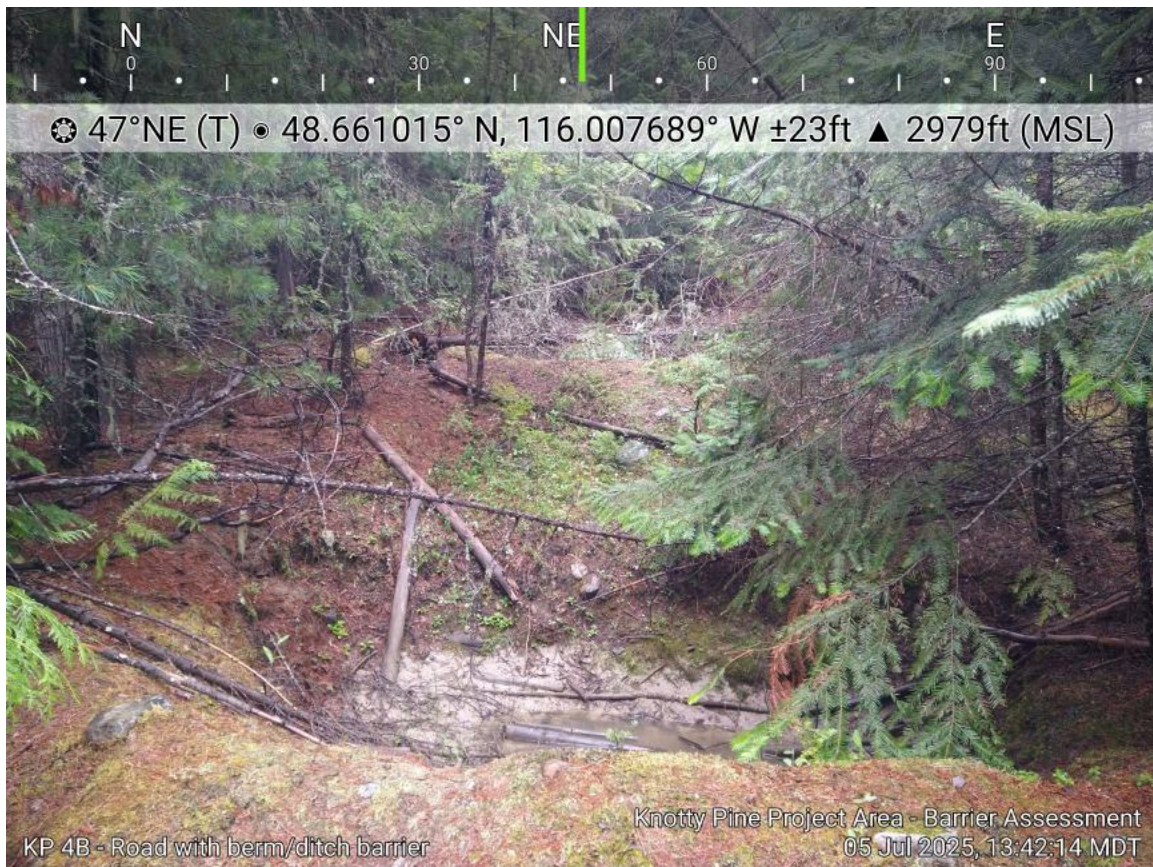
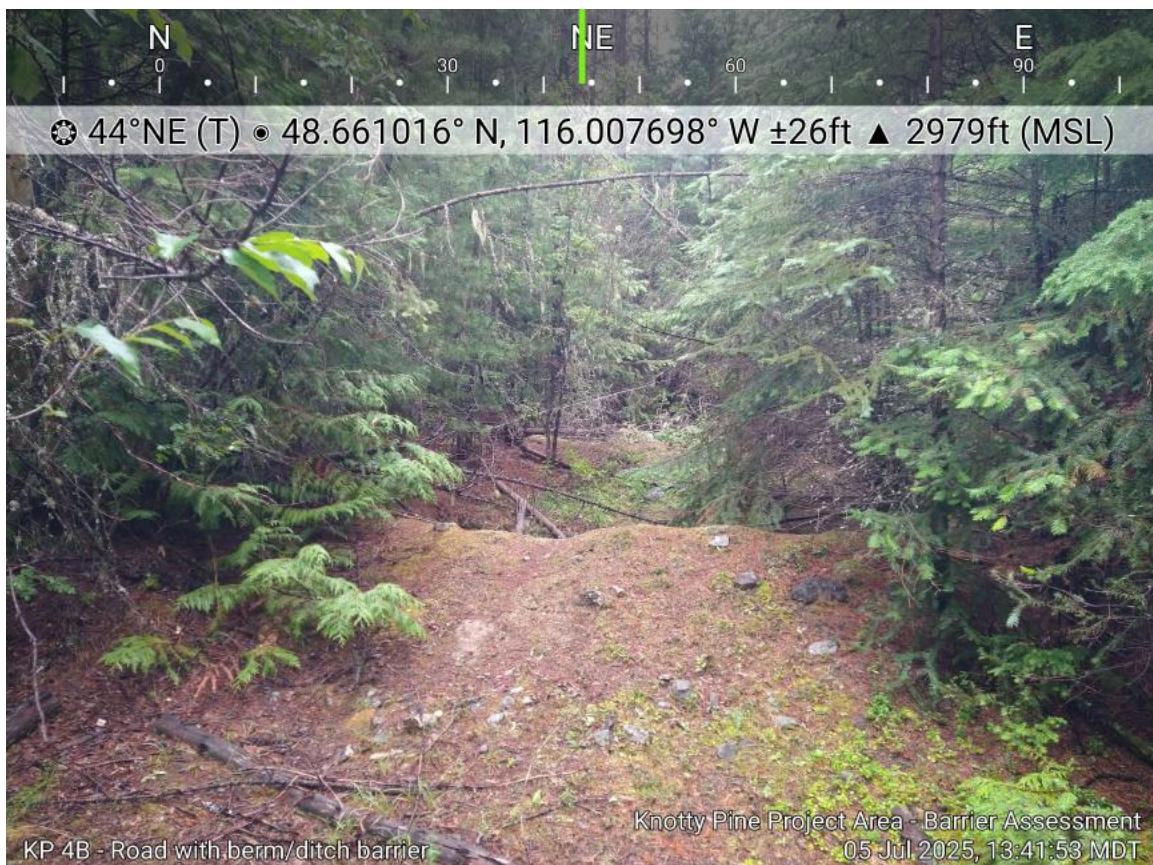
#### 4B-Blocked road with berm ditch barrier

The effectiveness of this barrier is negated by the ineffectiveness of barriers 4, 4A and 4C.

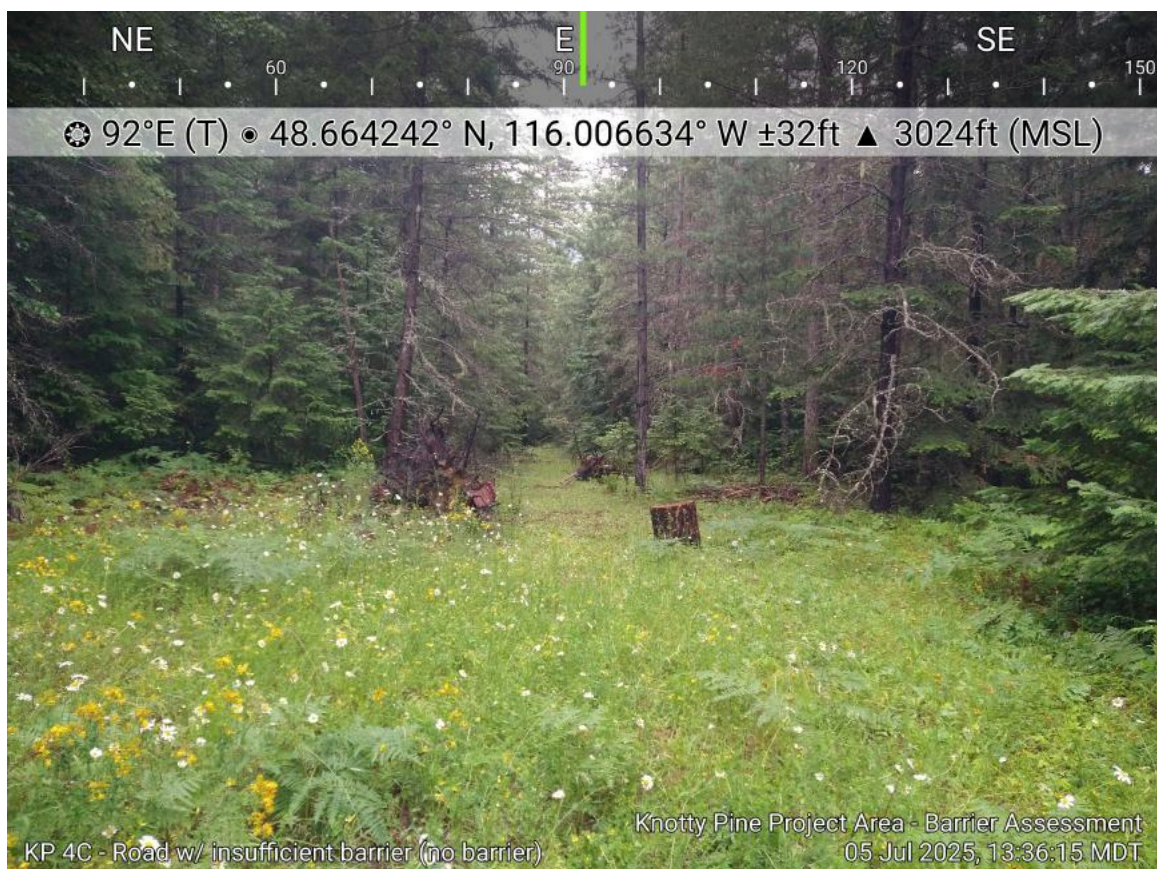
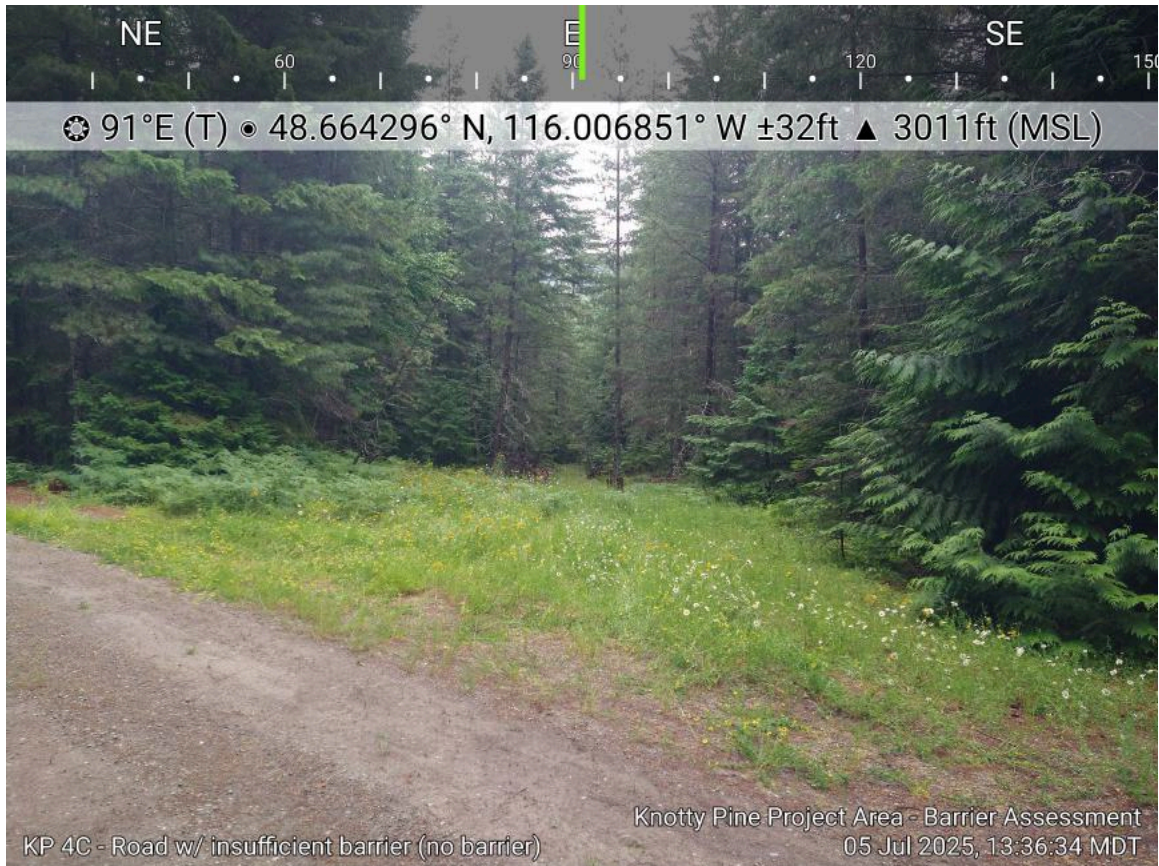
4C

Road with no barrier

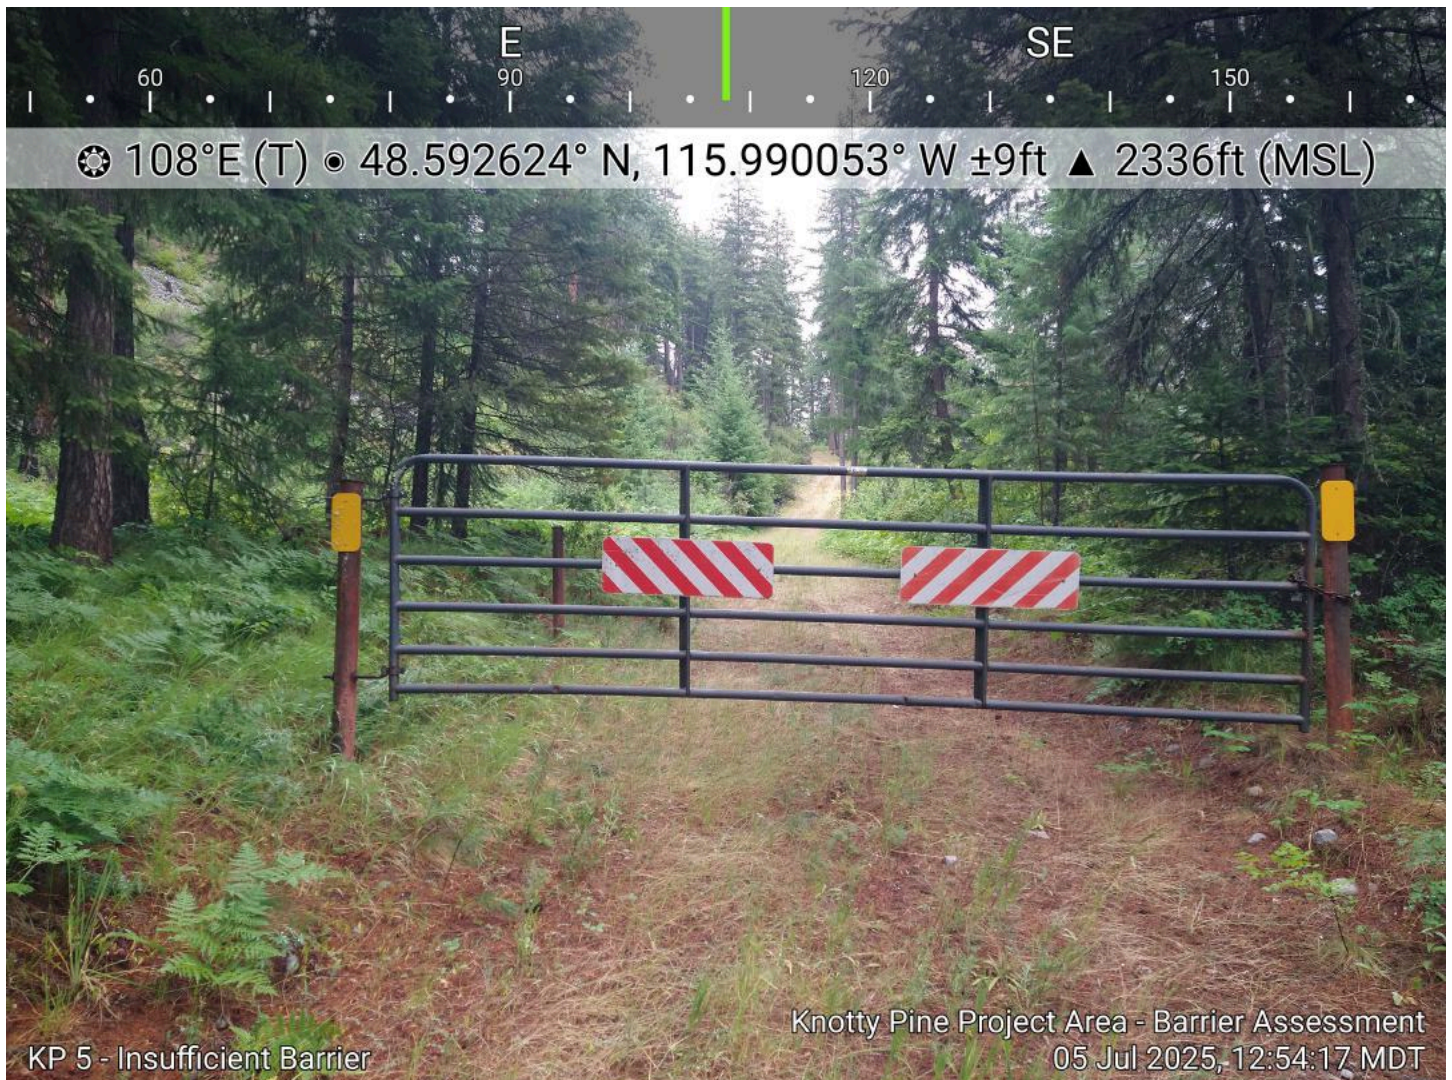
**KP 5- Coordinates: N 48.592669, W -115.99014**

Gated barrier with three clear detours around it. A motor-vehicle bypass begins 15 feet before the gate barrier on the left. Tire tracks, rutting, and destroyed vegetation show evidence of access. This route gains access behind the gate by the nearby power-line clear cut. It measures approximately 126 feet long. There is also a 13-foot gap directly to the left of the gate, offering an easy route around, though it shows minimal signs of MV use. The third route around the barrier leads to a closed road 150 feet behind the gate on the right, with trees and vegetation cleared. This route shows clear signs of motor vehicle use. In 2019, two YVFC field crew members observed illegal MV passage at this site and reported it to the 1-800-tip-mont hotline. (more pictures available of site)

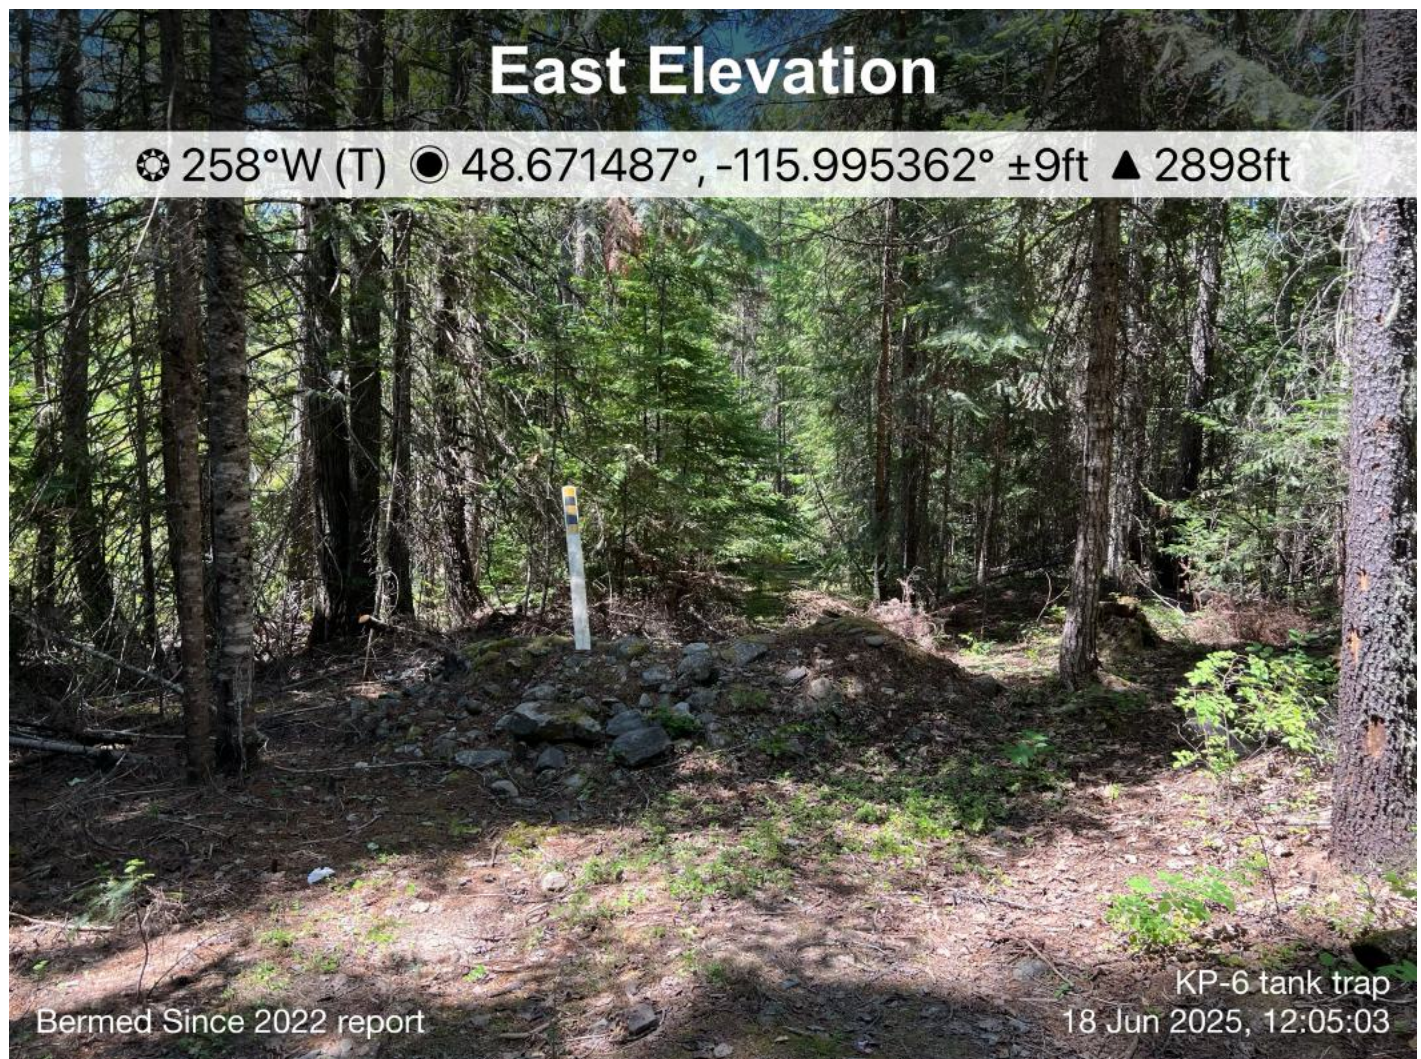
**KP 6- Coordinates: N 48.671487, W -115.995362**

The barrier has been remediated with a berm since 2022. The barrier is currently effective at blocking four-wheel, two-axle traffic. The berm is permeable to 2-wheel traffic (see photos). In 2022, the trail was open with no barrier with ample room for illegal motor vehicle access. Tracks and rutting were present along the lower stretch of the trail. Access distance was in excess of the dispersed camping rule. There was also evidence of illegal firewood gathering in the floodplain, with wood rounds and log segments left in the stream.

Trail access extends well over\* 50 miles into core grizzly habitat.

Remedy: Needs an effective barrier and “no motorized access” signage. Due to the surrounding landscape, a gate would be effective here, or at a minimum, boulders.

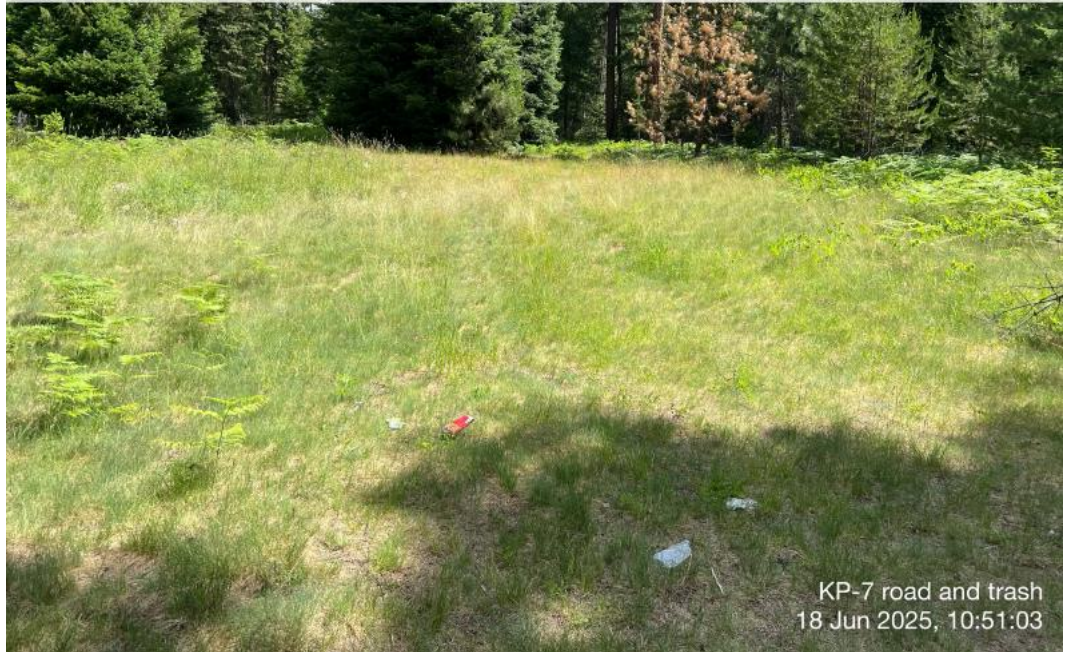
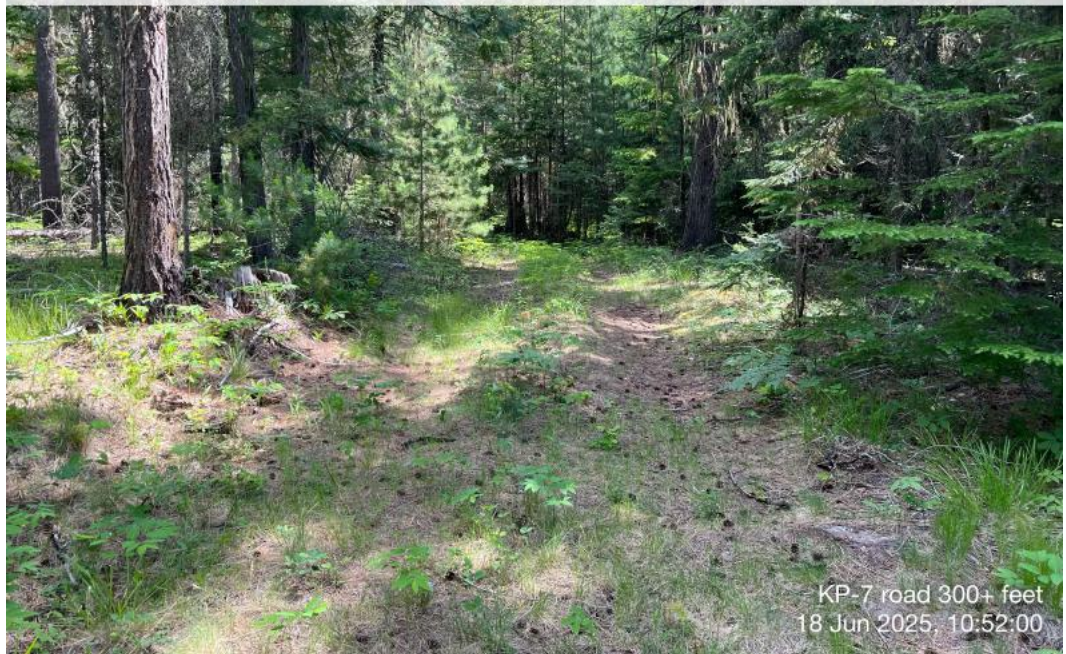
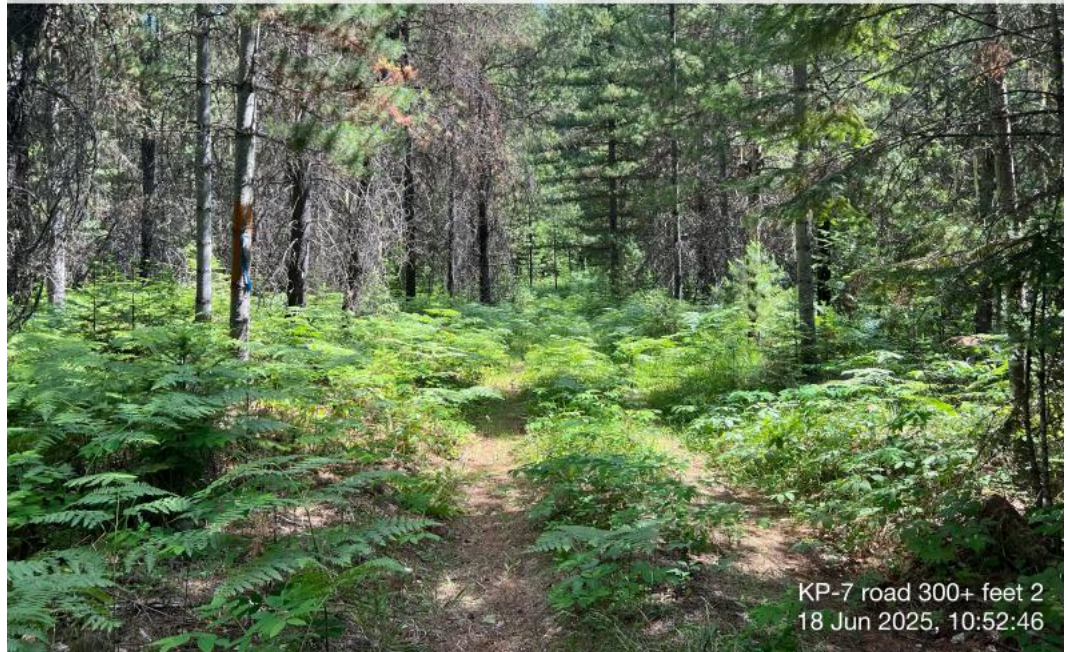
KP-7 road and trash  
18 Jun 2025, 10:51:03

The site appears to be user-created and is open access to a meadow from the main road. Two roads exceeding 300 feet leave the meadow and enter core grizzly habitat, with no barriers present. Litter present is evidence of trespass.

KP-7 road 300+ feet  
18 Jun 2025, 10:52:00

Remedy: Berm, gate and/or boulders, this is currently open access.

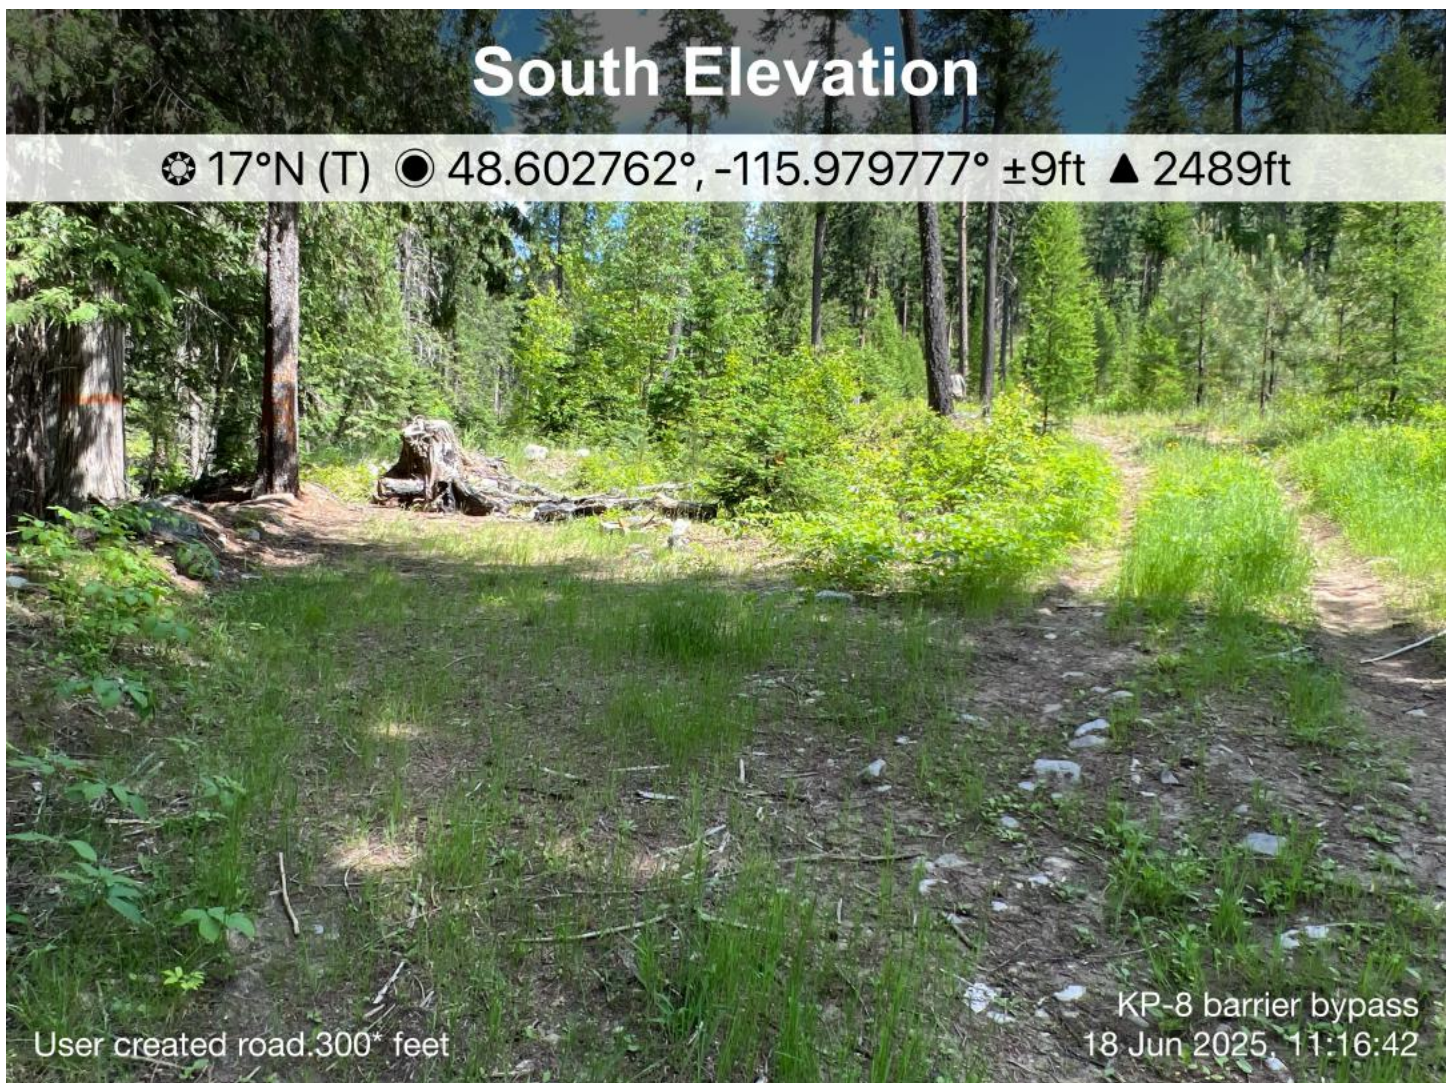
The road to the right extends approximately\* 1.5 miles into core grizzly bear habitat.

The barrier blocking the road is comprised a berm, a root ball, and stacked timber.

Remedy: Additional berm / signage

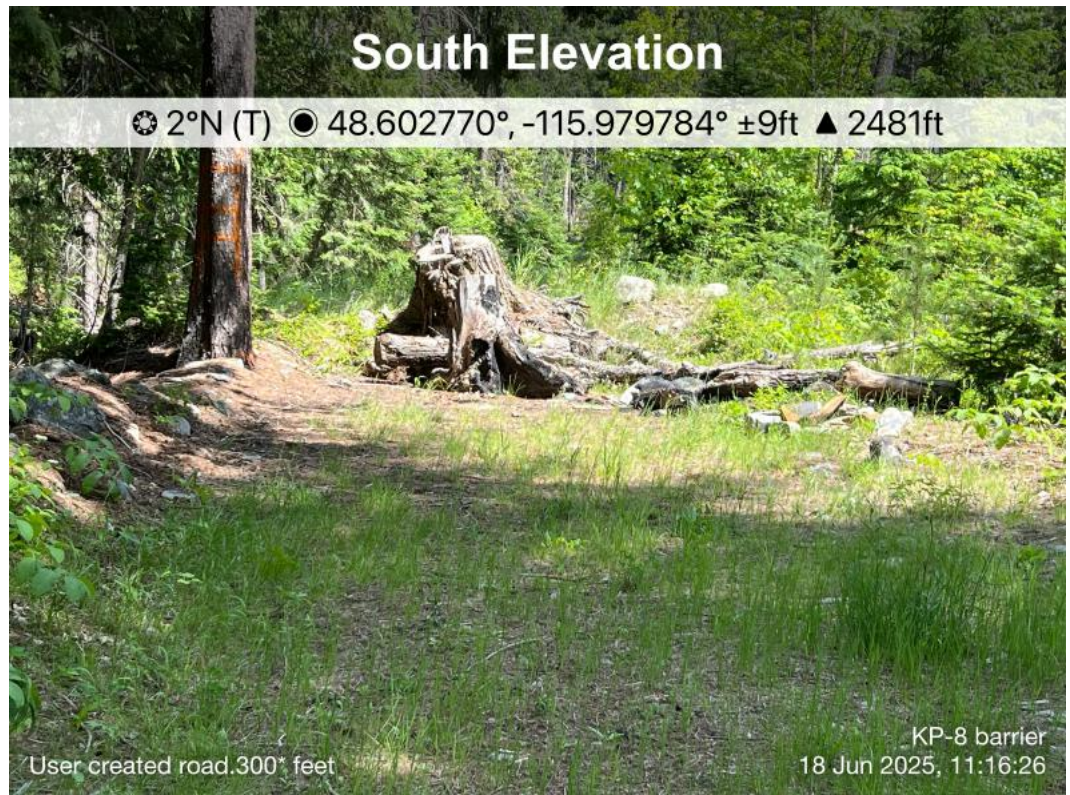
The barrier is pictured below, left, a berm with a root ball and logs. The barrier is easily bypassed by motor vehicles on the road to the right. The bypass begins about 30' before berm.
